March 3, 2014

Re: 2013 Tower City Bridge Inspections and Maintenance Recommendations

## Inspection Photos

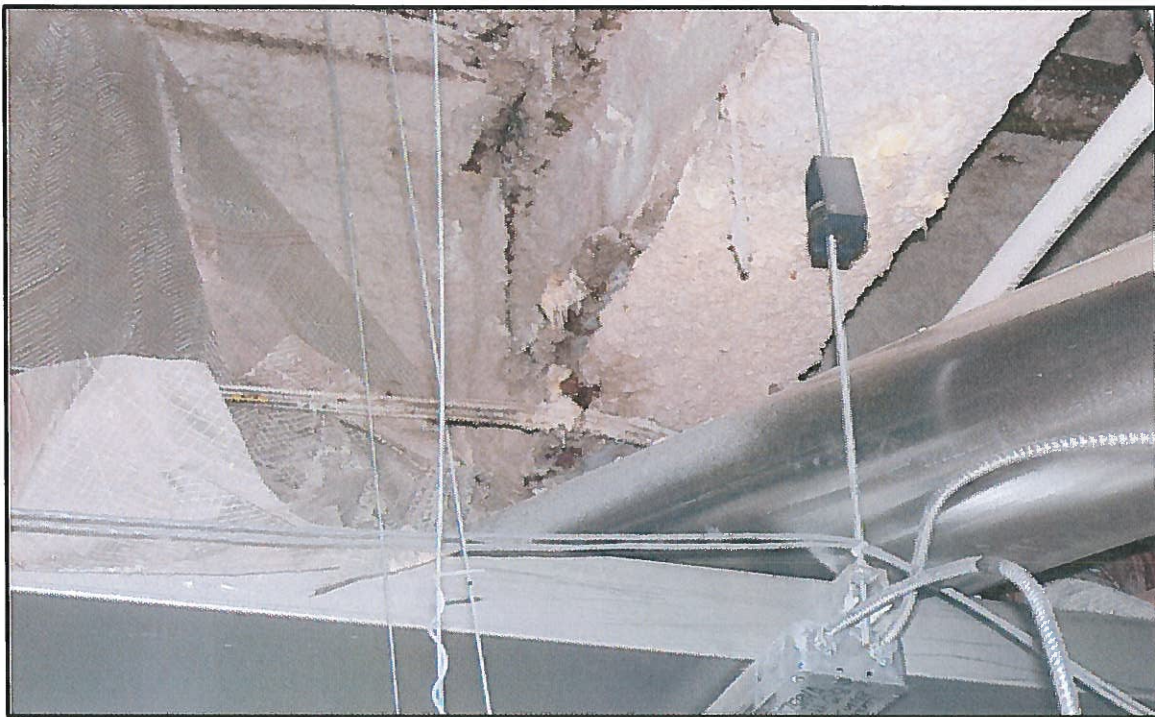
Photo 1 – Active leak in Unit 24, showing typical signs of minor beam corrosion at active leaks

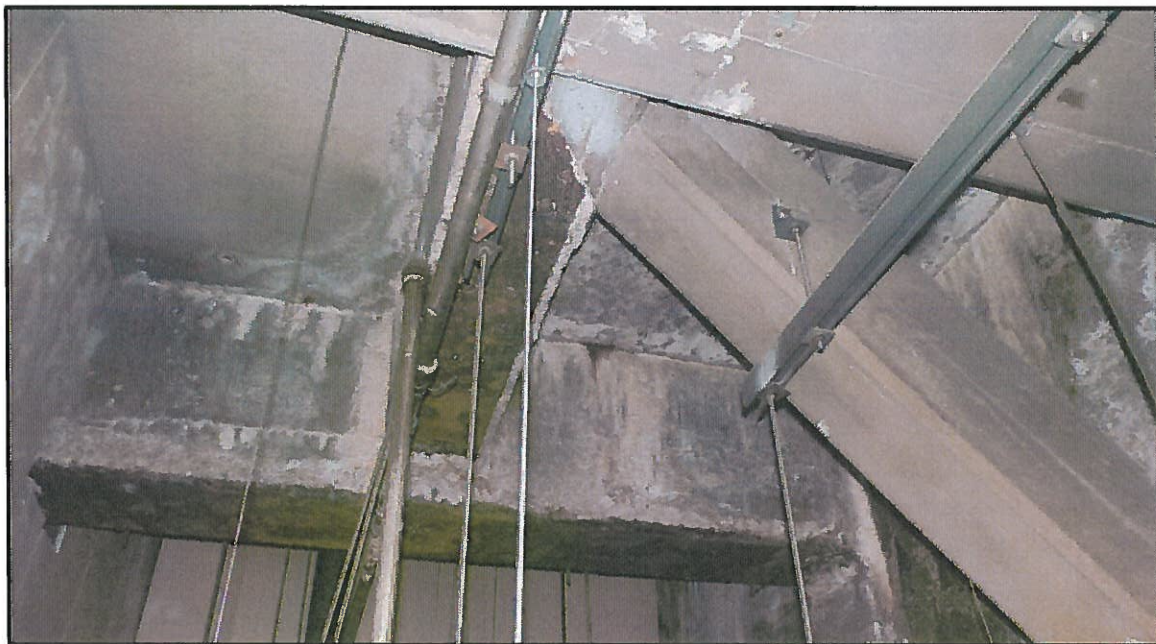
Photo 2 – Active leak in Unit 6, showing typical beam corrosion after removal of fireproofing concrete

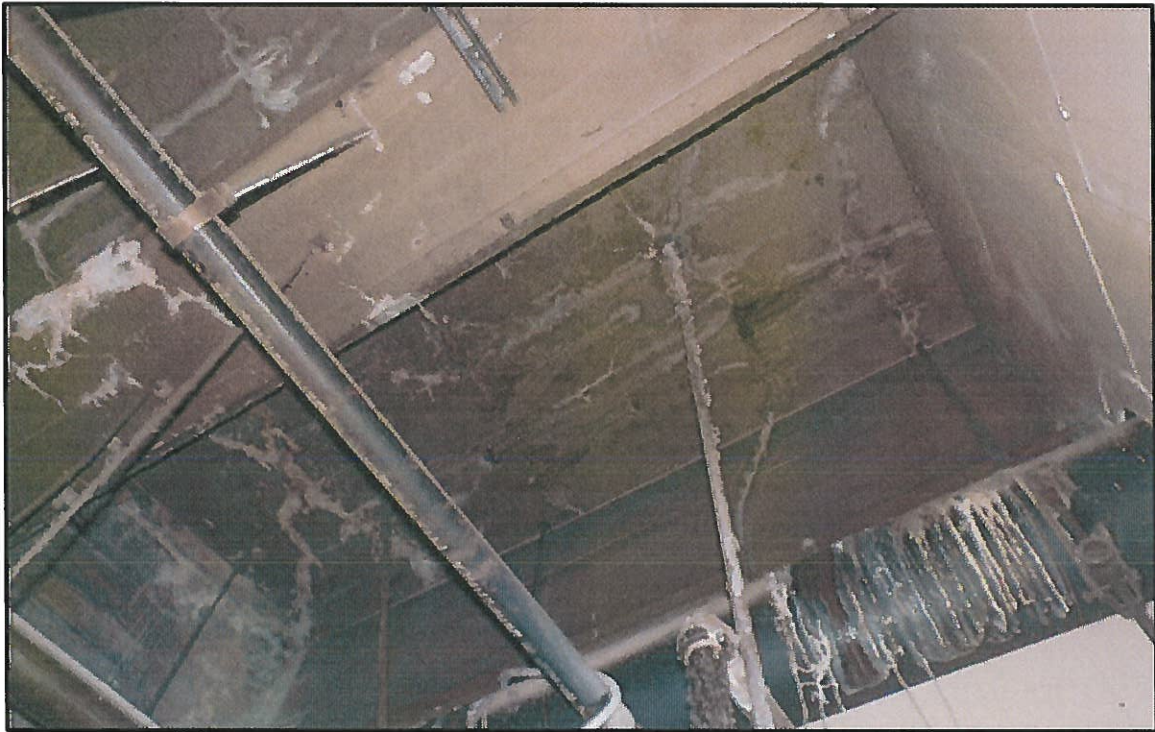
Photo 3 – Active Leak in Unit 26, showing typical map cracking in deficient deck locations

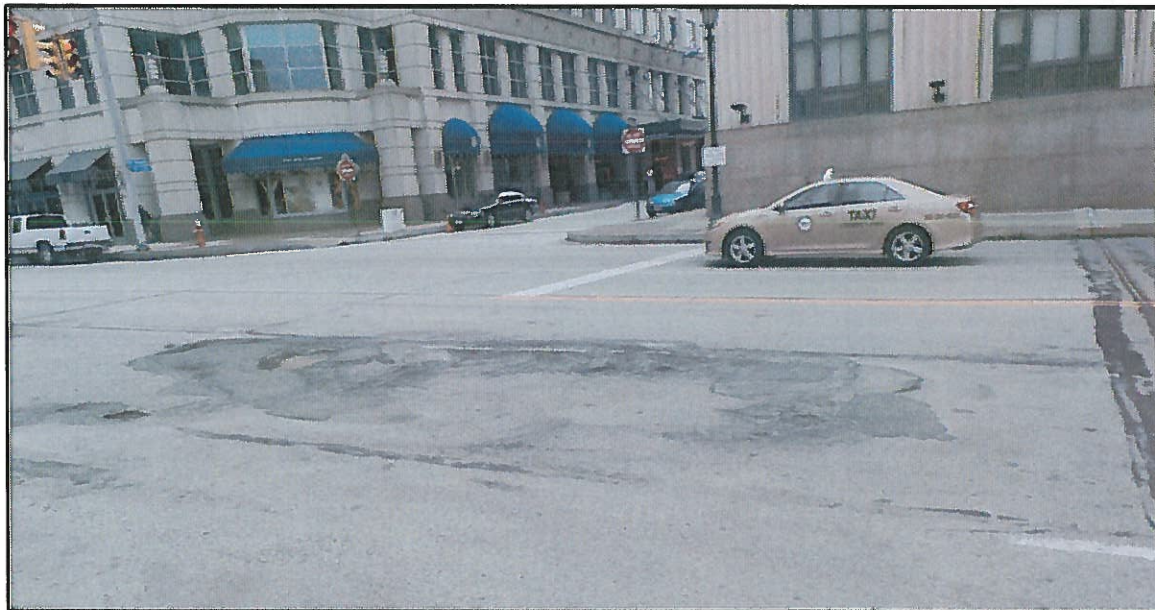
Photo 4 – Deficient asphalt wearing surface in the westbound lanes of Prospect Avenue in Unit 5

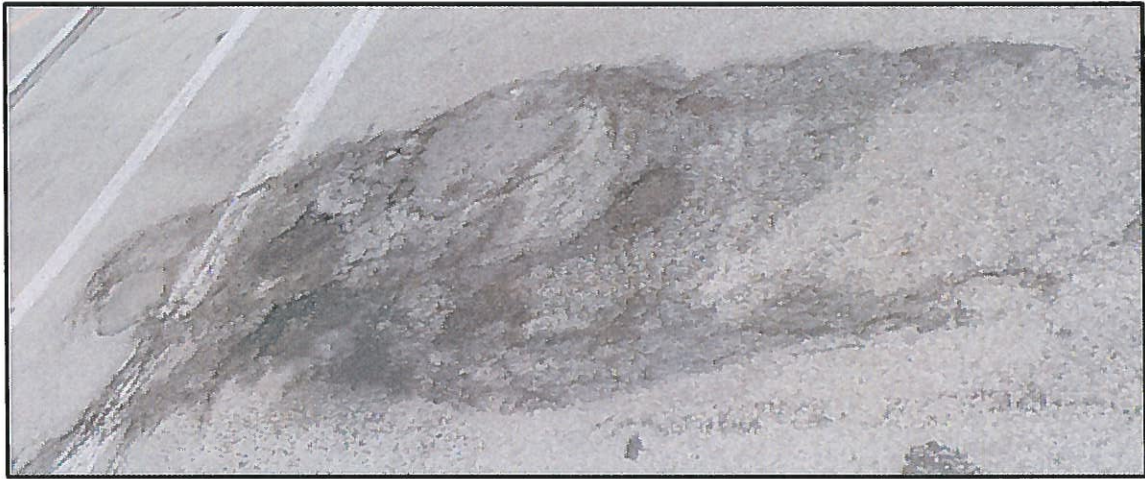
Photo 5 – Deficient asphalt wearing surface in the westbound lanes of Prospect Avenue in Unit 5

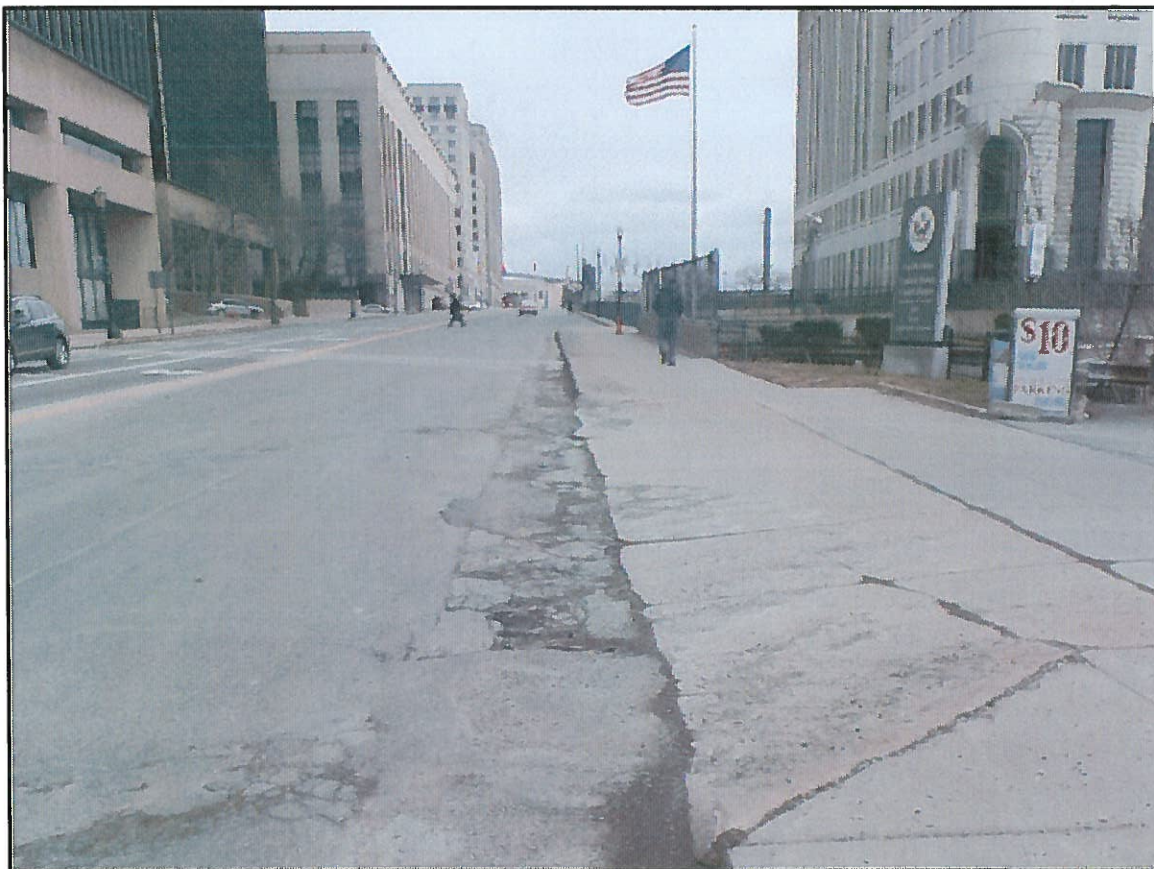
Photo 6 – Deficient asphalt wearing surface in the eastbound lanes of Prospect Avenue in Units 14 & 15

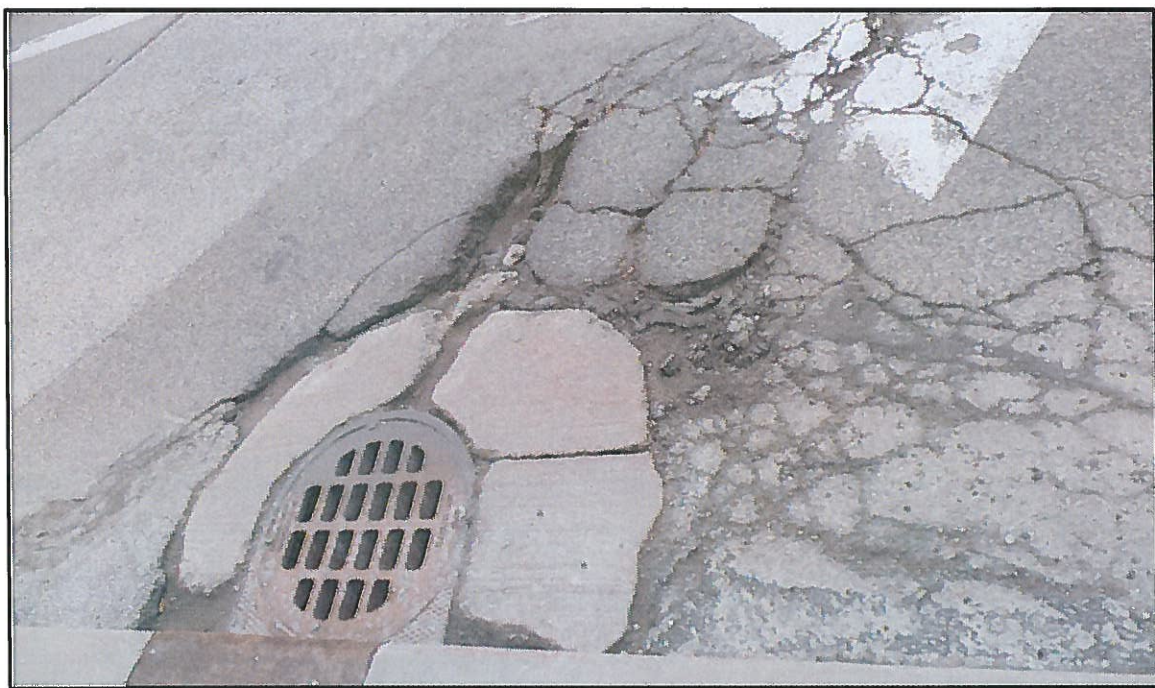
Photo 7 – Deficient asphalt wearing surface and settled catch basin in the westbound lanes of Prospect Avenue in Unit 14

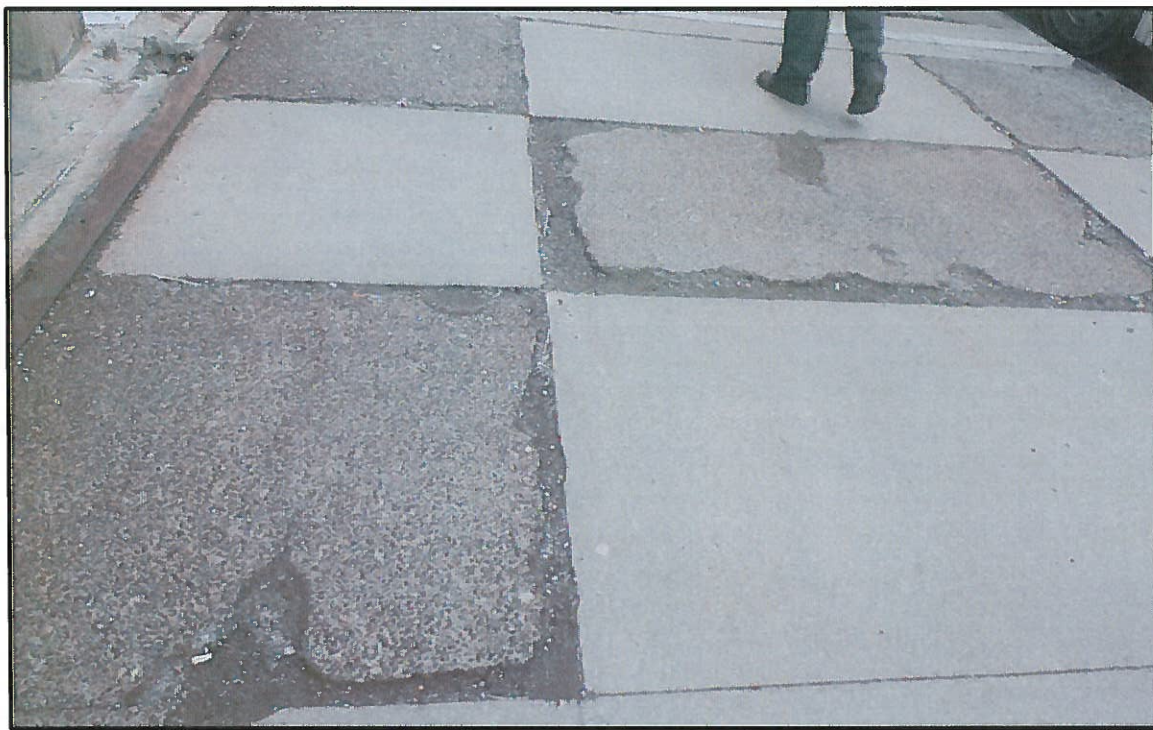
Photo 8 – Typical deficient decorative aggregate sidewalk panels

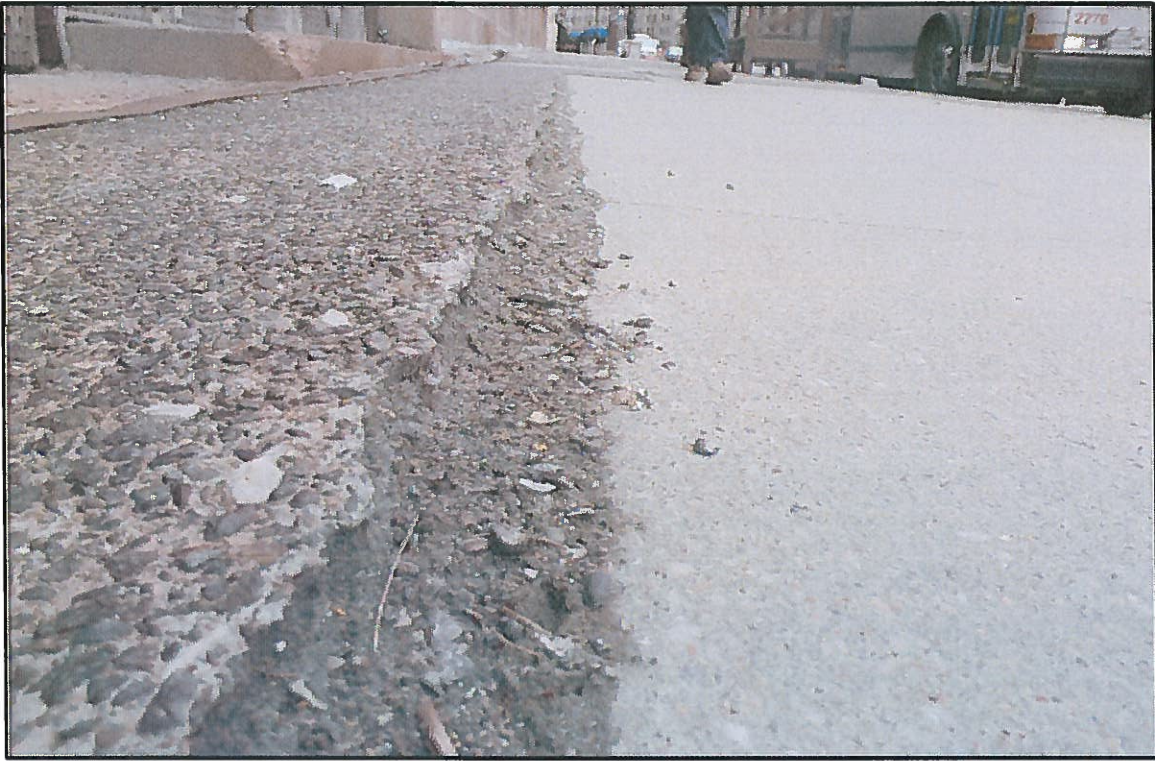
Photo 8 - Typical growth of decorative aggregate sidewalk panels

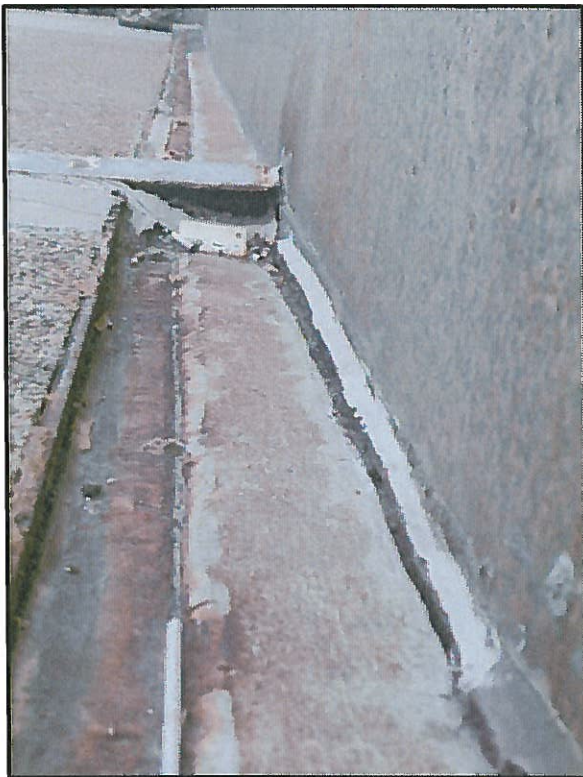
- There are spalls in the concrete along the joint armor.
- At the building joint along the M. K. Ferguson Building, the sidewalk is up to 2" higher than the joint leading to popped up and separated joint armor plates, the worst sections are on the western ½ of the north joint.

Photo 9 - Settling of the north building joint along the M. K. Fergusson Building.

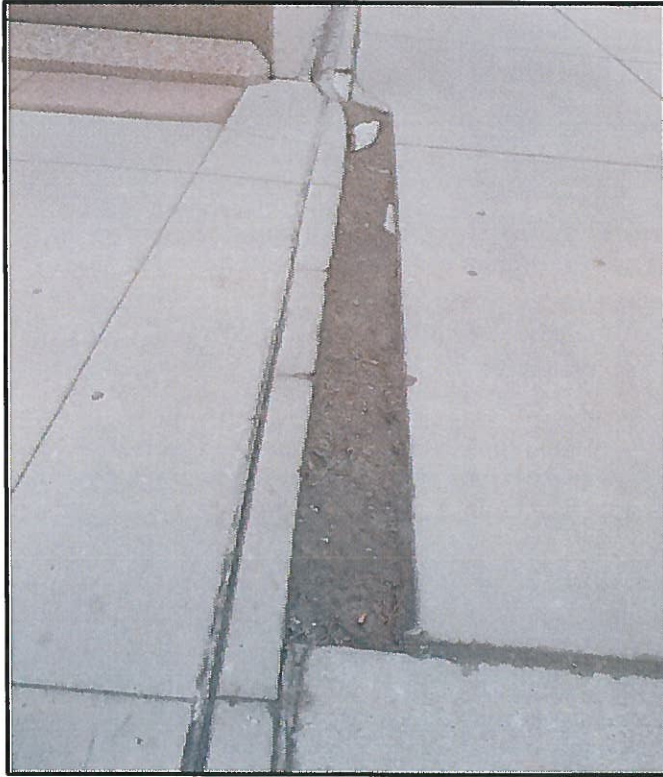
Photo 10 - Missing concrete  
along the building joint at the  
south side of Unit 1

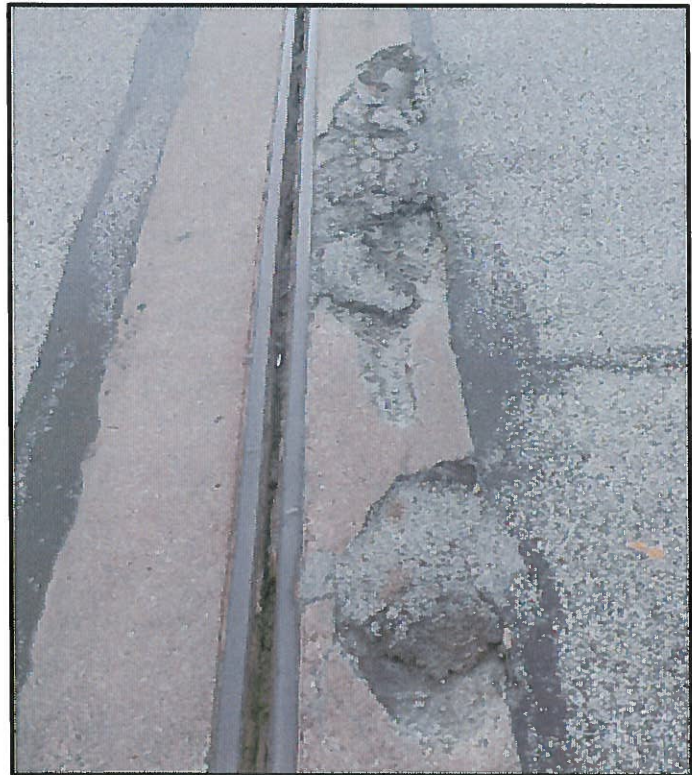
Photo 11 - Typical fractured  
concrete at the roadway  
expansion joints

Many expansion joint leaks have been sealed with a poured sealant. This maintenance generally works as a short-term repair; however several of these repairs have broken. Additionally the concrete surrounding the expansion joints is broken in many locations. Considering the age and performance of the expansion joints and the inability to replace the joint gland, replacement of all deck expansion joints is recommended.

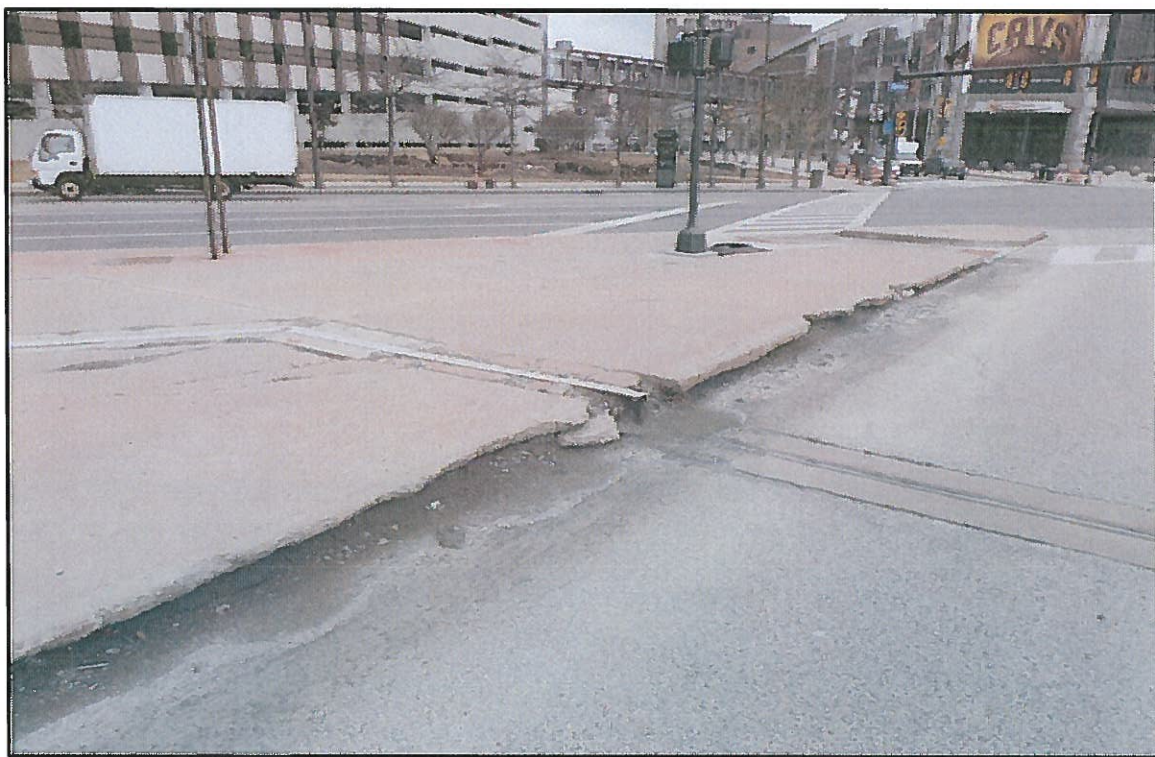
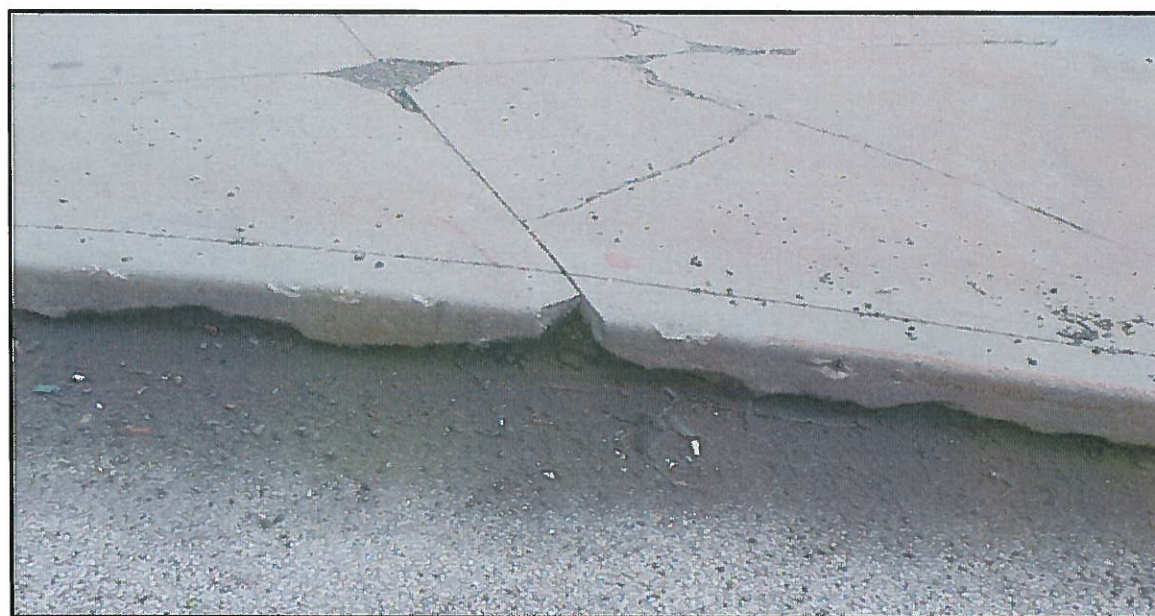
Photos 12 & 13 – Severely undercut curbs at the concrete island at the east end of Huron Ave.

The curbs are cracked, spalled and undercut in some locations, especially on the traffic island in Unit 31.

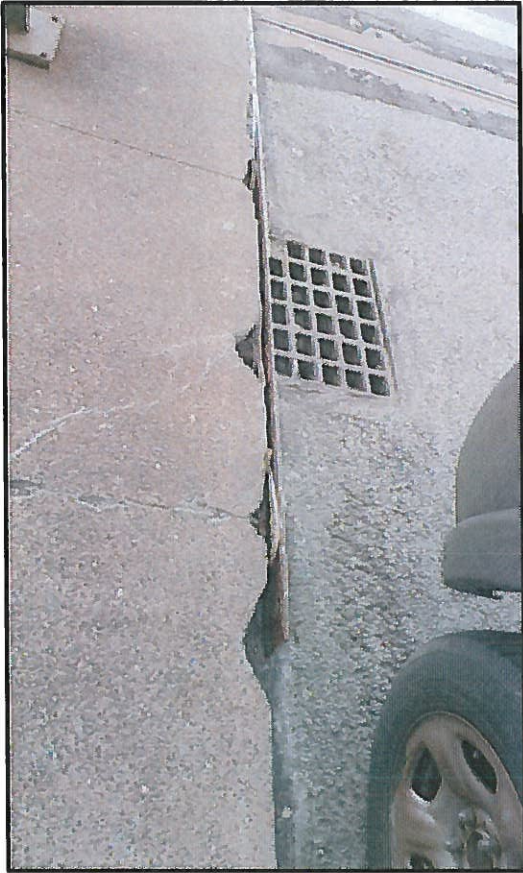
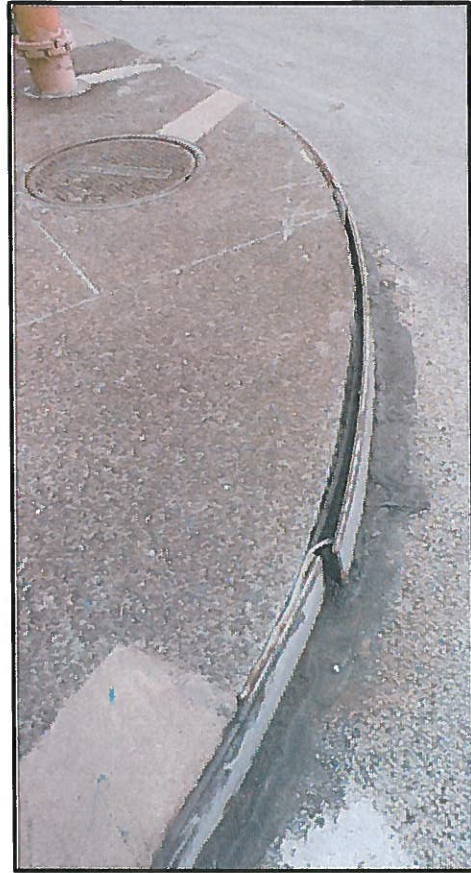
Photos 14 & 15 - Typical loose and missing curb plates

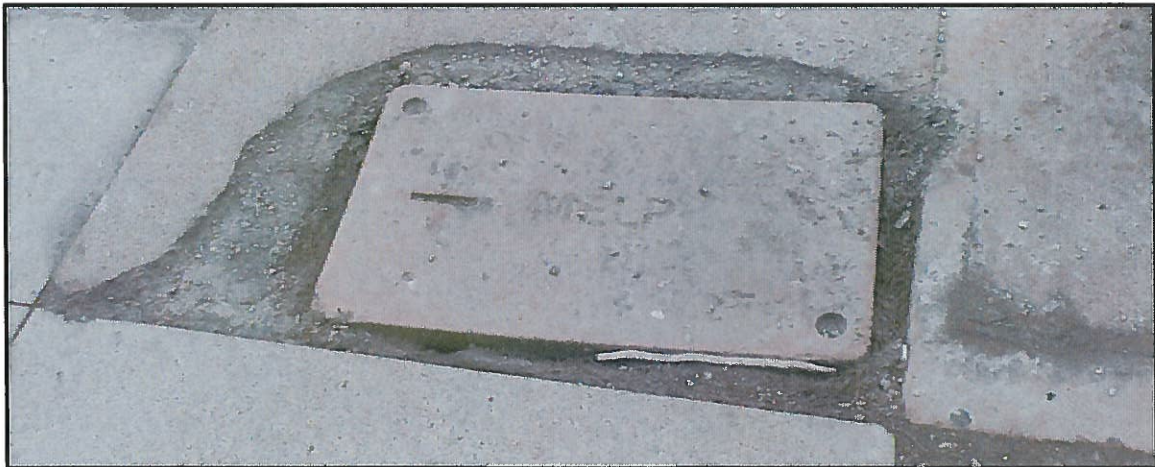
- The sealing caulk around the pullboxes in the sidewalk has been removed. This provides a direct avenue for water infiltration.

Photo 16 - Typical pull box with missing caulk sealer
