Asbestos Demolition Survey Report

ODOT District 6

**DEL-US36-18.79
8579 State Route 37
Sunbury, Ohio**

December 20, 2022

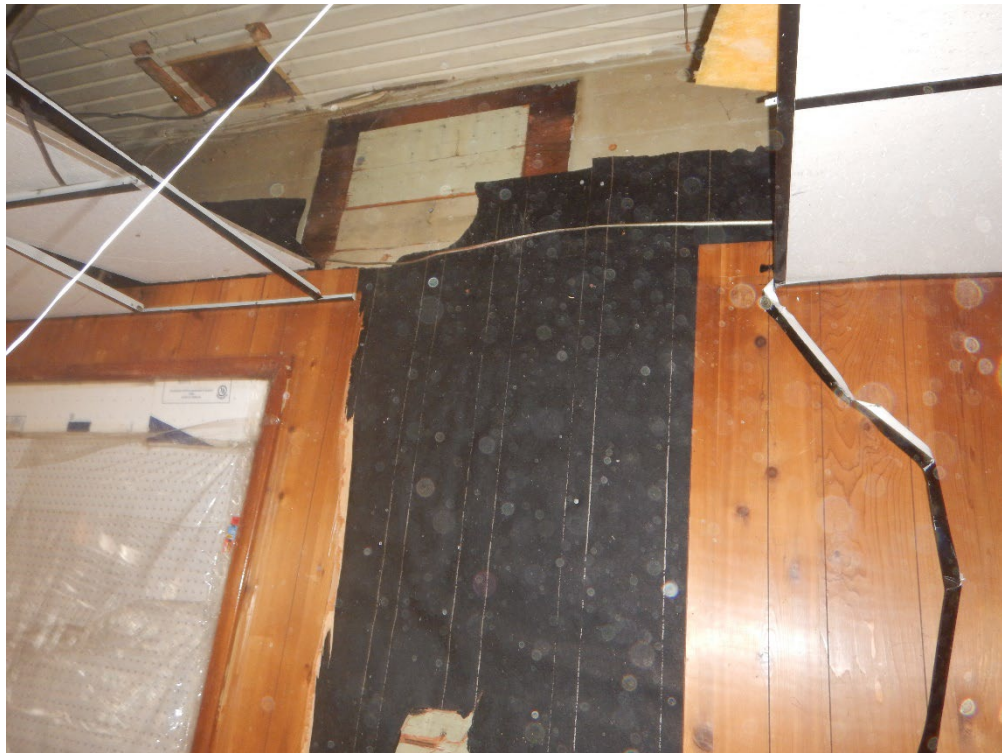
Photo 1:

HA-3
Black paper found walls
under a top layer of laminate
wood paneling.

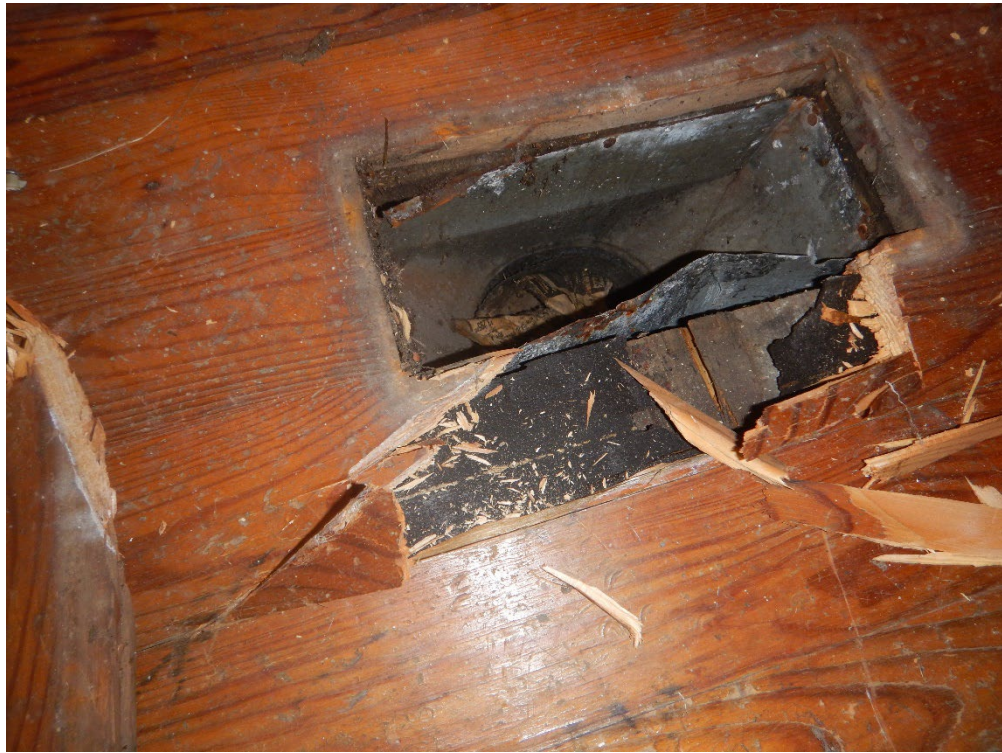
Photo 2:

HA-2
Black paper found as second
layer of flooring under
hardwood top layer.

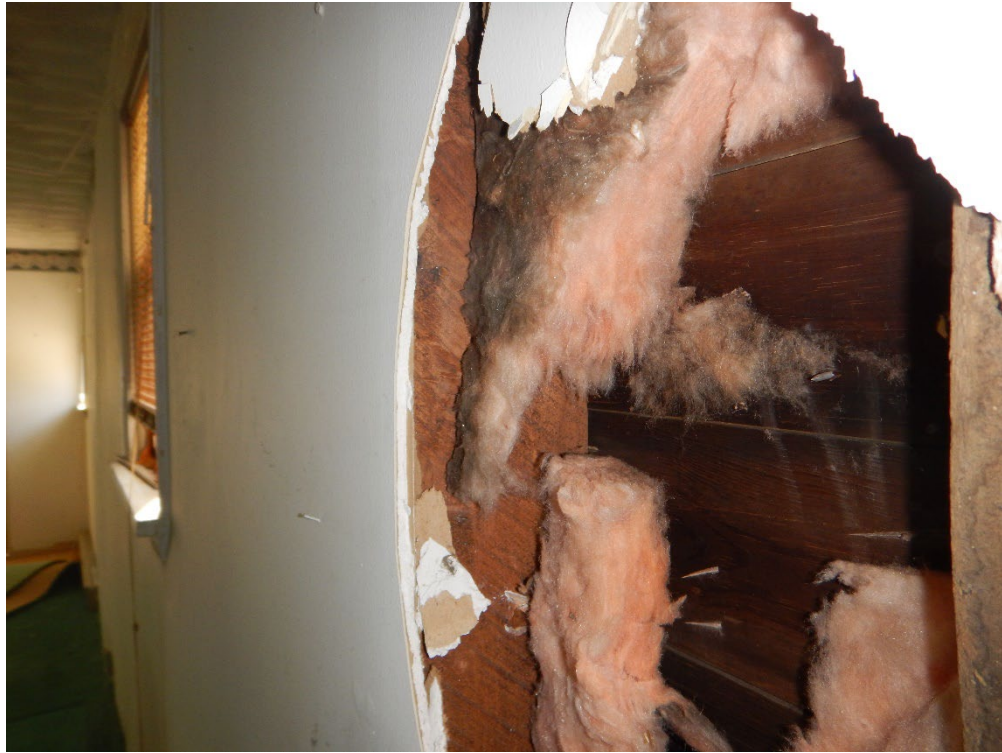
Photo 3:

- Homogenous Area (HA) – 4: Drywall with joint compound found on the walls of both the first and second floors of the structure. This material contains 3% chrysotile asbestos. There is approximately 1,760 square feet of this material within the structure.
- Homogenous Area (HA) – 5: Skim coat found on the ceiling of the second floor of the structure only. This material contains 3% chrysotile asbestos. There is approximately 880 square feet of this material within the structure.

HA-4
Drywall with joint compound
found on walls of first and
second floor of the structure.

Laboratory analysis indicated that all of the other samples collected of suspect material were not asbestos containing. All ACM material should be disposed of in an approved EPA facility.

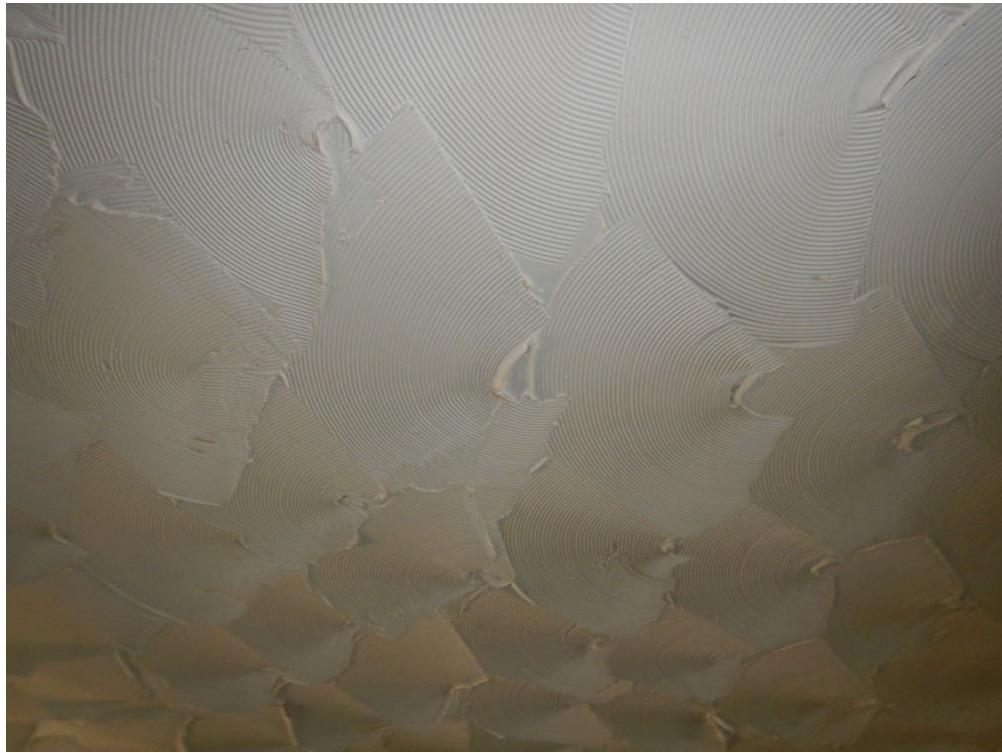
Photo 4:

HA-5
Textured skim coat on ceiling
of second floor of structure.
