Pavement & Core Photo Log

Roadway Project

FRA-70-0.00 PID 116949 NEAS Project No.: 23-0028

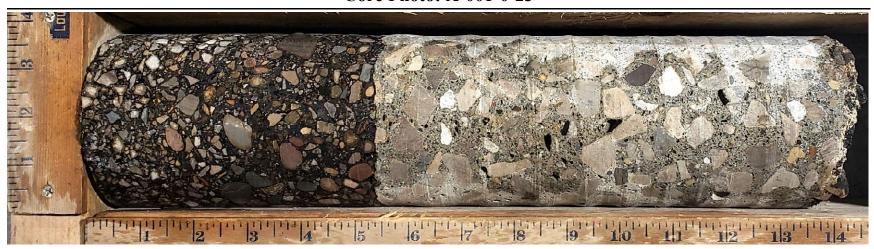
Core Photo: X-001-0-23

Core Information					
Core	e Diameter (i	in):	3	.75	
Core	Total Length	(in):	1	17	
Layers	Core Composition & Thickness (in)			Remarks/ Condition	
	Asphalt	Concrete	Brick		
1	5.5			Good	
2		9		Good	
3	2.5			Not Recovered	
4					
Rebar Encountered	N/E

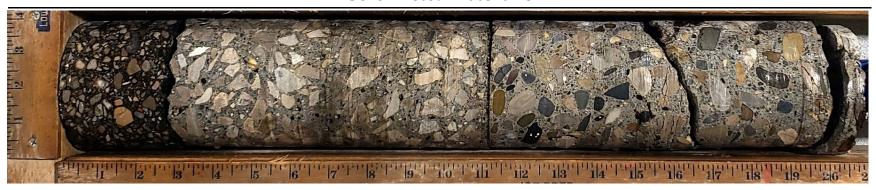
Core Photo: X-003-0-23

Core Information				
Core	e Diameter (i	in):	3.	.75
Core	Total Length	(in):	20	0.5
Layers	Core Com	Core Composition & Thickness (in)		
	Asphalt	Concrete	Brick	Condition
1	2.75			Good
2		8.25		Good
3		9.5		Poor
4				
Rebar	1.0" form stake @ 17"			
Encountered		#2 rebar	@ 20.25"

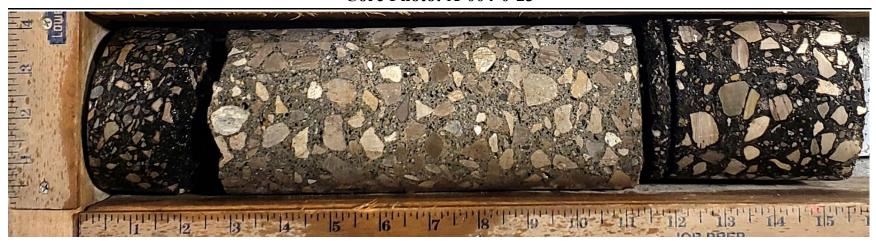
Core Photo: X-004-0-23

Core Information					
Core	e Diameter (i	n):	3.	75	
Core	Total Length	(in):	1	6	
Layers	Core Composition & Thickness (in)			Remarks/ Condition	
	Asphalt	Concrete	Brick	0 011 01 01 01 1	
1	2.5			Good	
2		9		Good	
3	0.5			Good	
4	4			Good	
Rebar Encountered	N/E

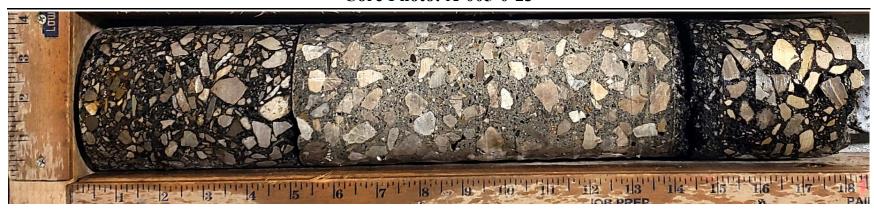
Core Photo: X-005-0-23

Core Information				
Core	e Diameter (i	n):	3.	75
Core	Fotal Length	(in):	18	3.5
Layers	Core Comp	Core Composition & Thickness (in)		
	Asphalt	Concrete	Brick	
1	5			Good
2		9		Good
3	4.5			Fair
4				
Rebar Encountered	N/E

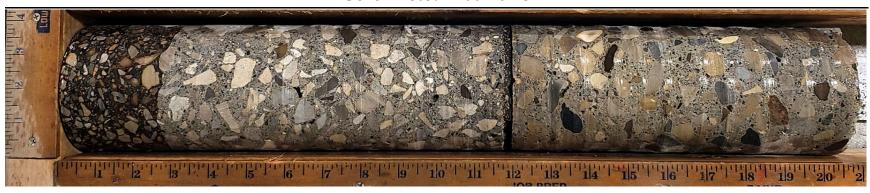
Core Photo: X-007-0-23

Core Information				
Core	e Diameter (i	n):	3.	75
Core	Fotal Length	(in):	2	1
Layers	Core Comp	Core Composition & Thickness (in)		
	Asphalt	Concrete	Brick	Condition
1	2.75		·	Good
2		9		Good
3	0.25		·	Good
4		9		Good
Rebar Encountered	#2 rebar @ 16"

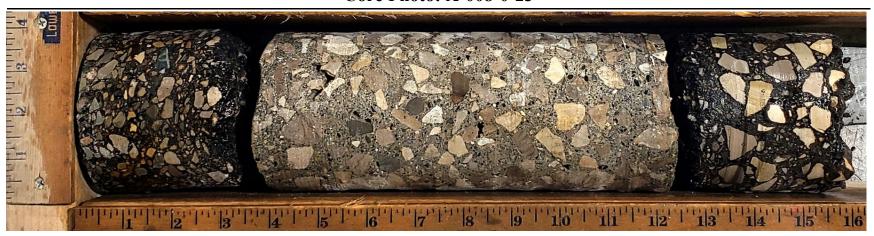
Core Photo: X-008-0-23

Core Information					
Core	e Diameter (i	n):	3.	75	
Core	Fotal Length	(in):	1	.6	
Layers	Core Comp	Core Composition & Thickness (in)			
	Asphalt	Concrete	Brick	Condition	
1	3.5			Good	
2		9		Good	
3	3.5			Good	
4					
Rebar Encountered	N/E

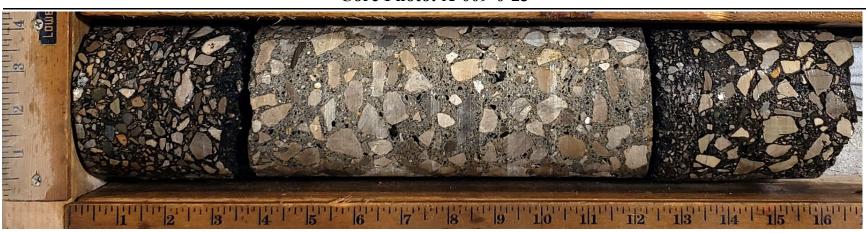
Core Photo: X-009-0-23

Core Information					
Core	e Diameter (i	n):	3.	3.75	
Core	Fotal Length	(in):	1	.7	
Layers	Core Comp	Core Composition & Thickness (in)			
	Asphalt	Concrete	Brick		
1	3.75			Good	
2		8.75		Good	
3	1			Good	
4	3.5			Good	
Rebar Encountered	N/E

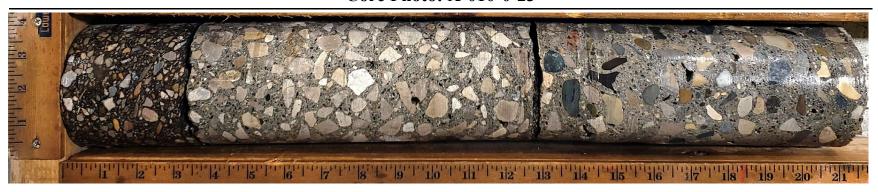
Core Photo: X-010-0-23

Core Information				
Core	e Diameter (i	n):	3.	75
Core	Fotal Length	(in):	2	22
Layers	Core Comp	Core Composition & Thickness (in)		
	Asphalt	Concrete	Brick	
1	3.5			Good
2		9.25		Good
3	0.25			Good
4		9		Good
Rebar Encountered	#2 rebar @ 17"

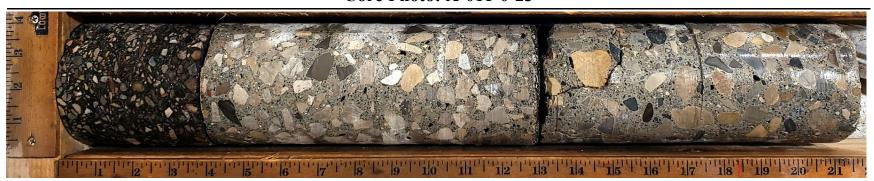
Core Photo: X-011-0-23

Core Information					
Core	e Diameter (i	in):	3.	75	
Core	Total Length	(in):	2	22	
Layers	Core Comp	Core Composition & Thickness (in)			
	Asphalt	Concrete	Brick	Condition	
1	4			Good	
2		9		Good	
3	0.25			Good	
4		8.75		Poor	
Rebar Encountered	N/E

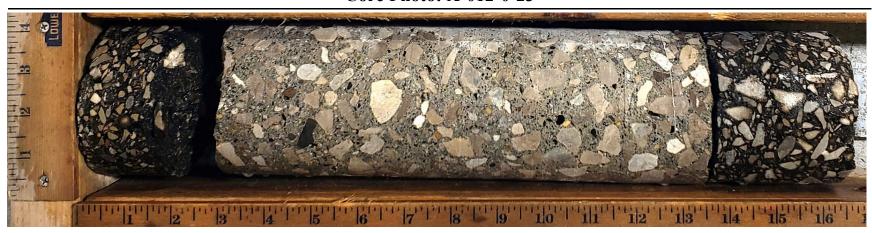
Core Photo: X-012-0-23

Core Information					
Core	e Diameter (i	in):	3.	75	
Core	Fotal Length	(in):	1	7	
Layers	Core Composition & Thickness (in)			Remarks/ Condition	
	Asphalt	Concrete	Brick	Containin	
1	3			Poor	
2		10.75		Good	
3	3.25			Good	
4					
Rebar Encountered	N/E

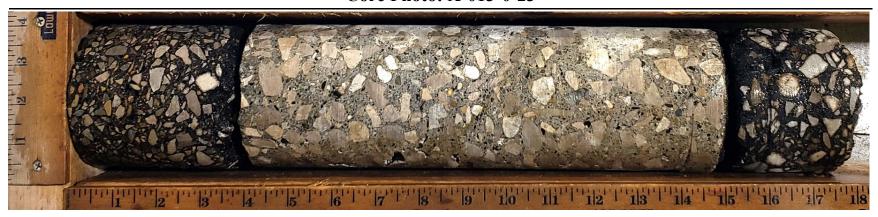
Core Photo: X-013-0-23

Core Information					
Core Diameter (in): 3.75					
Core	Fotal Length	(in):	18	.25	
Layers	Core Composition & Thickness (in)			Remarks/ Condition	
	Asphalt	Concrete	Brick	0 011 01 01 01	
1	4			Good	
2		11.25		Good	
3	3			Fair	
4					
Rebar Encountered	N/E

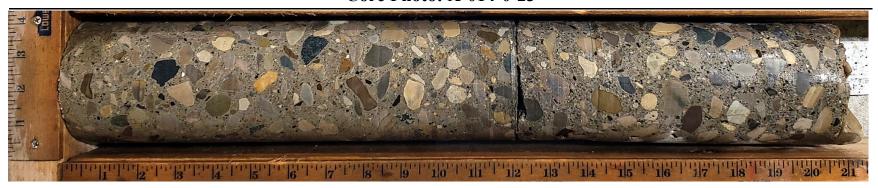
Core Photo: X-014-0-23

Core Information					
Core	Core Diameter (in): 3.75				
Core	Total Length	(in):	21	.25	
Layers	Core Composition & Thickness (in)			Remarks/ Condition	
	Asphalt	Concrete	Brick		
1		12.25		Good	
2		9		Good	
3					
4					
Rebar Encountered	N/E

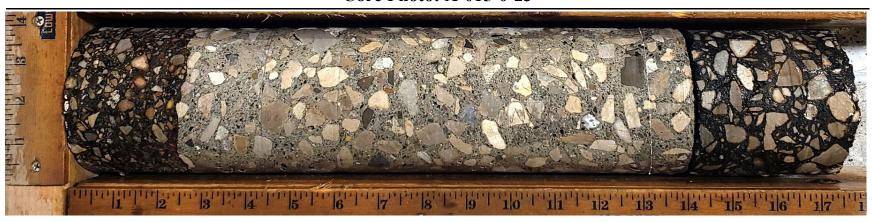
Core Photo: X-015-0-23

Core Information					
Core Diameter (in): 3.75					
Core	Total Length	(in):	1	8	
Layers	Core Composition & Thickness (in)			Remarks/ Condition	
	Asphalt	Concrete	Brick	0 011 011 011	
1	2.5			Good	
2		11.75		Good	
3	3.75			Good	
4					
Rebar Encountered	N/E

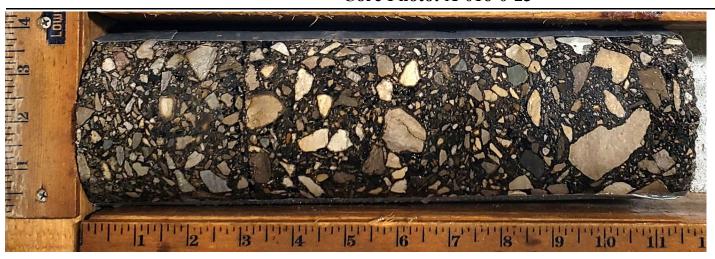
Core Photo: X-016-0-23

Core Information				
Core Diameter (in): 3.				75
Core	Fotal Length	(in):	1	2
Layers	Core Composition & Thickness (in)			Remarks/ Condition
	Asphalt	Concrete	Brick	
1	3.25			Good
2	5.5			Good
3	3.25			Good
4				
Rebar				
Encountered

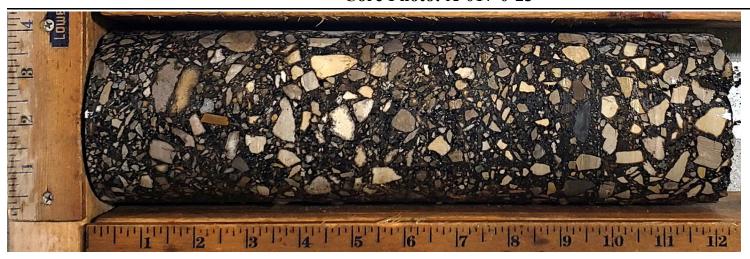
Core Photo: X-017-0-23

Core Information					
Core Diameter (in): 3.75					
Core	Fotal Length	(in):	12	2.5	
Layers	Core Composition & Thickness (in)			Remarks/ Condition	
	Asphalt	Concrete	Brick		
1	7.5			Good	
2	2.5			Good	
3	2.5			Good	
4					
Rebar					
Encountered

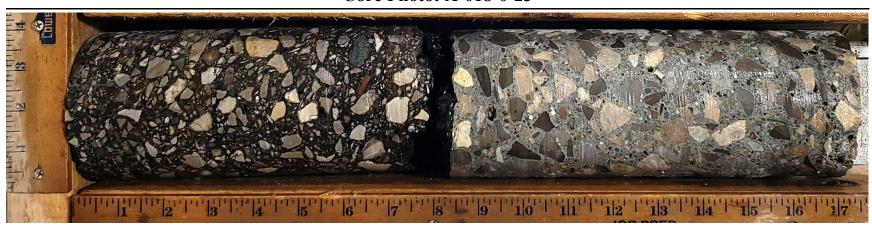
Core Photo: X-018-0-23

Core Information					
Core	Core Diameter (in):			.75	
Core	Total Length	(in):	1	18	
Layers	Core Composition & Thickness (in)			Remarks/ Condition	
	Asphalt	Concrete	Brick	0 011 01 01 01	
1	3.5			Good	
2	5			Poor	
3		9.5		Good	
4					
Rebar Encountered	#2 rebar @ 13"

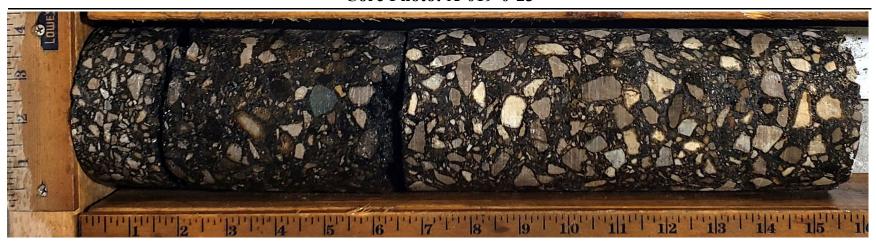
Core Photo: X-019-0-23

Core Information					
Core Diameter (in): 3.75					
Core	Fotal Length	(in):	1	6	
Layers	Core Composition & Thickness (in)			Remarks/ Condition	
	Asphalt	Concrete	Brick		
1	1.75			Good	
2	5			Fair	
3	9.25			Good	
4					
Rebar					
Encountered

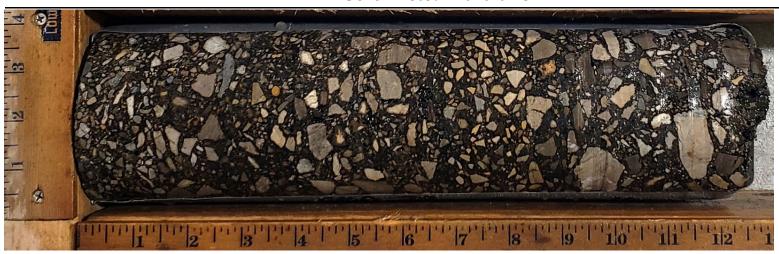
Core Photo: X-020-0-23

Core Information				
Core Diameter (in): 3.7				75
Core	Fotal Length	(in):	1	3
Layers	Core Composition & Thickness (in)			Remarks/ Condition
	Asphalt	Concrete	Brick	
1	6.5			Good
2	2			Good
3	4.5			Good
4				
Rebar				
Encountered

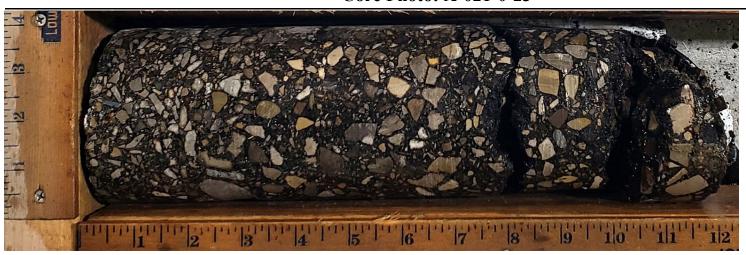
Core Photo: X-021-0-23

Core Information					
Core	.75				
Core	Fotal Length	(in):	1	12	
Layers	Core Composition & Thickness (in)			Remarks/ Condition	
	Asphalt	Concrete	Brick		
1	7			Good	
2	5			Poor	
3					
4					
Rebar					
Encountered

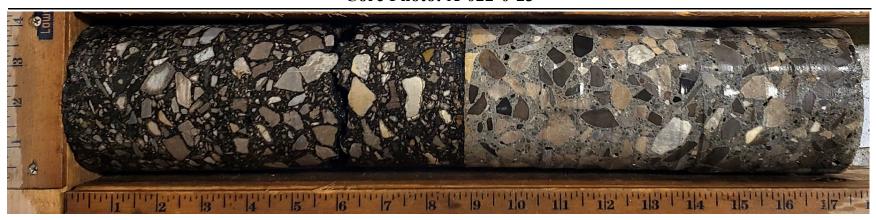
Core Photo: X-022-0-23

Core Information					
Core Diameter (in): 3.75					
Core	Fotal Length	(in):	1	8	
Layers	Core Composition & Thickness (in)			Remarks/ Condition	
	Asphalt	Concrete	Brick	Condition	
1	9			Poor	
2		9		Good	
3					
4					
Rebar Encountered	N/E

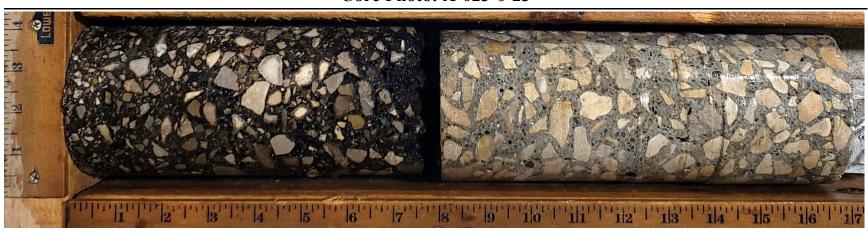
Core Photo: X-023-0-23

Core Information				
Core Diameter (in): 3.75				
Core	Fotal Length	(in):	17	.25
Layers	Core Composition & Thickness (in)			Remarks/ Condition
	Asphalt	Concrete	Brick	
1	8			Fair
2		9.25		Good
3				
4				
Rebar Encountered	#2 rebar @ 12.5"
