June 27, 2019

Re: Asbestos Sampling & Analysis Report
HAM-75-7.85 Demo 2, PID 110305
Parcel 94: North Amer. Financial Services Building
125 Citycentre Drive, Cincinnati, Ohio 45216

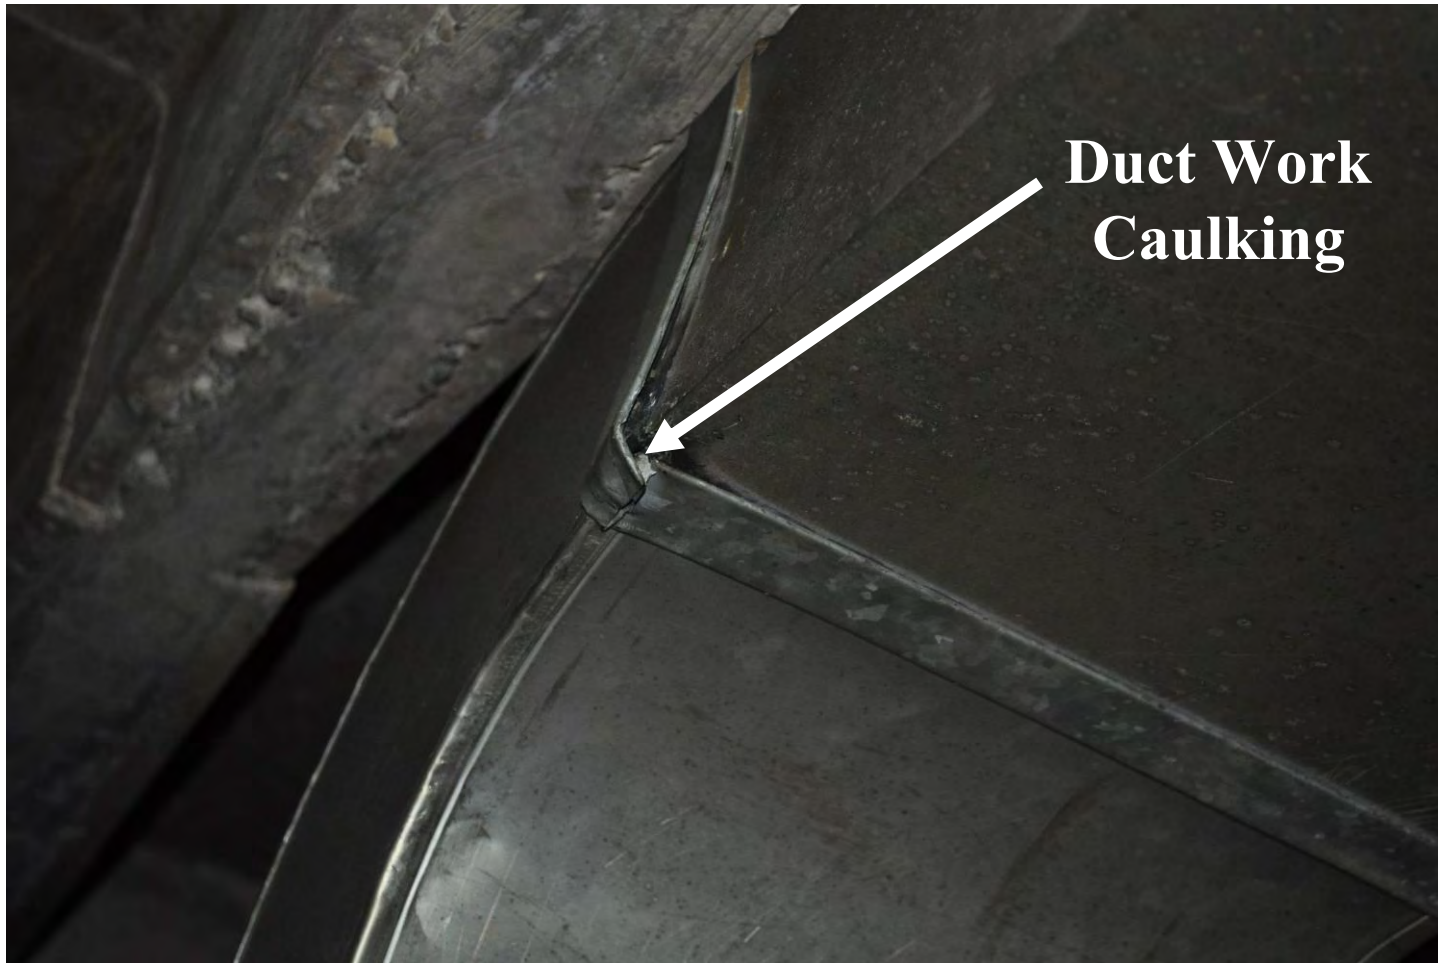
The duct work caulking materials are present inside the false ceilings located on the first and second stories of the North American Financial Services Building. The window grout/caulking and inside glass cover grout/caulking are present on all the windows within in the building. The Floor tile and tile mastic are present in the basement as well as the first and second stories of the building.

**Photograph 1: Example of ACM Material
Duct Work Caulking inside False Ceiling**

These materials are friable or will likely become friable during future renovation/demolition activities. As such, these materials are collectively assumed to be regulated and must be managed per the applicable State of Ohio requirements that may include their transport to an appropriately permitted facility for waste disposal. Further, if demolition/renovation activities uncover any materials that were not identified/evaluated in this letter report, work should be stopped and the area isolated until the applicable materials can be assessed by an AHES. Likewise, abatement of any RACM identified must be conducted by an asbestos abatement contractor who is licensed by the State of Ohio.

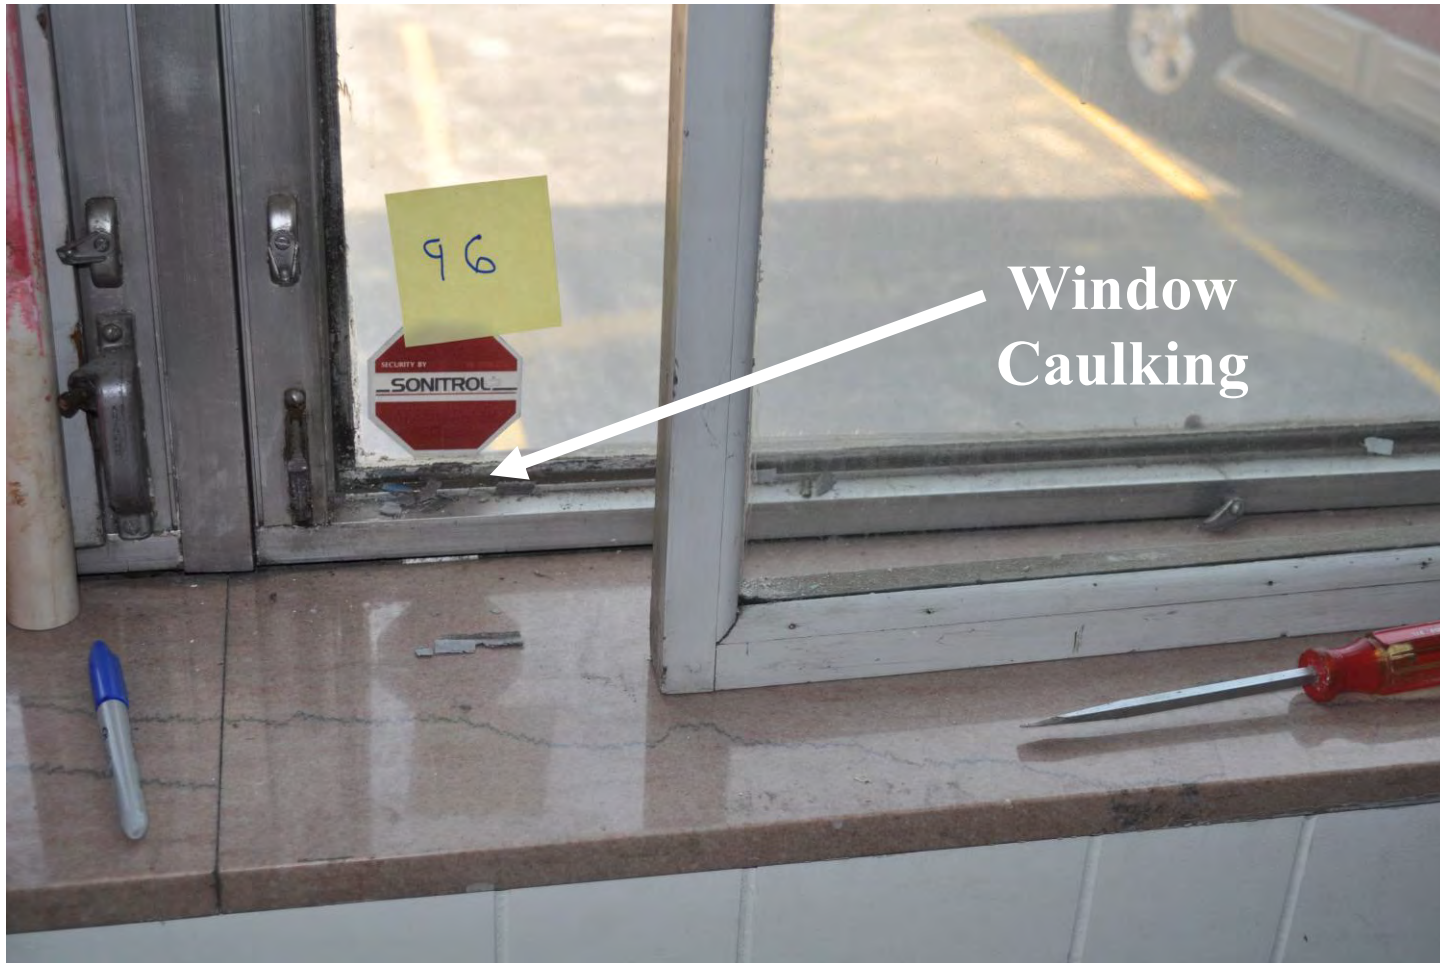
Window
Caulking

**Photograph 2: Example of ACM Material
Window Grout/Glazing under Glass Cover**

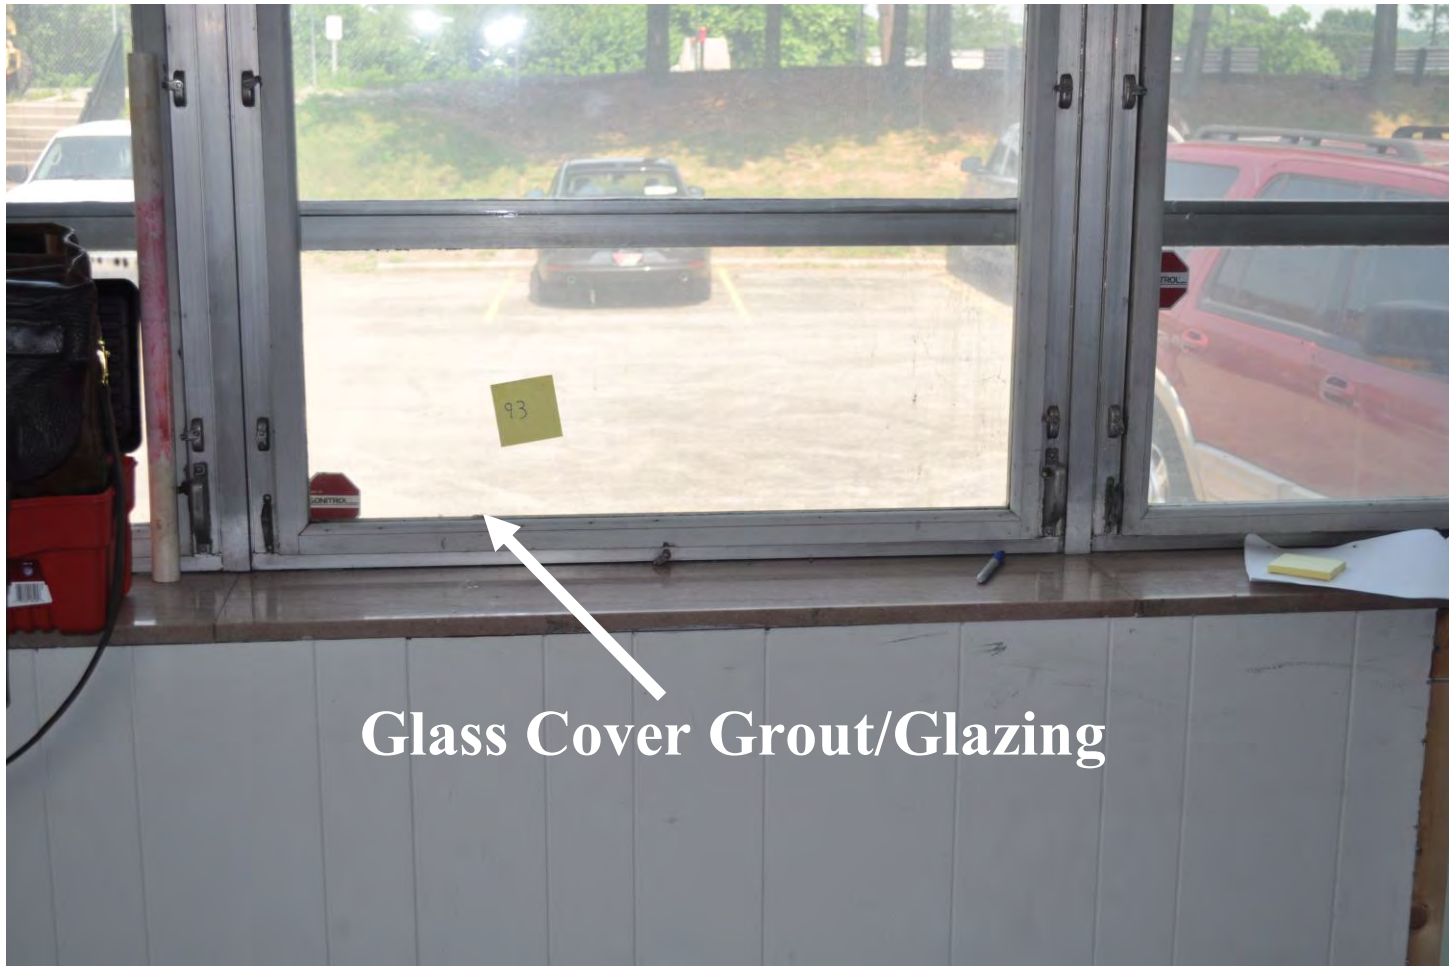
Glass Cover Grout/Glazing

**Photograph 3: Example of ACM Material
Glass Cover Grout/Glazing**

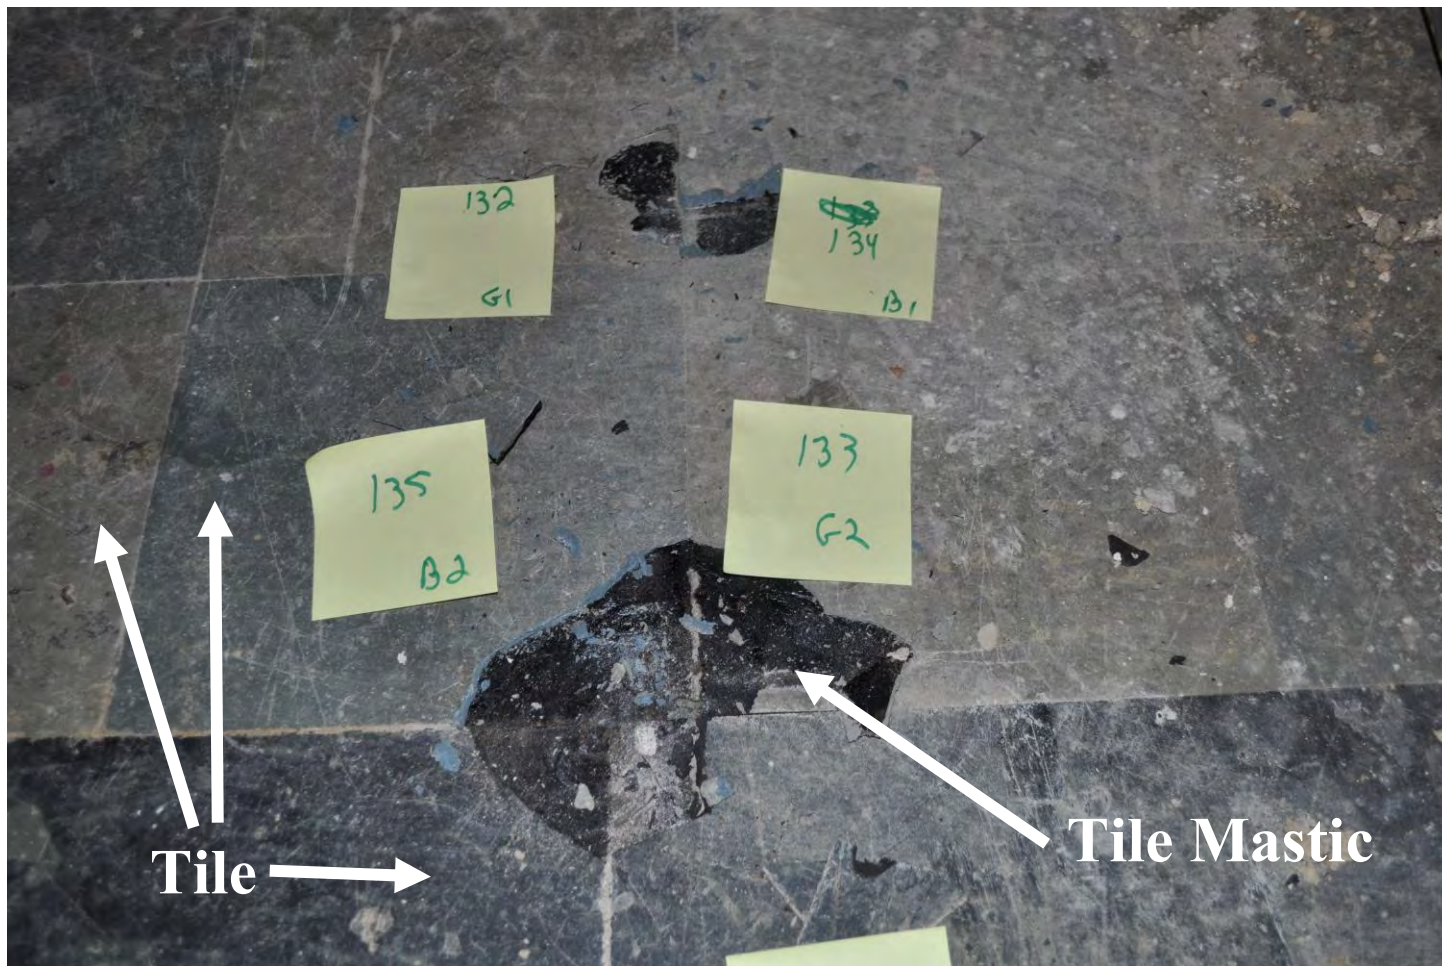
**Photograph 4: Example of ACM Materials
Various Floor Tile & Tile Mastic**

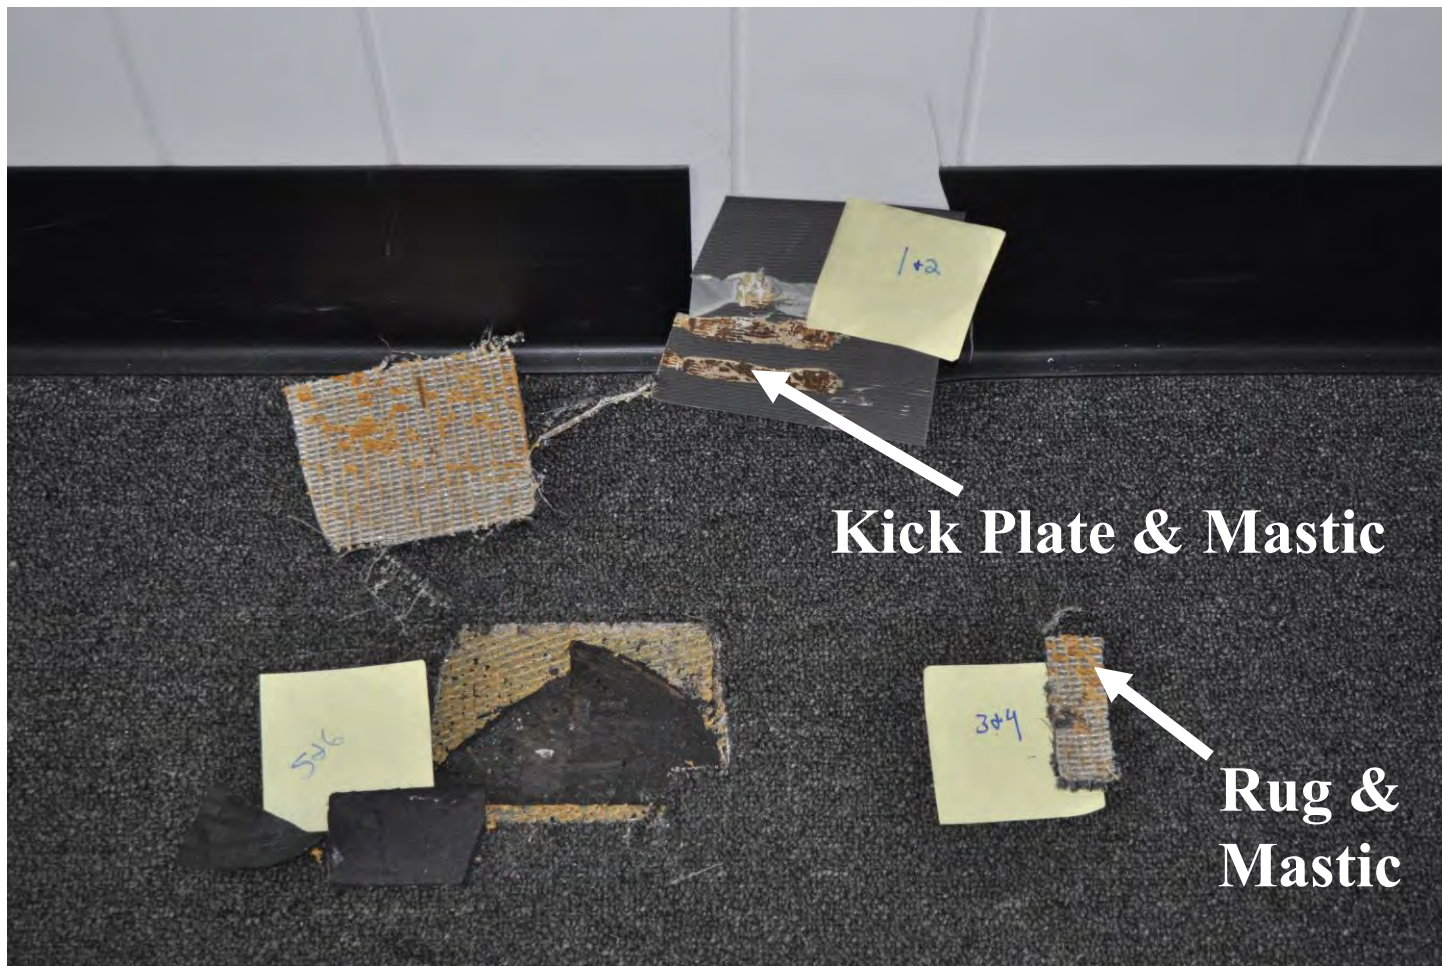
**Photograph 5: Example of PACM Materials
Rug, Kick Plate & Mastics**

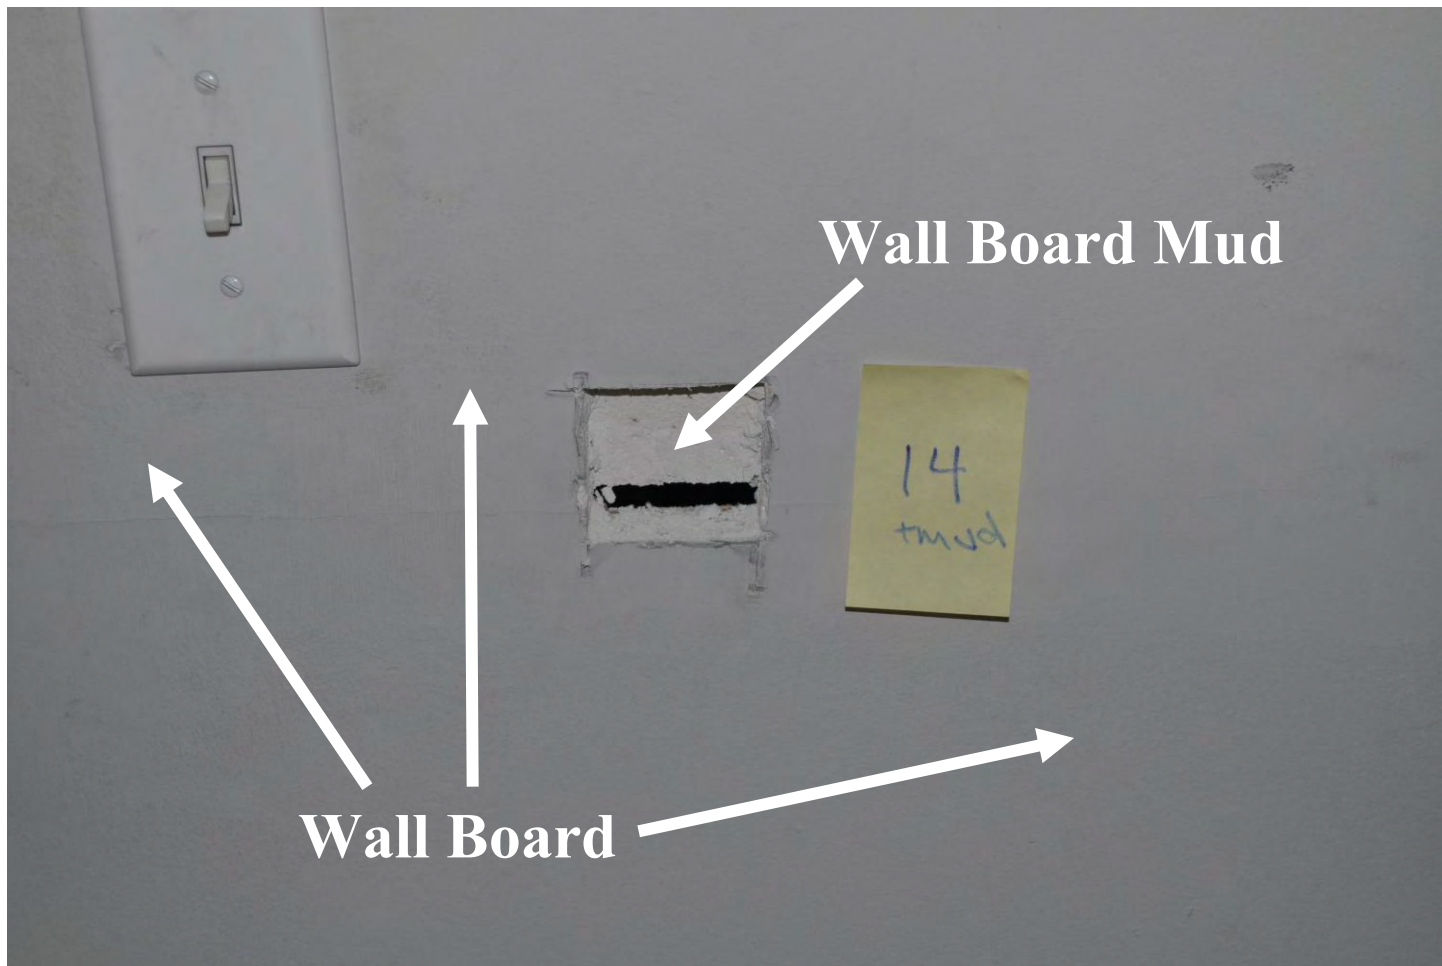
**Photograph 6: Example of PACM Materials
Wall Board & Mud**

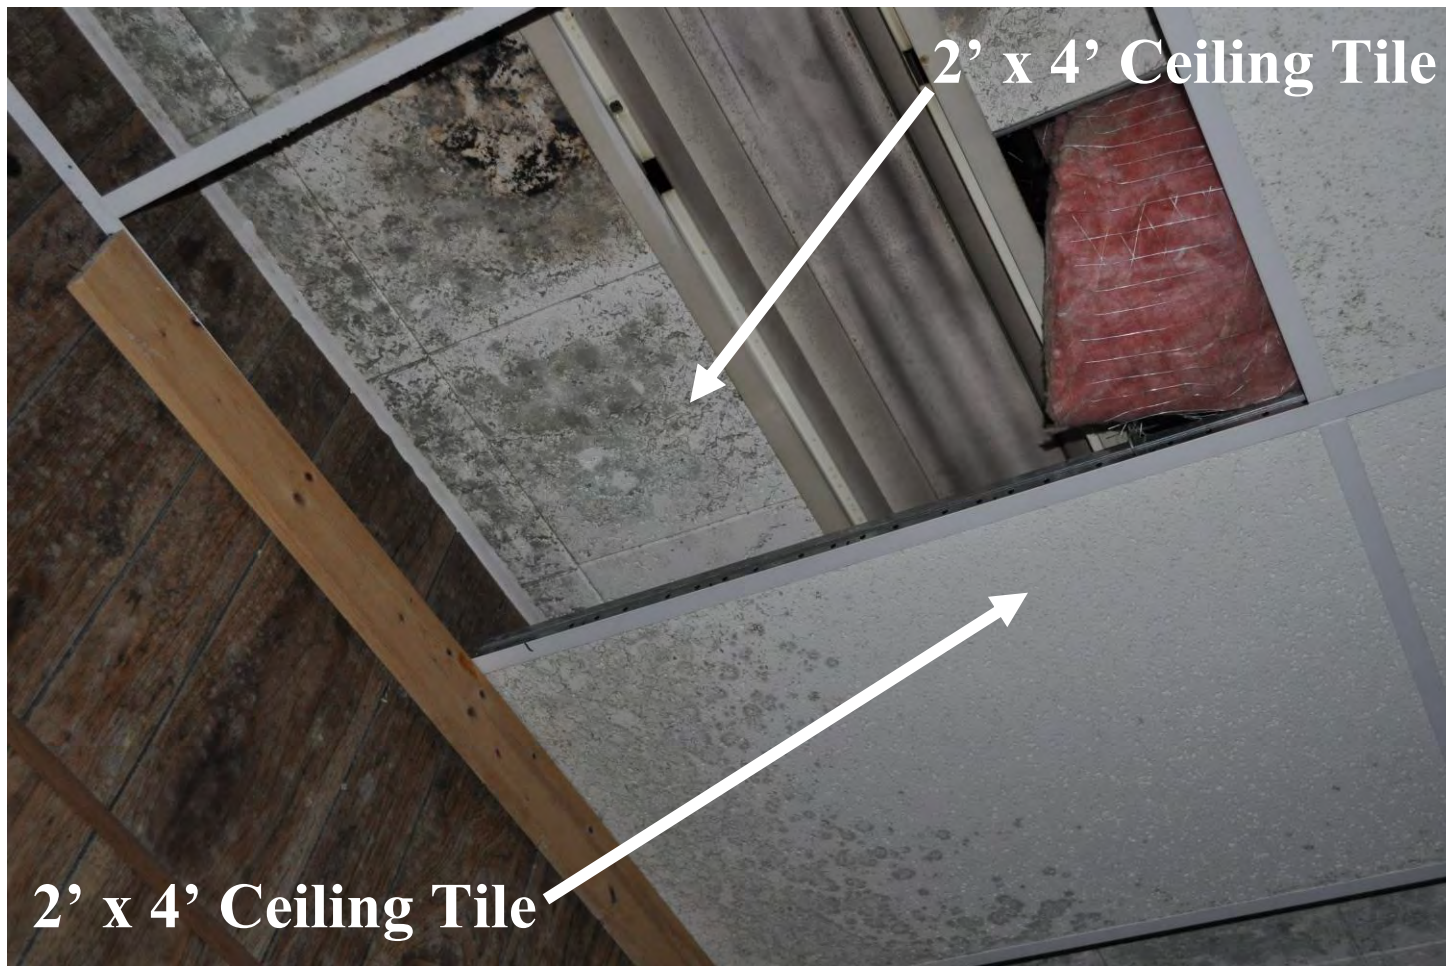
**Photograph 7: Example of PACM Materials
Different Types of Ceiling Tile**

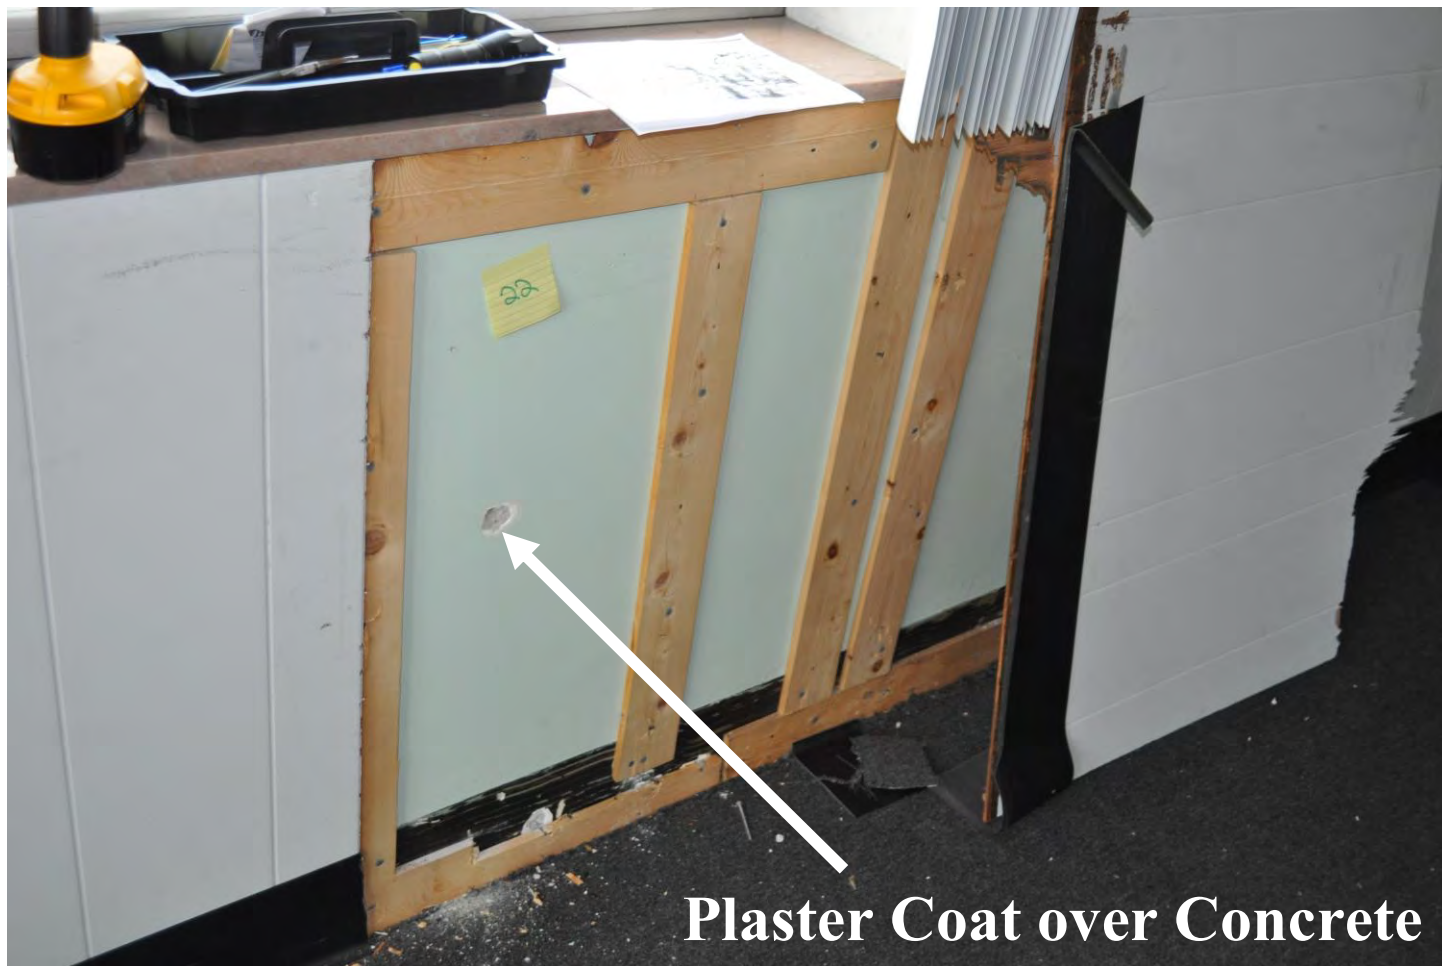
Plaster Coat over Concrete

**Photograph 8: Example of PACM Materials
Plaster Coating over Concrete**

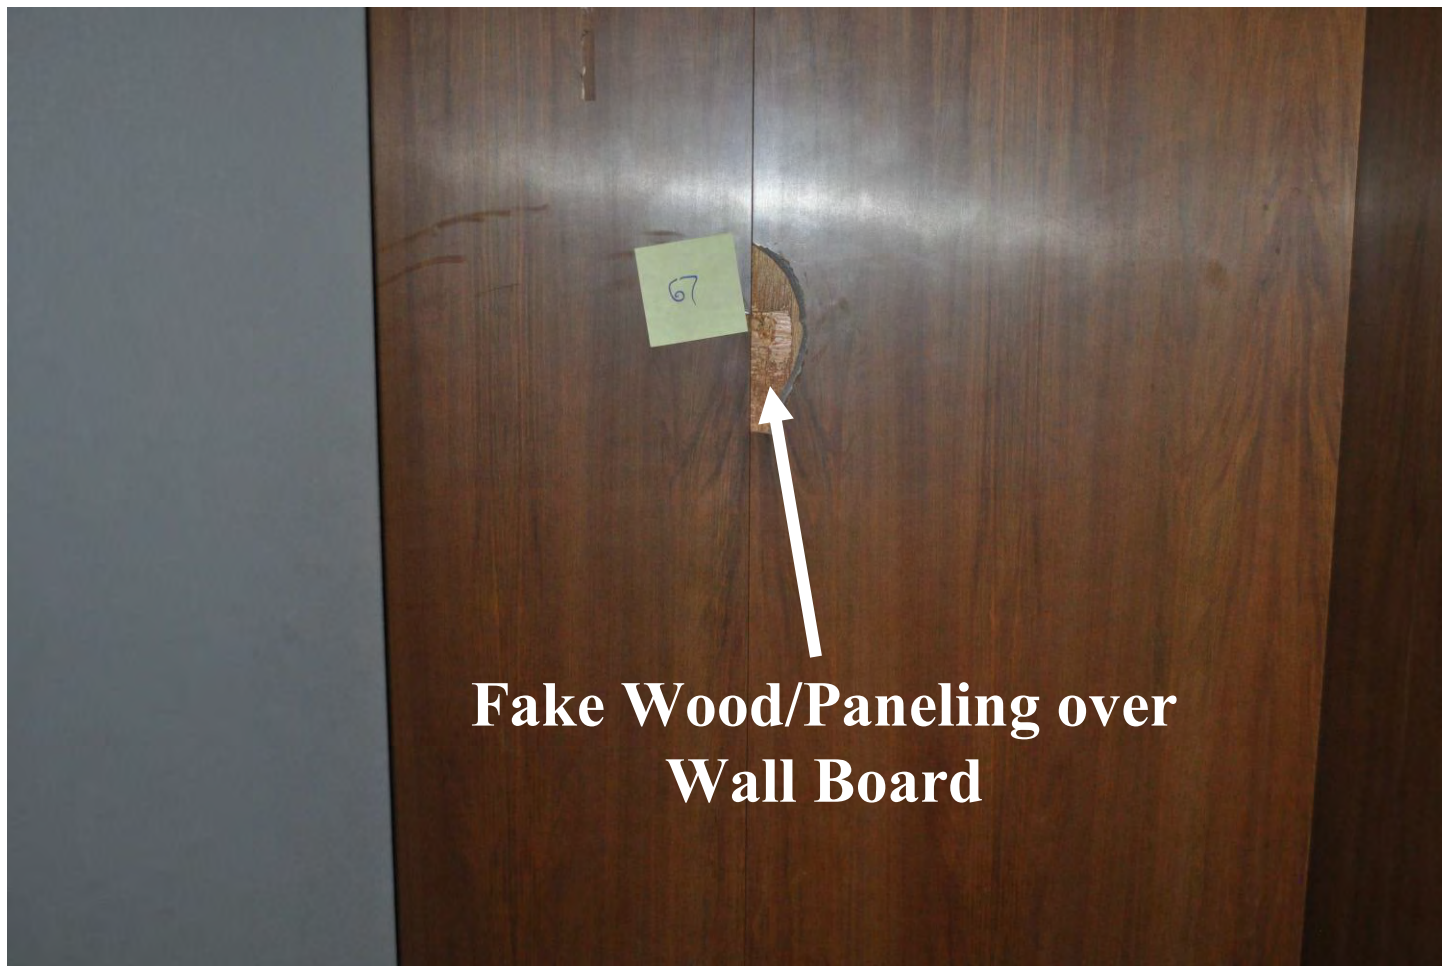
**Fake Wood/Paneling over
Wall Board**

**Photograph 9 Example of PACM Materials
Fake Wood/Paneling Covered Wall Board**

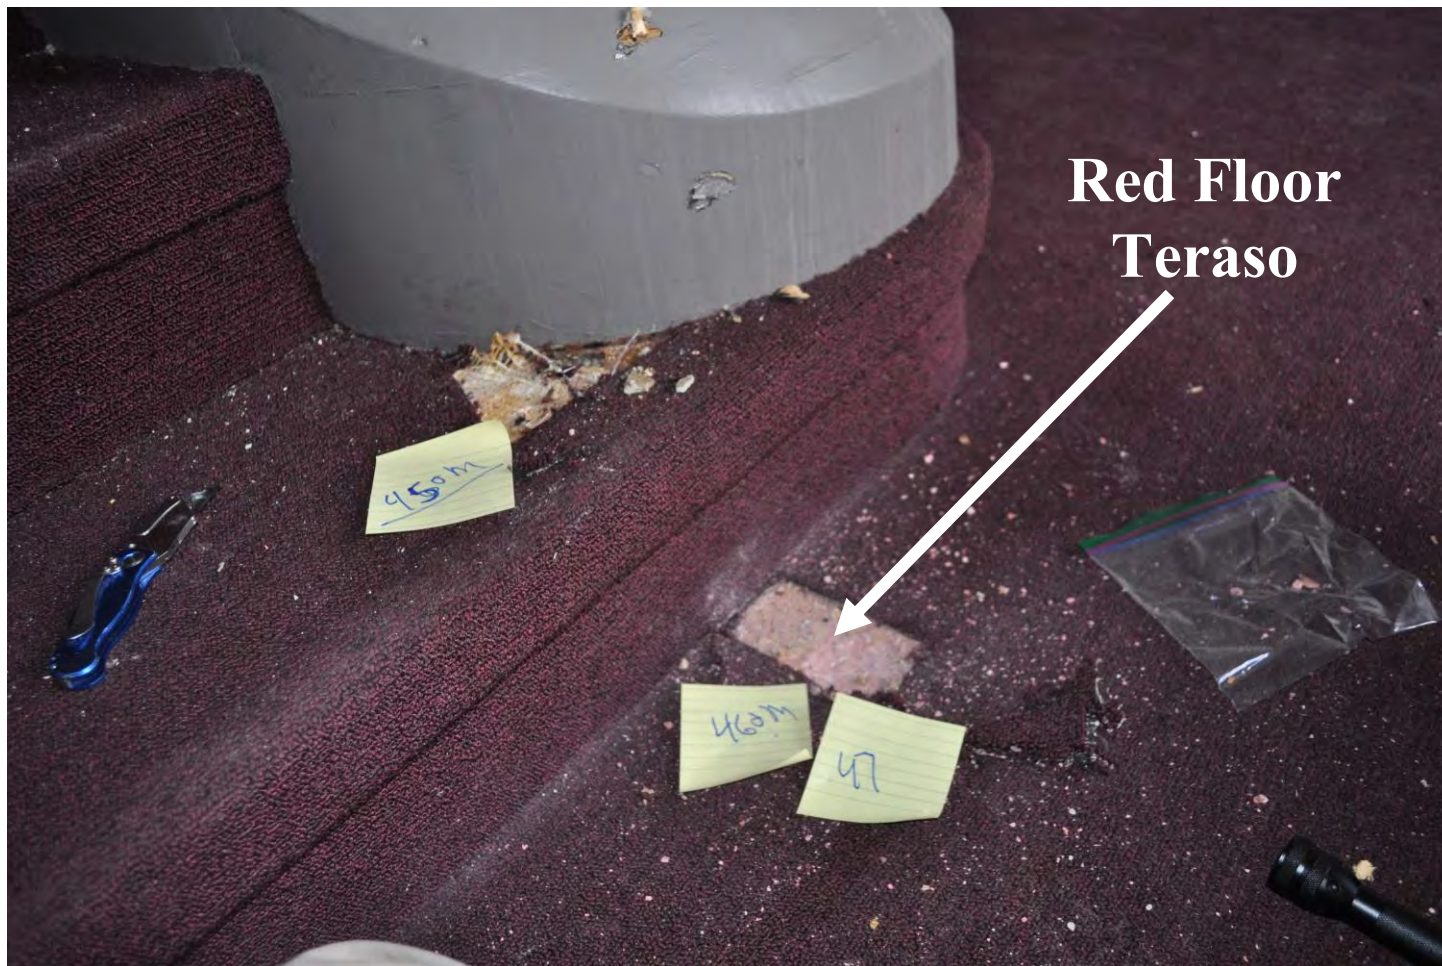
**Red Floor
Teraso**

**Photograph 10 Example of PACM Material
Red Floor Teraso**

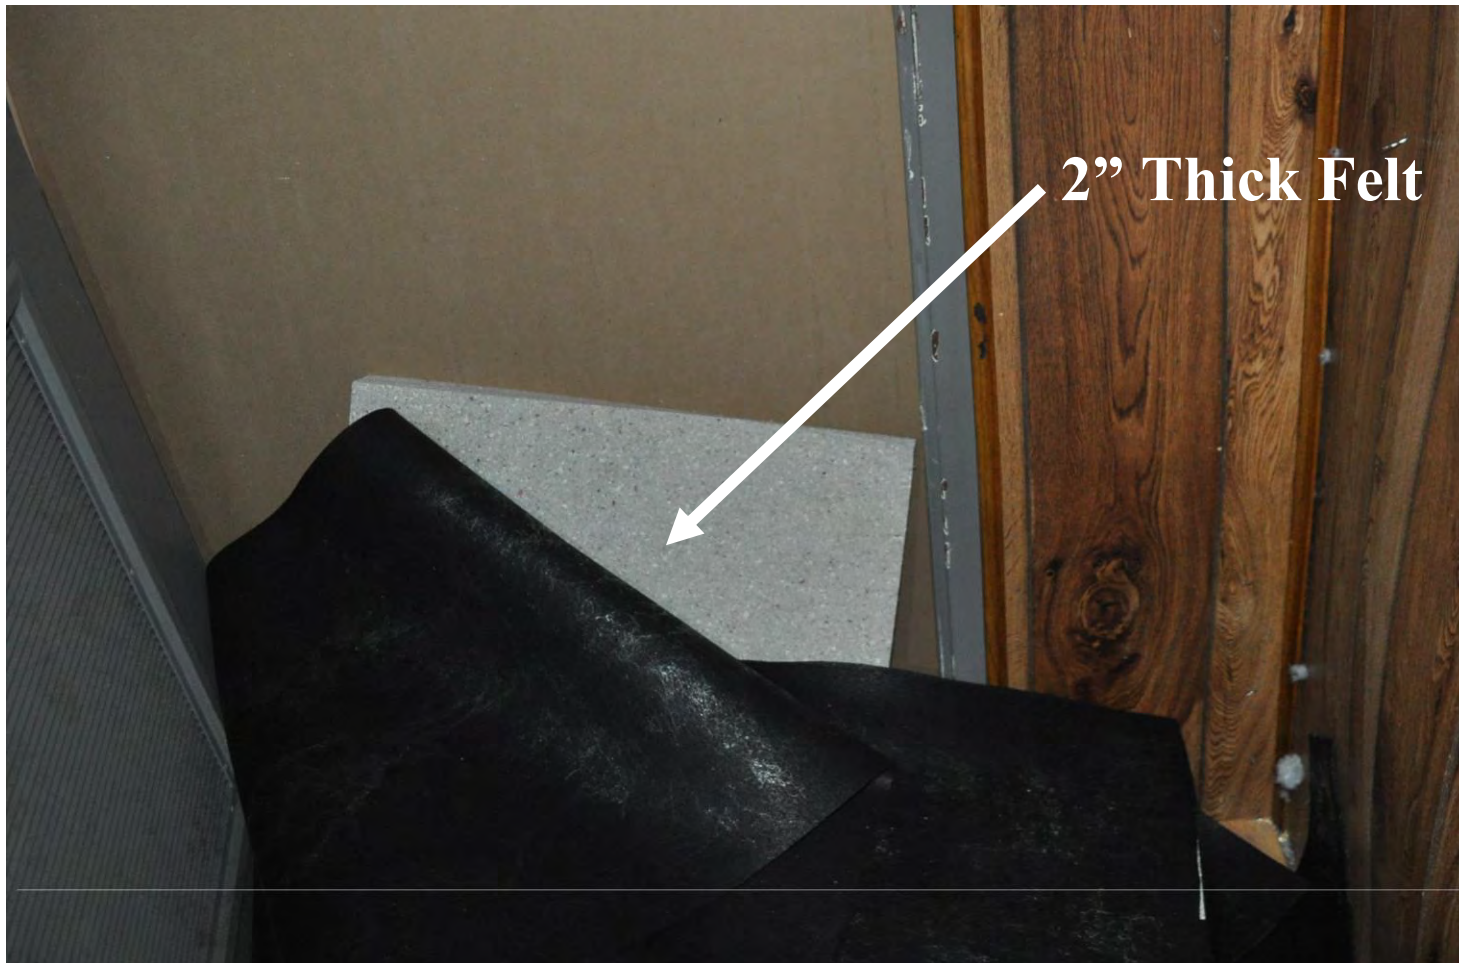
**Photograph 11 Example of PACM Material
Unused Layer of Light Gray Felt**

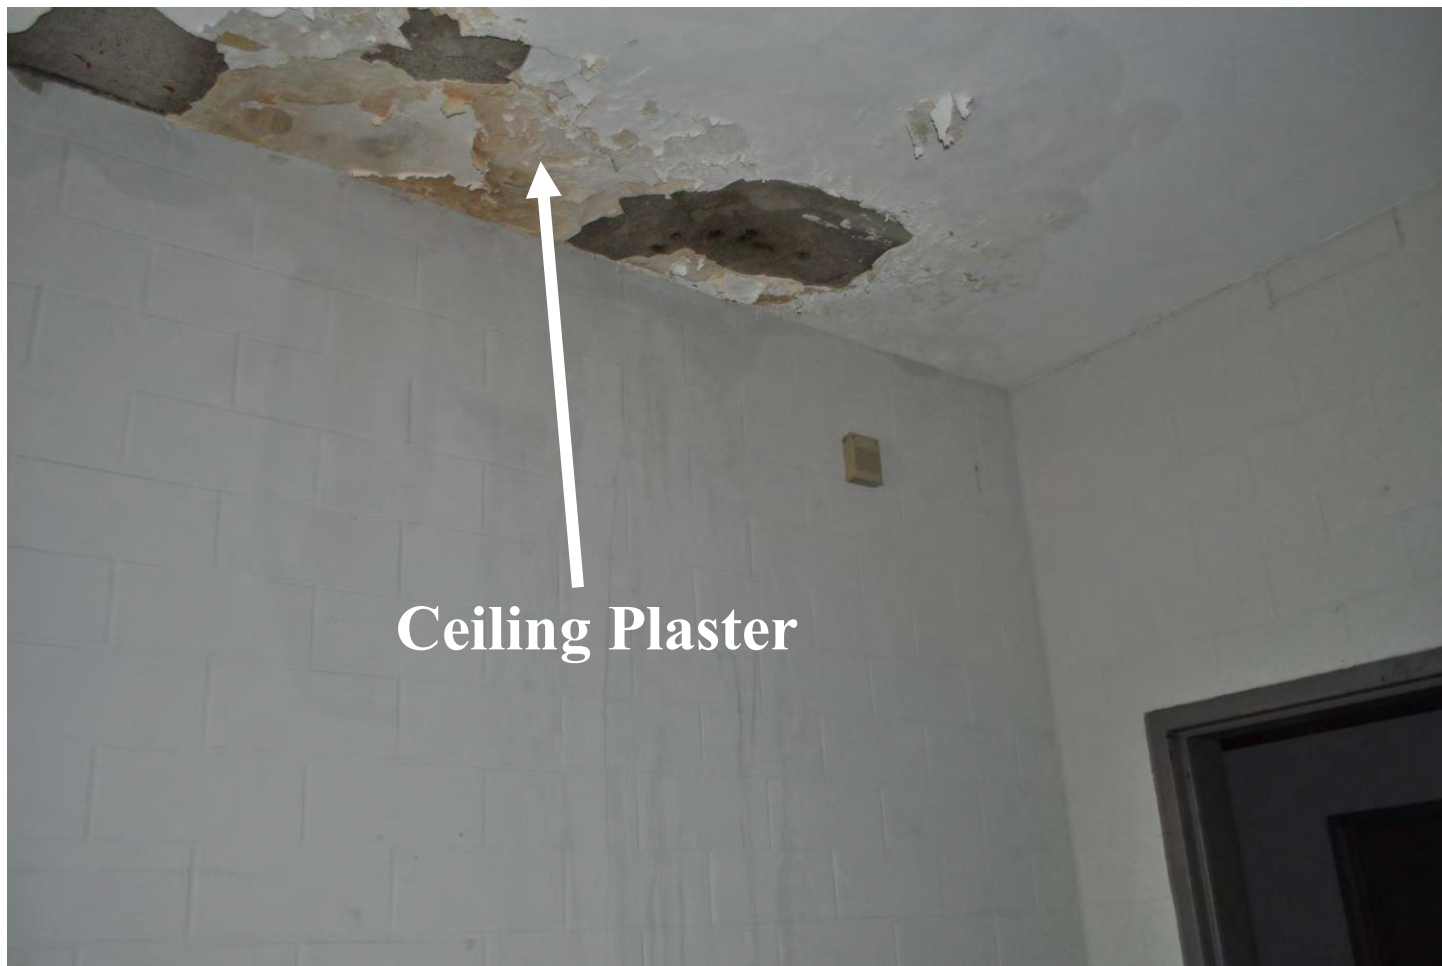
Ceiling Plaster

**Photograph 12 Example of PACM Material
Ceiling Plaster**

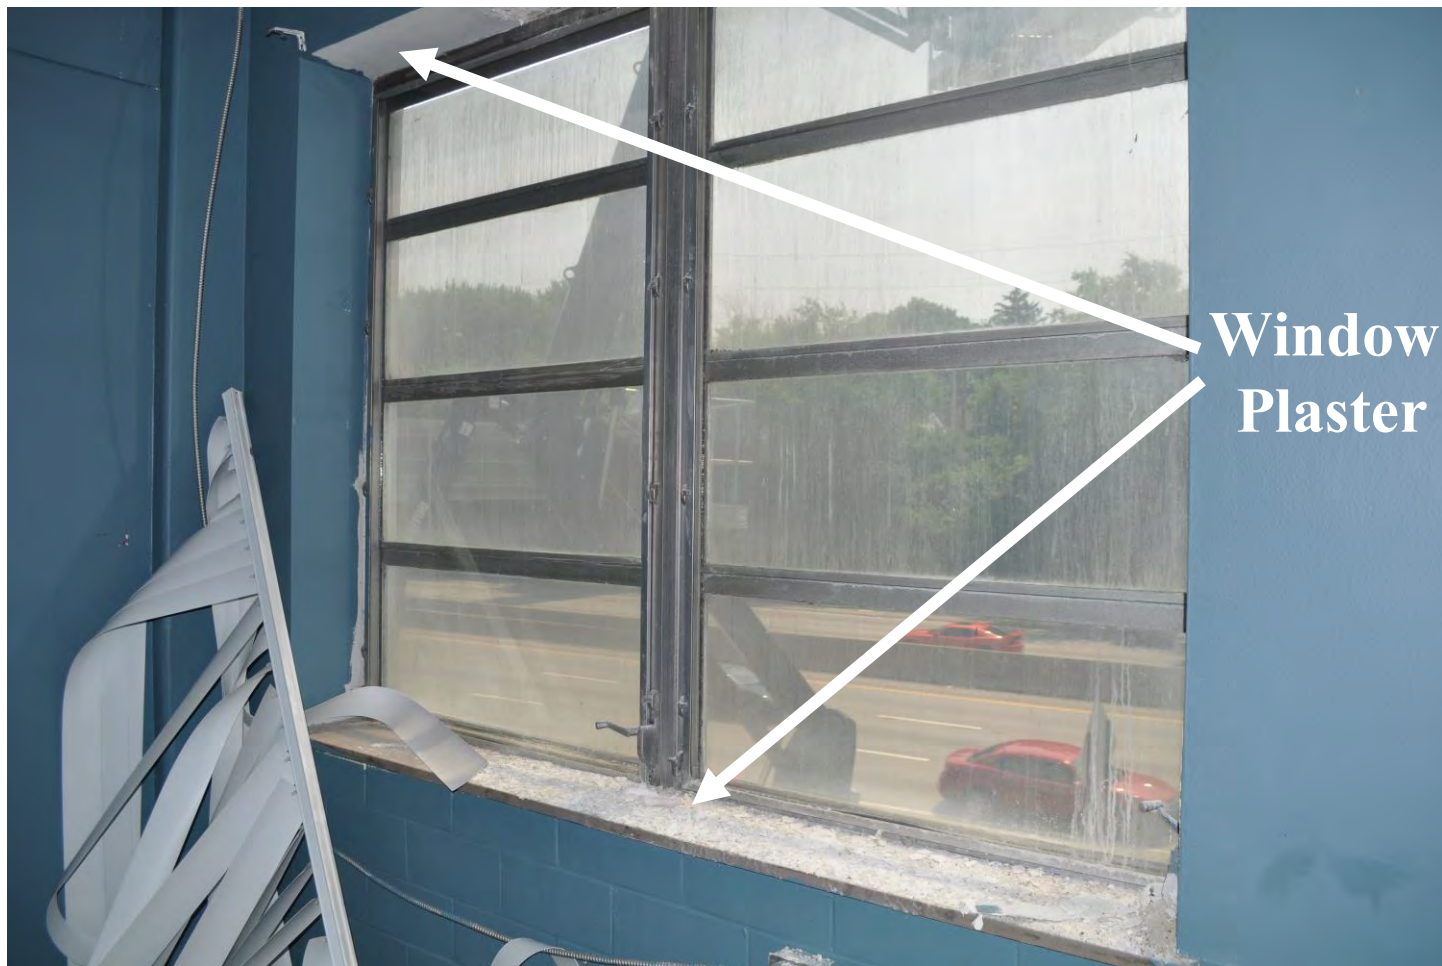
**Window
Plaster**

**Photograph 13 Example of PACM Material
Window Plaster**

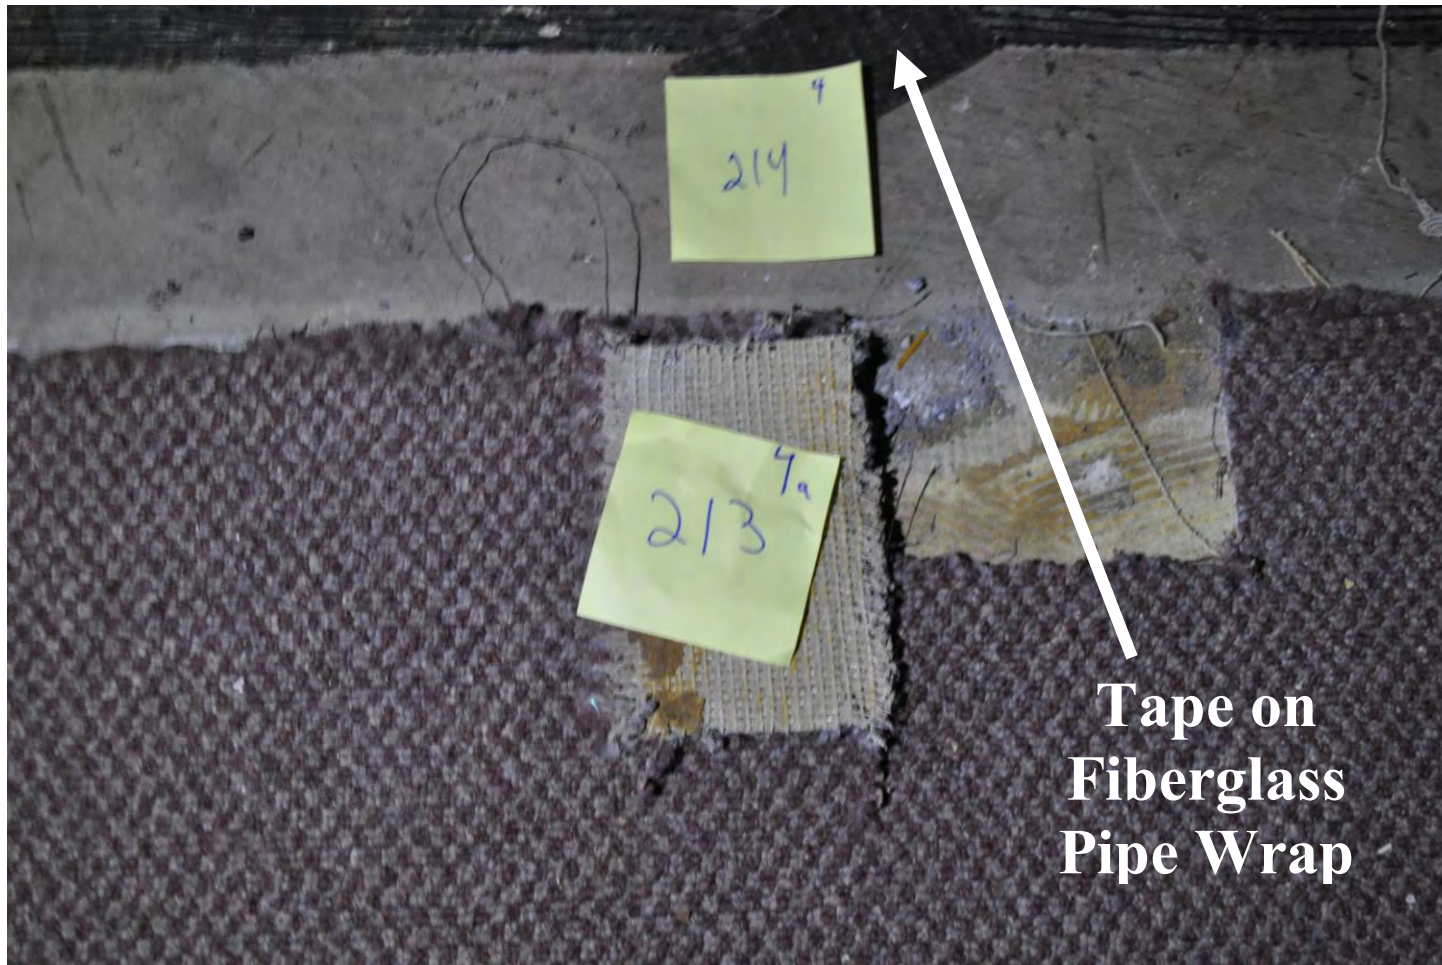
**Tape on
Fiberglass
Pipe Wrap**

**Photograph 14 Example of PACM Material
Tape on 8" Diameter Fiberglass Pipe Wrap**
