Reference: **District 12/3 Subsurface Investigation for Pavement & Bridges
PID No. 114573 Agreement No. 36312**

**Pavement Core Exploration – Data Report
Task Order No. D12-17
LAK-640-0.00 Pavement Cores (PID 89274)**
Willowick and Eastlake, Lake County, Ohio
S&ME Project No. 216069T

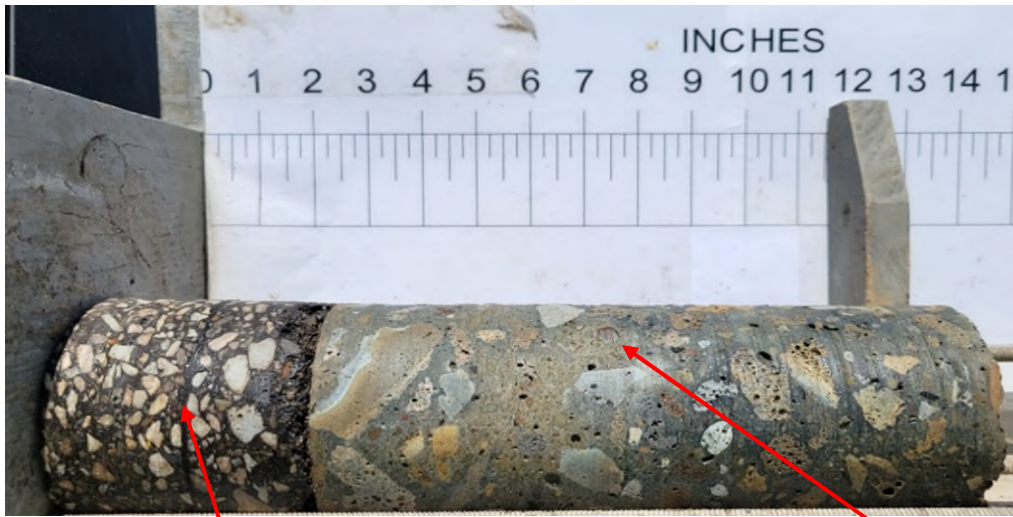
- Geosynthetic fabric was observed between the upper asphalt courses in cores X-001-0-23 and X-002-0-23, at the depths of 1¾ and 1½ inches, respectively.

- Slag concrete was encountered beneath the asphalt at X-001-0-23 and X-002-0-23, with thicknesses of 8¼ and 7¾ inches, respectively. Reinforcing steel was observed in the concrete at X-001-0-23 and X-002-0-23, approximately 3¾ and 2¼ inches beneath the top of concrete, respectively.

fabric

Reinforcing Steel

1	Core Number / Thickness	X-001-0-23 / Asphalt = 3¼" Slag Concrete = 8¼"
	Remarks	Geosynthetic fabric was observed approximately 1¾" below the asphalt surface. Reinforcing steel was observed approximately 3¾" below the top of concrete.

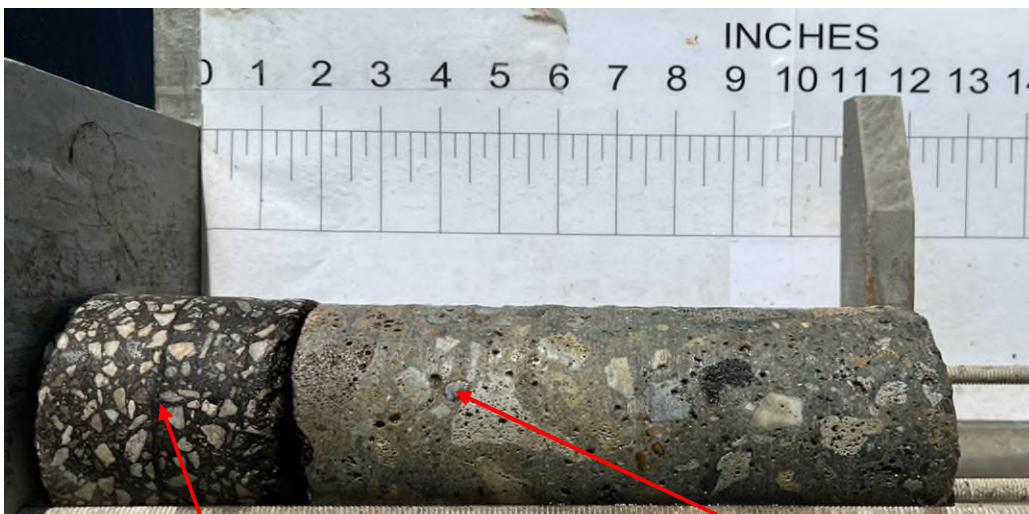
fabric

Reinforcing Steel

2	Core Number / Thickness	X-002-0-23 / Asphalt = 3 " Slag Concrete = 7¾"
	Remarks	Geosynthetic fabric was observed approximately 1½" below the asphalt surface. Steel was observed approximately 2¼" below the top of concrete.

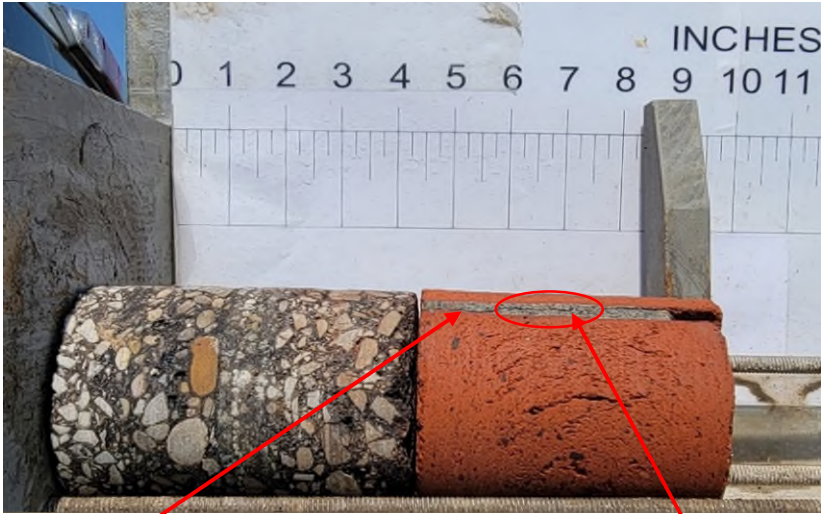
<p style="text-align: center;"> Joint between bricks Vertical crack in mortar </p>		Date: 5/10/2023
		Photographer: SHS
3	Core Number / Thickness	X-003-0-23 / Asphalt = 4¼" Brick Paver = 4"
	Remarks	The core encountered a joint between the pavers. The joint appeared to be filled with cracked mortar.

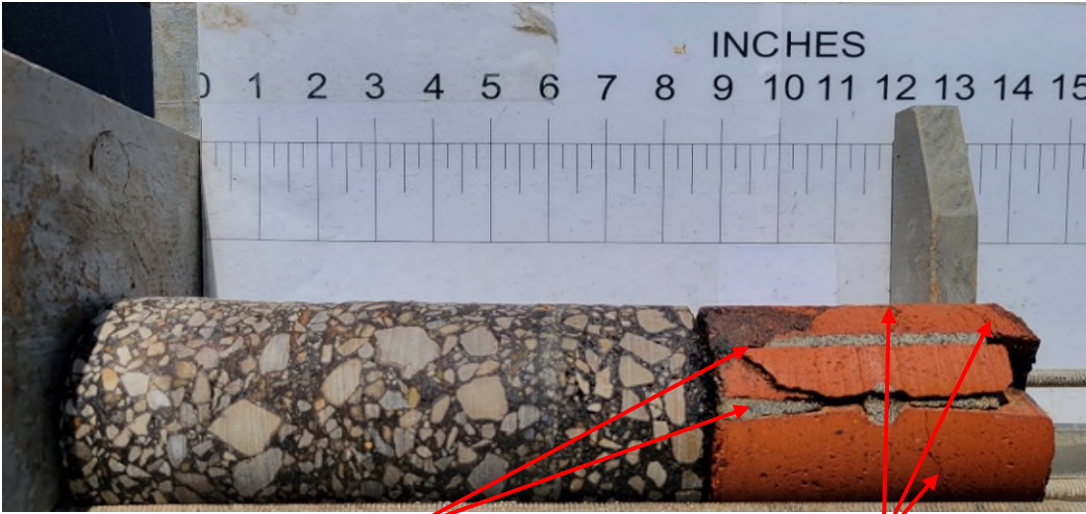
X-004-0-23	41.642550°	-81.446759°	Westbound Vine Street, Left Lane 460 feet west of E. 340th St.	8	4	-	-	12	The core encountered a joint between the pavers. Horizontal cracks were observed in the paver, and a corner piece broke off during coring.
	X-005-0-23	41.642569°	-81.439921°	Westbound Vine Street, Left Lane 80 feet west of E. 349th St.	10¼	4	-	-	14¼	The core encountered a joint between the pavers.
	X-006-0-23	41.642505°	-81.433082°	Eastbound Vine Street, Right Lane 160 feet east of E. 357th St.	3¾	-	-	8¾	12½	
	X-007-0-23	41.642618°	-81.429774°	Westbound Vine Street, Right Lane Just east of E. 363rd St.	3½	-	-	8¼	11¾

<p style="text-align: center;"> Joints between bricks Horizontal cracks </p>		Date: 5/10/2023
		Photographer: SHS
4	Core Number / Thickness	X-004-0-23 / Asphalt = 8" Brick Paver = 4"
	Remarks	The core encountered a joint between the pavers. Horizontal cracks were observed in the paver, and a corner piece broke off during coring.

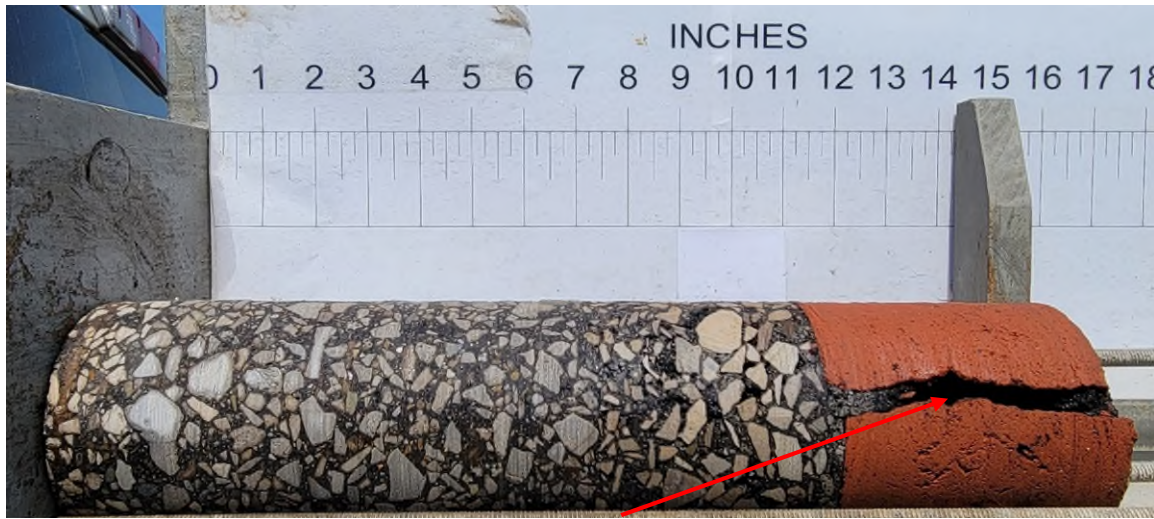
Joint between bricks

5	Core Number / Thickness	X-005-0-23 / Asphalt = 10¼" Brick Paver = 4"
	Remarks	The core encountered a joint between the pavers.

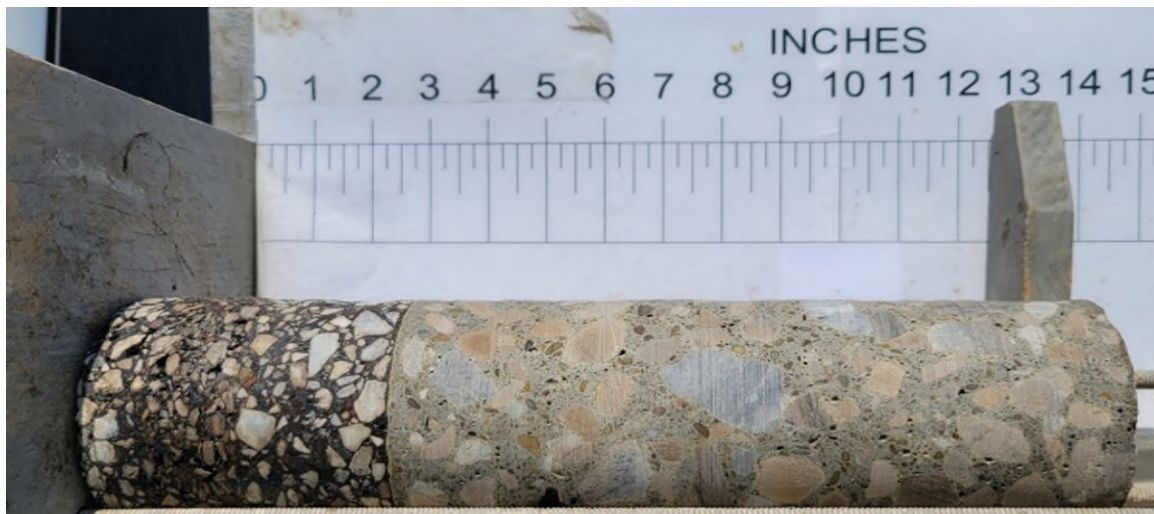
6	Core Number / Thickness	X-006-0-23 / Asphalt = 3¾" Concrete = 8¾"
	Remarks

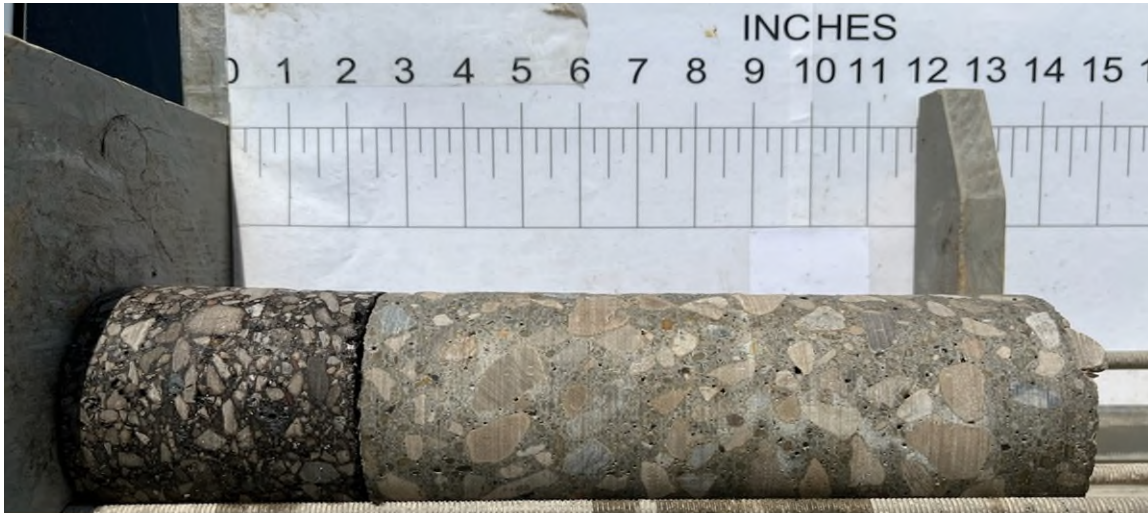
7	Core Number / Thickness	X-007-0-23 / Asphalt = 3½" Concrete = 8¼"
	Remarks
