Inspection Date: 06/27/2024

Structure Number: 5765145

Ohio Bridge Inspection Summary Report**MOT-T0067-0060 (5765145)**2: District 79492 - VANDALIA (MOT county)
ict
07

Bridge Inspection Report

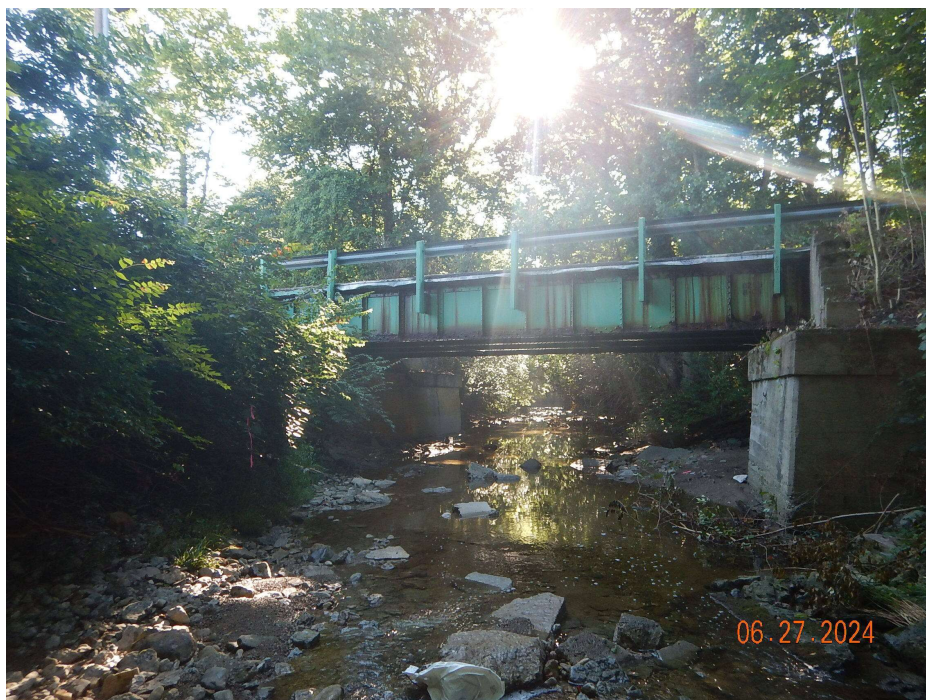
PHOTO 1

Description Upstream elevation

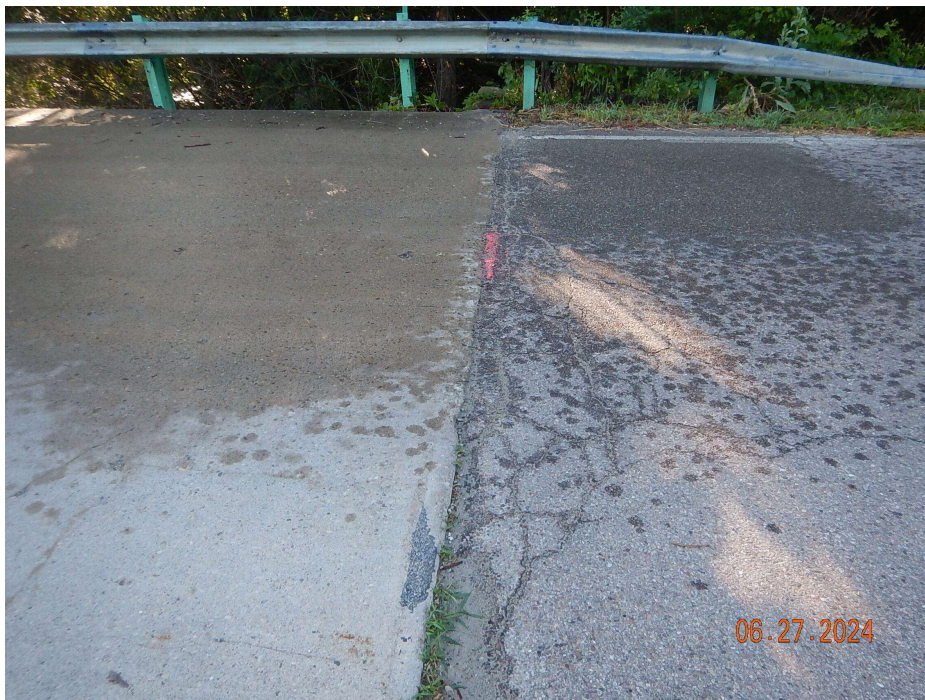
PHOTO 4

Description South bridge limit

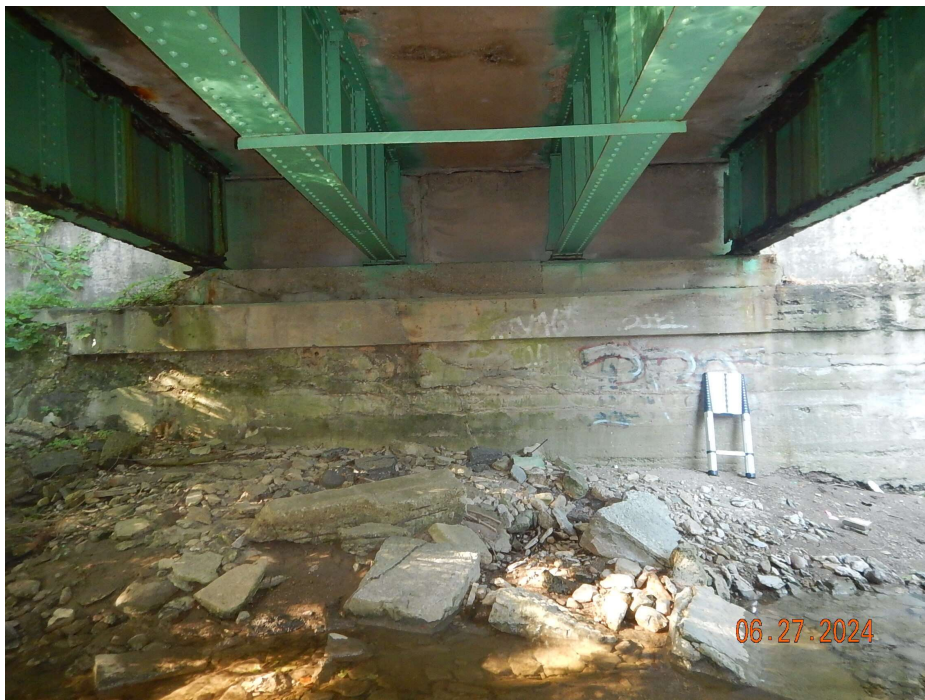
PHOTO 12

There is progressive disintegration of concrete exposing aggregate along the face of abutments, at abutment caps, and beam seats. Severe spalling and cracking under Girder 4 beam seat. Spalling under Girder 1 beam seat at North abutment (negligible loss of bearing, avg 3 ft wide and 4.75 ft tall). Full height spall under Girder 1 on North abutment face, with scaling and unsound concrete surround. Spalling under Girder 4 beam seat on North abutment. Spalling below beam seats in abutment wall typical.

Description South abutment

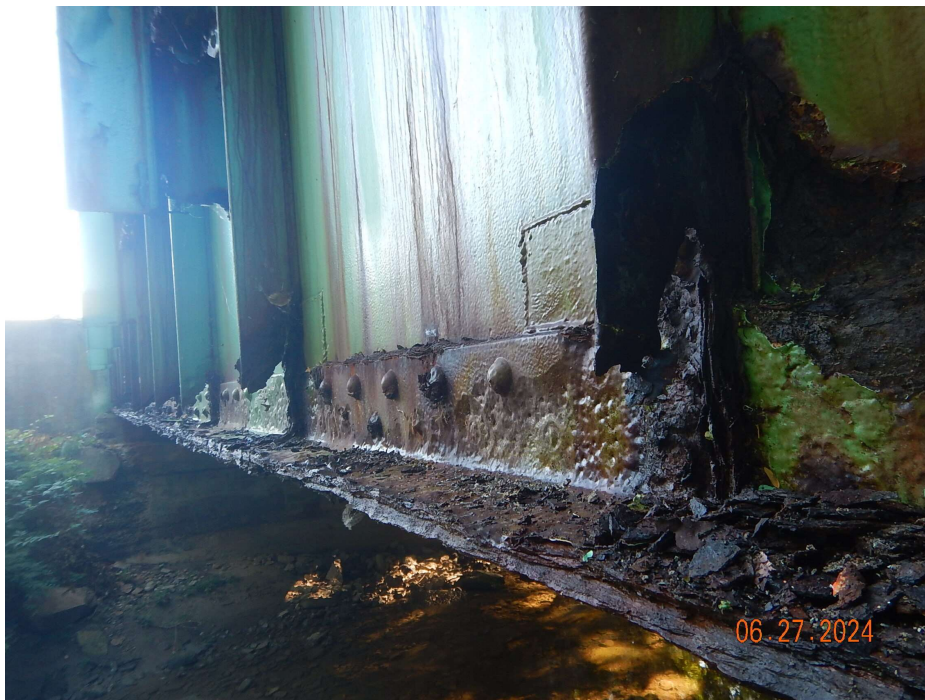
PHOTO 16

- Girder 1, 10 stiffeners at exterior
- Girder 4, all stiffeners at exterior face
- Girder 4, 5 stiffeners at interior face

Description G1, section loss at bottom of transverse stiffeners

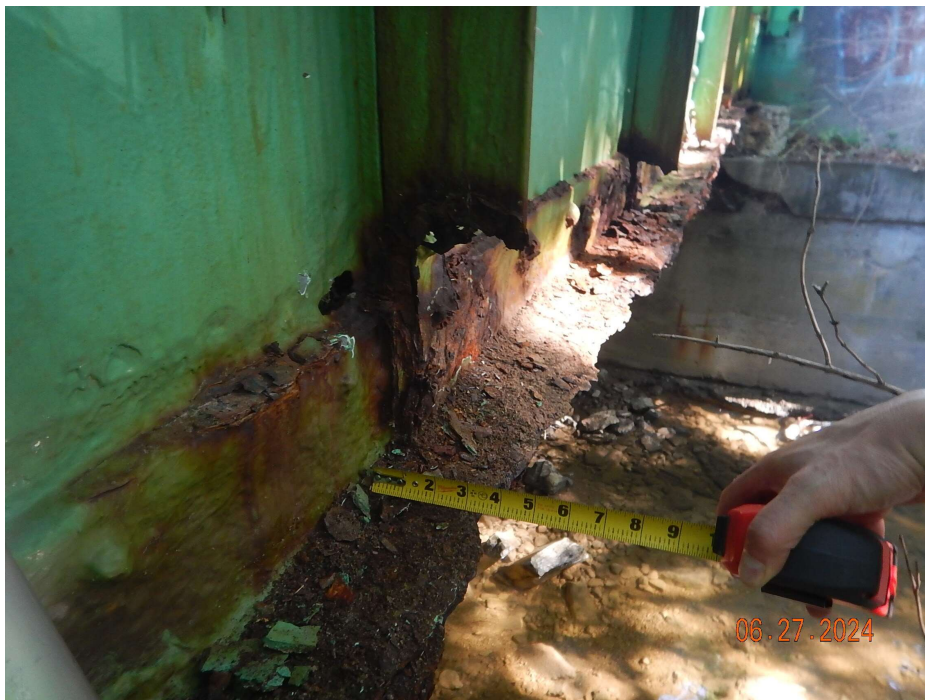
PHOTO 23

Fascia girders have laminar corrosion with section loss to the bottom flange and the top flange, severe bottom flange section loss near beam ends. Bottom plate of built-up exterior girders near midspan note section loss; 1/8" painted over pitting to the webs. 75-100% loss to numerous rivet heads, most severe at exterior girder fascias. Half the length of G4 up to 30% section loss to bottom flange.

Description G1, section loss at midspan

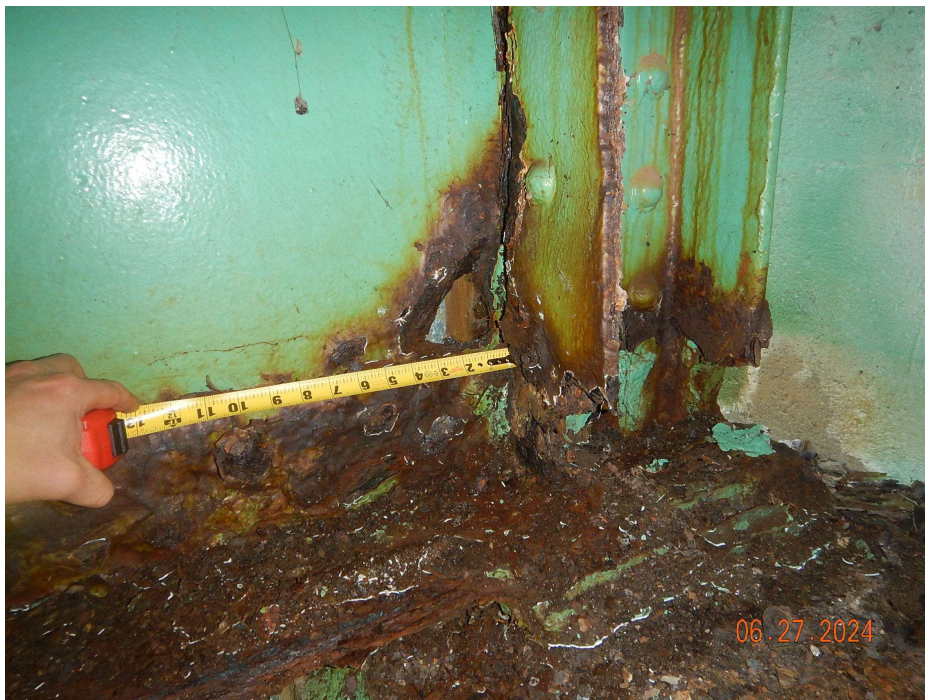
PHOTO 24

- Girder 1: bottom 6-8" of stiffener and 2-4" of top flange and bottom flange at interior face with 100% section loss. Hole (3" x 3") in web near north abutment bearing.
- Girder 4: 3' length from each abutment knife edge corrosion at bottom flange, both sides up to 50% section loss. Missing 3" x 9" portion of bottom flange, interior side. Bearing stiffeners at south abutment 100% loss. 2-4" of top flange and bottom flange at interior face with 100% section loss.

Description G1 near north abutment, 3" diameter hole in web
