Facility Carried: S CASSEL ROAD

## Ohio Bridge Inspection Summary Report

**MOT-T0067-0060 (5765145)**

6: Feature Ints POPLAR CREEK

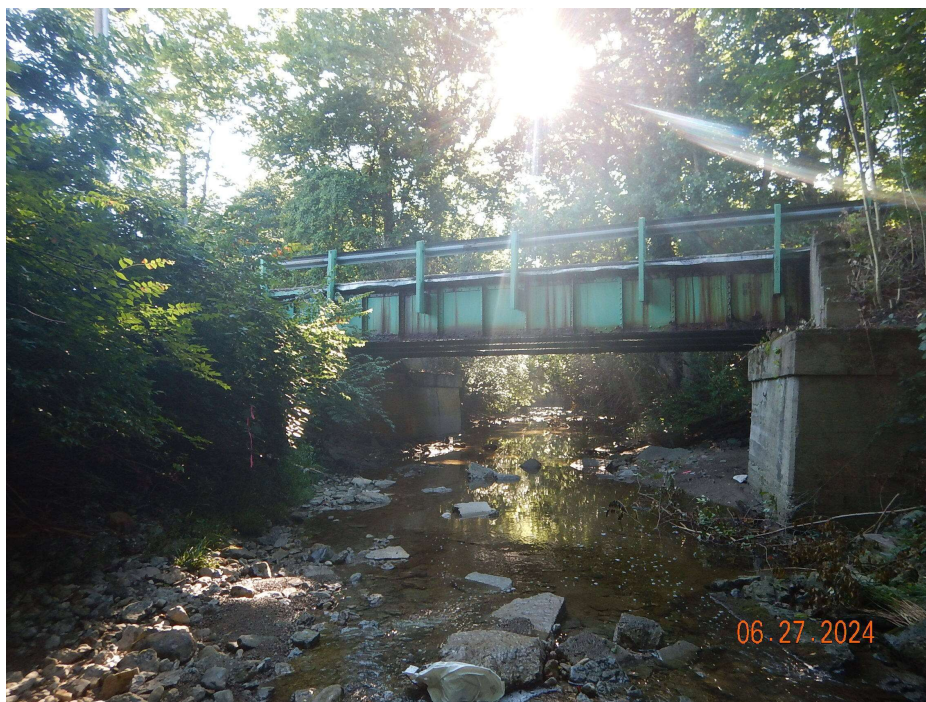
PHOTO 1

Description Upstream elevation

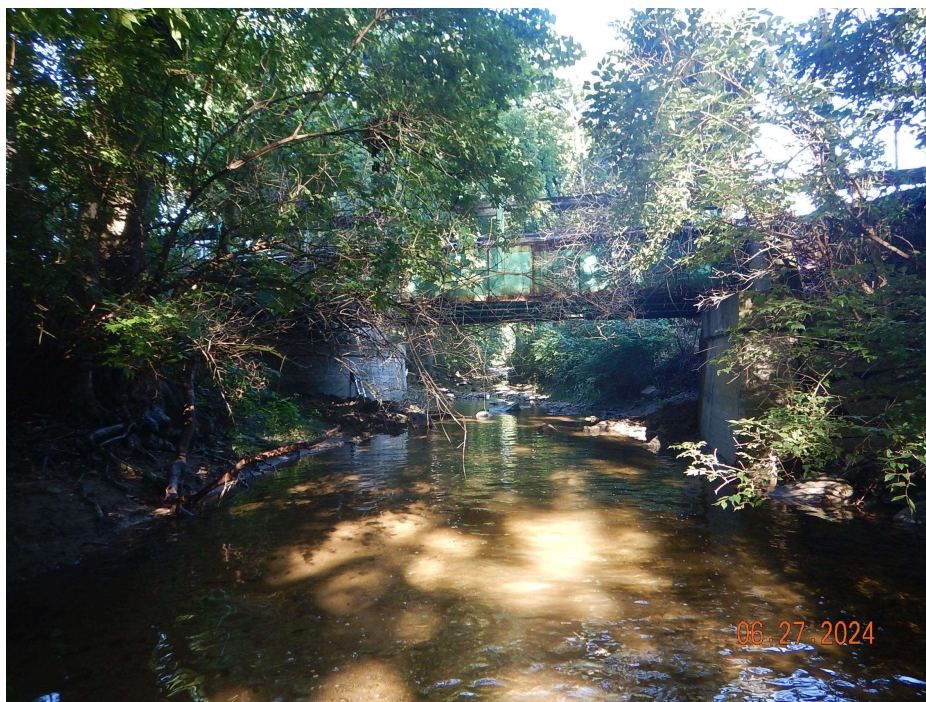
PHOTO 2

Description Downstream elevation

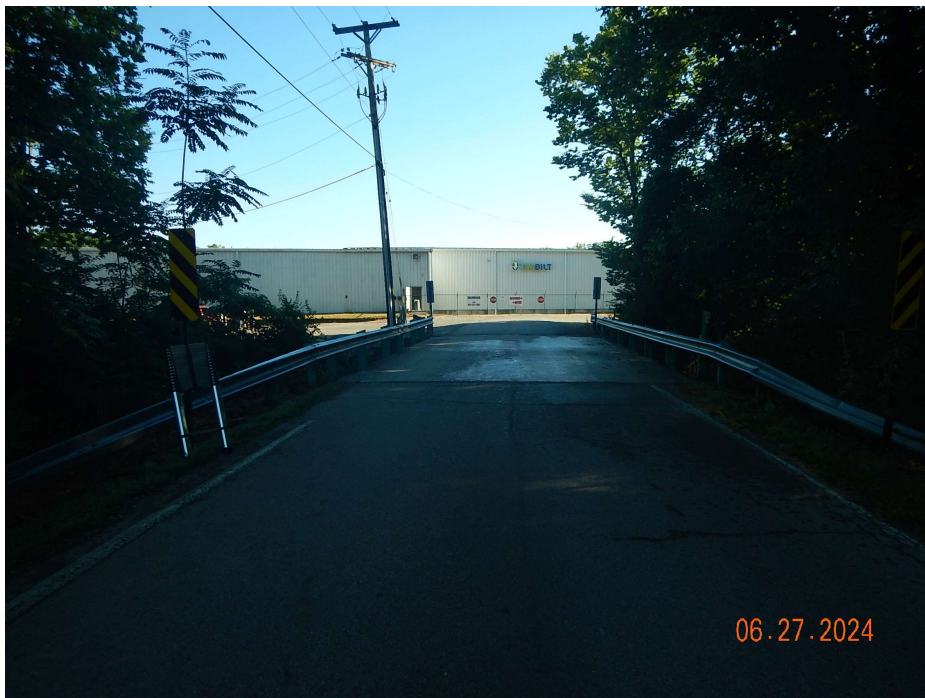
PHOTO 3

Description End view looking north

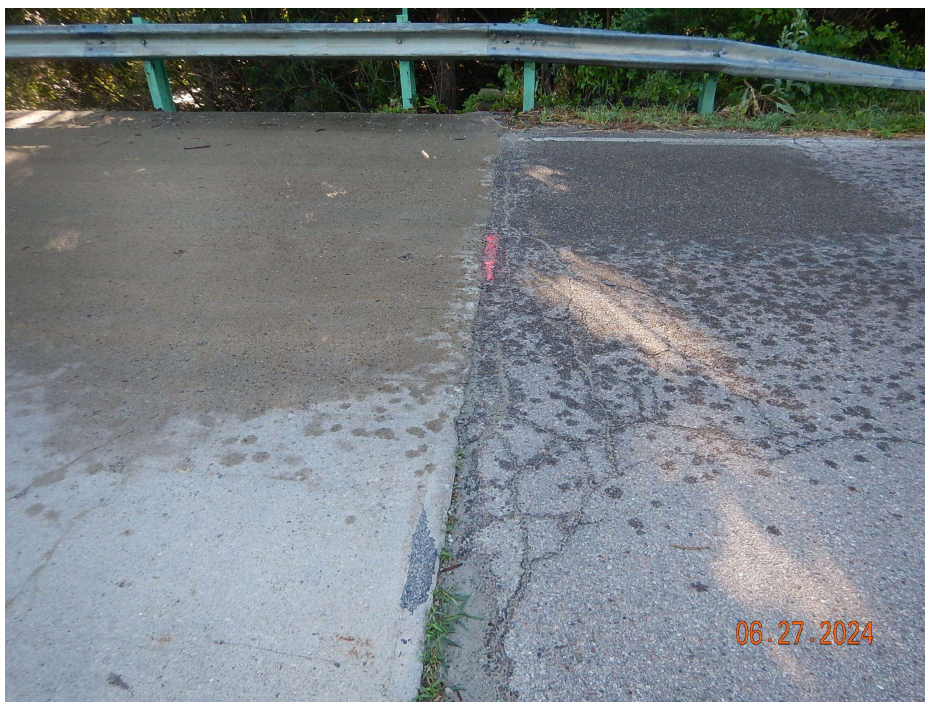
PHOTO 4

Description South bridge limit

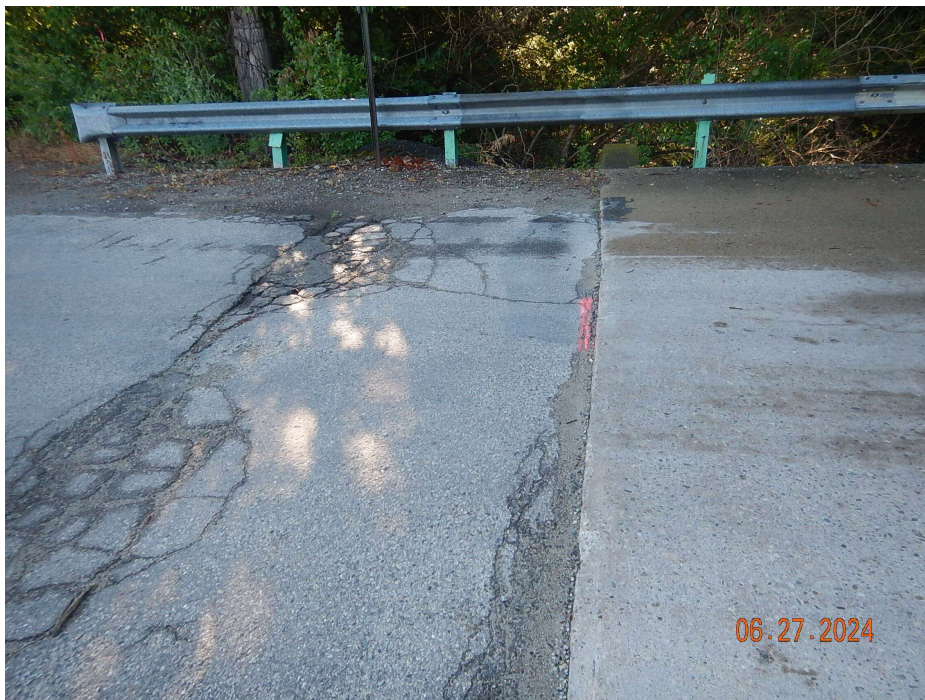
PHOTO 5

Wide map cracking in the wearing surface throughout both approaches. Most severe at north approach. Voids and previous patches have failed at the North approach, potholes forming.

Description North bridge limit

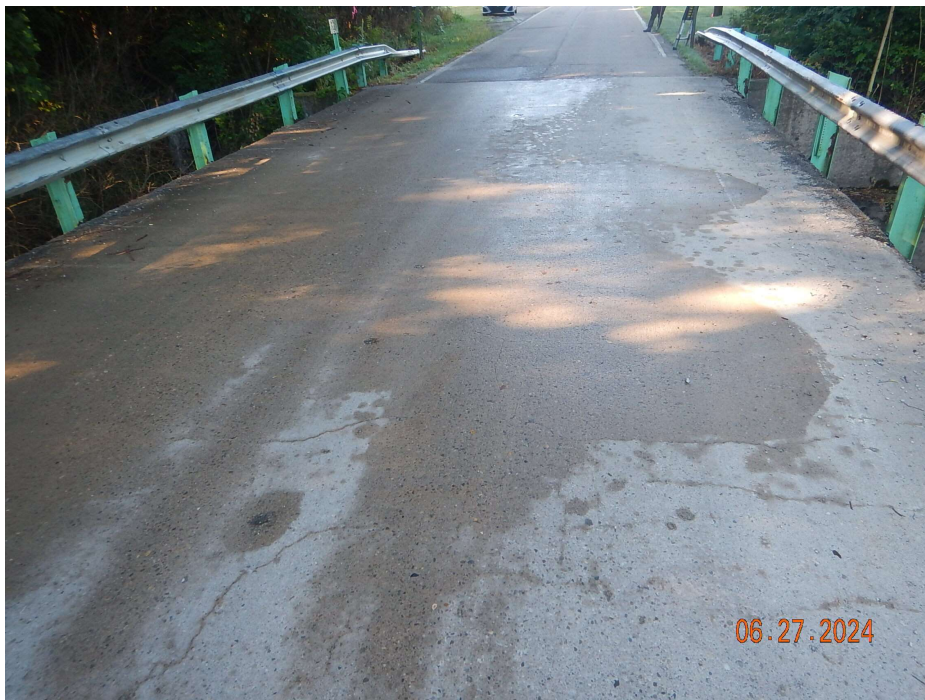
PHOTO 6

Hairline transverse cracks; hairline longitudinal and diagonal cracks at the South; Spalls along East and West edges with previous asphalt patches. Patch along West edge failed and spall for half of bridge length. Full-length spall on East edge.

Description Wearing surface

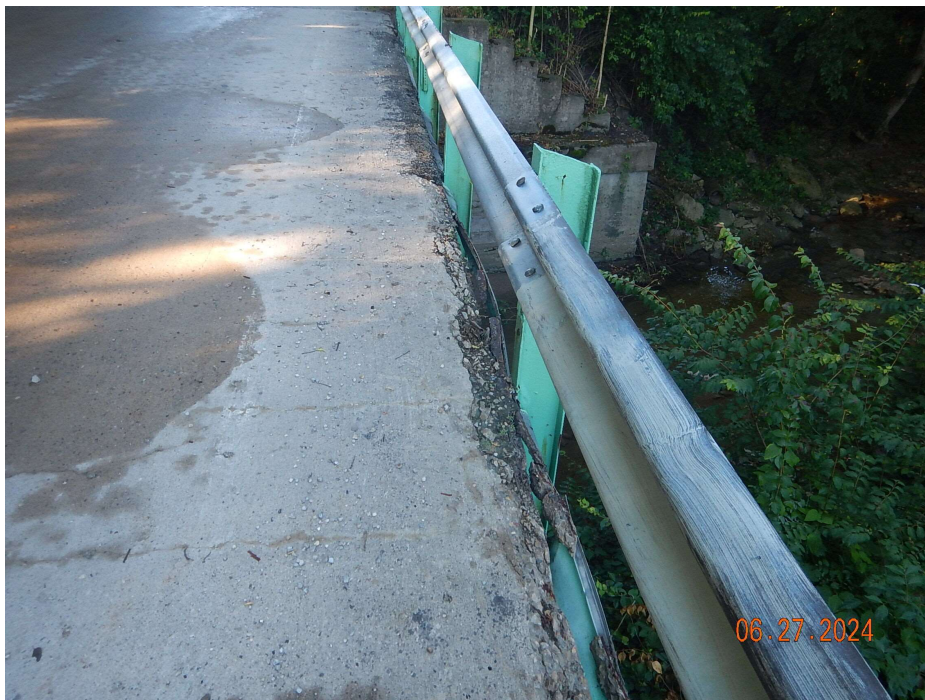
PHOTO 7

Spalling along both fascias, up to 2 reinforcement bars exposed. Spalling along the haunches (typ) partially exposing the top flange in some areas. Top flange laminar corrosion along fascias.

Description West deck edge and railing

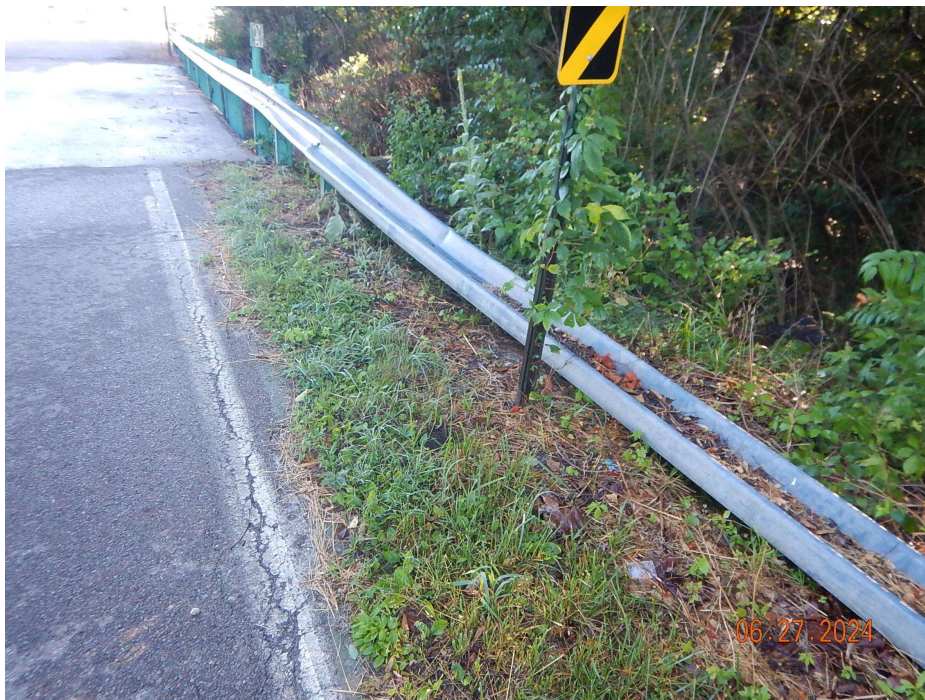
PHOTO 8

Missing post and impact damage at the Southeast. Posts not tall enough and disconnected from rail at Northeast. I beam at southwest termination does not meet requirements.

Description Impact damage at southeast

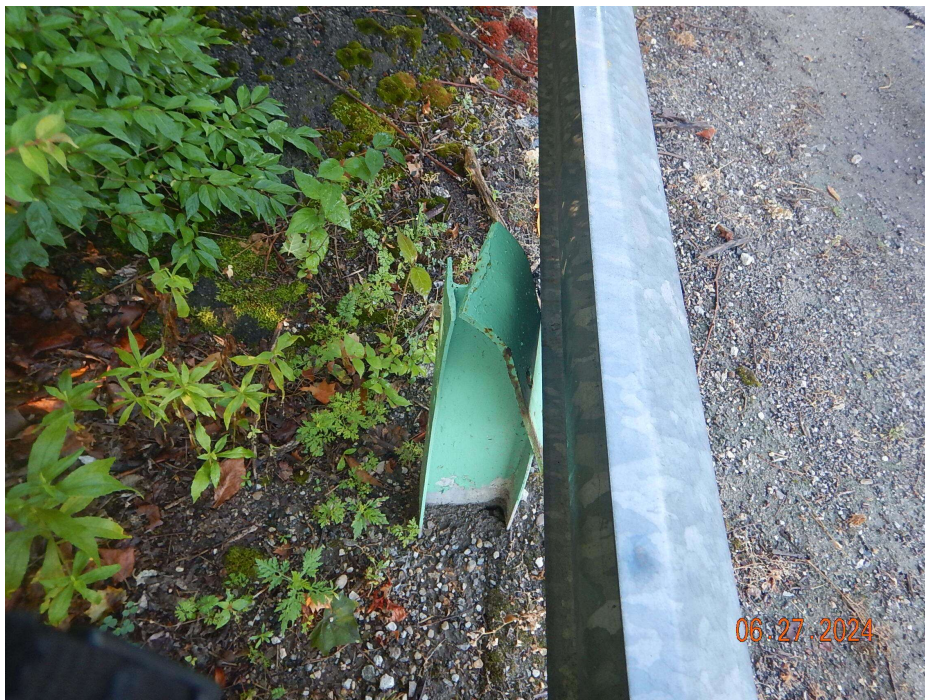
PHOTO 9

Detached rail post at southeast and southwest corners. Multiple posts along both fascias have section loss at top of web and connection I-beam extension.

Description East rail at north detached post

2024: Immediate recommendation: Restore bearing below G1 and G4. Protect abutments and wingwalls with large diameter rock channel protection. It is recommended to program structure for replacement. Replace/repair compromised rail connections.

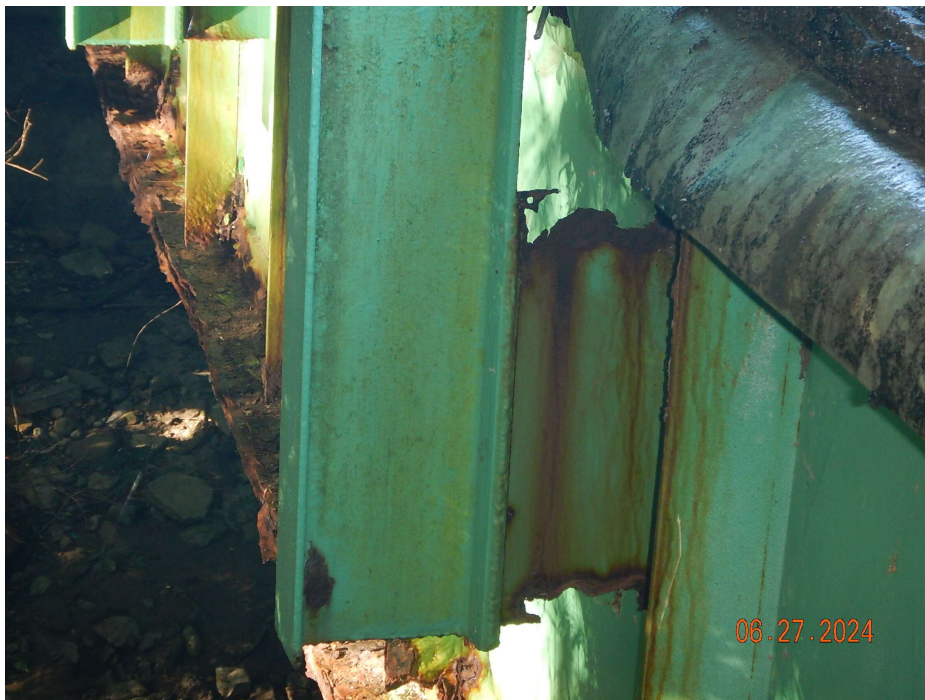
PHOTO 10

Description Rail extension, I beam connection section loss at northeast

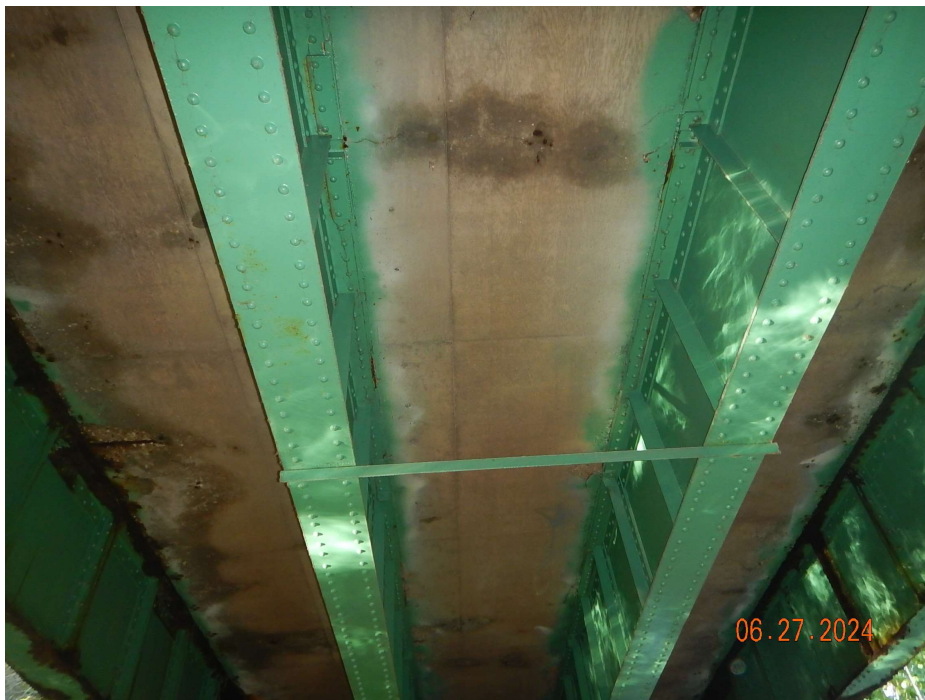
PHOTO 11

Spalling along the haunches typical with exposed rebar at Beams 3 and 4. Heavy saturation on underside of beams at bays 1 and 3, isolated locations in bay 2.

Description Typical underside

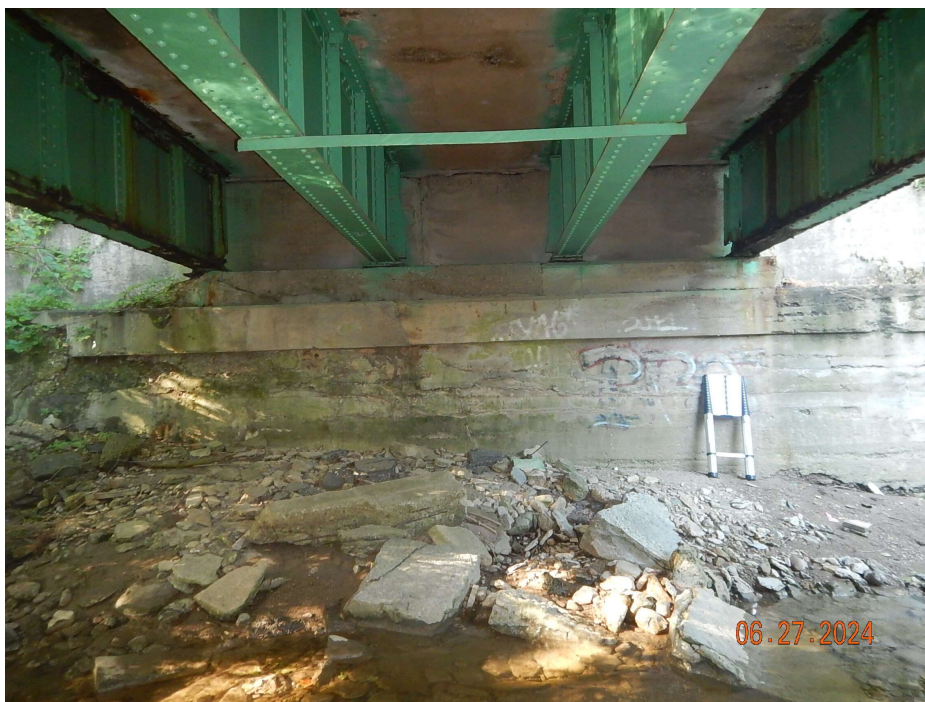
PHOTO 12

There is progressive disintegration of concrete exposing aggregate along the face of abutments, at abutment caps, and beam seats. Severe spalling and cracking under Girder 4 beam seat. Spalling under Girder 1 beam seat at North abutment (negligible loss of bearing, avg 3 ft wide and 4.75 ft tall). Full height spall under Girder 1 on North abutment face, with scaling and unsound concrete surround. Spalling under Girder 4 beam seat on North abutment. Spalling below beam seats in abutment wall typical.

Description South abutment

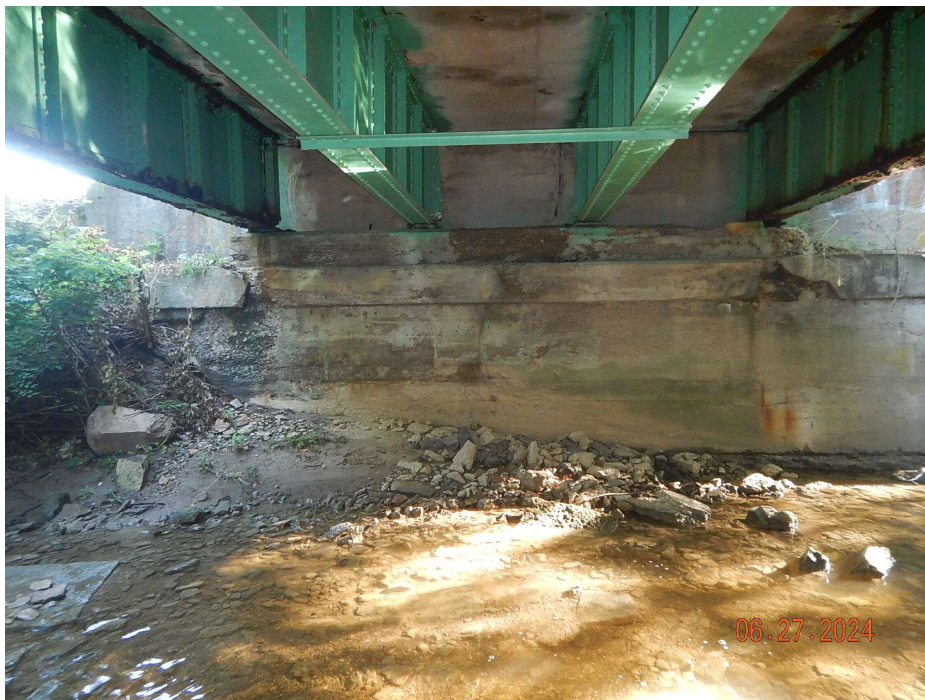
PHOTO 13

Description North abutment

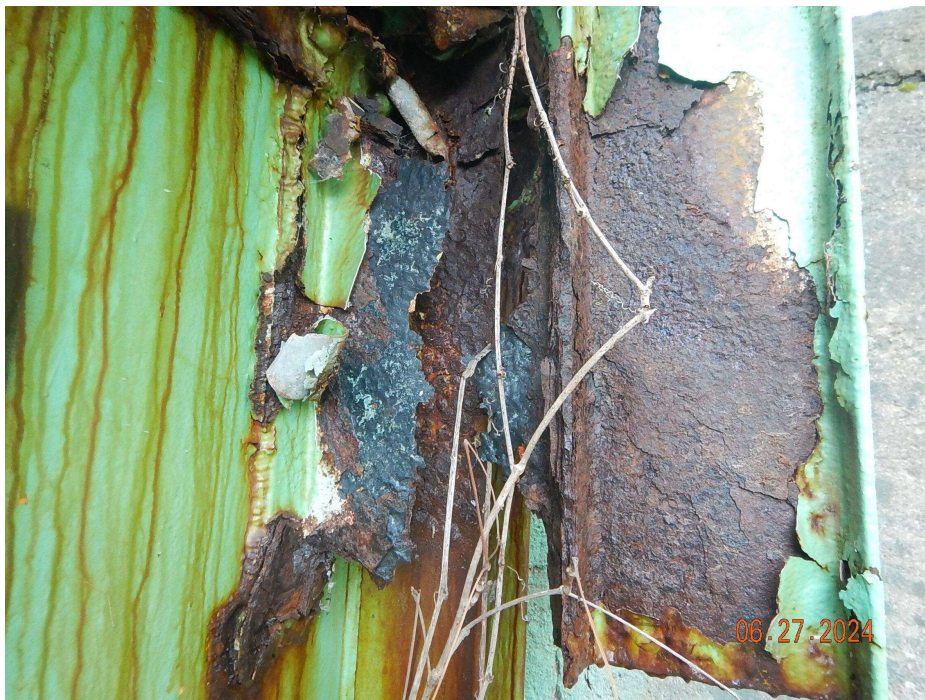
PHOTO 14

Description First post from south abutment, west fascia, note compromised rail post attachment

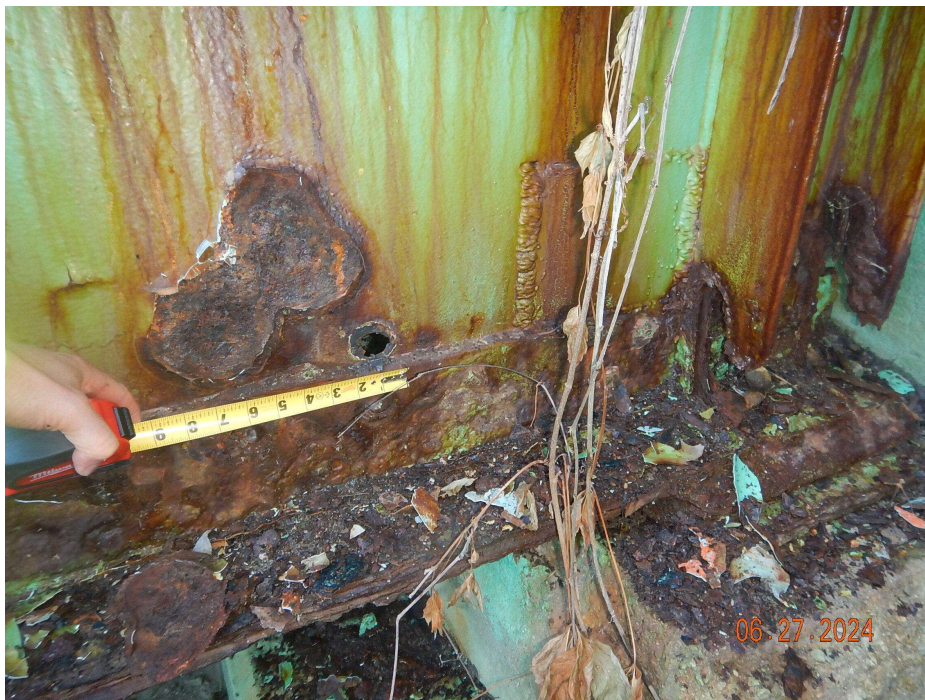
PHOTO 15

- Girder 1, north end, 3.75" corrosion hole in web
- Girder 1, 18" from centerline of bearing, 2" diameter hole surrounded by 1/8" loss (2" x 18").
- Girder 4, near midspan, (3) 2" corrosion holes in the web

Description G1 at south abutment, 2" diameter hole in bottom of web, 18" from centerline of bearing

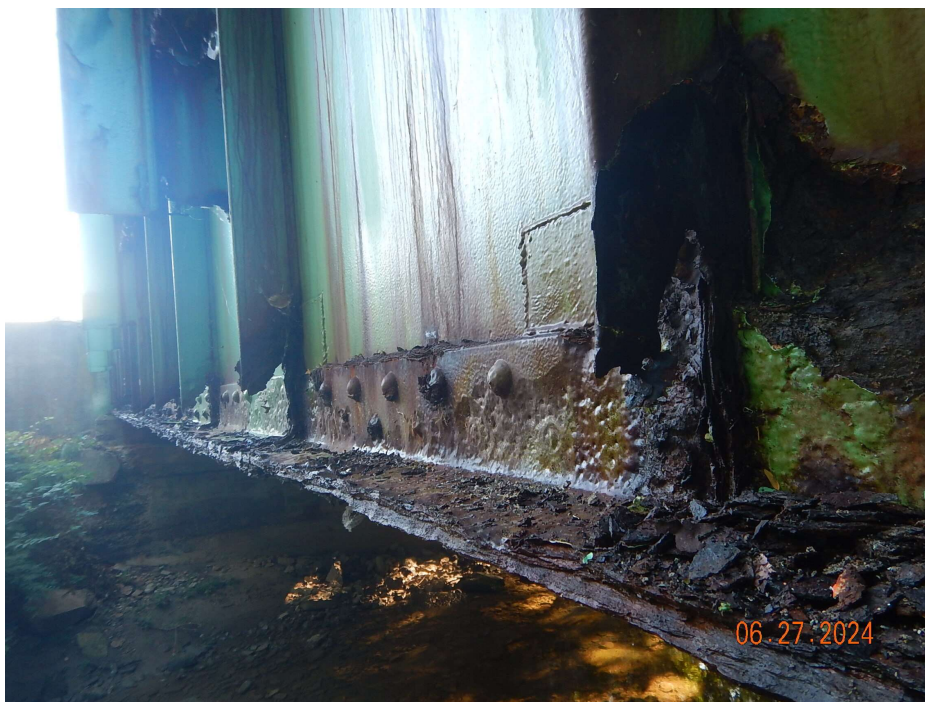
PHOTO 16

- Girder 1, 10 stiffeners at exterior
- Girder 4, all stiffeners at exterior face
- Girder 4, 5 stiffeners at interior face

Description G1, section loss at bottom of transverse stiffeners

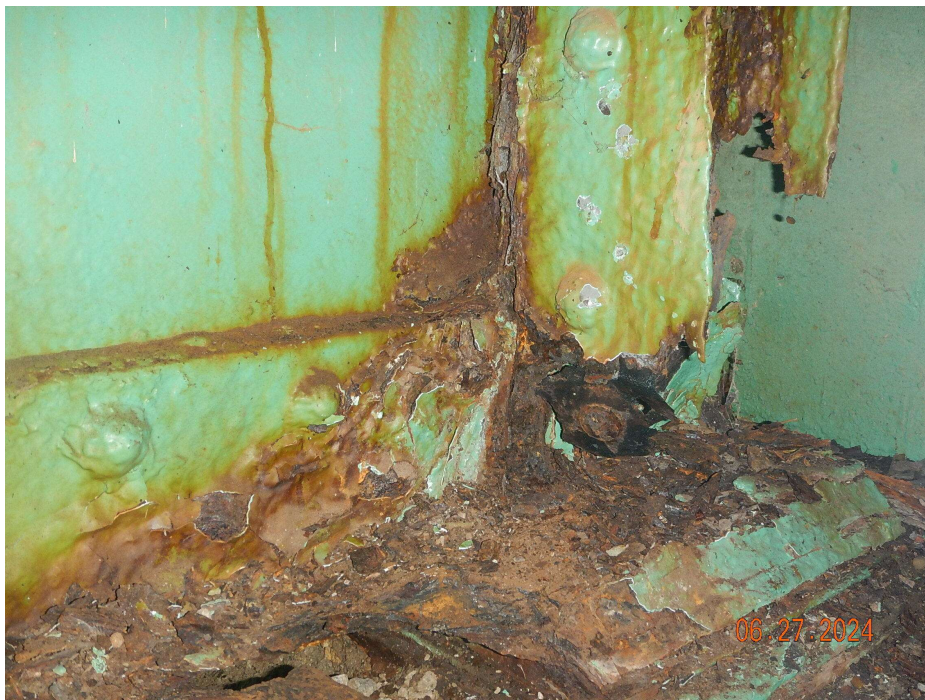
PHOTO 17

- Girder 1: bottom 6-8" of stiffener and 2-4" of top flange and bottom flange at interior face with 100% section loss. Hole (3" x 3") in web near north abutment bearing.
- Girder 4: 3' length from each abutment knife edge corrosion at bottom flange, both sides up to 50% section loss. Missing 3" x 9" portion of bottom flange, interior side. Bearing stiffeners at south abutment 100% loss. 2-4" of top flange and bottom flange at interior face with 100% section loss.

Description G4 at south abutment, note 100% section loss of bottom flange and bearing stiffener

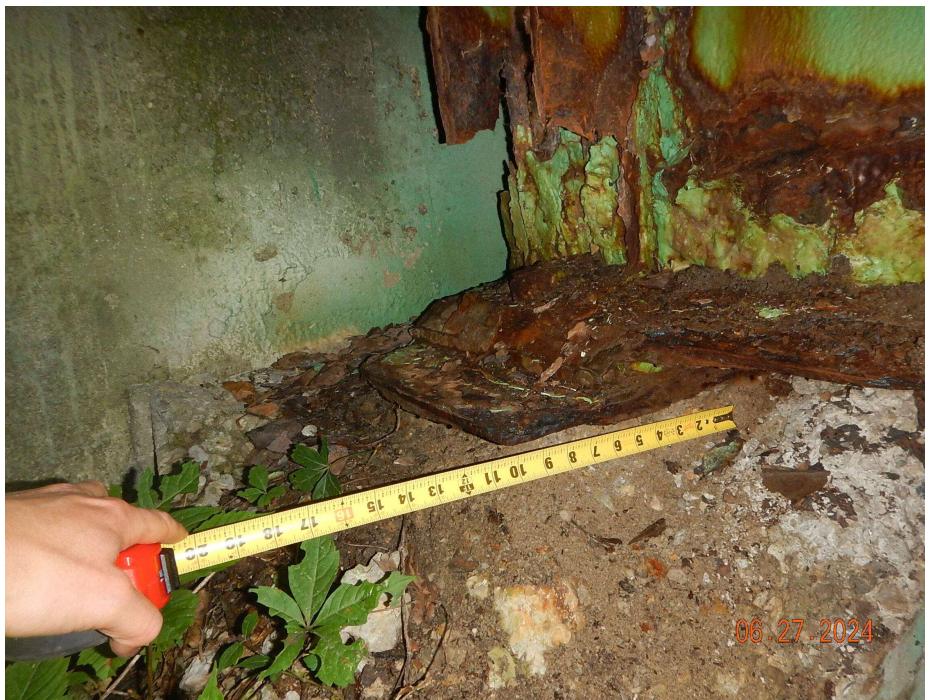
PHOTO 18

Loss of bearing under the masonry plate at both ends of G1, ~25% at South end (14" x 20.5"), ~20% at North end with cracking and spalling extending to lower ledge of abut of Girder 4. Spalling under North end of Girder 1 up to masonry plate. Concrete at bearings is disintegrating, exposing aggregate.

Description Undermined bearings at G4, south abutment

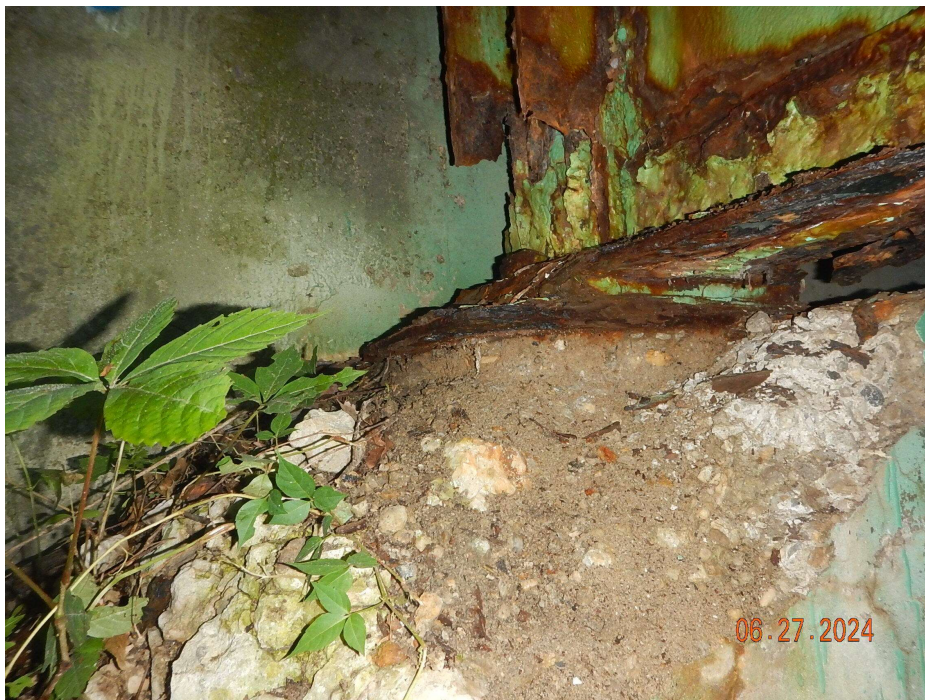
PHOTO 19

Description Undermined bearings at G4, south abutment

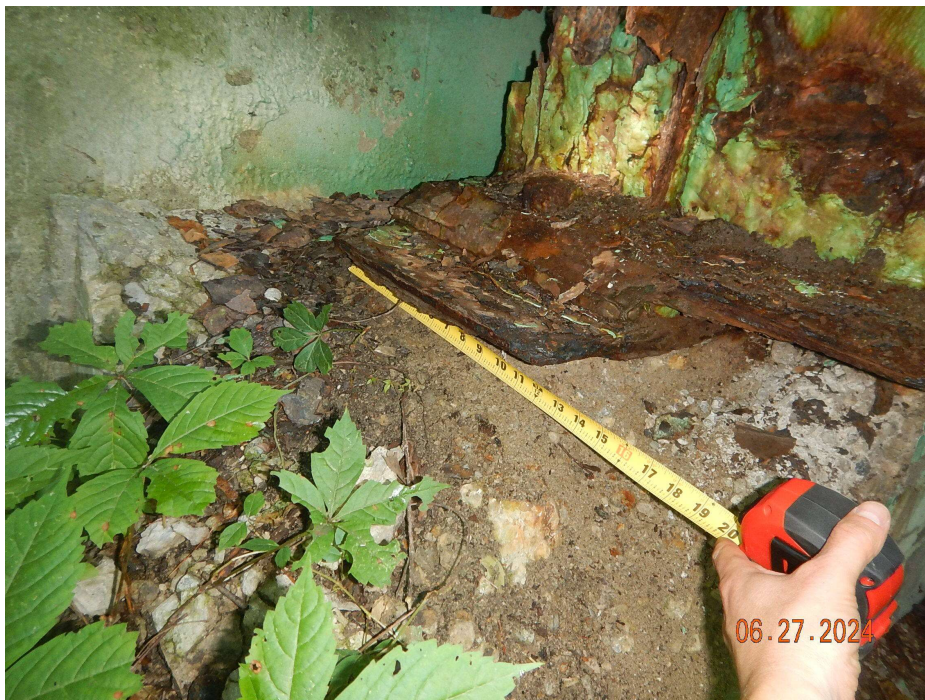
PHOTO 20

Description Undermined bearings at G4, south abutment

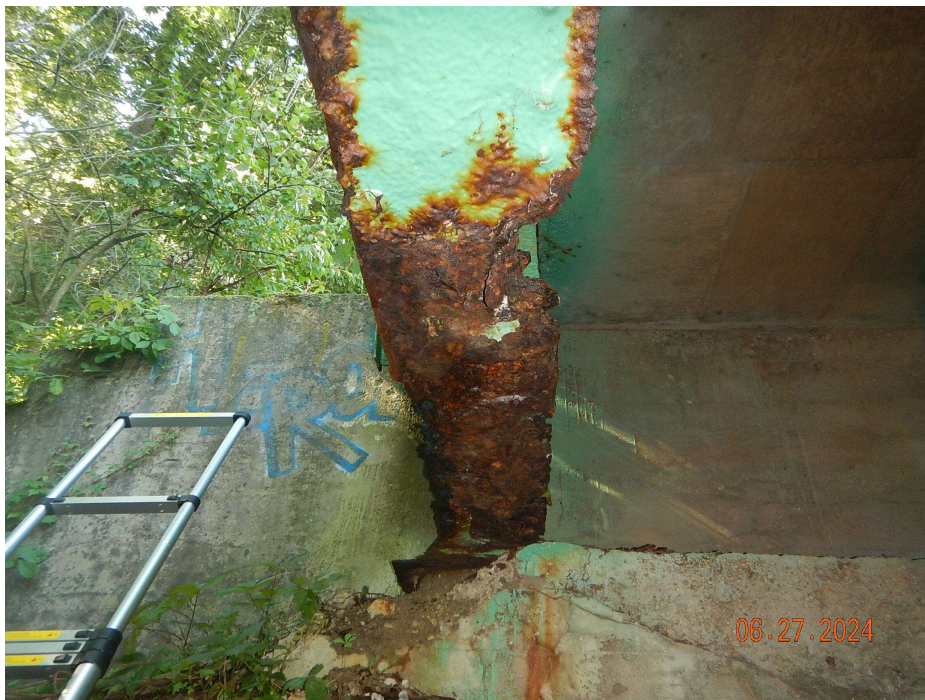
PHOTO 21

Description G4 at south abutment, bottom flange deterioration of end 4', up to 50% loss

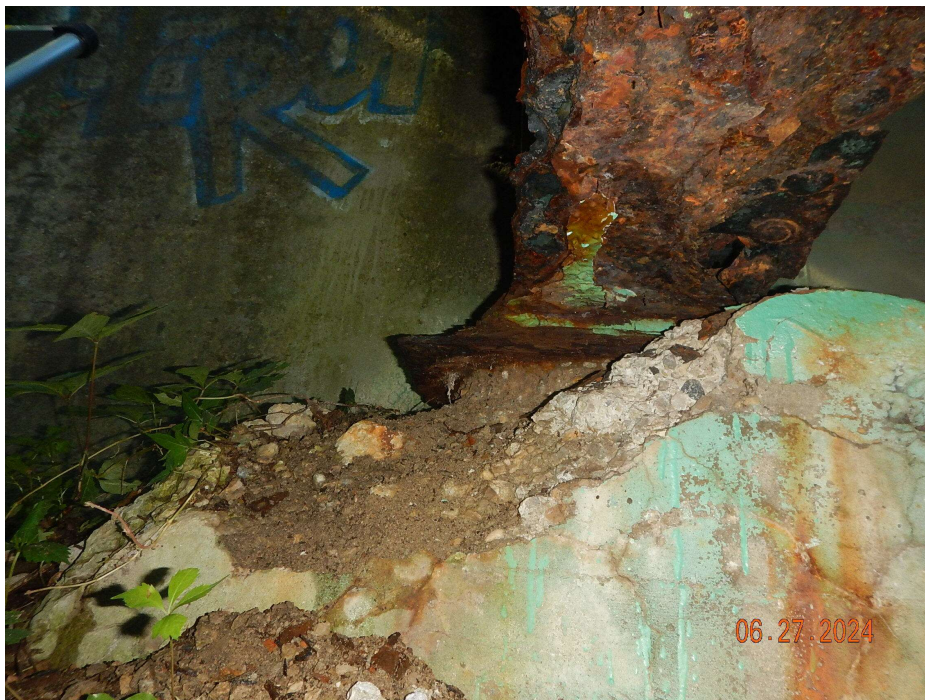
PHOTO 22

2023 Inspection and Load Rating Review: LOS incorporated in load rating is still reasonable, along with the additional factor for poor condition. Corrosion is progressing, but not at an accelerated rate. Biggest concern is the loss of bearing area at the seats.

Description G4, loss of bearing

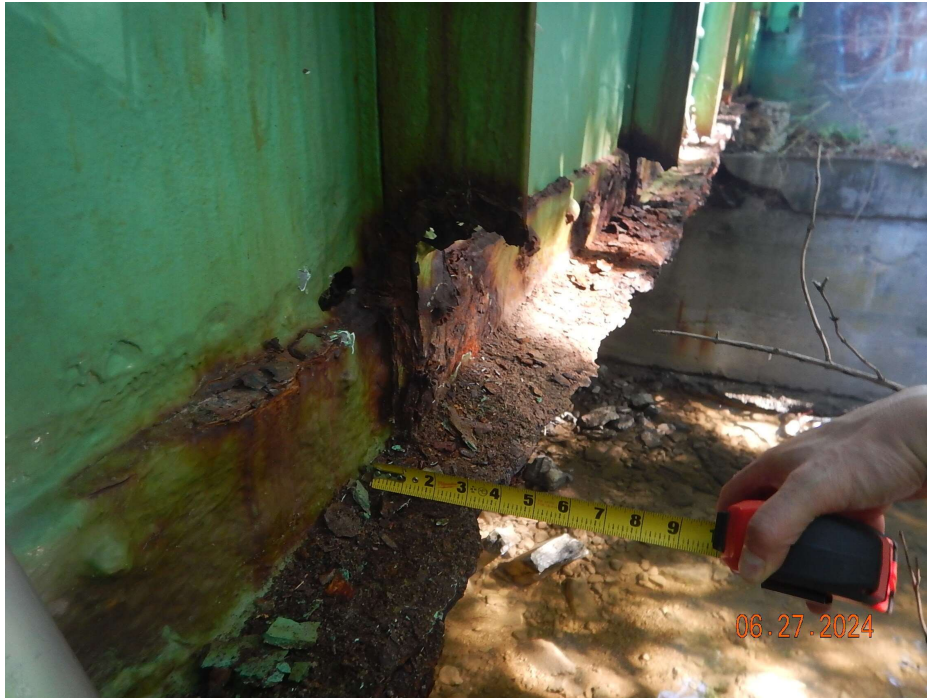
PHOTO 23

Fascia girders have laminar corrosion with section loss to the bottom flange and the top flange, severe bottom flange section loss near beam ends. Bottom plate of built-up exterior girders near midspan note section loss; 1/8" painted over pitting to the webs. 75-100% loss to numerous rivet heads, most severe at exterior girder fascias. Half the length of G4 up to 30% section loss to bottom flange.

Description G1, section loss at midspan

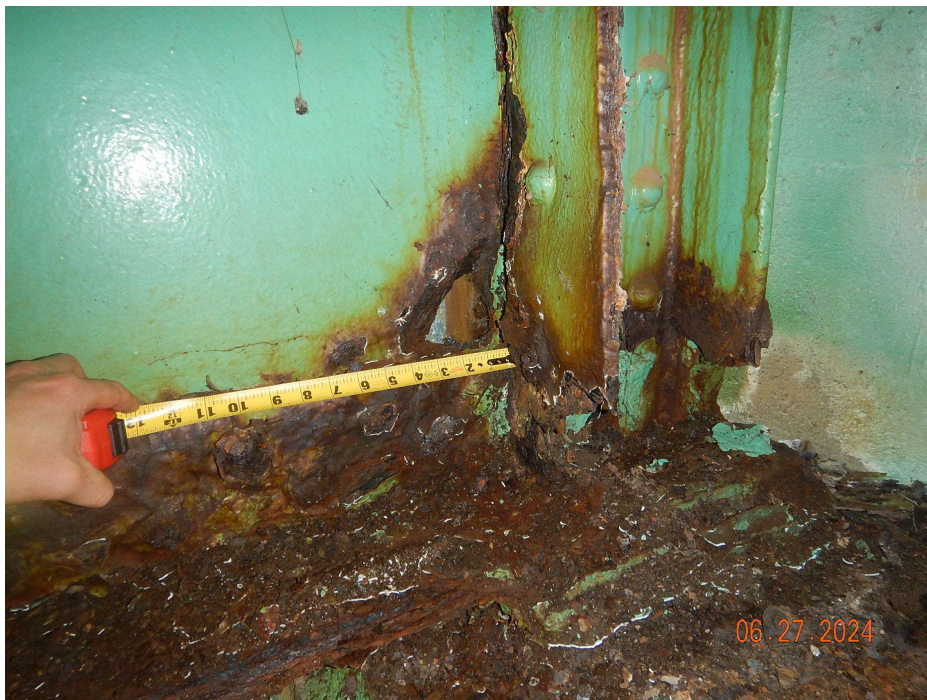
PHOTO 24

Description G1 near north abutment, 3" diameter hole in web

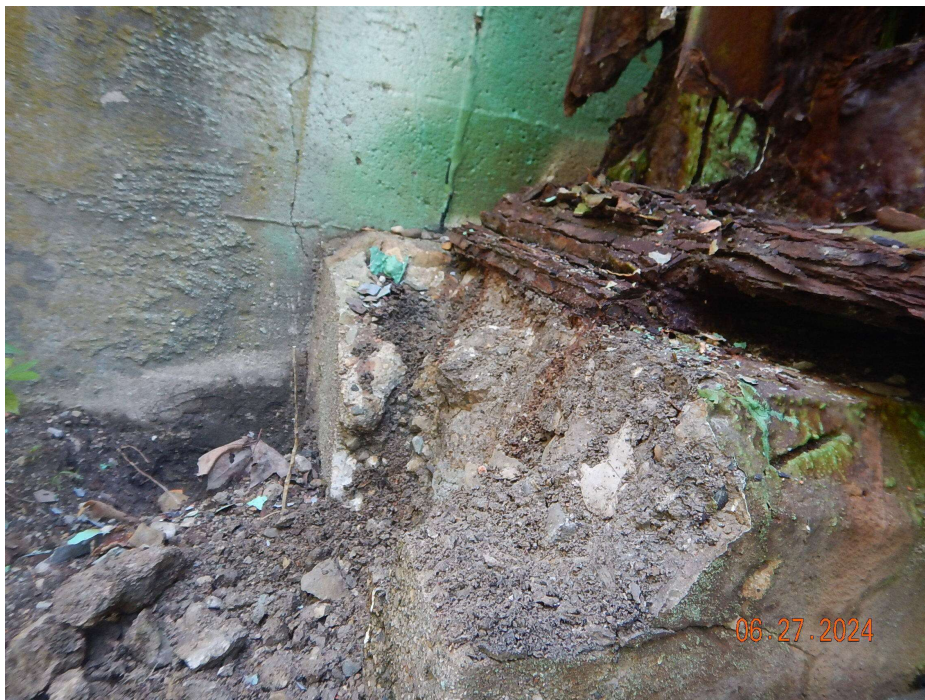
PHOTO 25

Description North abutment, spall under G1

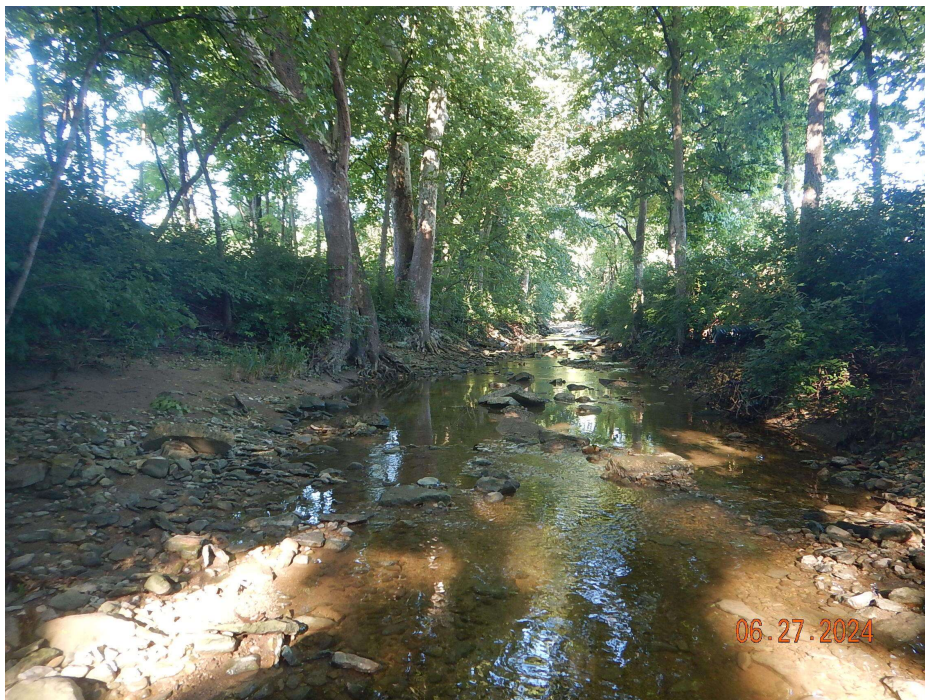
PHOTO 26

Sparse/minimal channel protection upstream and downstream. Some protection near bridge at base of wingwalls.

Description Upstream channel

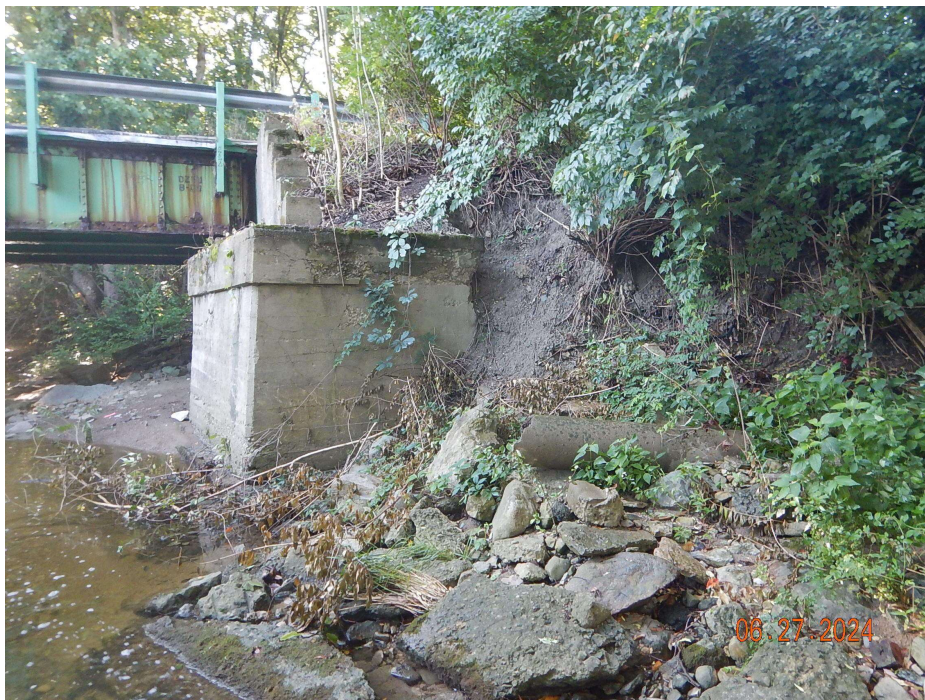
PHOTO 27

Vegetation from the embankment is encompassing the West fascia. Steep embankments and erosion at southeast and southwest corner of structure.

Spalling and cracking typical. Footing exposed at Southwest and Northeast corners. Heavy spalling on backside of southwest wingwall at erosion area.

Description Southwest embankment erosion

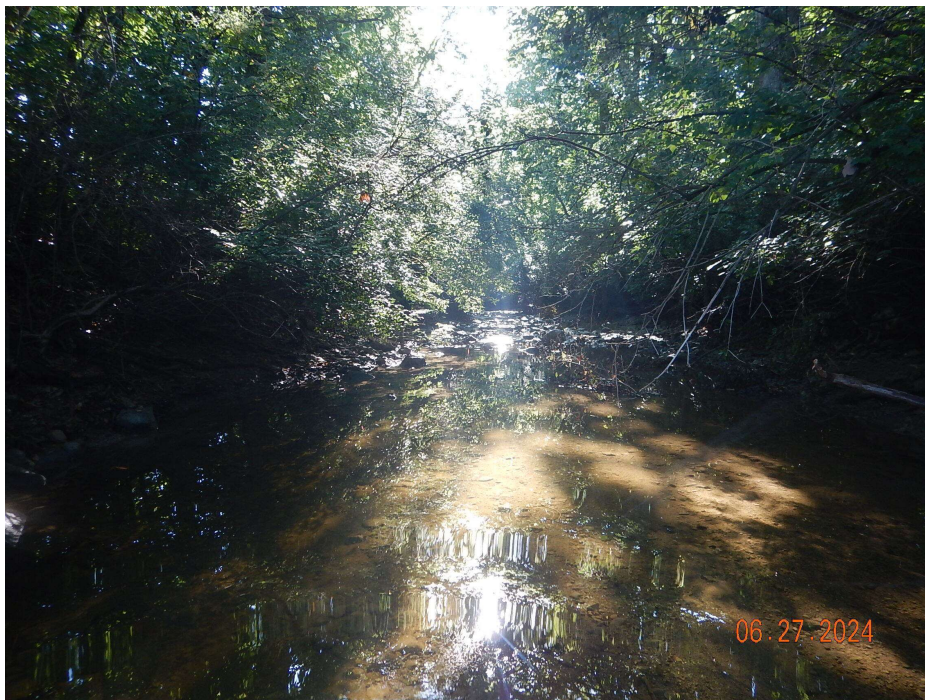
PHOTO 28

Description Downstream channel
