Inspection Date: 06/06/2025

Facility Carried: S CASSEL ROAD

## Ohio Bridge Inspection Summary Report

**MOT-T0067-0060 (5765145)**

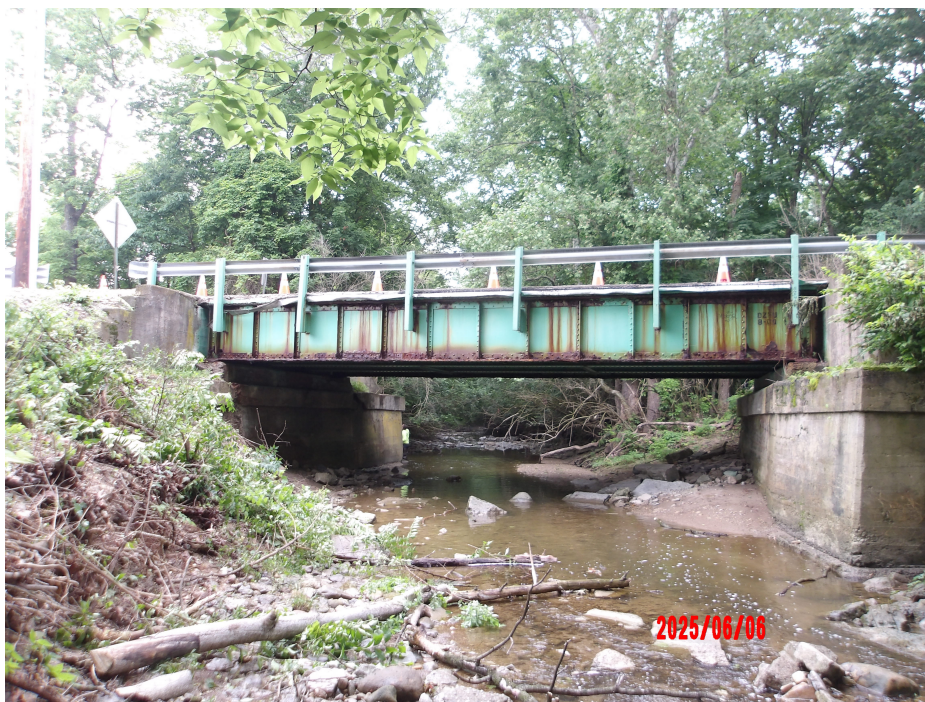
PHOTO 1 Condition

Description Upstream elevation

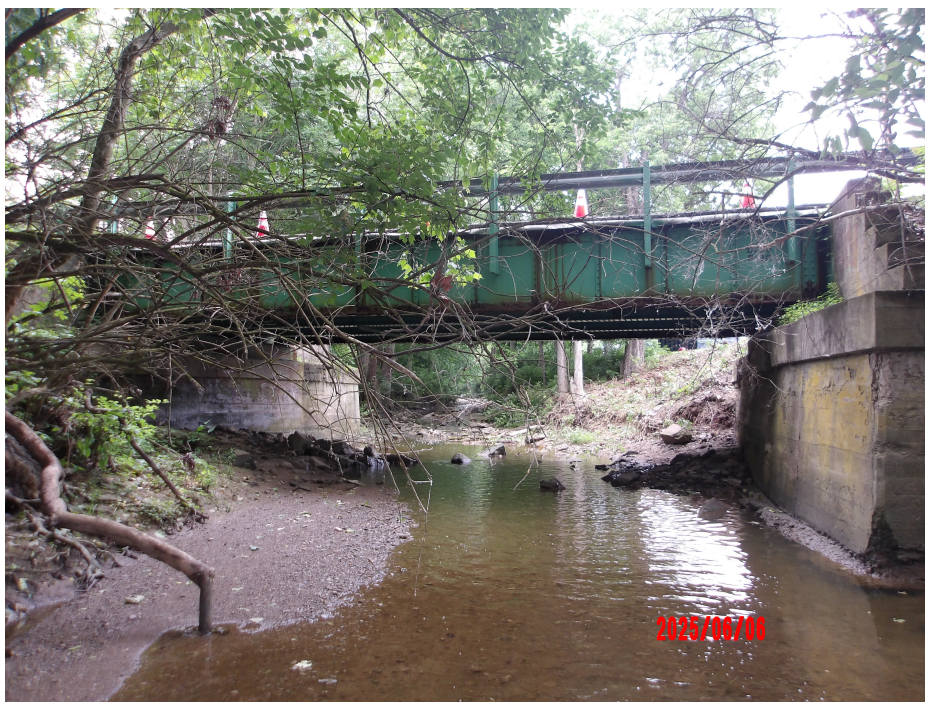
PHOTO 2 Condition

Description Downstream elevation

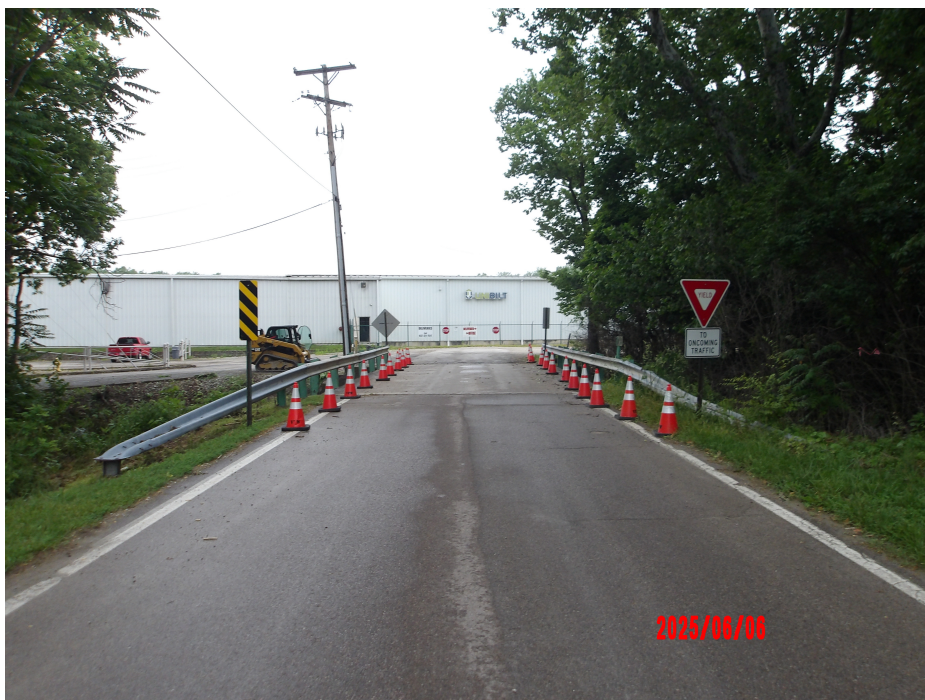
PHOTO 3 Condition  
Description End view looking north

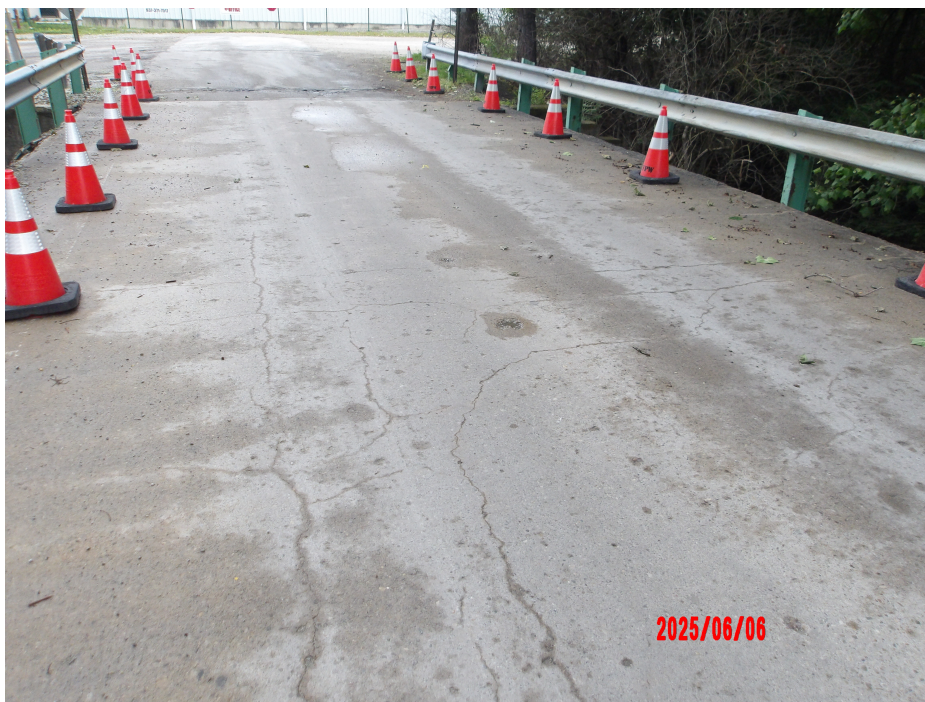
Hairline transverse cracks; hairline longitudinal and diagonal cracks at the south; Spalls along east and west edges with previous asphalt patches. Patch along west edge failed and spall for half of bridge length. Full-length spall on east edge.

PHOTO 4 Condition  
Description Wearing surface

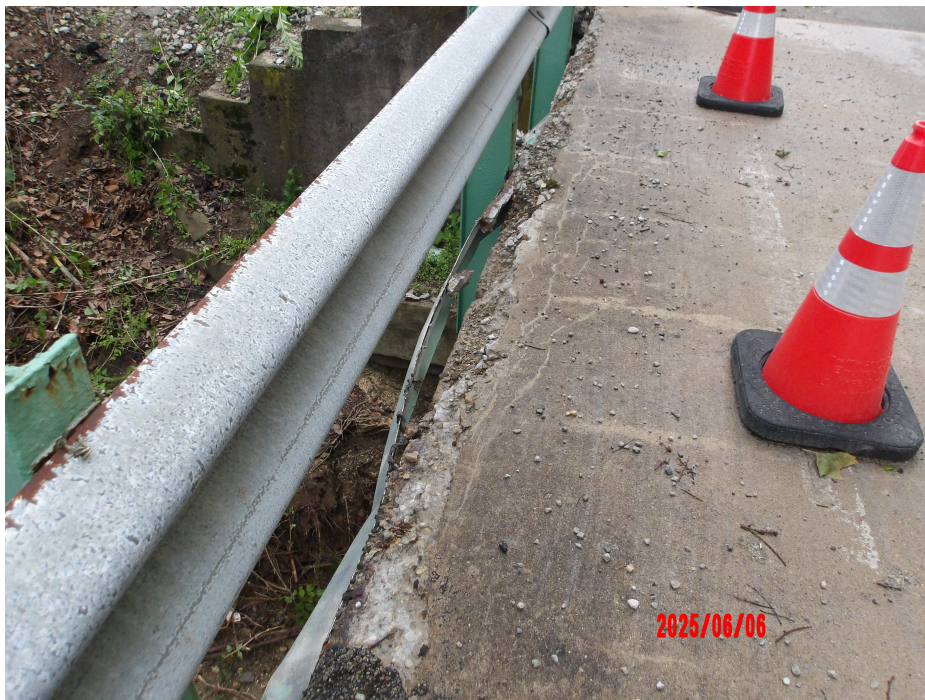
PHOTO 5 Condition

Spalling along both fascia, up to 2 reinforcement bars exposed. Spalling along the haunches (typical) partially exposing the top flange in some areas. Top flange laminar corrosion along both fascia.

Description Unsound concrete along west deck edge

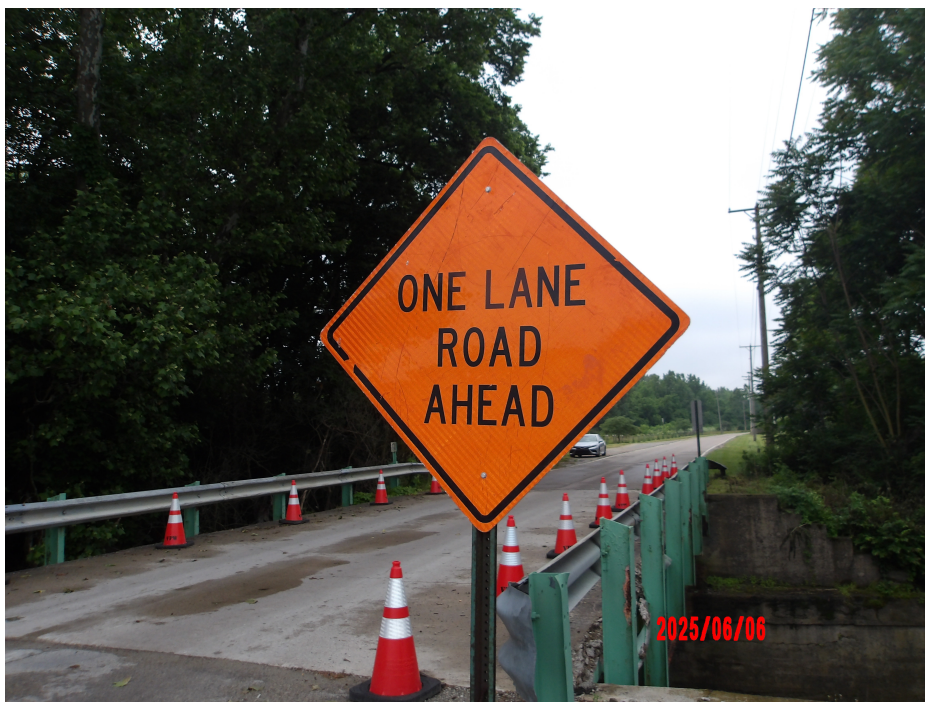
PHOTO 6 Condition

"Yield To Oncoming Traffic" sign at south end, "One Lane Road Ahead" sign at north end, both added since 2024 routine inspection.

Description One lane sign at north approach

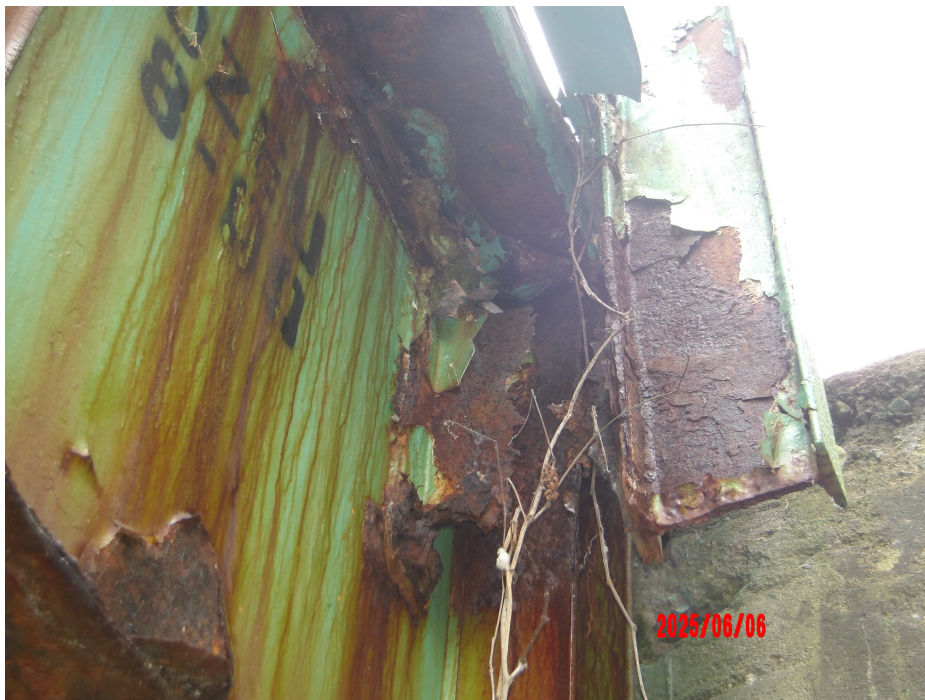
Detached rail post at southeast and southwest corners. Multiple posts along both fascia have section loss at top of web and connection I-beam extension.

PHOTO 7      Condition  
Description      Detached rail post at southwest section bridge

2025: Immediate recommendation: Restore bearing below G1 and G4. Cones were deployed to channel traffic to 1 lane at the center of the bridge, but cones are temporary and can be easily moved/removed. Protect abutments and wingwalls with large diameter rock channel protection. Replace/repair compromised rail connections. Design is underway for replacement bridge (ODOT PID 120484), scheduled for construction Q1 of 2027.

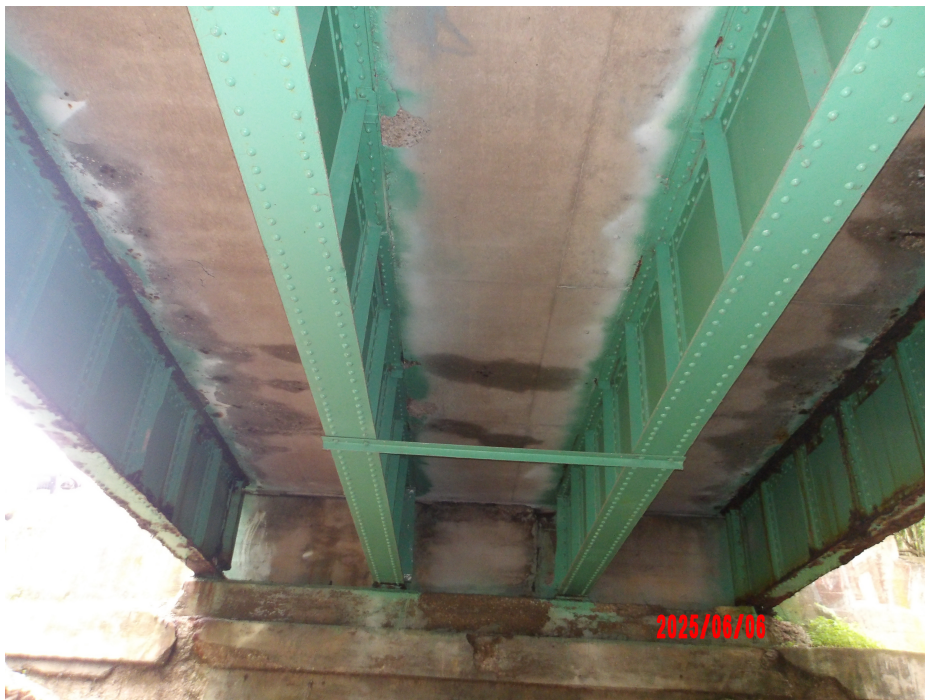
Spalling along the haunches typical with exposed rebar at Beams 3 and 4. Heavy saturation and delamination on underside of deck at Bays 1 & 3, isolated locations in Bay 2.

PHOTO 8      Condition  
Description      Typical underside of bridge

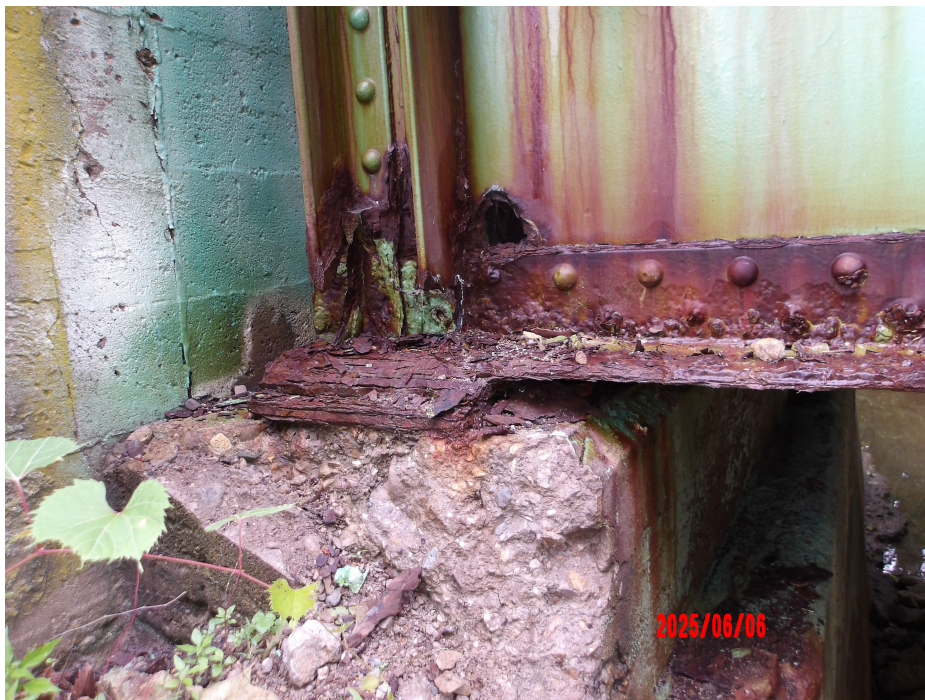
- Girder 1: bottom 6-8" of stiffener and 2-4" of top flange and bottom flange at interior face with 100% section loss. Hole (3" x 3") in web near north abutment bearing.
- Girder 4: 3' length from each abutment knife edge corrosion at bottom flange, both sides up to 50% section loss. Missing 3" x 9" portion of bottom flange, interior side. Bearing stiffeners at south abutment 100% loss. 2-4" of top flange and bottom flange at interior face with 100% section loss.

PHOTO 9 Condition  
Description Girder 1 at north abutment

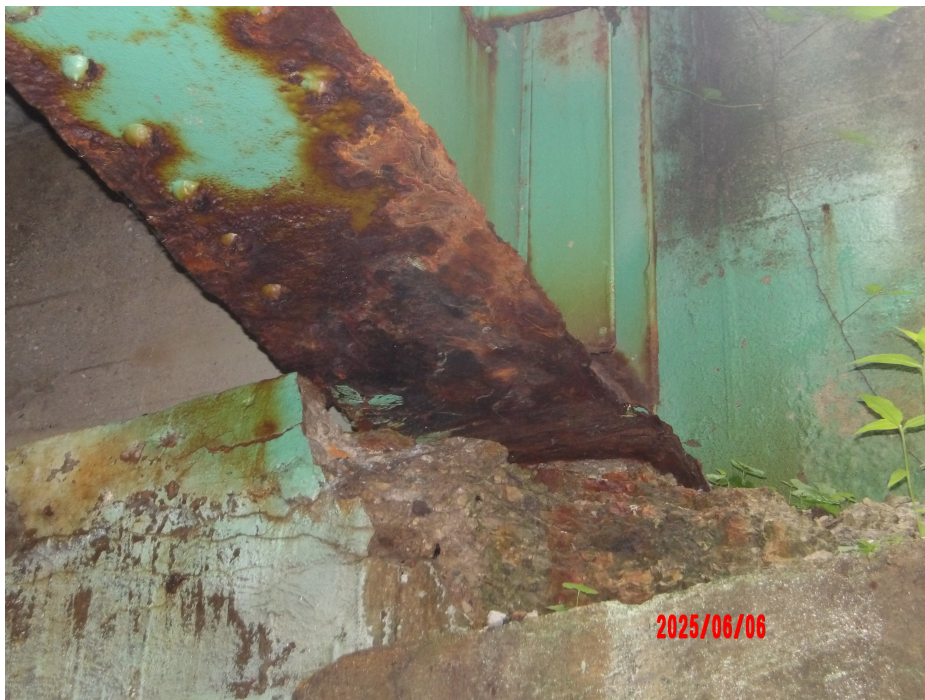
PHOTO 10 Condition  
Description Girder 4 at north abutment

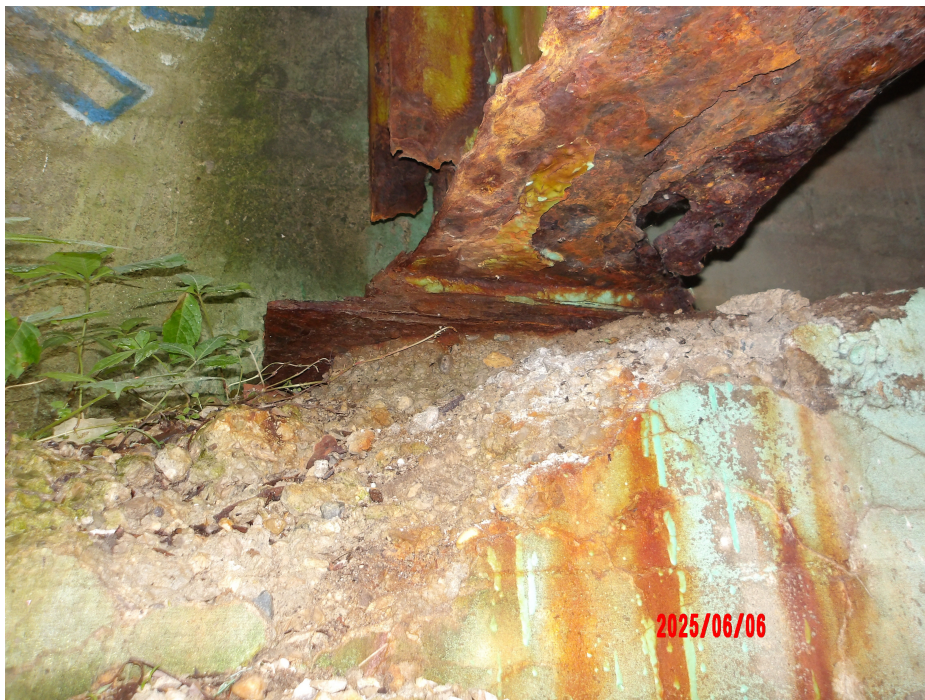
PHOTO 11 Condition  
Description Girder 4 at south abutment

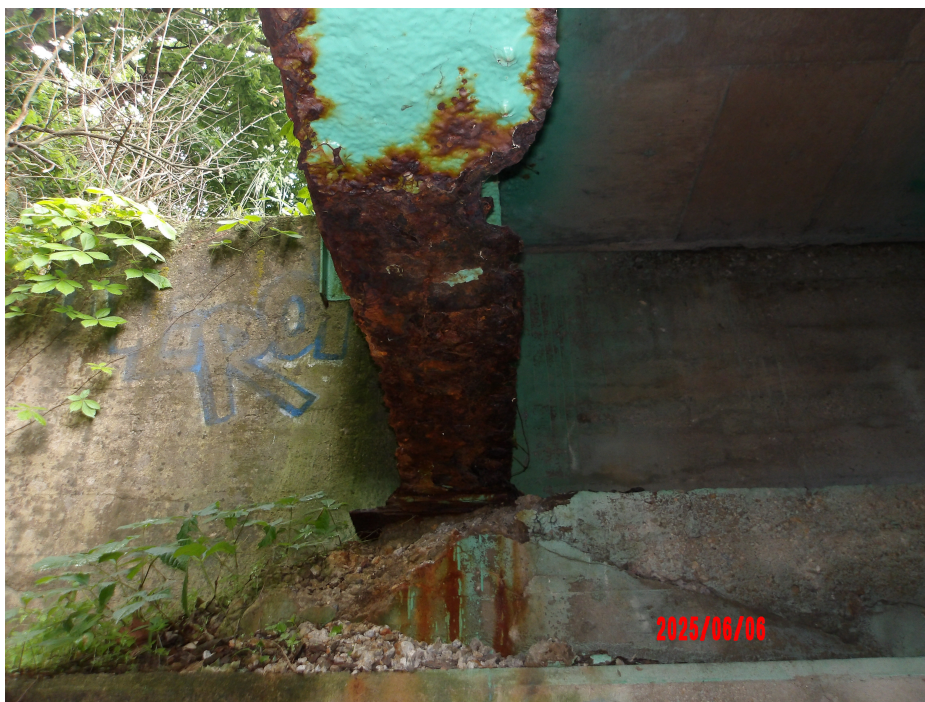
PHOTO 12 Condition  
Description Girder 4 at south abutment

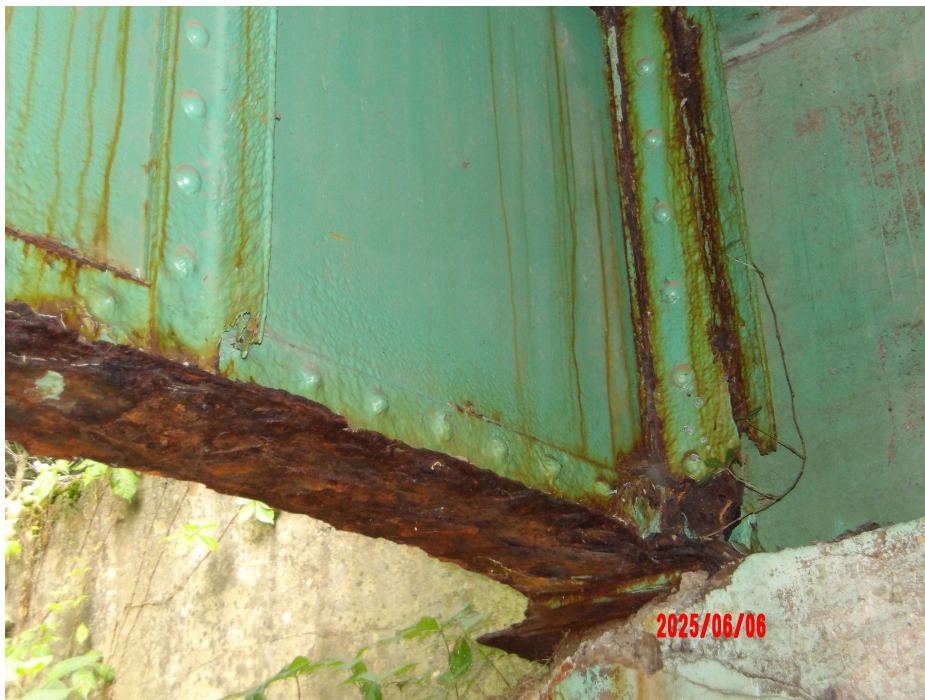
PHOTO 13 Condition

Description Girder 4 at south abutment

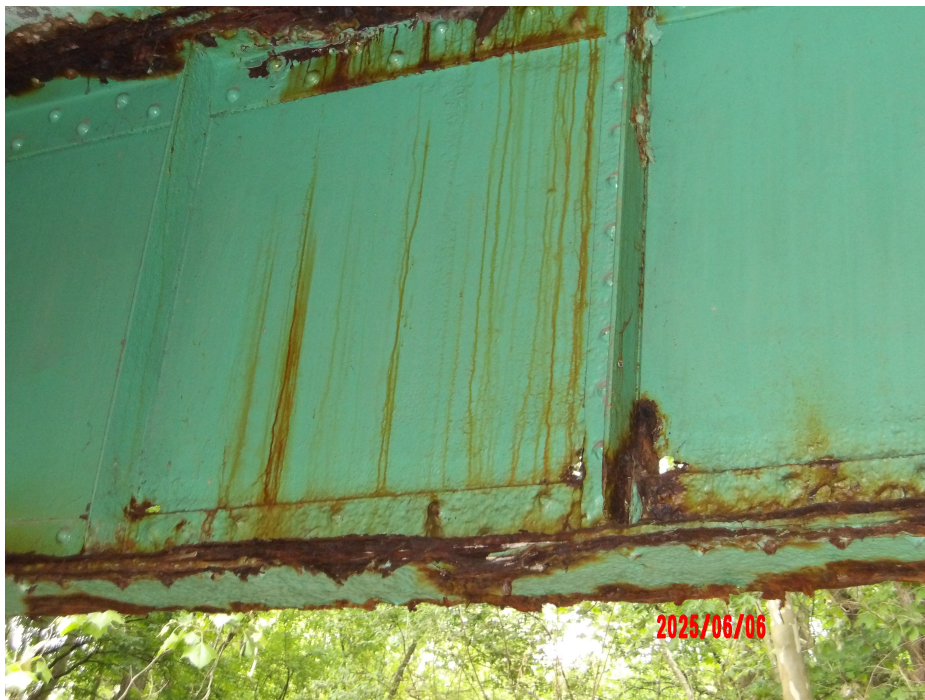
PHOTO 14 Condition

- Girder 1, north end, 3.75" corrosion hole in web
- Girder 1, 18" from centerline of bearing, 2" diameter hole surrounded by 1/8" loss (2" x 18").
- Girder 4, near midspan, (3) 2" corrosion holes in the web

Description Web holes at Girder 4

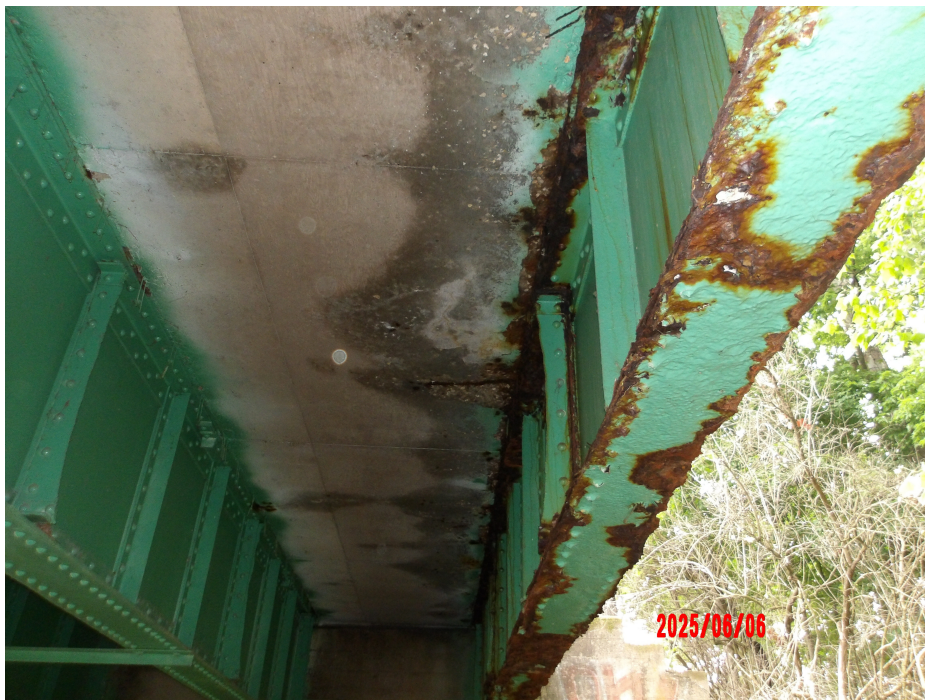
PHOTO 15 Condition

Description Deck saturation at Bay 3

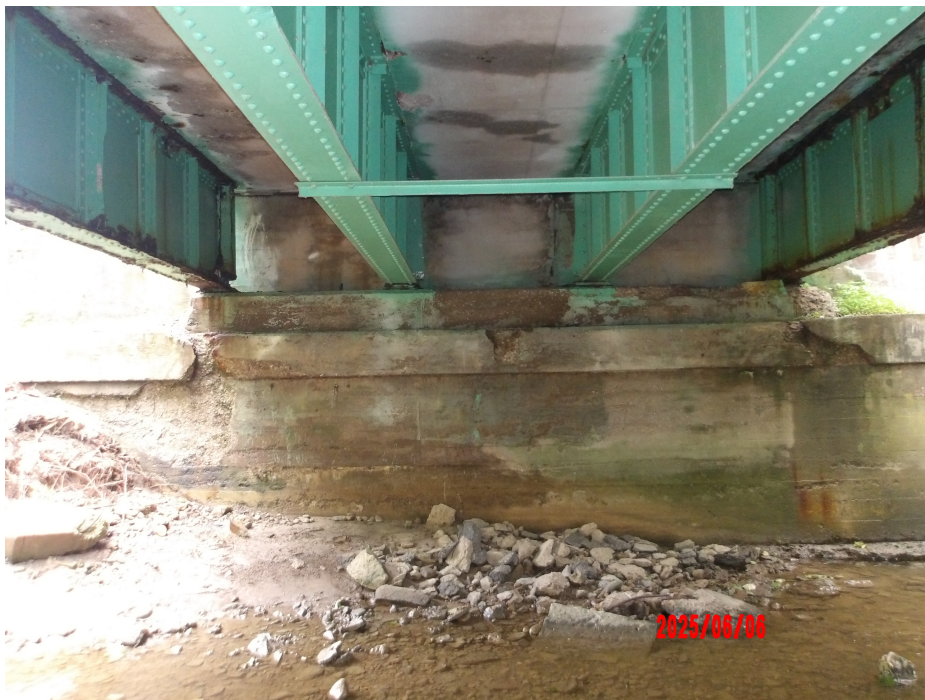
PHOTO 16 Condition

and beam seats. Severe spalling and cracking under Girder 4 beam seats. Spalling under Girder 1 beam seat at north abutment (negligible loss of bearing, avg 3 ft wide and 4.75 ft tall). Full height spall under Girder 1 at north abutment face, with scaling and unsound concrete surround. Spalling under Girder 4 beam seat at north abutment. Spalling below beam seats in abutment wall typical.

Description North abutment

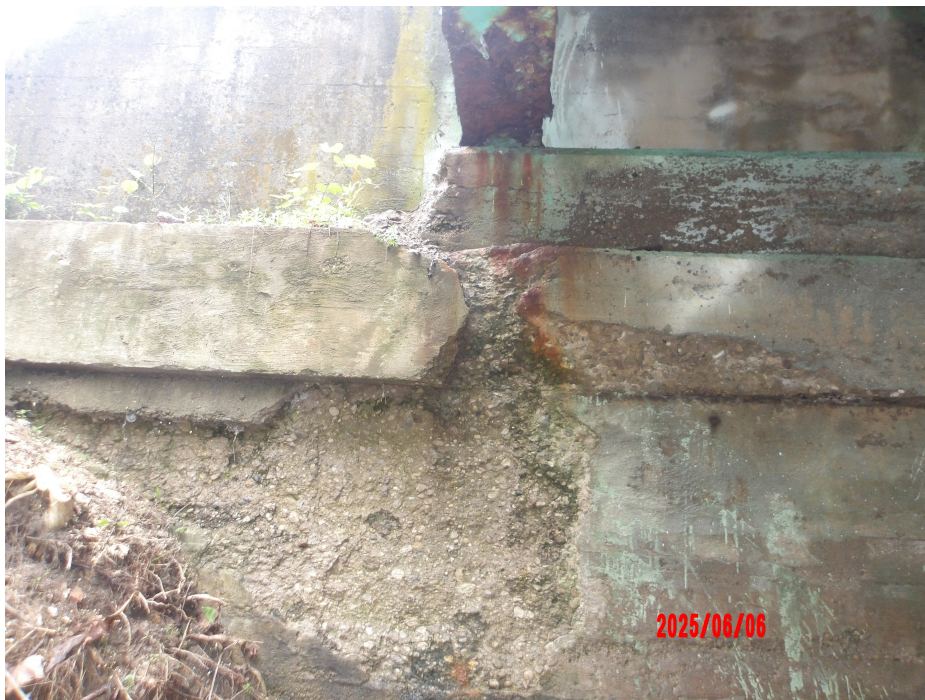
PHOTO 17 Condition

Loss of bearing under the masonry plate at both ends of G1, ~25% at South end (14" x 20.5"), ~20% at North end with cracking and spalling extending to lower ledge of abut of Girder 4. Spalling under north end of Girder 1 up to masonry plate. Concrete at bearings is disintegrating, exposing aggregate.

Description North abutment below Girder 1

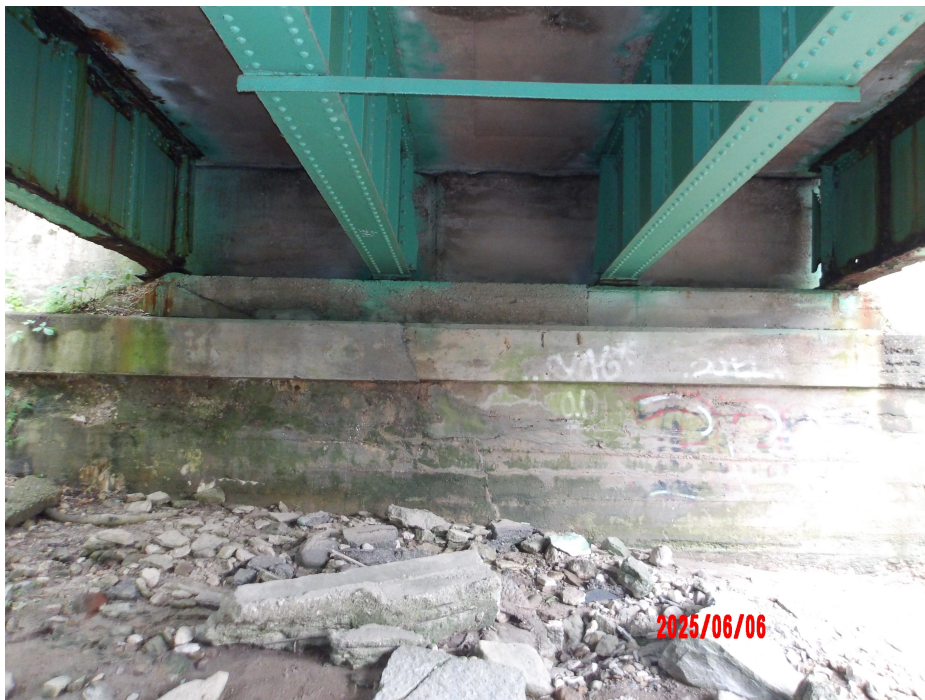
PHOTO 18 Condition

Description South abutment

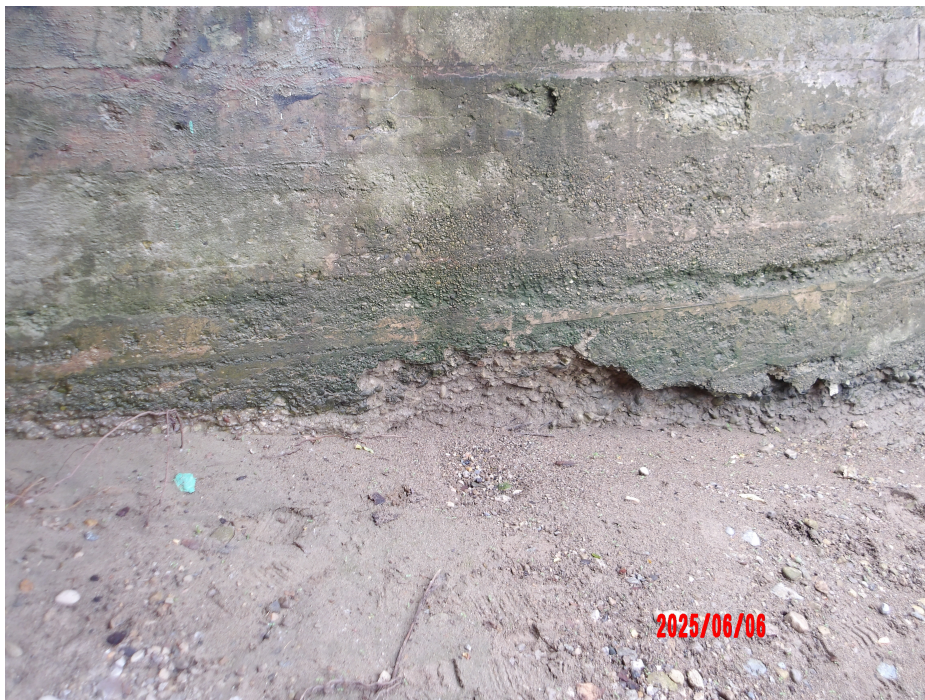
PHOTO 19 Condition

Description Scaling concrete at south abutment below girder 1

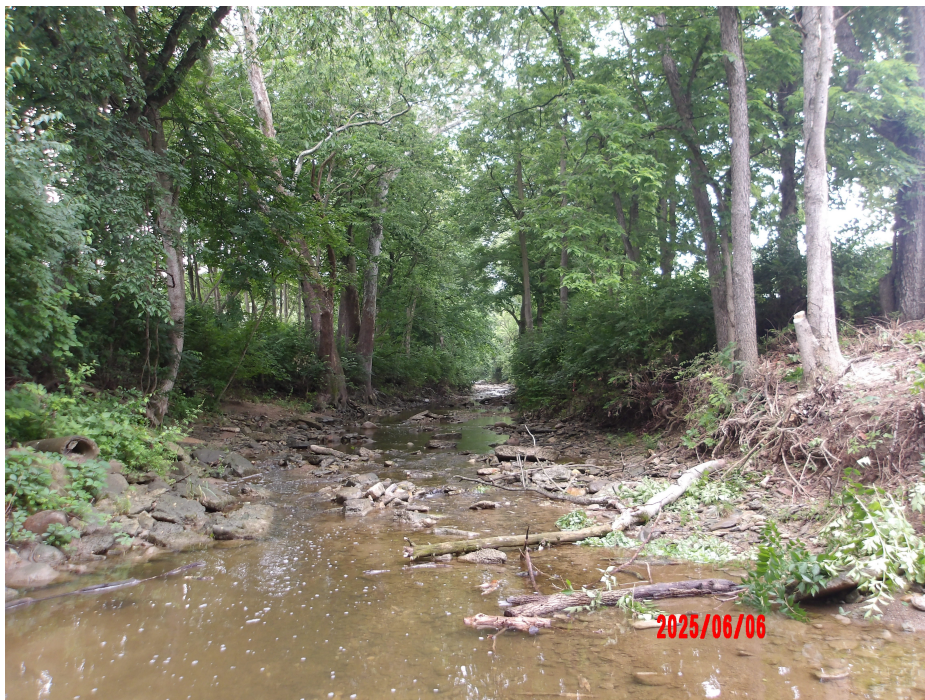
PHOTO 20 Condition

Sparse/minimal channel protection upstream and downstream. Some protection near bridge at base of wingwalls.

Description Upstream channel

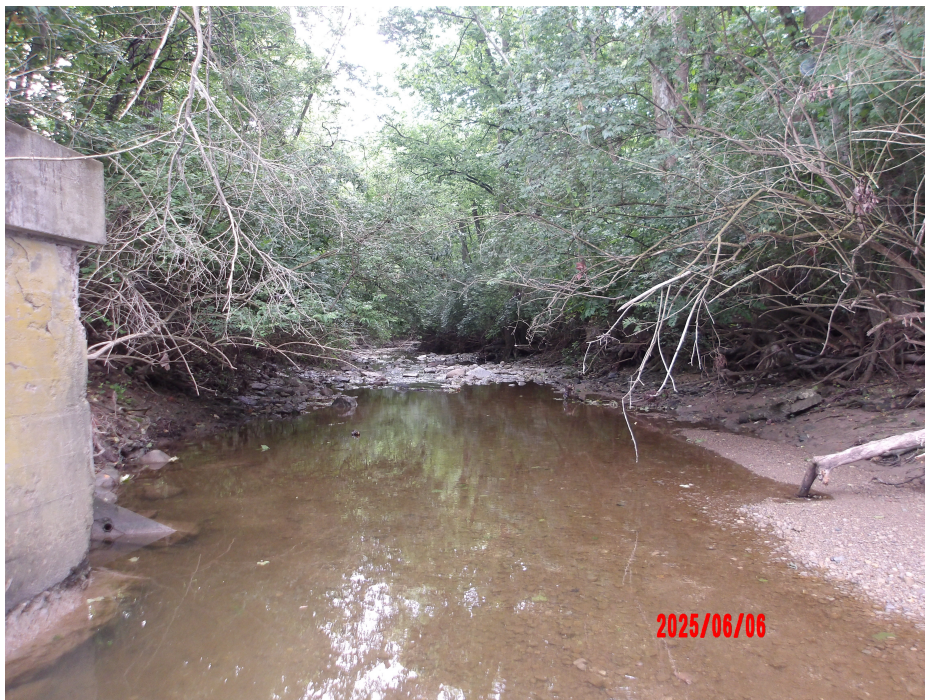
PHOTO 21 Condition  
Description Downstream channel
