# Asbestos Demolition Survey Report

**MRG-60-21.42  
10515 SR-60  
McConnellsville, Ohio**

**Project Number P402190066**

**November 13, 2019**

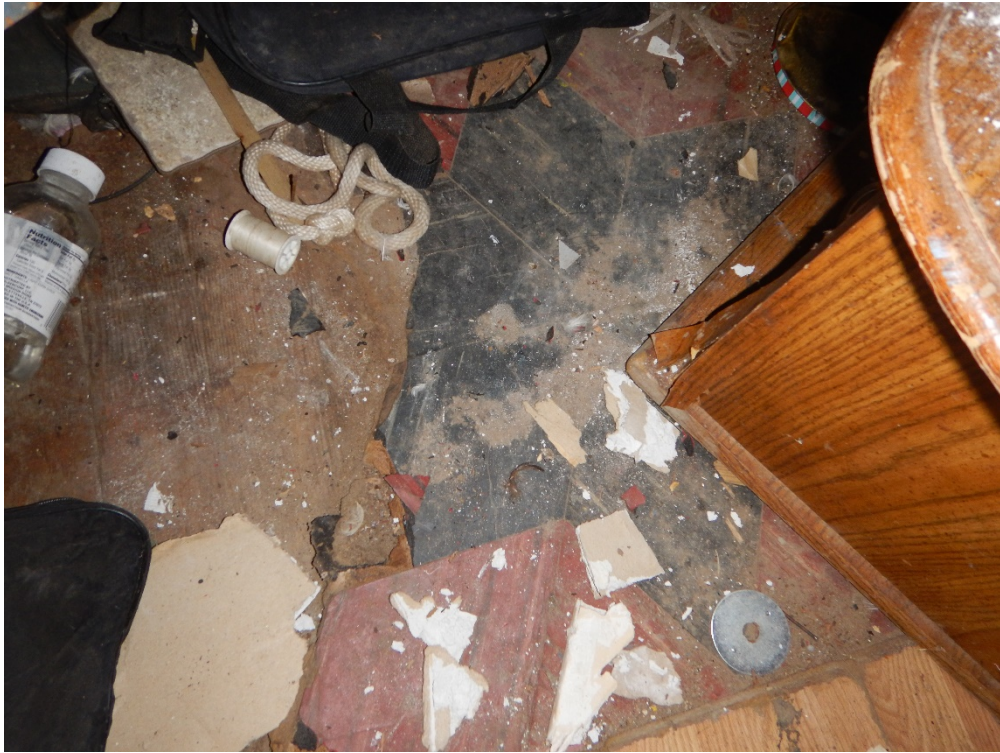
Photo 1:

- Homogenous area (HA)-1: Red floor tile located in the living room only. The floor tile contains 2% chrysotile asbestos. Approximately 50 square feet of this material is assumed to exist within the structure.

HA-1 and HA-2: Red and black floor tile, in living room only.

All asbestos containing building materials must be removed prior to demolition. No further investigation is warranted. All asbestos containing material removed must be disposed of at an OEPA approved facility with a NESHAP condition in the facility's air permit that allows acceptance of RACM. In the event additional suspect ACBM is discovered after demolition activities have begun, the contractor should contact a certified asbestos hazard evaluation specialist to conduct bulk sampling of the suspect material and wait for analytical results prior to continuing demolition activities. A Notification of Demolition form should be completed and submitted to the Ohio Environmental Protection Agency at least then working days prior to demolition activities. A Notification of Demolition form has been partially completed for the structure, and is included in Appendix E.

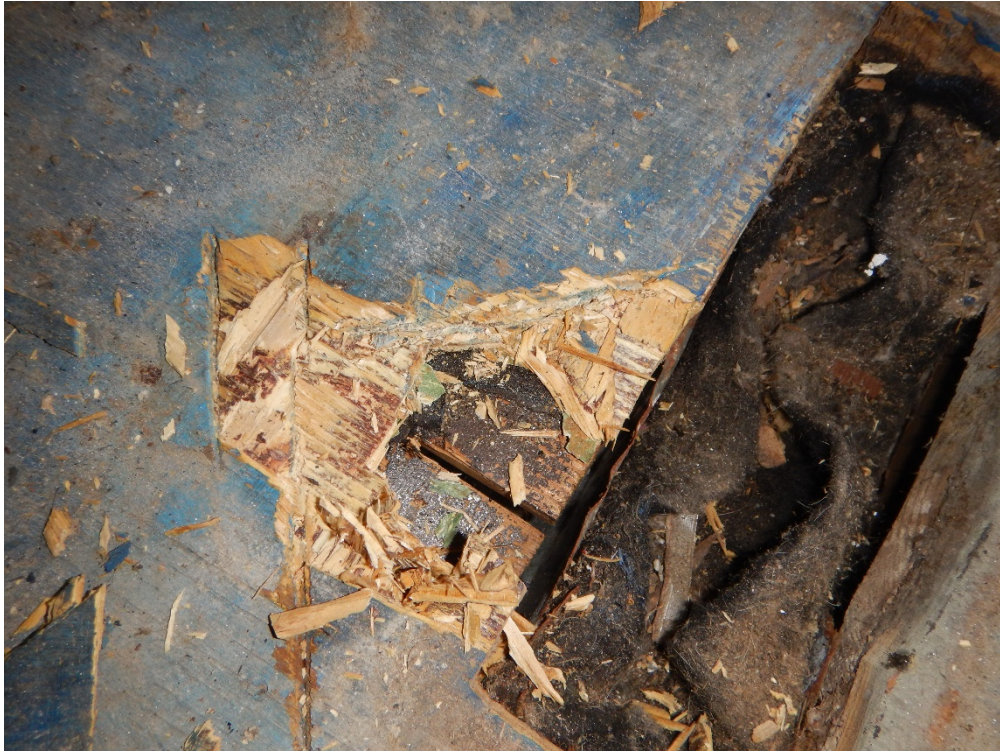
Photo 2:

HA-3: Green floor tile in kitchen under plywood.

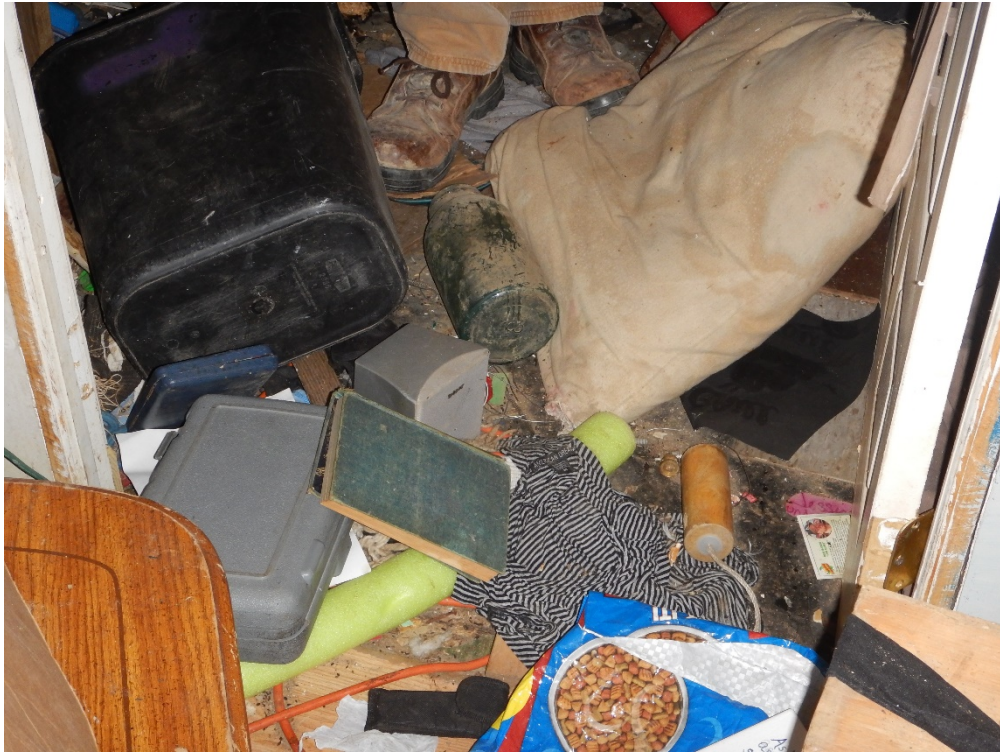
Photo 3:  
HA-4: Asphalt flooring  
located in Room #1 only.

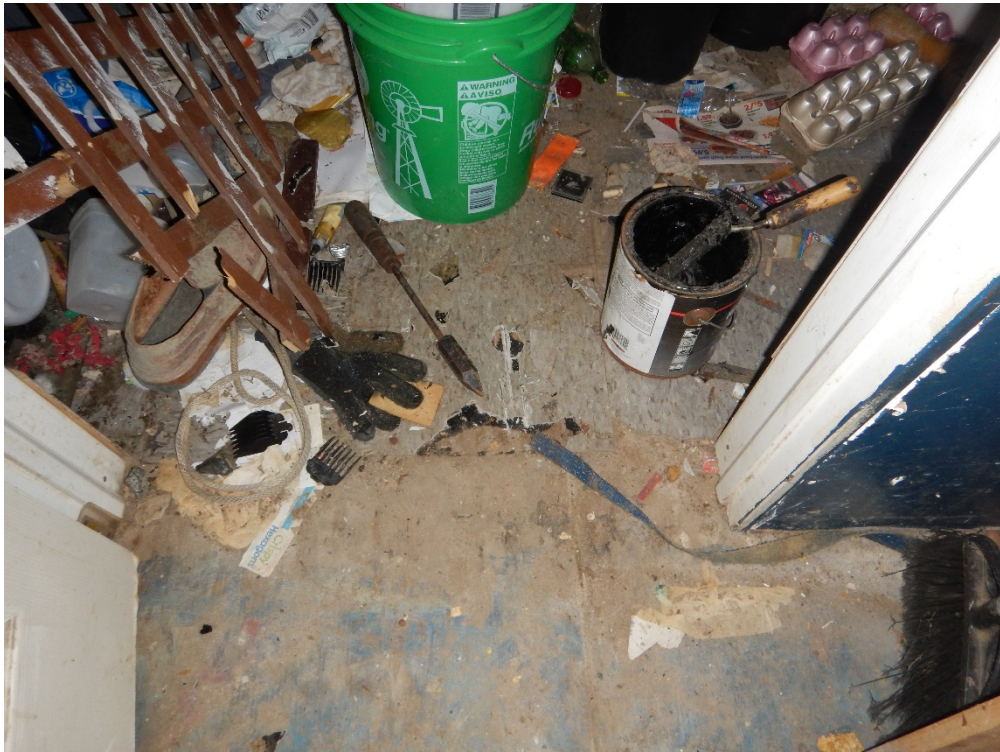
Photo 4:  
HA-5: Gray 12x12 floor tile, in  
bathroom only.

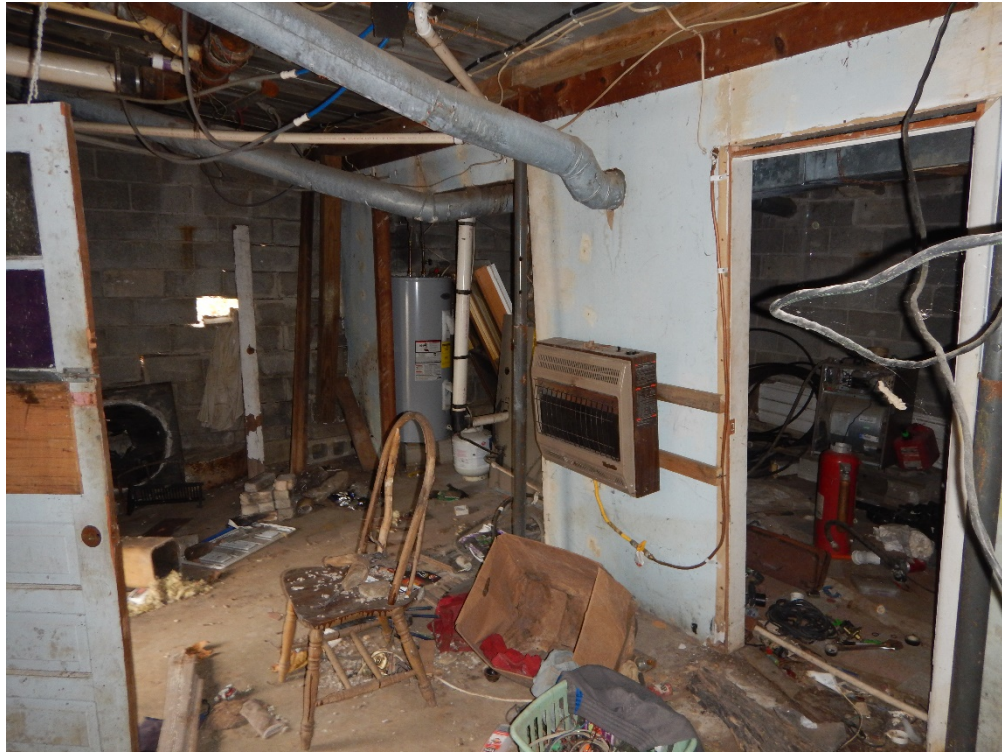
- Homogenous area (HA)-6: Drywall joint compound (mud) located in the basement only. The joint compound contains 3% chrysotile asbestos. Approximately 150 square feet of this material is assumed to exist within the structure.

Photo 5:  
 HA-6: Basement drywall, view of drywall in the furnace room of the basement.

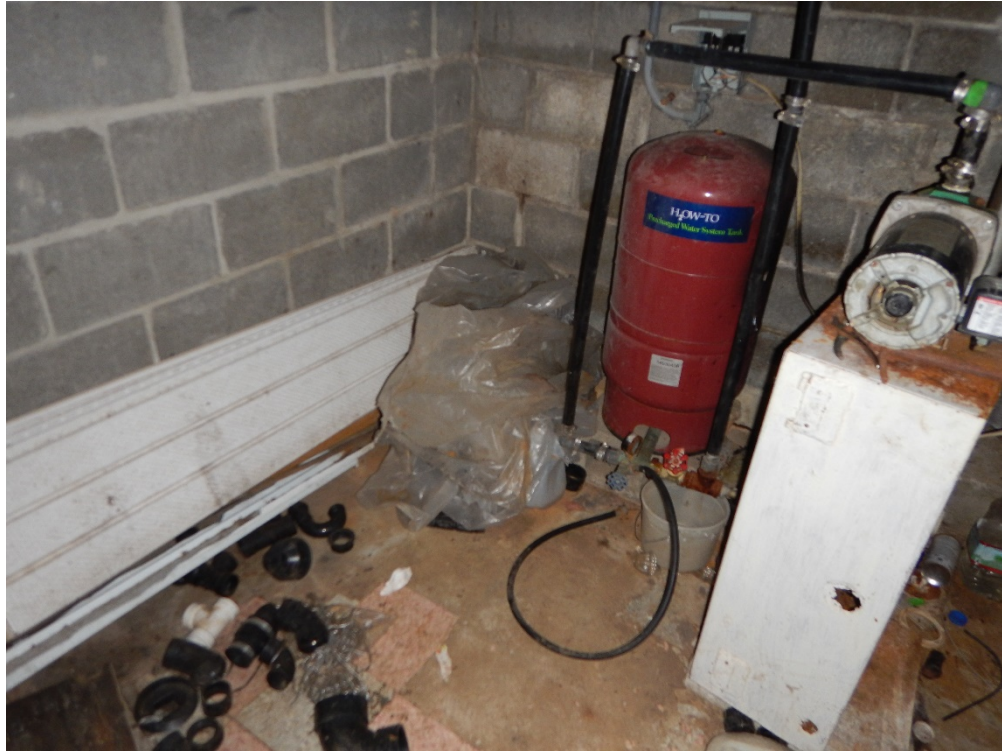
- Homogenous area (HA)-7: Gray 9x9 floor tile, located on the floor of the furnace room in the basement only. The floor tile contains 3% chrysotile asbestos. It is assumed approximately 55 square feet of this material exists within the structure.

- Homogenous area (HA)-8: Pink 9x9 floor tile, located on the floor of the furnace room in the basement only. The floor tile contains 3% chrysotile asbestos. Approximately 55 square feet of this material exists within the structure.

Photo 6:  
 HA-7 and HA-8: Gray and Pink 9x9 floor tile, located in furnace room of basement only.

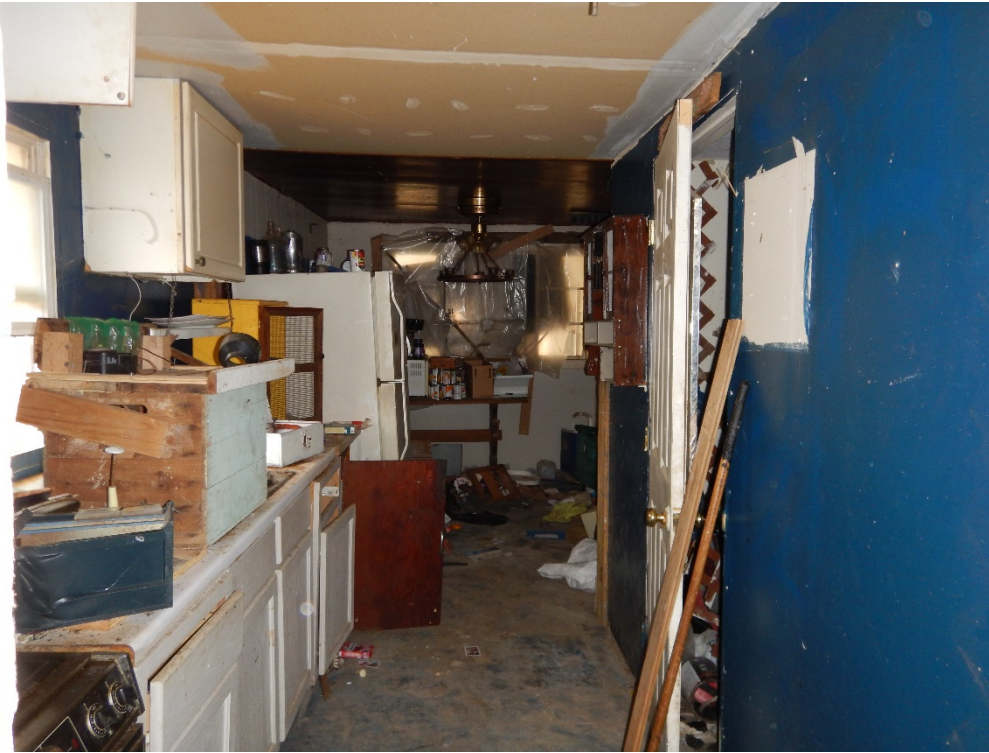
Photo 7:

- Homogenous area (HA)-10: Beige drywall joint compound associated with the walls of the main floor of the house. The joint compound contains 2% chrysotile asbestos. It is assumed approximately 200 square feet of this material exists within the structure.

- Homogeneous area (HA)-11: Beige drywall joint compound associated with the ceilings on the main floor of the structure. The joint compound contains 3% chrysotile asbestos. Approximately 175 square feet of this material is present within the structure.

HA-10 and HA-11: Drywall on walls and ceiling throughout main floor of structure.

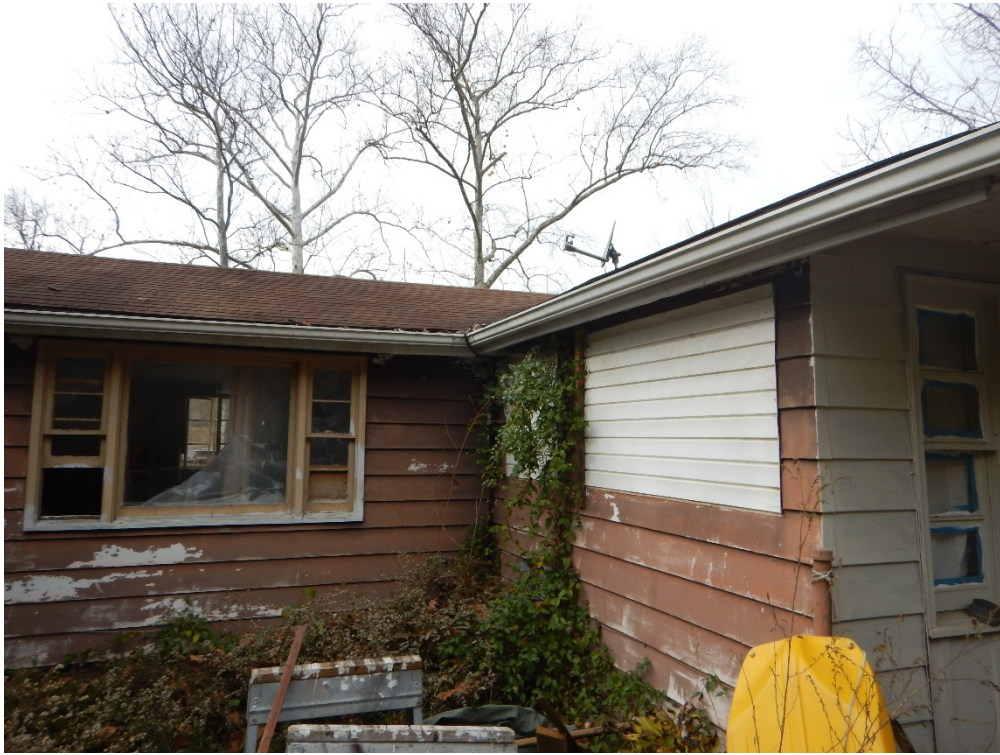
Photo 8:

HA-12: Asphalt shingles on roofing of main structure.

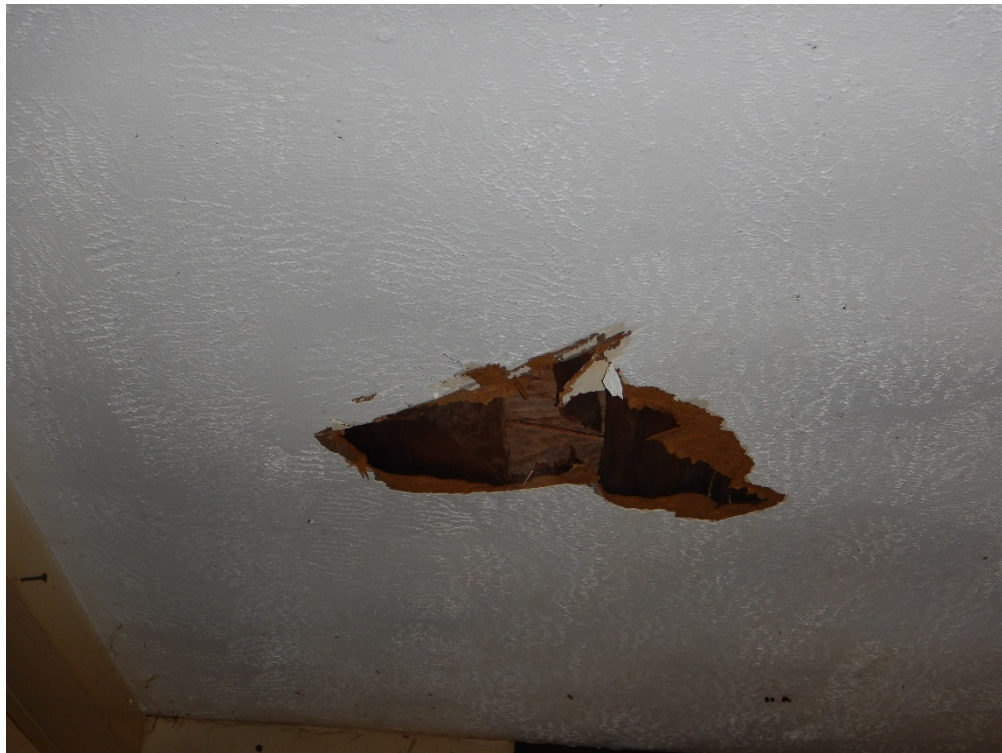
Photo 9:

- Homogenous area (HA)-13: Textured skim coat applied to plywood on the ceiling of the living room only. This material contains 3% chrysotile asbestos. Approximately 100 square feet of this material exists within the structure.

HA-13: Textured surfacing on living room ceiling only.

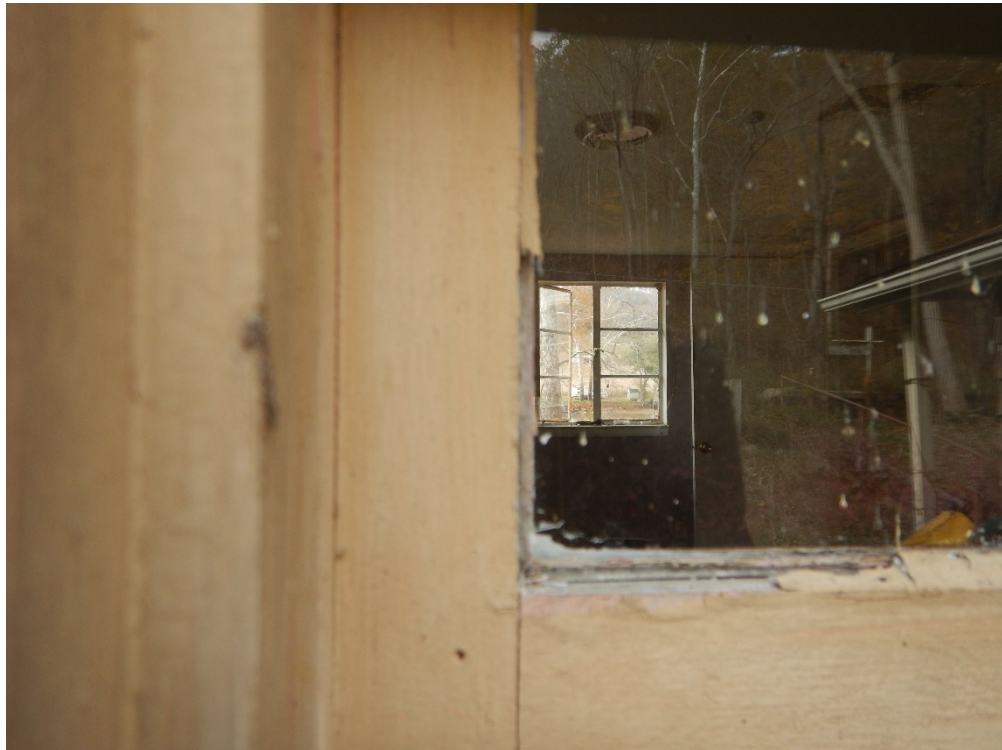
Photo 10:

HA-15: Window glazing.
