MUS-IR 70-7.29 PID-113243

Photo Log

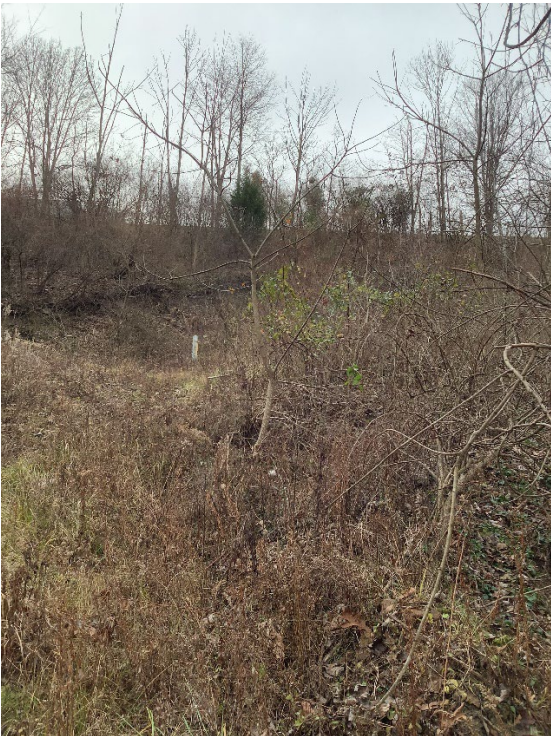
Photo 4 – north side facing south toward IR-70 – material from slip to be removed

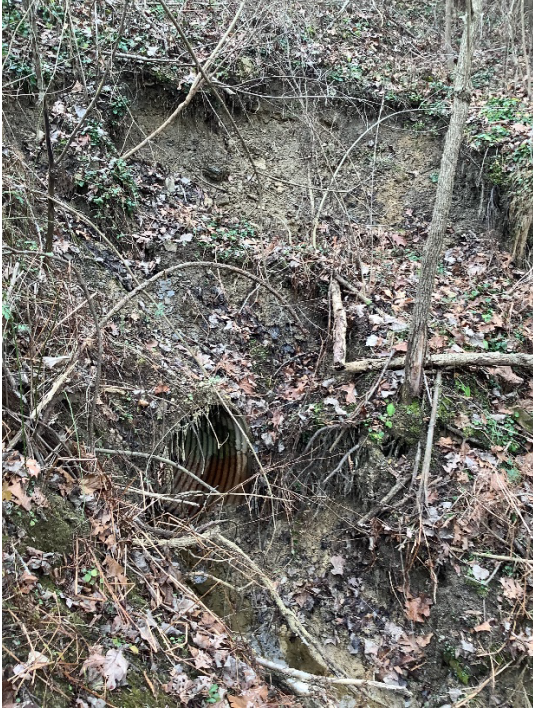
Photo 5 – UNT to Timber Run, slip material covering headwall to be removed, new headwall installed, pipe repaired, and RCP placed.

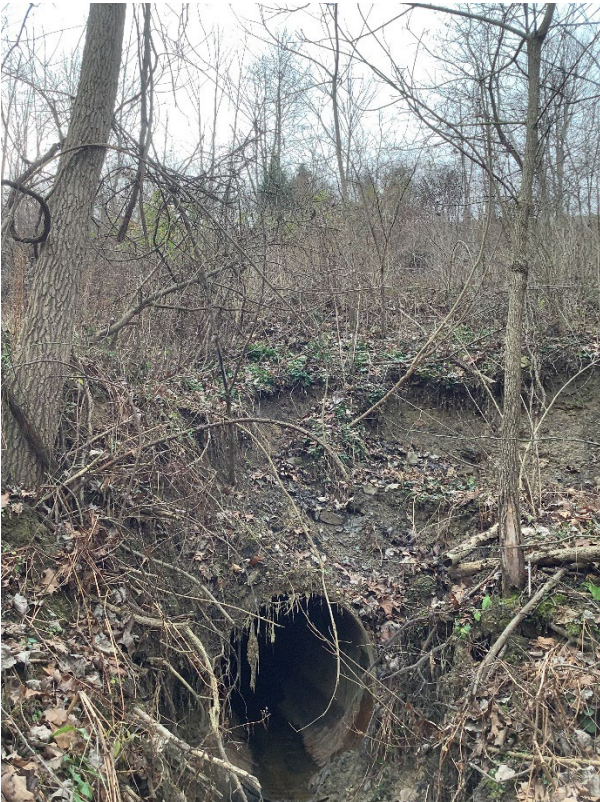
Photo 6 – Hillside uphill from culvert facing south toward IR-70, note slip material

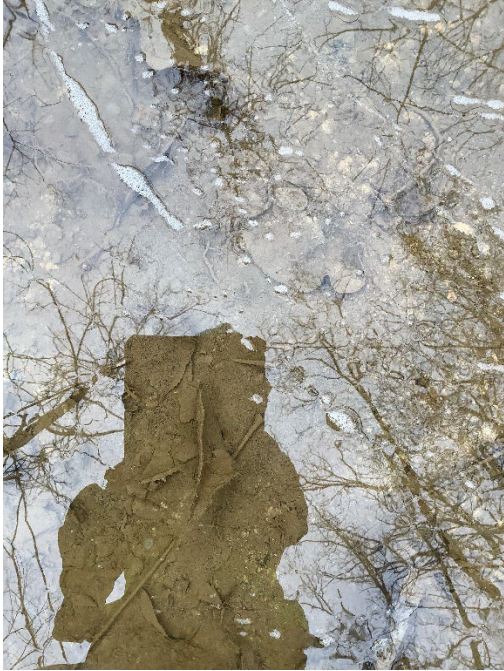
Photo 6 – Stream substrate at culvert outlet, combination of gravel, sand and silt with some detritus

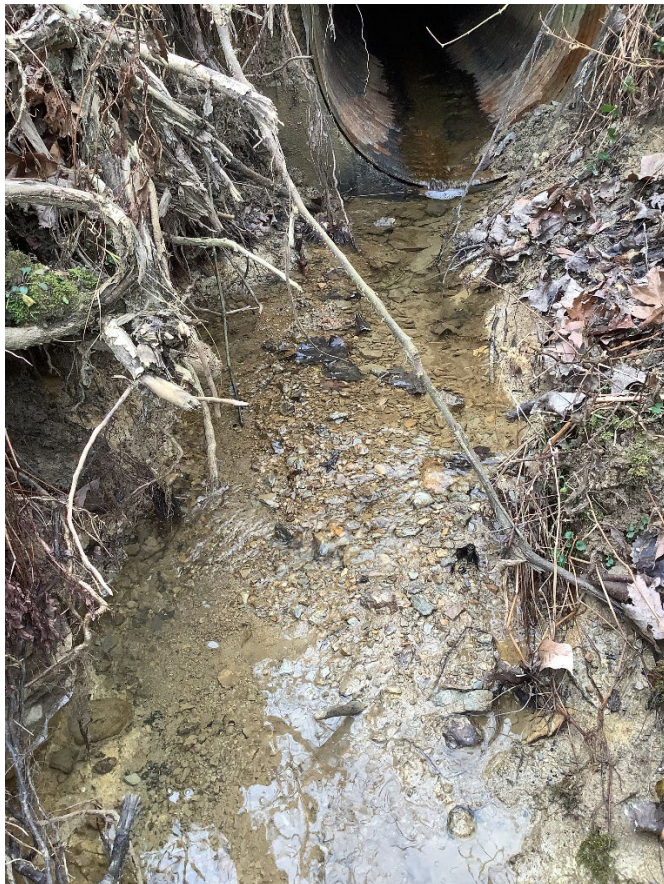
Photo 7 – Stream substrate at outlet, consistent throughout project area

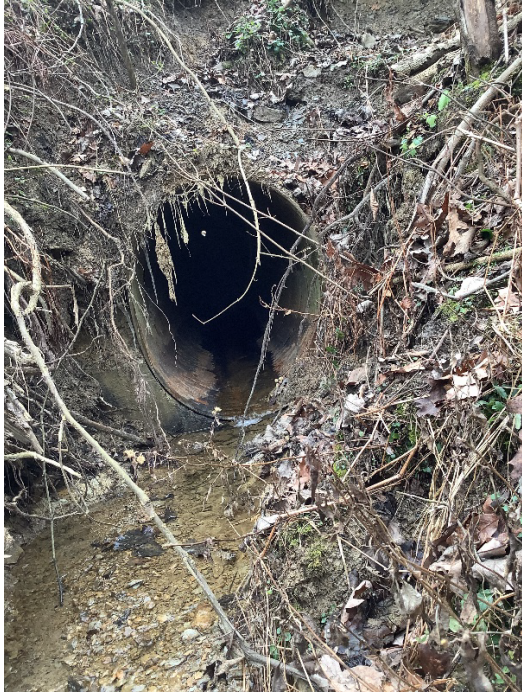
Photo 8 – compression of culvert due to material that has slipped

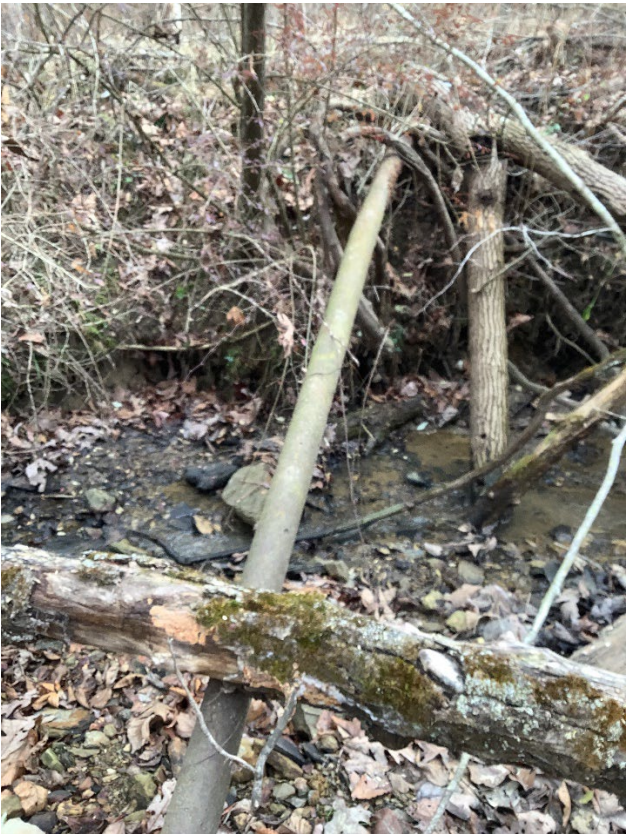
Photo 11- Corroded metal pipe crossing stream near ROW fence

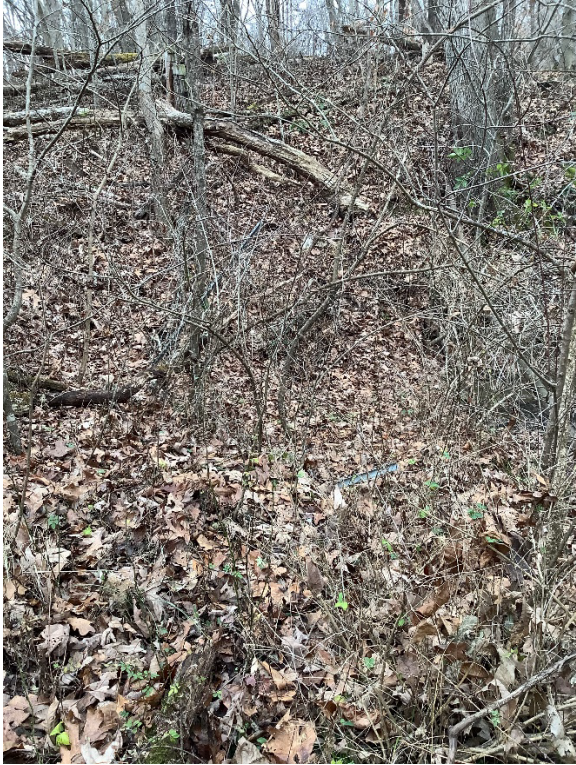
Photo 14 – RWO fence facing uphill (west). SWH for bats off ROW and will not be impacted.

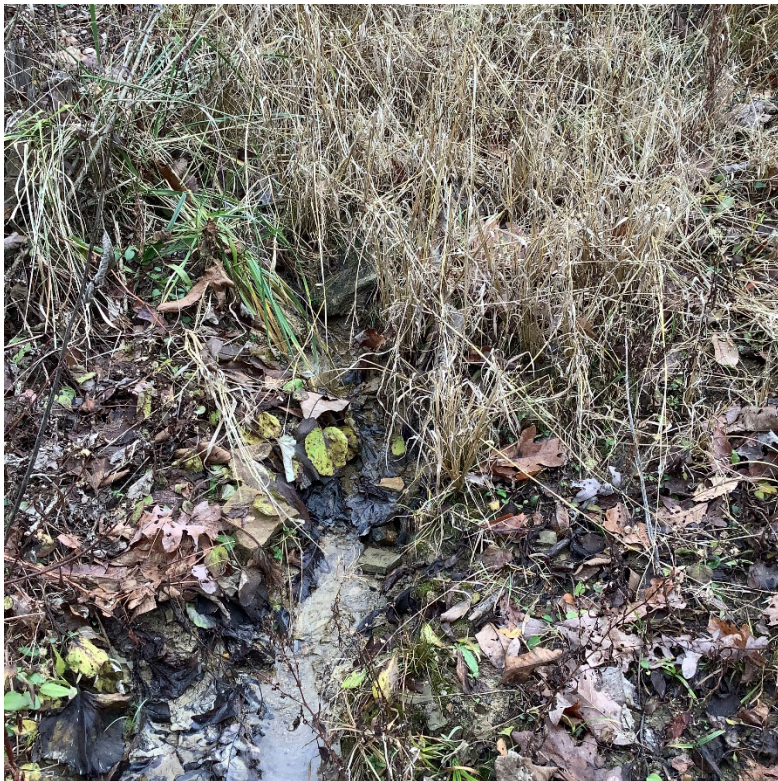
Photo 15 – Drainage/seep creating wetland

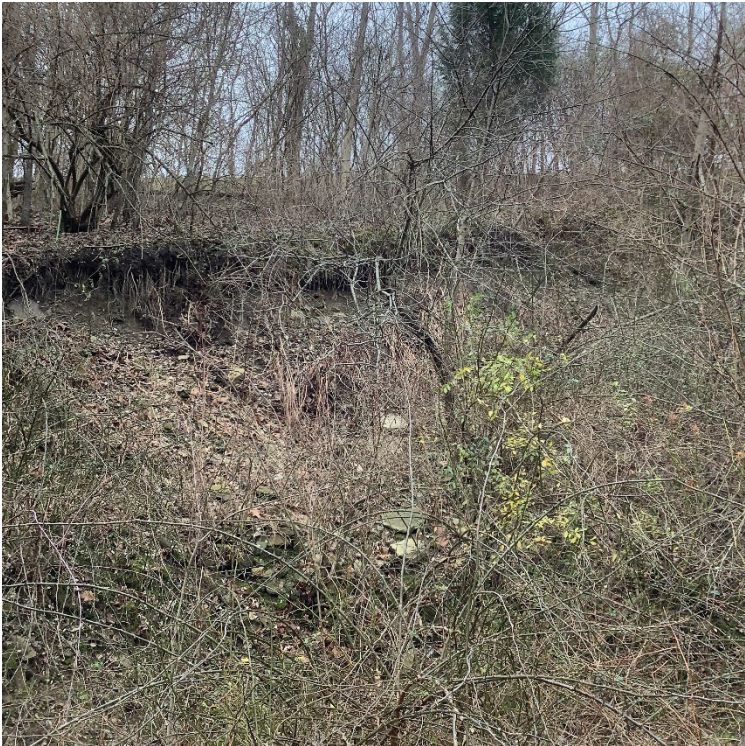
Photo 23 – Slip on hillside facing south toward IR-70

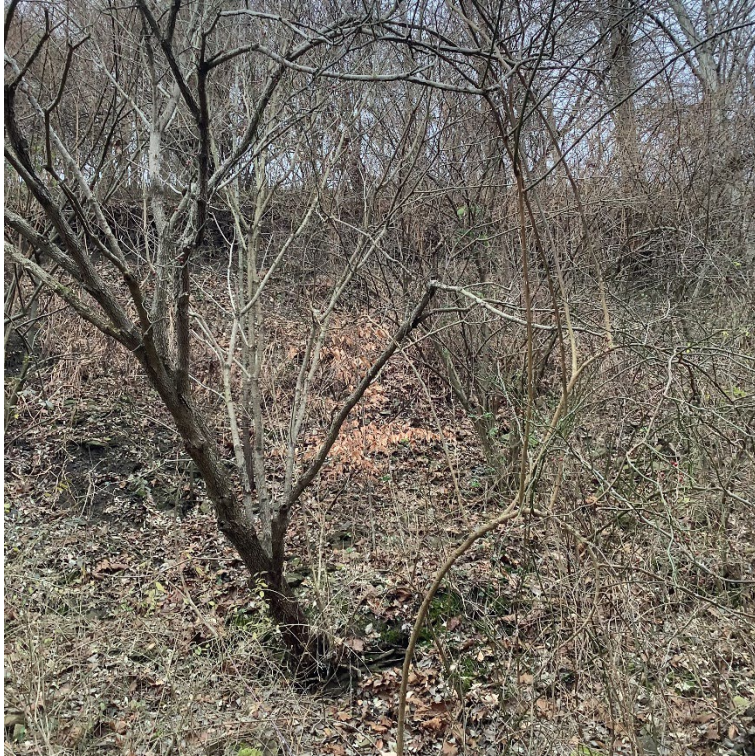
Photo 24 – Scrub/Shrub habitat to be removed

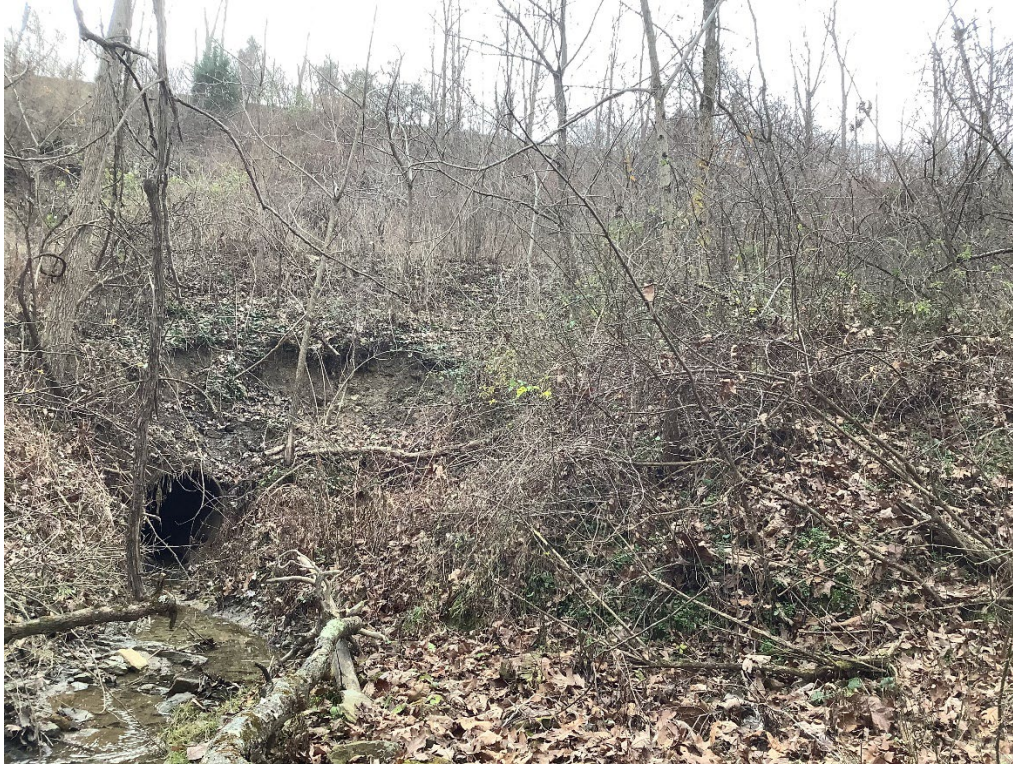
Photo 27- Trees to be removed on south side of ROW fence – larger trees on north side of fence will not be removed.
