September 7, 2018

Subject: Asbestos Survey of the POR 00014 12960 Bridge (SFN #6700691/ PID 105860) State Route 14 over State Route 5 and State Route 44 in Portage County, Ohio (L&A 18-0347)

APPENDIX C
BULK SAMPLE LOCATION DIAGRAM

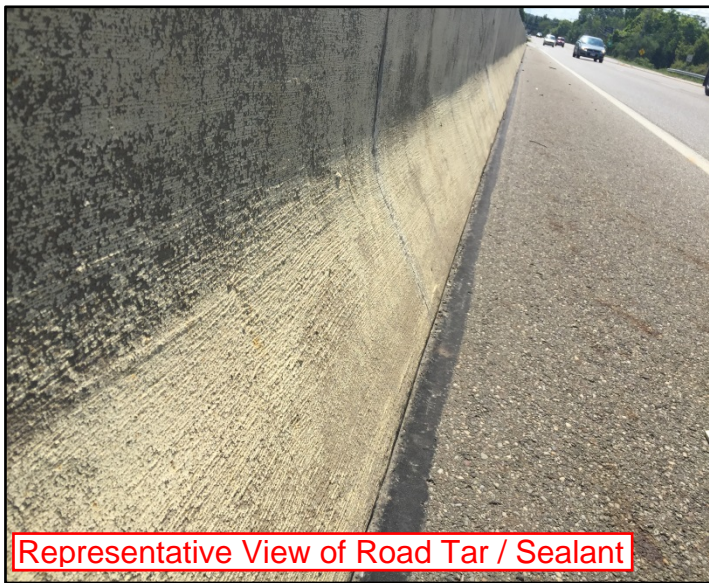
Representative View of Road Tar / Sealant

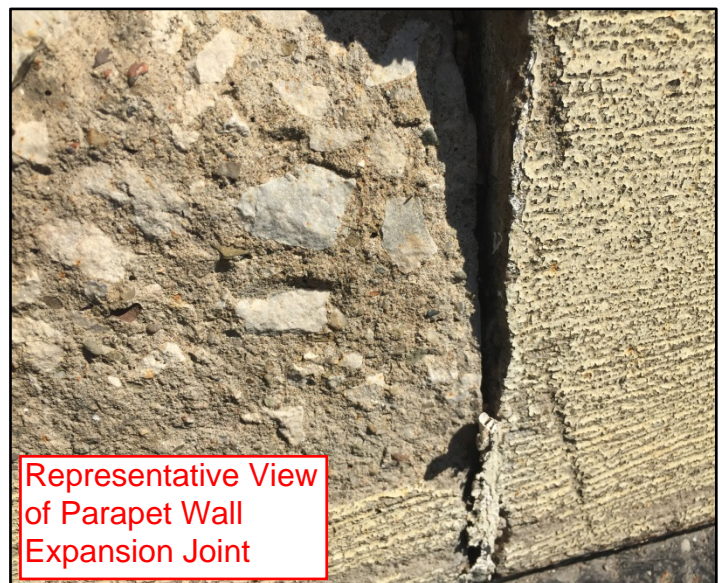
Representative View of Parapet Wall Expansion Joint

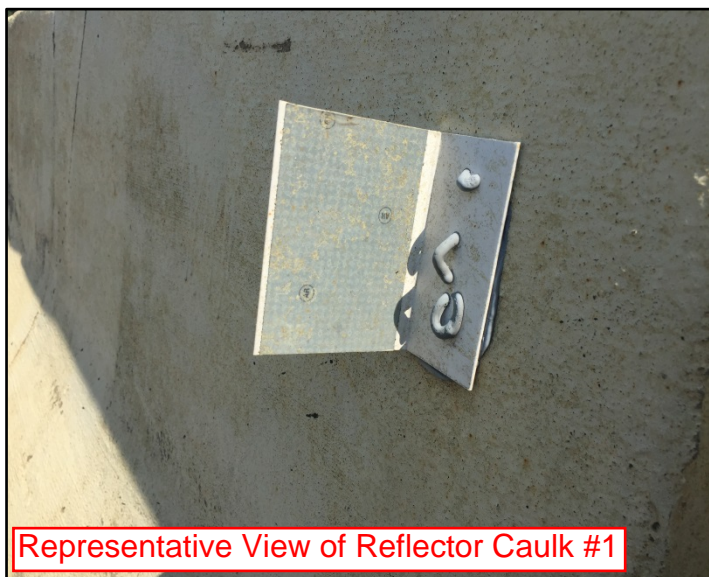
Representative View of Reflector Caulk #1
