Asbestos Survey

459 Blinn St.

Akron, OH 44310

Date of Inspection: August 9, 2019

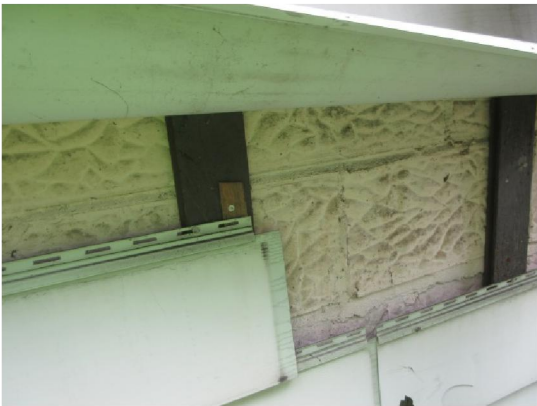
Transite Siding – No

459 Blinn St – No Transite

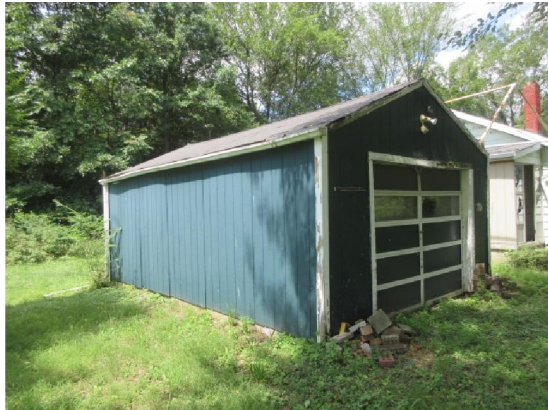
459 Blinn St - Garage

All non-friable roofing and floor tile/mastic were assumed to be asbestos containing materials. The amount of roofing on the dwelling including garage is approximately 1,000 total square feet and is in fair condition. The amount of flooring throughout the dwelling is approximately 162 total square feet and is in fair condition; kitchen and bath.

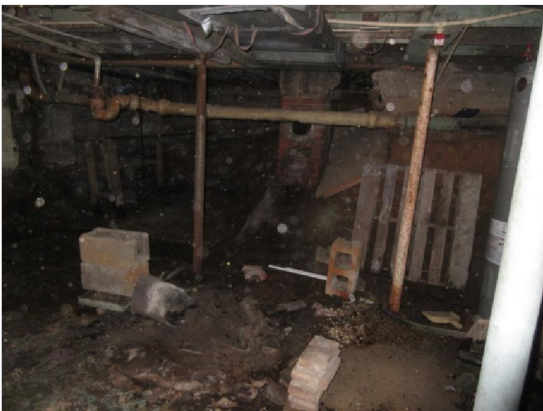
459 Blinn St – Basement

- ***Seam Tape – Approximately 8 square feet of asbestos containing seam tape was identified in the basement on various ducts and returns. The material is in fair condition and is friable.***

The following table presents a list of asbestos containing materials and assumed asbestos containing materials identified during the inspection and should be removed prior to the onset of demolition activity:
