THE WOO-281-12.65 PROJECT CONSISTS OF THE REPAIR OF A LANDSLIDE IMPACTING THE EASTBOUND TRAVEL LANE AND THE SLOPE BELOW THE ROADWAY OF S.R. 281, FROM APPROXIMATELY STA 670+00 TO STA 669+00.

**LANDSLIDE EXPLORATION
STA. 665+50.00 TO STA. 671+00.00**

**W00-281-12.65
SLOPE REPAIR**

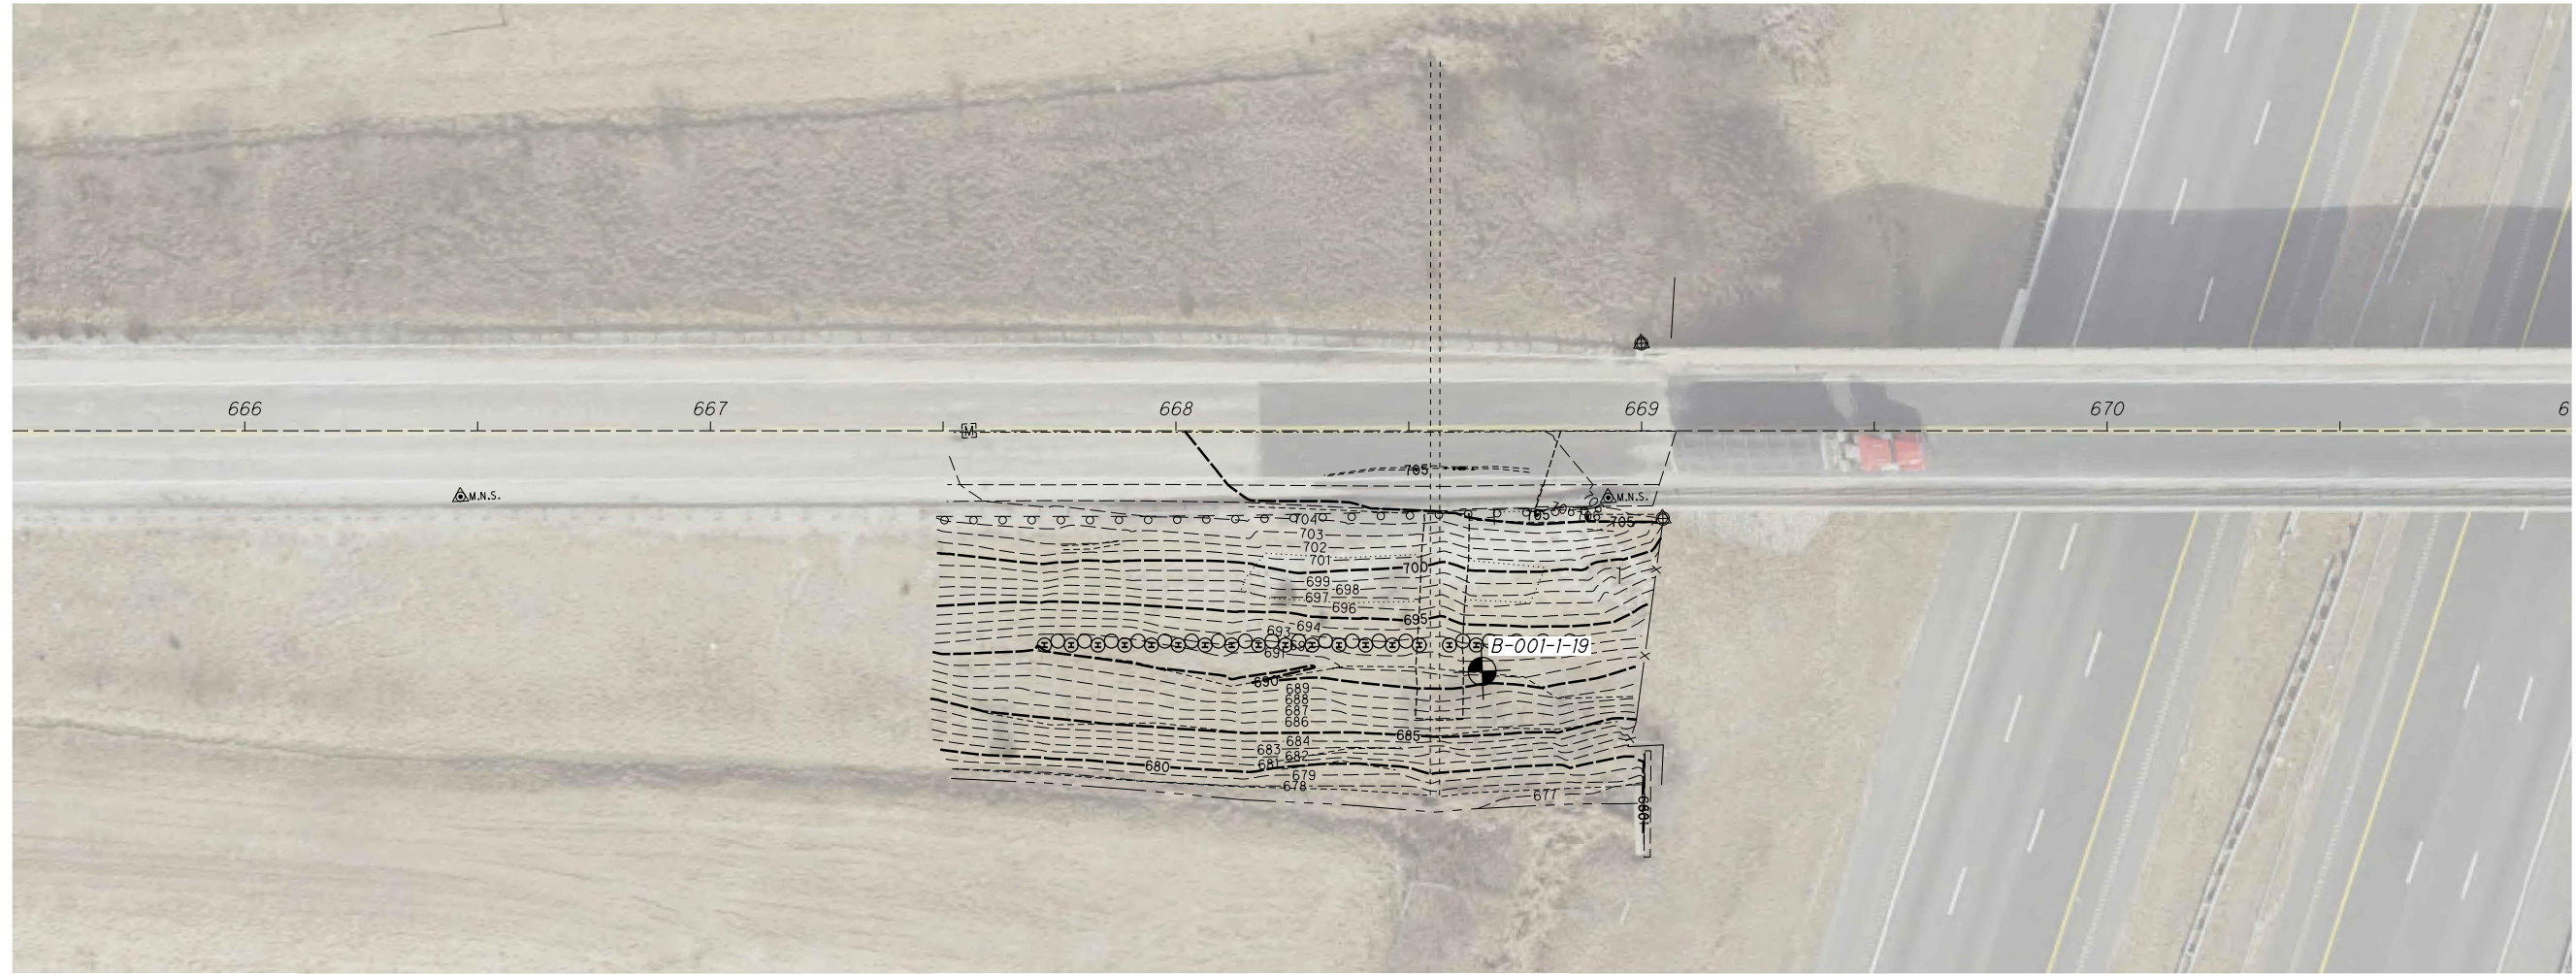
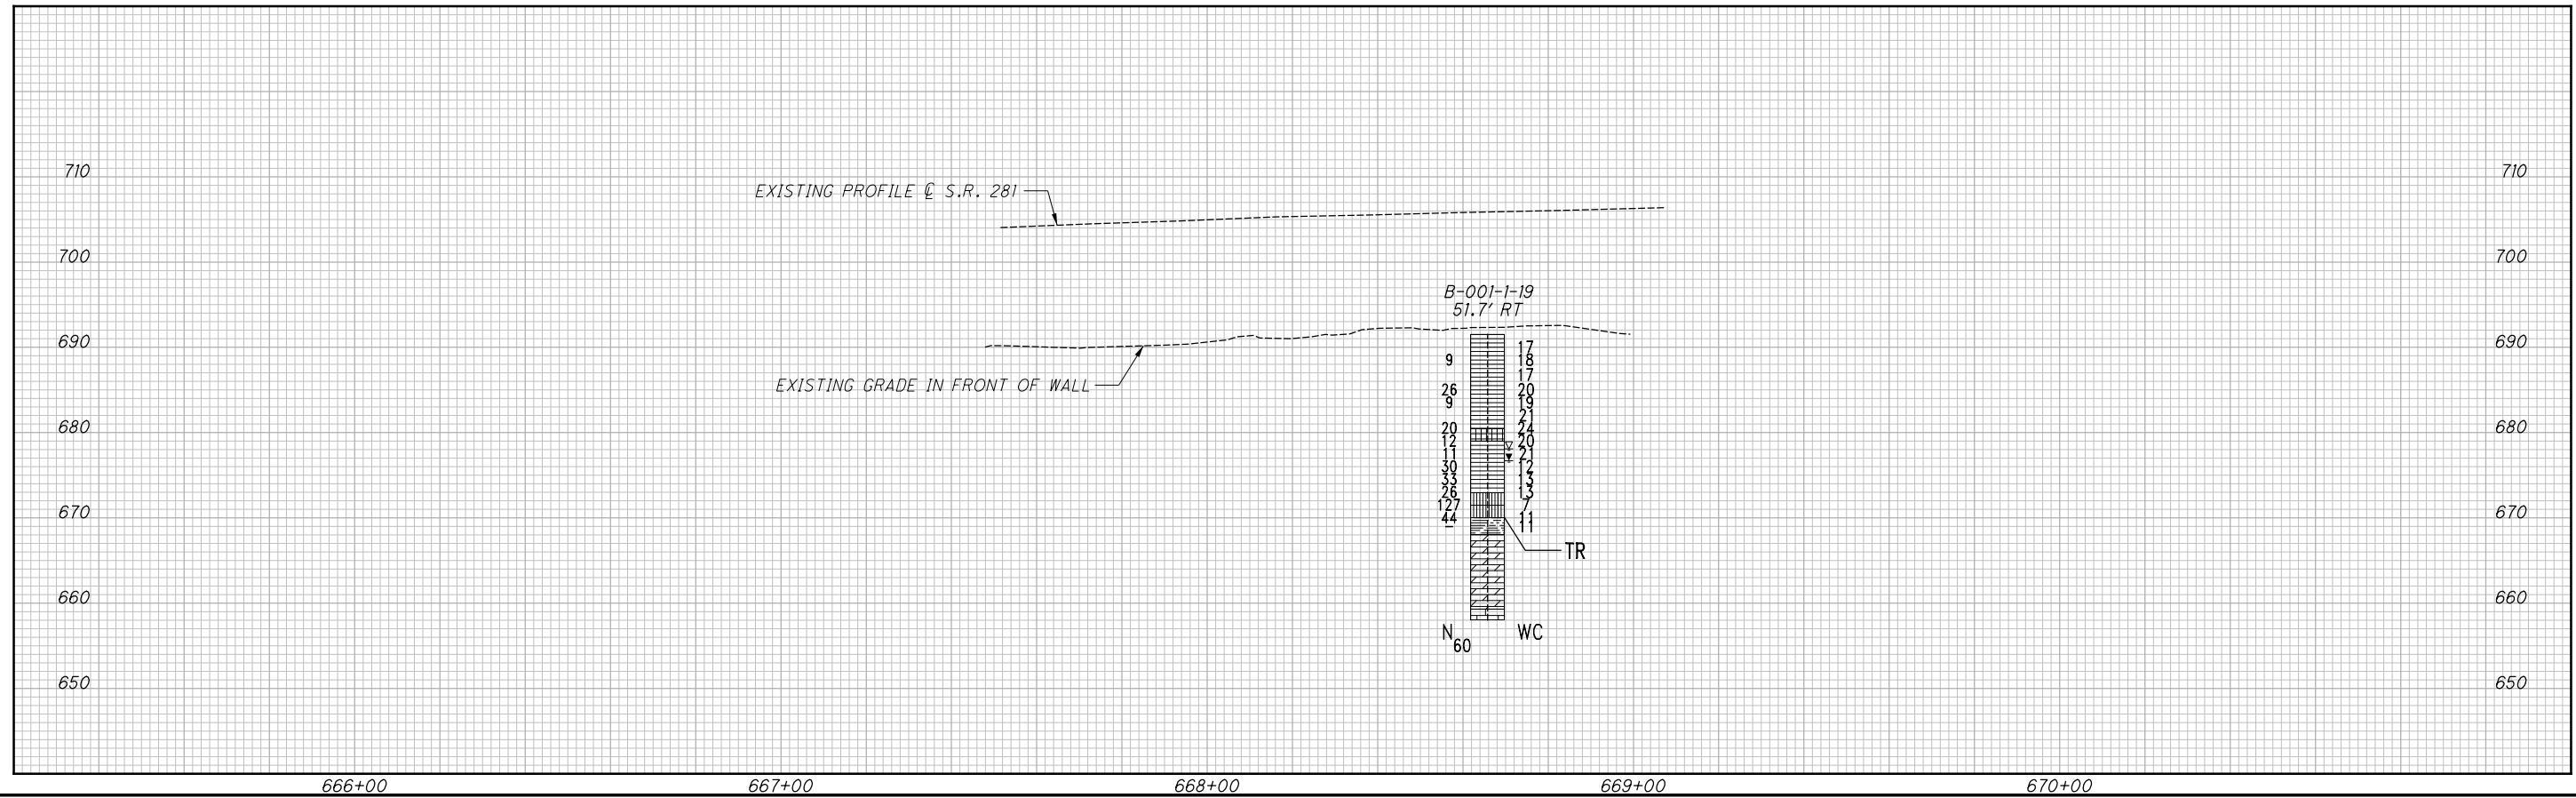
A GEOTECHNICAL RECONNAISSANCE OF THE SITE WAS PERFORMED ON SEPTEMBER 9, 2019. THE ROADWAY AT THIS LOCATION SITS ATOP THE APPROACH EMBANKMENT TO THE OVERPASS OF INTERSTATE 75. A LONGITUDINAL CRACK IN THE SR 281 ROADWAY PAVEMENT WAS FOUND AT THE TIME OF RECONNAISSANCE.

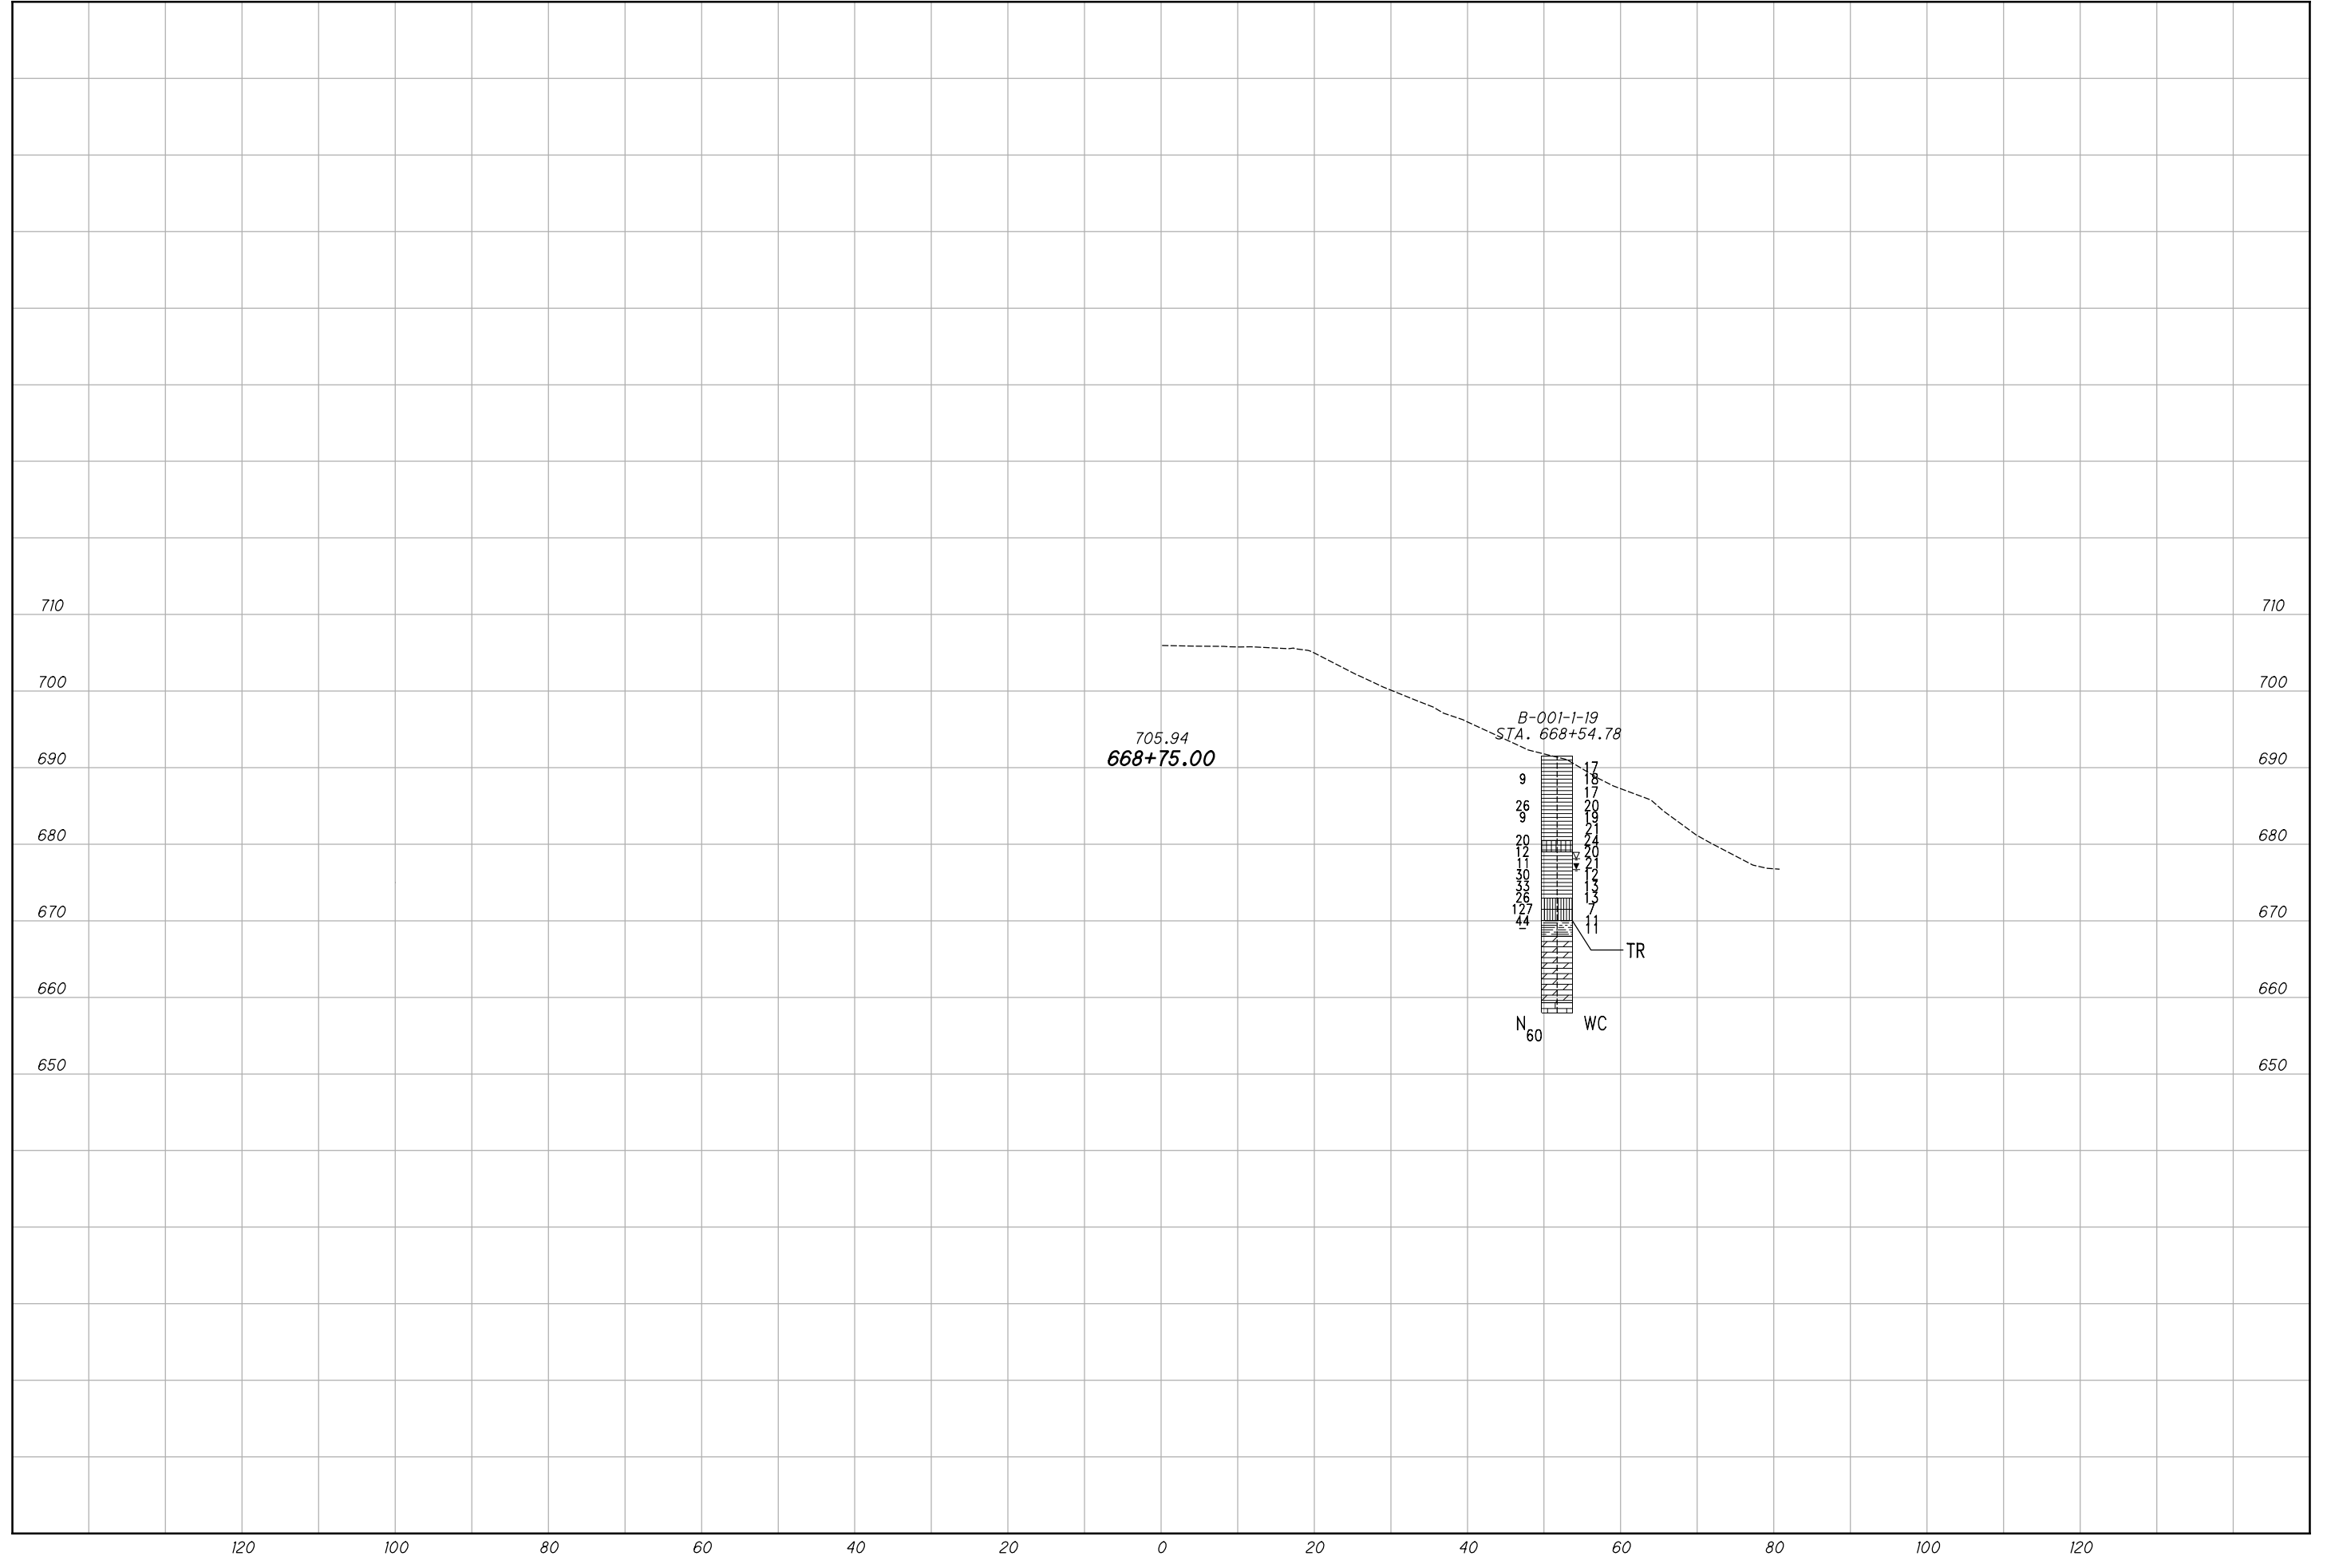
**LANDSLIDE EXPLORATION
CROSS SECTION STA. 668+75**

THE GENERALIZED SOIL PROFILE AT MID-SLOPE CONSISTS OF APPROXIMATELY 18.5 FEET OF SOFT TO VERY STIFF SILTY CLAY (A-6b) AND CLAY (A-7-6). BENEATH THIS SOIL, A MEDIUM DENSE TO VERY DENSE SANDY SILT (A-4a) WAS ENCOUNTERED. THESE SOILS EXTENDED TO A DEPTH OF 33.5 FEET, WHERE BEDROCK WAS ENCOUNTERED. WATER WAS ENCOUNTERED IN THE SOIL BORING AT A DEPTH OF 13.4 FEET DURING DRILLING AND AT 14.8 FEET PRIOR TO ROCK CORING.
