Craig Memorial Bascule Bridge

Over the Maumee River

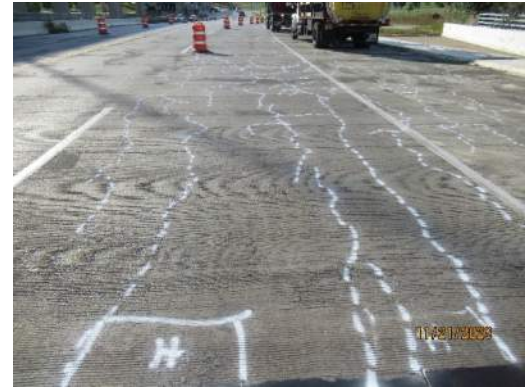
South approach concrete slab, SB lanes

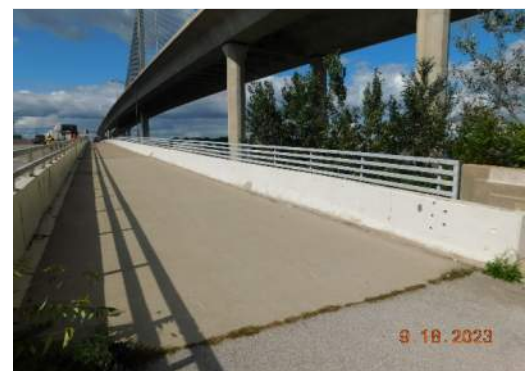
Southeast sidewalk / trail barrier & railing

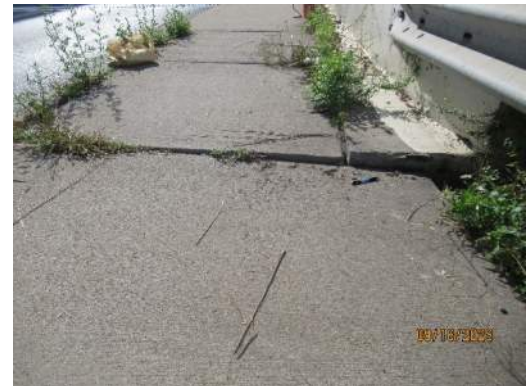
Northwest sidewalk settlement at transition

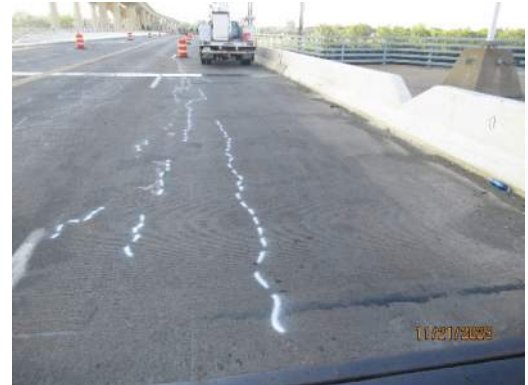
Span 4 deck surface, SB lanes

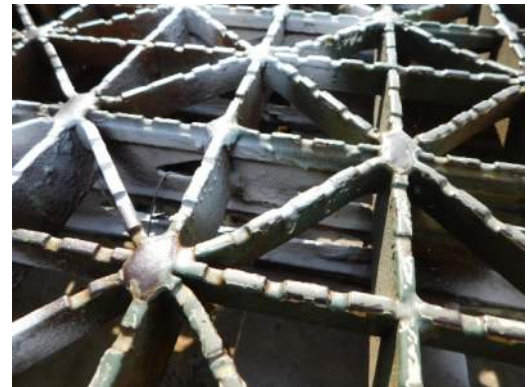
Grid deck main bar corrosion holes

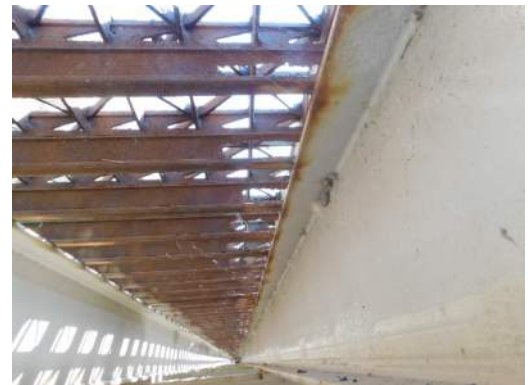
Grid deck main bar corrosion holes

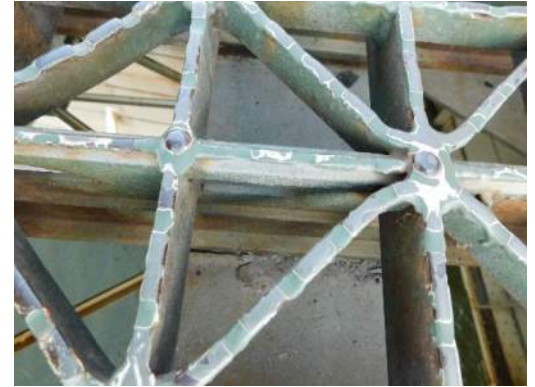
Grid deck main bar to stringer top flange broken welds

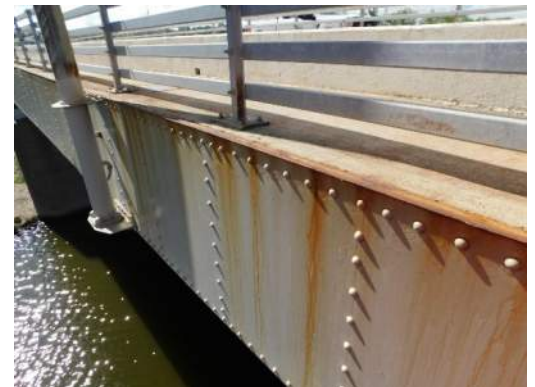
Span 2 East fascia packing corrosion

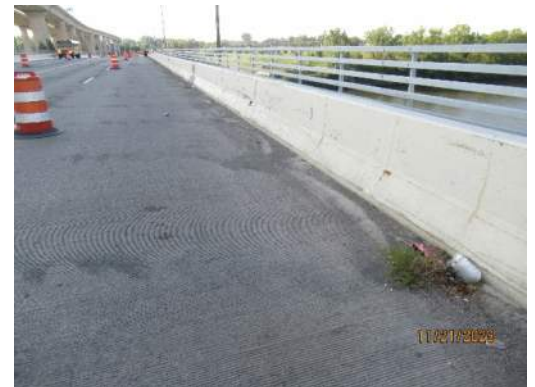
Span 3 west roadway barrier, typical cracks

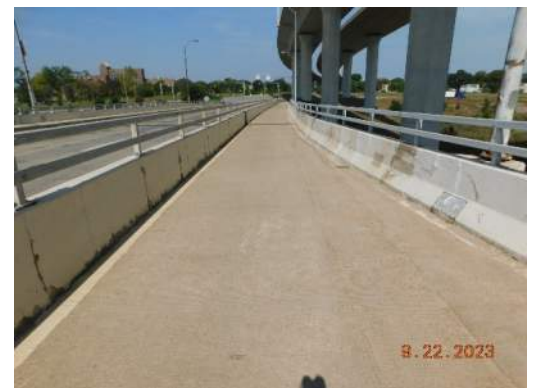
Span 8 east roadway and exterior barriers, typical cracking

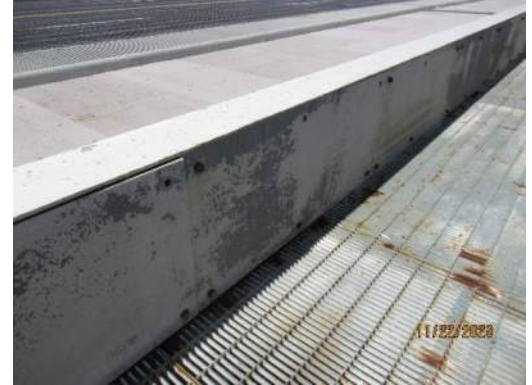
Span 5 south leaf east trail to sidewalk barrier, missing bolts at vertical plate

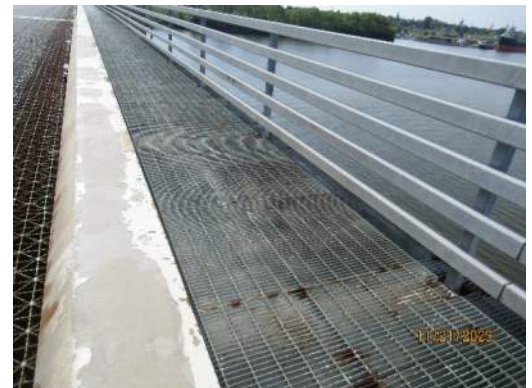
Span 5 North leaf West sidewalk

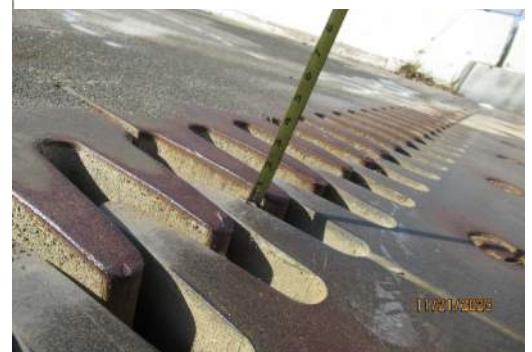
South abutment finger joint, SB right lane

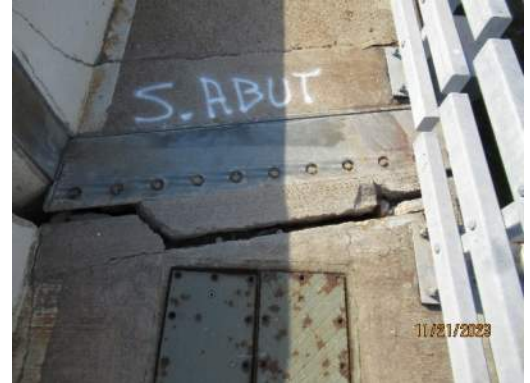
South abutment joint, West sidewalk

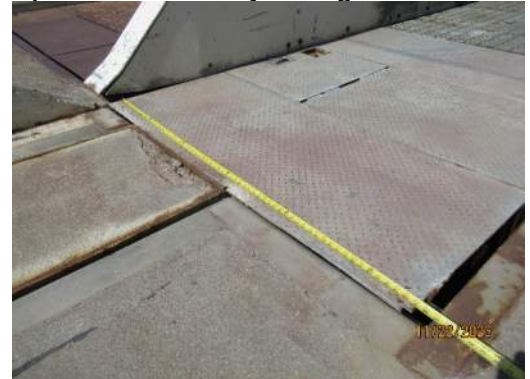
Span 5 South leaf East sidewalk joint cover at rear break joint

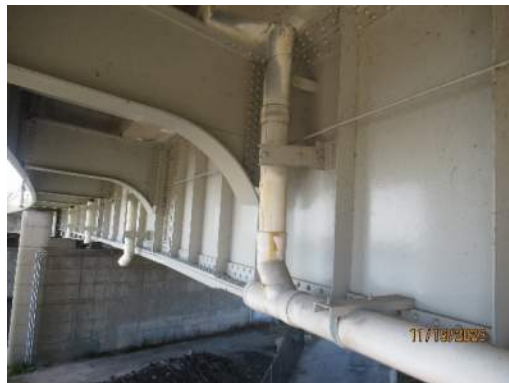
Span 7 drainage downspouts and piping

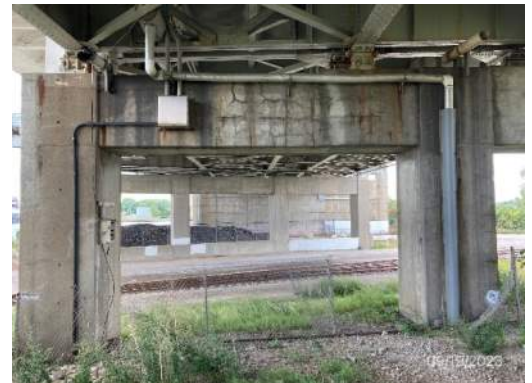
Pier 8 drainage troughs and piping

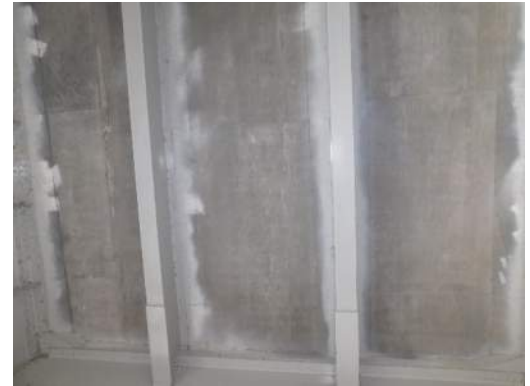
Span 2 deck underside typical general view

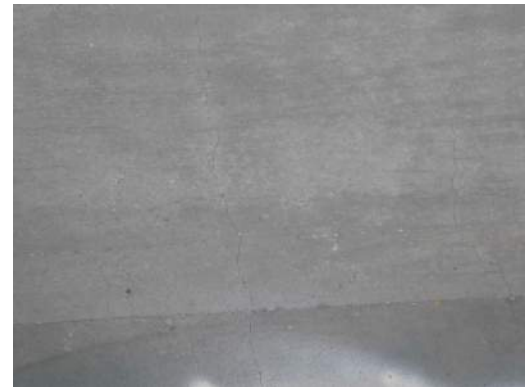
Span 2 deck underside typical shrinkage map cracking

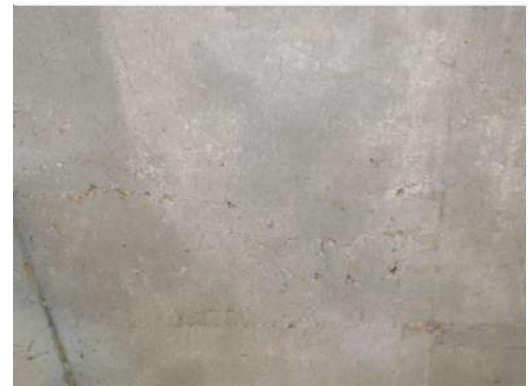
Span 2 deck underside typical shrinkage map cracking and honeycombing

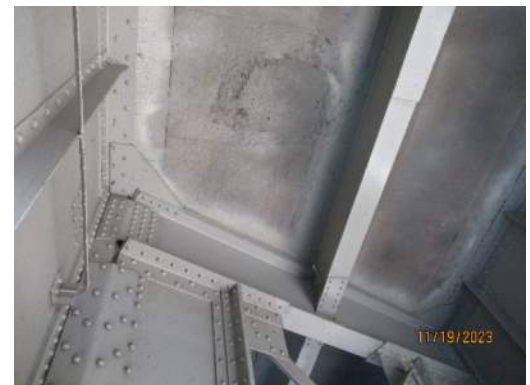
Span 7 deck underside typical patch repair

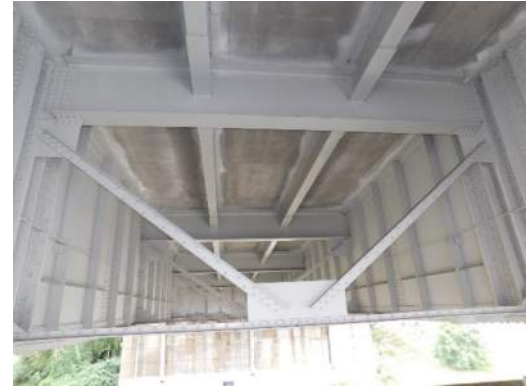
Span 1 typical interior framing

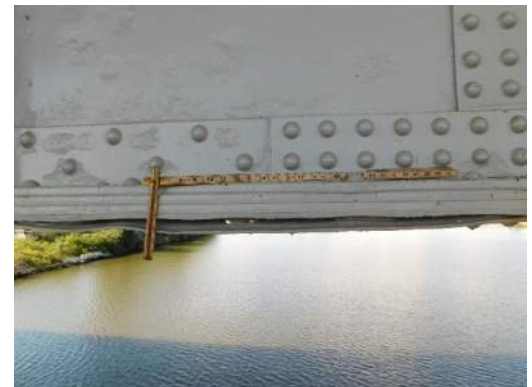
Span 2 Girder 4W east BF pack rust & SL

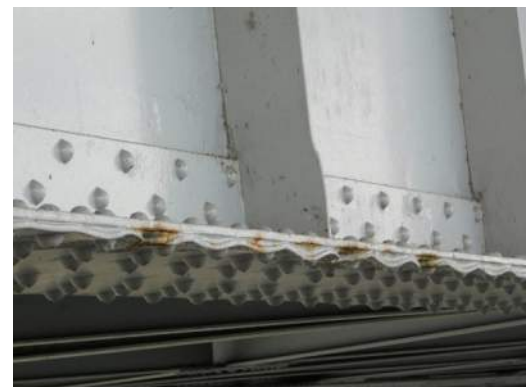
Span 3 Girder 4W east BF pack rust

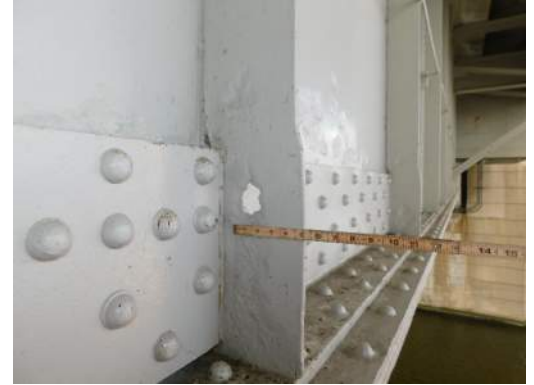
Span 4 Girder 4W stiffener hole

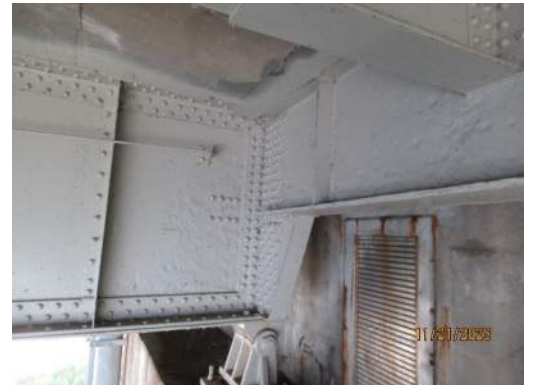
Span 9 Girder 1W bearing stiffener pack rust

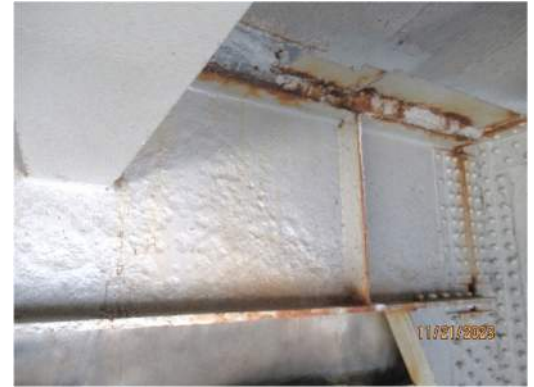
Span 1 FB0s at South abutment, web SL

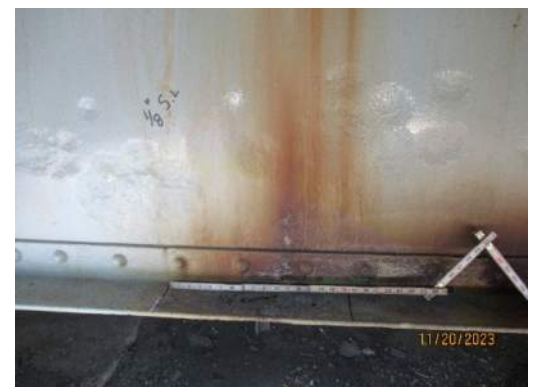
Span 8 FB20s south BF and web SL

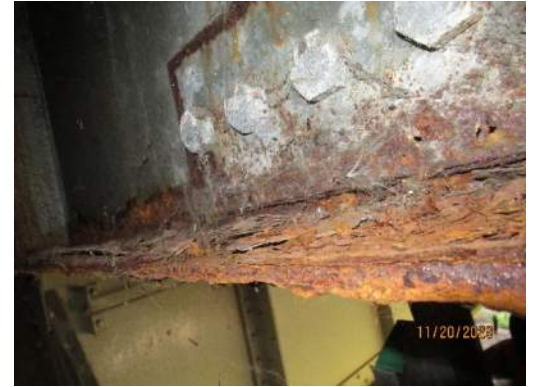
Span 10 FB11s at North abutment, BF SL

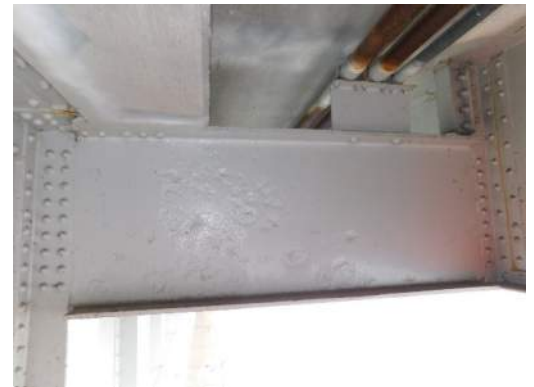
Span 3 West exterior FB20s web SL

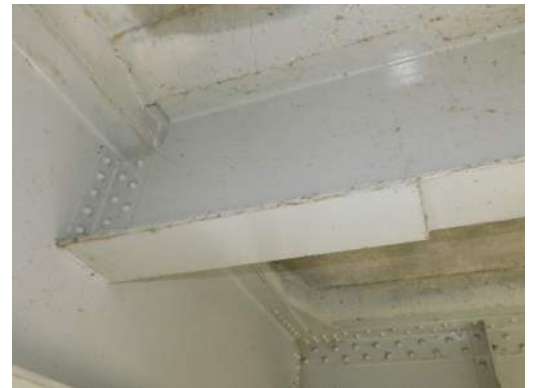
Span 2 Stringer 6W at FB15s typical connection

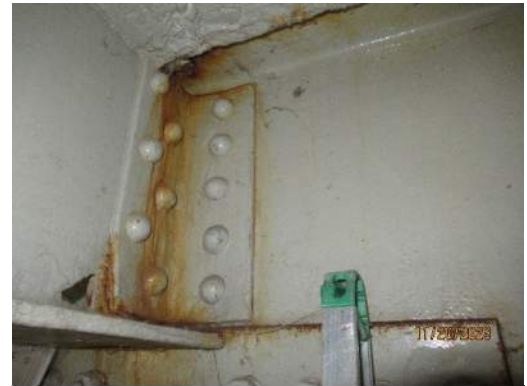
Span 10 Stringer 3W at FB11s, hole in web

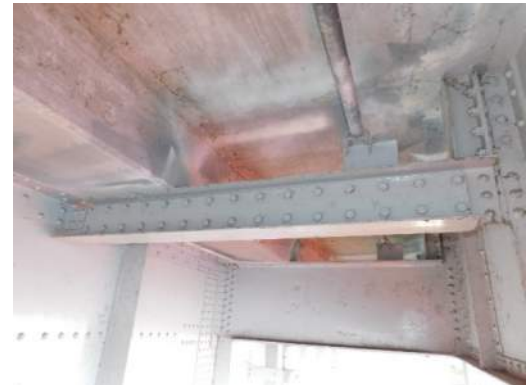
Span 6 East sidewalk repair between FB1s and FB2s

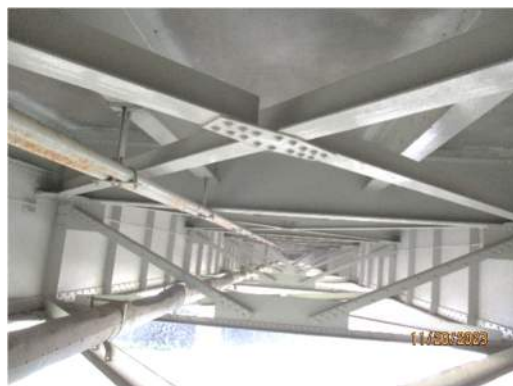
Span 9 typical bracing in good condition

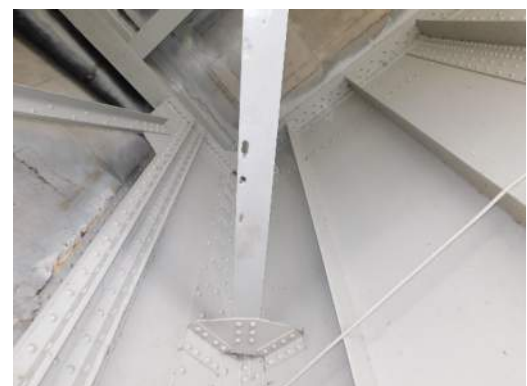
Span 4 lower diagonal to G2W flange holes

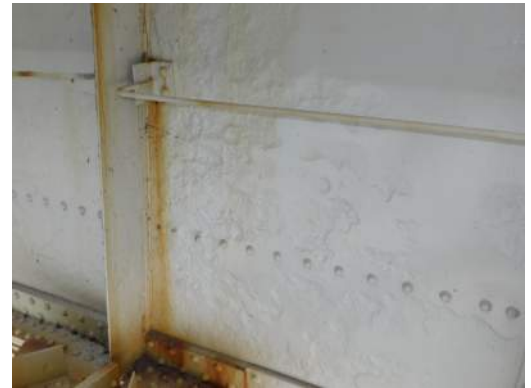
Span 5 South leaf, G3W, East lower web SL

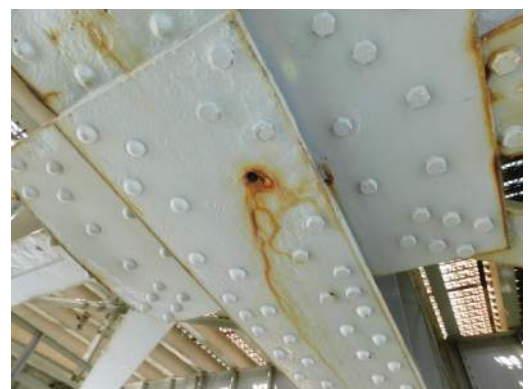
Span 5 North leaf G3W missing bolt at BF

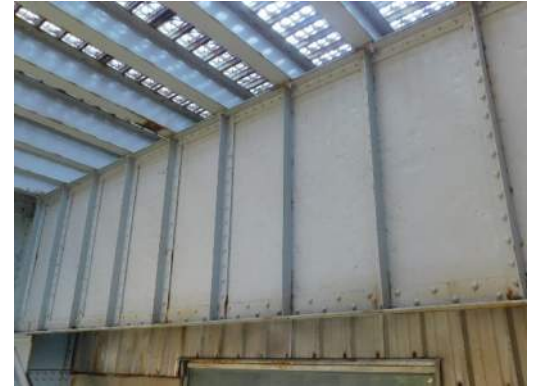
Span 5 South leaf, FB7s web SL throughout

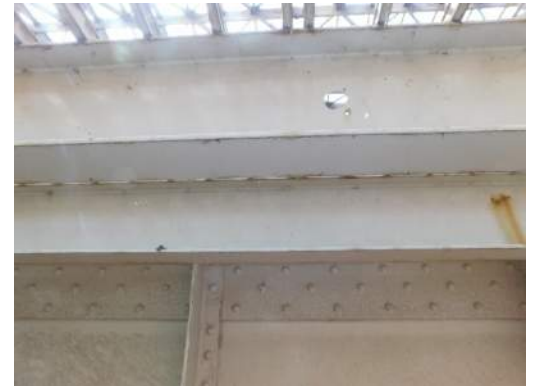
Span 5 North leaf, Stringers 10W + 11W web holes

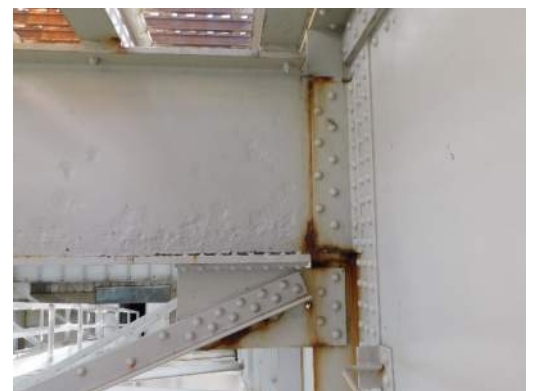
Span 5 K-brace connection plate hole

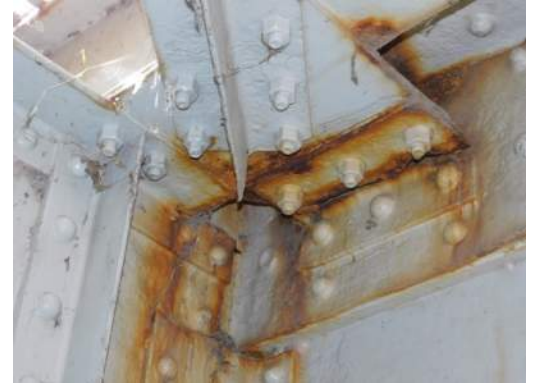
Span 5 South leaf, upper diagonal at FB7s north side to G3W east side

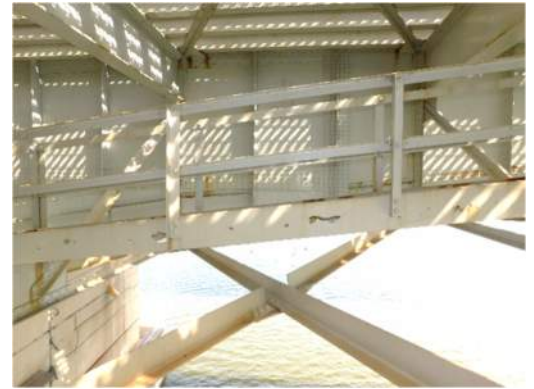
Span 5 North leaf, catwalk channel web holes

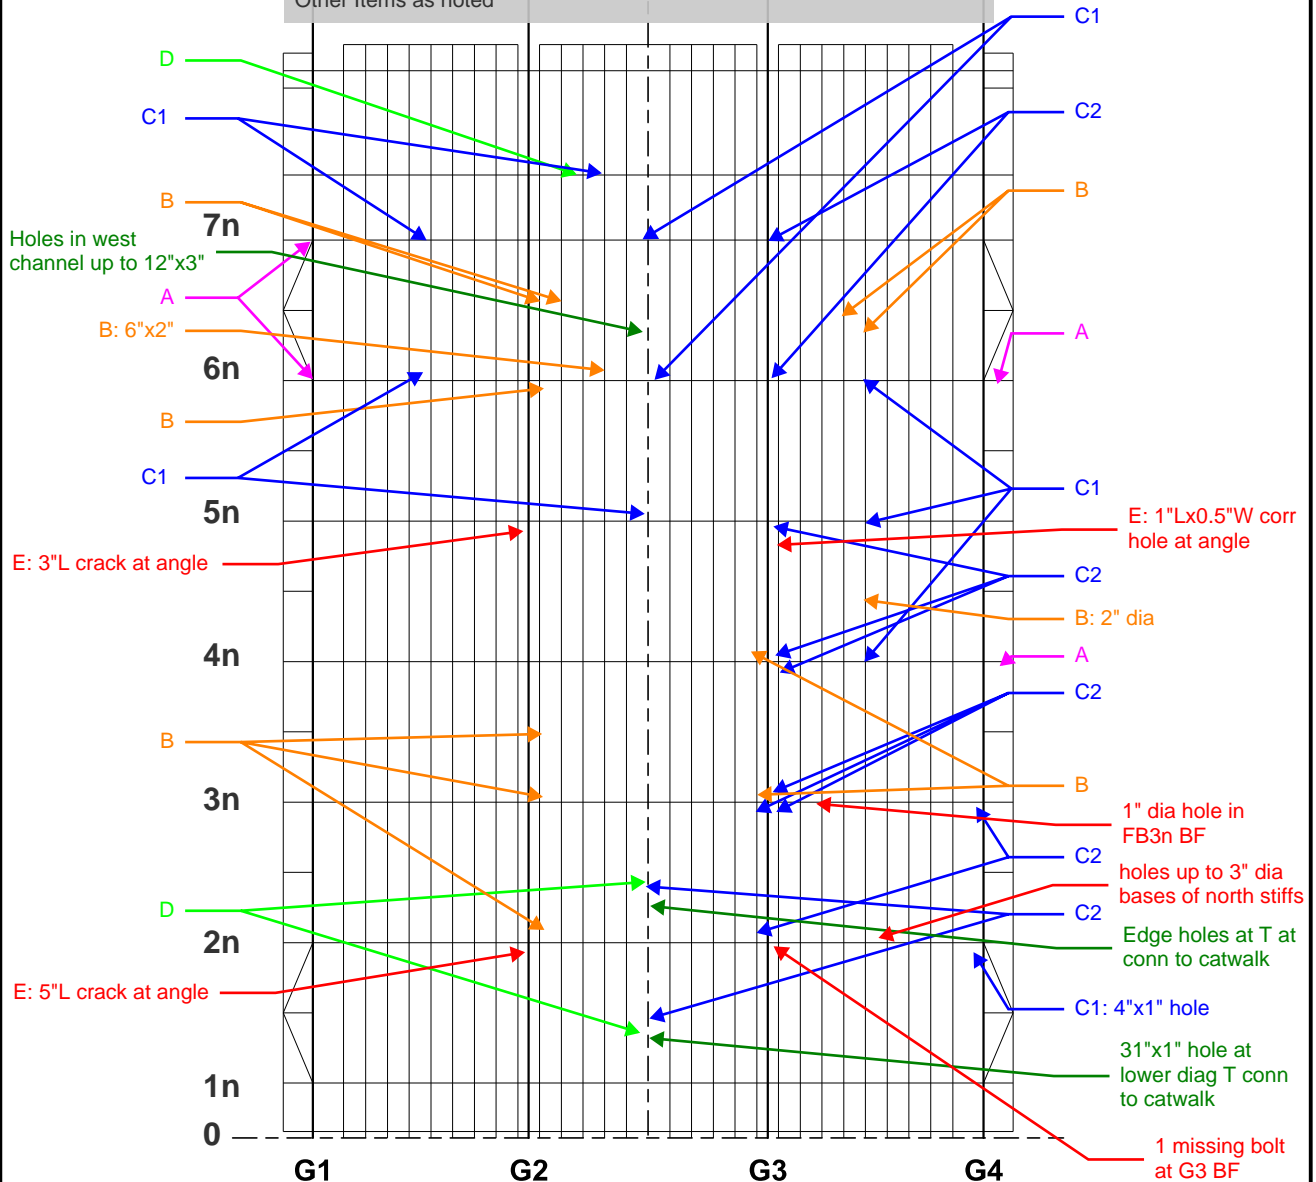
- A - Sidewalk beam or post web hole, 1" dia., dim u.o.n.
- B - Stringer web hole, 1" dia., dim u.o.n.
- C1 - K-bracing SL (1/16"-3/16")
- C2 - Diag bracing SL (1/16"-3/16")
- D - PR at bracing connection
- E - Corrosion cracking / broken connection angle upper diagonal to FB/G
- Other Items as noted

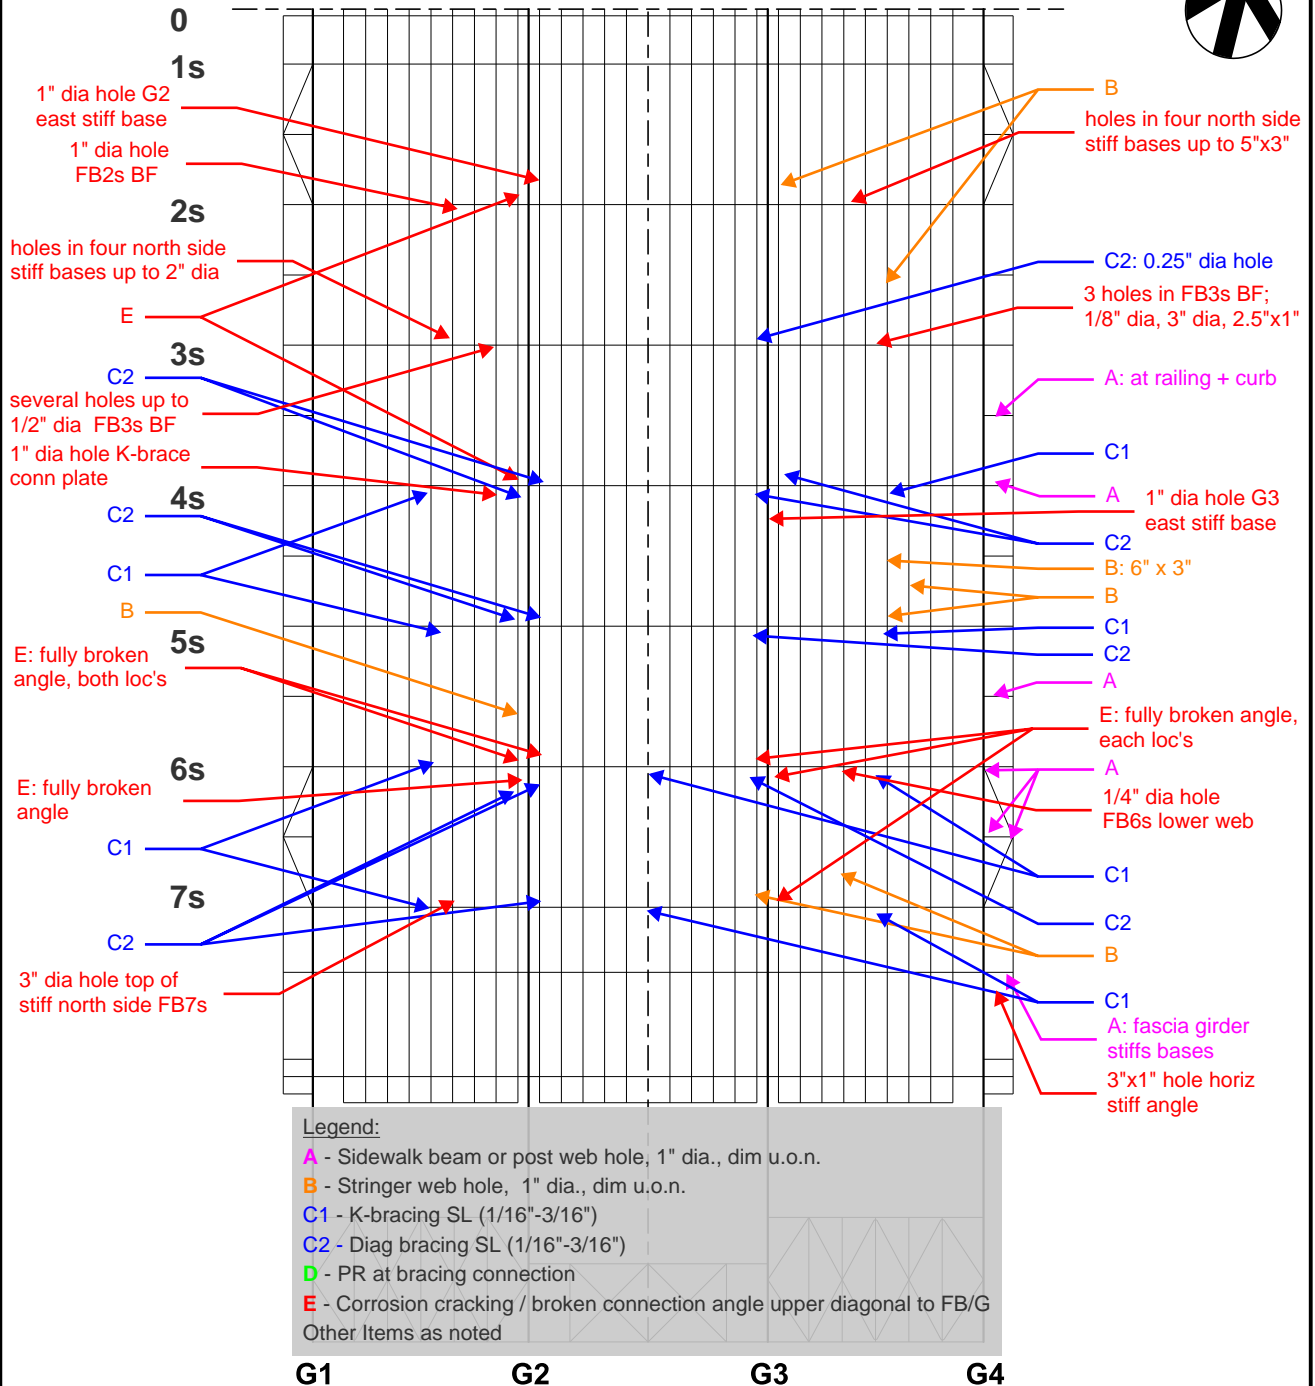
SPAN 5 SOUTH BASCULE

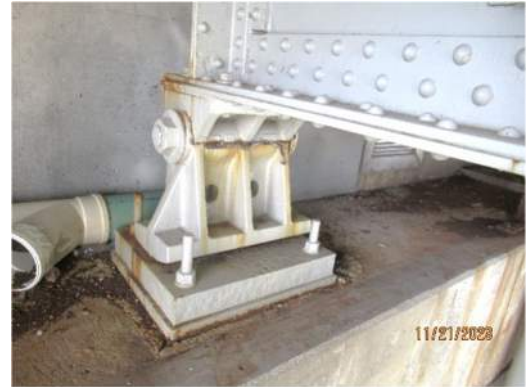
South abutment Rocker Bearing 4W

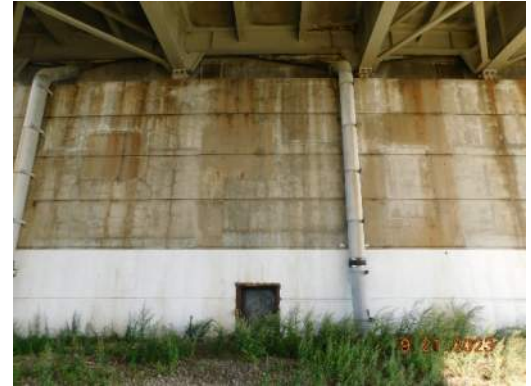
South abutment stem wall, middle section

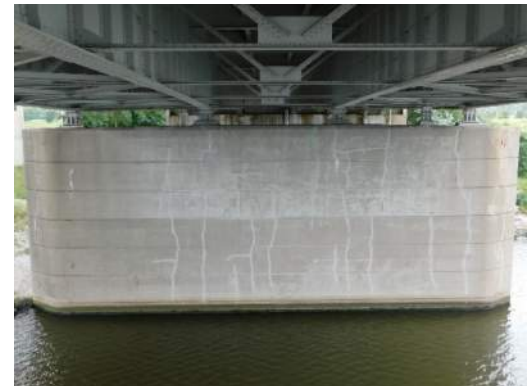
Pier 1 North face, crack repairs throughout

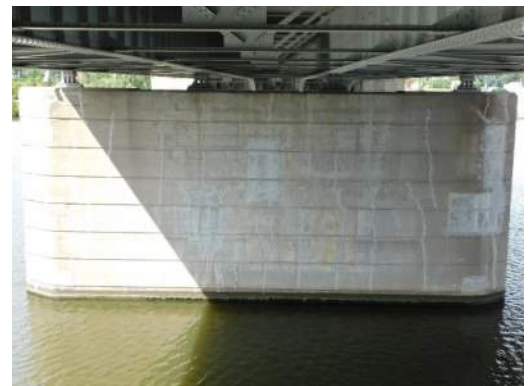
Pier 3 South face, crack and patch repairs

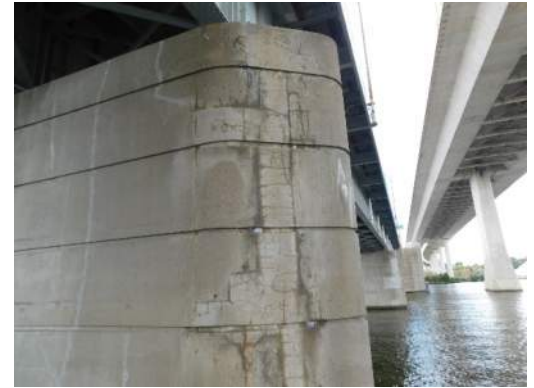
Pier 3, South side at East end, cracking in patched areas

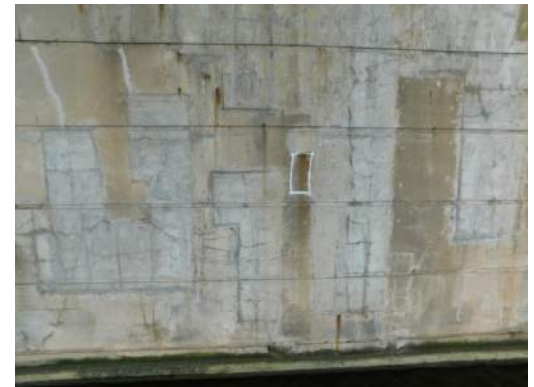
Pier 4, South face detail view, East side

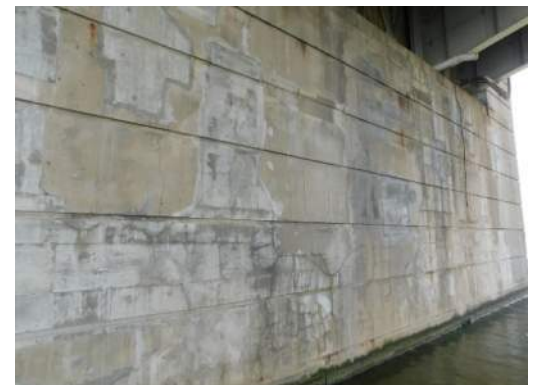
Pier 5 North face detail view, center to west

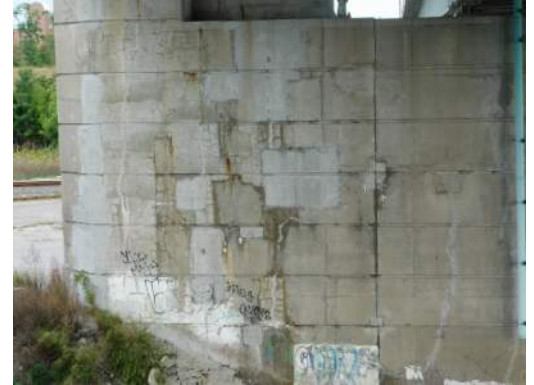
Pier 6, South side detail view, West side

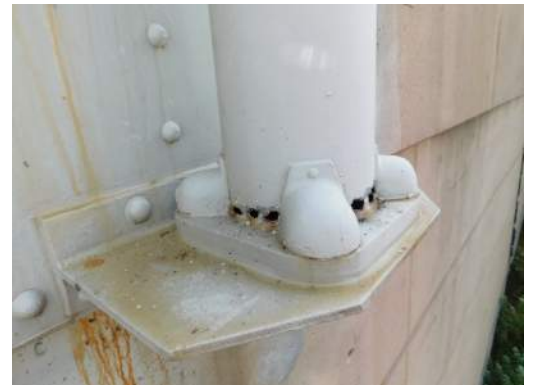
Span 1 West side light pole base with holes

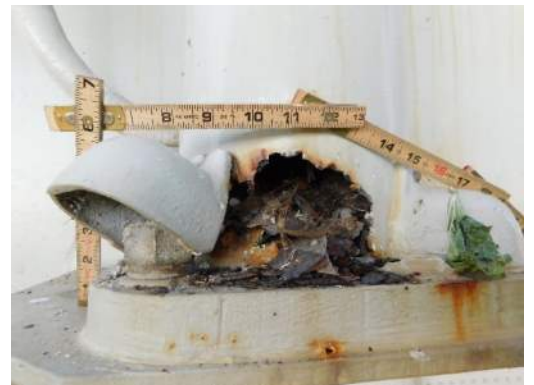
Span 1 East side light pole base with holes

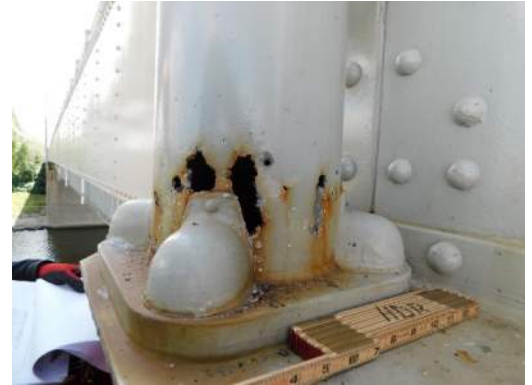
Span 3, FB18s East side light pole base with holes

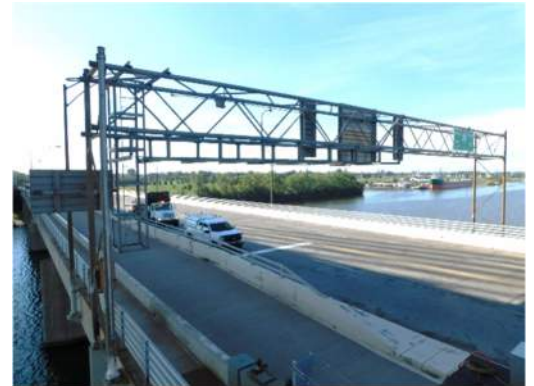
Span 4 sign gantry north elevation

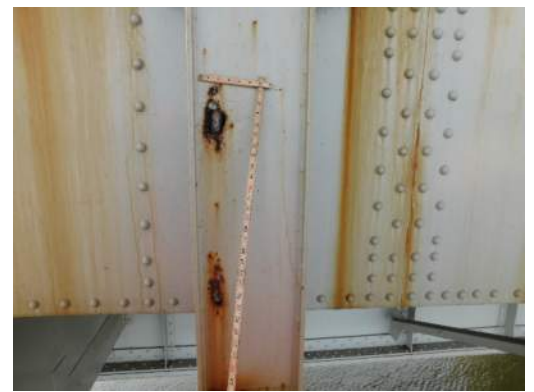
Span 6 East fascia support, holes at south post base web plate

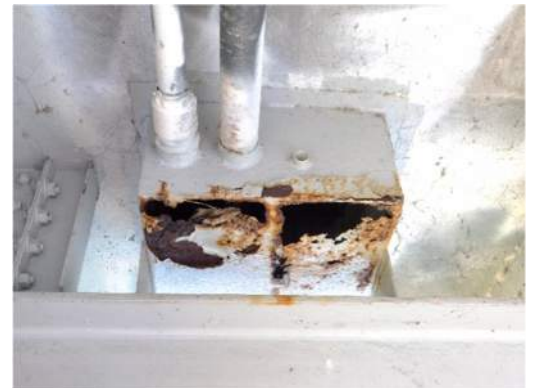
Span 3 junction box at FB18s east exterior, corrosion holes in box

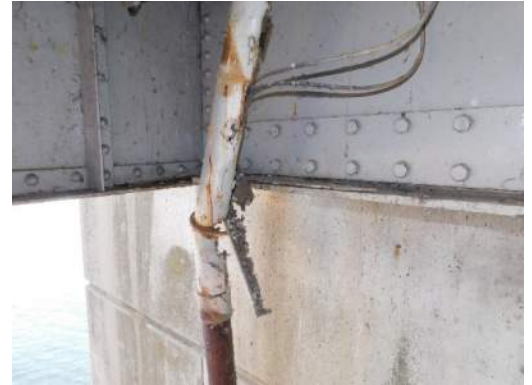
Span 6 at Pier 5, broken conduit below East sidewalk

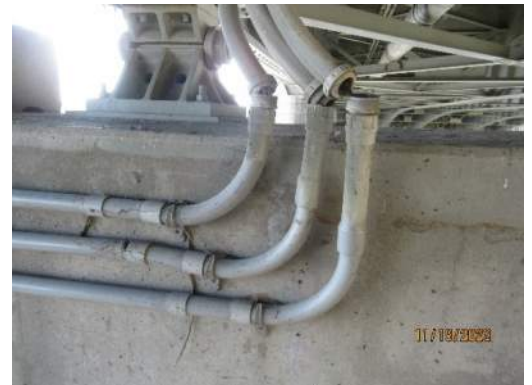
Pier 6 North side, disconnected conduits with rope supports

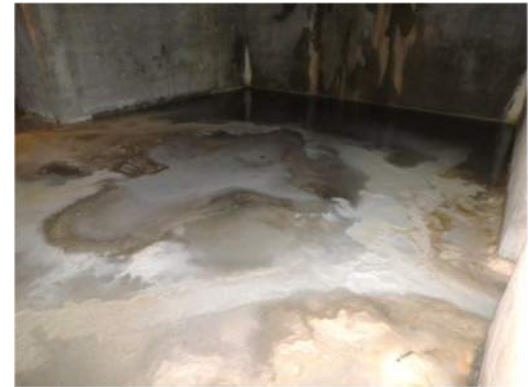
Pier 4 Basement Level F water & silt

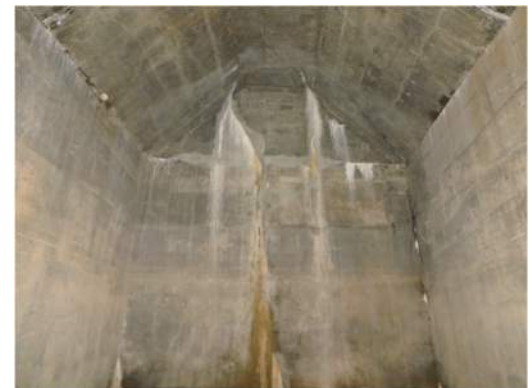
Pier 4 Basement Level F exterior wall cracks

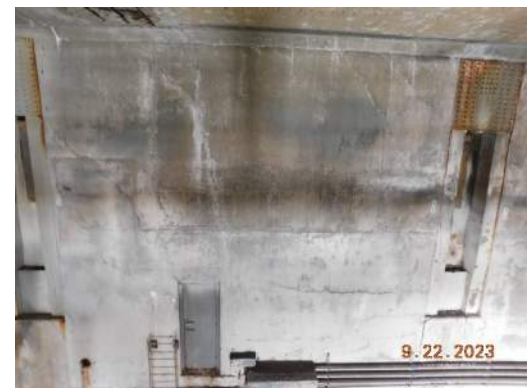
Pier 5 Counterweight Pit Level E upper wall diagonal cracking throughout

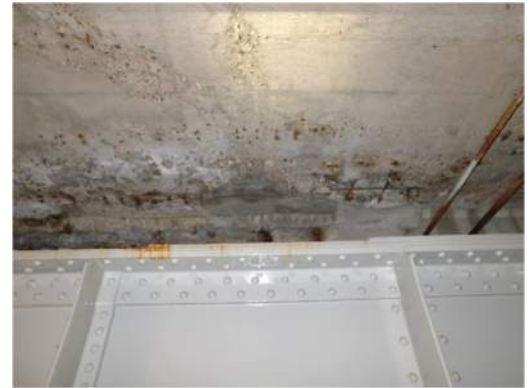
Pier 4 roadway span underside (Level C), deck spalling above G4W

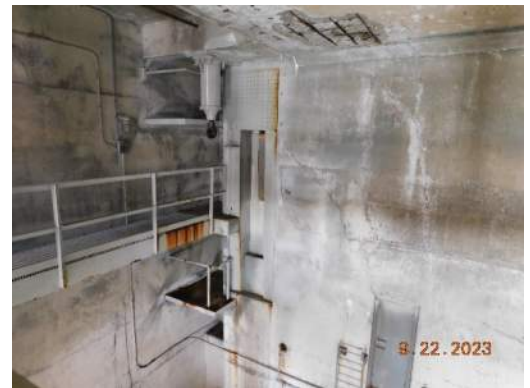
Pier 5 roadway span underside (Level C), deck spalling above G1W

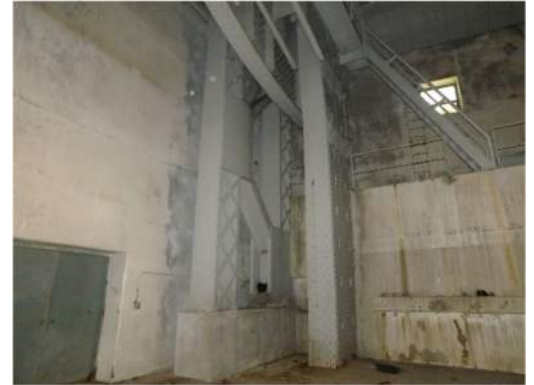
Pier 4 Trunnion Tower 1W lower portion

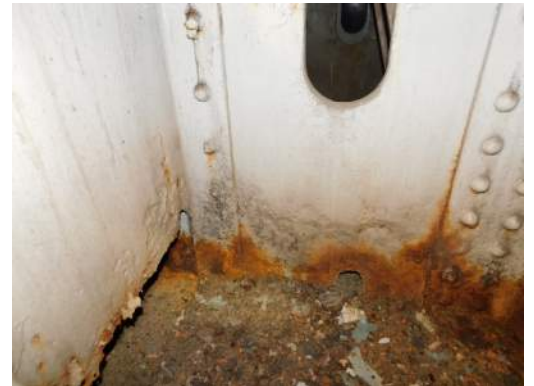
Pier 4 Trunnion Tower 3W, West leg interior at base, typical corrosion and section loss

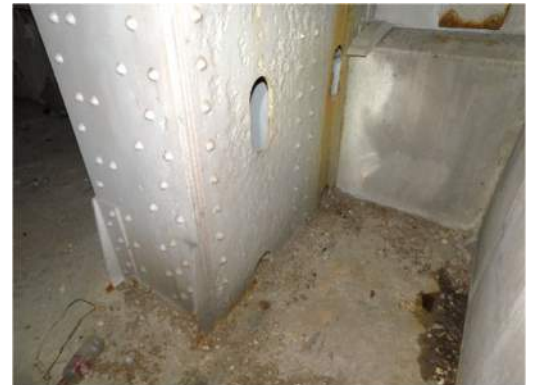
Pier 4 Trunnion Tower 4W, West leg base, exterior plate section loss

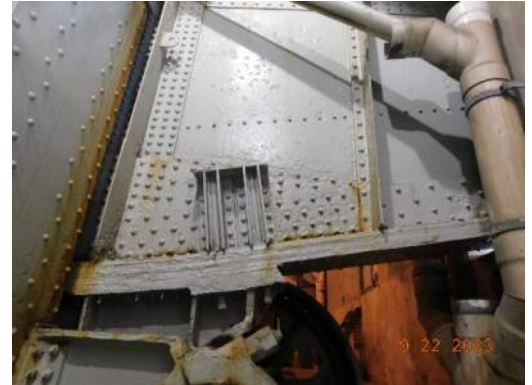
Pier 4, G3W East face widespread painted over section loss

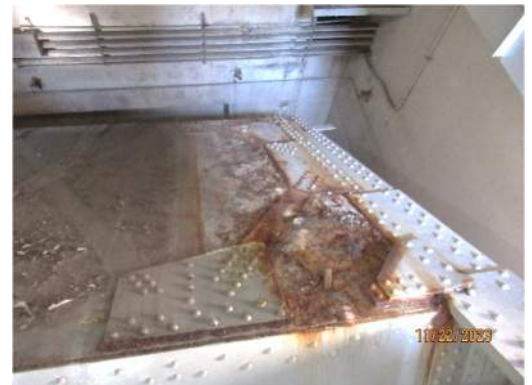
Pier 5, counterweight top at east side

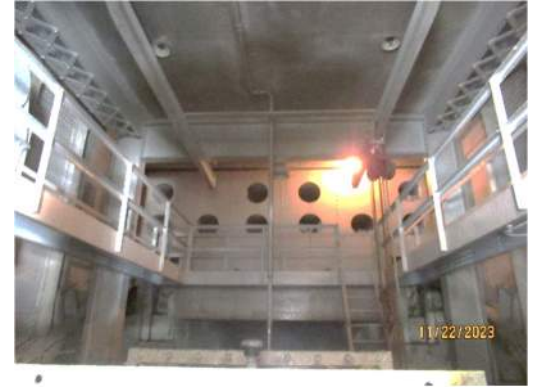
Pier 5 upper catwalks and counterweight pockets, general view at G1W-G2W

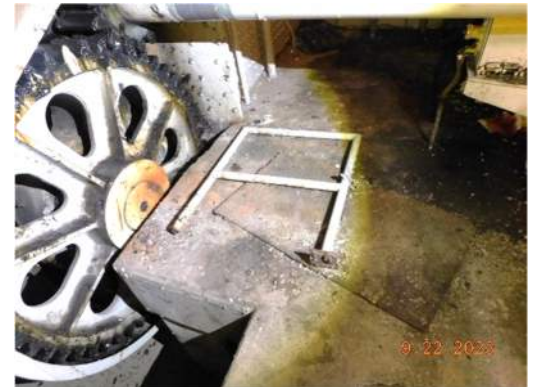
Pier 5, broken railing at machinery level

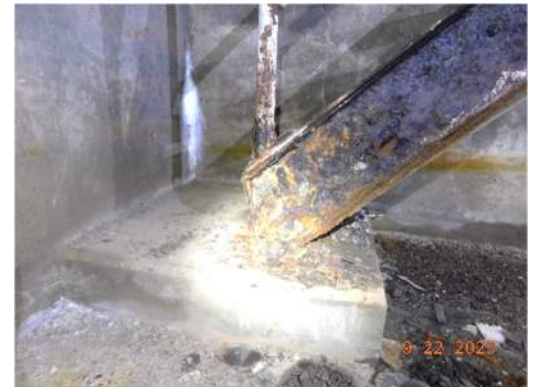
Pier 5 base of stairs at Level F heavy corrosion and hole in web

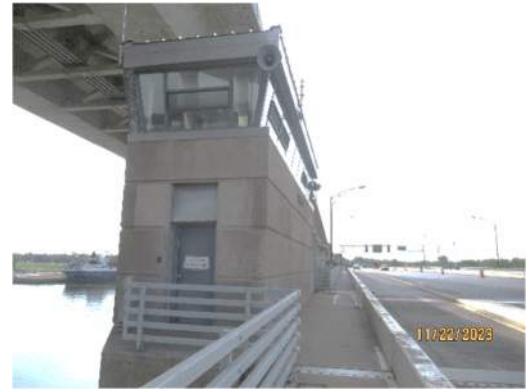
Pier 5, Operator house and roadway access

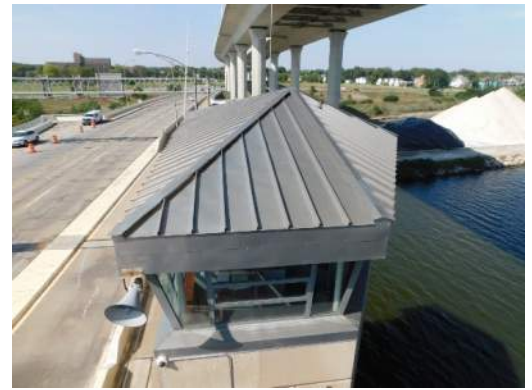
Pier 5 Operator house roof in good condition

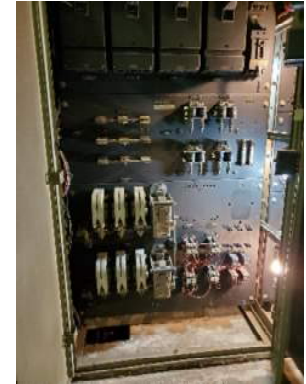
Photo E4: South Leaf Motor Starter Cabinet

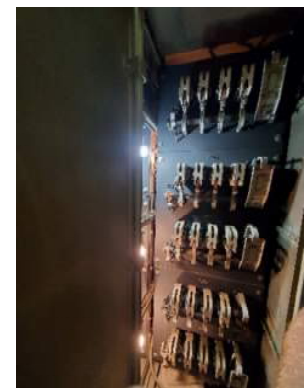
Photo E6: South Leaf Motor Starter Cabinet

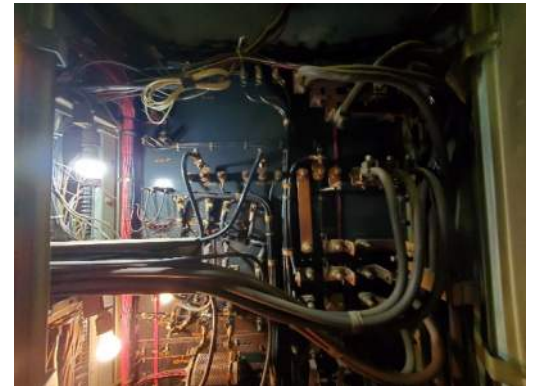
Photo E7: Back Side of the South Leaf Motor Starter Cabinet

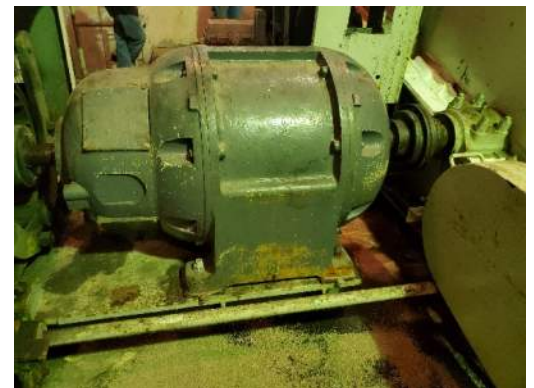
Photo E9: Southeast Main Drive Motor

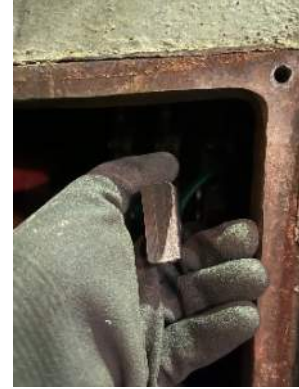
Photo E10: Southeast Main Drive Motor Brush

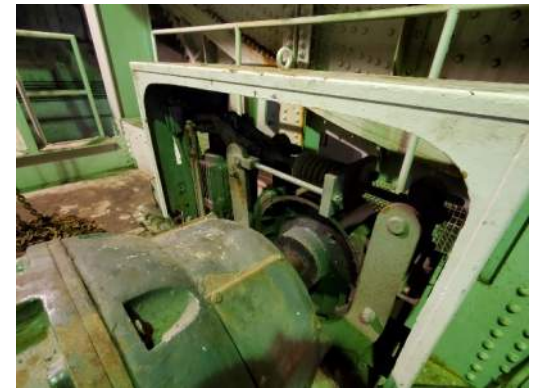
Photo E11: Northeast Motor Brake

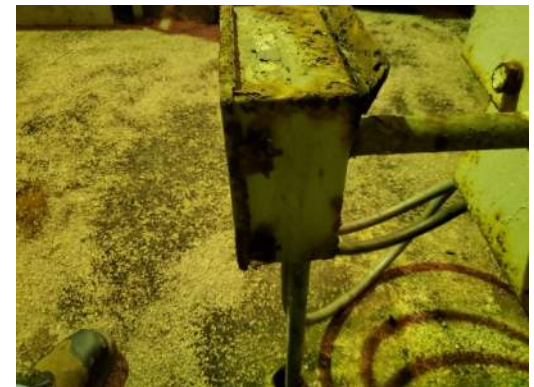
Photo E12: Motor Brake Junction Box

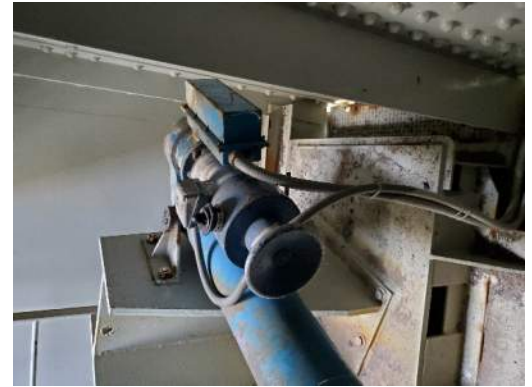
Photo E13: Southeast Traffic Gate Acuator

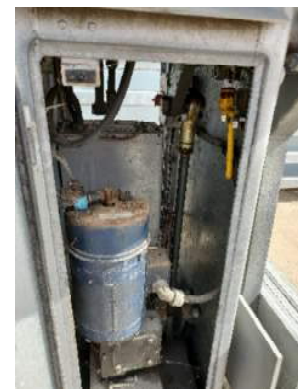
Photo E14: Northeast Traffic Gate

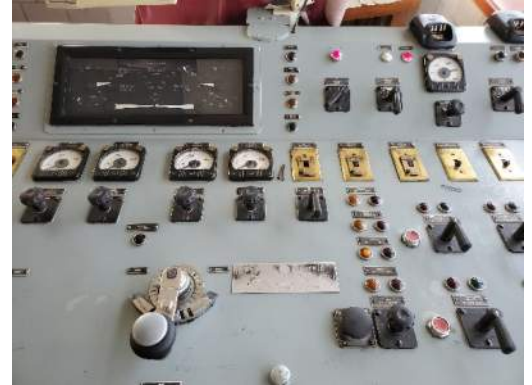
Photo E16: Control Console

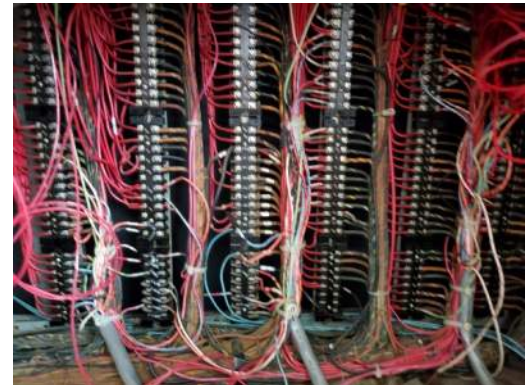
Photo E17: Control Console Interior

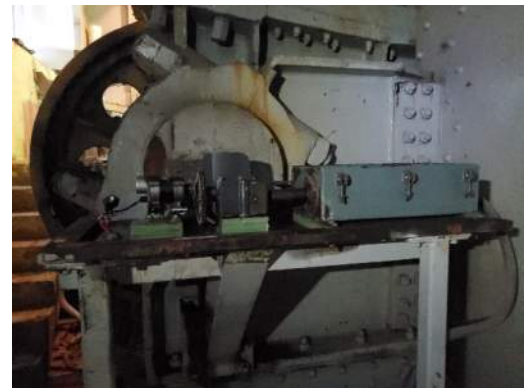
Photo E18: North Leaf Rotary Cam Limit Switch and Selsyn

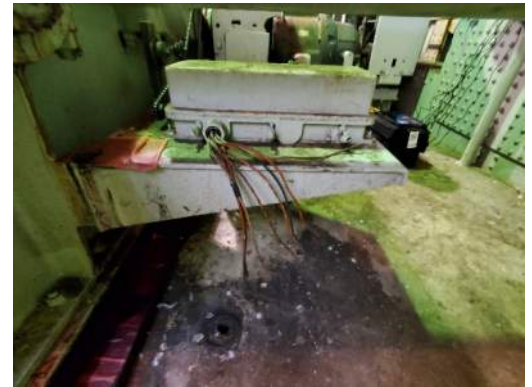
Photo E19: Abandoned Rotary Cam Limit Switch

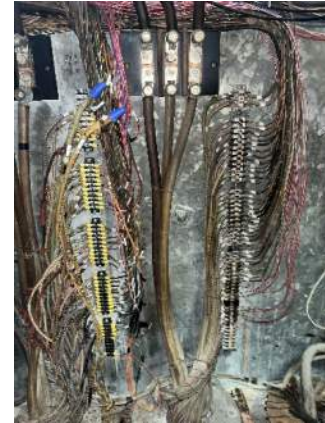
Photo E22: South Pier Submarine Cable Termination Cabinet

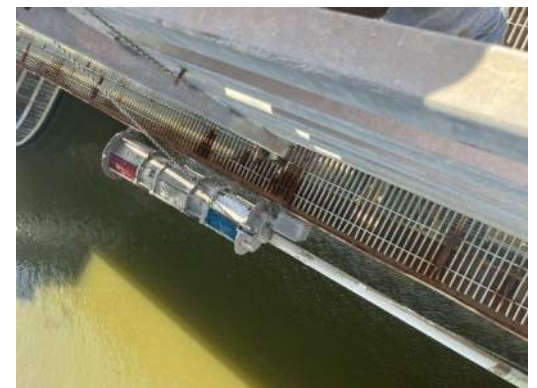
Photo E23: Southeast Navigation Light
