Craig Memorial Bascule Bridge

Over the Maumee River

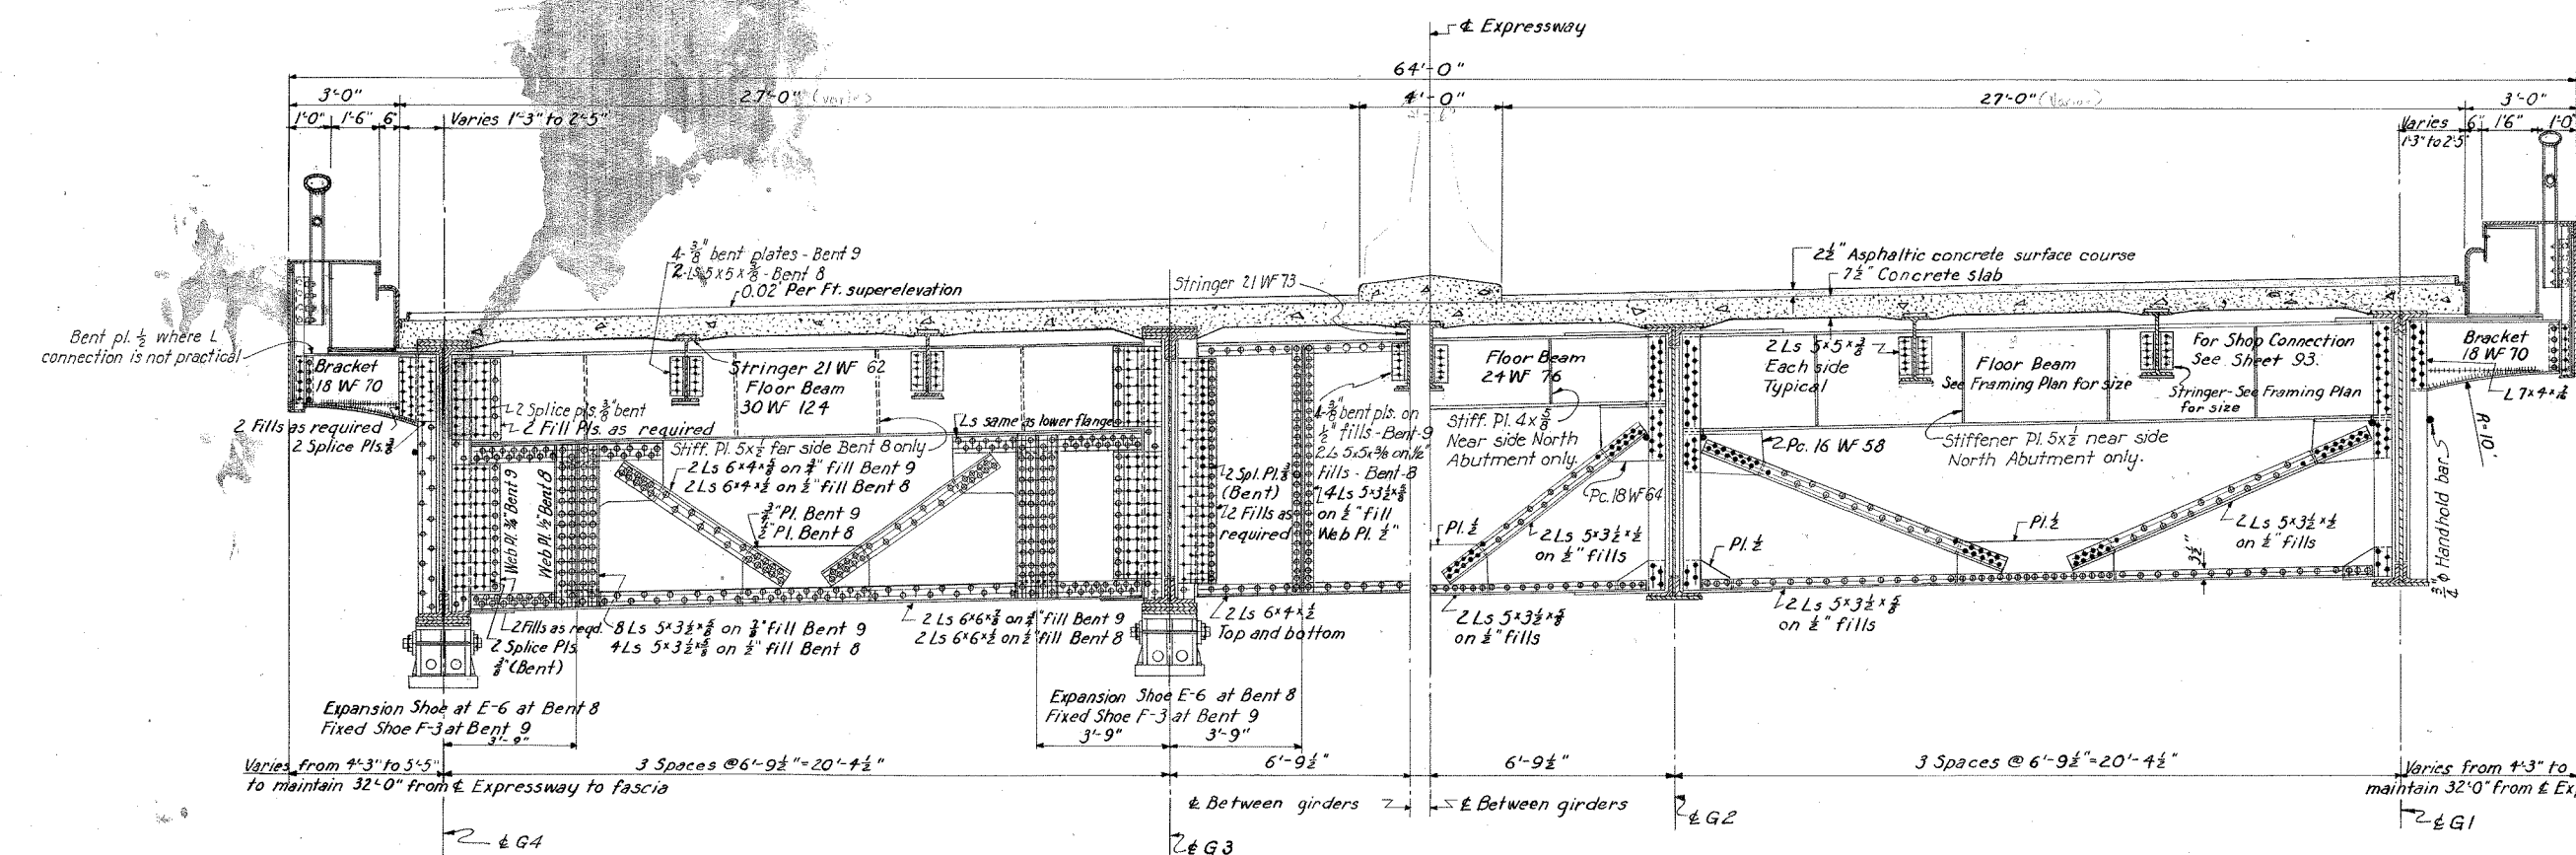
HALF CROSS SECTION AT BENT 9
Cross section at Bent 8 similar except as noted

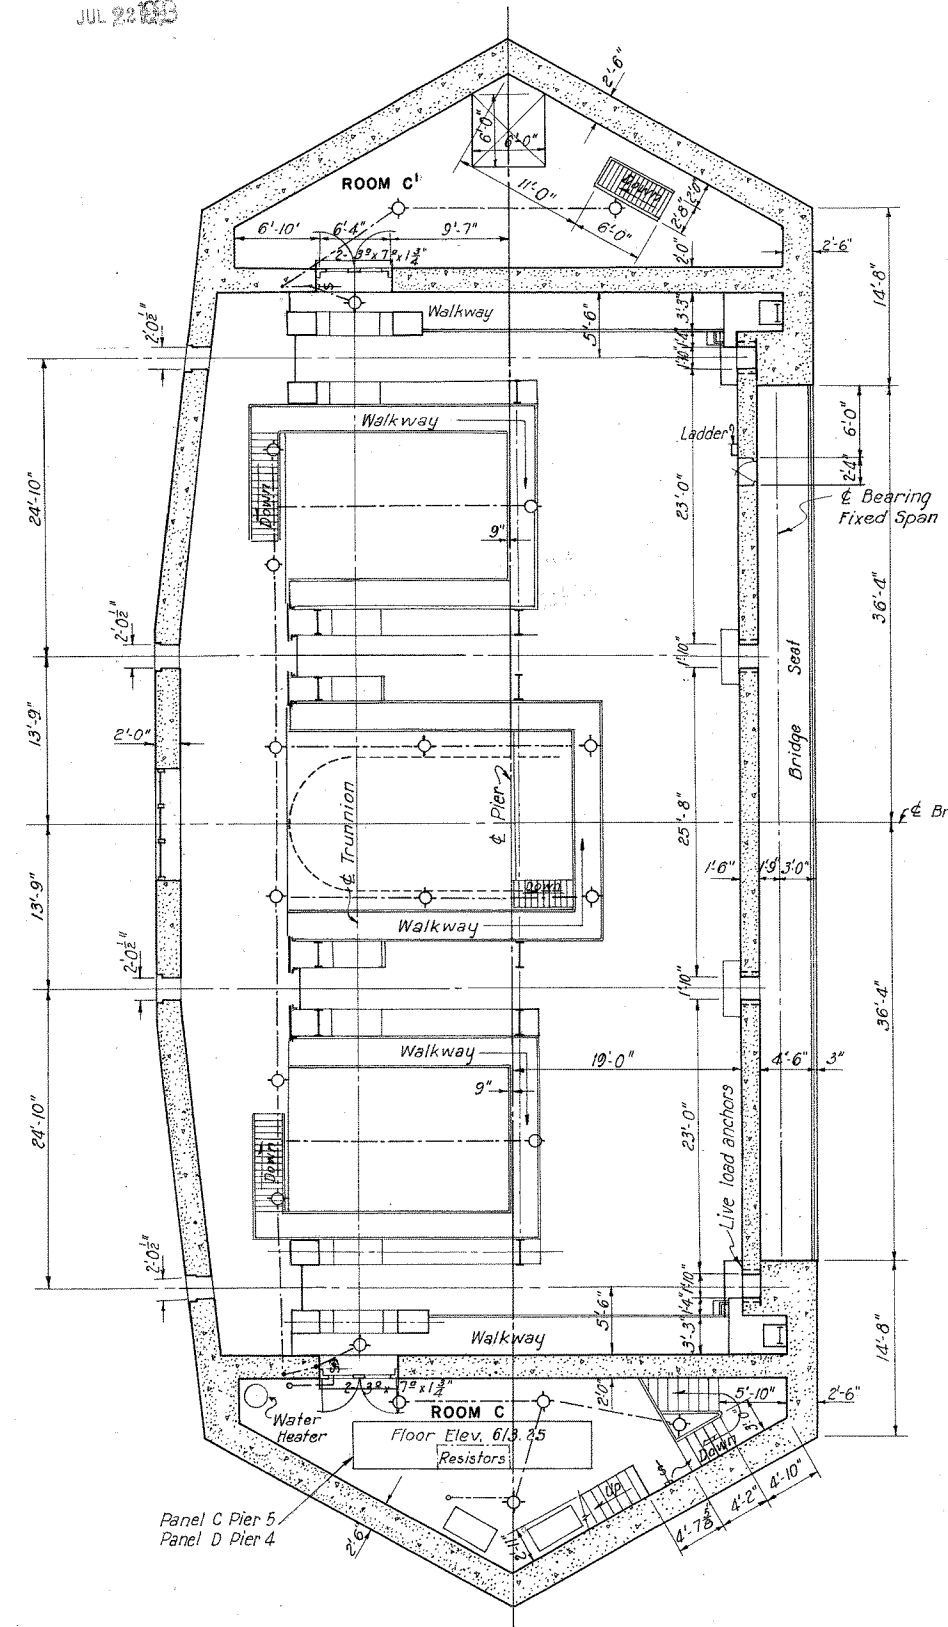
PLAN AT UPPER WALKWAYS
Walkways Elev. 615.00
Rooms C & C' Elev. 613.25

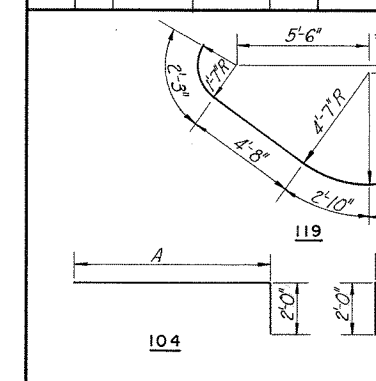
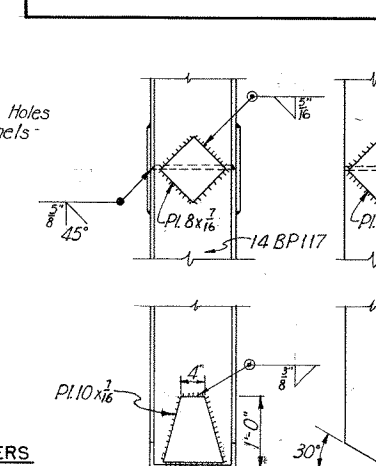
GENERAL NOTES ON PIERS

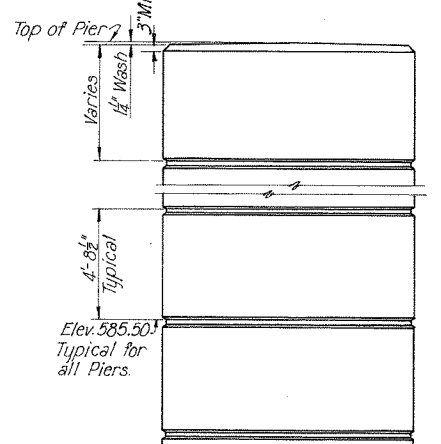
END ELEVATION SHOWING RUSTICATION
Scale: 3/4" = 1'-0"

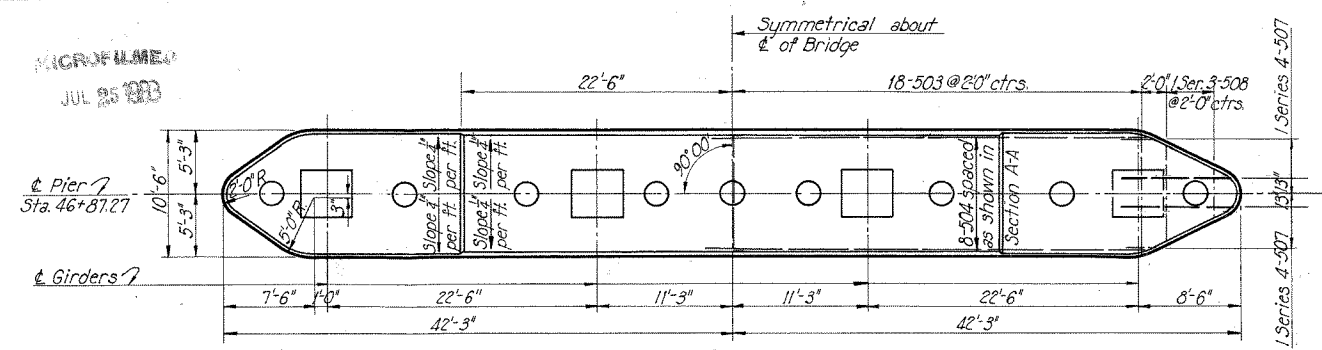
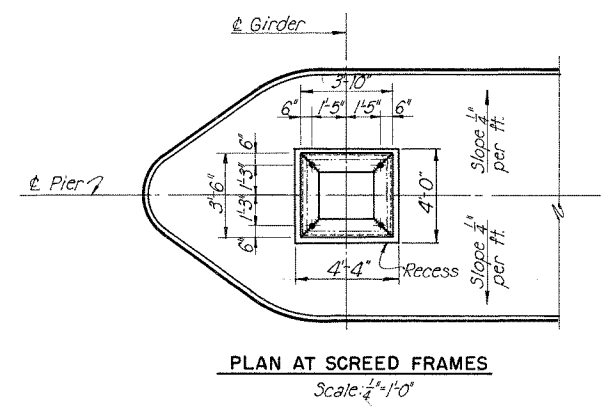
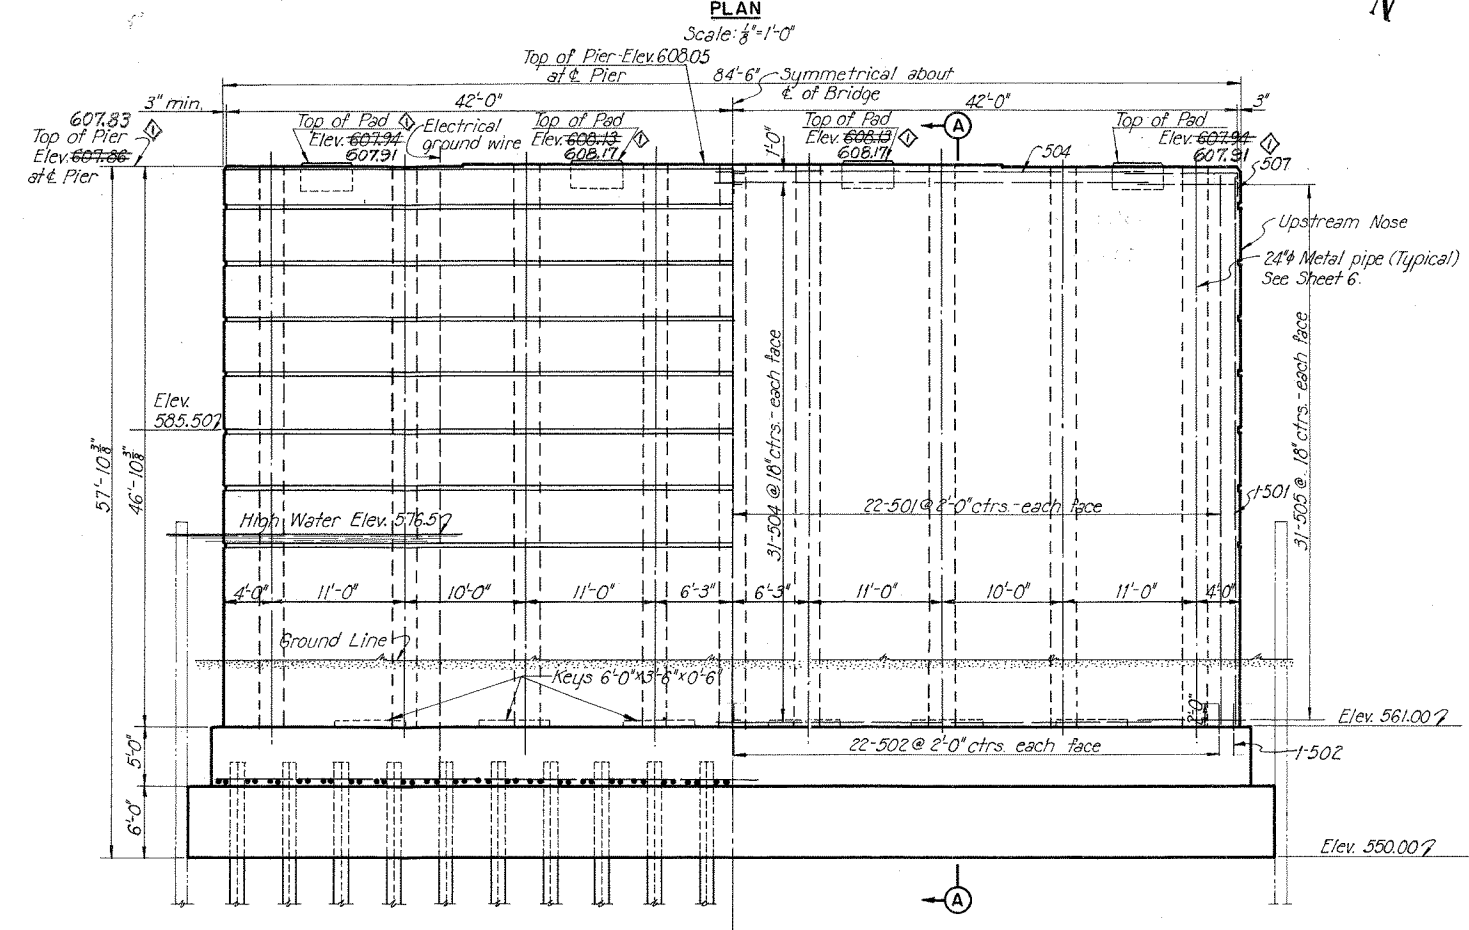
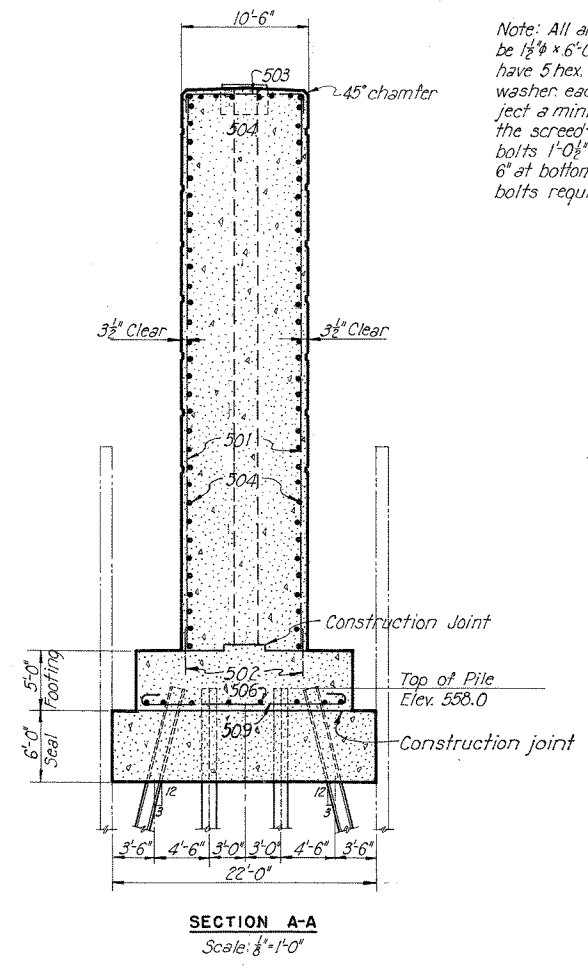
Note: All anchor bolts shall be 1 1/2" x 6'-0" long and shall have 5 hex. nuts and 1-3/2" x 1/2" washer each. Bolts shall project a minimum of 8" above the screed-frame. Thread bolts 1'-0 1/2" at top end and 6" at bottom end. Sixteen bolts required for Pier 2.

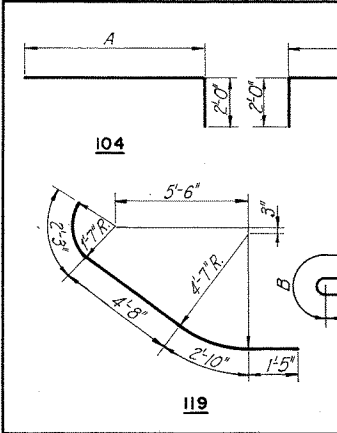
Note: For typical screed frame details, rustication details, pile details, and general notes on piers, see Sheet 6.

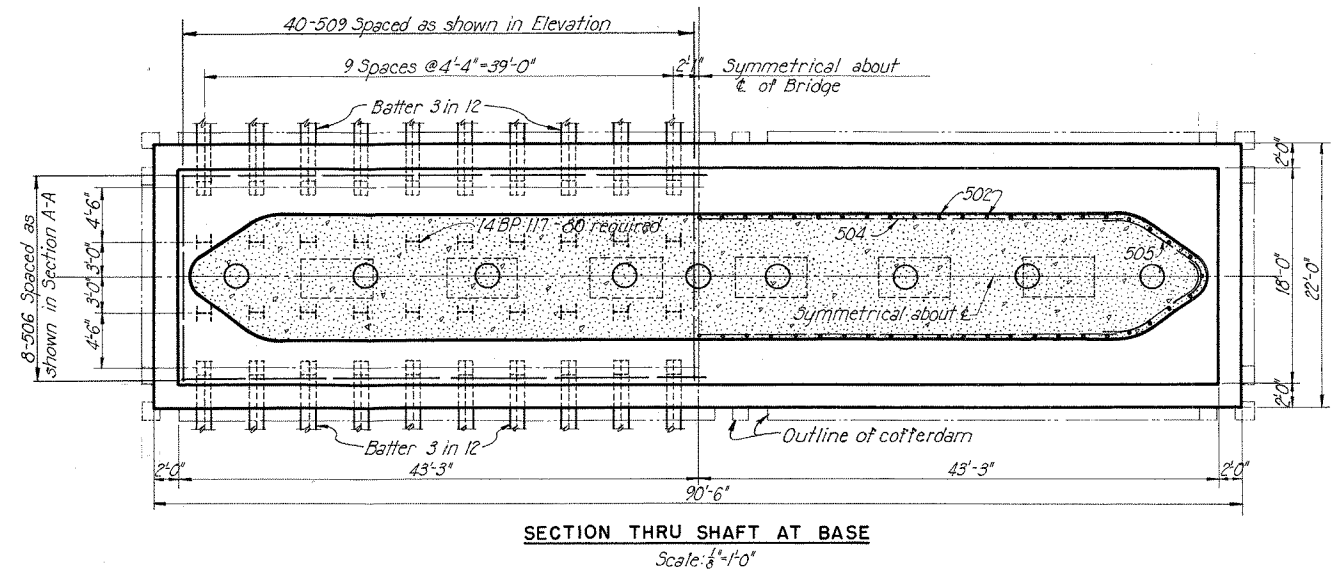
MICROFILMED
JUL 25 1963

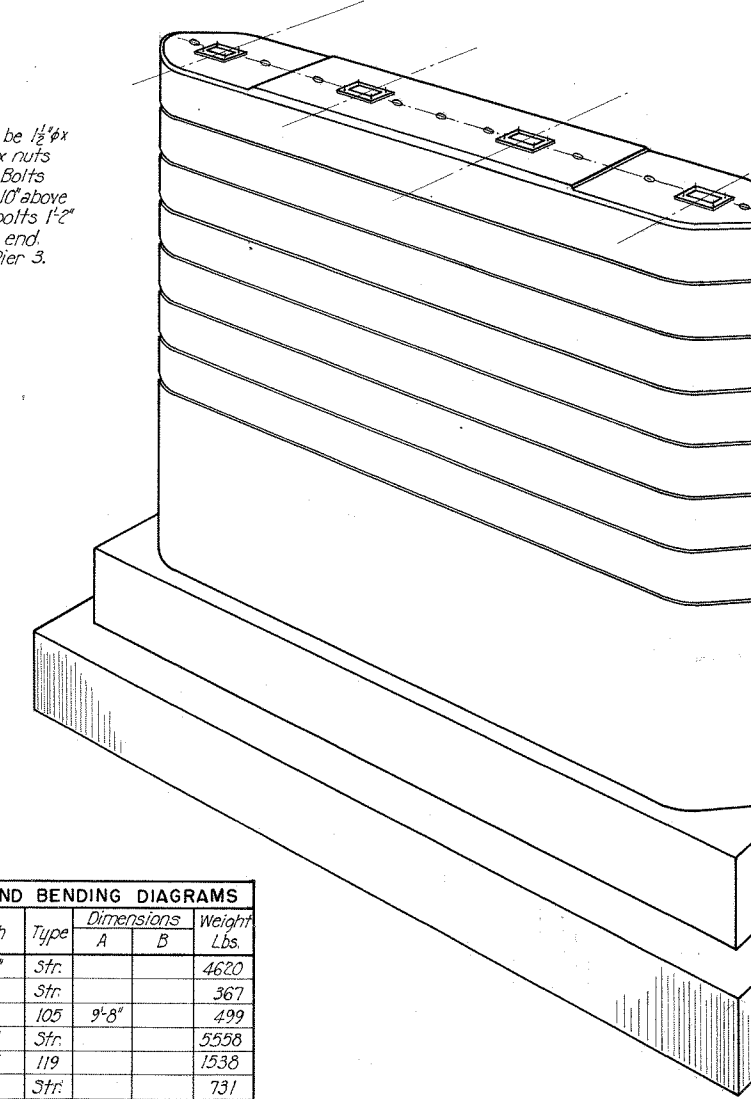
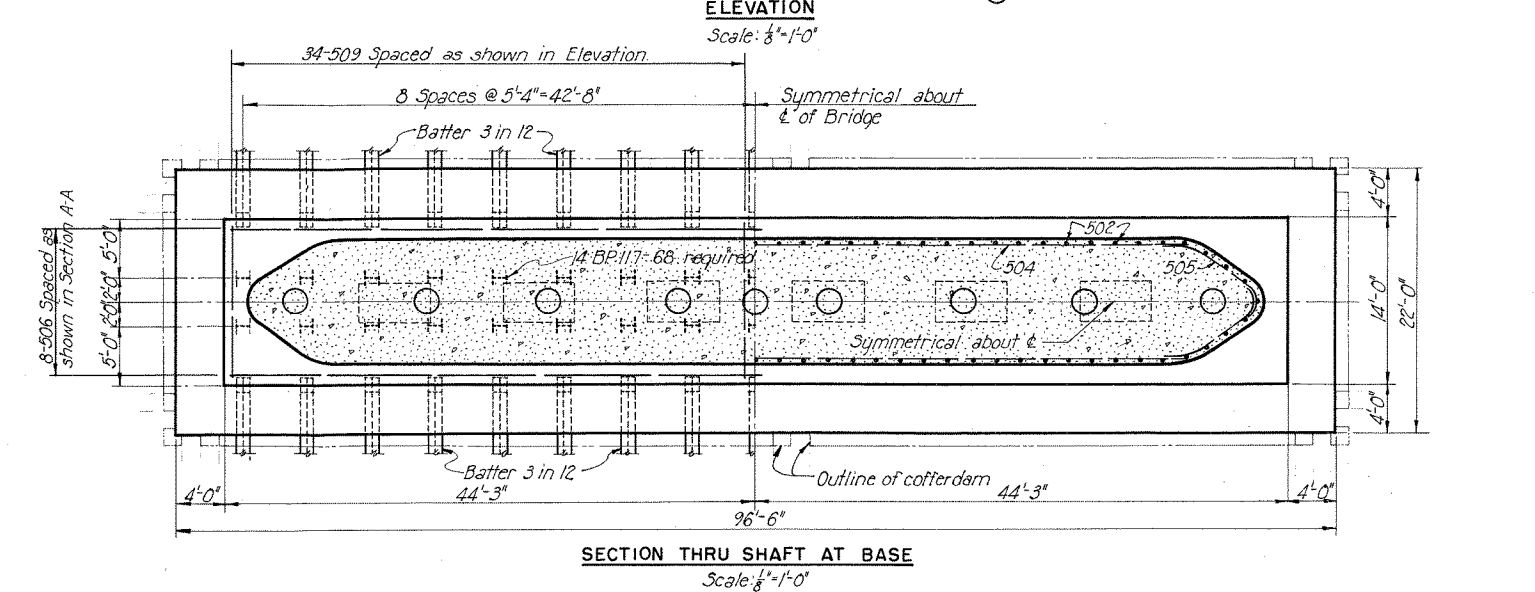
Mark	Size	Number	Length	Type	Dimensions		Weight Lbs.	
					A	B		
501	5	88	50'-4"	Str.			4620	
502	5	88	4'-0"	Str.			367	
503	5	35	13'-8"	105	9'-8"		499	
504	5	148	36'-0"	Str.			5558	
505	5	132	11'-2"	119			1538	
506	5	16	43'-9"	Str.			731	
507	5	4 Series of 4	5'-6" to 10'-1"	104	3'-6" to 8'-1"		130	
508	5	2 Series of 3	8'-4" to 13'-6"	105	4'-4" to 9'-6"		68	
509	5	68	14'-9"	100	13'-1"	10"	1047	
Test replacement bar	5	1	8'-0"	Str.			9	
Total								14,567

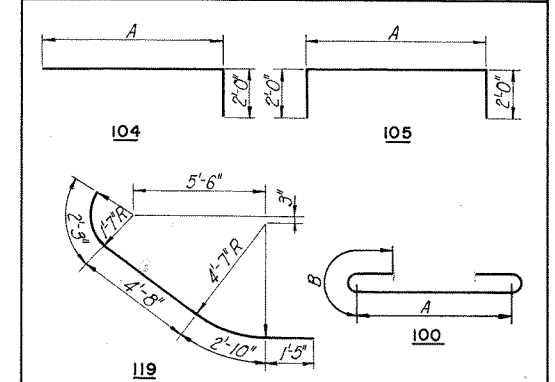
Note: For typical screed frame details, rustication details, pile details and general notes on piers, see Sheet 6.

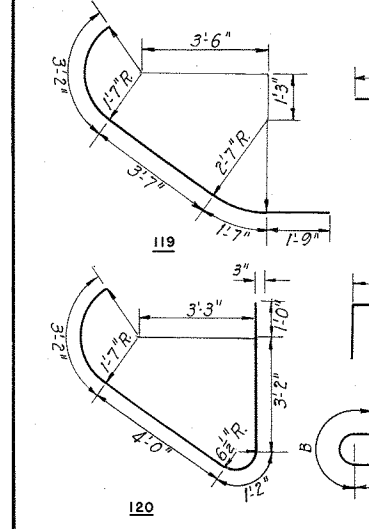
Mark	No.	Length	Type	Dimension
501	114	44'-9"	Sfr	A
502	222	4'-0"	Sfr	
503	136	25'-0"	Sfr	
504	70	10'-1"	119	
505	10	12'-6"	120	
506	37	11'-10"	105	7'-10"
507	3	16'-6"	105	7'-10"
508	7	15'-8"	105	3'-0"
509	4	20'-6"	105	7'-10"
510	22	11'-0"	Sfr	
511	6	10'-1"	104	5'-9"
512	3	27'-1"	104	20'-9"
513	3	13'-7"	104	7'-3"
514	1	20'-9"	Sfr	
515	1	17'-3"	104	14'-3"
516	1	12'-11"	104	7'-3"
517	108	14'-9"	100	13'-1"
518	12	56'-3"	Sfr	
519	6	7'-9"	104	5'-9"
				Total

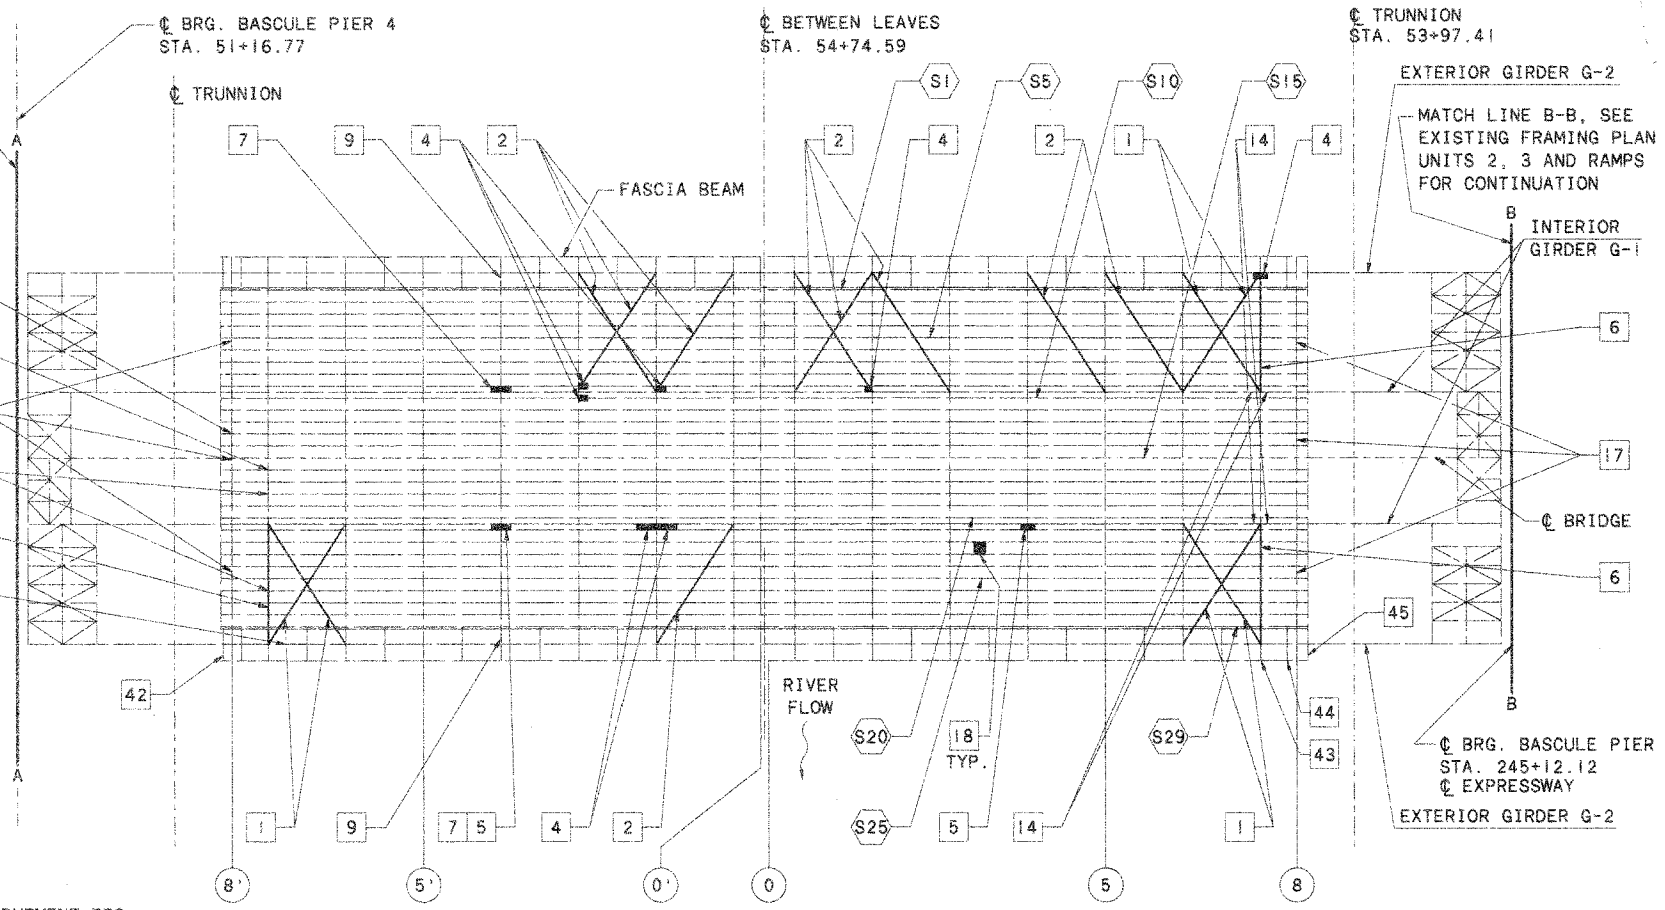
EXISTING FRAMING PLAN - BASCULE PLAN
STATIONING GIVEN FOR ϕ BRIDGE EXCEPT WHERE NOTED.

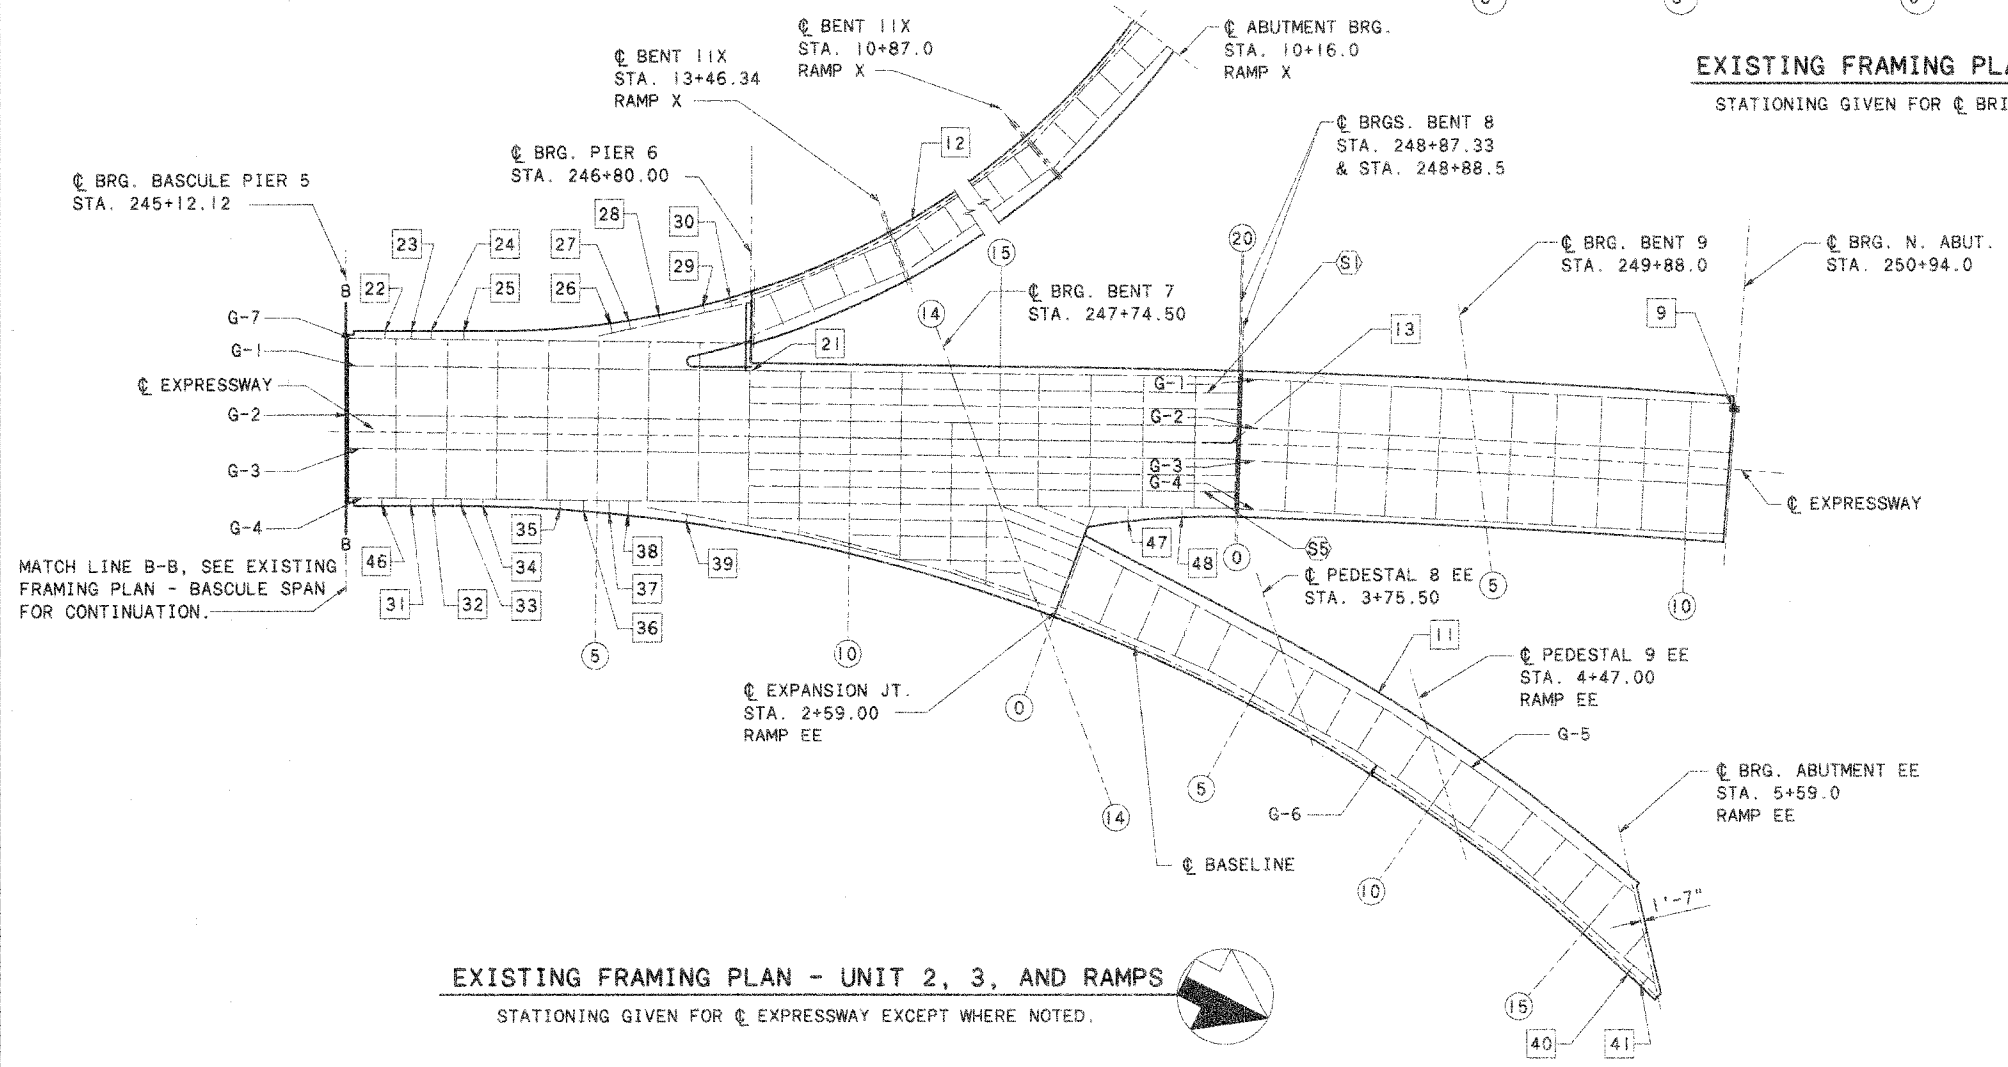
EXISTING FRAMING PLAN - UNIT 2, 3, AND RAMPS
STATIONING GIVEN FOR ϕ EXPRESSWAY EXCEPT WHERE NOTED.

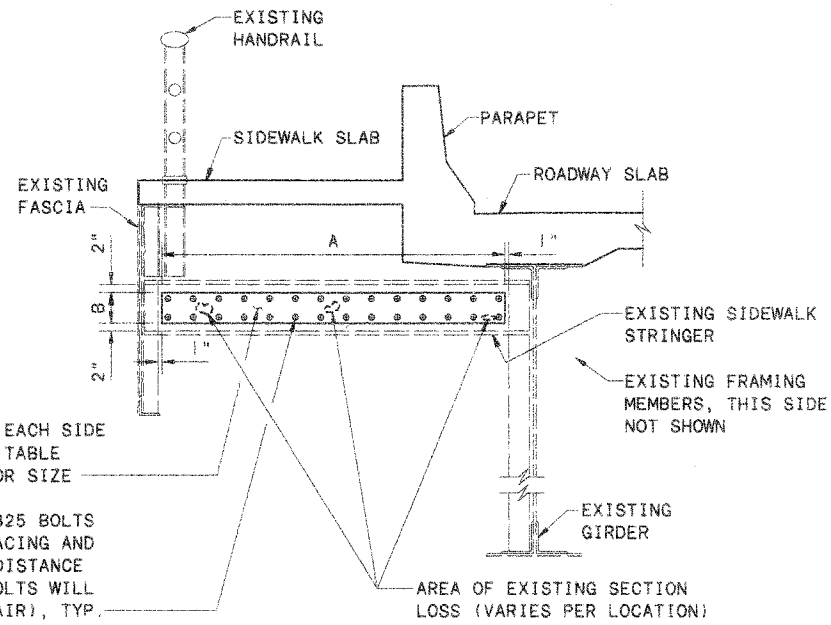
SIDEWALK STRINGER REPAIR

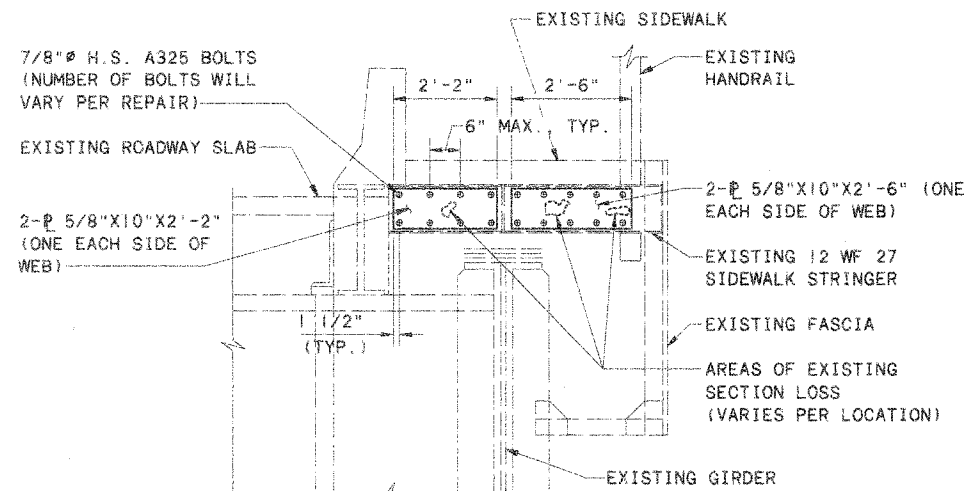
SIDEWALK STRINGER REPAIR

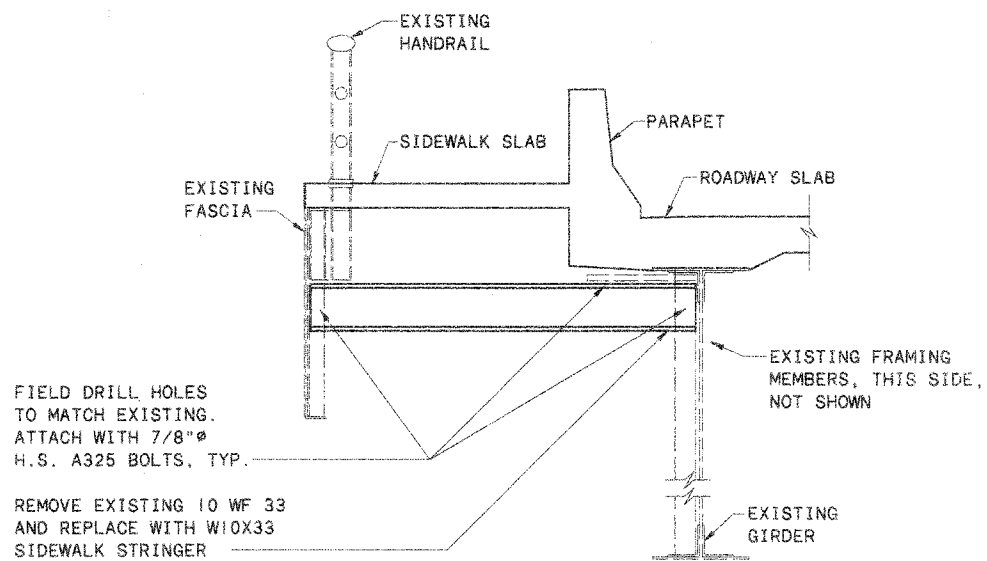
SIDEWALK STRINGER REPAIR

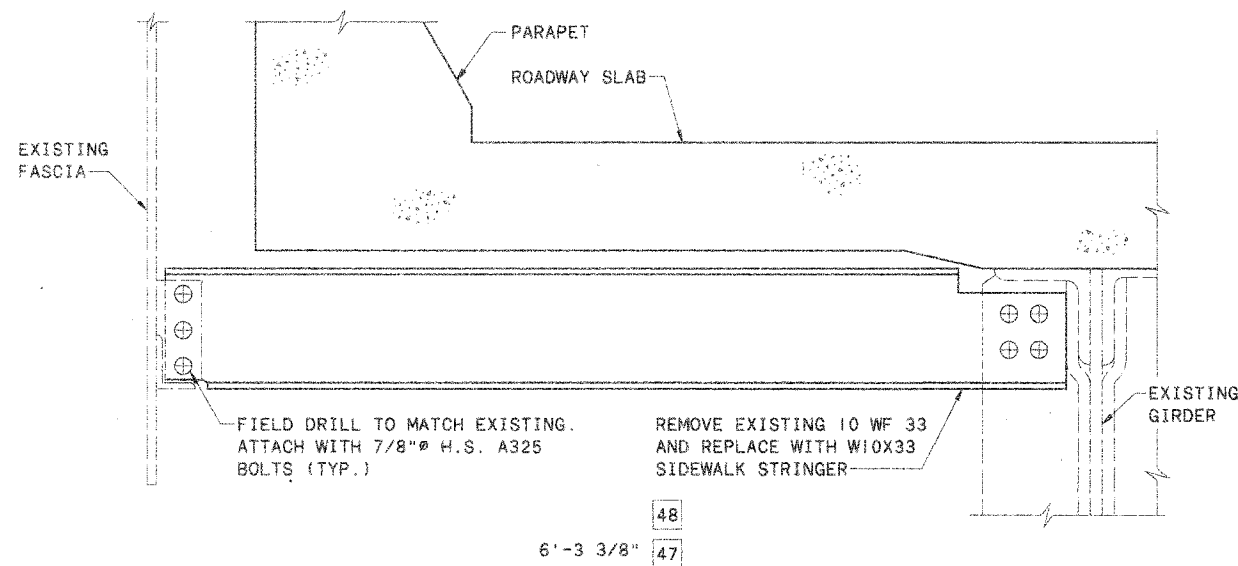
SIDEWALK STRINGER REPLACEMENT DETAIL 47 AND 48

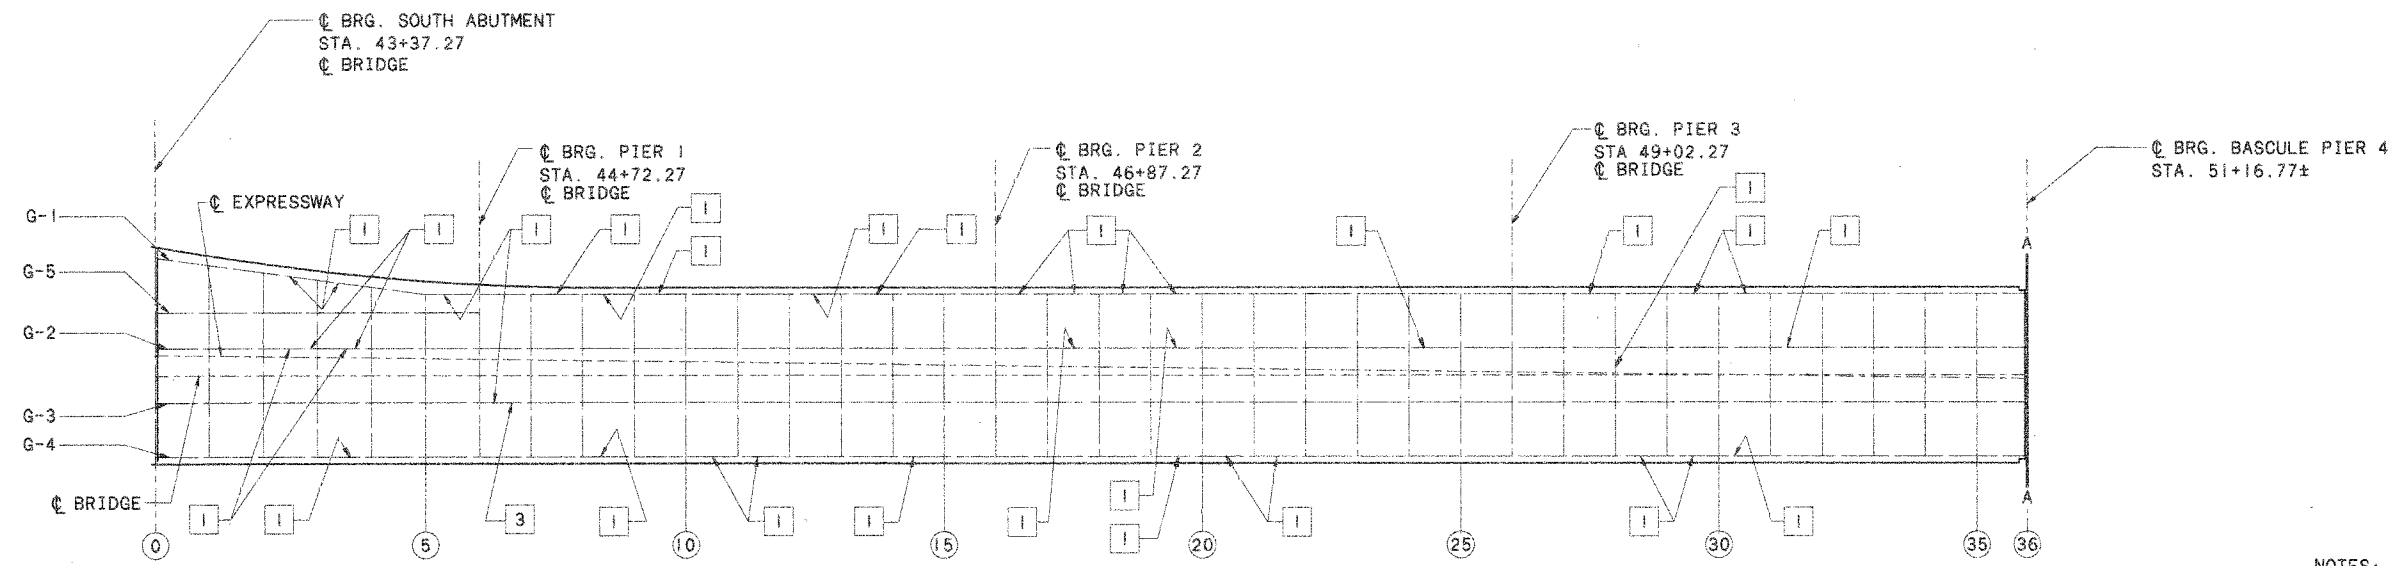
NOTES:
 - NOT ALL FRAMING MEMBERS SHOWN FOR CLARITY.
 - CONTRACTOR SHALL VERIFY LOCATIONS OF REPAIRS.
 - REPAIR AREAS ARE LOCATED ON ARROWHEAD SIDE.

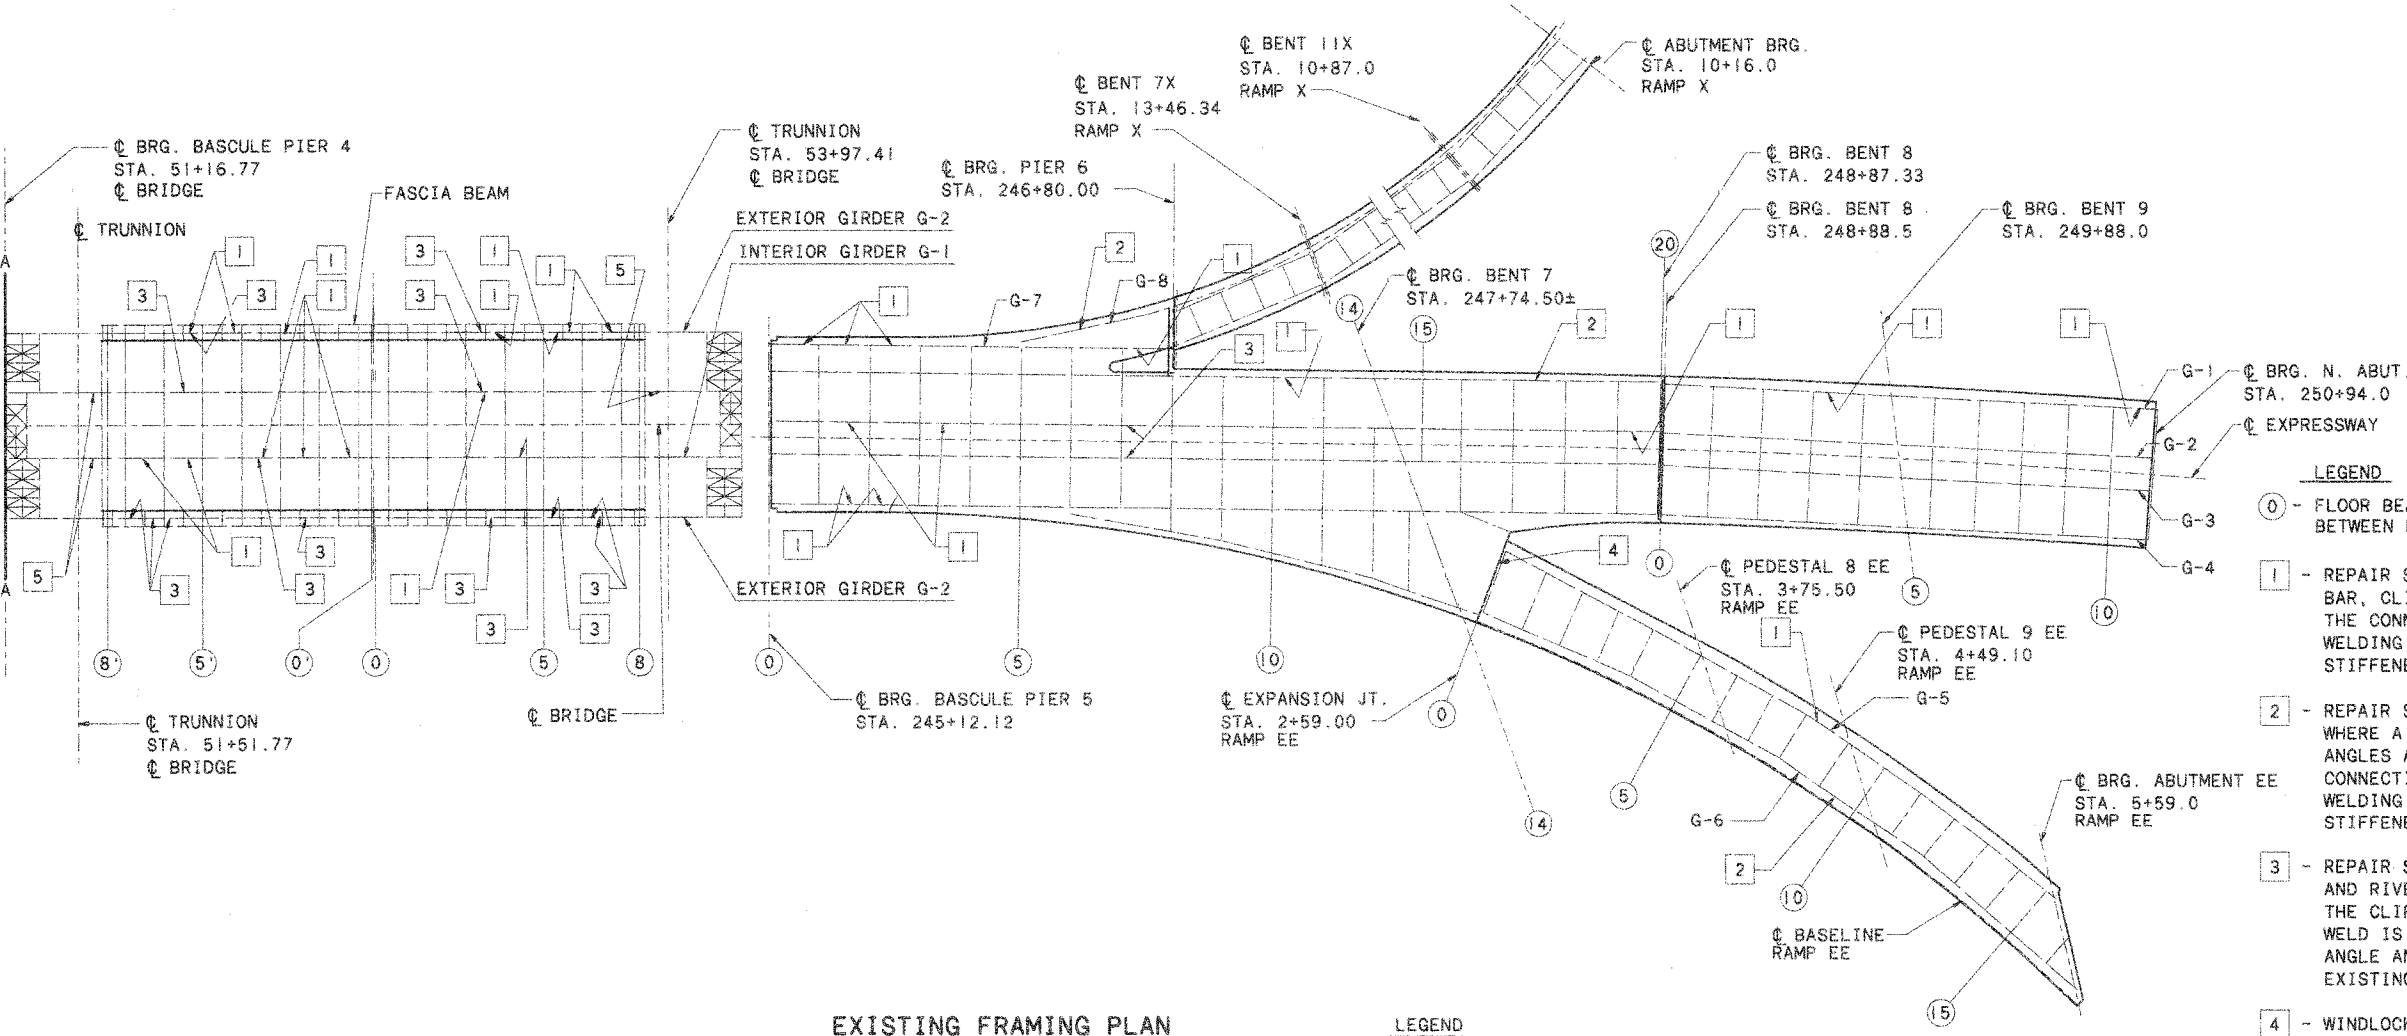
- LEGEND**
- ① - FLOOR BEAM NUMBER (NUMBERED CONSECUTIVELY BETWEEN LIMITS SHOWN)
 - ① - REPAIR SHALL CONSIST OF REPLACING BENT 3/4"Ø BAR, CLIP ANGLES AND RIVETS ASSOCIATED WITH THE CONNECTION ON THE CLIP ANGLE TO GIRDER AND WELDING BAR TO NEW ANGLE AND EXISTING STIFFENERS.
 - ② - REPAIR SHALL CONSIST OF ADDING 3/4"Ø BAR WHERE A BAR IS MISSING AND REPLACING CLIP ANGLES AND RIVETS ASSOCIATED WITH THE CONNECTION OF THE CLIP ANGLE TO GIRDER AND WELDING BAR TO NEW ANGLE AND EXISTING STIFFENERS.
 - ③ - REPAIR SHALL CONSIST OF REPLACING CLIP ANGLES AND RIVETS ASSOCIATED WITH THE CONNECTION OF THE CLIP ANGLE TO GIRDER WHERE THE EXISTING WELD IS BROKEN. WELD EXISTING BAR TO NEW ANGLE AND REPAIR ANY BROKEN TACK WELDS BETWEEN EXISTING BAR AND EXISTING STIFFENERS.
 - ④ - WINDLOCK REPAIR
 - ⑤ - PINION SUPPORT REHABILITATION

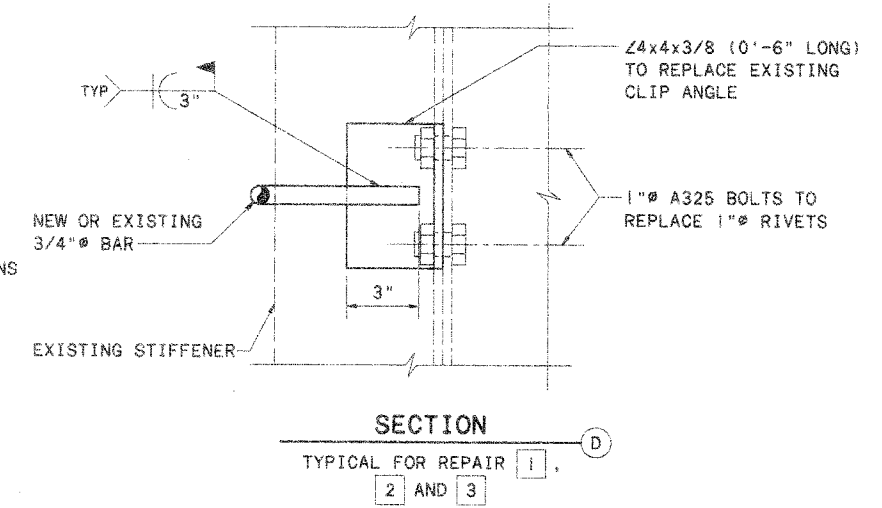
SECTION D
TYPICAL FOR REPAIR 1, 2 AND 3

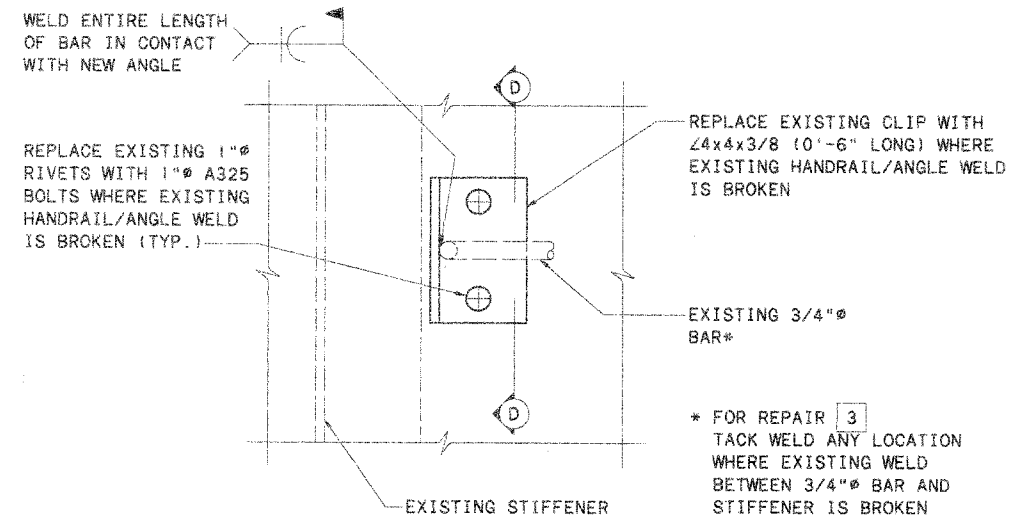
HANDRAIL REPLACEMENT DETAIL
TYPICAL FOR REPAIR 3

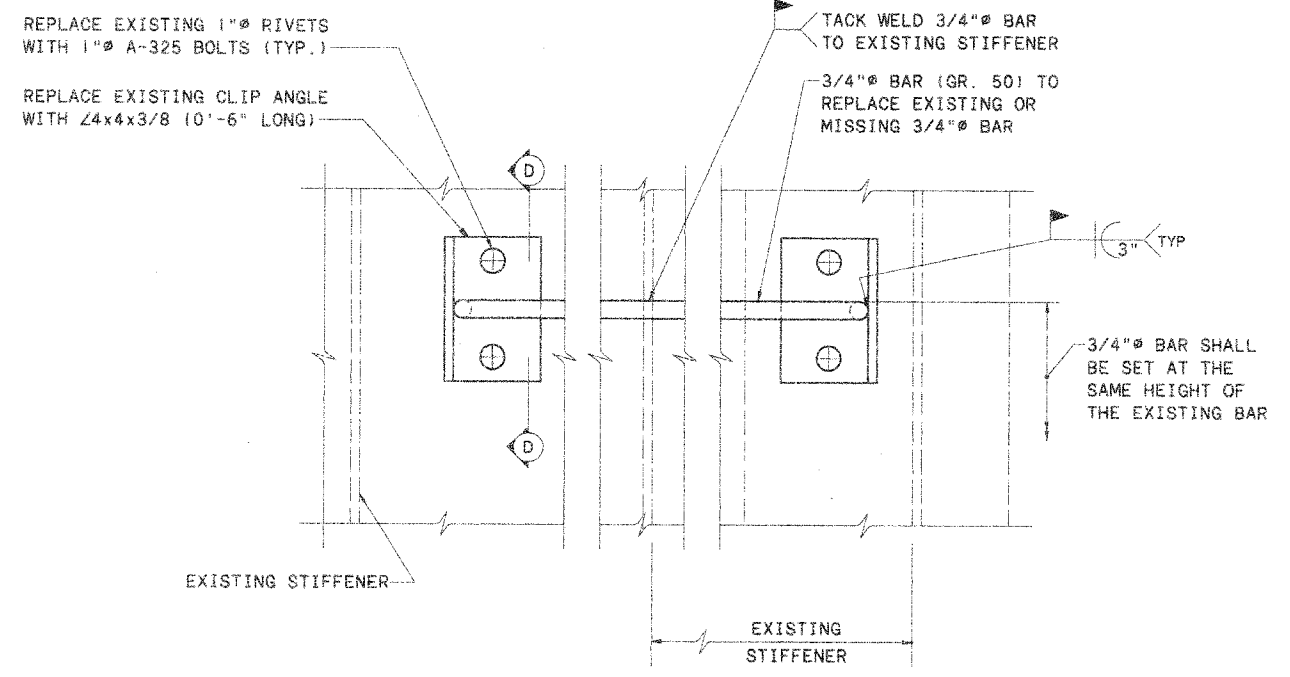
HANDRAIL REPLACEMENT DETAIL
TYPICAL FOR REPAIR 1 AND 2

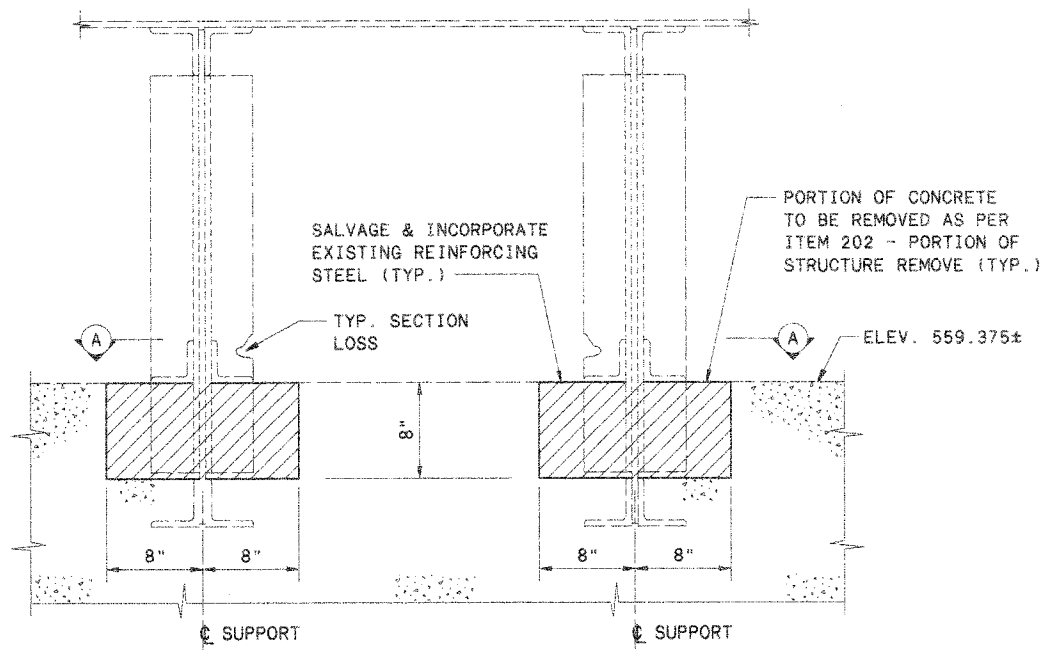
REMOVAL ELEVATION
PINION NOT SHOWN FOR CLARITY.
