Craig Memorial Bascule Bridge

Over the Maumee River

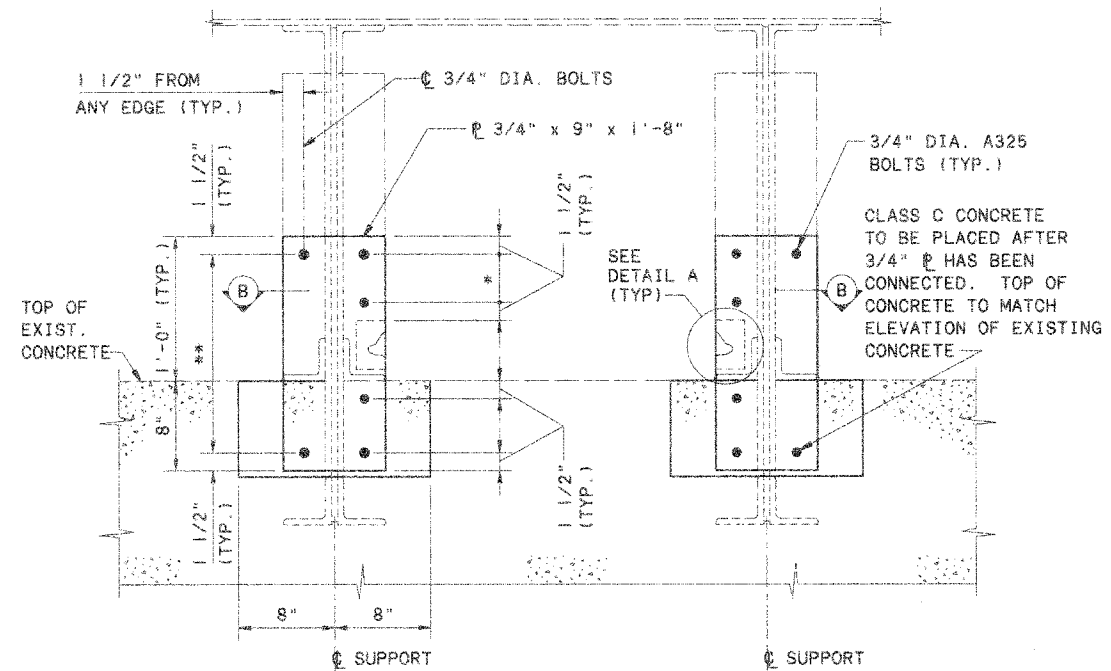
CONCRETE REMOVAL LIMITS

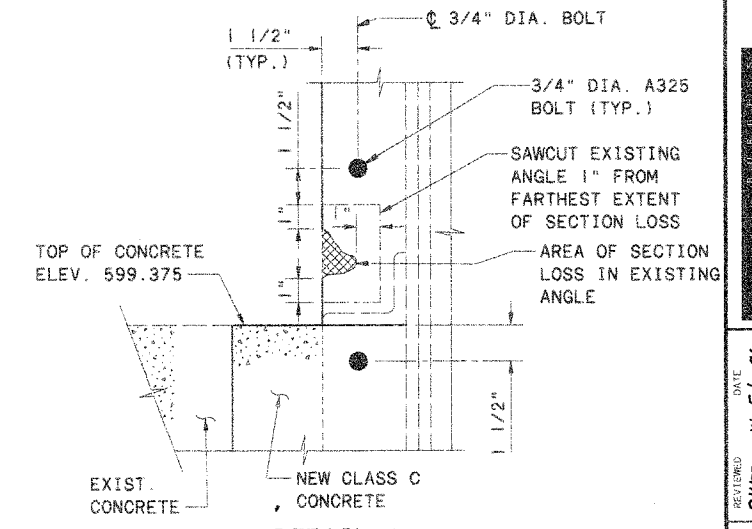
DETAIL A
3/4" P NOT SHOWN FOR CLARITY

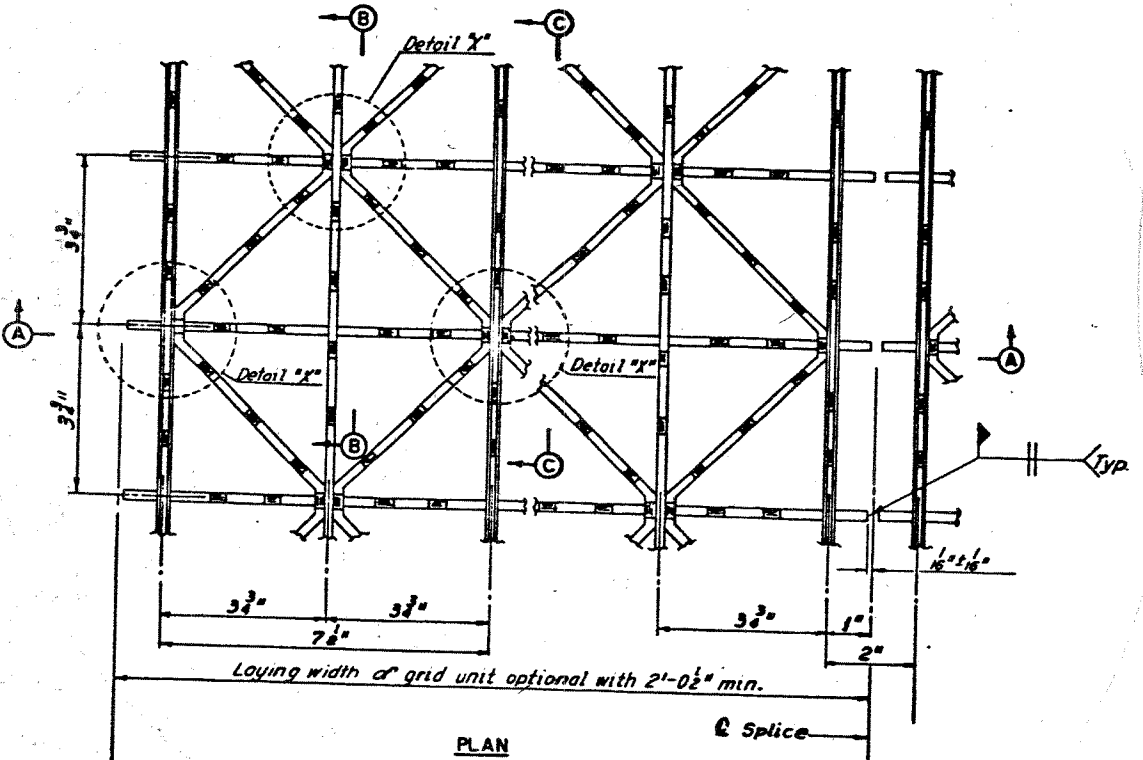
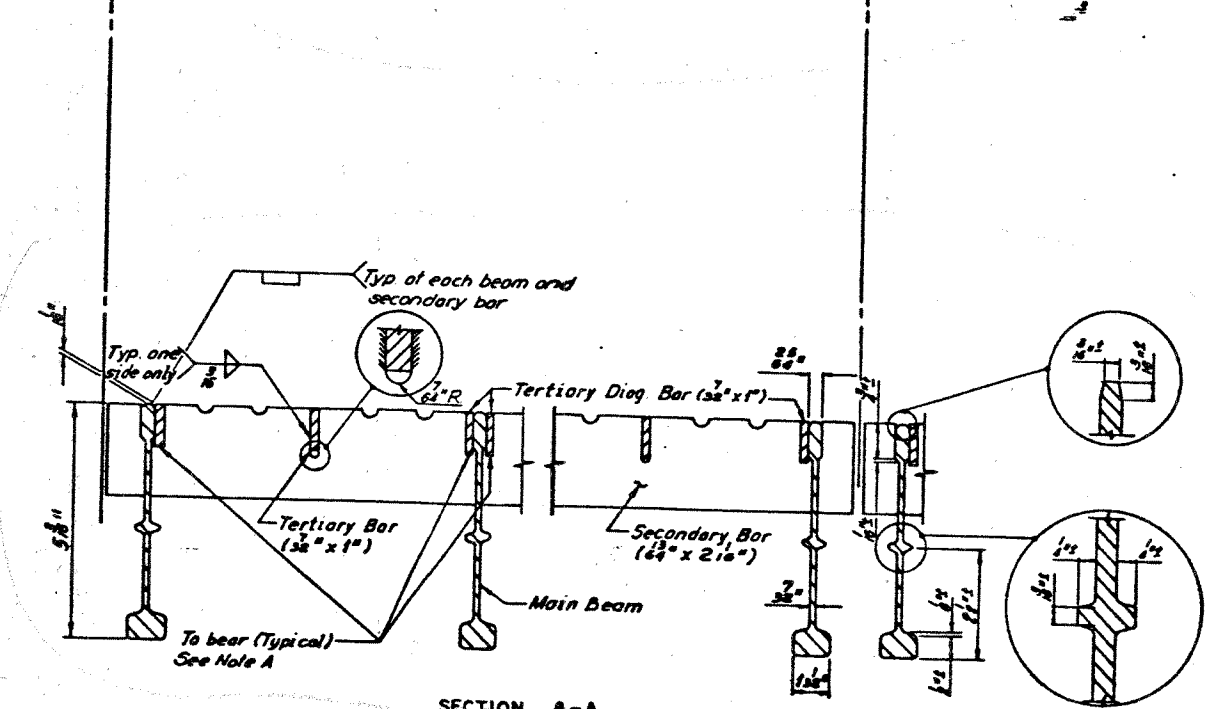
Final dimensions including all fillet dimensions shall be submitted to the Director for approval. Calculations shall be included with this submittal showing that the minimum specified section moduli are provided.

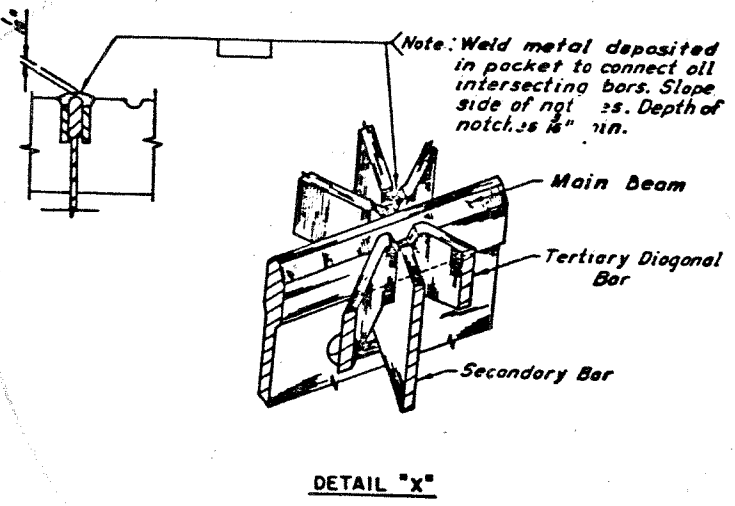
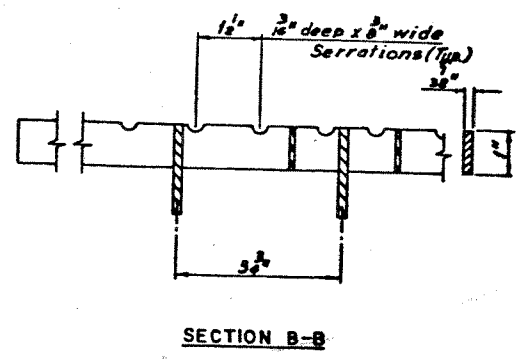
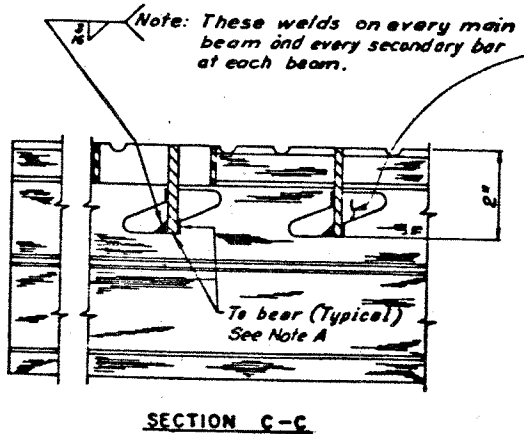
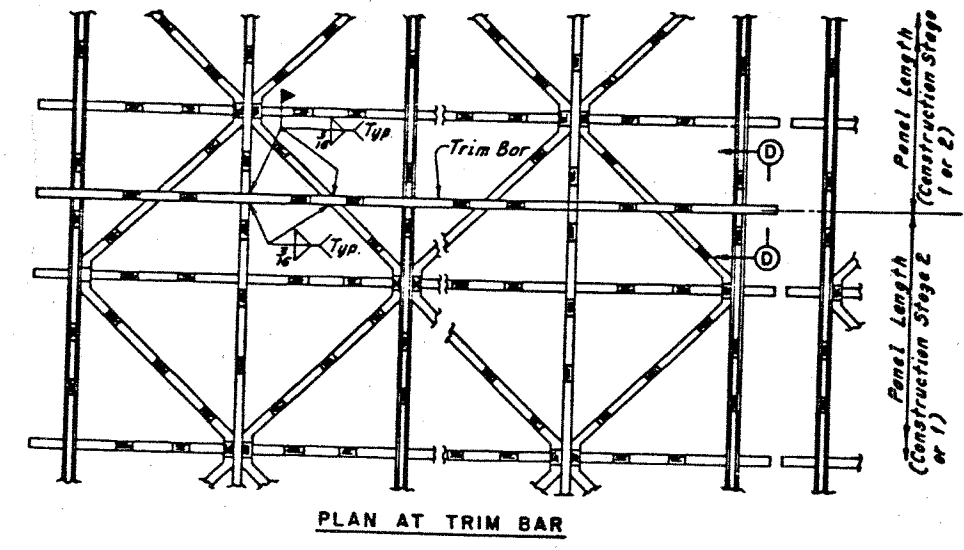
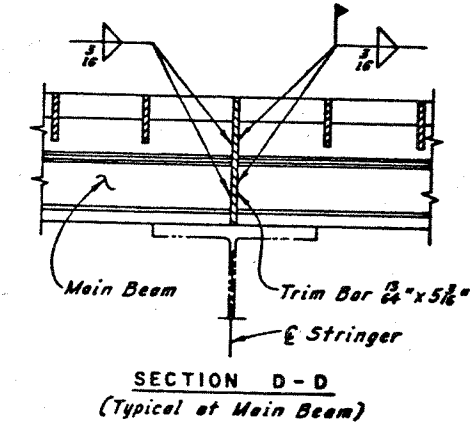
METAL FORM STRIPS
Metal form strips, where required, shall be No 20 gauge or thicker of such width and fit as to make reasonable mortar tight joints. The metal form strips shall be A-366 steel.

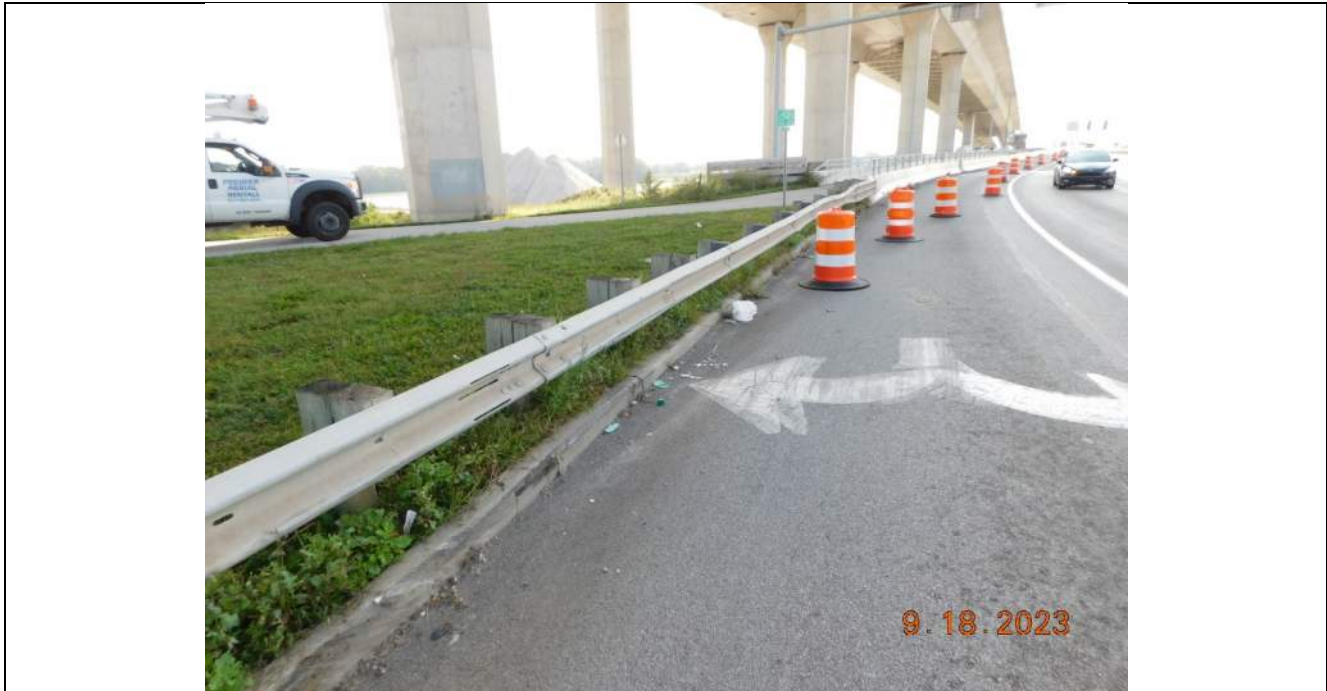
Photo S-27 - [North Approach] -Northeast guard railing approach, minor impact damage, Looking Southeast

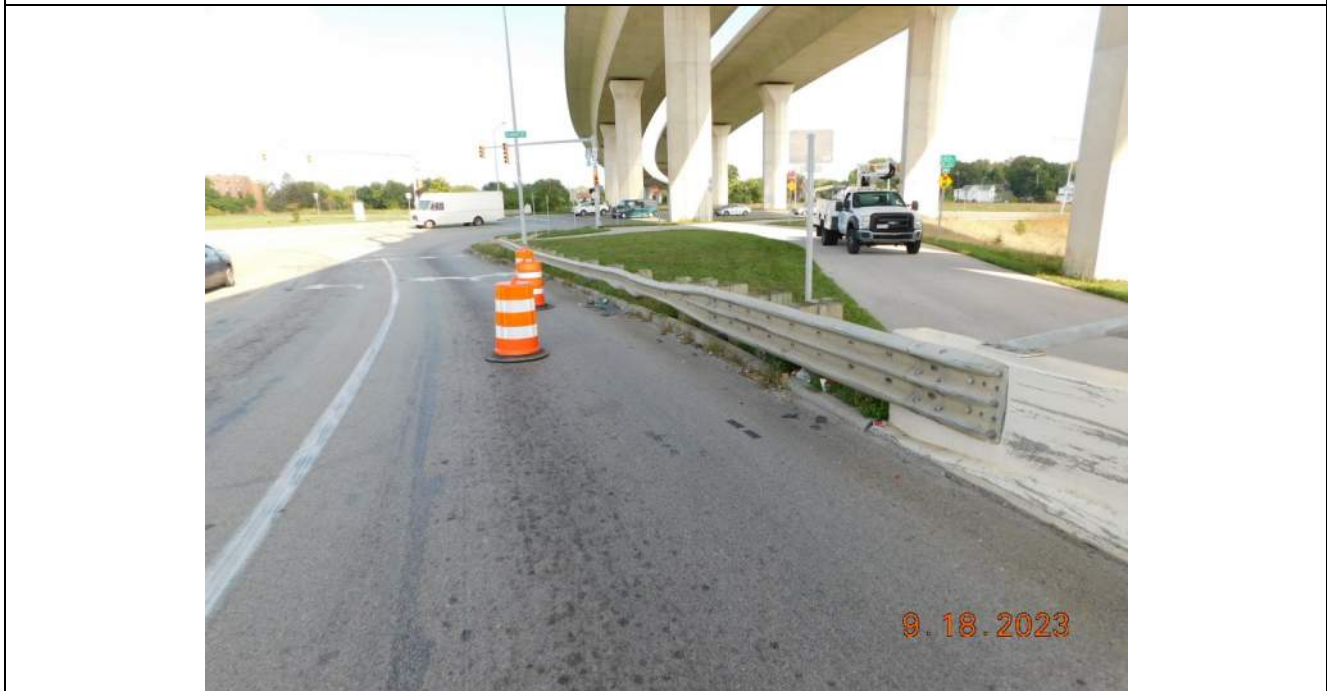
Photo S-28 - [North Approach] -Northeast guard railing transition and barrier, minor impact damage, Looking Northeast

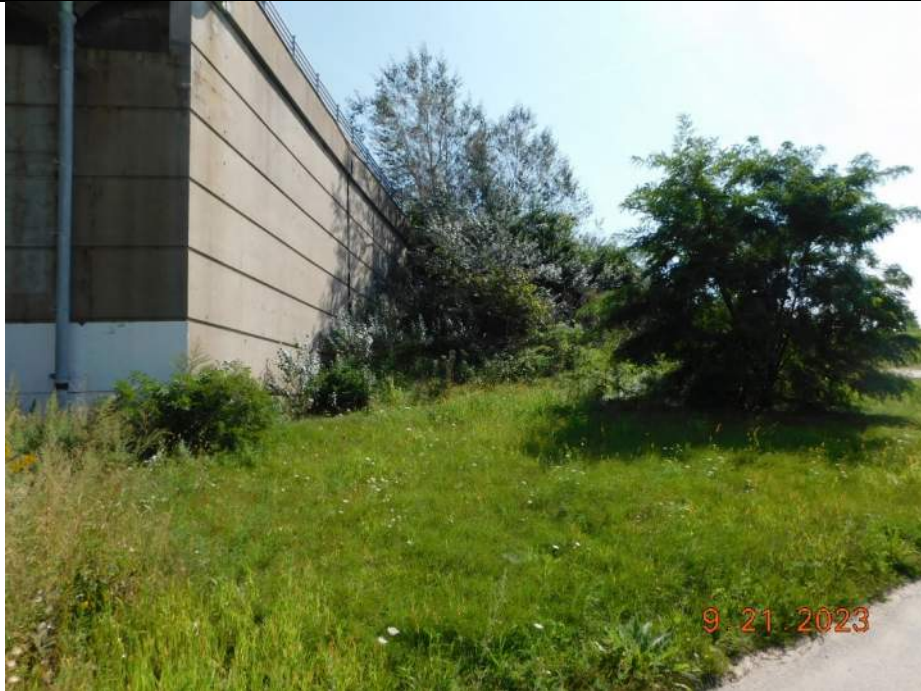
Photo S-29 - [South Approach] -Southwest approach slope, general view, Looking Southwest

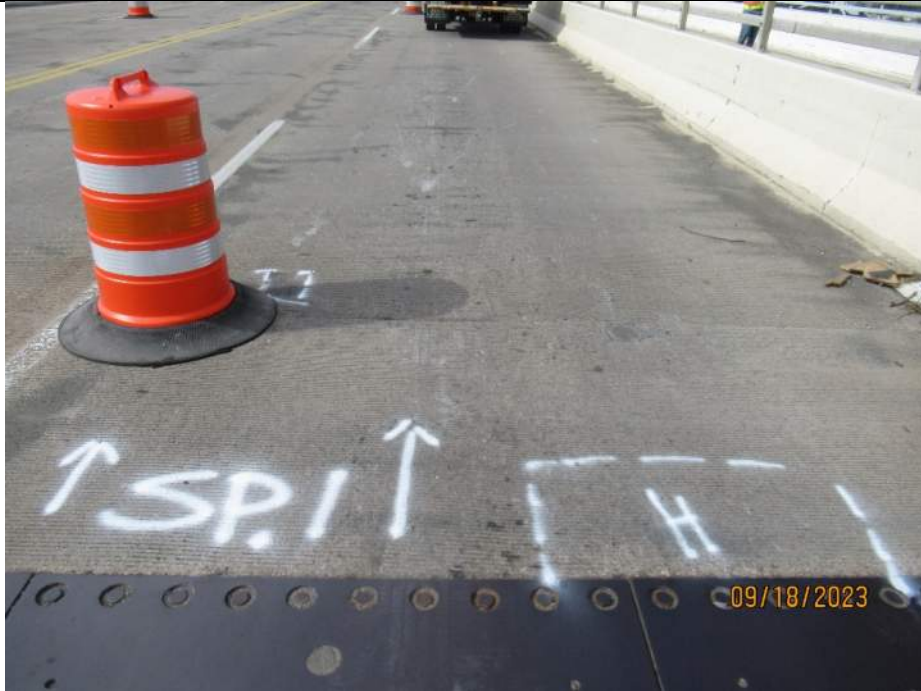
Photo S-35 - [Span 1] -Roadway deck and wearing surface, NB lanes at south end of span, Looking North

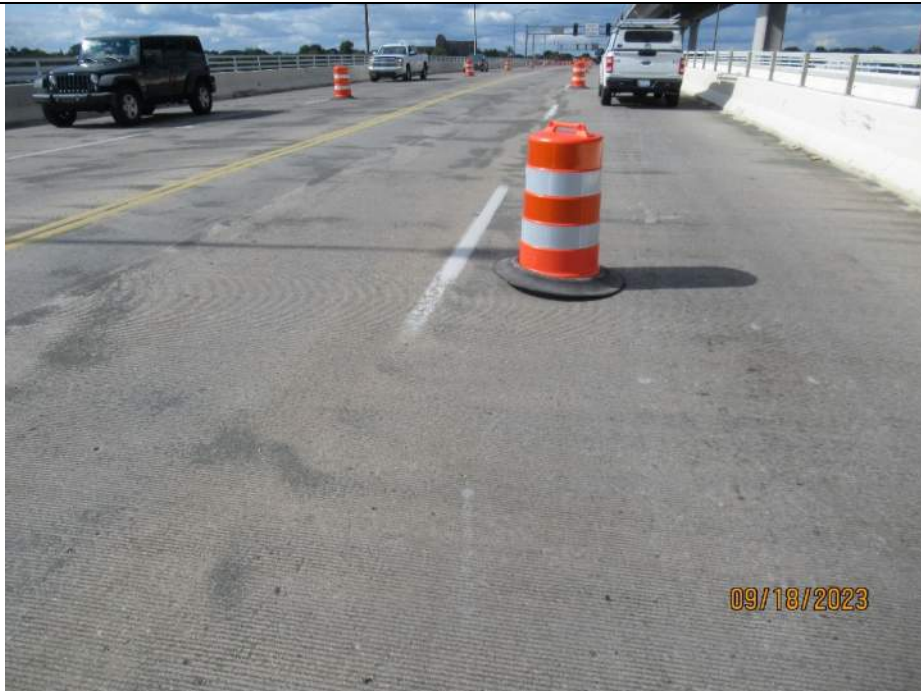
Photo S-36 - [Span 1] -Roadway deck and wearing surface, NB lanes at mid-span, Looking North

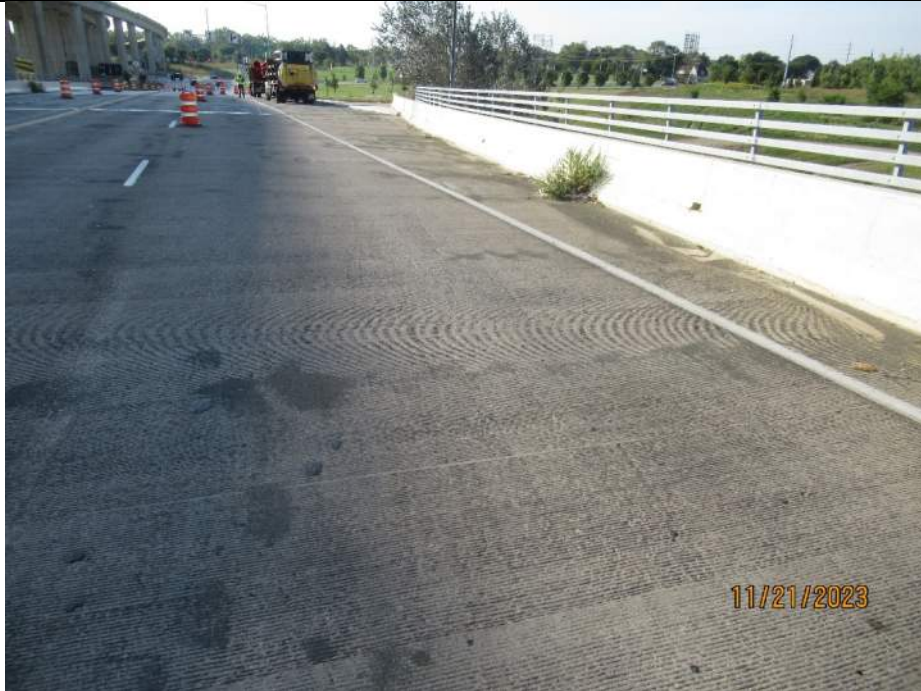
Photo S-37 - [Span 1] -Roadway deck and wearing surface, SB lanes near north end of span, Looking South

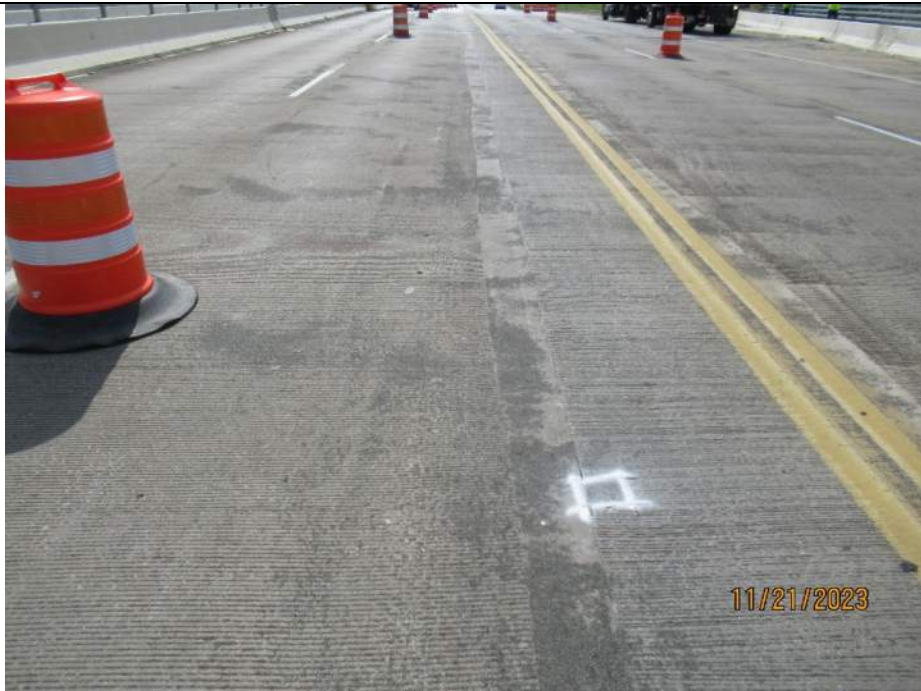
Photo S-38 - [Span 1] -Roadway deck and wearing surface, middle lanes near mid-span, Looking South

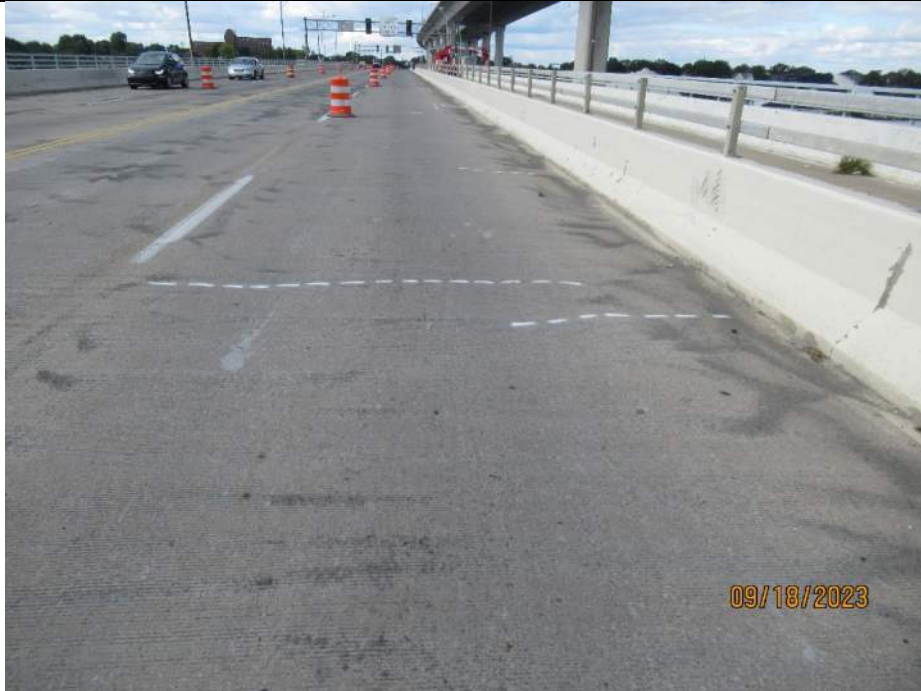
Photo S-39 - [Span 2] -Roadway deck and wearing surface, NB lanes at mid-span, Looking North

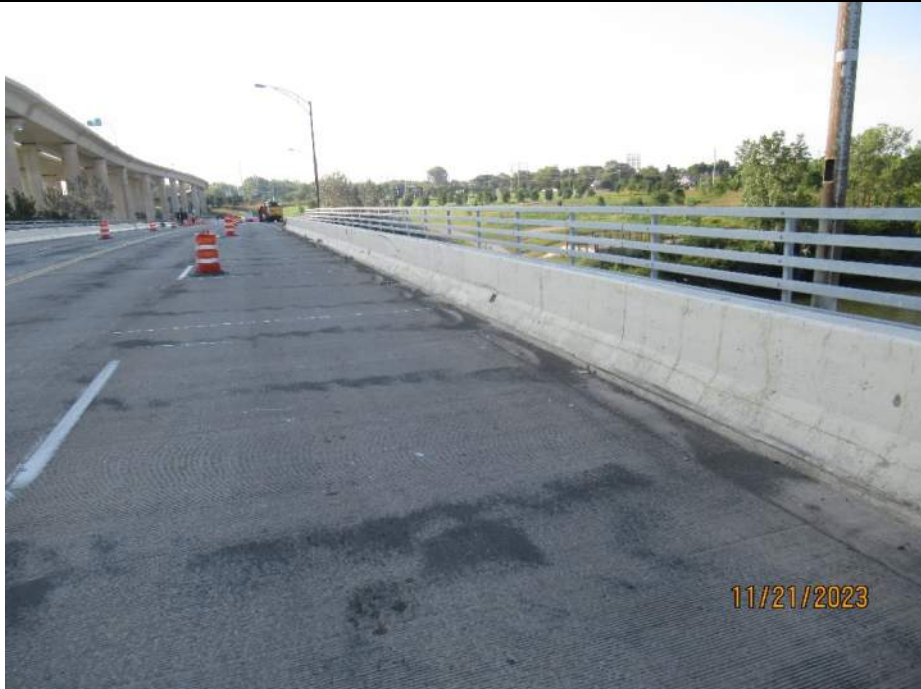
Photo S-40 - [Span 2] -Roadway deck and wearing surface, SB lanes near north end of span, Looking South

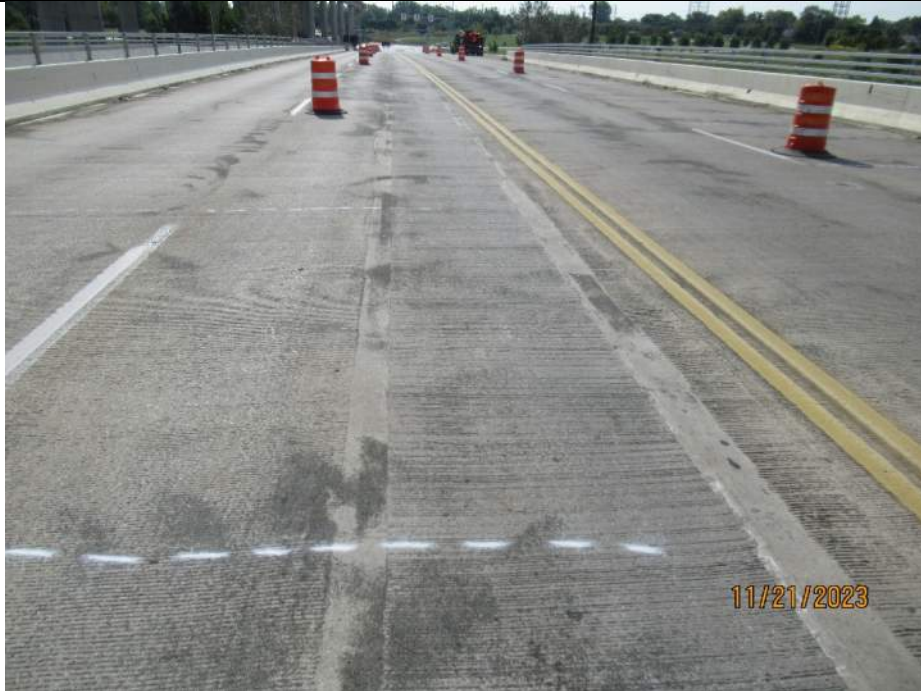
Photo S-41 - [Span 2] -Roadway deck and wearing surface, middle lanes from north end of span, Looking South

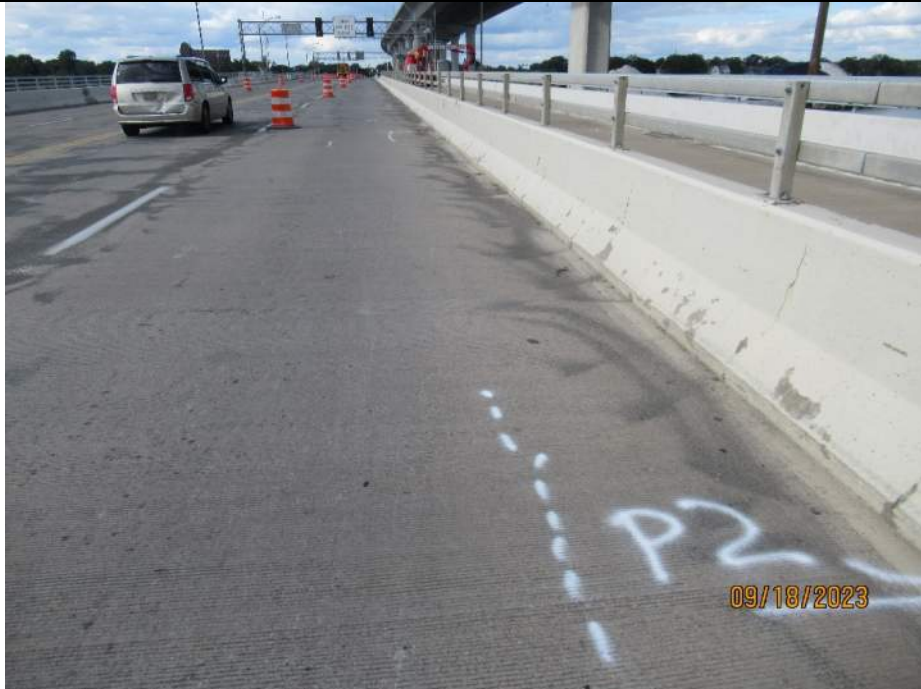
Photo S-42 - [Span 3] -Roadway deck and wearing surface, NB lanes at south end of span, Looking North

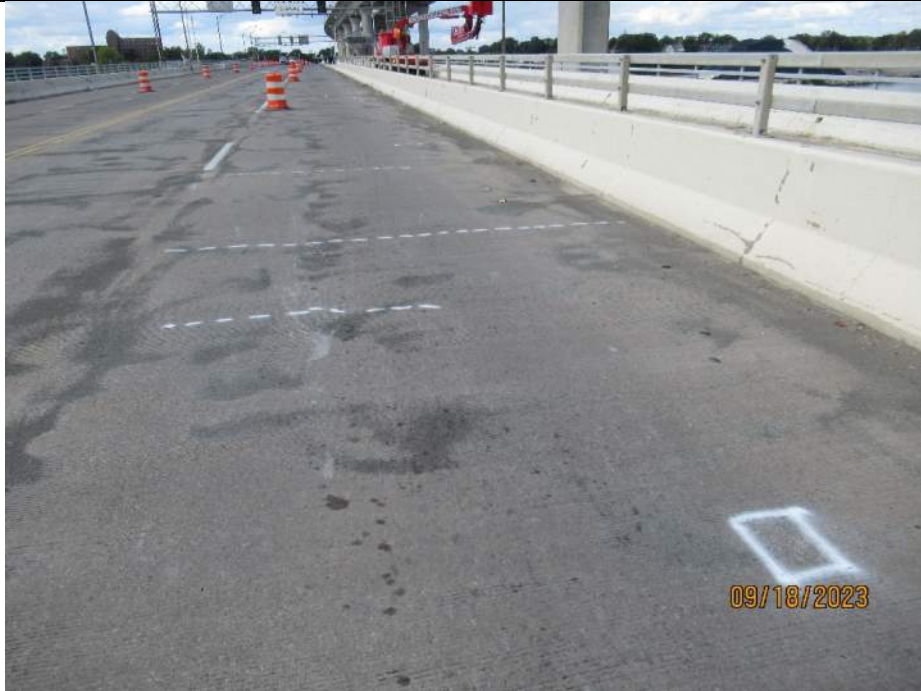
Photo S-43 - [Span 3] -Roadway deck and wearing surface, NB lanes at mid-span, Looking North

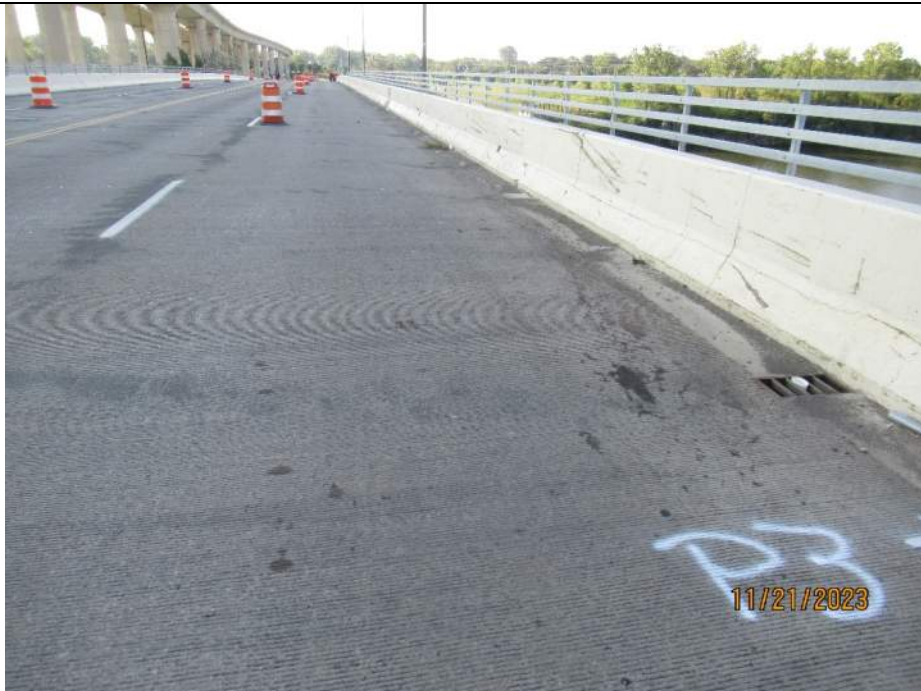
Photo S-44 - [Span 3] -Roadway deck and wearing surface, SB lanes at north end of span, Looking South

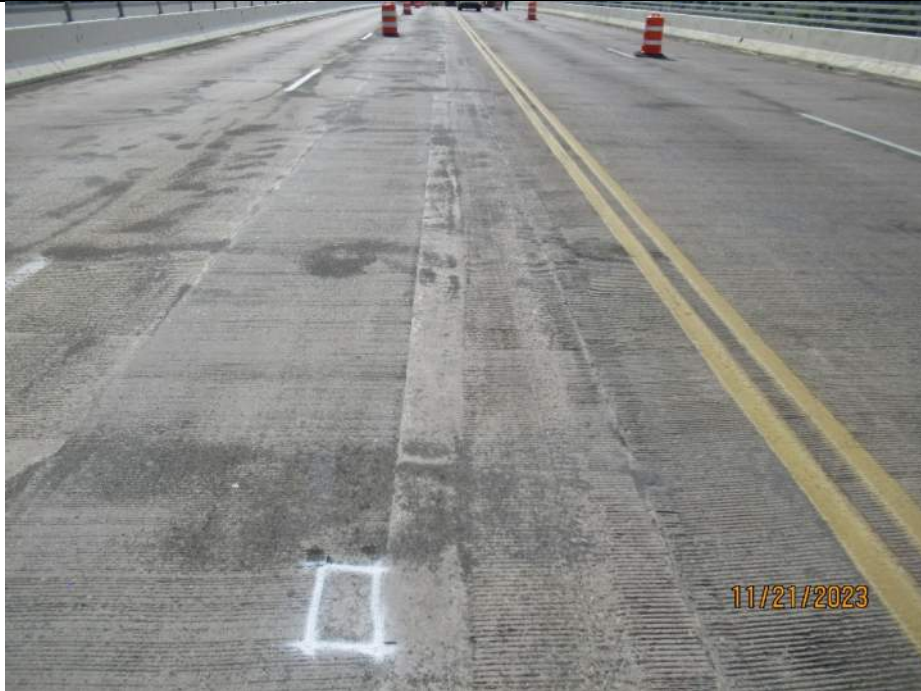
Photo S-45 - [Span 4] -Roadway deck and wearing surface, middle lanes near mid-span, Looking South

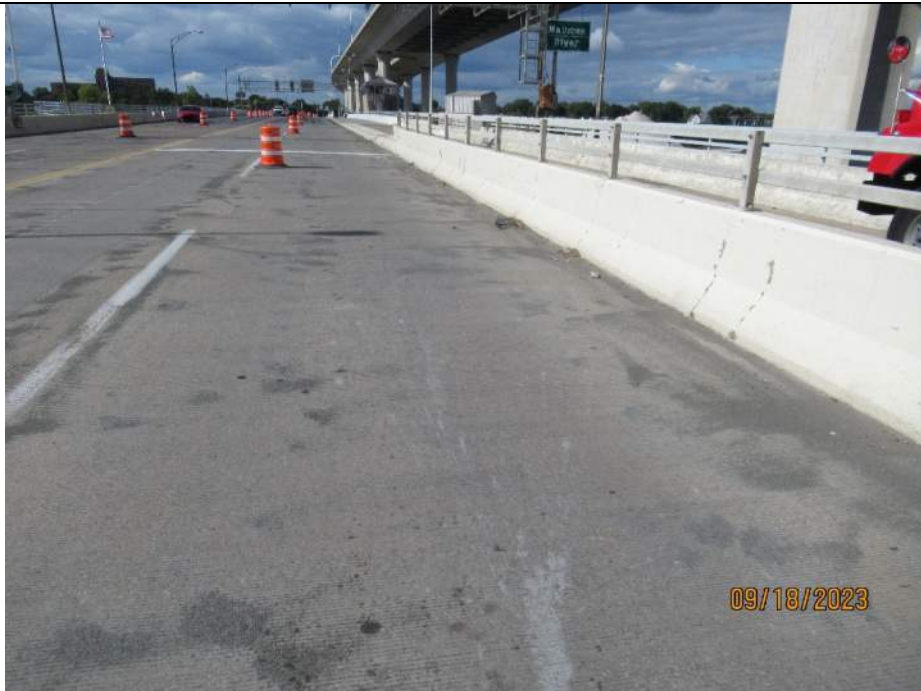
Photo S-46 - [Span 4] -Roadway deck and wearing surface, NB lanes south of mid-span, Looking North

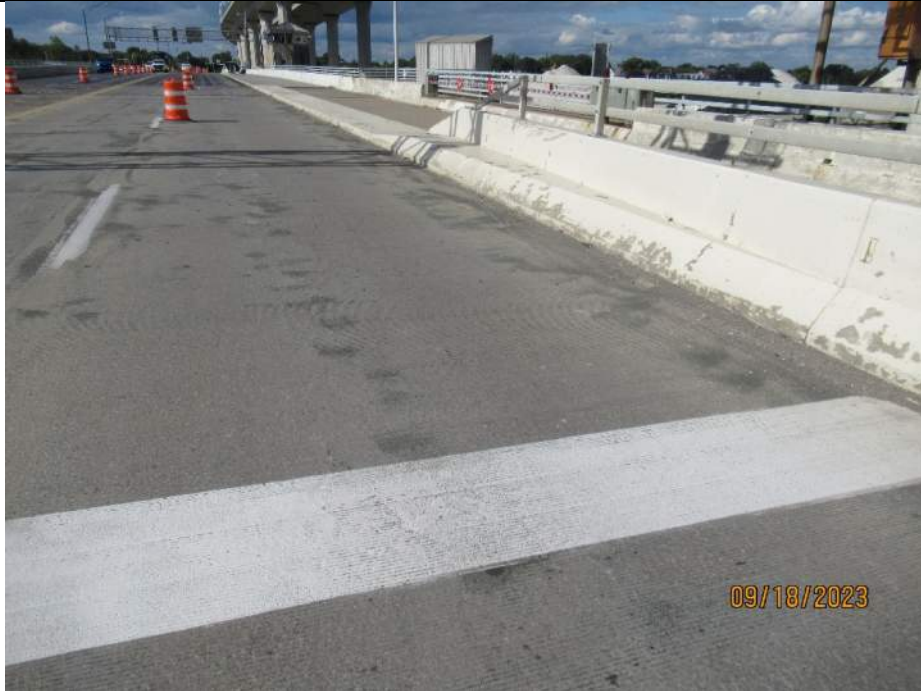
Photo S-47 - [Span 4] -Roadway deck and wearing surface, NB lanes north of mid-span, Looking North

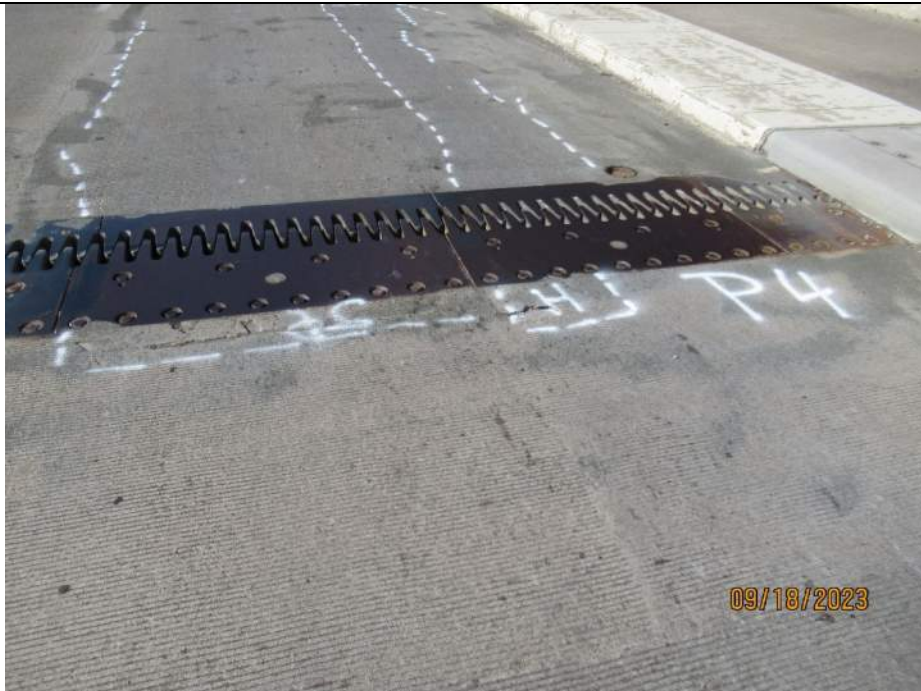
Photo S-48 - [Span 4] -NB right lane detail view of deck cracking, spalling and delamination along finger joint plates, Looking North

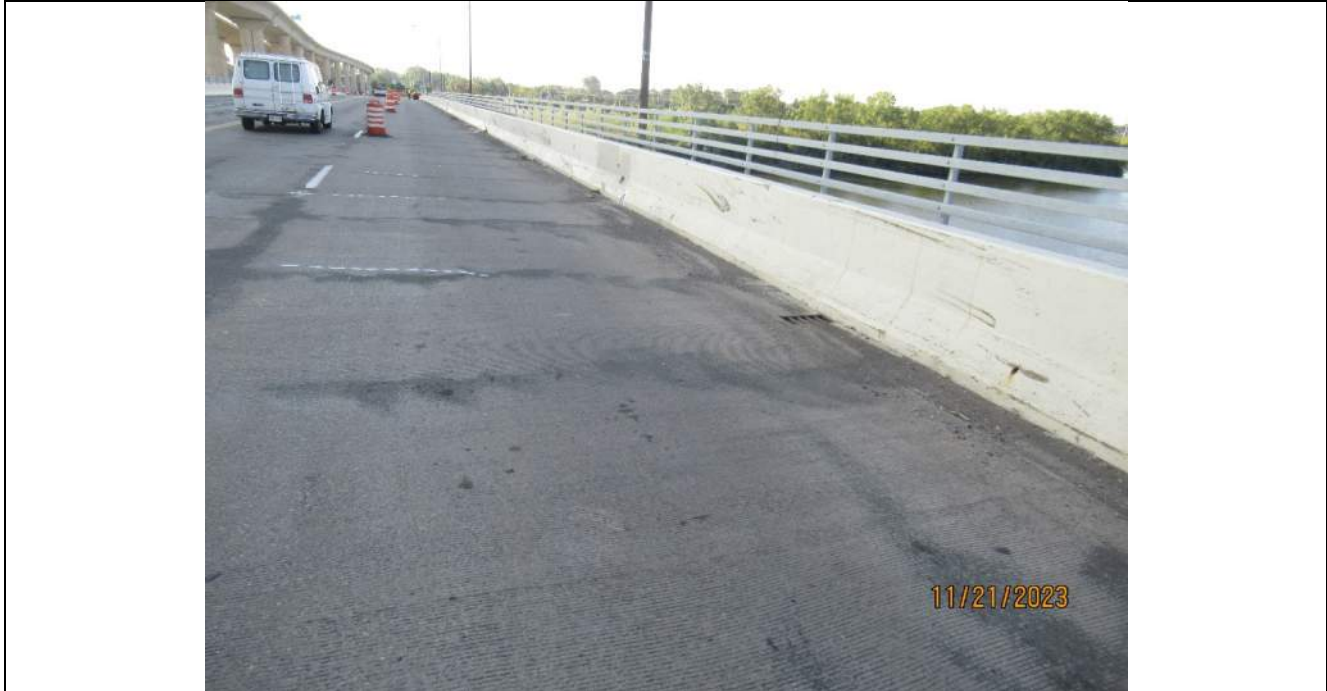
Photo S-49 - [Span 4] -Roadway deck and wearing surface, SB lanes near mid-span, Looking South

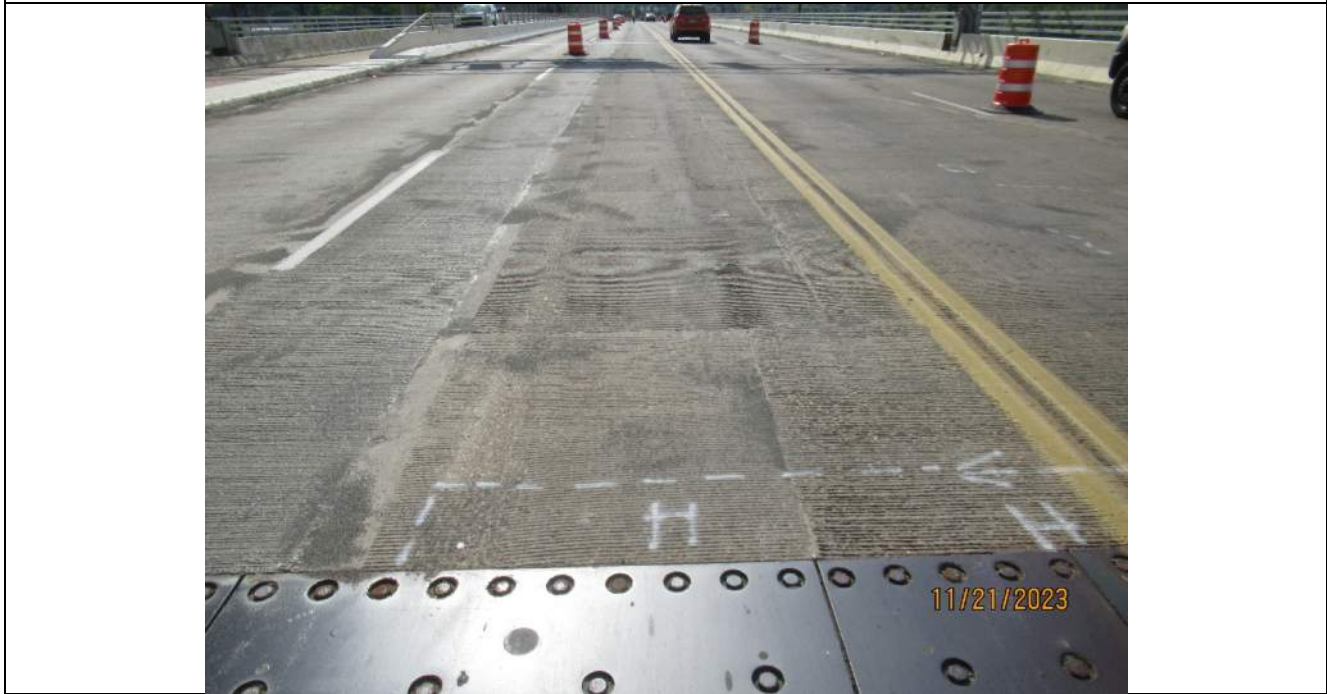
Photo S-50 - [Span 4] -Roadway deck and wearing surface, middle lanes from north end of span, Looking South

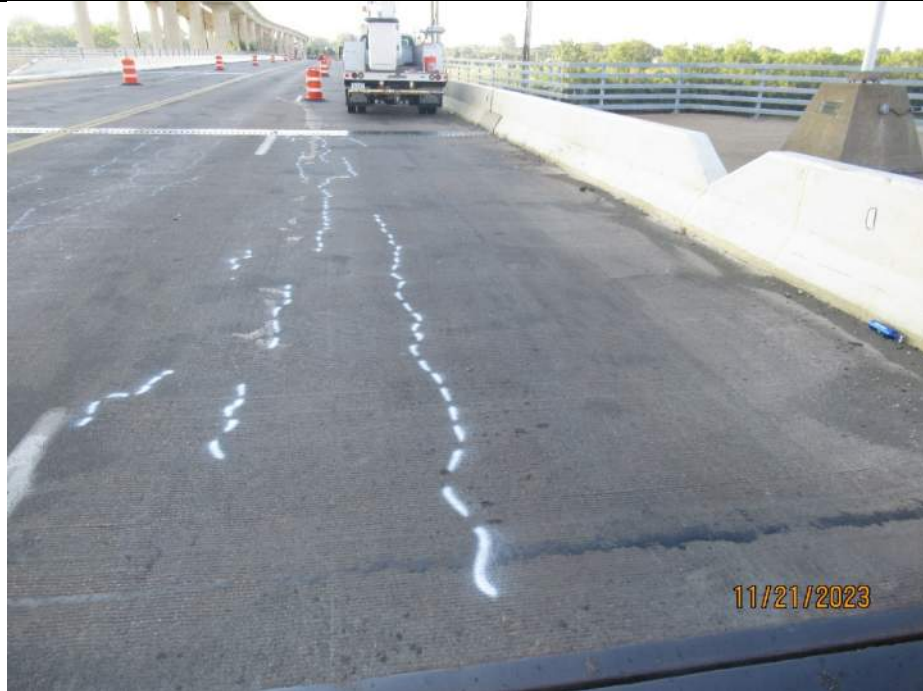
Photo S-51 - [Pier 4 Span] -Roadway deck and wearing surface, SB lanes, Looking South

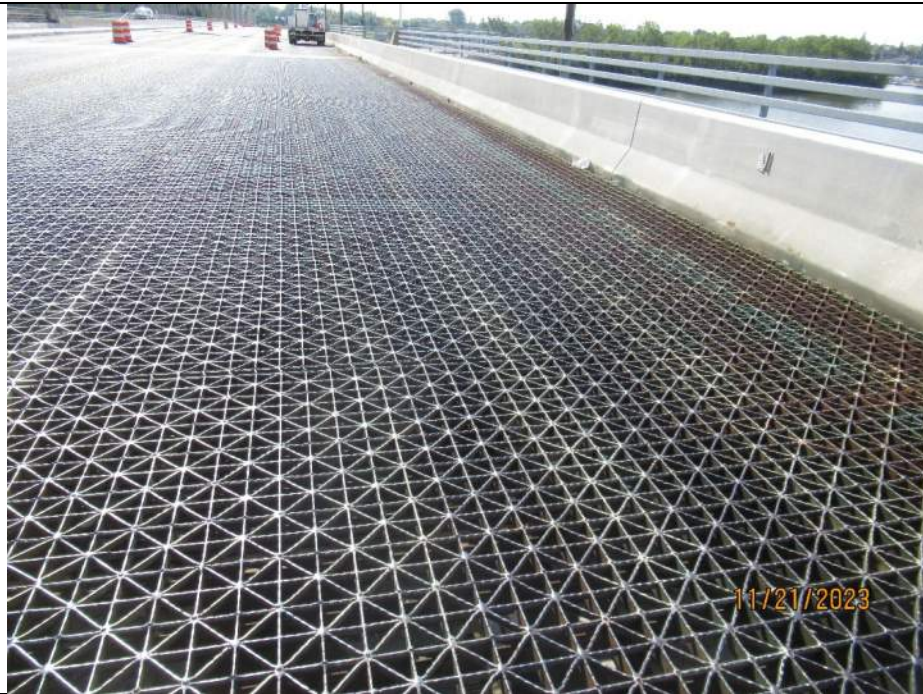
Photo S-52 - [Span 5] -South leaf SB lanes general view of grid deck and roadway barrier, Looking South

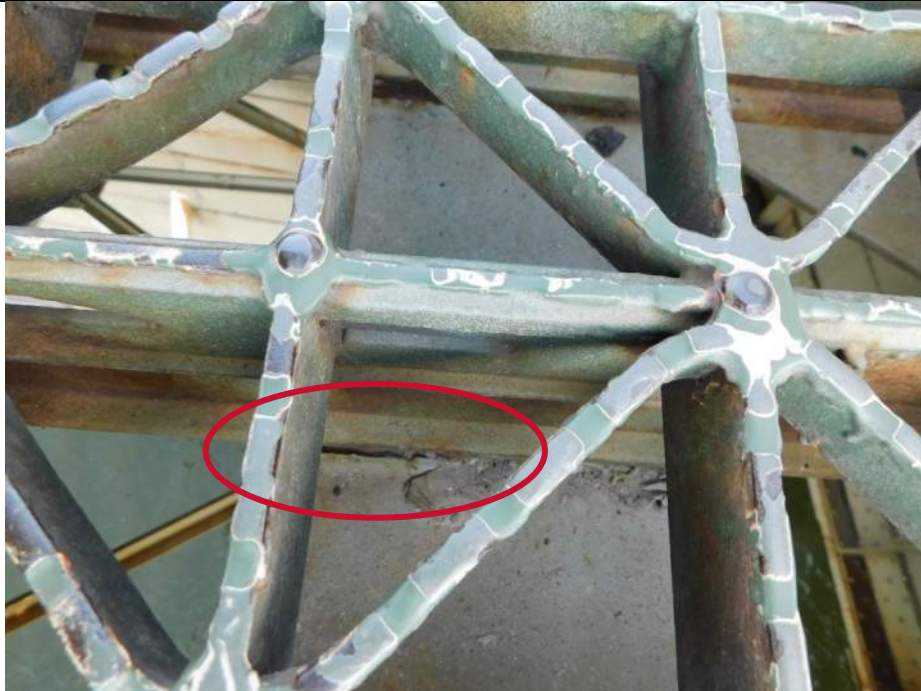
Photo S-53 - [Span 5] -Detail view of grid deck with broken weld connecting lower main bar to stringer top flange, South leaf in SB lanes near Pier 4, Looking North

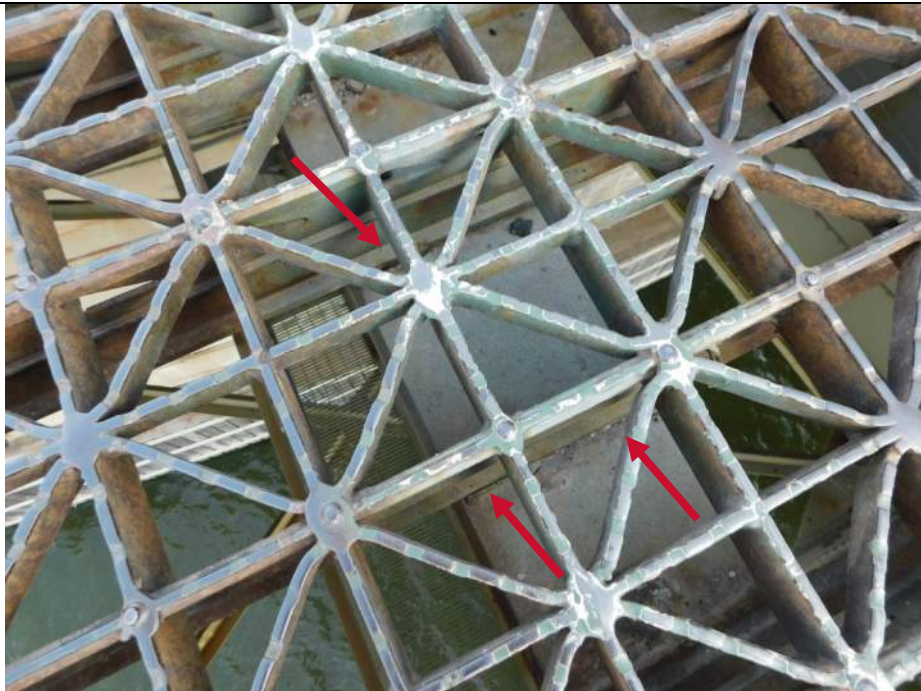
Photo S-54 - [Span 5] -Detail view of grid deck with broken weld connecting lower main bar to stringer top flange, South leaf in SB lanes near Pier 4, Looking North

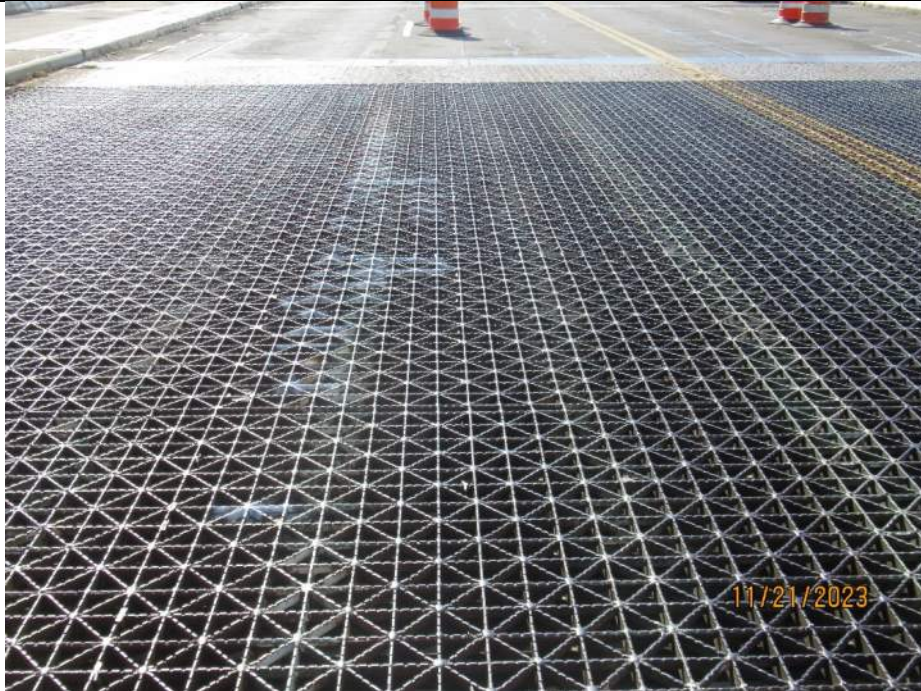
Photo S-55 - [Span 5] -South leaf, general view of grating noting locations of corrosion holes with white spray chalk, Looking South

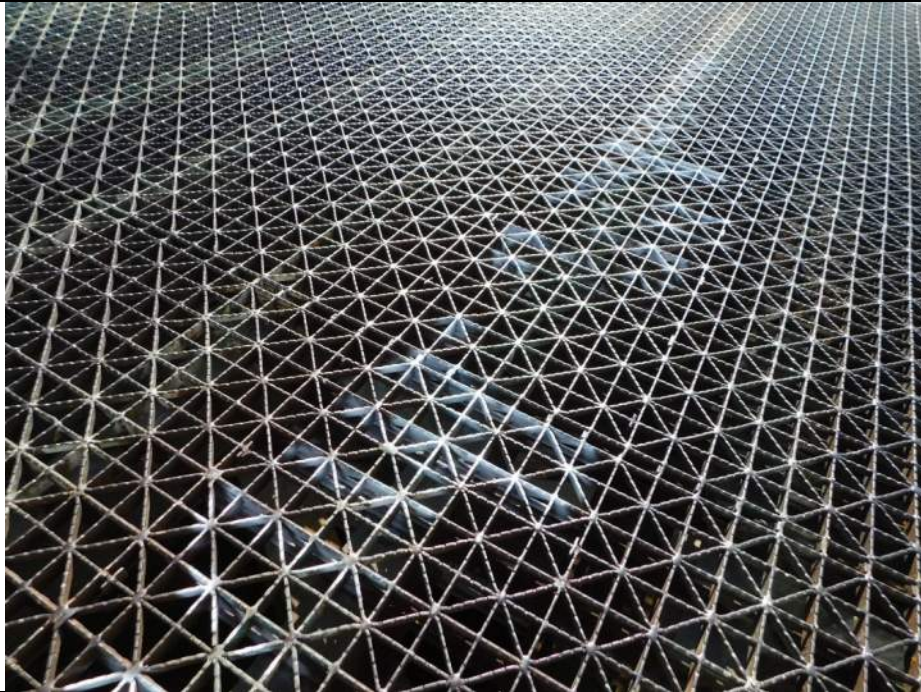
Photo S-56 - [Span 5] -South leaf, general view of grating noting locations of corrosion holes with white spray chalk, Looking South

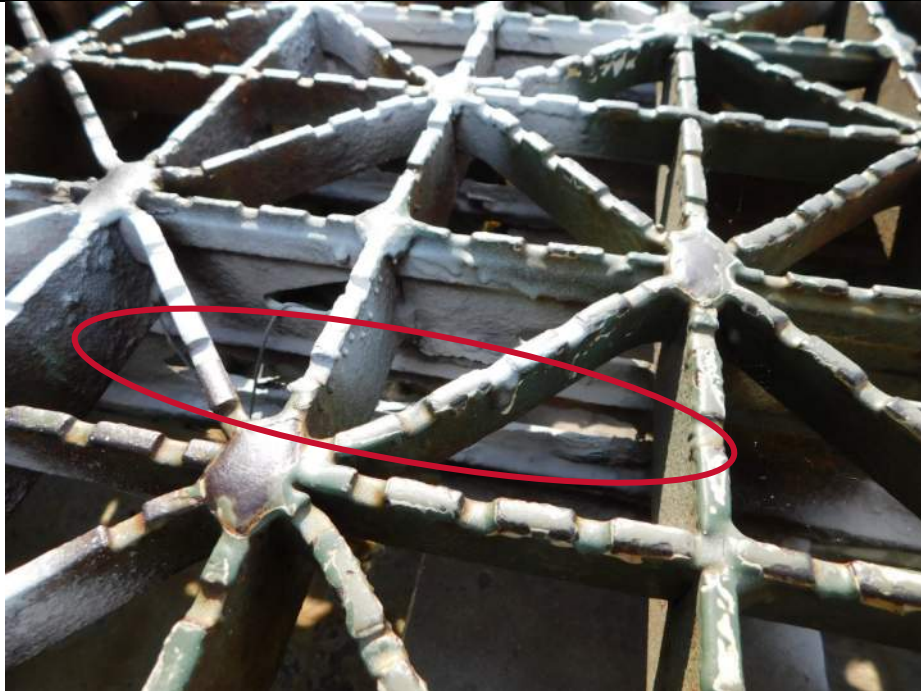
Photo S-58 - [Span 5] -Detail view of grid deck with corrosion holes in lower main bars above Stringer 16W, typical location between FB6s-7s, Looking North
