Craig Memorial Bascule Bridge

Over the Maumee River

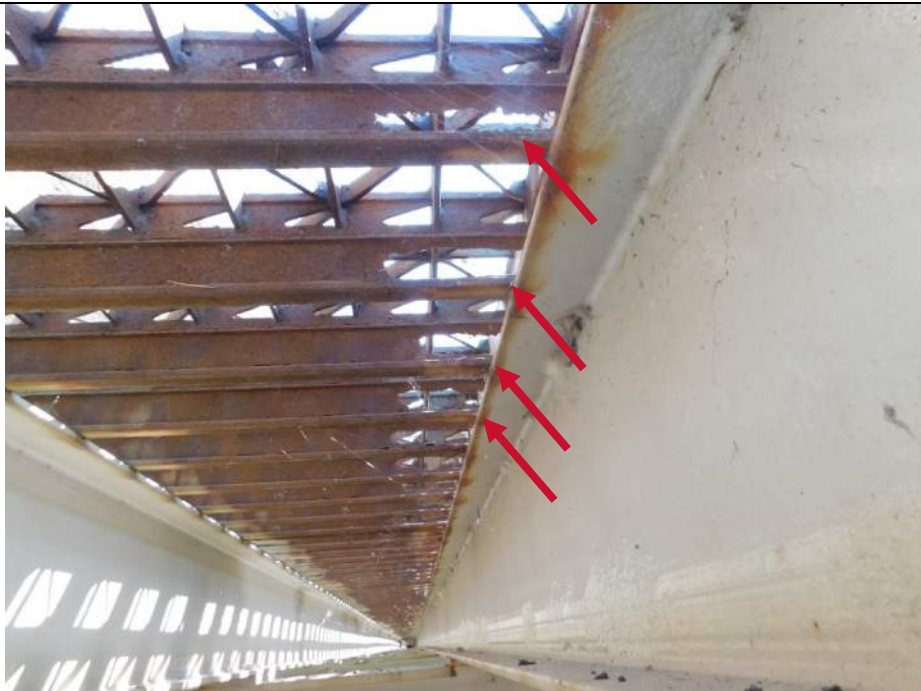
Photo S-57 - [Span 5] -Detail view of grid deck with corrosion holes in lower main bars above Stringer 17W between FB5n-6n, Looking South

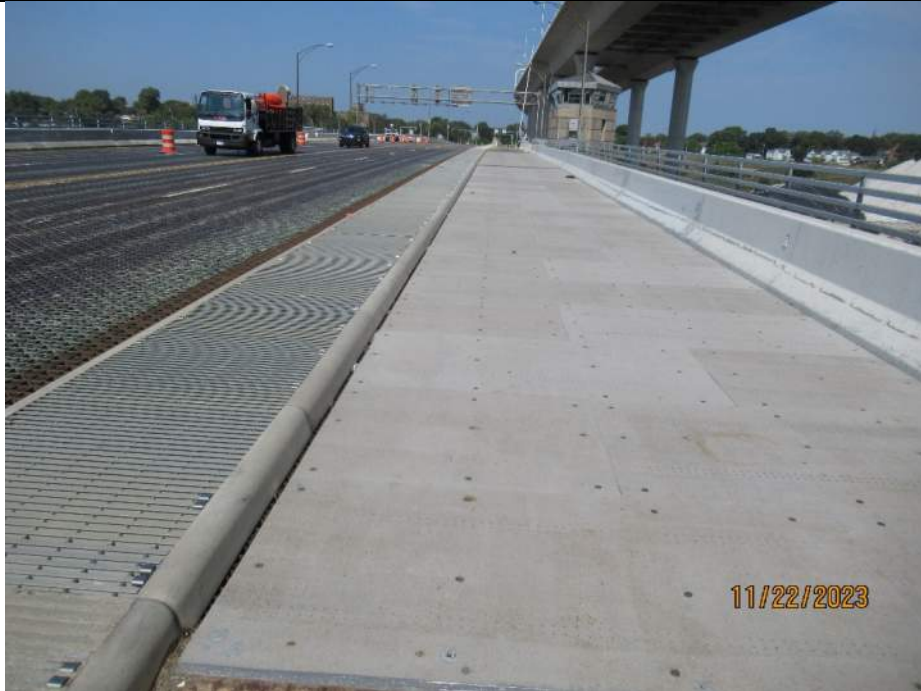
Photo S-59 - [Span 5] -South leaf NB lanes, raised curb and panel-covered trail segment, general view of elements in good condition, Looking North

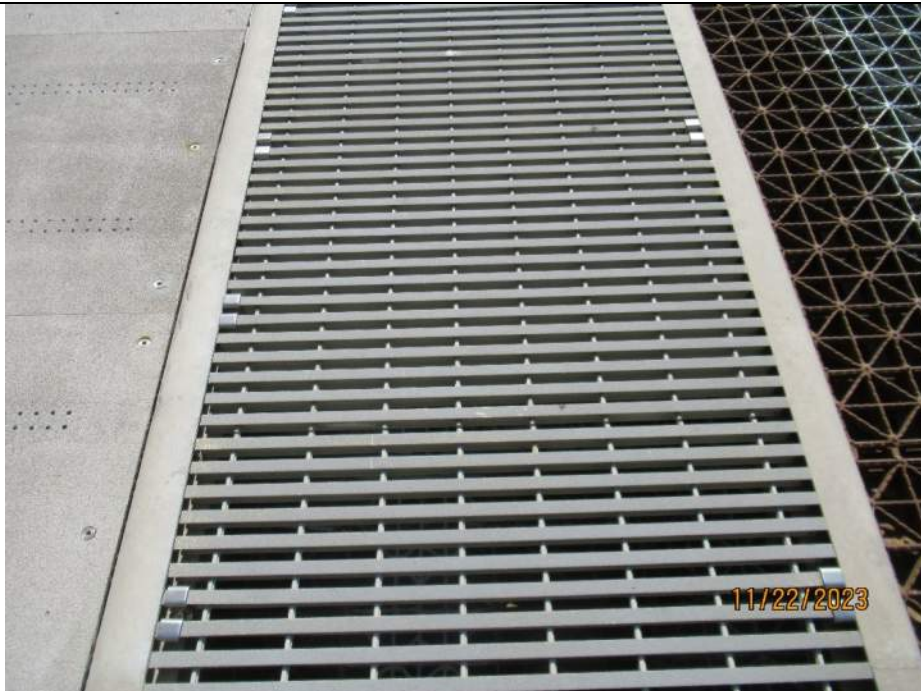
Photo S-60 - [Span 5] -South leaf NB raised curb, detail view of typical good condition, Looking North

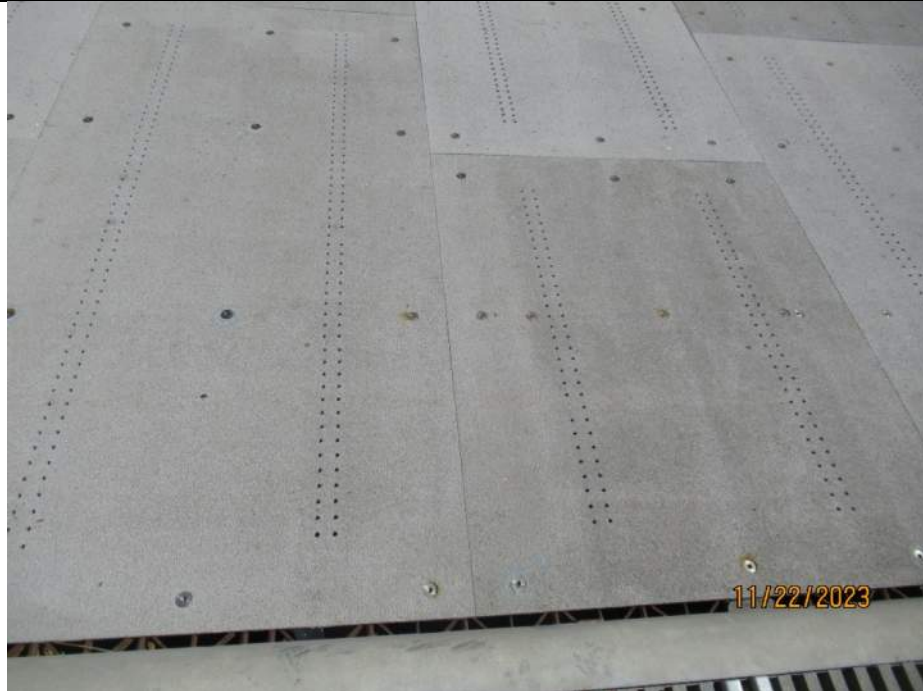
Photo S-61 - [Span 5] -South leaf trail segment, detail view of bolted panel sections in good condition, Looking East

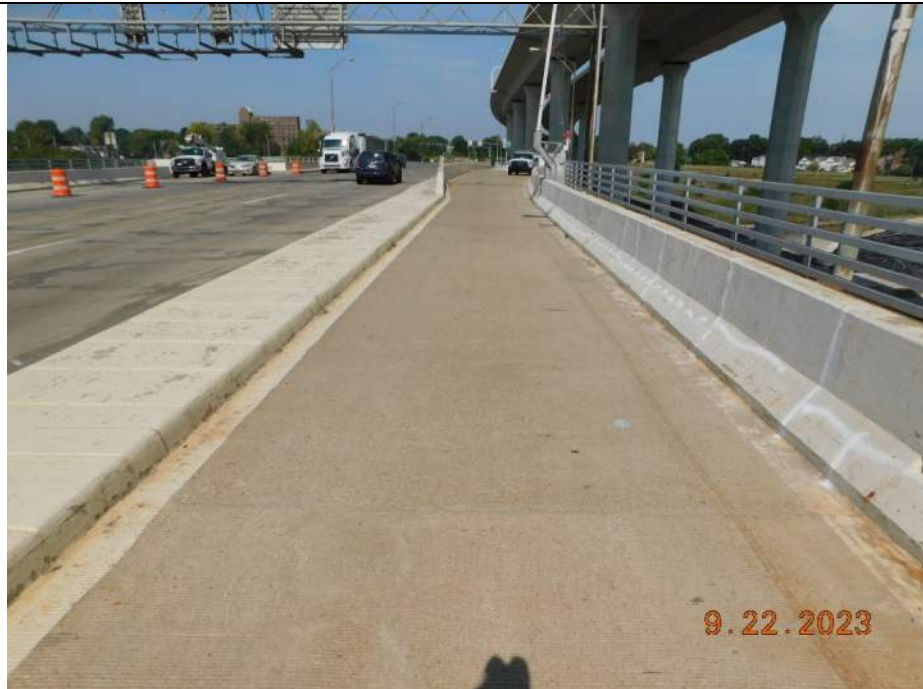
Photo S-62 - [Span 6] -Roadway deck and wearing surface, East trail, Looking North

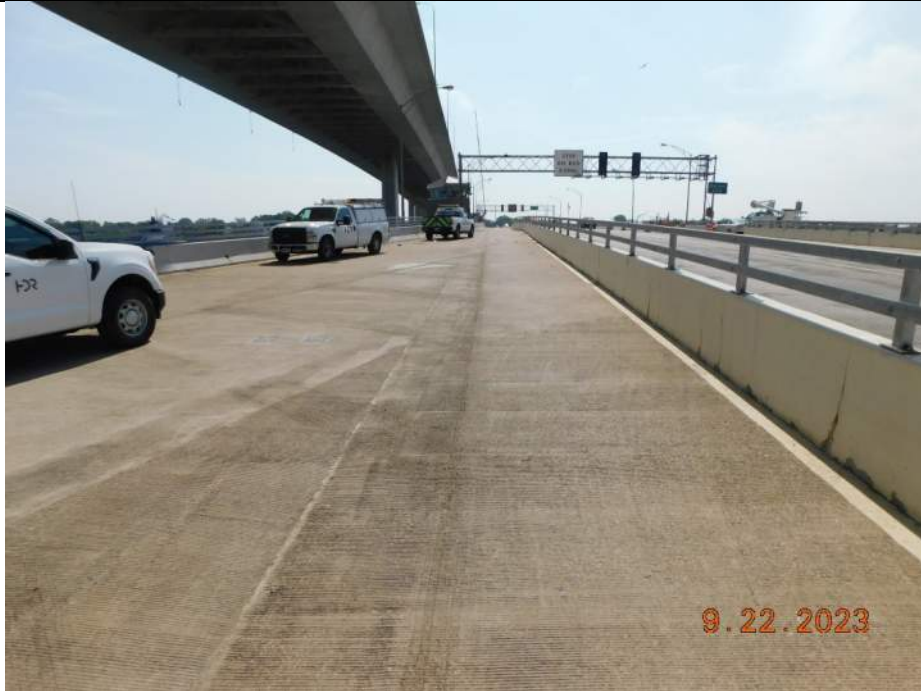
Photo S-63 - [Span 7] -Roadway deck and wearing surface, East trail and flare area, Looking South

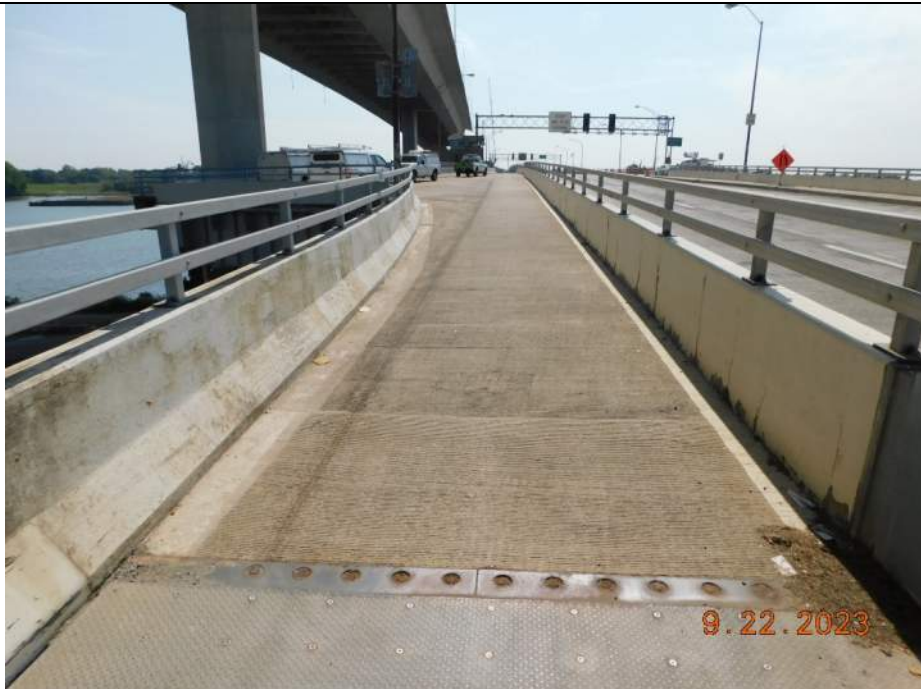
Photo S-64 - [Span 8] -Roadway deck and wearing surface, East trail, Looking South

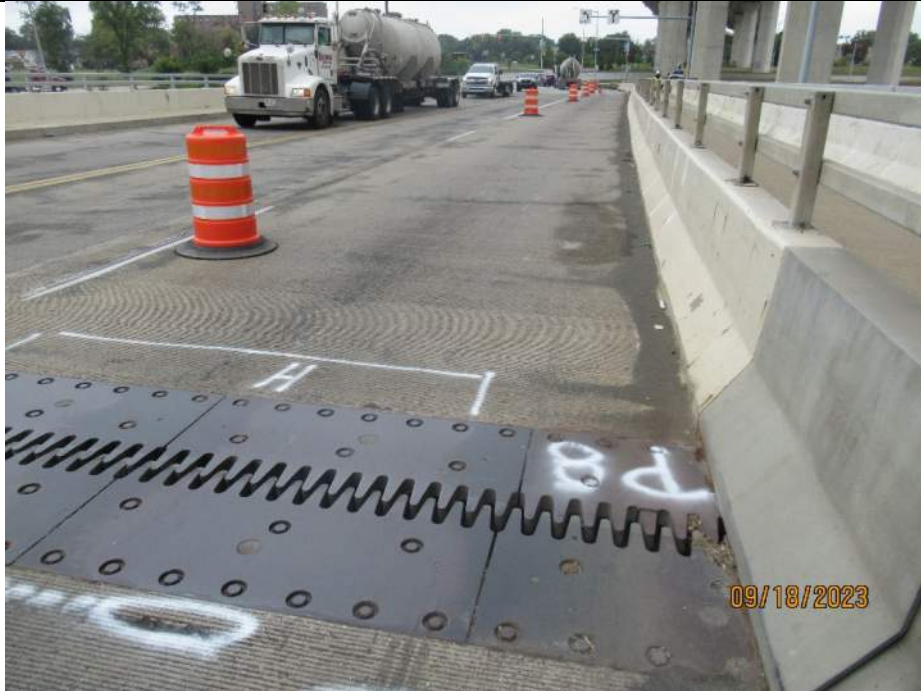
Photo S-65 - [Span 9] -Roadway deck and wearing surface, NB right lane from Pier 8, Looking North

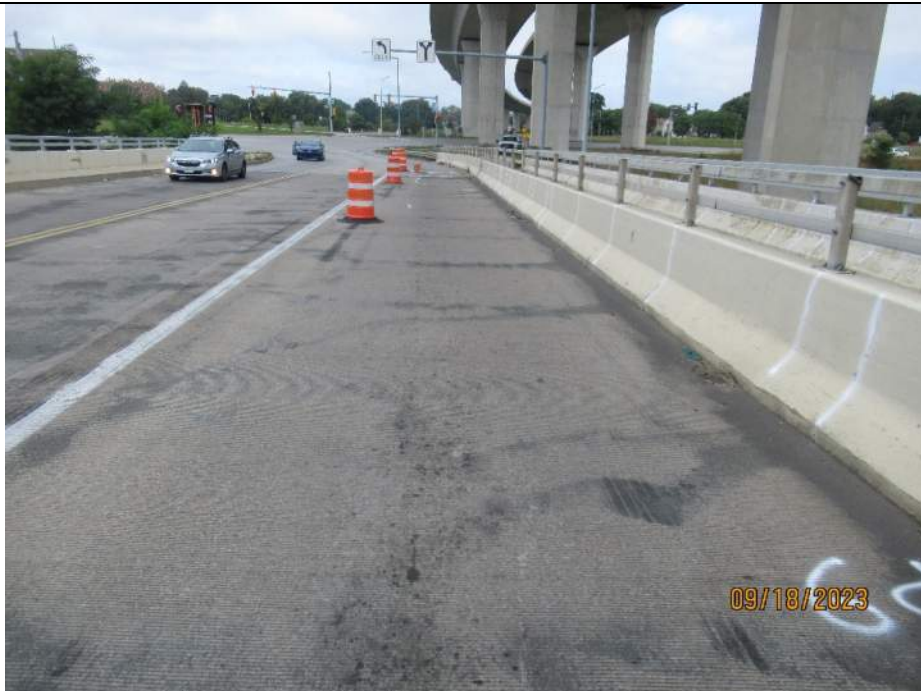
Photo S-66 - [Span 10] -Roadway deck and wearing surface, NB right lane from Pier 9, Looking North

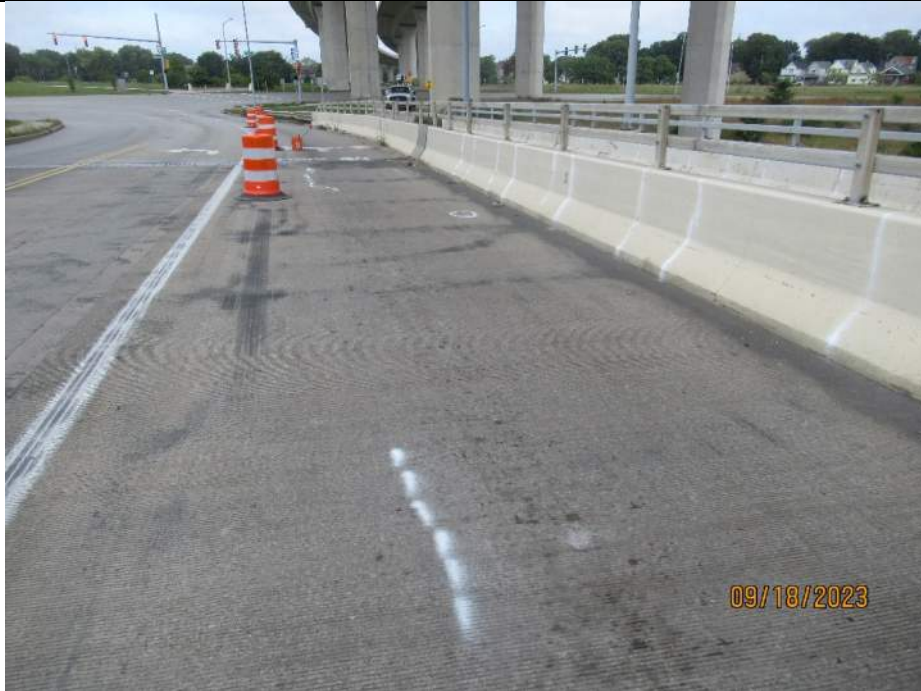
Photo S-67 - [Span 10] -Roadway deck and wearing surface, NB right lane from midspan, Looking North

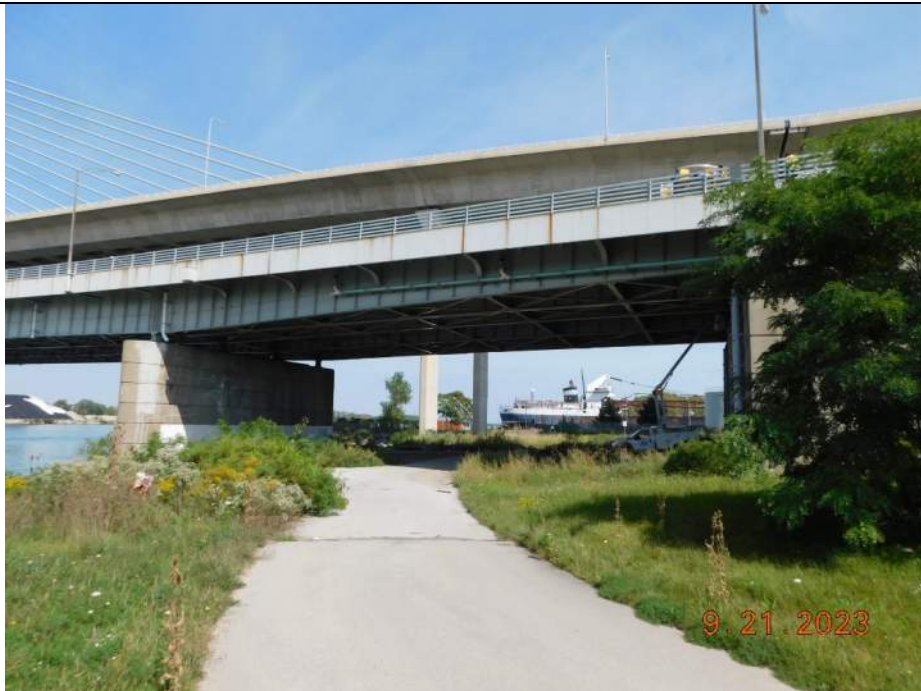
Photo S-68 - [Span 1] -West fascia, general view, Looking East

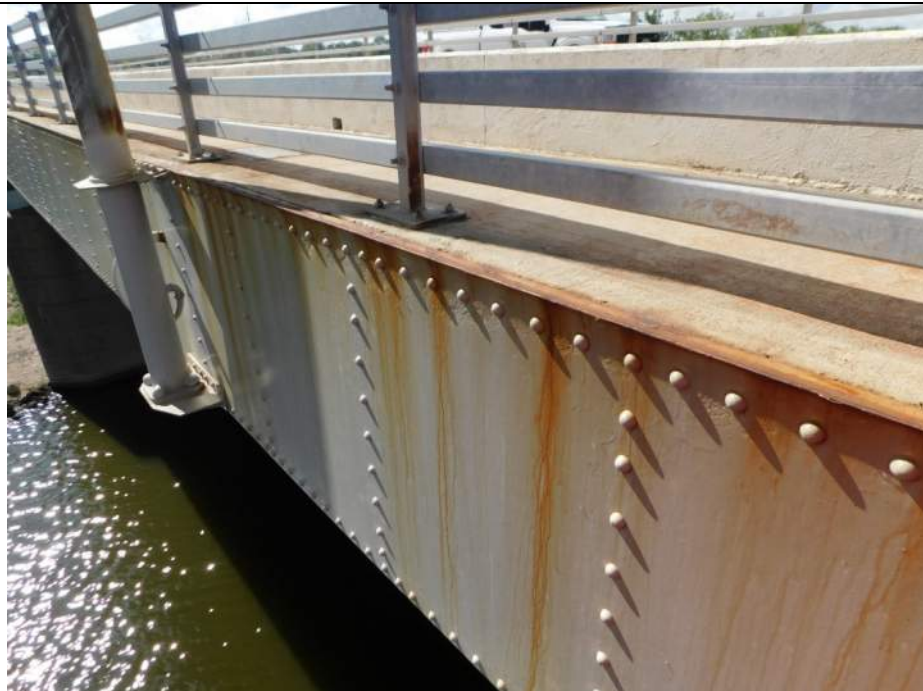
Photo S-70 - [Span 2] -East fascia, detail view of typical packing corrosion at sidewalk edge and fascia plate, Looking Southwest

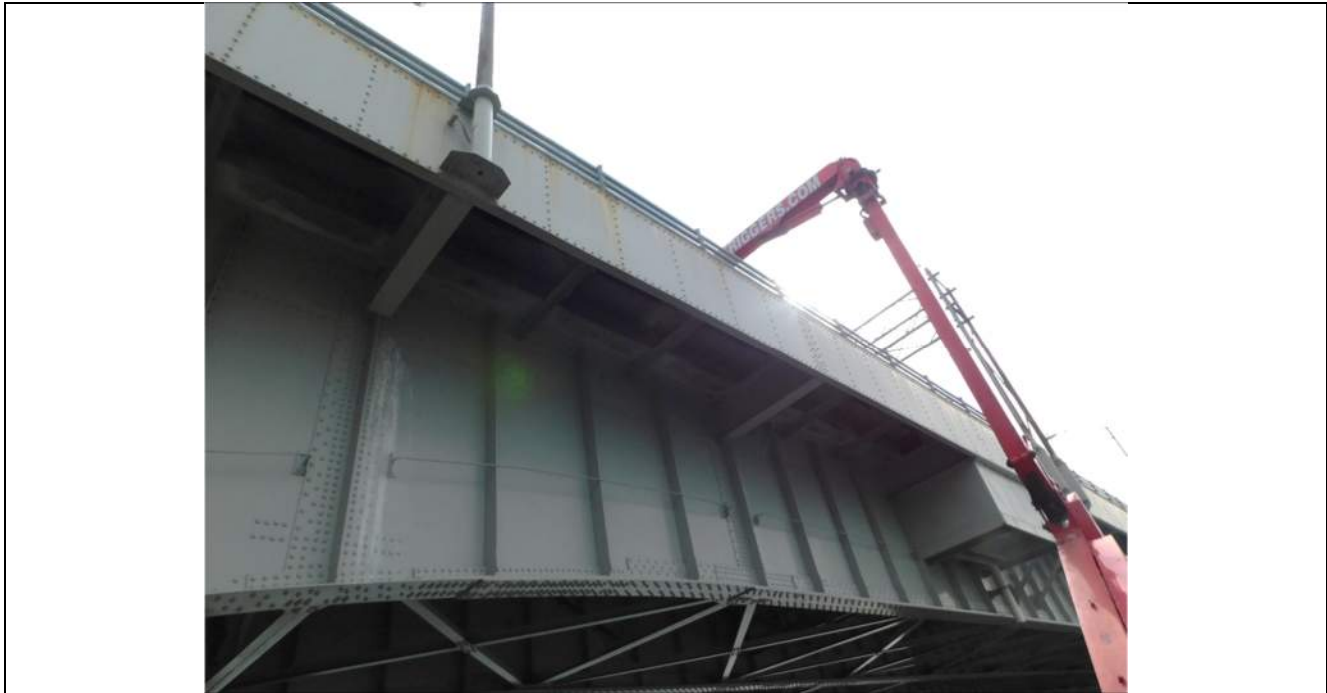
Photo S-71 - [Span 4] -West fascia and framing, general view, Looking Southeast

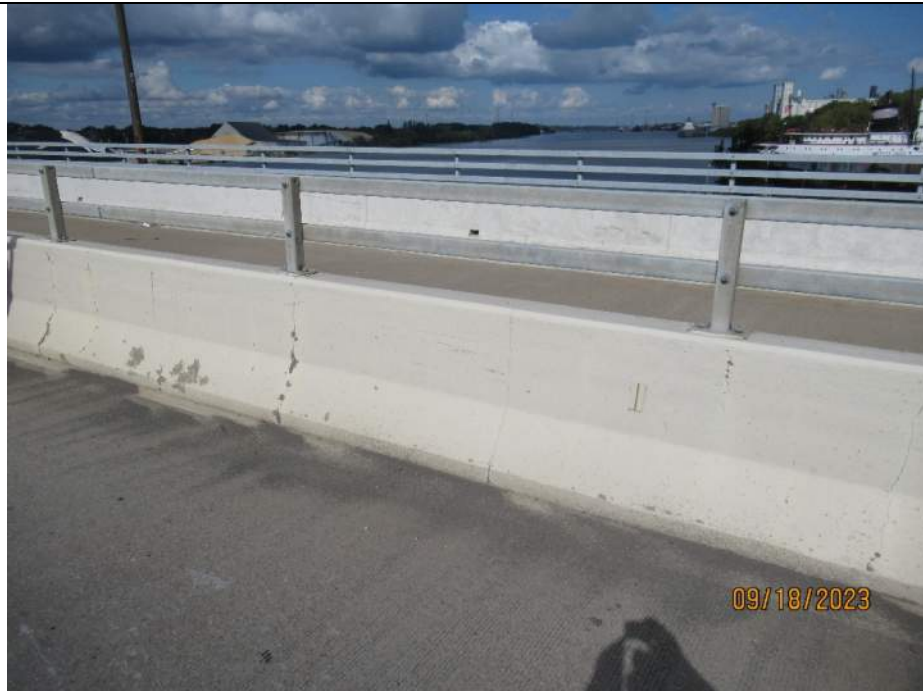
Photo S-82 - [Span 1] -East roadway barrier, typical full height vertical cracking, Looking East

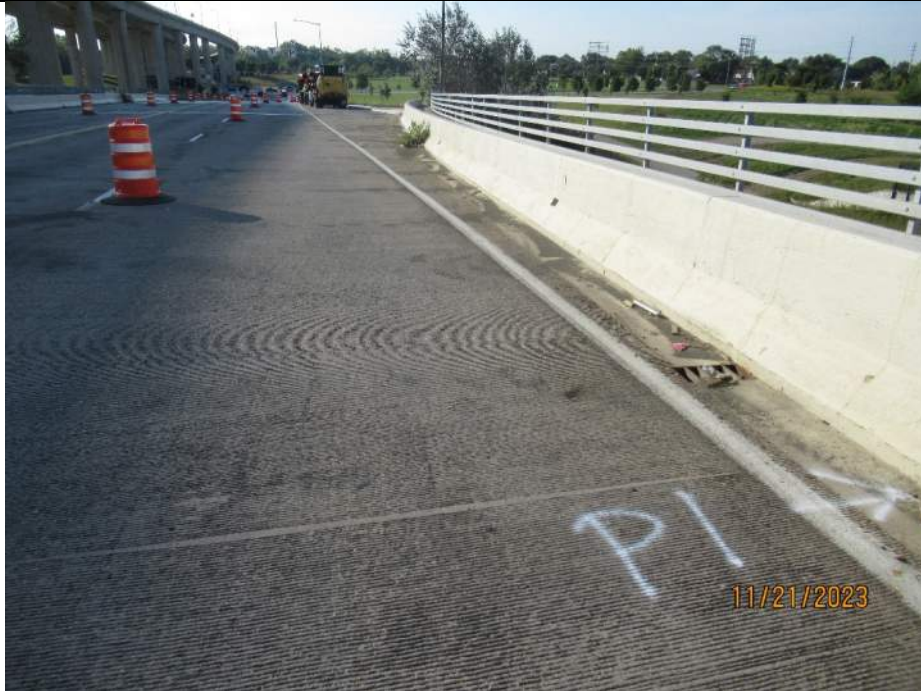
Photo S-83 - [Span 1] -West roadway barrier, typical vertical cracking, Looking Southwest

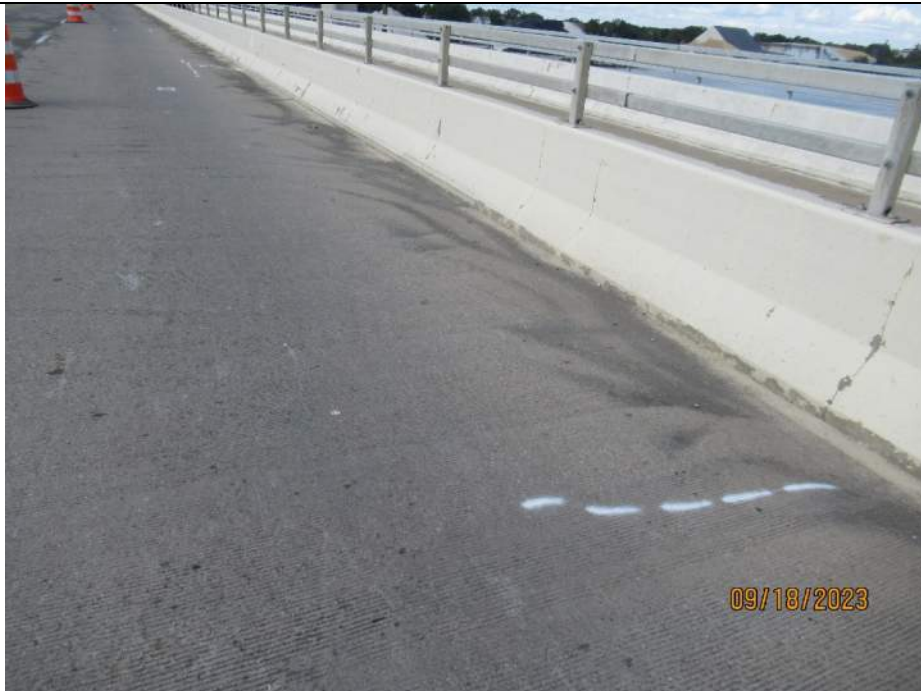
Photo S-84 - [Span 2] -East roadway barrier, typical full height vertical cracking, Looking East

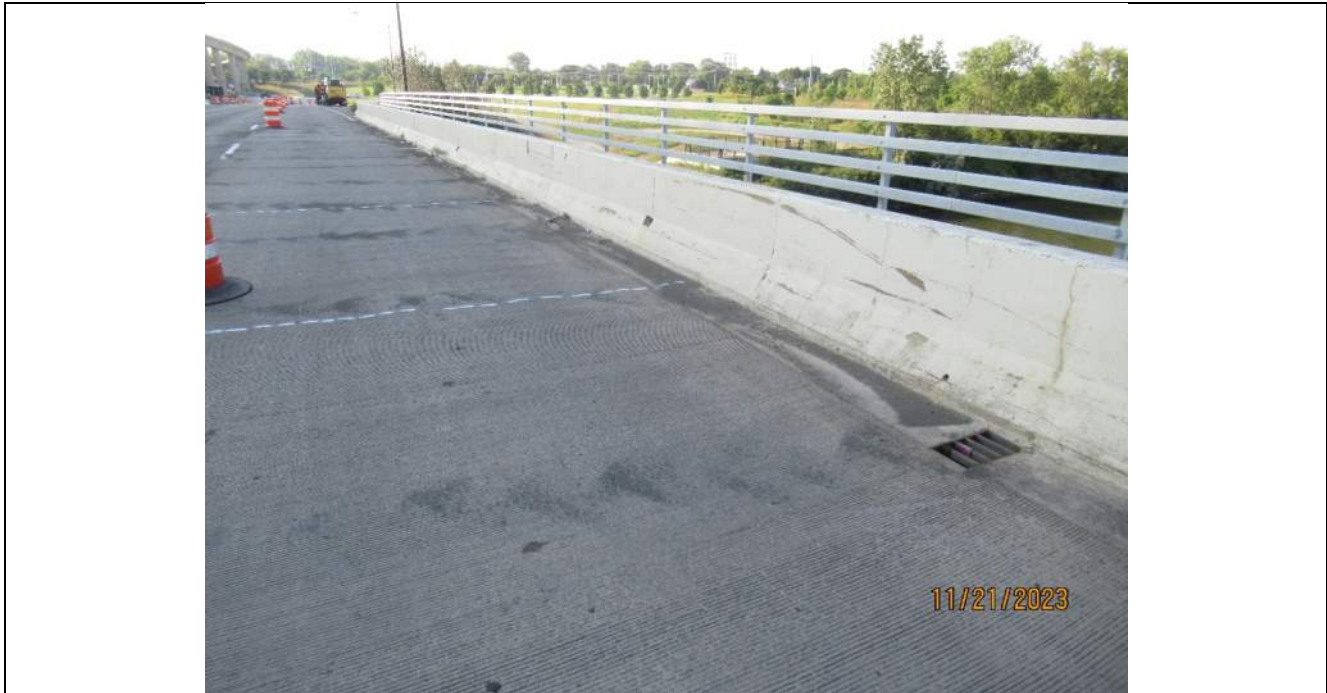
Photo S-85 - [Span 2] -West roadway barrier, typical minor impact scrapes and vertical cracking, Looking Southwest

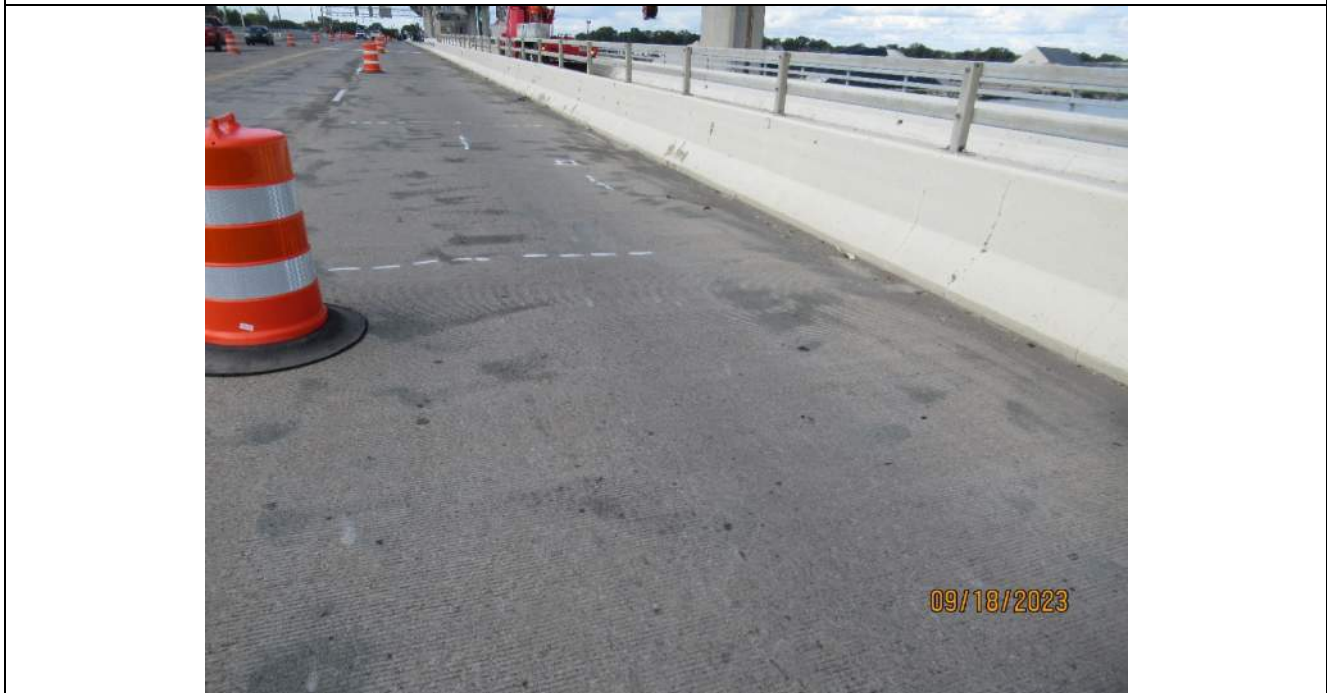
Photo S-86 - [Span 3] -East roadway barrier, typical full height vertical cracking, Looking East

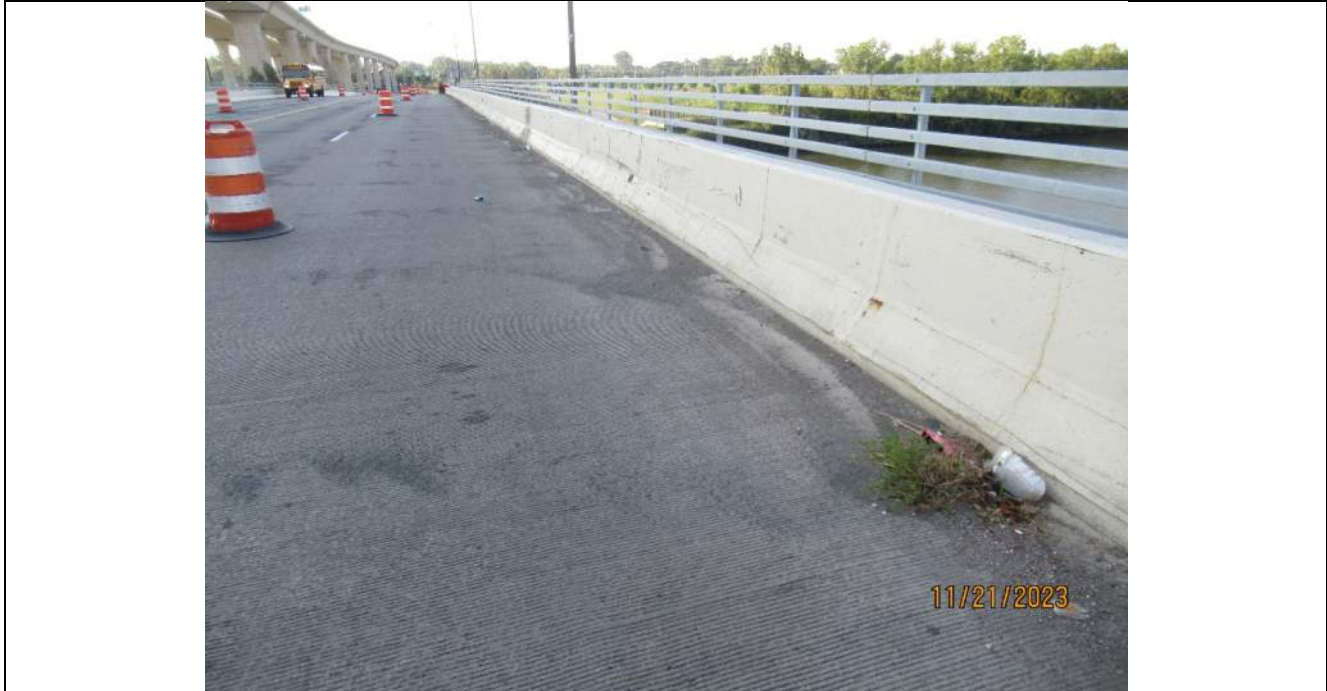
Photo S-87 - [Span 3] -West roadway barrier, typical minor impact scrapes and vertical cracking, Looking Southwest

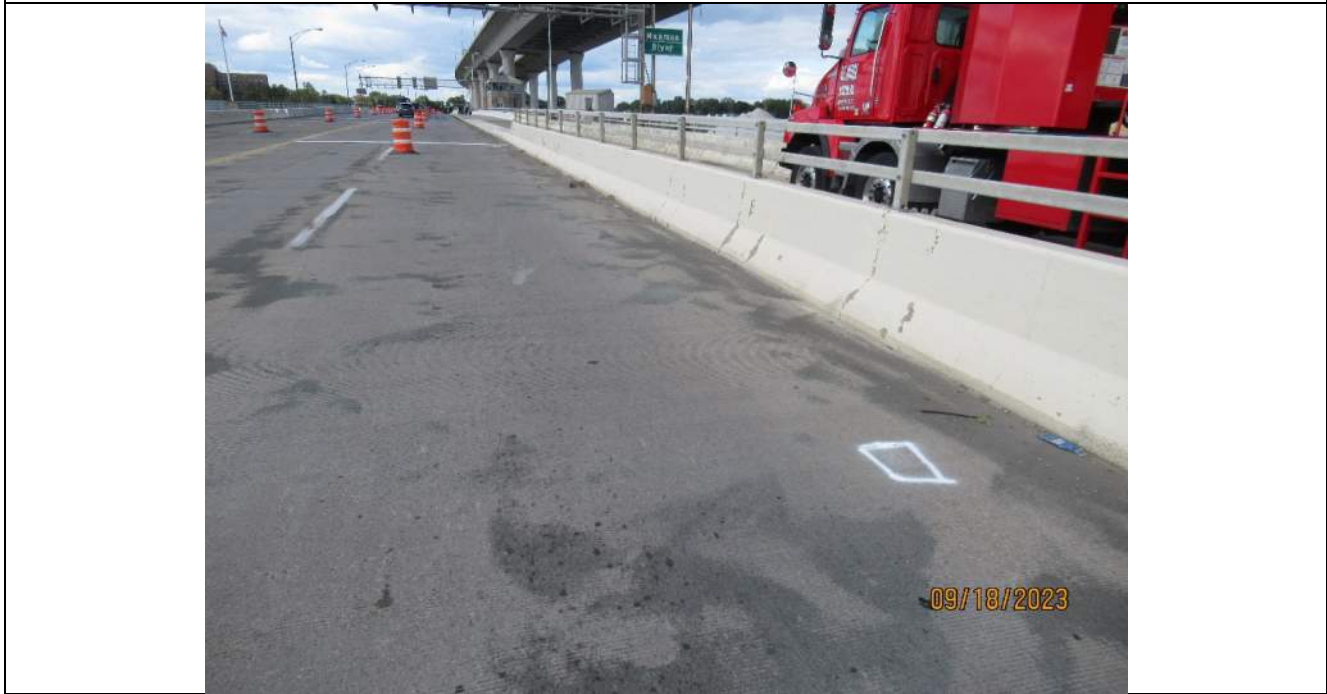
Photo S-88 - [Span 4] -East roadway barrier, typical full height vertical cracking, Looking Northeast

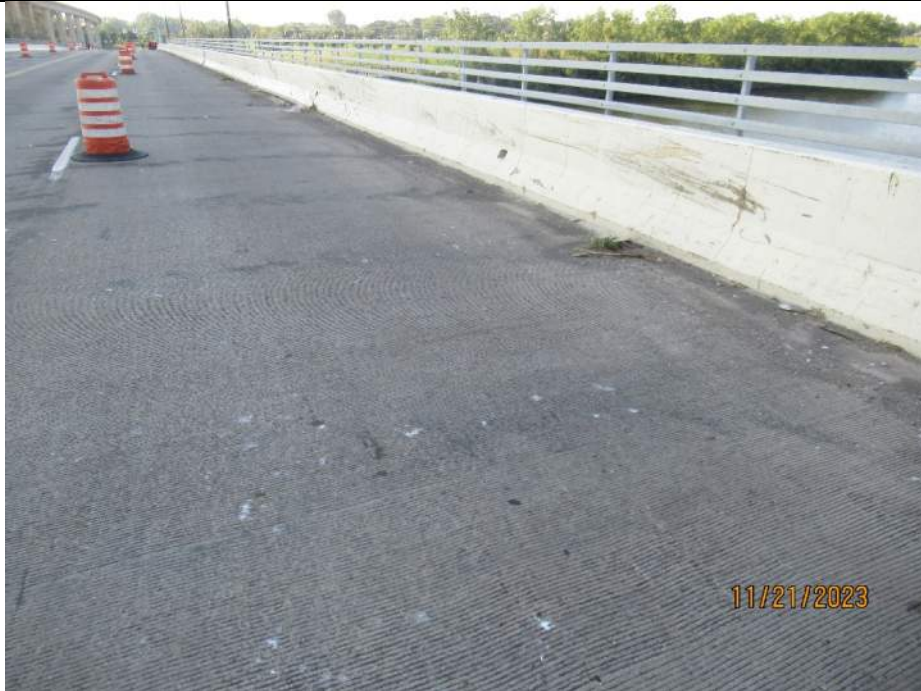
Photo S-89 - [Span 4] -West roadway barrier, typical full height vertical cracking, Looking South

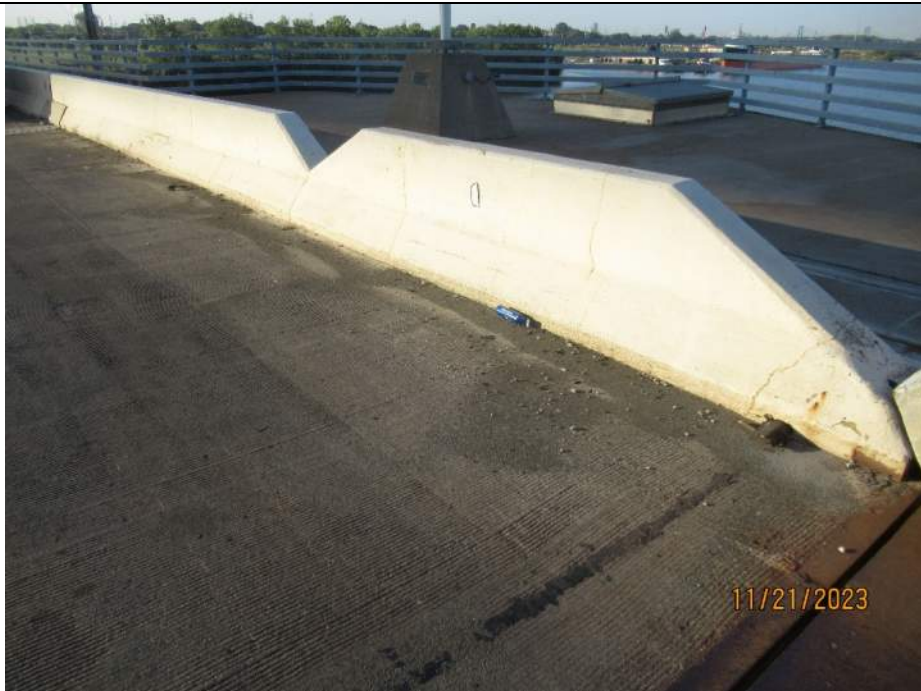
Photo S-90 - [Pier 4 Span] -West roadway barrier, typical vertical cracks, Looking Southwest

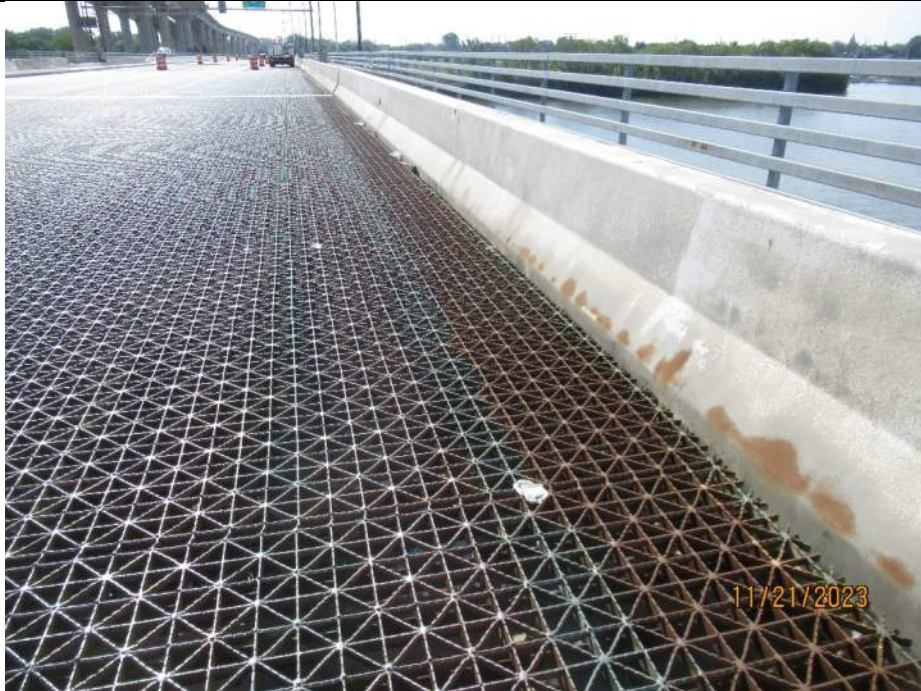
Photo S-91 - [Span 5] -North leaf, West roadway steel barrier, minor corrosion at base, peeling paint throughout, Looking South

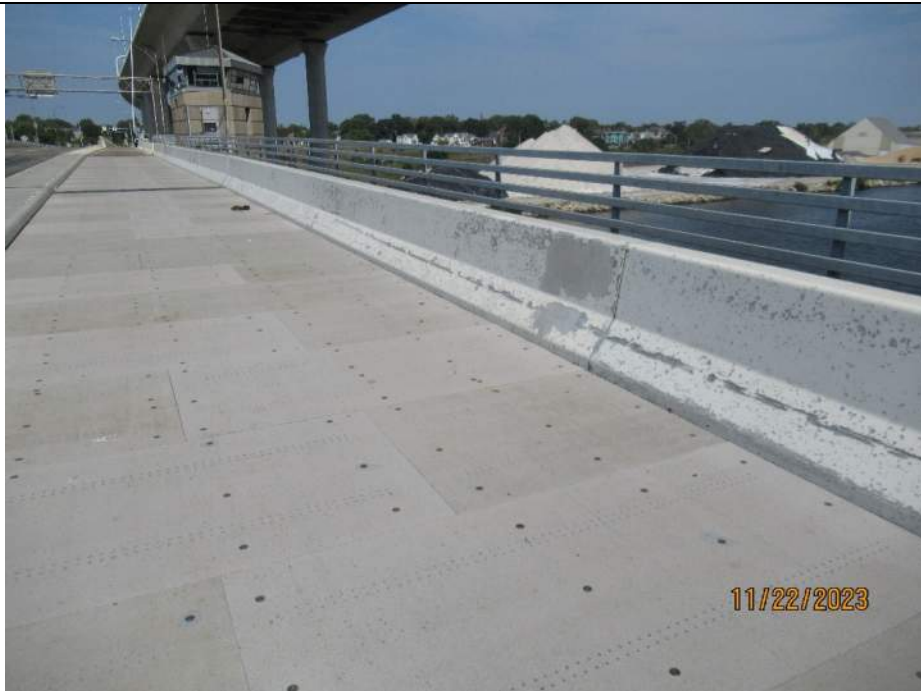
Photo S-92 - [Span 5] -South leaf, East roadway / trail steel barrier, generally good condition with flaking and peeling paint, Looking Northeast

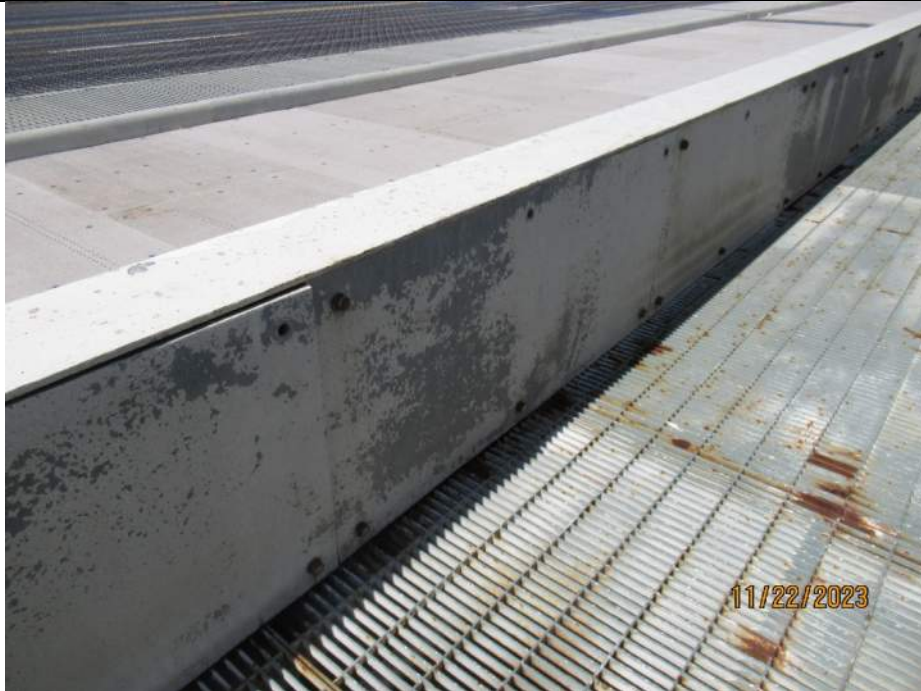
Photo S-93 - [Span 5] -South leaf East roadway / trail steel barrier, East side, scattered missing connection bolts for vertical plate, Looking Northwest

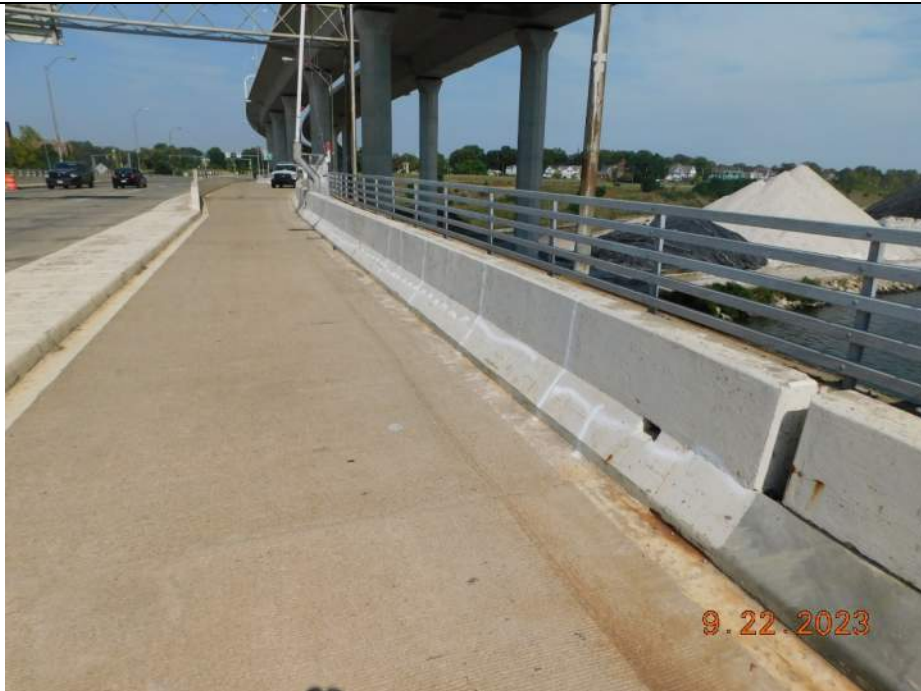
Photo S-94 - [Span 6] -East roadway / trail barrier, typical full height vertical cracking and isolated longitudinal cracking at lower slope, Looking North

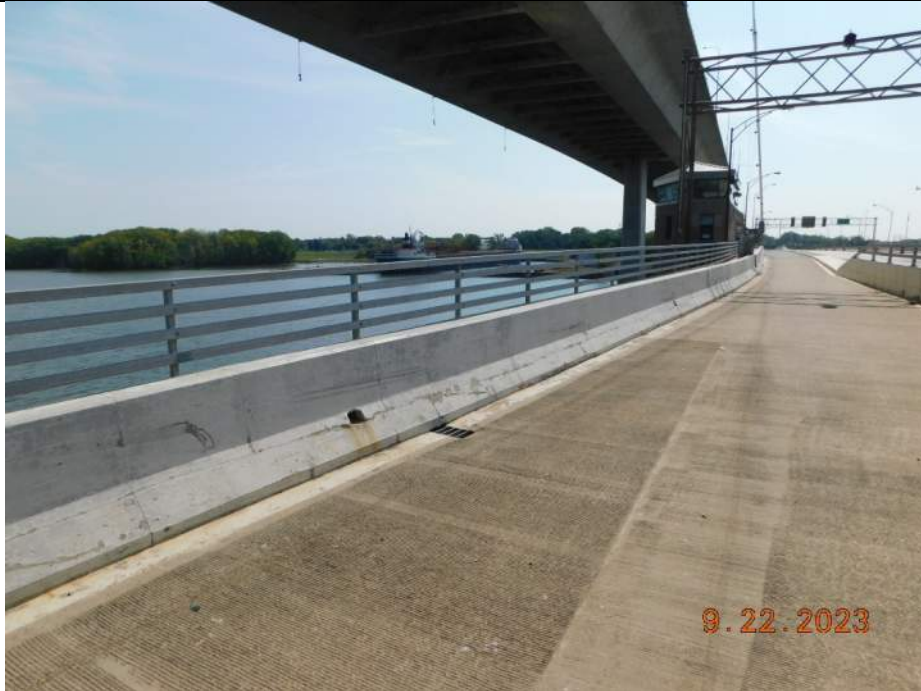
Photo S-95 - [Span 6] -East sidewalk / trail barrier and railing, typical full height vertical cracking, Looking South

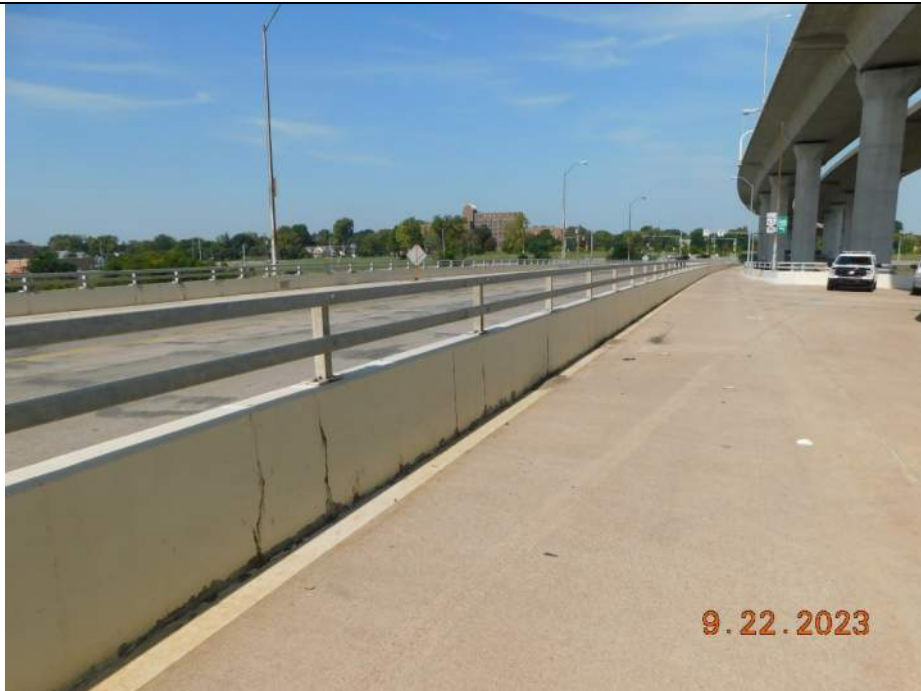
Photo S-96 - [Span 7] -East roadway / trail barrier, typical full height vertical cracking , Looking North

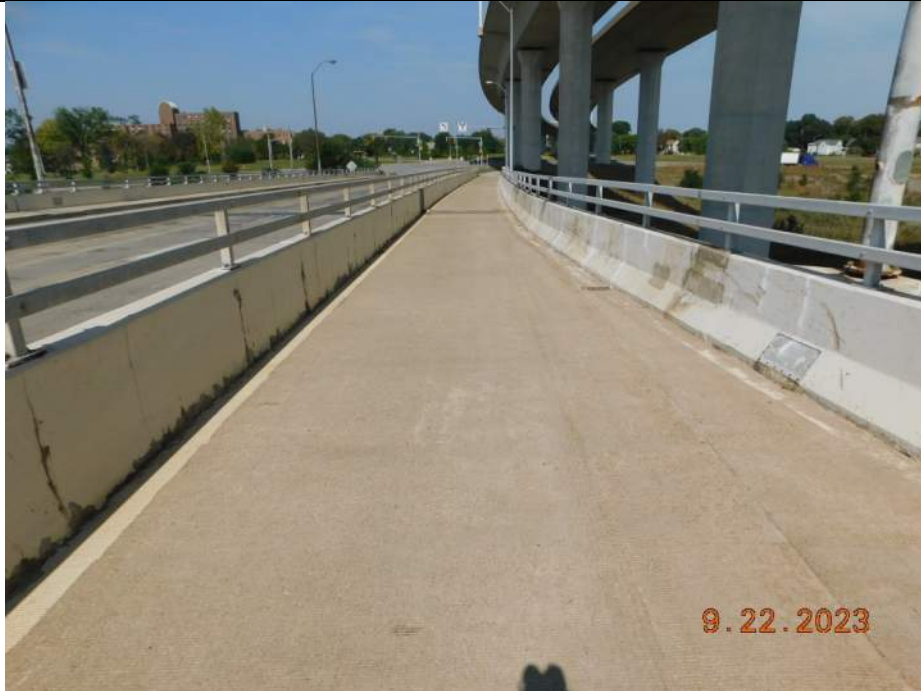
Photo S-97 - [Span 8] -East roadway & trail / sidewalk barriers and top railings, typical full height vertical cracking, Looking North

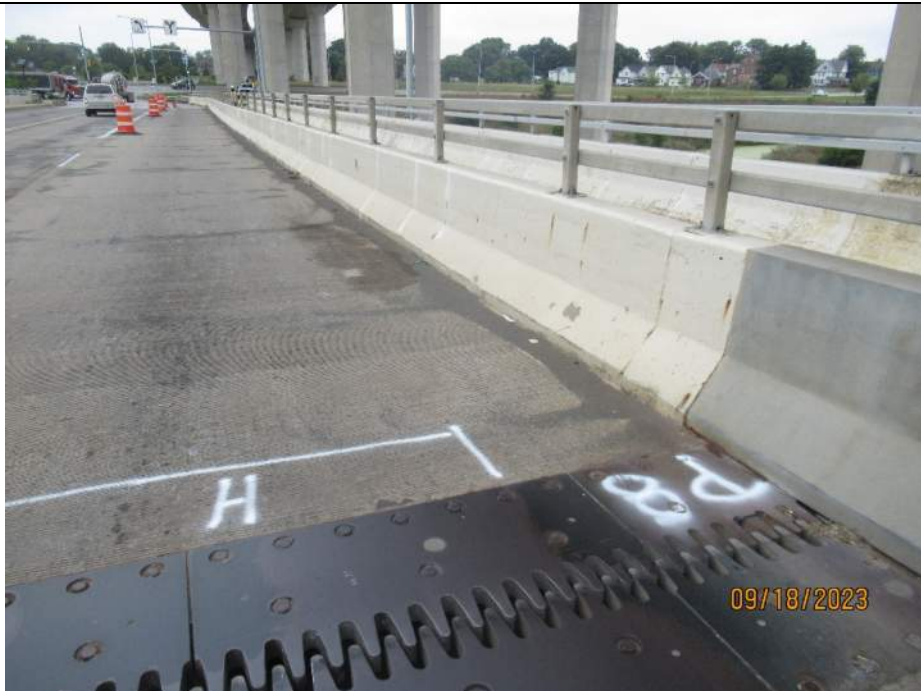
Photo S-98 - [Span 9] -East roadway barrier and top railing, trail / sidewalk barrier and railing in background, typical full height vertical cracking, Looking Northeast

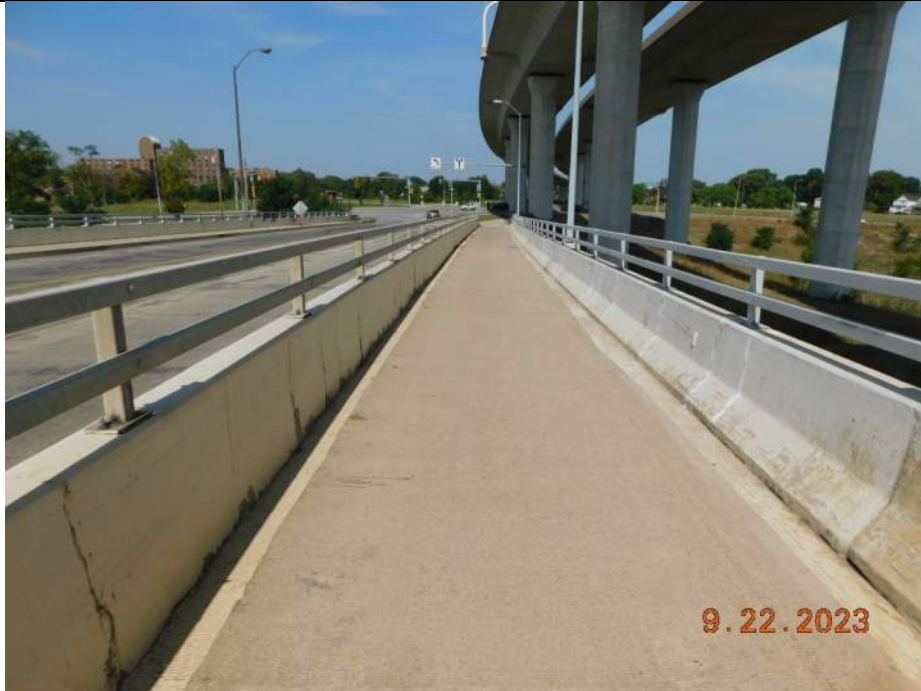
Photo S-99 - [Span 9] -East roadway & trail / sidewalk barriers and top railings, typical full height vertical cracking, Looking North

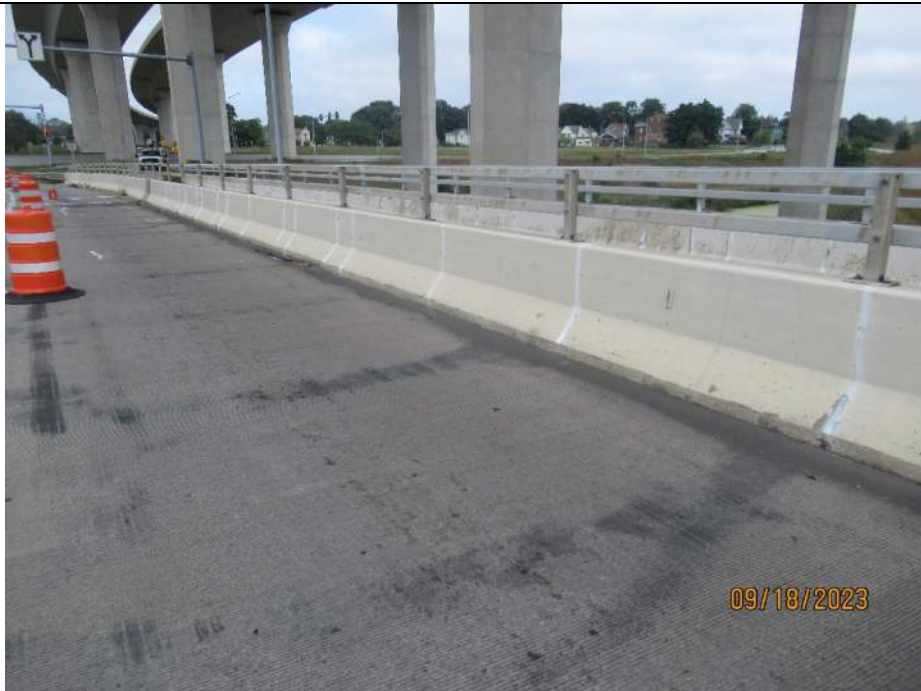
Photo S-100 - [Span 10] -East roadway barrier and top railing, trail barrier and railing in background, typical full height vertical cracking, Looking Northeast
