Craig Memorial Bascule Bridge

Over the Maumee River

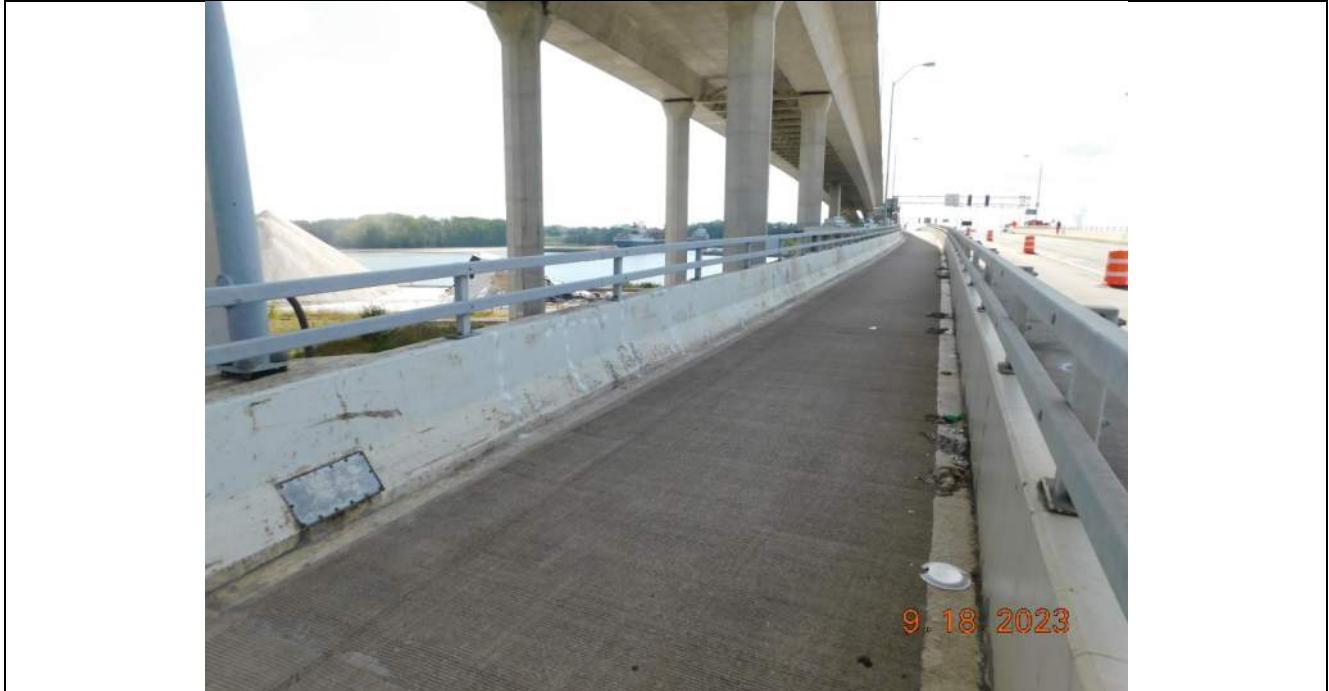
Photo S-101 - [Span 10] -East sidewalk / trail barrier and top railing, typical full height vertical cracking, Looking Southeast

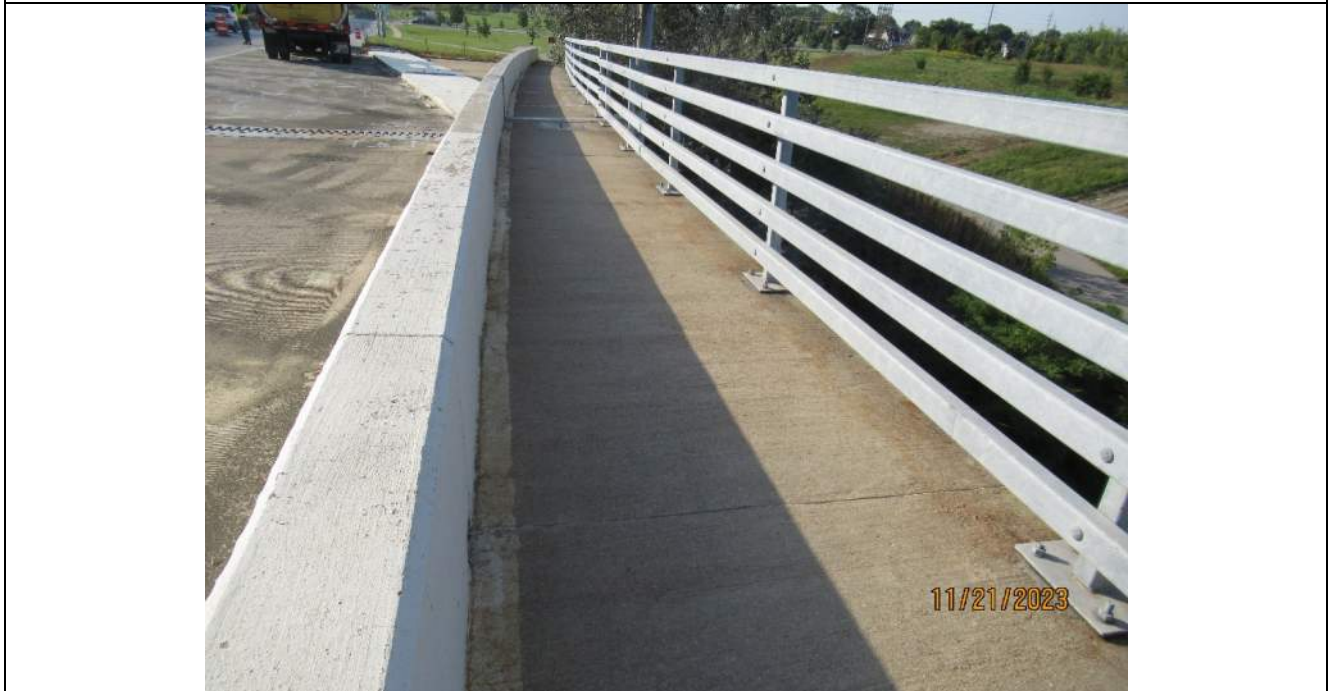
Photo S-102 - [Span 1] -West pedestrian railing and sidewalk, typical good condition, Looking Southwest

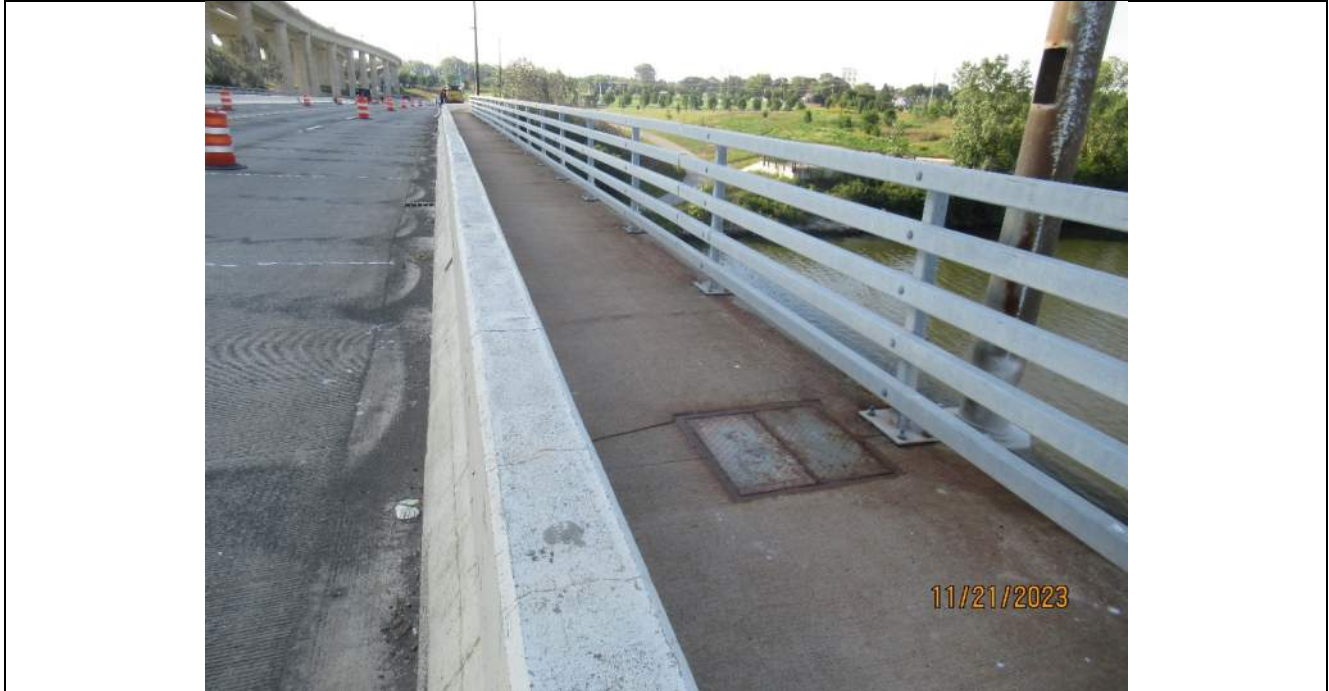
Photo S-103 - [Span 2] -West pedestrian railing and sidewalk, typical good condition, Looking Southwest

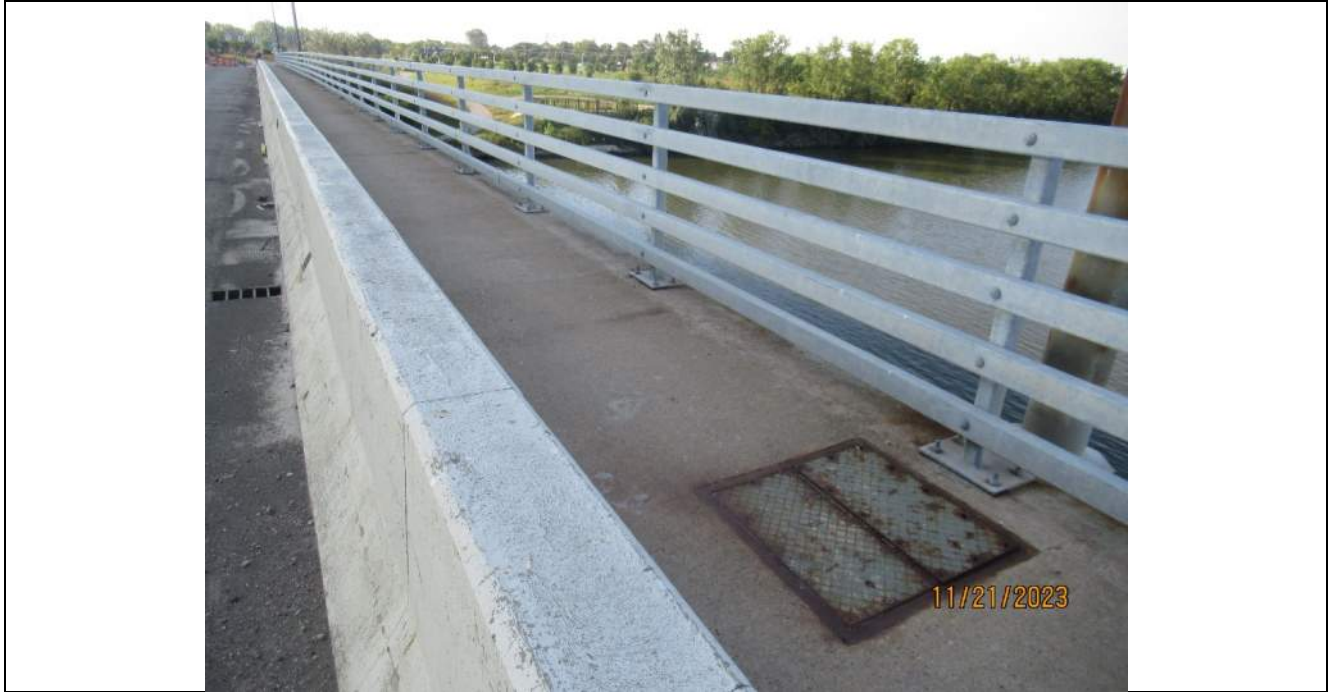
Photo S-104 - [Span 3] -West pedestrian railing and sidewalk, typical good condition, Looking Southwest

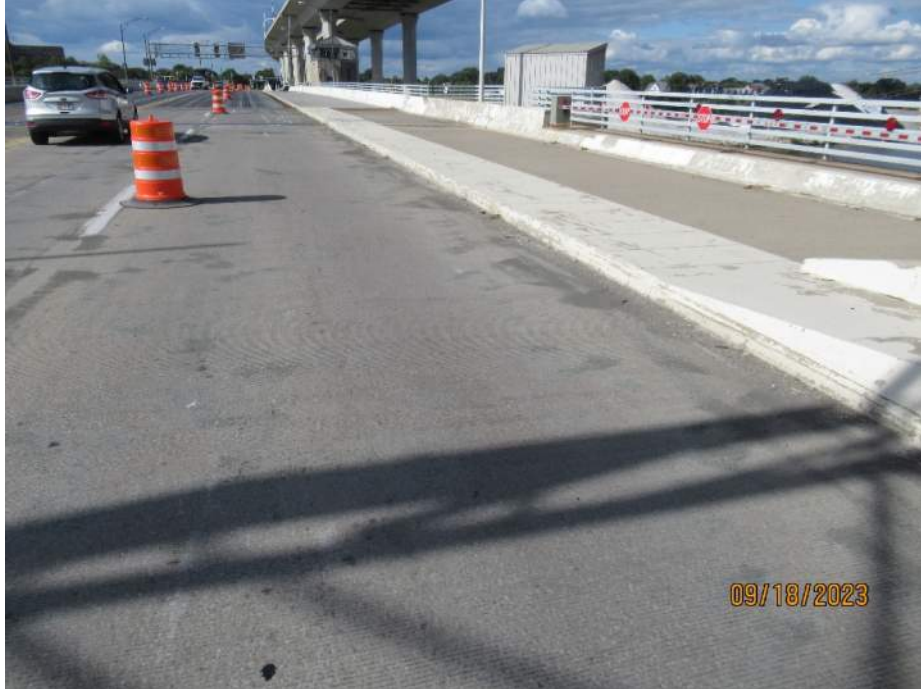
Photo S-105 - [Span 4] -Concrete curb / median island between northbound lanes and mixed use trail, minor scrapes in coating, generally good condition, Looking Northeast

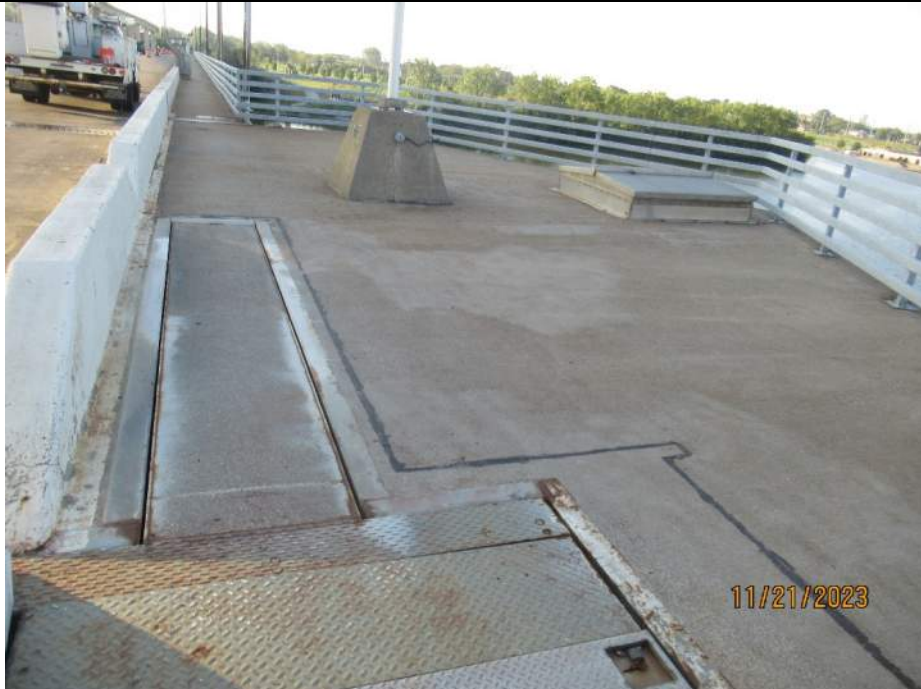
Photo S-106 - [Pier 4 Span] -West sidewalk and railings, good condition general view, Looking Southwest

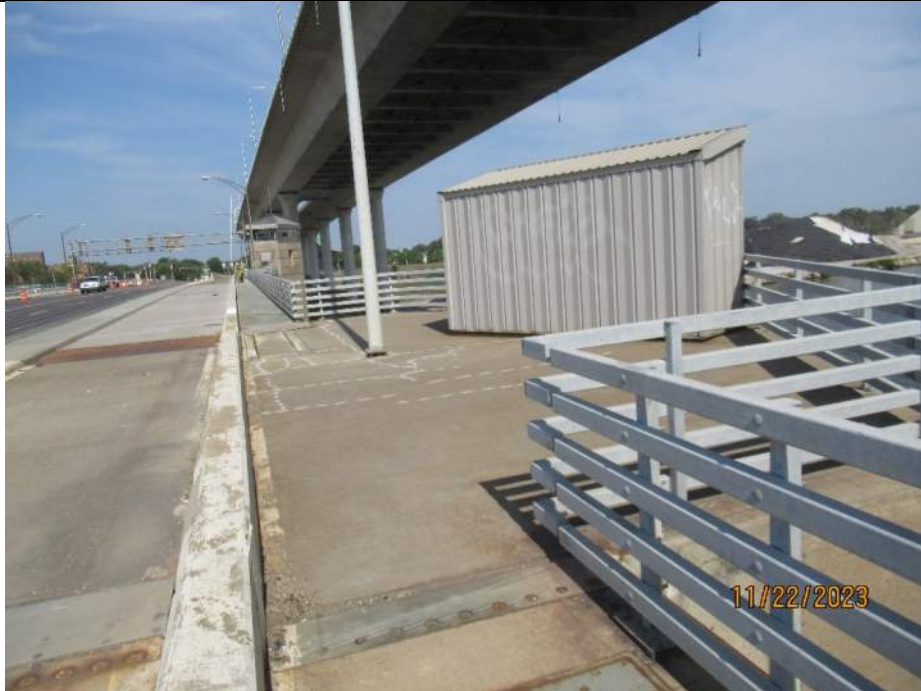
Photo S-107 - [Pier 4 Span] -East sidewalk and railings, good condition general view, Looking North

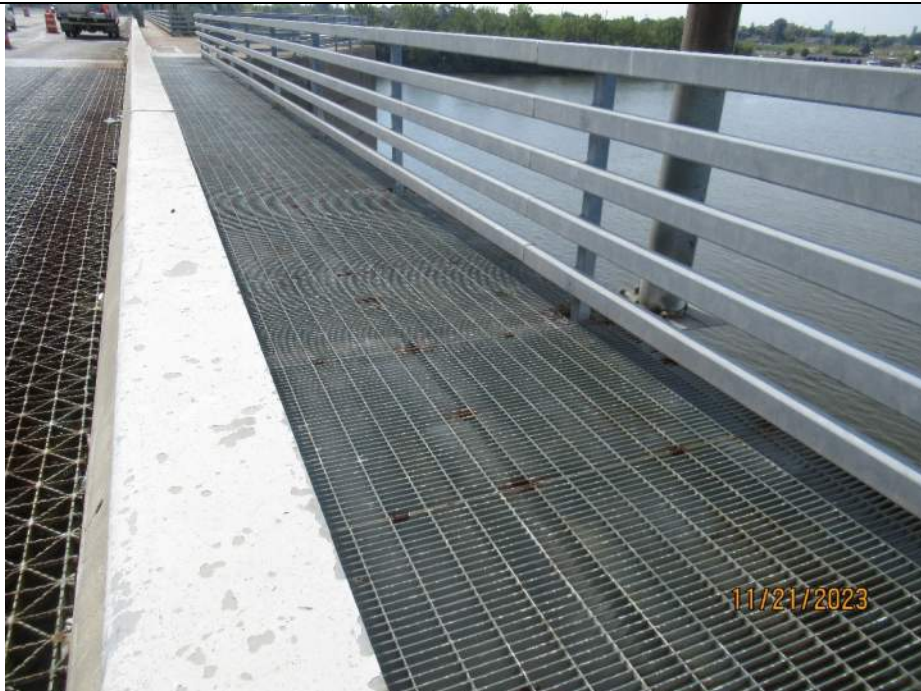
Photo S-108 - [Span 5] -South leaf west sidewalk and railing, typical good condition with spots of corrosion, Looking South

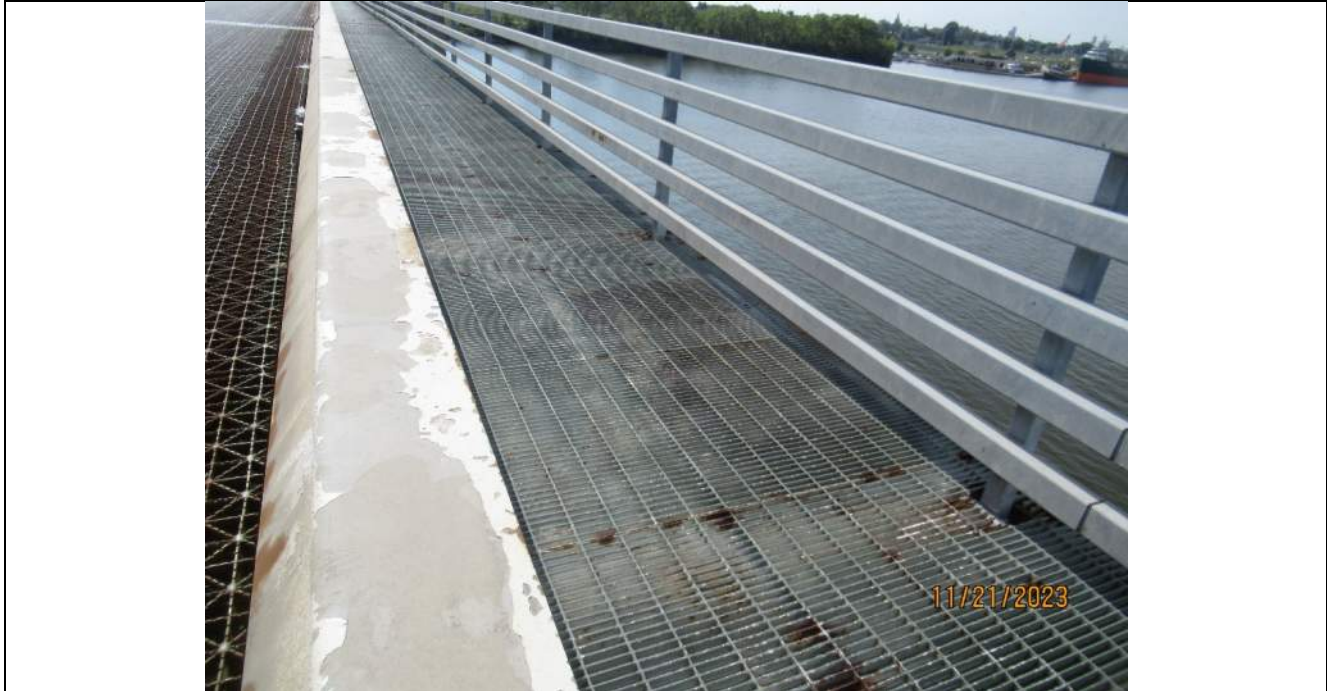
Photo S-109 - [Span 5] -North leaf west sidewalk and railing, typical good condition with spots of corrosion, Looking South

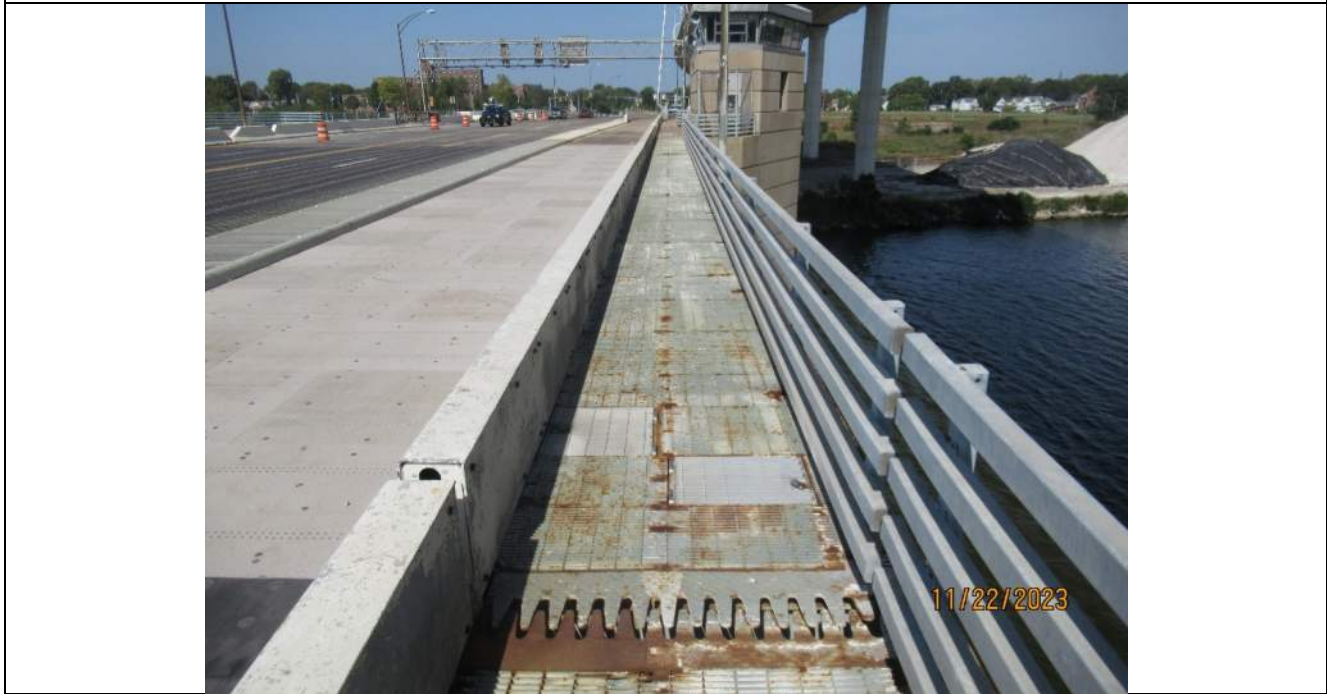
Photo S-110 - [Span 5] -North leaf east sidewalk and railing, typical good condition of rail and widespread minor corrosion to sidewalk grating, Looking North

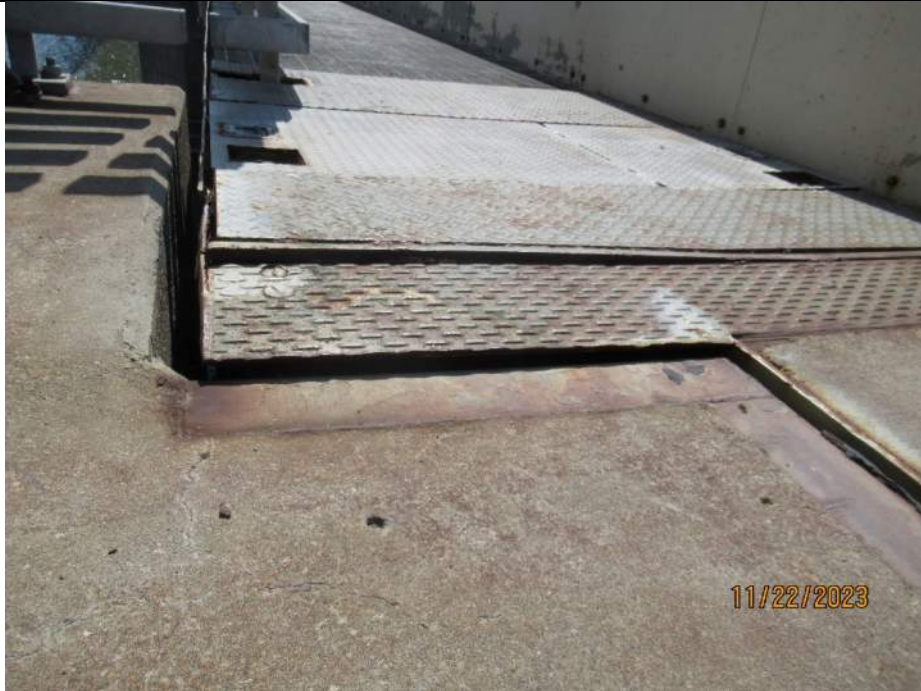
Photo S-111 - [Span 5] -North leaf east sidewalk at north end, vertical misalignment along longitudinal and transverse breaks presents minor tripping hazard, Looking South

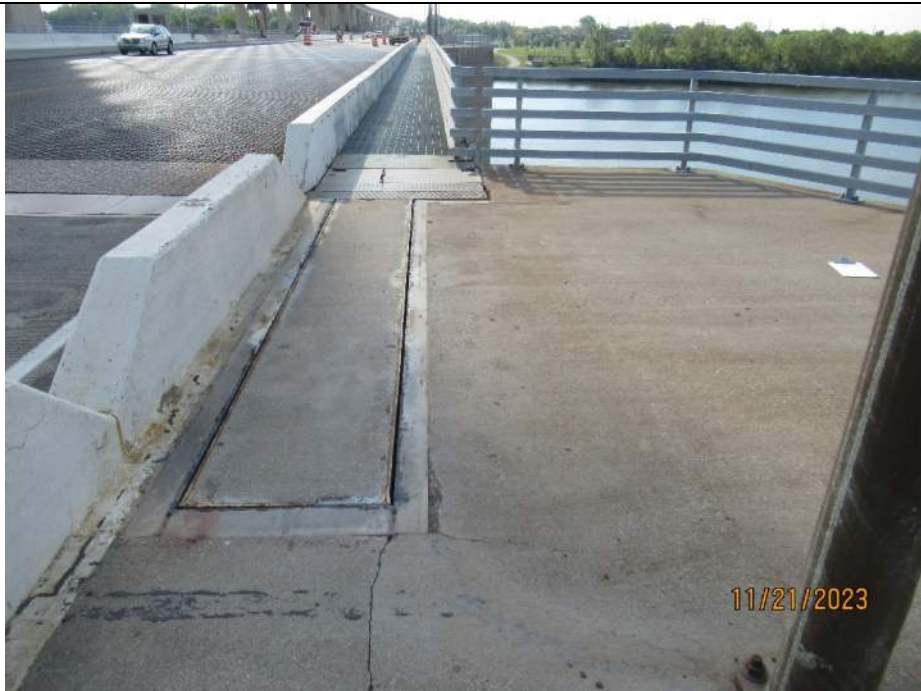
Photo S-112 - [Pier 5 Span] -West sidewalk and railings, good condition general view, Looking South

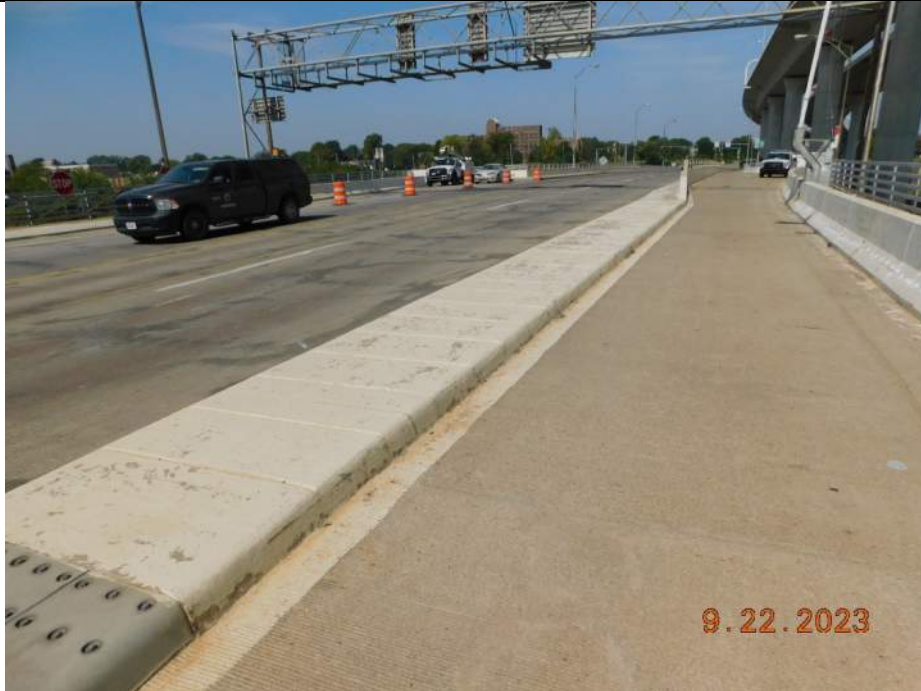
Photo S-113 - [Span 6] -Concrete curb / median island between northbound lanes and mixed use trail, minor scrapes in coating, generally good condition, Looking Northwest

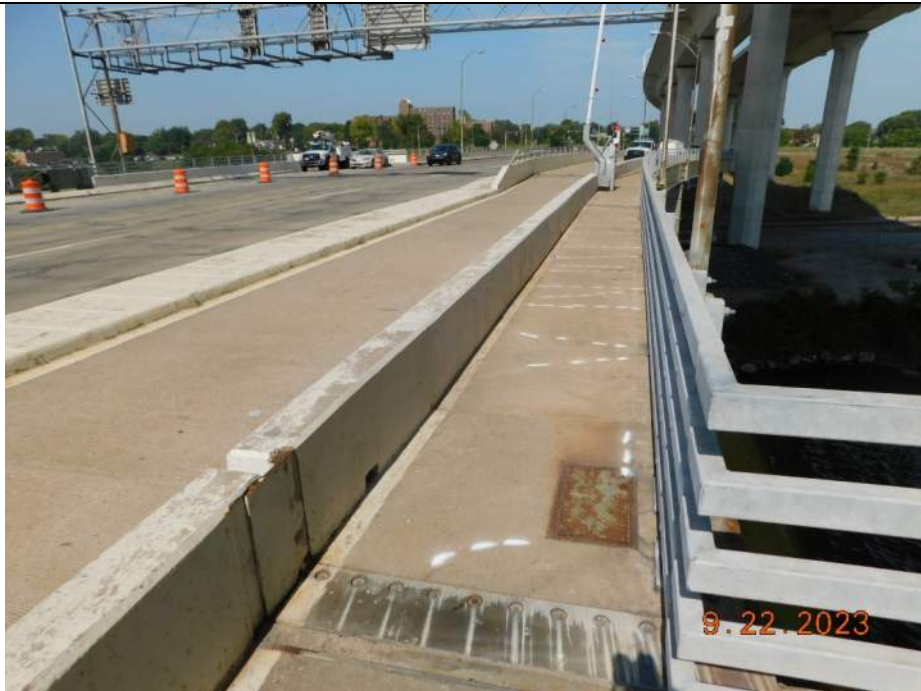
Photo S-114 - [Span 6] -East sidewalk and trail topside, barrier and railings, good condition general view, Looking North

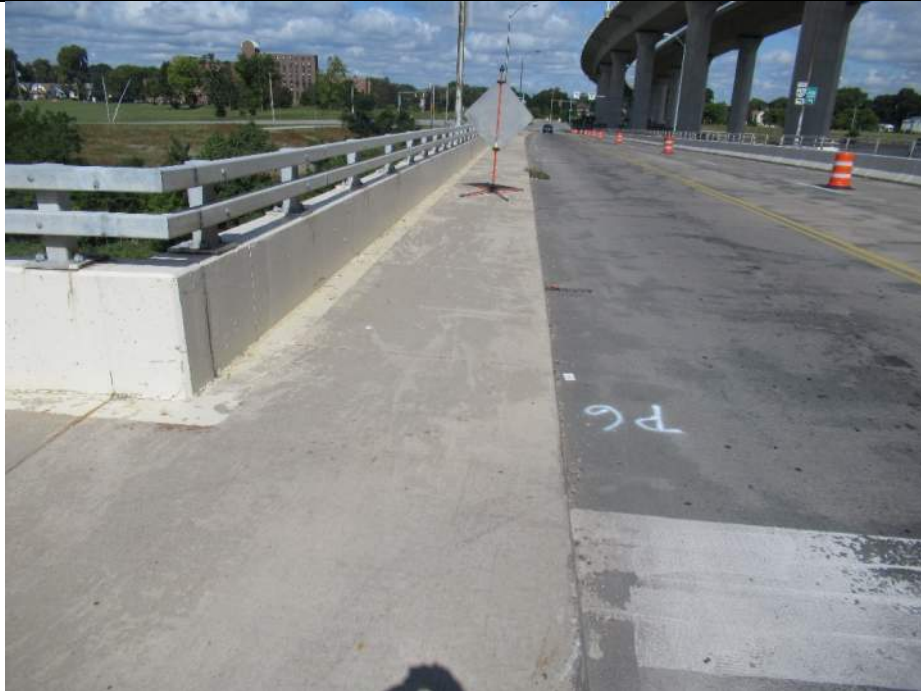
Photo S-115 - [Span 7] -West sidewalk, barrier and railing, good condition general view, Looking North

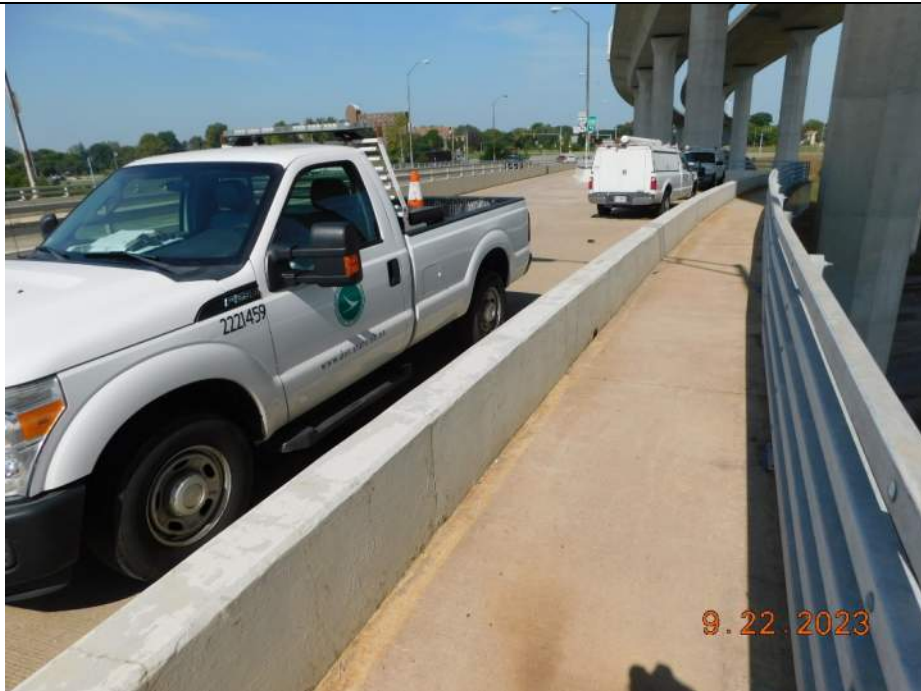
Photo S-116 - [Span 7] -East sidewalk, railing and barrier, good condition general view, Looking North

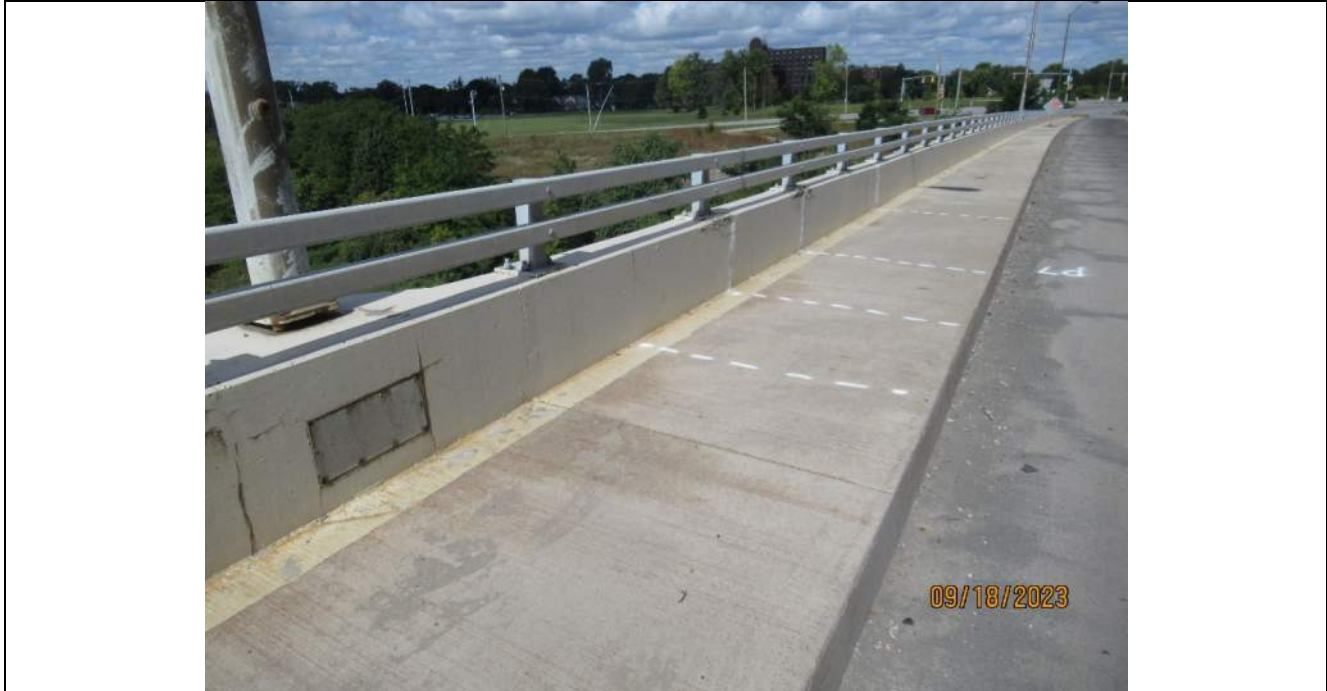
Photo S-117 - [Span 7 & 8] -West sidewalk, barrier and railing, minor transverse and vertical cracking, Looking North

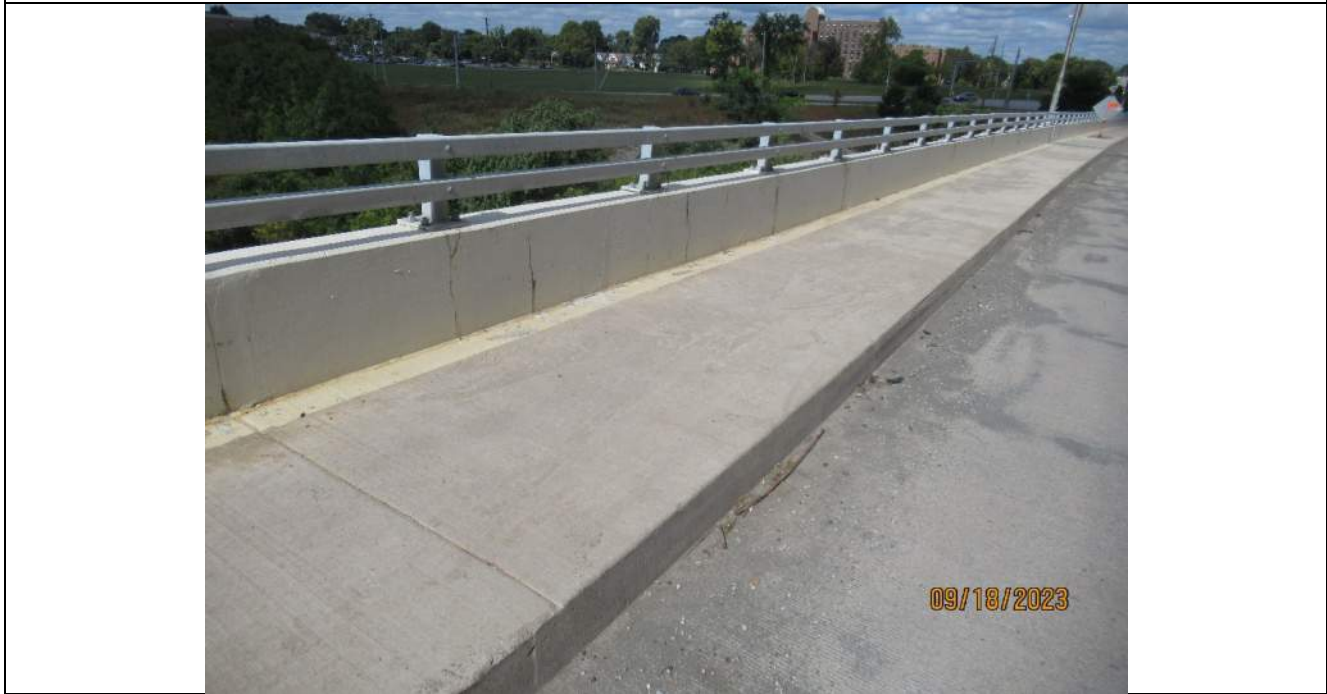
Photo S-118 - [Span 8] -West sidewalk, barrier and railing, minor transverse and vertical cracking, Looking North

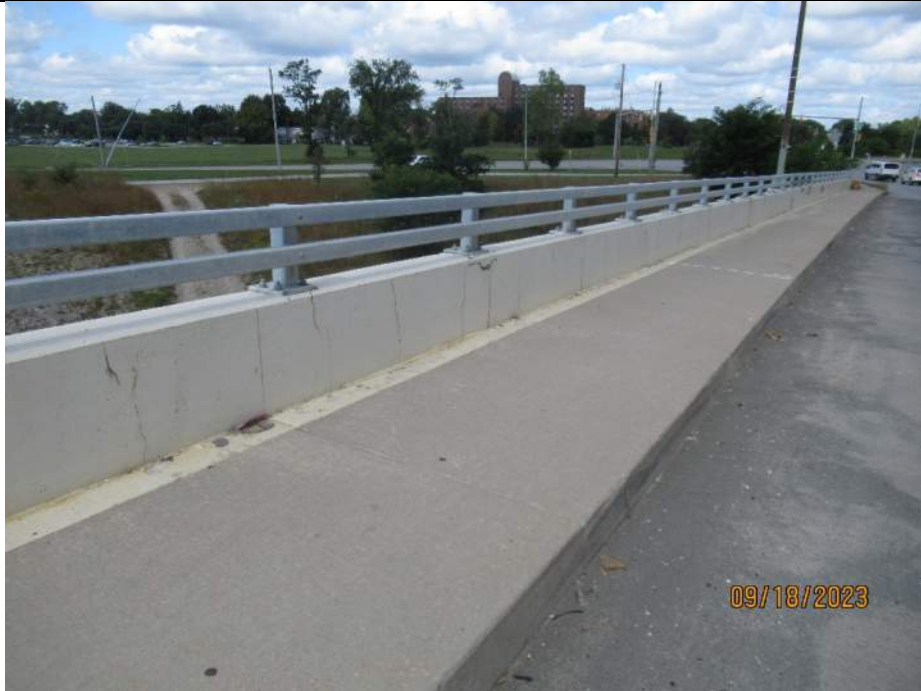
Photo S-119 - [Span 9] -West sidewalk, barrier and railing, minor transverse and vertical cracking, Looking North

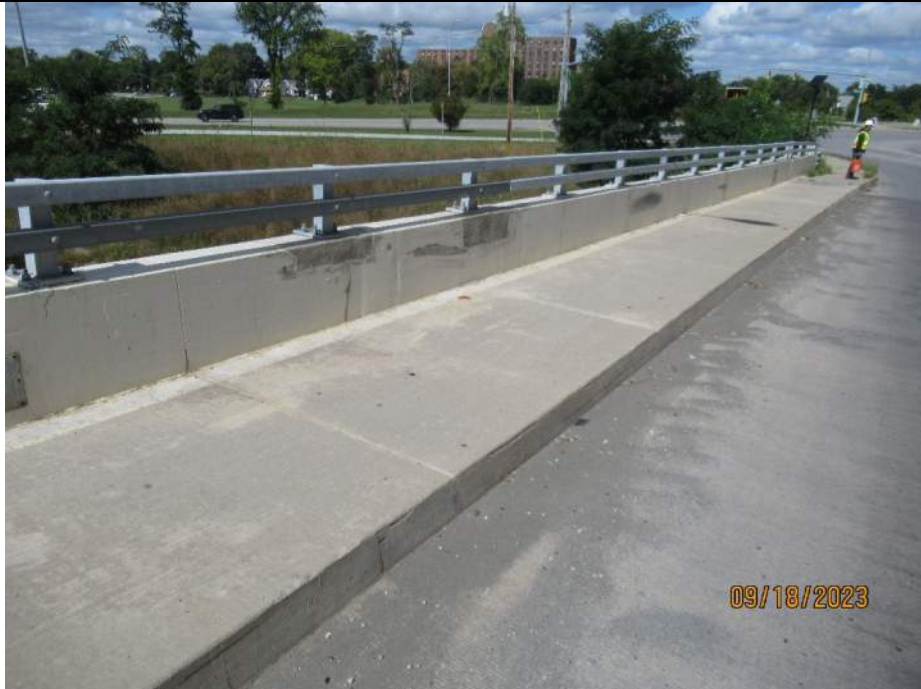
Photo S-120 - [Span 10] -West sidewalk, barrier and railing, minor transverse and vertical cracking, patch repairs to barrier, Looking North

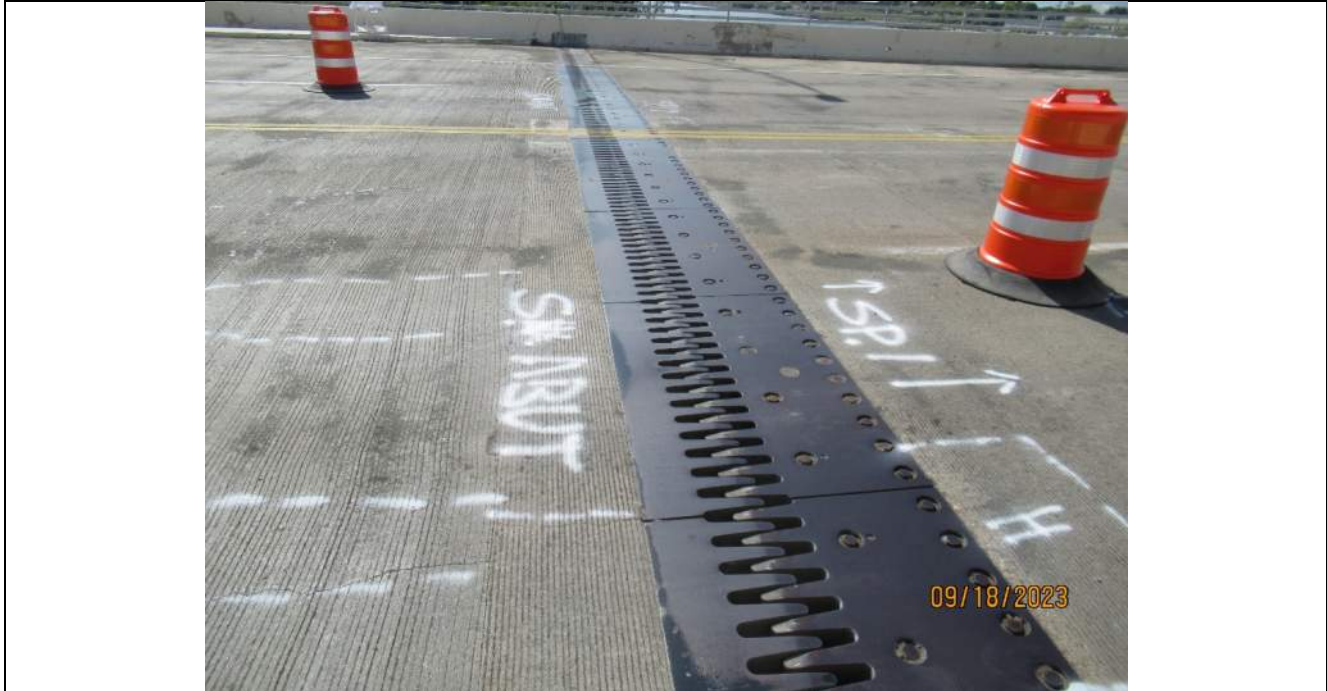
Photo S-121 - [South Abutment] -Abutment reference line finger joint general view from NB lanes, Looking West

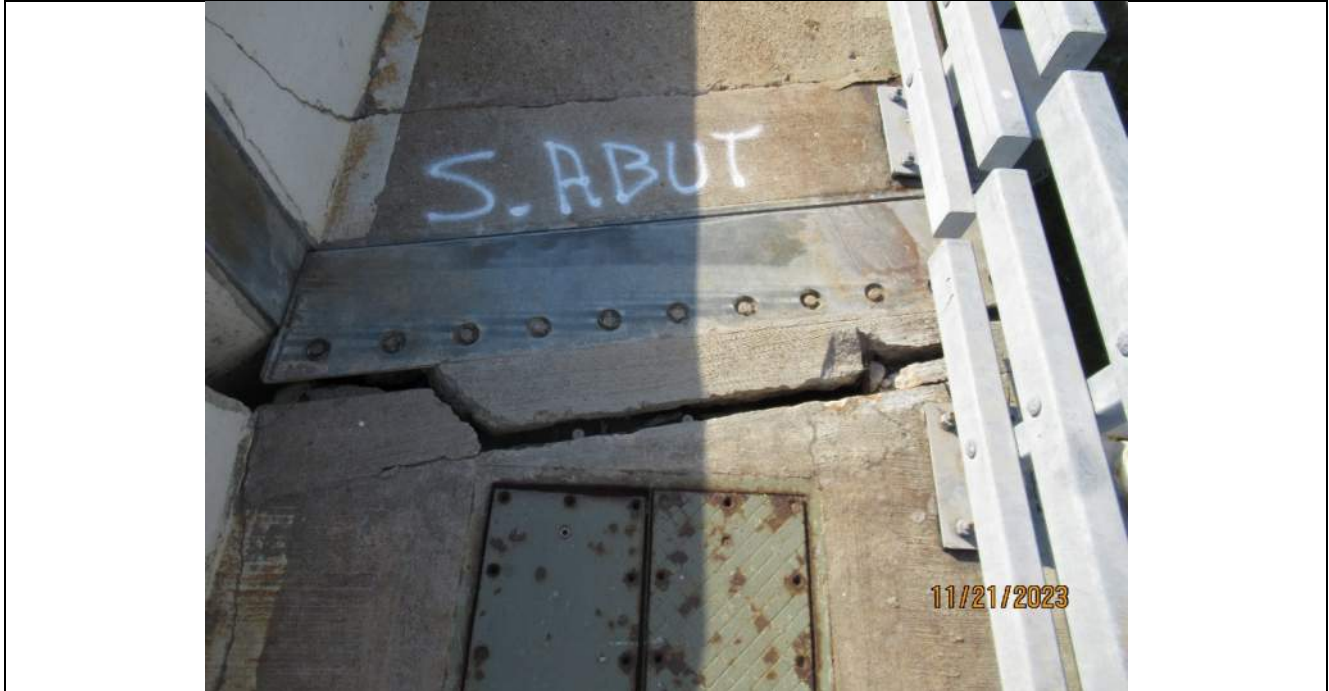
Photo S-123 - [South Abutment] -Abutment reference line sliding plate joint at West sidewalk, joint has seized and broken apart at the north header, Looking South

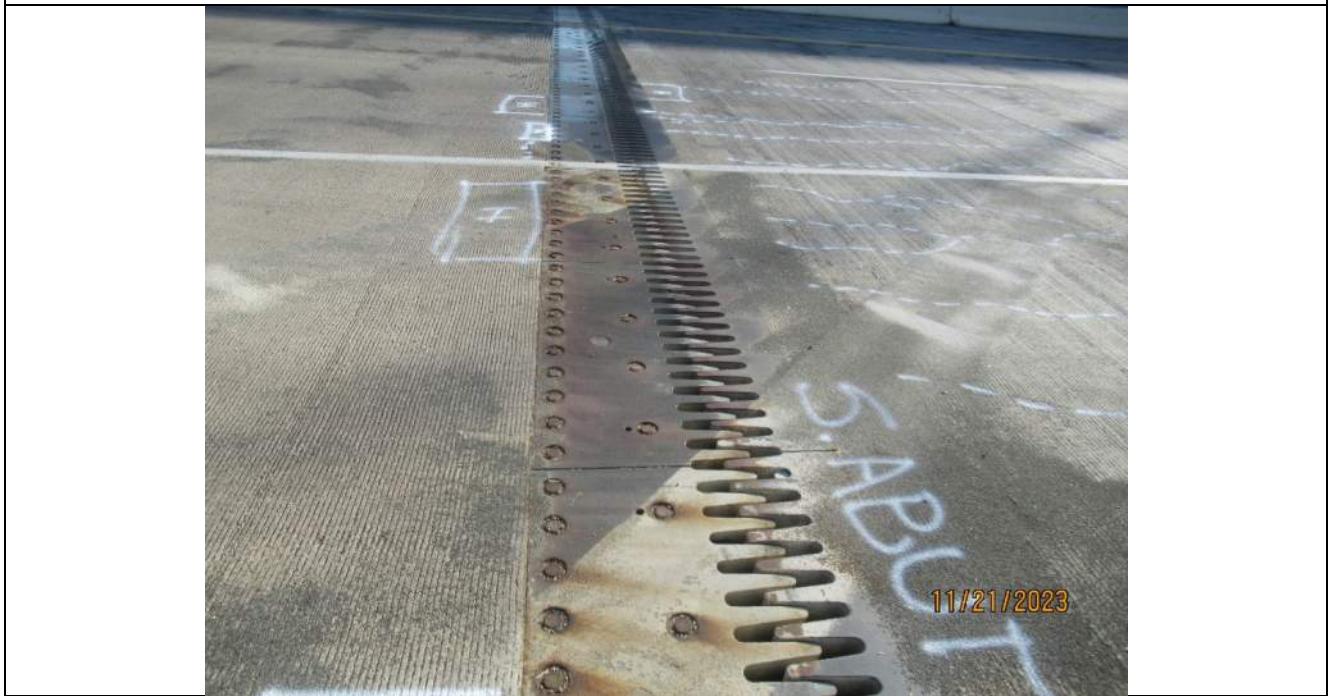
Photo S-124 - [South Abutment] -Abutment reference line finger joint general view in SB shoulder, Looking East

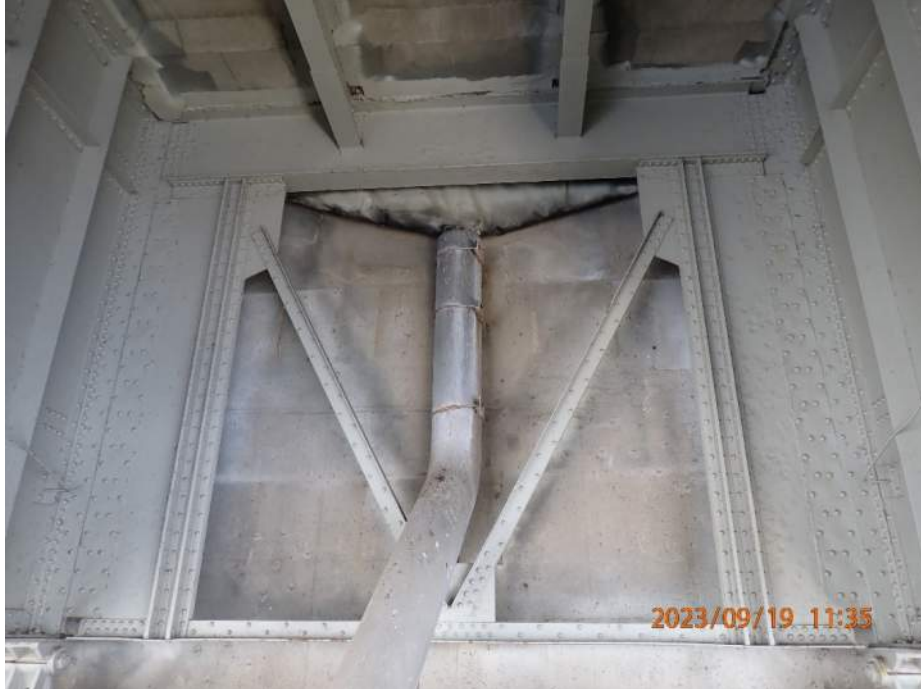
Photo S-135 - [Pier 4] -Underside of finger joint, view of elastomeric trough and drainage downspout (b/w G2-G3), connection to pier, generally good condition, Looking North

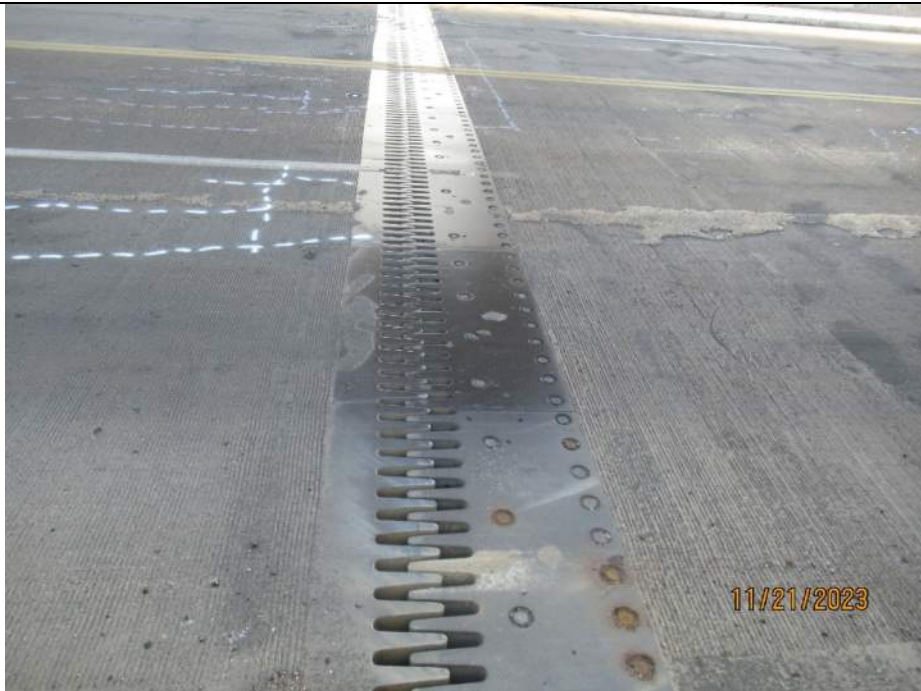
Photo S-136 - [Pier 5] -Expansion finger joint general view across SB roadway lanes, Looking East

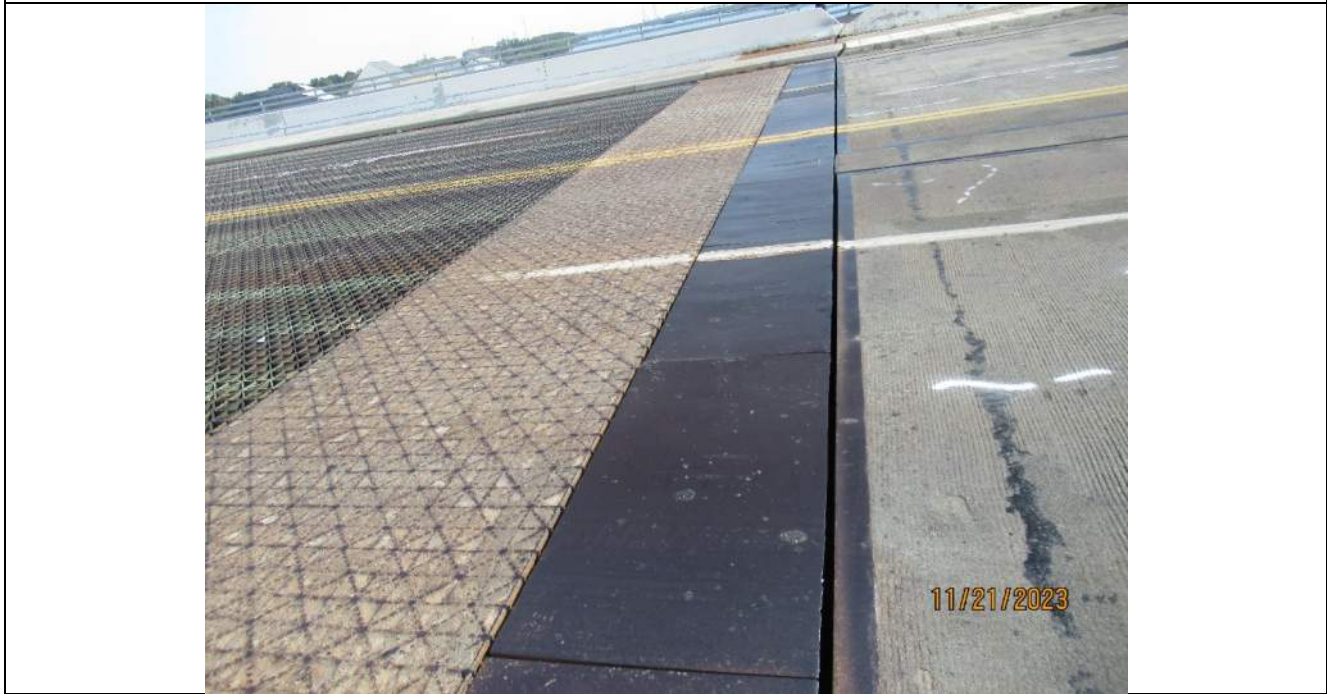
Photo S-142 - [Span 5] -South leaf rear break joint, good condition general view, Looking East

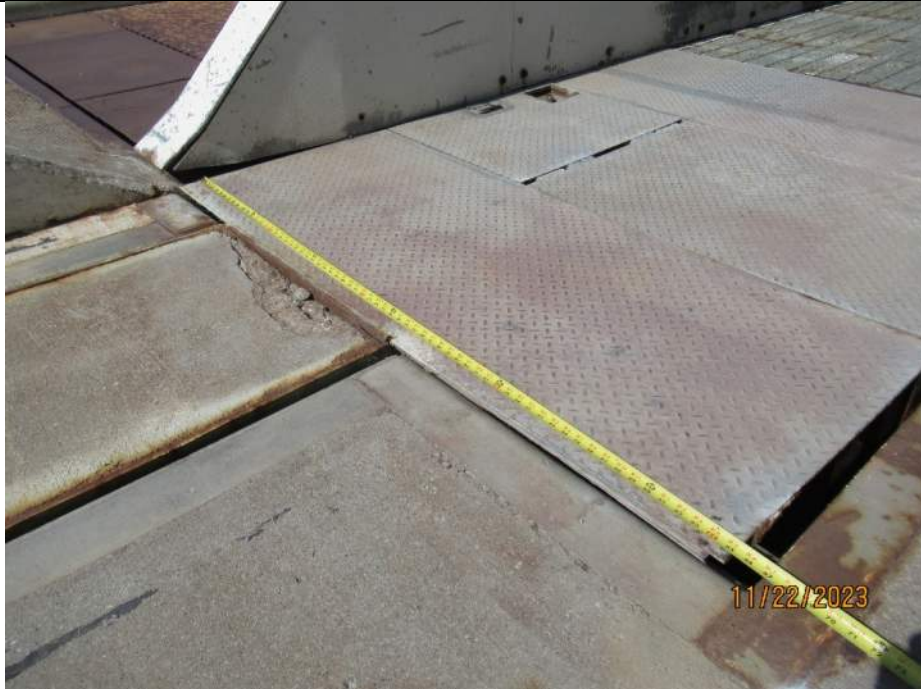
Photo S-143 - [Span 5] -South leaf rear break joint at East sidewalk, diamond plating at longitudinal break is uplifted and presents a minor tripping hazard, Looking Northwest

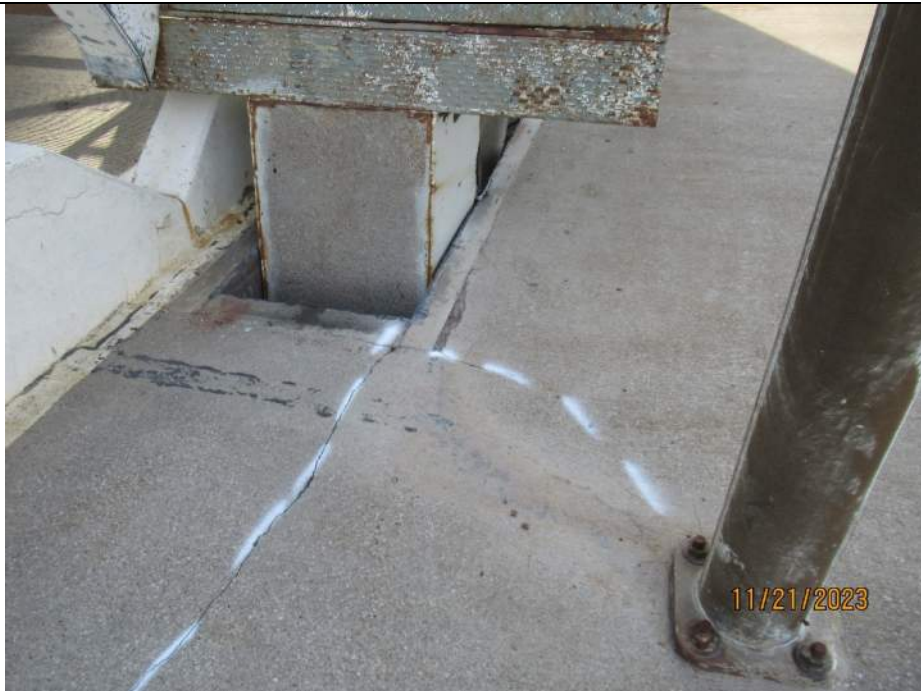
Photo S-144 - [Pier 5] -North rear break joint at Girder 1W longitudinal break, slight rubbing/wear between break edge angles and girder cap vertical plates, Looking South

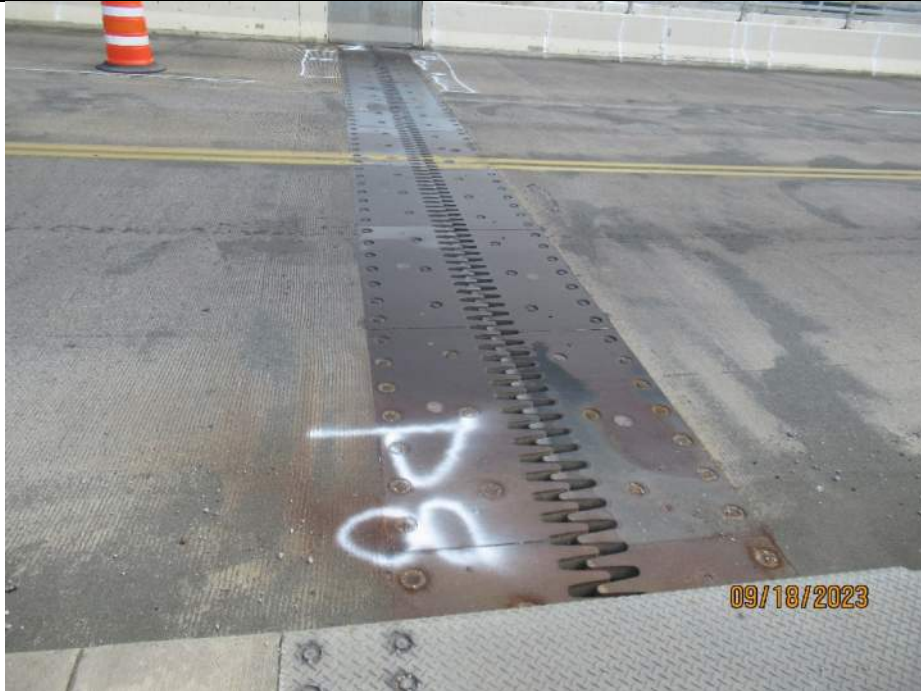
Photo S-145 - [Pier 8] -Expansion finger joint general view across roadway lanes, Looking East
