Craig Memorial Bascule Bridge

Over the Maumee River

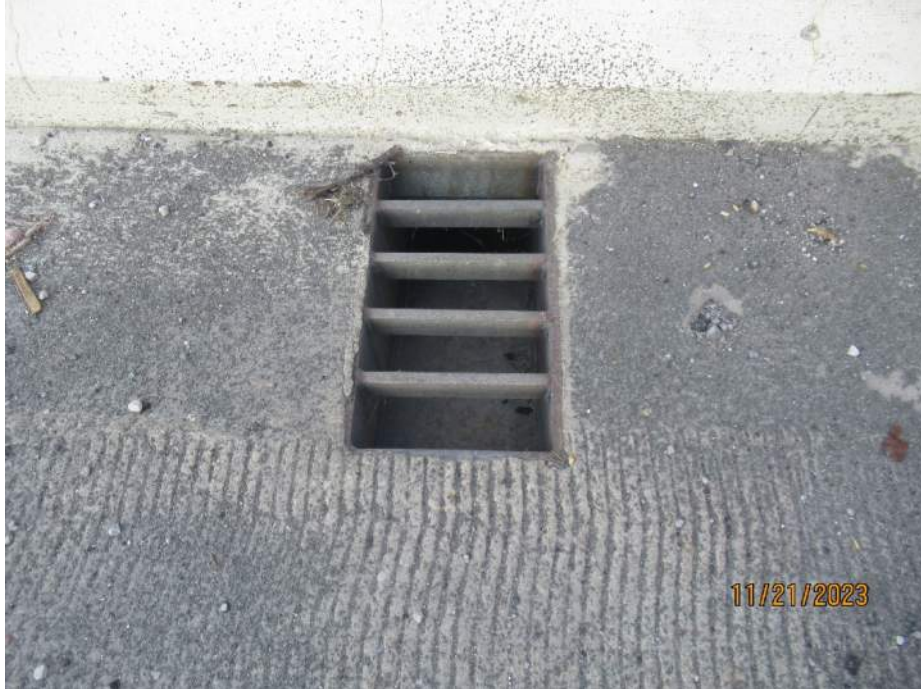
Photo S-149 - [Span 4] -Typical roadway drain next to barrier, clear and good condition, SB lanes near mid-span shown, Looking West

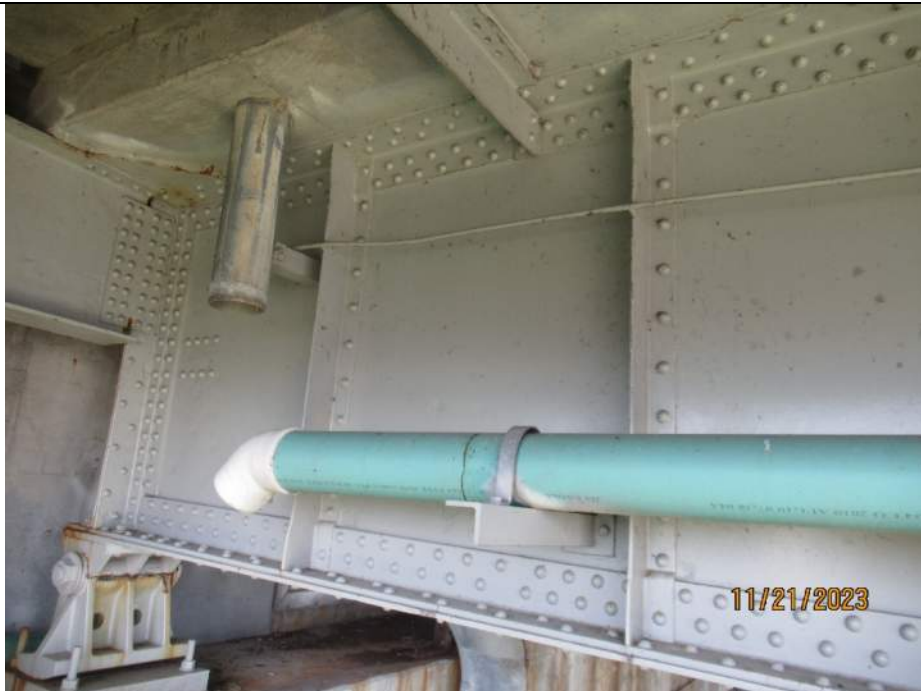
Photo S-150 - [Span 1] -Downspouts at South abutment and east side of span are disconnected at the abutment, Looking Southwest

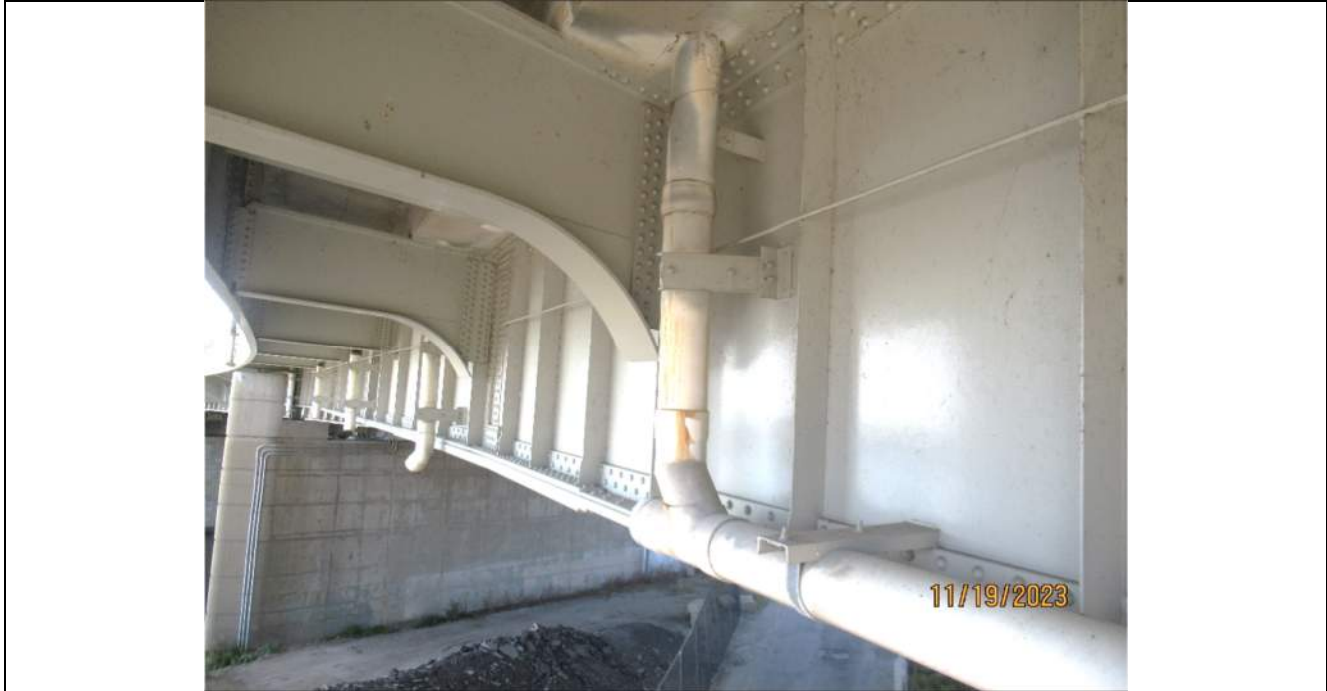
Photo S-151 - [Span 7] -Drainage downspouts, piping and supports along Girder 5W (west flare exterior girder), generally good condition, Looking Southwest

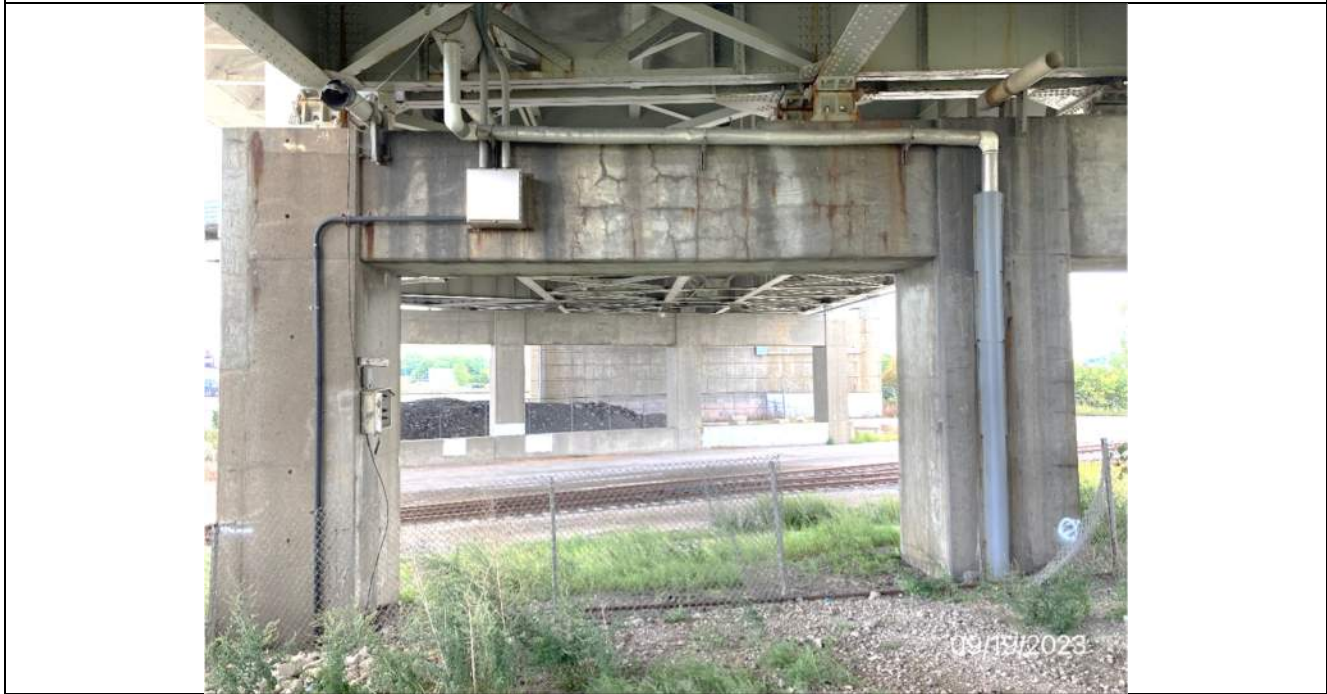
Photo S-152 - [Pier 8] -Drainage troughs are not connected to downspouts at pier and downspouts have missing segments, Looking South

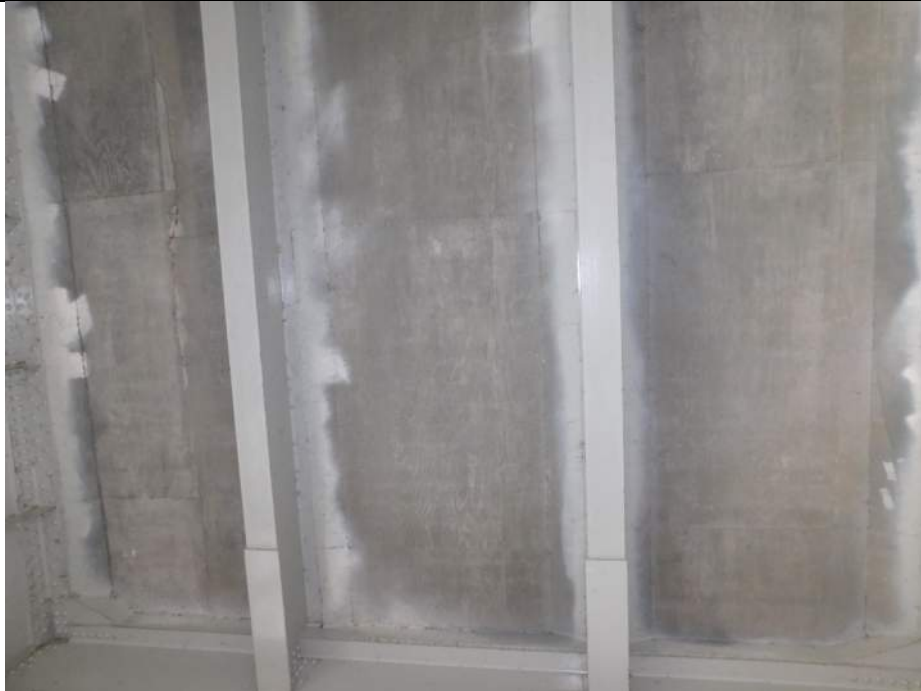
Photo S-153 - [Span 2] -Deck underside, general view between Floorbeams 6S & 7S, Stringers 3S & 4S, Looking South

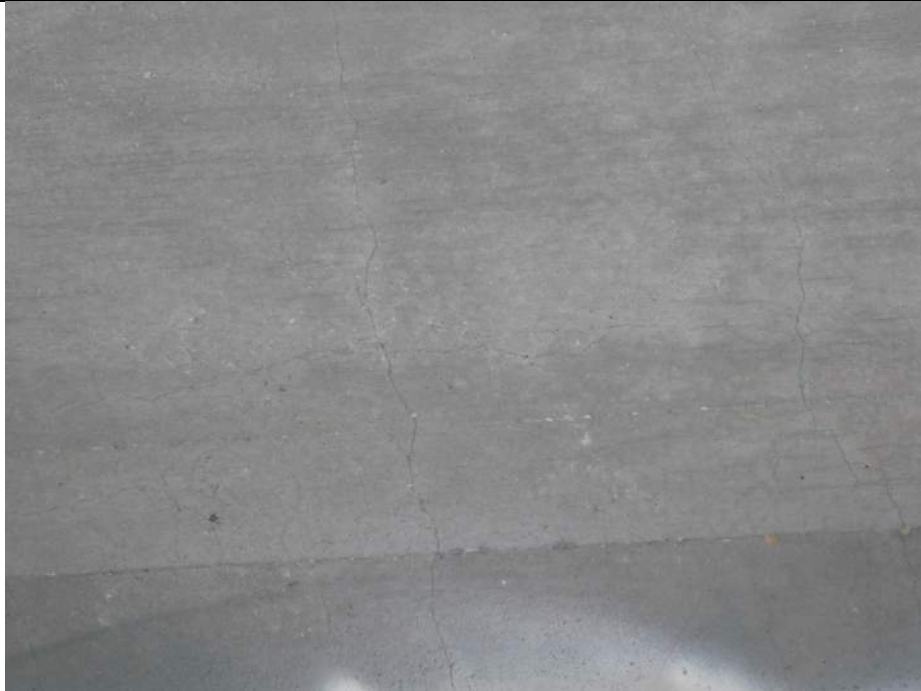
Photo S-155 - [Span 2] -Deck underside, close up view of typical 0.01-0.02" map cracking / shrinkage cracking between Floorbeams 6S & 7S, Girder 2W and Stringer 3W, Looking West

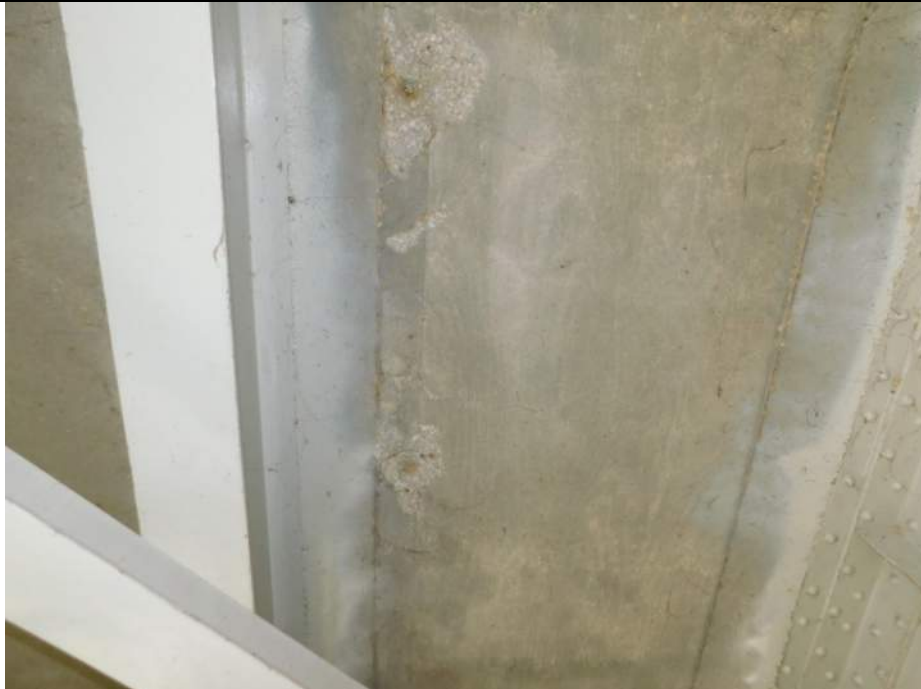
Photo S-156 - [Span 2] -Deck underside, between Floorbeam 9S-10S and Stringers 5W-6W, minor pop-out spalls in deck (below trail-roadway barrier), Looking South

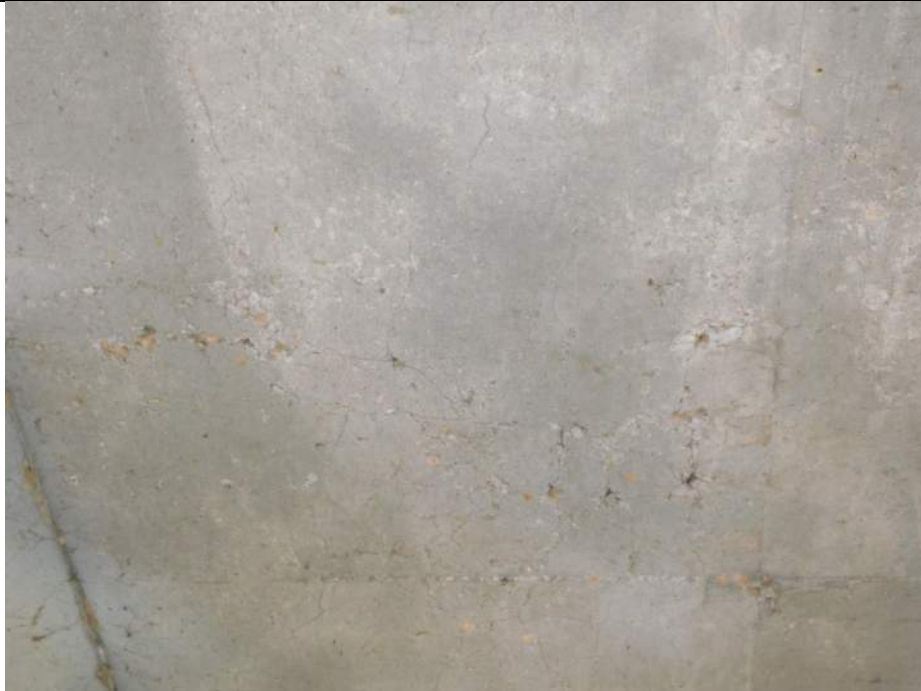
Photo S-157 - [Span 2] -Deck underside, between Floorbeam 14S-15S and Stringers 5W-6W, typical minor map cracking and honeycombing, Looking South

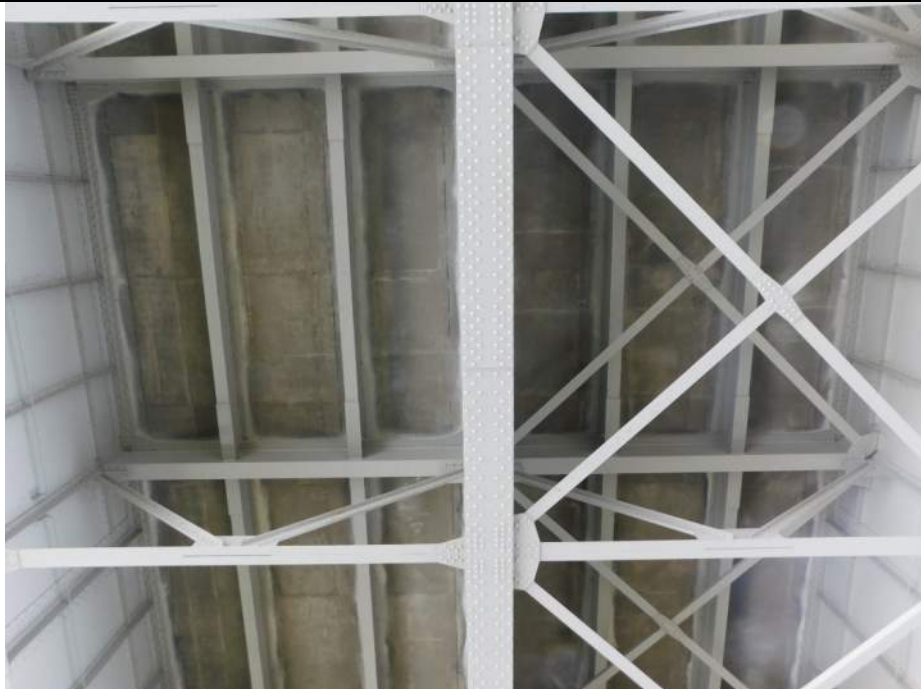
Photo S-158 - [Span 3] -Deck underside, general view between Floorbeam 20S-21S, Girders 2W-4W, Looking North

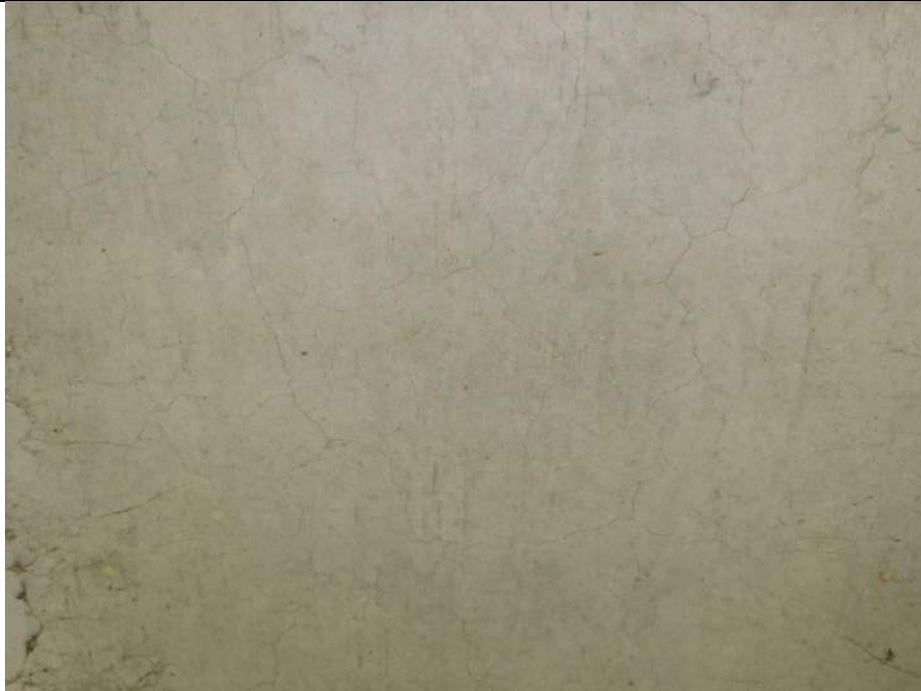
Photo S-159 - [Span 6] -Deck underside, detail view between Floorbeam 2S-3S, Stringers 2W-3W, typical minor map cracking / shrinkage cracking, scattered throughout, Looking South

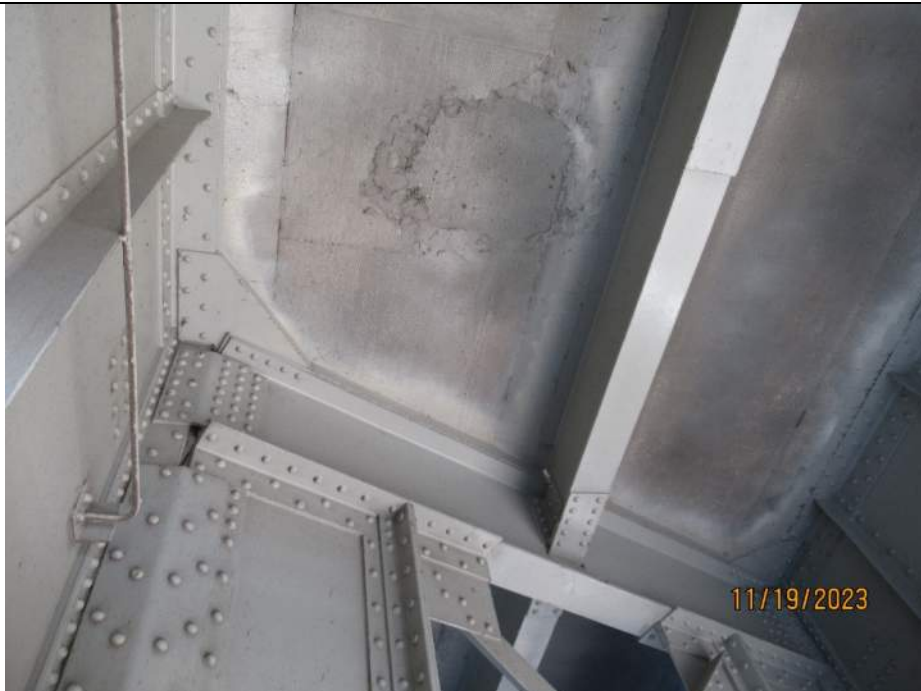
Photo S-160 - [Span 7] -Deck underside, between Girders 2W-3W south of FB14S, isolated patch repair in deck, Looking North

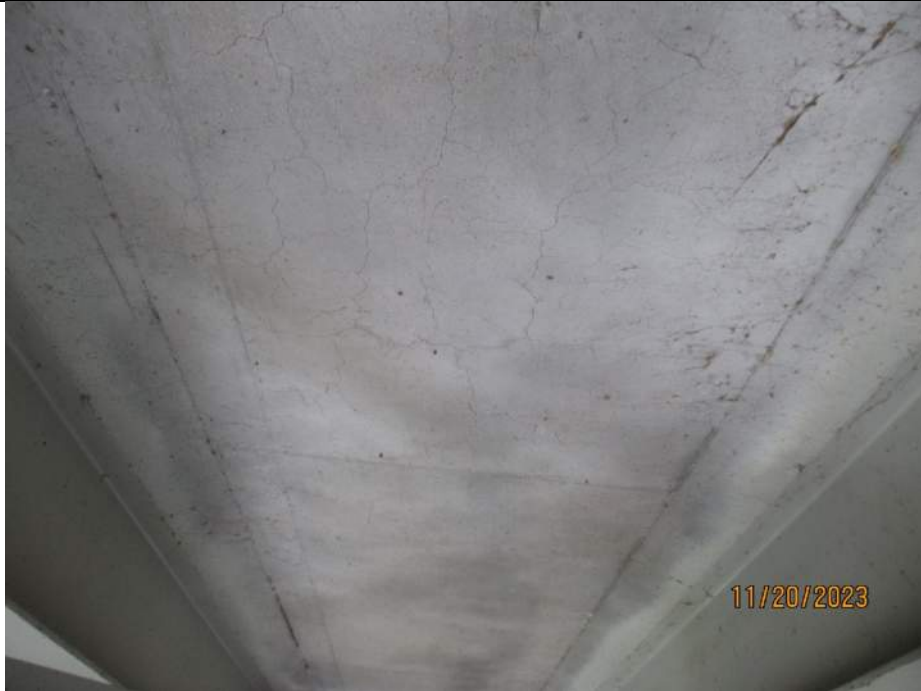
Photo S-161 - [Span 8] -Deck underside, between Stringers 1W-2W and Floorbeams 17S-18S, typical random / map cracking, Looking North

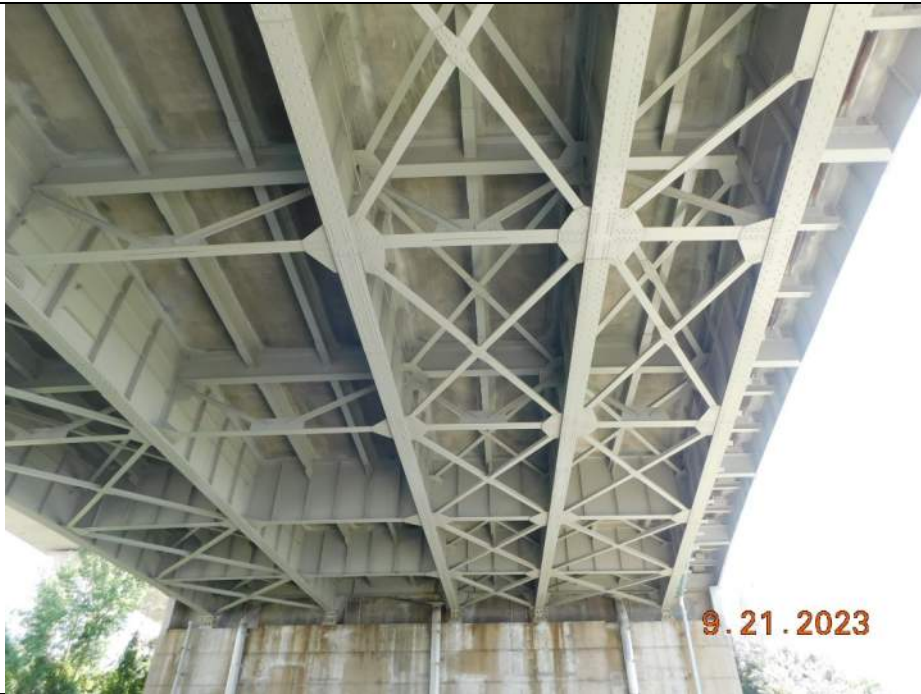
Photo S-162 - [Span 1] -Span framing and underside general view, Looking North

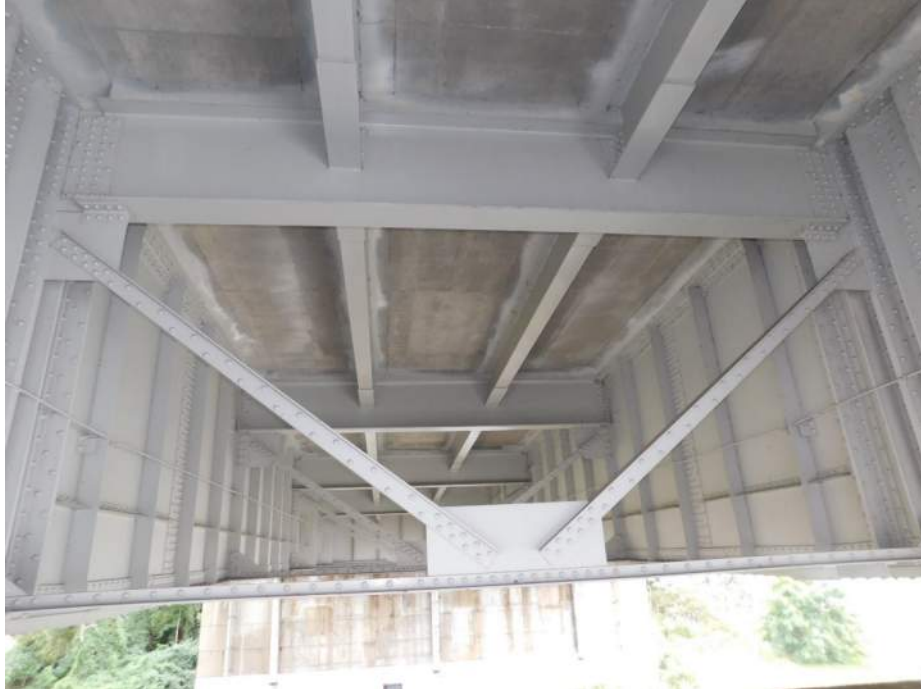
Photo S-173 - [Span 1] -Interior framing between Girders 2W-3W at FB6S, paint in typically good condition throughout, Looking South

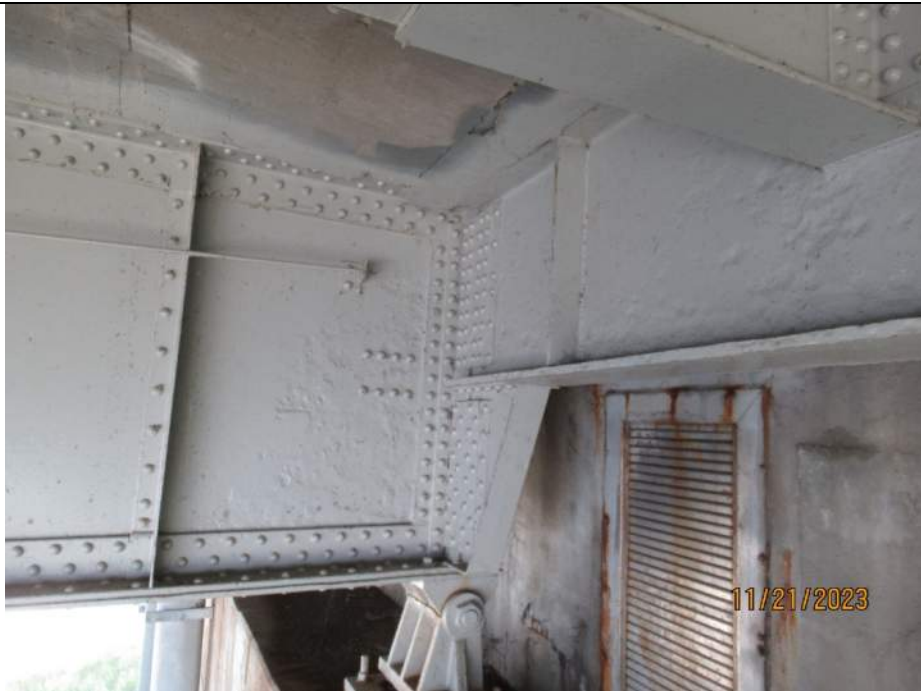
Photo S-174 - [Span 1] -Girder 4W West face at FB0S, scattered section loss up to 0.125" deep across web and bottom flange, floorbeam connection, similar at floorbeam, Looking Southeast

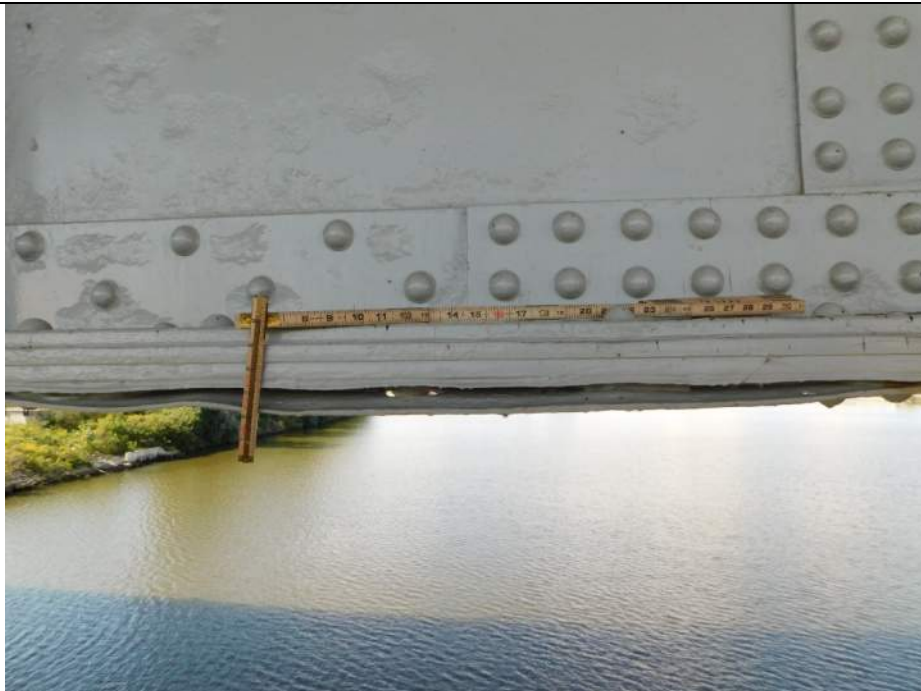
Photo S-176 - [Span 2] -Girder 4W East bottom flange, cleaned packing corrosion with section loss to the plate, Looking West

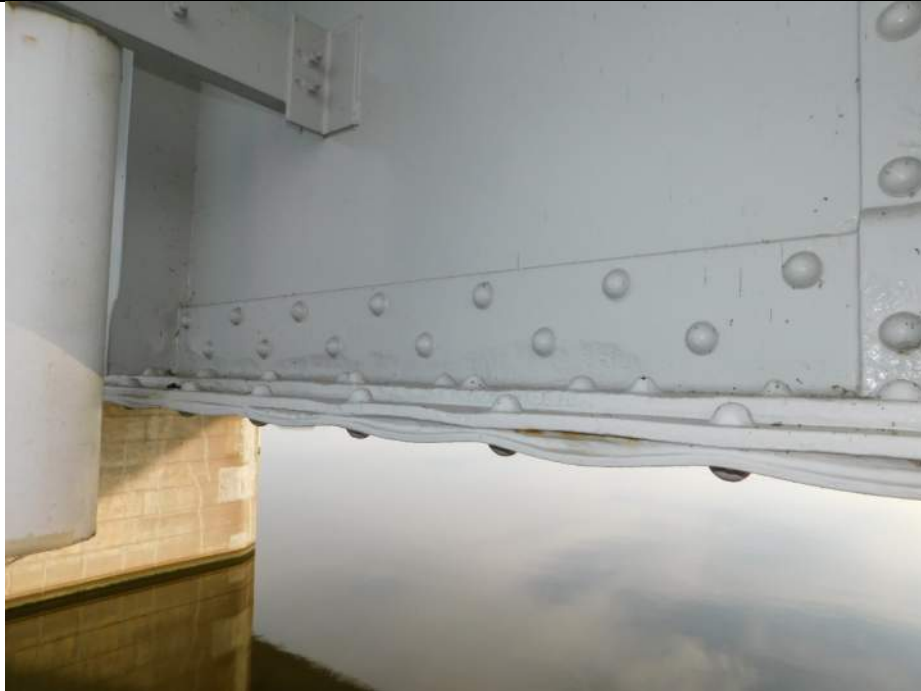
Photo S-177 - [Span 3] -Girder 1W West bottom flange, warping of cover plates due to packing corrosion and isolated section loss to BF angle, Looking Northeast

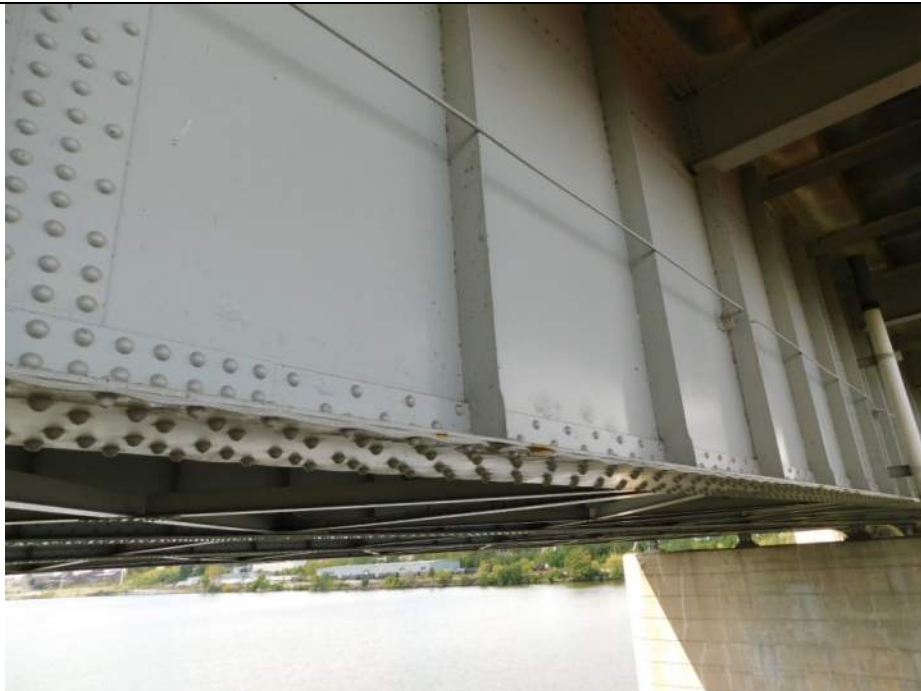
Photo S-178 - [Span 3] -Girder 4W East bottom flange, warping of cover plates due to packing corrosion, general view, Looking Northwest

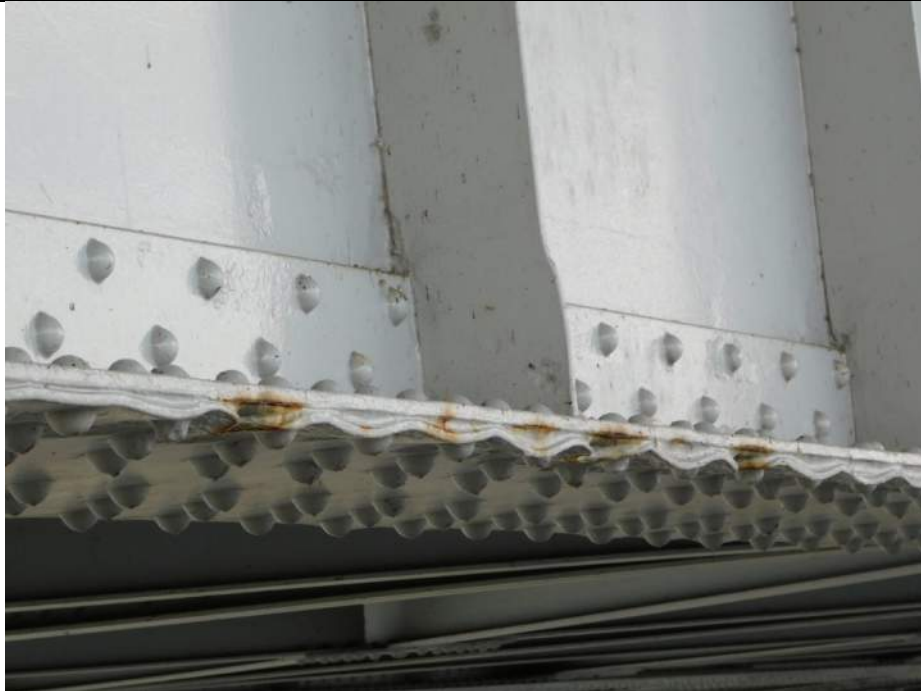
Photo S-179 - [Span 3] -Girder 4W East bottom flange, warping of cover plates due to packing corrosion, detail view FB18-19, Looking Northwest

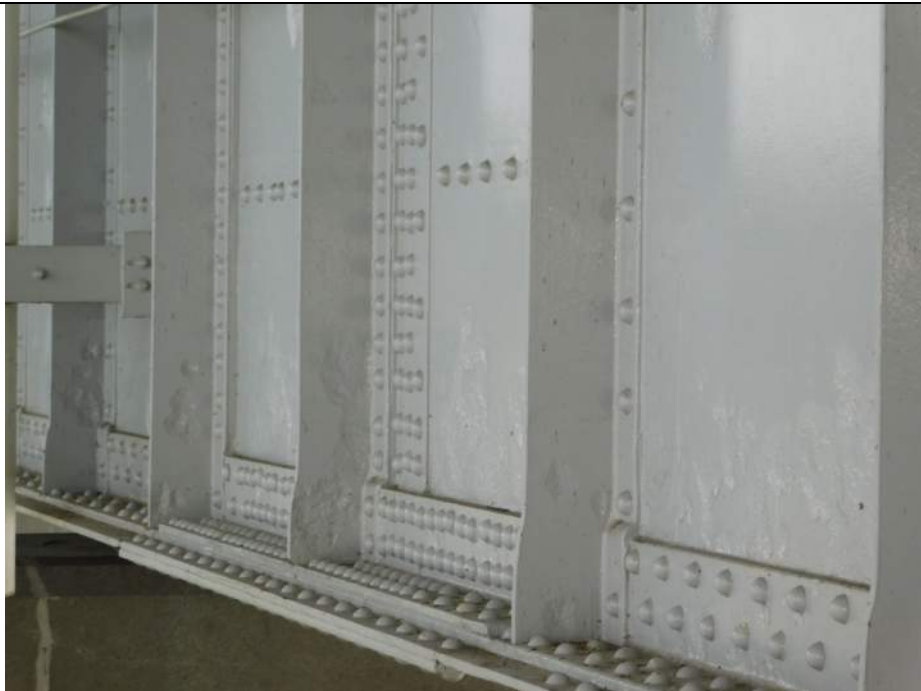
Photo S-180 - [Span 4] -Girder 4W East lower web between FB28S-29S exhibits typical scattered painted over section loss to lower web up to 0.125" deep, Looking Southwest

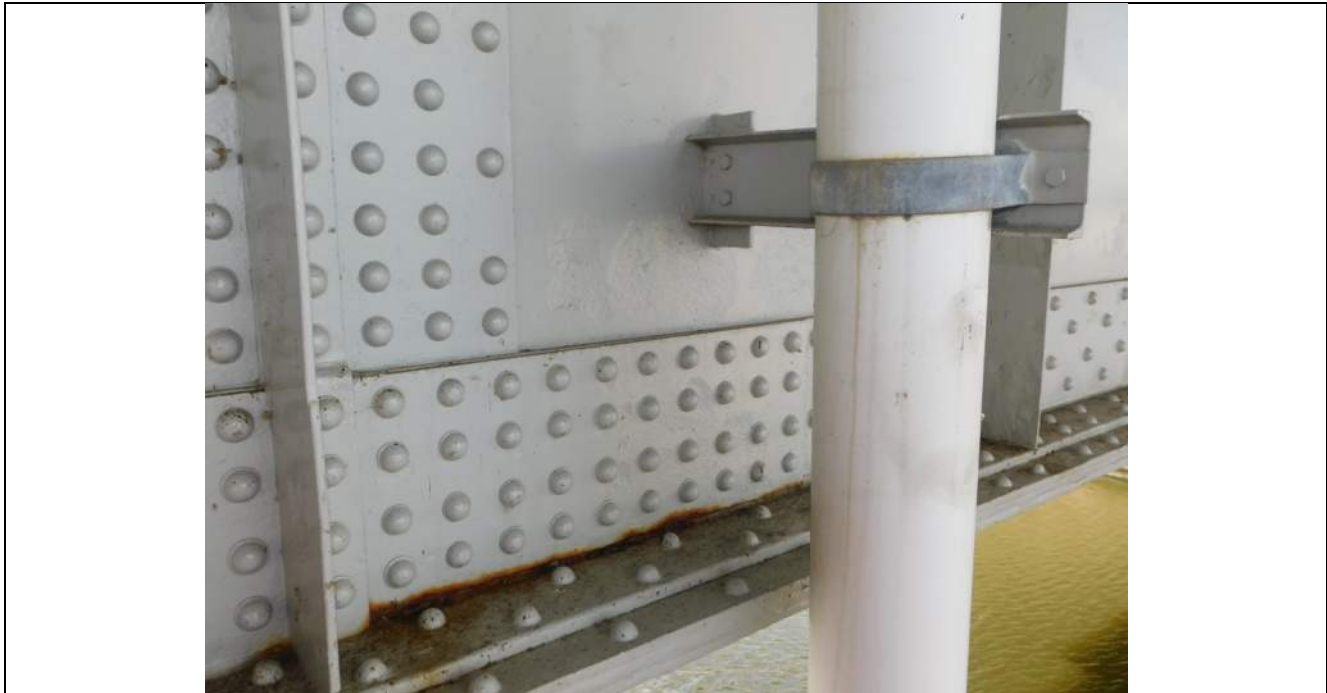
Photo S-181 - [Span 4] -Girder 4W East lower web between FB29S-30S exhibits minor localized corrosion along edge of thickener plate and localized section loss to web at drainage location, Looking Northwest

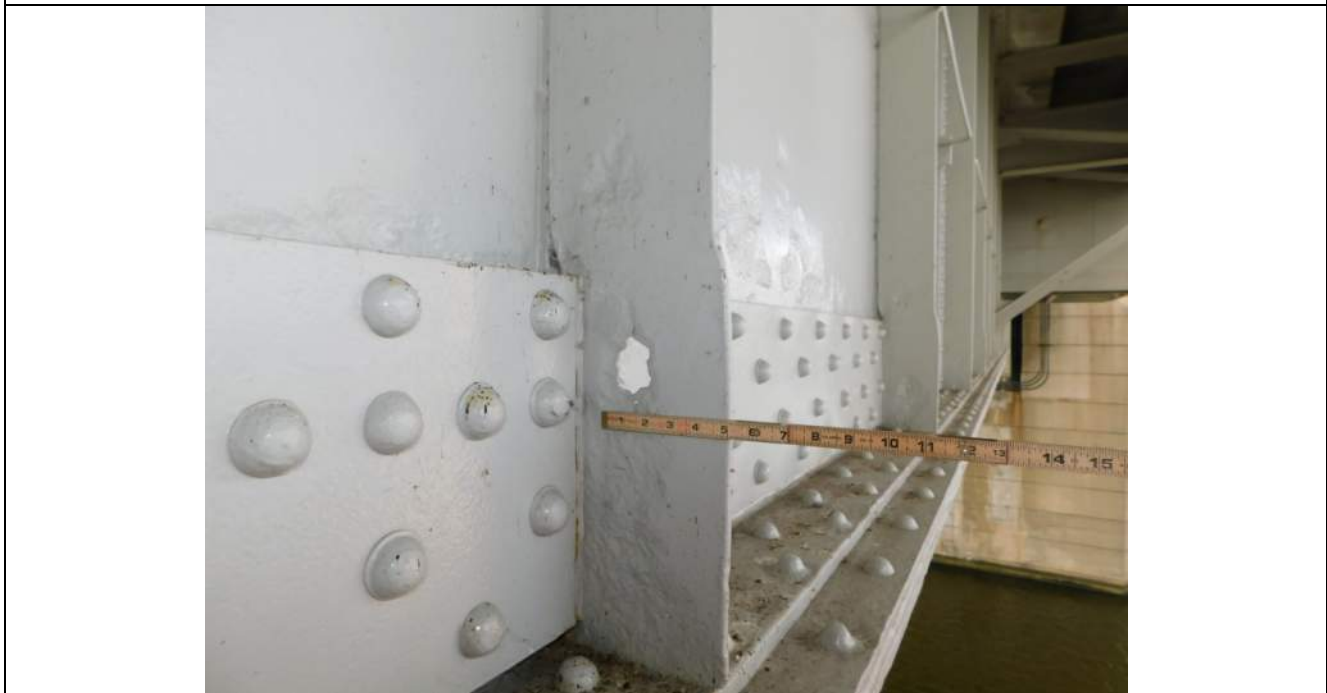
Photo S-182 - [Span 4] -Girder 4W East lower web between FB30S-31S exhibits a 2" diameter hole in the base of the vertical stiffener, Looking Northwest

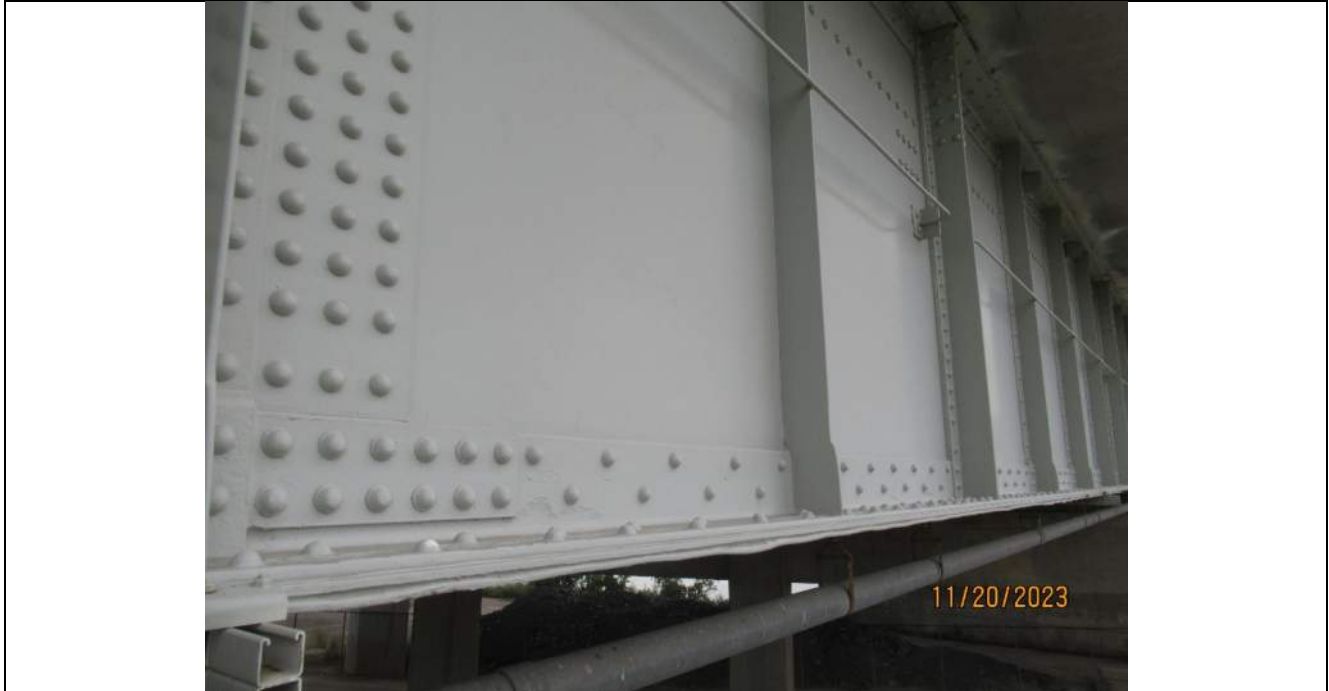
Photo S-183 - [Span 8] -Girder 1W West bottom flange, warping of cover plates due to packing corrosion, general view, Looking Southeast

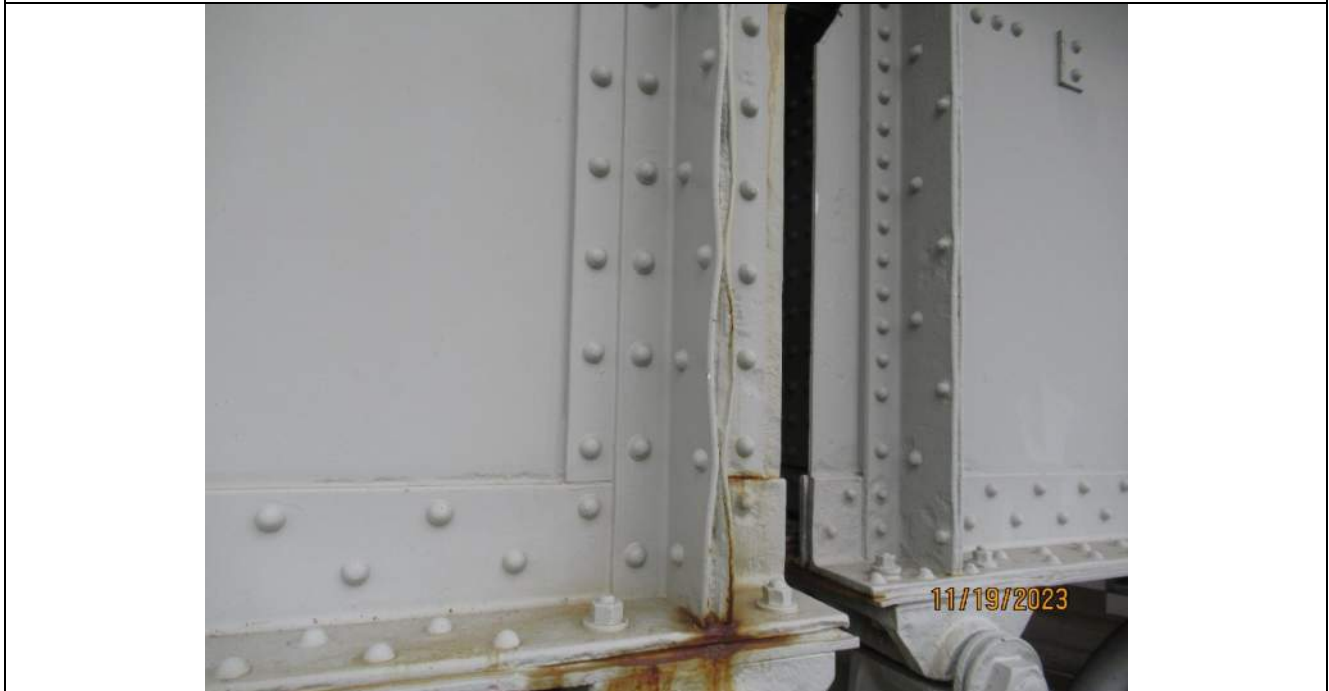
Photo S-184 - [Span 9] -Girder 1W west bearing stiffener angles at Pier 8 exhibit up to 1.25" thick packing corrosion and warping between the outstanding legs, Looking East

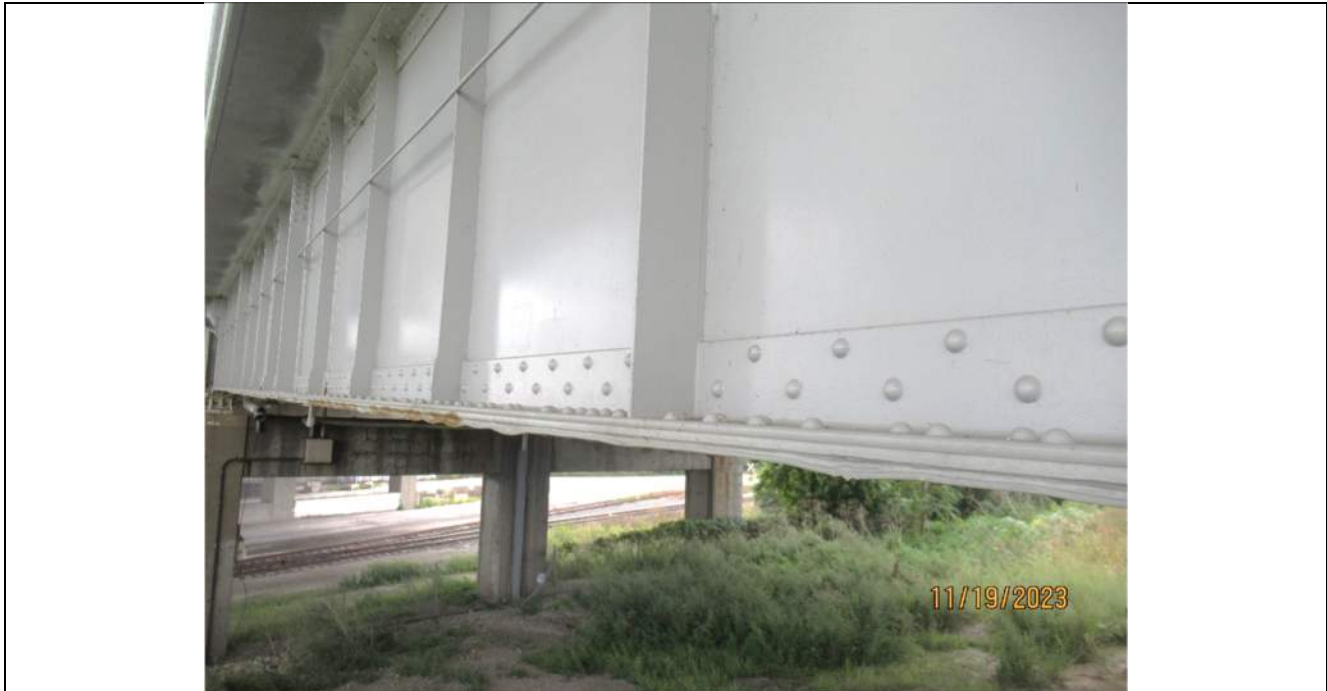
Photo S-185 - [Span 9] -Girder 4W east bottom flange cover plate warping due to up to 1" thick pack rust between plates, Looking Southwest

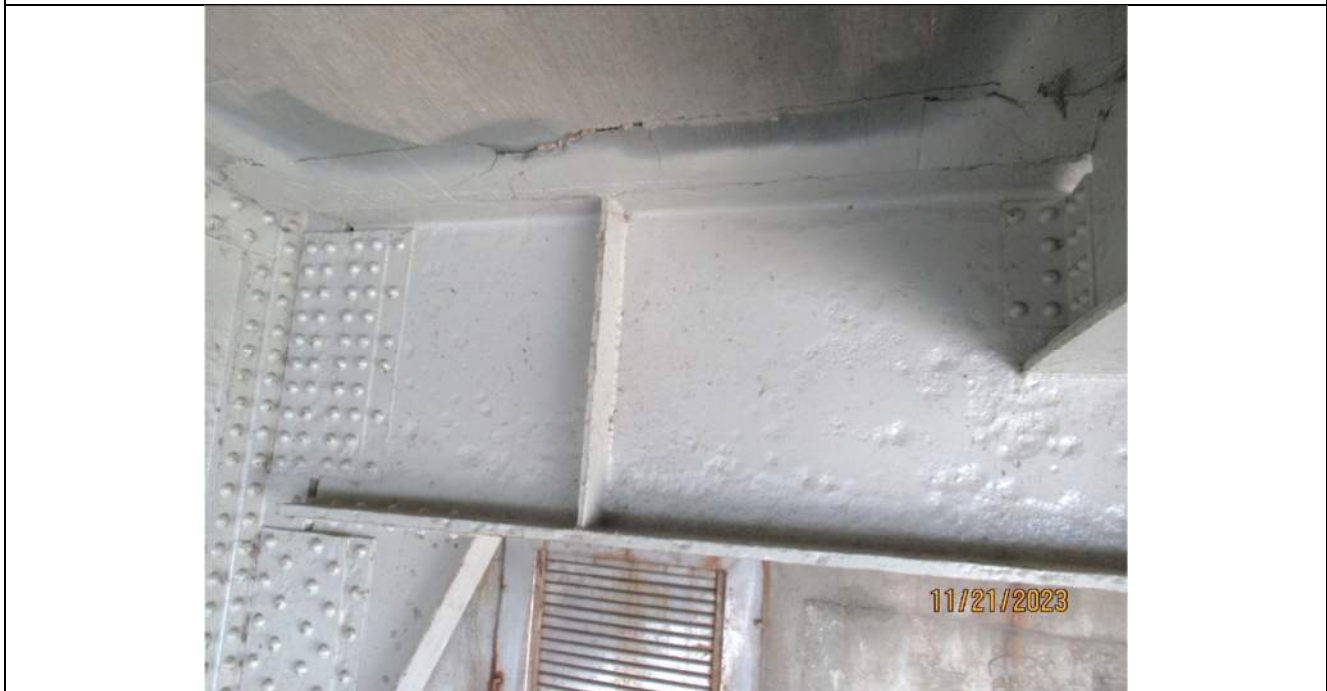
Photo S-186 - [Span 1] -Floorbeam 0S at the South Abutment widespread painted over deep section loss to the web and flanges, area next to Girder 3W, Looking South

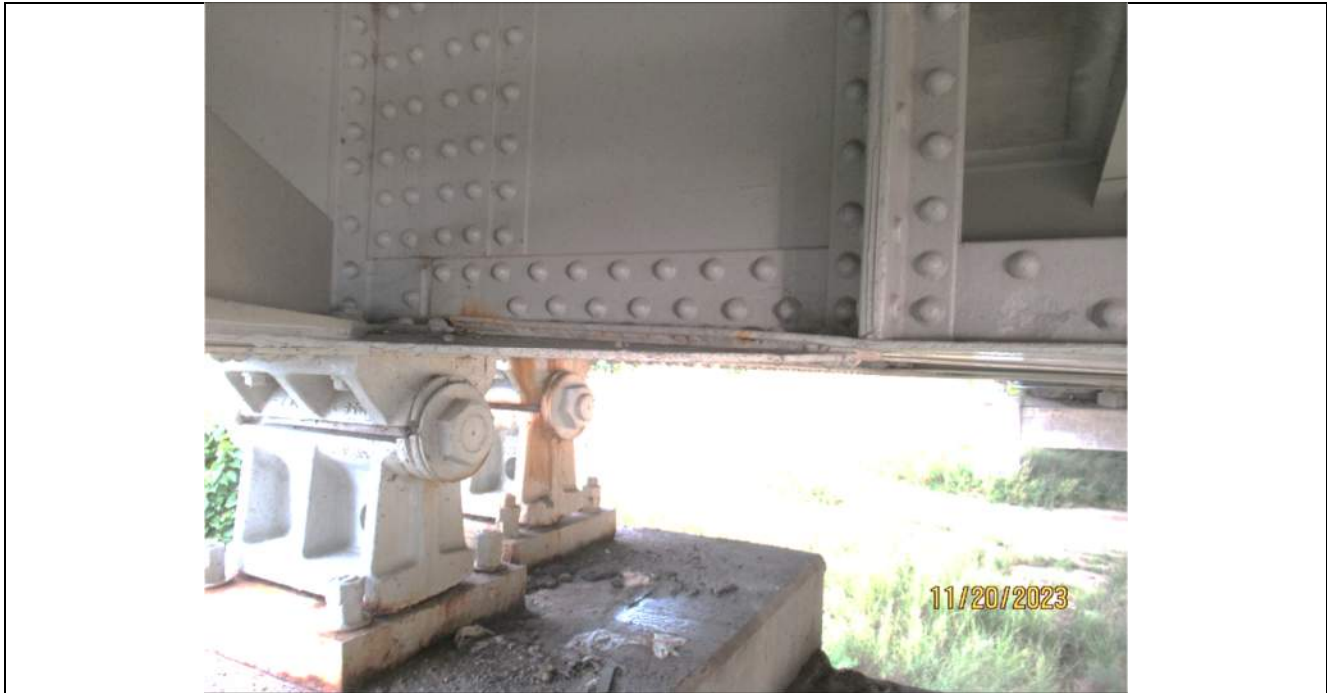
Photo S-191 - [Span 8] -Floorbeam 20S south bottom flange, pack rust and warping of flange angle at the lower diagonal connection plate, Looking North

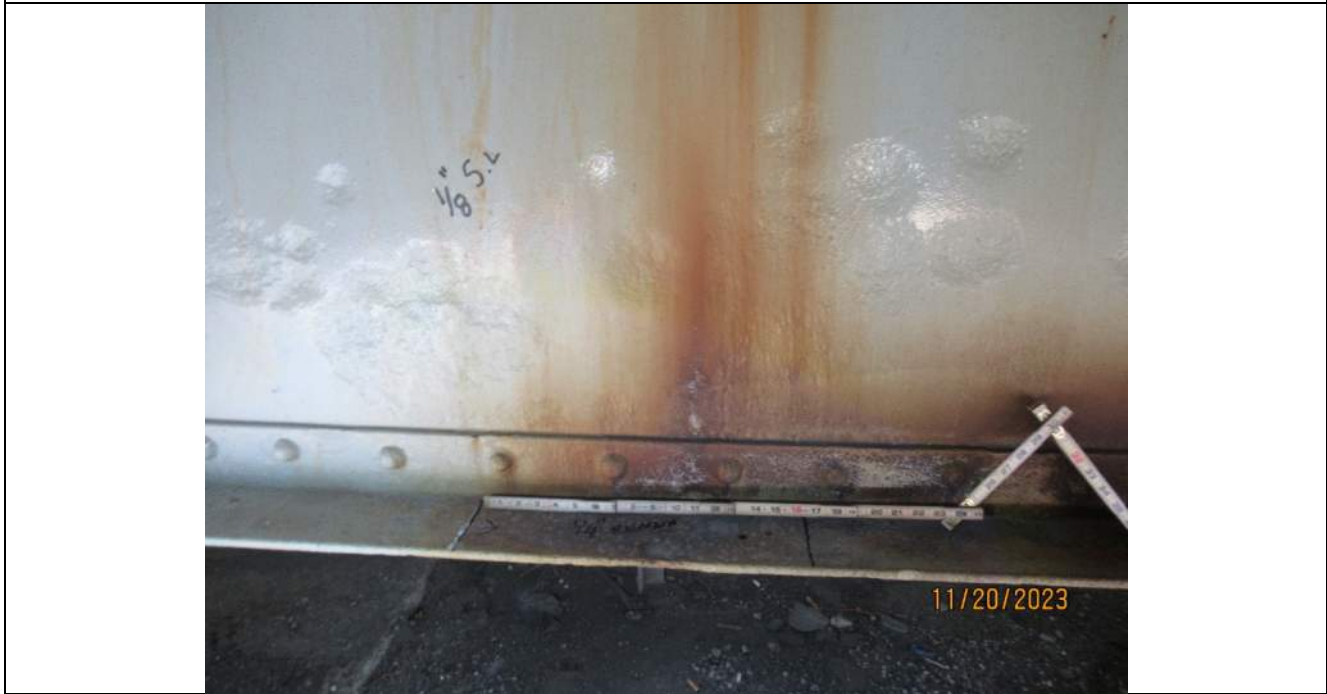
Photo S-192 - [Span 8] -Floorbeam 20S, south lower web and bottom flange between G2W-G3W, typical scattered web section loss and localized section loss at bottom flange, Looking North

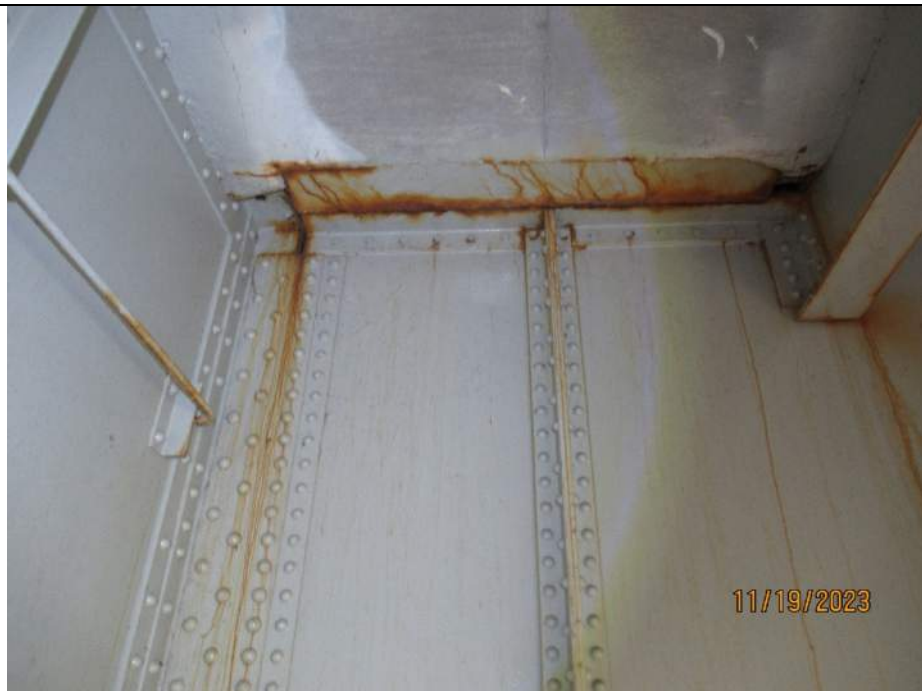
Photo S-194 - [Span 9] -Floorbeam 0S, North face between Stringer 3W and Girder 3W, rust staining and active corrosion across top flange, Looking South

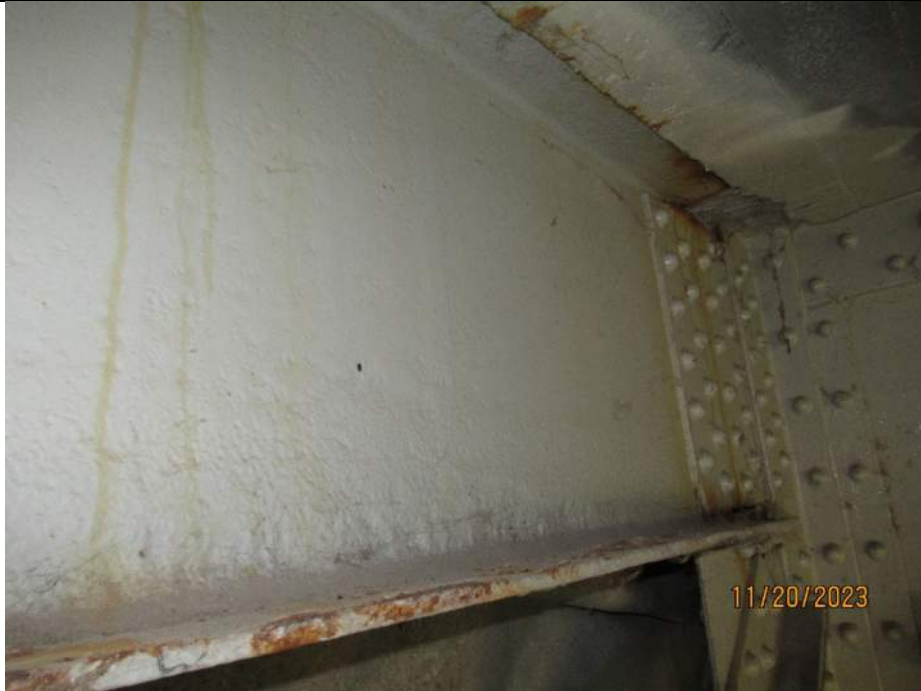
Photo S-195 - [Span 10] -Floorbeam 11S, South face east half between G2W-3W, typical section loss throughout web, Looking North
