Craig Memorial Bascule Bridge

Over the Maumee River

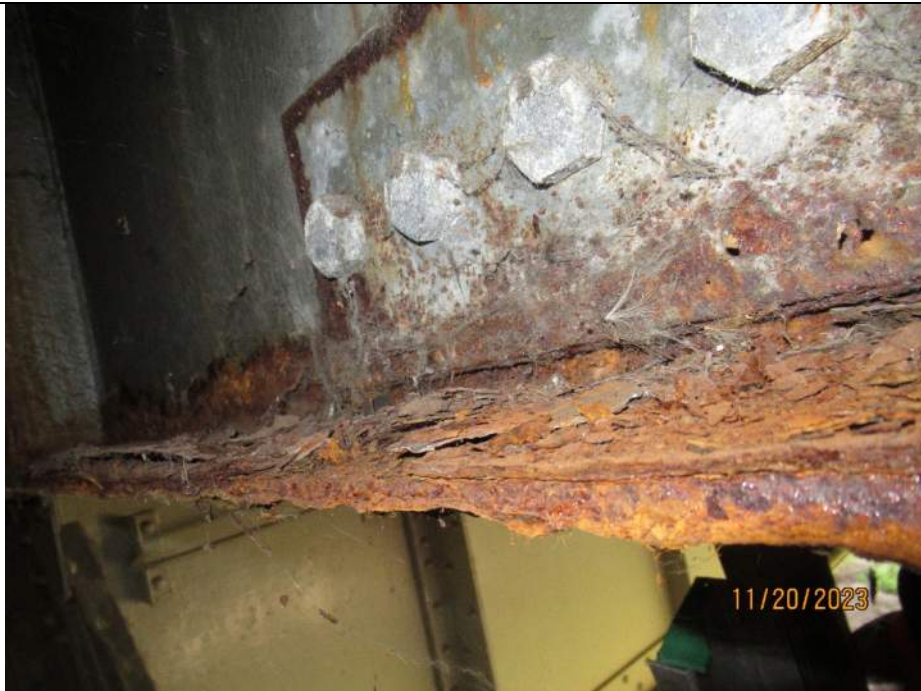
Photo S-196 - [Span 10] -Floorbeam 11S, North face bottom flange active corrosion and section loss at east half between G2W-3W, Looking East

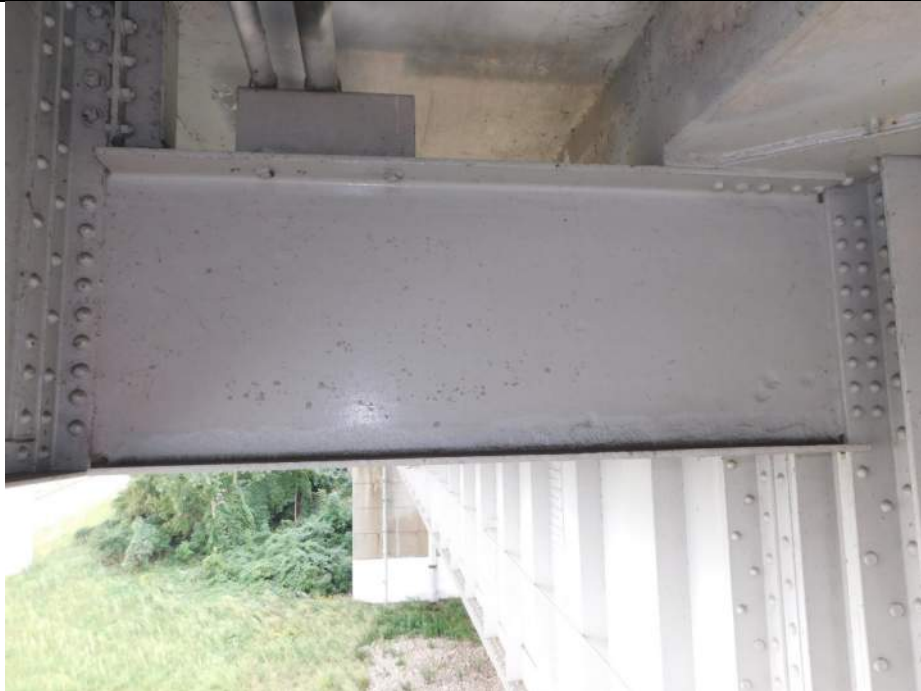
Photo S-197 - [Span 2] -Floorbeam 6S, East exterior, North face, typical painted over section loss up to 0.125" deep across lower web, Looking South

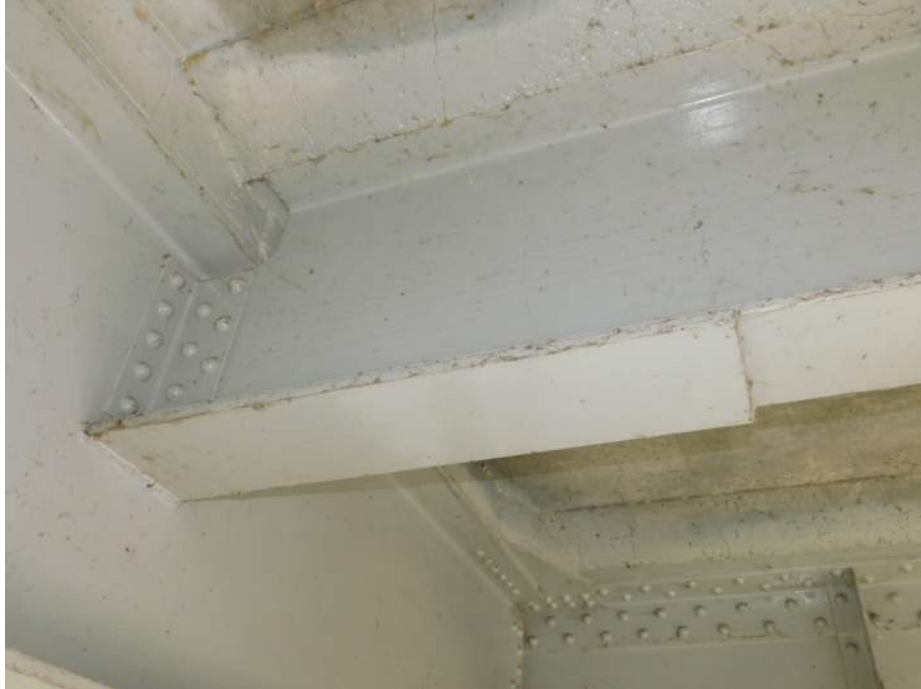
Photo S-201 - [Span 2] -Stringer 6W at connection to Floorbeam 15S, typical welded bottom flange connection plate, stringer, and connections in typical good condition, Looking Northeast

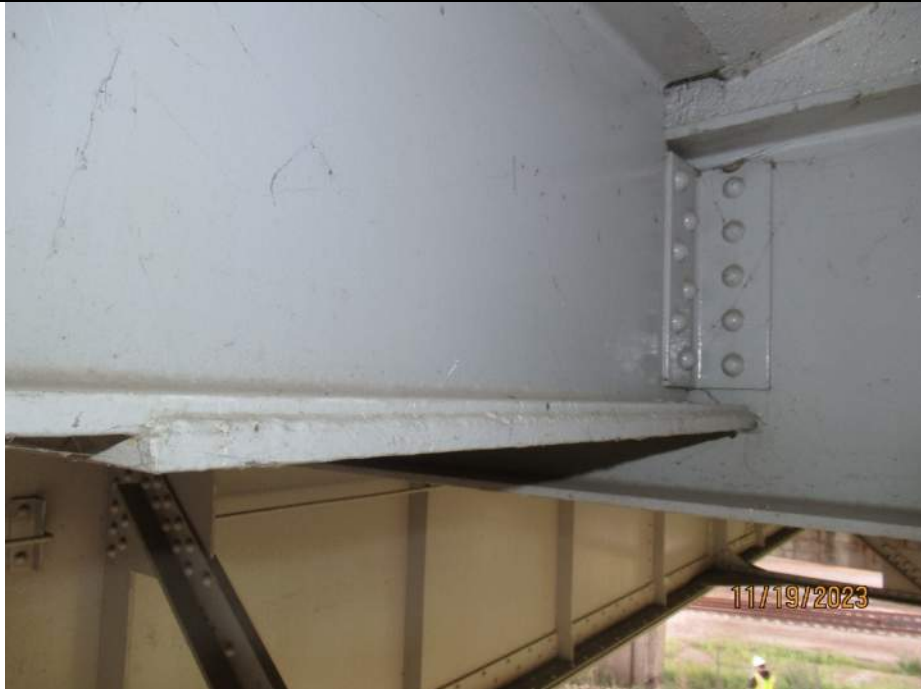
Photo S-202 - [Span 9] -Stringer 3W at connection to Floorbeam 3S, typical welded bottom flange connection plate, connection, and components in good condition, Looking South

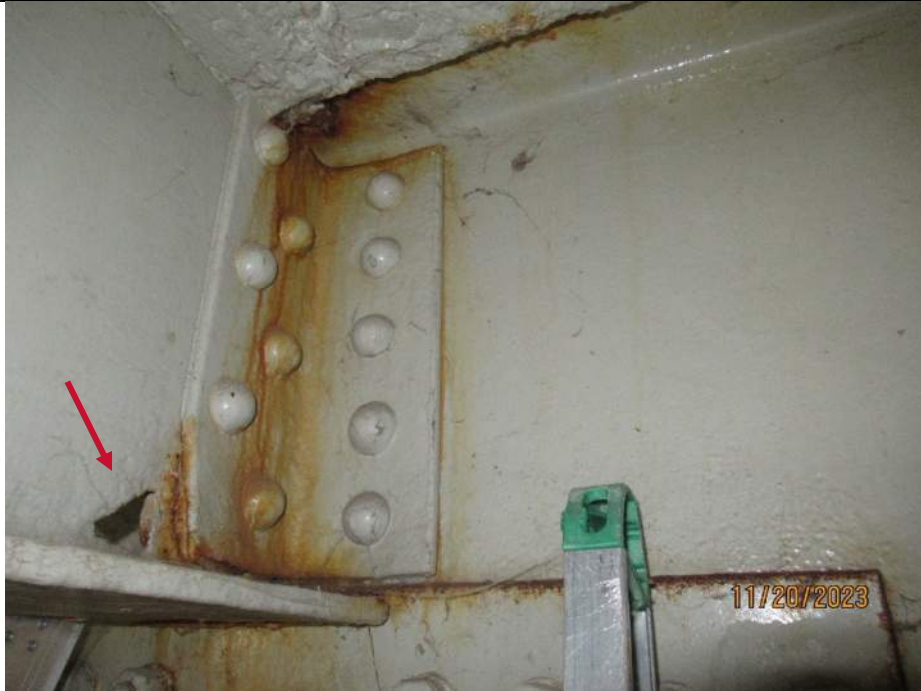
Photo S-203 - [Span 10] -Stringer 3W at the North Abutment exhibits a 2" diameter hole in the lower web at the connection to Floorbeam 11S, Looking North

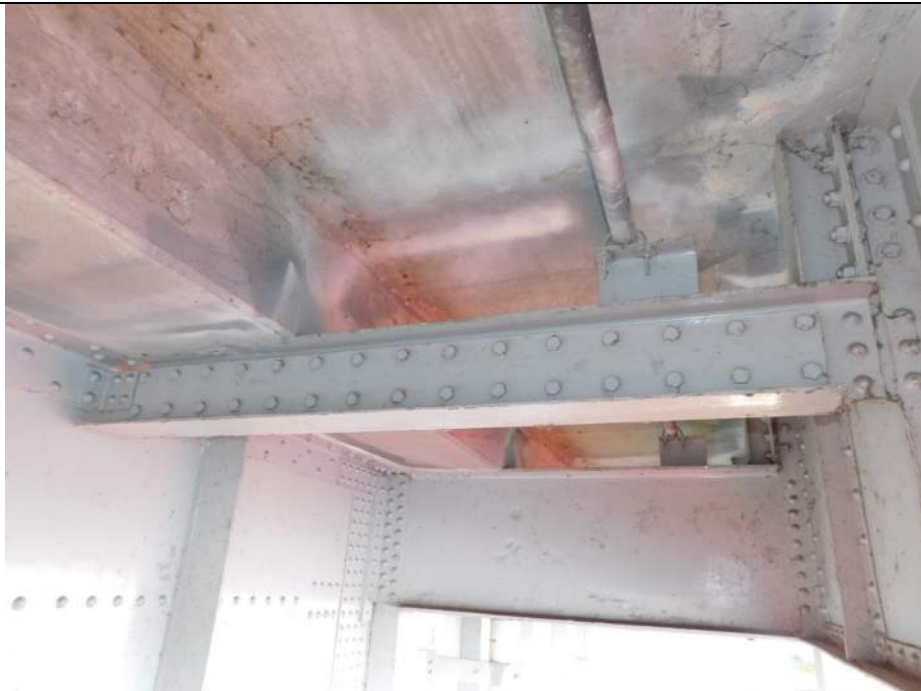
Photo S-206 - [Span 6] -Reinforcement repair to sidewalk framing member, typical, at east sidewalk between Floorbeams 1S and 2S, Looking North

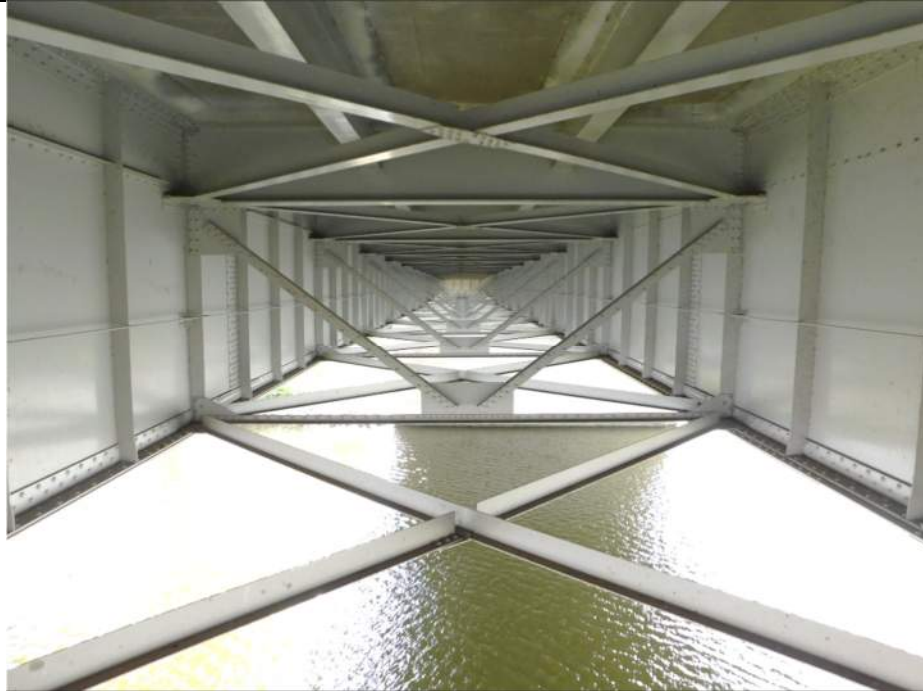
Photo S-207 - [Span 2] -General view of diagonal and transverse bracing between Girders 3W and 4W at Floorbeam 14S, Looking South

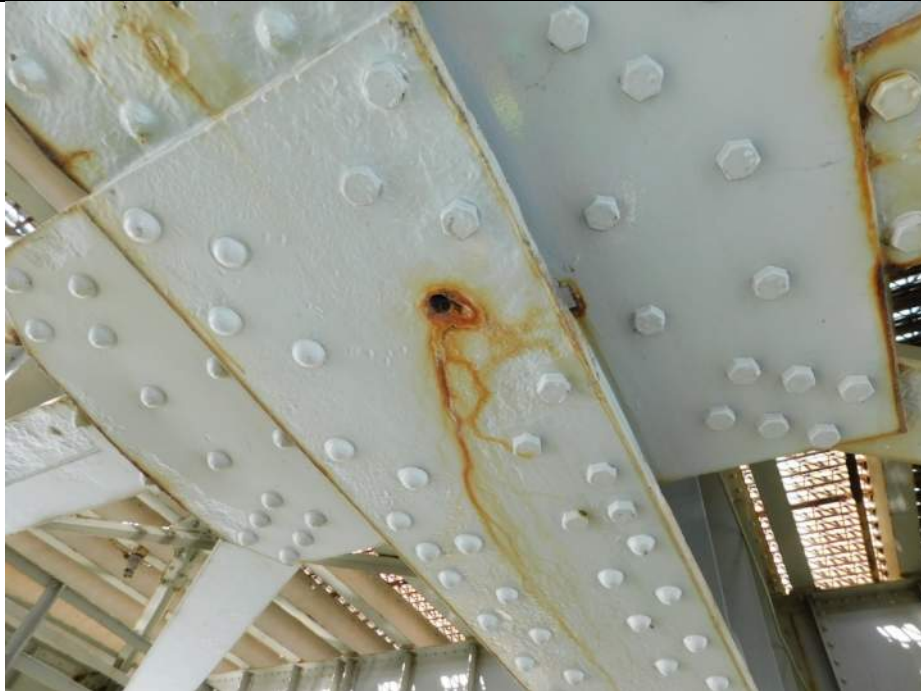
Photo S-215 - [Span 5, North Leaf] -Girder 3W, bottom flange at FB2n, one missing bolt at repaired diagonal bracing connection plate, Looking Northwest

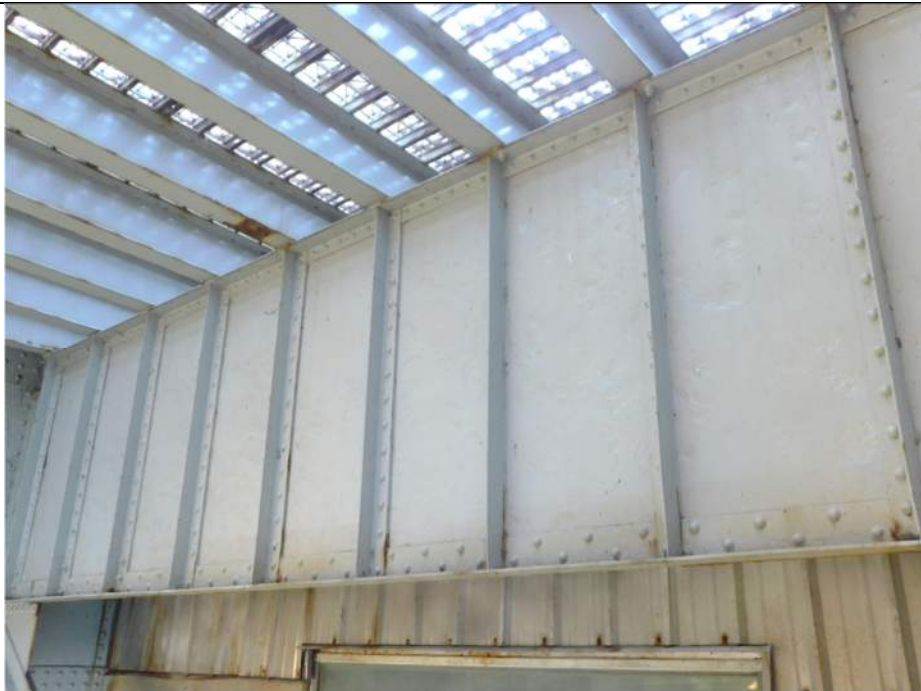
Photo S-216 - [Span 5, South Leaf] -Floorbeam 7s between G2W-G3W, typical section loss scattered throughout web, Looking South

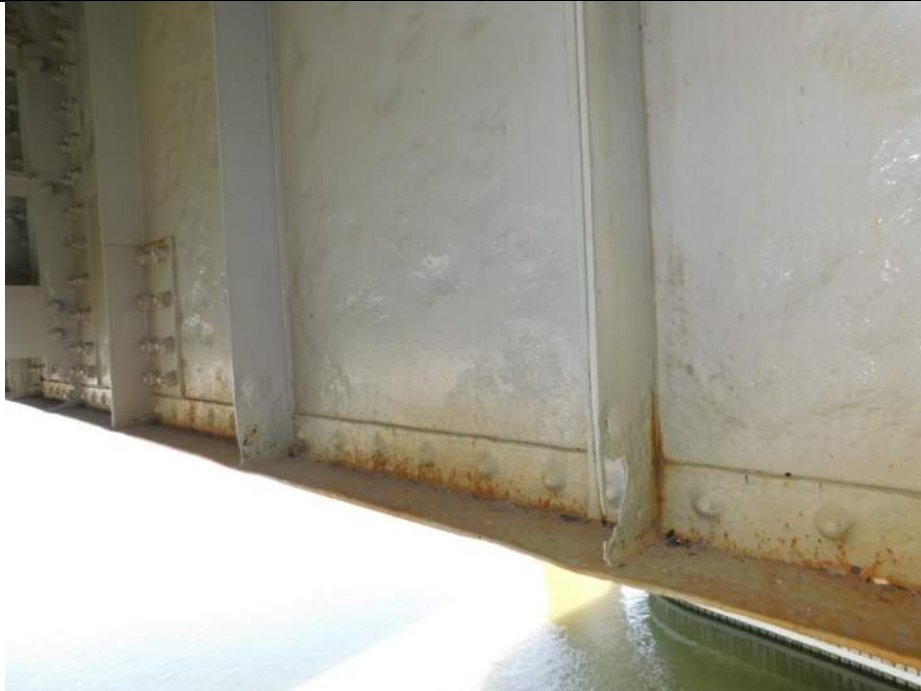
Photo S-225 - [Span 5, South Leaf] -Floorbeam 2s, north face between G3W-G4W, holes in bottom of web stiffeners up to 6" dia. and web reinforcement repair, Looking Northwest

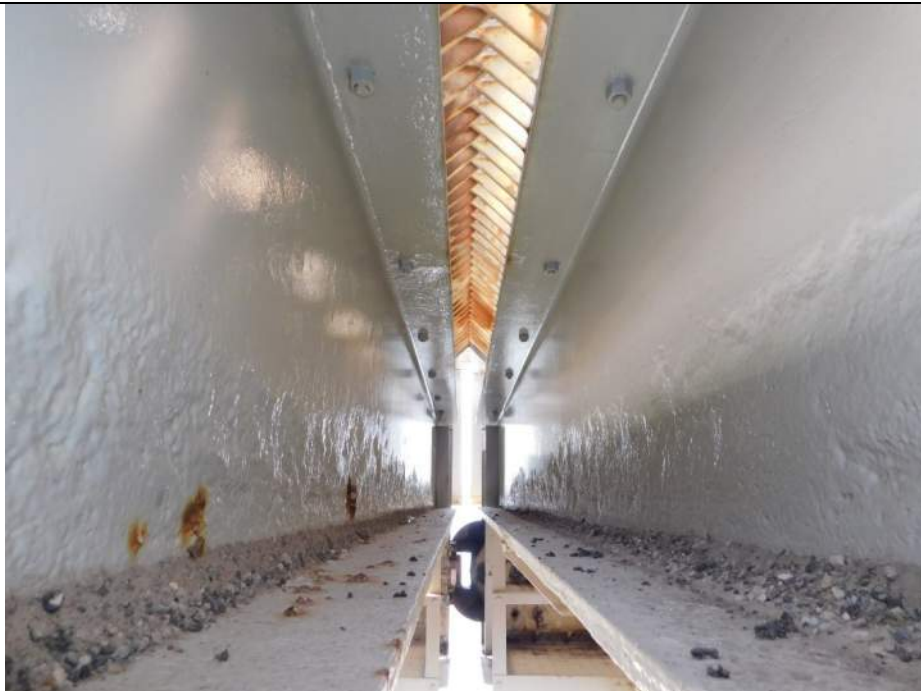
Photo S-226 - [Span 5, North Leaf] -Floorbeams 0n+0s at center break joint between G1W-G2W, typical section loss across lower webs and minor debris accumulation, Looking West

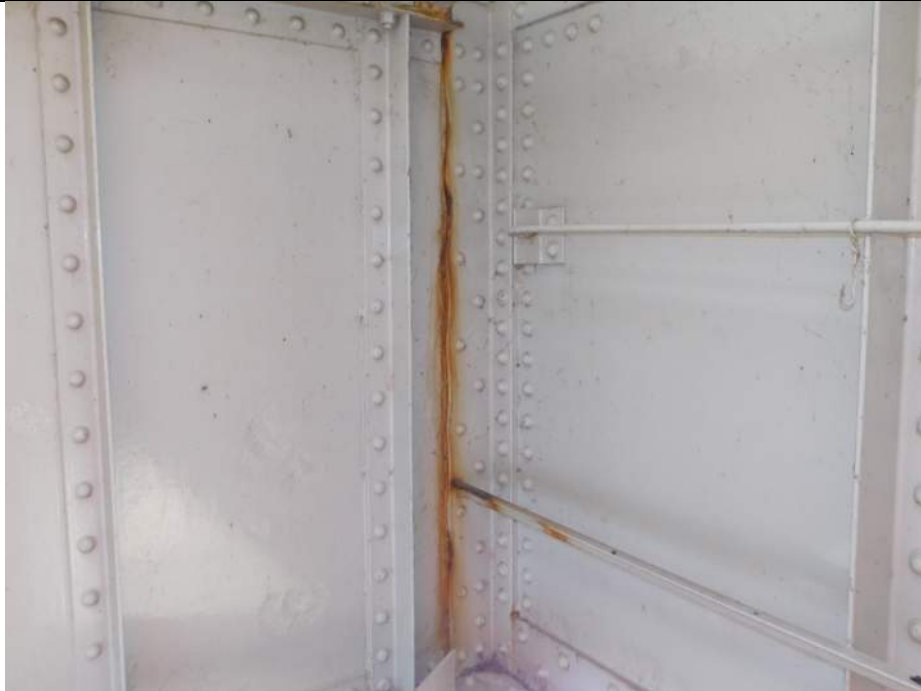
Photo S-227 - [Span 5, North Leaf] -Floorbeam 1n at east side G2W, typical packing corrosion with warping at connection angle, Looking South

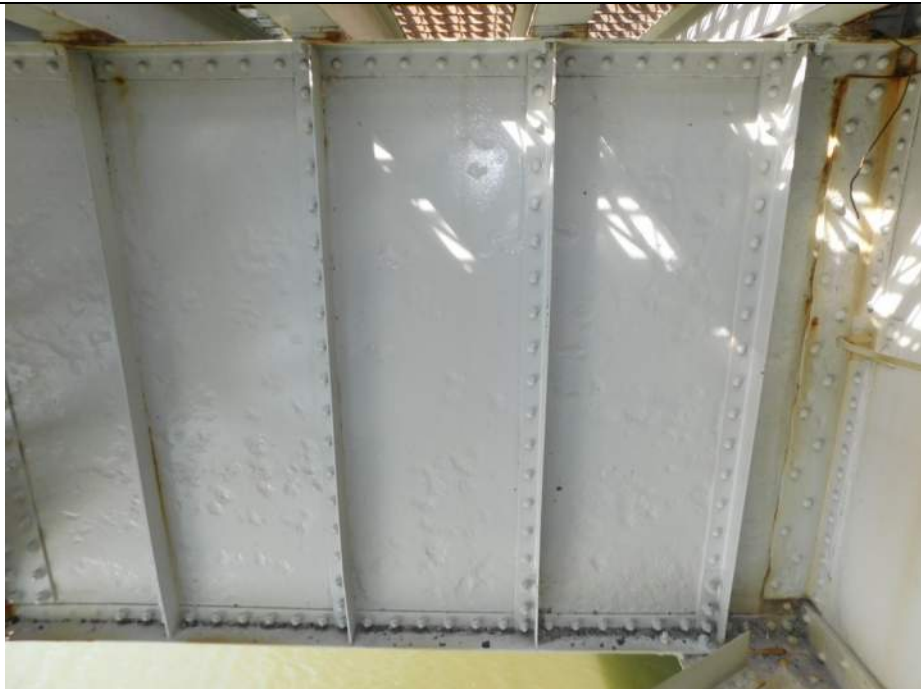
Photo S-228 - [Span 5, North Leaf] -Floorbeam 3n south face at west side G2W, typical section loss scattered throughout web and packing corrosion at connection angle, Looking North

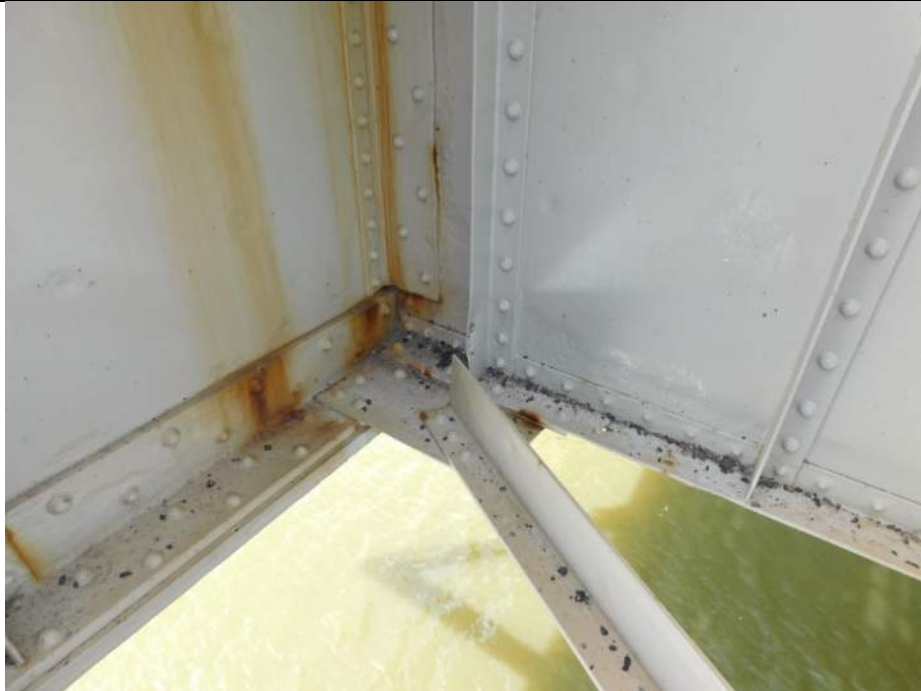
Photo S-229 - [Span 5, North Leaf] -Floorbeam 3n at east side G2W, typical section loss, minor debris, and small holes at base of web stiffener, Looking North

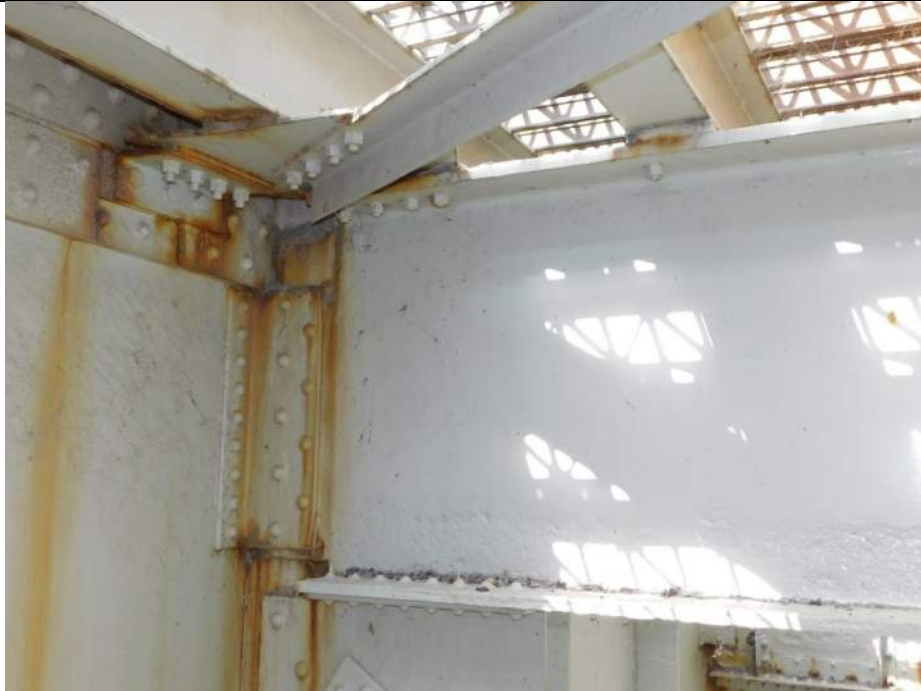
Photo S-231 - [Span 5, North Leaf] -Floorbeam 6n at G2W, typical lower web and bottom flange section loss including rivet head section loss, pack rust at connection and repaired upper diagonal connection, Looking North

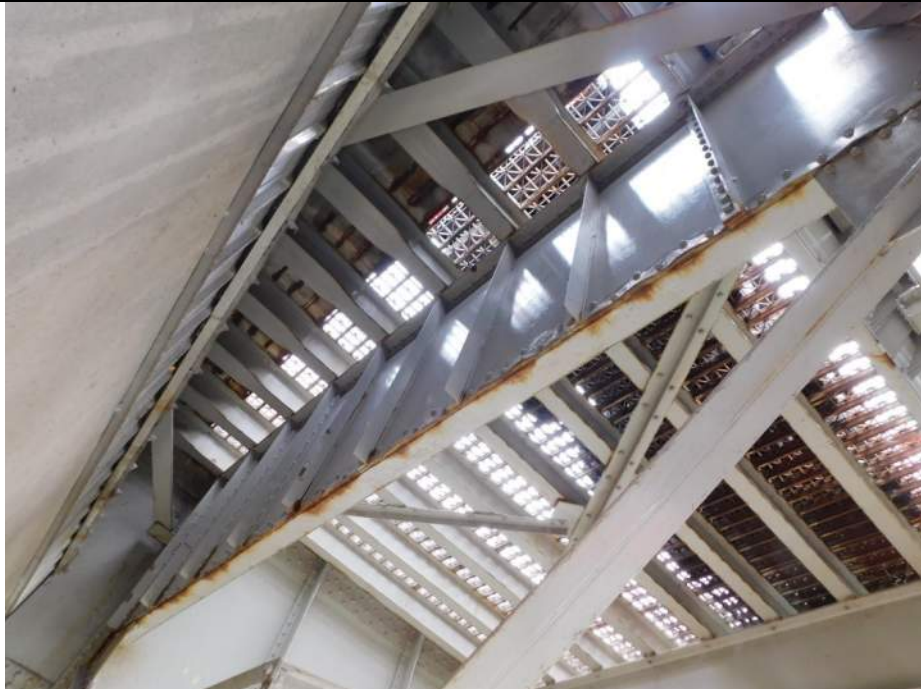
Photo S-232 - [Span 5, North Leaf] -Floorbeam 7n between G1W-G2W, packing corrosion with warping to bottom of web plate along north face, Looking East

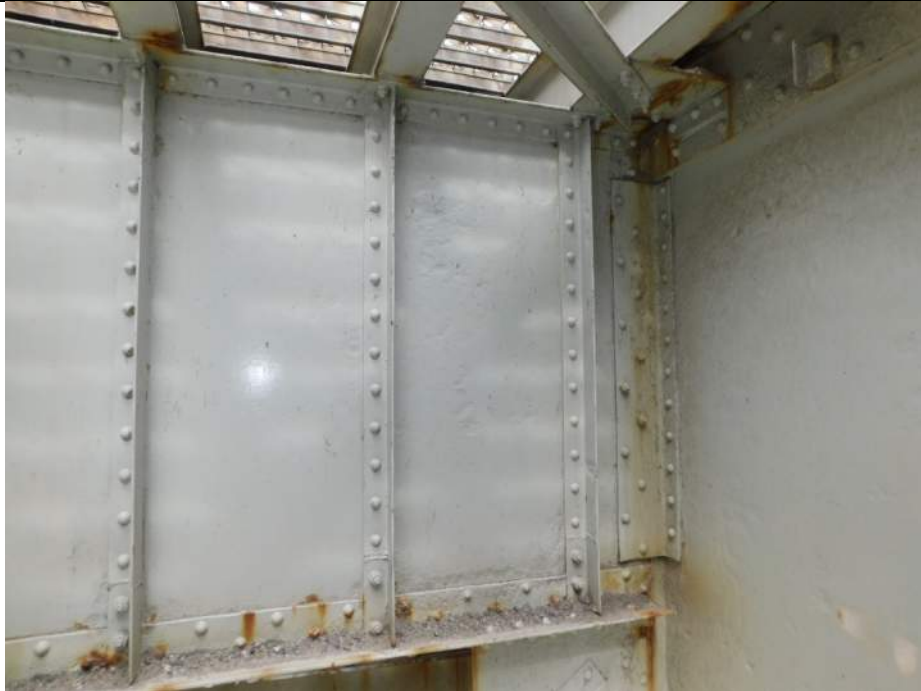
Photo S-233 - [Span 5, North Leaf] -Floorbeam 7n between G1W-2W, typical web and bottom flange section loss, debris at bottom flange, repairs to bases of web stiffeners, Looking South

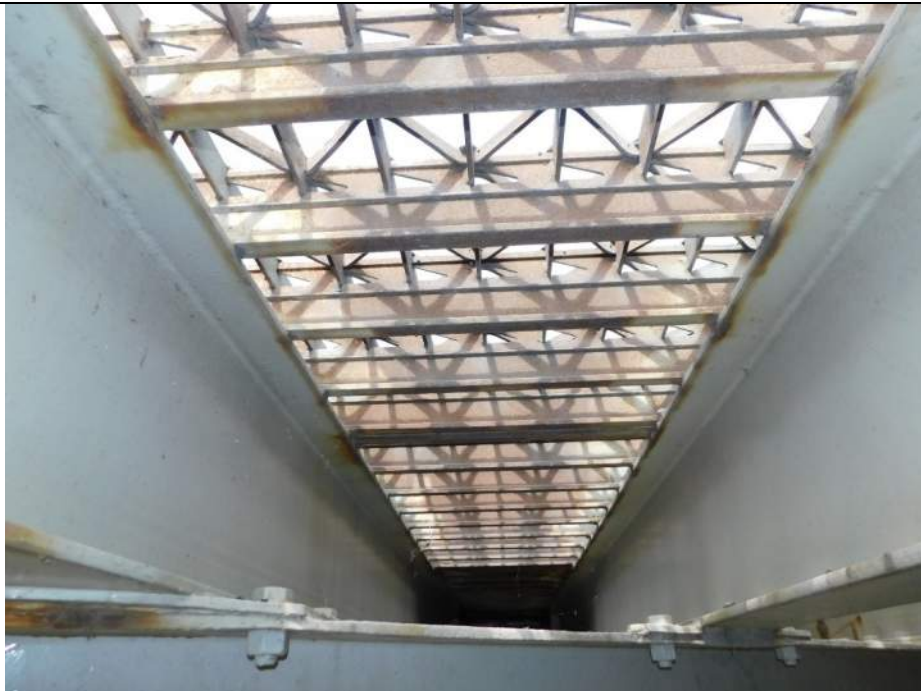
Photo S-234 - [Span 5, North Leaf] -Stringers 7W-8W and grid deck lower main bars, between FB6n-FB7n, general view of typical good condition, Looking North

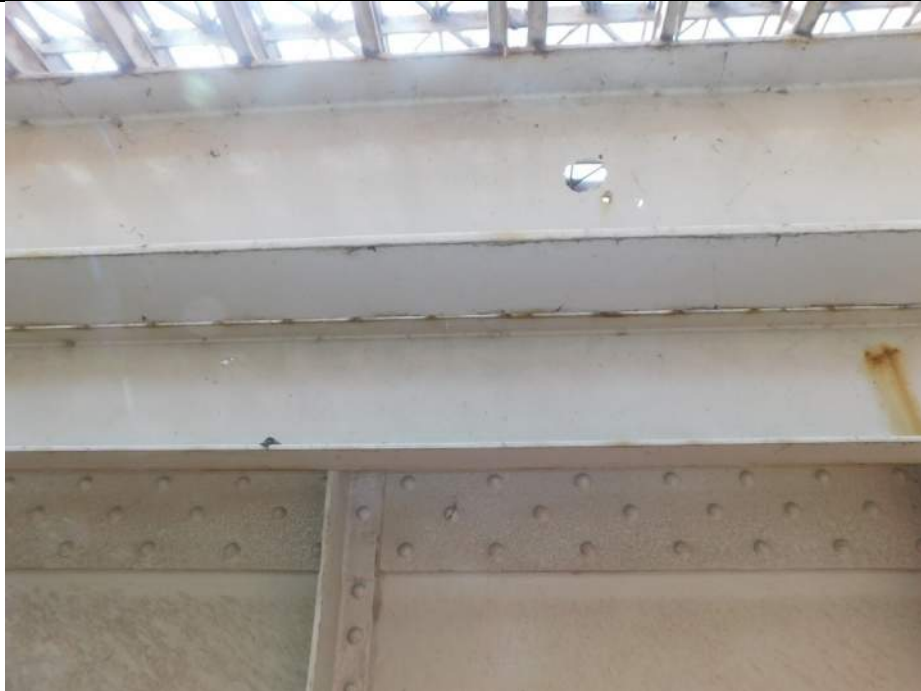
Photo S-235 - [Span 5, North Leaf] -Stringers 10W+11W at mid-panel, holes in web up to 3" diameter, Looking West

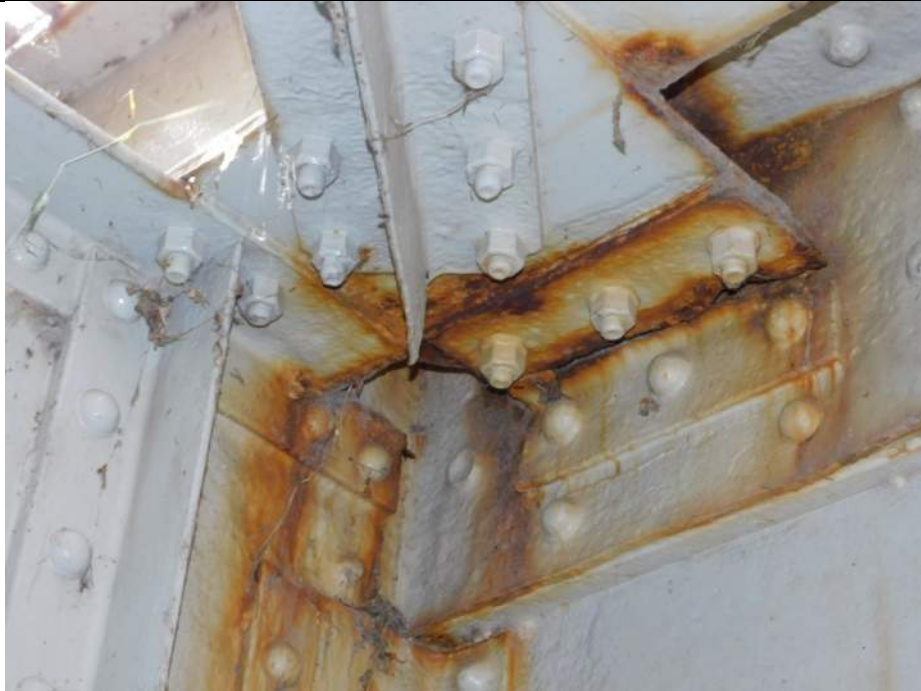
Photo S-237 - [Span 5, South Leaf] -Upper diagonal bracing at FB7s north side to G3W east side, connection angle fully cracked/broken, Looking Southwest

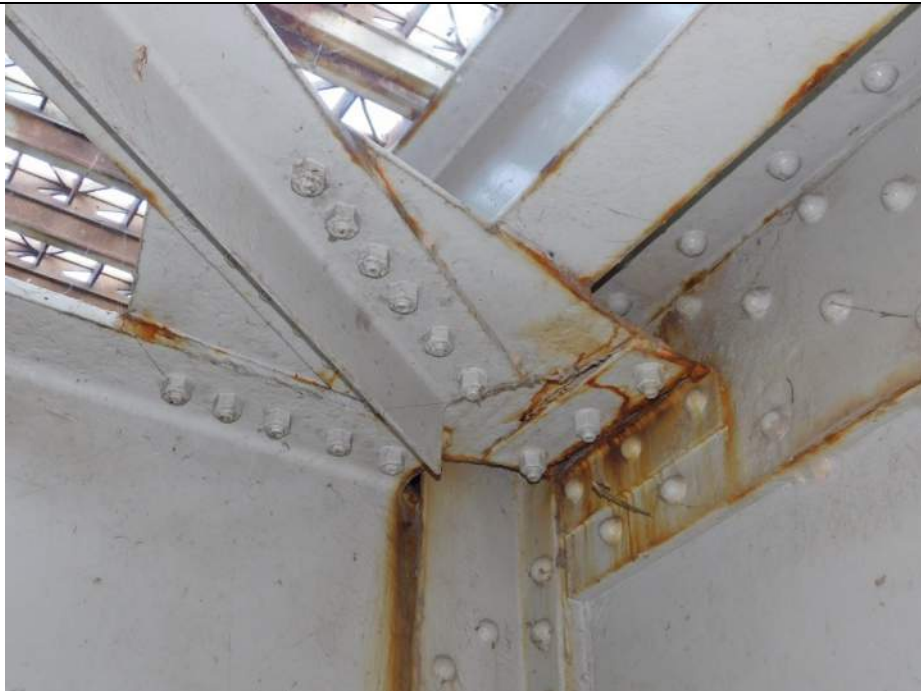
Photo S-238 - [Span 5, South Leaf] -Upper diagonal bracing at FB6s south side to G2W west side, connection angle fully cracked/broken, Looking Northeast

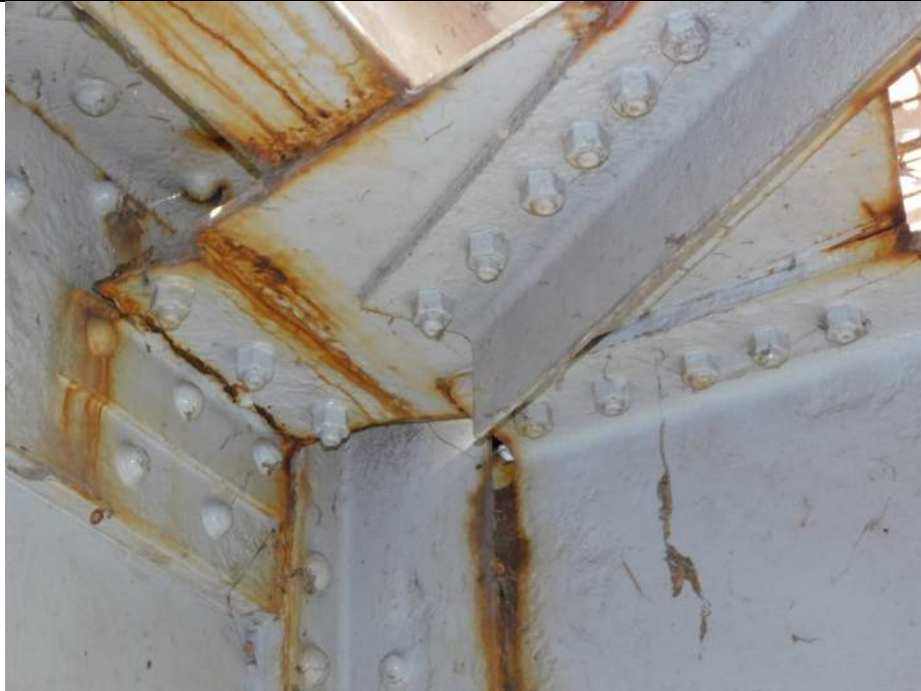
Photo S-239 - [Span 5, South Leaf] -Upper diagonal bracing at FB6s south side to G3W west side, connection angle fully cracked/broken, Looking Northwest

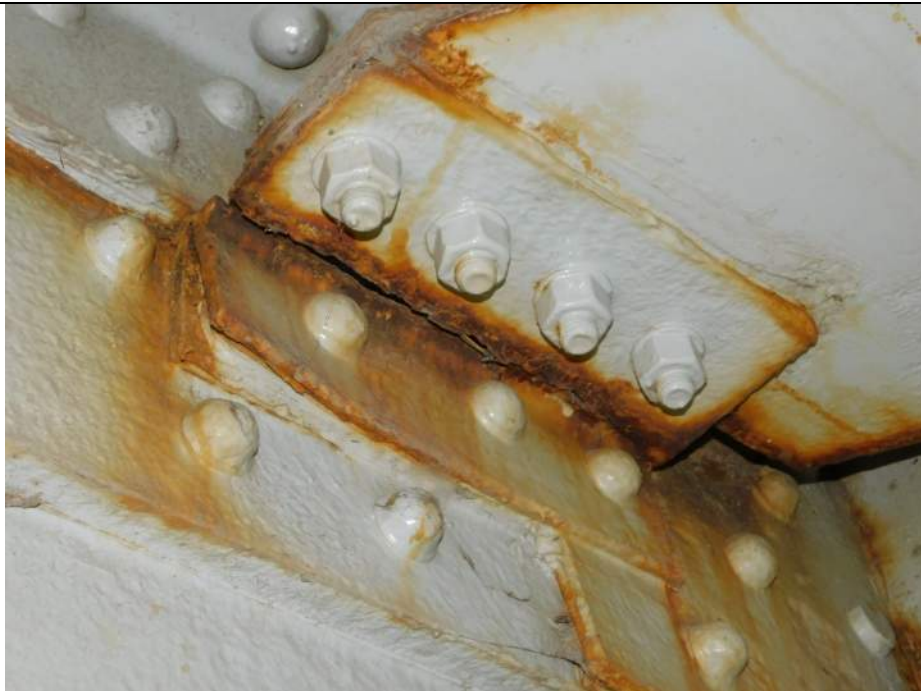
Photo S-240 - [Span 5, South Leaf] -Upper diagonal bracing at FB6s north side to G2W west side, connection angle fully cracked/broken, Looking Southeast

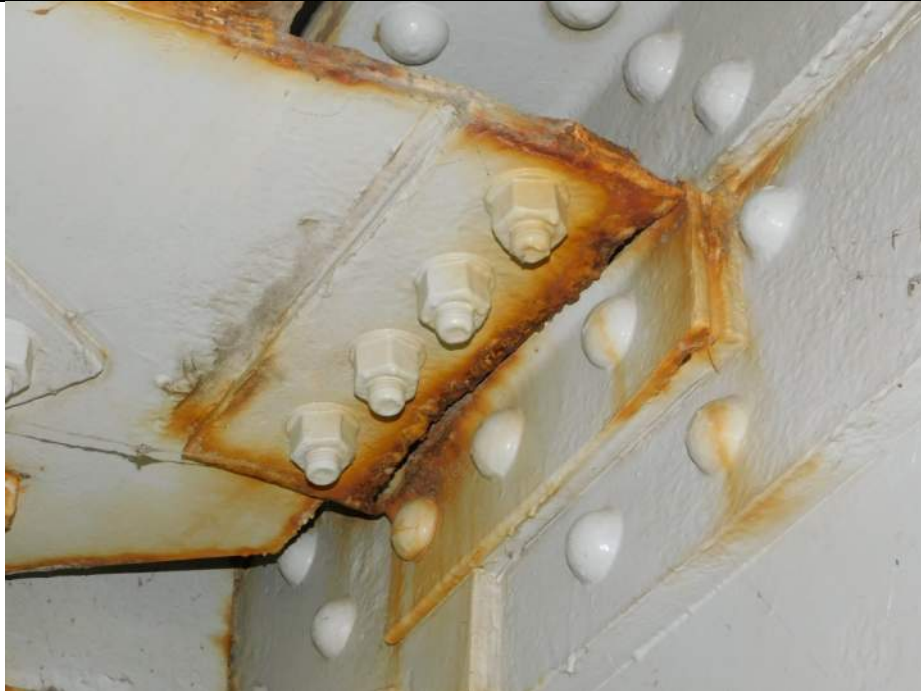
Photo S-241 - [Span 5, South Leaf] -Upper diagonal bracing at FB6s north side to G2W east side, connection angle fully cracked/broken, Looking Southwest

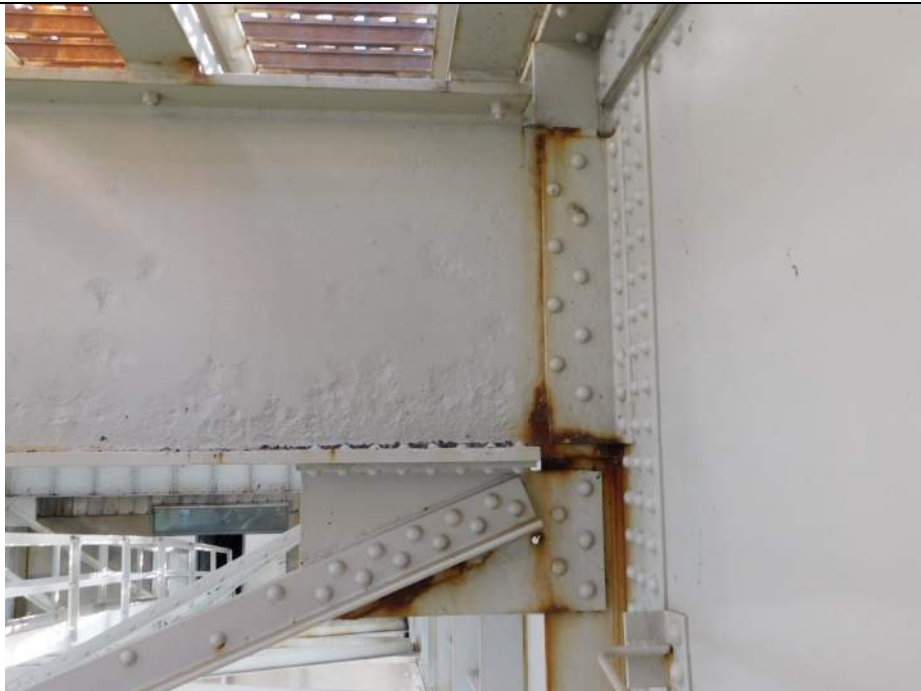
Photo S-242 - [Span 5, South Leaf] -K-bracing below FB4s between G2W-G3W, 1" dia hole in connection plate, Looking South (note typical PR and SL to FB web & connection)

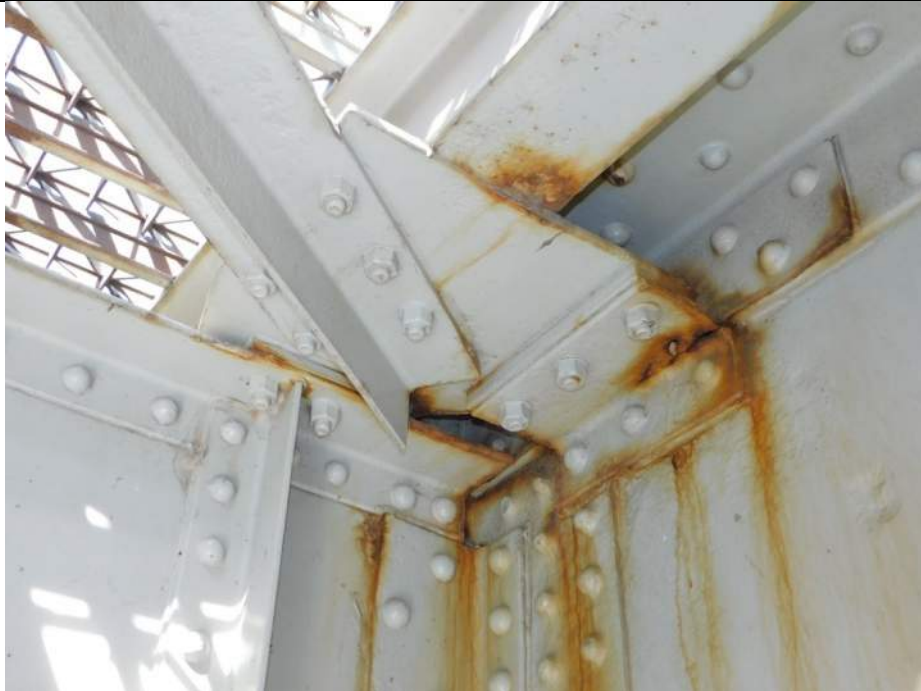
Photo S-243 - [Span 5, North Leaf] -Upper diagonal bracing at FB2n south side to G2W west side, 5" L crack in connection angle, Looking Northeast

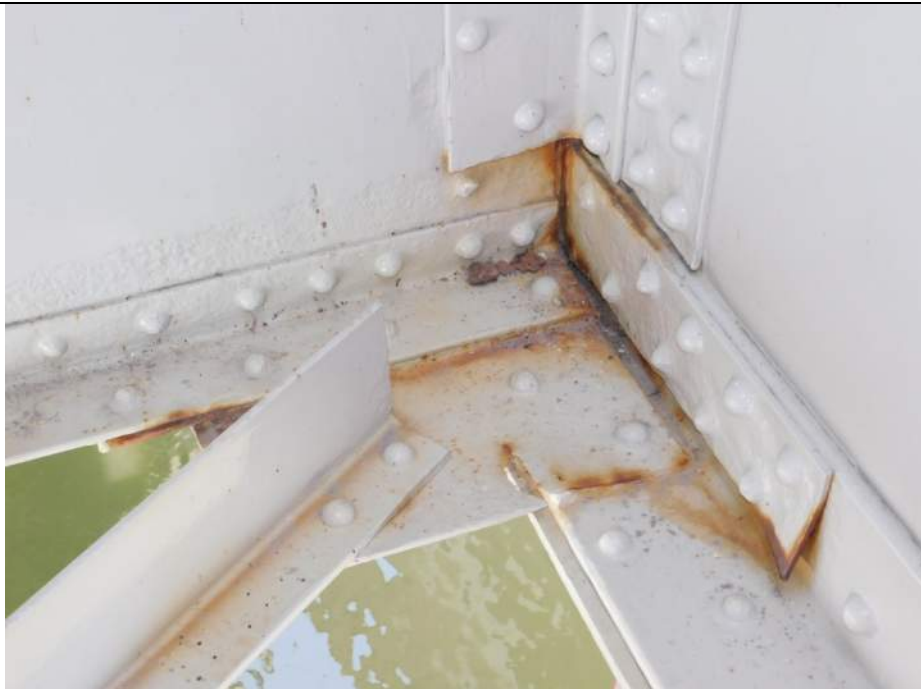
Photo S-244 - [Span 5, North Leaf] -Lower diagonal bracing connection plate with 4" x 1" hole, at south side FB2n and G4W west side connection, Looking North

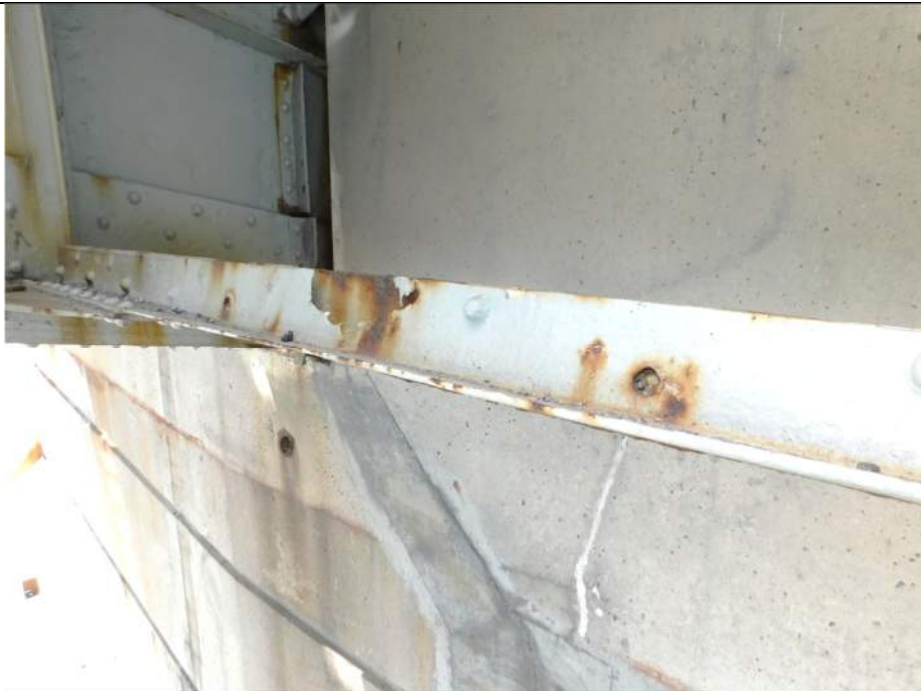
Photo S-246 - [Span 5, North Leaf] -K-bracing below FB7n between G2W-G3W, typical section loss and packing corrosion throughout members, including large hole in angle, Looking West

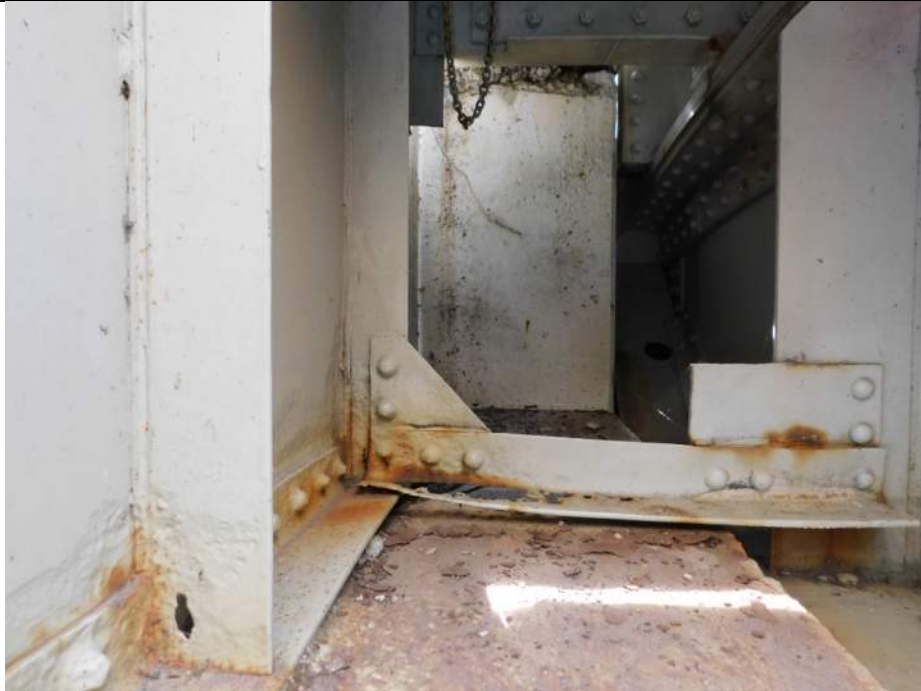
Photo S-247 - [Span 5, South Leaf] -East sidewalk support and fascia girder, typical section loss and corrosion hole in support angle and stiffener across from FB7s, Looking South

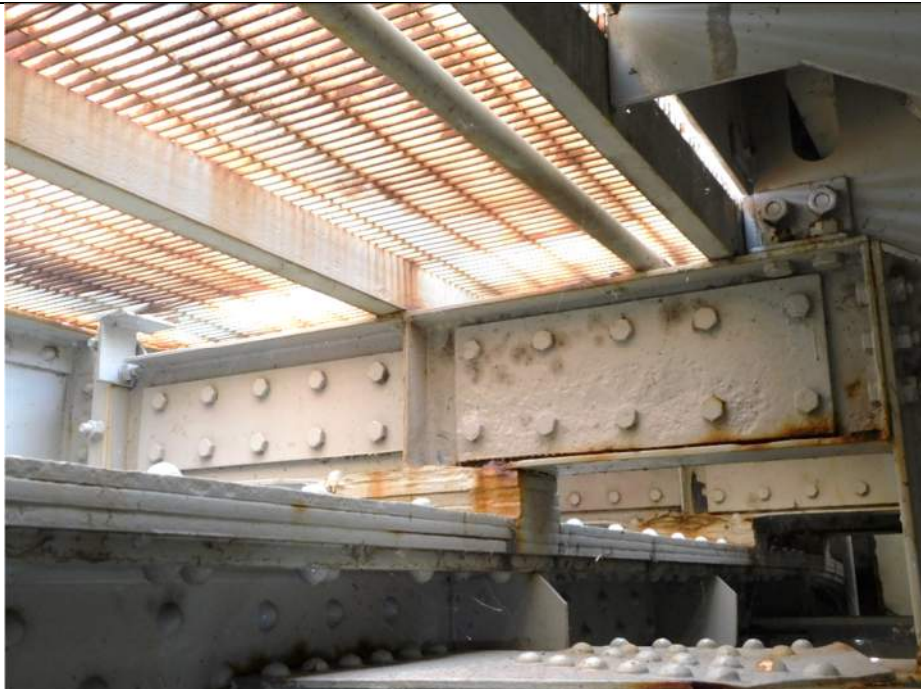
Photo S-248 - [Span 5, South Leaf] -East sidewalk support beams with reinforcement repairs over corrosion holes in webs at FB7s, Looking South

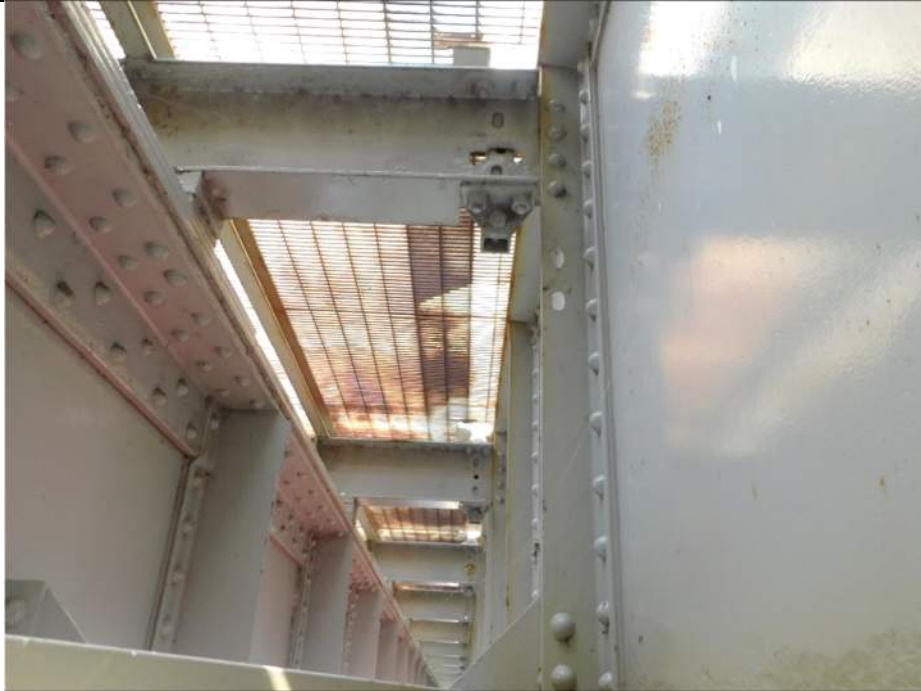
Photo S-249 - [Span 5, South Leaf] -East sidewalk and railing support beams with scattered corrosion holes in webs between FB7s-FB5s, Looking North

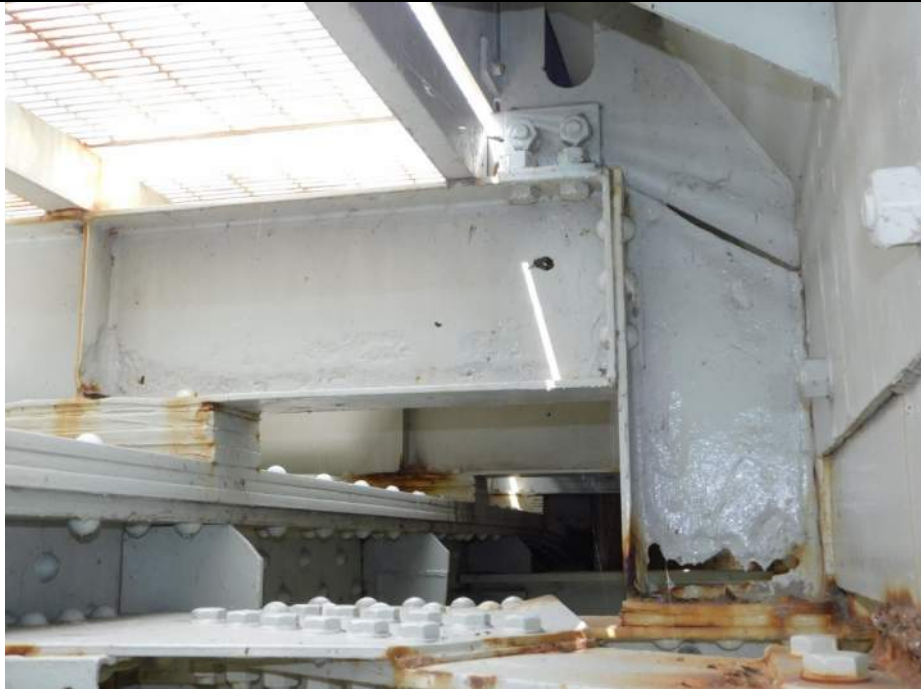
Photo S-250 - [Span 5, North Leaf] -West sidewalk support beam and post at FB7n, holes in beam web and base of post, Looking North

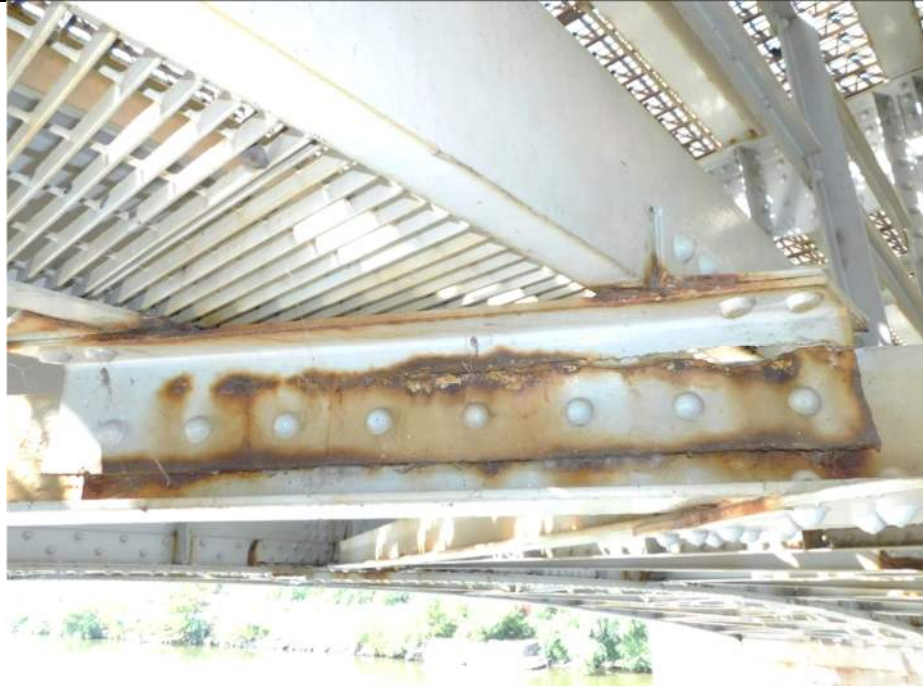
Photo S-251 - [Span 5, North Leaf] -Upper T-section support below center catwalk (G2W-G3W) between FB1n-FB2n at diagonal bracing connection exhibits a 31" L x 1" H corrosion hole in the web with pack rust throughout, Looking Northwest

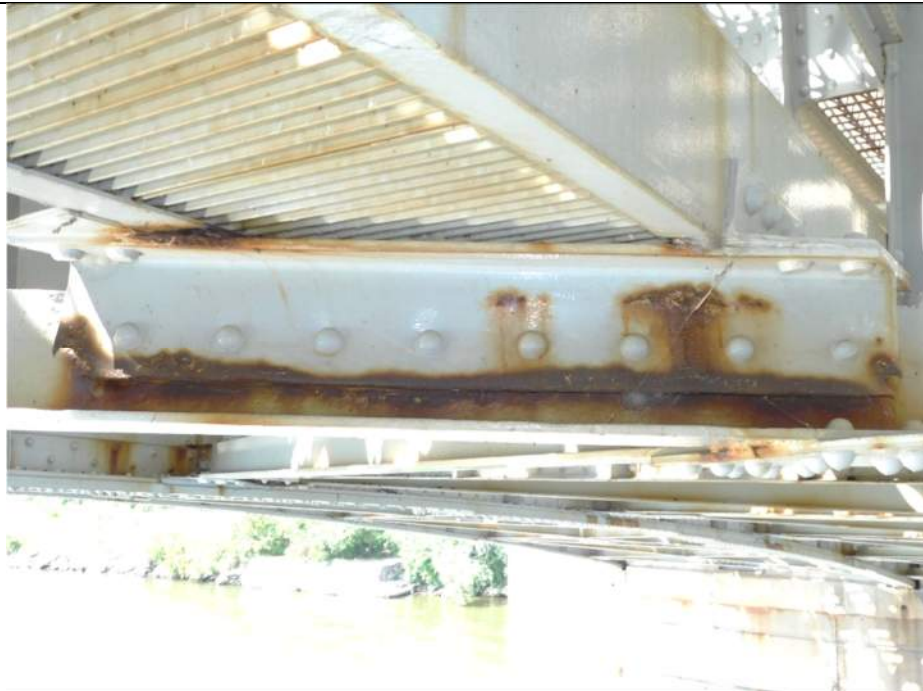
Photo S-252 - [Span 5, North Leaf] -Upper T-section support below center catwalk (G2W-G3W) between FB2n-FB3n at diagonal bracing connection exhibits a pack rust throughout and small edge holes, Looking Northwest
