Craig Memorial Bascule Bridge

Over the Maumee River

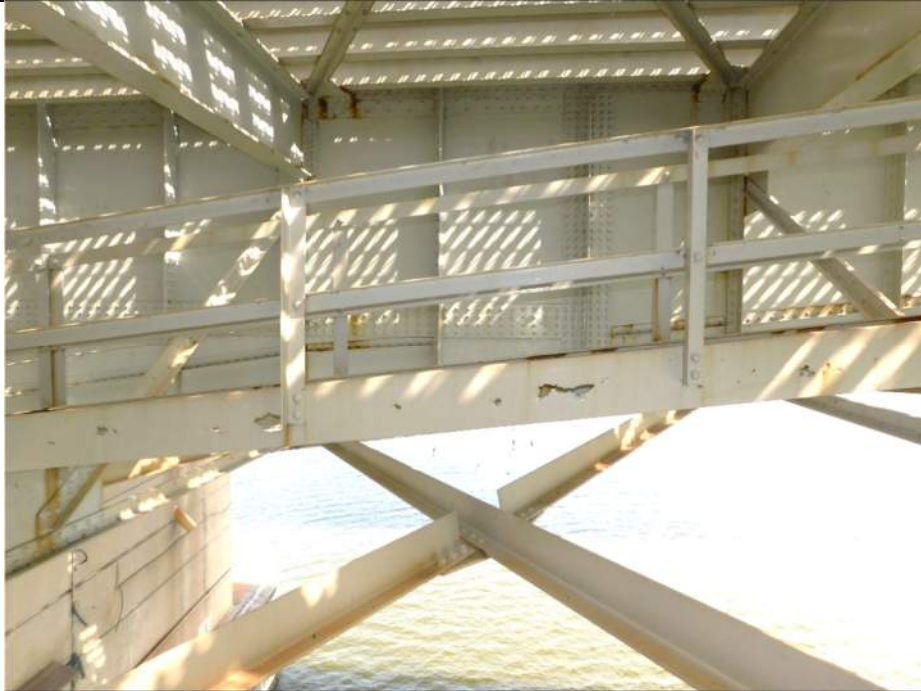
Photo S-253 - [Span 5, North Leaf] -Middle catwalk, west support channel exhibits several large holes in the web between FB5n-FB6n, Looking East

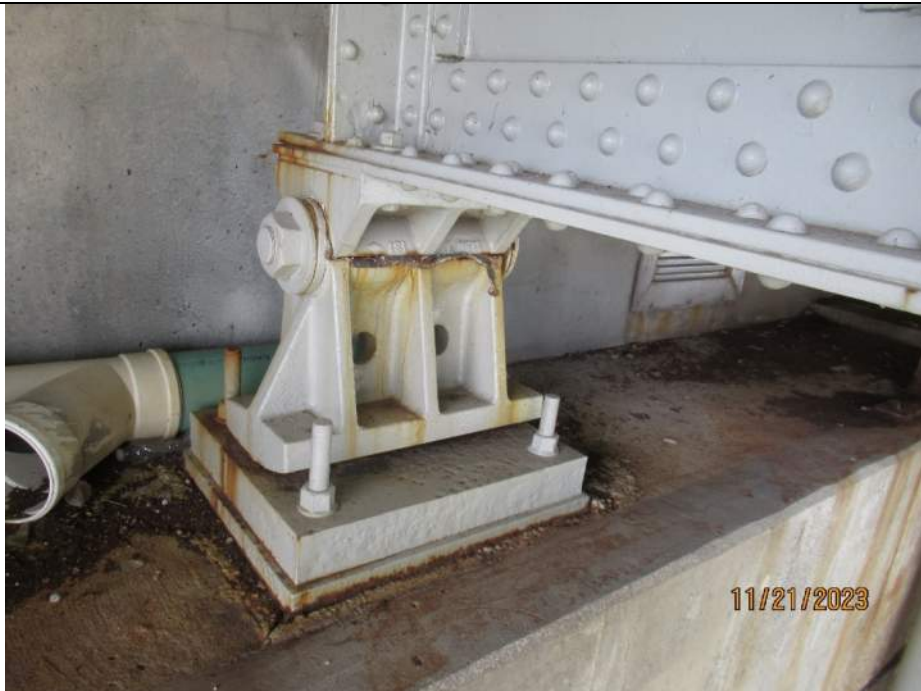
Photo S-254 - [South Abutment] -Bearing 4W, typical minor rust stains and bleeding corrosion, Looking South

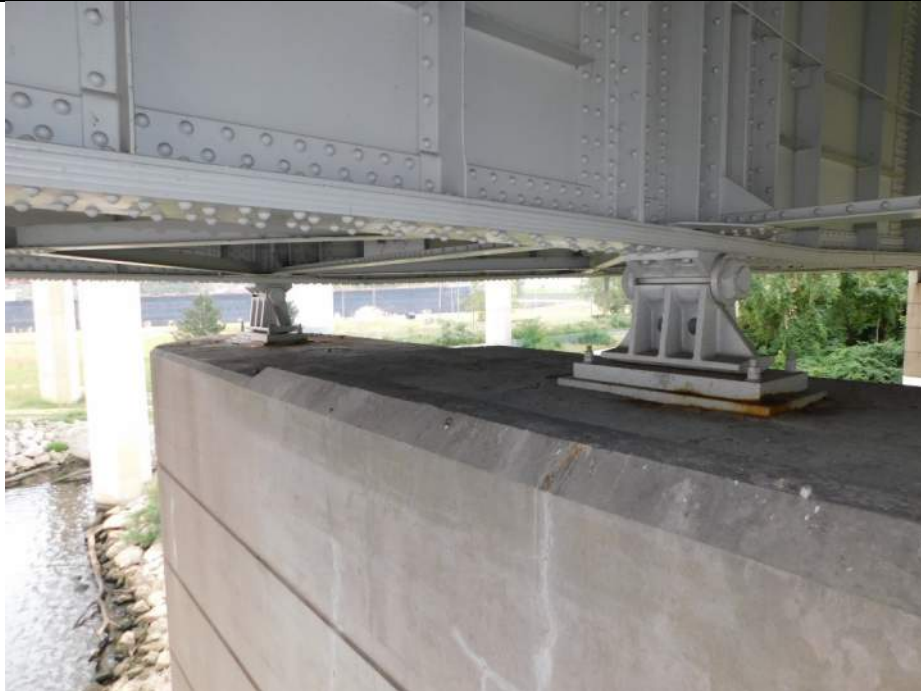
Photo S-255 - [Pier 1] -Bearings 3W and 4W, typical minor tilt to north in contraction, good condition, Looking East

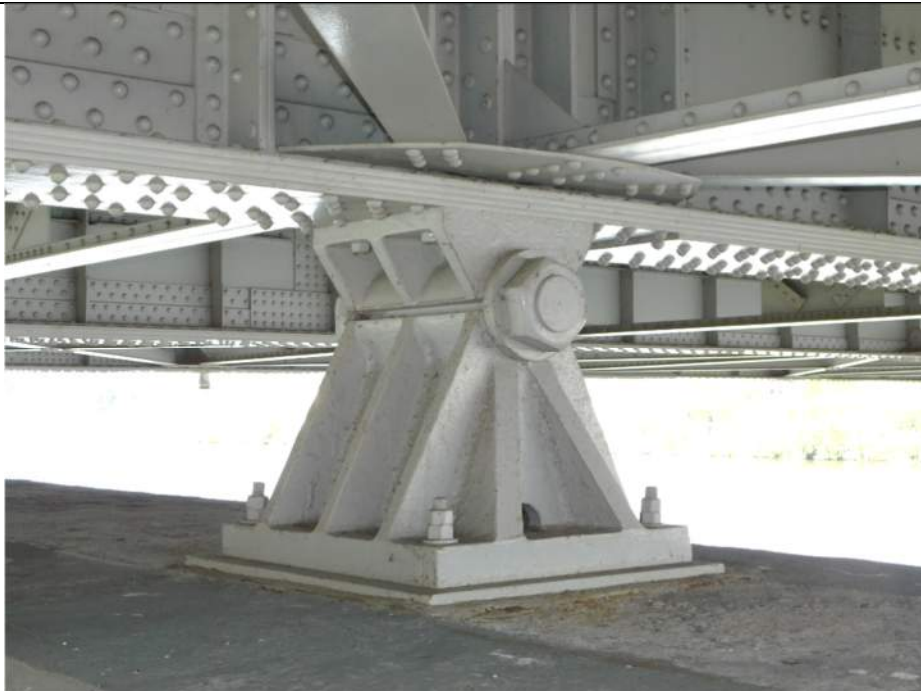
Photo S-256 - [Pier 2] -Bearing 3W general view, typical good condition of fixed bearings, Looking North

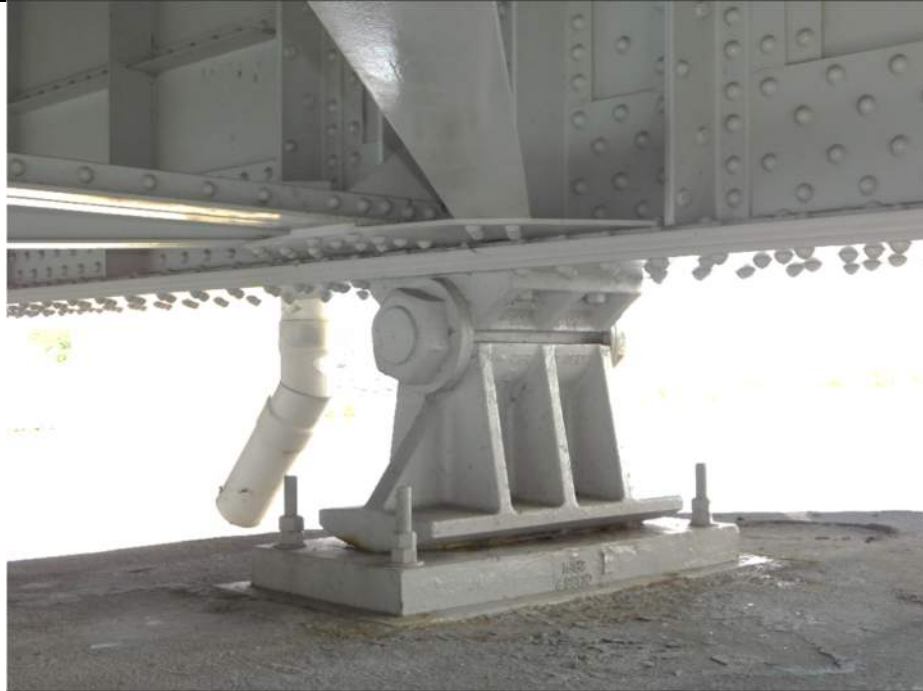
Photo S-257 - [Pier 3] -Bearing 4W general view, typical minor tilt to south in contraction, good condition, Looking Northeast

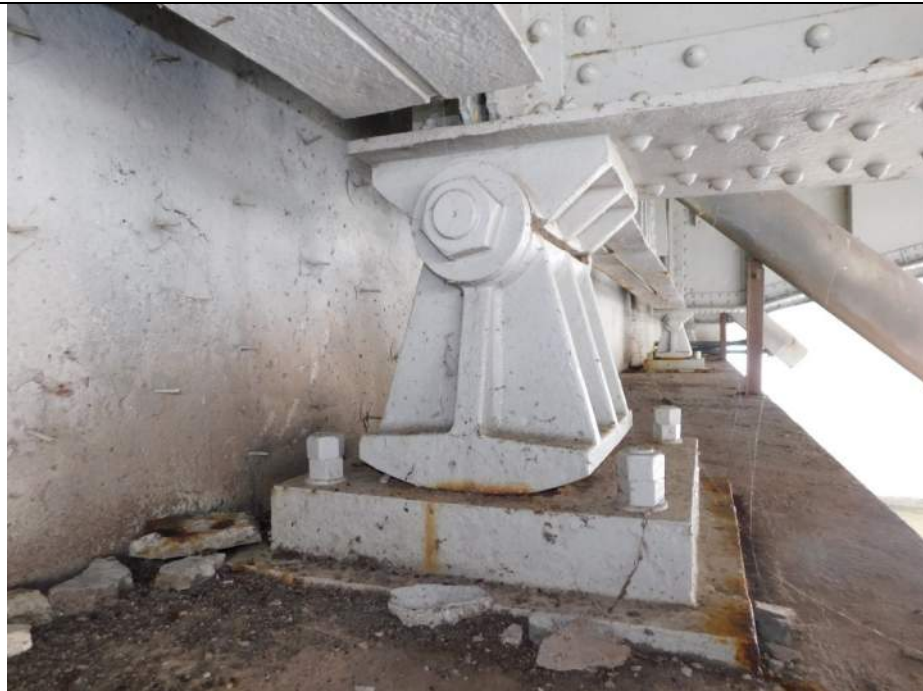
Photo S-258 - [Pier 4] -Bearing 2W at South side of Bascule Pier 4, general view of bearing generally plumb, Looking East

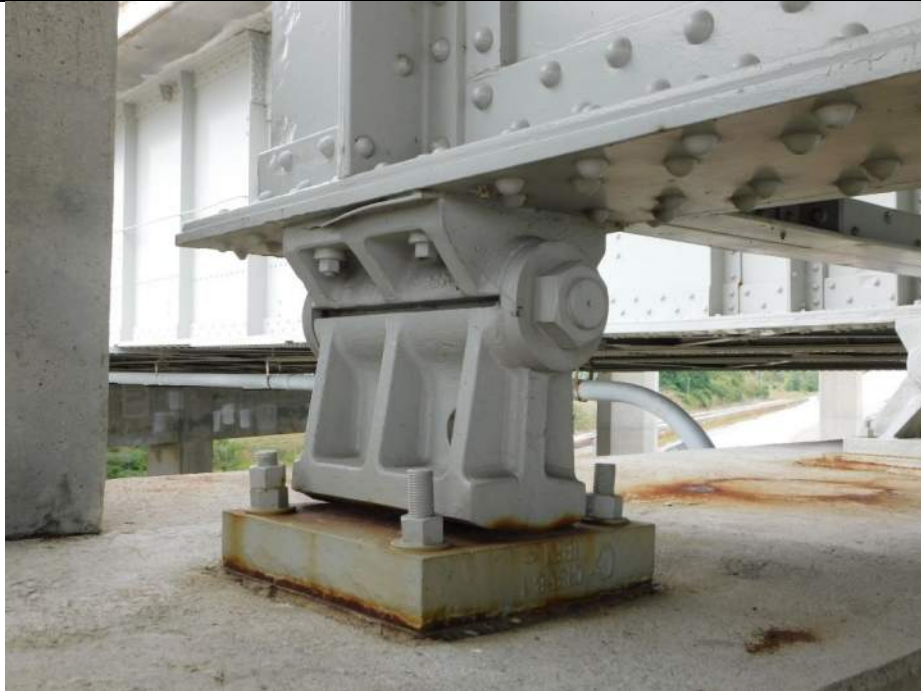
Photo S-263 - [Pier 6] -Bearing 5W, West exterior girder bearing at pier, moderate blister and bleeding corrosion around masonry plate and at lower rocker, Looking North

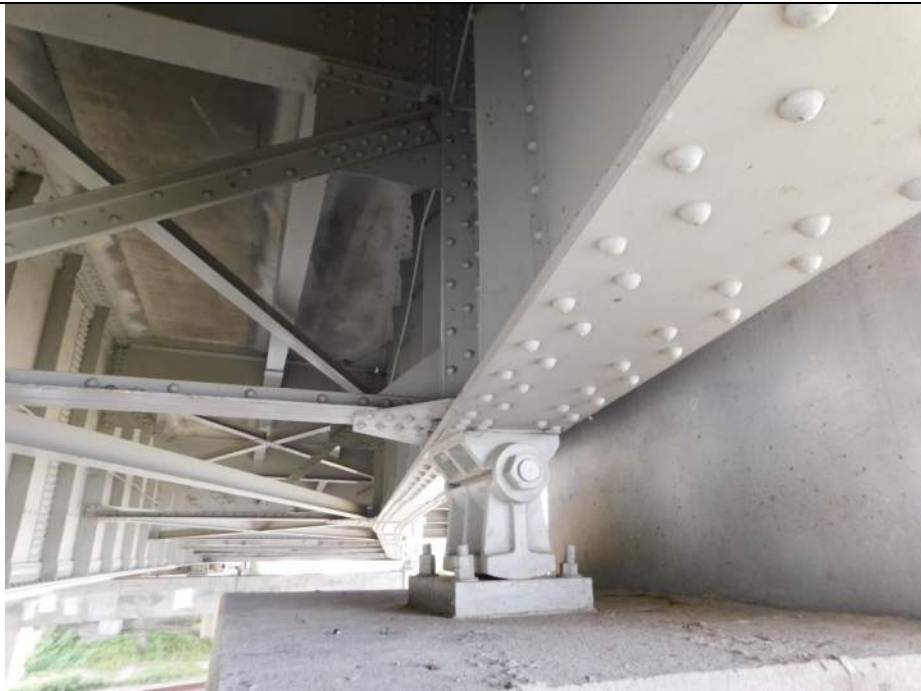
Photo S-264 - [Pier 6] -Bearing 7W, East flare girder bearing at pier, general view in good condition, Looking North

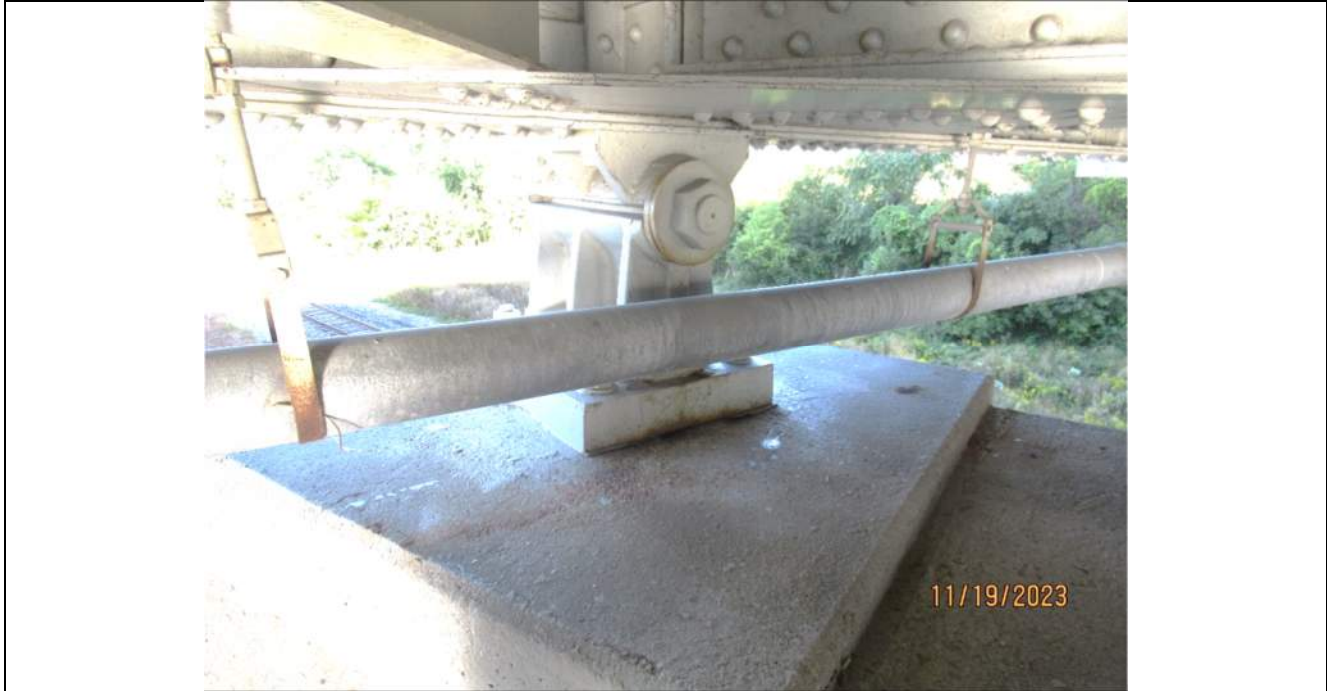
Photo S-265 - [Pier 7] -Bearing 1W, rocker bearing in good condition and generally plumb, Looking Northwest

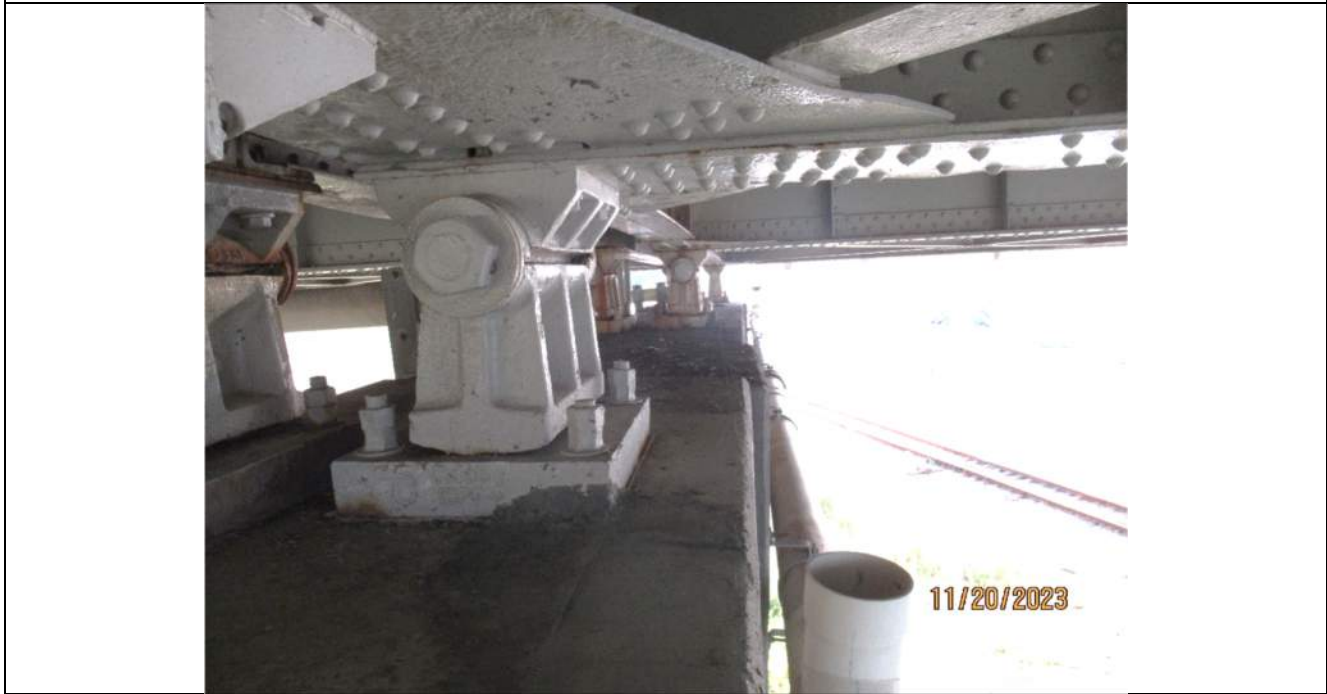
Photo S-266 - [Pier 8] -Bearings 2W, 3W, 4W (Span 8 side), minor to moderate blistering and bleeding corrosion, debris across pier top, Looking East

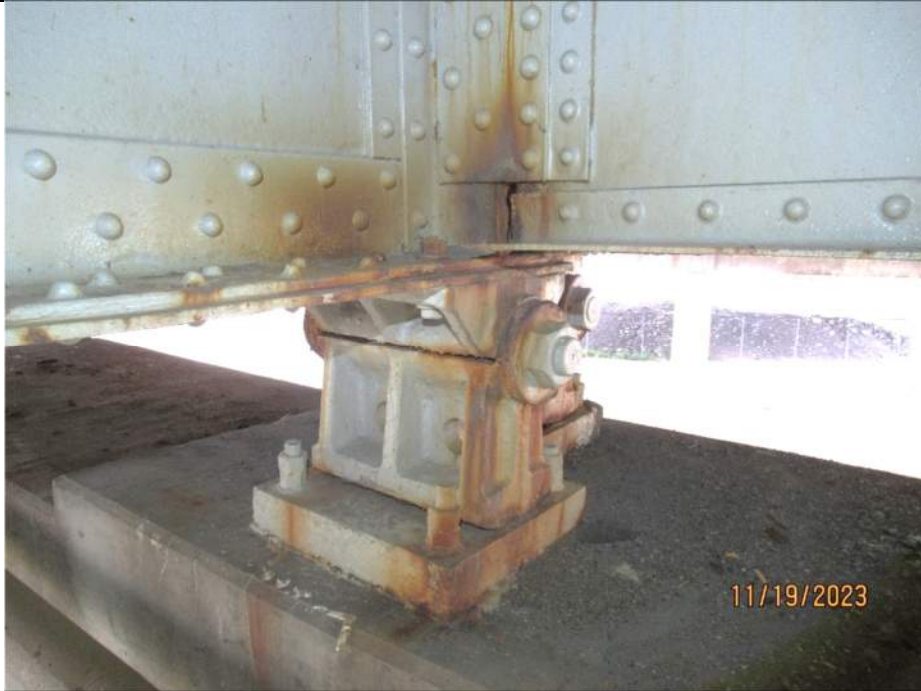
Photo S-267 - [Pier 8] -Bearing 3W (Span 9 side), moderate blistering and bleeding corrosion with staining throughout, generally plumb, Looking Southeast

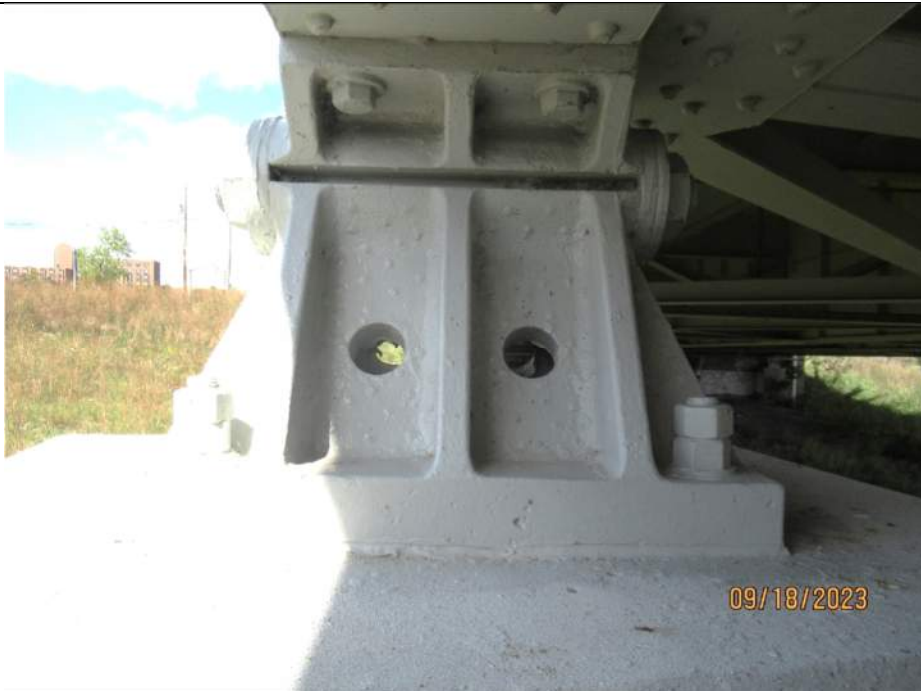
Photo S-268 - [Pier 9] -Bearing 1W, fixed bearing in good condition, typical for Pier 9 fixed bearings, Looking North

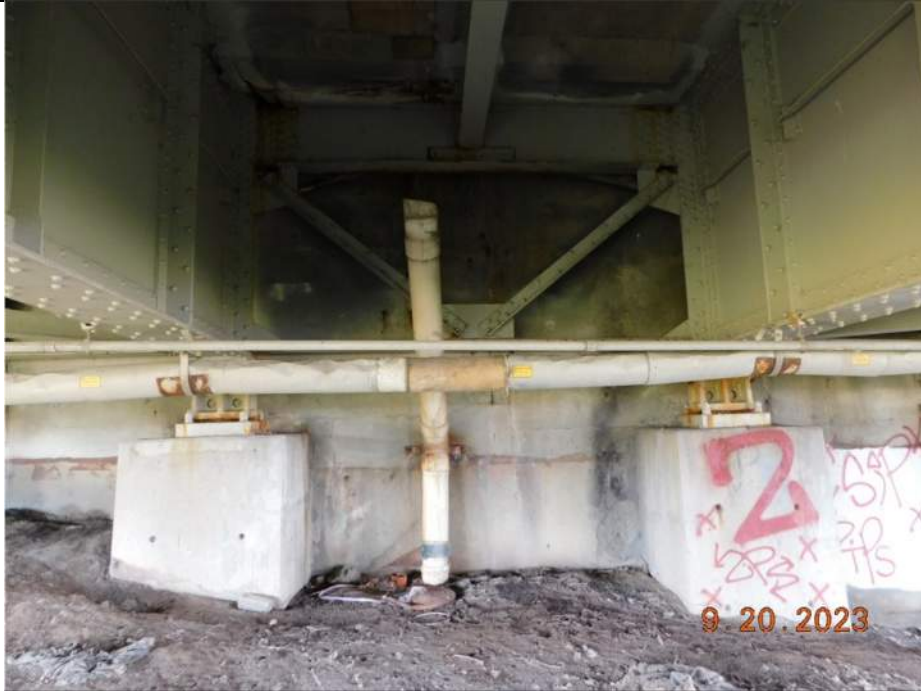
Photo S-269 - [North Abutment] -Bearings 2W and 3W, typical minor rust stains and bleeding corrosion to rockers and masonry plates, Looking North

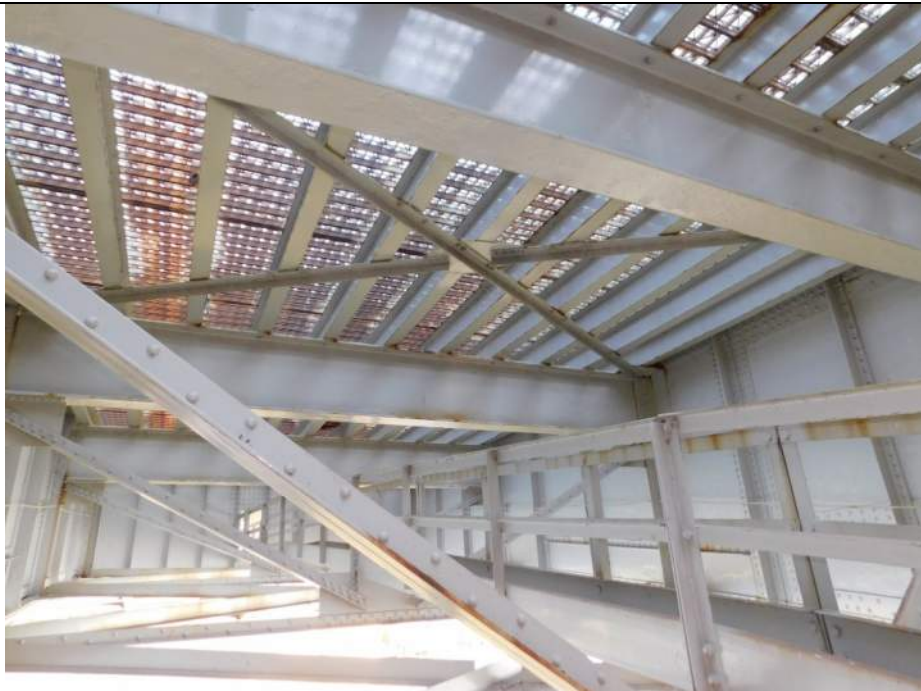
Photo S-270 - [Span 5, South Leaf] -Stringers, floorbeams, bracing and catwalk between G2W-G3W and FB5s-6s-7s, general view of paint in good condition, Looking North

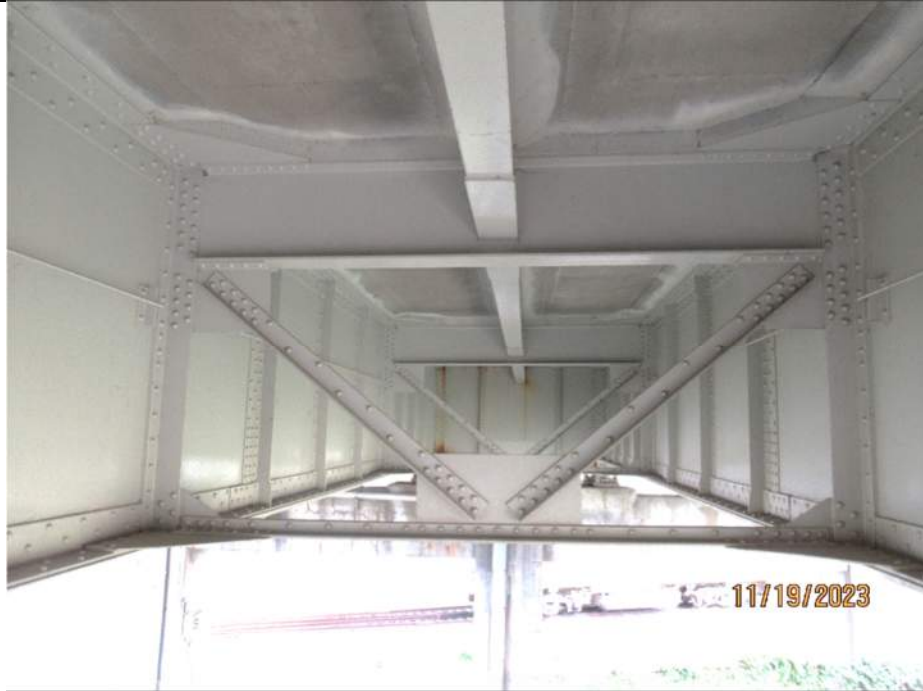
Photo S-271 - [Span 9] -Girders 2W & 3W, Floorbeams 0s-1s-2s, Stringer 3W and secondary framing, general view of paint in good condition, Looking South

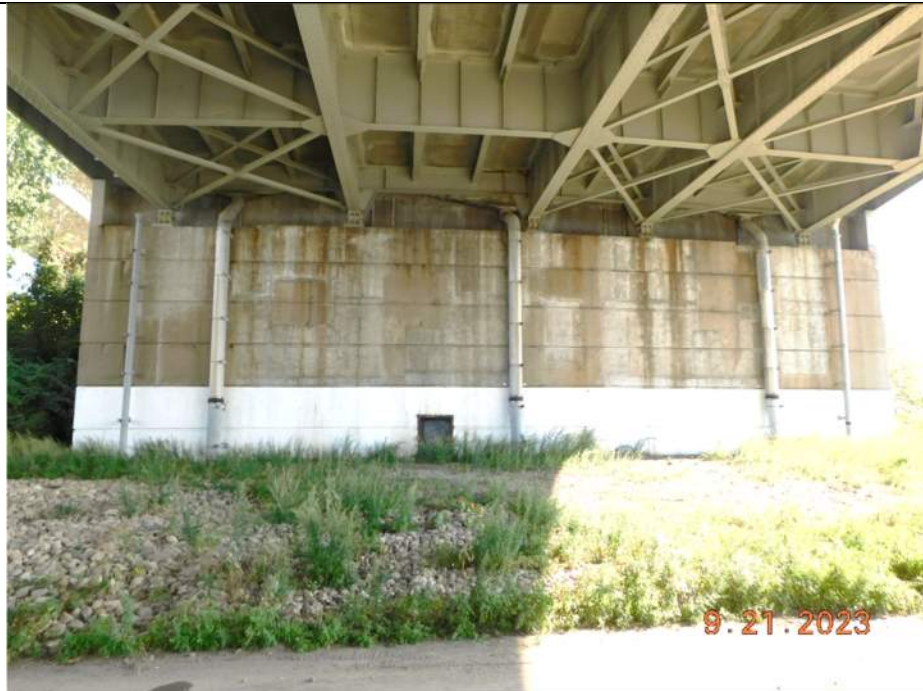
Photo S-272 - [South Abutment] -Abutment stem and back wall general view, Looking South

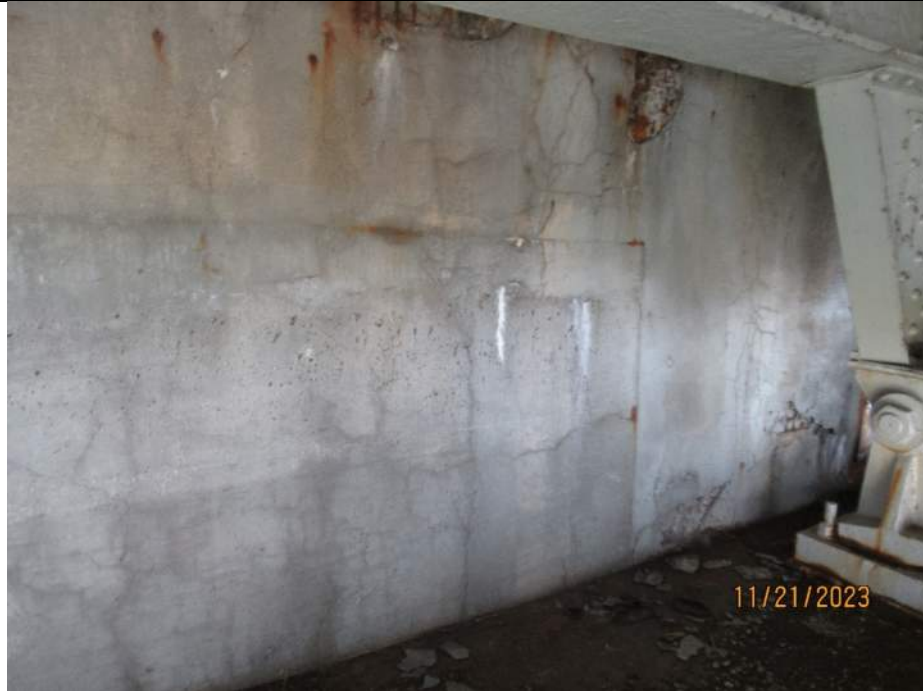
Photo S-275 - [South Abutment] -Abutment backwall at Girder 3W, cracking throughout and minor delamination and shallow spalls, Looking South

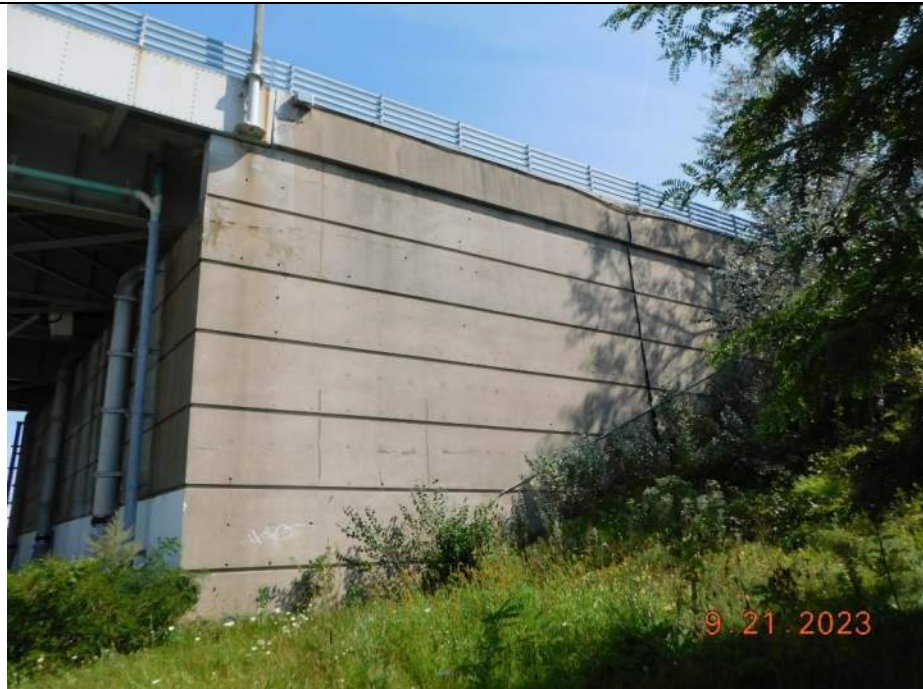
Photo S-276 - [South Abutment] -Abutment West wingwall, Looking Southeast

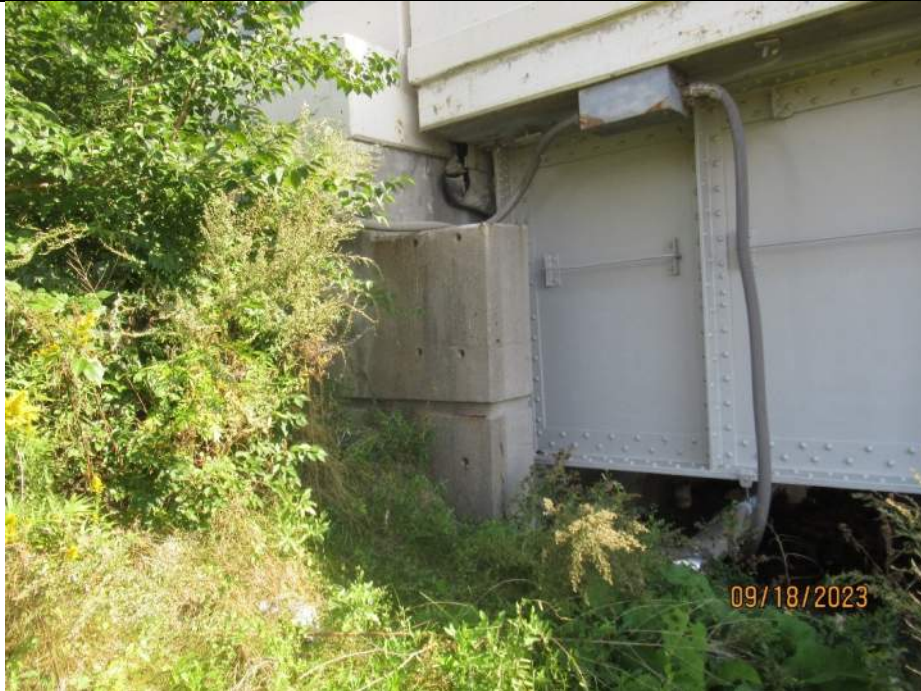
Photo S-281 - [North Abutment] -Abutment backwall and cheek at West wingwall, cracks propagating from corner where walls meet, general view, Looking Northeast

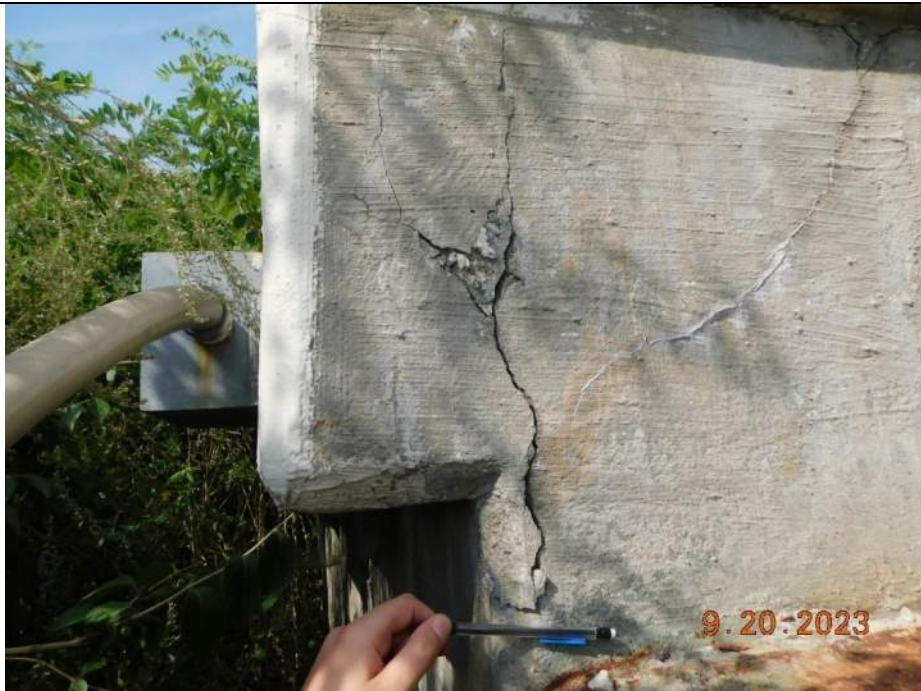
Photo S-282 - [North Abutment] -West side of backwall at West wingwall, vertical cracking at wall corner, Looking North

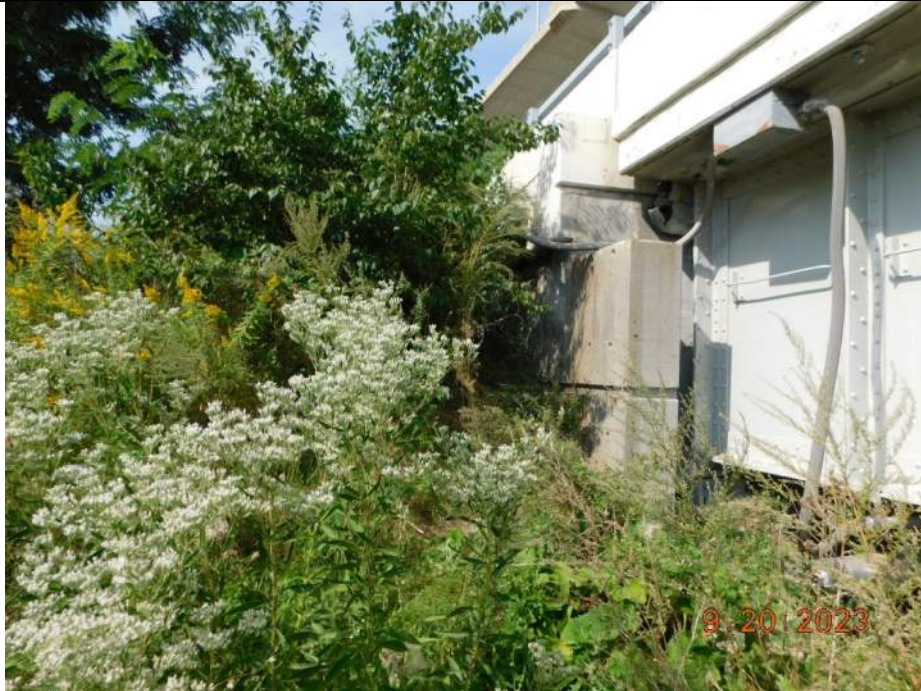
Photo S-283 - [North Abutment] -Abutment West wingwall, Looking North

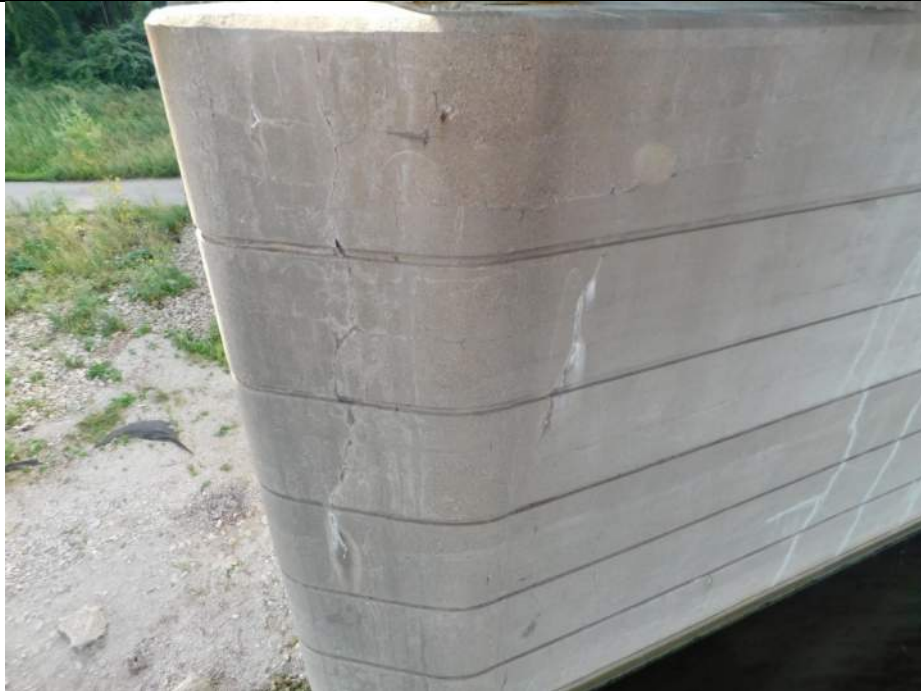
Photo S-287 - [Pier 1] -Pier north side at east end, detail view of vertical cracking, Looking Southwest

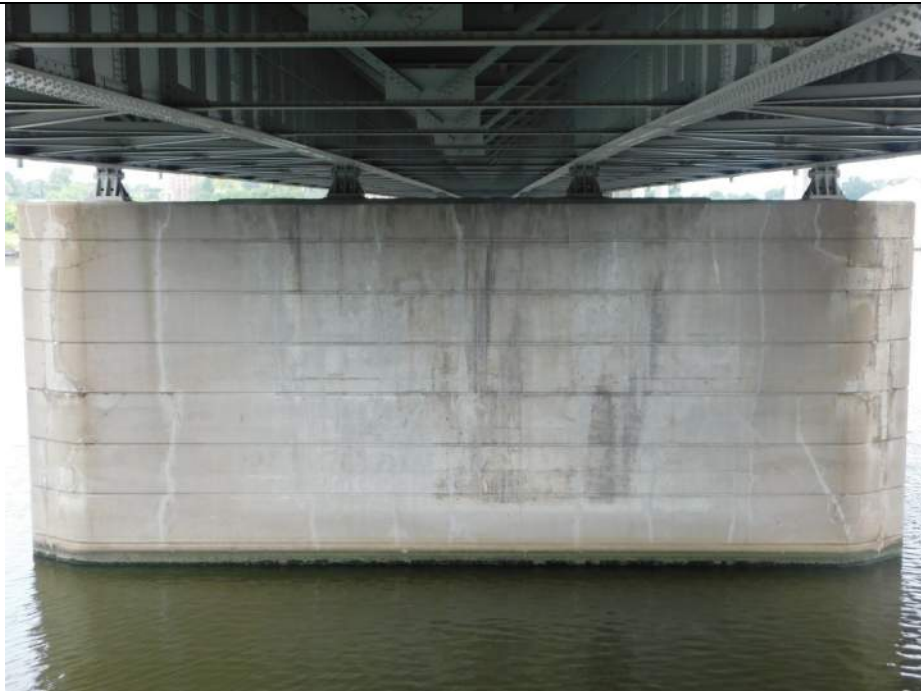
Photo S-288 - [Pier 2] -Pier South face, general view, Looking North

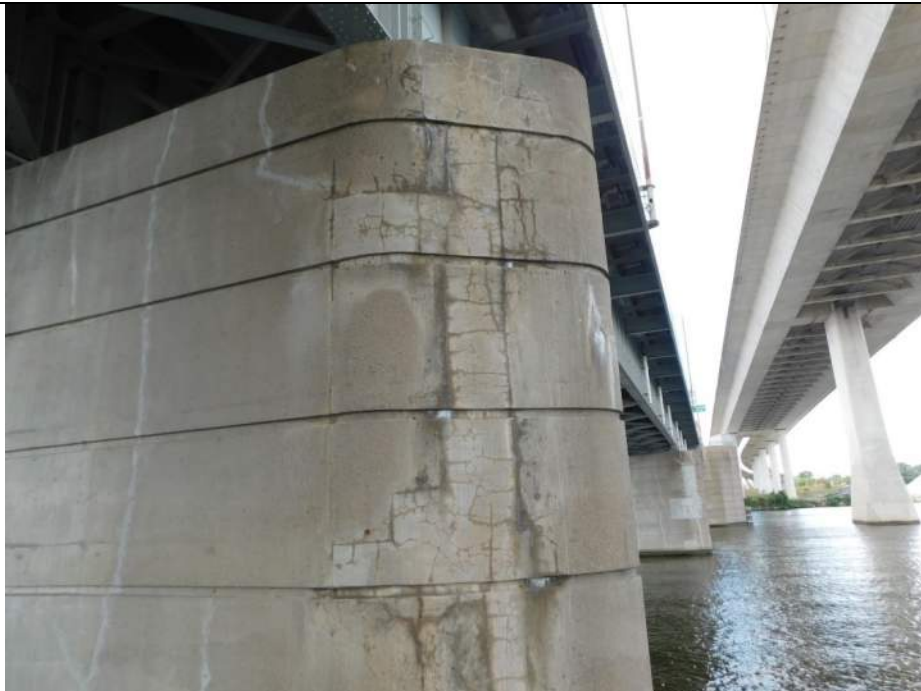
Photo S-292 - [Pier 3] -Pier south side at east end, detail view of shrinkage cracking and dampness throughout repair areas, Looking North

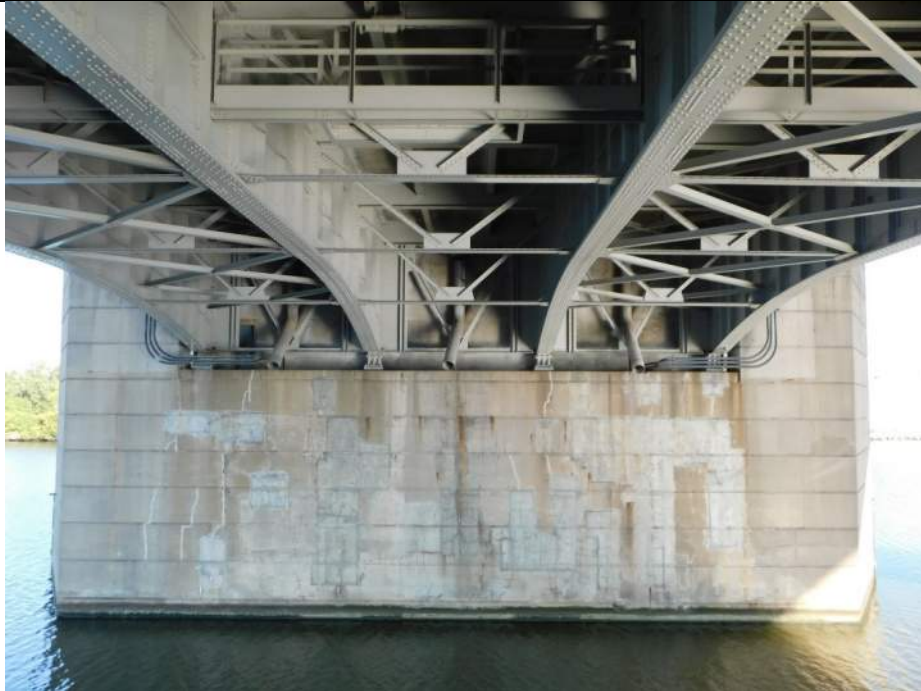
Photo S-293 - [Pier 4] -Pier South face, general view, Looking North

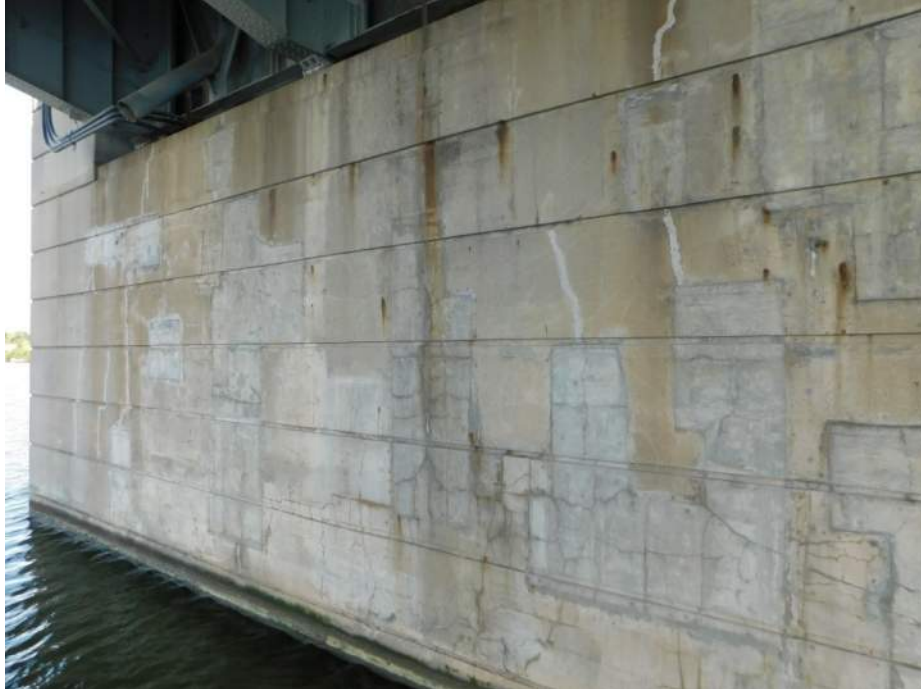
Photo S-295 - [Pier 4] -Pier South face, detail view of widespread patch and crack repairs, cracking in and around repair areas, Looking Northwest

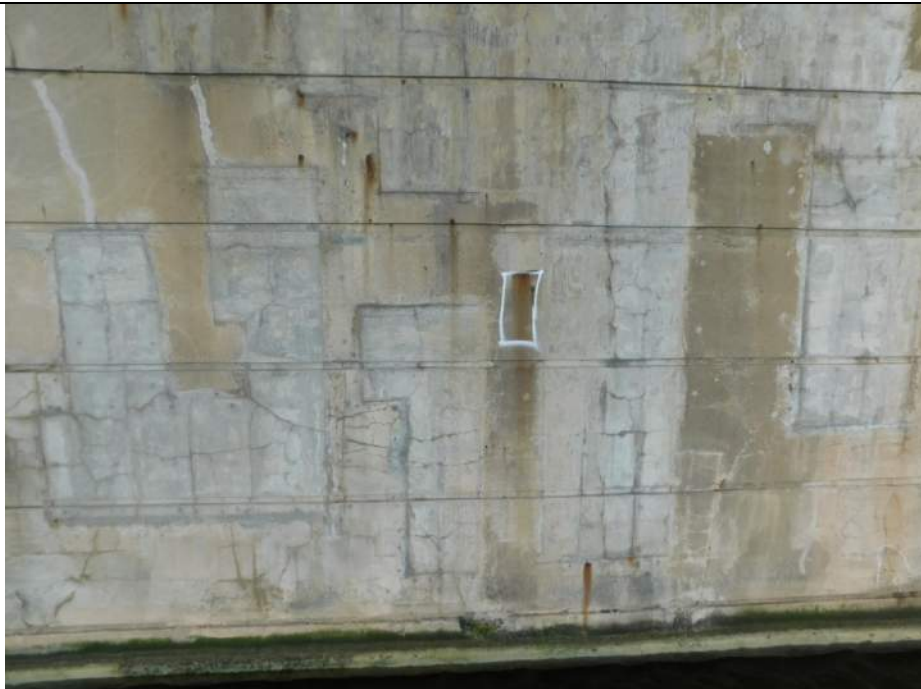
Photo S-296 - [Pier 4] -Pier South face, detail view of widespread patch and crack repairs, cracking in and around repair areas, Looking Northeast

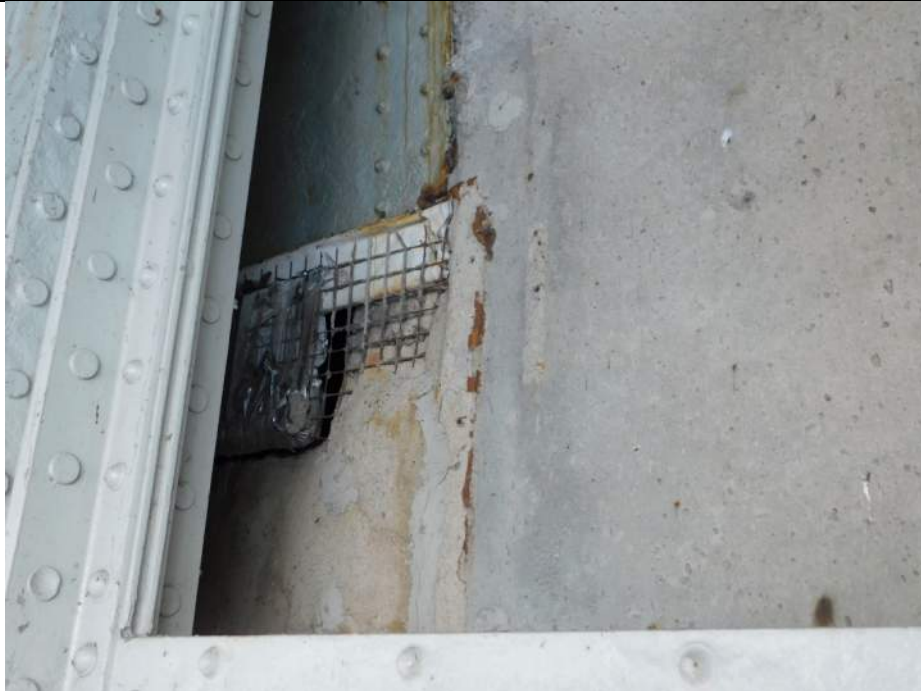
Photo S-297 - [Pier 4] -Hole in pier wall with temporary repair, south wall of pier at Girder 3W, Looking North

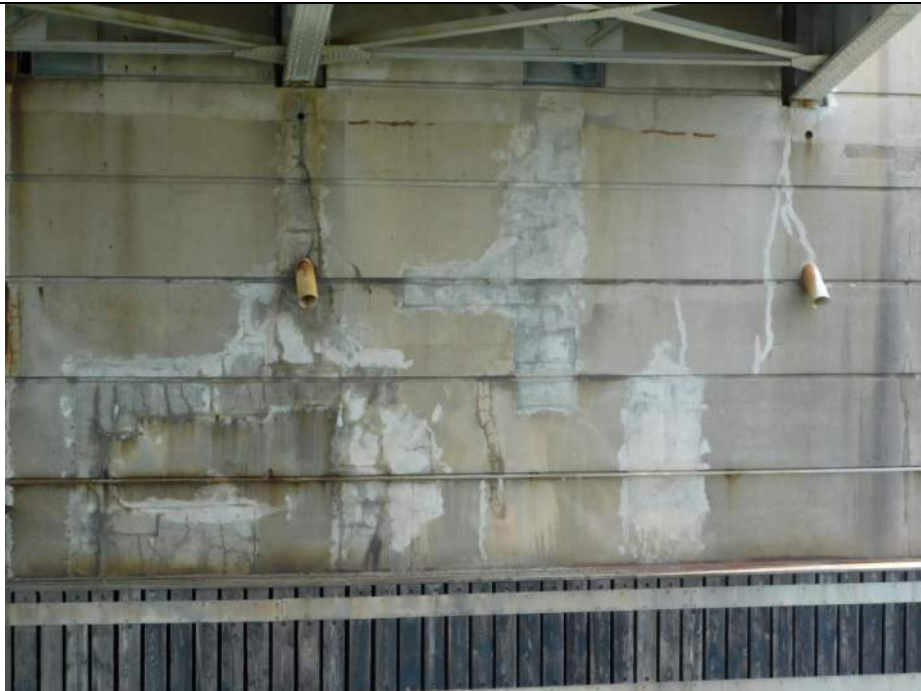
Photo S-298 - [Pier 4] -Detail view of repairs and cracking across west half of north face, Looking South

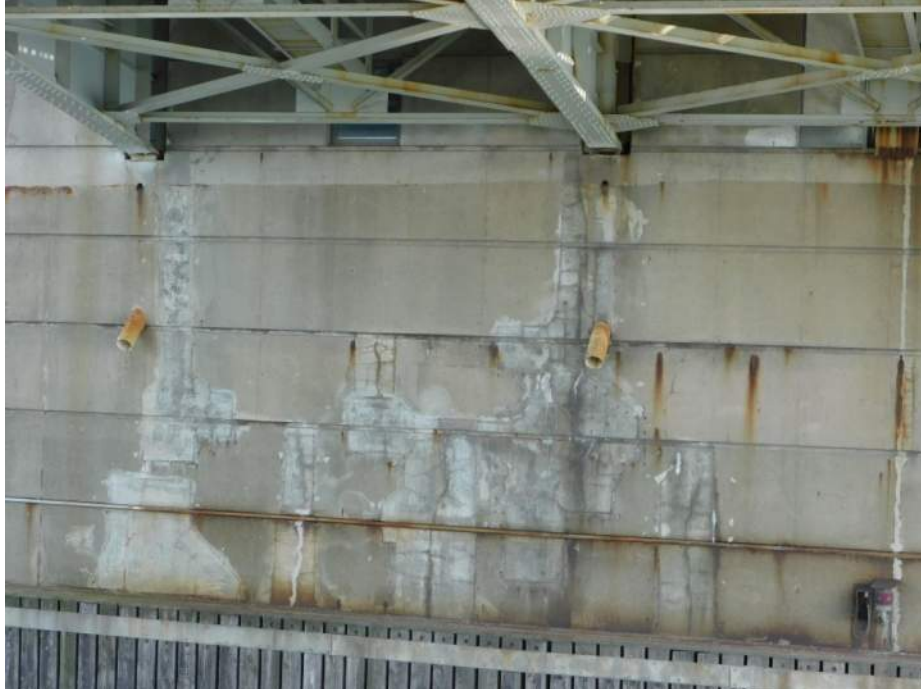
Photo S-299 - [Pier 4] -Detail view of repairs and cracking across east half of north face, Looking South

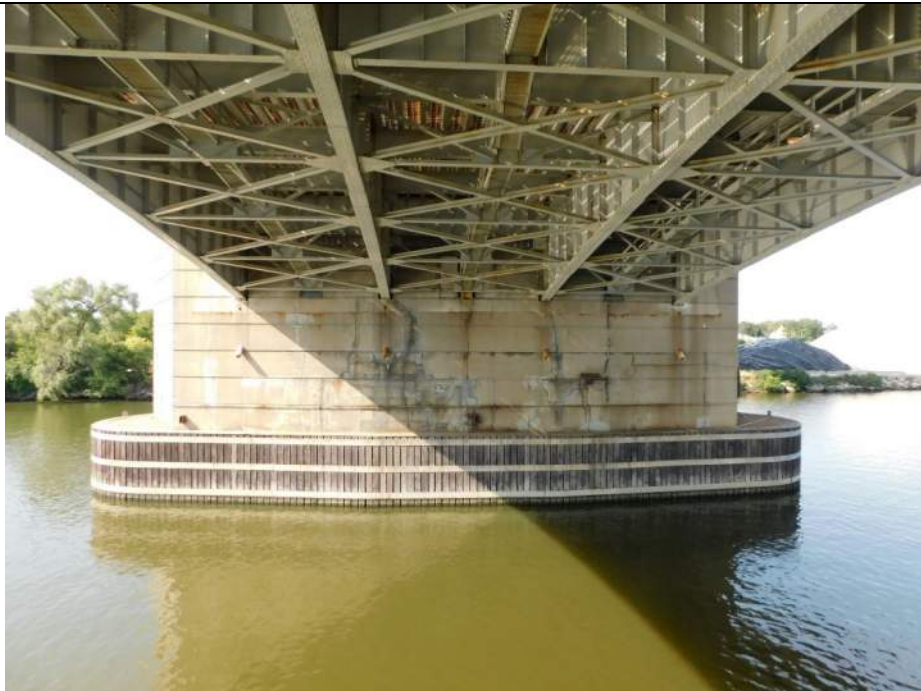
Photo S-300 - [Pier 5] -Pier South face, general view, Looking North

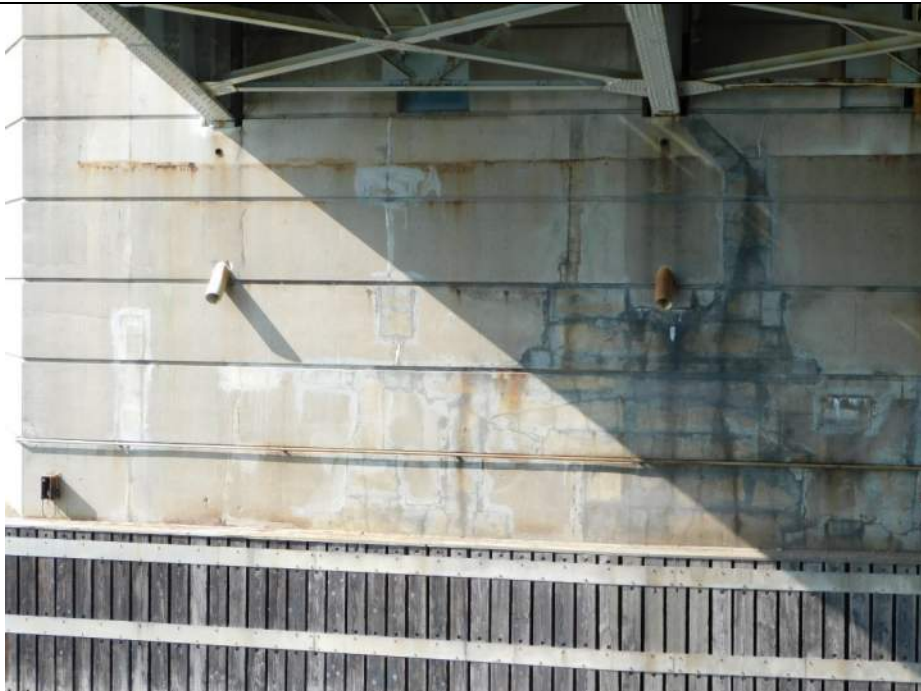
Photo S-302 - [Pier 5] -Detail view of repairs and cracking across west half of south face, Looking North

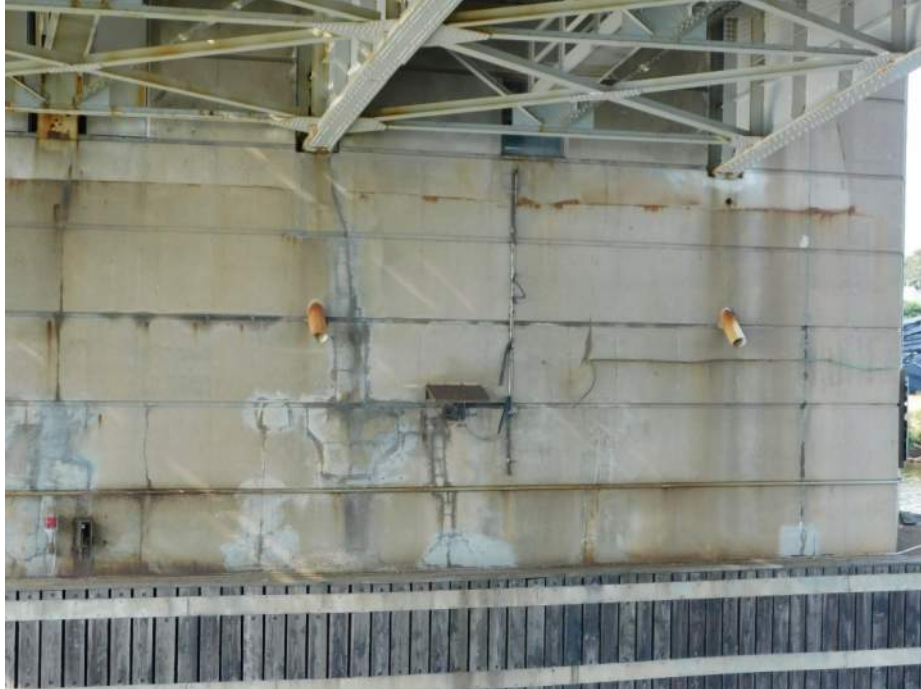
Photo S-303 - [Pier 5] -Detail view of repairs and cracking across east half of south face, Looking North

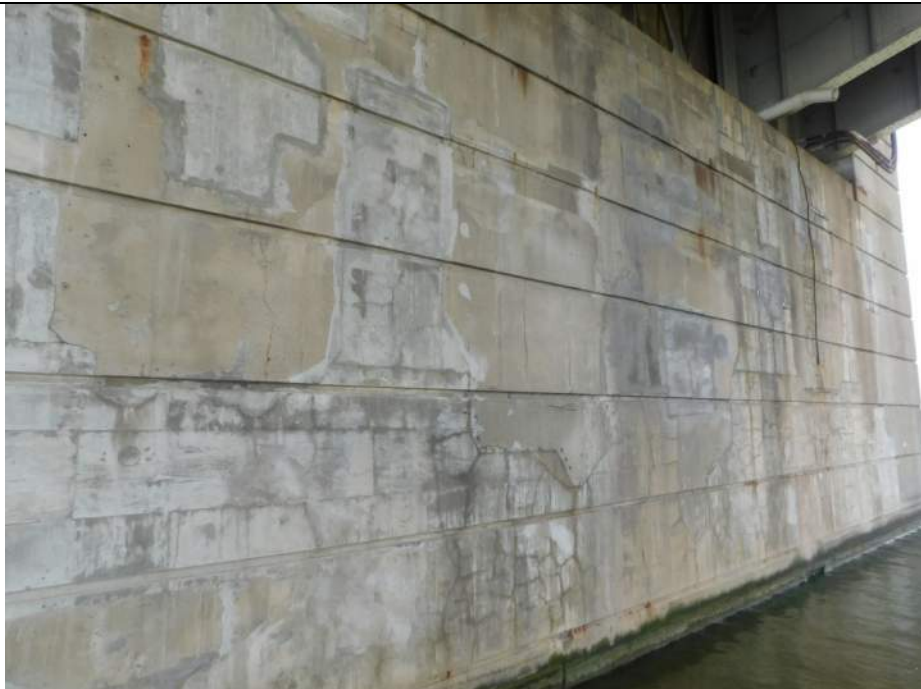
Photo S-304 - [Pier 5] -Pier North face, detail view of widespread patch repairs with scattered cracking, Looking Southwest
