Craig Memorial Bascule Bridge

Over the Maumee River

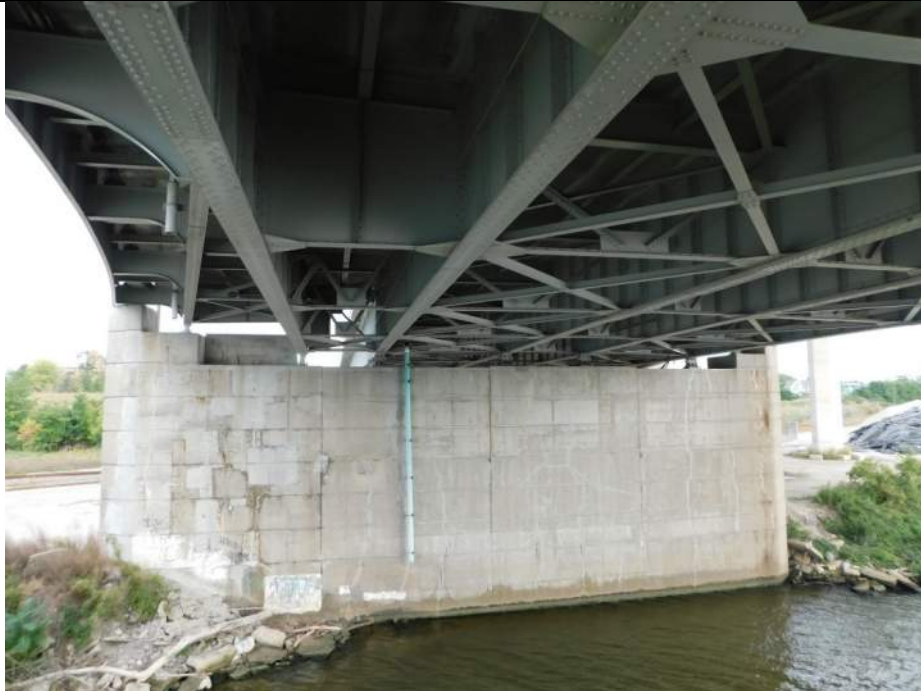
Photo S-305 - [Pier 6] -Pier South face, general view, Looking North

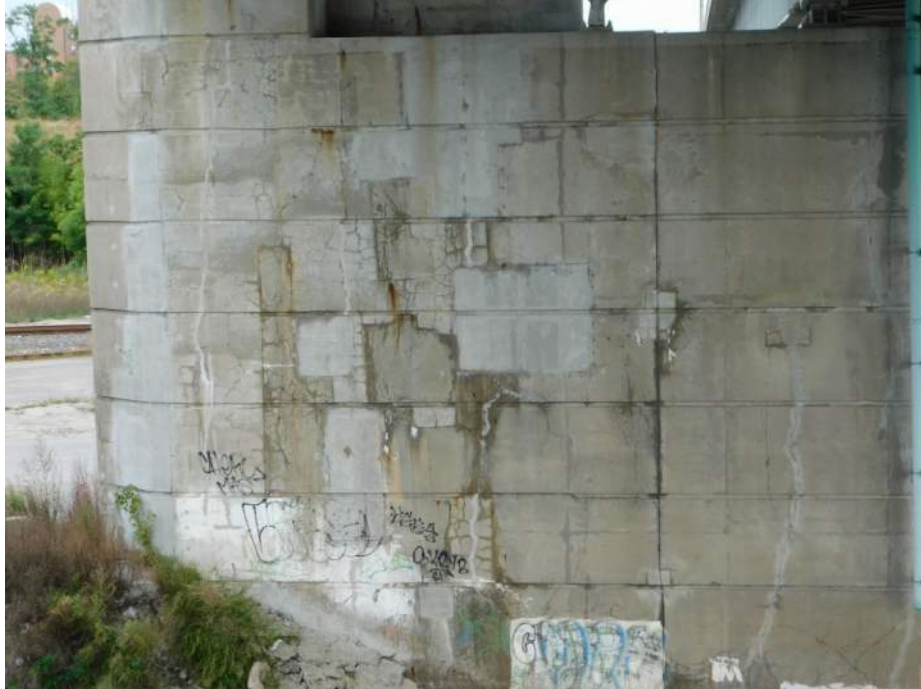
Photo S-307 - [Pier 6] -Pier South face, detail view of west side patch and crack repairs throughout with scattered cracking, Looking North

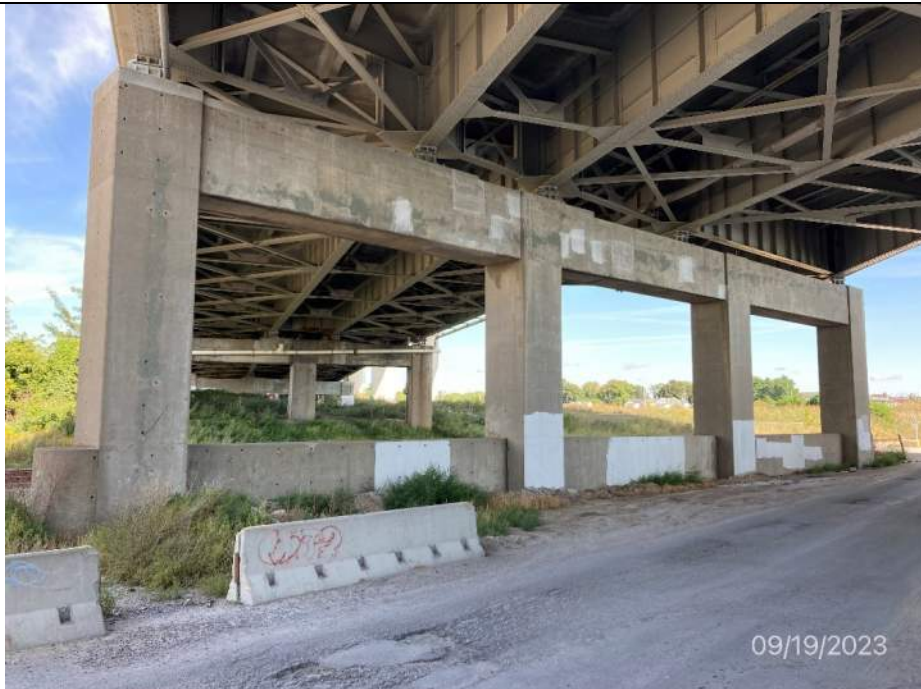
Photo S-308 - [Pier 7] -Pier South face, general view, Looking North

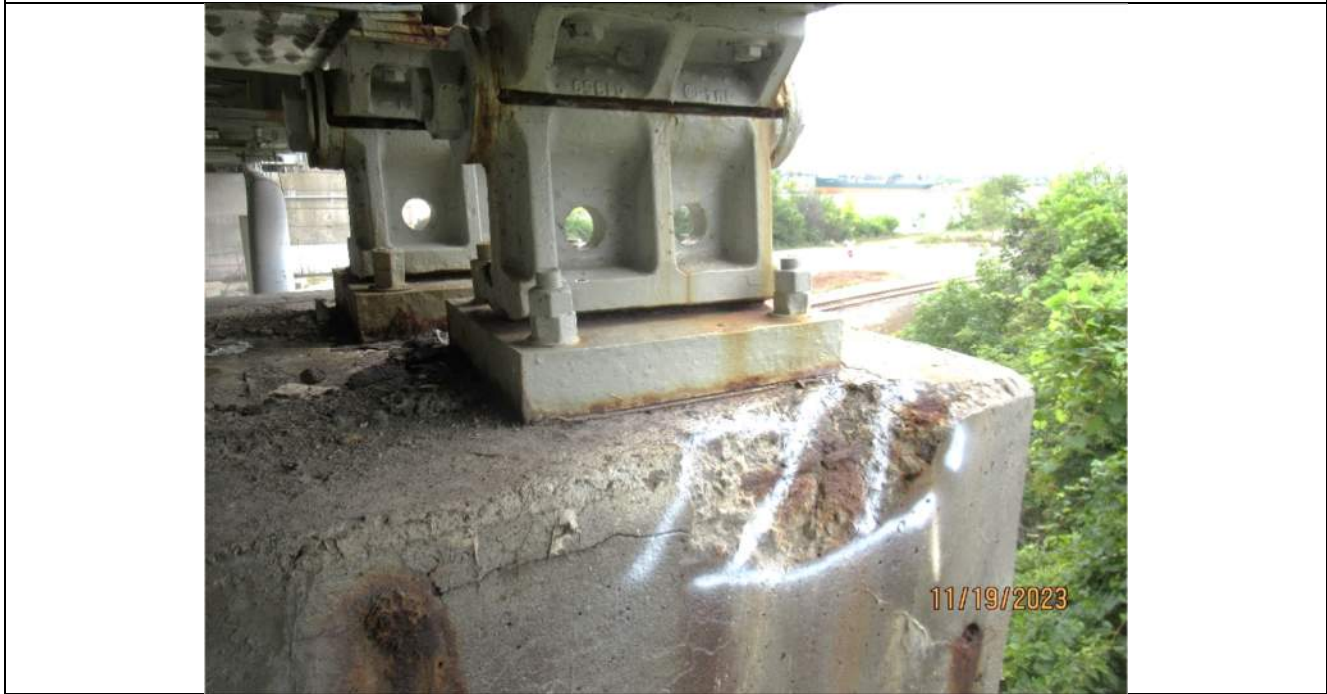
Photo S-312 - [Pier 8] -Pier North face below Bearing 1W, corner spall with exposed rebar, Looking South

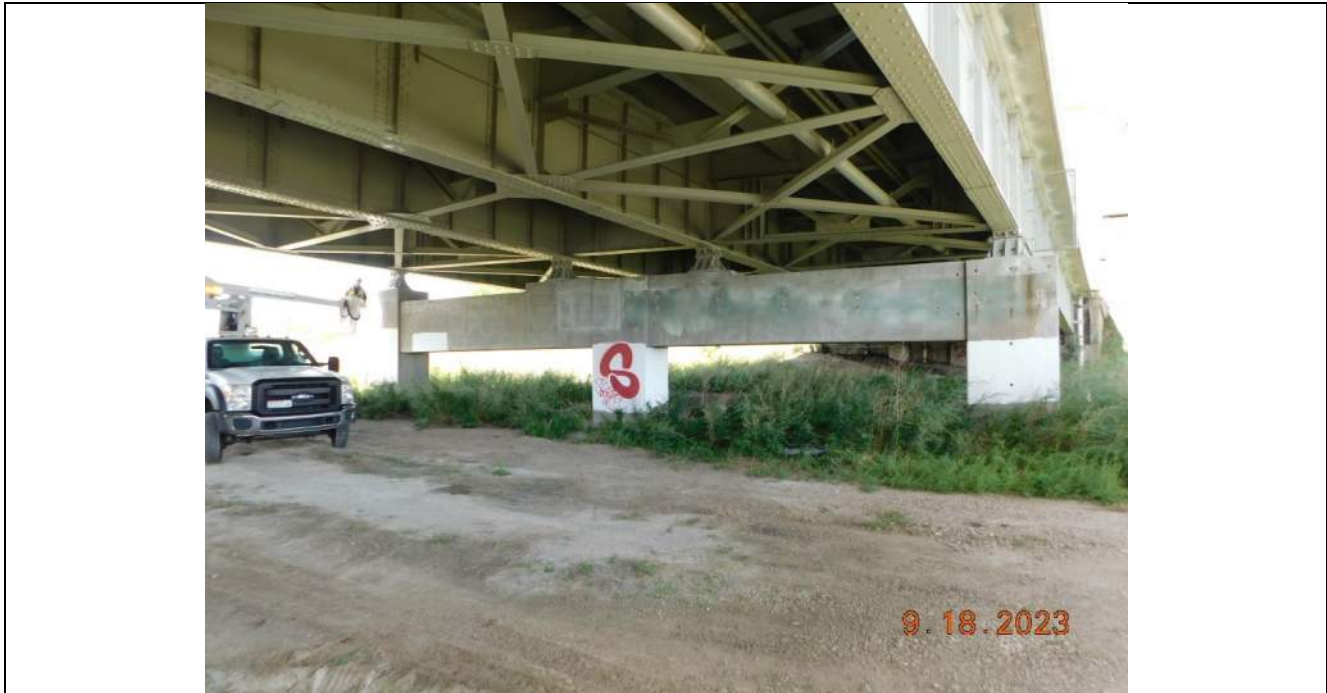
Photo S-313 - [Pier 9] -Pier South face, general view, Looking North

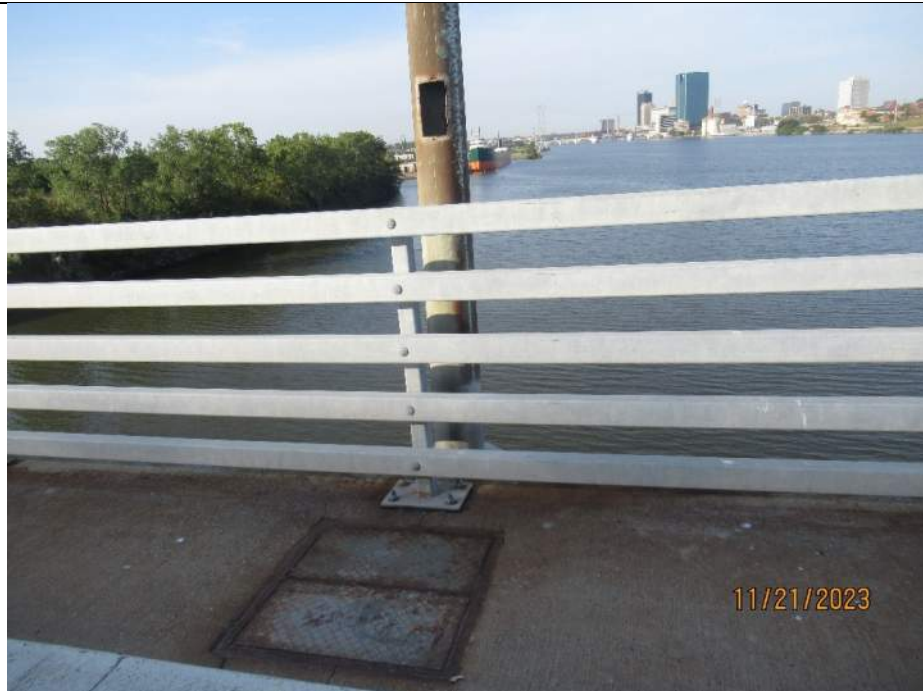
Photo S-317 - [Span 2] -West side light pole, missing access cover above pedestrian railing, typically good condition otherwise, Looking West

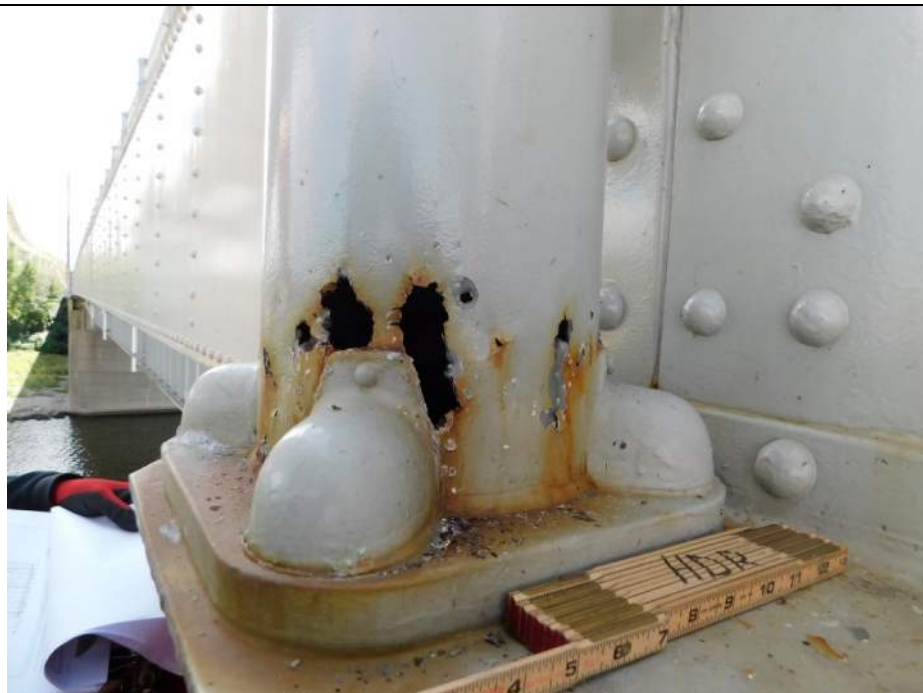
Photo S-318 - [Span 3] -East side light pole at Floorbeam 18S, holes in base of pole around north half, open hand hole cover above, Looking South

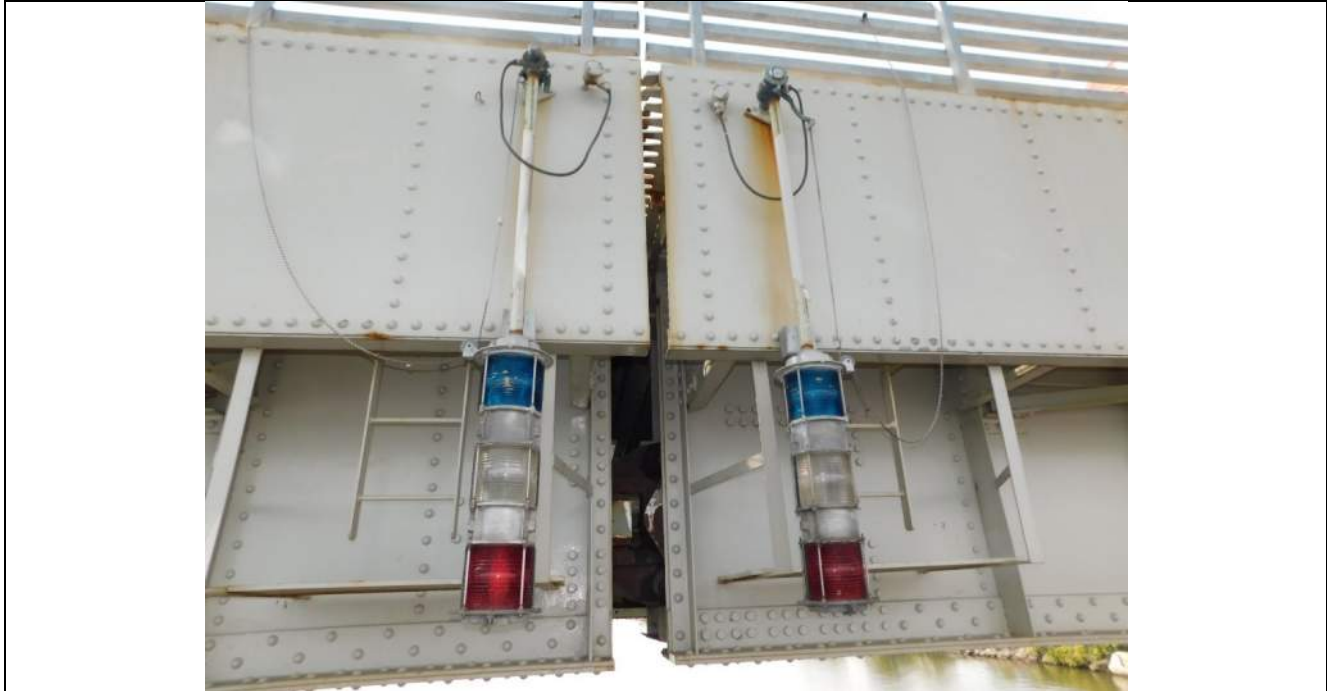
Photo S-321 - [Span 5] -East side navigational lights, good condition, lights not functional, Looking West

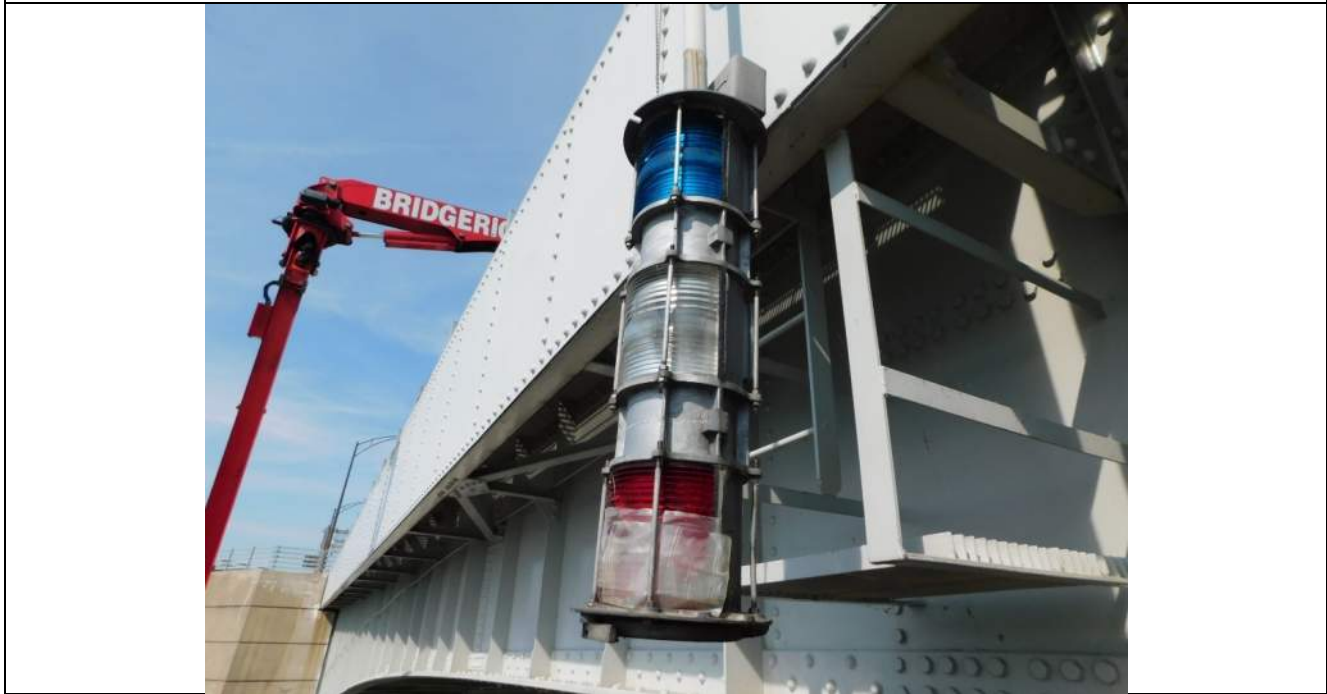
Photo S-322 - [Span 5] -West side, north navigational light, cracked glass at bottom light, lights not functional, Looking North

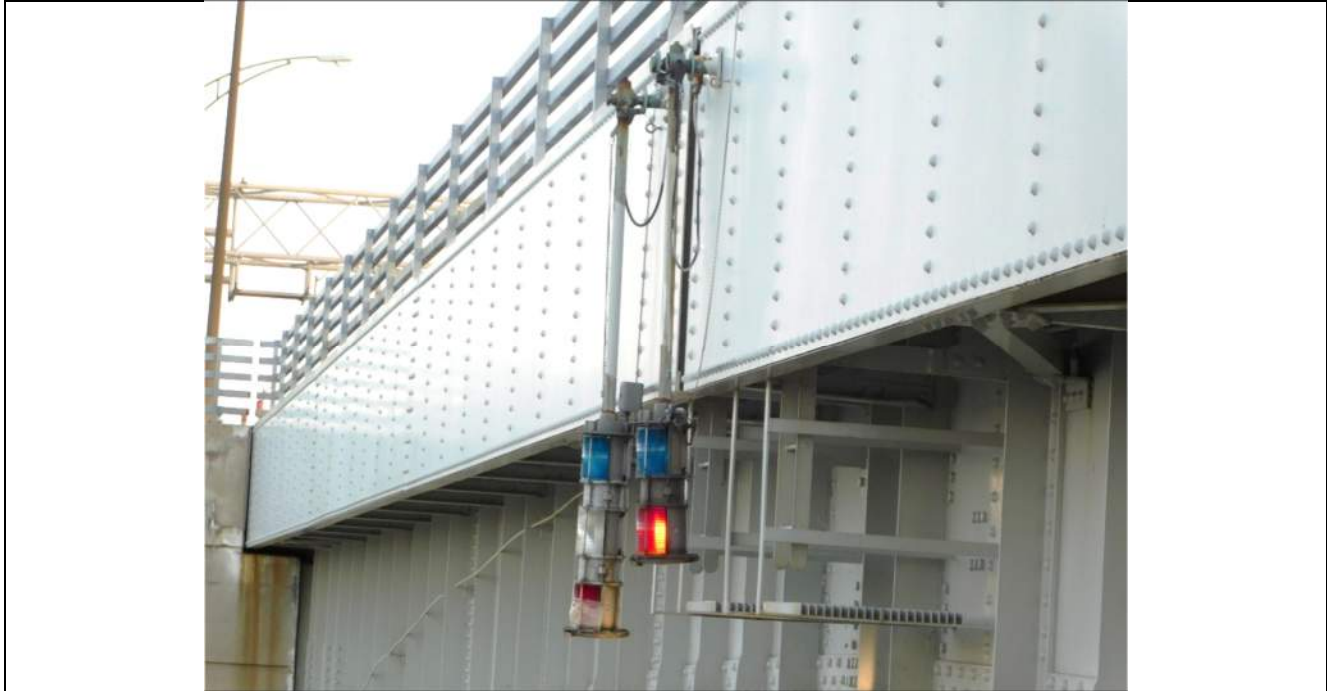
Photo S-323 - [Span 5] -West side navigational lights, north light not functional, south light functional, Looking North

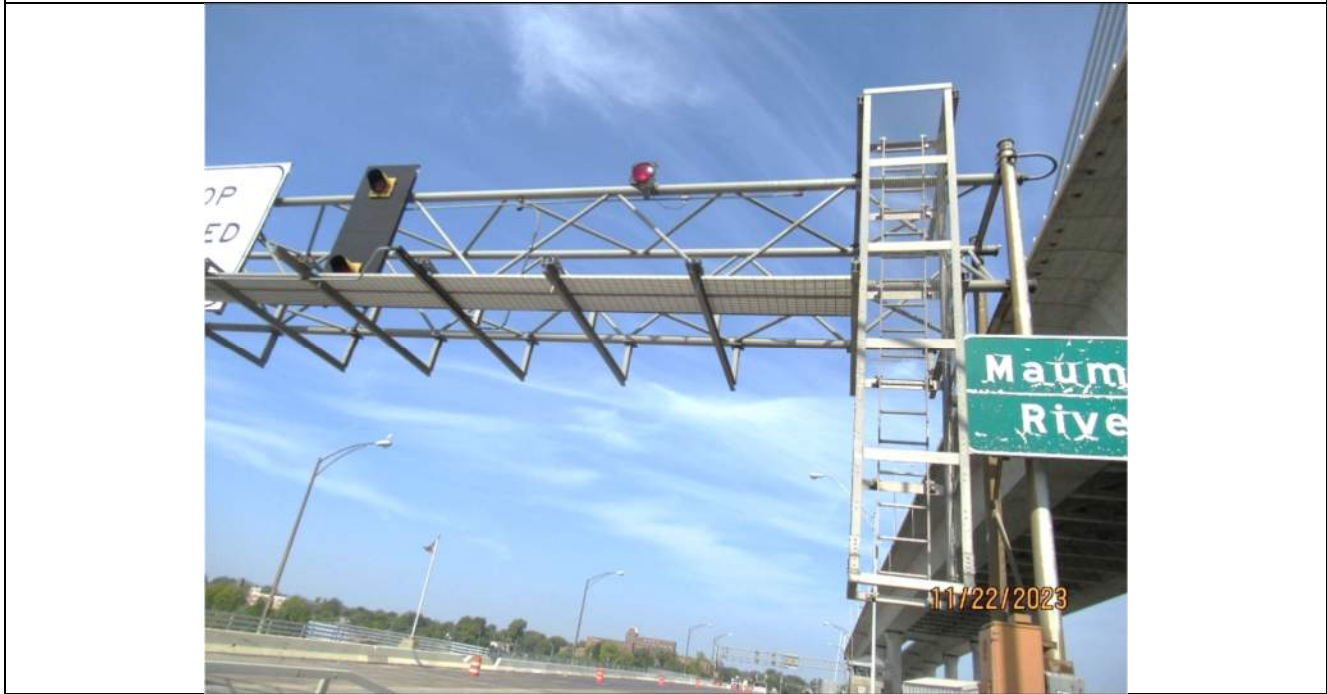
Photo S-326 - [Span 4] -Overhead Sign Gantry, South elevation east half, detail view, components in good condition, Looking North

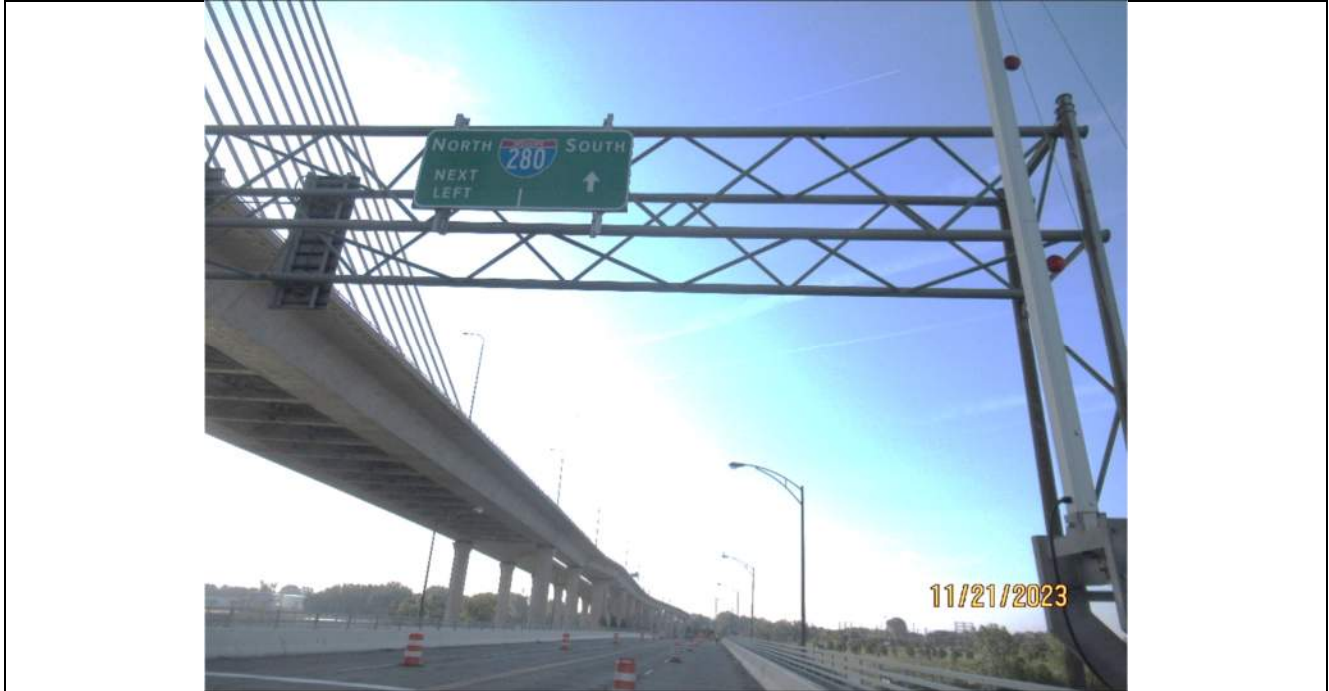
Photo S-327 - [Span 4] -Overhead Sign Gantry, North elevation west half, detail view, components in good condition, Looking South

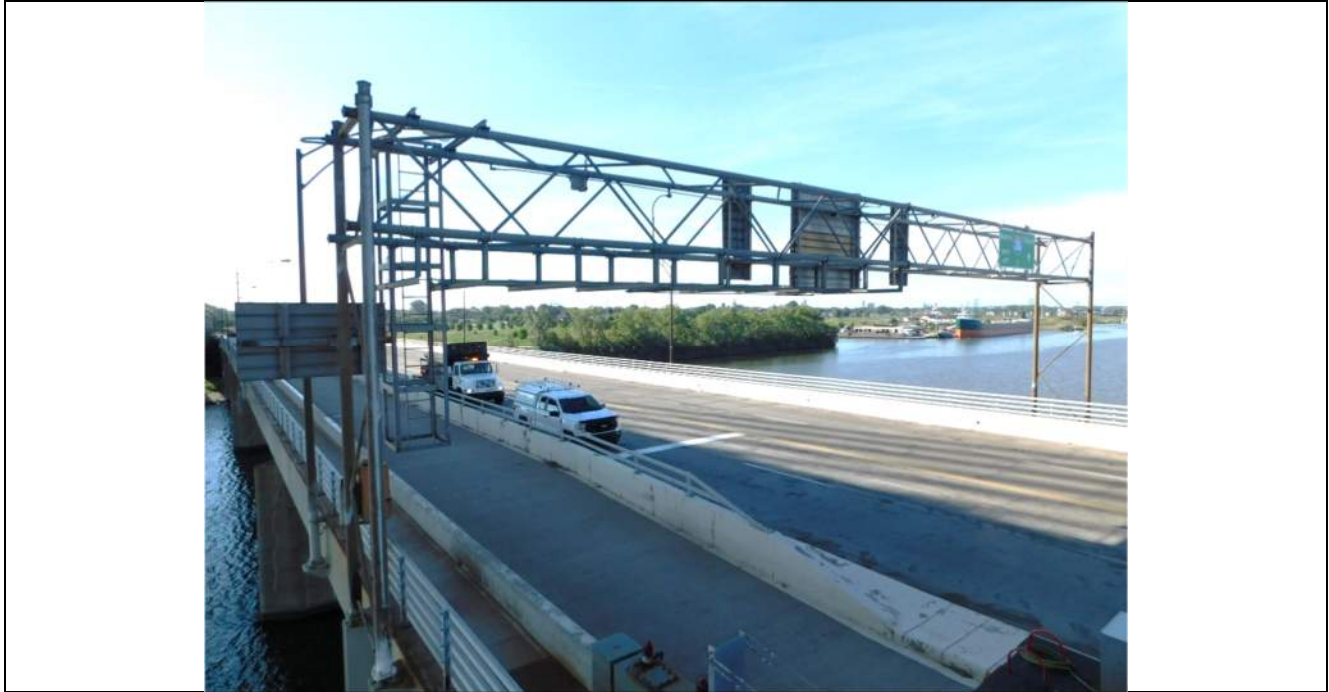
Photo S-328 - [Span 4] -Overhead Sign Gantry, general north elevation view from east side, Looking Southwest

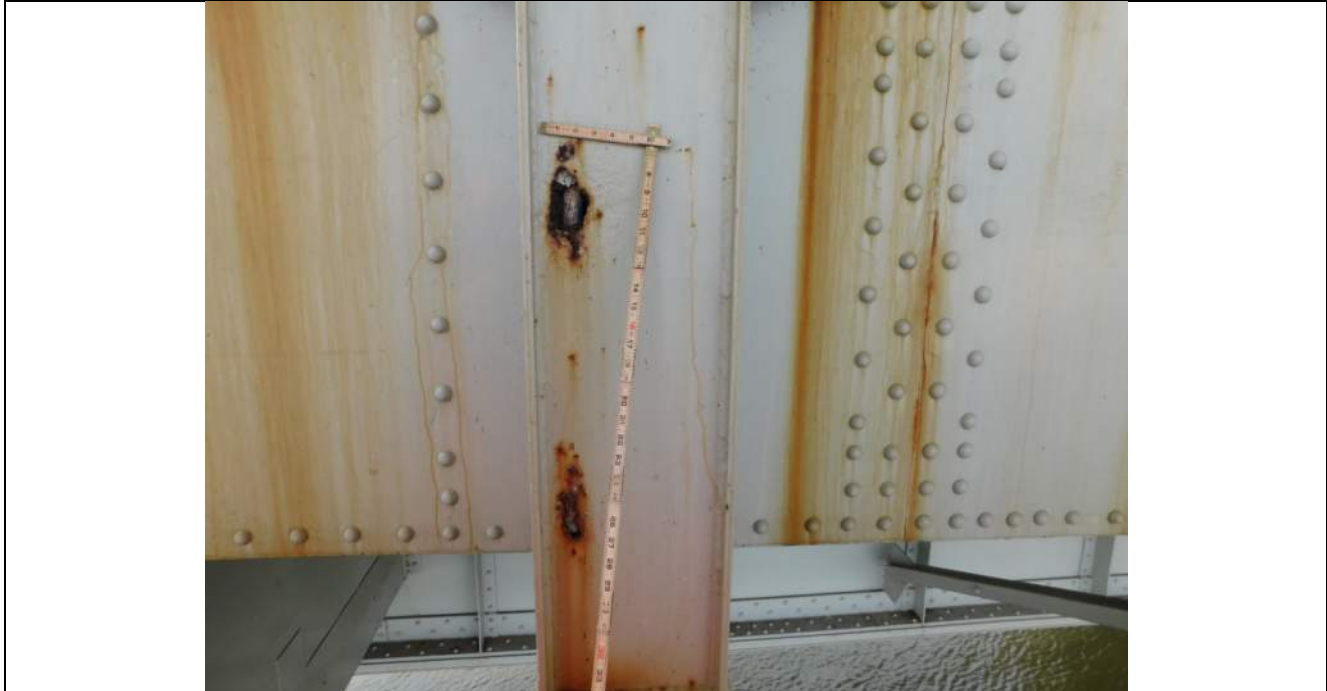
Photo S-329 - [Span 6] -Sign gantry support connection at East fascia, south post base exhibits two corrosion holes in the east plate up to 4" x 2", Looking West

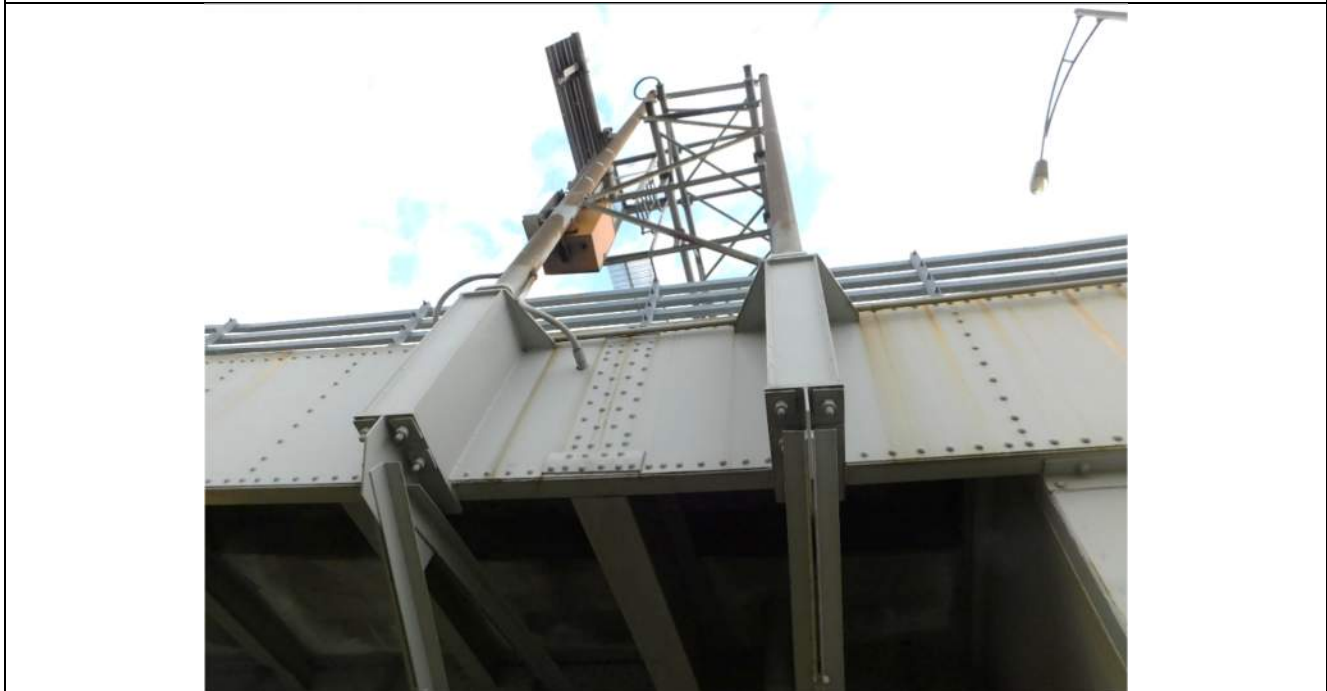
Photo S-330 - [Span 6] -Sign gantry support connections at West fascia, posts and bases in good condition, Looking East

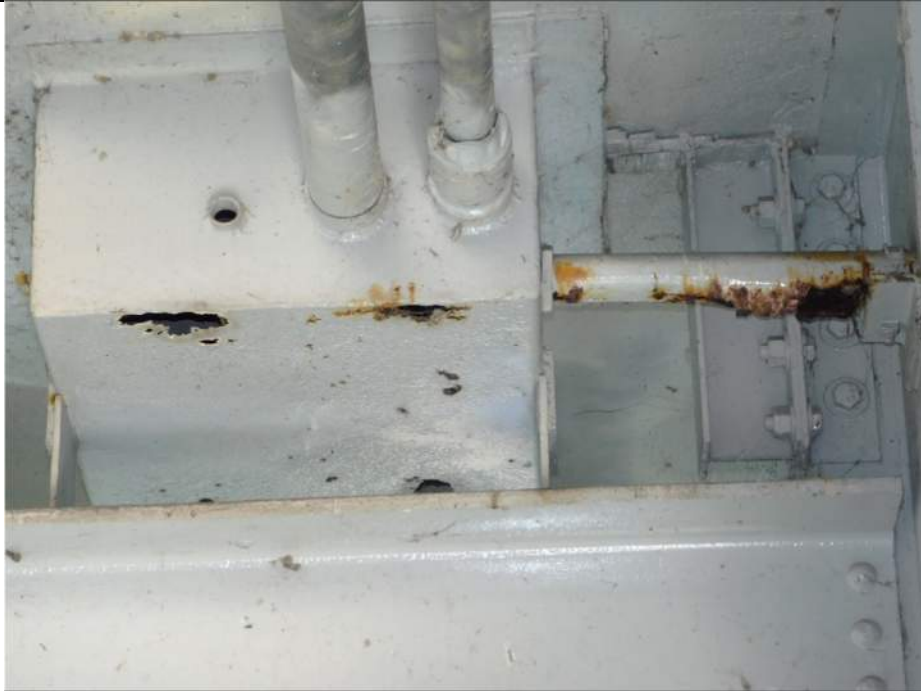
Photo S-331 - [Span 2] -Electrical junction box and conduit above Floorbeam 11S East exterior, holes in box and conduit, Looking North

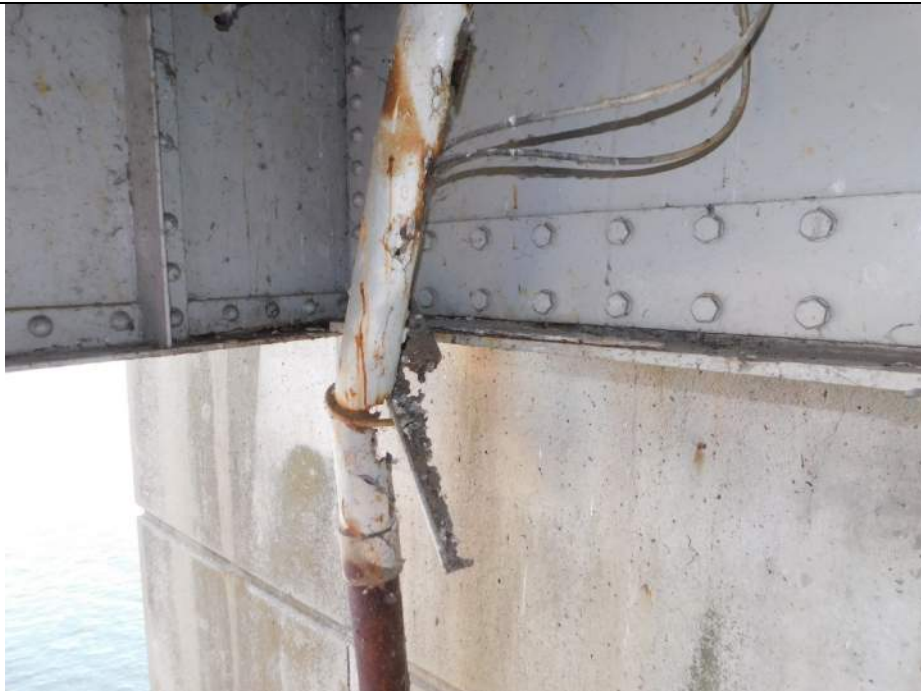
Photo S-334 - [Span 6] -Electrical conduit exhibits 100% SL and a broken support angle at connection to East exterior FB0S with exposed wiring, Looking Southeast

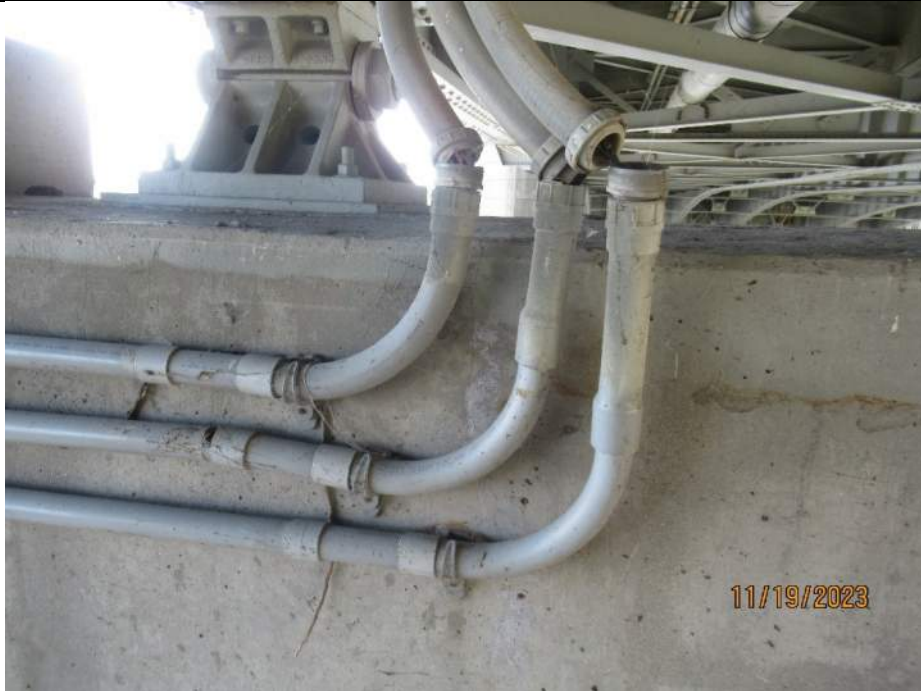
Photo S-335 - [Pier 6] -Three conduits at north face of pier are disconnected with exposed wiring, Looking South

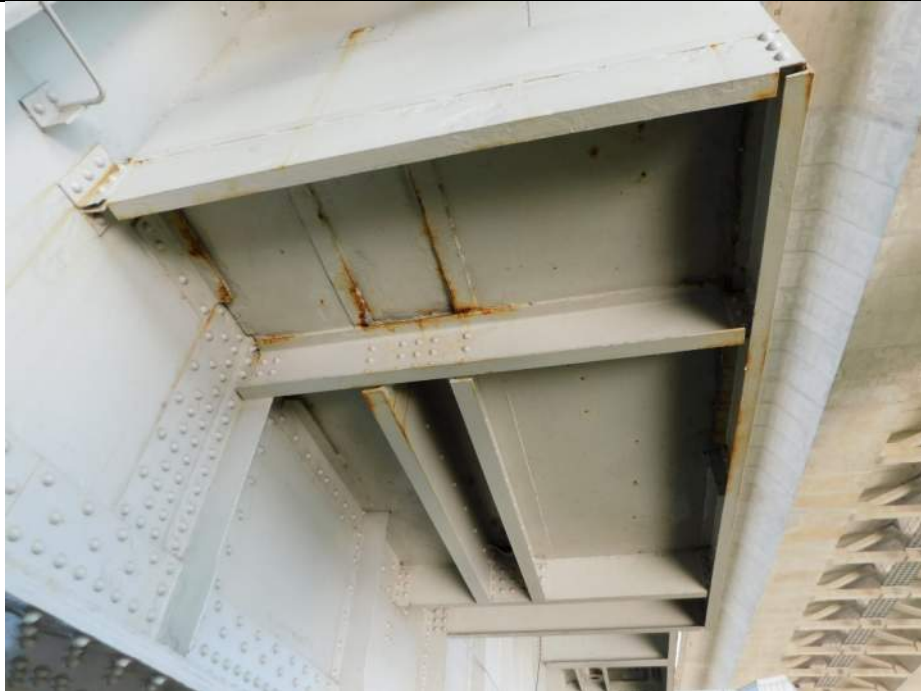
Photo S-337 - [Span 4] -Swing gate operational support and housing attached to G4W, east side lower framing, minor bleeding corrosion and painted over edge section loss throughout, Looking Northeast

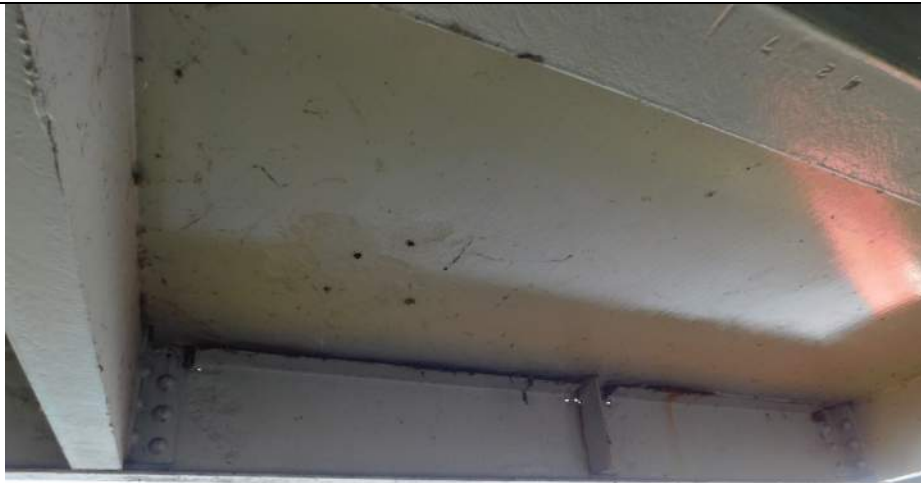
Photo S-338 - [Span 6] -Swing gate operational support and housing attached to G4W, east side lower framing, painted over section loss and small holes in east channel, Looking East

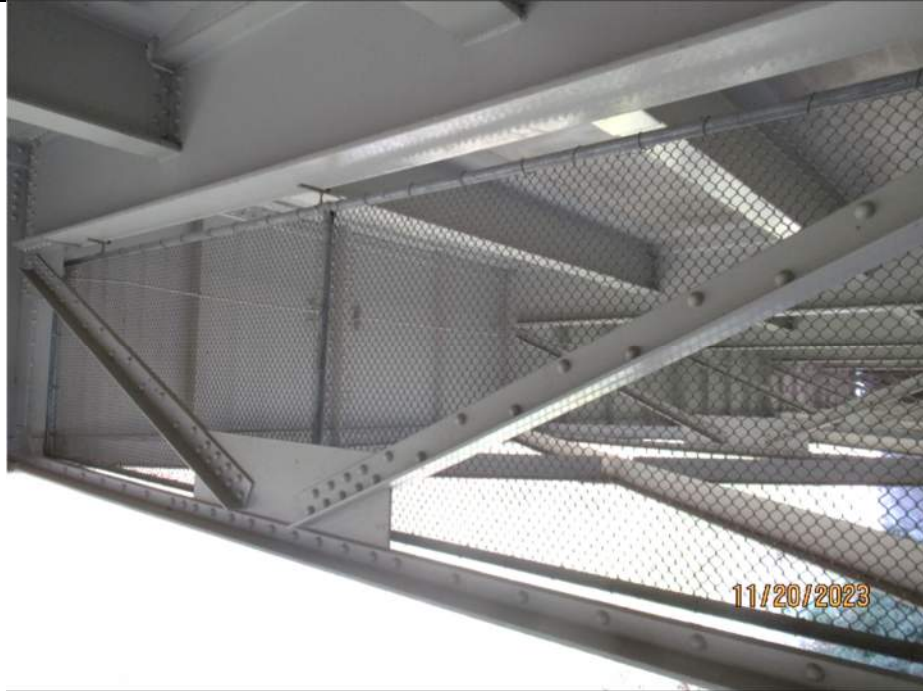
Photo S-339 - [Span 10] -Security fencing along Floorbeam 6S is in good condition, including connections to floorbeams, girders, bracing members, view between G1W-G2W, Looking Northwest

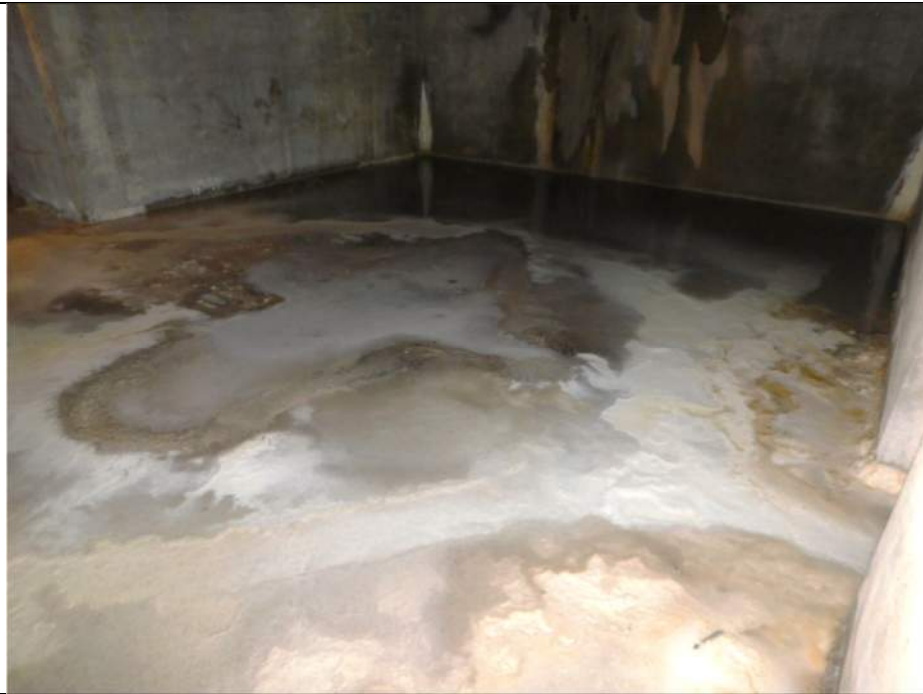
Photo S-340 - [Pier 4 Interior] -Basement Level (Level F), Room 4W, water and silt accumulation across floor, Looking South

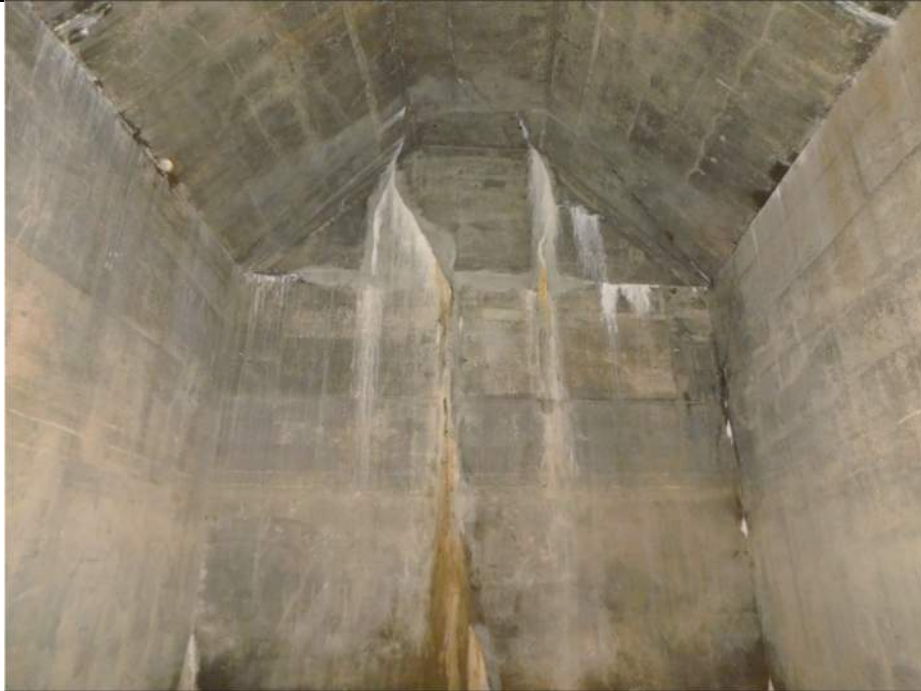
Photo S-341 - [Pier 4 Interior] -Basement Level (Level F), Room 2W, vertical cracking in North wall with heavy efflorescence, Looking North

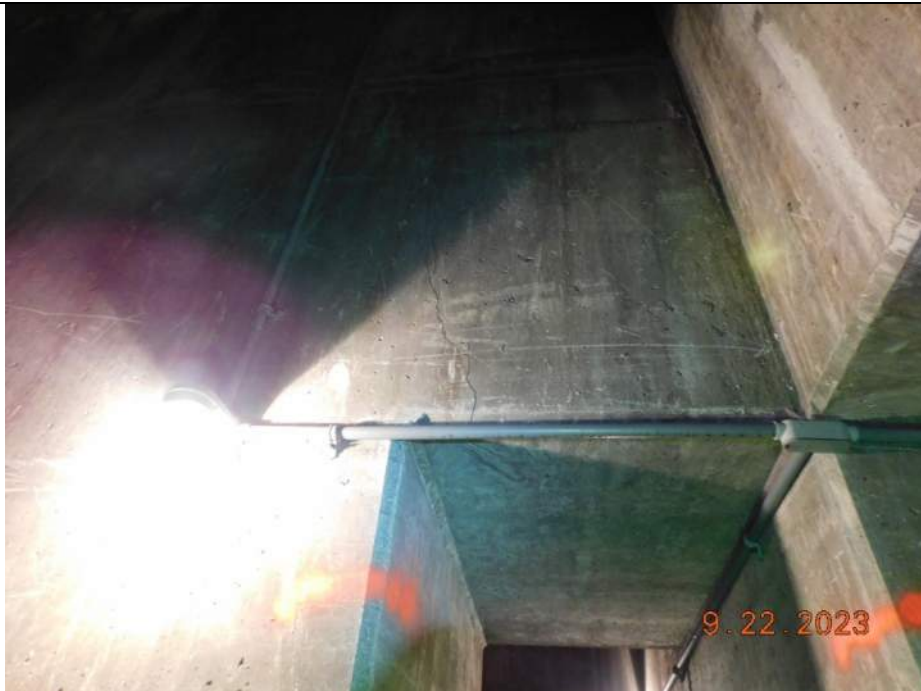
Photo S-342 - [Pier 5 Interior] -Basement Level (Level F), Room 1W, diagonal cracking in interior wall above doorway between north and south sides of west exterior room, Looking North

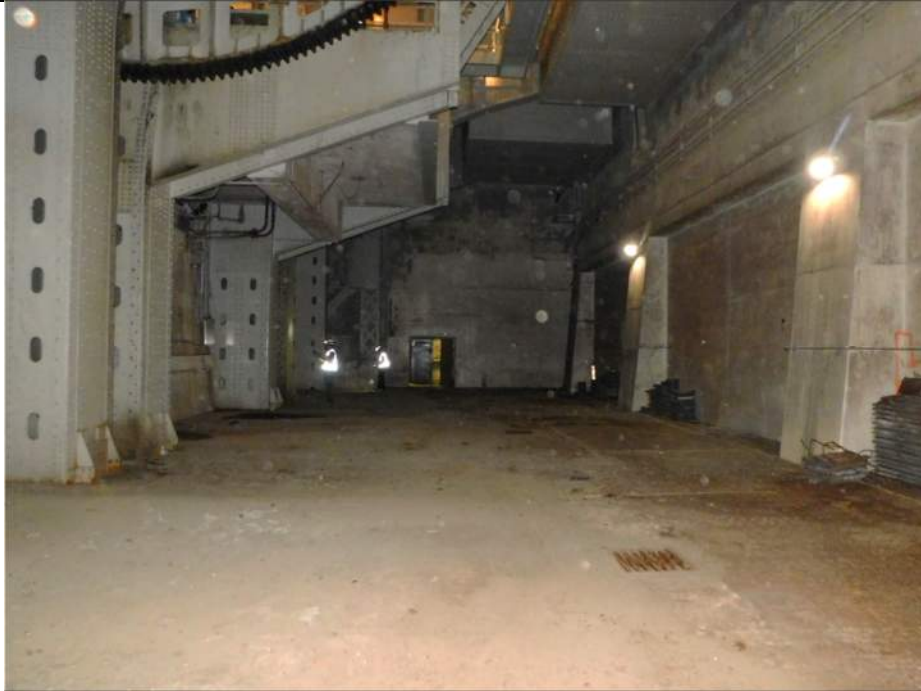
Photo S-343 - [Pier 4 Interior] -Counterweight Pit (Level E), general view of interior, Looking East

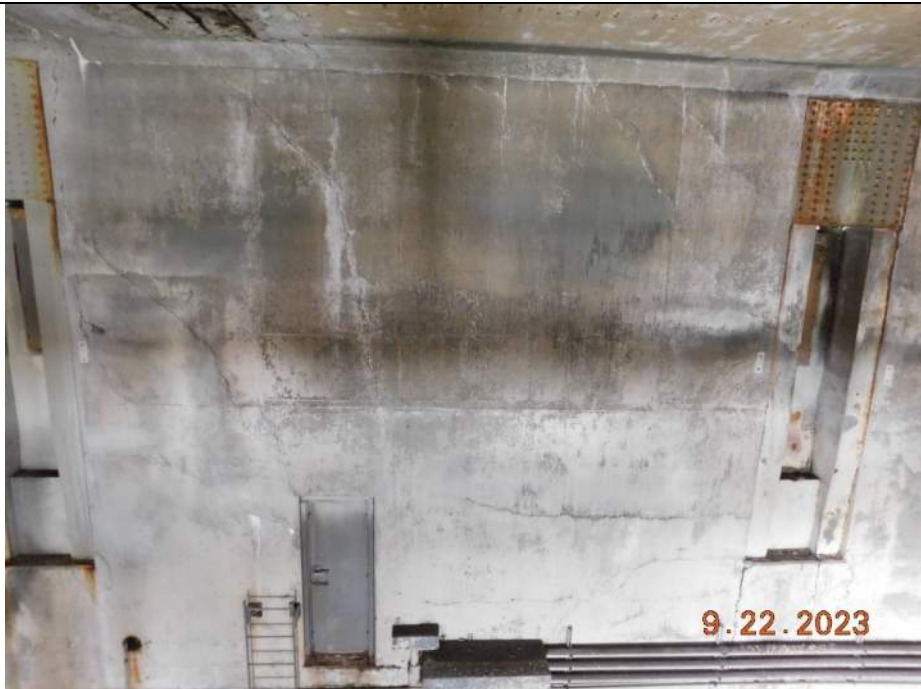
Photo S-344 - [Pier 5 Interior] -Counterweight Pit (Level E), upper North wall diagonal cracking throughout between girder live load bearing cut-outs, Looking North

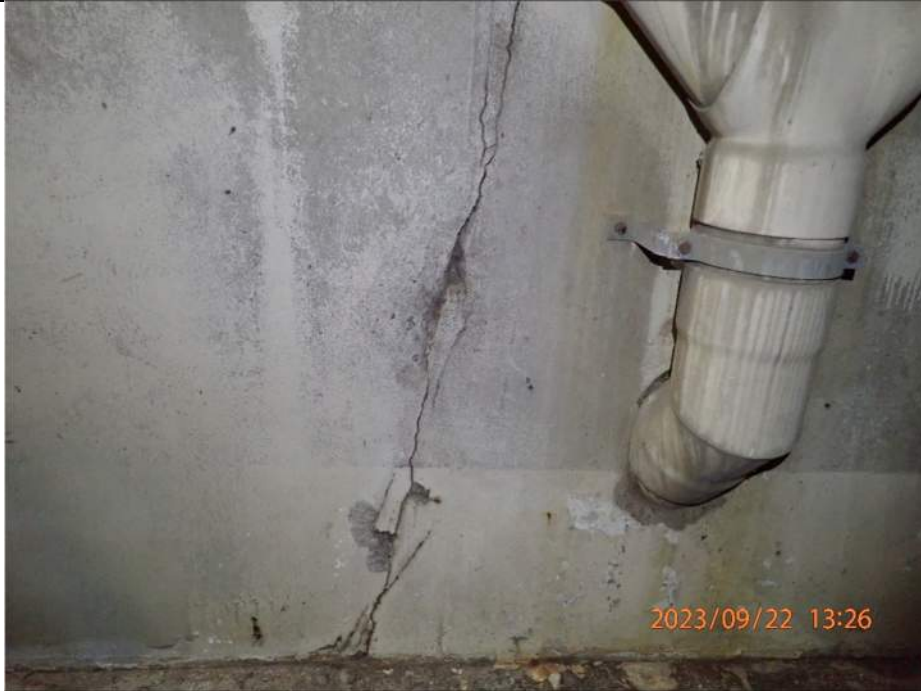
Photo S-345 - [Pier 4 Interior] -Machinery level (Level D) channel side wall between Girders 3W and 4W, wide vertical crack behind drainage pipe, Looking North

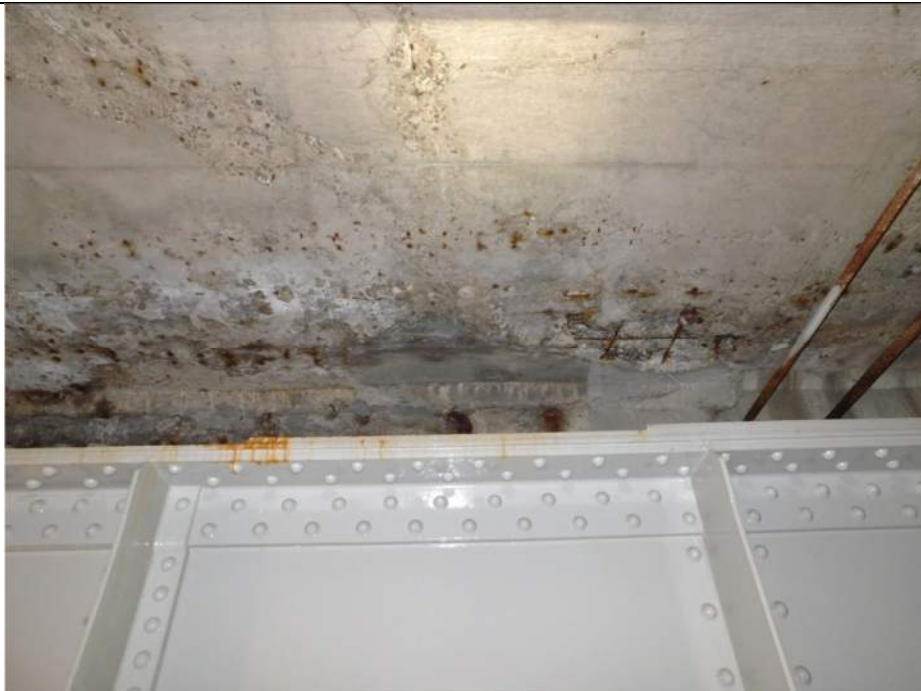
Photo S-346 - [Pier 4 Interior] -Girder 4W at roadway span underside (Level C), view of cracking and small spalls to deck underside above counterweight, Looking West

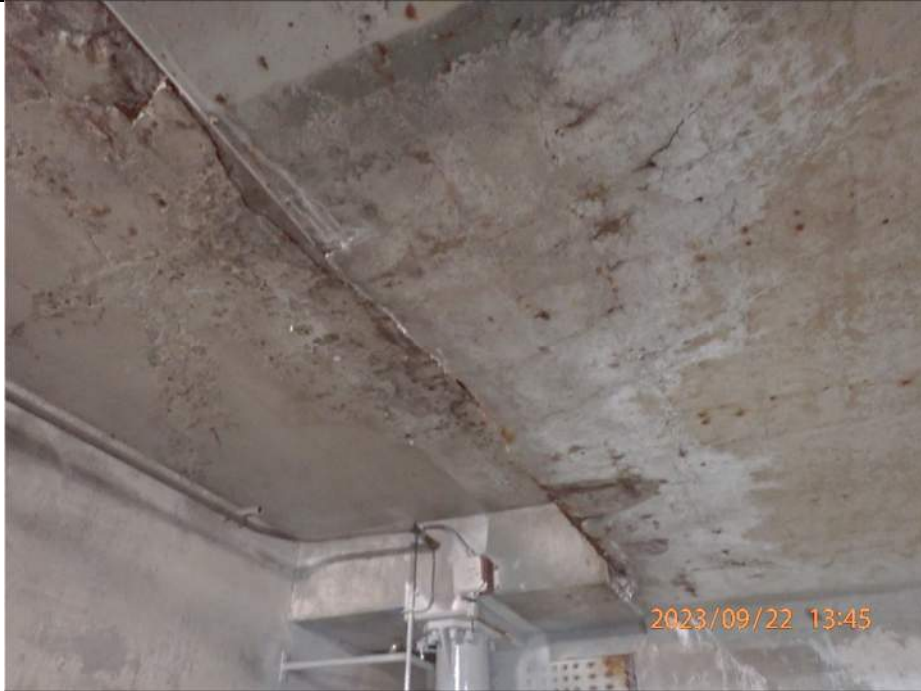
Photo S-347 - [Pier 4 Interior] -Roadway span underside (Level C) above Girder 4W, view of cracking and small spalls to deck underside above counterweight, Looking Southeast

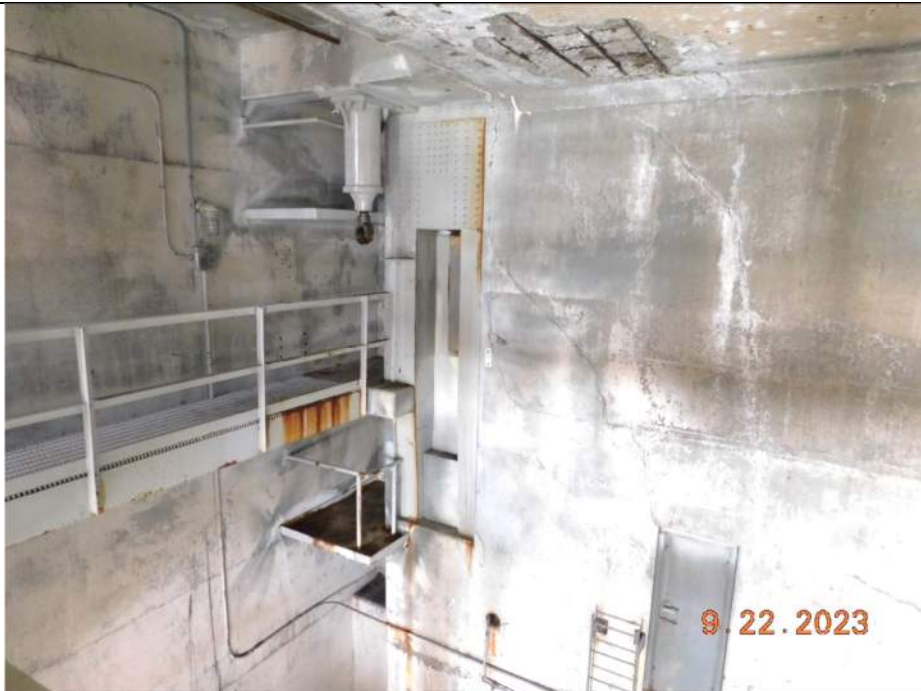
Photo S-348 - [Pier 5 Interior] -Roadway span underside (Level C), view of 4 ft x 3 ft spall to deck underside above counterweight at G1W, Looking Northwest
