Craig Memorial Bascule Bridge

Over the Maumee River

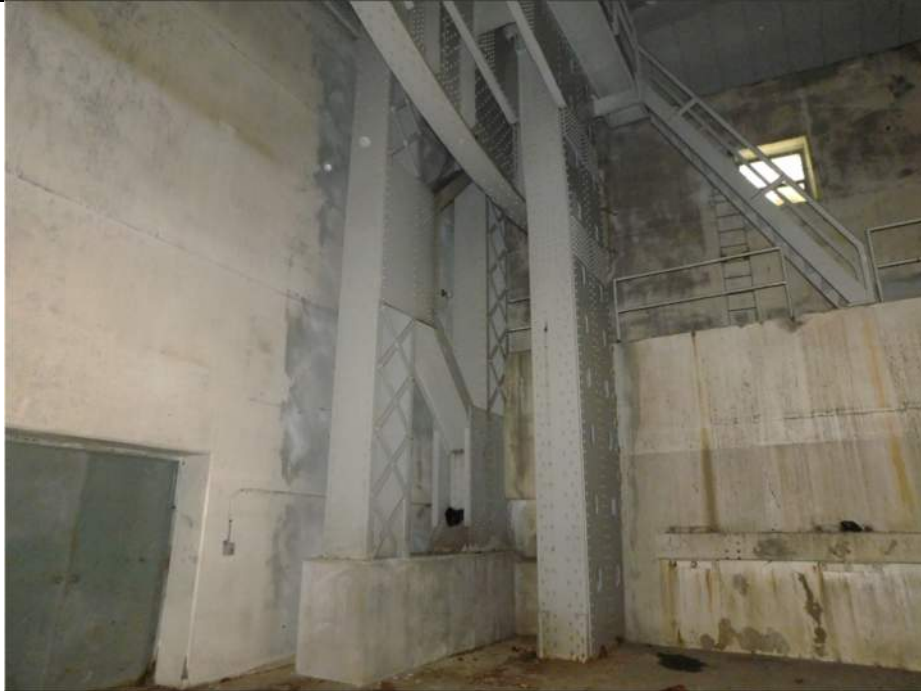
Photo S-349 - [Pier 4 Interior] -Trunnion Tower 1W general view of lower portion of paired tower legs, Looking Northwest

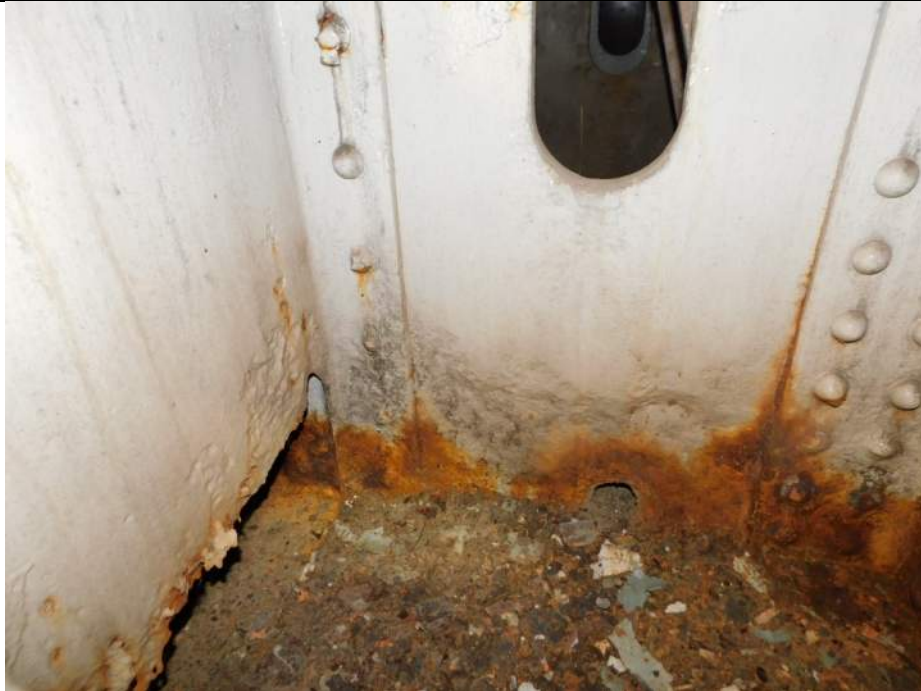
Photo S-351 - [Pier 4 Interior] -Trunnion Tower 3W West leg interior at base, active section loss and corrosion hole in diaphragm, Looking Northeast

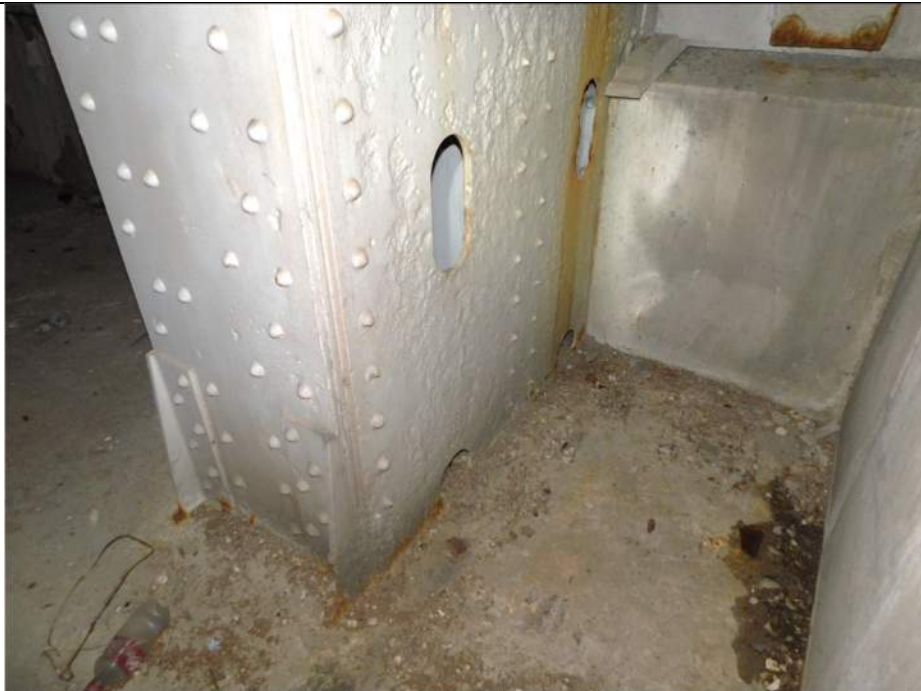
Photo S-352 - [Pier 4 Interior] -Tower 4W West leg at base, exterior of East plate, painted over section loss throughout, Looking Northwest

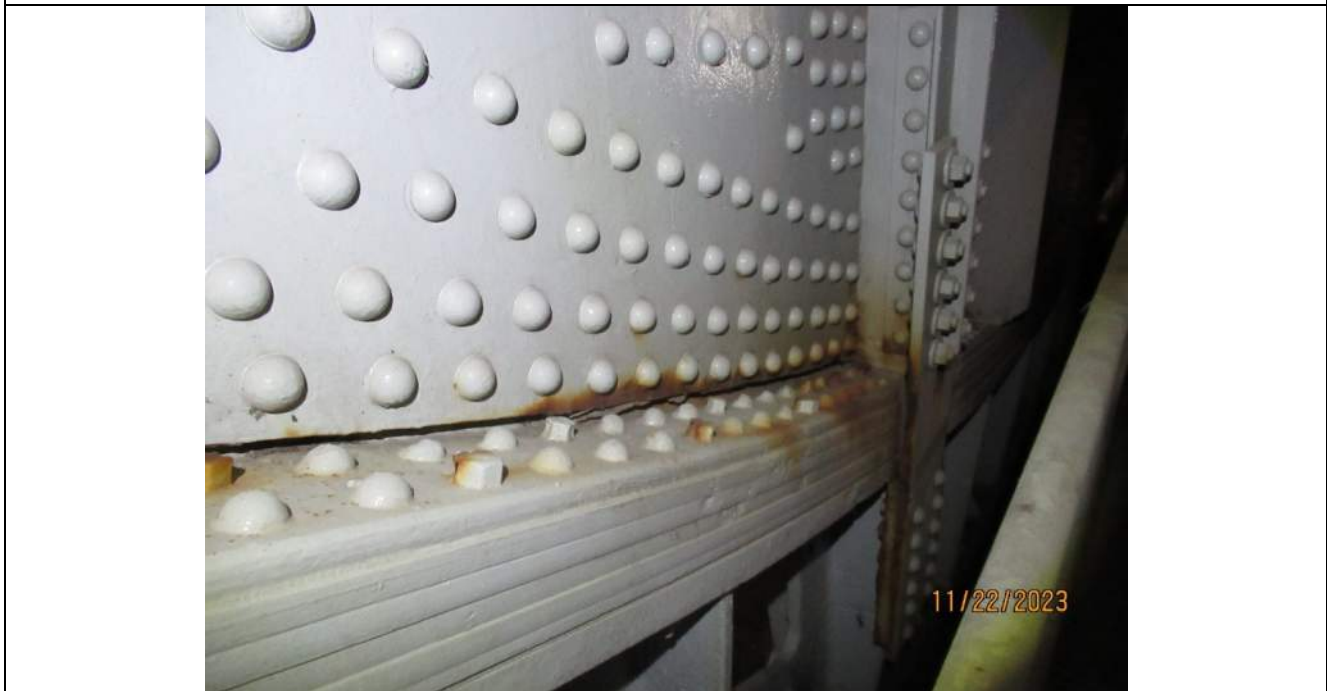
Photo S-358 - [Pier 5 Interior] -Girder 3W, West face behind the trunnion bearing, typical localized minor corrosion to plate edge above bottom flange, Looking East

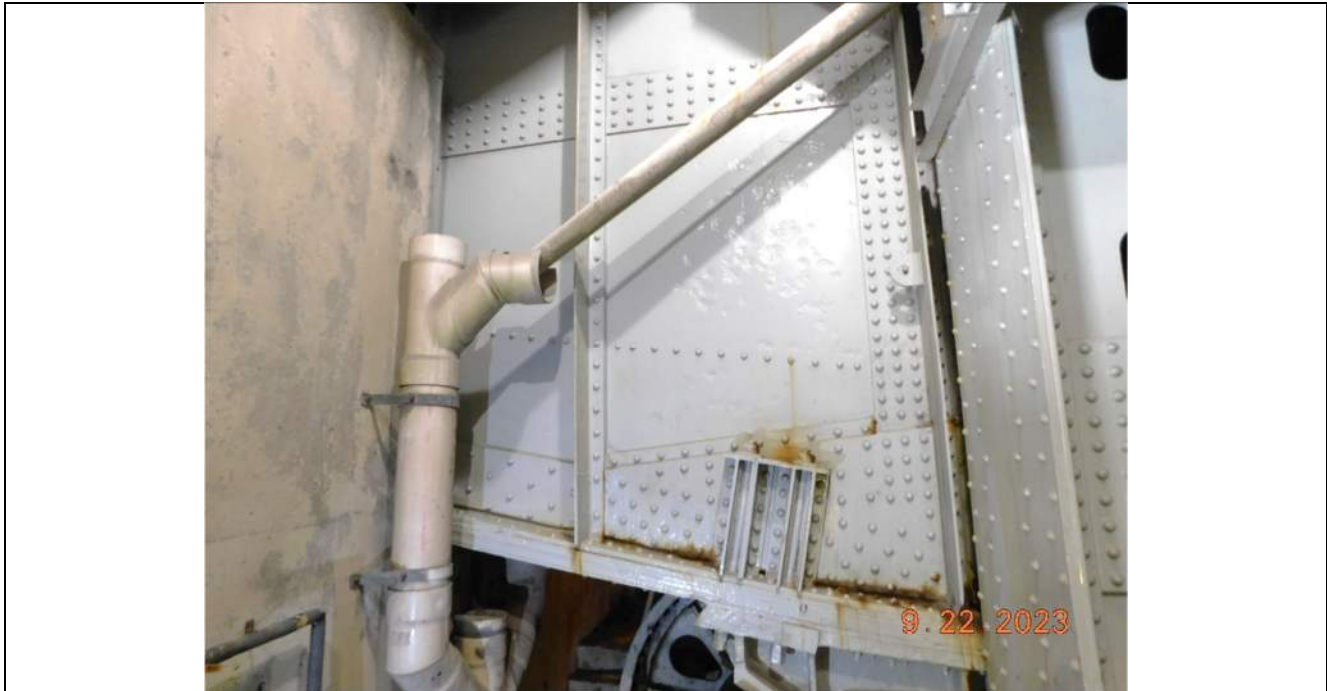
Photo S-359 - [Pier 5 Interior] -Girder 3W, East face between pier wall and trunnion tower, typical painted over section loss to web plate and minor corrosion along bottom flange, Looking West

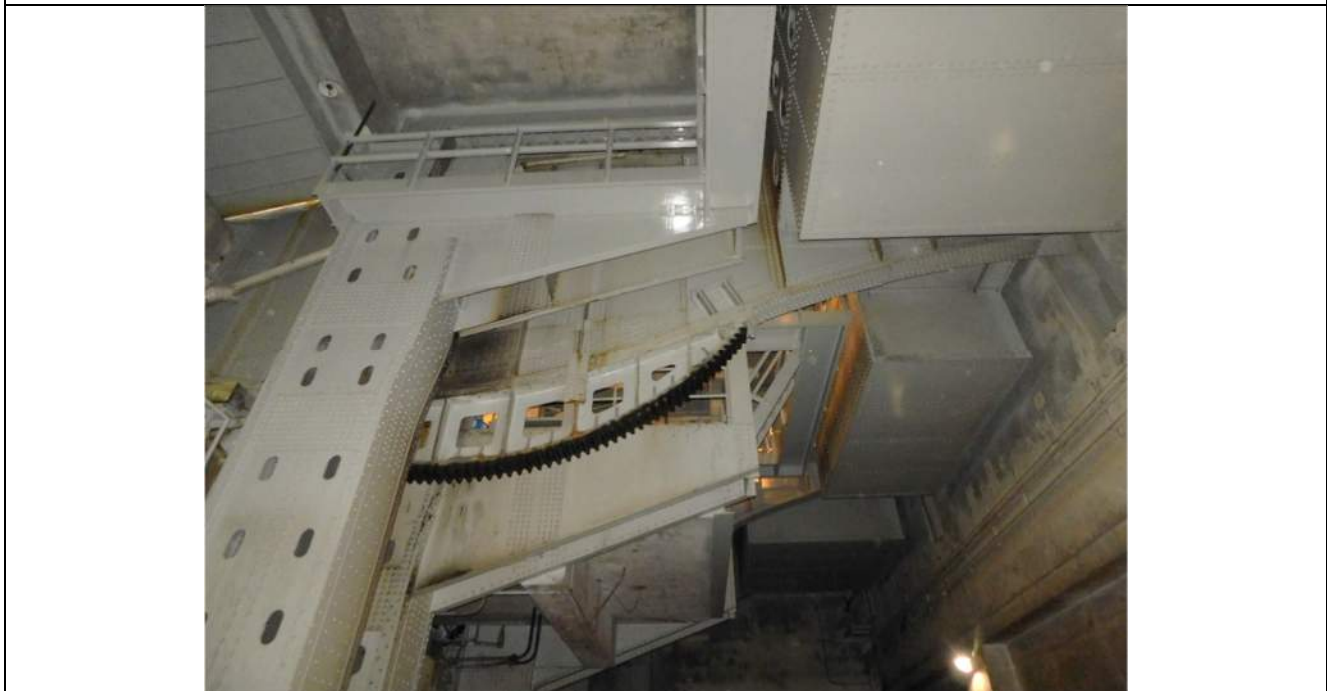
Photo S-360 - [Pier 4 Interior] -Counterweight undersides at girder tails, general view of lower portions at G2W, G3W, Looking East

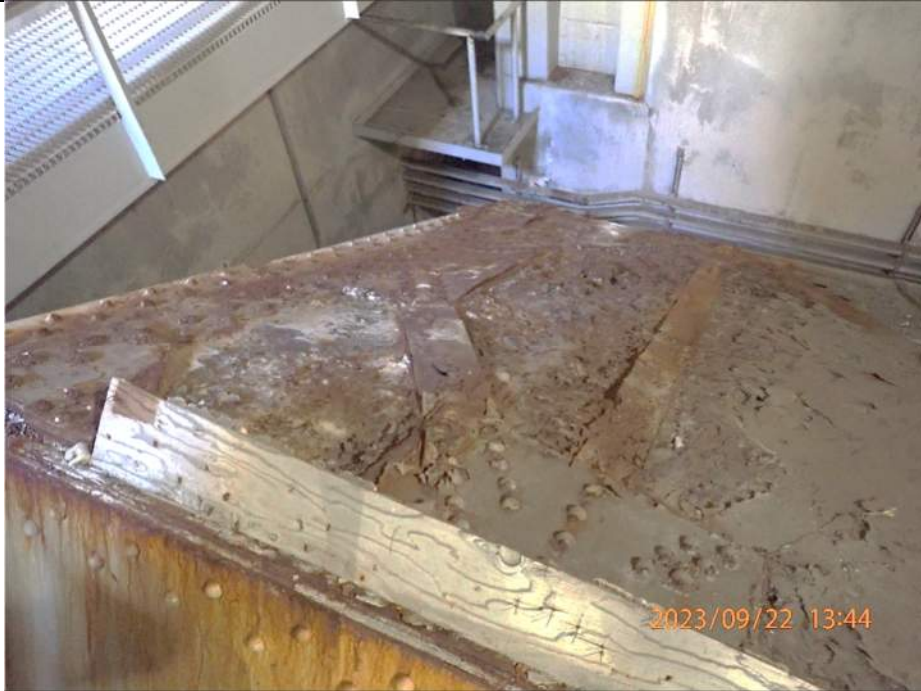
Photo S-361 - [Pier 4 Interior] -Counterweight top at east side (G4W) with moderate corrosion and minor spalling deterioration across the top of the block, Looking Southeast

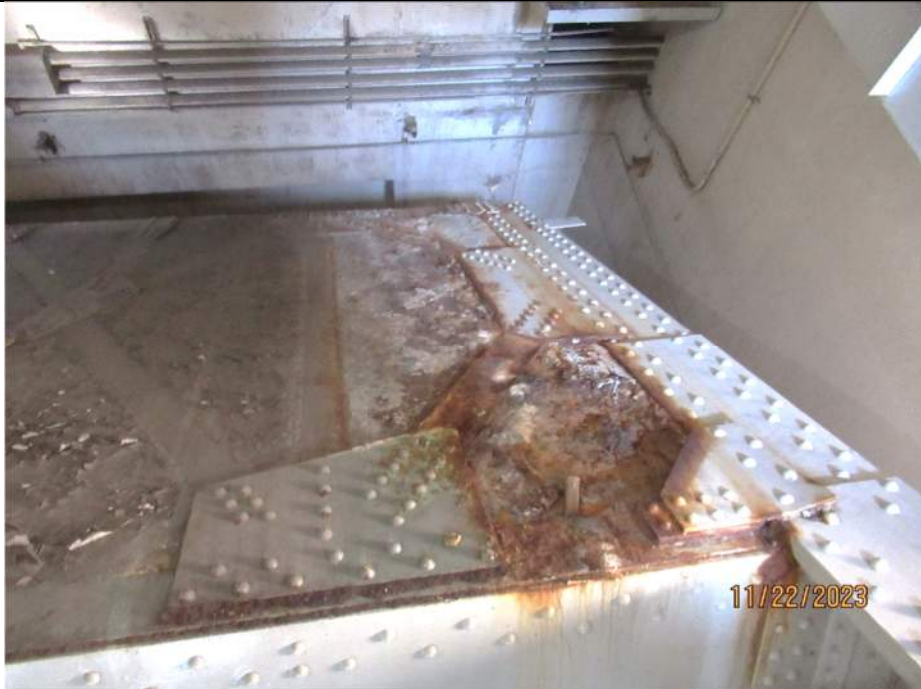
Photo S-362 - [Pier 5 Interior] -Counterweight top at east side (G4W) with moderate corrosion and minor spalling deterioration across the top of the block, Looking North

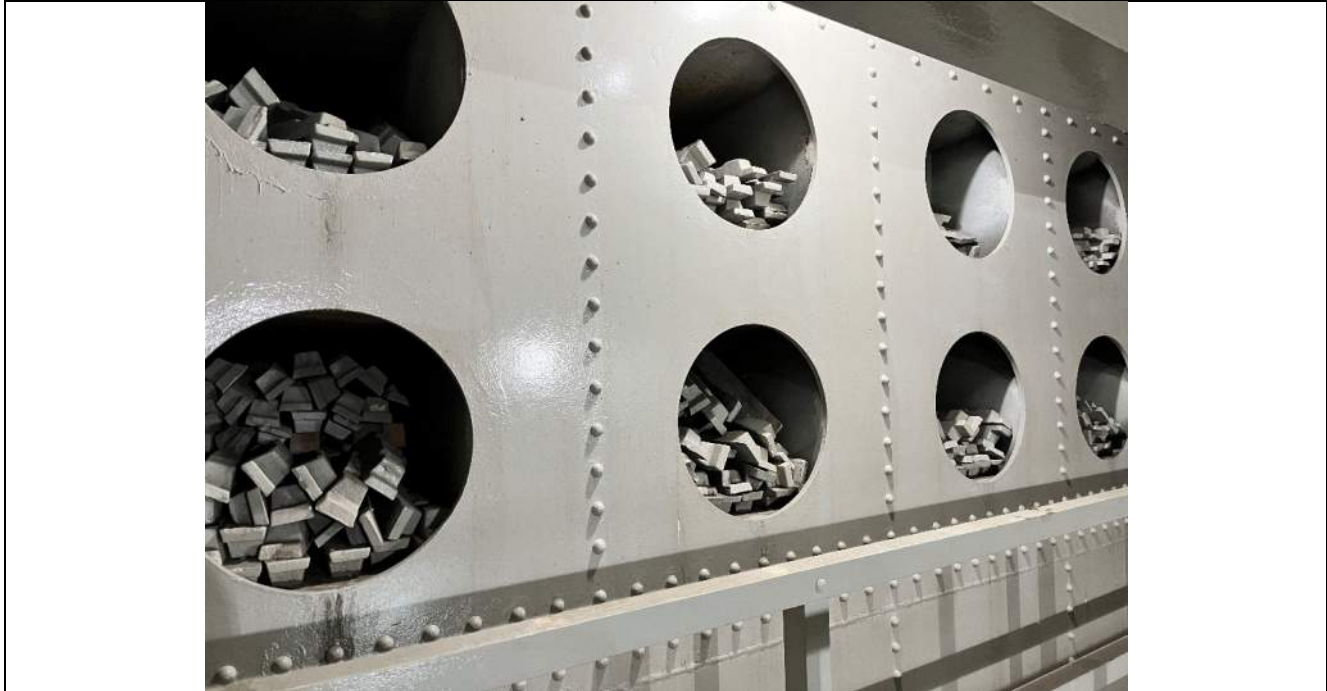
Photo S-363 - [Pier 5 Interior] -Counterweight pockets and blocks detail view, between G3W-G4W, Looking Northeast

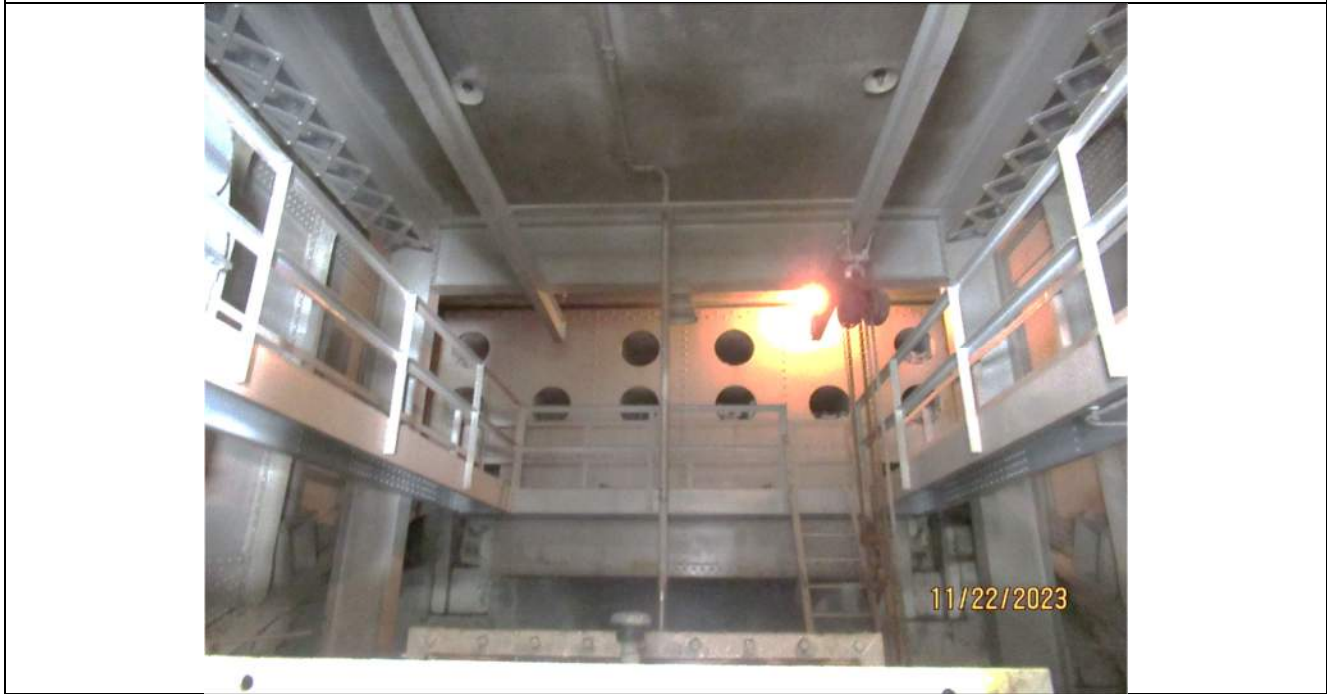
Photo S-364 - [Pier 5 Interior] -Upper catwalks between G1W and G2W in good condition, Looking North

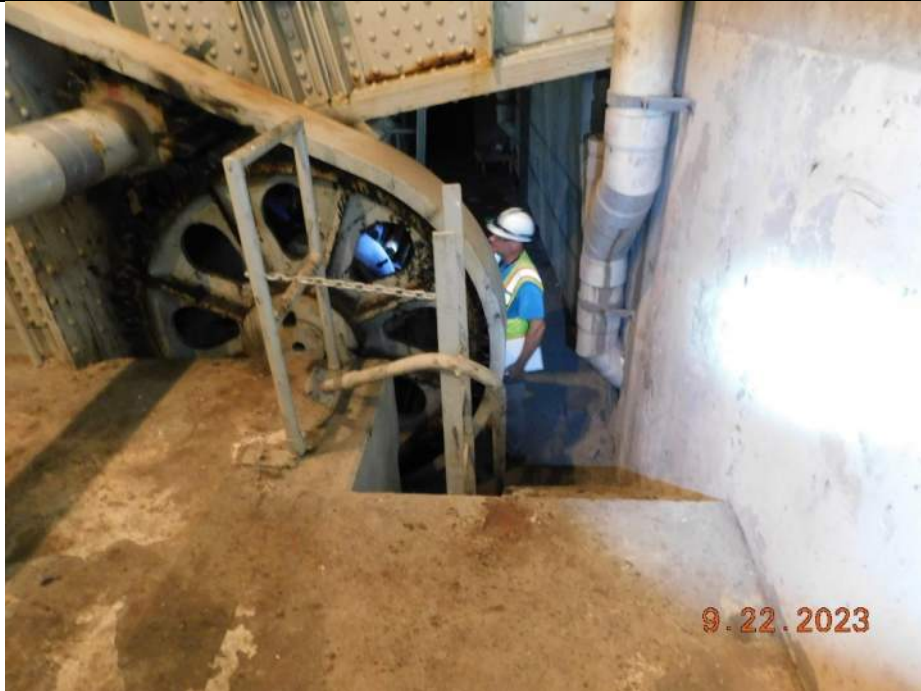
Photo S-365 - [Pier 4 Interior] -Machinery level railing is broken at the east side of G3W, Looking North

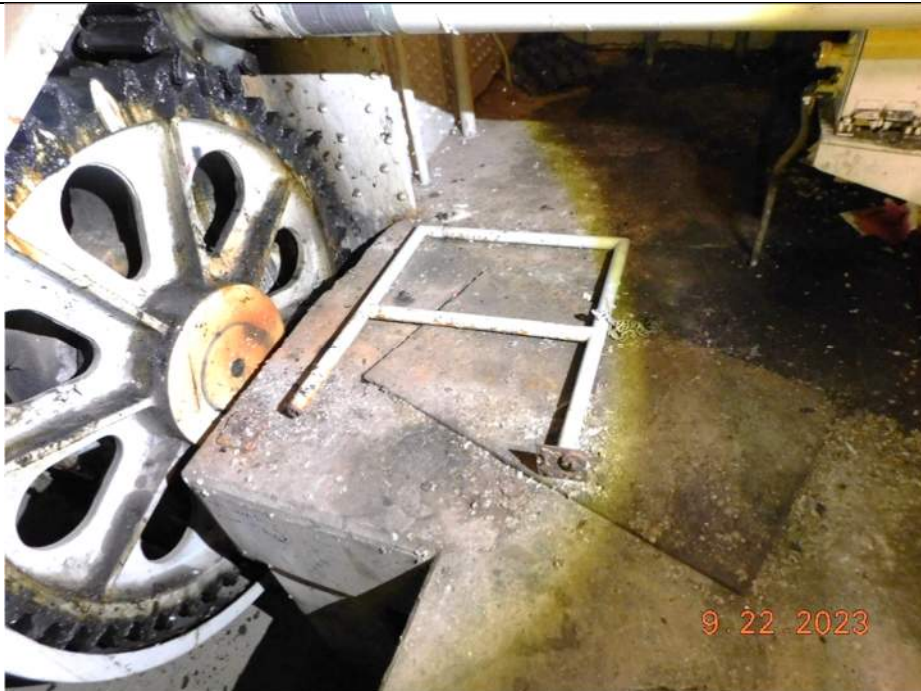
Photo S-366 - [Pier 5 Interior] -Machinery level railing is broken at the west side of G3W, Looking West

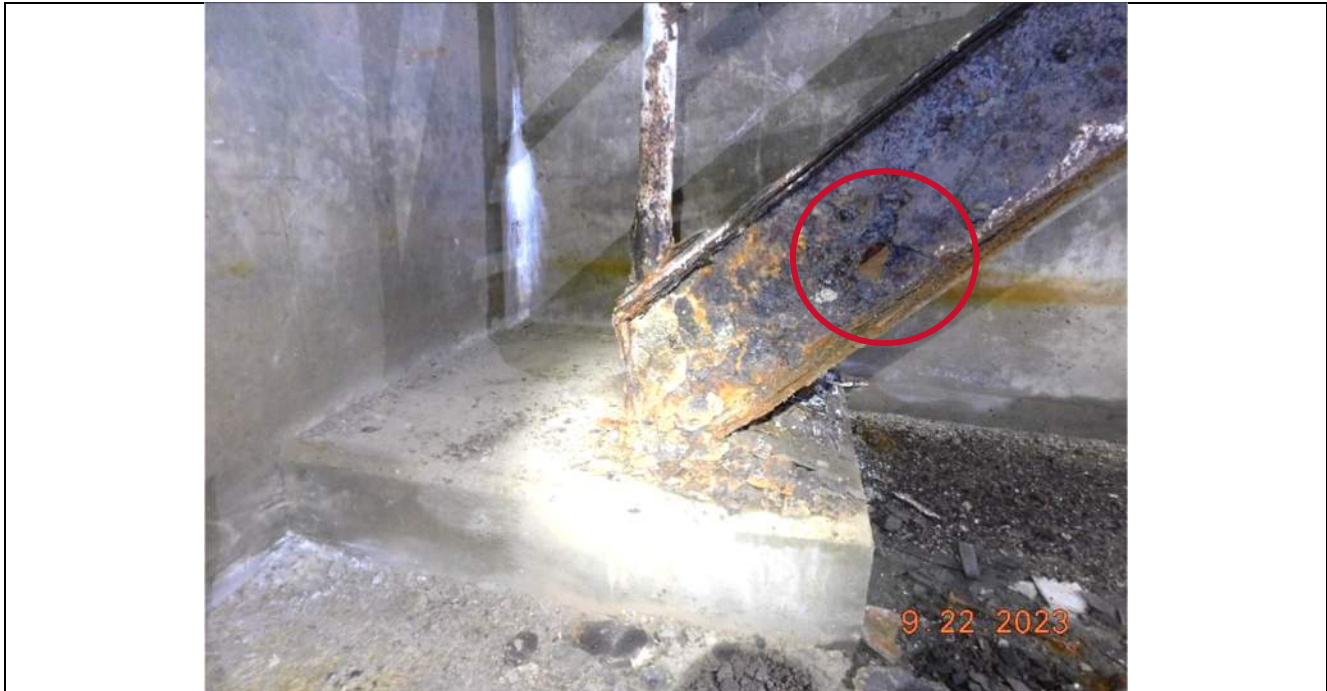
Photo S-367 - [Pier 5 Interior] -Level F, base of stairs in East exterior room, heavy corrosion, section loss, hole in channel web, Looking East

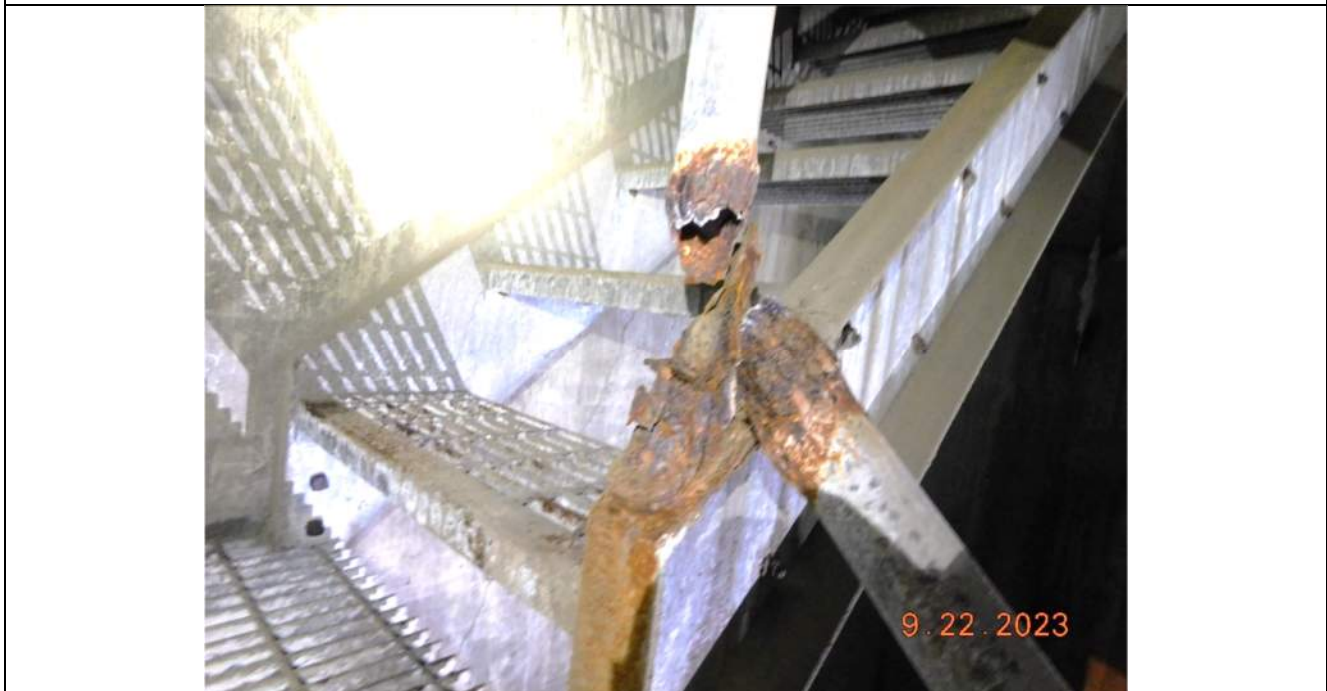
Photo S-368 - [Pier 5 Interior] -Level F, mid-level of stairs in East exterior room, 100% section loss to post and railing, Looking South

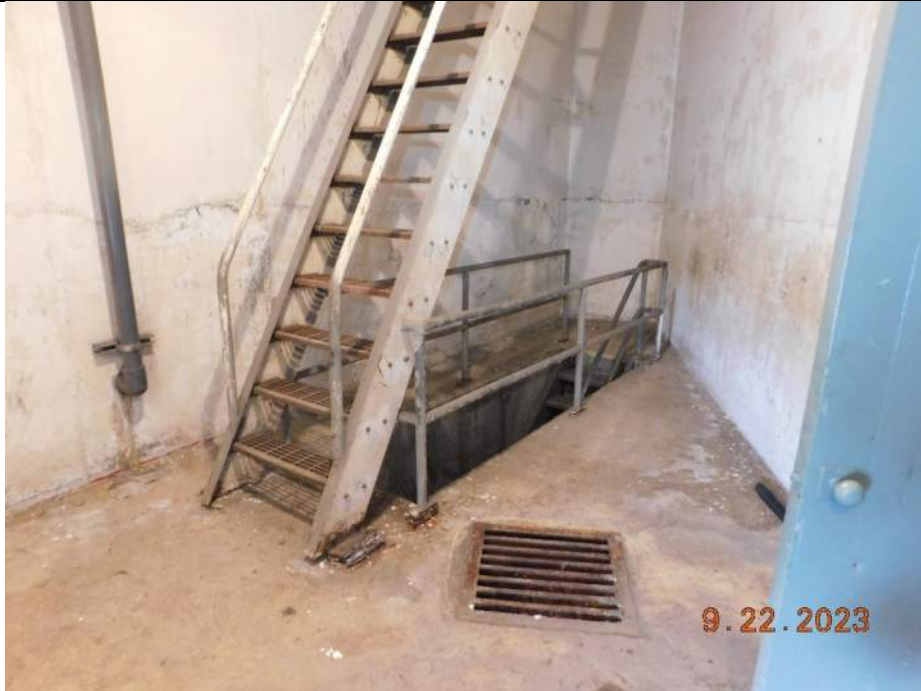
Photo S-369 - [Pier 5 Interior] -Level E, East exterior room, packing corrosion at railing and stairs connections to floor, Looking South

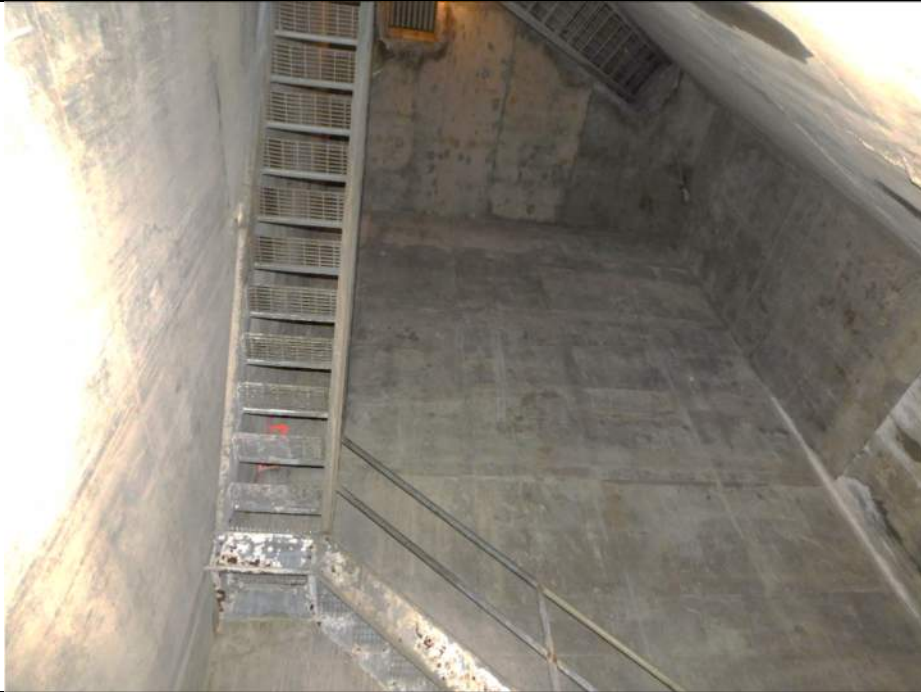
Photo S-370 - [Pier 4 Interior] -Basement Level, Room 1W, access staircase with moderate degradation of galvanizing and minor spot corrosion, Looking South

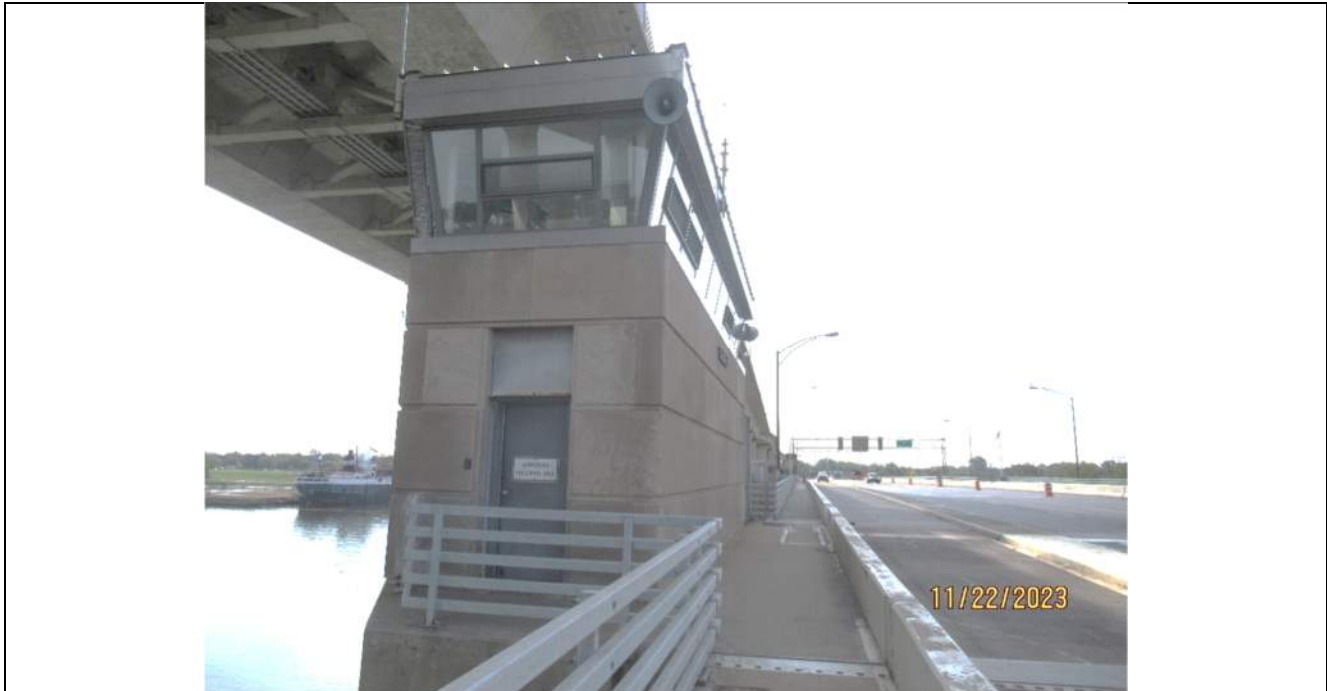
Photo S-371 - [Control House Exterior] -North side and access from roadway level, general view, Looking South

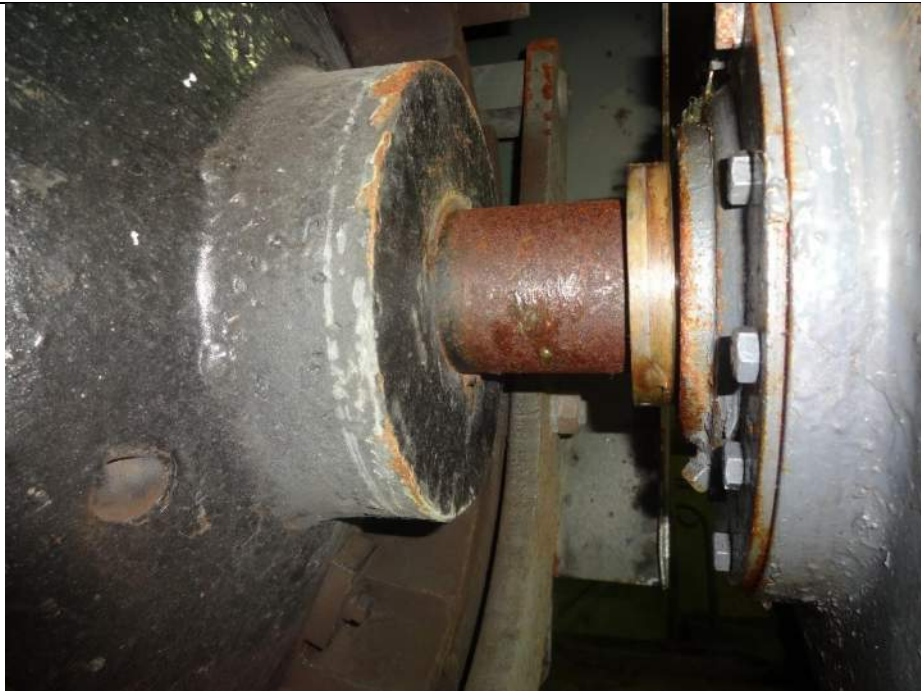
Photo 2 - [North Machinery Room] – Note surface corrosion on motor shafts and hubs.

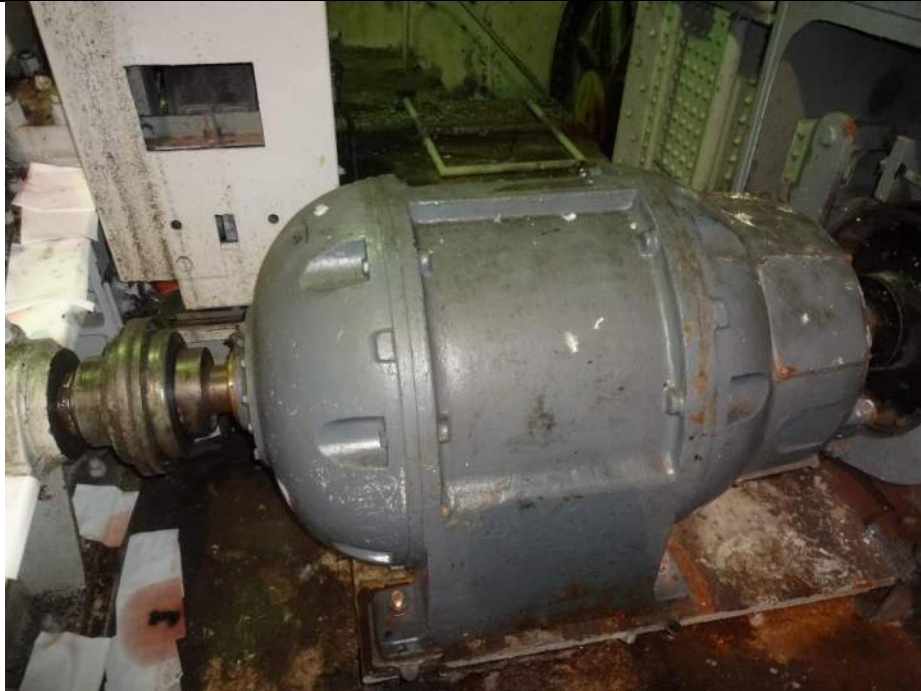
Photo 3 - [North Machinery Room] – Note surface corrosion and paint failure on motor housing and shims.

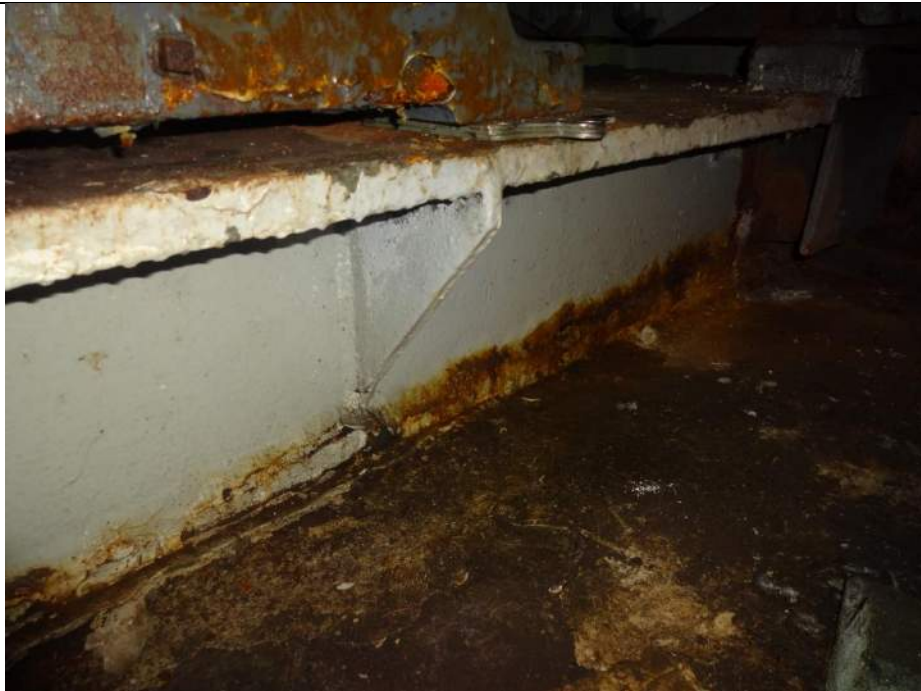
Photo 4 - [North Machinery Room] – Note surface corrosion on base of motor support and use of finger shims.

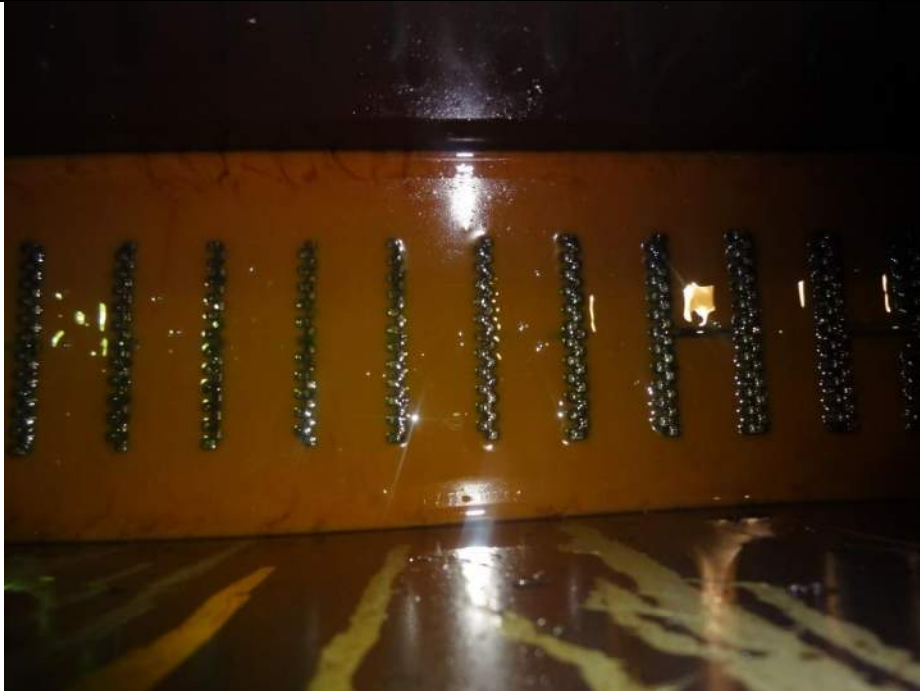
Photo 5 - [North Machinery Room] - Oil in chain housing is contaminated with dirt and debris.

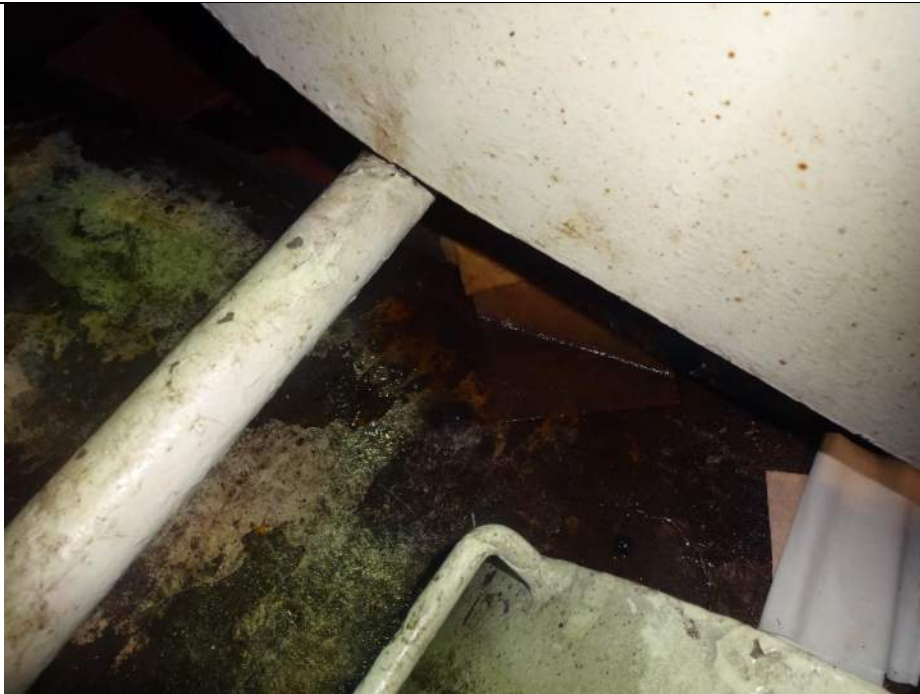
Photo 6 - [North Machinery Room] – Note oil leak from chain housing.

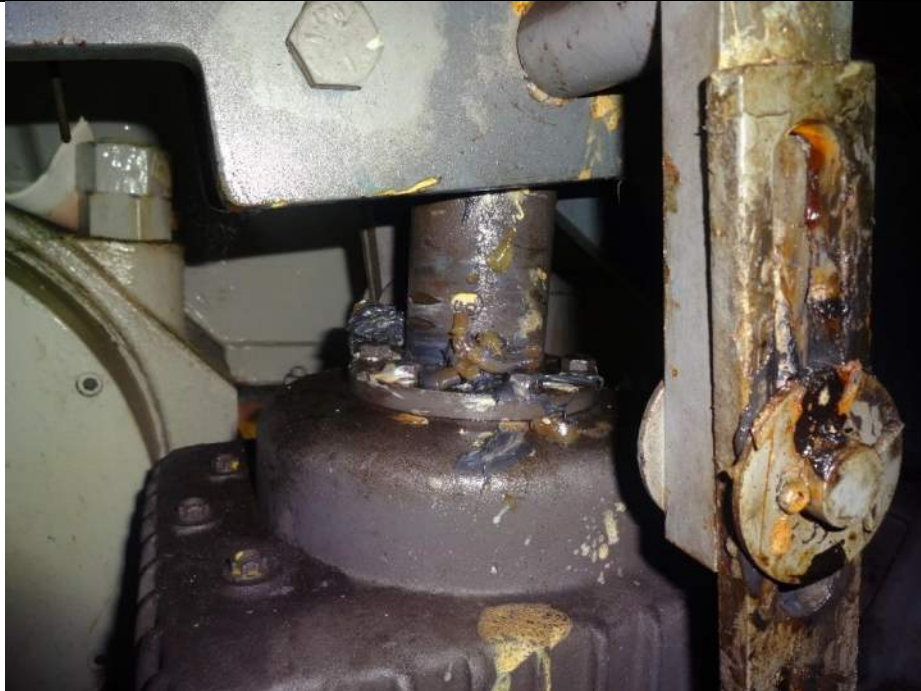
Photo 7 - [North Machinery Room] – Note oil purge from top of thruster on motor brake.

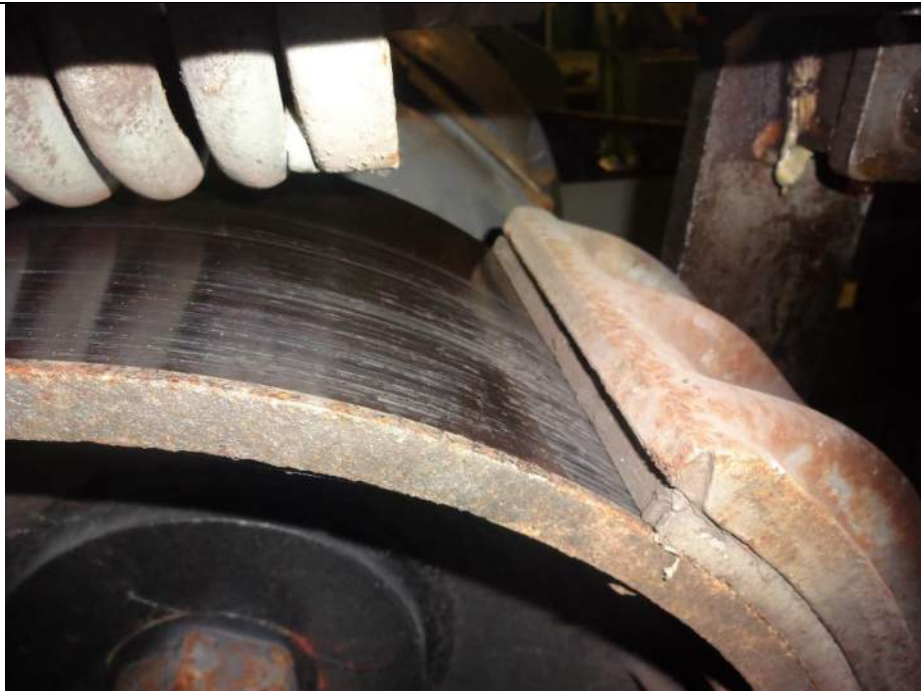
Photo 8 - [North Machinery Room] - Scoring and rust contamination is on brake wheel surface.

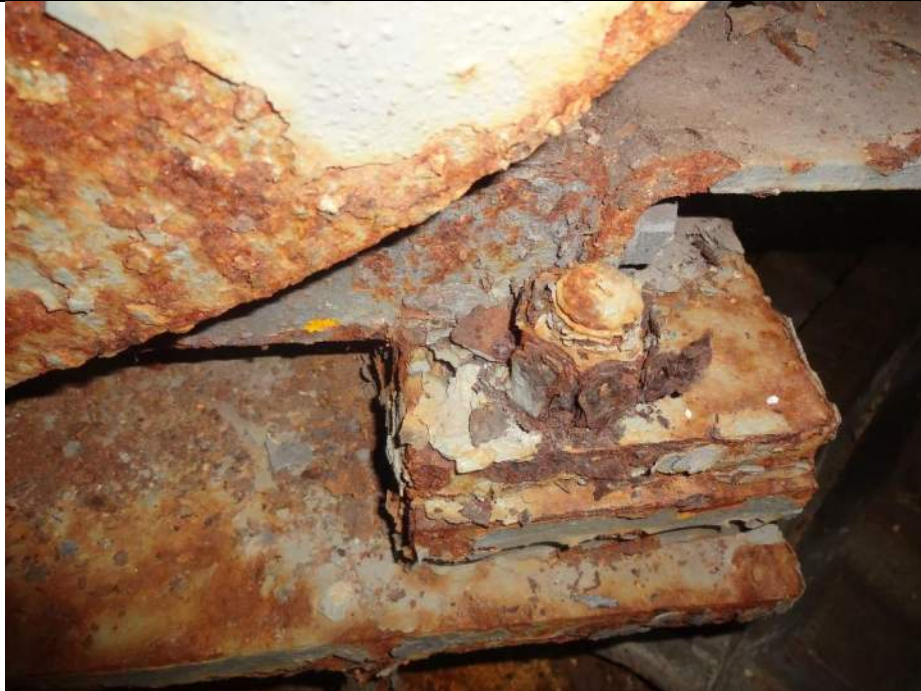
Photo 9 - [North Machinery Room] – Note minor paint failure, surface corrosion, corrosion on the base, corrosion on fasteners and seized bolts on both the motor brakes on the North side.

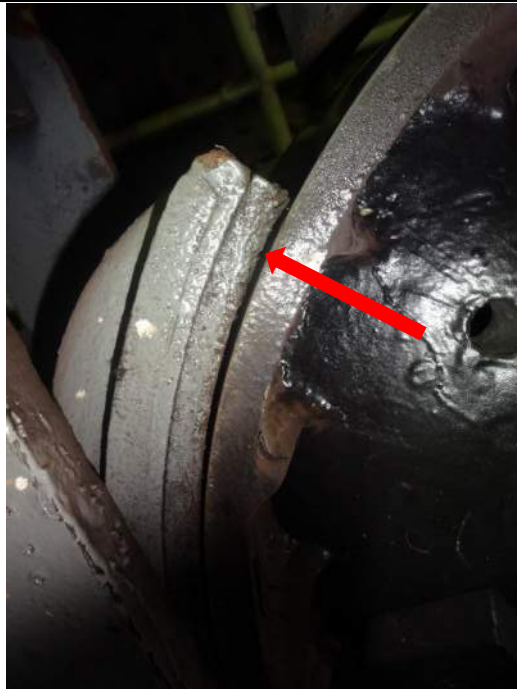
Photo 10 - [NW Motor Brake] – Note poor brake pad contact.

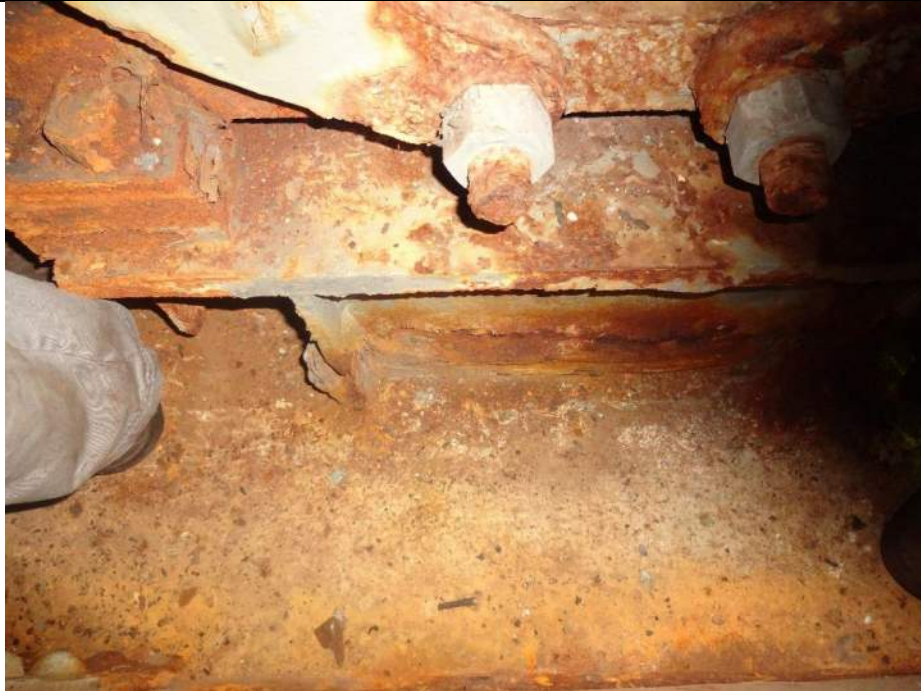
Photo 11 - [NW Motor Brake] – Note severe corrosion and section loss on motor brake support.

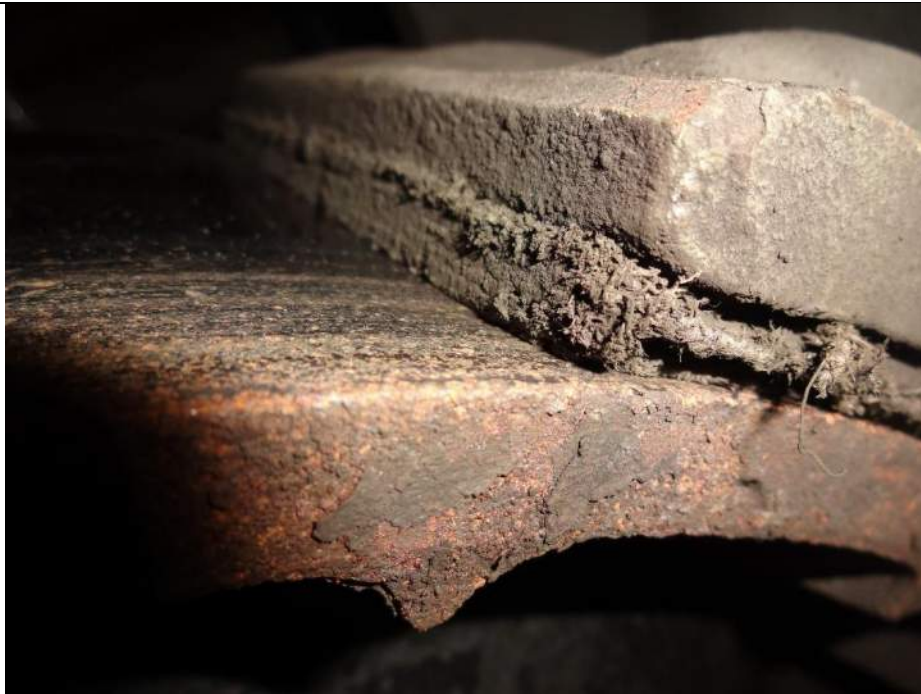
Photo 12 - [SW Motor Brake] - Top 30% of the north pad on motor brake stays in contact after release.

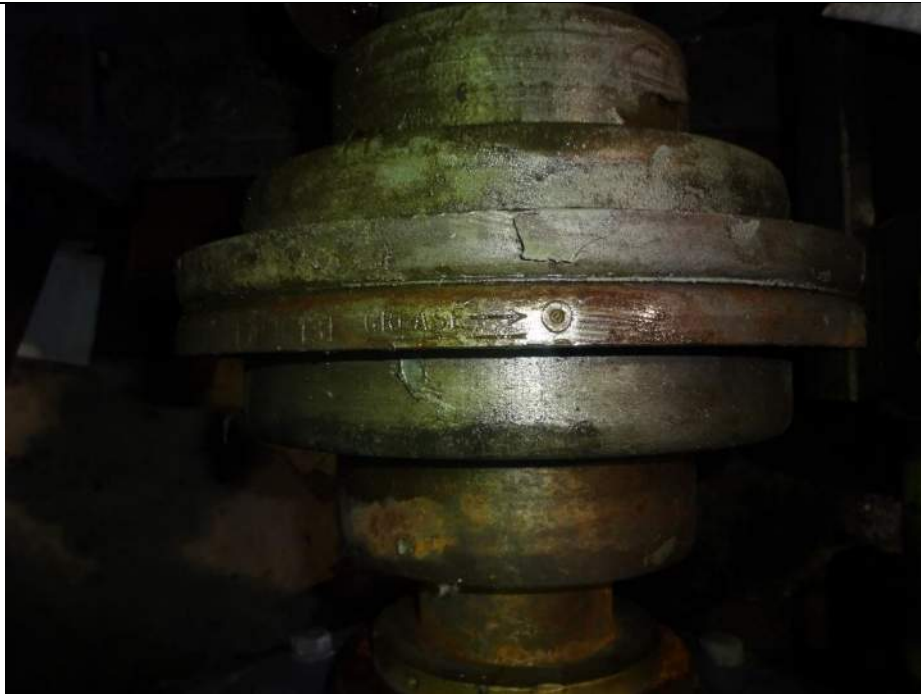
Photo 14 - [North Machinery Room] – Note surface corrosion and paint failure on couplings along with stripped grease plugs.

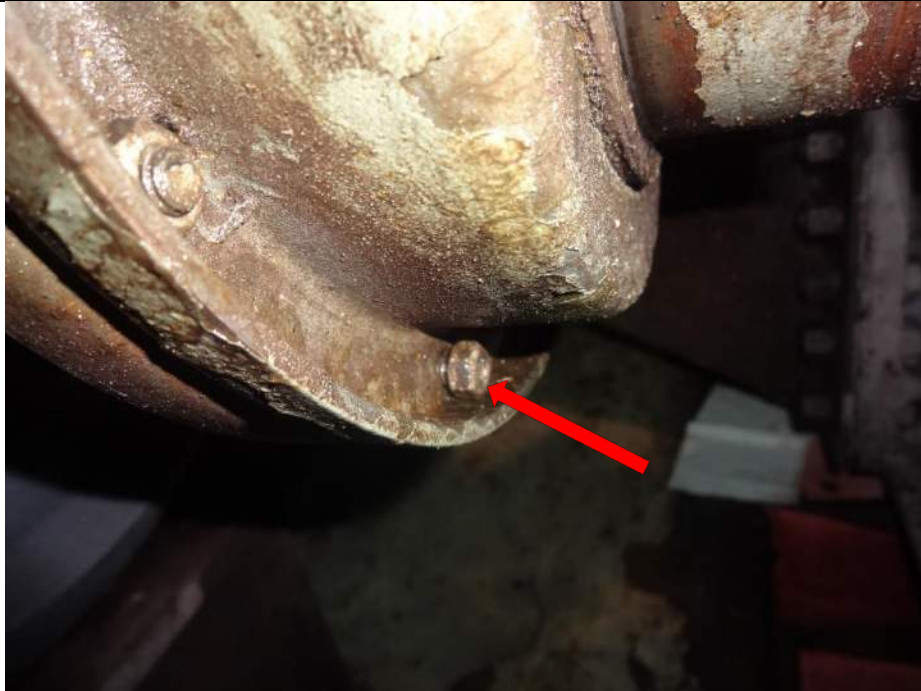
Photo 15 - [NE Coupling] – Note loose nut on coupling.

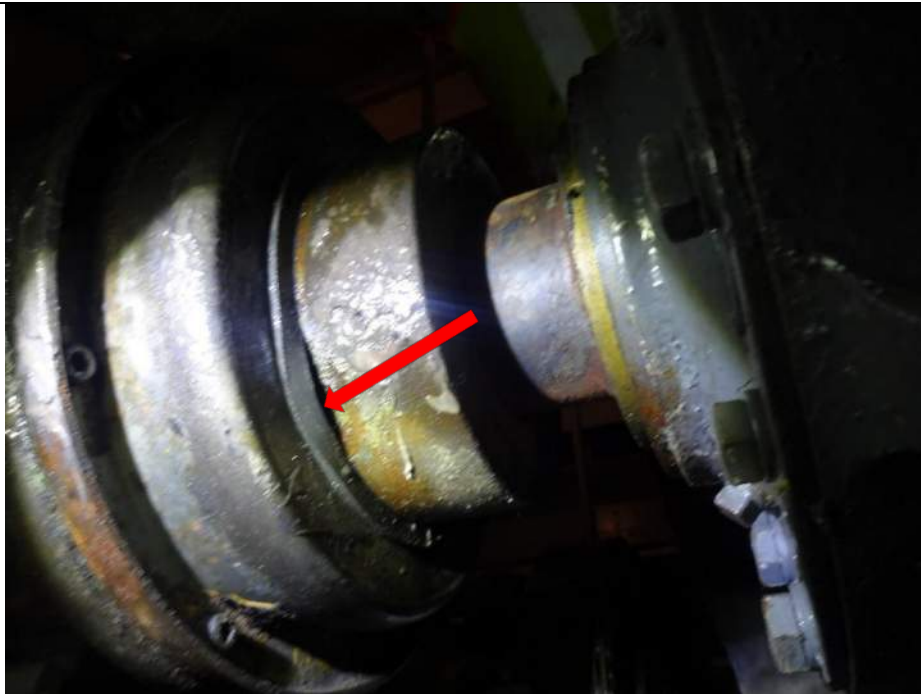
Photo 16 - [SW Coupling] - Coupling has slight bulging on the O-ring that is meant to act as a seal.
