Craig Memorial Bascule Bridge

Over the Maumee River

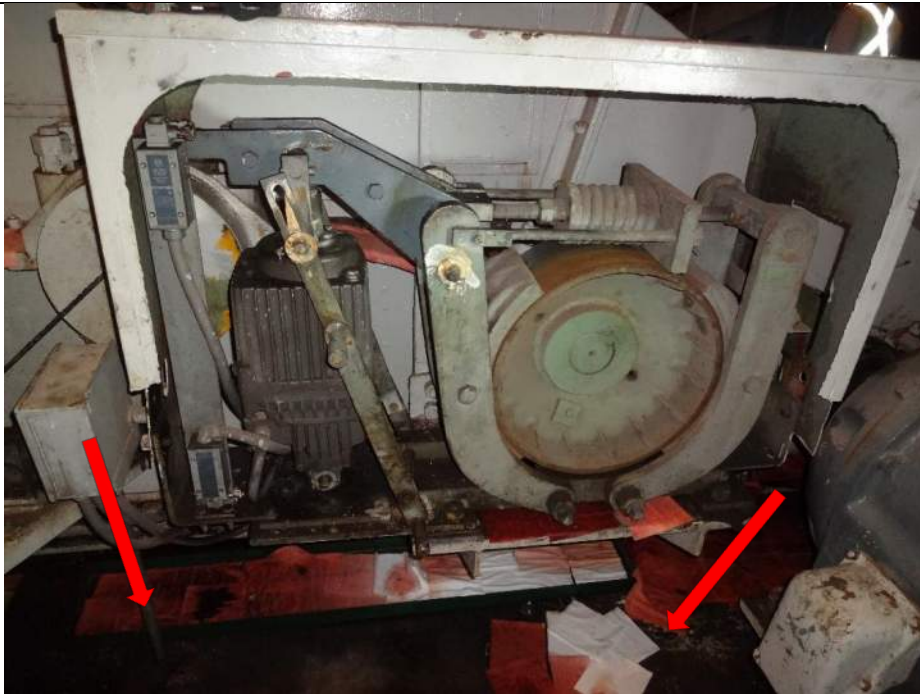
Photo 18 - [South Machinery Room] - Oil leaks outside of central gear boxes and is soaked up by using copious amounts of rags.

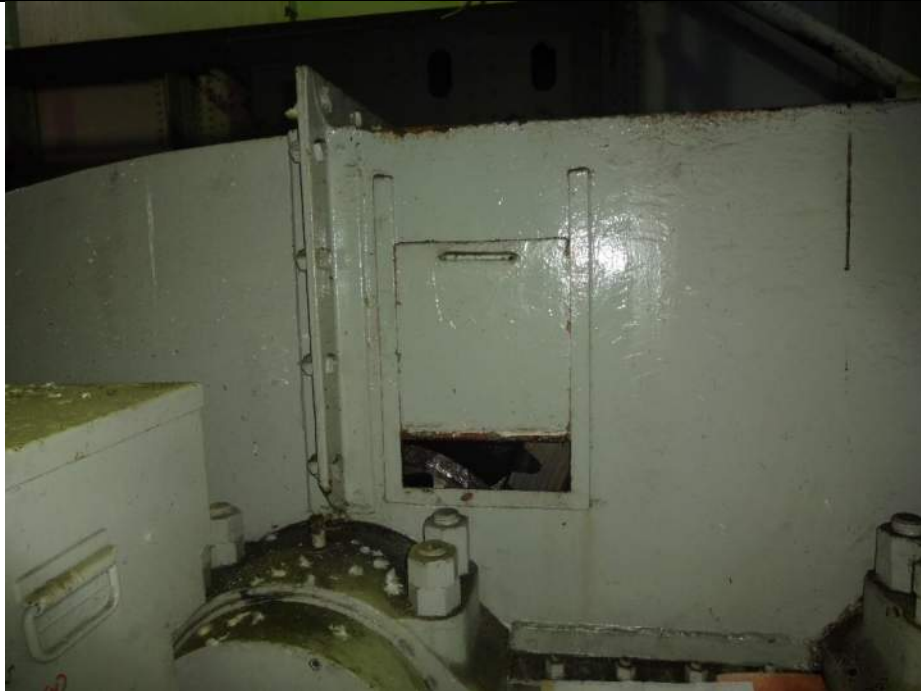
Photo 19 - [North Machinery Room] - Inspection hatches on central gear enclosure do not fully open due to being painted over.

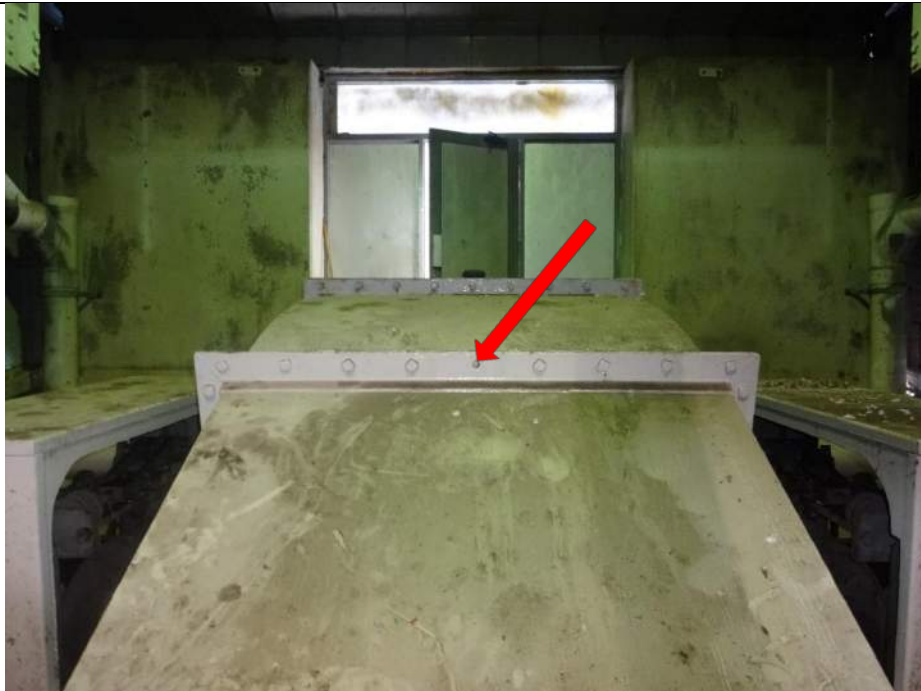
Photo 20 - [North Machinery Room] – Fastener is missing on the seam of central gear enclosure.

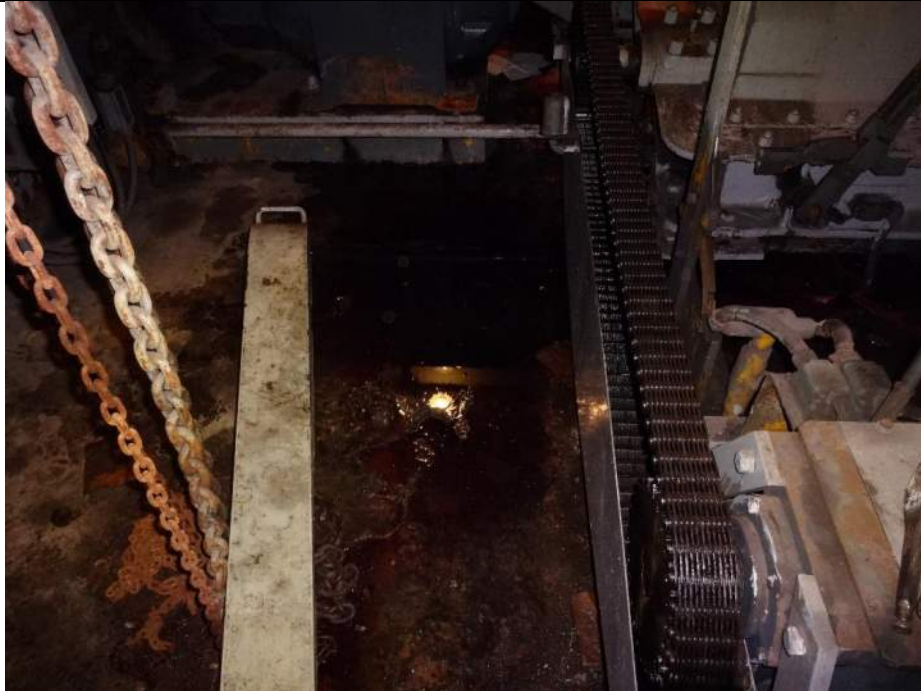
Photo 21 - [South Machinery Room] - South side gear box severely leaks oil most likely due to overfilling. Puddles of lubricant all over floor.

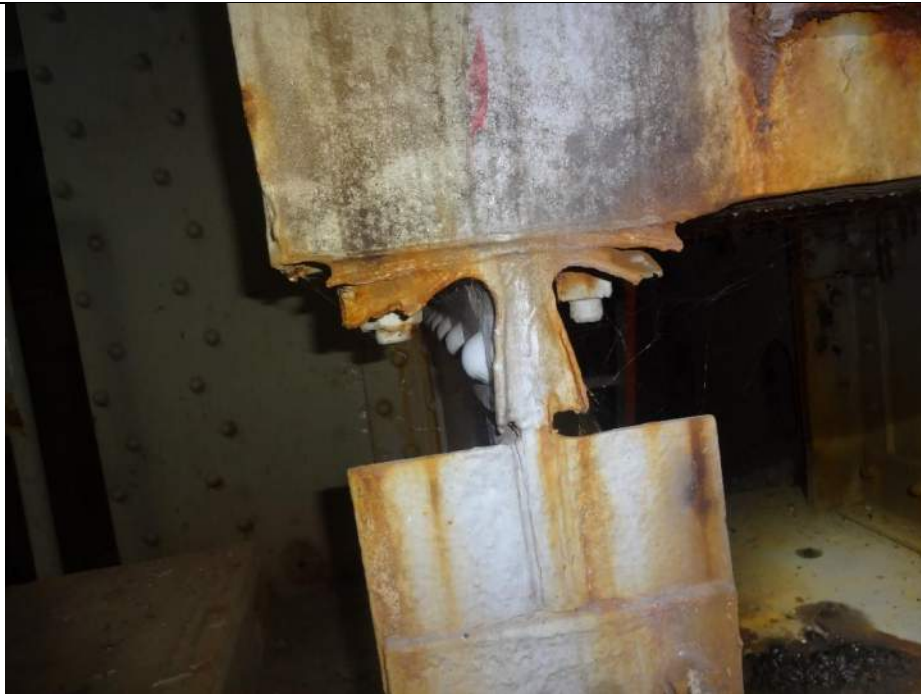
Photo 22 - [NW B1 Bearing] - Pack rust is below base of B1 bearing.

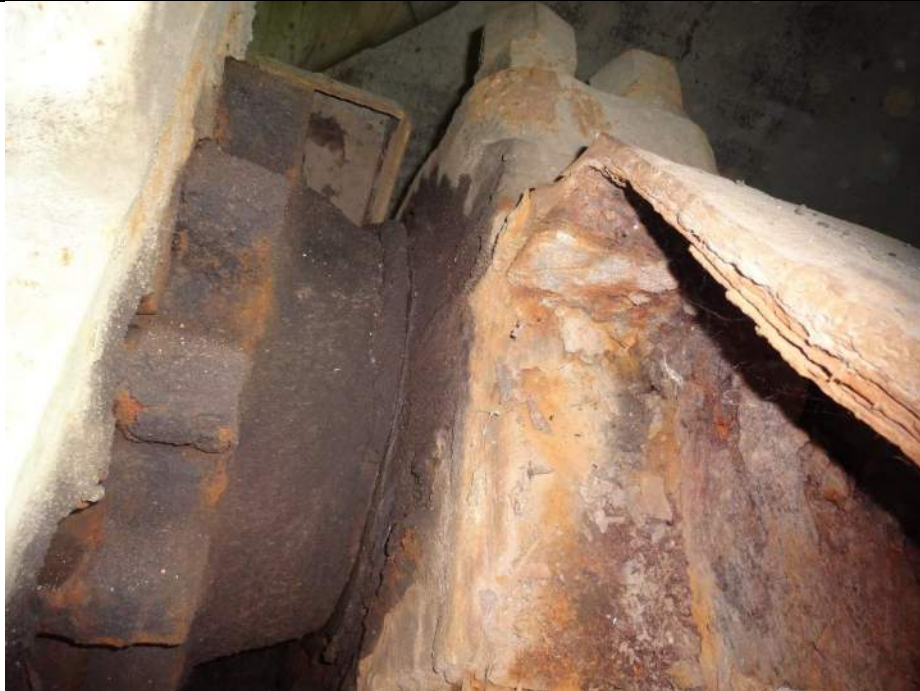
Photo 23 - [NW B1 Bearing] - Severe corrosion is on the inboard side of B1 bearing.

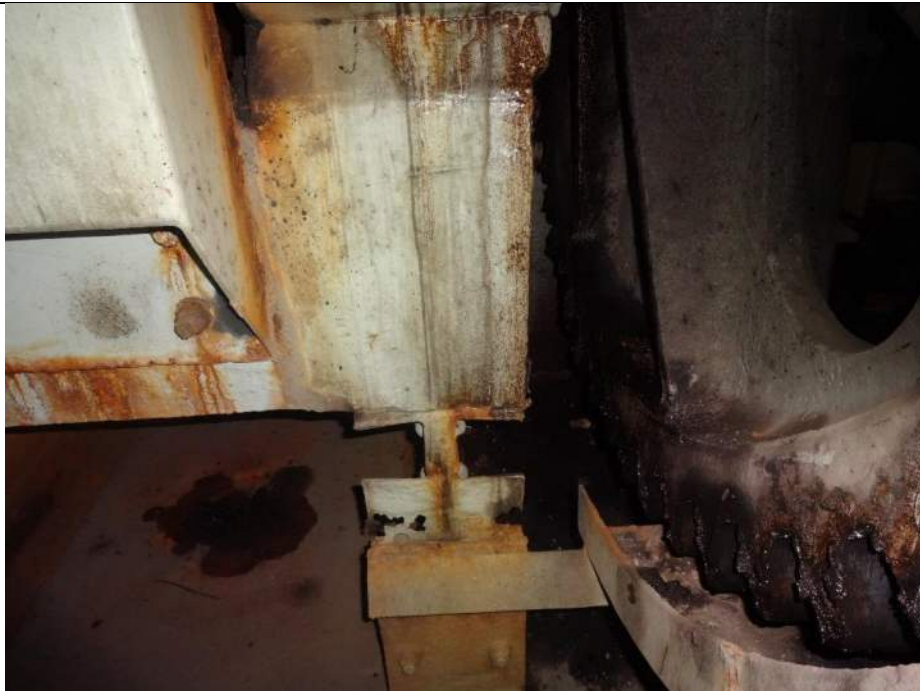
Photo 24 - [NW Corner of North Machinery Room] – There is severe corrosion of fasteners and section loss of base for B2 & B3.

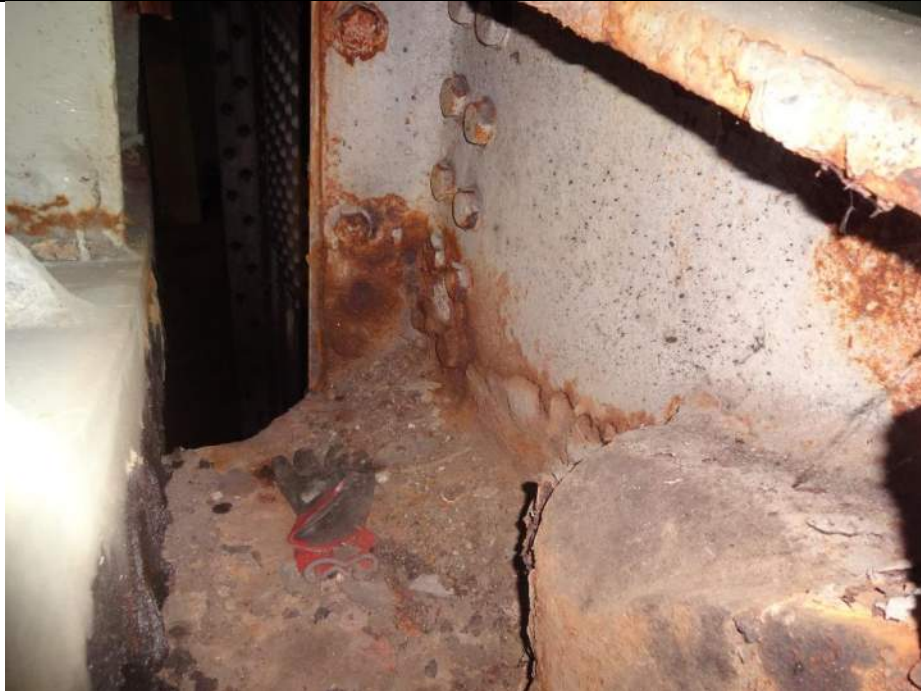
Photo 25 - [NE B1 Bearing] - Moderate surface corrosion is present on fasteners and inboard side of B1 bearing anchorage.

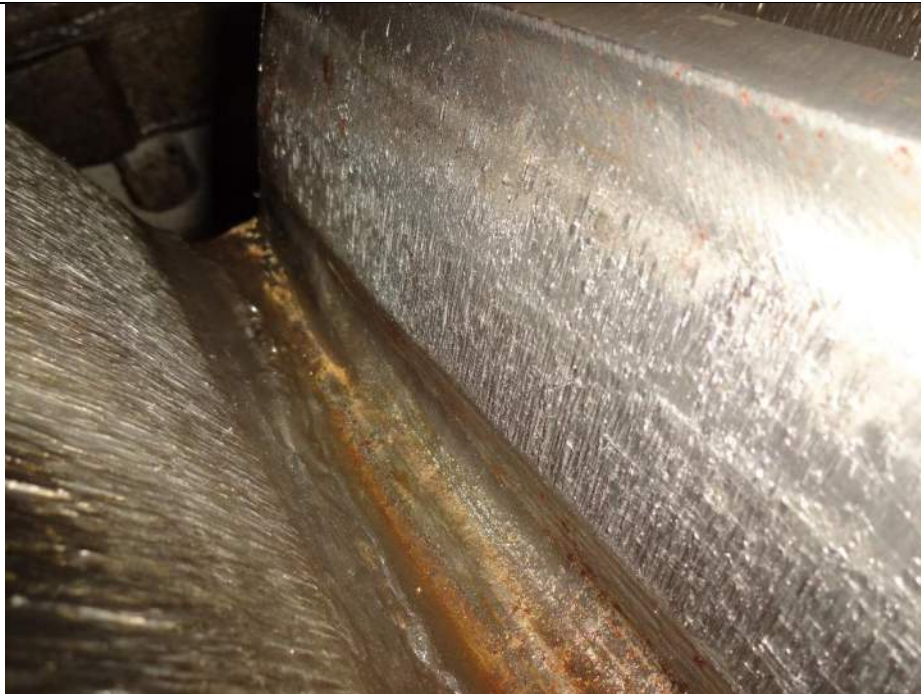
Photo 26 - [South Machinery Room] – Note severe scoring across all open gear faces on both sides.

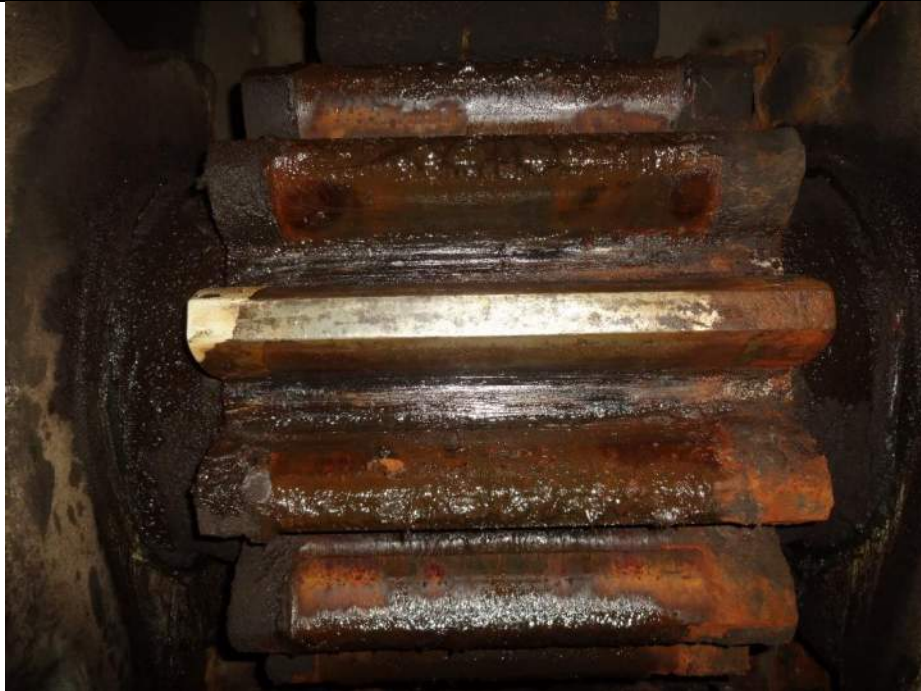
Photo 27 - [SE Corner of South Machinery Room] - Moderate surface corrosion exists on opening and closing faces of teeth as well as rust build up near the edges.

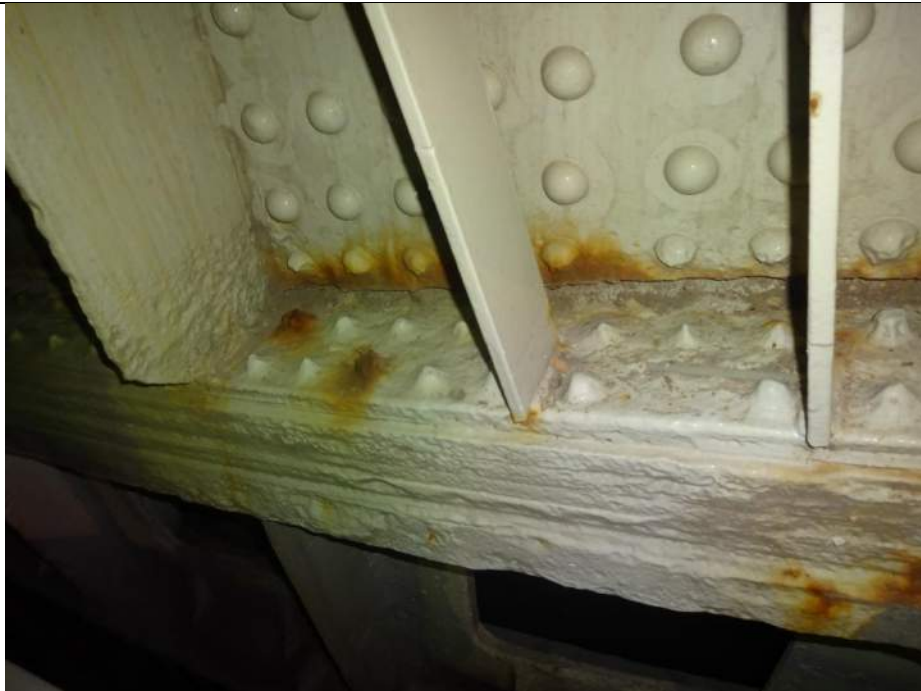
Photo 28 - [NW Rack Segment] - Severe corrosion and section loss appears to be painted over on rack segment fasteners.

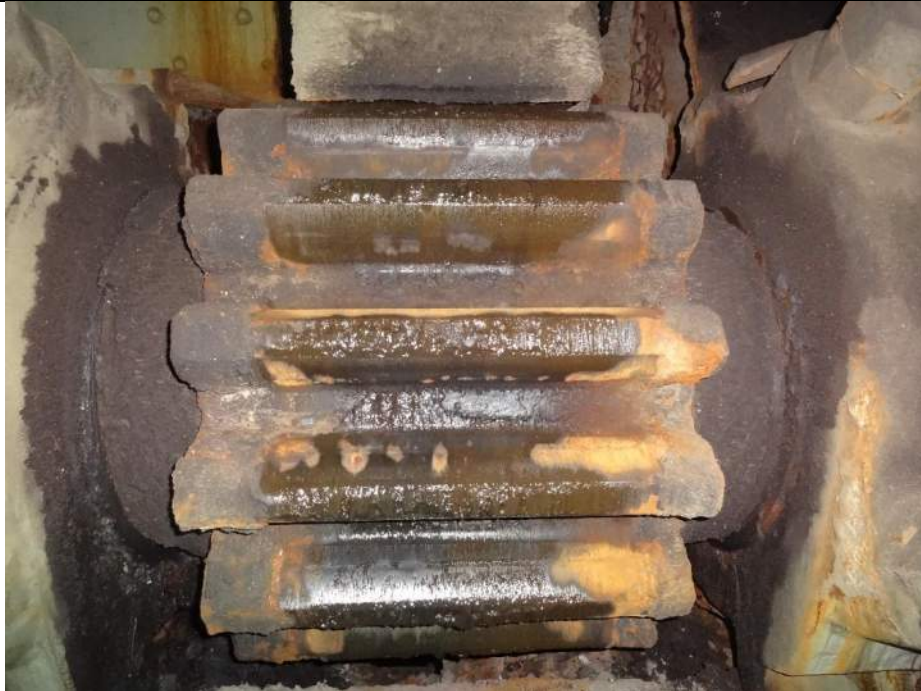
Photo 29 - [NW P1 Gear] – Note poorly lubricated P1 gear with contaminated lubrication that contains dirt and debris.

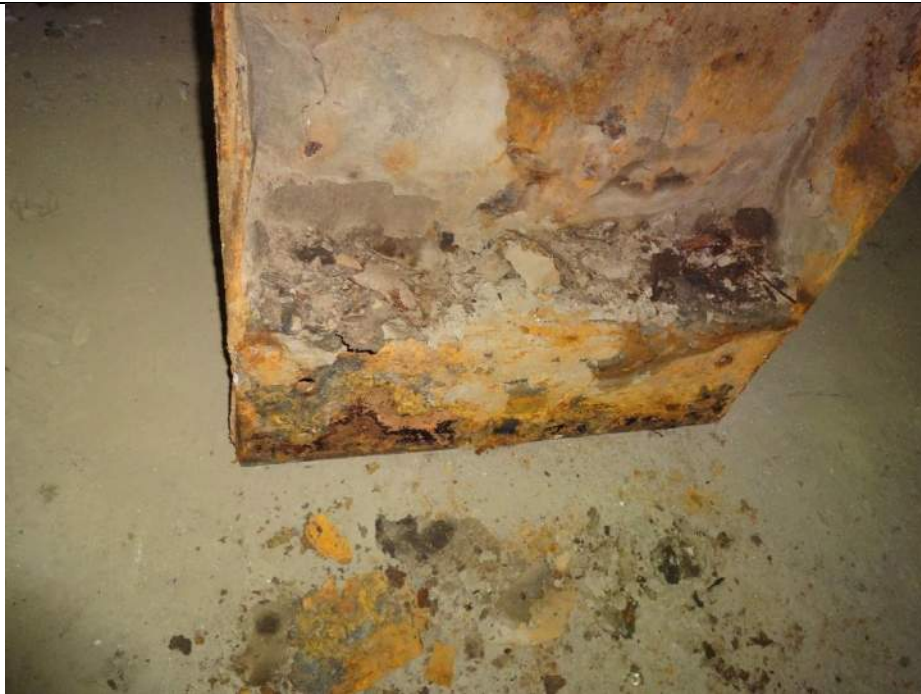
Photo 30 - [North Machinery Room] – Note severely corroded gear cover and failing gear cover gasket.

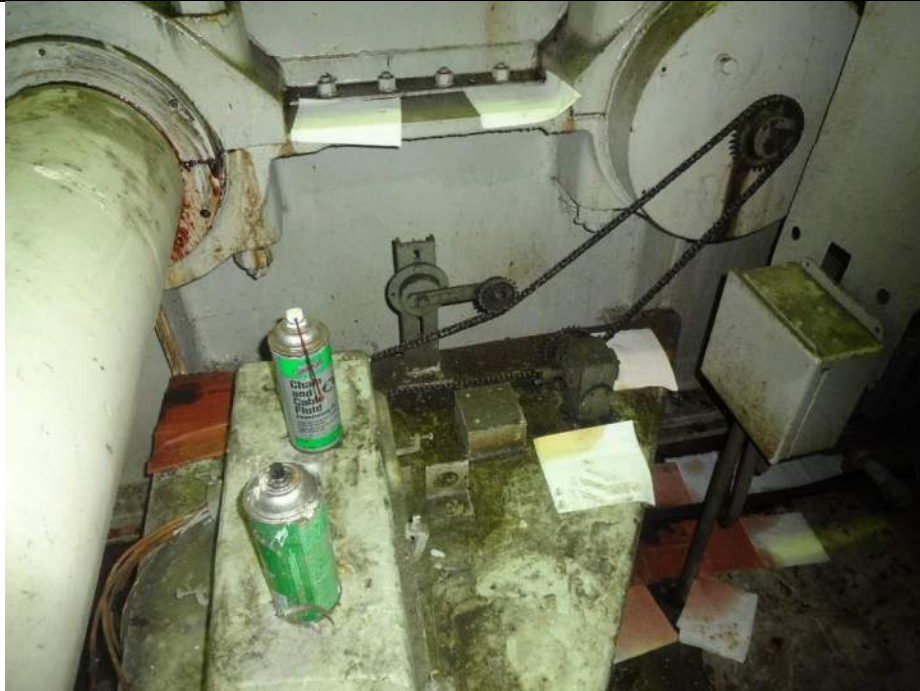
Photo 31 - [North Machinery Room] - Abandoned span drive machinery on North side of bridge is still being maintained.

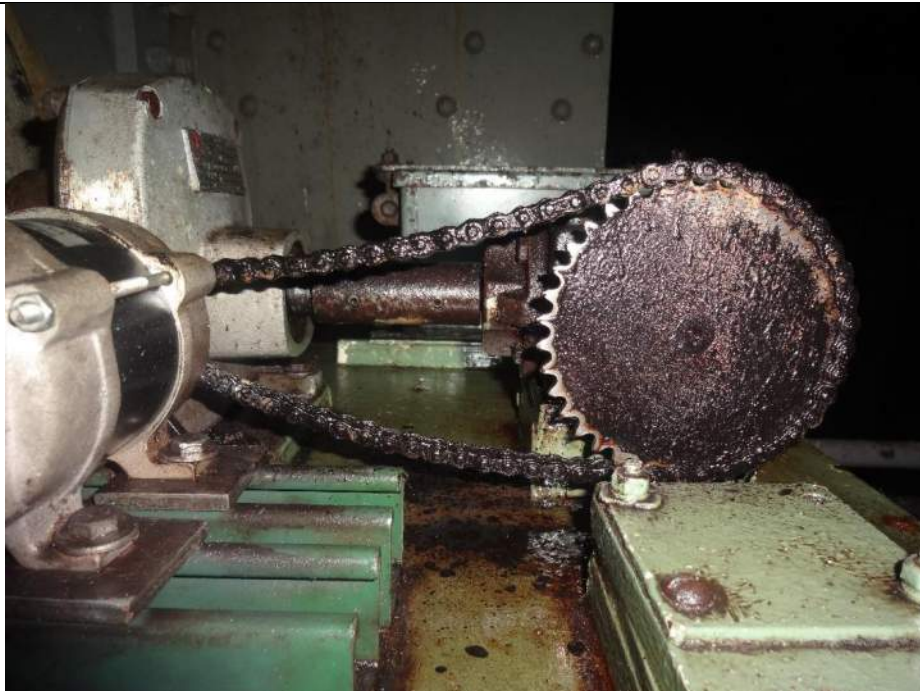
Photo 32 - [North Machinery Room] - North side span drive machinery has corrosion on shafting and loose chain.

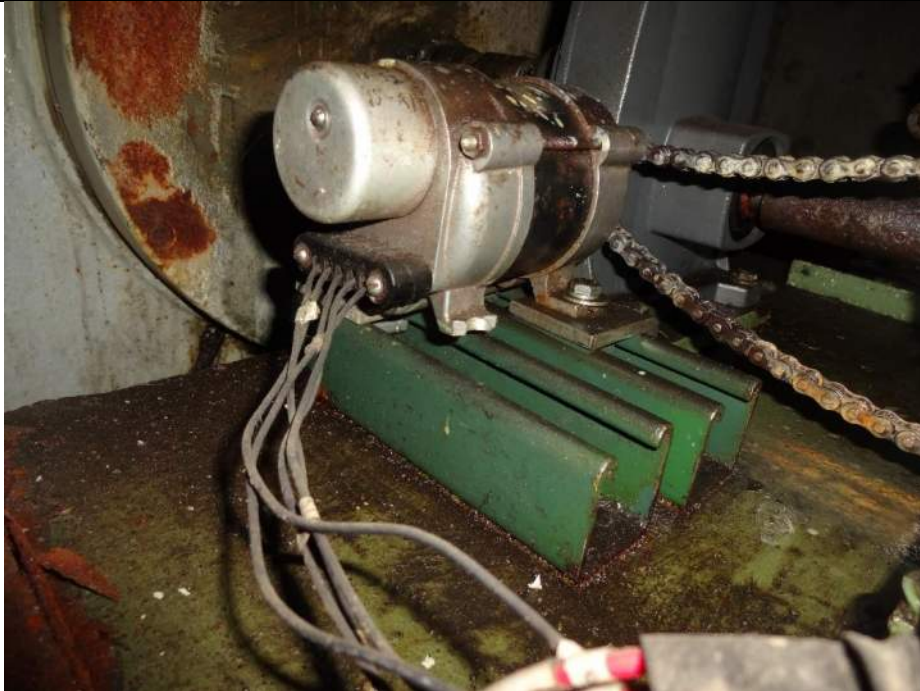
Photo 33 - [South Machinery Room] - South side span drive control machinery has missing foot mount on selsyn motor and a loose chain.

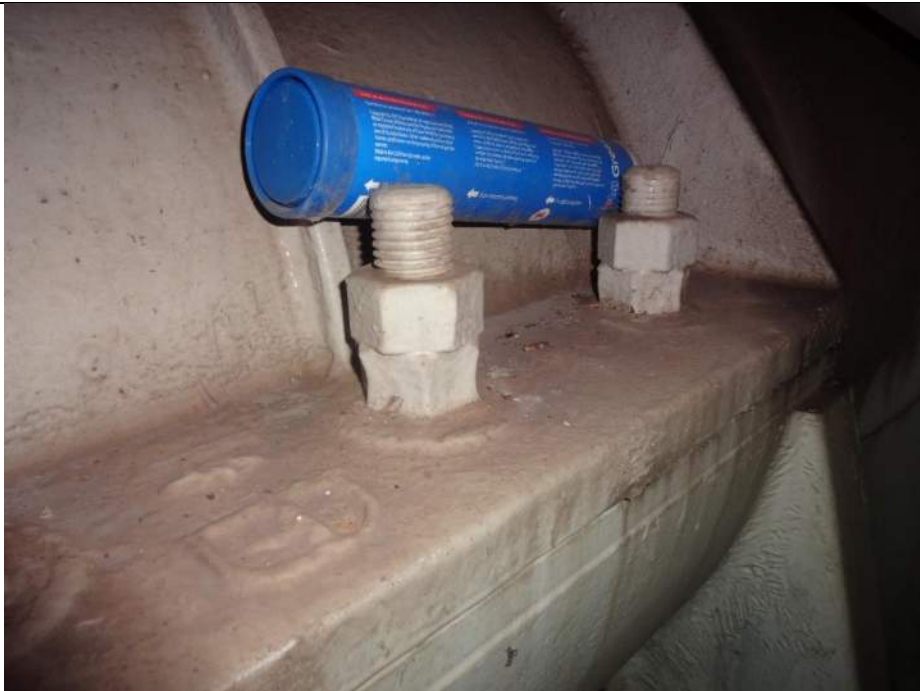
Photo 34 - [NW Outer Trunnion] – Note the section loss on trunnion bearing nuts that have been painted over.

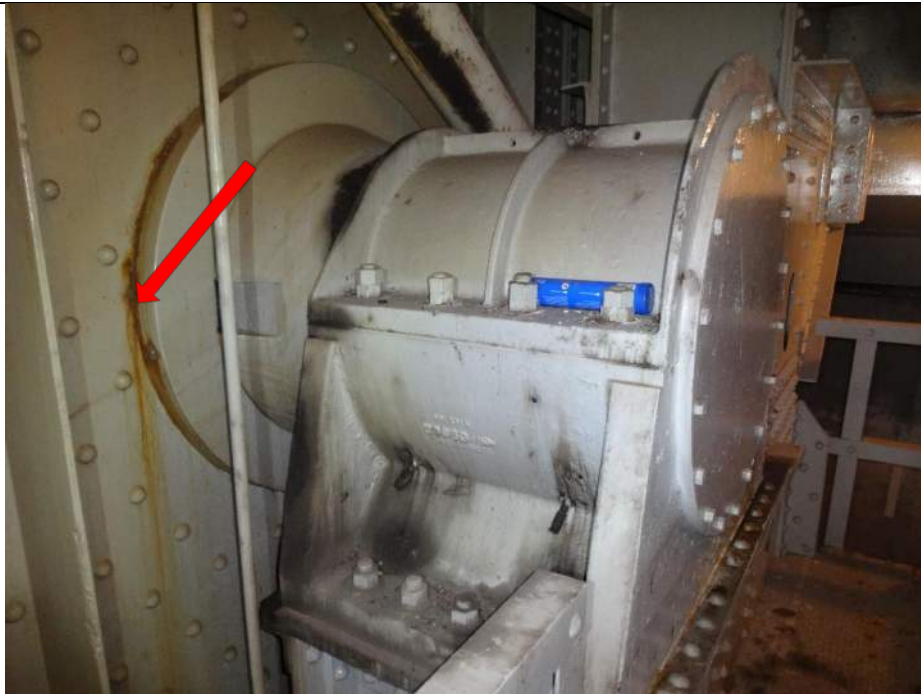
Photo 36 - [SW Inner Trunnion] - Corrosion is present on collars of trunnion bearings.

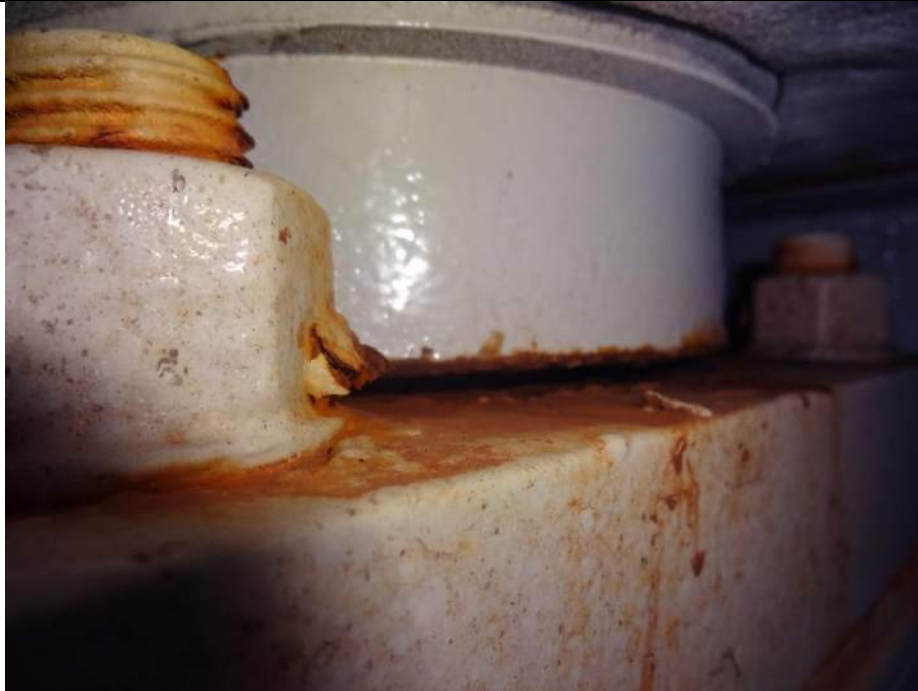
Photo 37 - [NW Outboard Live Load Shoe] - Minor surface corrosion is evident on contacting surface of live load shoes as well as an 1/8" gap.

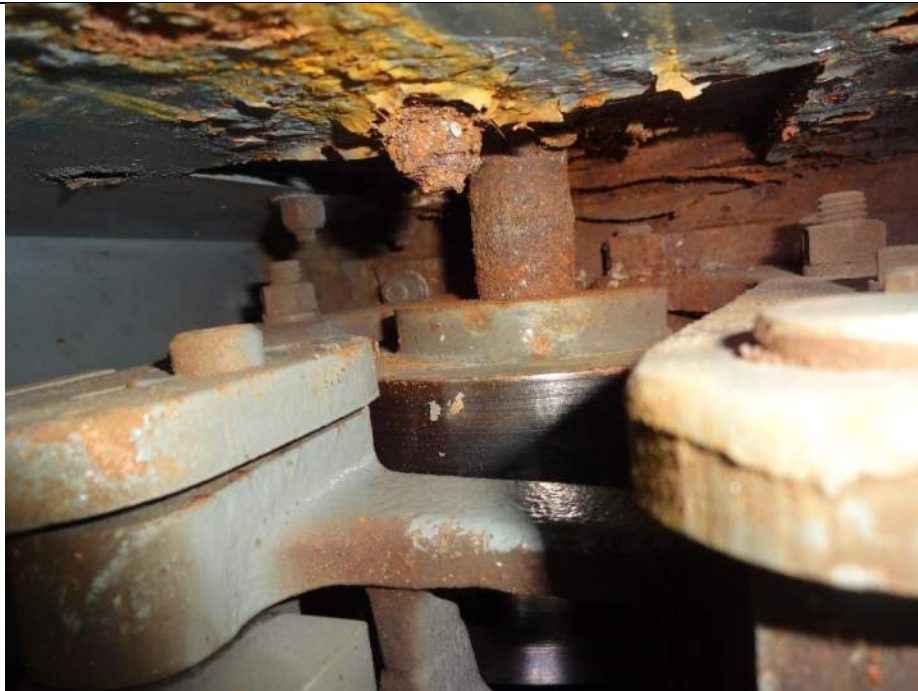
Photo 38 - [Span Lock Thruster Brake] – Note severely corroded thruster brake shaft on span lock. Linkages are also not well lubricated.

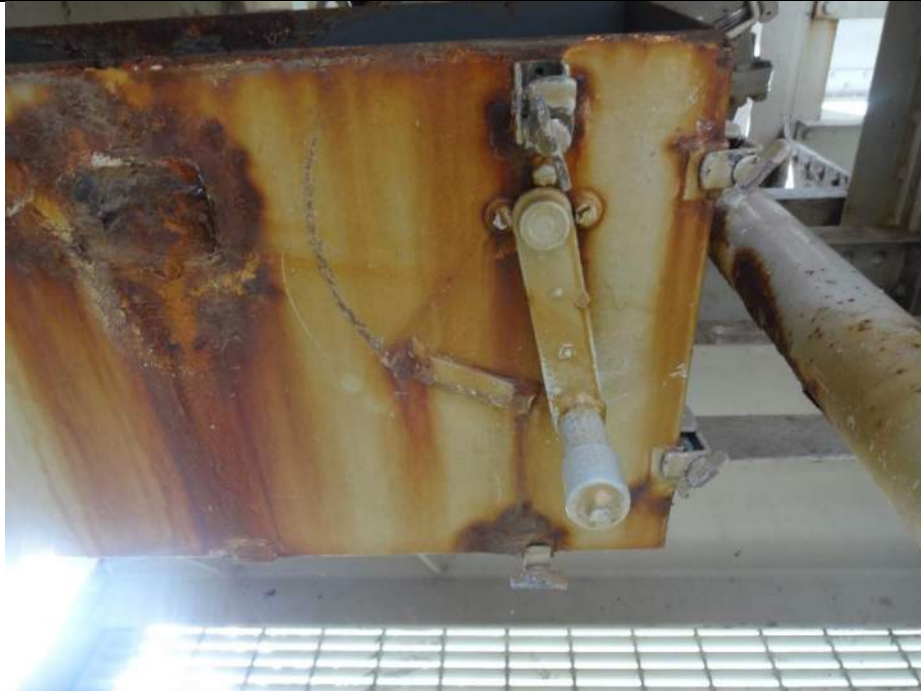
Photo 39 - [Span Lock Thruster Brake] - Span lock thruster brake lever is severely corroded and cannot be removed due to seized wingnuts.

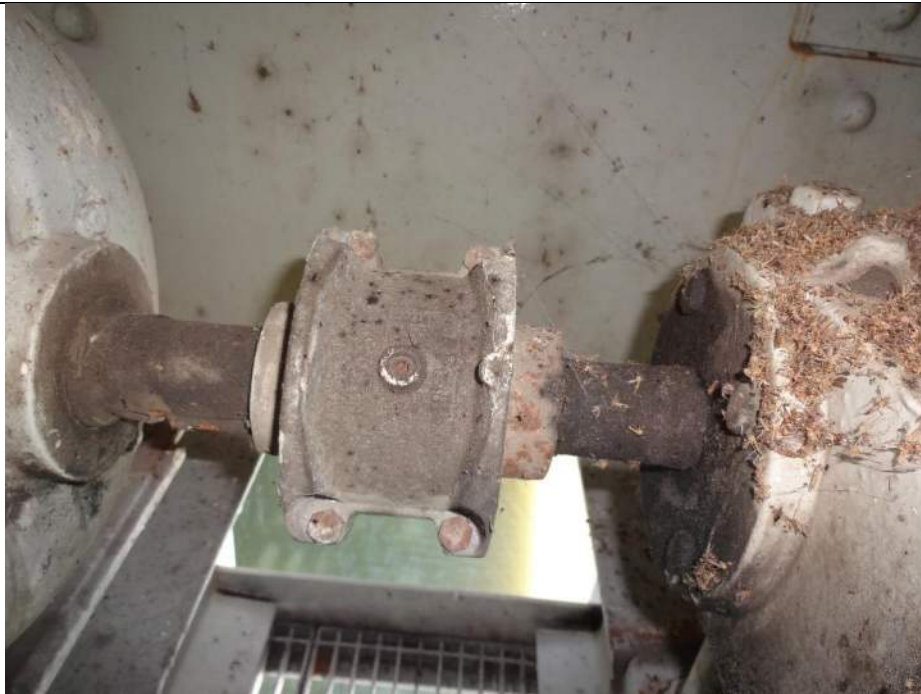
Photo 40 - [Span Lock Motor] – Note heavy corrosion on motor shafts and keys.

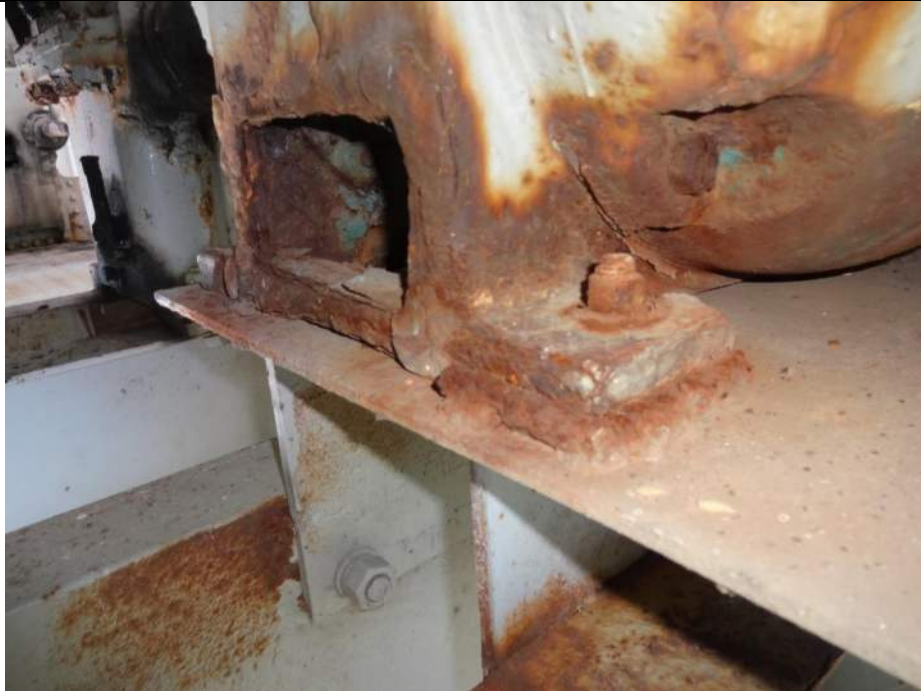
Photo 41 - [Span Lock Motor] – Note heavy corrosion on SE motor foot mount.

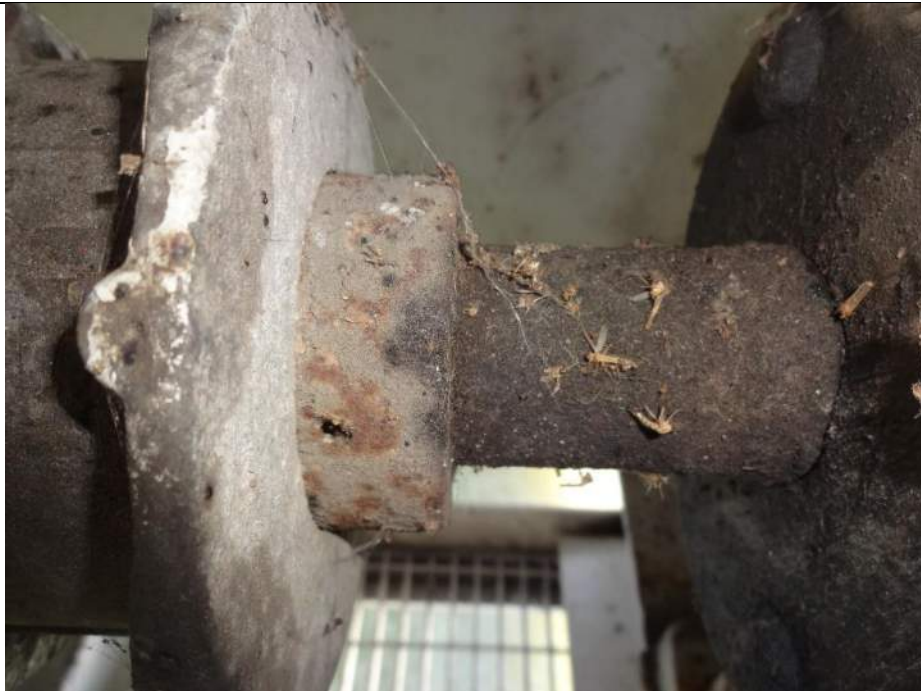
Photo 42 - [Span Locks] - Non-lubricated motor coupling with plugs and gaskets are covered with paint.

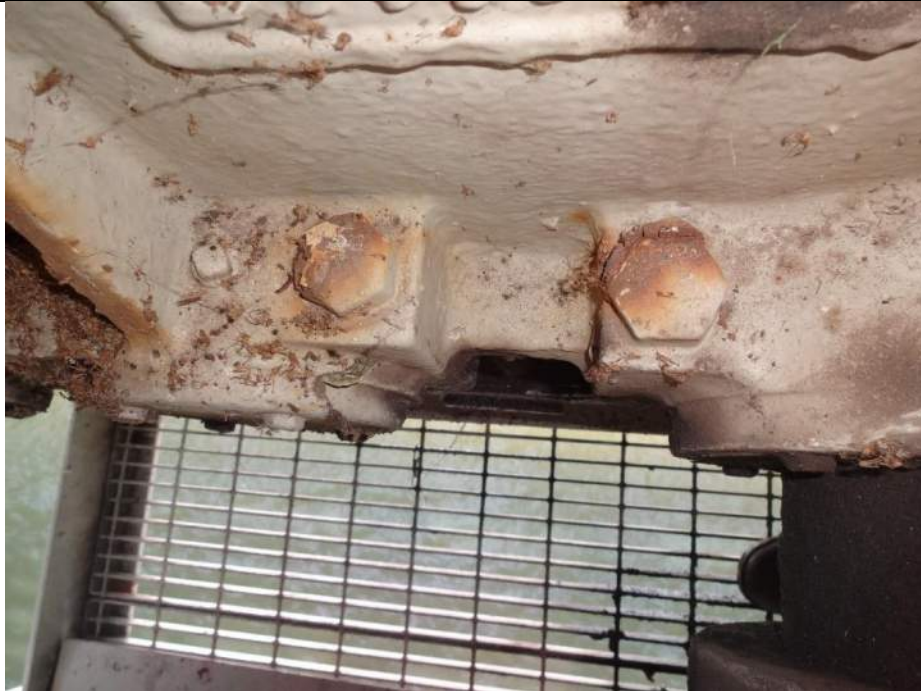
Photo 43 - [Span Lock Reducer] - Isolated corrosion is on fasteners on reducer housing.

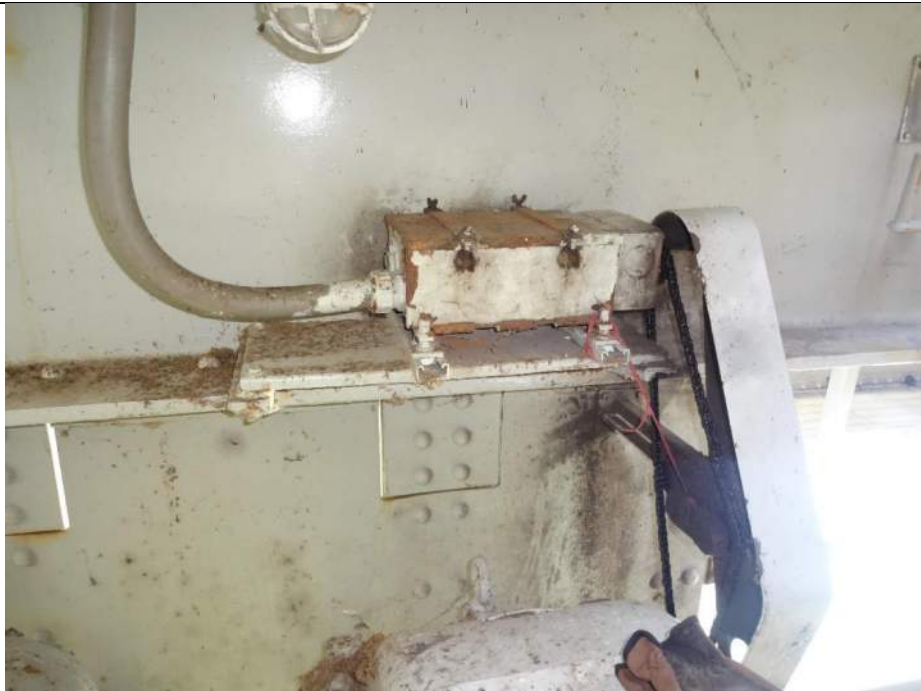
Photo 44 - [RLCS Instrumentation] – Note top wingnuts seized, old oil on chain, tensioner held by wire and heavy corrosion on top surface

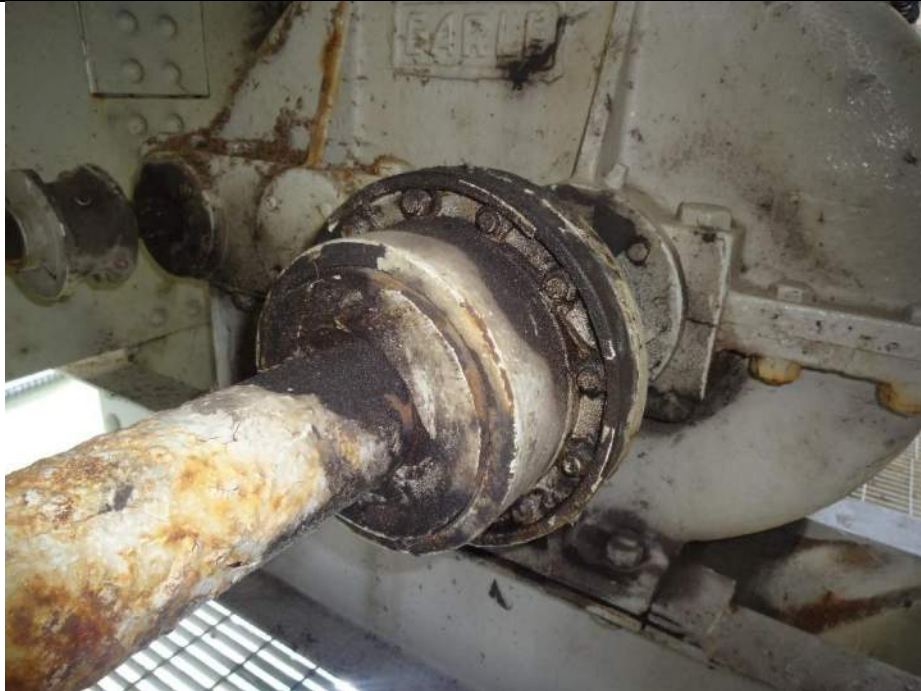
Photo 45 - [NW Span Lock Couplings] - Couplings exhibit minor paint failure, moderate grease purging, and rusted hubs.

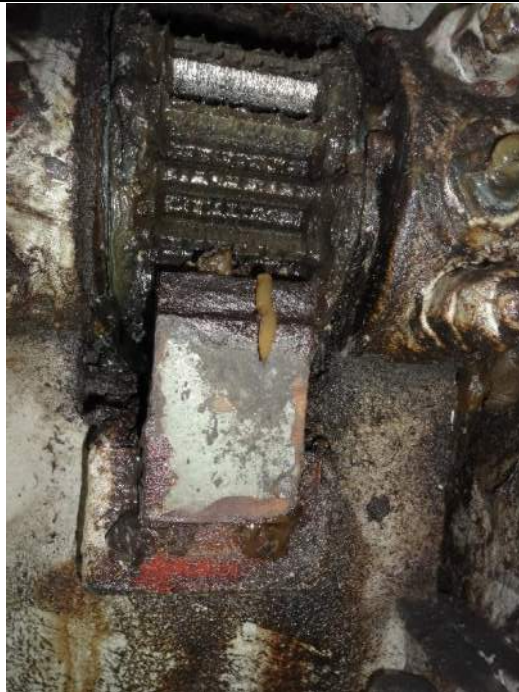
Photo 46 - [NW Inboard Locking Mechanism] – Note paint failure, corrosion, old grease and debris contaminating lubrication in locking mechanism.

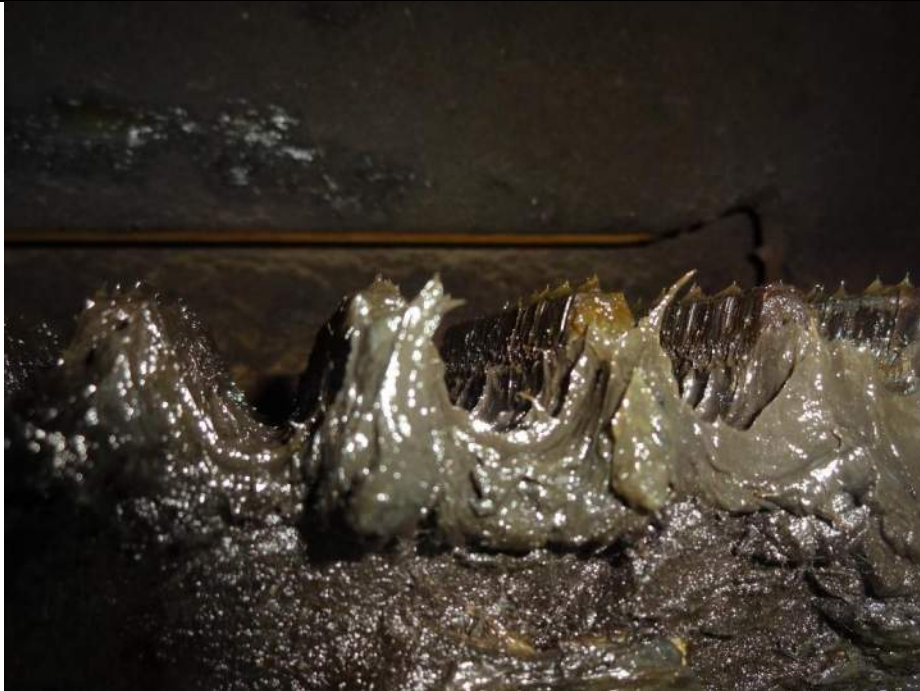
Photo 47 - [NW Inboard Locking Mechanism] - Moderate scoring exists on rack and pinion teeth.

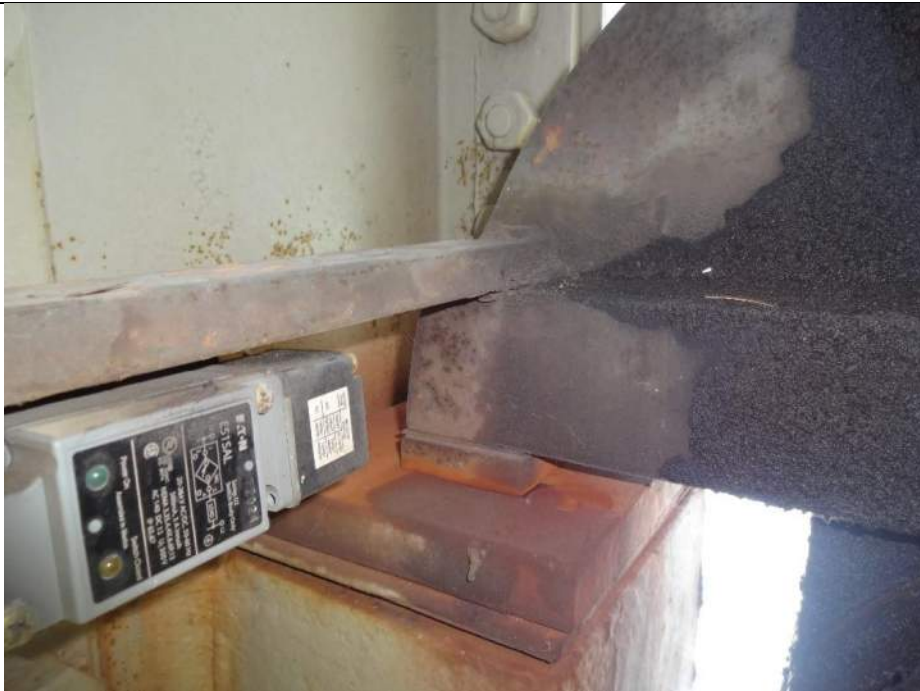
Photo 48 – [NW Inboard Locking Mechanism] – Severely corroded countersunk bolts and pack rust is forming on receiver plates.

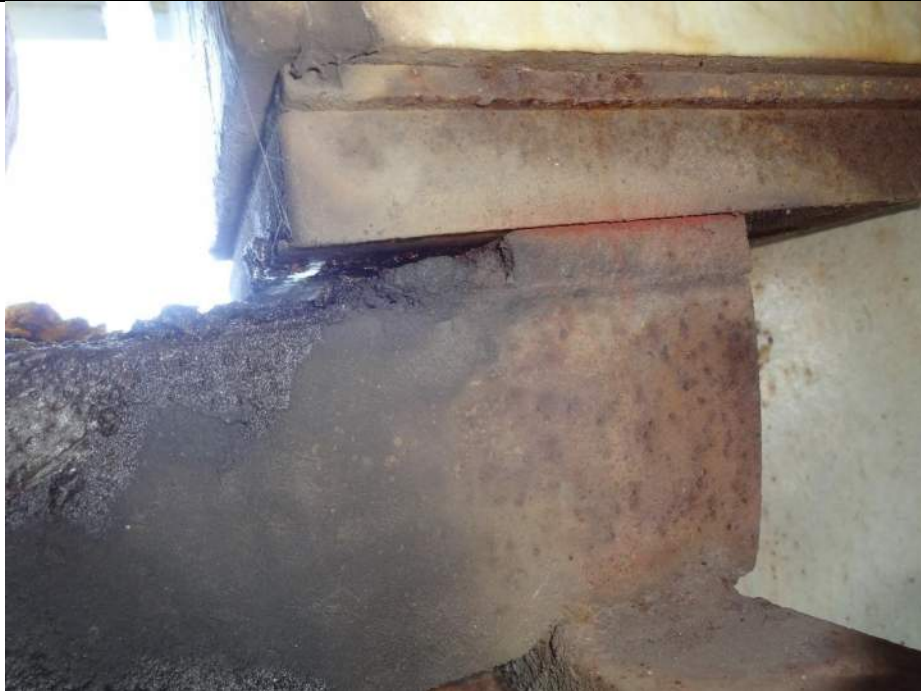
Photo 49 - [NE Inboard Locking Mechanism] - Locking mechanism has pack rust starting to form on receiver plates.

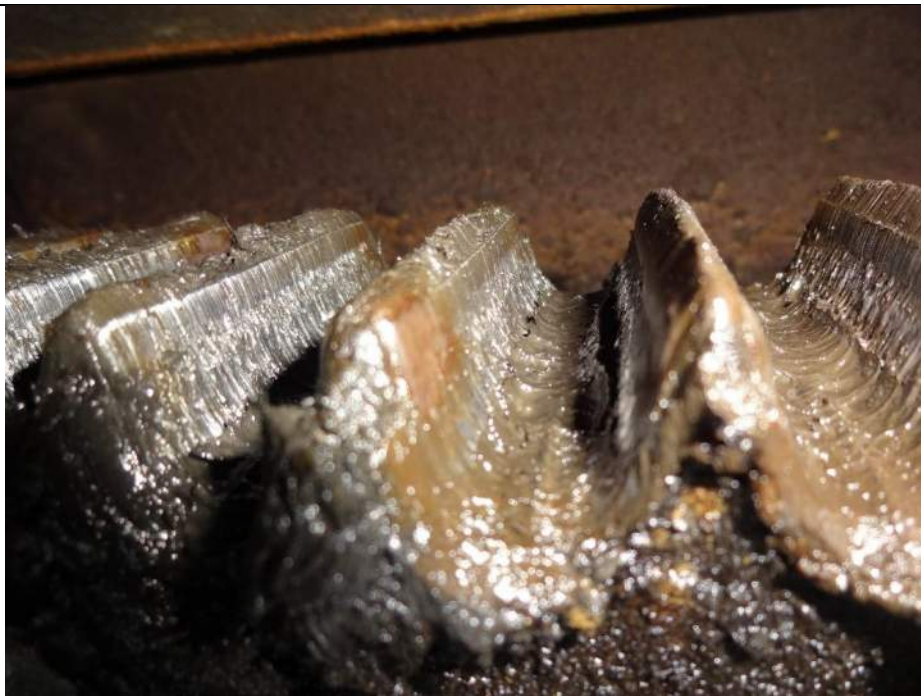
Photo 50 - [NW Outboard Locking Mechanism] - Heavy scoring is present on locking mechanism teeth.

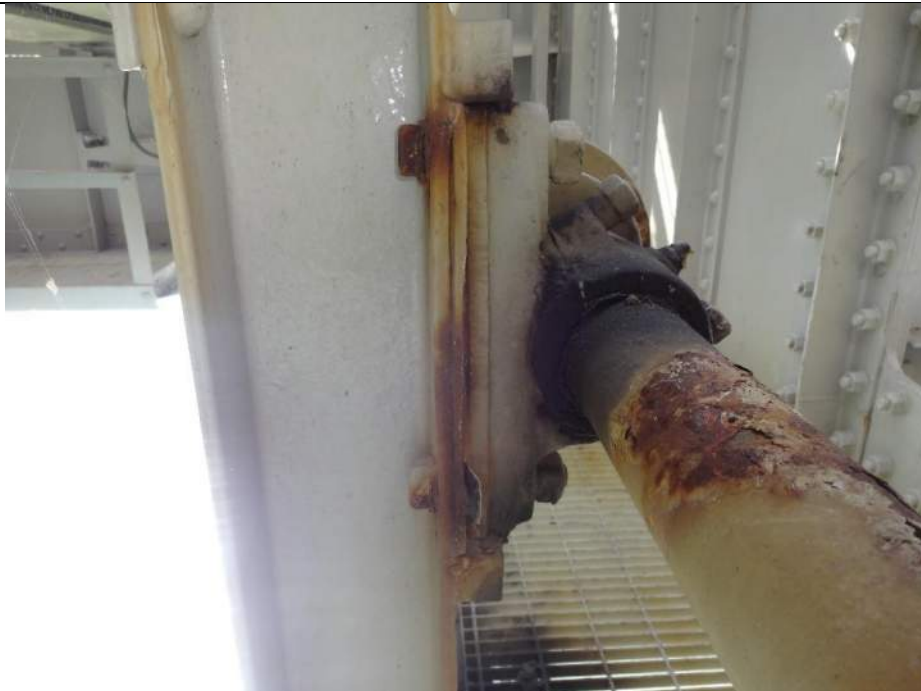
Photo 54 - [NW Span Lock Bearings] – Note pack rust forming, paint failure, isolated corrosion on fasteners on bearings.

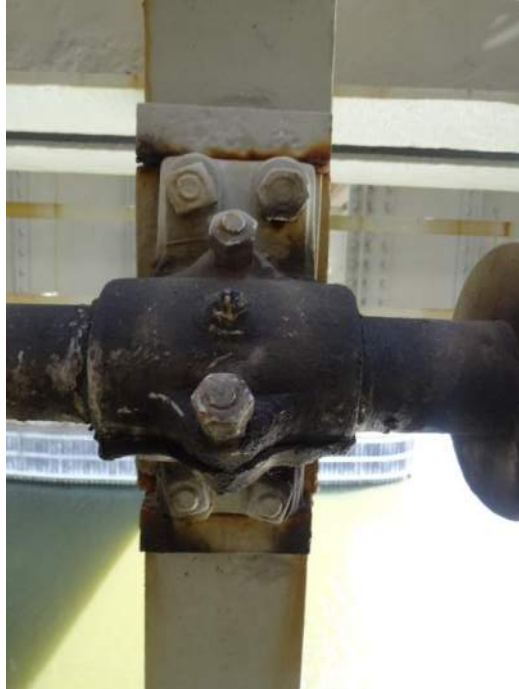
Photo 55 - [NW Span Lock Bearings] – Note top two bolts on bearing using mismatched hardware: one hex nut and one square nut.

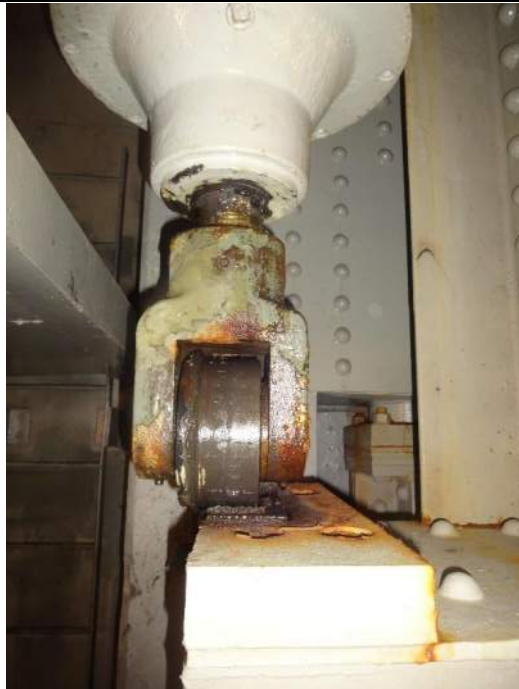
Photo 56 - [NW Seated Buffer] - Seated buffers exhibit transverse misalignment with strike plate as well as some minor surface corrosion.

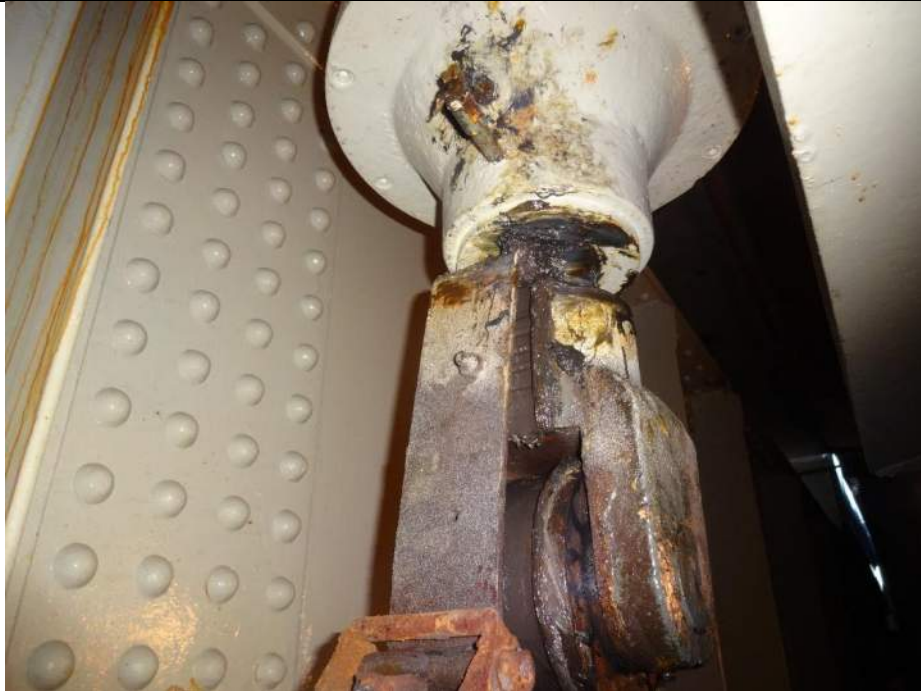
Photo 57 - [SW Seated Buffer] - Seated buffer exhibits minor surface corrosion and corrosion on back lever that is meant to extend rod.
