Craig Memorial Bascule Bridge

Over the Maumee River

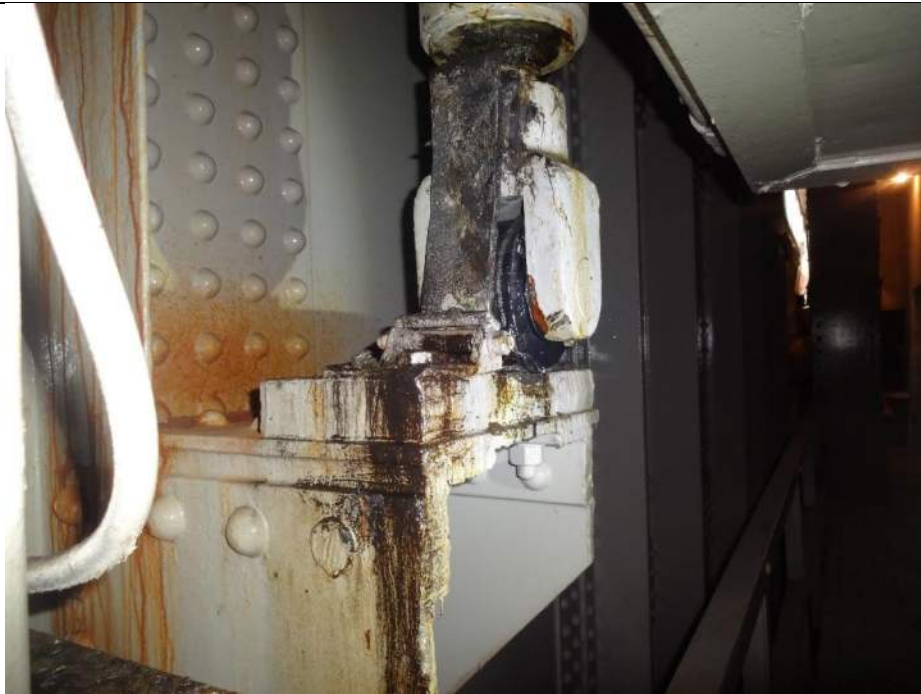
Photo 58 - [SE Seated Buffer] - Seated buffer has moderate grease purge.

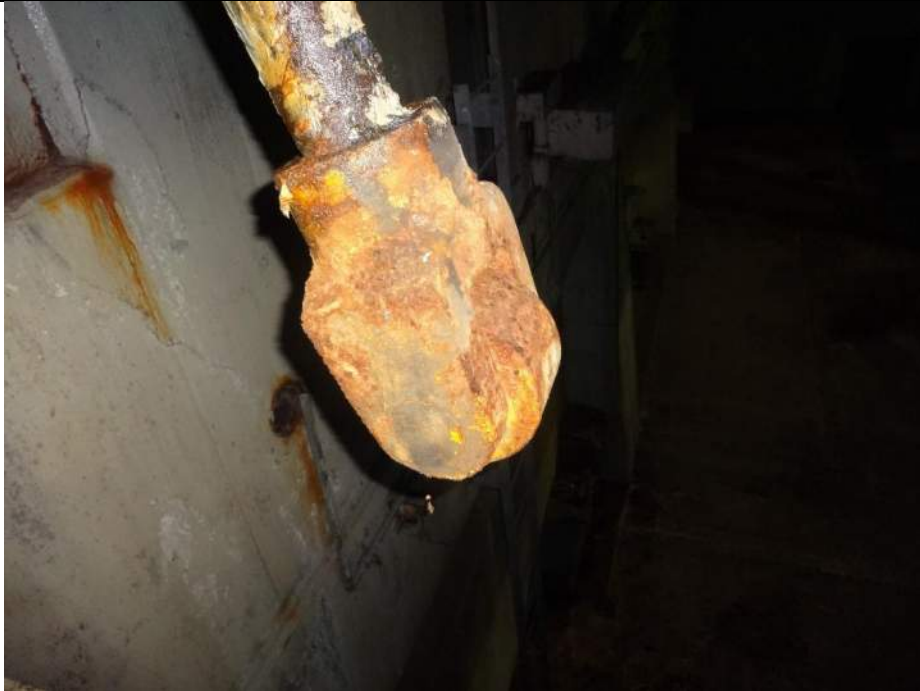
Photo 59 - [NW Raised Buffer] - Rollers of raised buffers are severely corroded and seized.

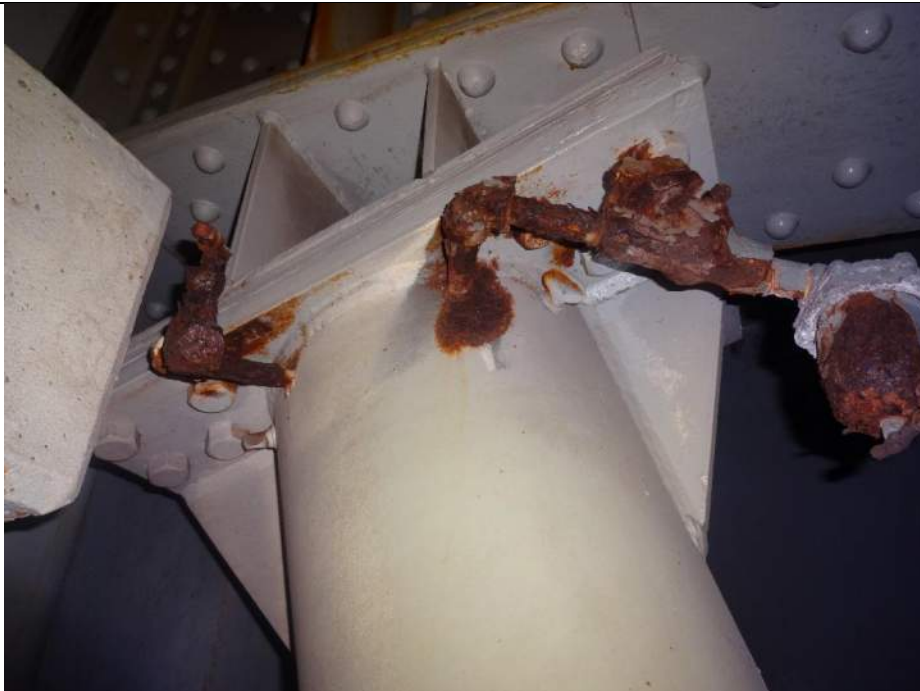
Photo 60 - [NW Raised Buffer] - Relief valves on North side of bridge are severely corroded on raised buffers.

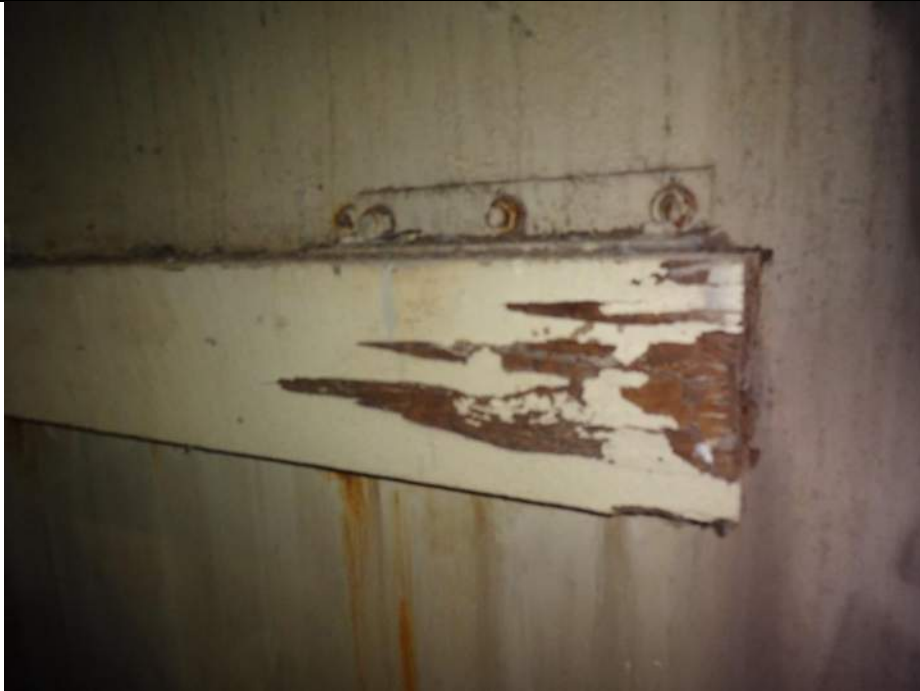
Photo 61 - [North CW Pit] - Wooden counterweight bumpers exhibit isolated fastener corrosion and wood failure.

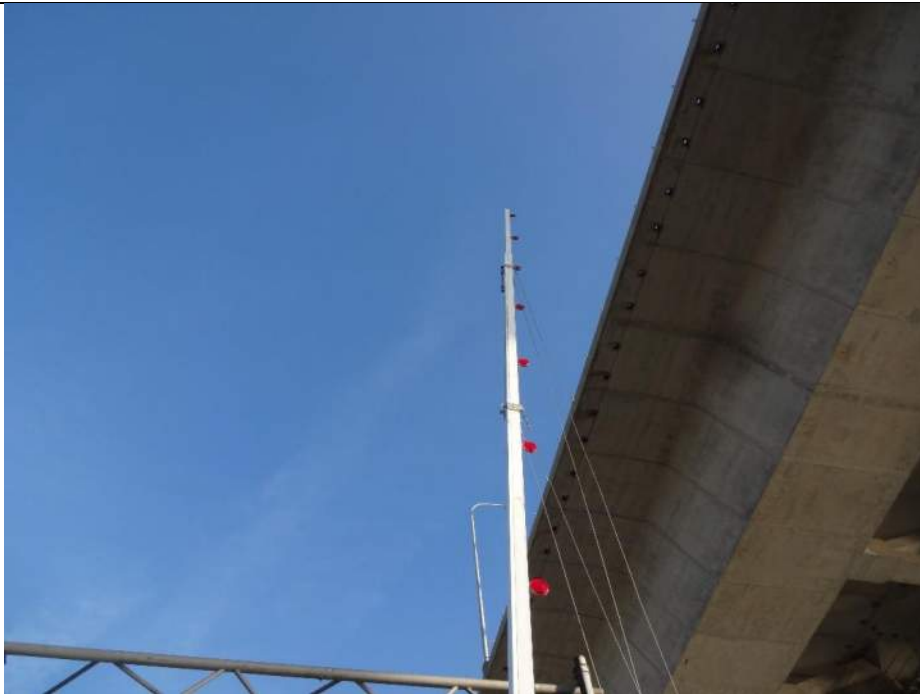
Photo 62 - [NE Traffic Gate] - Vertical traffic gates have loose guy wires.

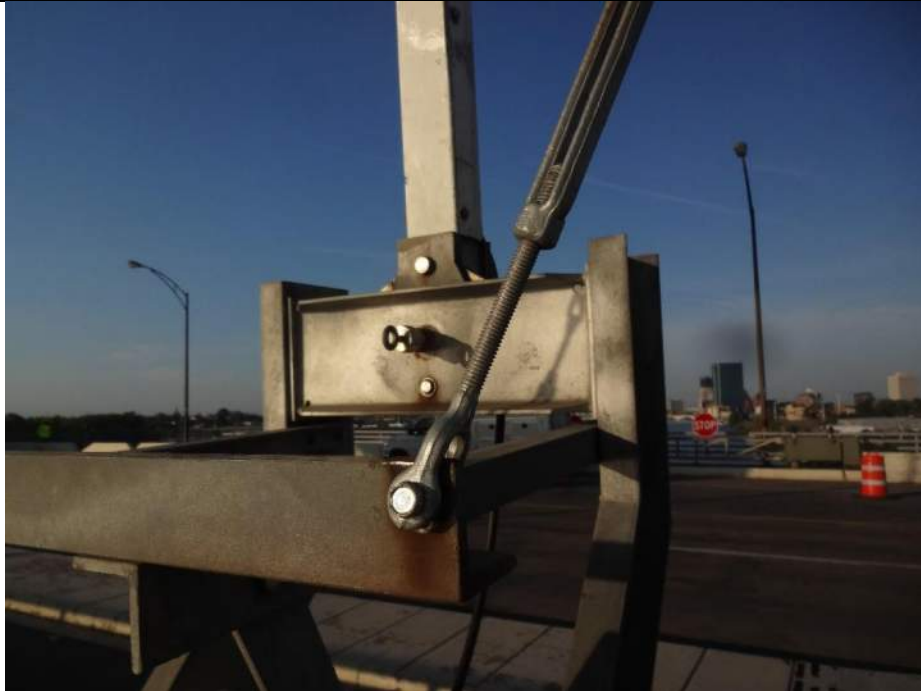
Photo 63 - [NE Traffic Gate] – Note missing jam nut on turnbuckle.

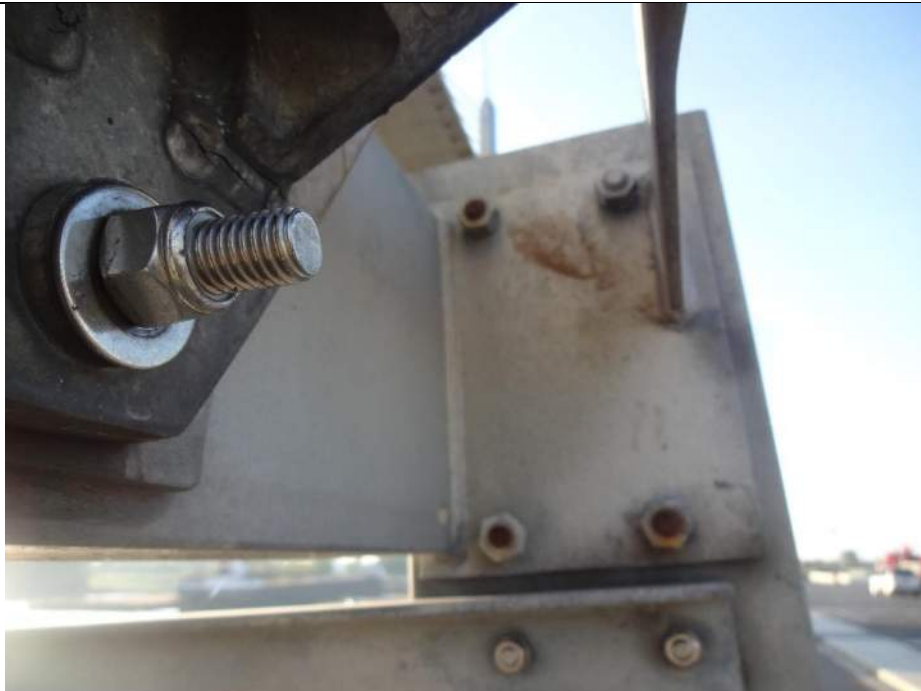
Photo 64 - [NE Traffic Gate] - Cracked welds are at base of gate arm and isolated corrosion is present on fasteners of arm connector.

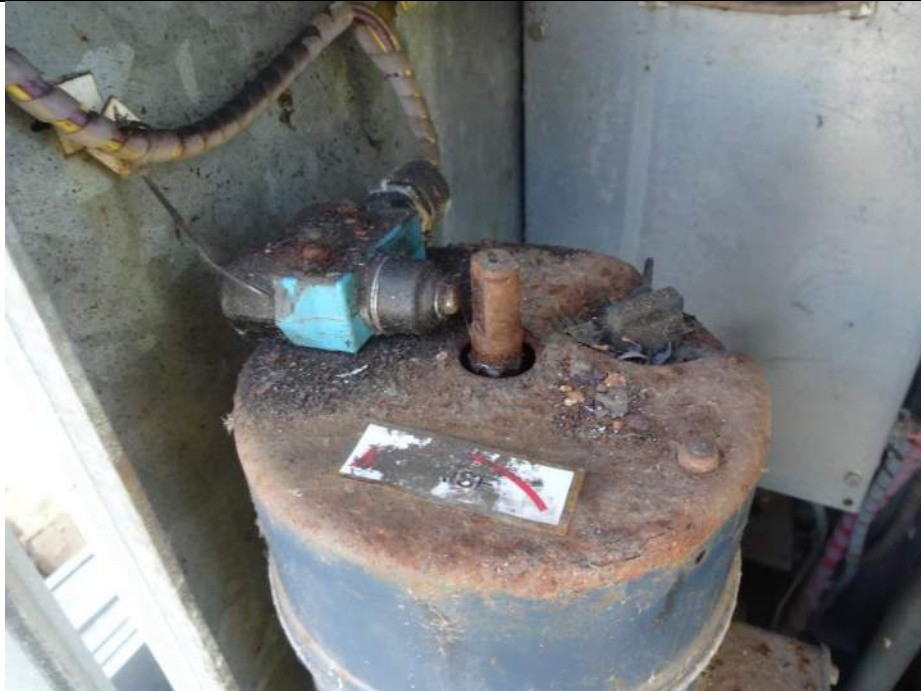
Photo 65 - [NE Traffic Gate] – Note the heavy corrosion on top of motor, hand crank shaft and limit switch fasteners.

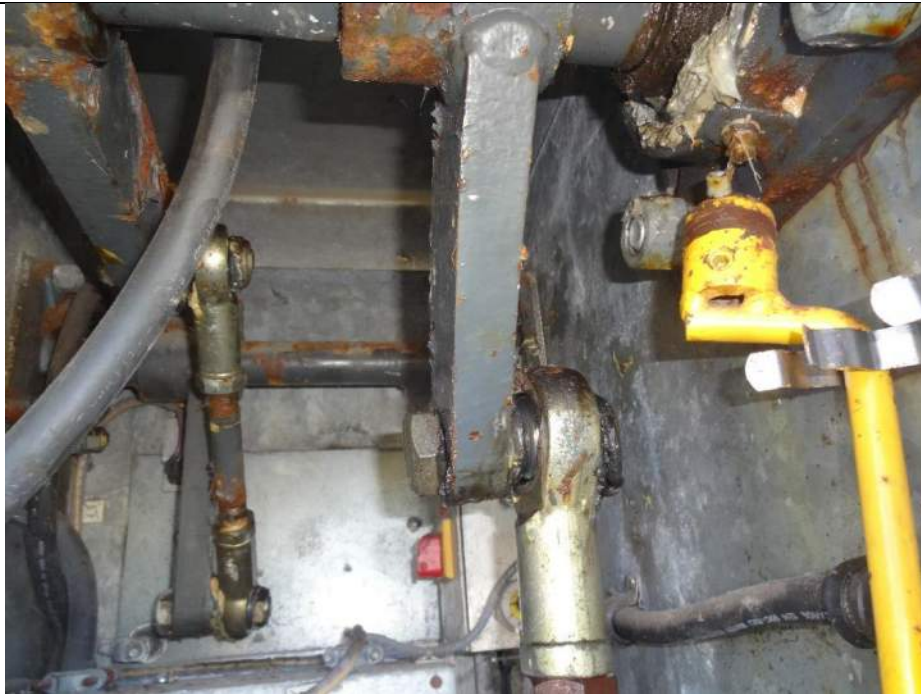
Photo 66 - [NE Traffic Gate] - Widespread corrosion and paint failure is present across all movable components.

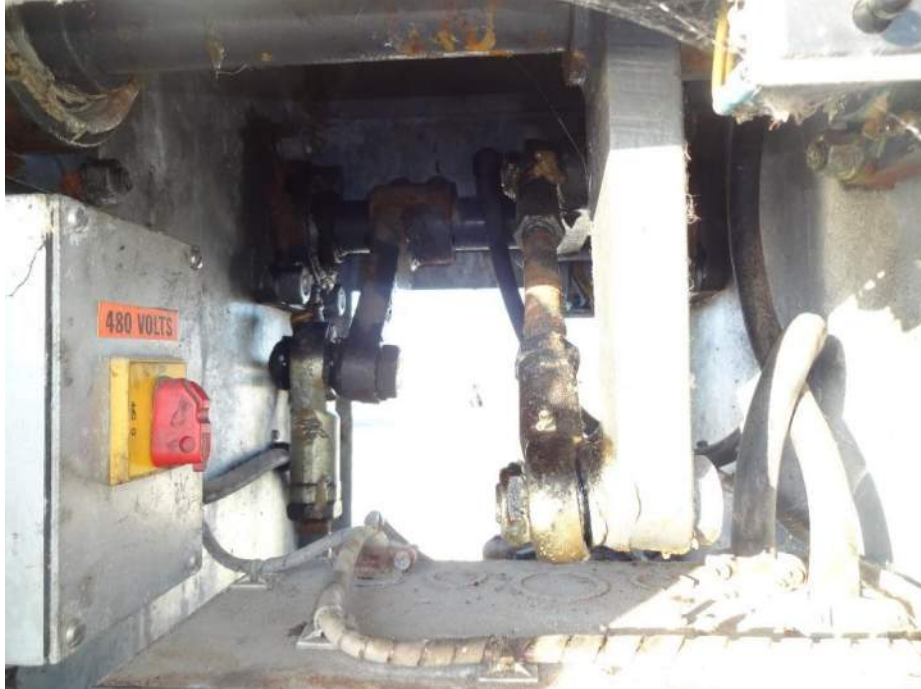
Photo 67 - [NE Traffic Gate] - Crank arm has misalignment possibly due to deformation.

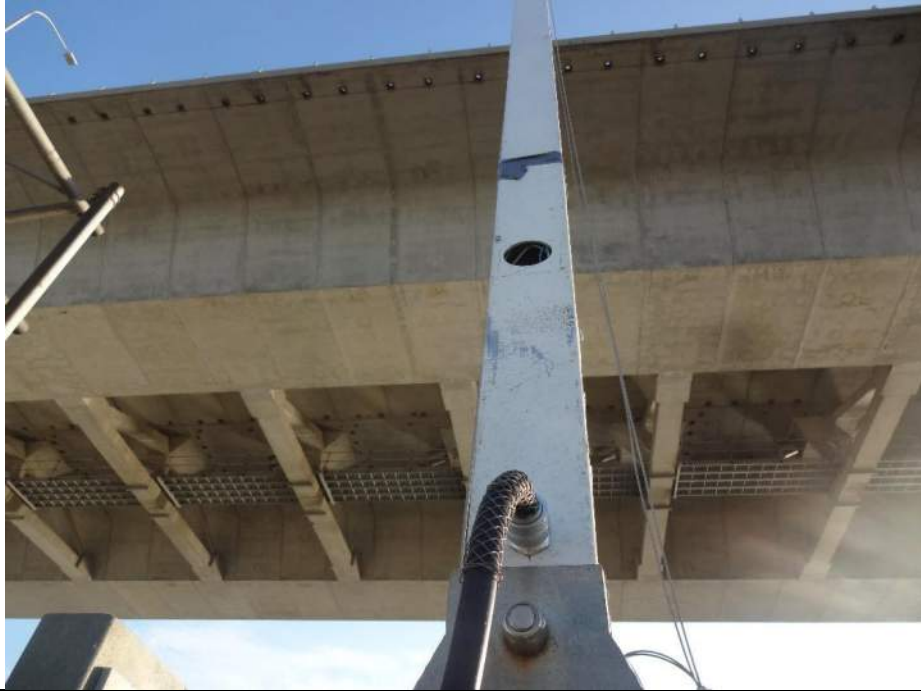
Photo 69 - [NE Traffic Gate] - Cover for electrical access below gate arm is missing.

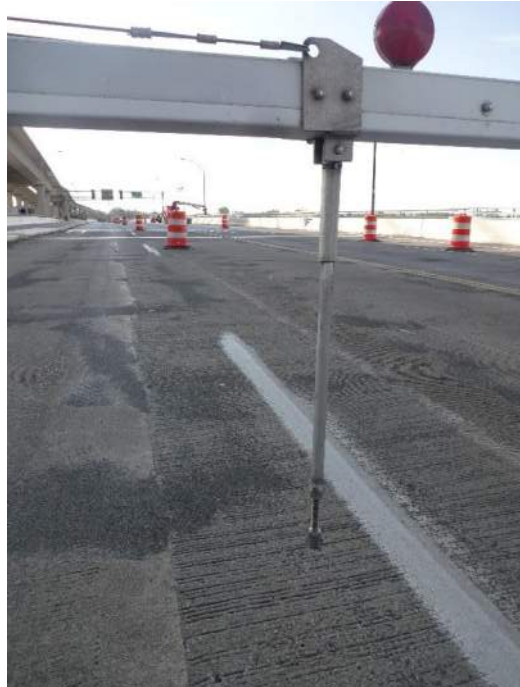
Photo 70 - [NE Traffic Gate] - Gate bumper does not contact the roadway when gate is down.

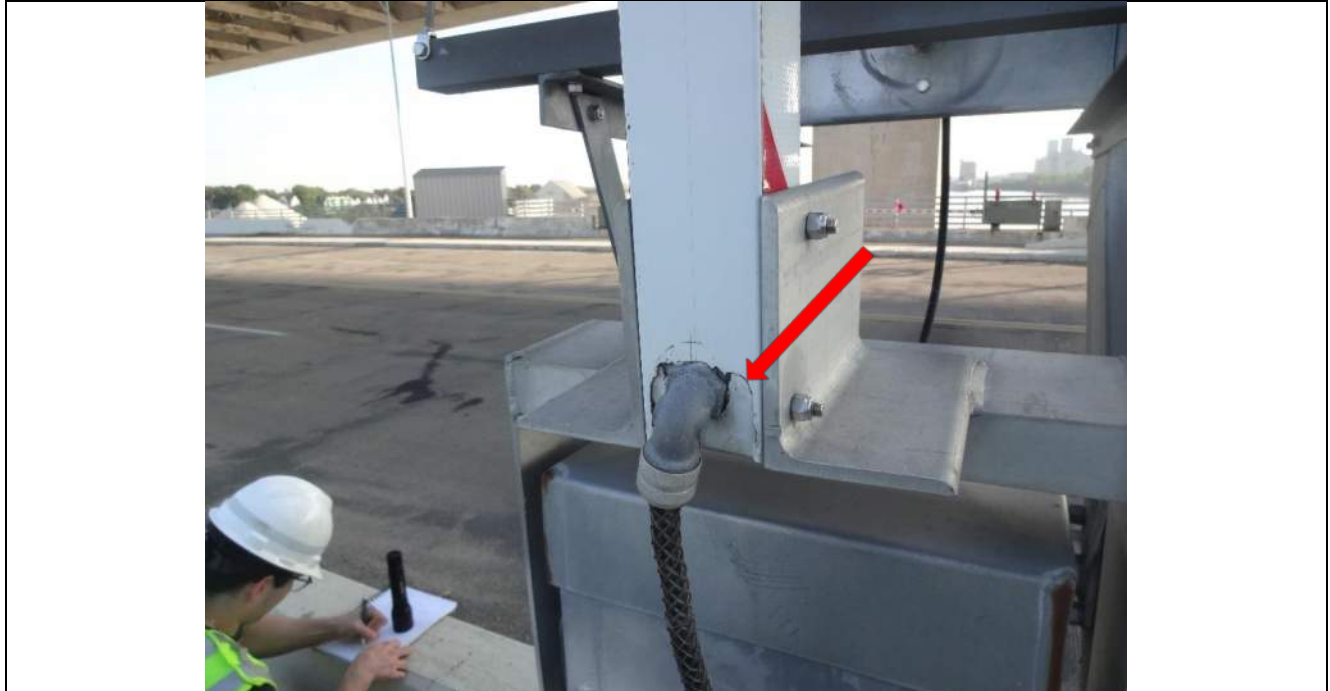
Photo 71 - [SW Traffic Gate] - Gate arm has crack at base where conduit inlet is located.

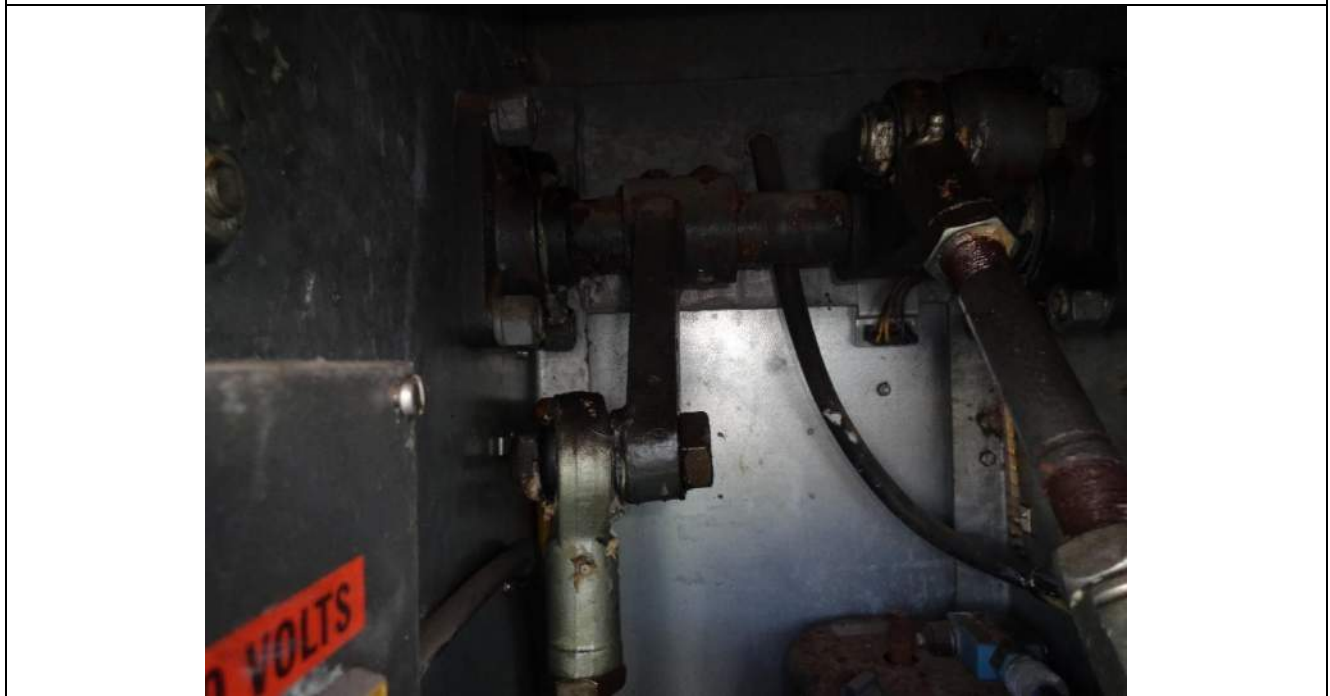
Photo 72 - [SW Traffic Gate] - Levers exhibit slight deformation and misalignment.

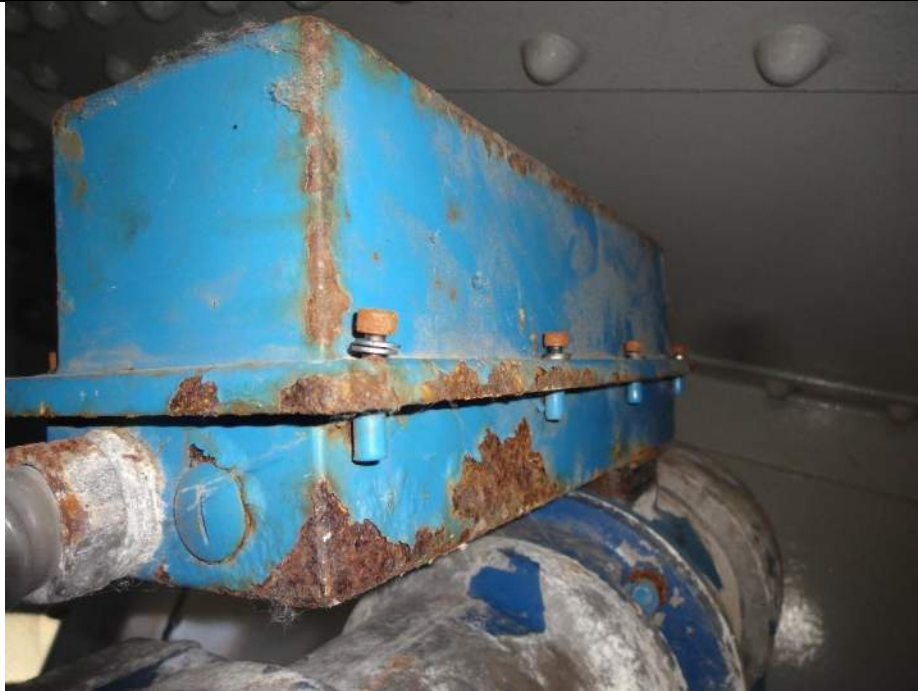
Photo 73 - [SE Swing Gate] – Note loose fasteners on RACO limit switch housing for swing gate.

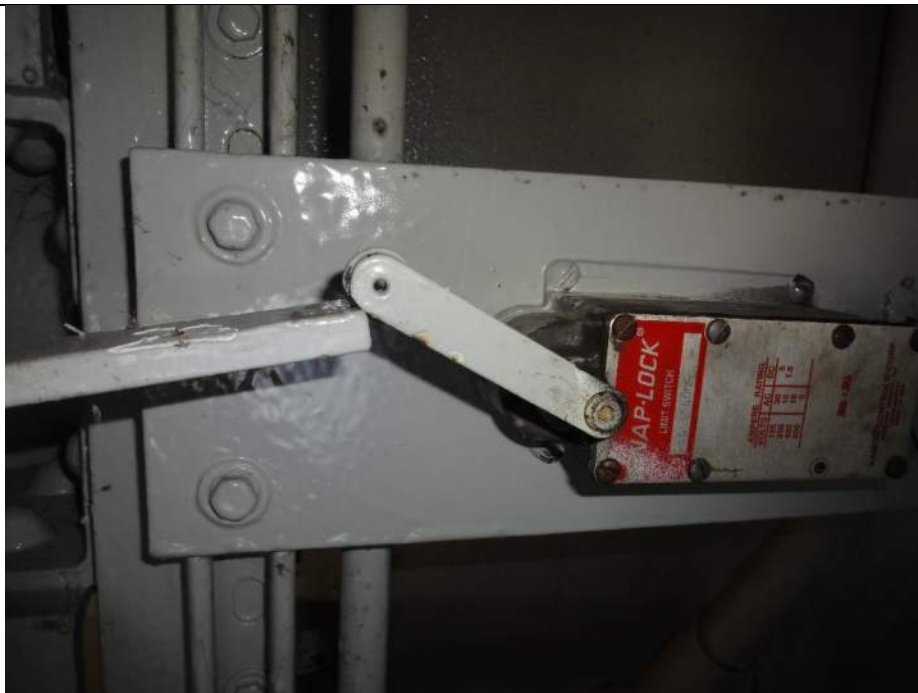
Photo 74 - [SE Swing Gate] - Limit switches have seized rollers due to paint and make poor contact with their targets.

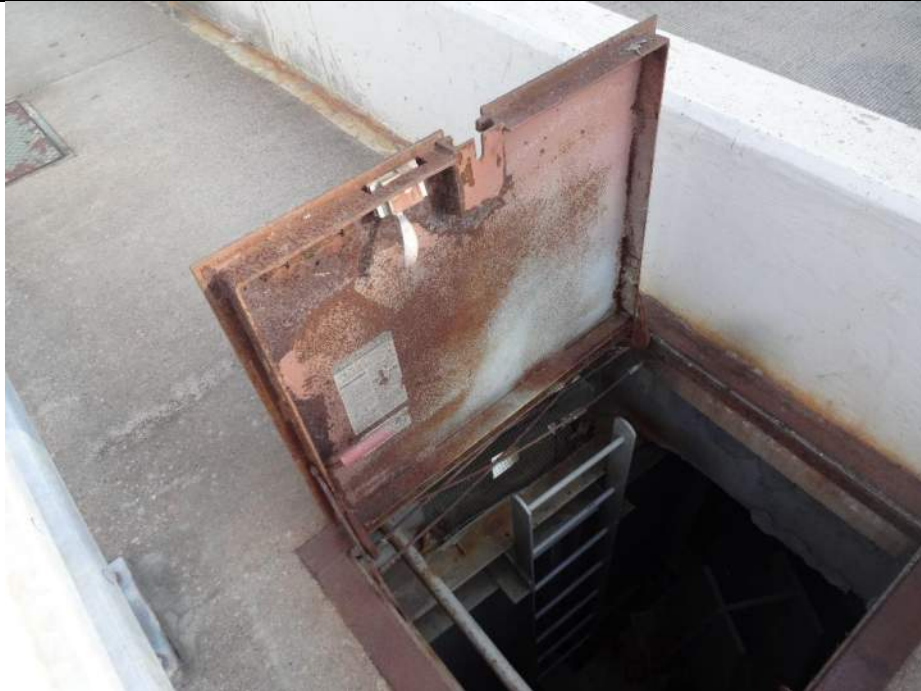
Photo 75 - [SE Swing Gate] - Heavy corrosion is present on access doors and hinges to access swing gate machinery.

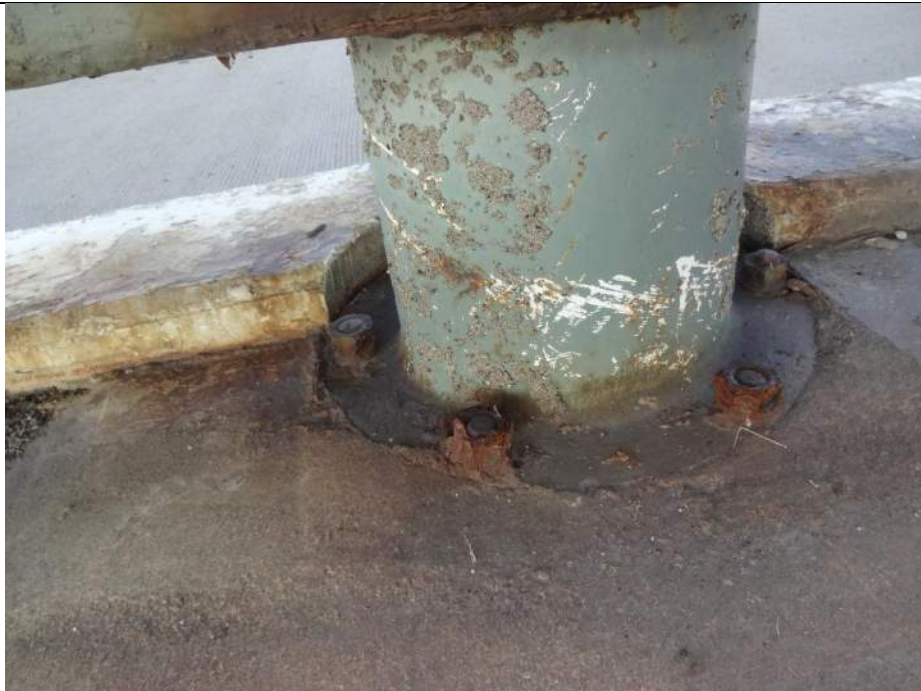
Photo 76 - [SE Swing Gate] - Severe corrosion and section loss exist on upper bearing anchors of swing gate.

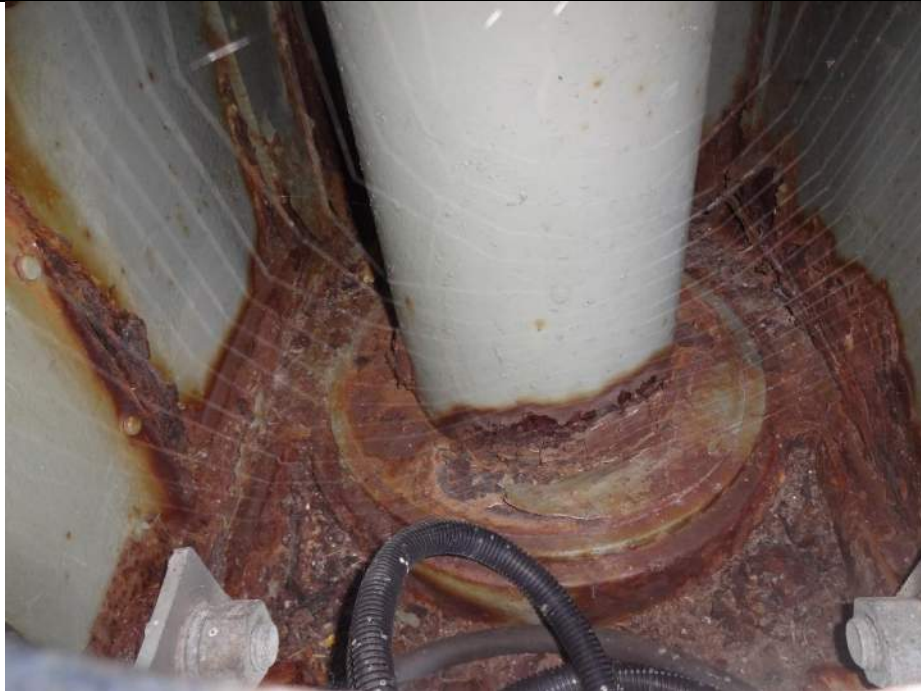
Photo 77 - [SE Swing Gate] - Heavy corrosion is on bearing and shaft inside swing gate housing.

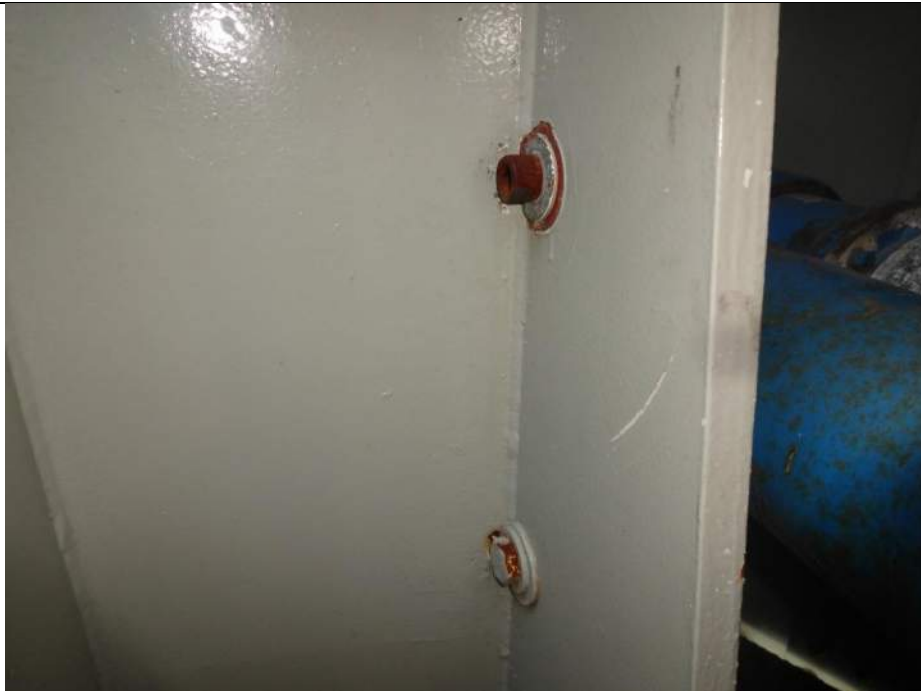
Photo 78 - [NW Swing Gate] - Mismatched actuator bolts are being used on swing gate.

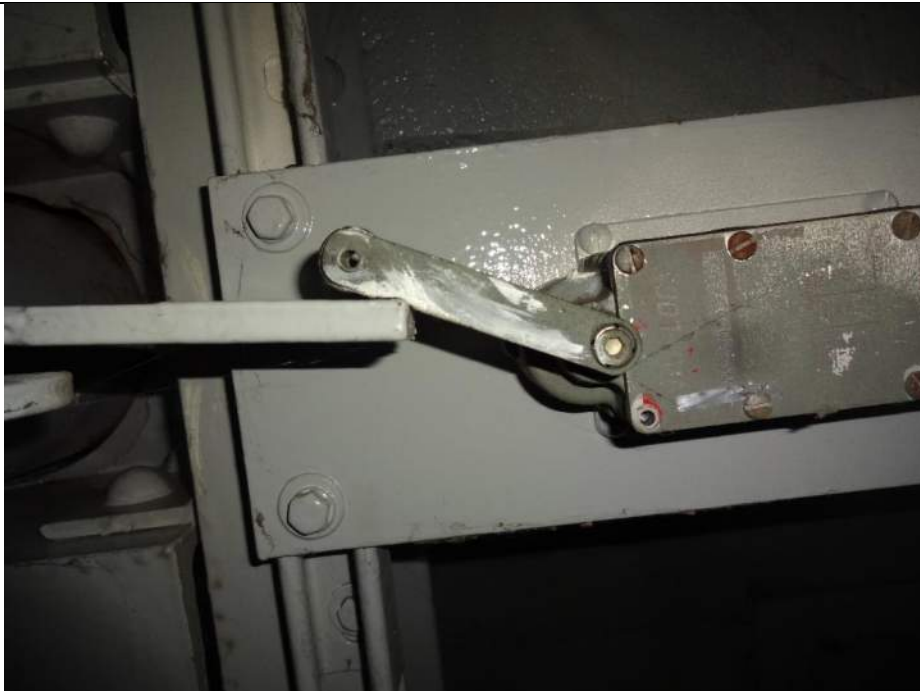
Photo 80 - [NW Swing Gate] – Rollers, though in better condition than SE gate, are misaligned.

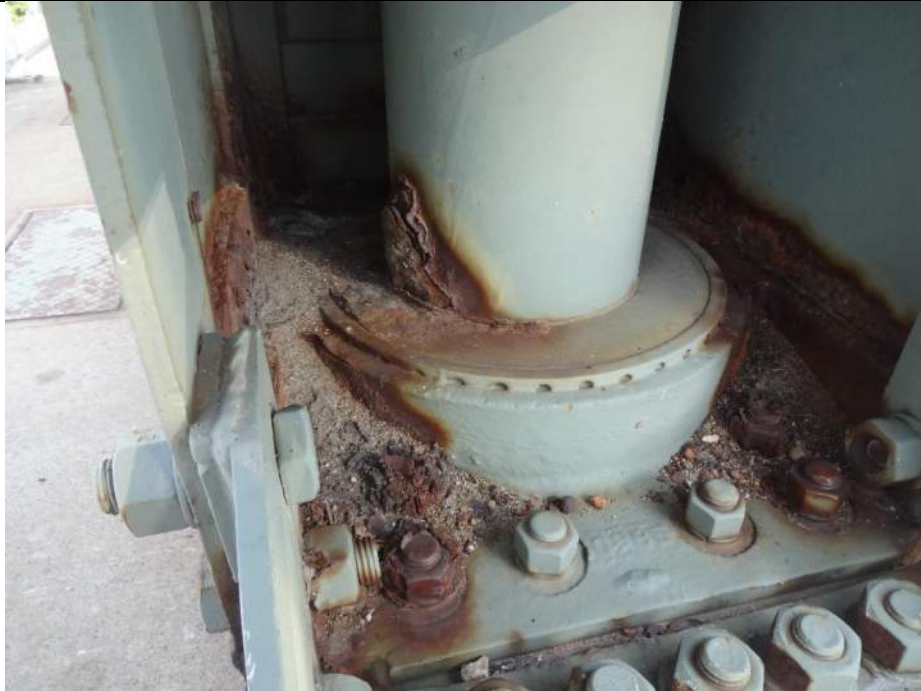
Photo 81 - [NW Swing Gate] – Note severe corrosion on upper bearing fasteners and shaft.

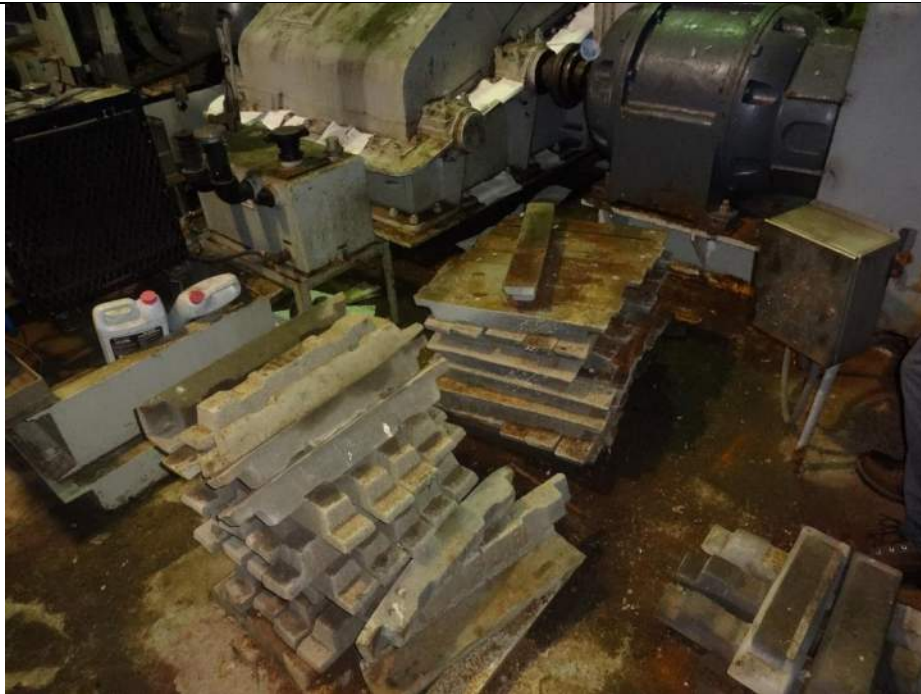
Photo 82 - [North Machinery Room] - Counterweight stacks are present throughout machinery rooms.

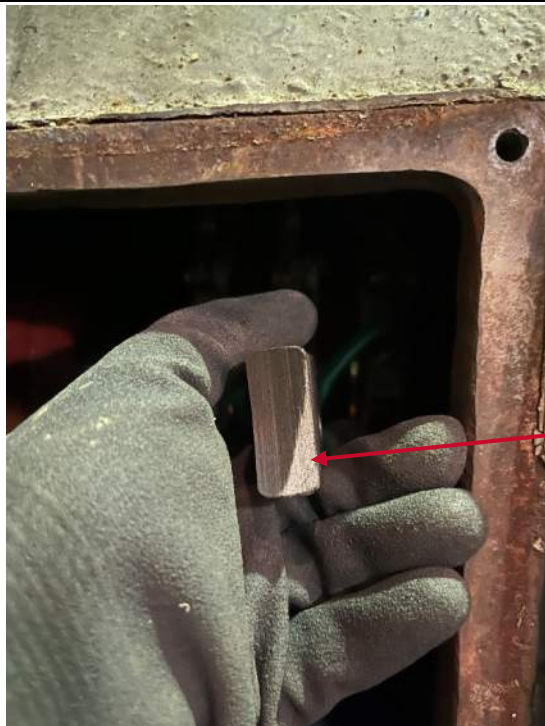
Photo E-10: Southeast Main Drive Motor Brush Wear. Note that the brush is not wearing evenly

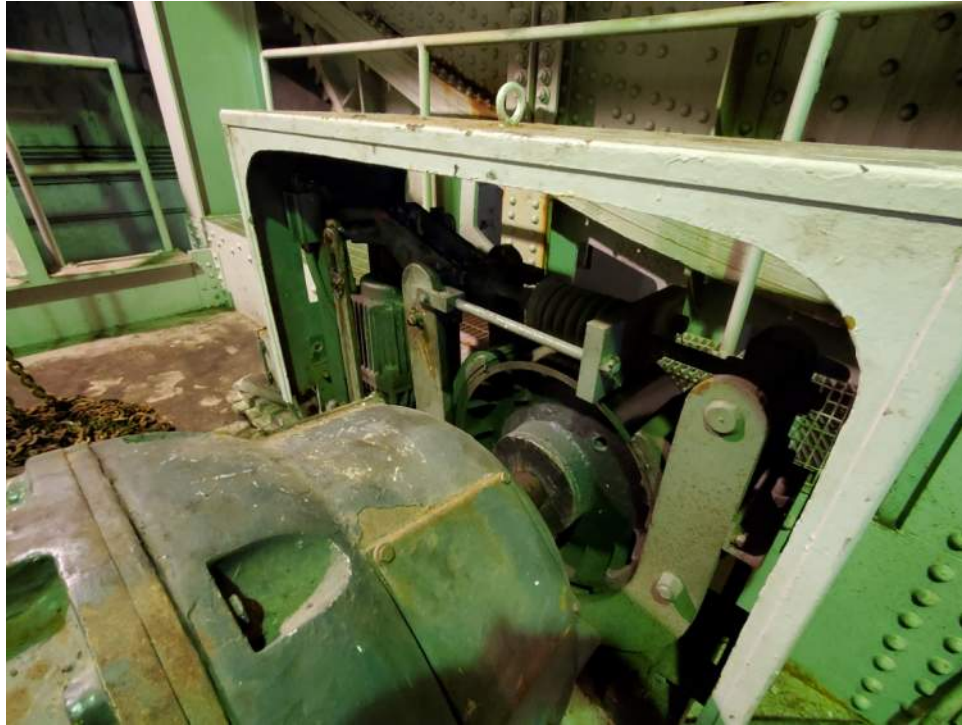
Photo E-11: Northeast Motor Brake

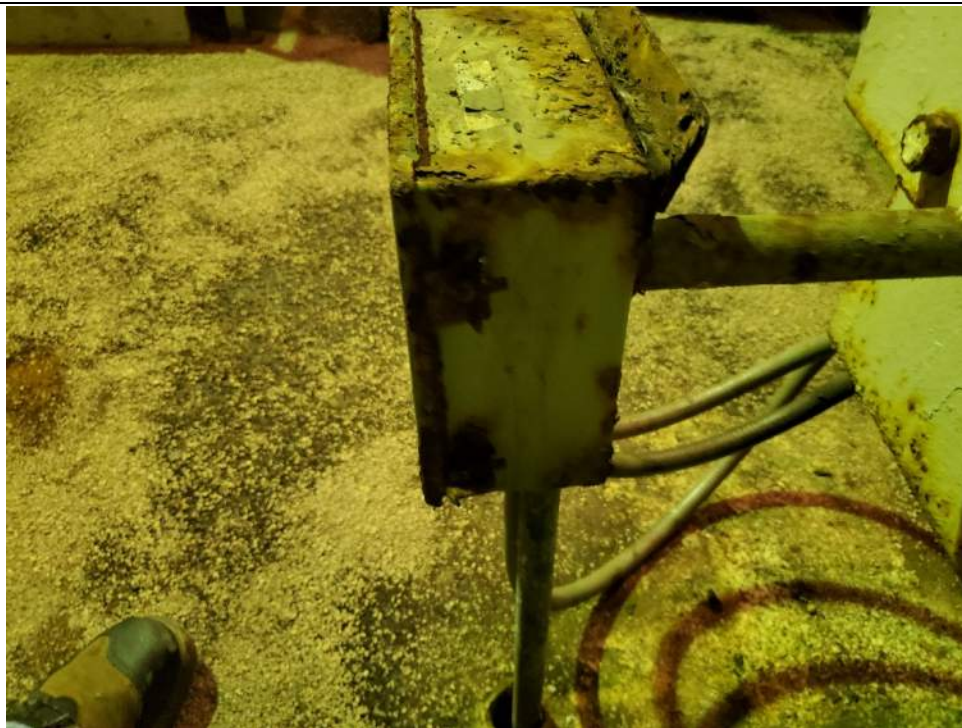
Photo E-12: Motor Brake Junction Box. Note the severe corrosion on the junction box and conduit. Also note that the junction box is not properly mounted as it is only supported by

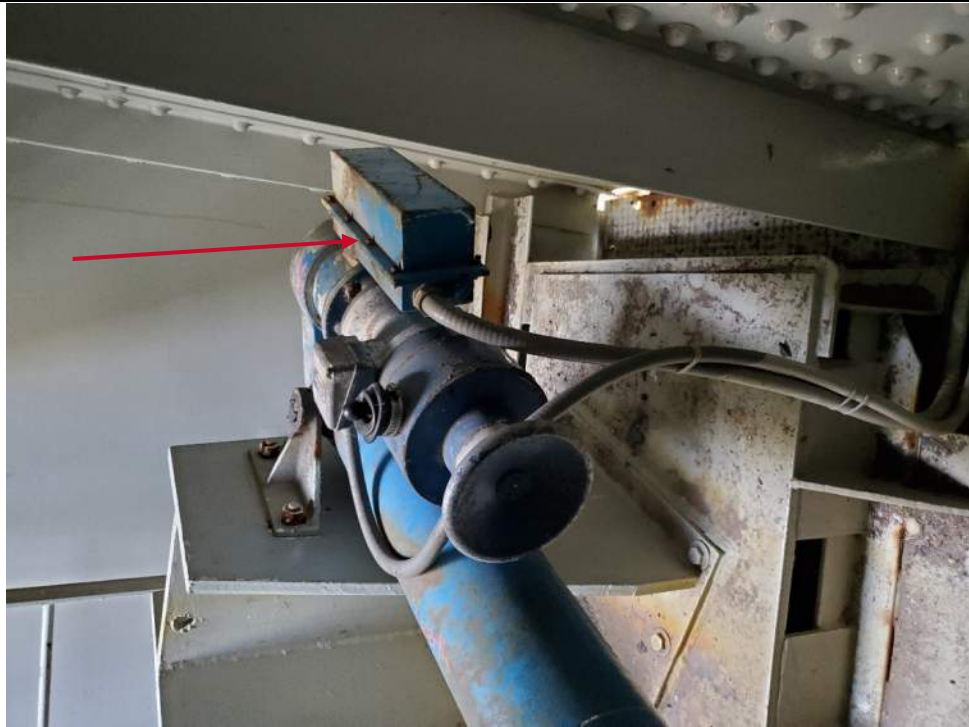
Photo E-13: Southeast Traffic Gate Actuator. Note the corrosion and the abandoned in place rotary cam limit switch.

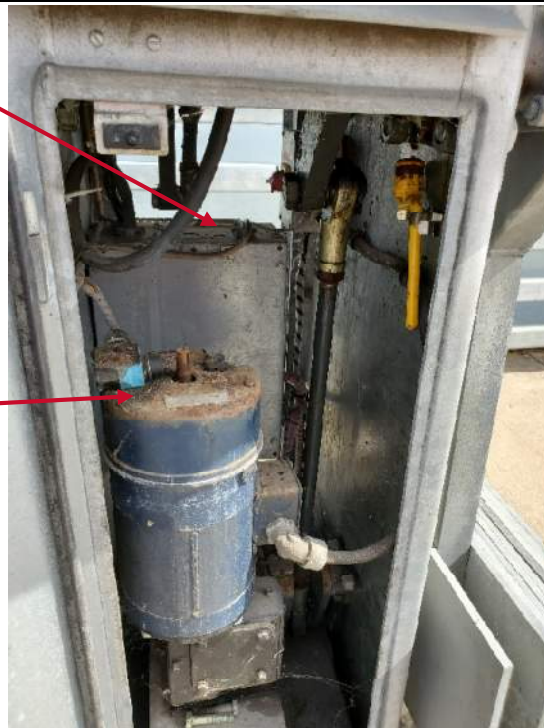
Photo E-14: Northeast Traffic Gate. Note the corrosion within the gate

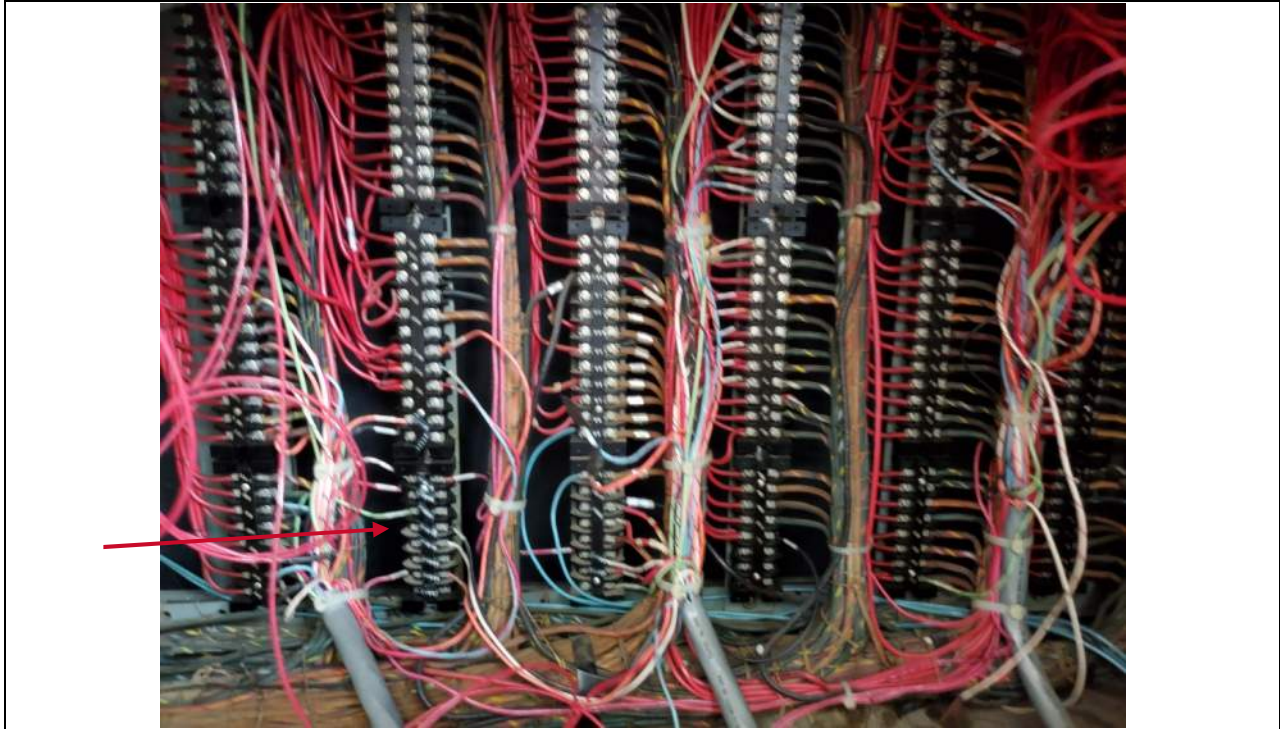
Photo E-17: Control Console Interior. Note the missing wire numbers on almost all the conductors

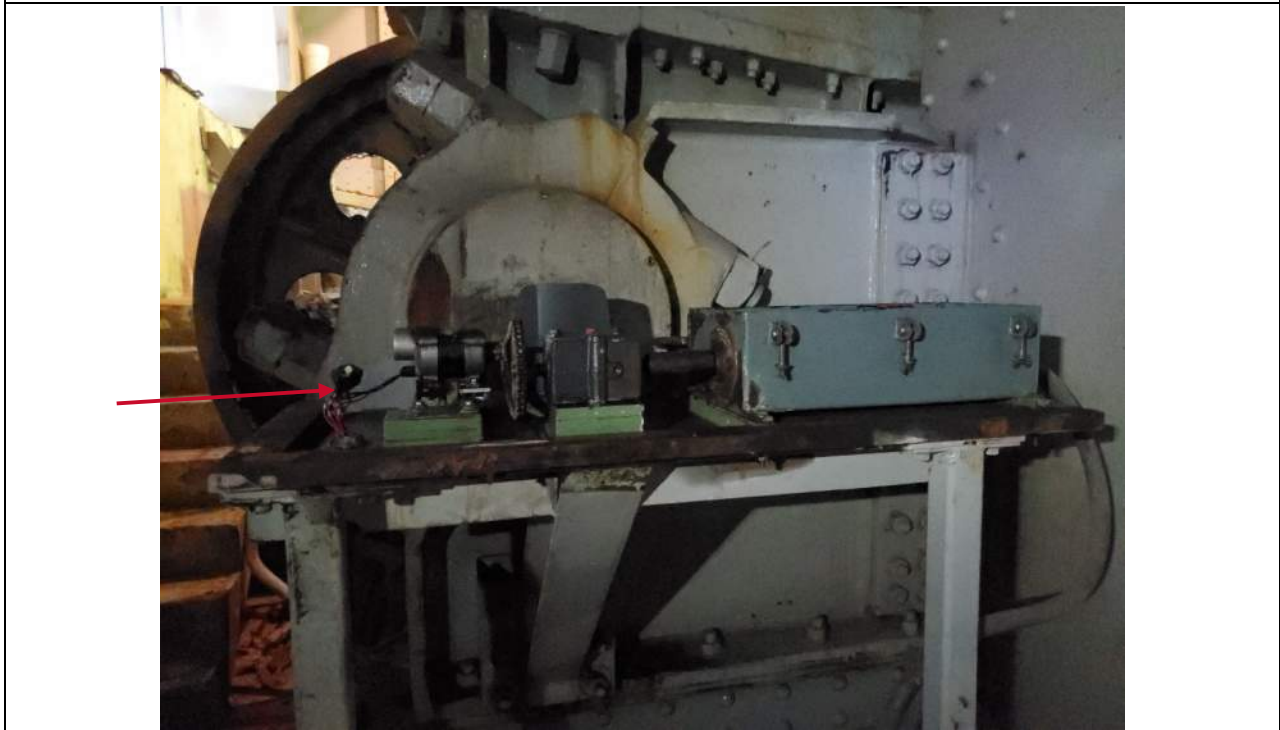
Photo E-18: North Leaf Rotary Cam Limit Switch. Note the wire nuts at the selsyn transmitter.

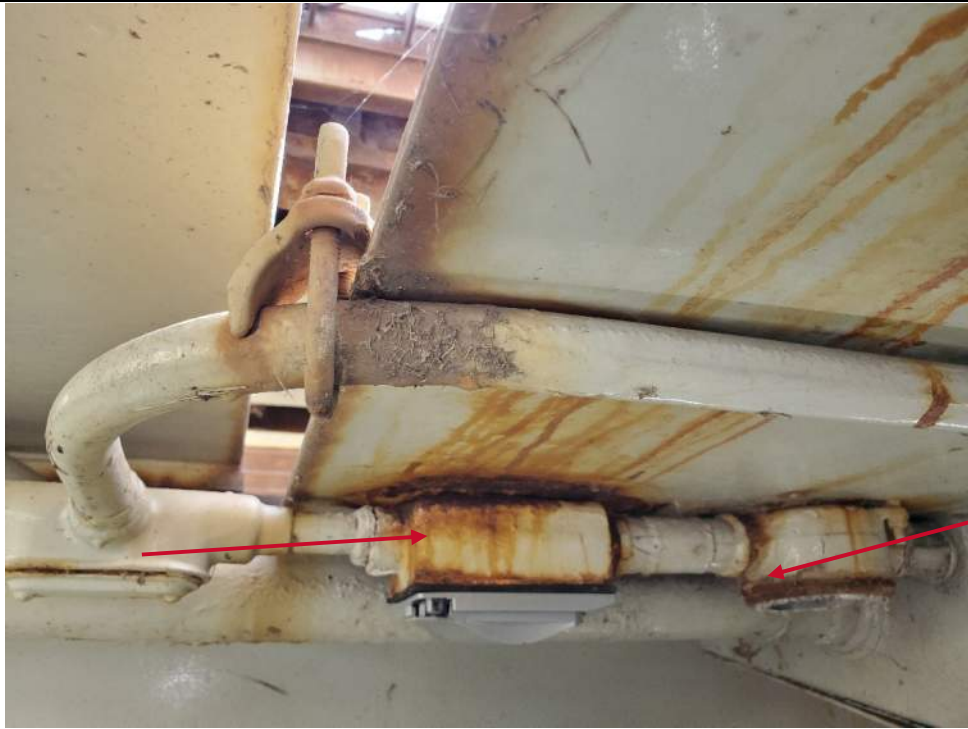
Photo E-21: Conduit near the Southeast Traffic Gate Actuator. Note the corrosion.

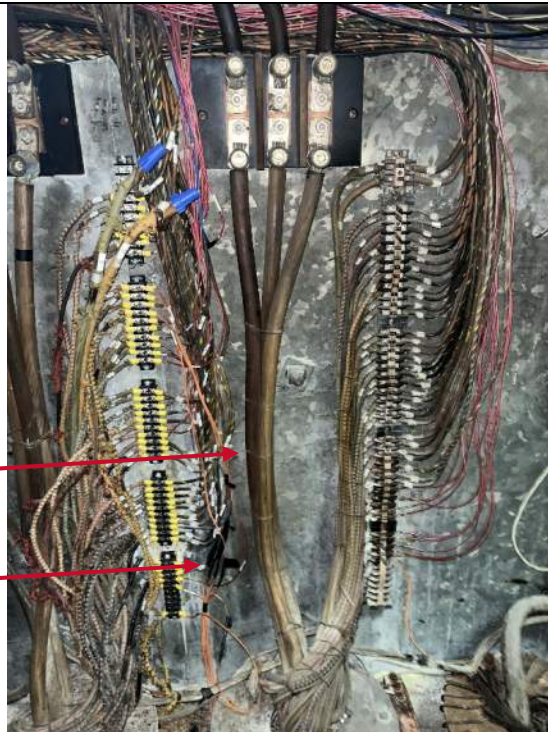
Photo E-22: South Pier Submarine Cable Termination Cabinet. Note the discolored conductors due to a previous electrical fire.

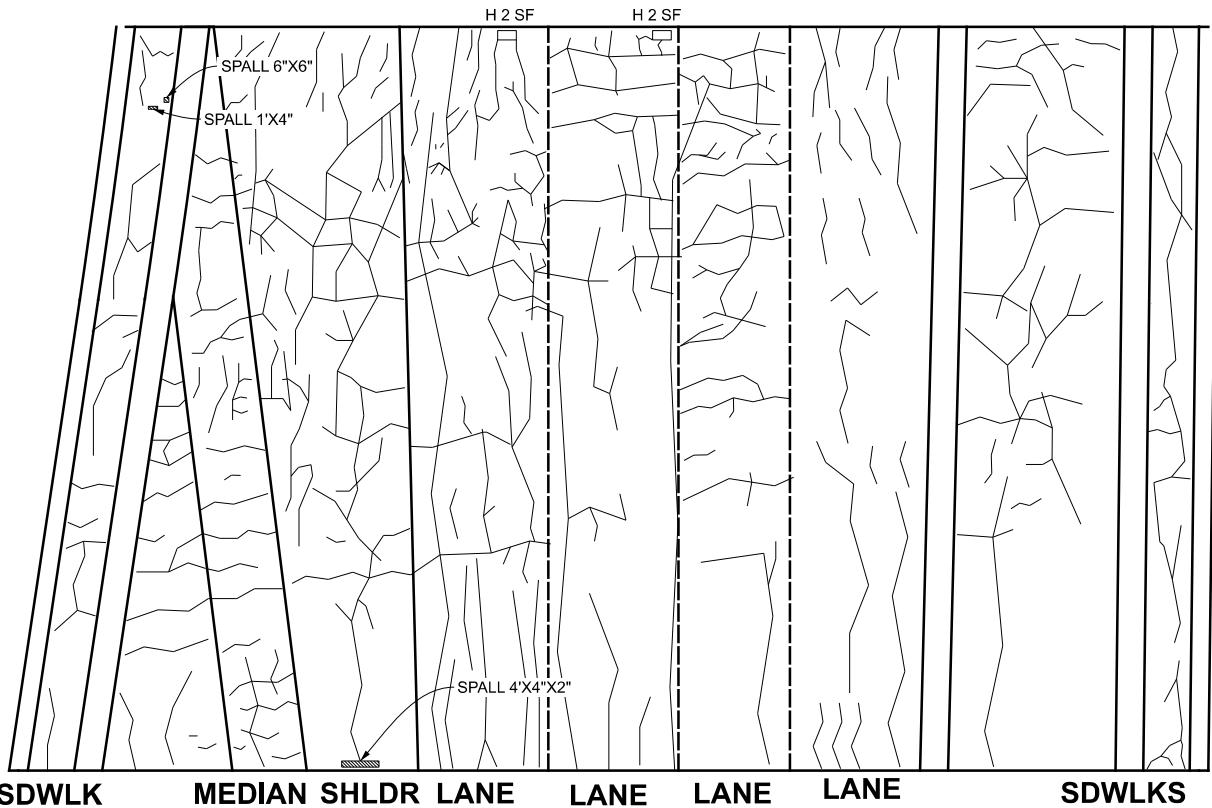
DETERIORATION QUANTITIES:
 Cracking <1/32": 1849.43 LF
 Delamination: 4 SF
 Spalling: 1.9 SF
