Craig Memorial Bascule Bridge

Over the Maumee River

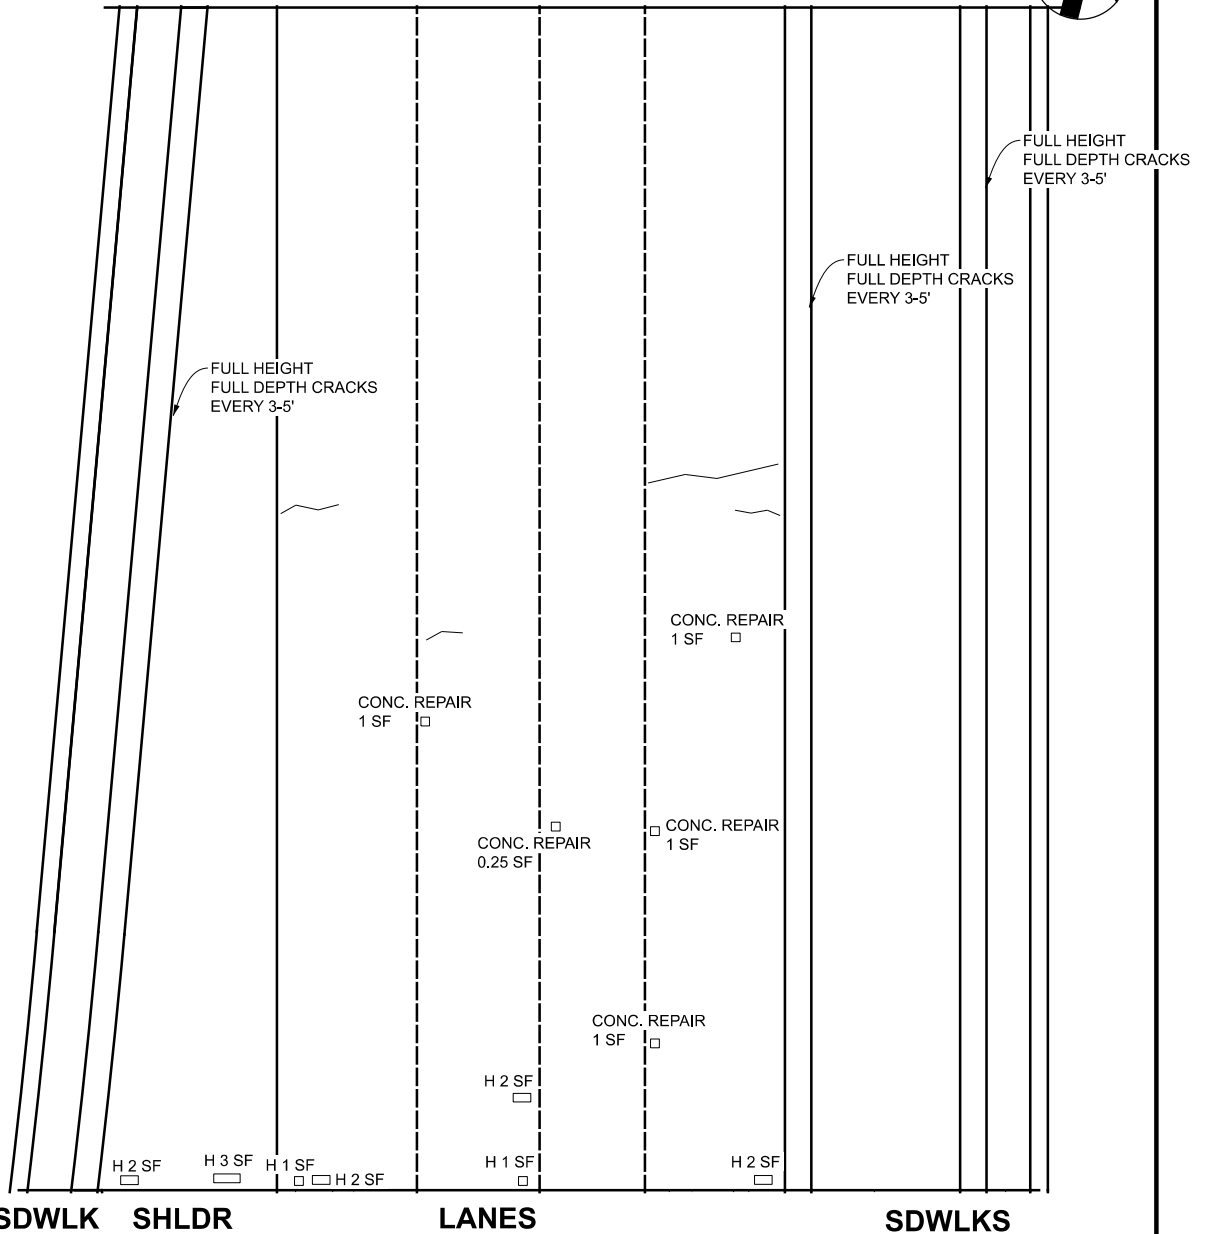
DETERIORATION QUANTITIES:
 Cracking <1/32": 31.95 LF
 Delamination: 13 SF

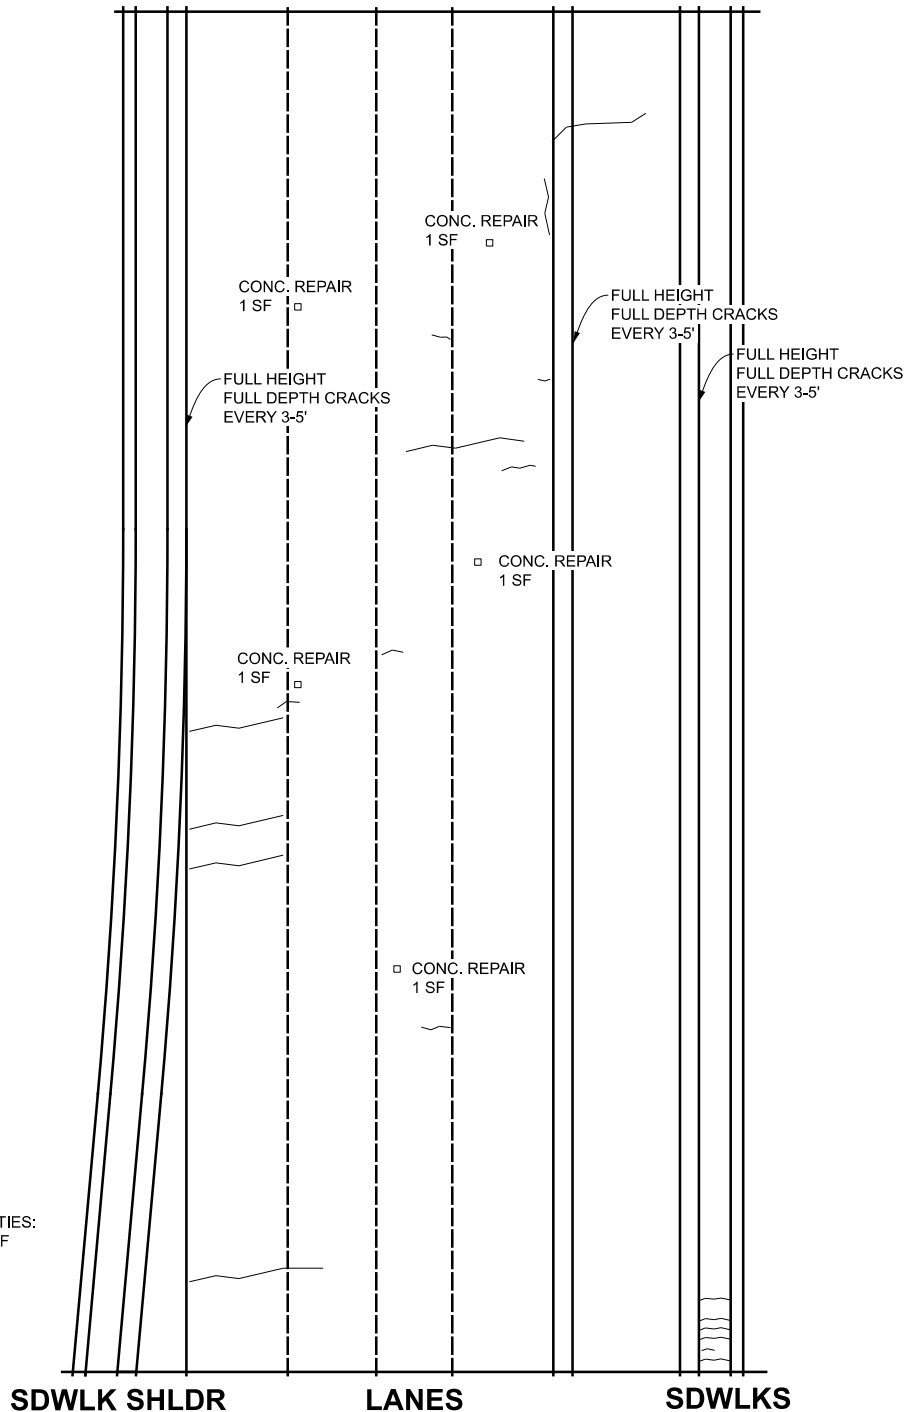
DETERIORATION QUANTITIES:
 Cracking <1/32": 118.36 LF

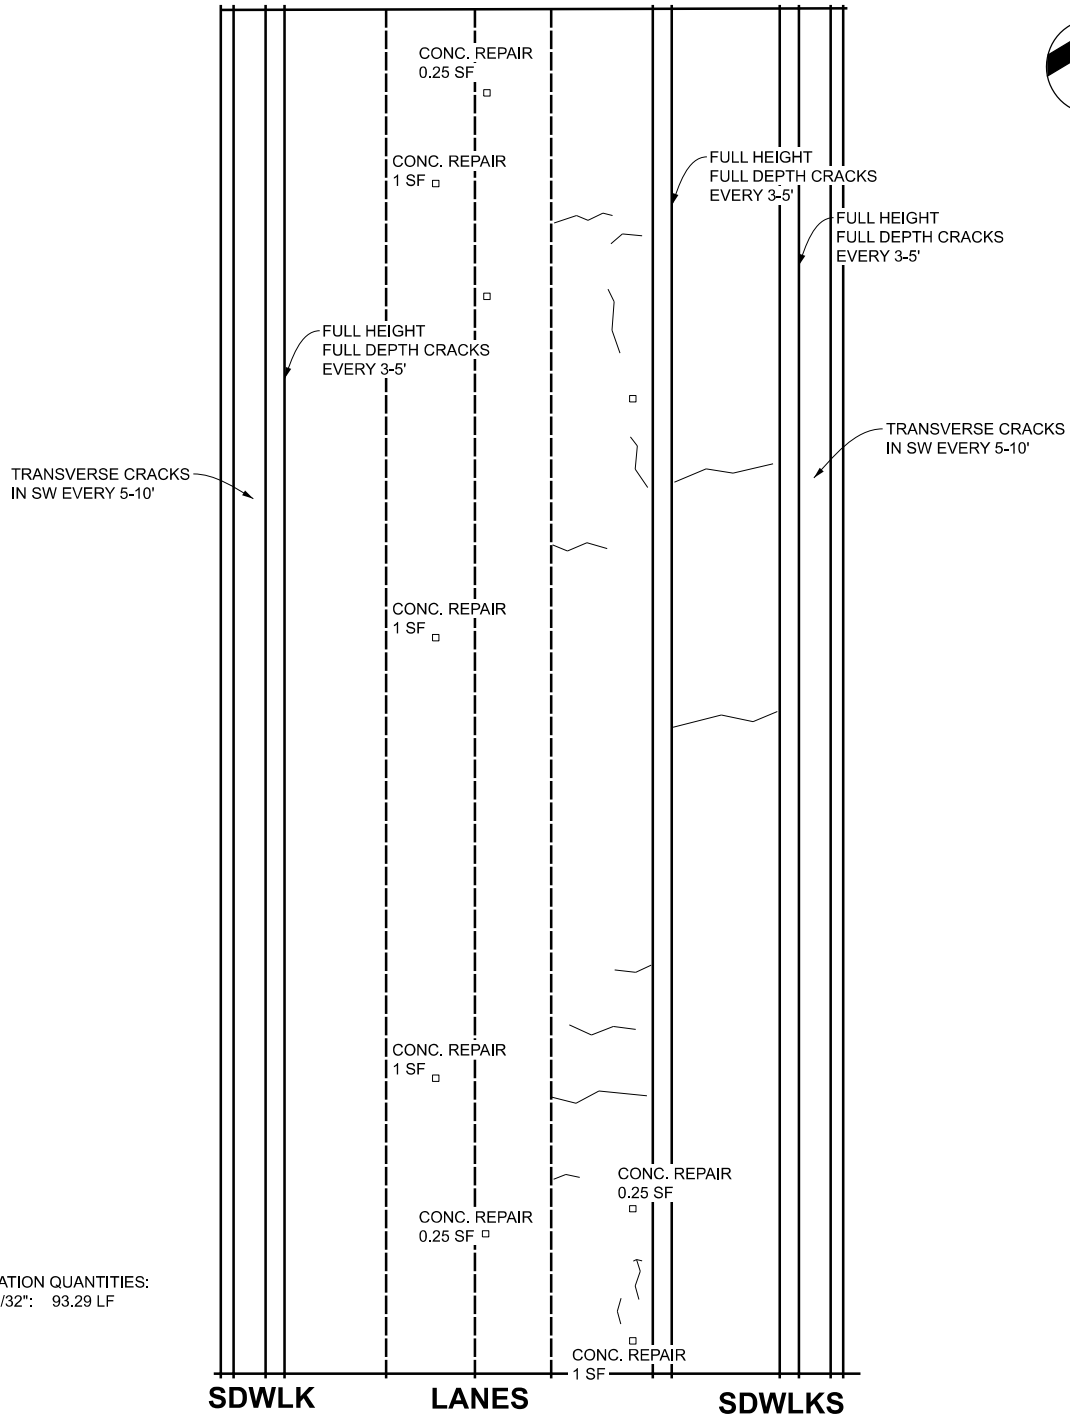
DETERIORATION QUANTITIES:
 Cracking <1/32": 93.29 LF

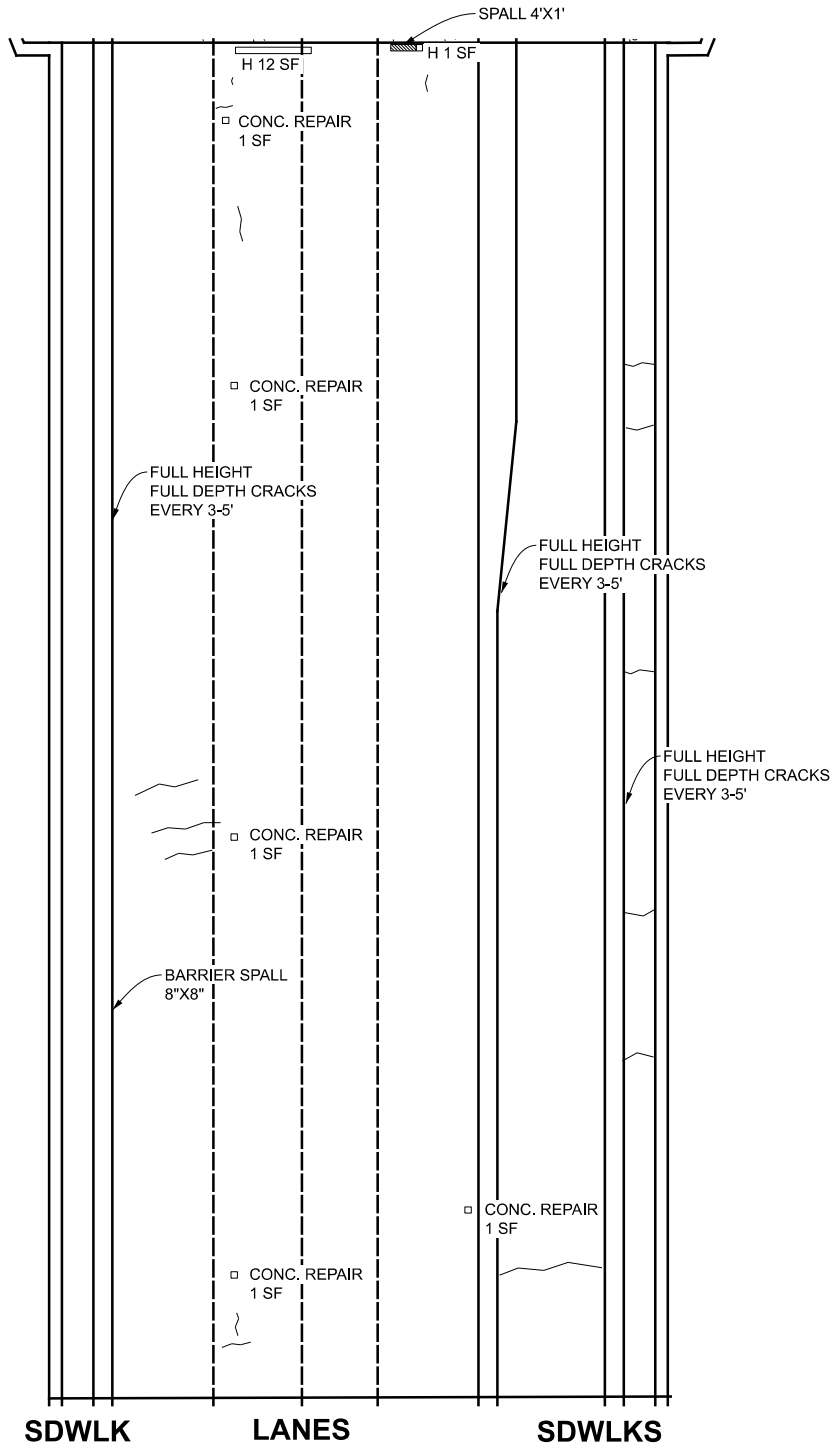
DETERIORATION QUANTITIES:
 Cracking <1/32": 50.85 LF
 Delamination: 13 SF
 Spalling: 4 SF

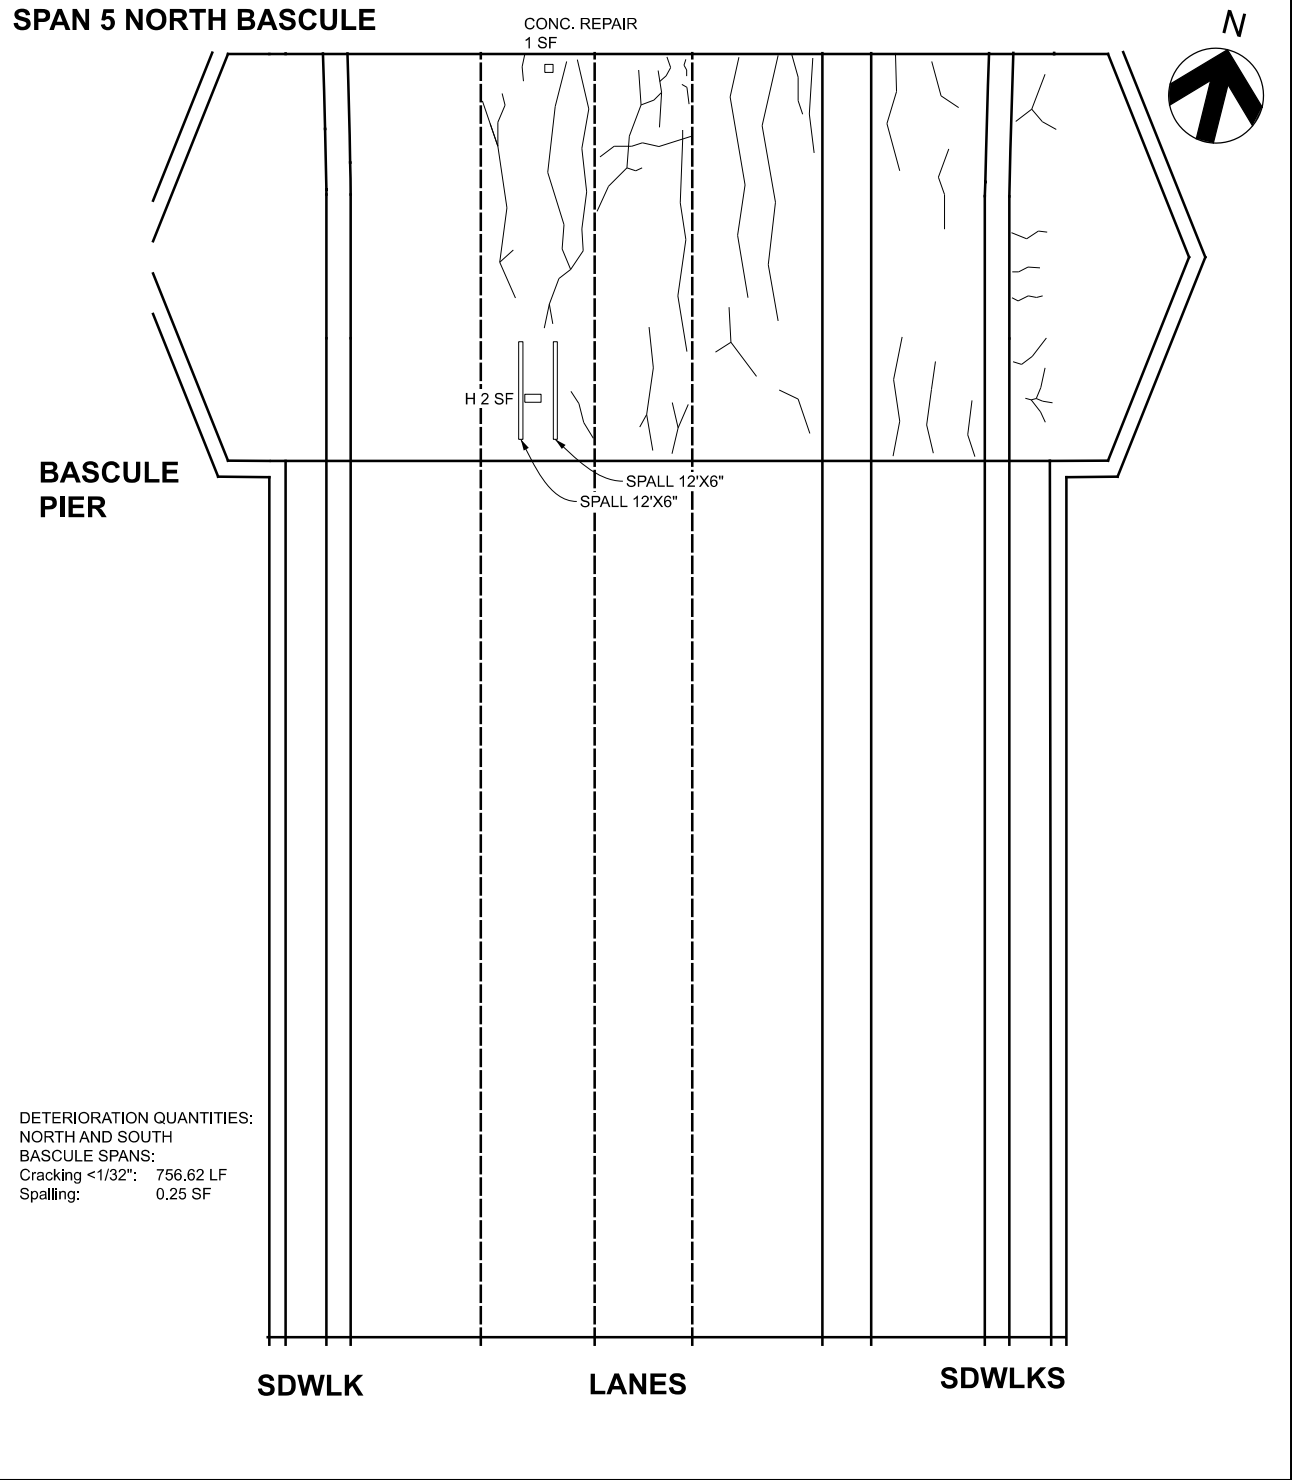
DETERIORATION QUANTITIES:
 NORTH AND SOUTH
 BASCULE SPANS:
 Cracking <1/32": 756.62 LF
 Spalling: 0.25 SF

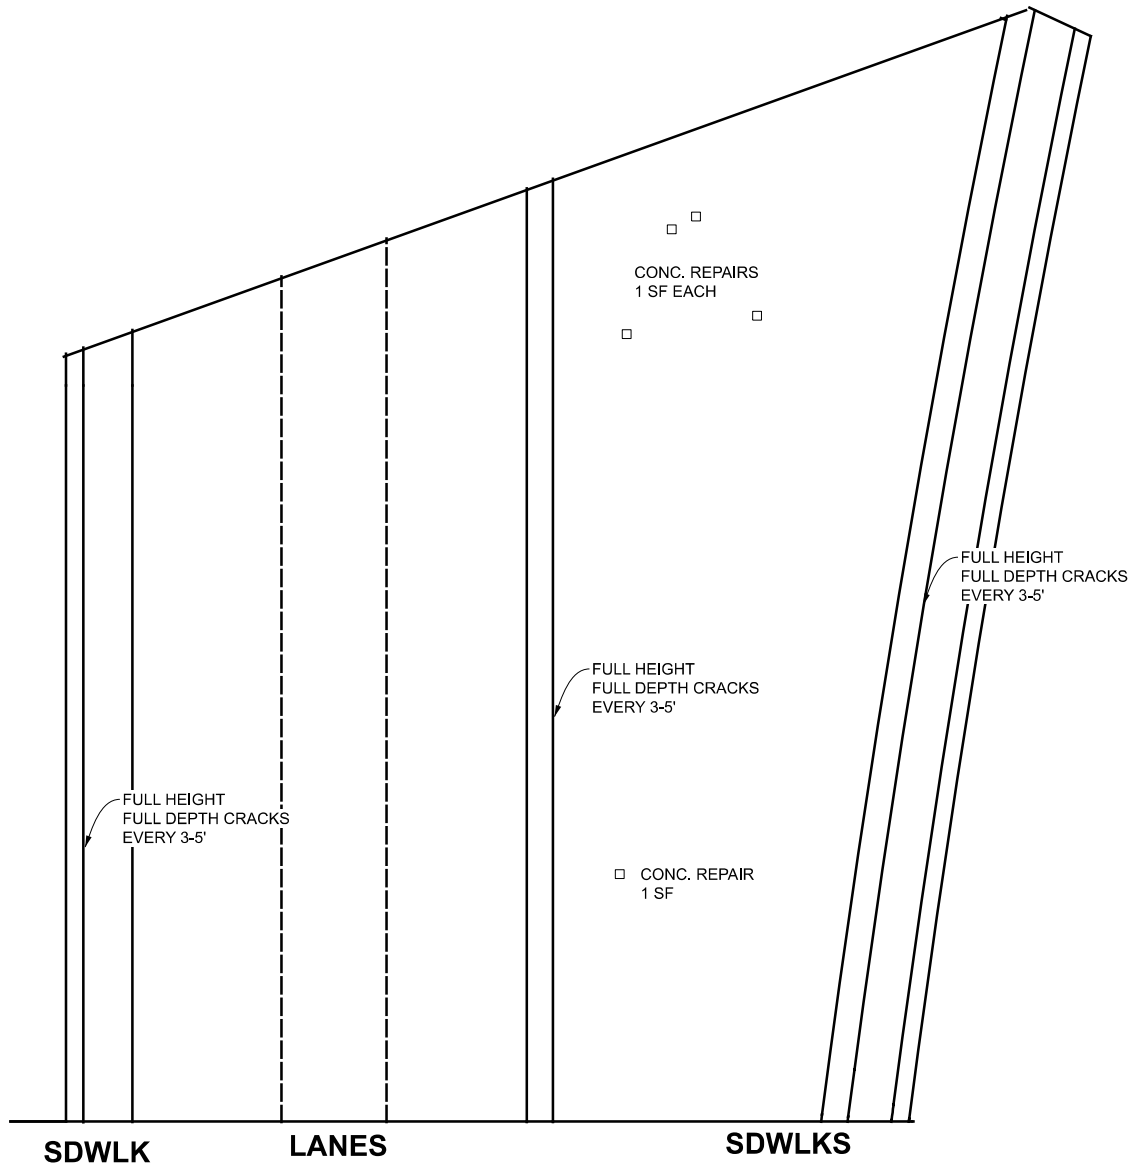
DETERIORATION QUANTITIES:
 Cracking <1/32": 0 LF
 Delamination: 0 SF
 Spalling: 0 SF

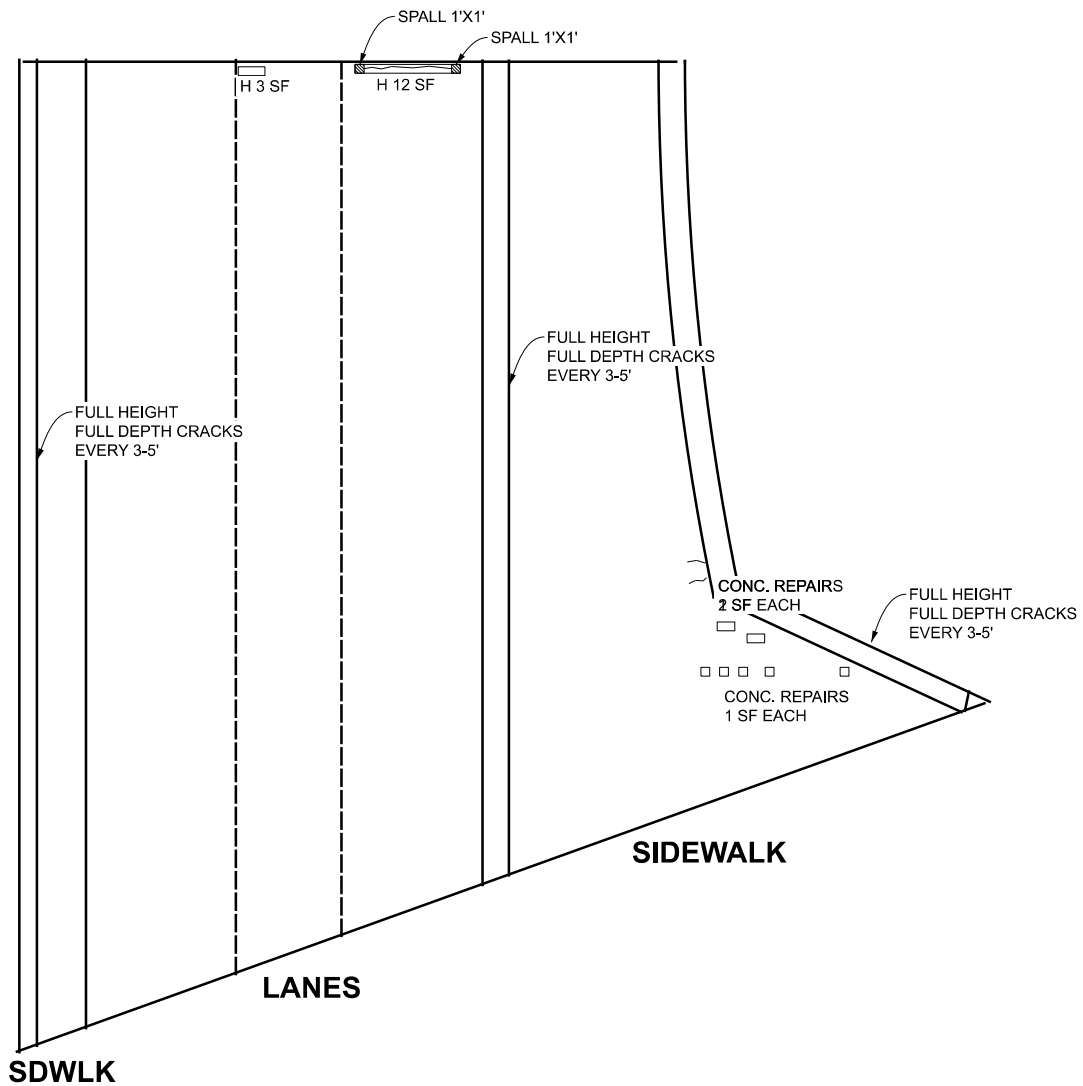
DETERIORATION QUANTITIES:
 Delamination: 15 SF
 Spalling: 2 SF

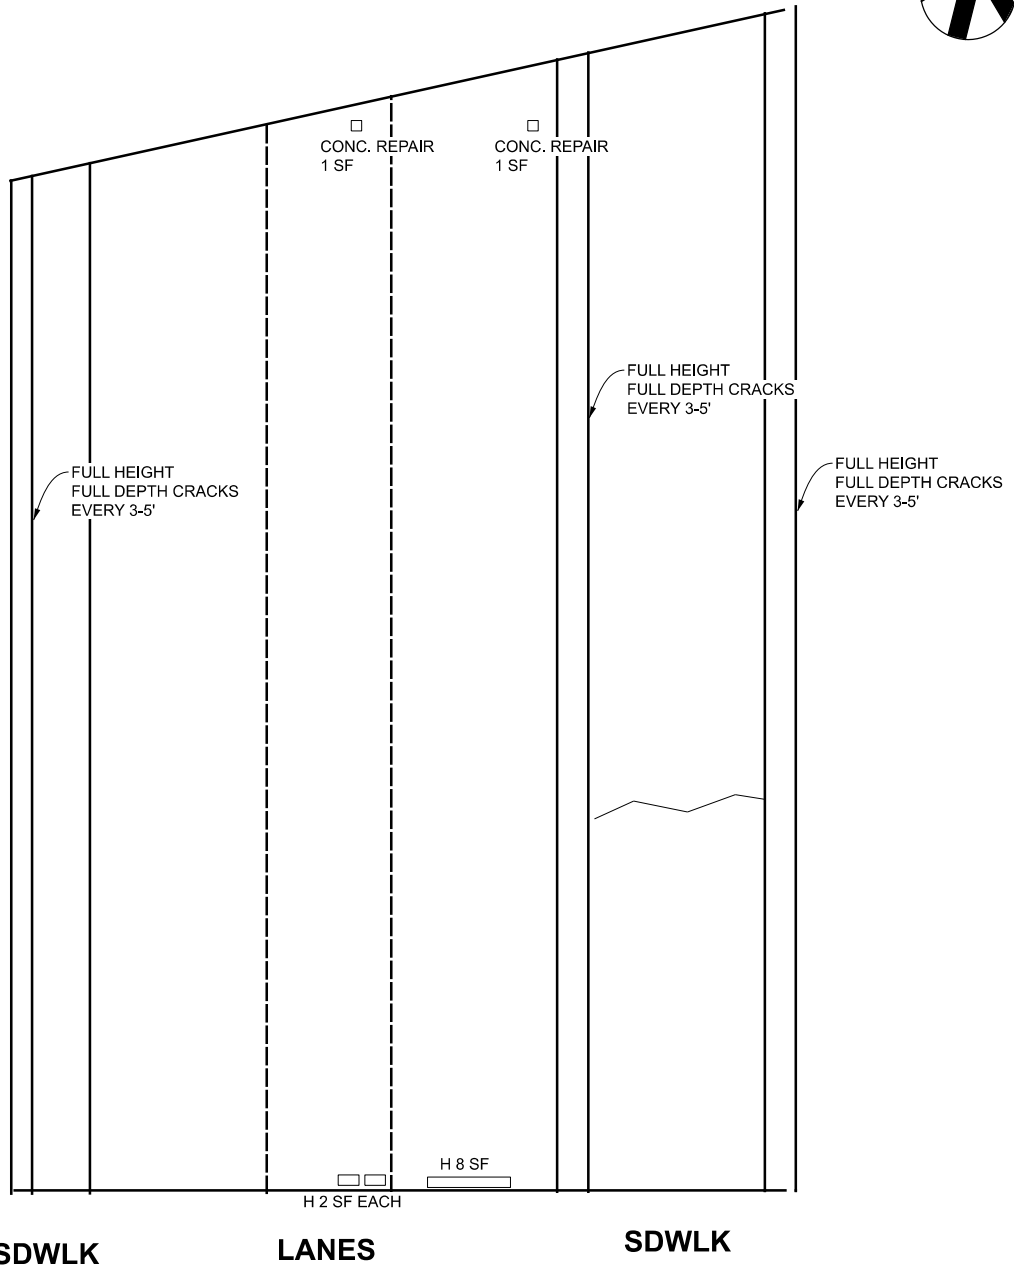
DETERIORATION QUANTITIES:
 Delamination: 12 SF

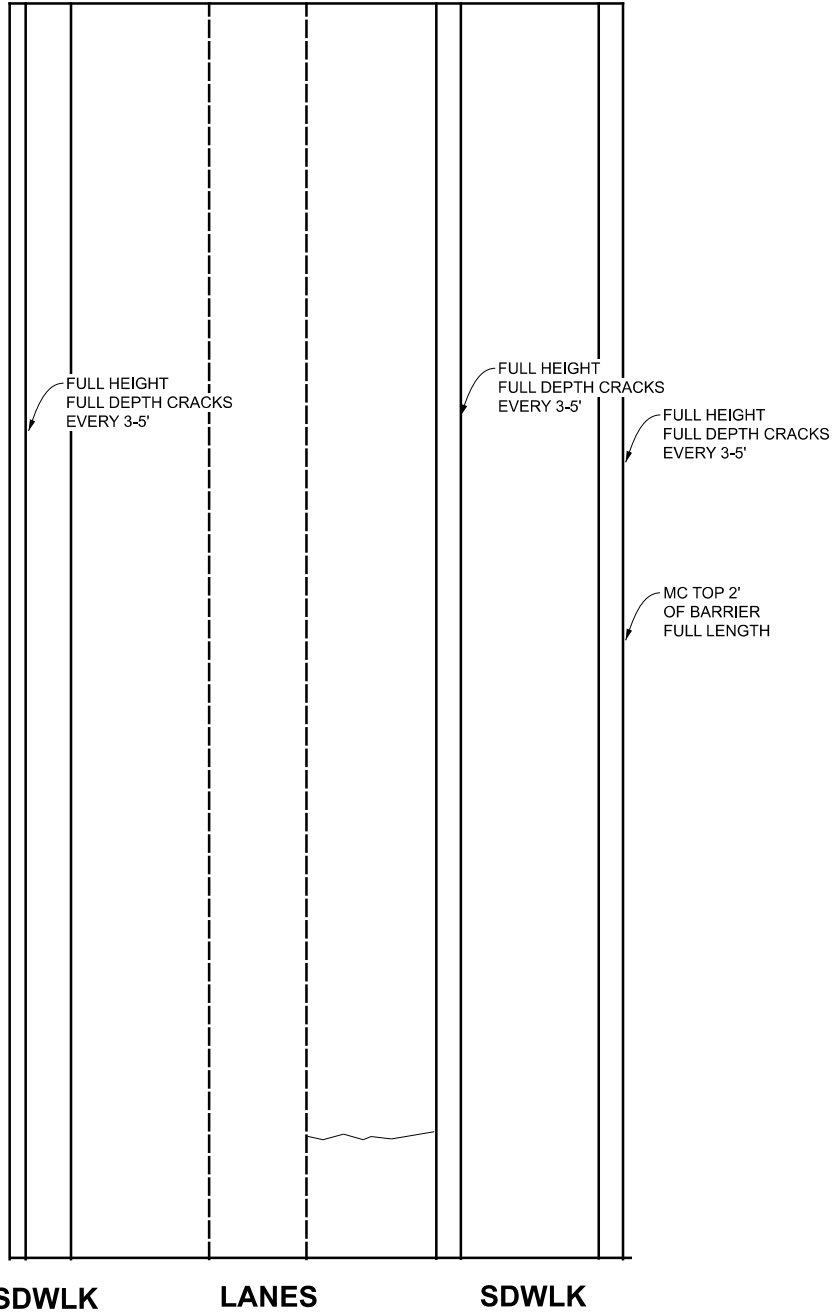
DETERIORATION QUANTITIES:
Cracking <1/32": 16.6 LF

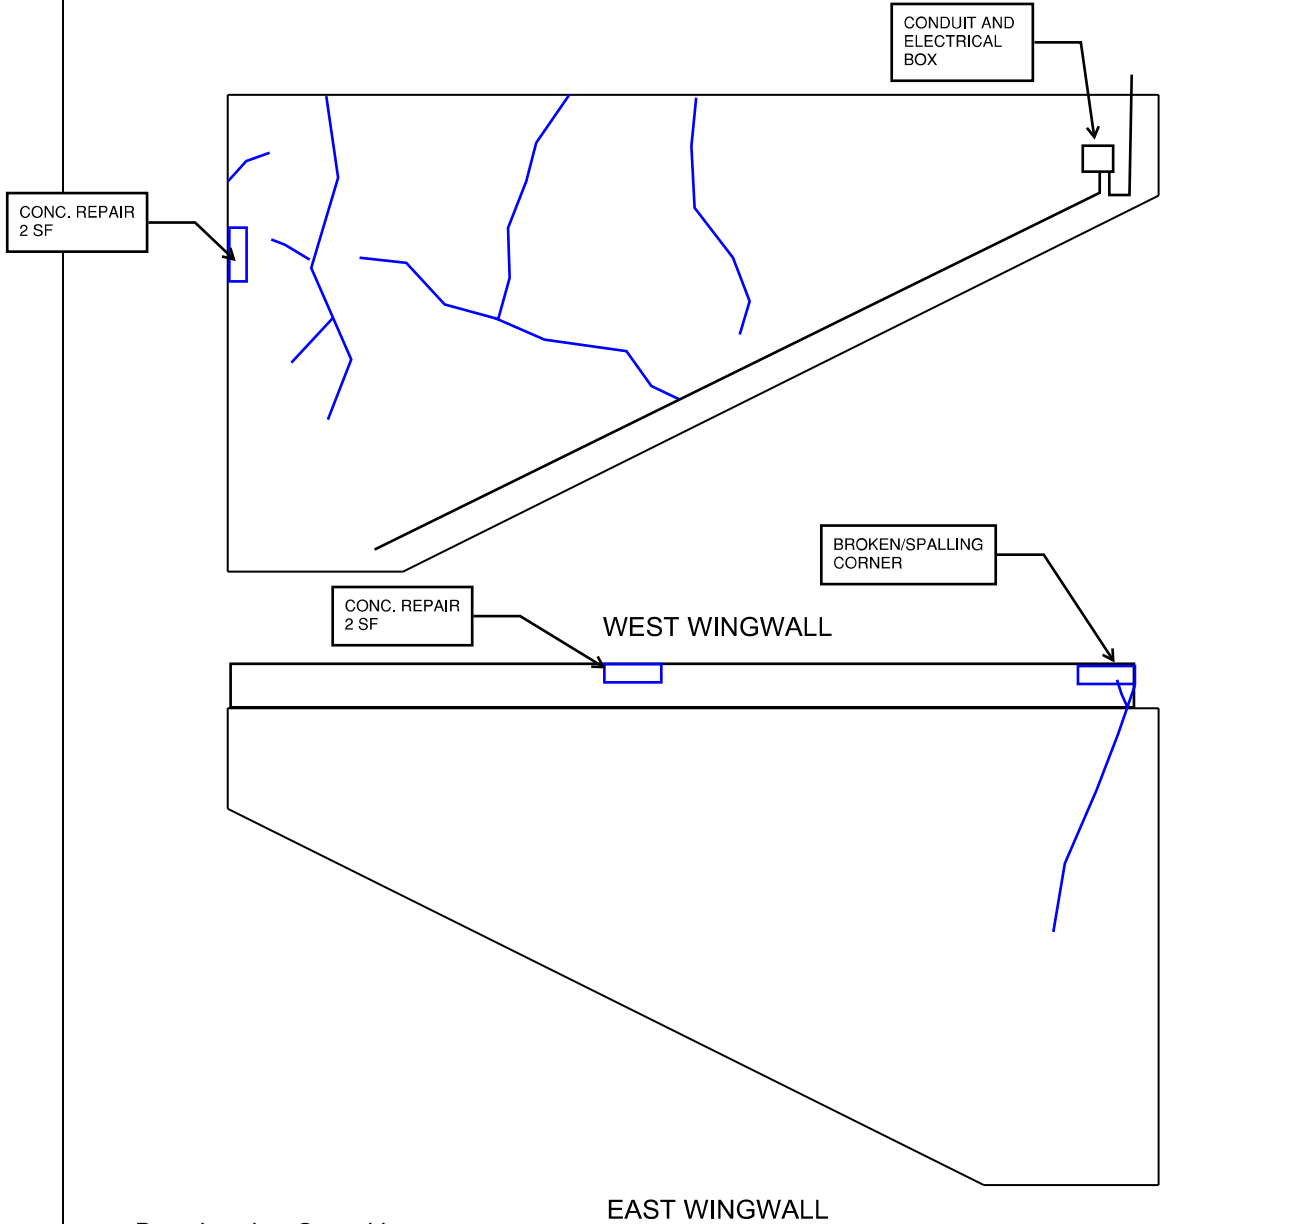
Deterioration Quantities:
Cracking <1/32": 115.52 LF
Spalling: 0.5 SF

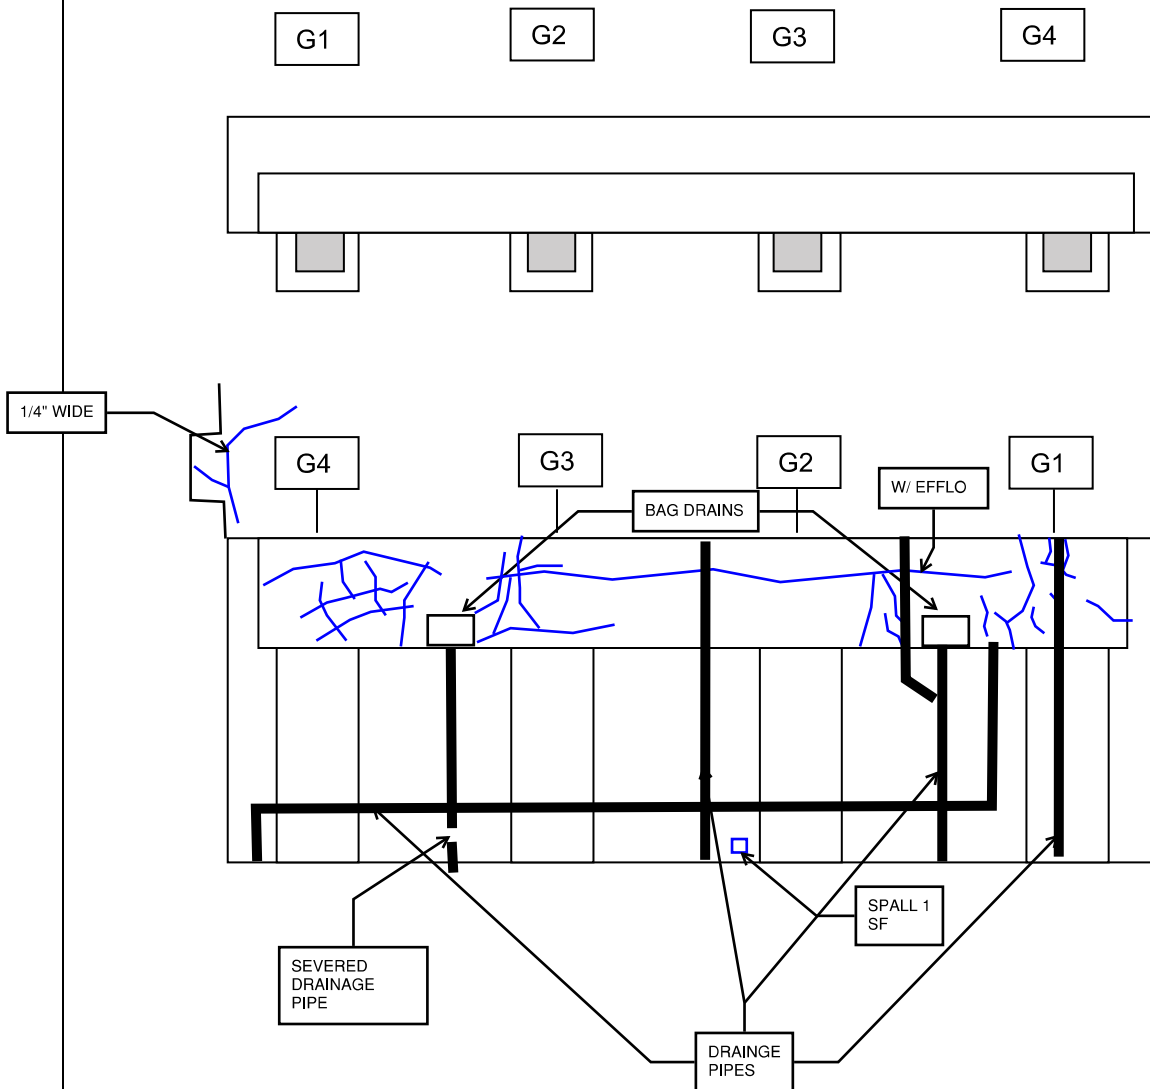
Deterioration Quantities:
 Cracking <1/32": 103.9 LF
 Cracking up to or >1/8": 9.48 LF
 Spalling: 1 SF

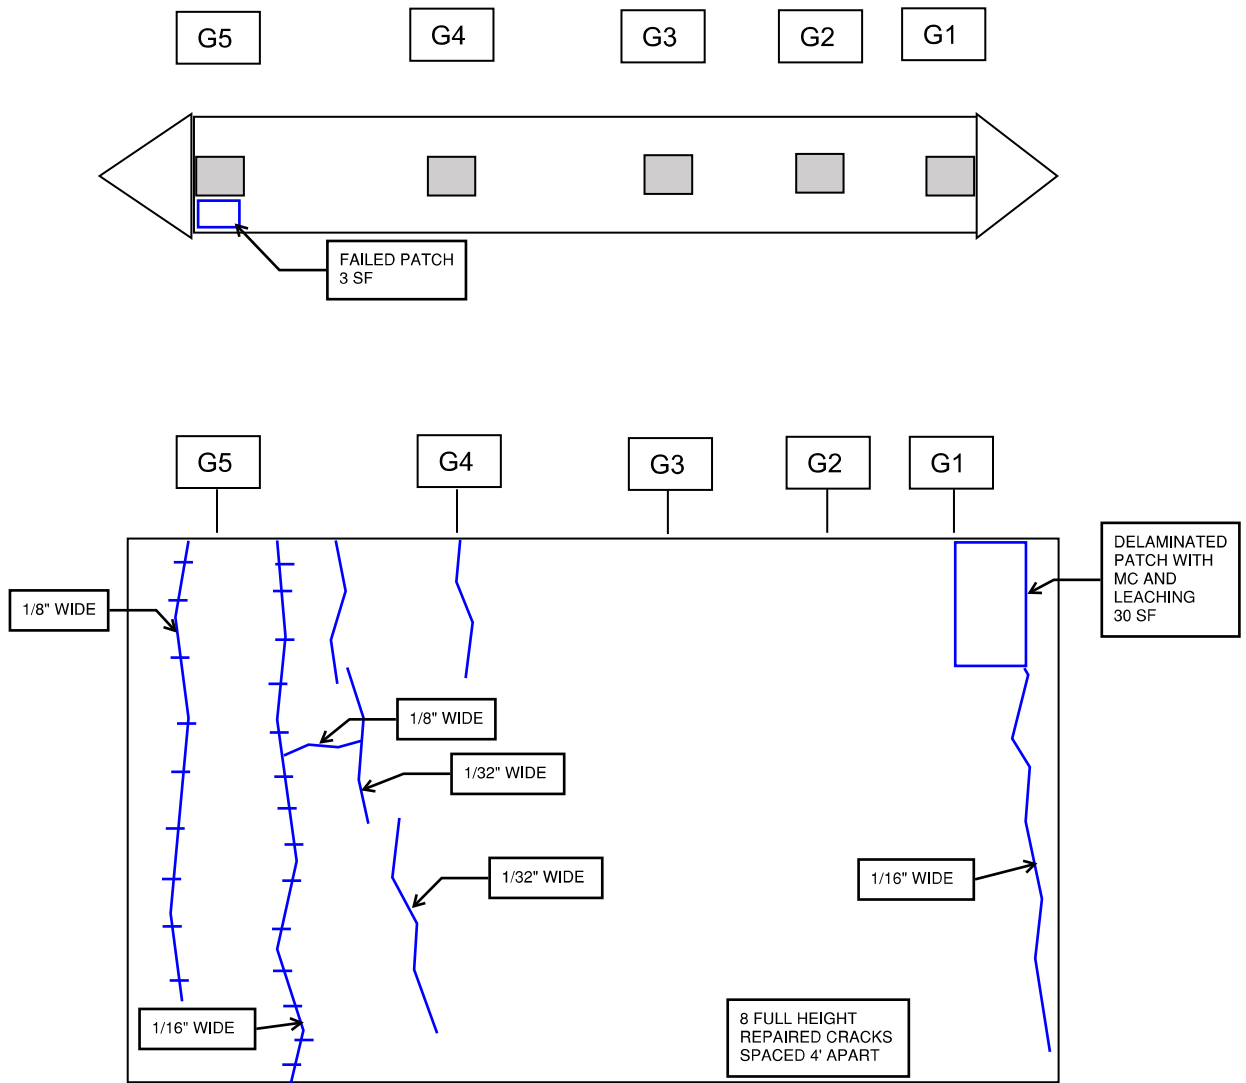
Deterioration Quantities:
Cracking < 1/32": 4 LF
Cracking up to or >1/8": 118 LF
Map Cracking: 30 SF

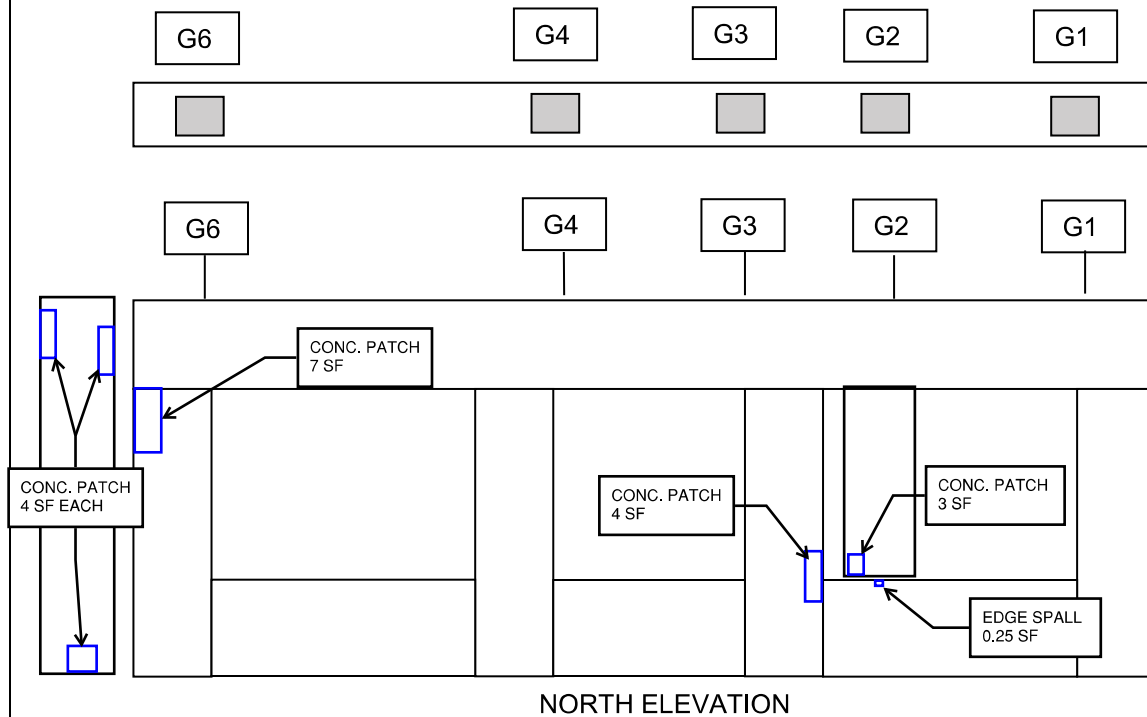
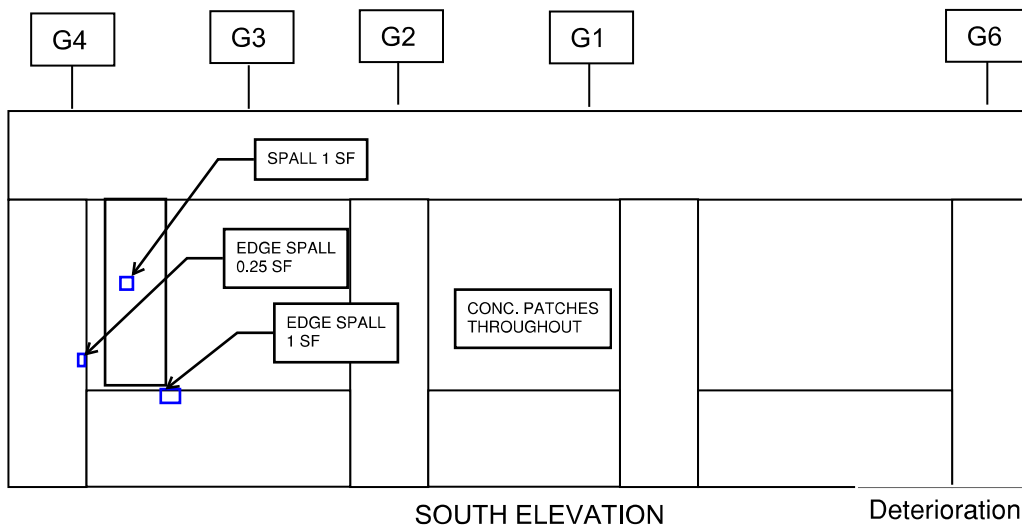
Deterioration Quantities:
Spalling: 1.25 SF

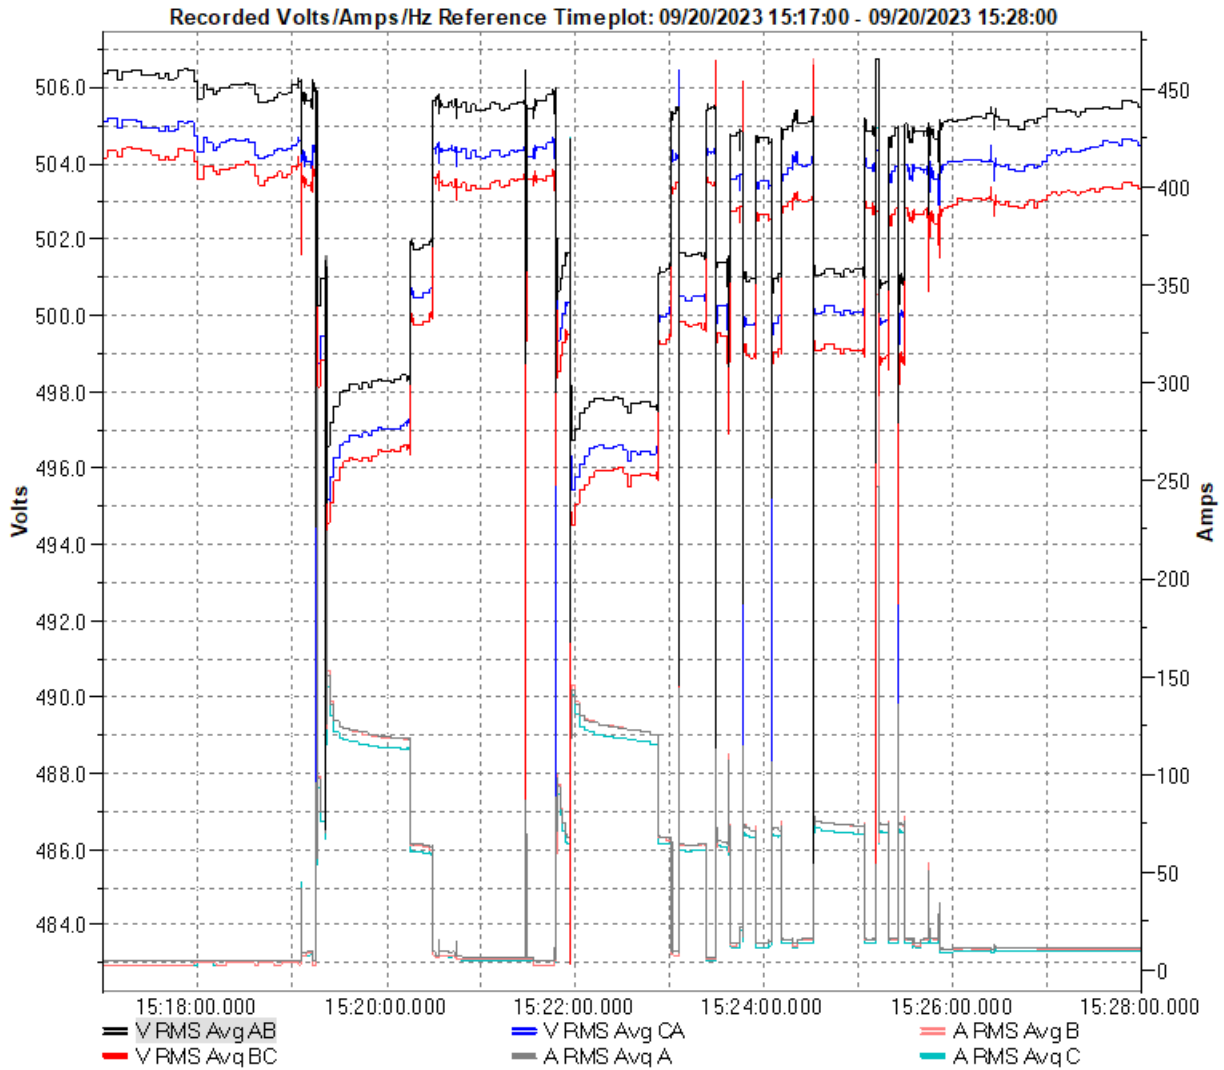
At the time of inspection with the bridge at standby, utility voltage from the main transformer was observed to be 506.71V RMS. During the bridge opening, the lowest observed voltage was 482.87V RMS.
