District 2 Planning & Engineering

W00-64-5.40 Safety Study

SR-64 at Bishop Road (Township Road 208)

12/15/2023

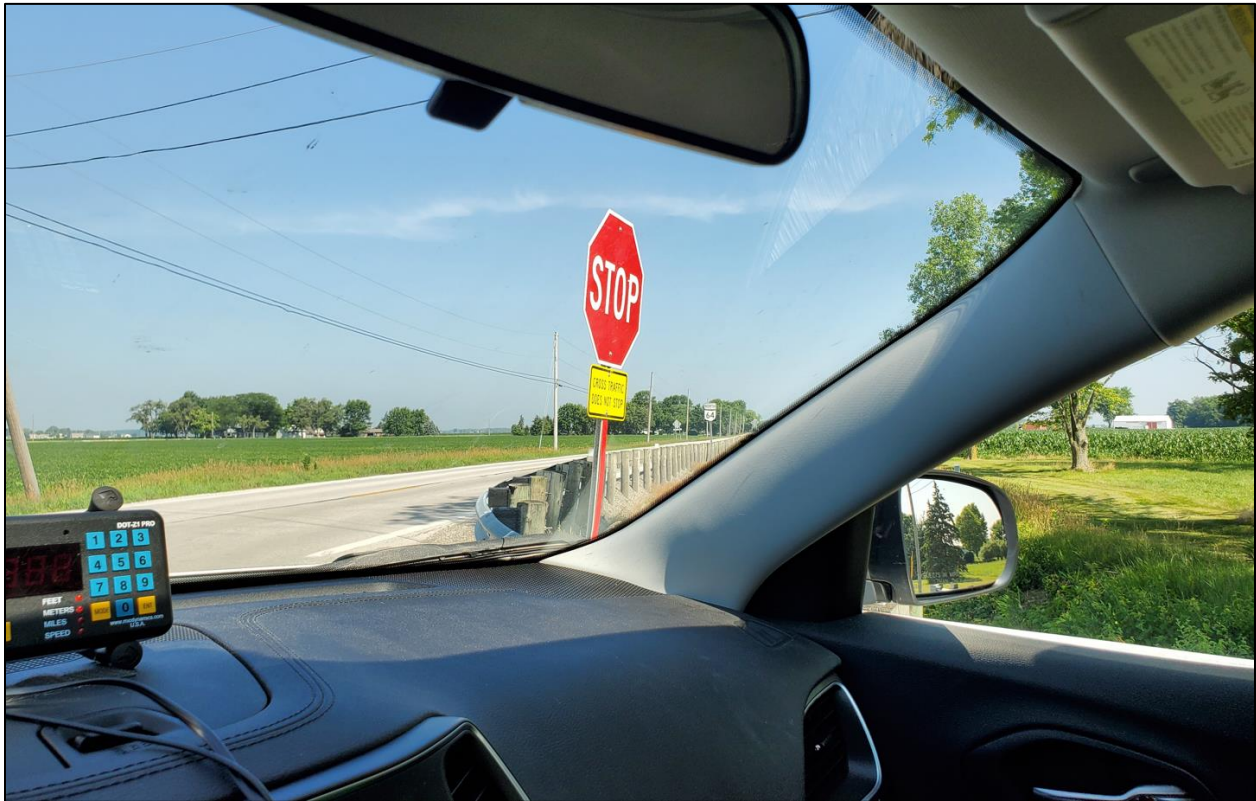
For drivers stopped on Bishop Rd., this means that to see oncoming SR-64 traffic on their left side, they have to turn their head further back than what's comfortable. That could be a reason why the stop lines are installed so far back from the edge line (24 feet back on the east leg and 36 feet back on the west leg), so that the angle to turn your head is reduced. Three of the angle crashes were near-side driver's side impacts, which could be a result of this acute skew angle.

Vehicle obstructs sight distance as a result of intersection skew

The skew of the intersection results in the vehicle frame between the window & door on the passenger side obstructing the driver's view of SR-64 to their right (see pictures on the next page). This limits how far and/or how clearly the driver can see oncoming SR-64 traffic. Six of the angle crashes were far-side passenger side impacts, which could be a result of this unique sight obstruction. Drivers could mitigate this if they line-up more perpendicular to SR-64 when stopping.

Picture of driver's point-of-view stopped on WB Bishop Rd. looking north

Realigning the approaches of Bishop Rd. would address the skew angle & vehicle frame obstruction issues which are occurring with the current intersection configuration. By aligning the Bishop Rd. approaches at closer to a 90° angle with SR-64, stopped motorists should be able to see oncoming traffic more clearly & directly out of their vehicle windows. For some corners of the intersection, it would also be possible to provide wider radii to facilitate turning vehicles.

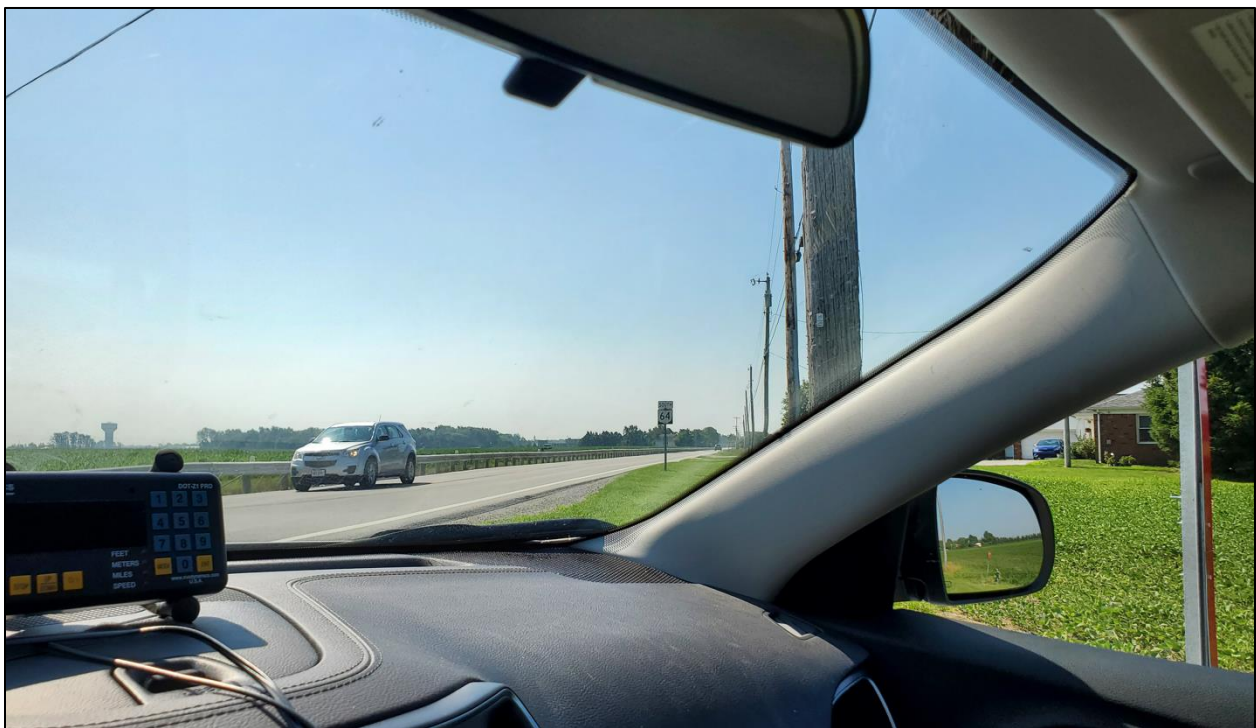
Picture of driver's point-of-view stopped on EB Bishop Rd. looking south

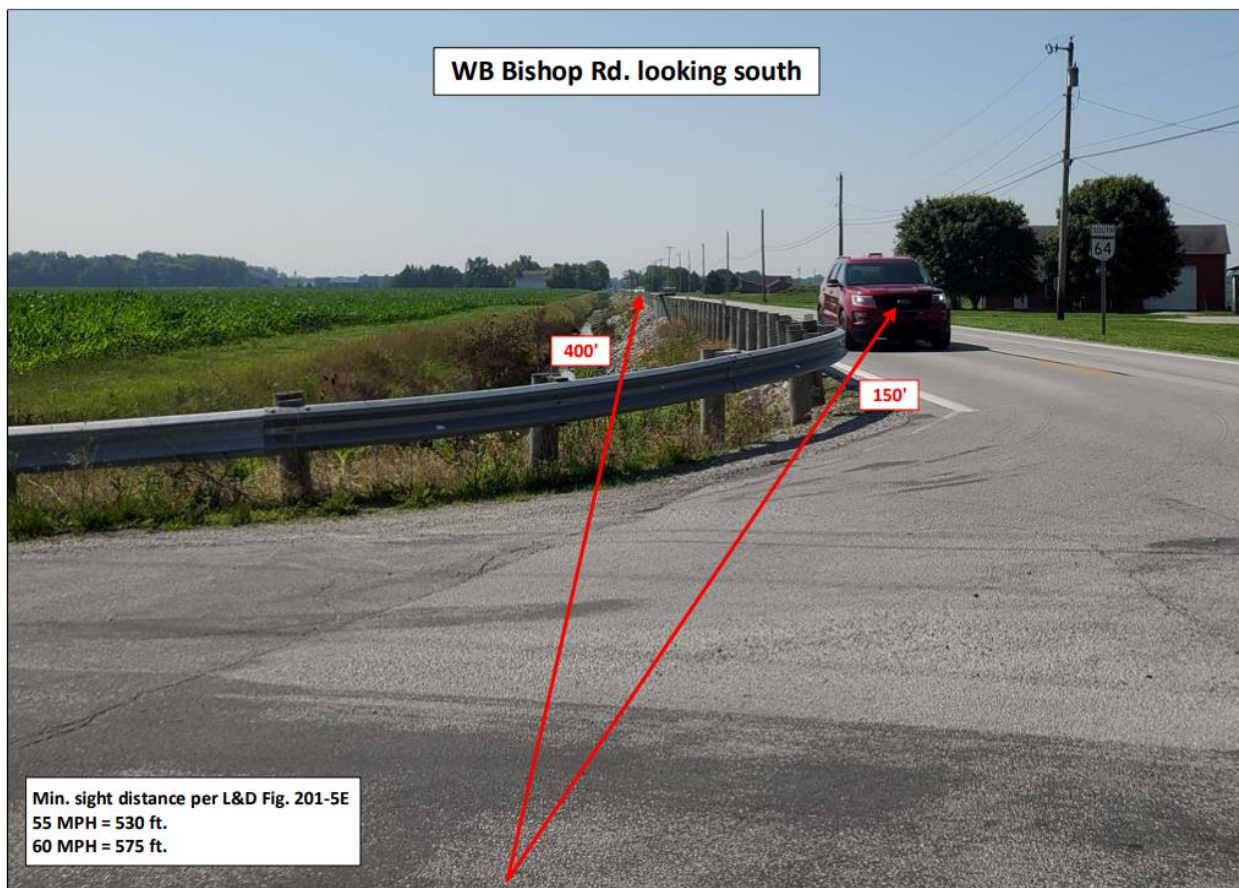
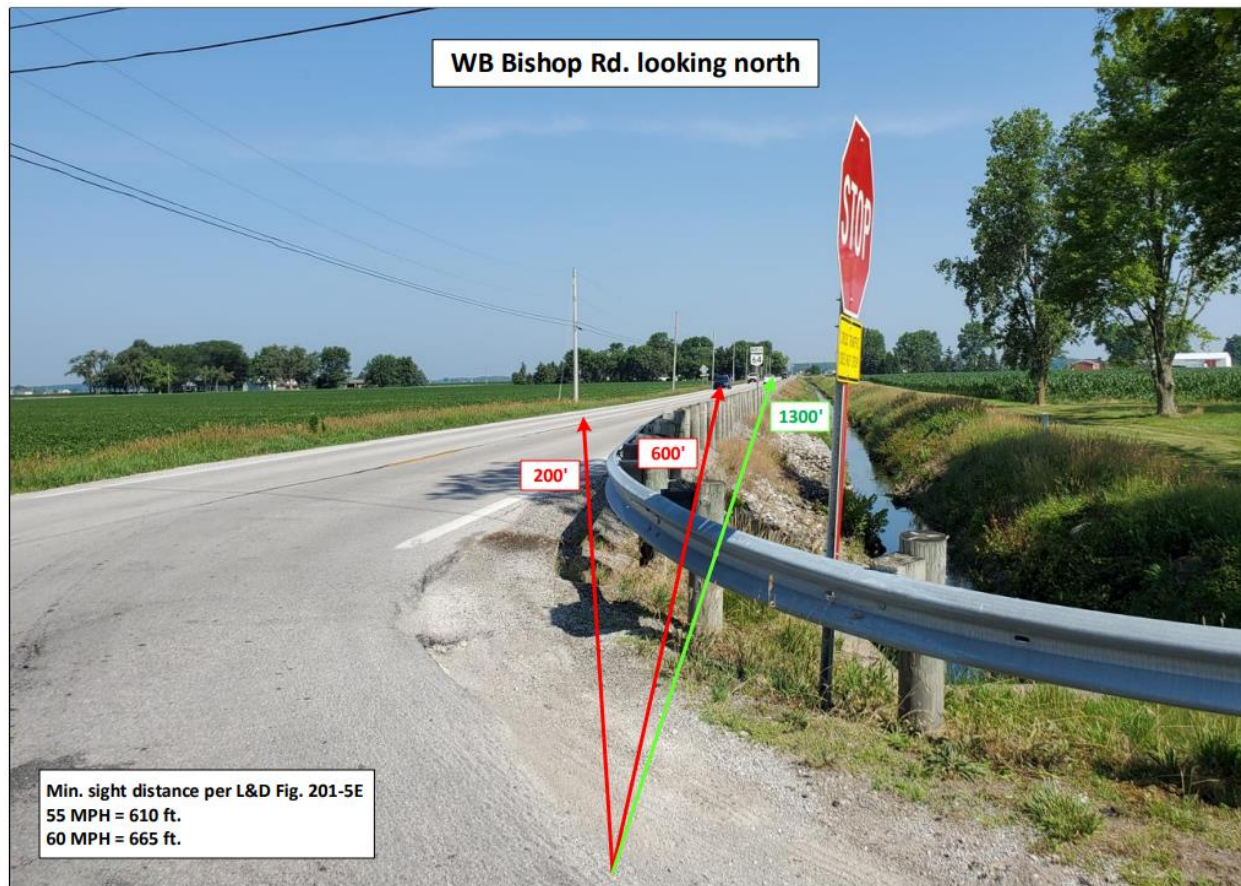
Guardrail restricts sight distance

The guardrail on the east side of SR-64 significantly limits how visible oncoming SR-64 traffic is. There are no other large objects which limit sight distance, so the tops of vehicles are mostly visible. However, the guardrail effectively completely blocks the view of the bottom of oncoming vehicles, which may also include headlights depending on how high or low the stopped driver on Bishop Rd. sits. The limited sight of oncoming vehicles may also make it difficult to judge how far in advance of the intersection they actually are. This may result in Bishop Rd. traffic prematurely pulling out onto SR-64, resulting in angle crashes. Five of the angle crashes involved a driver coming from WB Bishop Rd., which could be a result of the limited sight distance caused by the guardrail.

It is possible to shift SR-64 slightly to the west so that traffic on the east leg of Bishop Rd. stops past the line of guardrail. With the guardrail no longer obstructing the view of oncoming traffic, the overall sight distance would increase substantially.

Another option to increase the sight distance is by filling-in the ditch and shortening the guardrail runs to the point necessary to create sufficient intersection sight distance per current L&D standards. The total length of the necessary ditch enclosure to achieve sufficient intersection sight distance is estimated to be about 740 feet. The roadway alignments would stay intact. The culvert would either need to be extended or replaced, depending on what is deemed most practical based on constructability & the condition/remaining life cycle of the existing culvert. There would also likely be environmental concerns which would need to be addressed since the ditch would be impacted.
