UNDERWATER BRIDGE INSPECTION REPORT

STRUCTURE NO. 3500578 (HEN-6-1650)
US-6 OVER MAUMEE RIVER
HENRY COUNTY, OH
DISTRICT 2

April 2020

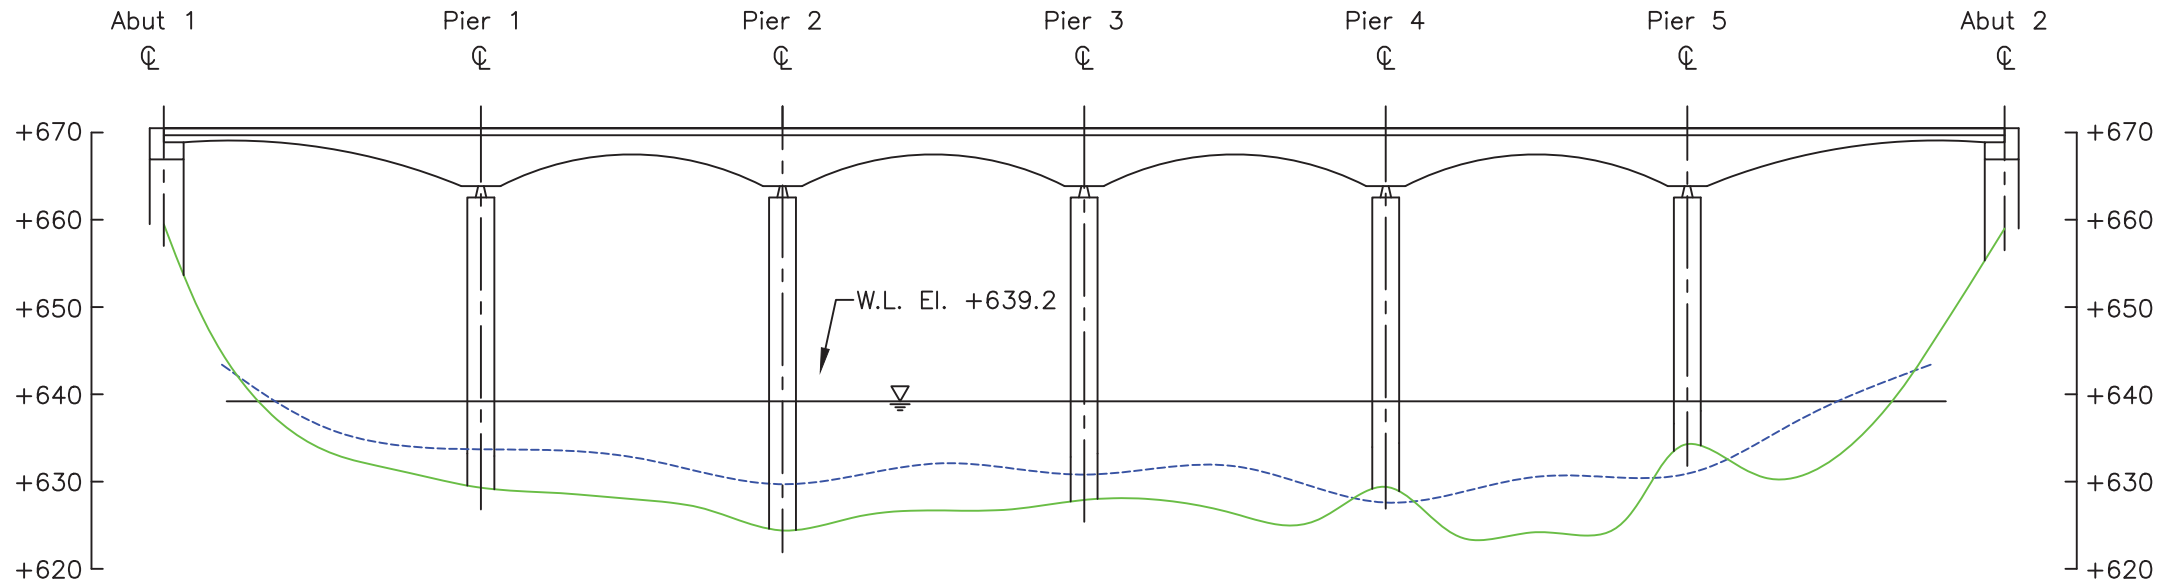
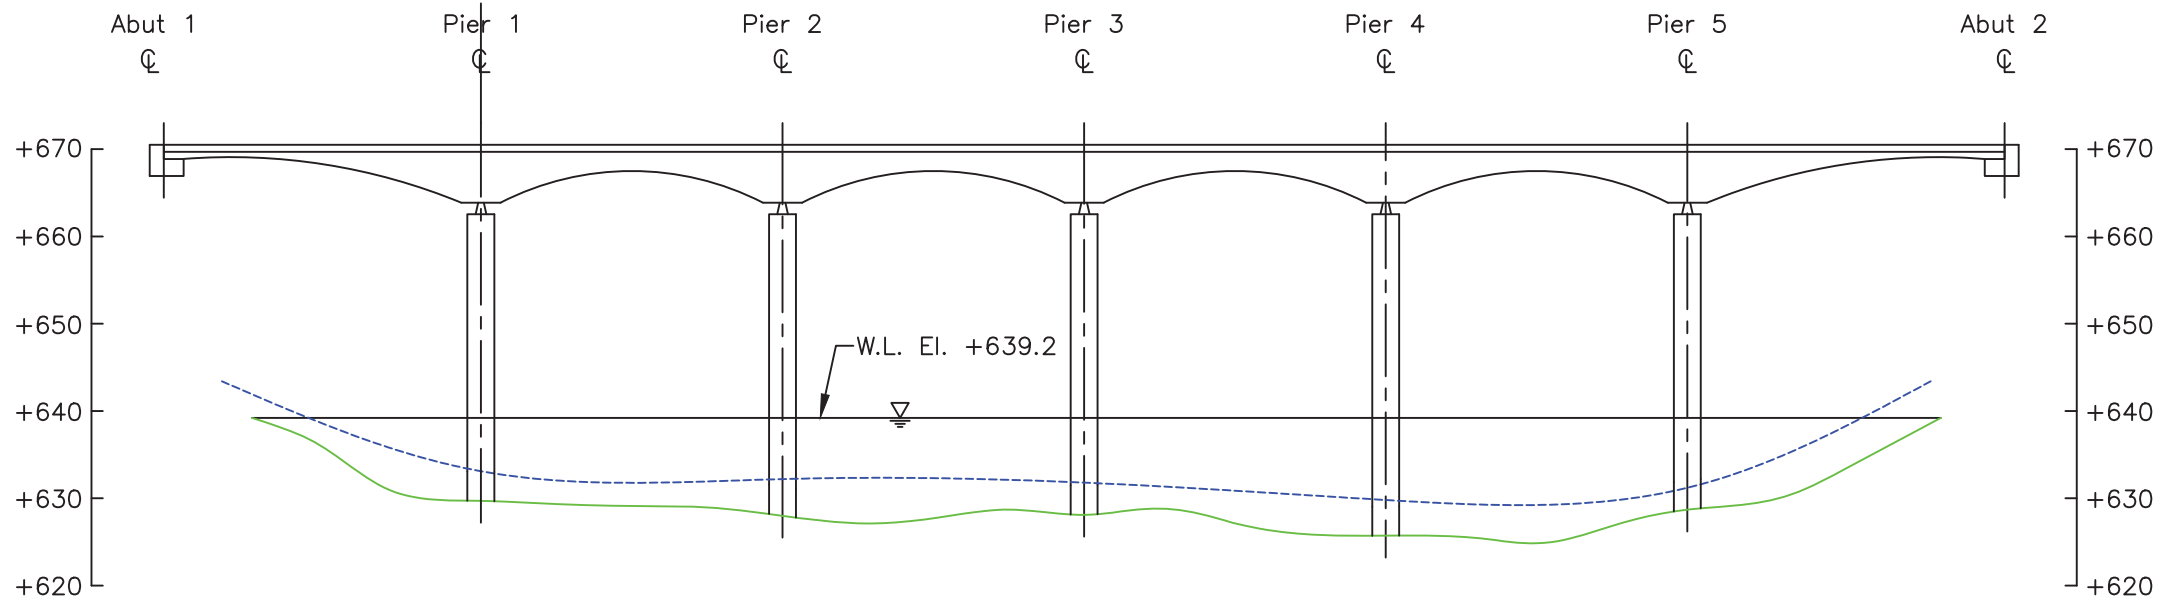
US-6 OVER MAUMEE RIVER
STRUCTURE NO. 3500578 (HEN-6-1650)
CROSS SECTIONS - UPSTREAM
HENRY COUNTY, OHIO

Overall, the submerged substructure units of Structure No. 3500578 (HEN-6-1650) were in good condition below water. A comparison of the soundings recorded during the previous inspection on June 23, 2015 and the soundings taken during this inspection revealed footing exposure at Piers 3 and 4. Since no design or as-built plans were available for the bridge, the amount of embedment of the footings in the channel bottom is unknown. As a result, the channel bottom configuration should continue to be monitored during future underwater inspections to verify that localized scour or overall channel degradation is not occurring and that both pier footings remain adequately embedded in the channel bottom. Design or as-built drawings for the bridge should be obtained and reviewed, if possible, prior to the next underwater inspection to determine the exact construction of the piers and their foundations.

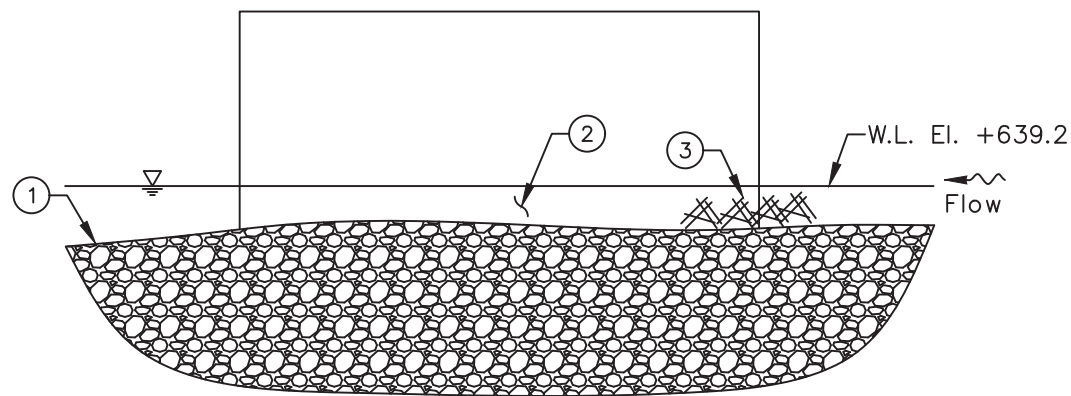
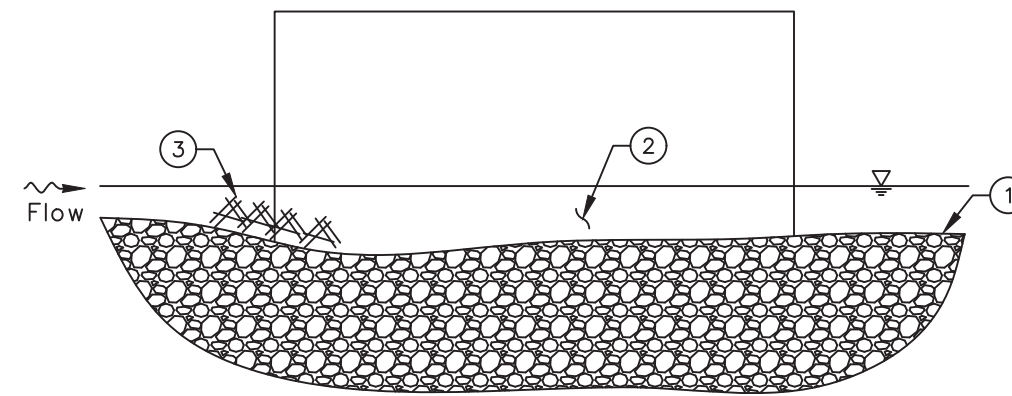
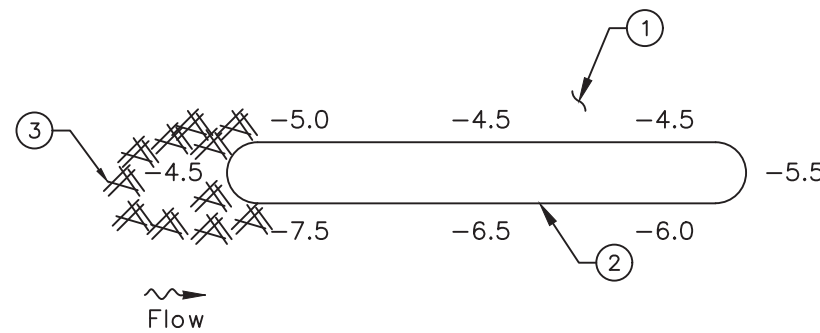
The channel bottom material consisted of sand, light marine growth and cobbles up to 6 in. diameter with approximately 2 in. probe rod penetration. Moderate timber debris consisting of logs up to 6 in. diameter were observed on the upstream nose extending from channel bottom to the water line up to 10 ft radius around the nose. The submerged portions of the pier were sound and smooth with no defects observed. Refer to Figure 6 in Exhibit 1 for detailed inspection notes of Pier 1. Refer to Photographs 9 and 10 in Exhibit 2 for views of Pier 1.

- ① The channel bottom material consisted of sand, light marine growth and cobbles up to 6 in. diameter with approximately 2 in. probe rod penetration.
- ② The submerged portions of the pier were sound and smooth with no defects observed.
- ③ Moderate timber debris consisting of logs up to 6 in. diameter were observed on the upstream nose extending from channel bottom to the water line up to 10 ft radius around the nose.

- Remove timber debris from all piers.
- Place riprap at exposed footings at Piers 3 and 4.
- Monitor spalls on Piers 2 and 3.

The timber debris accumulations at Piers 1 through 5 is obstructing channel flow and is the cause of scour and footing exposure and should be removed at this time. Removal of the timber debris will reduce excessive lateral loads on the pier, limit further debris accumulation, and reduce the likelihood of channel bottom degradation resulting from obstructed flow.

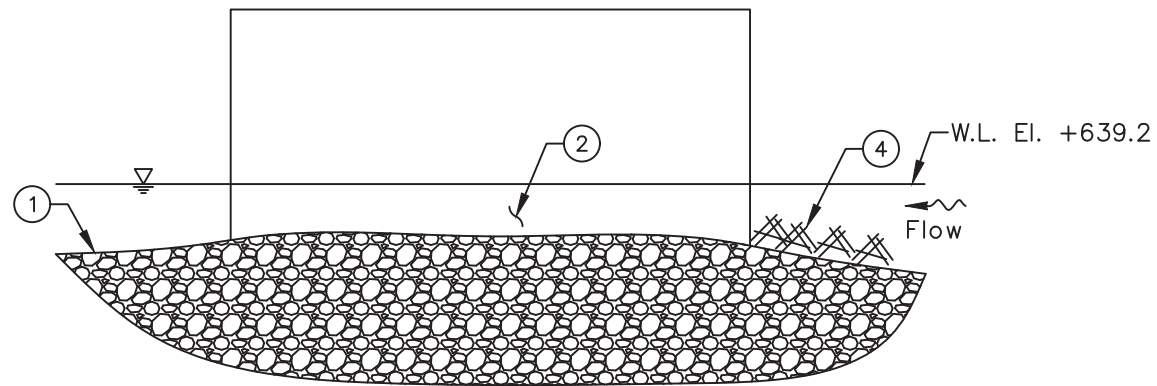
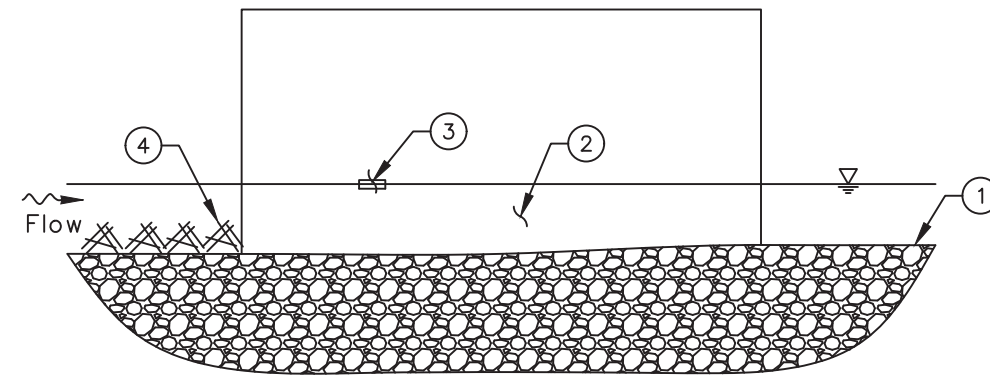
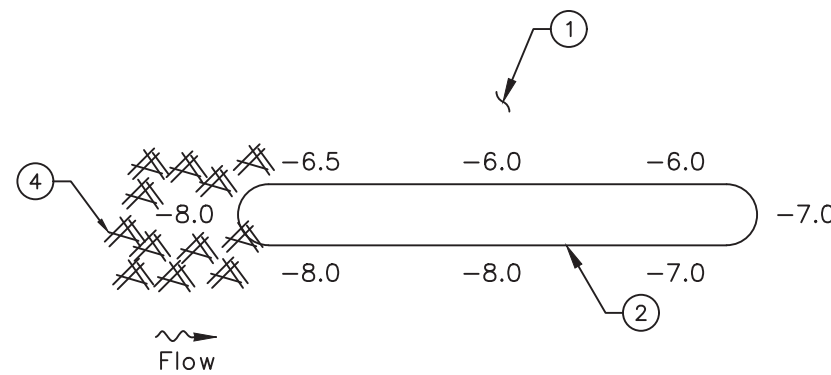
The channel bottom material consisted of riprap up to 12 in. diameter and gravel. Moderate timber debris consisting of logs up to 6 in. diameter were observed on the upstream nose extending from channel bottom to the water line up to 10 ft radius around the nose. The submerged portions of the pier were sound and smooth with no defects observed. A spall was located on the south face at the waterline, measuring 3 ft long by 1 ft high by 2 in. diameter. Refer to Figure 7 in Exhibit 1 for detailed inspection notes of Pier 2. Refer to Photographs 11 and 12 in Exhibit 2 for views of Pier 2.

- ① The channel bottom material consisted of riprap up to 12 in. diameter and gravel.
- ② The submerged portions of the pier were sound and smooth with no defects observed.
- ③ A spall was located on the south face at the waterline, measuring 3 ft long by 1 ft high by 2 in. diameter.
- ④ Moderate timber debris consisting of logs up to 6 in. diameter were observed on the upstream nose extending from channel bottom to the water line up to 10 ft radius around the nose.

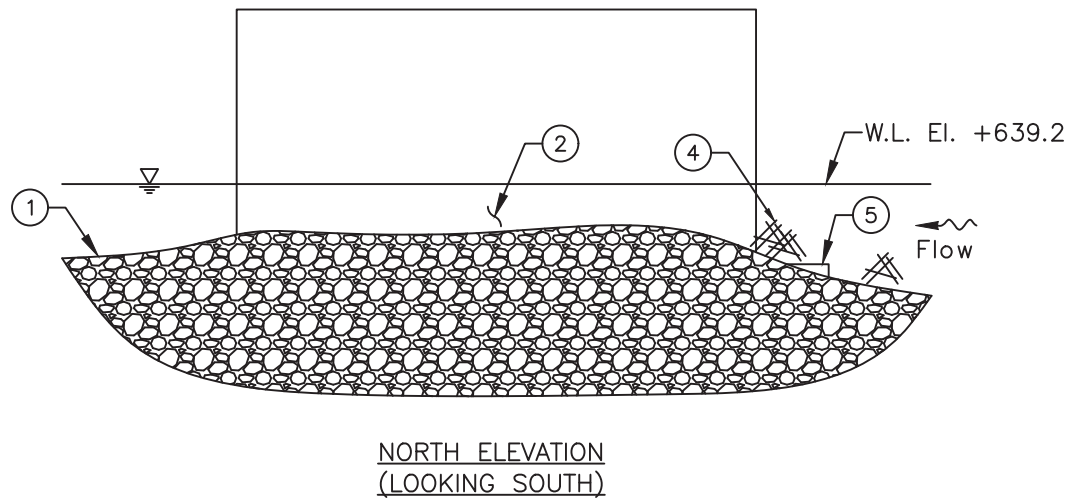
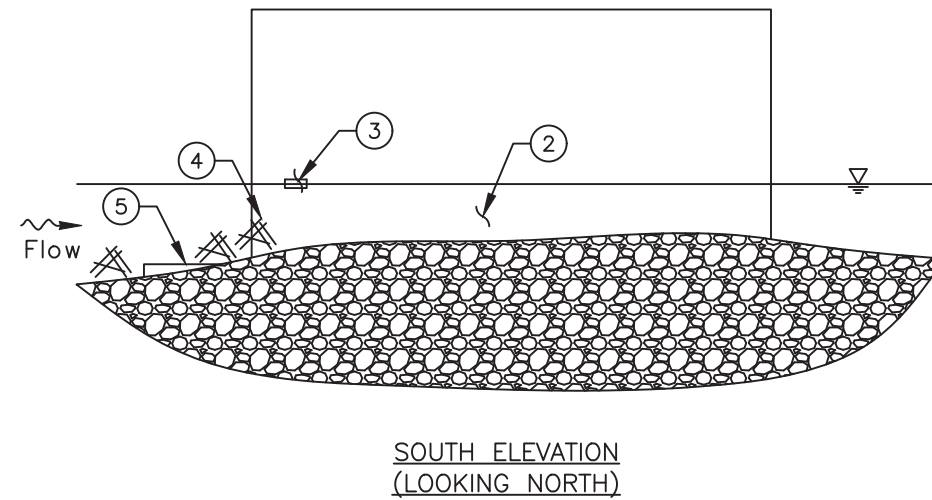
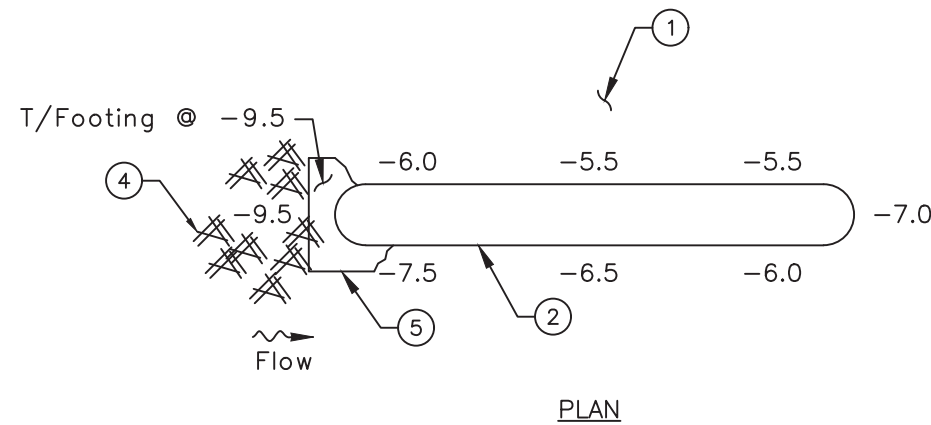
The channel bottom material consisted of cobbles and river rock up to 2 in. diameter with no probe rod penetration. Moderate timber debris consisting of logs up to 6 in. diameter were observed on the upstream nose extending from channel bottom to the water line up to 10 ft radius around the nose. The submerged portions of the pier were sound and smooth with no defects observed. A spall was located on the south face at the waterline, measuring 2.5 ft long by 1 ft high by 2 in. diameter. Footing exposure was observed at the upstream nose of the pier. Refer to Figure 8 in Exhibit 1 for detailed inspection notes of Pier 3. Refer to Photographs 13 and 14 in Exhibit 2 for views of Pier 3.

- ① The channel bottom material consisted of cobbles and river rock up to 2 in. diameter with no probe rod penetration.
- ② The submerged portions of the pier were sound and smooth with no defects observed.
- ③ A spall was located on the south face at the waterline, measuring 2.5 ft long by 1 ft high by 2 in. deep.
- ④ Moderate timber debris consisting of logs up to 6 in. diameter were observed on the upstream nose extending from channel bottom to the water line up to 10 ft radius around the nose.
- ⑤ Footing exposure was observed at the upstream nose of the pier.

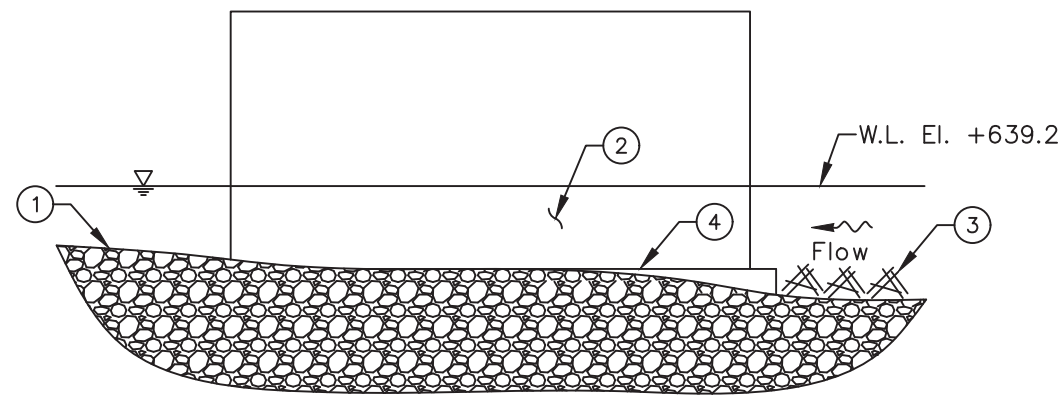
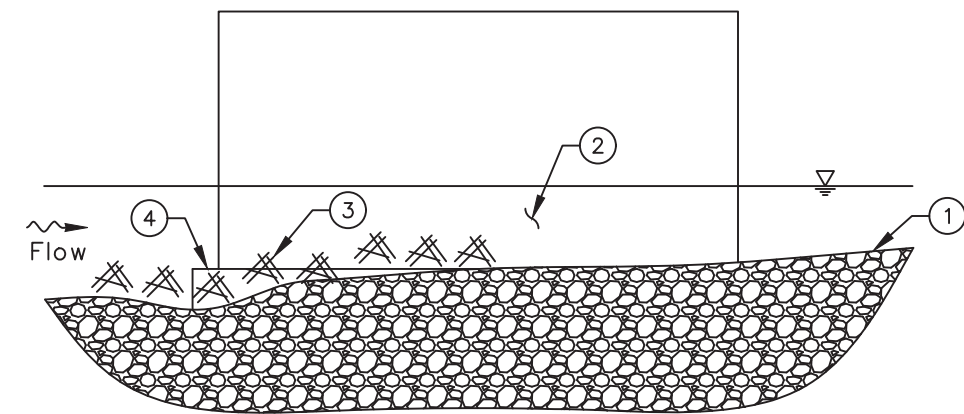
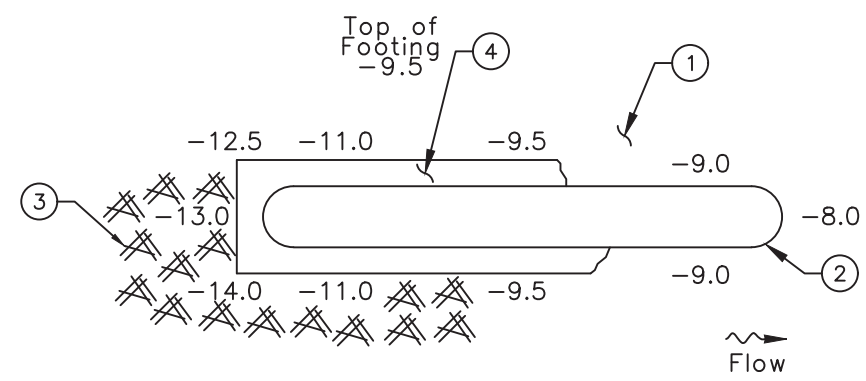
US-6 OVER MAUMEE RIVER
 STRUCTURE NO. 3500578 (HEN-6-1650)
 PIER 4
 HENRY COUNTY, OHIO

The channel bottom material consisted of cobbles and river rock up to 2 in. diameter with no probe rod penetration. Moderate timber debris consisting of logs up to 6 in. diameter was observed along the upstream nose and south face extending from -6 ft to the waterline up to a 10 ft away from the face of the pier. The submerged portions of the pier were sound and smooth with no defects observed. The top of footing was observed at -9.5 ft with a maximum vertical exposure of 4.5 ft at the southwest corner. The footing was exposed from approximately the downstream 1/4 point along the south face around the upstream nose to the downstream

1/4 point of the north face. Refer to Figure 9 in Exhibit 1 for detailed inspection notes of Pier 4. Refer to Photographs 15 and 16 in Exhibit 2 for views of Pier 4.

- ① The channel bottom material consisted of cobbles and river rock up to 2 in. diameter with no probe rod penetration.
- ② The submerged portions of the pier were sound and smooth with no defects observed.
- ③ Moderate timber debris consisting of logs up to 6 in. diameter was observed along the upstream nose and south face extending from -6 ft to the waterline up to a 10 ft away from the face of the pier.
- ④ The top of footing was observed at -9.5 ft with a maximum vertical exposure of 4.5 ft at the southwest corner. The footing was exposed from approximately the downstream 1/4 point along the south face around the upstream nose to the downstream 1/4 point of the north face.

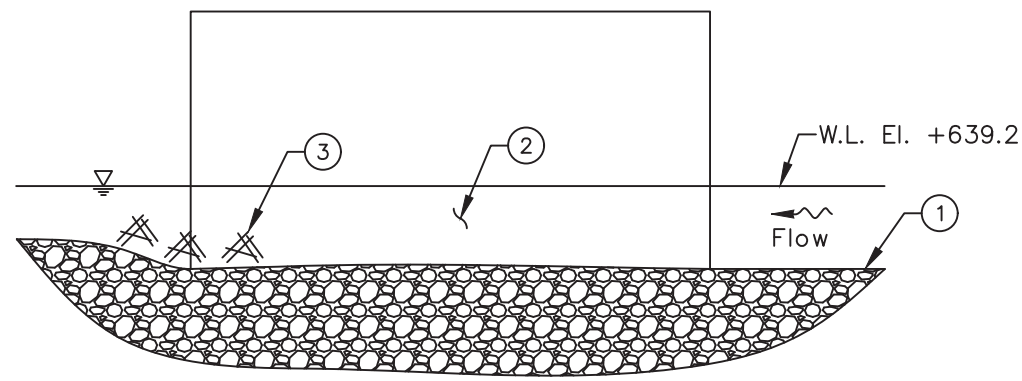
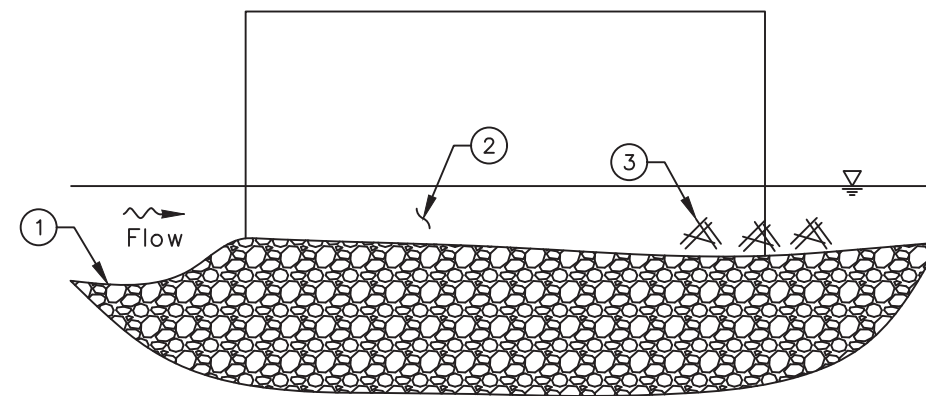
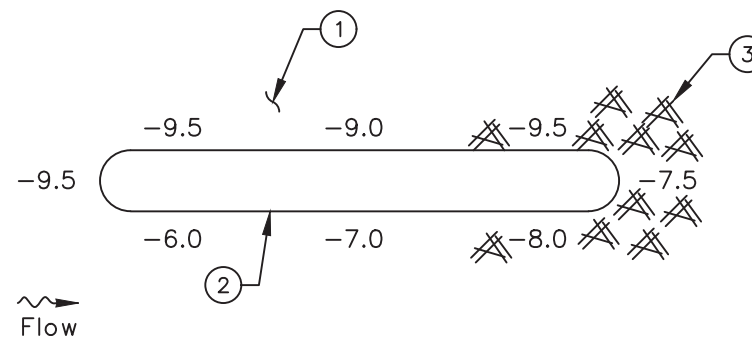
The channel bottom material consisted of tree debris up to 3 in. diameter and river rock up to 2 in. diameter. The submerged portions of the pier were sound and smooth with no defects observed. Refer to Figure 10 in Exhibit 1 for detailed inspection notes of Pier 5. Refer to Photographs 17 through 19 in Exhibit 2 for views of Pier 5 and typical concrete condition at the waterline.

- ① The channel bottom material consisted of tree debris up to 3 in. diameter and river rock up to 2 in. diameter.
- ② The submerged portions of the pier were sound and smooth with no defects observed.
- ③ Moderate timber debris accumulation measuring up to 8 in. diameter was observed on the downstream nose of the pier.

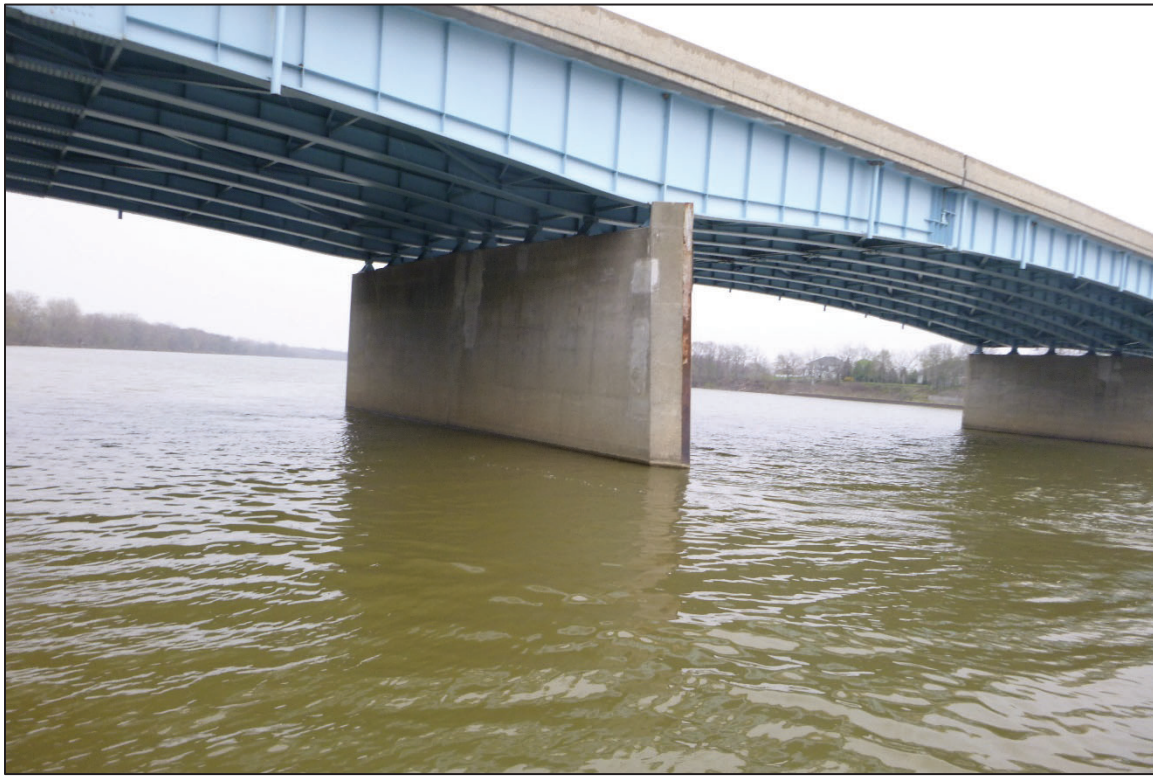
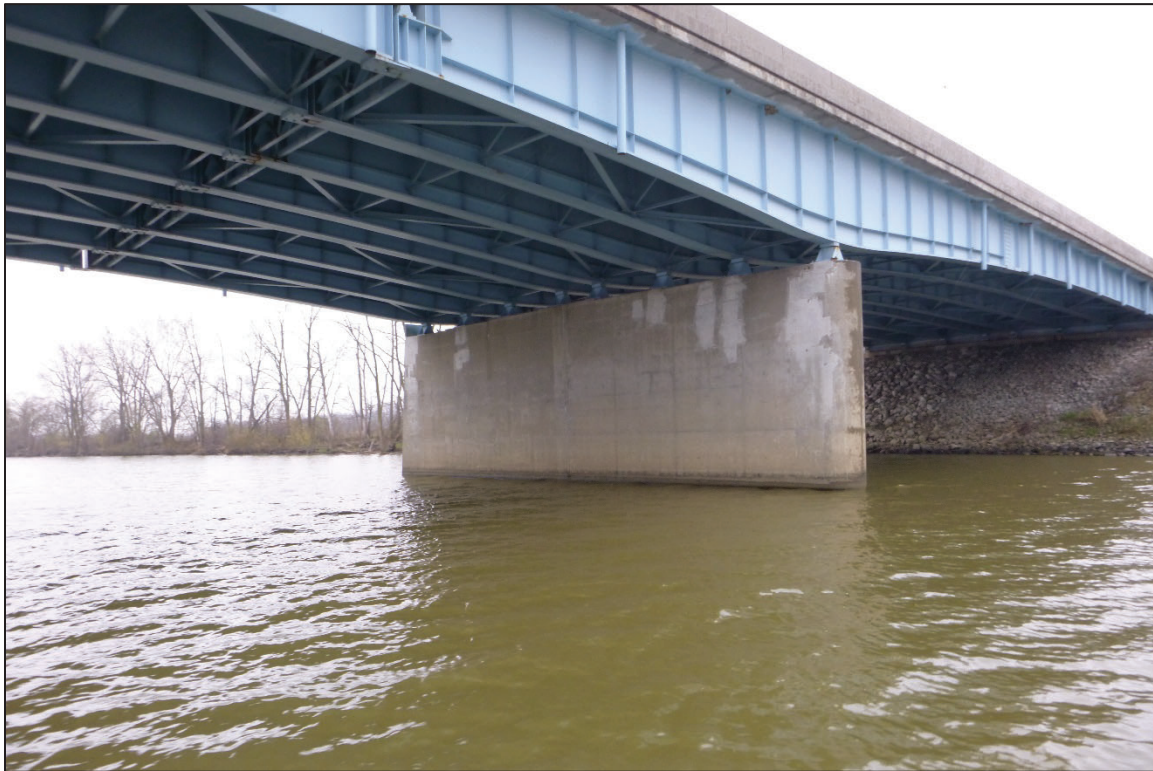
Photograph No. 9: View of the North Face of Pier 1, Looking Southeast.

Photograph No. 10: View of the South Face of Pier 1, Looking Northwest.

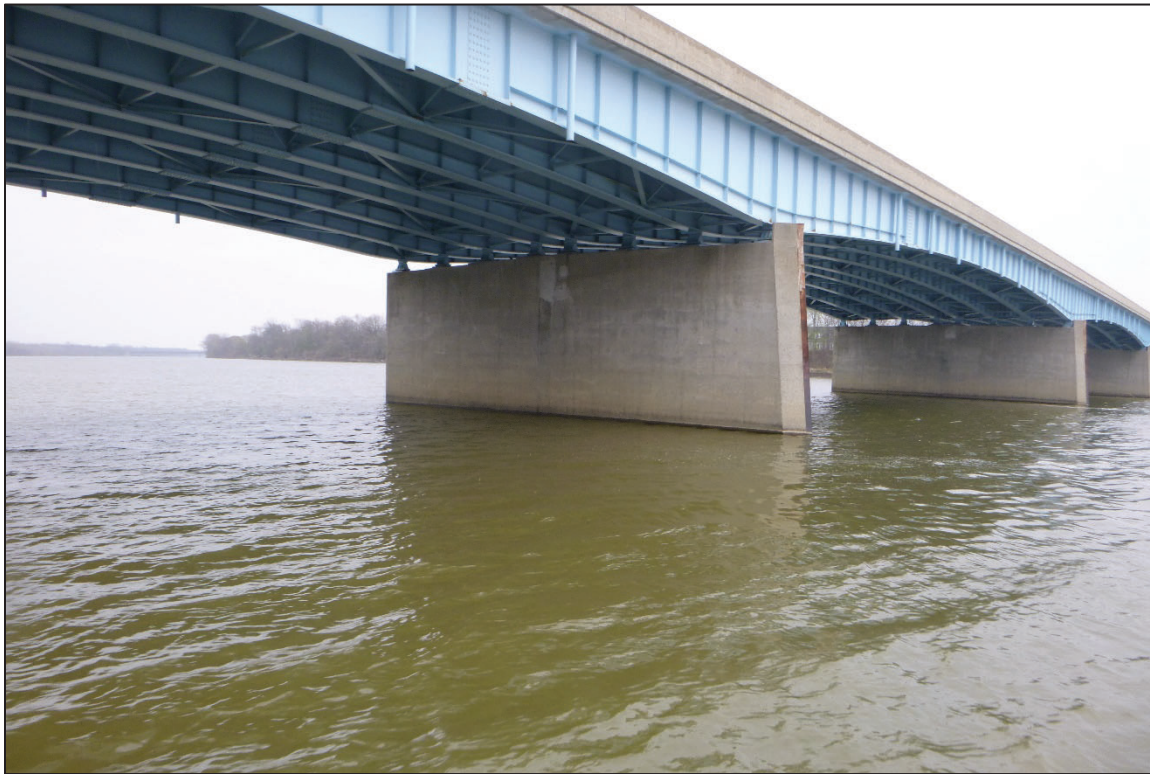
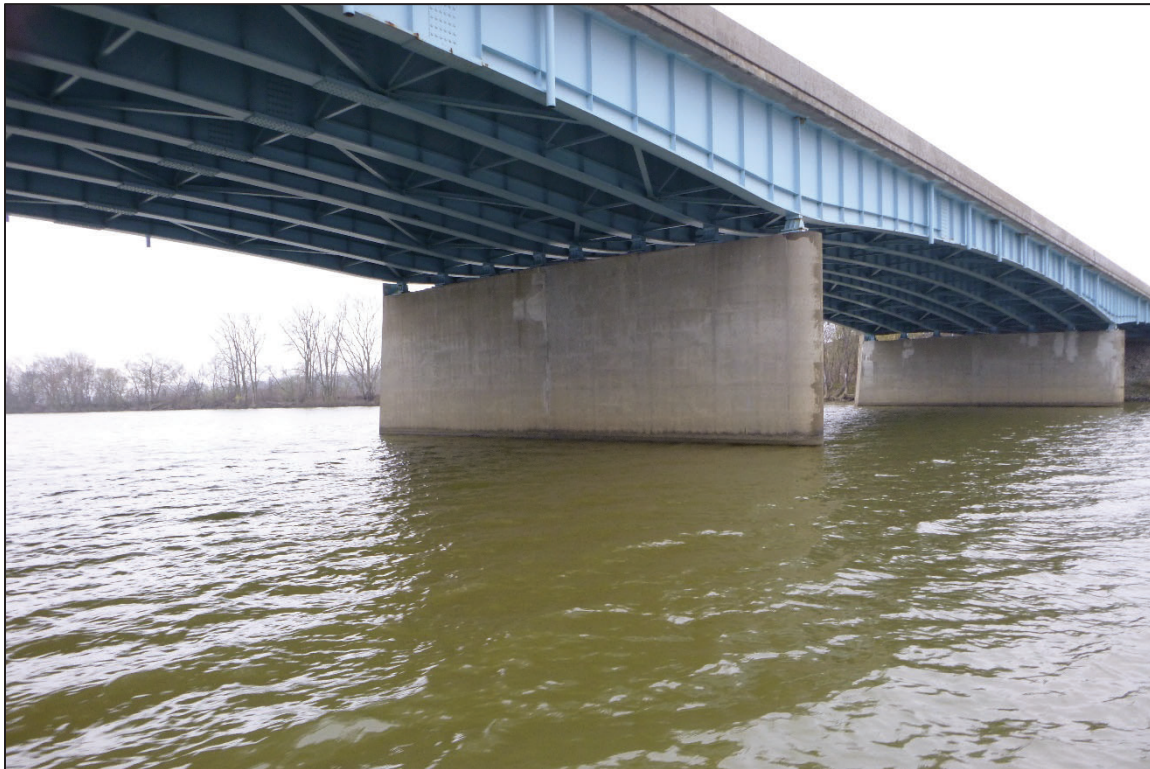
- The submerged portions of the pier were sound and smooth with no defects observed.
 - A spall was located on the south face at the waterline, measuring 3 ft long by 1 ft high by 2 in. diameter.

Photograph No. 11: View of the North Face of Pier 2, Looking Southeast.

Photograph No. 12: View of the South Face of Pier 2, Looking Northwest.

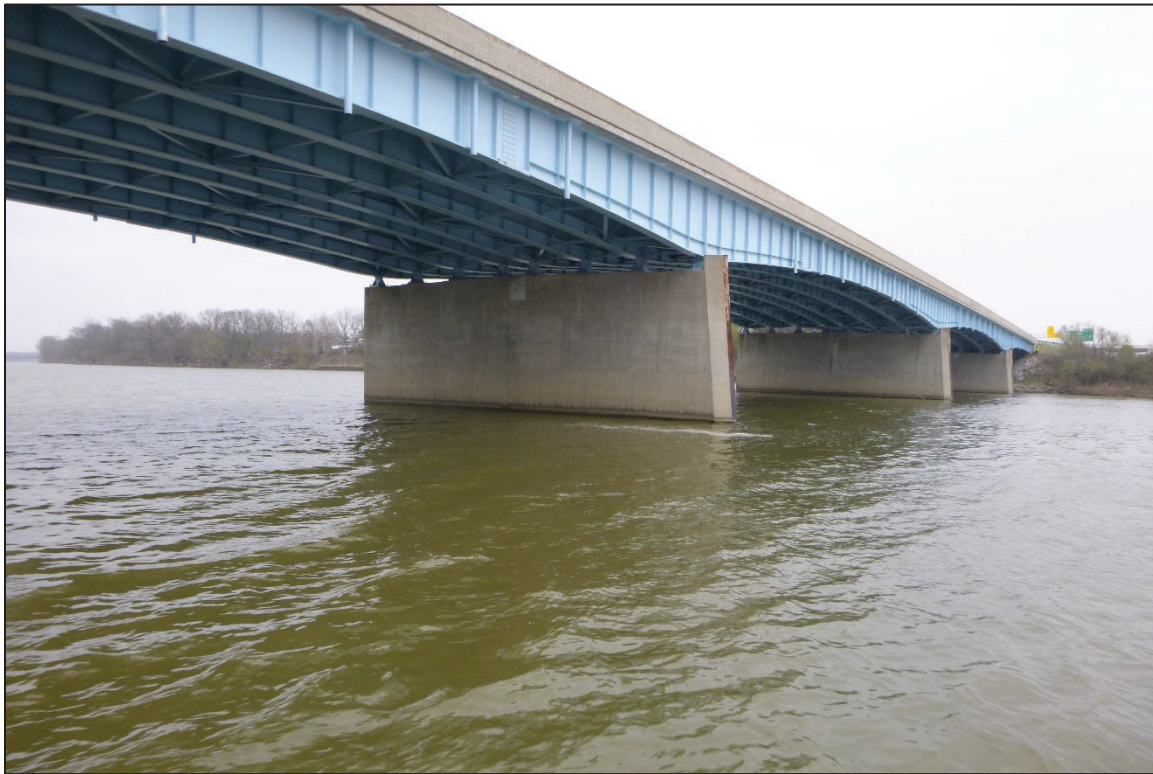
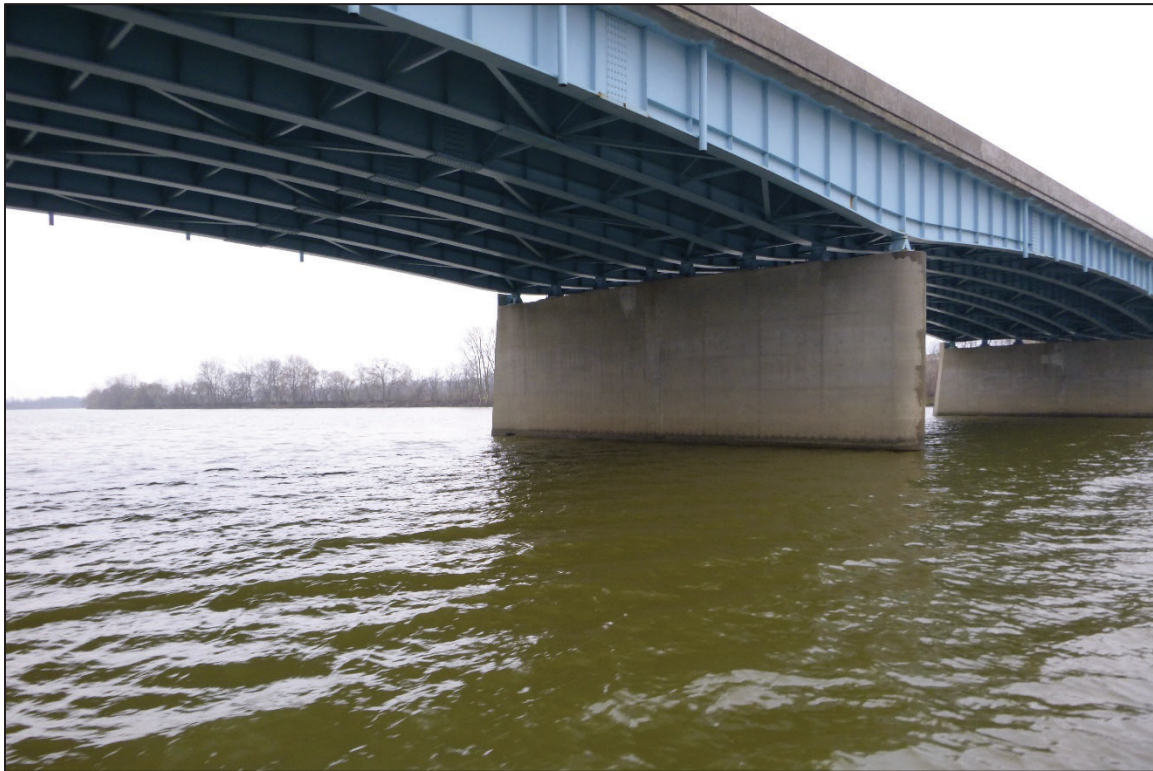
-
- A spall was located on the south face at the waterline, measuring 2.5 ft long by 1 ft high by 2 in. diameter.
 - Footing exposure was observed at the upstream nose of the pier.

Photograph No. 13: View of the North Face of Pier 3, Looking Southeast.

Photograph No. 14: View of the South Face of Pier 3, Looking Northwest.

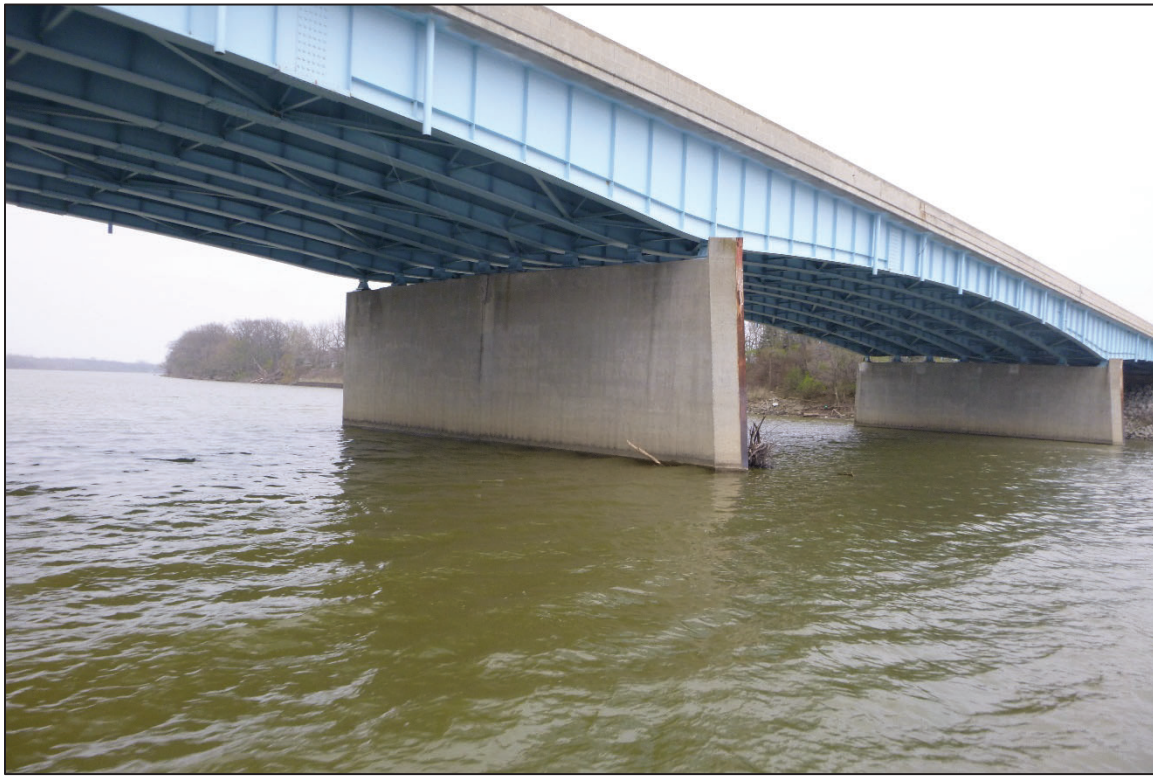
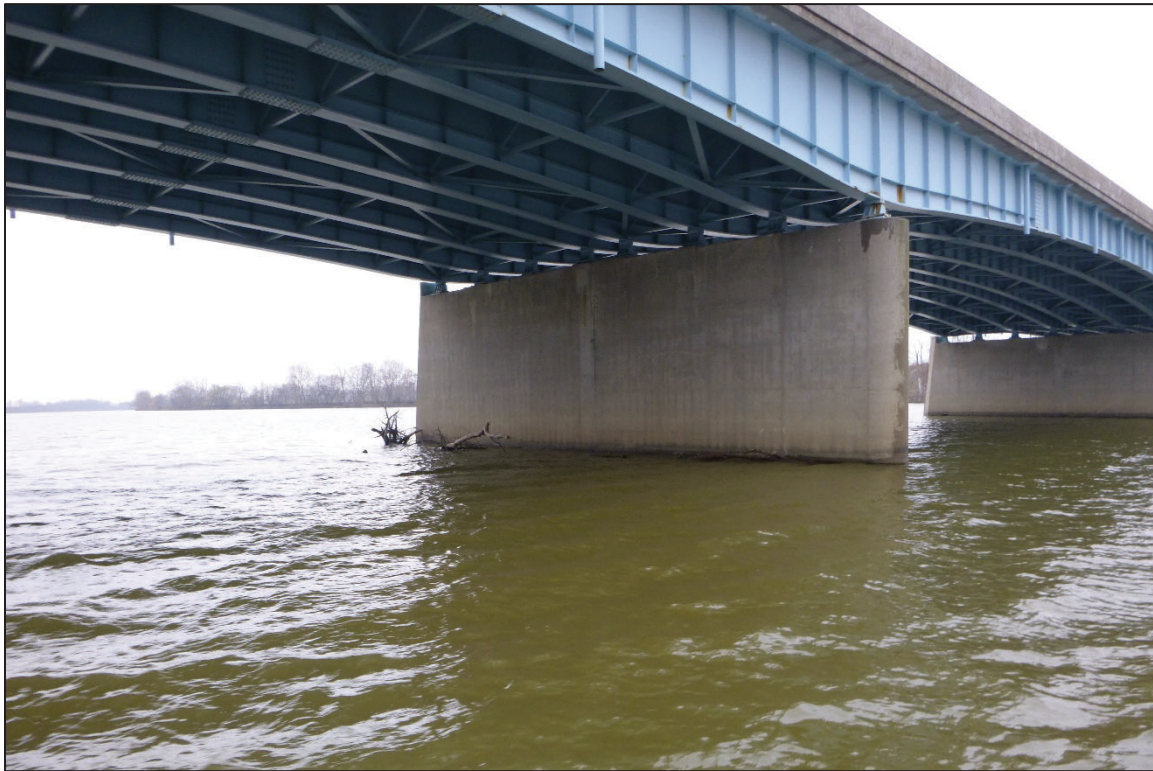
- The submerged portions of the pier were sound and smooth with no defects observed.
 - The top of footing was observed at -9.5 ft with a maximum vertical exposure of 4.5 ft at the southwest corner. The footing was exposed from approximately the downstream 1/4 point along the south face around the upstream nose to the downstream 1/4 point of the north face.

Photograph No. 15: View of the North Face of Pier 4, Looking Southeast.

Photograph No. 16: View of the South Face of Pier 4, Looking Northwest.

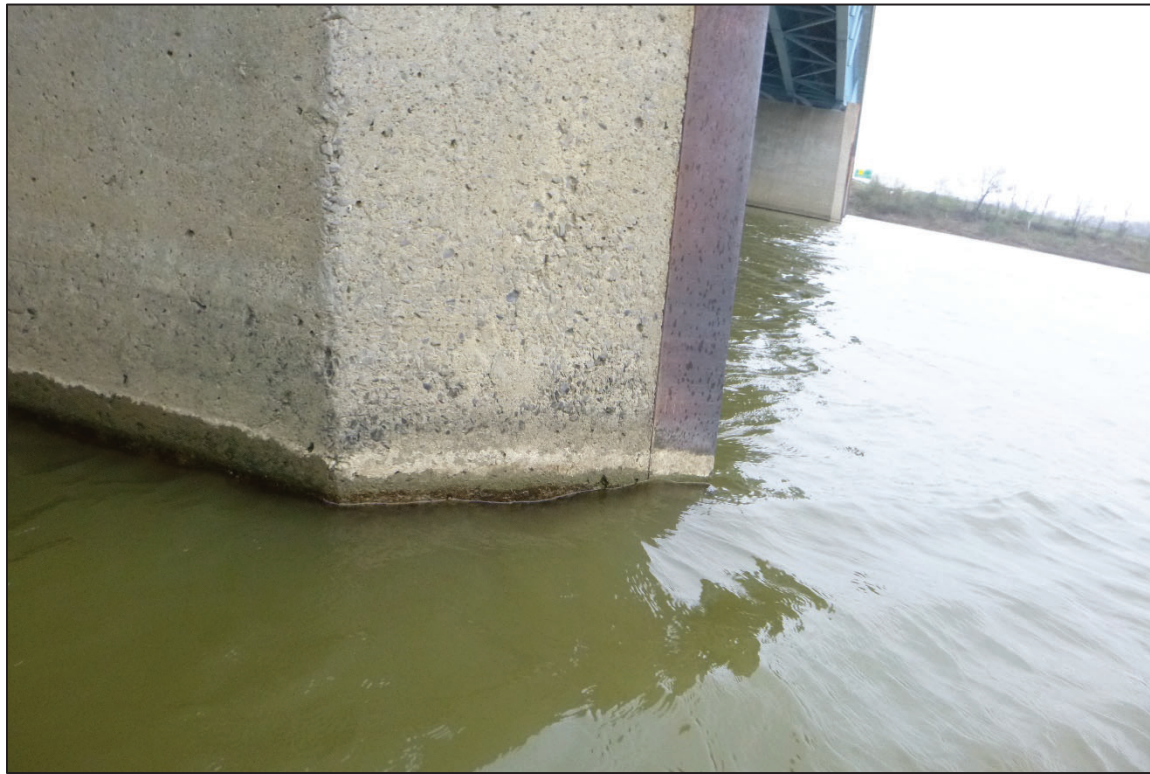
Photograph No. 19: View of the Typical Concrete Condition at the Waterline, Looking South.
