UNDERWATER BRIDGE INSPECTION REPORT

STRUCTURE NO. 3502384 (HEN-108-1561)
SR 108 OVER MAUMEE RIVER
HENRY COUNTY, OH
DISTRICT 2

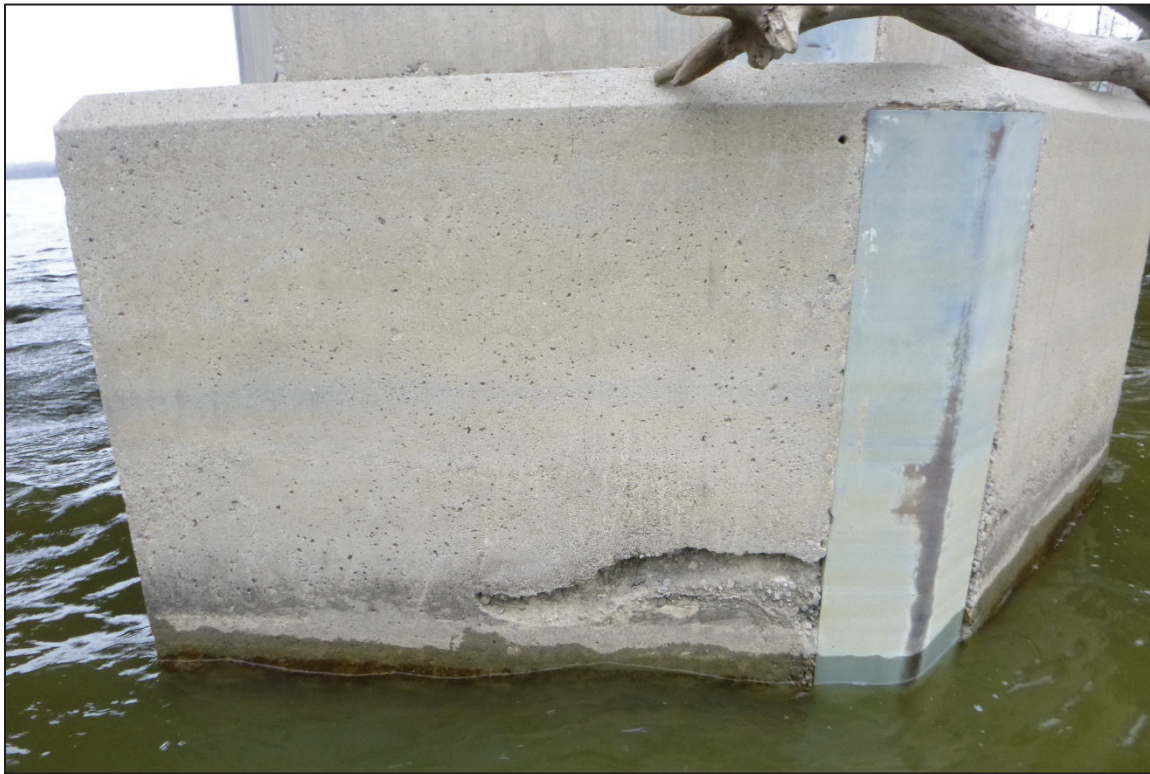
Photograph No. 15: View of the Spall on the Upstream Nose of Pier 3, Looking East.

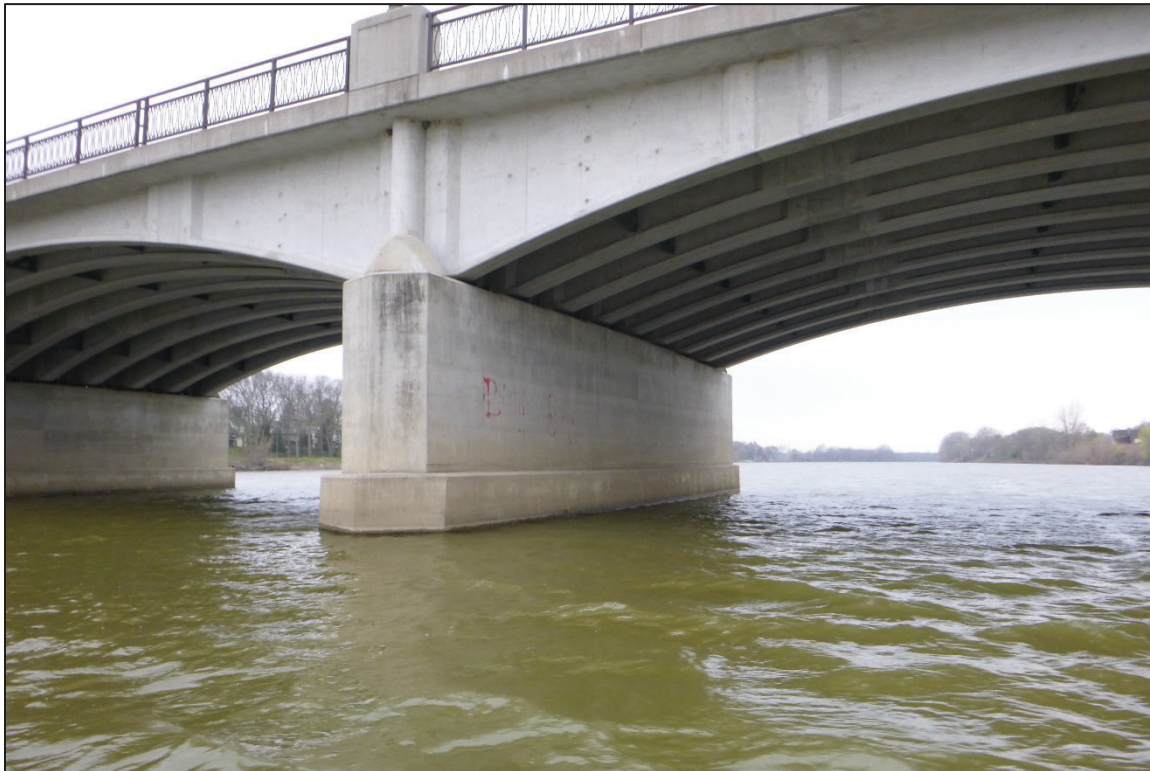
Photograph No. 16: View of the North Face of Pier 4, Looking Southwest.

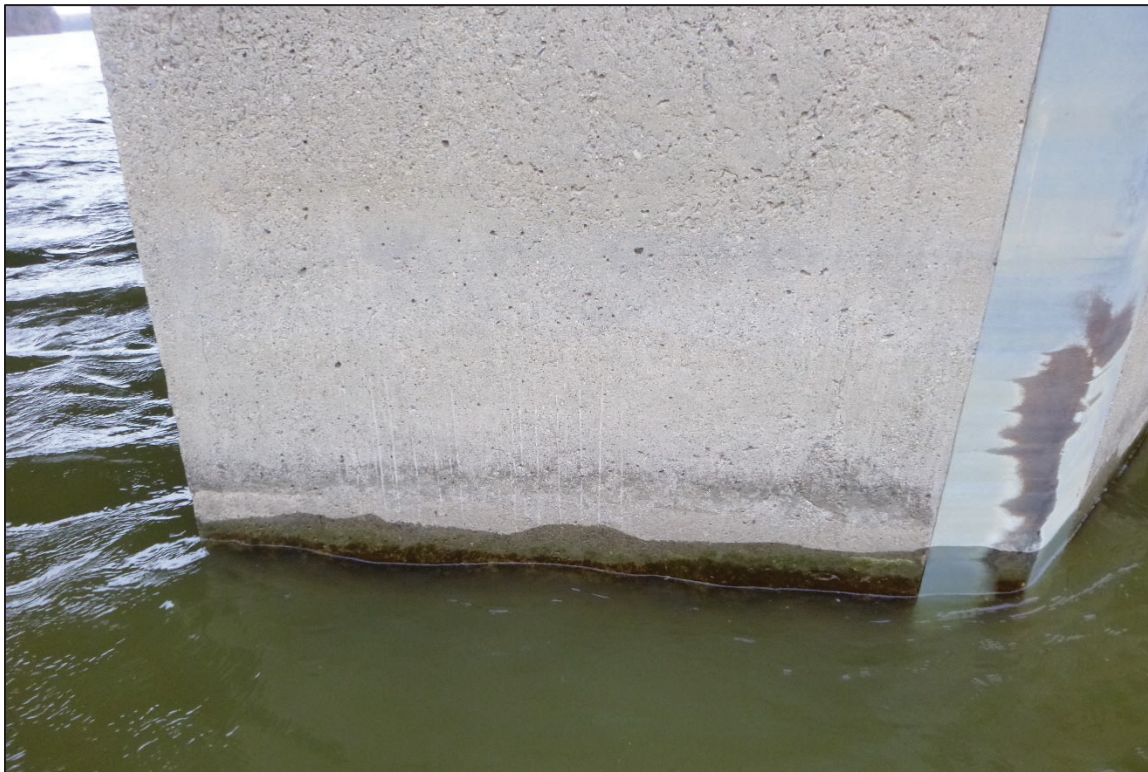
Photograph No. 22: View of the Typical Concrete and Steel Condition at the Waterline on the Upstream Nose of Pier 6, Looking East.
