UNDERWATER BRIDGE INSPECTION REPORT

STRUCTURE NO. 3502392 (HEN-109-1820)
SR 109 OVER MAUMEE RIVER
HENRY COUNTY, OH
DISTRICT 2

April 2020

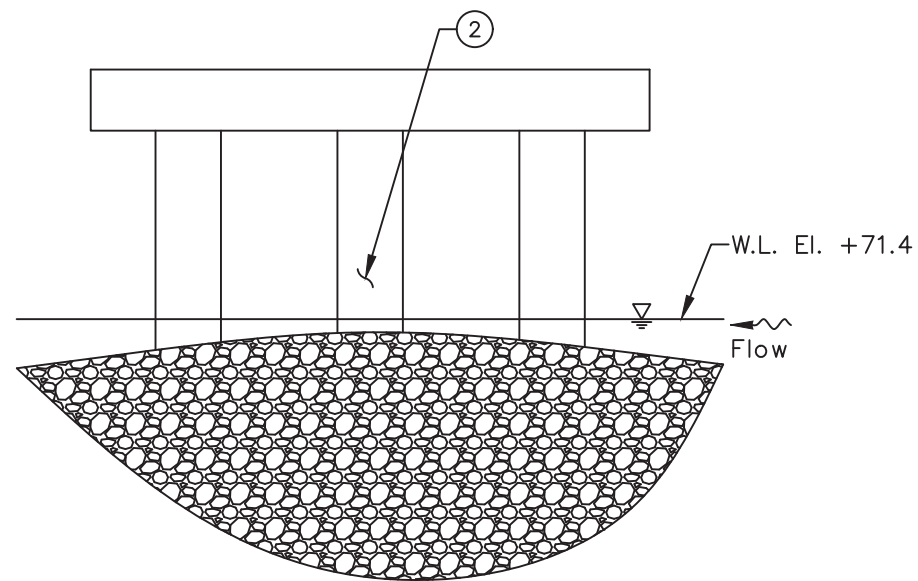
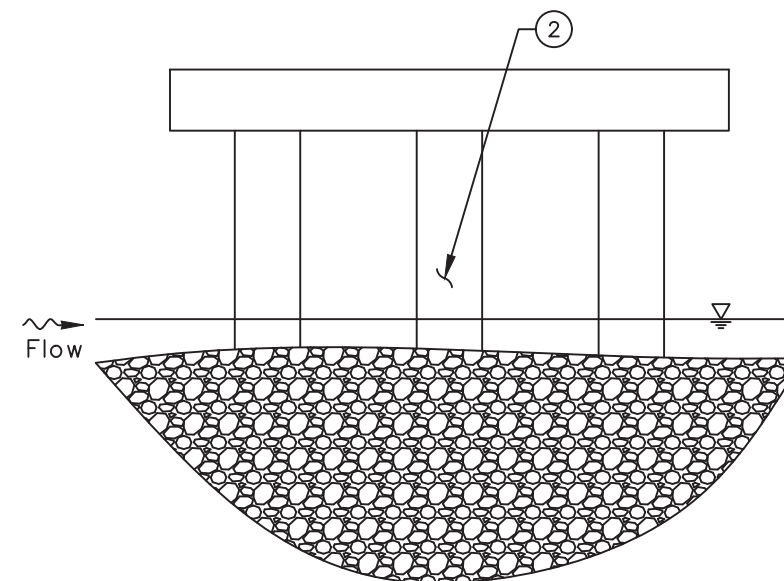
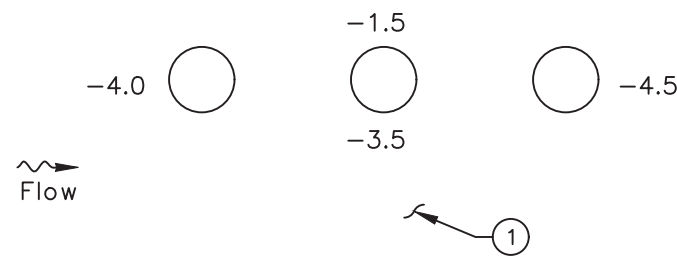
SR-109 OVER MAUMEE RIVER
STRUCTURE NO. HEN-109-1820
BENT 1
HENRY COUNTY, OHIO

The channel bottom material consisted of riprap up to 18 in. diameter with no probe rod penetration. The steel typically exhibited light surface corrosion with no pitting observed. Refer to Figure 7 in Exhibit 1 for detailed inspection notes of Bent 1. Refer to Photographs 9 and 10 in Exhibit 2 for views of Bent 1.

- ① The channel bottom material consisted of riprap up to 18 in. diameter with no probe rod penetration.
- ② The steel typically exhibited light surface corrosion with no pitting observed.

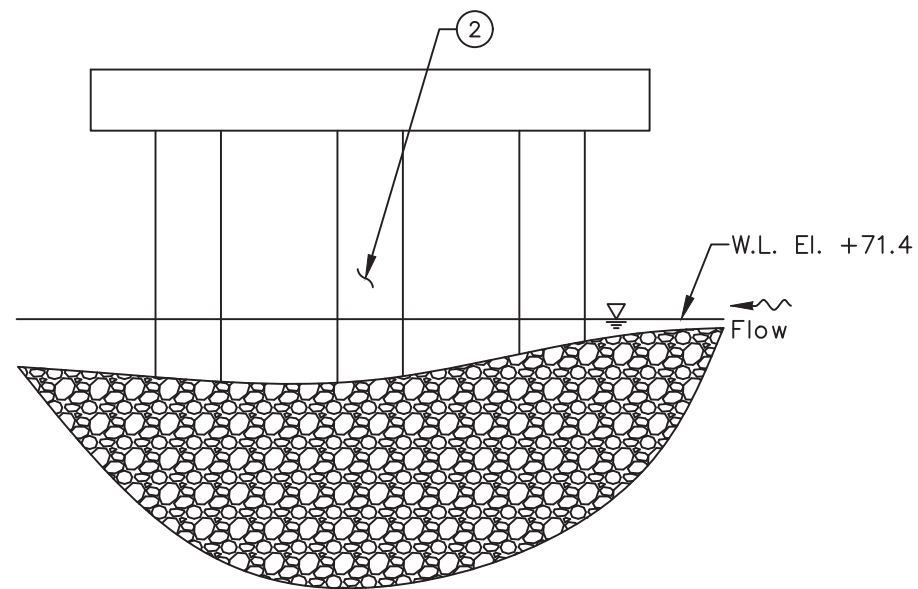
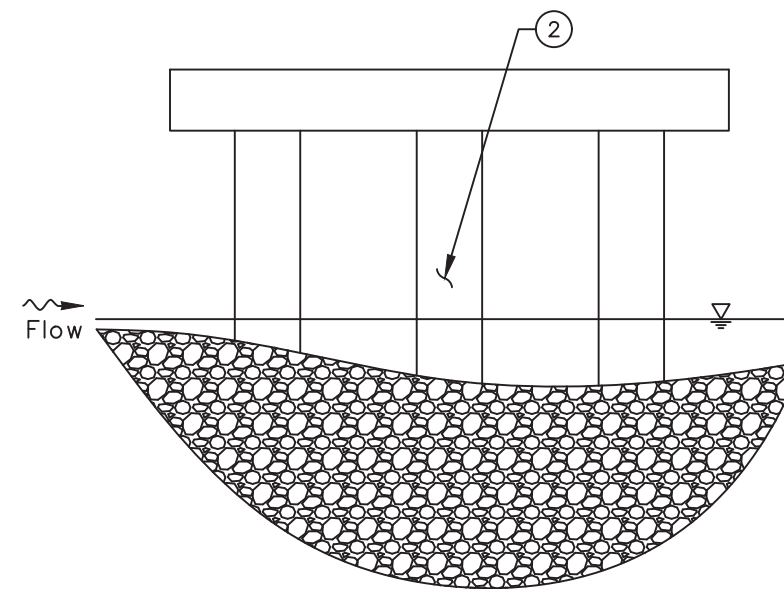
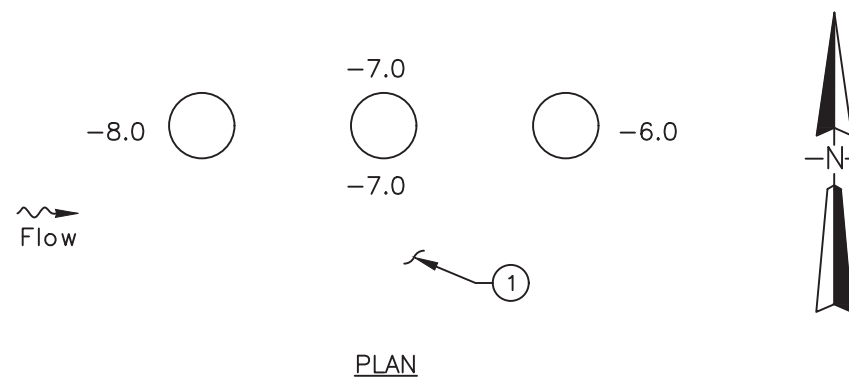
SR-109 OVER MAUMEE RIVER
STRUCTURE NO. HEN-109-1820
BENT 2
HENRY COUNTY, OHIO

The channel bottom material consisted of riprap up to 18 in. diameter with no probe rod penetration. The steel typically exhibited light surface corrosion with no pitting observed. Refer to Figure 8 in Exhibit 1 for detailed inspection notes of Bent 2. Refer to Photographs 11 and 12 in Exhibit 2 for views of Bent 2.

- ① The channel bottom material consisted of riprap up to 18 in. diameter with no probe rod penetration.
- ② The steel typically exhibited light surface corrosion with no pitting observed.

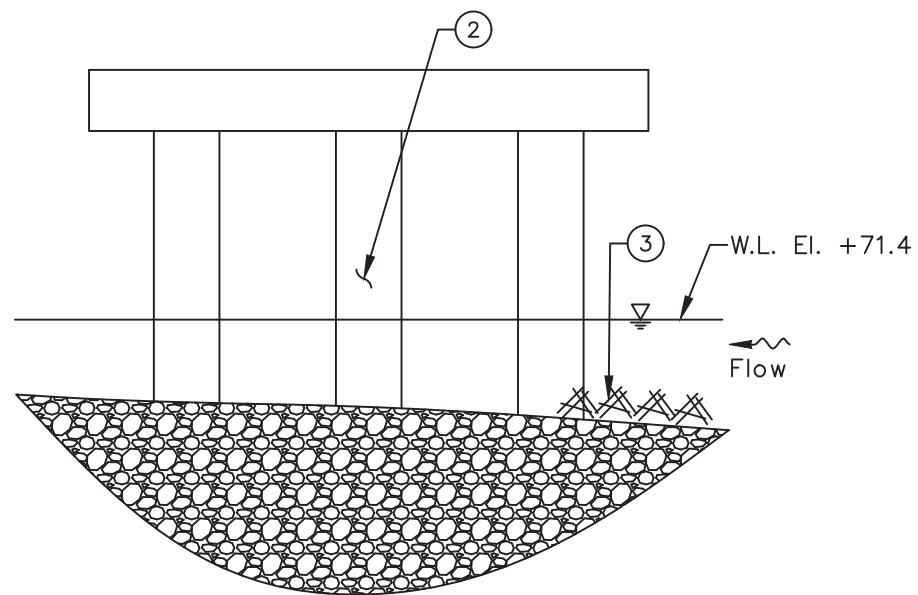
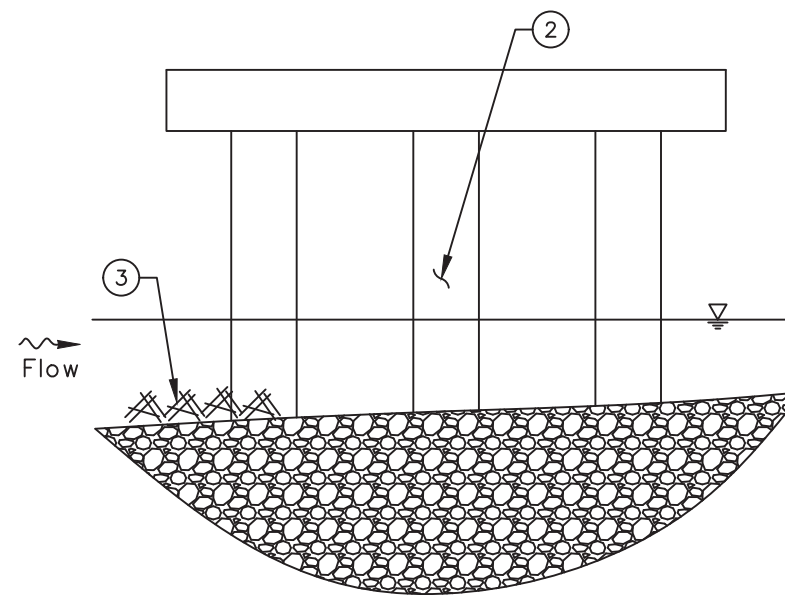
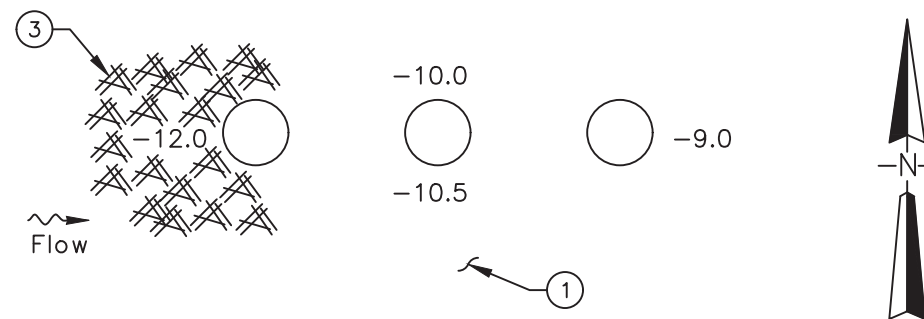
SR-109 OVER MAUMEE RIVER
 STRUCTURE NO. HEN-109-1820
 BENT 3
 HENRY COUNTY, OHIO

The channel bottom material consisted of riprap up to 18 in. diameter with no probe rod penetration. The steel typically exhibited light surface corrosion with no pitting observed. Light timber debris, consisting of branches up to 6 in. diameter, was observed on the upstream nose extending up to a 10 ft radius off the pier. Refer to Figure 9 in Exhibit 1 for detailed inspection notes of Bent 3. Refer to Photographs 13 and 14 in Exhibit 2 for views of Bent 3.

- ① The channel bottom material consisted of riprap up to 18 in. diameter with no probe rod penetration.
- ② The steel typically exhibited light surface corrosion with no pitting observed.
- ③ Light timber debris, consisting of branches up to 6 in. diameter, was observed on the upstream nose extending up to a 10 ft radius off the pier.

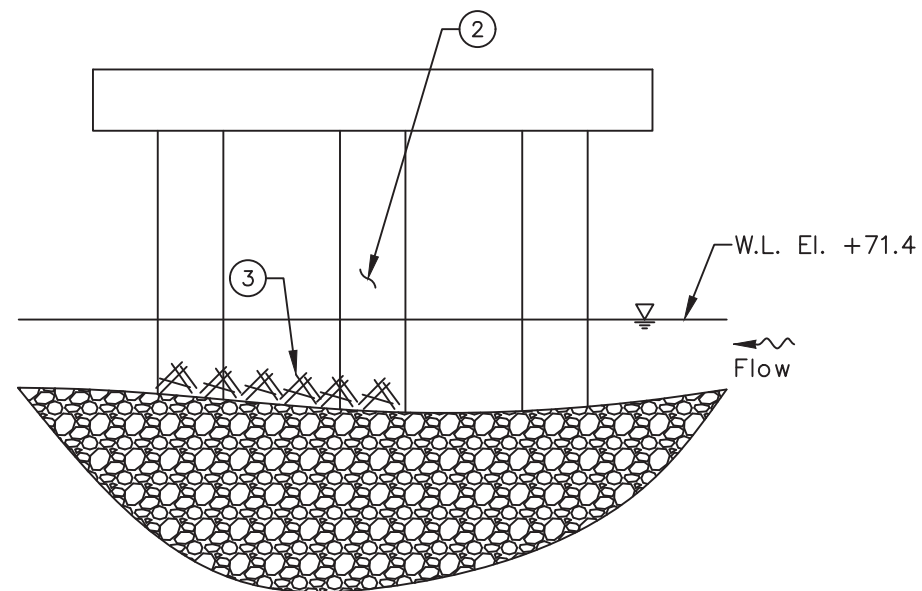
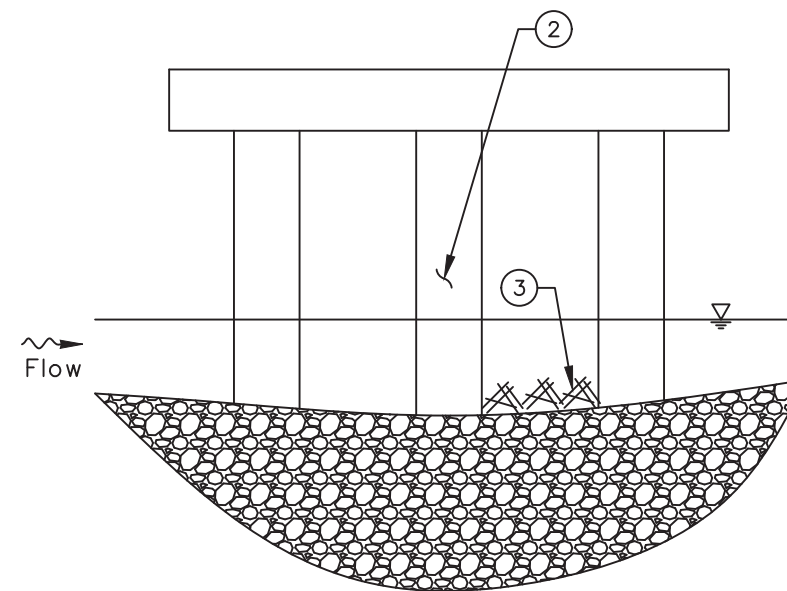
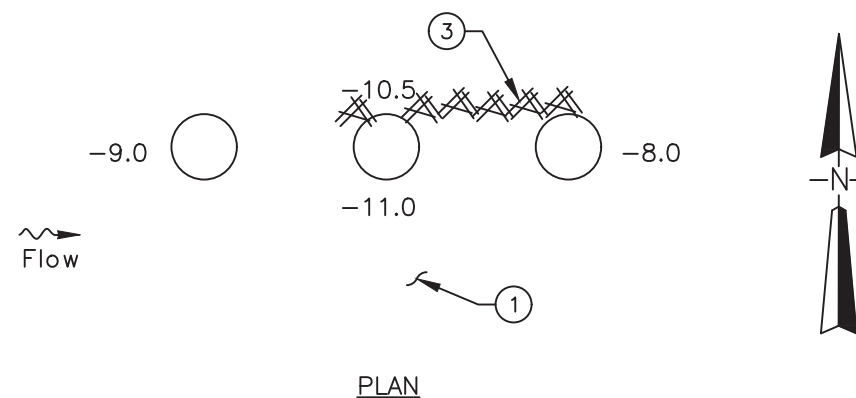
SR-109 OVER MAUMEE RIVER
 STRUCTURE NO. HEN-109-1820
 BENT 4
 HENRY COUNTY, OHIO

The channel bottom material consisted of riprap up to 18 in. diameter with no probe rod penetration. The steel typically exhibited light surface corrosion with no pitting observed. Light timber debris, consisting of branches up to 4 in. diameter, was observed on the channel bottom extending from Column B to Column C. Refer to Figure 10 in Exhibit 1 for detailed inspection notes of Bent 4. Refer to Photographs 15 and 16 in Exhibit 2 for views of Bent 4.

- ① The channel bottom material consisted of riprap up to 18 in. diameter with no probe rod penetration.
- ② The steel typically exhibited light surface corrosion with no pitting observed.
- ③ Light timber debris, consisting of branches up to 4 in. diameter, was observed on the channel bottom extending from Column B to Column C.

The timber debris accumulations at Bents 4, 5, and 7 did not significantly affect the channel flow, and as a result, does not require removal at this time. If the debris accumulation increases in size or density, it may be necessary to remove the debris to reduce excessive lateral loads on the bent, limit further debris accumulation, and reduce the likelihood of channel bottom degradation resulting from obstructed flow.

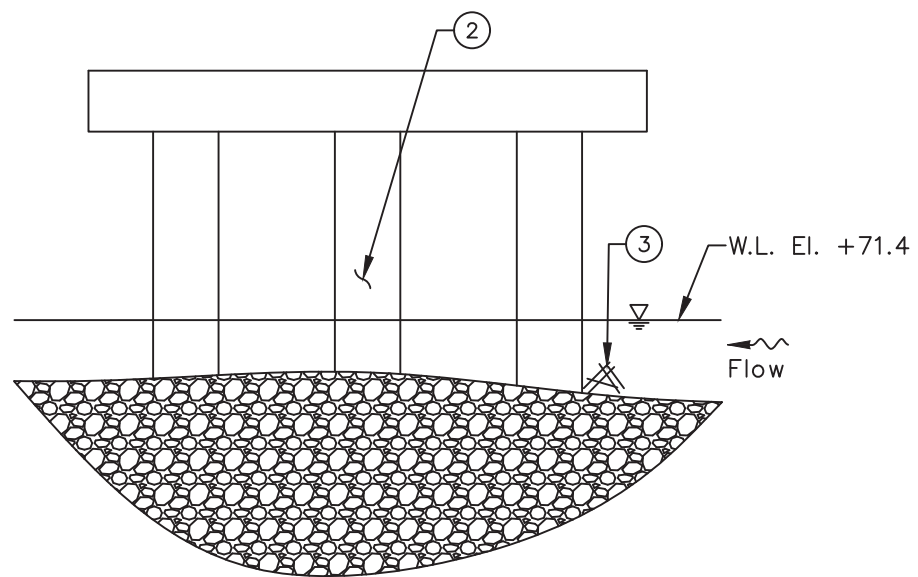
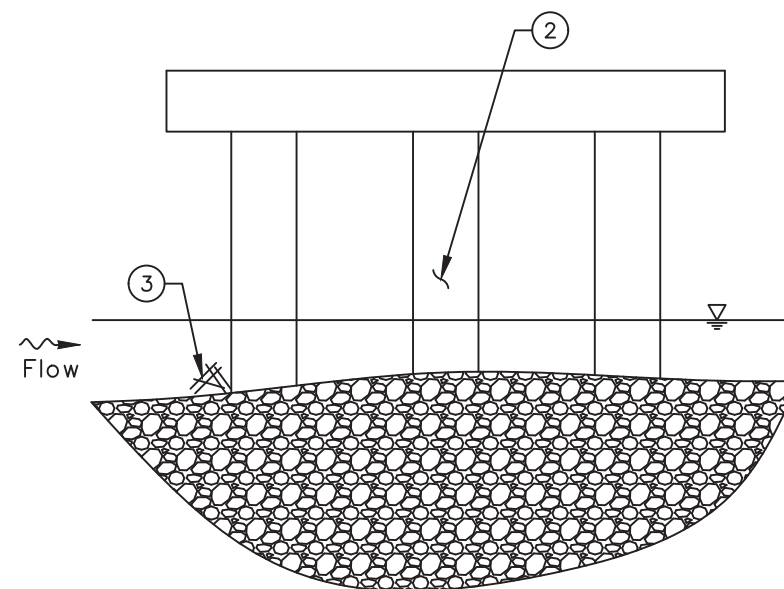
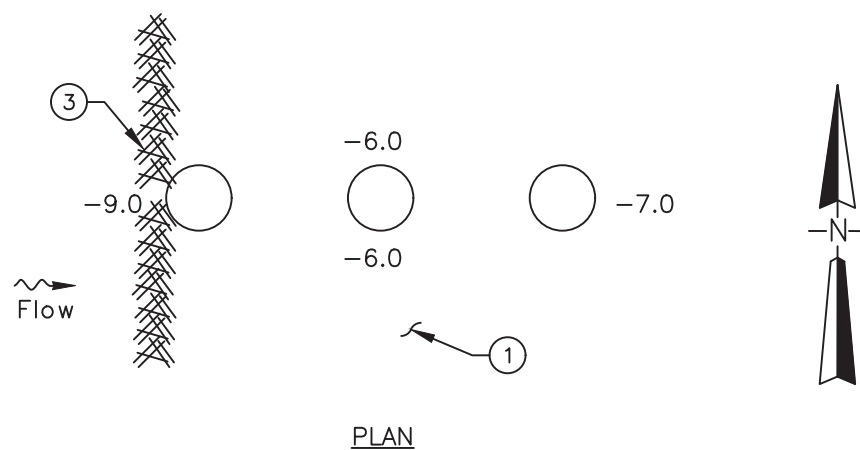
SR-109 OVER MAUMEE RIVER
 STRUCTURE NO. HEN-109-1820
 BENT 5
 HENRY COUNTY, OHIO

The channel bottom material consisted of riprap up to 18 in diameter with no probe rod penetration. The steel typically exhibited light surface corrosion with no pitting observed. One tree measuring approximately 9 in. diameter was observed on the channel bottom extending up to 6 ft from the north and south faces. Refer to Figure 11 in Exhibit 1 for detailed inspection notes of Bent 5. Refer to Photographs 17 and 18 in Exhibit 2 for views of Bent 5.

- ① The channel bottom material consisted of riprap up to 18 in. diameter with no probe rod penetration.
- ② The steel typically exhibited light surface corrosion with no pitting observed.
- ③ One tree measuring approximately 9 in. diameter was observed on the channel bottom extending up to 6 ft from the north and south faces.

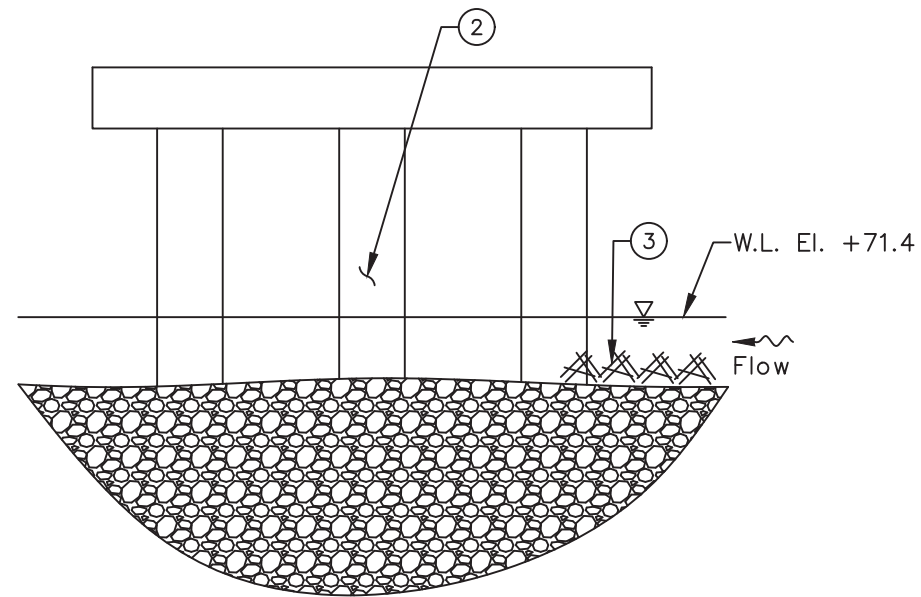
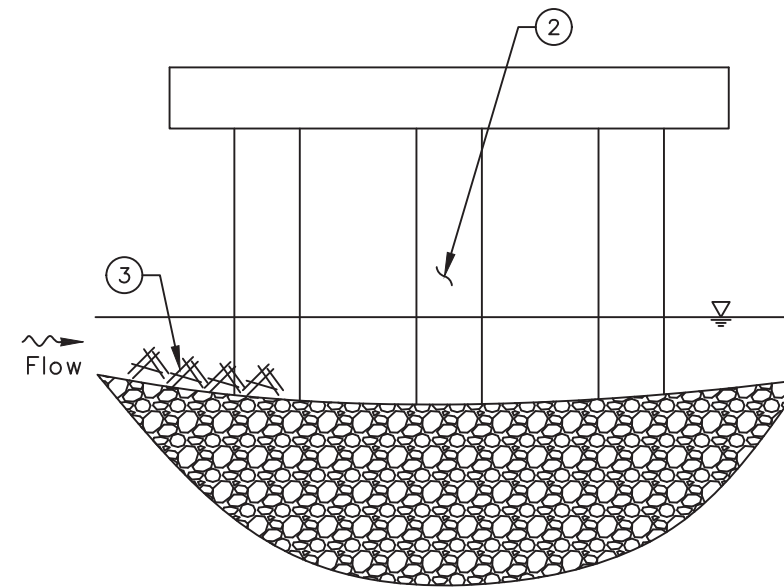
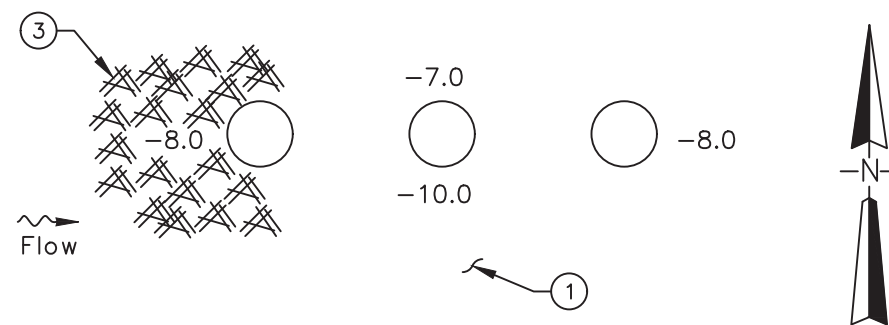
SR-109 OVER MAUMEE RIVER
 STRUCTURE NO. HEN-109-1820
 BENT 7
 HENRY COUNTY, OHIO

The channel bottom material consisted of riprap up to 18 in. diameter with no probe rod penetration. The steel typically exhibited light surface corrosion with no pitting observed. Light timber debris, consisting of branches up to 6 in. diameter, was observed on the upstream nose extending up to a 10 ft radius off the pier. Refer to Figure 13 in Exhibit 1 for detailed inspection notes of Bent 7. Refer to Photographs 21 and 22 in Exhibit 2 for views of Bent 7.

- ① The channel bottom material consisted of riprap up to 18 in. diameter with no probe rod penetration.
- ② The steel typically exhibited light surface corrosion with no pitting observed.
- ③ Light timber debris, consisting of branches up to 6 in. diameter, was observed on the upstream nose extending up to a 10 ft radius off the pier.

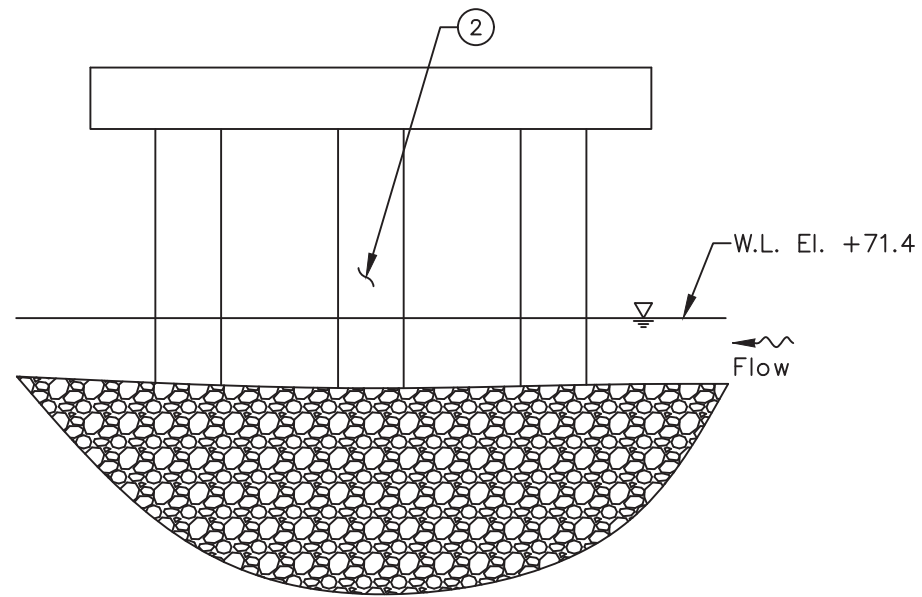
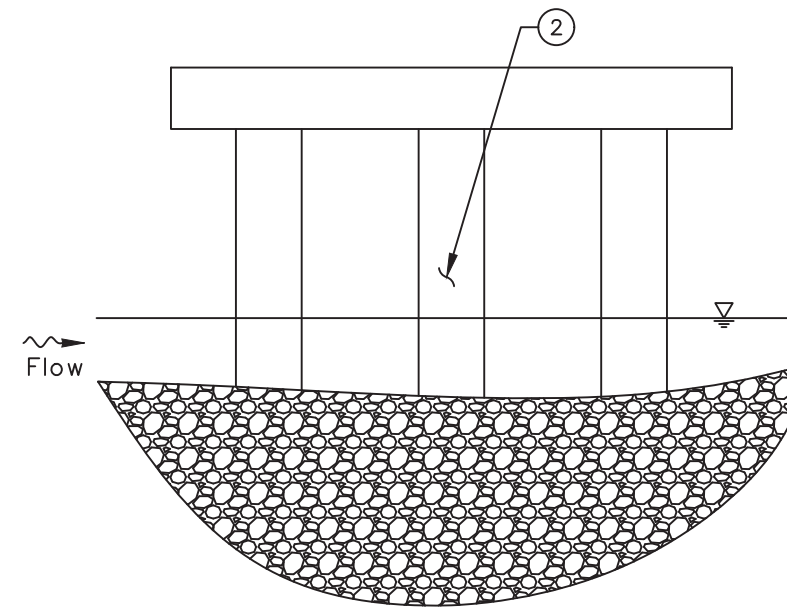
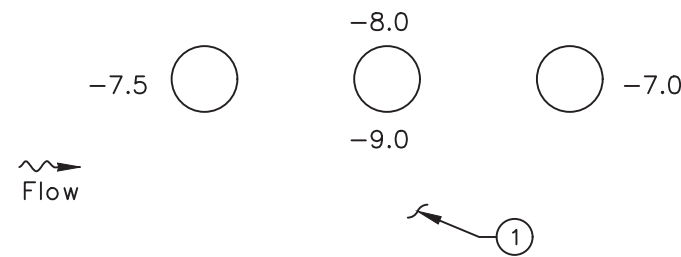
SR-109 OVER MAUMEE RIVER
 STRUCTURE NO. HEN-109-1820
 BENT 8
 HENRY COUNTY, OHIO

The channel bottom material consisted of riprap up to 18 in. diameter with no probe rod penetration. The steel typically exhibited light surface corrosion with no pitting observed. Refer to Figure 14 in Exhibit 1 for detailed inspection notes of Bent 8. Refer to Photographs 23 and 24 in Exhibit 2 for views of Bent 8.

- ① The channel bottom material consisted of riprap up to 18 in. diameter with no probe rod penetration.
- ② The steel typically exhibited light surface corrosion with no pitting observed.

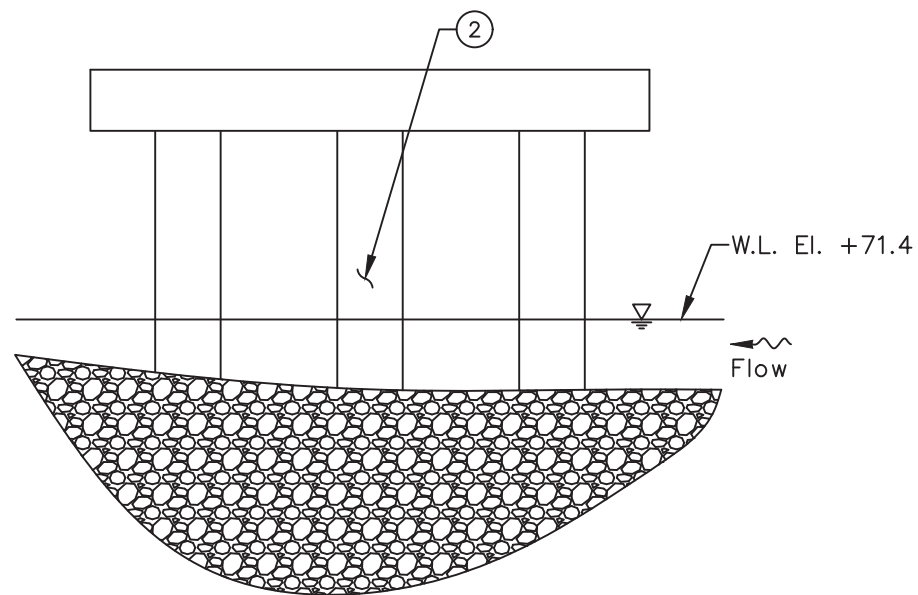
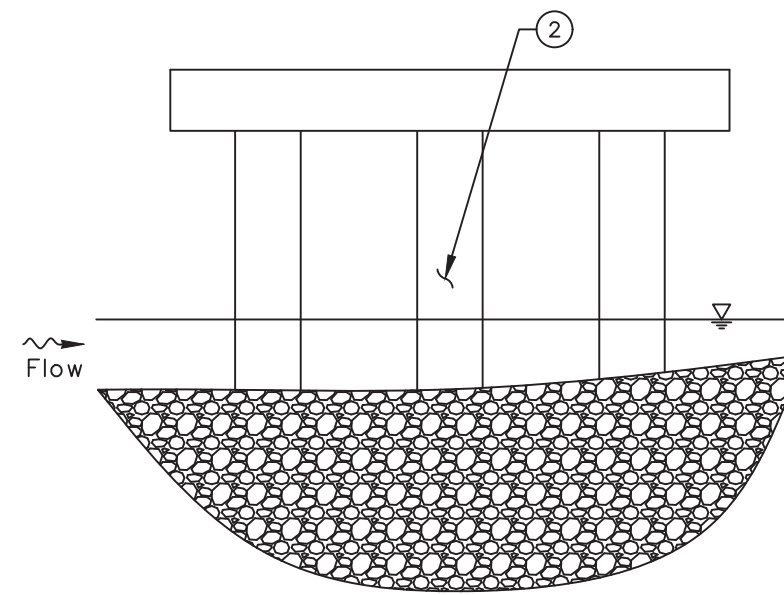
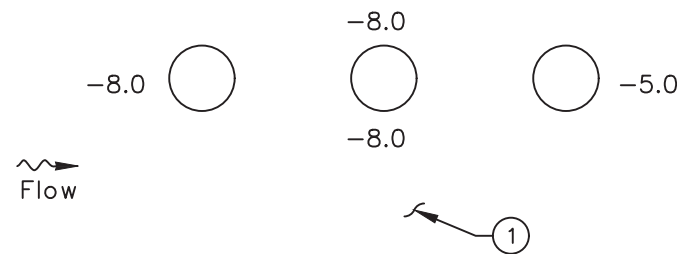
SR-109 OVER MAUMEE RIVER
STRUCTURE NO. HEN-109-1820
BENT 9
HENRY COUNTY, OHIO

The channel bottom material consisted of riprap up to 18 in. diameter with no probe rod penetration. The steel typically exhibited light surface corrosion with no pitting observed. Refer to Figure 15 in Exhibit 1 for detailed inspection notes of Bent 9. Refer to Photographs 25 and 26 in Exhibit 2 for views of Bent 9.

- ① The channel bottom material consisted of riprap up to 18 in. diameter with no probe rod penetration.
- ② The steel typically exhibited light surface corrosion with no pitting observed.

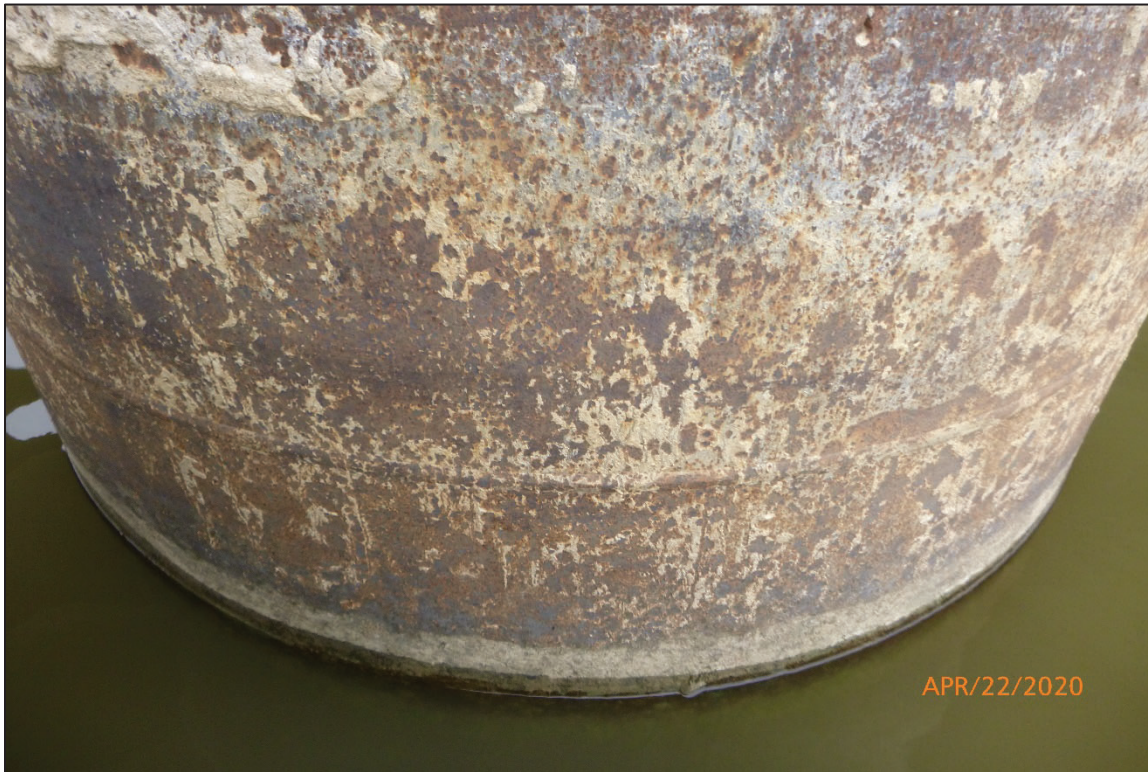
The surface corrosion of the protective steel at Bents 1 through 10 is a non-structural defect since the primary function of the steel is to protect the bents from impact damage. However, it is recommended that the steel condition be monitored during future underwater inspections to determine if the extent of deterioration is increasing. If the function of the steel becomes significantly reduced or the deterioration results in them becoming unstable, it may be necessary to repair them at that time.

Photograph No. 29: View of the Typical Steel Condition at the Waterline on the Upstream Nose of Bent 1, Looking East.
