# UNDERWATER BRIDGE INSPECTION REPORT

STRUCTURE NO. 4800451 (LUC-2-3175)  
SR-2 OVER  
CEDAR CREEK  
LUCAS COUNTY, OH  
DISTRICT 2

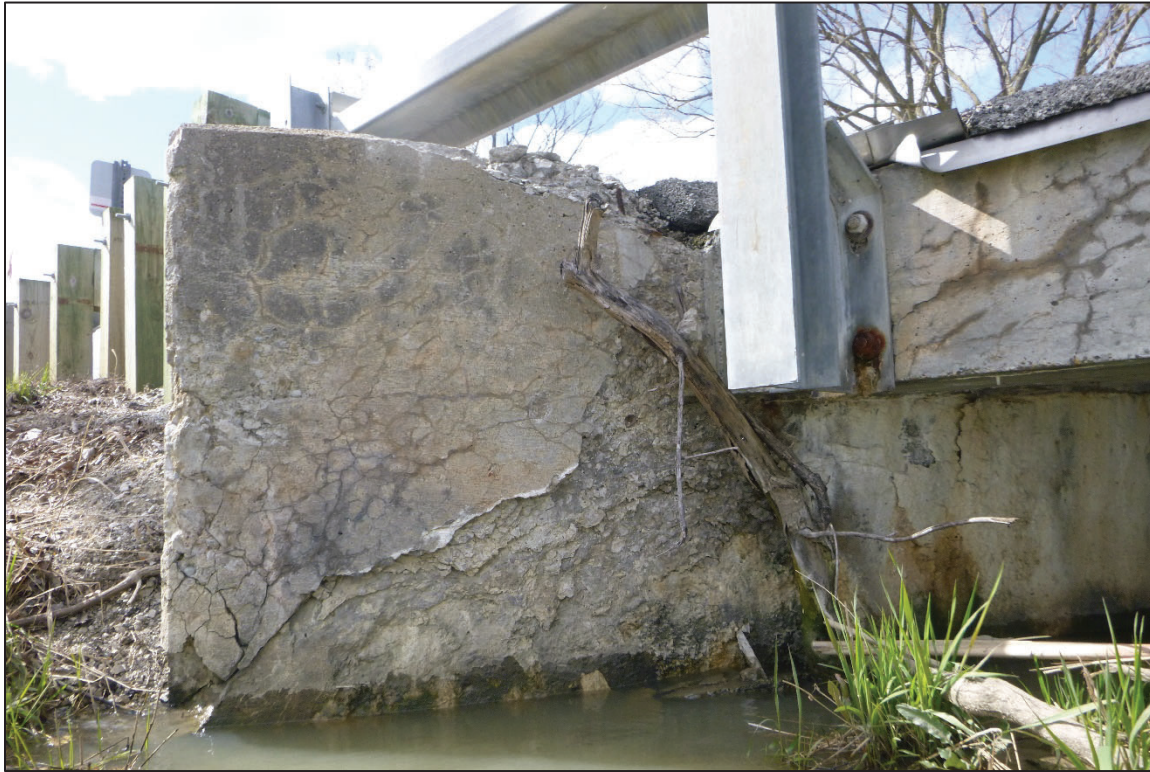
Photograph No. 11: View of Spalling on the South End of Abutment 1, Looking Northwest.

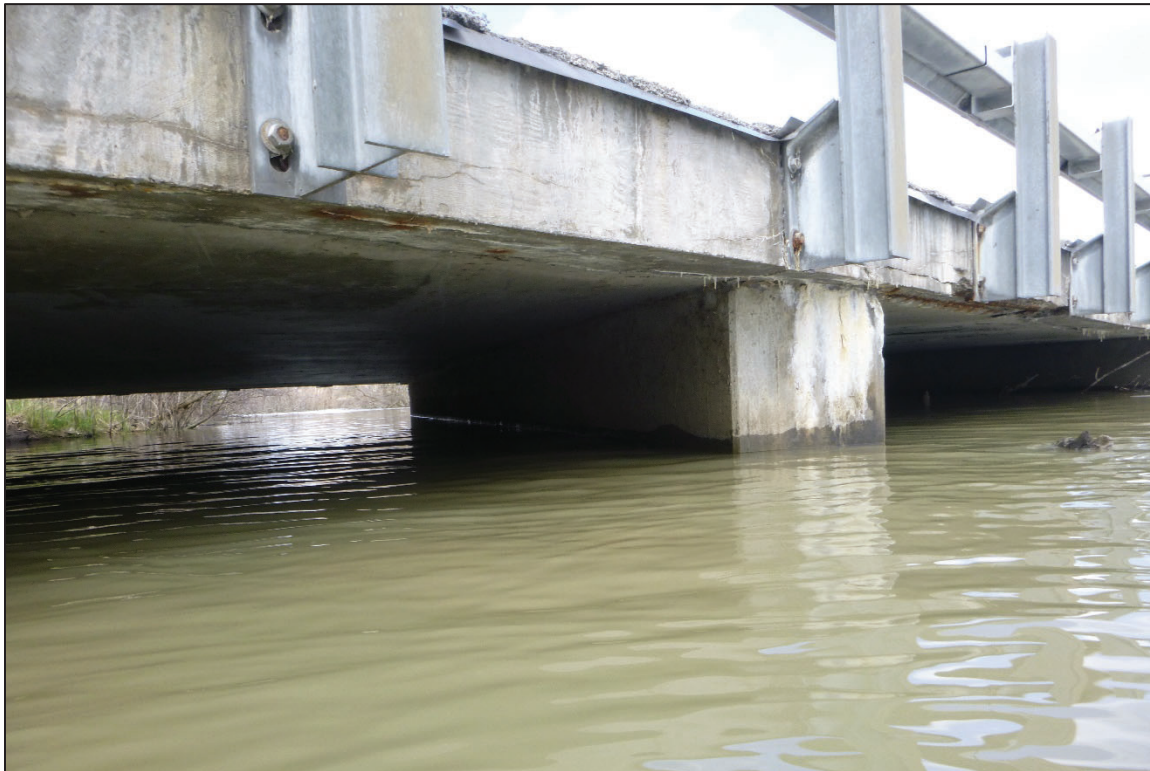
Photograph No. 12: View of the West Face of Bent 1, Looking Northeast.

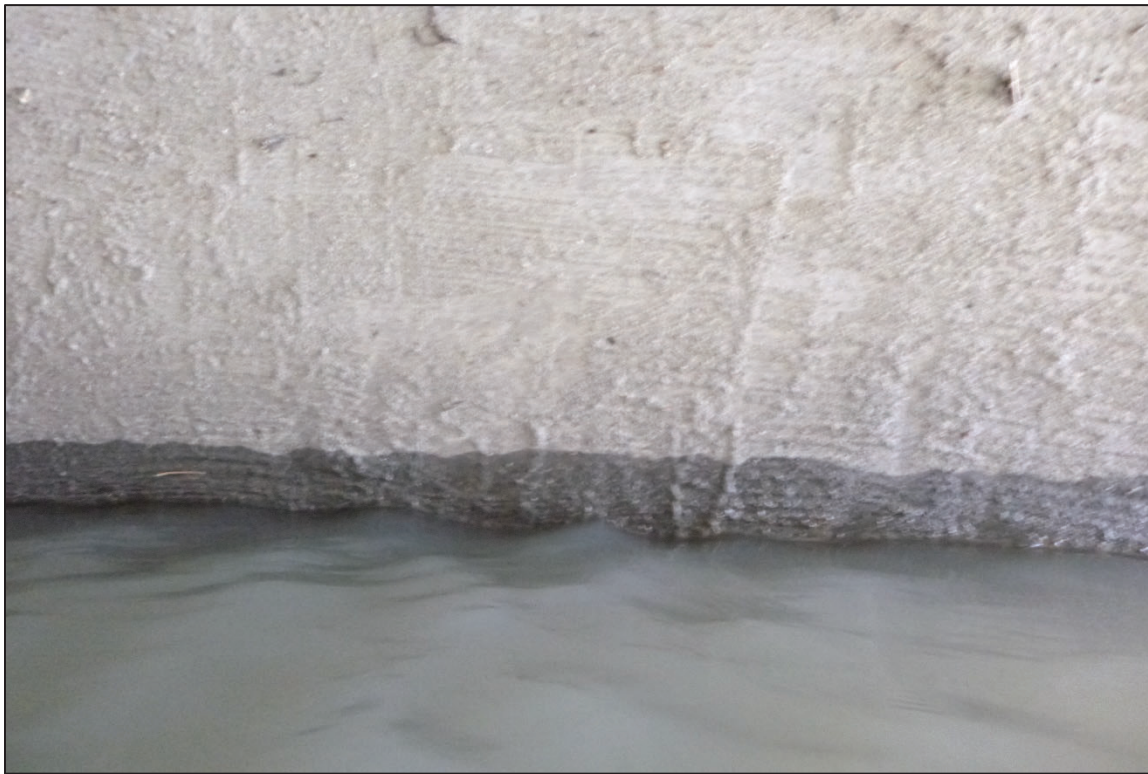
Photograph No. 18: View of the Typical Concrete Condition at the Waterline, Looking West.
