UNDERWATER BRIDGE INSPECTION REPORT

STRUCTURE NO. 4801741 (LUC-24-2656)
US-24 OVER OTTAWA RIVER
LUCAS COUNTY, OH
DISTRICT 2

April 2020

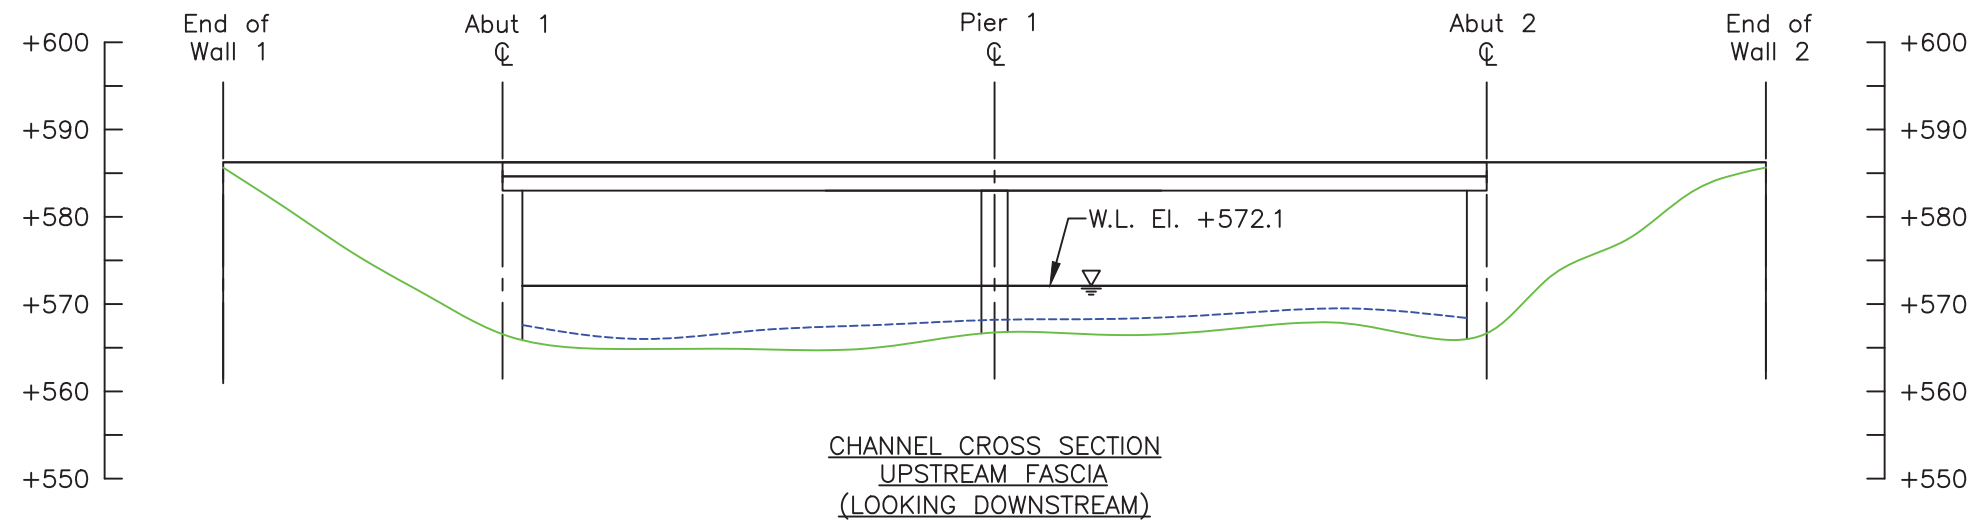
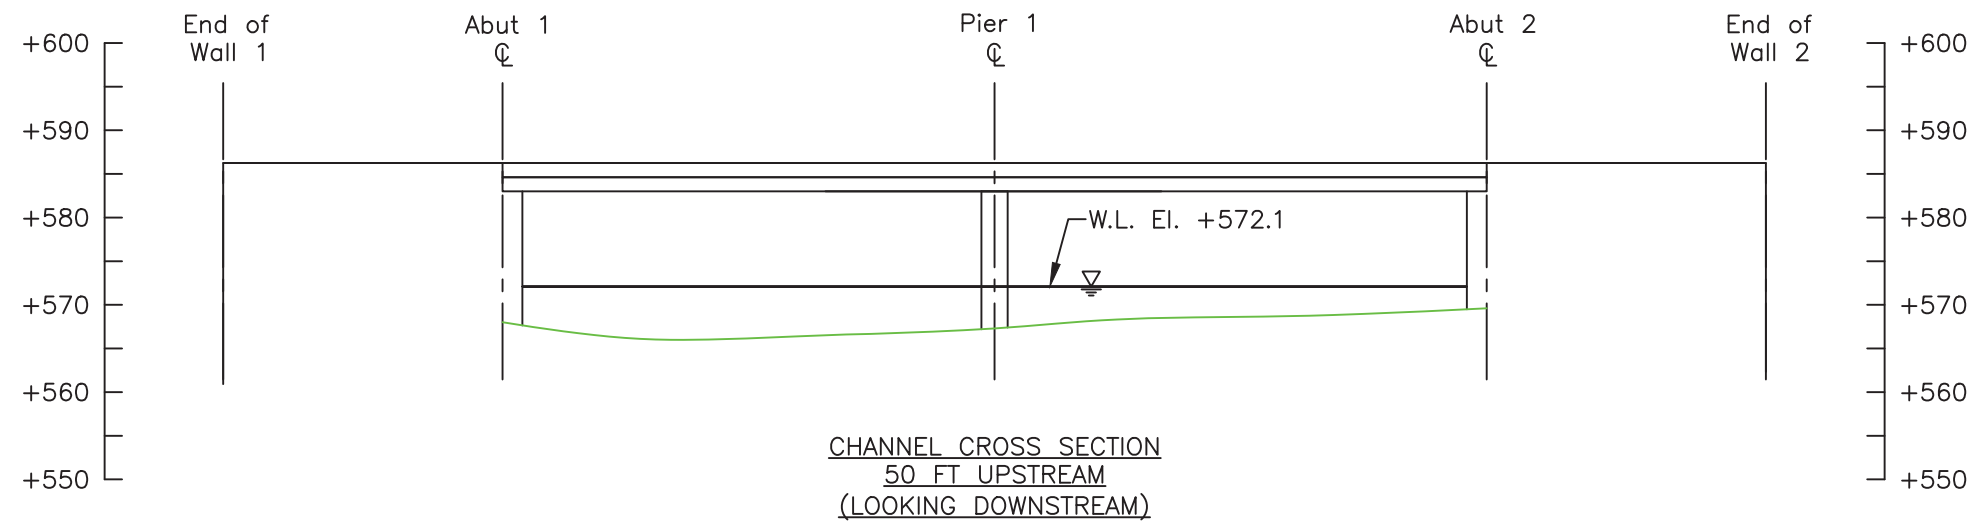
**US-24 OVER OTTAWA RIVER
STRUCTURE NO. 4801741 (LUC-24-2656)
CROSS SECTIONS - UPSTREAM
LUCAS COUNTY, OHIO**

Overall, the inspected substructure units of Structure No. 4801741 (LUC-24-2656) were in good condition. A comparison of the soundings recorded during the previous inspection on November 10, 2015 and the soundings taken during this inspection revealed no significant change in the channel bottom profile in the vicinity of the structure. Although no channel deficiencies were observed, the channel bottom should continue to be monitored during future underwater inspections to verify that localized scour or overall channel degradation is not occurring and that the pier footings remain adequately embedded in the channel bottom.

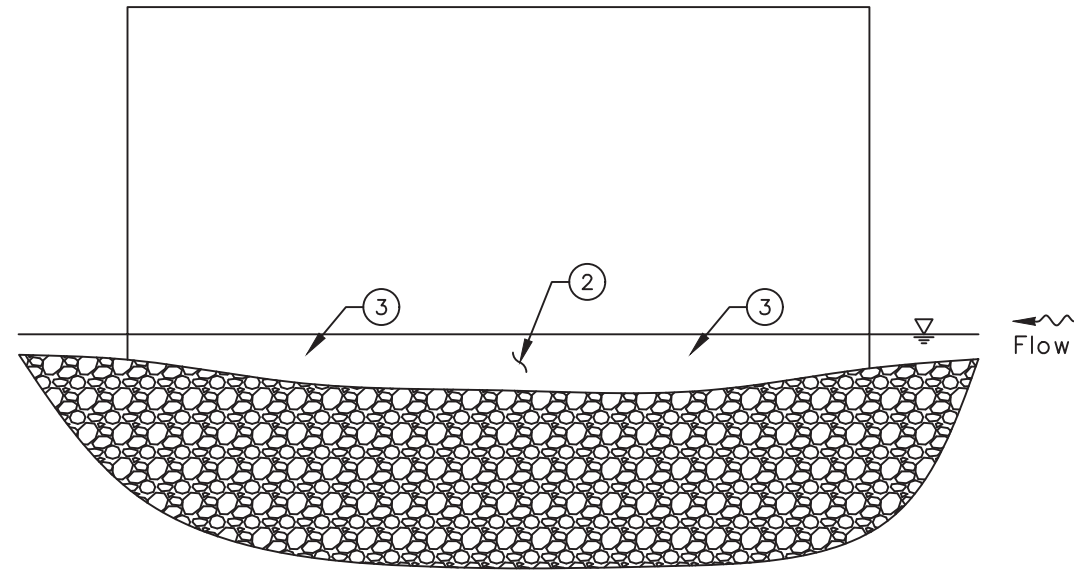
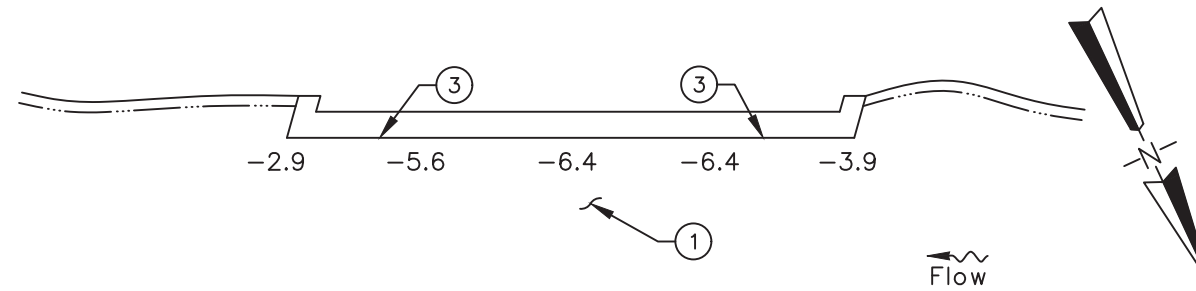
US-24 OVER OTTAWA RIVER
 STRUCTURE NO. 4801741 (LUC-24-2656)
 ABUTMENT 1
 LUCAS COUNTY, OHIO

The channel bottom material consisted of sand, silt, and scattered riprap up to 18 in. diameter with up to 6 in. probe rod penetration. The submerged portions of the pier were sound and smooth with no defects observed. Typical spalling was observed around the weep hole drains measuring up to 24 in. diameter by 2 in deep with no exposed steel reinforcement. Refer to Figure 6 in Exhibit 1 for detailed inspection notes of Abutment 1. Refer to Photograph 7 in Exhibit 2 for views of Abutment 1.

- ① The channel bottom material consisted of sand, silt, and scattered riprap up to 18 in. diameter with up to 6 in. probe rod penetration.
- ② The submerged portions of the pier were sound and smooth with no defects observed.
- ③ Typical spalling was observed around the weep hole drains measuring up to 24 in. diameter by 2 in. deep with no exposed steel reinforcement.

The spalling observed on Abutments 1 and 2 are not a structural concern at this time given its size compared to the overall pier size, and as a result, no repairs are recommended. This area should be monitored during future inspections for increasing extent or severity of the scaling and exposure of reinforcing steel. If

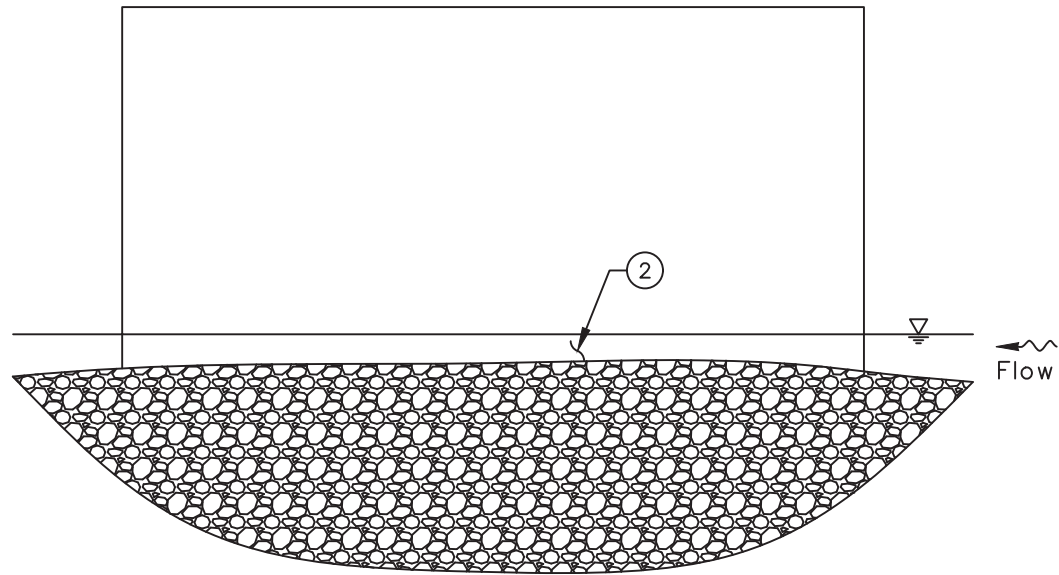
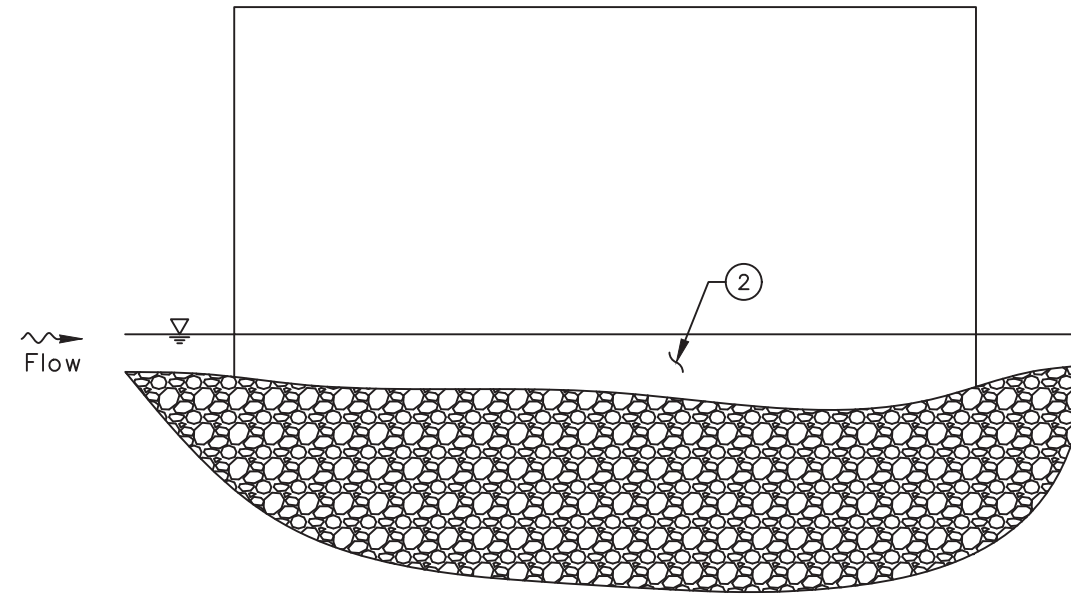
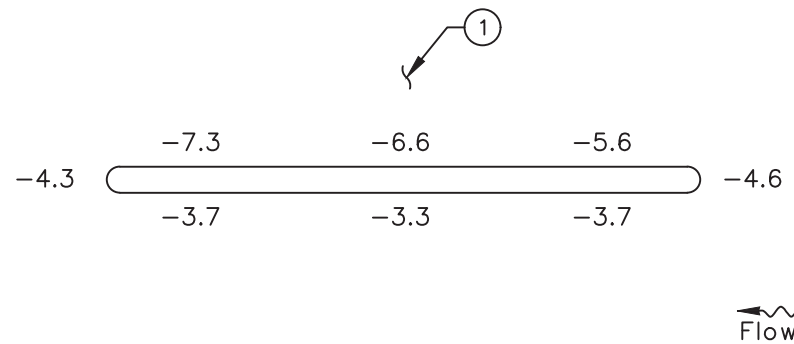
The channel bottom material consisted of sand, silt, and scattered riprap up to 18 in. diameter with up to 6 in. probe rod penetration. The submerged portions of the pier were sound and smooth with no defects observed. Refer to Figure 7 in Exhibit 1 for detailed inspection notes of Pier 1. Refer to Photographs 9 and 10 in Exhibit 2 for views of Pier 1 and typical concrete condition at the waterline.

- ① The channel bottom material consisted of sand, silt, and scattered riprap up to 18 in. diameter with up to 6 in. probe rod penetration.
- ② The submerged portions of the pier were sound and smooth with no defects observed.

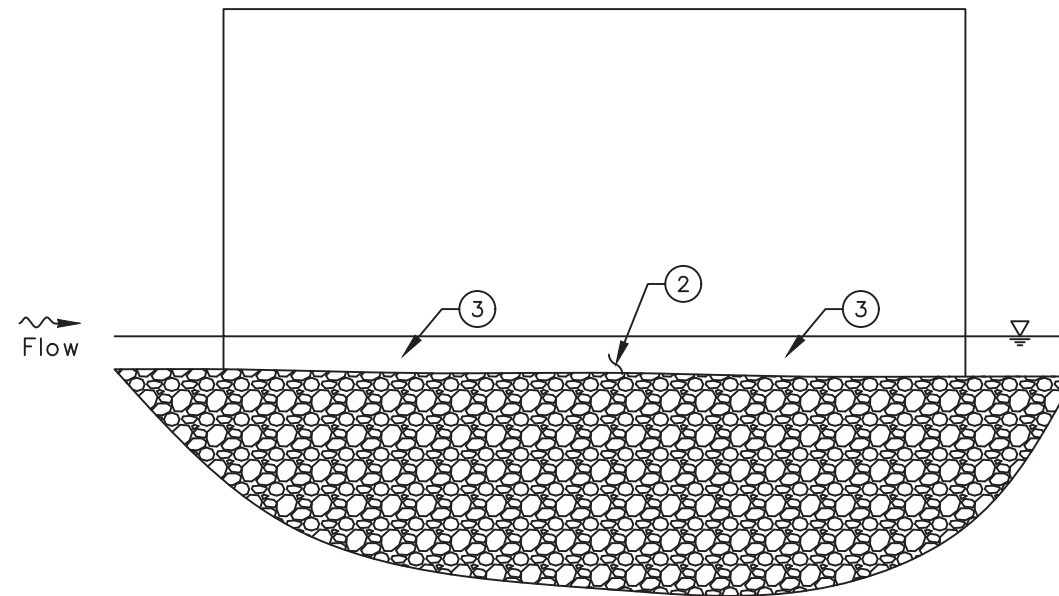
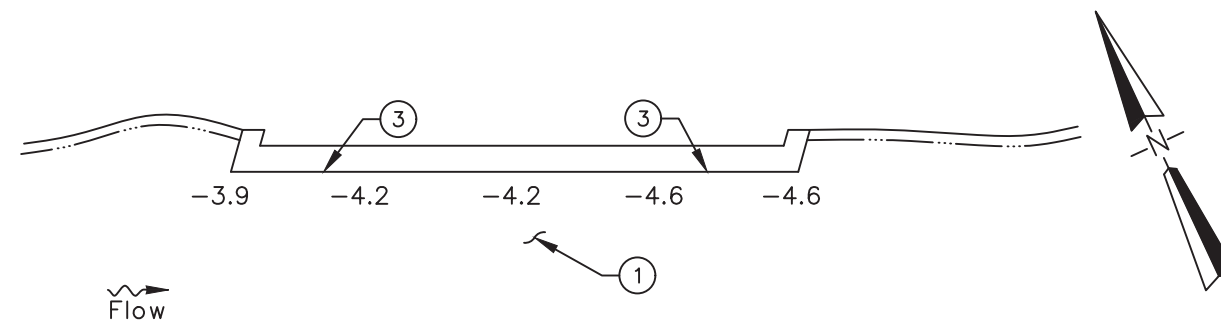
US-24 OVER OTTAWA RIVER
 STRUCTURE NO. 4801741 (LUC-24-2656)
 ABUTMENT 2
 LUCAS COUNTY, OHIO

The channel bottom material consisted of sand, silt, and scattered riprap up to 18 in. diameter with up to 6 in. probe rod penetration. The submerged portions of the pier were sound and smooth with no defects observed. Typical spalling was observed around the weep hole drains measuring up to 24 in. diameter by 2 in deep with no exposed steel reinforcement. Refer to Figure 8 in Exhibit 1 for detailed inspection notes of Abutment 2. Refer to Photograph 4 in Exhibit 2 for views of Abutment 2.

- ① The channel bottom material consisted of sand, silt, and scattered riprap up to 18 in. diameter with up to 6 in. probe rod penetration.
- ② The submerged portions of the pier were sound and smooth with no defects observed.
- ③ Typical spalling was observed around the weep hole drains measuring up to 24 in. diameter by 2 in. deep with no exposed steel reinforcement.

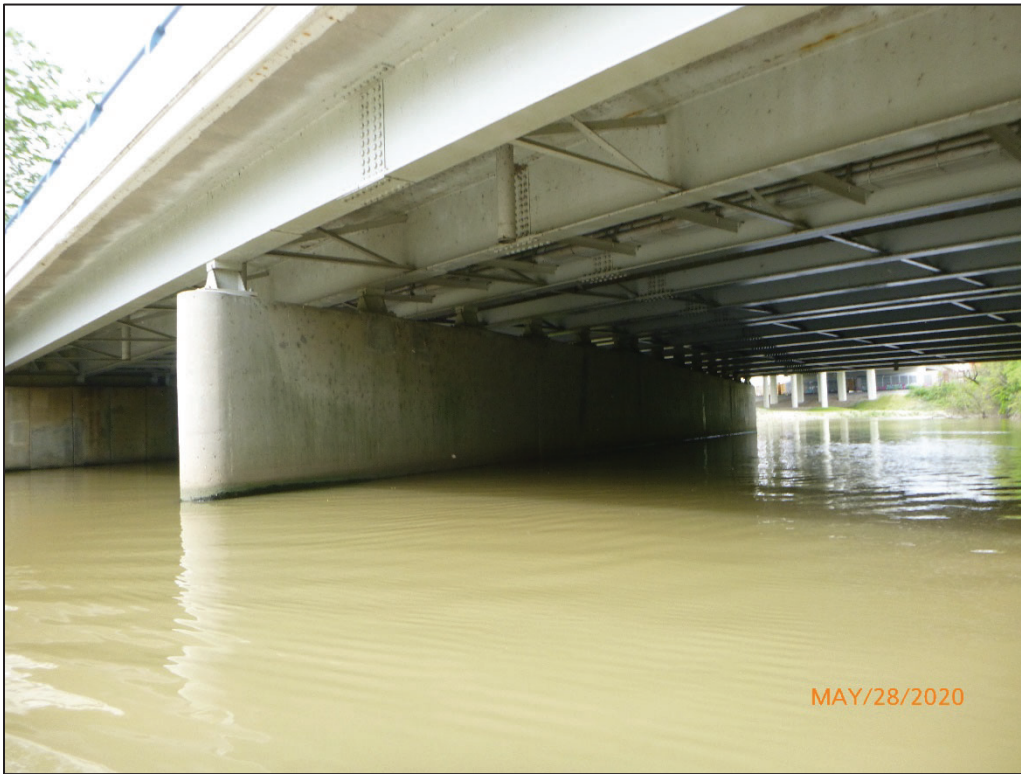
Photograph No. 9: View of the North Face of Pier 1, Looking Southwest.

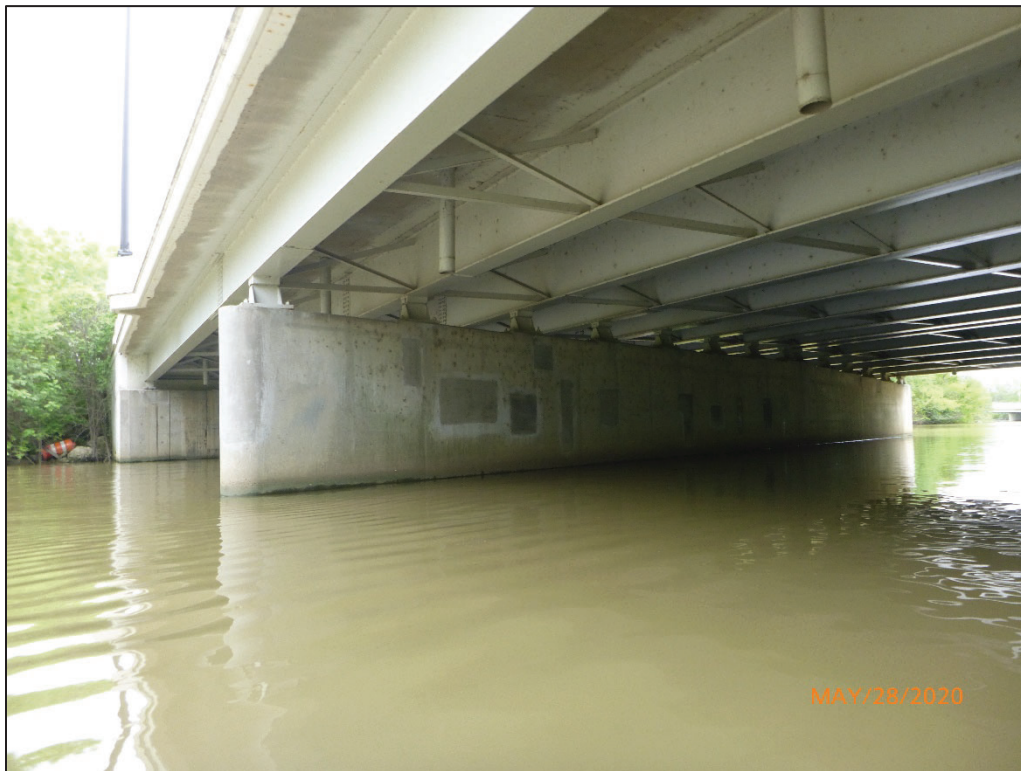
Photograph No. 10: View of the South Face of Pier 1, Looking Northeast.

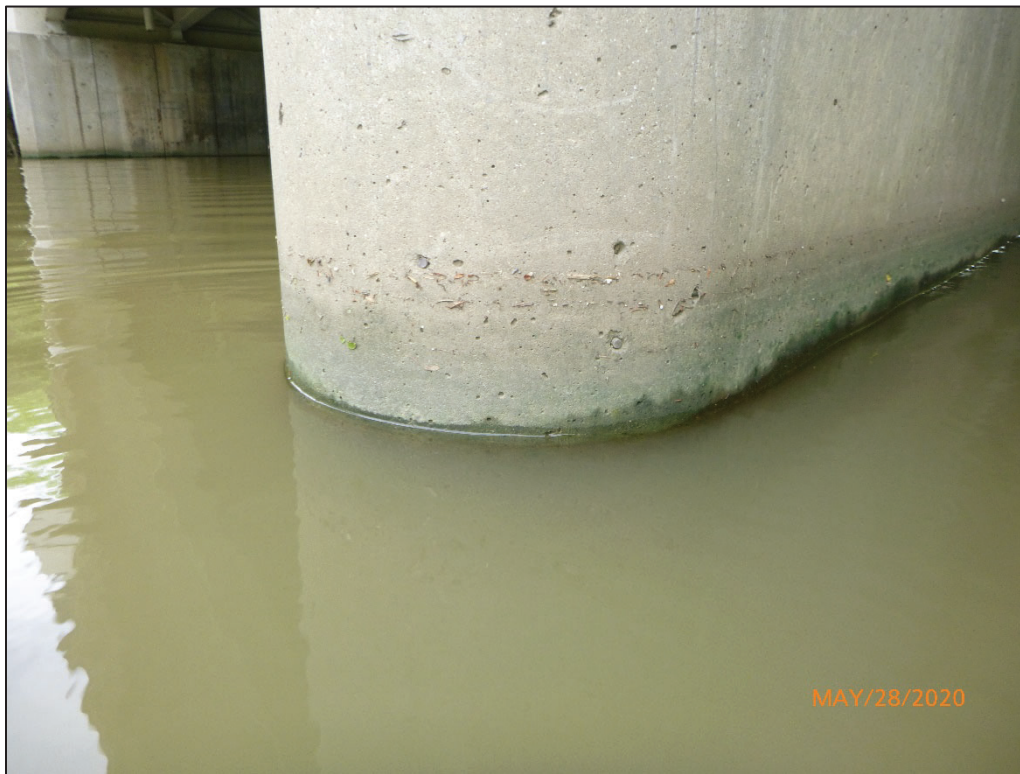
Photograph No. 11: View of the Typical Concrete Condition at the Waterline on the Upstream nose of Pier 1, Looking Northeast.

- Monitor concrete condition at the waterline.
- Monitor channel bottom to ensure footings remain properly embedded.
