UNDERWATER BRIDGE INSPECTION REPORT

STRUCTURE NO. 4804686 (LUC-75-1013)

I-75 OVER OTTAWA RIVER

April 2020

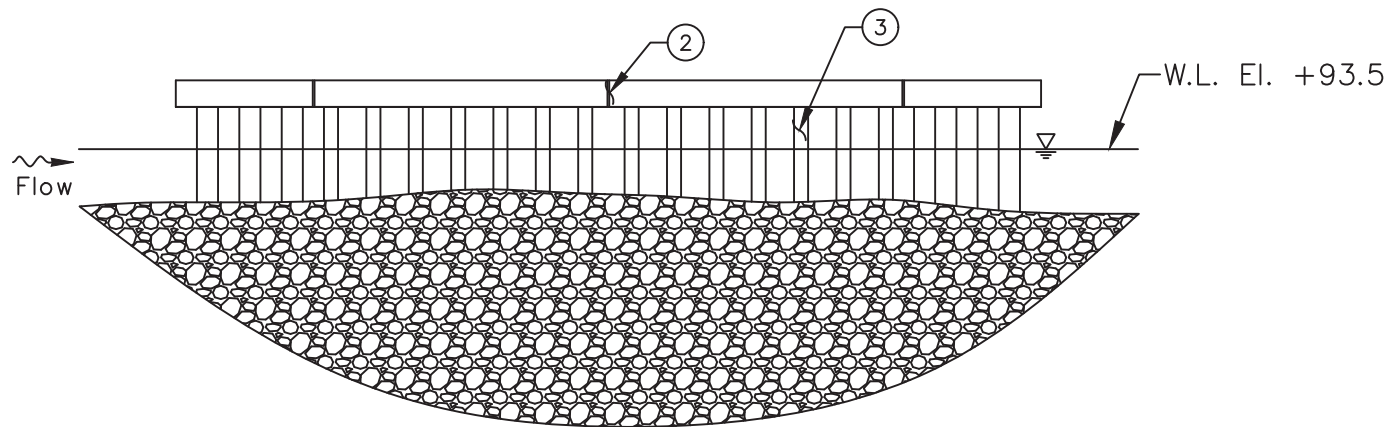
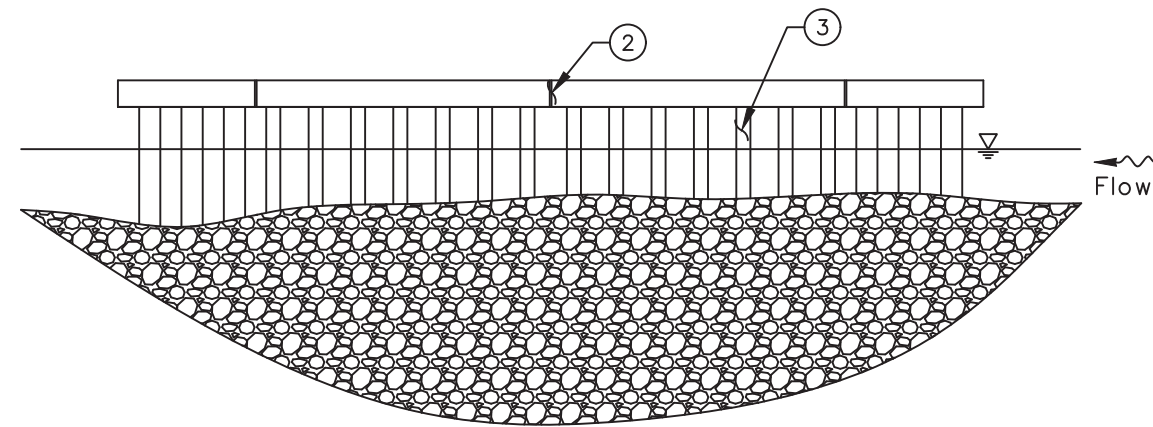
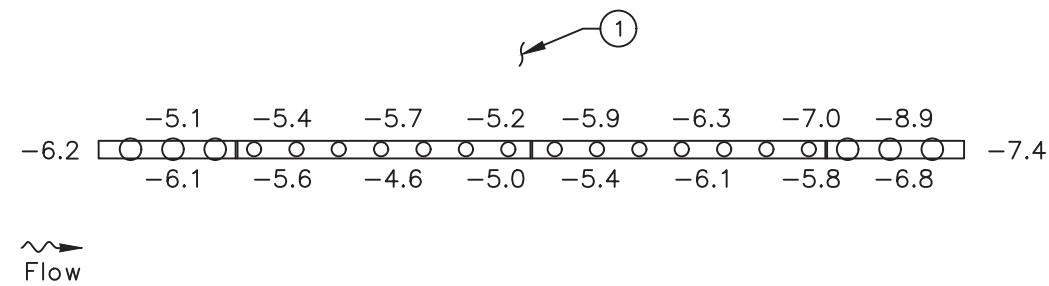
- ① The channel bottom material consisted of rip-rap up to 36 in. diameter with no probe rod penetration.
- ② The PVC jackets were typically in good condition with random splits on less than 5% of the piles.
- ③ The steel piles exhibited light pitting up to 1/32 in. deep with areas of minor corrosion up to 1/16 in. deep.

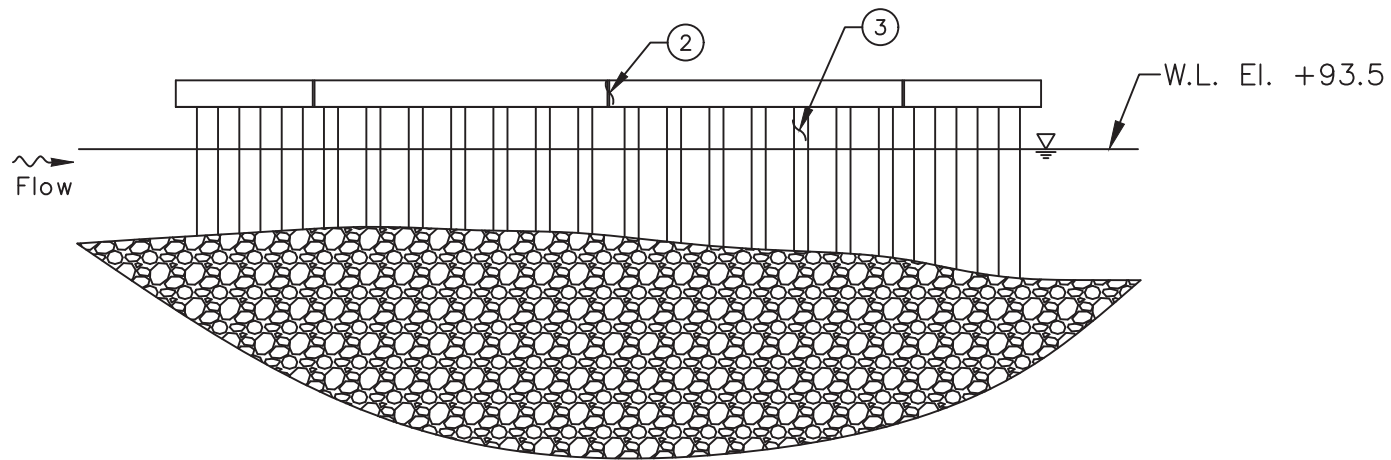
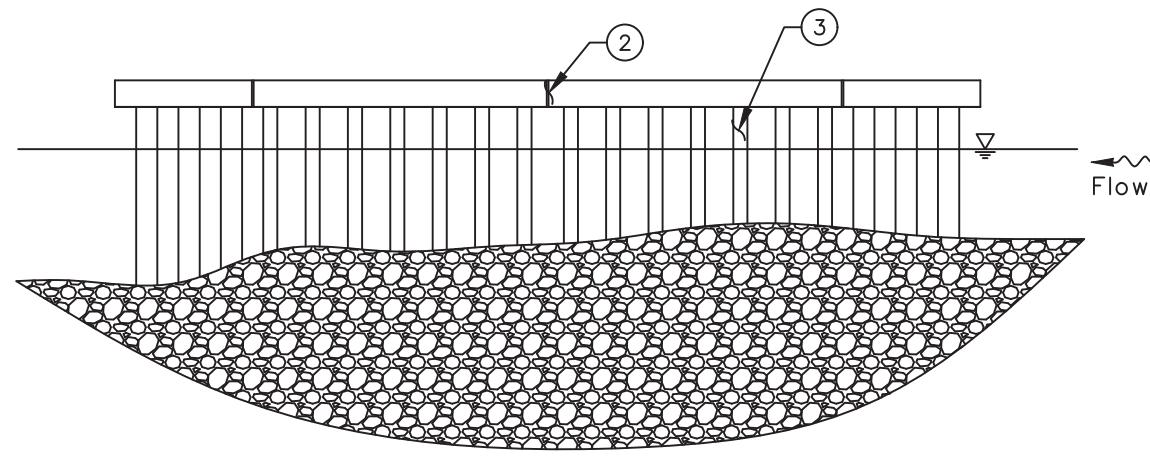
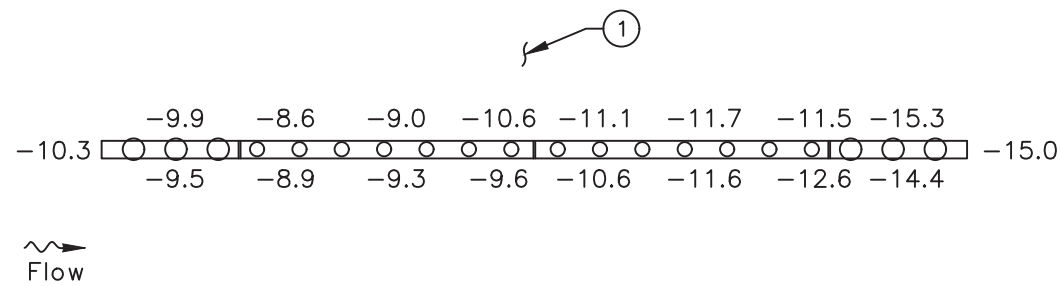
- ① The channel bottom material consisted of rip-rap up to 36 in. diameter with no probe rod penetration.
- ② The PVC jackets were typically in good condition with random splits on less than 5% of the piles.
- ③ The steel piles exhibited light pitting up to 1/32 in. deep with areas of minor corrosion up to 1/16 in. deep.

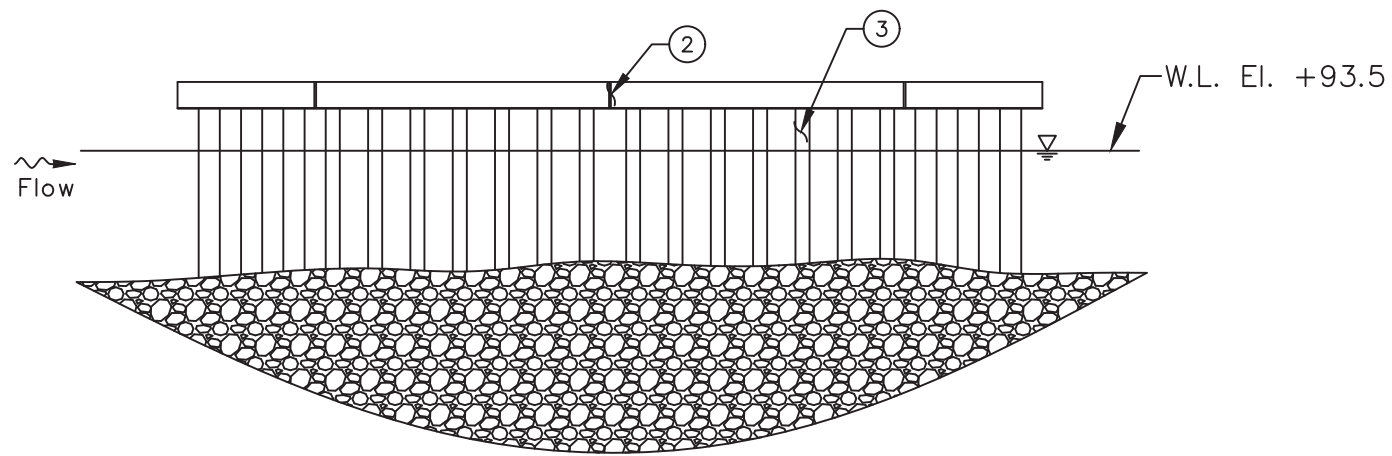
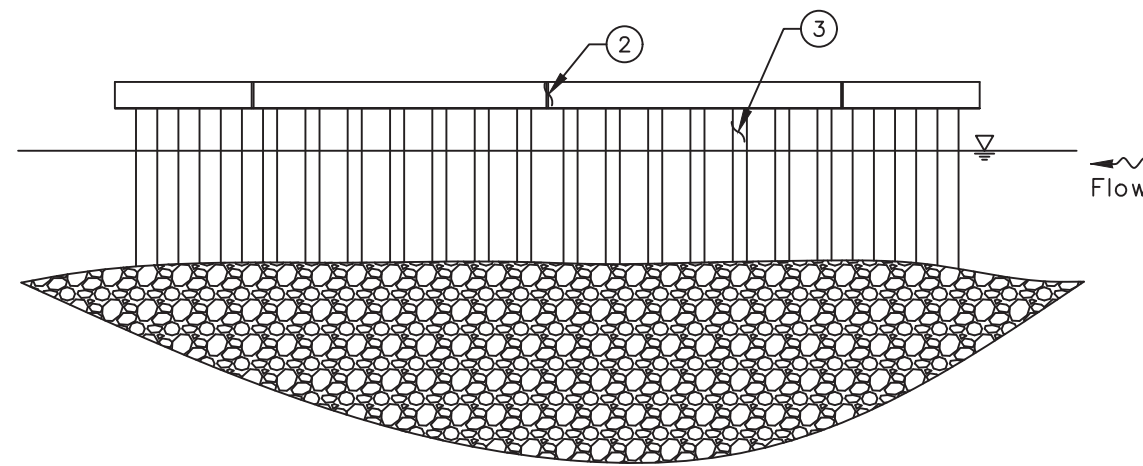
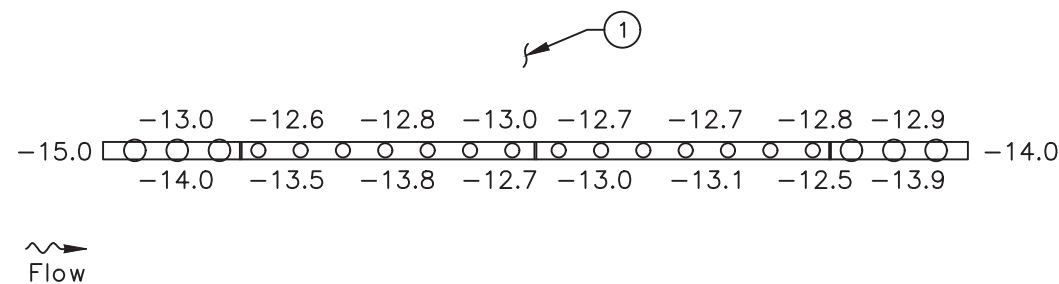
- ① The channel bottom material consisted of rip-rap up to 36 in. diameter with no probe rod penetration.
- ② The PVC jackets were typically in good condition with random splits on less than 5% of the piles.
- ③ The steel piles exhibited light pitting up to 1/32 in. deep with areas of minor corrosion up to 1/16 in. deep.

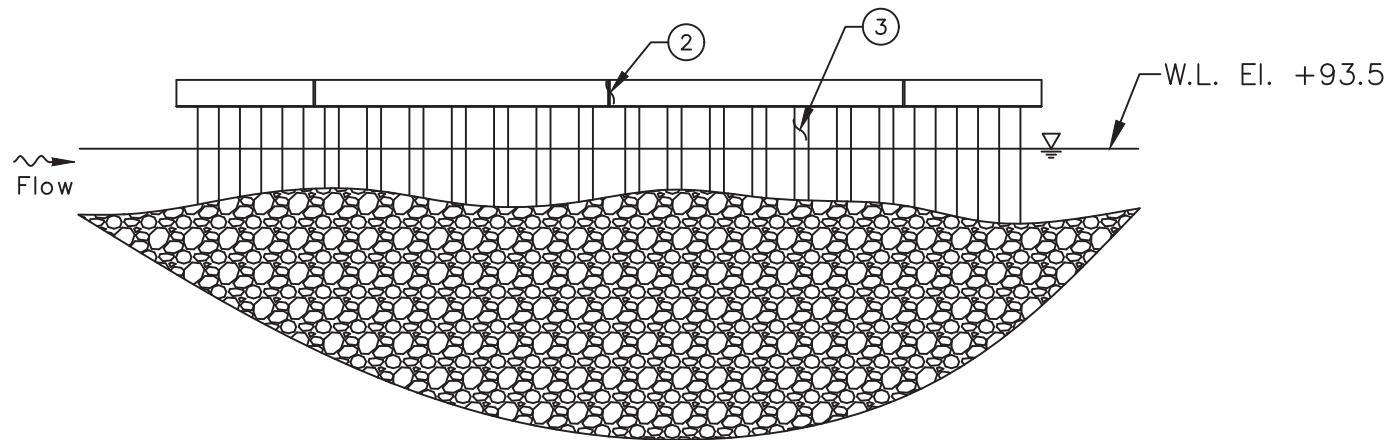
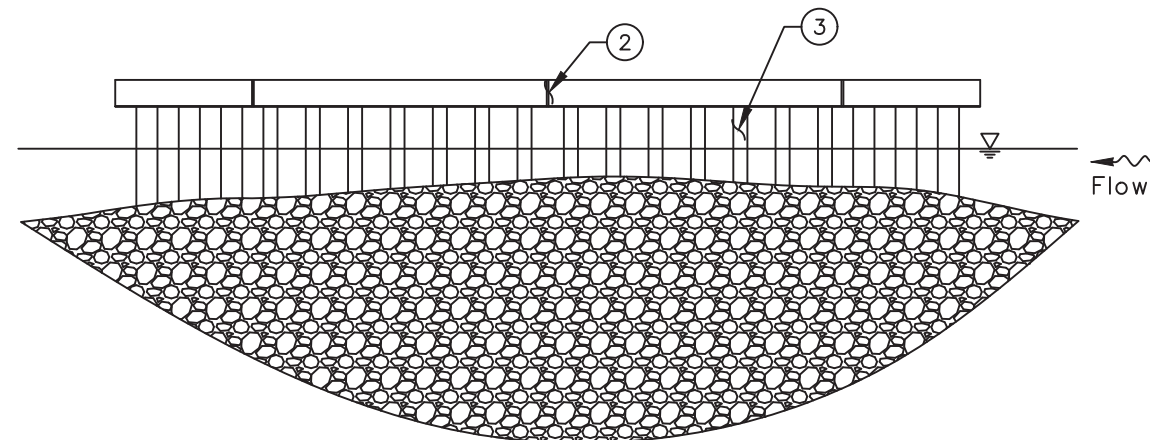
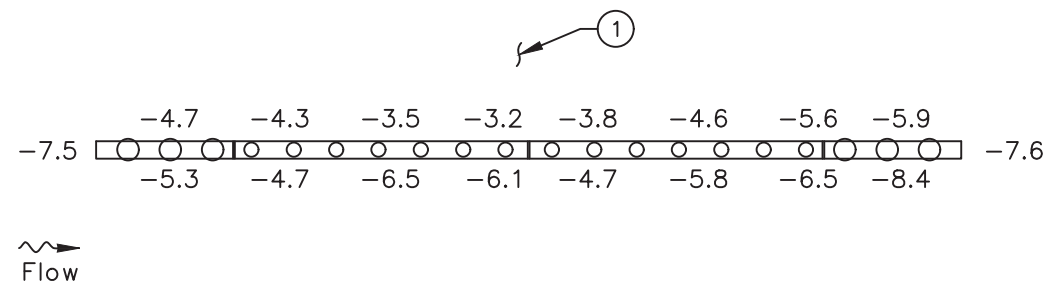
- ① The channel bottom material consisted of rip-rap up to 36 in. diameter with no probe rod penetration.
- ② The PVC jackets were typically in good condition with random splits on less than 5% of the piles.
- ③ The steel piles exhibited light pitting up to 1/32 in. deep with areas of minor corrosion up to 1/16 in. deep.

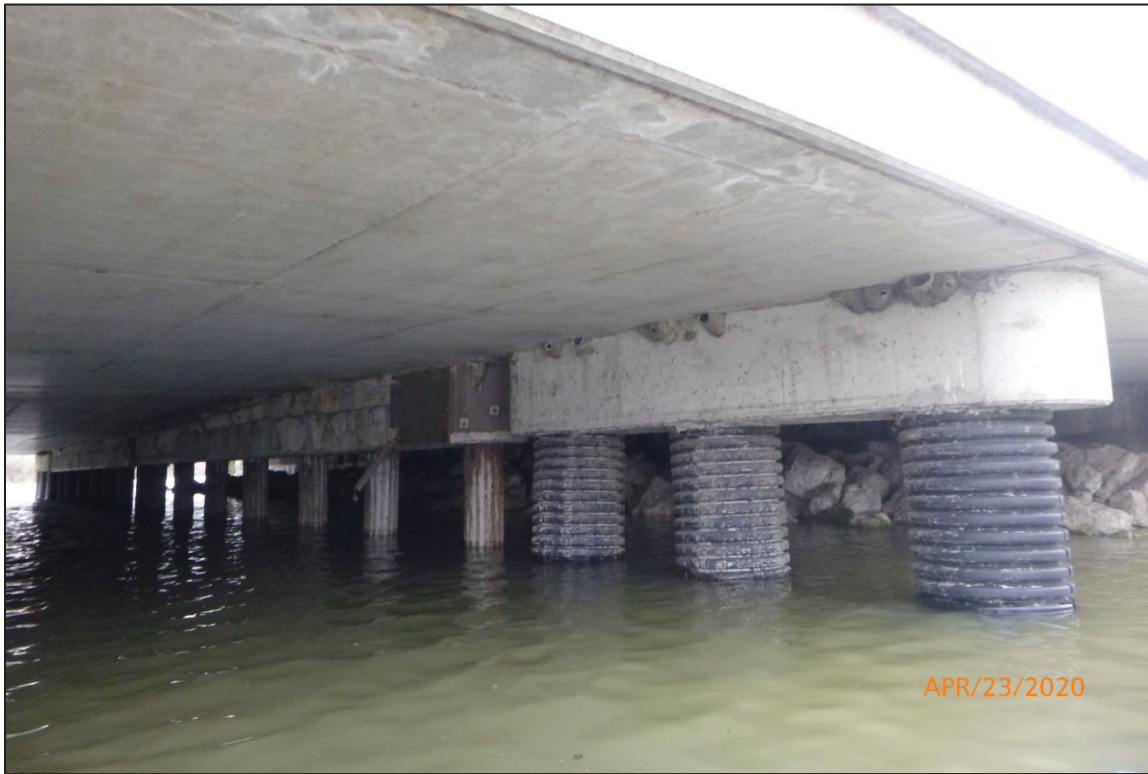
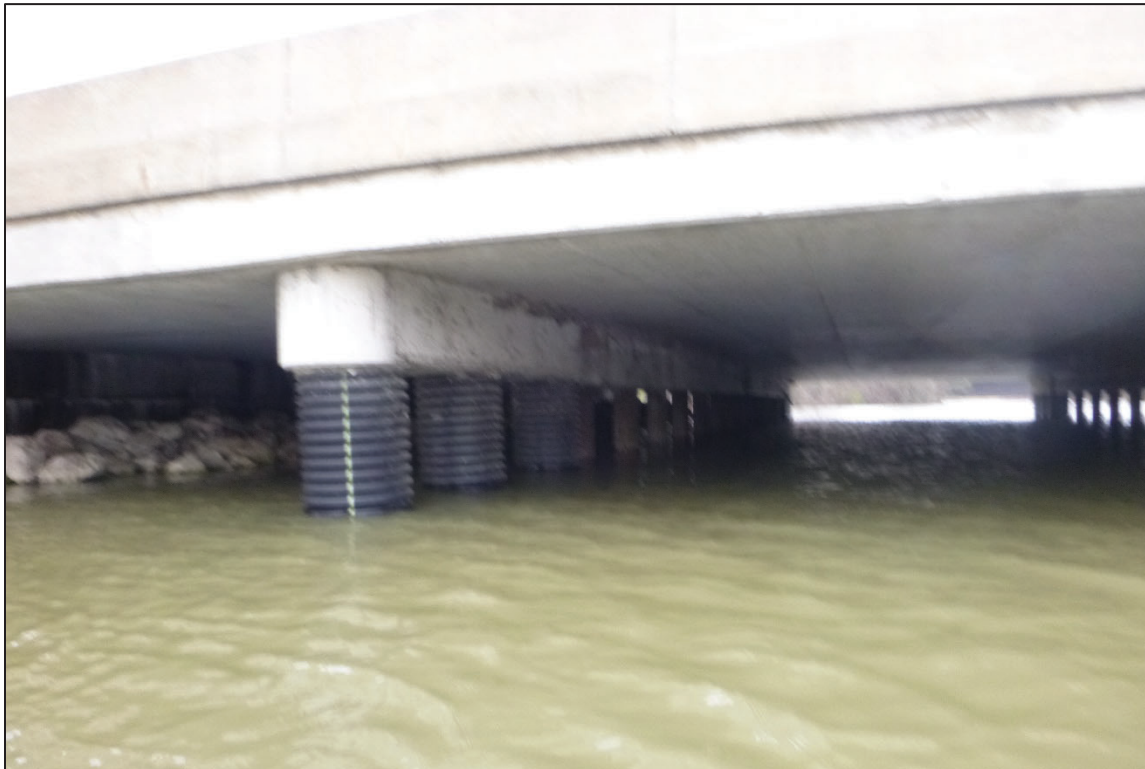
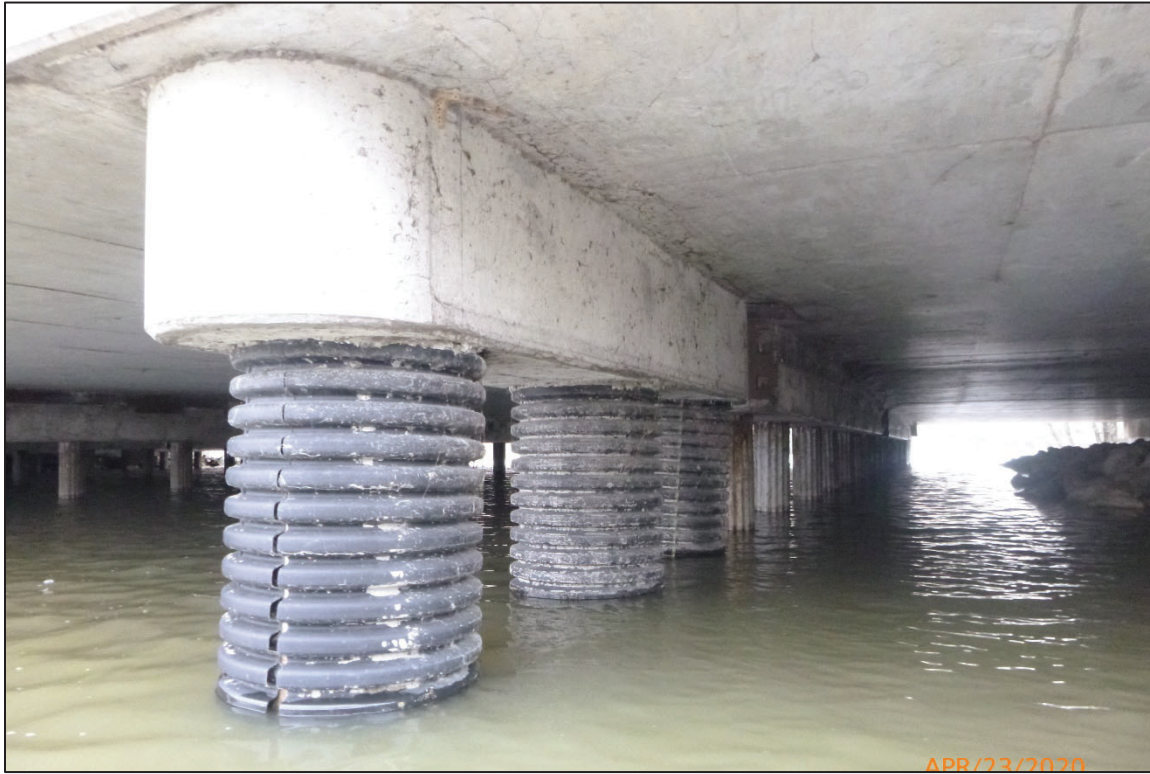
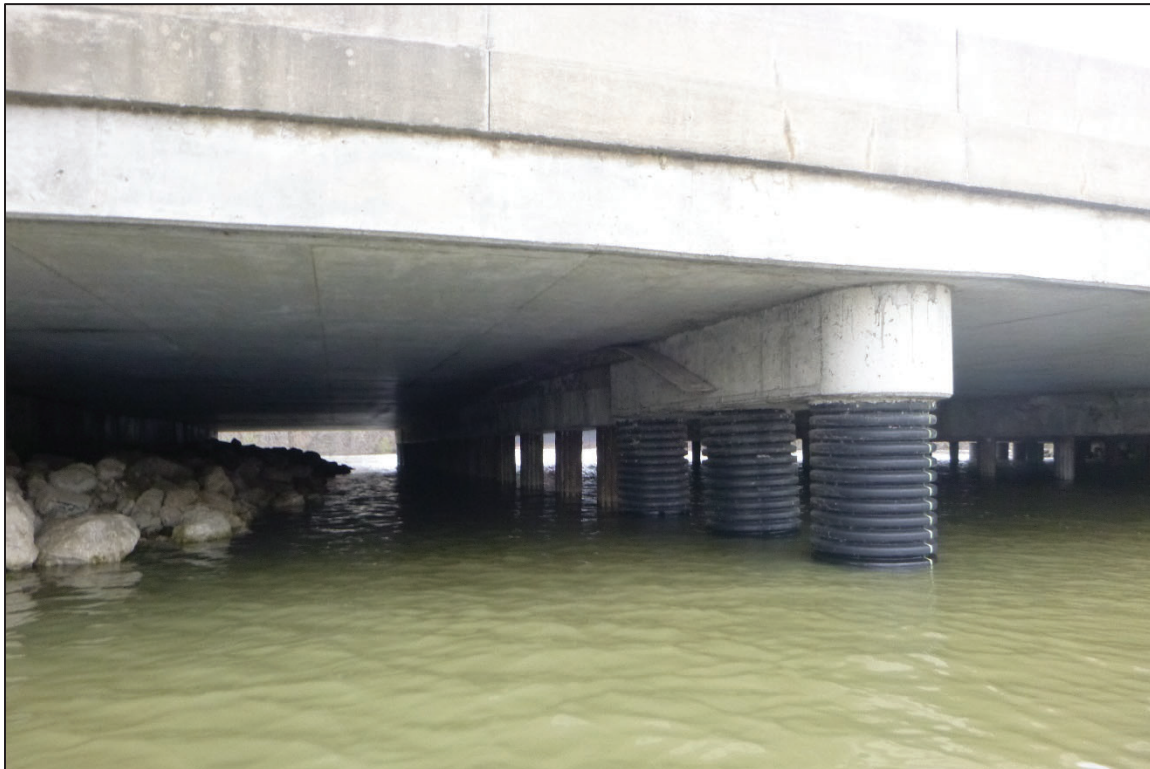
The channel bottom material consisted of rip-rap up to 36 in. diameter with no probe rod penetration. The PVC jackets were typically in good condition with random splits on less than 5% of the piles. The steel piles exhibited light pitting up to 1/32 in. deep with areas of minor corrosion up to 1/16 in. deep. Refer to Figure 6 in Exhibit 1 for detailed inspection notes of Bent 1. Refer to Photographs 11 through 14 in Exhibit 2 for views of Bent 1.

The corrosion of the steel piles at Bents 1 through 4 is a non-structural defect given its size compared to the overall pile size. However, it is recommended that the encasements be monitored during future underwater inspections to determine if the extent of deterioration is increasing. If the function of the steel encasements becomes significantly reduced or the deterioration results in the encasements becoming unstable, it may be necessary to repair them at that time.

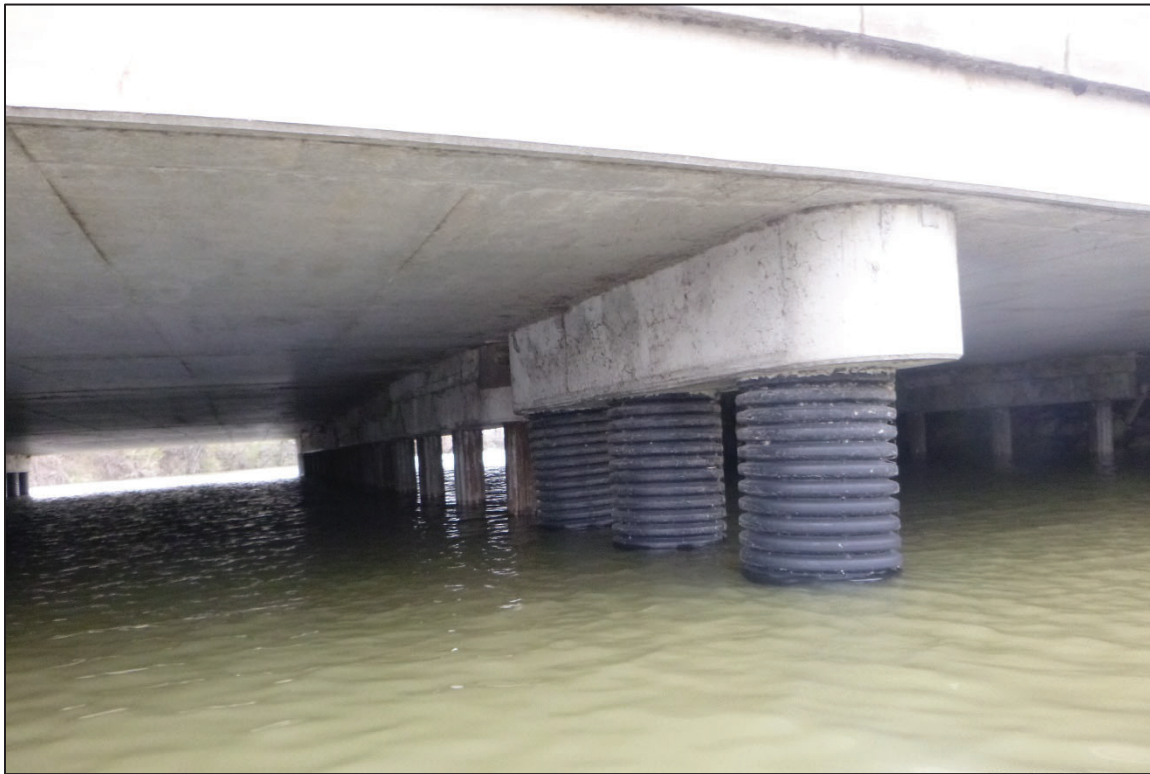
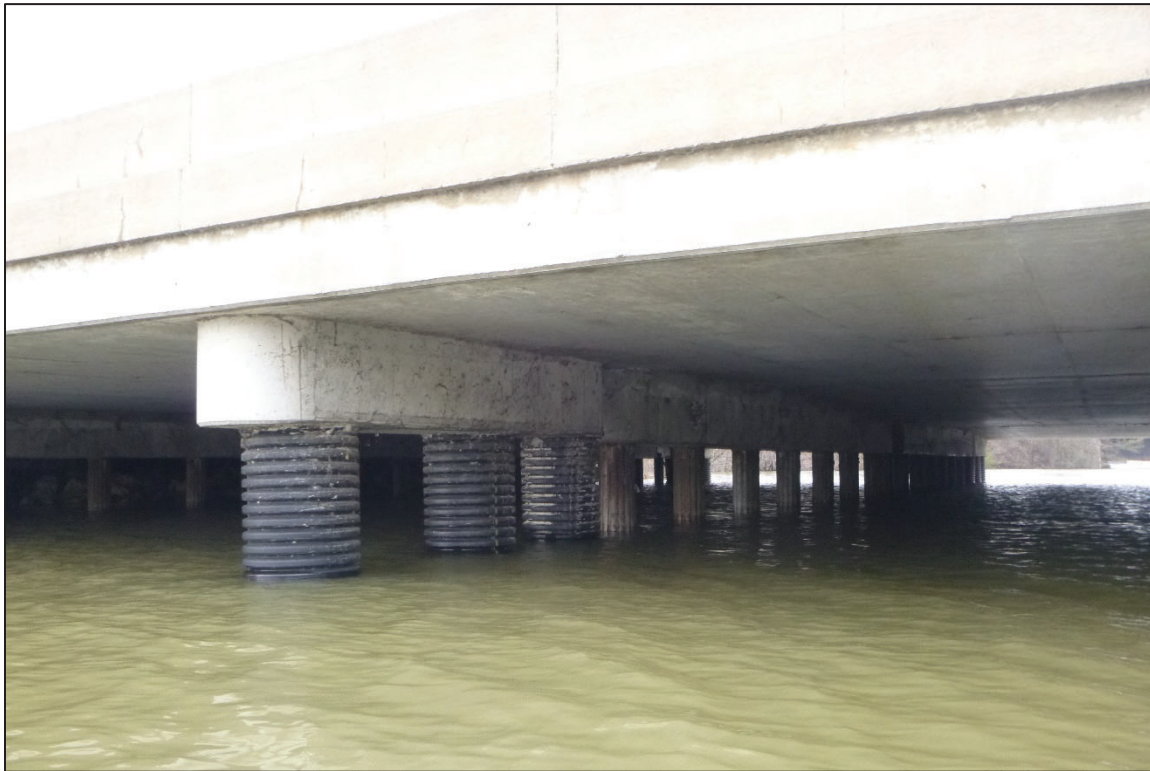
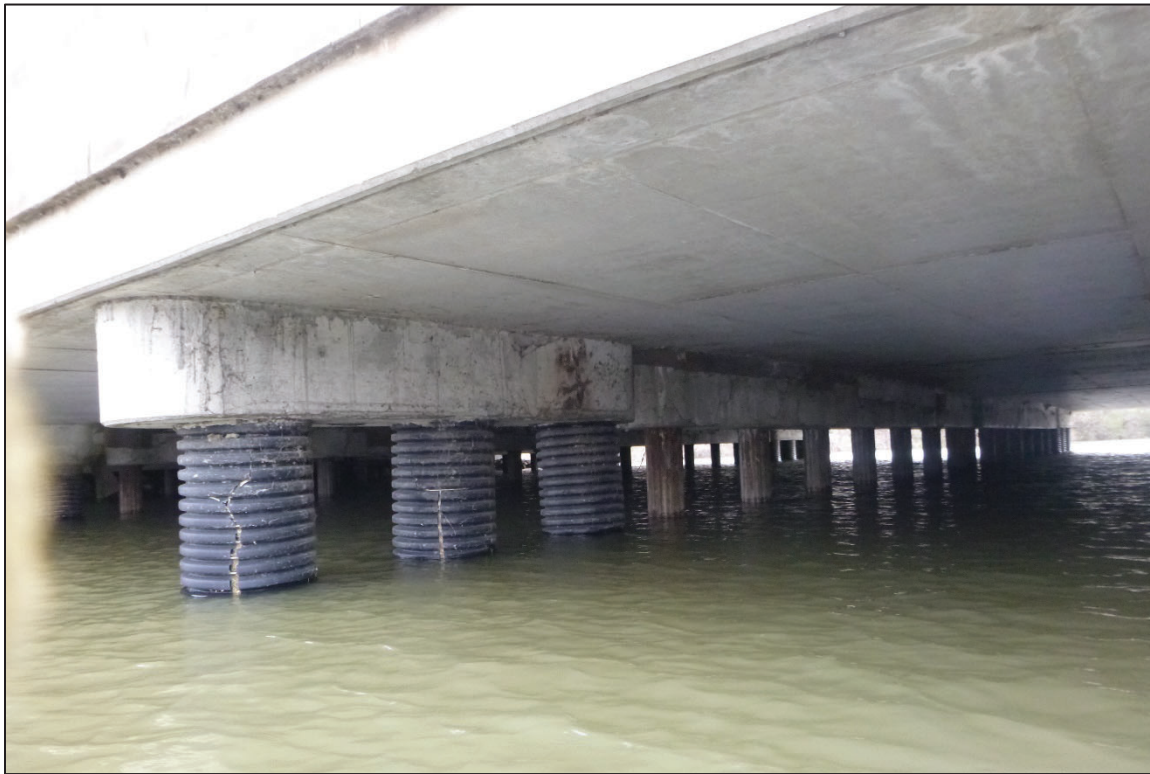
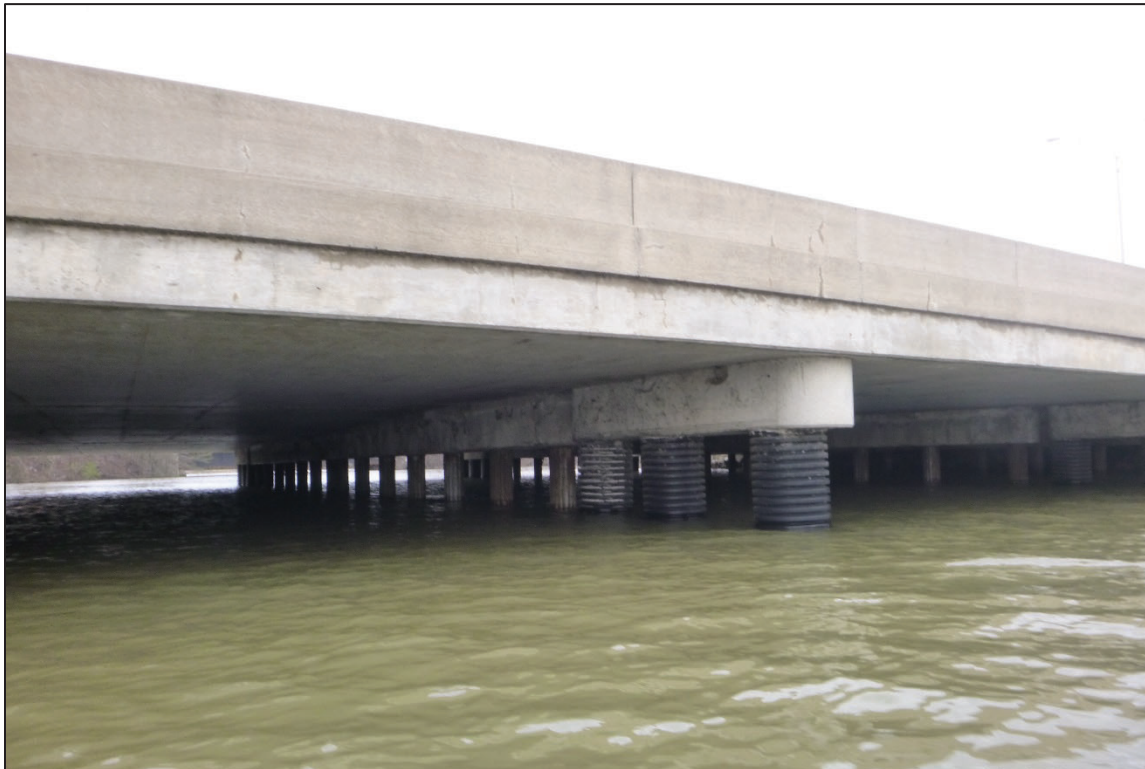
The channel bottom material consisted of rip-rap up to 36 in. diameter with no probe rod penetration. The PVC jackets were typically in good condition with random splits on less than 5% of the piles. The steel piles exhibited light pitting up to 1/32 in. deep with areas of minor corrosion up to 1/16 in. deep. Refer to Figure 7 in Exhibit 1 for detailed inspection notes of Bent 2. Refer to Photographs 15 through 18 in Exhibit 2 for views of Bent 2.

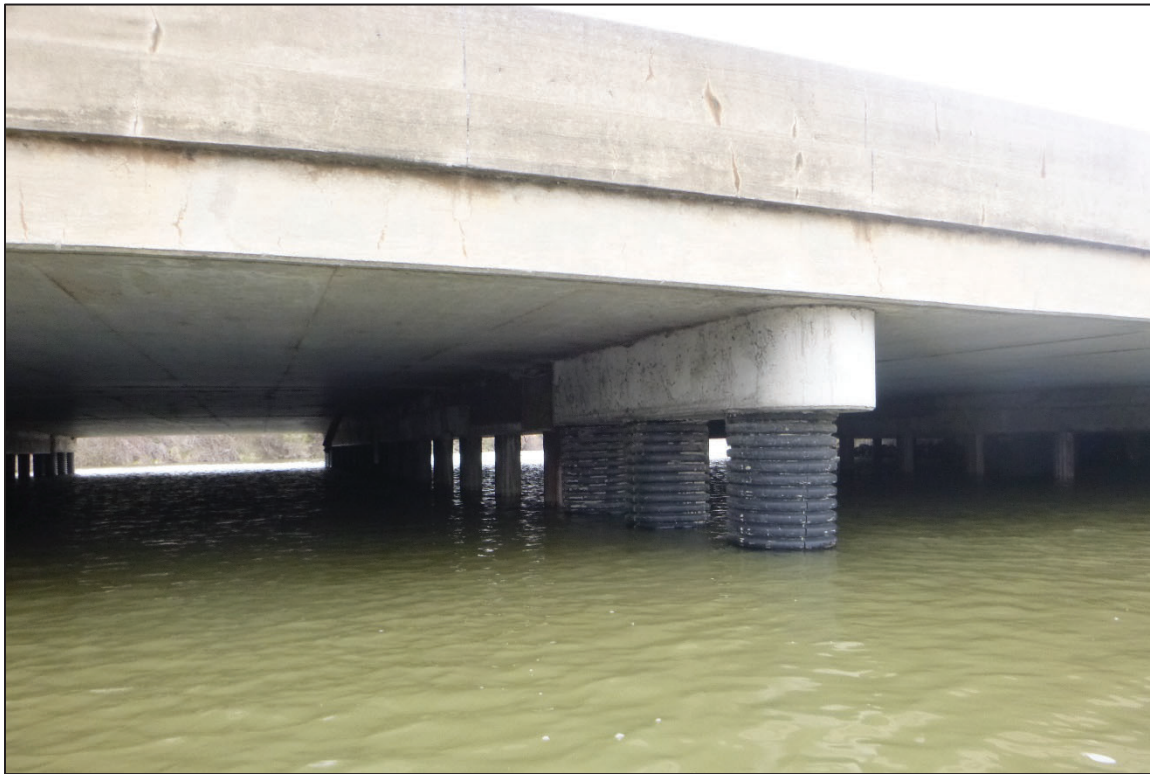
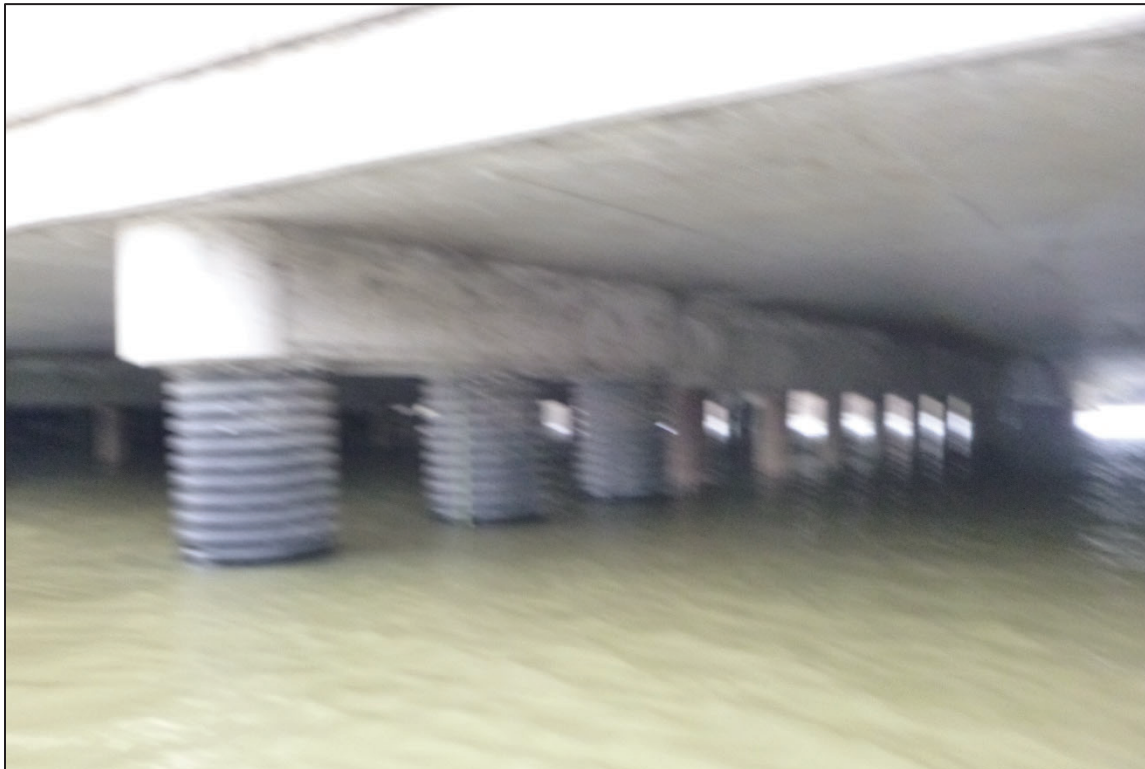
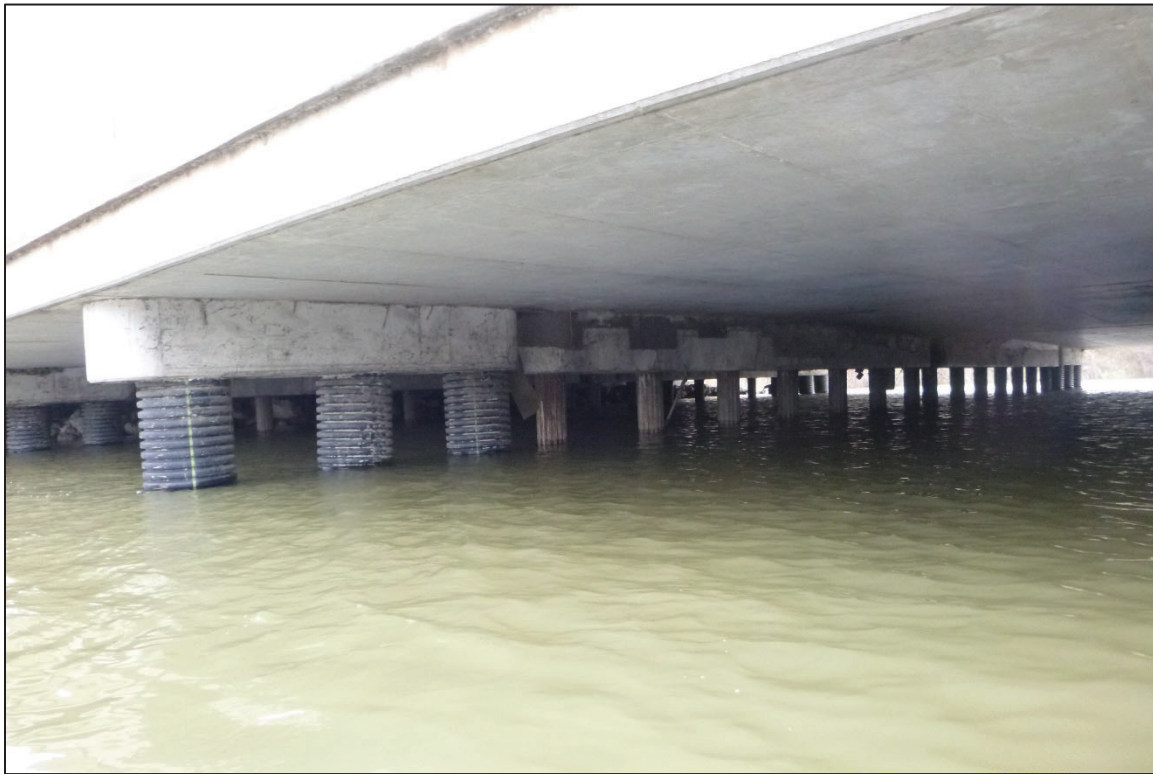
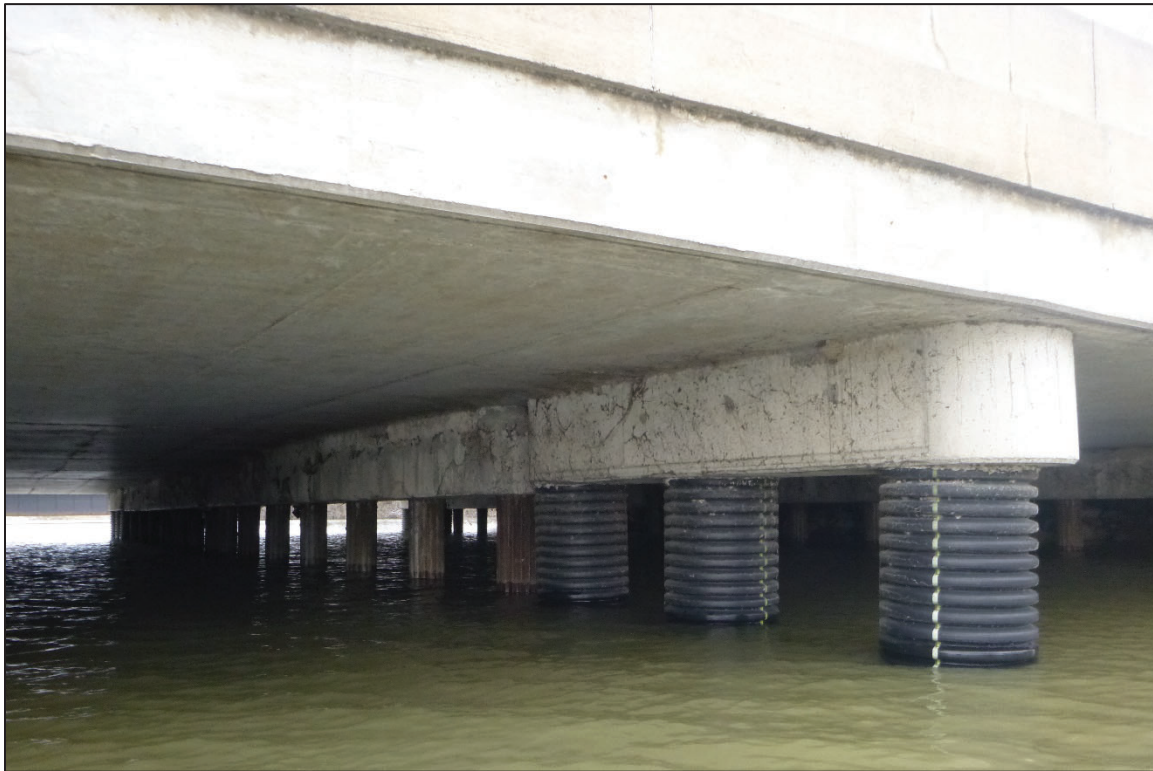
The channel bottom material consisted of rip-rap up to 36 in. diameter with no probe rod penetration. The PVC jackets were typically in good condition with random splits on less than 5% of the piles. The steel piles exhibited light pitting up to 1/32 in. deep with areas of minor corrosion up to 1/16 in. deep. Refer to Figure 8 in Exhibit 1 for detailed inspection notes of Bent 3. Refer to Photographs 19 through 22 in Exhibit 2 for views of Bent 3.

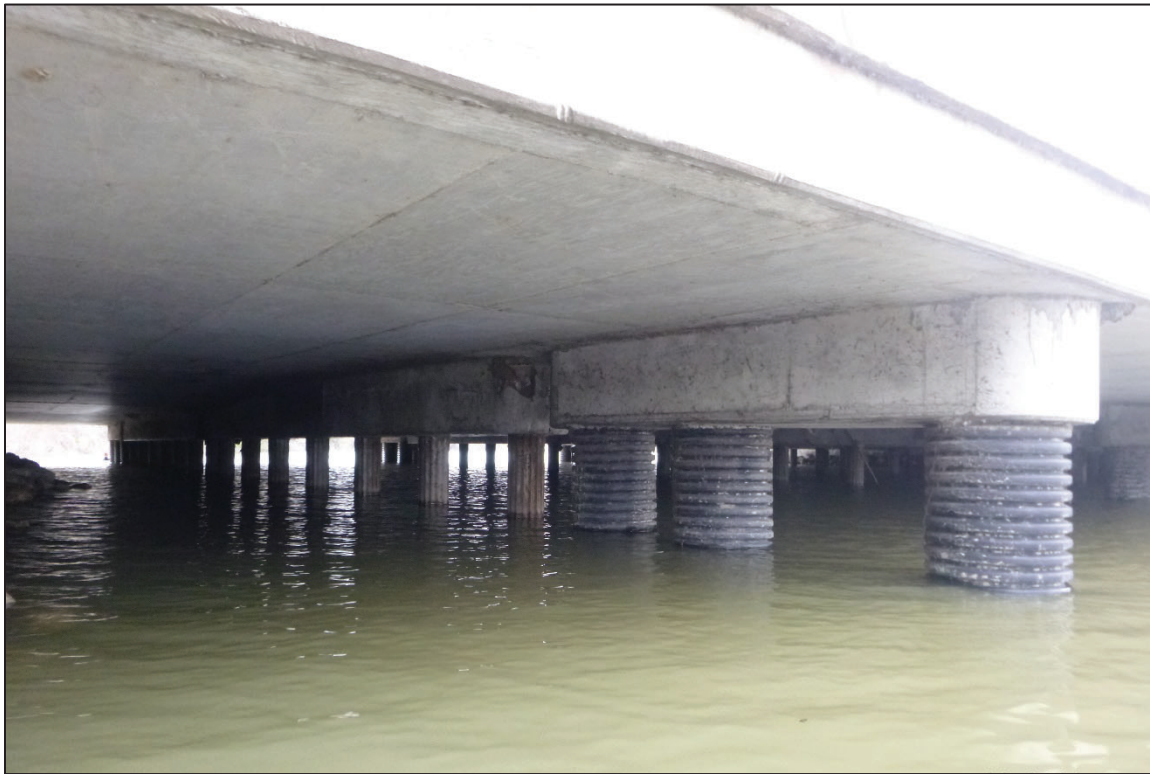
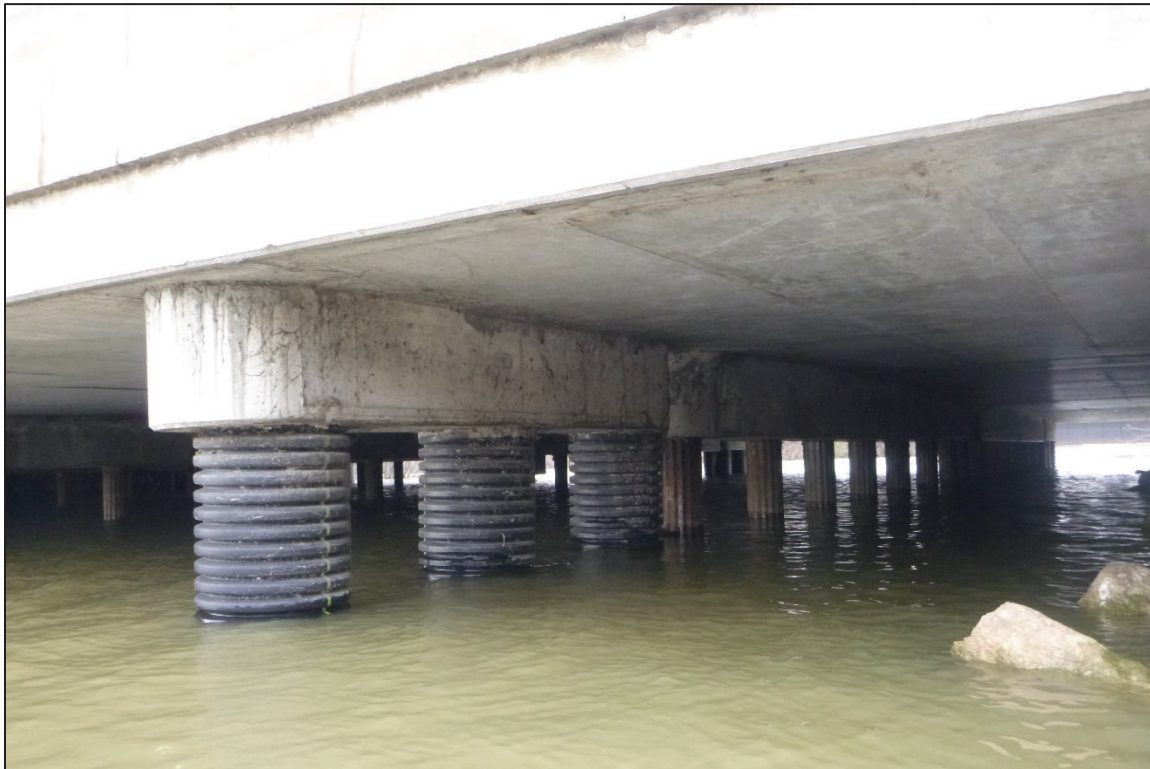
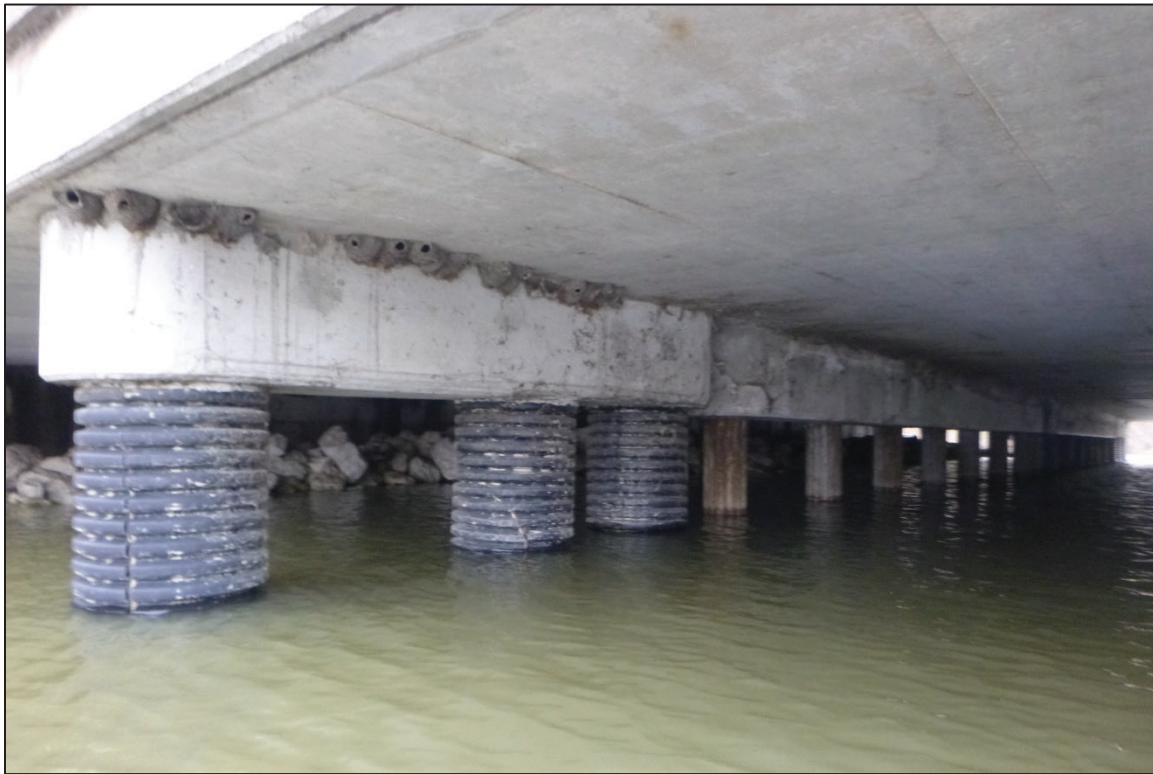
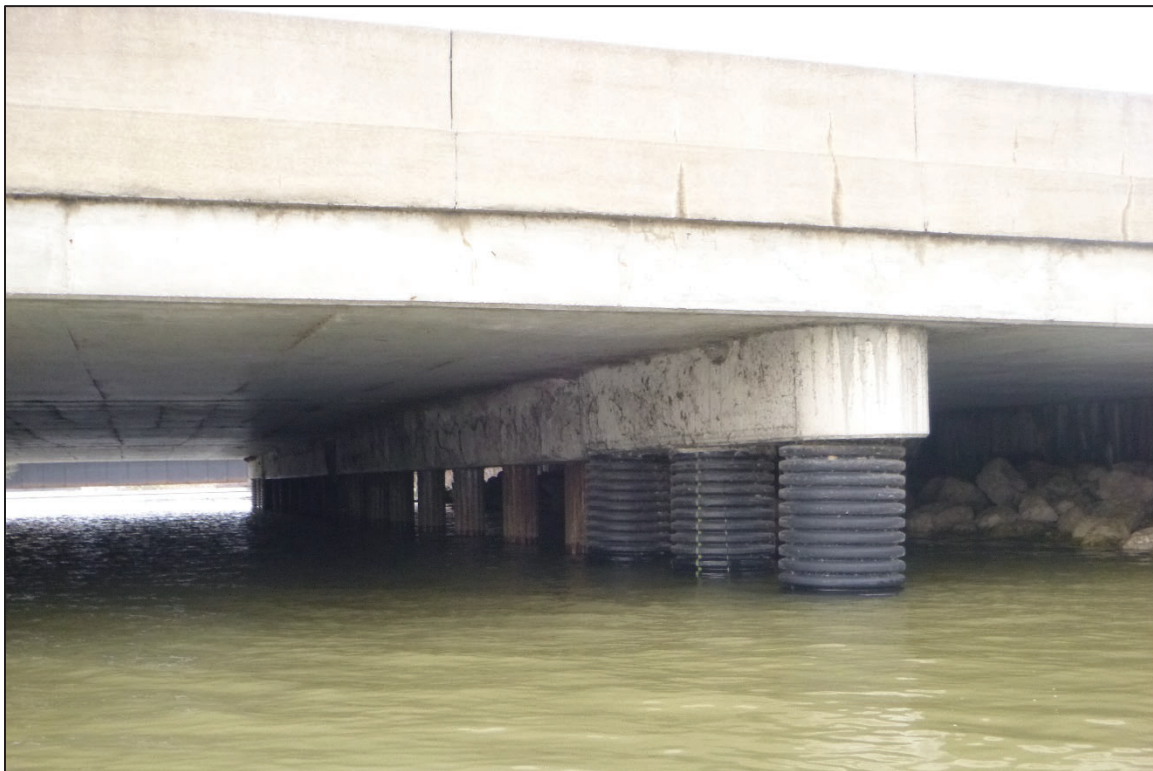
The channel bottom material consisted of rip-rap up to 36 in. diameter with no probe rod penetration. The PVC jackets were typically in good condition with random splits on less than 5% of the piles. The steel piles exhibited light pitting up to 1/32 in. deep with areas of minor corrosion up to 1/16 in. deep. Refer to Figure 9 in Exhibit 1 for detailed inspection notes of Bent 4. Refer to Photographs 23 through 28 in Exhibit 2 for views of Bent 4, typical concrete condition. and typical steel condition at the waterline.

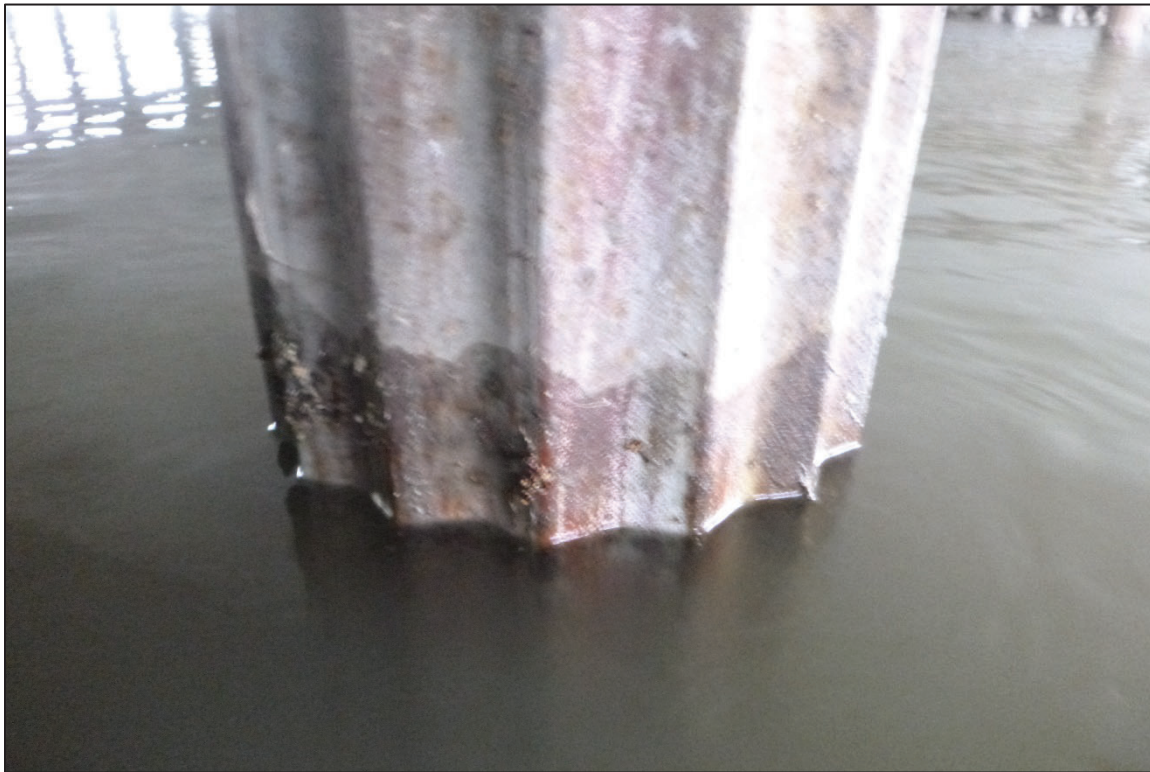
Photograph No. 27: View of the Typical Steel Condition at the Waterline, Looking Southwest.

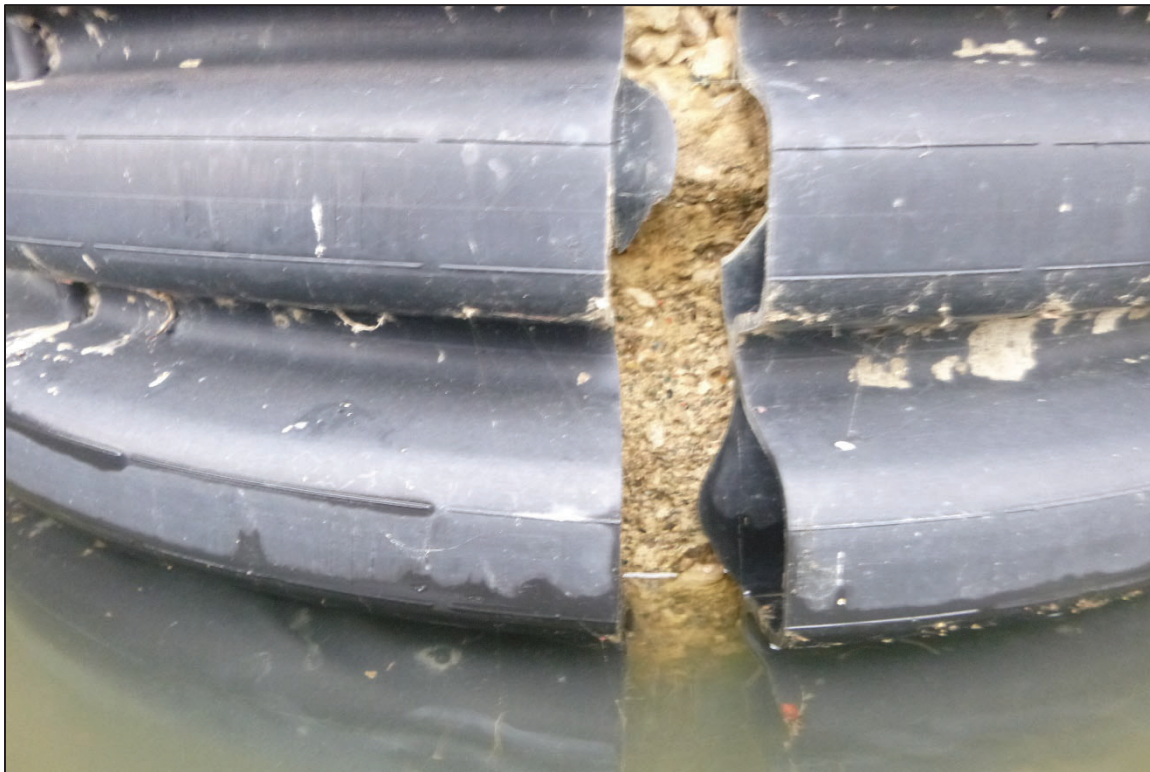
Photograph No. 28: View of the Typical Concrete Condition at the Waterline, Looking East.
