UNDERWATER BRIDGE INSPECTION REPORT

STRUCTURE NO. 4805909 (LUC-280-0346)
I-280 OVER MAUMEE RIVER
LUCAS COUNTY, OH
DISTRICT 2

May 2020

COLLINS
ENGINEERS INC.

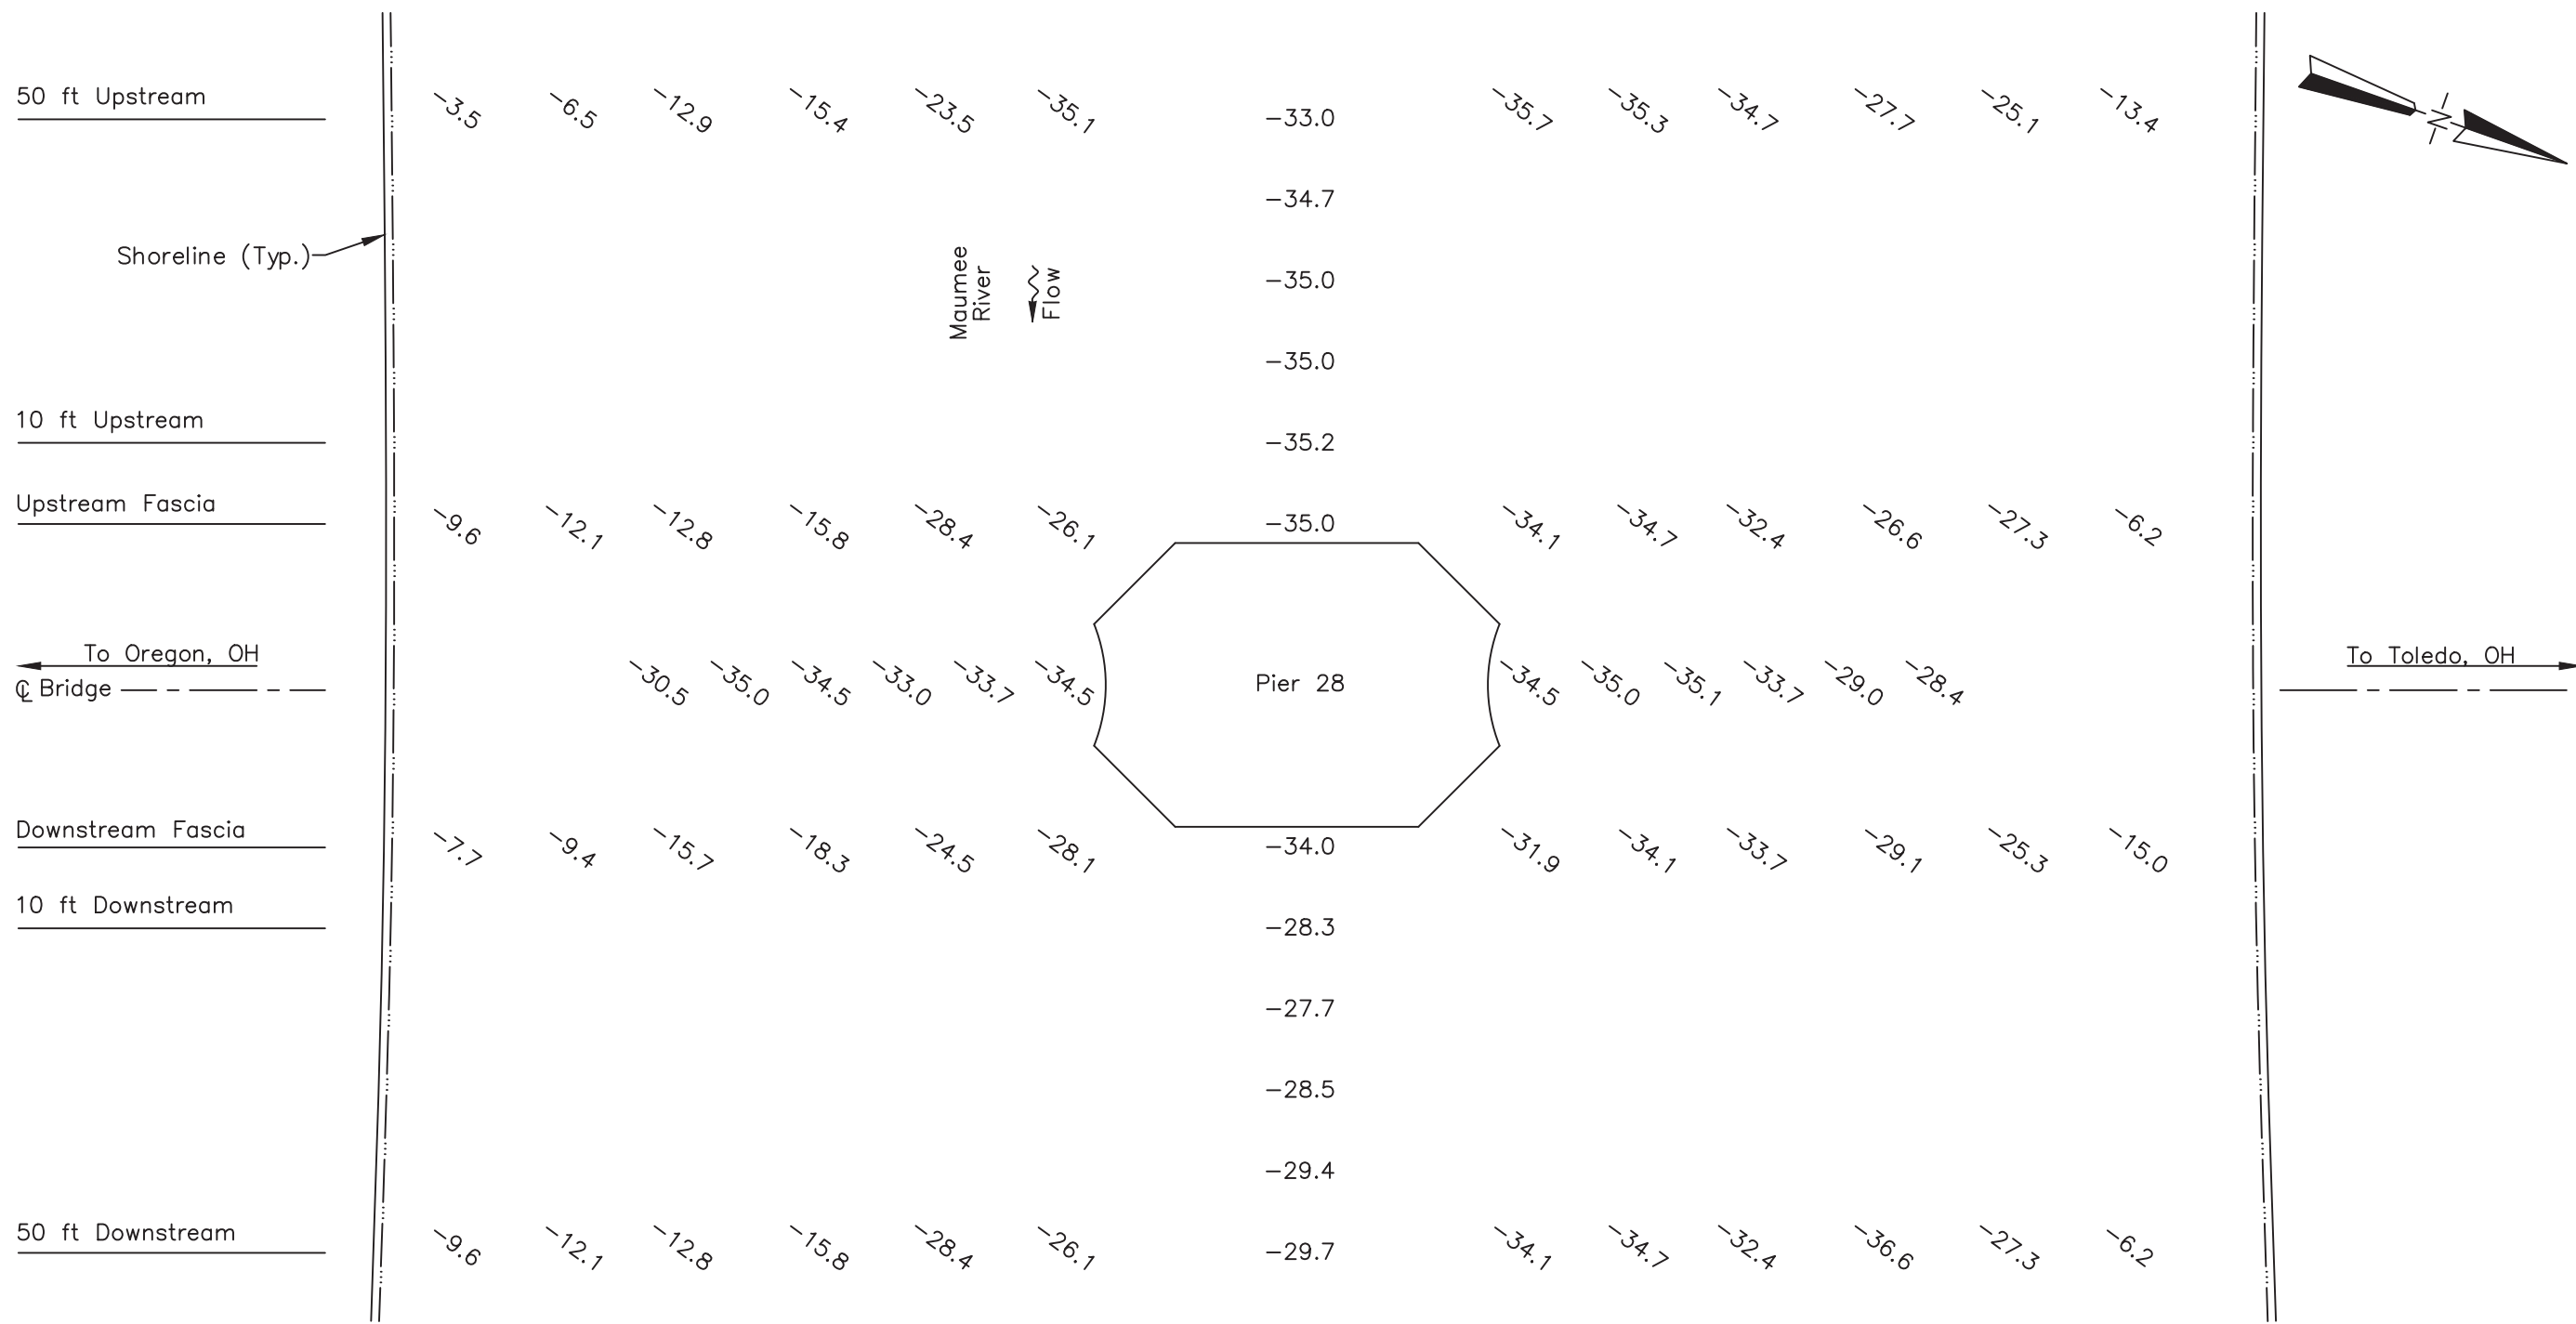
I-280 OVER MAUMEE RIVER
 STRUCTURE NO. 4805909 (LUC-280-0346)
 SOUNDING PLAN
 LUCAS COUNTY, OHIO

Overall, the inspected substructure units of Structure No. 4805909 (LUC-280-0346) were in very good condition. A comparison of the soundings recorded during the previous inspection on June 25, 2015 and the soundings taken during this inspection revealed no significant change in the channel bottom profile in the vicinity of the structure. Although no channel deficiencies were observed, the channel bottom should continue to be monitored during future underwater inspections to verify that localized scour or overall channel degradation is not occurring and that the pier footings remain adequately embedded in the channel bottom.

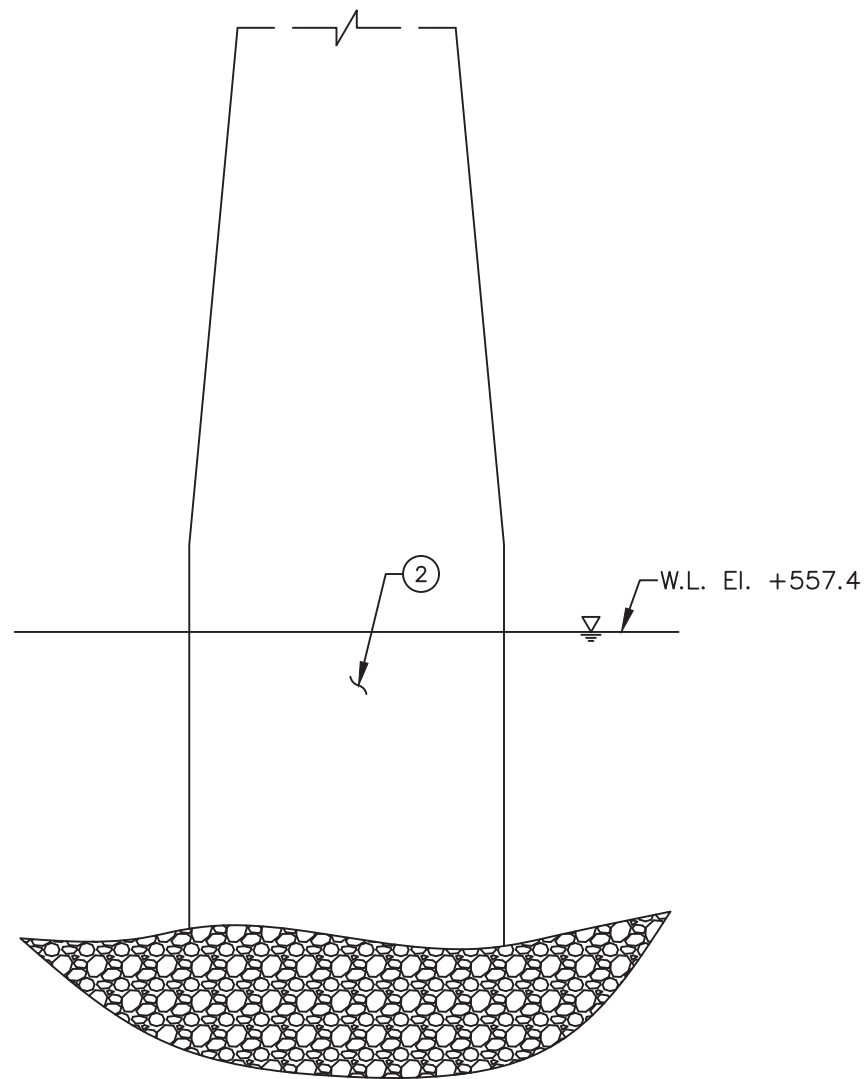
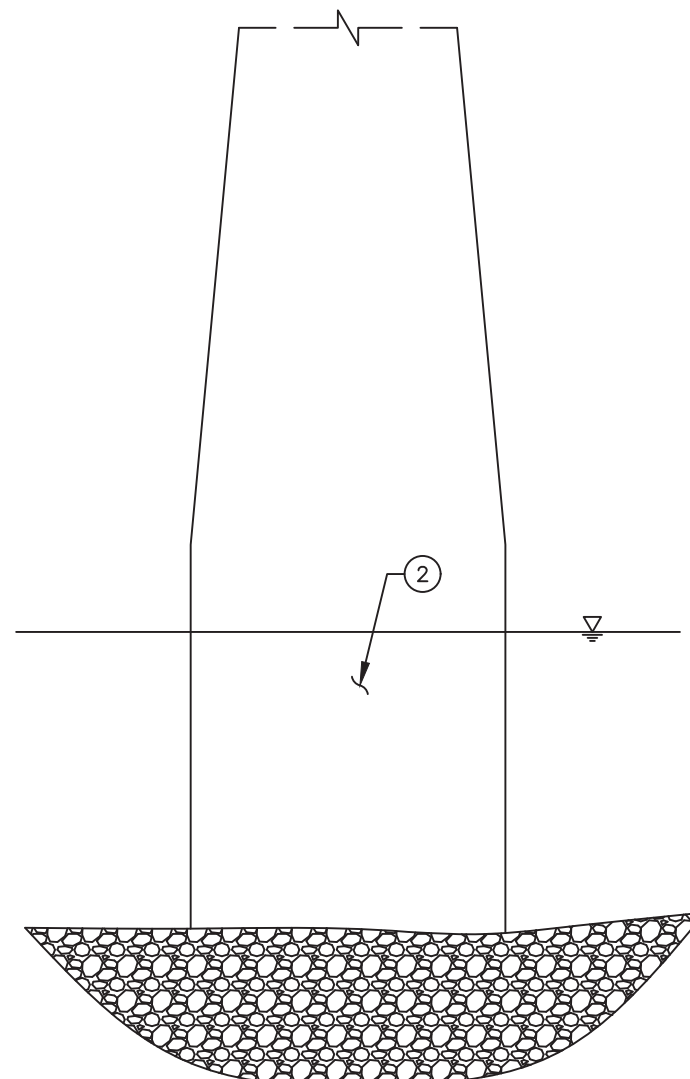
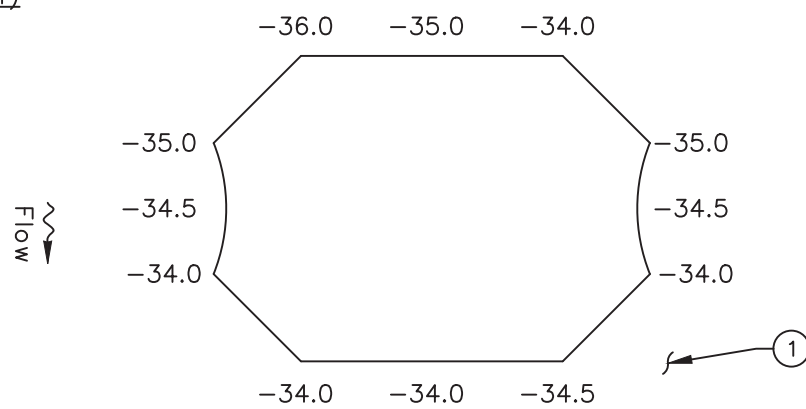
I-280 OVER MAUMEE RIVER
 STRUCTURE NO. 4805909 (LUC-280-0346)
 PIER 28
 LUCAS COUNTY, OHIO

The channel bottom material consisted of sand and scattered riprap up to 12 in. diameter with no probe rod penetration. The submerged portions of the pier were sound and smooth with no defects observed. Refer to Figure 6 in Exhibit 1 for detailed inspection notes of Pier 28. Refer to Photographs 9 through 11 in Exhibit 2 for views of Pier 28 and typical concrete condition at the waterline.

- ① The channel bottom material consisted of sand and scattered rip-rap up to 12 in. diameter with no probe rod penetration.
- ② The submerged portions of the pier were sound and smooth with no defects observed.

- Monitor channel bottom in the vicinity of Pier 28.
- Monitor concrete condition of Pier 28.

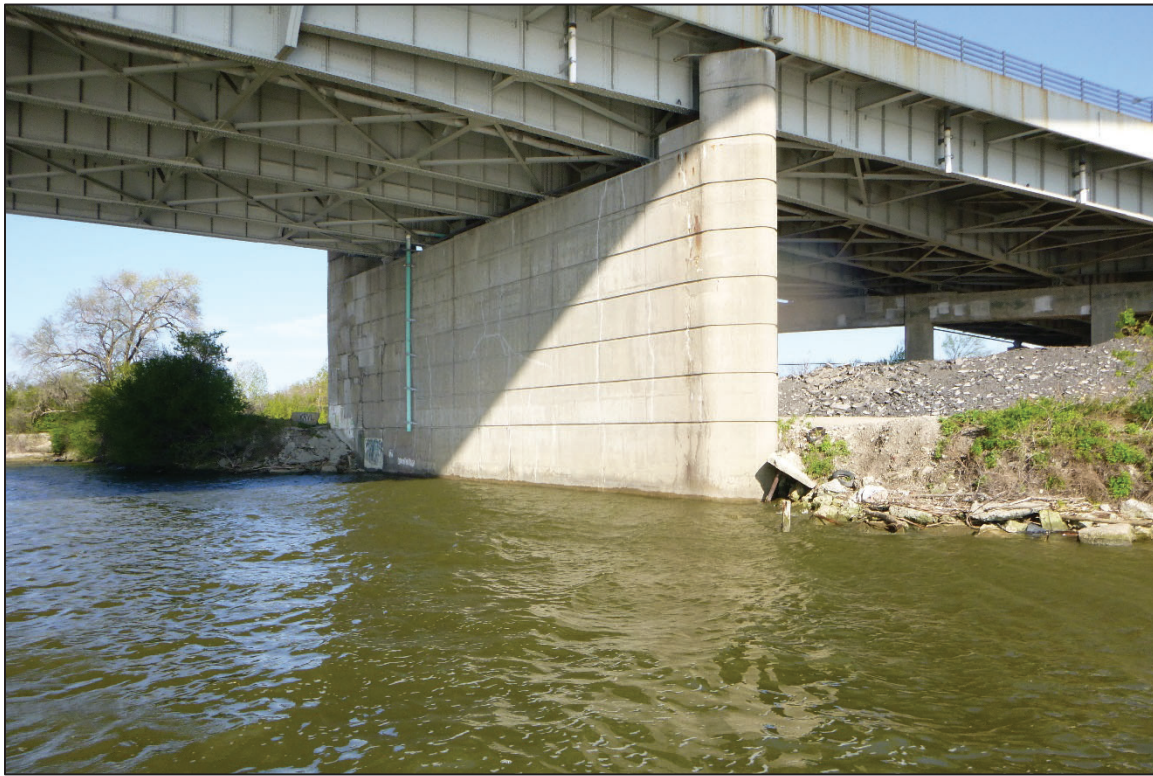
Photograph No. 3: View of the Northwest Embankment Upstream of the Structure, Looking West.

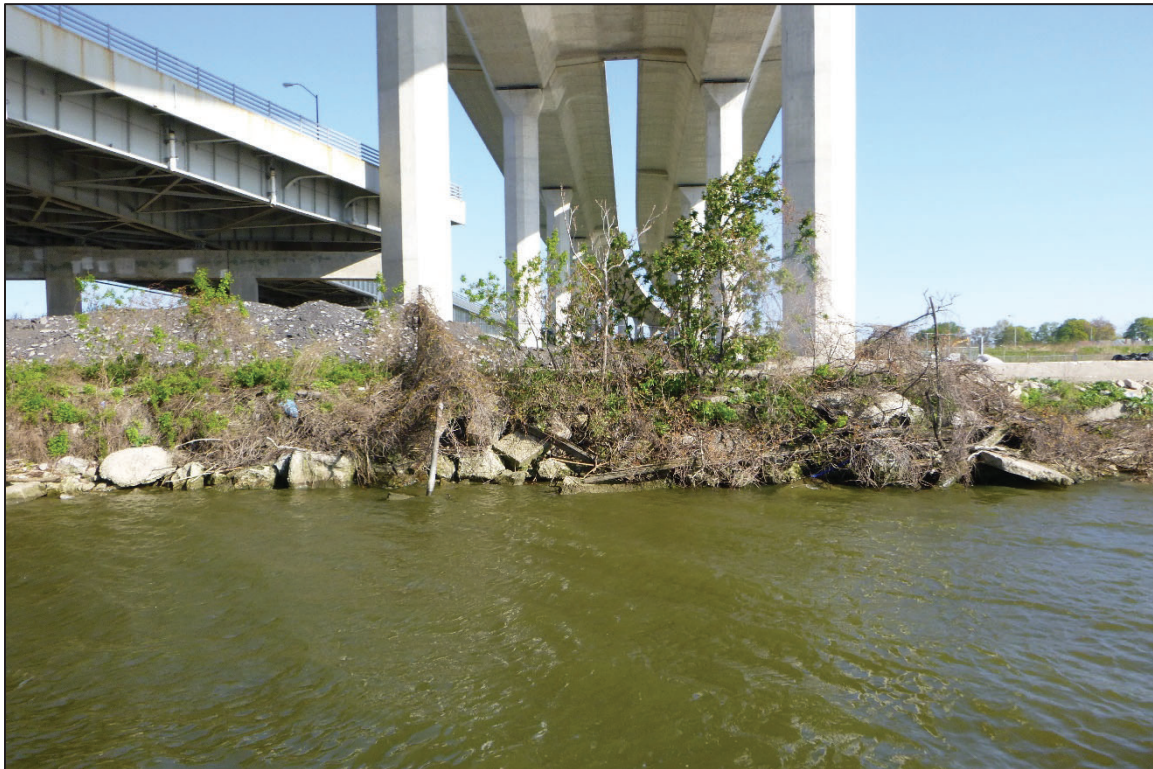
Photograph No. 4: View of the Northwest Embankment at the Structure, Looking Northwest.

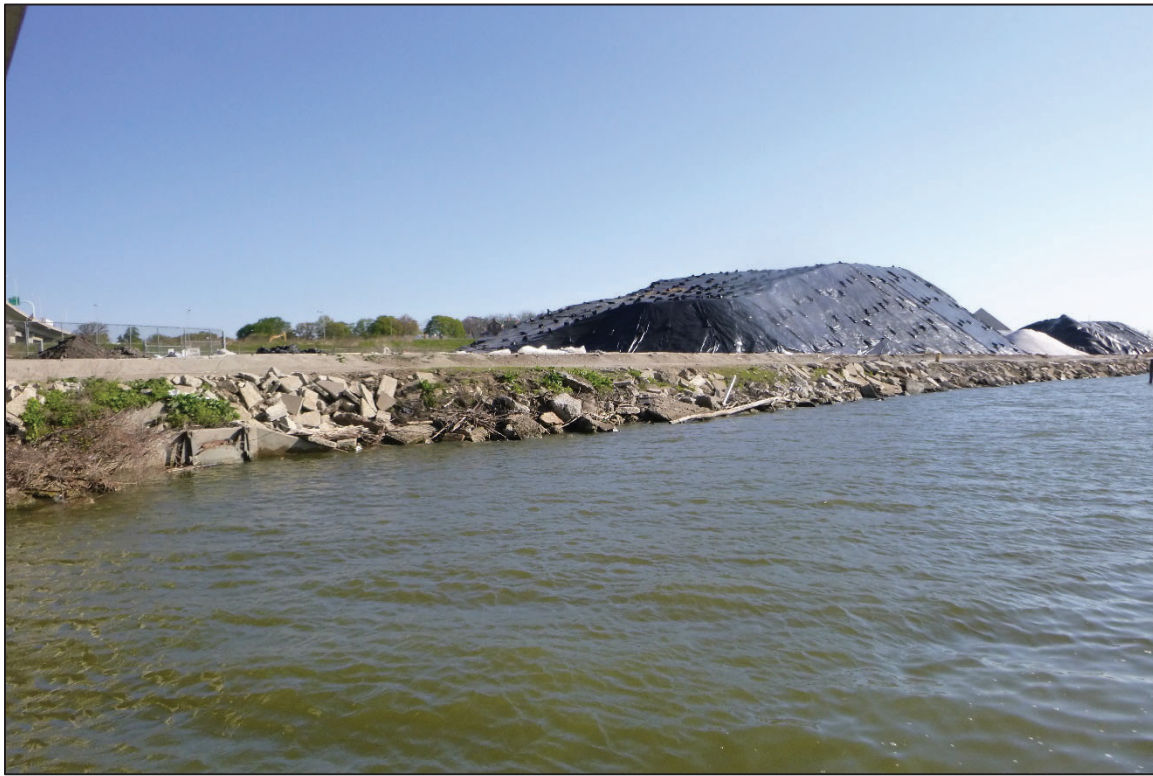
Photograph No. 5: View of the Northwest Embankment Downstream of the Structure, Looking North.

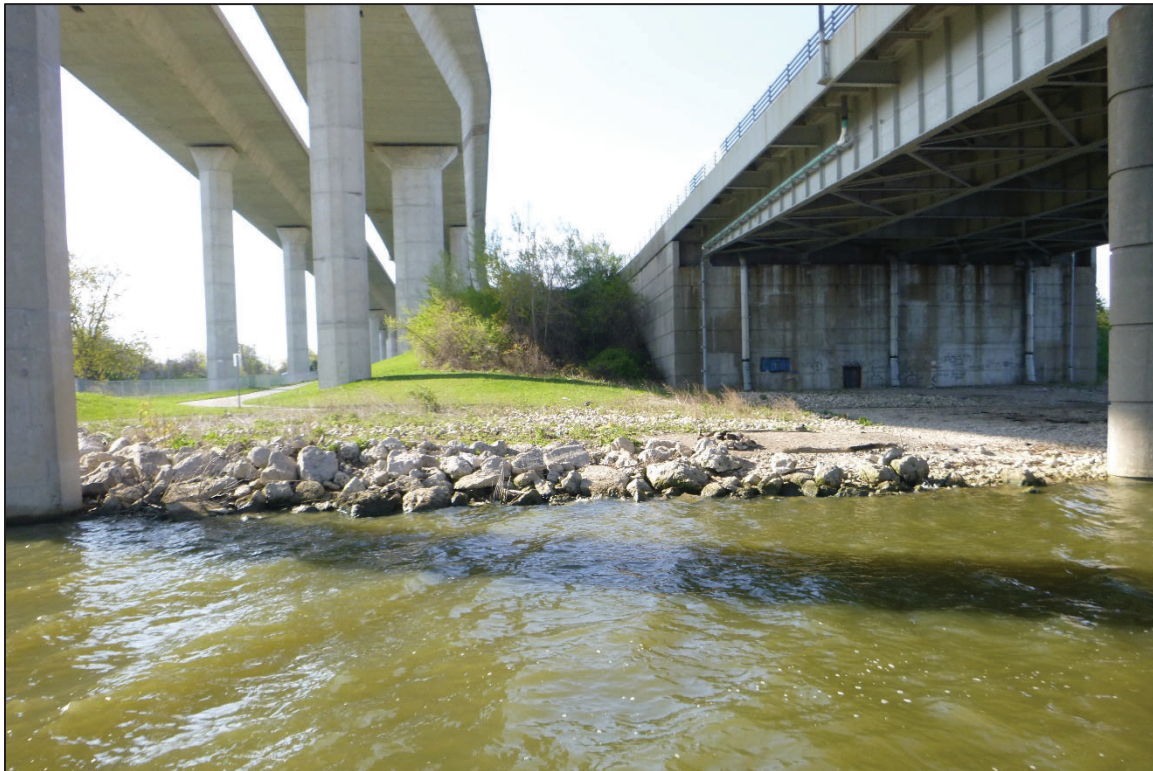
Photograph No. 6: View of the Southeast Embankment Upstream of the Structure, Looking Southeast.

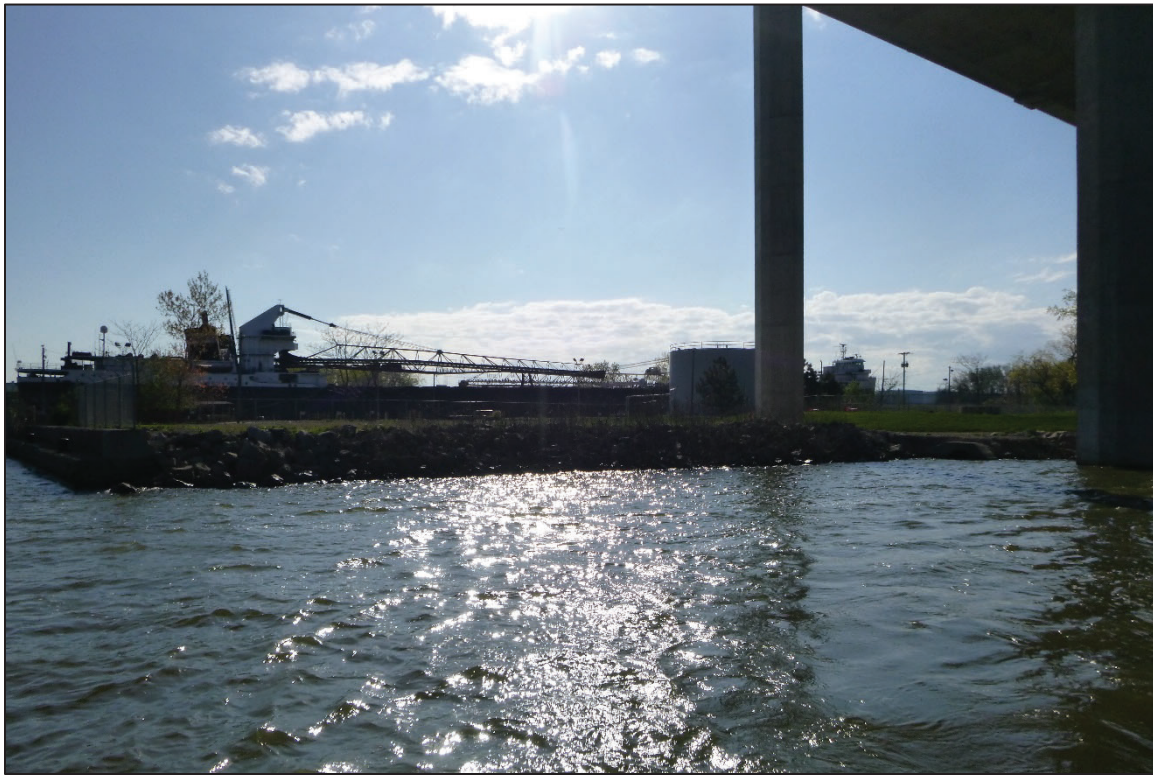
Photograph No. 7: View of the Southeast Embankment at the Structure, Looking East.

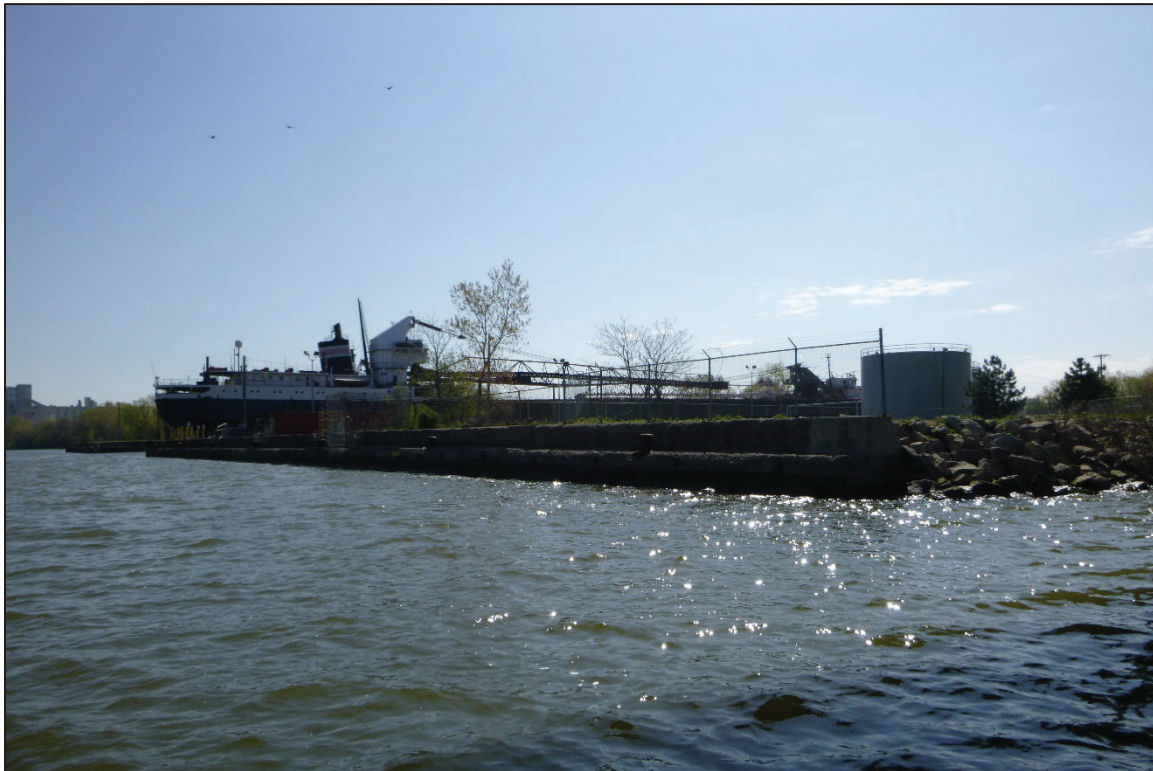
Photograph No. 8: View of the Southeast Embankment Downstream of the Structure, Looking East.

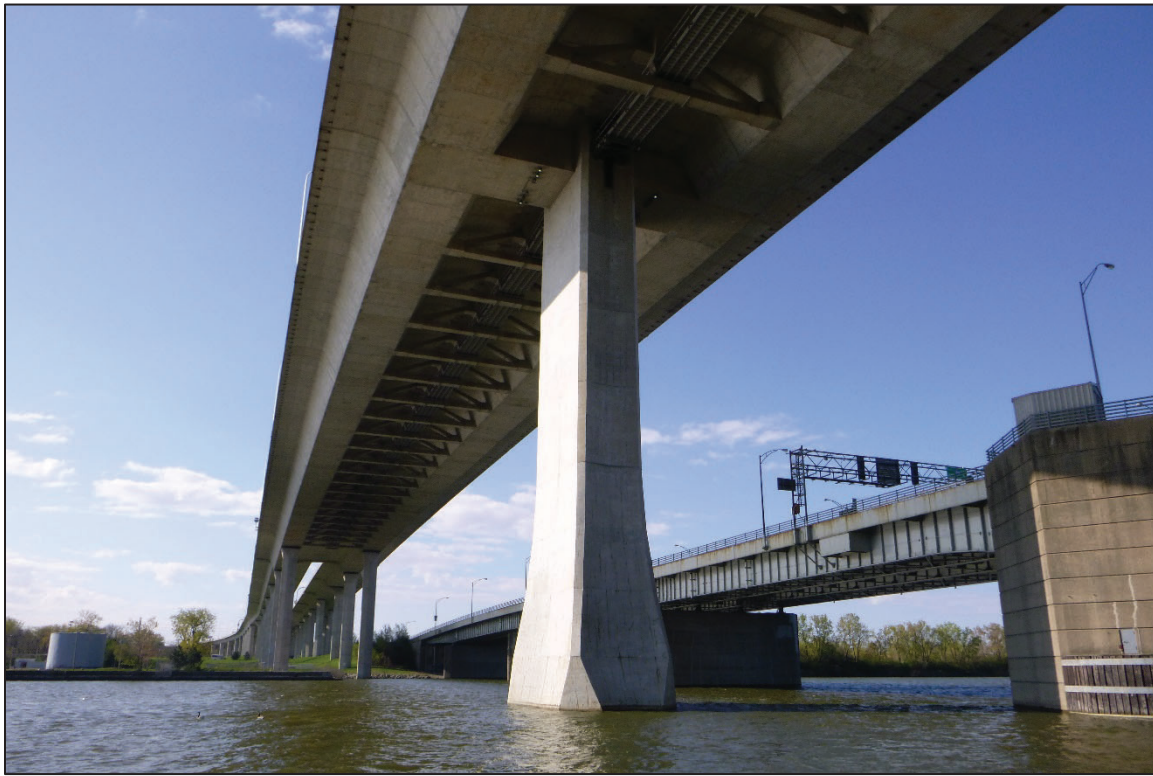
Photograph No. 9: View of the North Face of Pier 28, Looking Southeast.

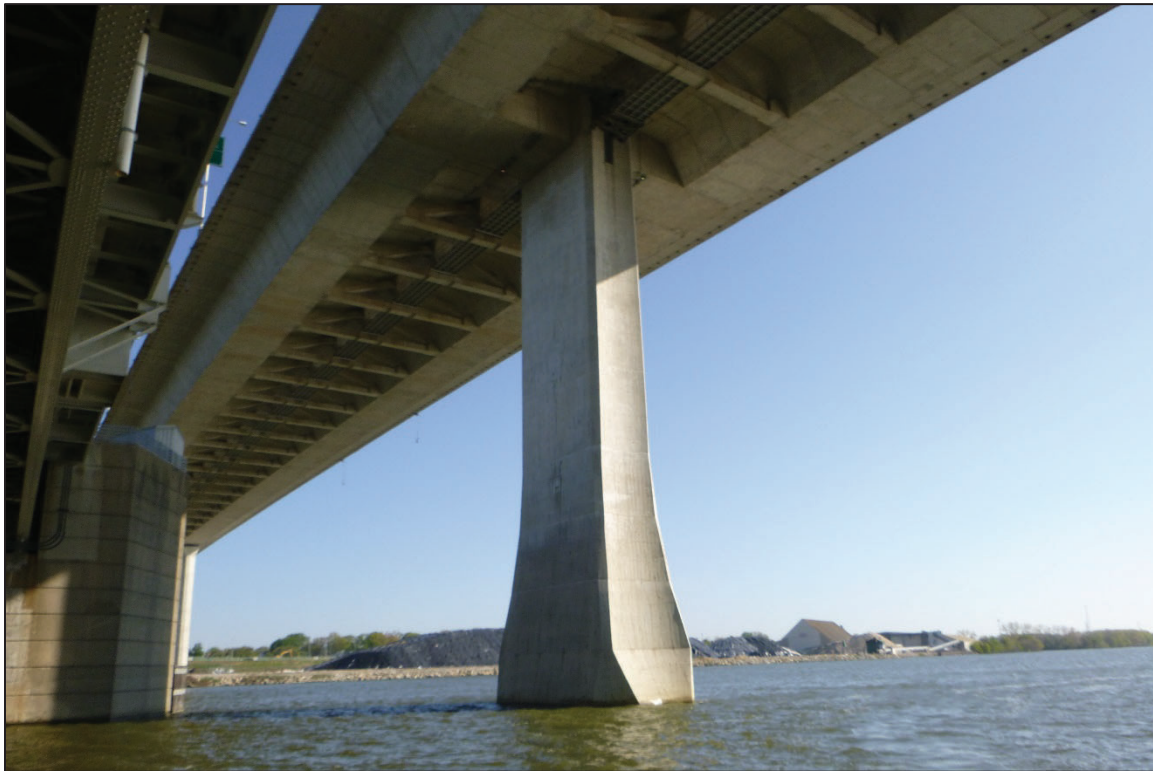
Photograph No. 10: View of the South Face of Pier 28, Looking North.

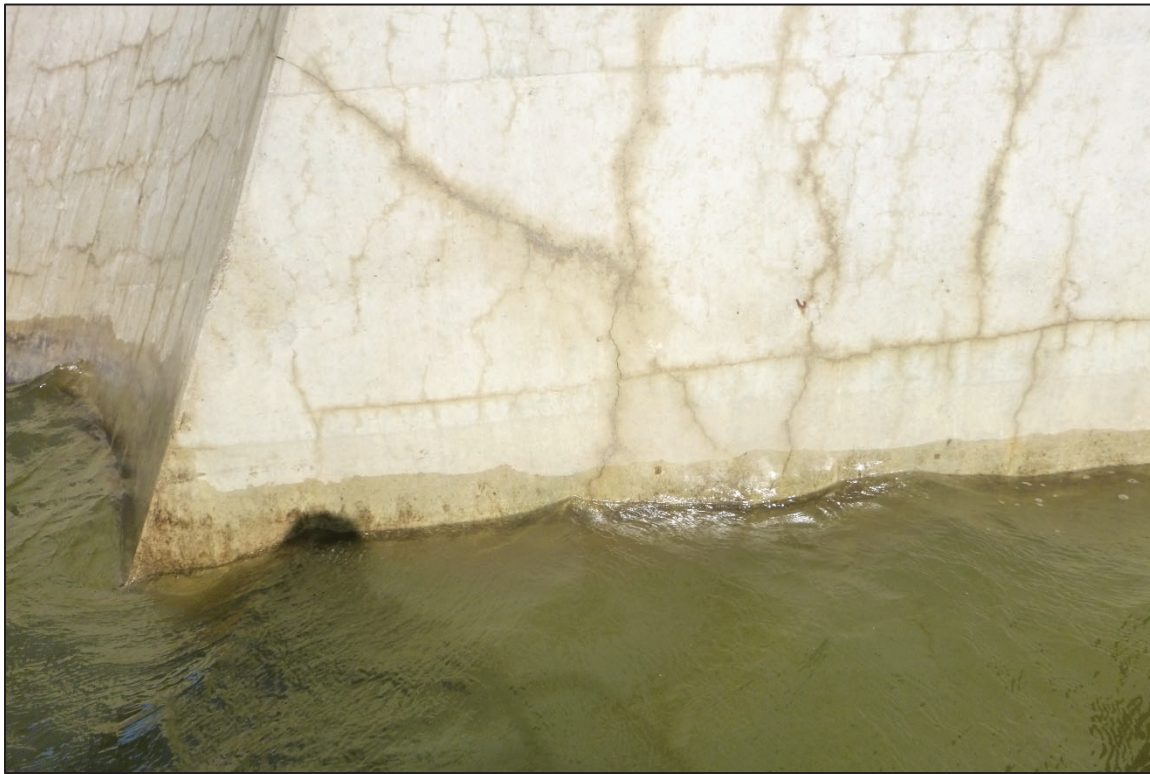
Photograph No. 11: View of the Typical Concrete Condition at the Waterline, Looking North.
