# UNDERWATER BRIDGE INSPECTION REPORT

STRUCTURE NO. 4805917 (LUC-65-0535)  
SR 65 OVER MAUMEE RIVER  
LUCAS COUNTY, OH  
DISTRICT 2

May 2020

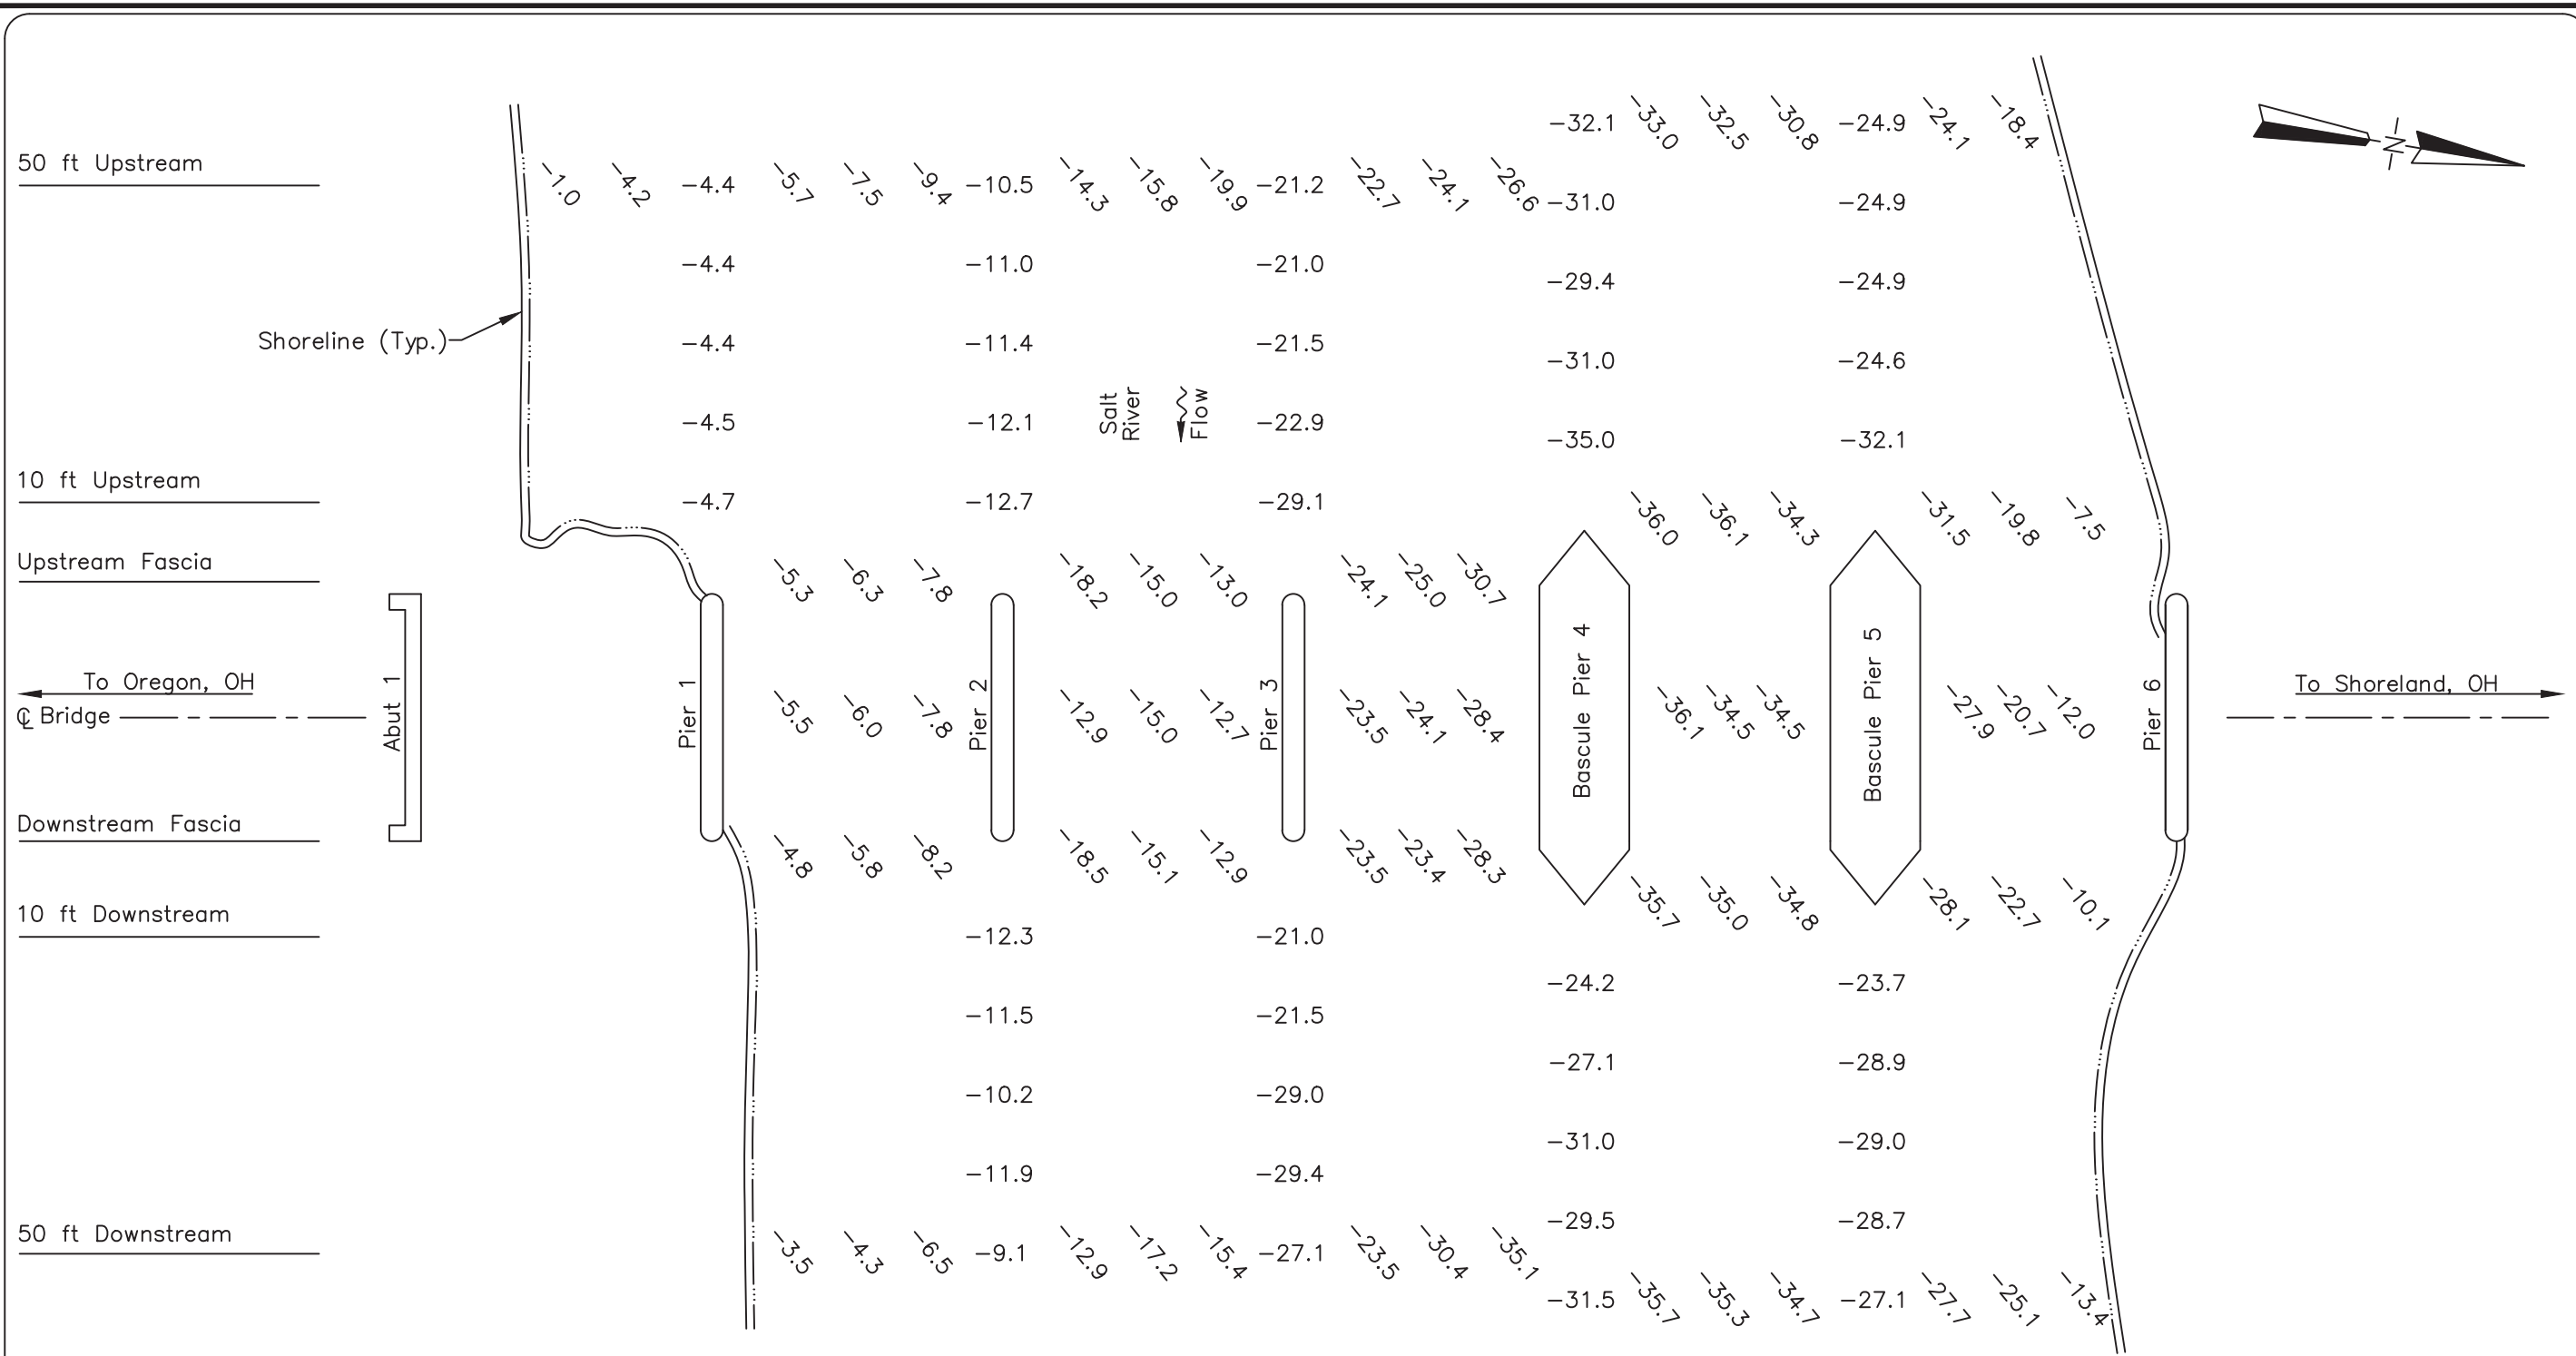
SOUNDING PLAN

Overall, the inspected substructure units of Structure No. 4805917 (LUC-65-0535) were in satisfactory condition. A comparison of the soundings recorded during the previous inspection on June 25, 2015 and the soundings taken during this inspection revealed no significant change in the channel bottom profile in the vicinity of the structure. Although no channel deficiencies were observed, the channel bottom should continue to be monitored during future underwater inspections to verify that localized scour or overall channel degradation is not occurring and that the pier footings remain adequately embedded in the channel bottom.

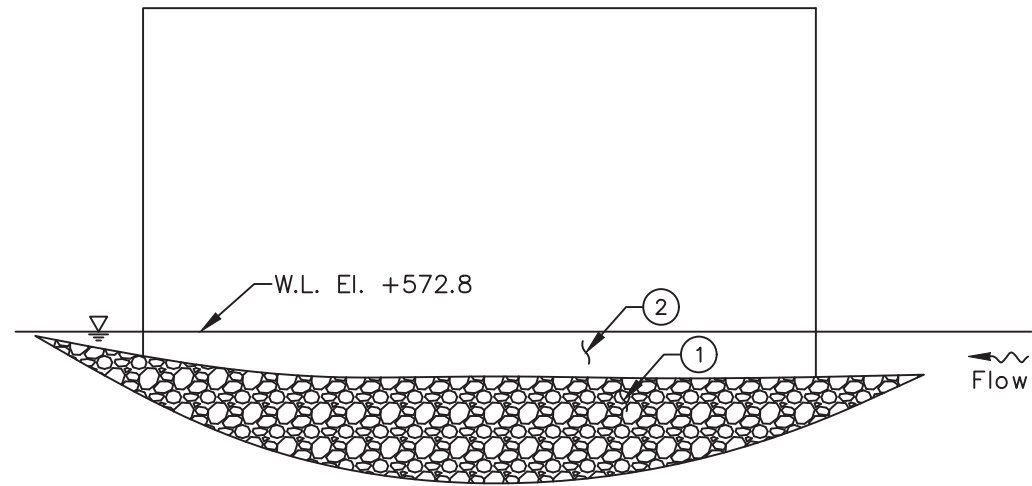
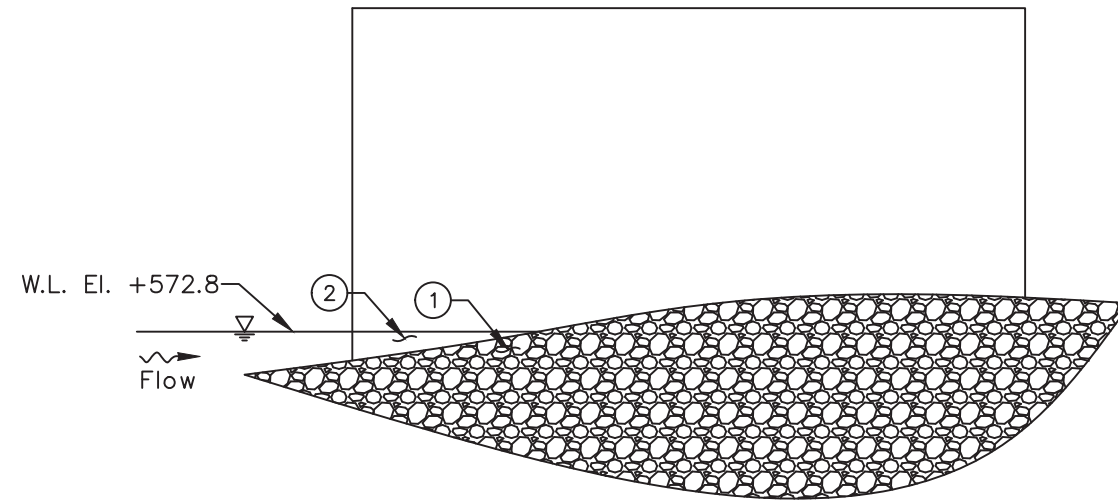
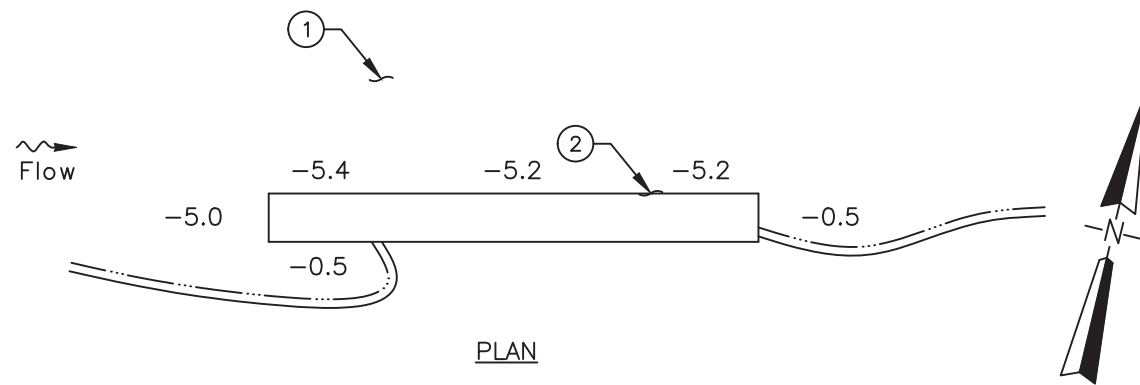
The channel bottom material consisted of sand, gravel, and cobbles with approximately 2 in. probe rod penetration. The submerged portions of the pier were sound and smooth with no defects observed. Refer to Figure 6 in Exhibit 1 for detailed inspection notes of Pier 1. Refer to Photograph 9 in Exhibit 2 for views of Pier 1.

- ① The channel bottom material consisted of sand, gravel and cobbles with approximately 2 in probe rod penetration.
- ② The submerged portions of the pier were sound and smooth with no defects observed.

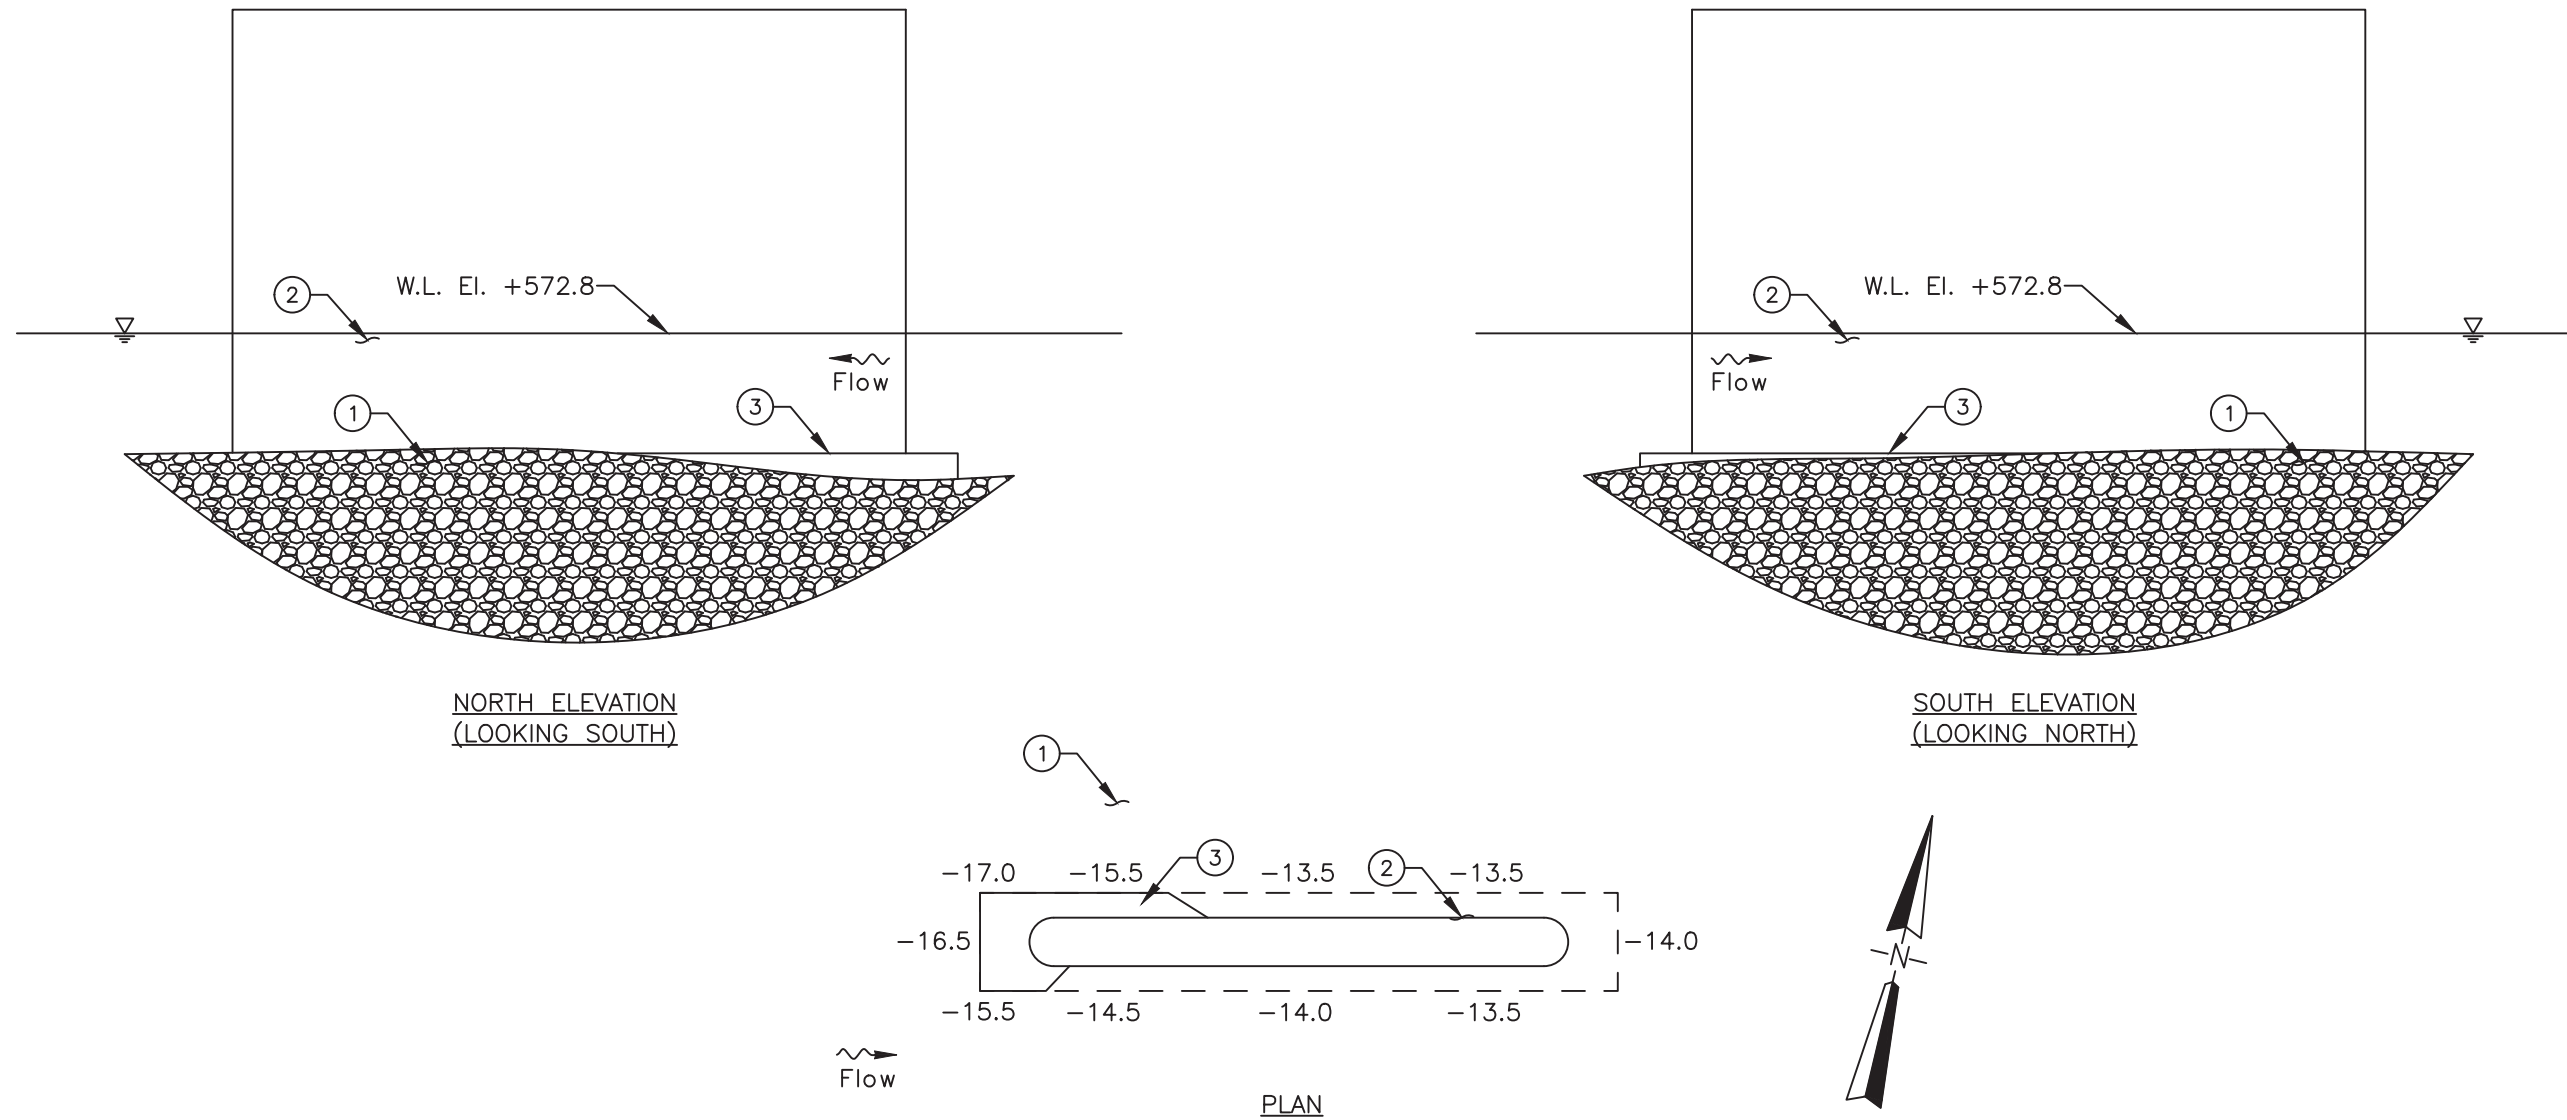
The channel bottom material consisted of sand, silt, and cobbles with approximately 6 in. probe rod penetration. The submerged portions of the pier exhibited heavy scaling up to 1/2 in. deep from the channel bottom to the waterline. Refer to Figure 7 in Exhibit 1 for detailed inspection notes of Pier 2. Refer to Photographs 10 and 11 in Exhibit 2 for views of Pier 2.

- ① The channel bottom material consisted of sand, gravel and cobbles with approximately 2 in. probe rod penetration.
- ② The submerged portions of the pier exhibited heavy scaling up to 1/2 in. deep from the channel bottom to the waterline.
- ③ The top of footing was exposed along the upstream nose to the upstream 1/4 point of the north face at -13.9 ft (EL. +558.9 ft) with a maximum vertical exposure of 3.1 ft at the northwest corner.

The scaling observed on Piers 2 through 5 is not a structural concern at this time given its size compared to the overall pier size, and as a result, no repairs are recommended. This area should be monitored during future inspections for increasing extent or severity of the scaling and exposure of reinforcing steel. If the extent or severity of the scaling is observed to be increasing or reinforcing steel becomes exposed, it may be necessary to repair the area at that time.

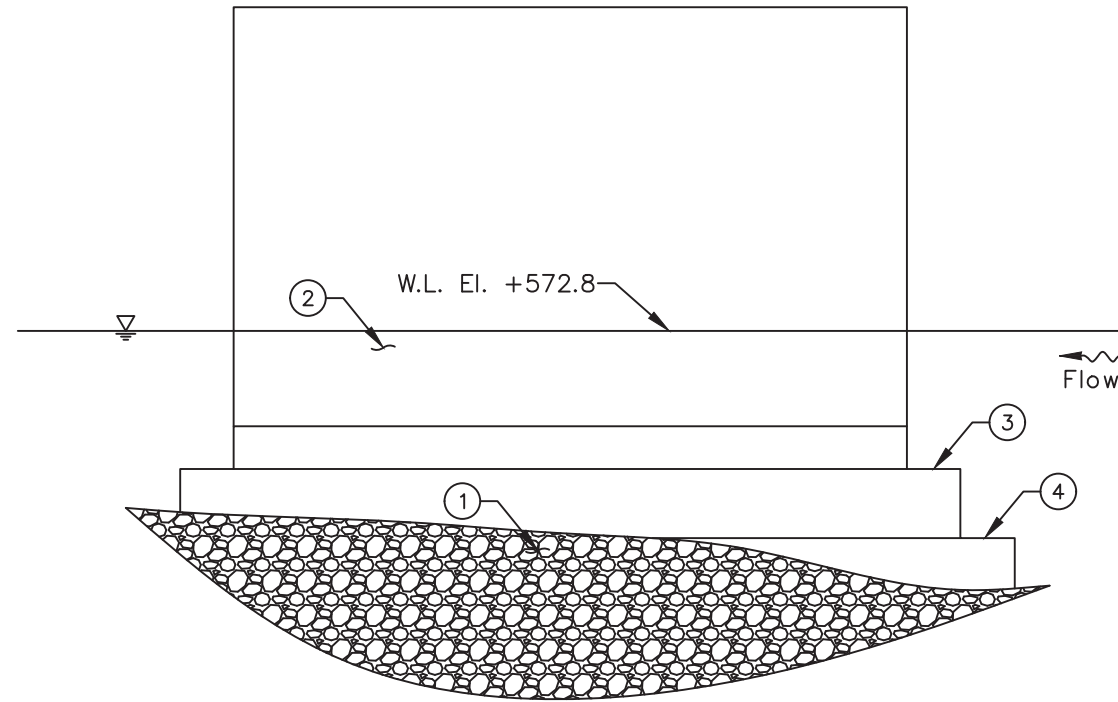
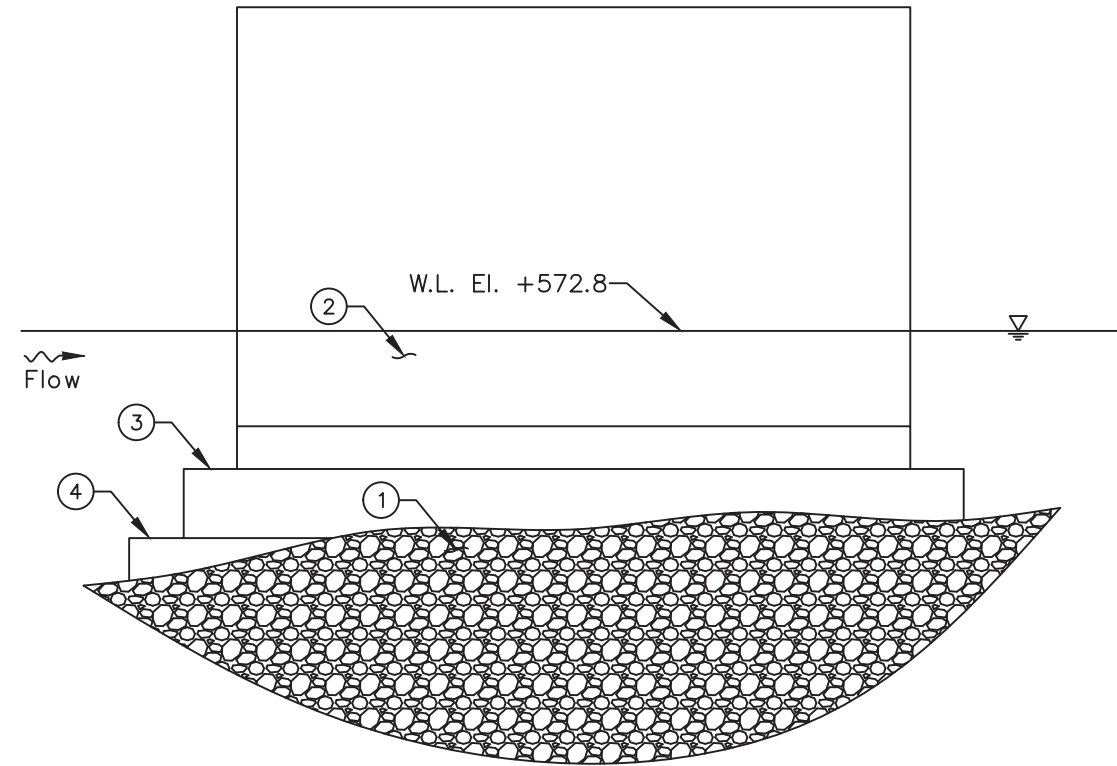
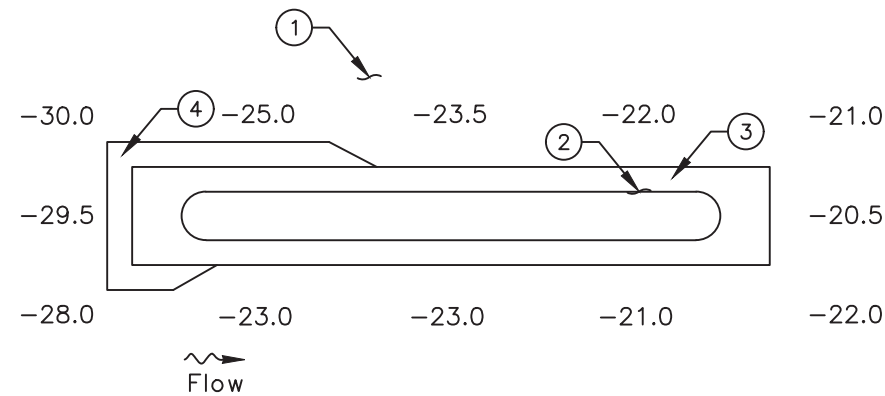
The channel bottom material consisted of sand with silt overlay with 6 to 8 in. of probe rod penetration with scattered cobbles. Scattered spalls were observed on seal concrete measuring up to 1 ft diameter. The submerged portions of the pier exhibited moderate scaling up to 1/4 in. Refer to Figure 8 in Exhibit 1 for detailed inspection notes of Pier 3. Refer to Photographs 12 and 13 in Exhibit 2 for views of Pier 3.

- ① The channel bottom material consisted of sand and scattered cobbles with silt overlay with up to 8 in. probe rod penetration.
- ② The submerged portions of the pier exhibited moderate scaling up to 1/4 in. deep extending from the top of footing to the waterline.
- ③ The top of footing was located at -16.0 ft (EL. +556.8 ft) and was exposed around the entire pier. The footing concrete was observed to be smooth and sound with no defect noted.
- ④ The top of seal was located at -24.0 ft (EL. +548.8 ft) and was exposed from the southwest corner around the upstream nose along the north face to approximately the midpoint of the pier with a maximum vertical exposure of 6.0 ft at the northwest corner. The seal concrete exhibited scattered spalls measuring approximately 1 ft diameter by 2 in. deep with no exposed steel reinforcement.

The spalls at Pier 3 are not structural concerns at this time; however, they should be repaired to prevent further deterioration. The repairs should include removal of unsound concrete to a minimum of 1 in. behind the reinforcing steel, cleaning and replacing reinforcing steel as required, and placing concrete designed to provide high durability with low permeability.

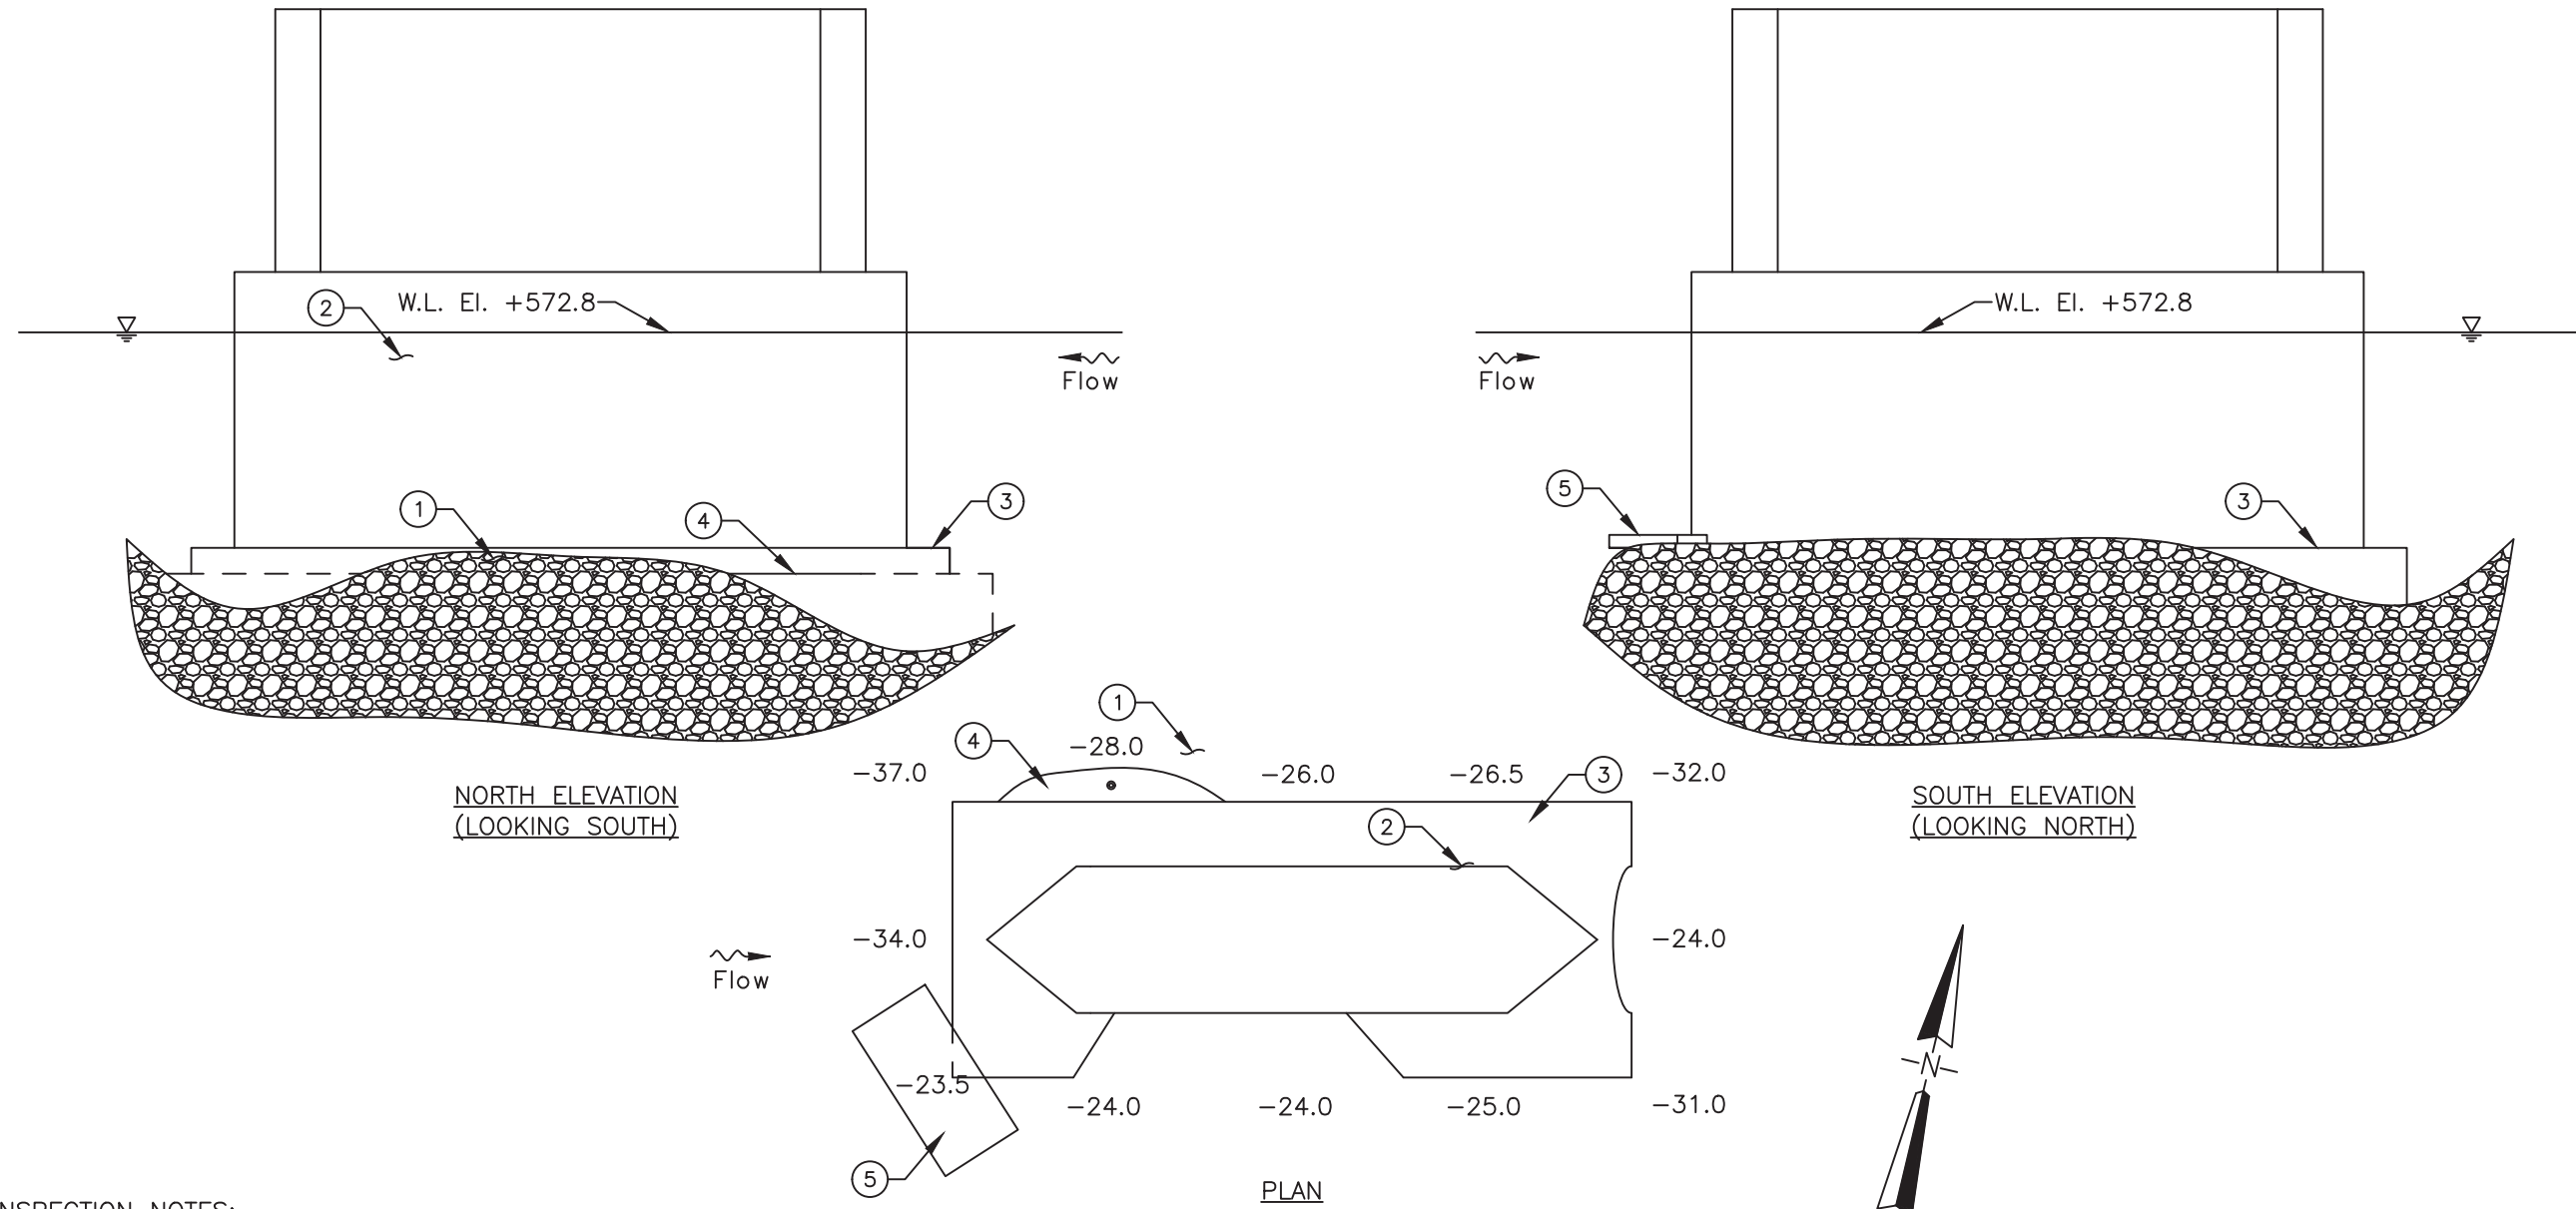
The channel bottom material consisted of sand, gravel, and cobbles with approximately 2 in. probe rod penetration. The submerged portions of the pier were sound and smooth with no defects observed. A band of moderate scaling was observed from -10 ft to -2 ft below the waterline up to 1/4 in. deep. Refer to Figure 9 in Exhibit 1 for detailed inspection notes of Bascule Pier 4. Refer to Photographs 14 and 15 in Exhibit 2 for views of Bascule Pier 4.

- ① The channel bottom material consisted of scattered rip-rap up to 12 in. diameter with silt infill with up to 6 in. probe rod penetration.
- ② The submerged portions of the pier exhibited moderate scaling up to 1/4 in. deep extending from -10 ft to -2 ft. Otherwise the submerged portions of the pier were observed to be smooth and sound with no defects noted.

- ③ The top of footing was located at -25.0 ft (EL. +547.8 ft) and was exposed from the southeast corner along the downstream nose to the north face and upstream nose ending at approximately the upstream quarter point with a maximum vertical exposure of 12.0 ft at the northwest corner. The footing concrete was observed to be smooth and sound with no defect noted.

- ④ The top of seal was located at -28.0 ft (EL. +544.8 ft) and was observed along the north face extending from 5 ft east of the upstream nose to approximately the mid-point of the pier.

- ⑤ One concrete slab was observed leaning on the upstream nose at the southwest corner measuring approximately 10 ft wide by 20 ft long by 8 in. deep.

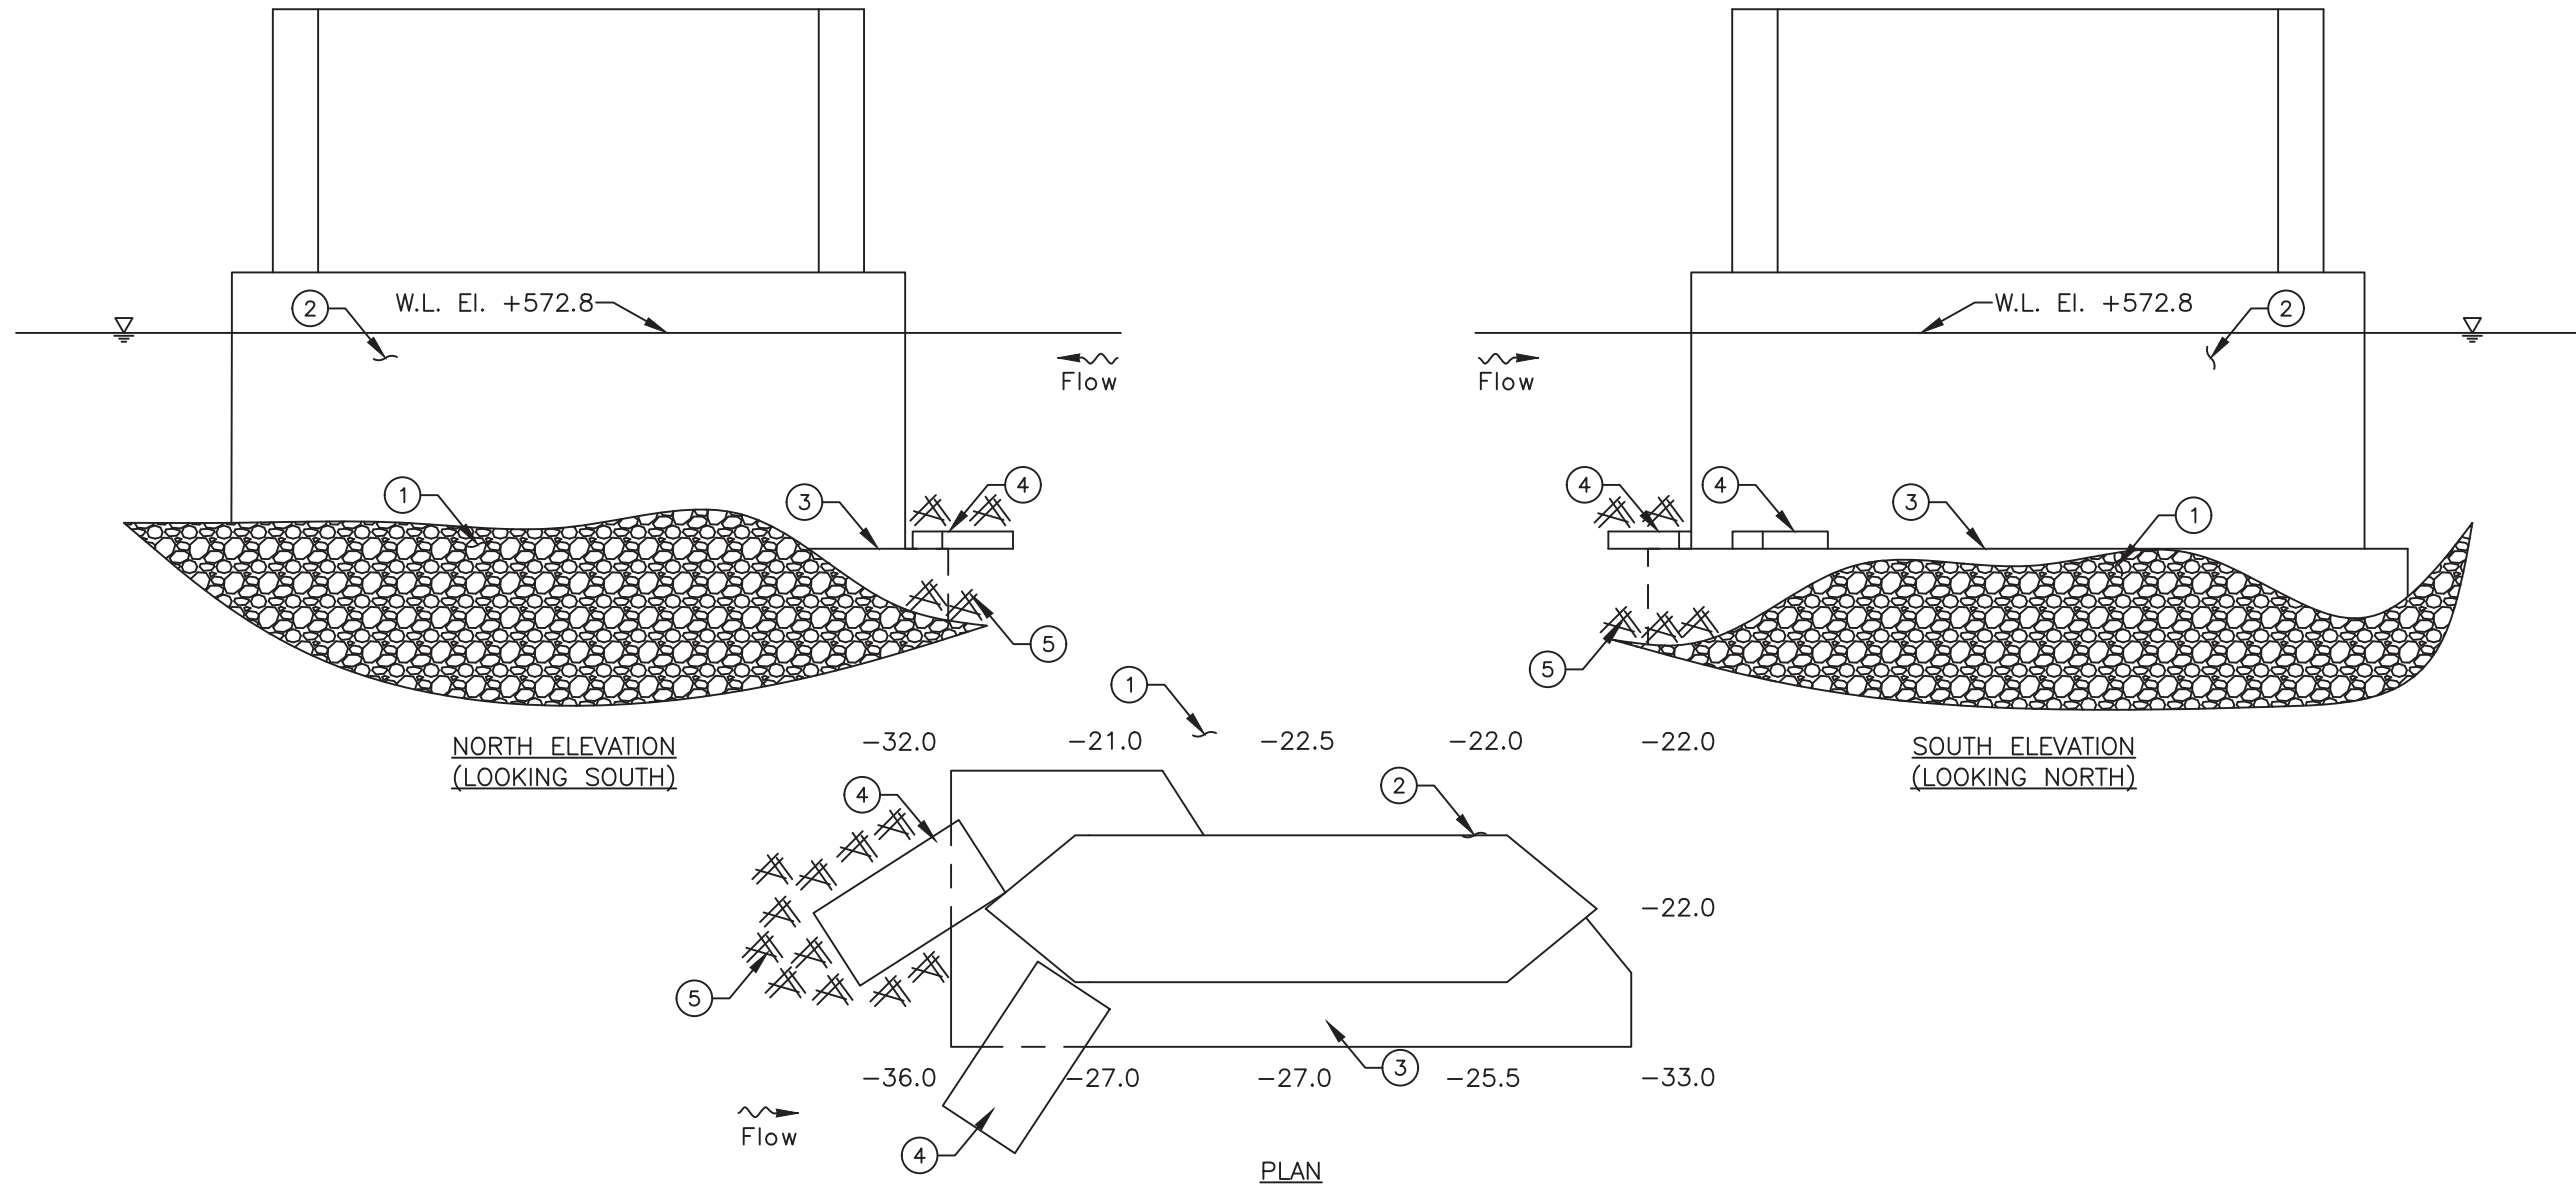
The channel bottom material consisted of scattered riprap up to 12 in. diameter with silt infill with up to 6 in. probe rod penetration. A band of moderate scaling was observed from -10 ft to -2 ft below the waterline up to 1/4 in. deep. Refer to Figure 10 in Exhibit 1 for detailed inspection notes of Bascule Pier 5. Refer to Photographs 16 through 19 in Exhibit 2 for views of Bascule Pier 5, typical concrete condition at the waterline, and typical fender condition at the waterline.

- ① The channel bottom material consisted of scattered rip-rap up to 12 in. diameter with silt infill with up to 6 in. probe rod penetration.
- ② The submerged portions of the pier exhibited moderate scaling up to 1/4 in. deep extending from -10 ft to -2 ft. Otherwise the submerged portions of the pier were observed to be smooth and sound with no defects.

- ③ The top of footing was located at -25.0 ft (EL. +547.8 ft) and was exposed from the southeast corner along the south face and upstream nose ending at approximately the upstream quarter point with a maximum vertical exposure of 11.0 ft at the southwest corner. The footing concrete was observed to be smooth and sound with no defect noted.

- ④ Two concrete slabs were observed leaning on the upstream nose measuring approximately 10 ft wide by 20 ft long by 8 in. deep.
- ⑤ Moderate timber debris accumulation consisting of logs and branches up to 12 in. diameter were observed on the upstream nose along the channel bottom and caught on the concrete slabs.

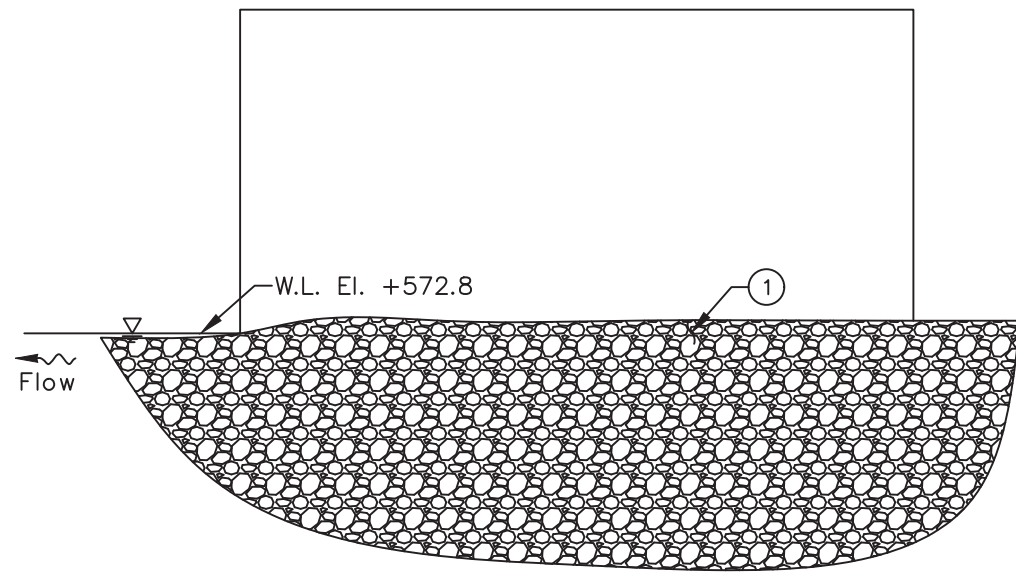
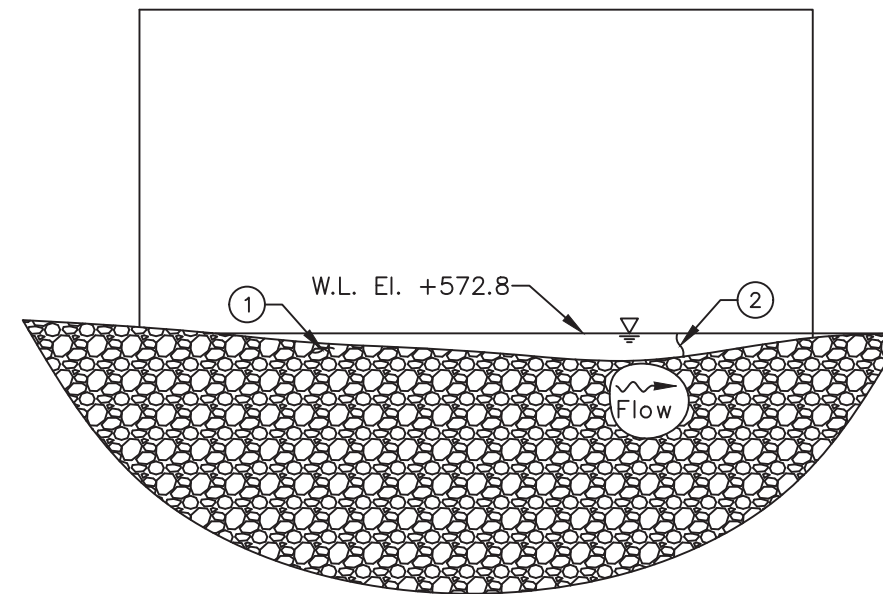
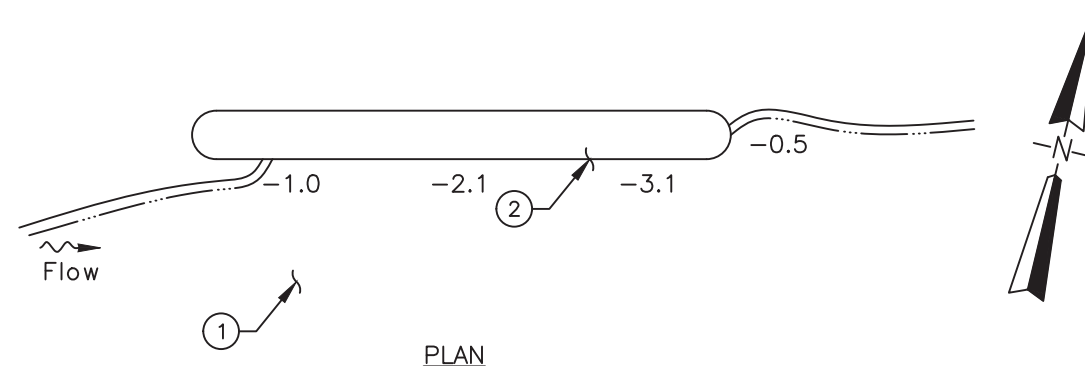
The channel bottom material consisted of sand, gravel, and cobbles with approximately 2 in. probe rod penetration. The submerged portions of the pier were sound and smooth with no defects observed. Refer to Figure 11 in Exhibit 1 for detailed inspection notes of Pier 6.

- ① The channel bottom material consisted of sand, gravel and cobbles with approximately 2 in probe rod penetration.
- ② The submerged portions of the pier were sound and smooth with no defects observed.

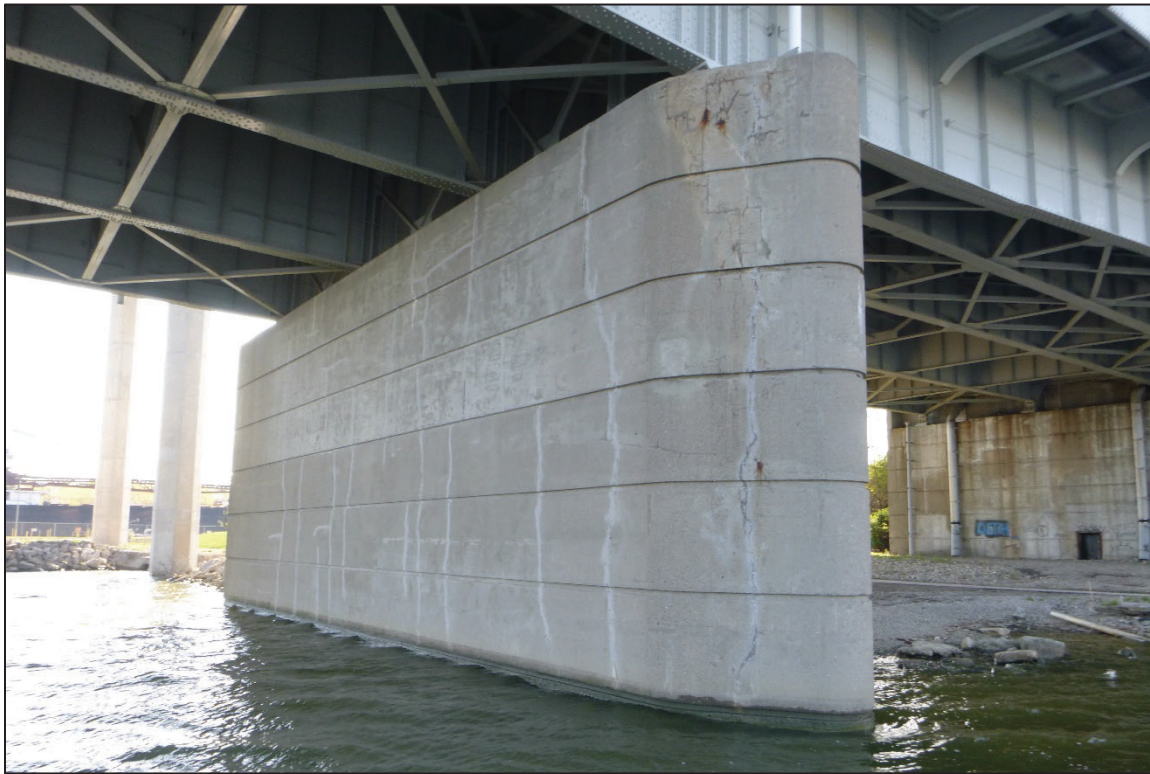
Photograph No. 9: View of the North Face of Pier 1, Looking East.

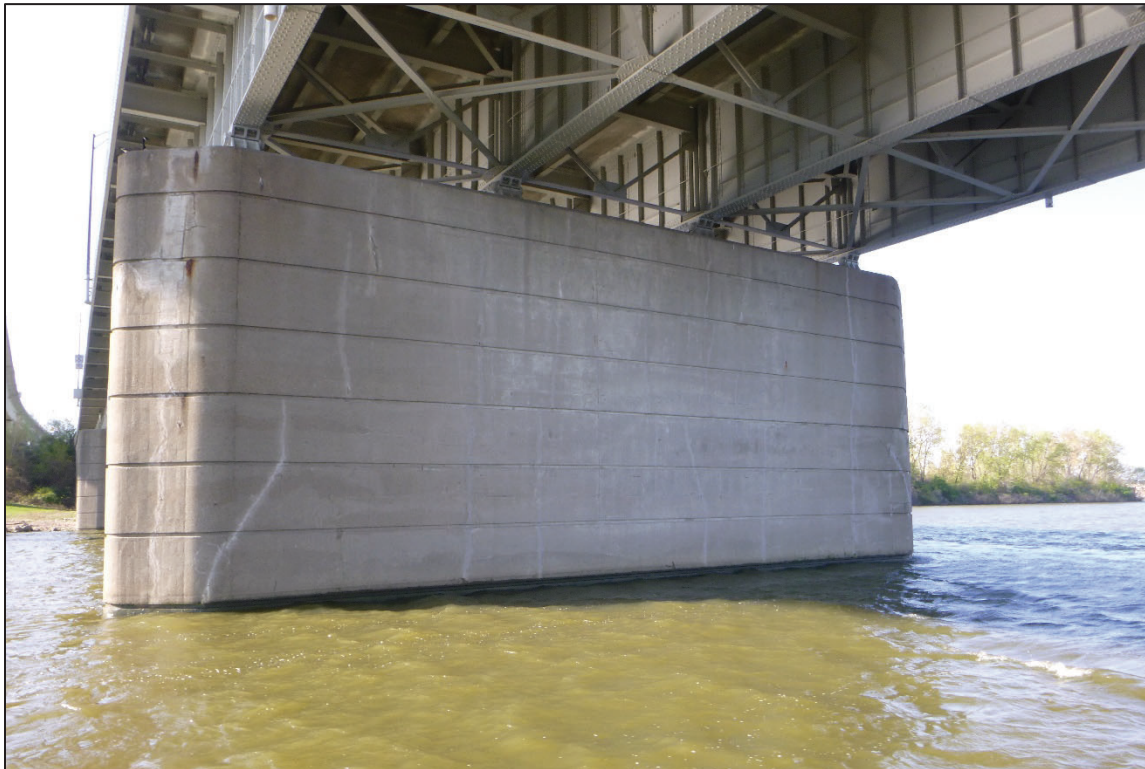
Photograph No. 10: View of the North Face of Pier 2, Looking Southeast.

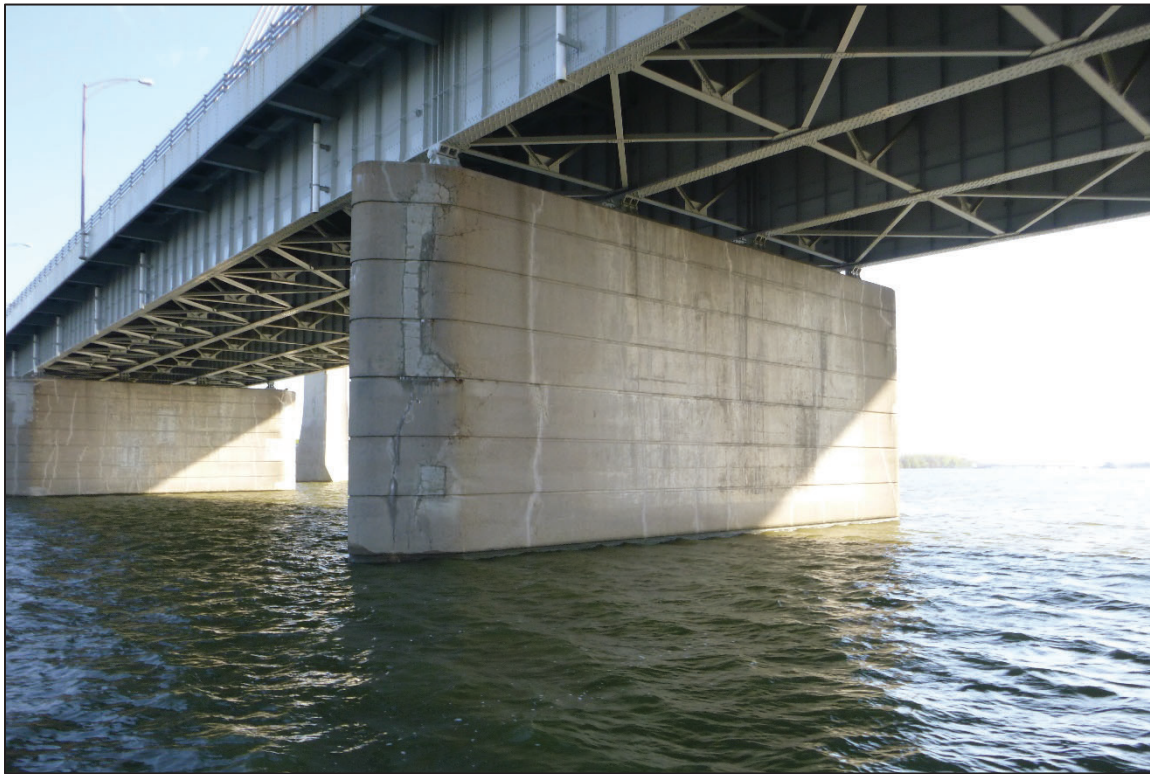
Photograph No. 11: View of the South Face of Pier 2, Looking North.
