# UNDERWATER BRIDGE INSPECTION REPORT

STRUCTURE NO. 4805917 (LUC-65-0535)  
SR 65 OVER MAUMEE RIVER  
LUCAS COUNTY, OH  
DISTRICT 2

May 2020

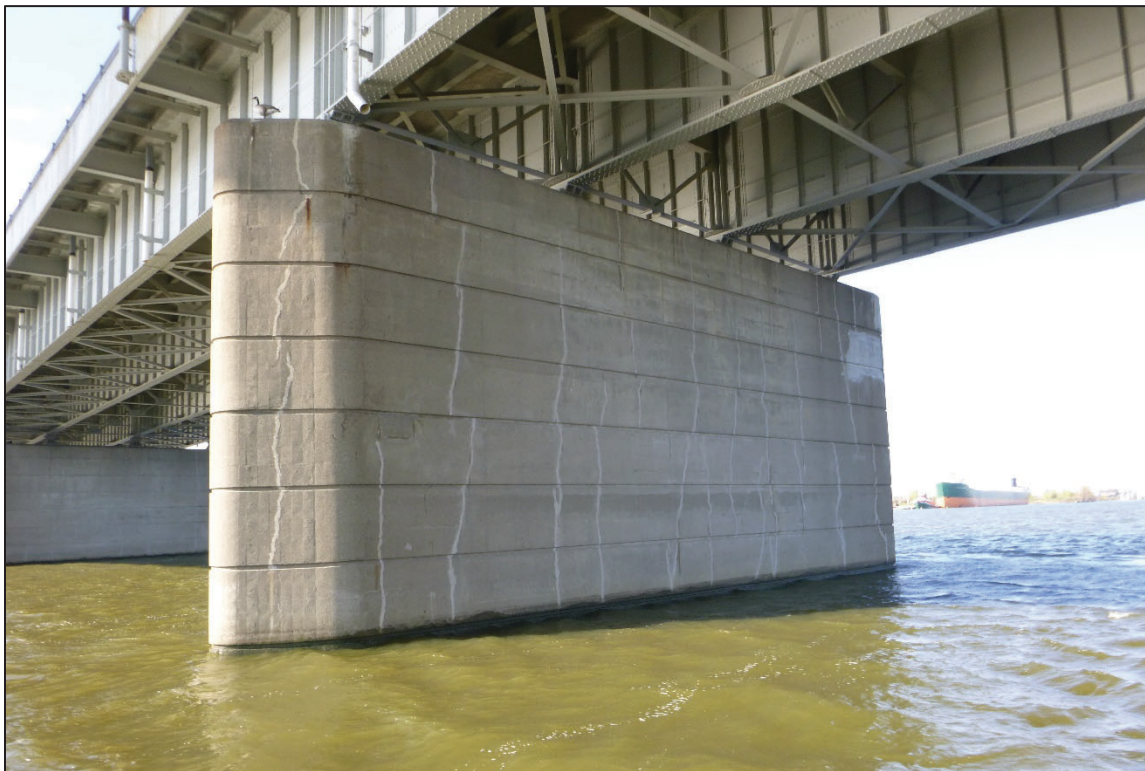
The channel bottom material consisted of sand with silt overlay with 6 to 8 in. of probe rod penetration with scattered cobbles. Scattered spalls were observed on seal concrete measuring up to 1 ft diameter. The submerged portions of the pier exhibited moderate scaling up to 1/4 in. Refer to Figure 8 in Exhibit 1 for detailed inspection notes of Pier 3. Refer to Photographs 12 and 13 in Exhibit 2 for views of Pier 3.

Photograph No. 12: View of the North Face of Pier 3, Looking South.

The spalls at Pier 3 are not structural concerns at this time; however, they should be repaired to prevent further deterioration. The repairs should include removal of unsound concrete to a minimum of 1 in. behind the reinforcing steel, cleaning and replacing reinforcing steel as required, and placing concrete designed to provide high durability with low permeability.

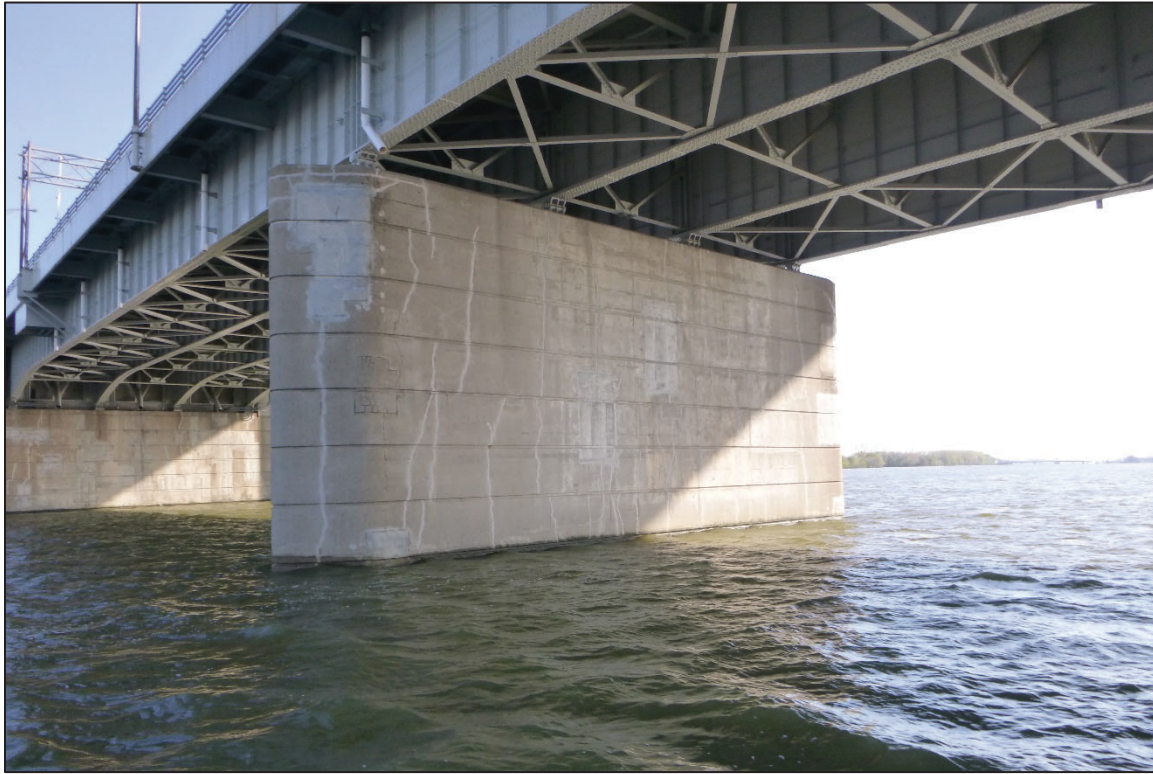
Photograph No. 13: View of the South Face of Pier 3, Looking North.

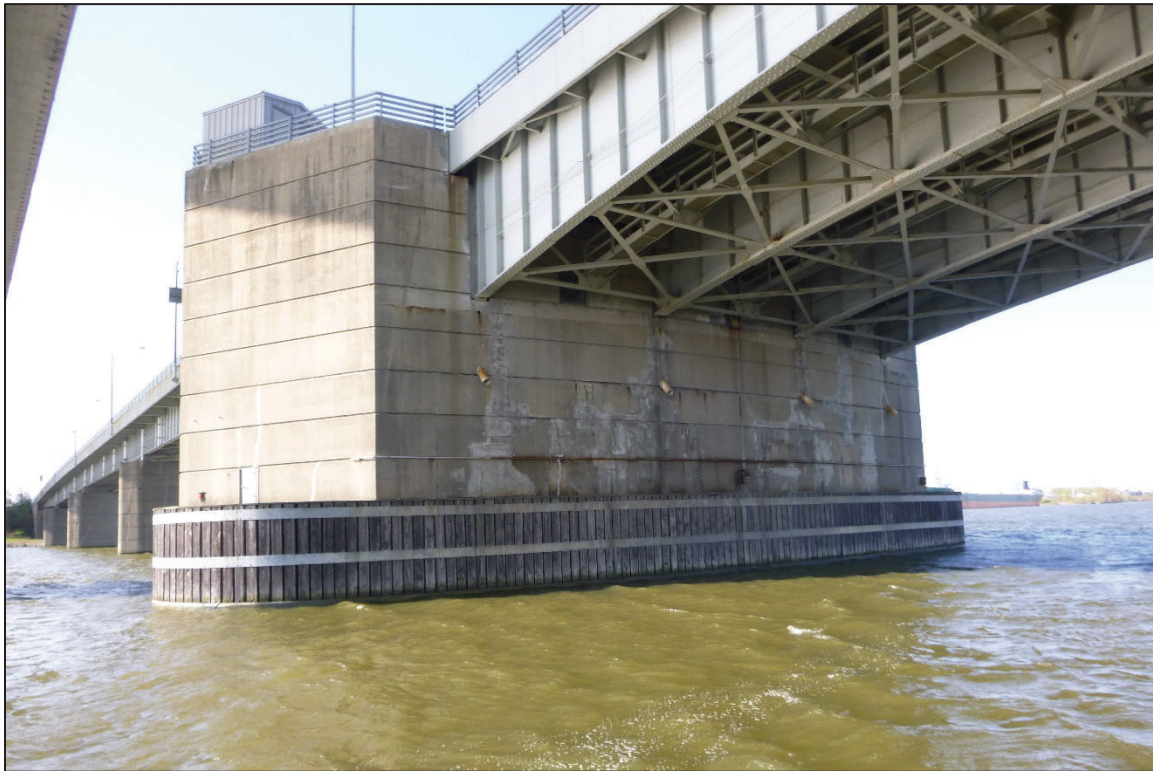
The channel bottom material consisted of sand, gravel, and cobbles with approximately 2 in. probe rod penetration. The submerged portions of the pier were sound and smooth with no defects observed. A band of moderate scaling was observed from -10 ft to -2 ft below the waterline up to 1/4 in. deep. Refer to Figure 9 in Exhibit 1 for detailed inspection notes of Bascule Pier 4. Refer to Photographs 14 and 15 in Exhibit 2 for views of Bascule Pier 4.

Photograph No. 14: View of the North Face of Pier 4, Looking South.

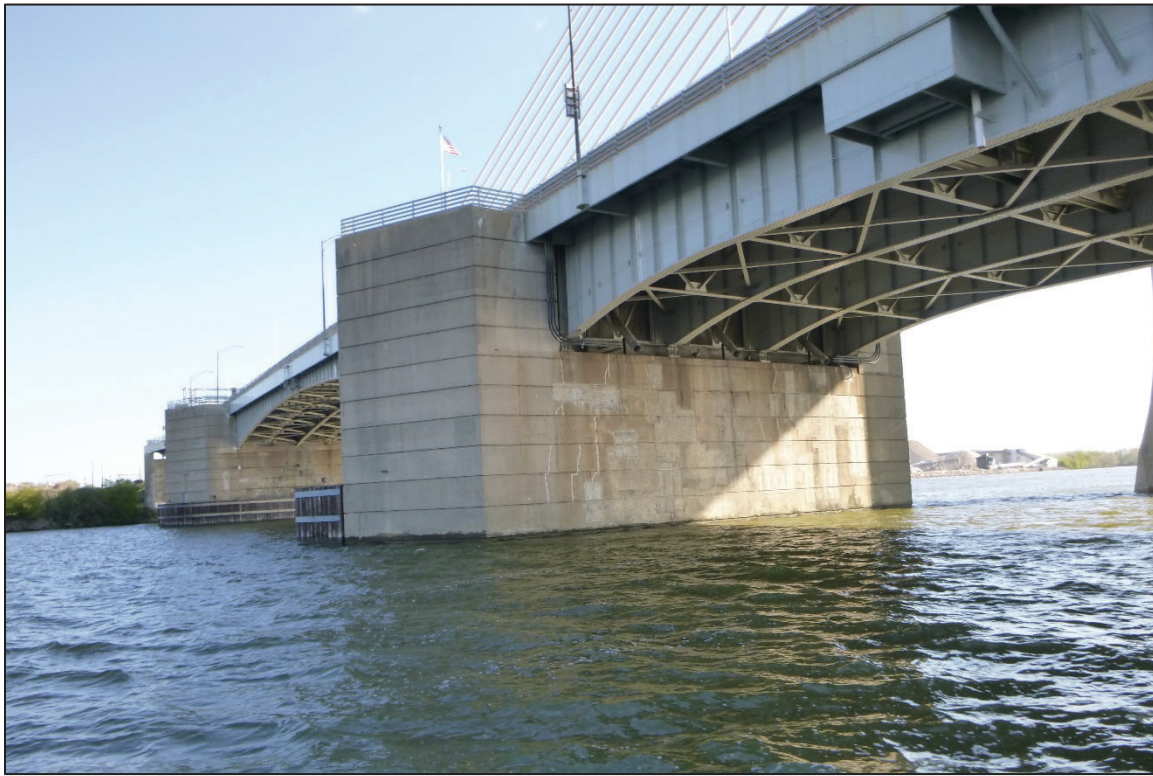
Photograph No. 15: View of the South Face of Bascule Pier 4, Looking North.

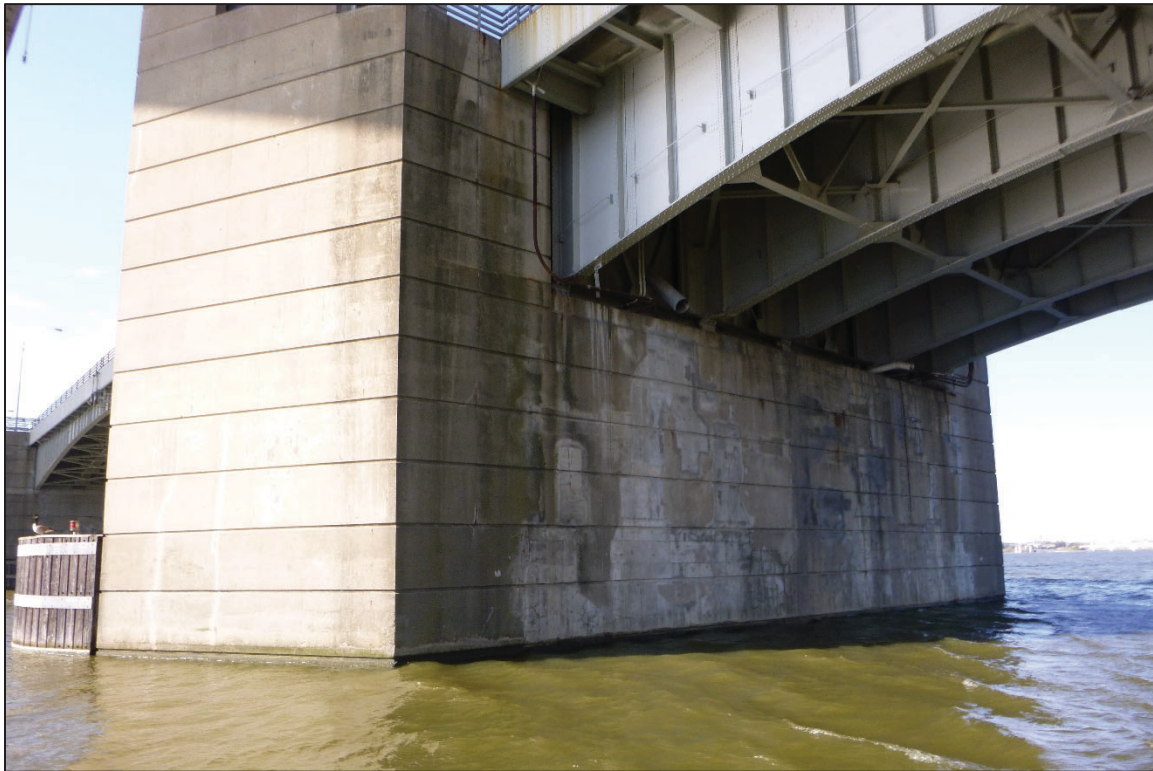
The channel bottom material consisted of scattered riprap up to 12 in. diameter with silt infill with up to 6 in. probe rod penetration. A band of moderate scaling was observed from -10 ft to -2 ft below the waterline up to 1/4 in. deep. Refer to Figure 10 in Exhibit 1 for detailed inspection notes of Bascule Pier 5. Refer to Photographs 16 through 19 in Exhibit 2 for views of Bascule Pier 5, typical concrete condition at the waterline, and typical fender condition at the waterline.

Photograph No. 16: View of the North Face of Bascule Pier 5, Looking South.

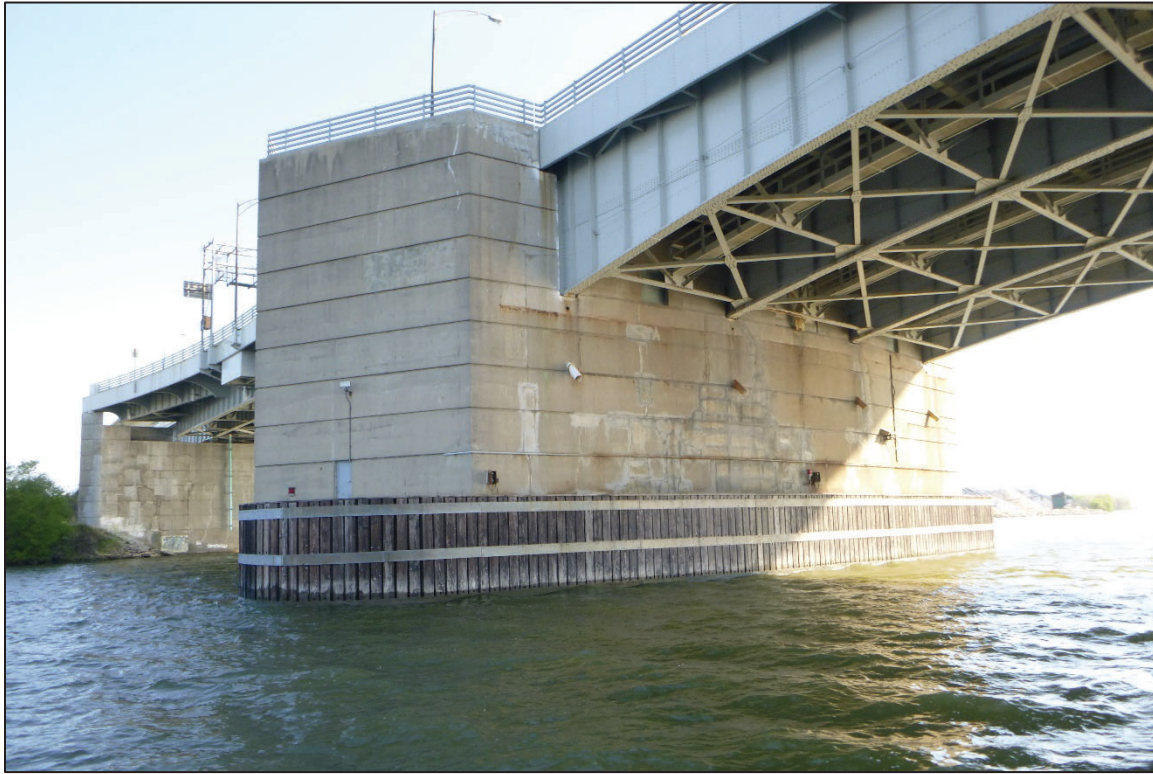
Photograph No. 17: View of the South Face of Bascule Pier 5, Looking North.

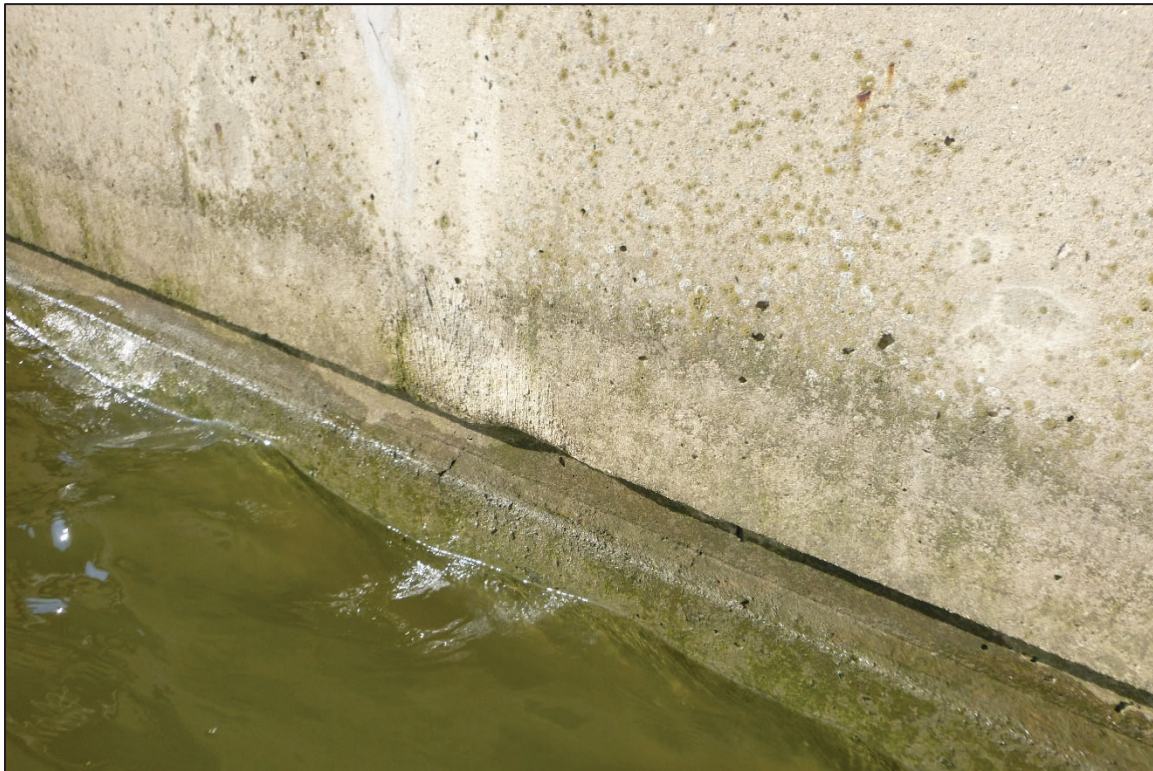
Photograph No. 18: View of the Typical Concrete Condition at the Waterline, Looking Southwest.

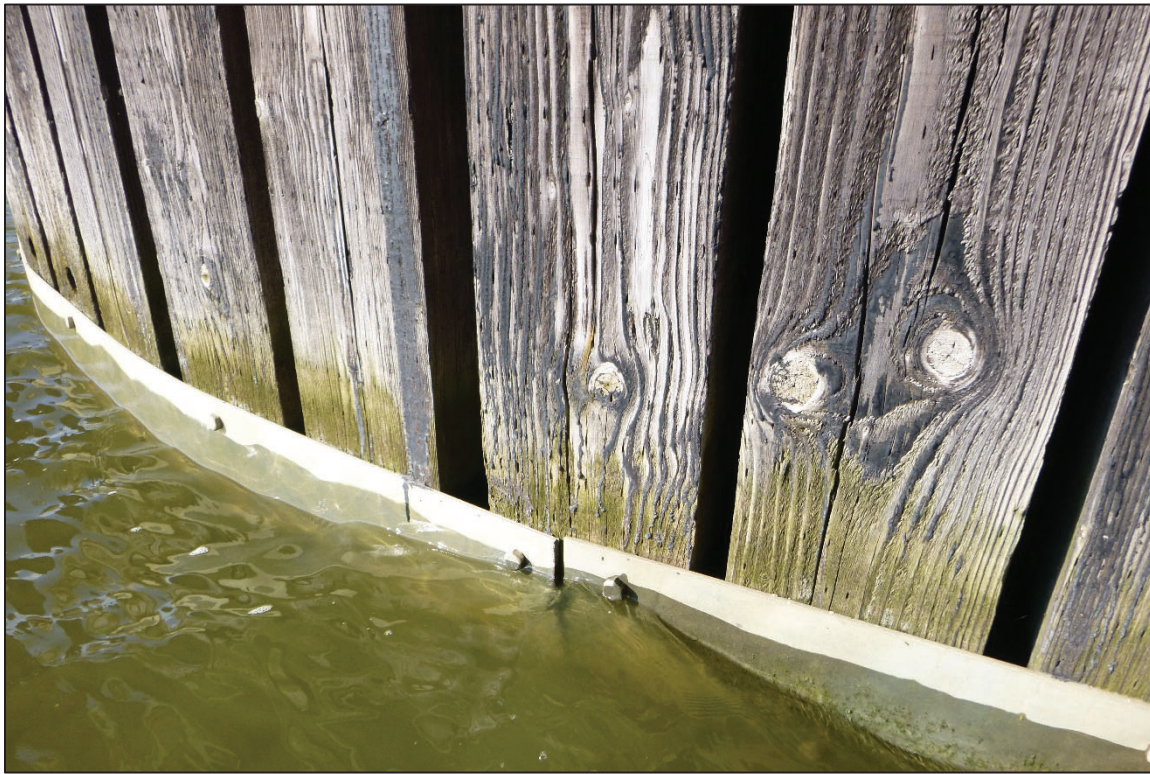
Photograph No. 19: View of the Typical Fender Condition at the Waterline, Looking Southwest.
