UNDERWATER BRIDGE INSPECTION REPORT

STRUCTURE NO. 4808428 (LUC-475-1503)
SANITARY SEWER UNDER I-475 EB
LUCAS COUNTY, OH
DISTRICT 2

May 2020

COLLINS
ENGINEERS INC.

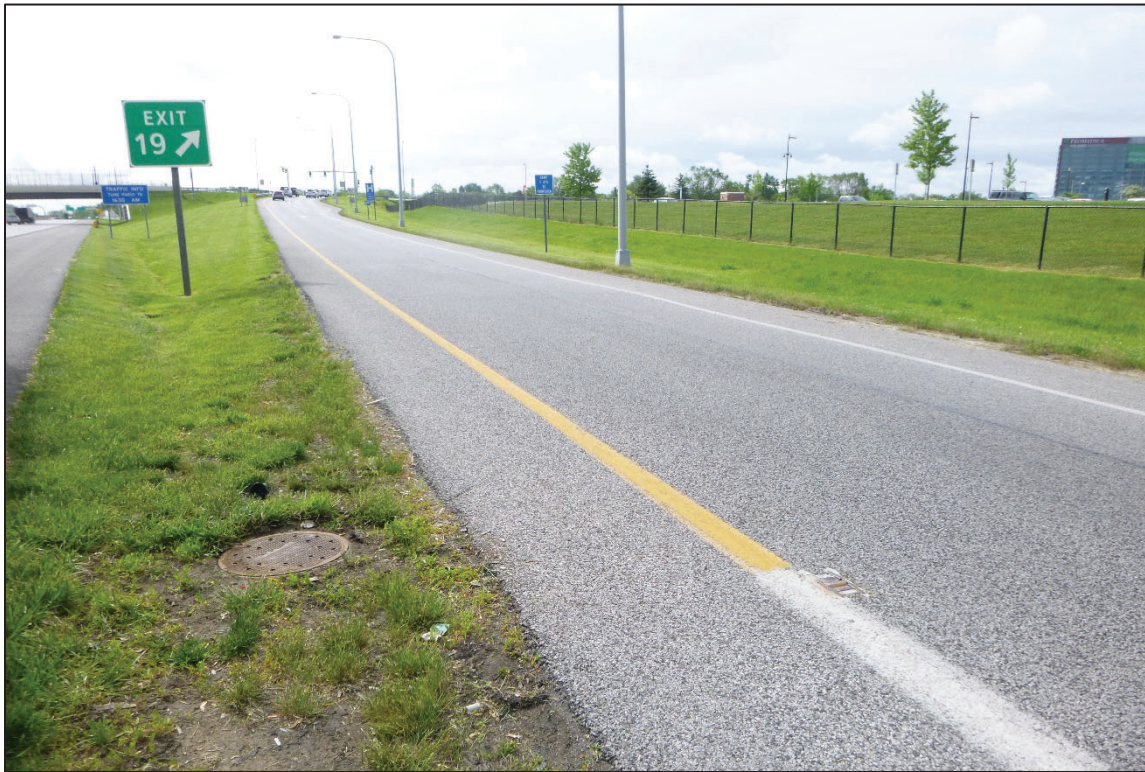
Photograph No. 1: Overall View of Access Location for Structure No. 4808428 (LUC-475-1503), Looking East.

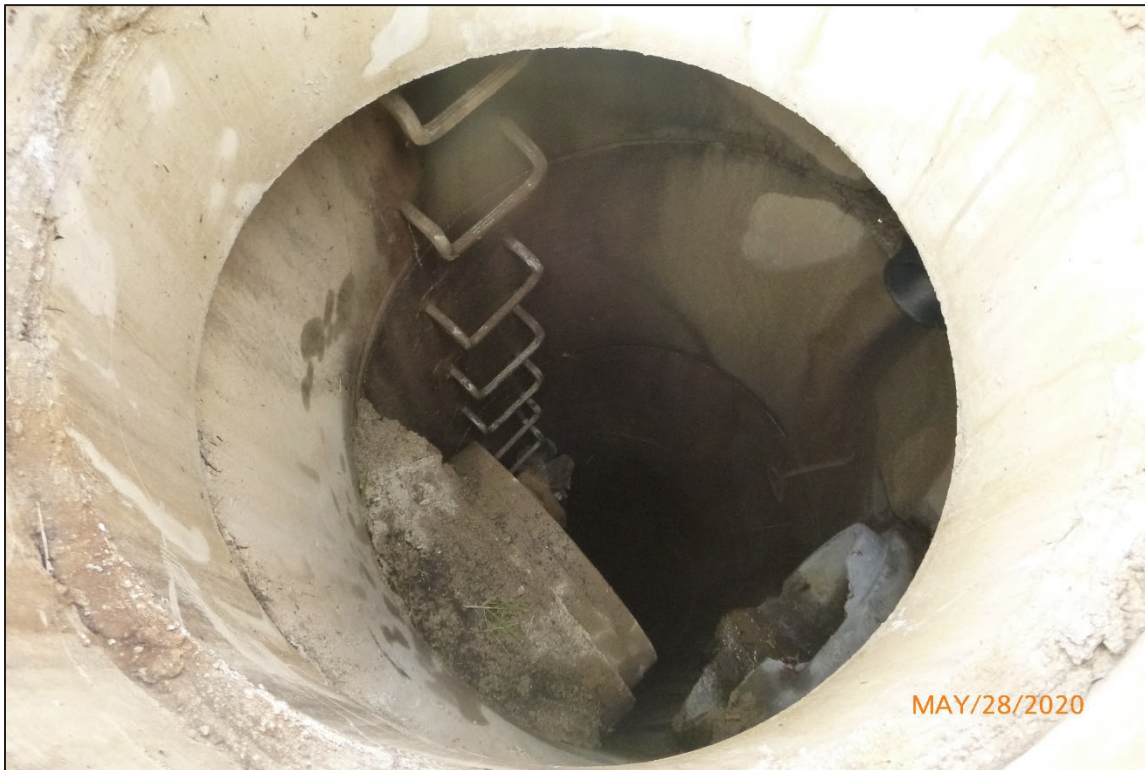
Photograph No. 2: Overall View of Manhole for Structure No. 4808428 (LUC-475-1503), Looking East.

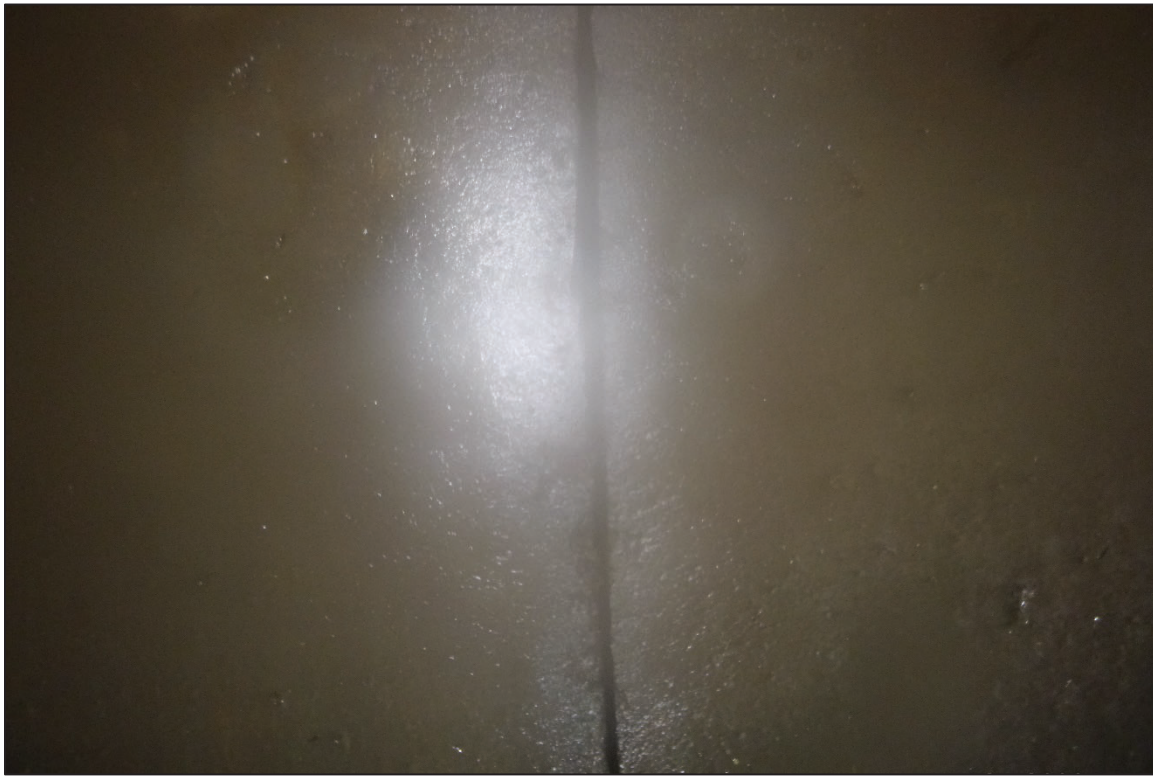
The storm sewer pipe exhibited light scaling up to 1/8 in deep and light marine growth along the bottom surface. Random areas of 4 in. diameter by 1/8 in. popouts were observed along the length of the pipe. Random areas of minor joint sealant failure were observed. No moisture leakage was detected. No significant defects that require attention were documented. Refer to Figure 3 in Exhibit 1 for design drawings for the storm sewer. Refer to Photographs 3 and 4 in Exhibit 2 for views of typical joint condition and typical concrete condition.

Photograph No. 3: View of the Typical Joint Condition, Looking South.

- Monitor minor popouts.
- Monitor joint sealant deterioration.

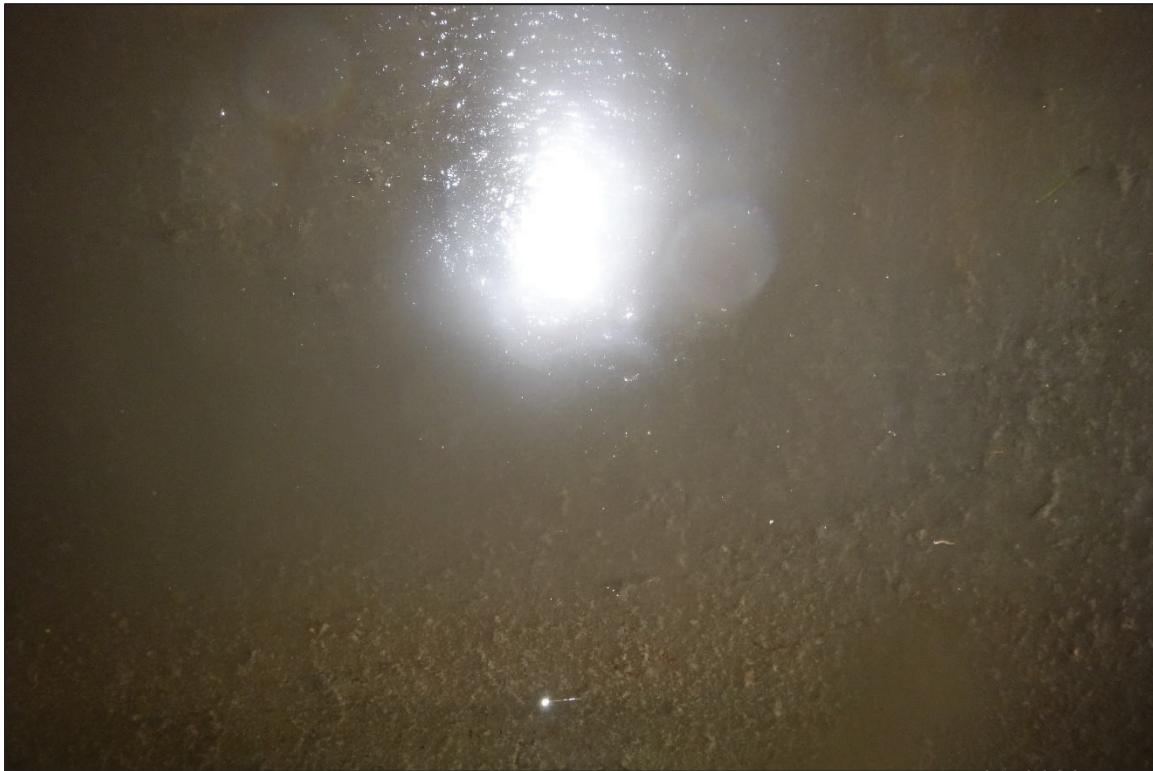
Photograph No. 4: View of the Typical Concrete Condition, Looking South.
