UNDERWATER BRIDGE INSPECTION REPORT

STRUCTURE NO. 4808479 (LUC-475-1538)
SANITARY SEWER UNDER RAMP TO I-475 EB
LUCAS COUNTY, OH
DISTRICT 2

May 2020

COLLINS
ENGINEERS INC.

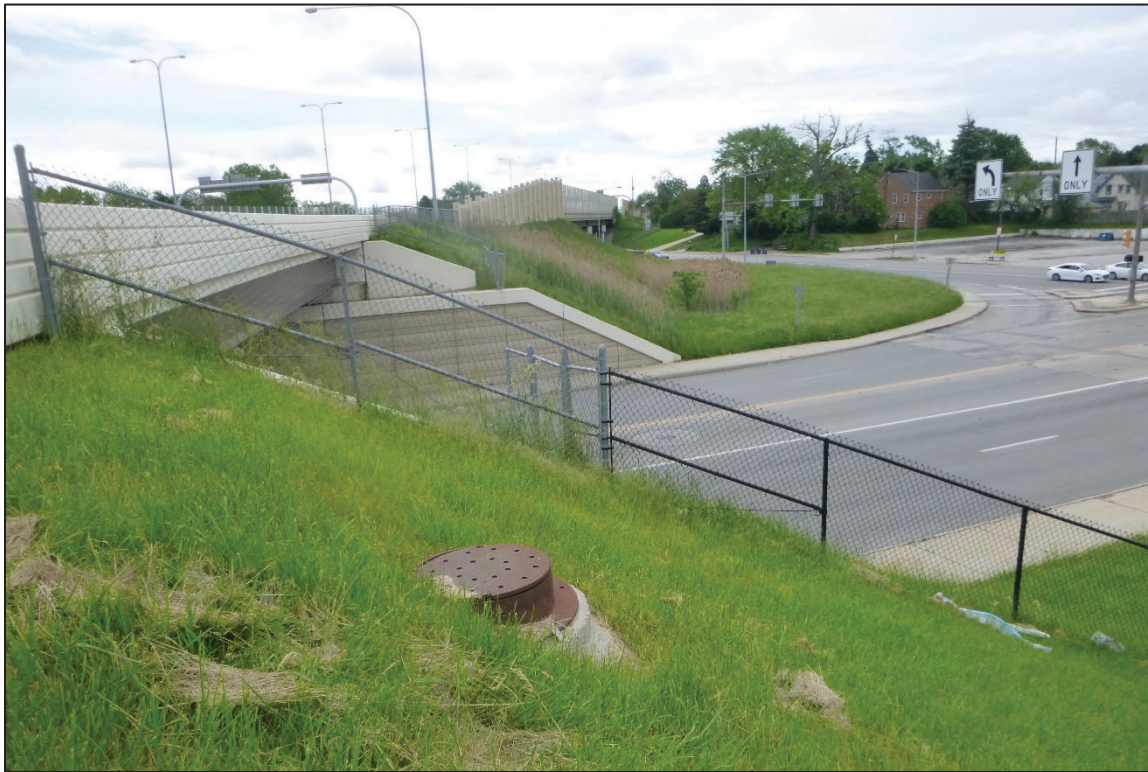
Photograph No. 1: Overall View of Access Location for Structure No. 4808479 (LUC-475-1538), Looking East.

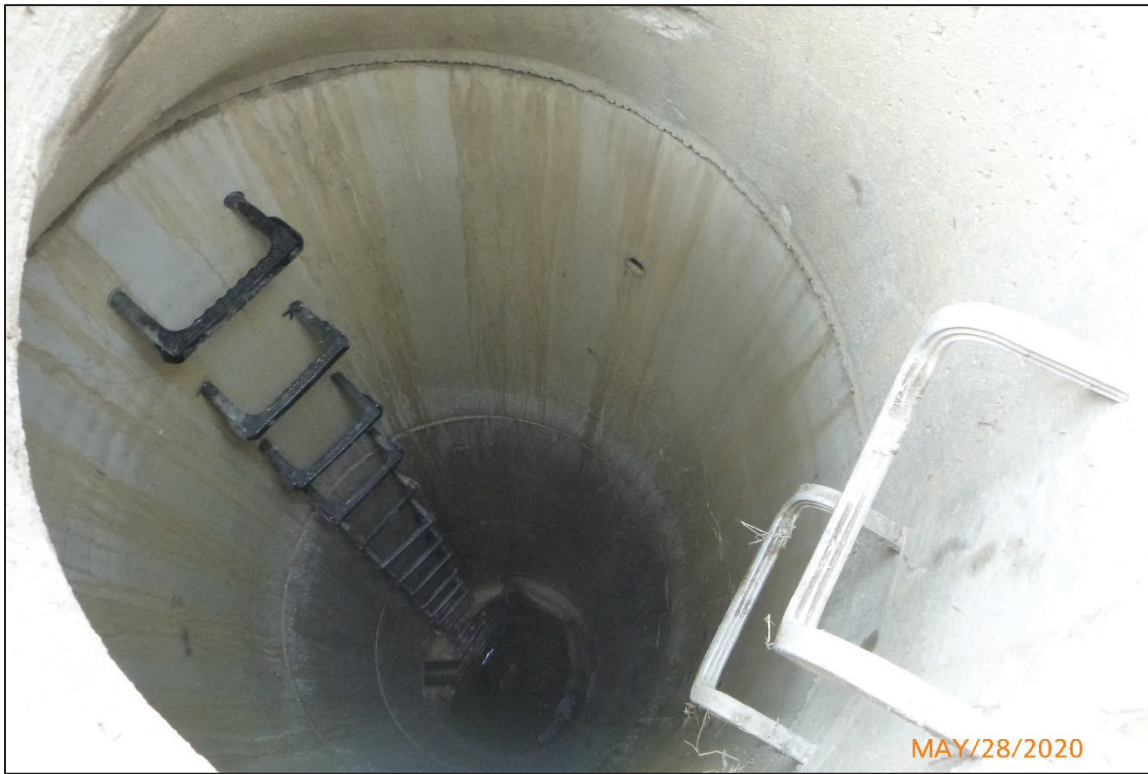
Photograph No. 2: Overall View of Manhole for Structure No. 4808479 (LUC-475-1538), Looking East.

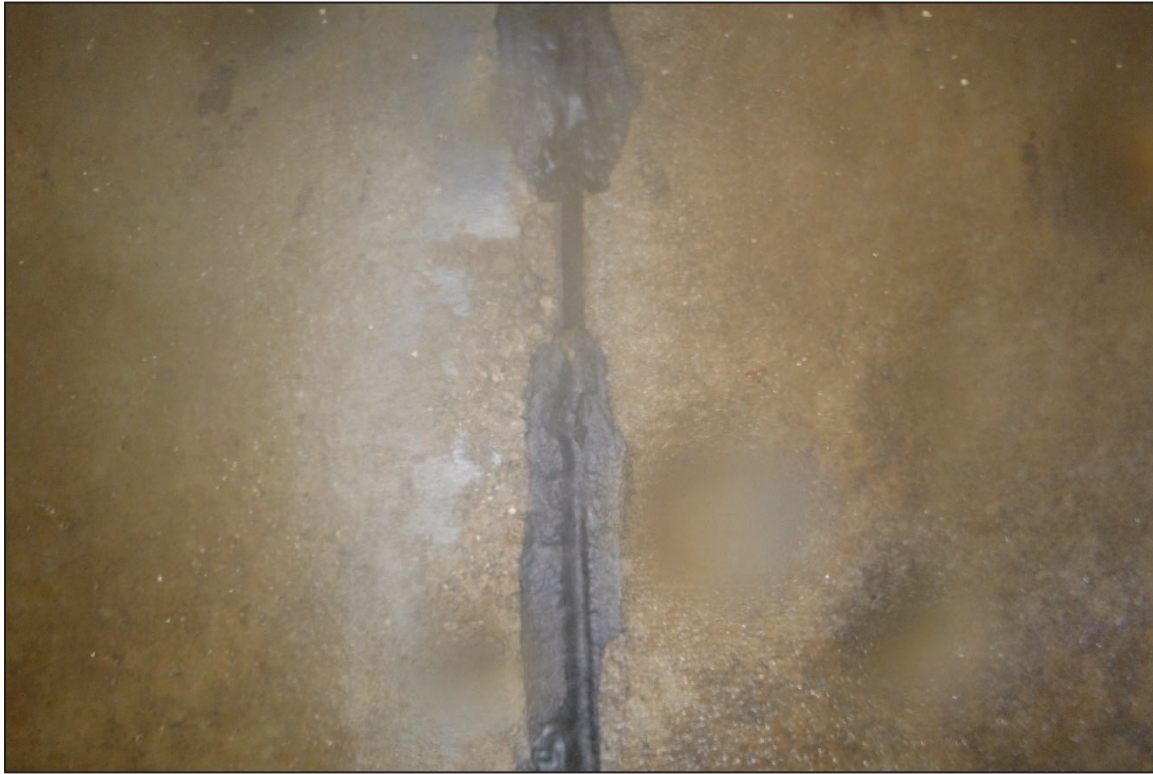
The storm sewer pipe exhibited light scaling up to 1/8 in deep and light marine growth along the bottom surface. Random areas of 4 in. diameter by 1/8 in. popouts were observed along the length of the pipe. Random areas of minor joint sealant failure were observed. No moisture leakage was detected. No significant defects that require attention were documented. Refer to Figure 3 in Exhibit 1 for design drawings for the storm sewer. Refer to Photographs 3 and 4 in Exhibit 2 for views of typical joint condition and typical concrete condition.

Photograph No. 3: View of the Typical Joint Condition, Looking South.

- Monitor minor popouts.
- Monitor joint sealant deterioration.

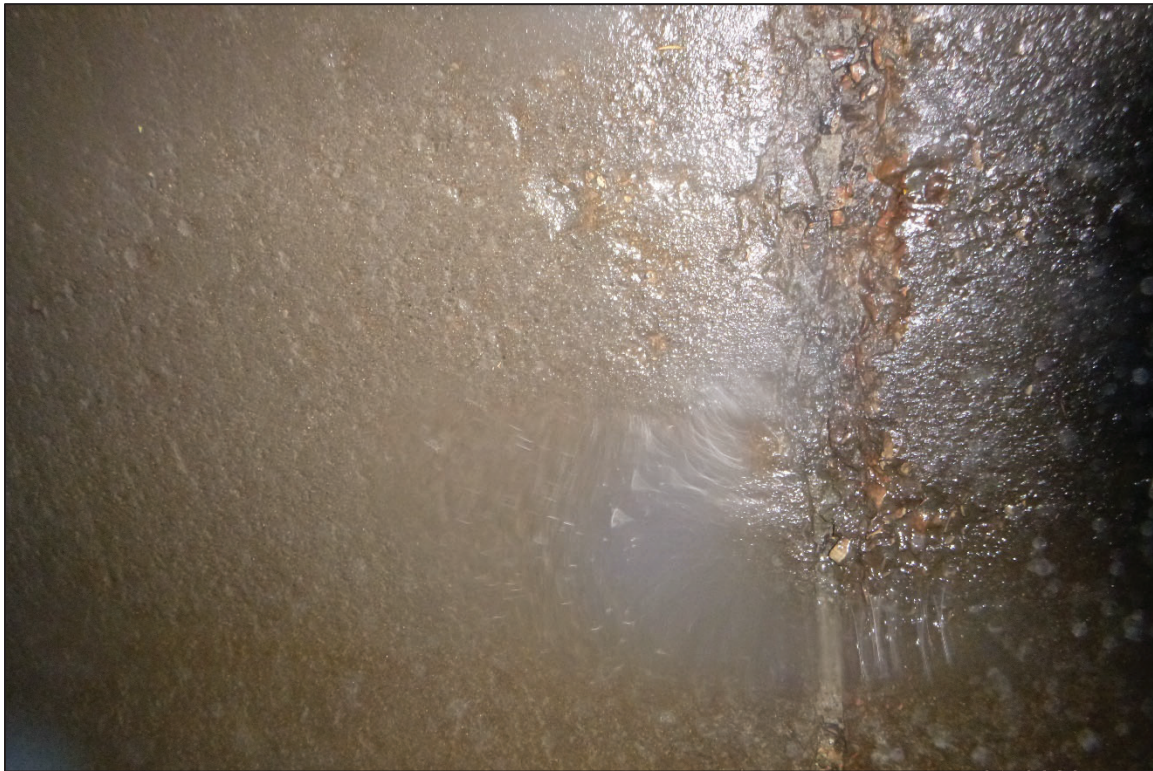
Photograph No. 4: View of the Typical Concrete Condition, Looking South.
