UNDERWATER BRIDGE INSPECTION REPORT

STRUCTURE NO. 6200044 (OTT-2-0016)
SR 2 OVER CRANE CREEK
OTTAWA COUNTY, OH
DISTRICT 2

April 2020

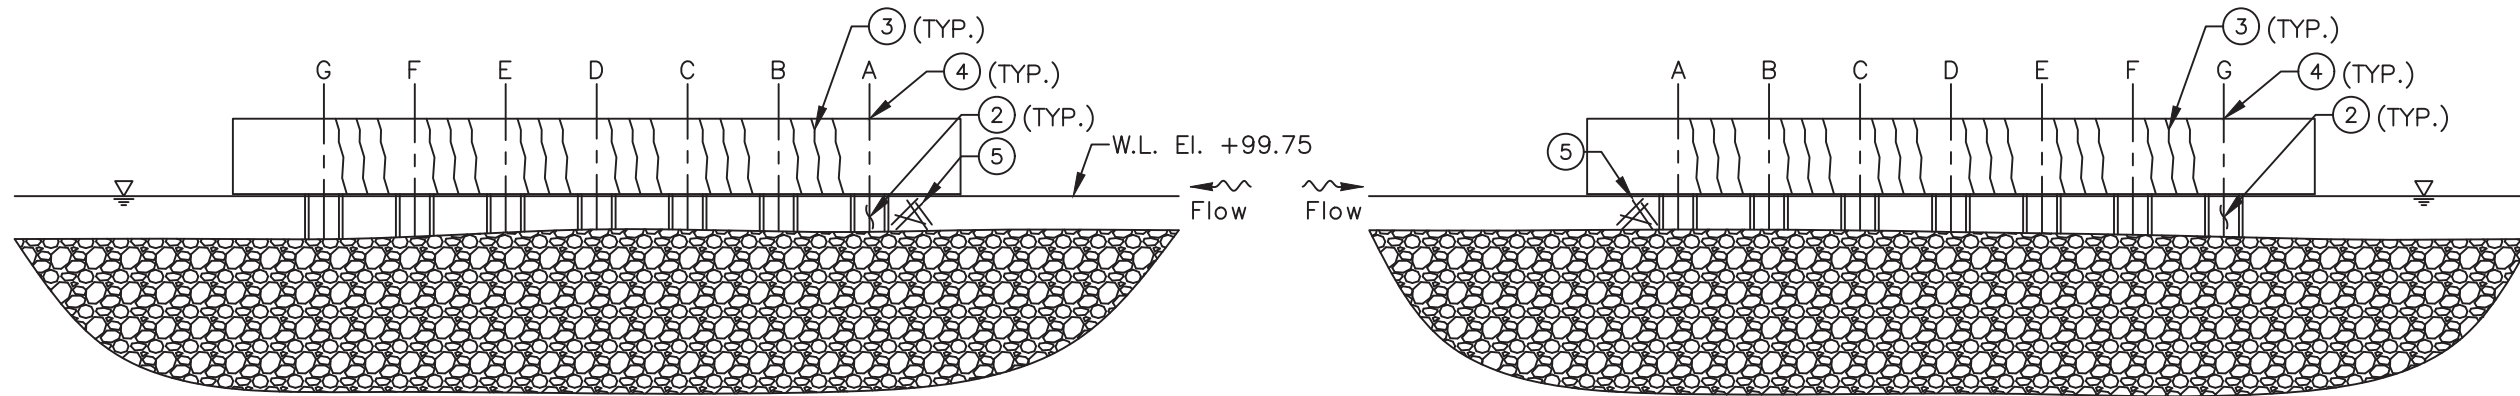
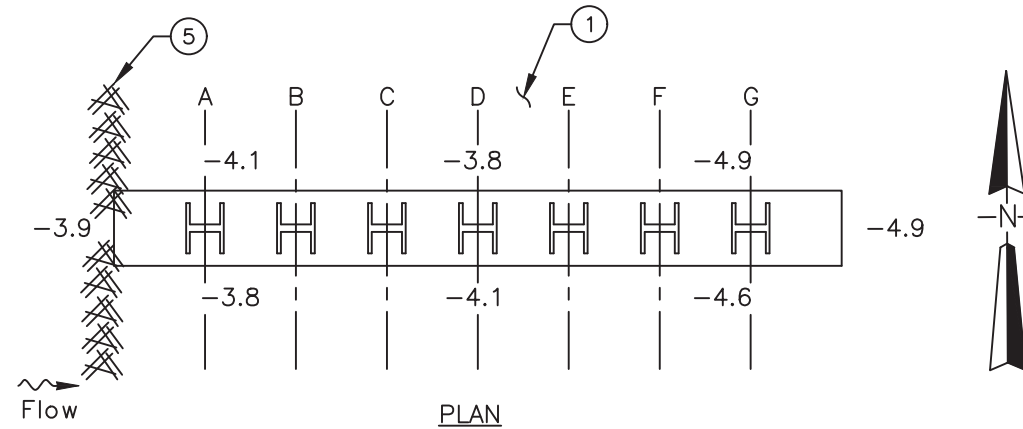
BENT 1

- ① The channel bottom material consisted of very light marine growth, rocks, and clay with approximately 2 in. probe rod penetration.
- ② Typical steel H-piles were in good condition with no defects noted.
- ③ Hairline cracks were observed throughout the bent cap at full height.
- ④ A crack measuring 1/4 in. was observed on the top of diaphragm.
- ⑤ Light timber debris consisting of branches up to 3 in. diameter was observed on the upstream nose extending up to 5 ft from both faces from the channel bottom to the waterline.

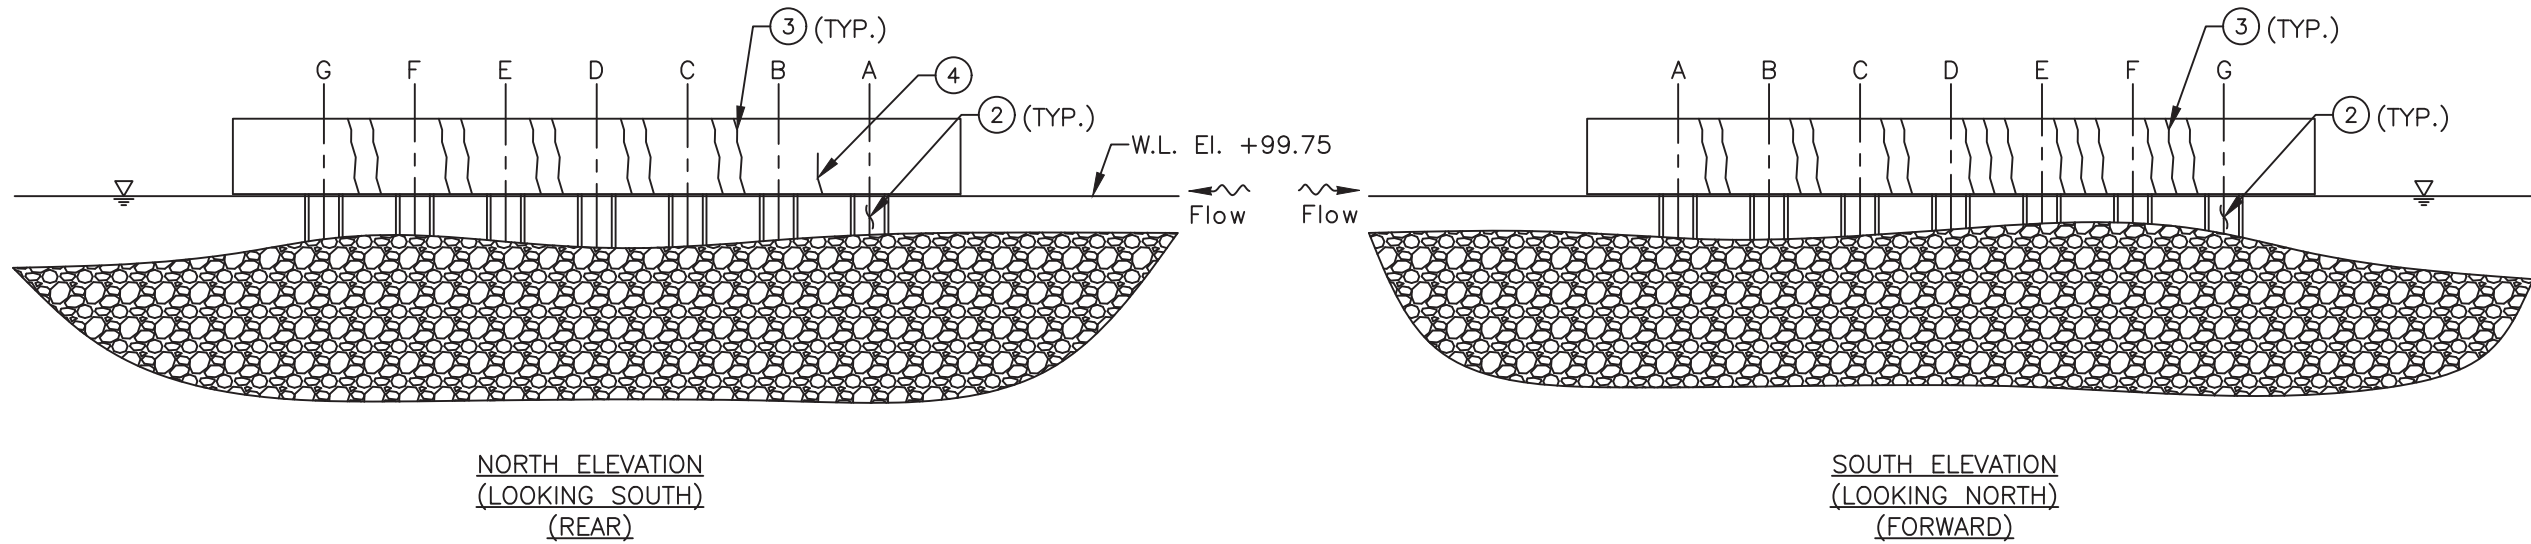
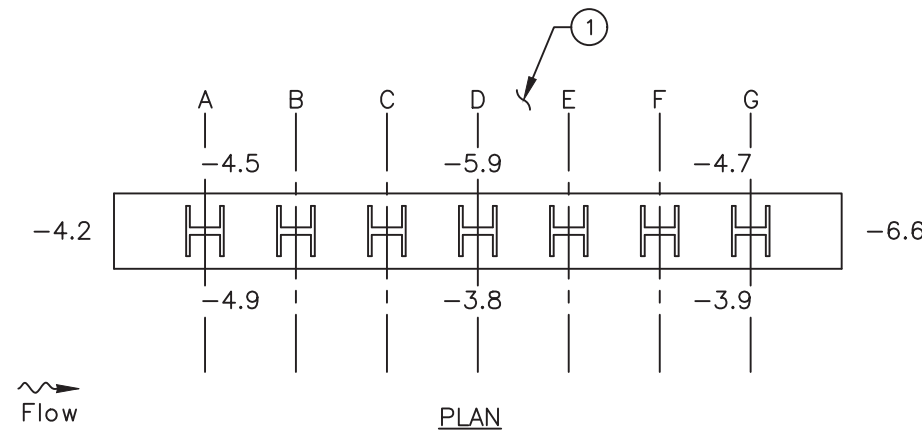
BENT 2

- ① The channel bottom material consisted of very light marine growth, rocks, and clay with approximately 2 in. probe rod penetration.
- ② Typical steel H-piles were in good condition with no defects noted.
- ③ Hairline cracks were observed throughout the bent cap at full height.
- ④ A hairline crack was observed measuring 2 in. long on the north bent cap between H-Piles A and B.

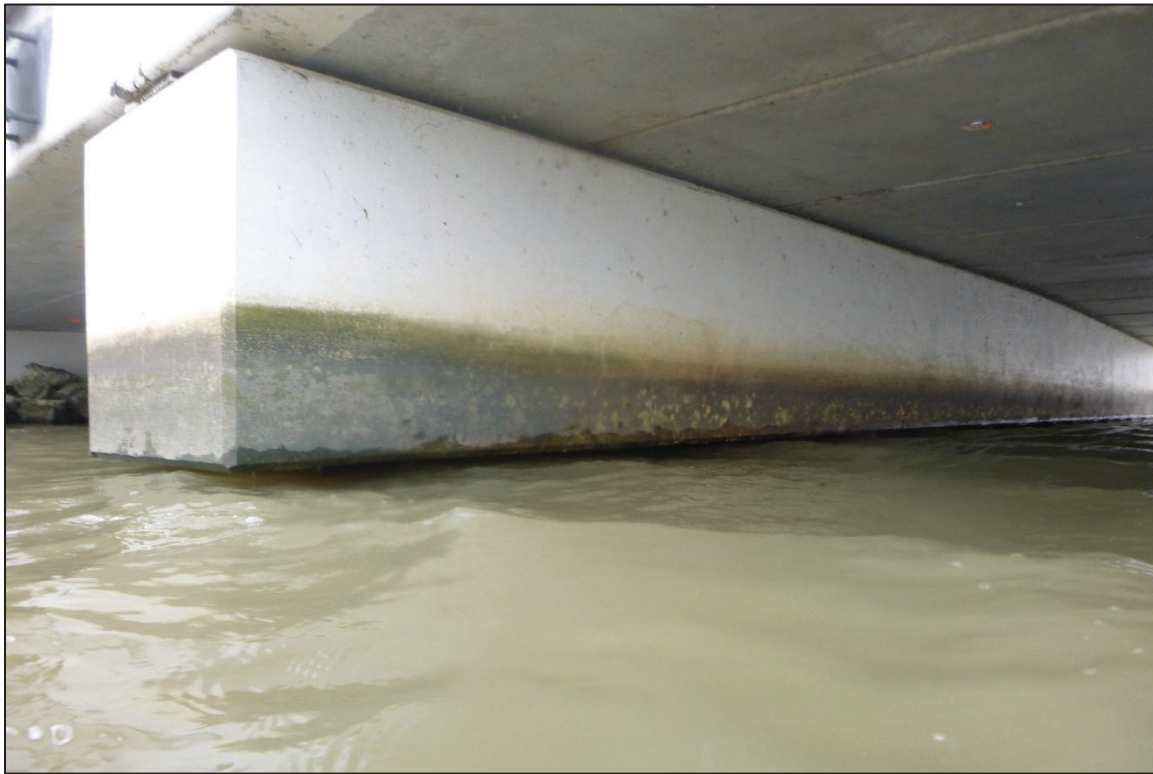
The channel bottom material consisted of very light marine growth, rocks, and clay with approximately 2 in. probe rod penetration. Typical steel H-piles were in good condition with no defects noted. Hairline cracks were observed throughout the bent cap at full height. A crack measuring 1/4 in. was observed on the top of diaphragm. Refer to Figure 6 in Exhibit 1 for detailed inspection notes of Bent 1. Refer to Photographs 9 and 10 in Exhibit 2 for views of Bent 1.

Photograph No. 9: View of the North Face of Bent 1, Looking Southwest.

The cracking observed on Bents 1 and 2 are not a structural concern at this time given its size compared to the overall pier size, and as a result, no repairs are recommended. This area should be monitored during future inspections for increasing extent or severity of the cracking and exposure of reinforcing steel. If the extent or severity of the cracking is observed to be increasing or reinforcing steel becomes exposed, it may be necessary to repair the area at that time.

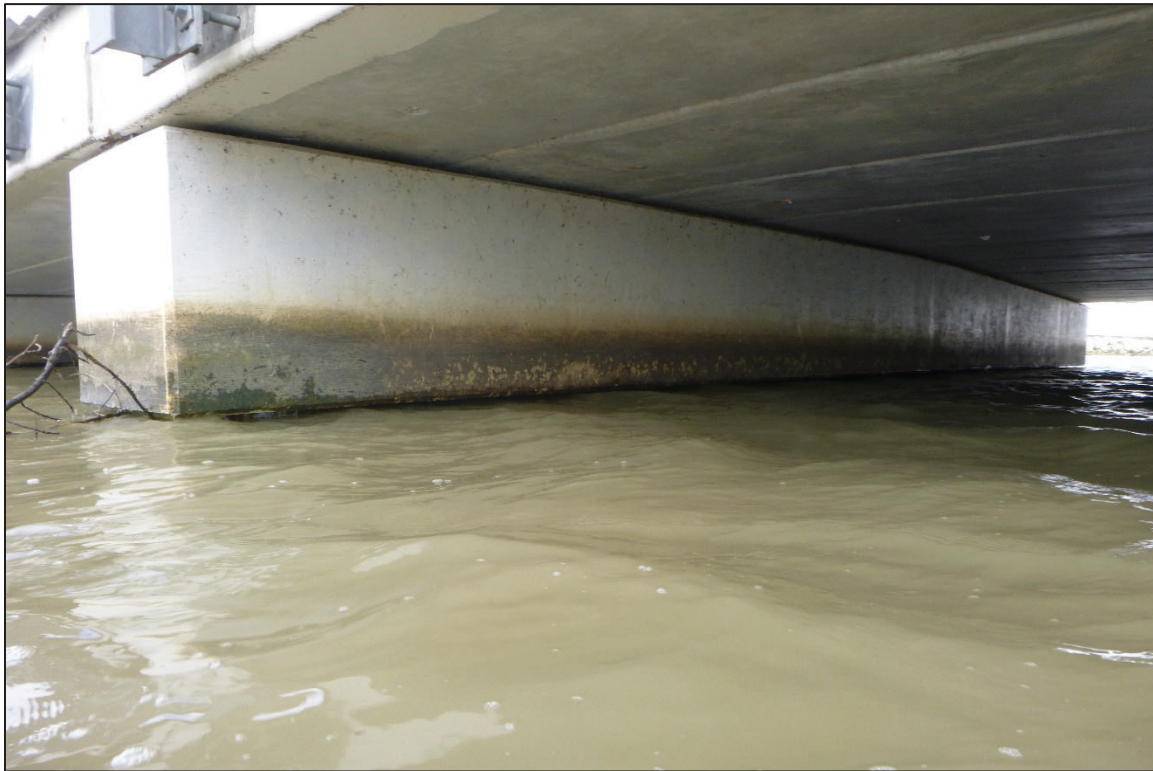
Photograph No. 10: View of the South Face of Bent 1, Looking Northeast.

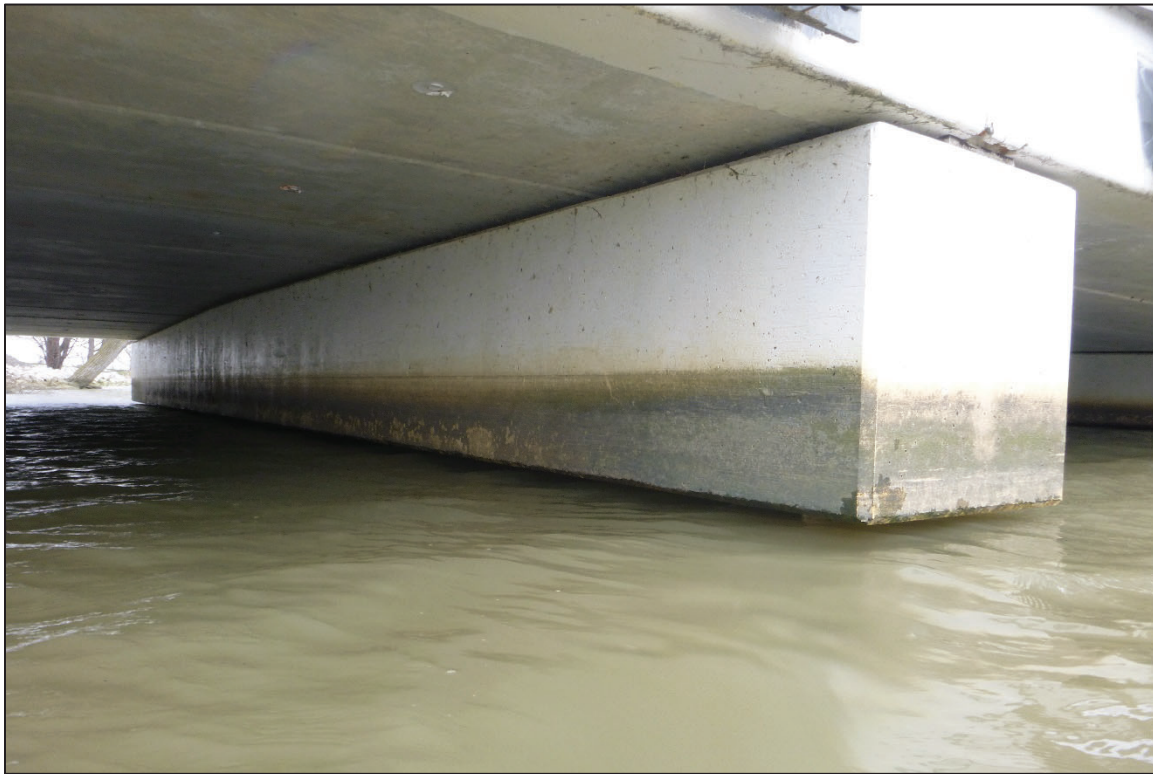
The channel bottom material consisted of very light marine growth, rocks, and clay with approximately 2 in. probe rod penetration. Typical steel H-piles were in good condition with no defects noted. Hairline cracks were observed throughout the pier cap at full height. A hairline crack was observed measuring 2 in. long on the north bent cap between H-Piles A and B. Refer to Figure 7 in Exhibit 1 for detailed inspection notes of Bent 2. Refer to Photographs 11 through 13 in Exhibit 2 for views of Bent 2 and typical concrete condition at the waterline.

Photograph No. 11: View of the North Face of Bent 2, Looking Southeast.

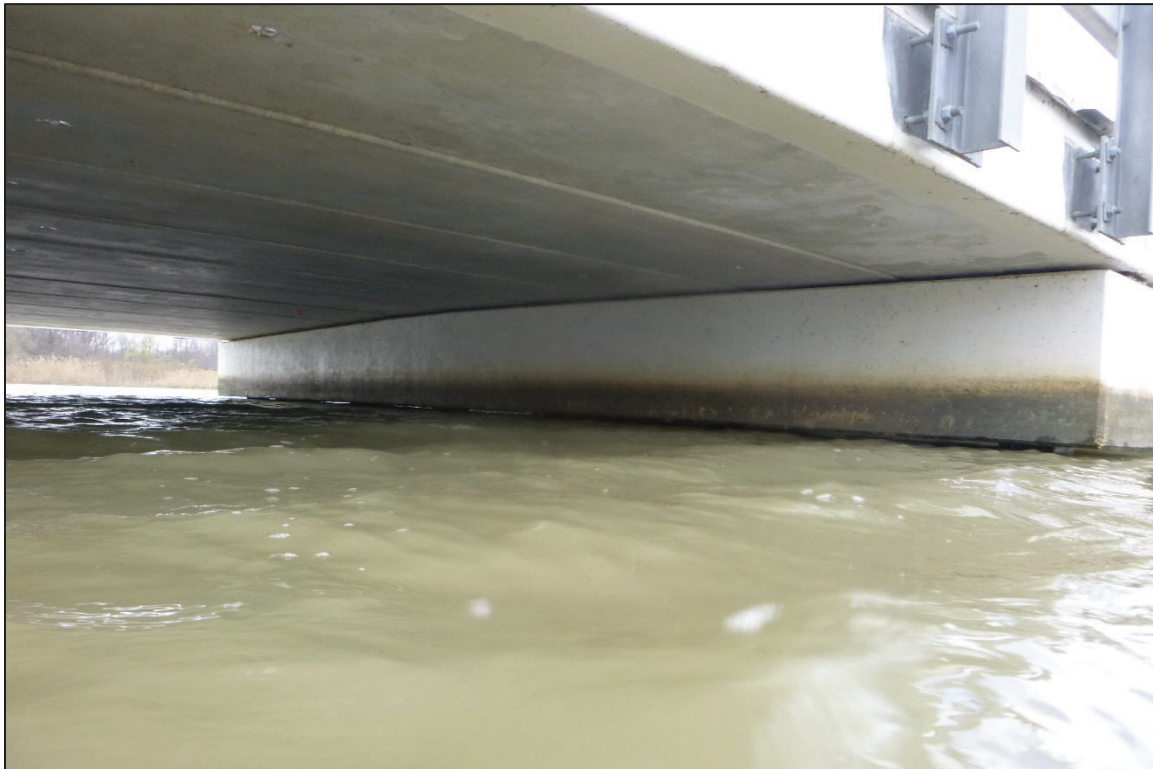
Photograph No. 12: View of the South Face of Bent 2, Looking Northwest.

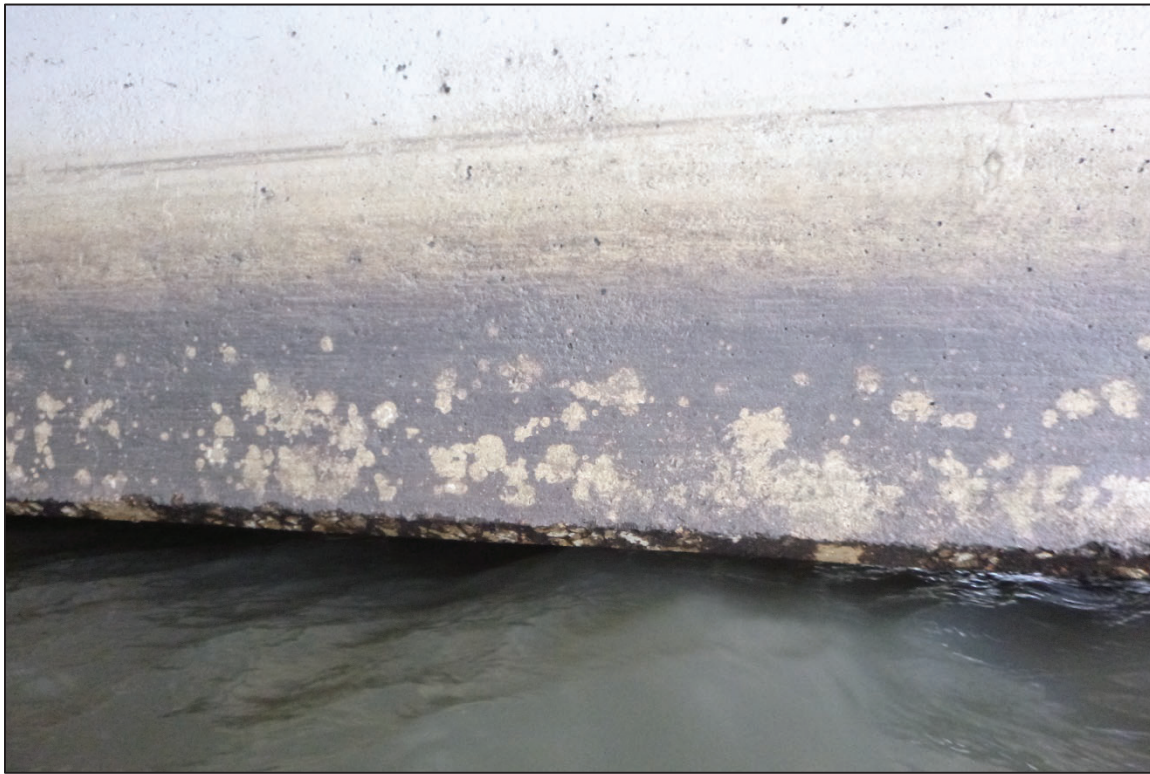
Photograph No. 13: View of the Typical Concrete Condition at the Waterline, Looking South.
