# UNDERWATER BRIDGE INSPECTION REPORT

STRUCTURE NO. 6200109 (OTT-2-0667)  
SR 2 OVER TURTLE CREEK  
OTTAWA COUNTY, OH  
DISTRICT 2

April 2020

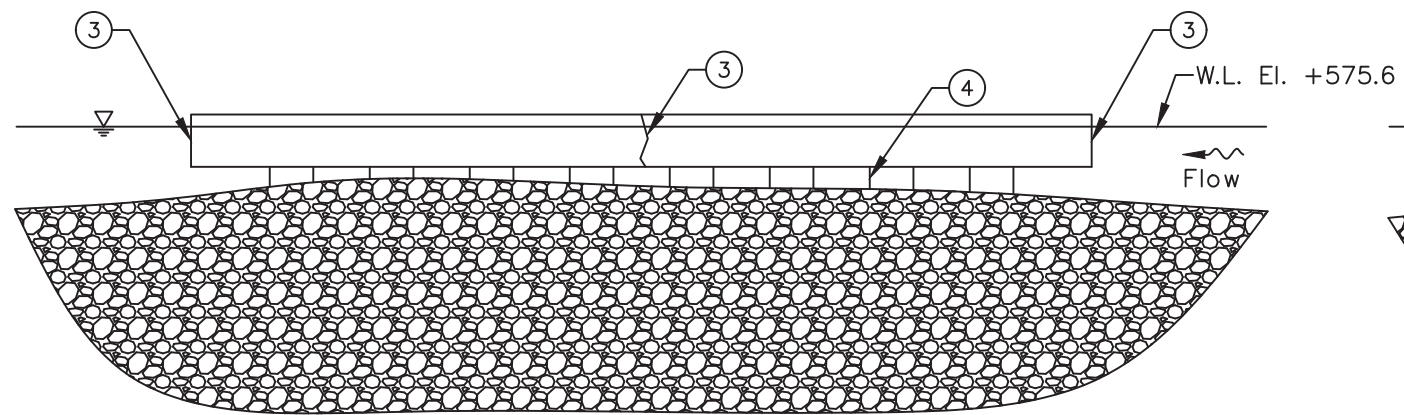
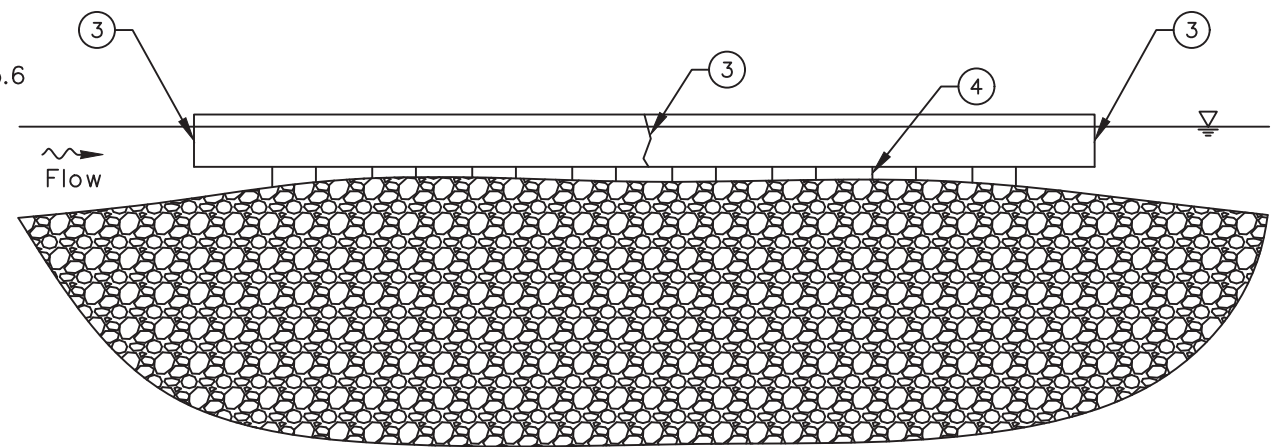
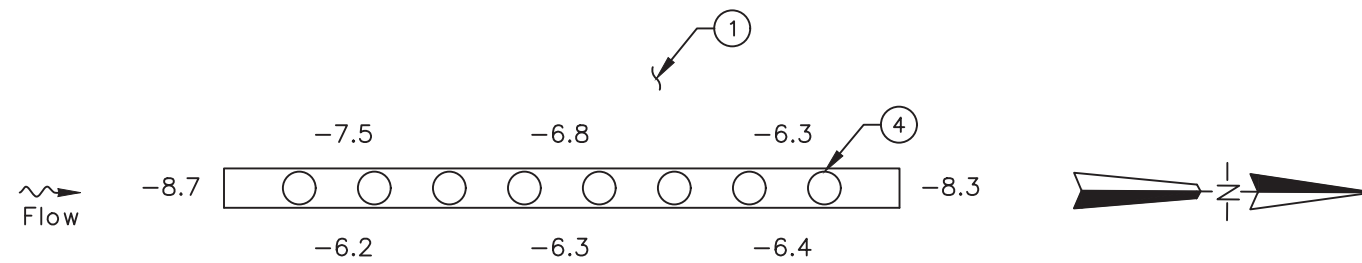
- ① The channel bottom material consisted of riprap up to 24 in. diameter with sand infill.
- ② The submerged portions of the pier were sound and smooth with no defects observed.
- ③ Full-depth hairline cracks were observed at the midpoint on the north, south, west, and east faces of the bent cap.
- ④ Typical steel condition exhibited light surface corrosion with pitting up to 1/32 in. deep.

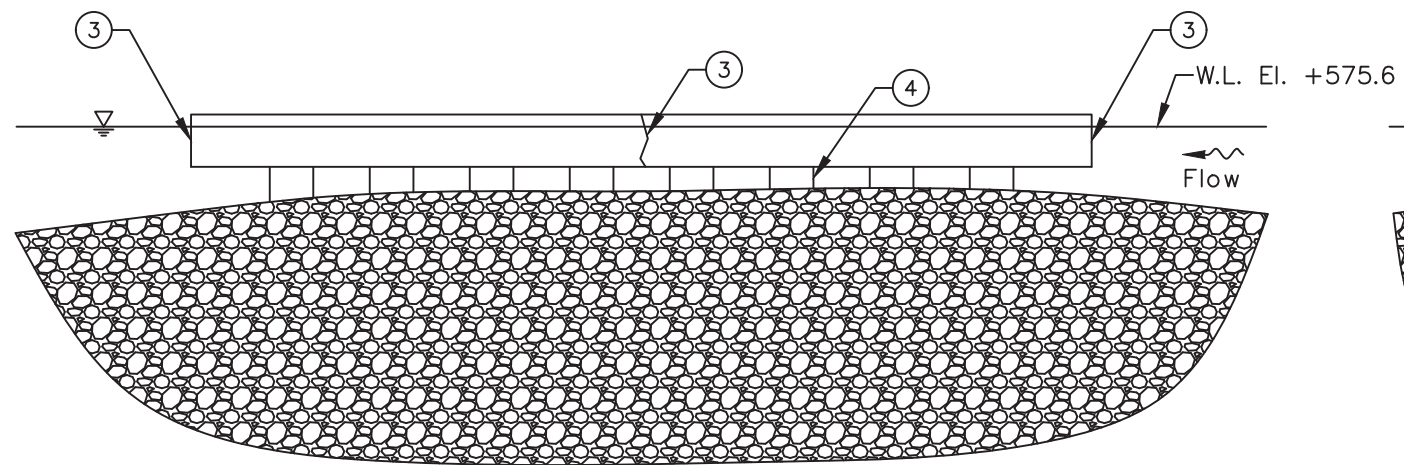
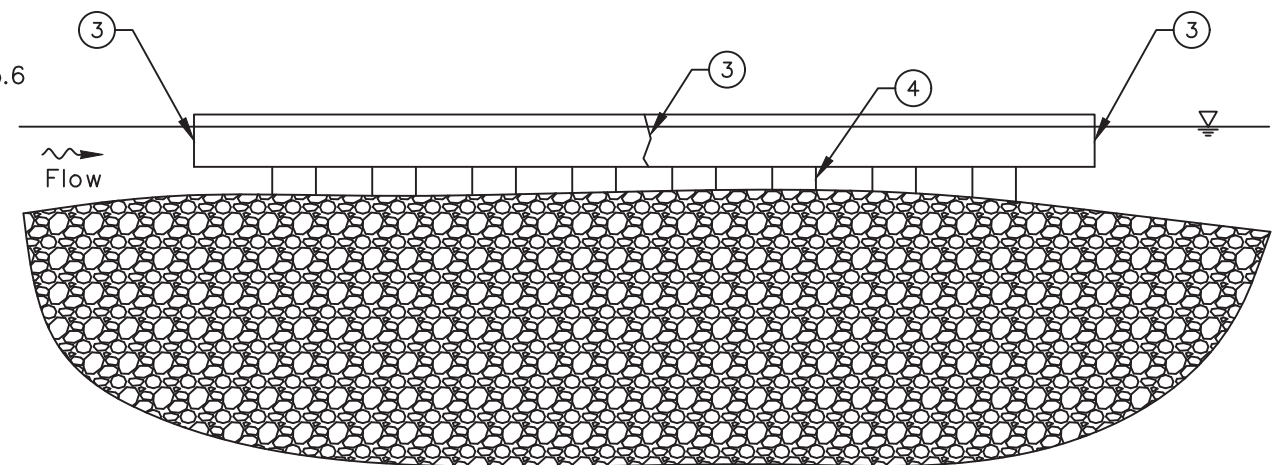
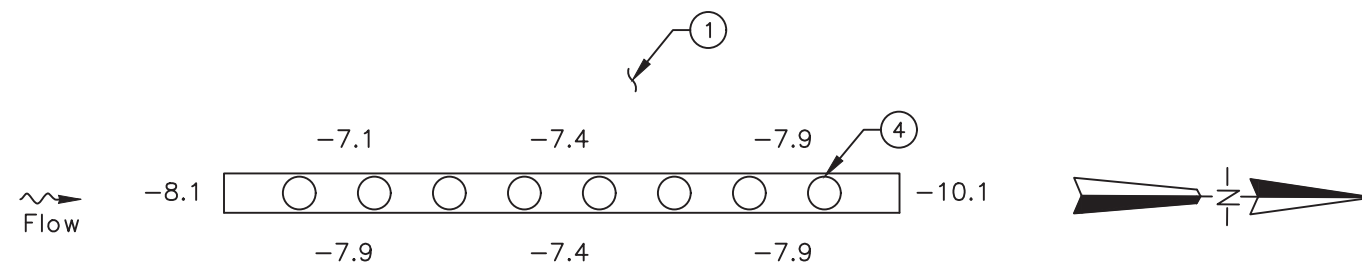
SR-2 OVER TURTLE CREEK  
 STRUCTURE NO. 6200109 (OTT-2-0667)  
 BENT 2  
 OTTAWA COUNTY, OHIO

- ① The channel bottom material consisted of riprap up to 24 in. diameter with sand infill.
- ② The submerged portions of the pier were sound and smooth with no defects observed.
- ③ Full-depth hairline cracks were observed at the midpoint on the north, south, west, and east faces of the bent cap.
- ④ Typical steel condition exhibited light surface corrosion with pitting up to 1/32 in. deep.

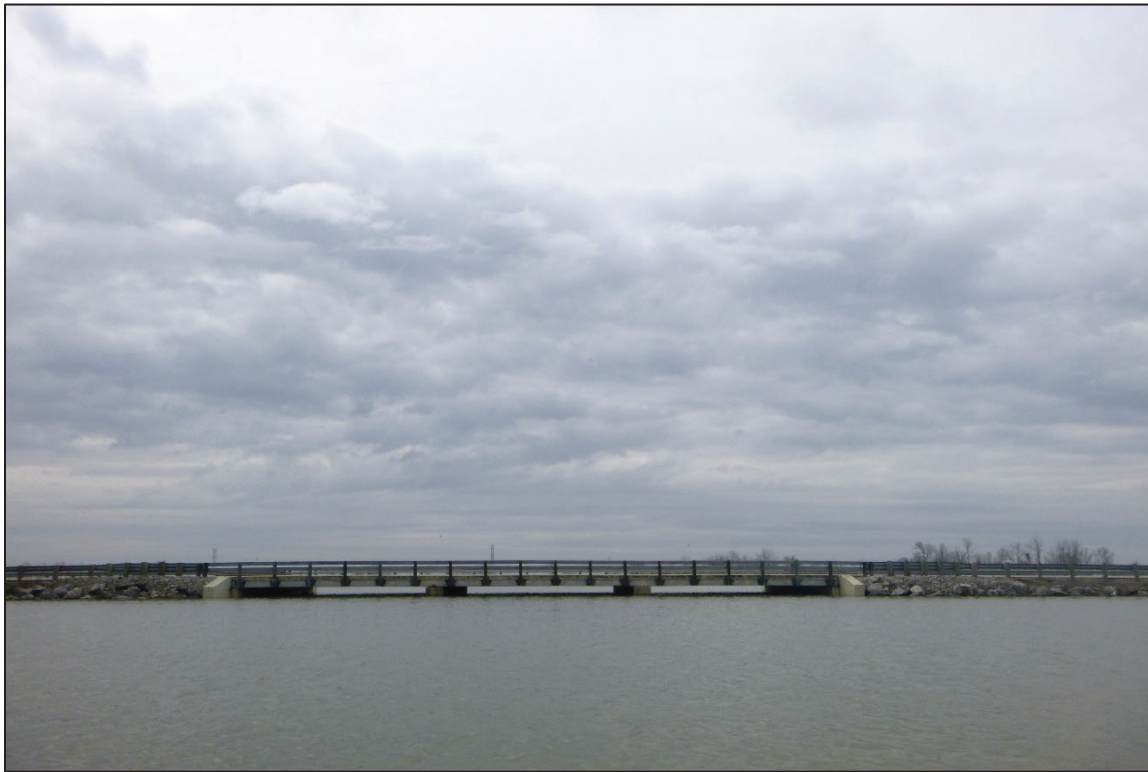
Photograph No. 1: Overall View of Structure No. 6200109 (OTT-2-0667), Looking South.

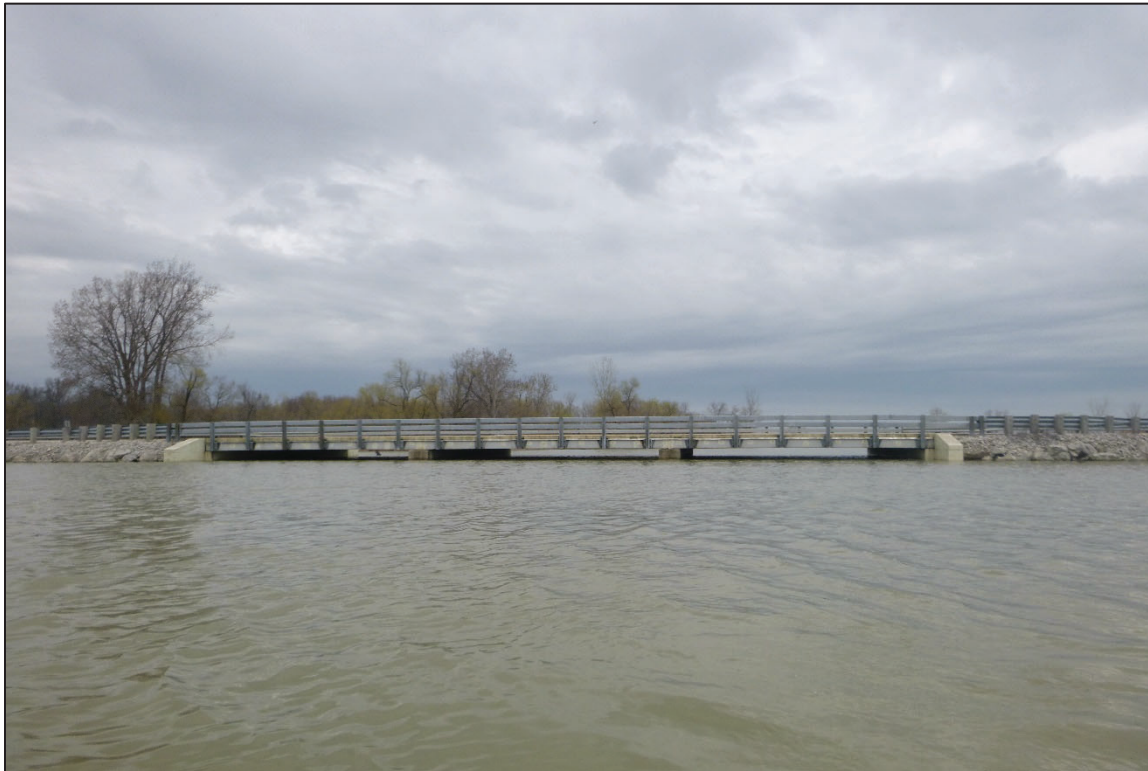
Photograph No. 2: Overall View of Structure No. 6200109 (OTT-2-0667), Looking North.

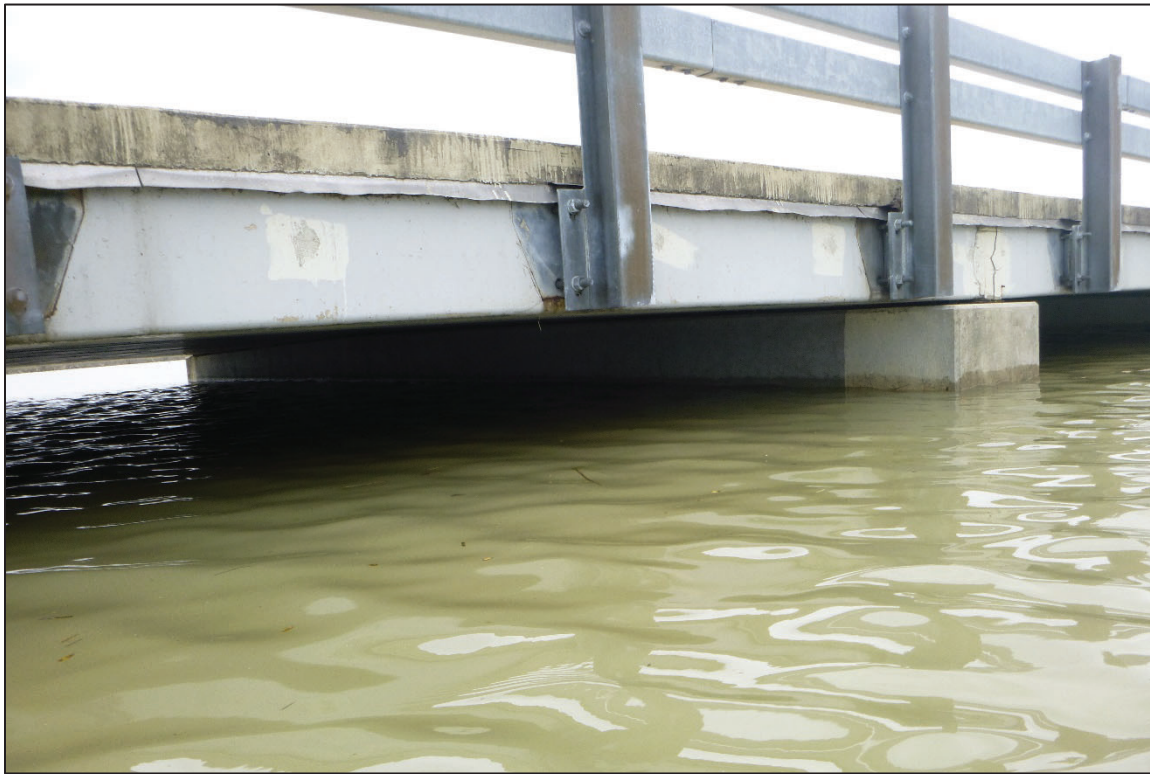
The channel bottom material consisted of riprap up to 24 in. diameter with sand infill. The submerged portions of the bent were sound and smooth with no defects observed. Full-depth hairline cracks were observed at the midpoint on the north, south, west, and east faces of the bent cap. Typical steel condition exhibited light surface corrosion with pitting up to 1/32 in. deep. Refer to Figure 6 in Exhibit 1 for detailed inspection notes of Bent 1. Refer to Photographs 11 and 12 in Exhibit 2 for views of Bent 1.

Photograph No. 11: View of the East Face of Bent 1, Looking Southwest.

The hairline cracks at Bents 1 and 2 are not structural concerns at this time. However, the cracks do provide a means for water infiltration and freeze-thaw damage. It is therefore recommended that these cracks be monitored during future underwater inspections. If further crack propagation or increased crack widths are observed, it may be necessary to repair the cracks by injection or patching with a repair material suitable for underwater applications.

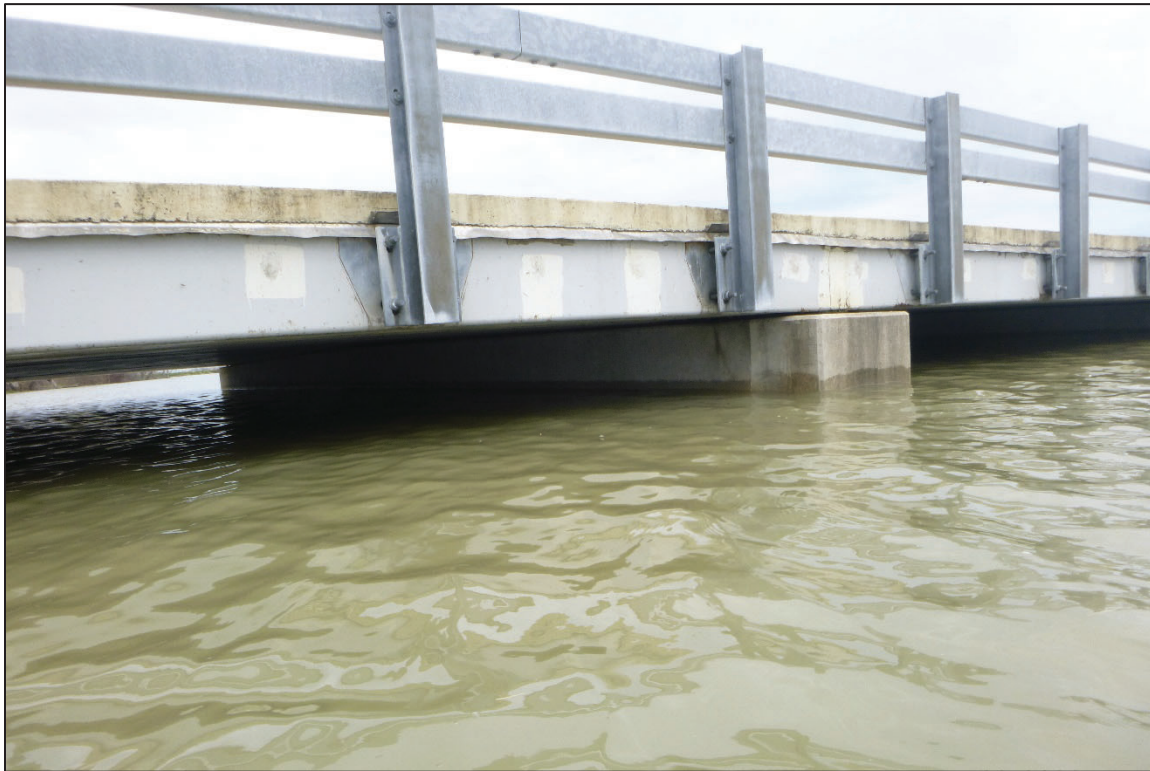
Photograph No. 12: View of the West Face of Bent 1, Looking Northeast.

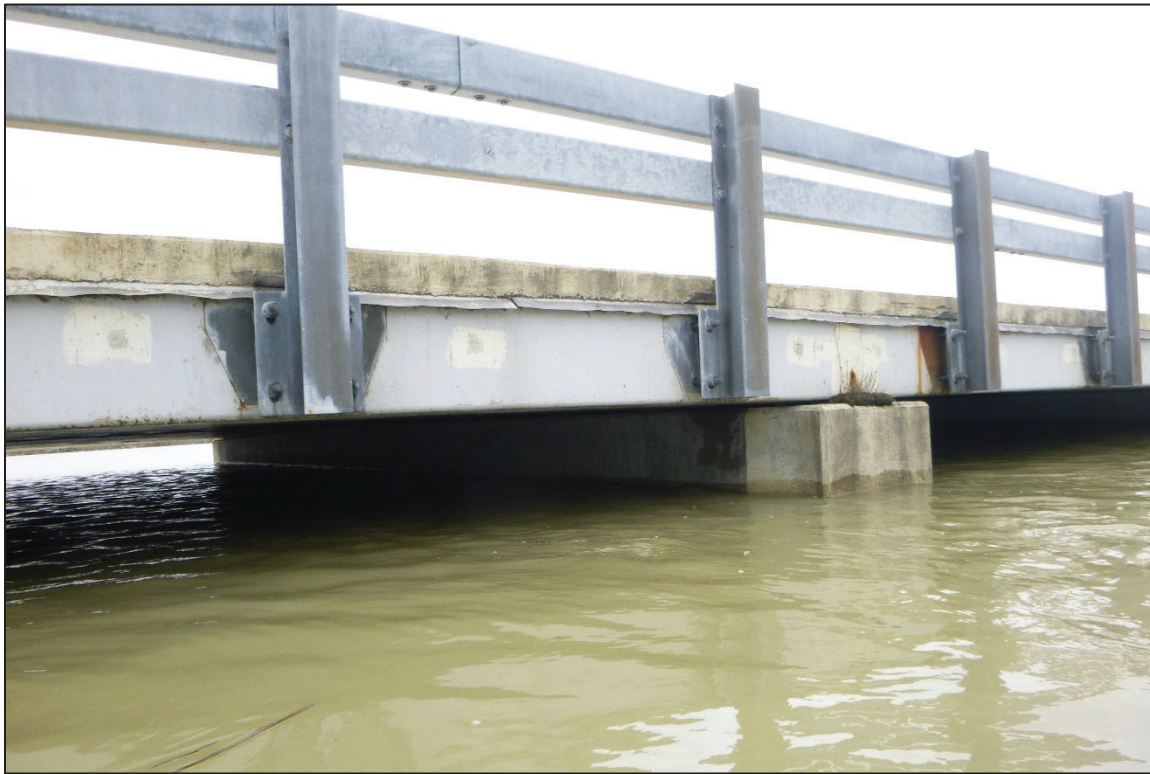
The channel bottom material consisted of riprap up to 24 in. diameter with sand infill. The submerged portions of the bent were sound and smooth with no defects observed. Full-depth hairline cracks were observed at the midpoint on the north, south, west, and east faces of the bent cap. Typical steel condition exhibited light surface corrosion with pitting up to 1/32 in. deep. Refer to Figure 7 in Exhibit 1 for detailed inspection notes of Bent 2. Refer to Photographs 13 through 15 in Exhibit 2 for views of Bent 2 and typical concrete condition at the waterline.

Photograph No. 13: View of the East Face of Bent 2, Looking Southwest.

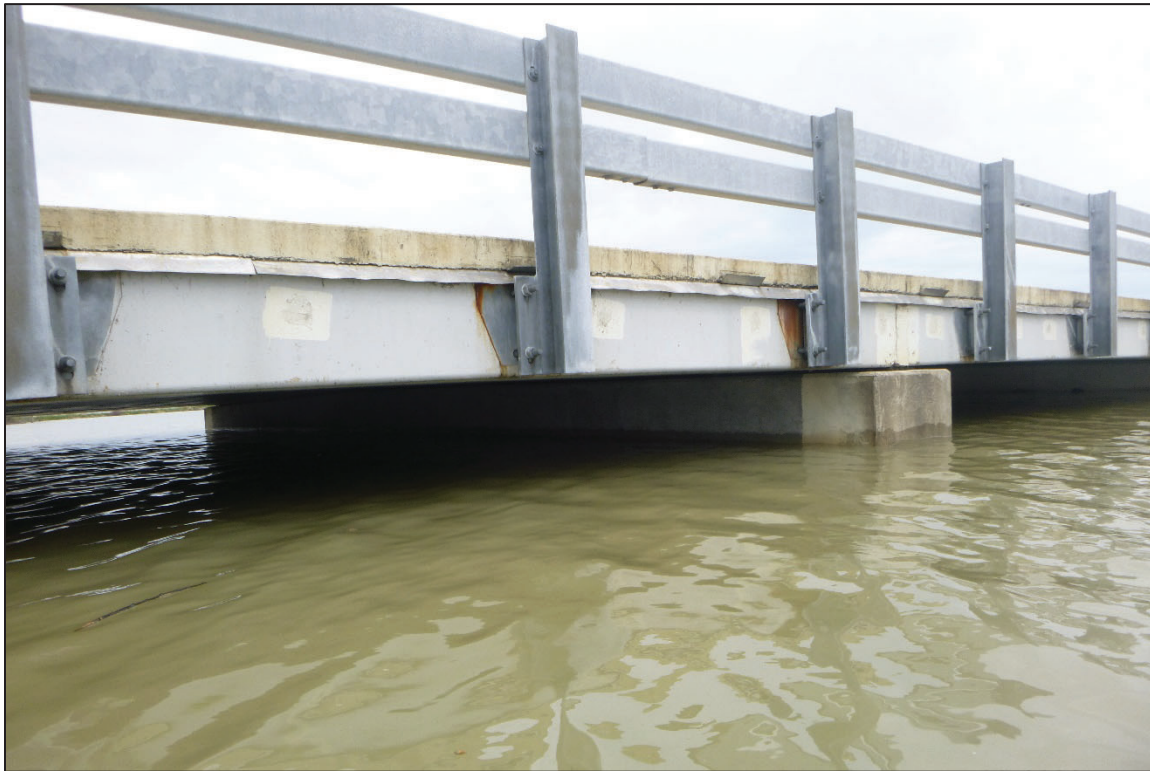
Photograph No. 14: View of the West Face of Bent 2, Looking Northeast.

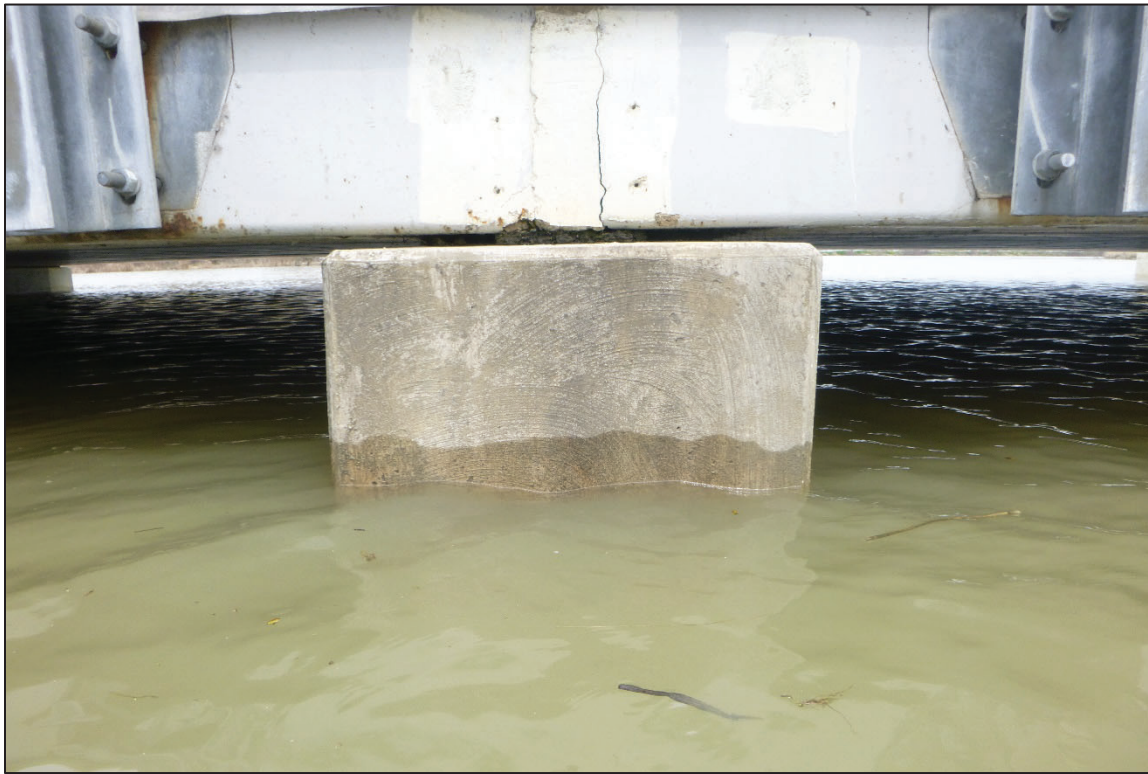
Photograph No. 15: View of the Typical Concrete Condition at the Waterline, Looking North.
