UNDERWATER BRIDGE INSPECTION REPORT

STRUCTURE NO. 6200133 (OTT-2-1079)
SR 2 OVER TOUSSAINT RIVER
OTTAWA COUNTY, OH
DISTRICT 2

May 2020

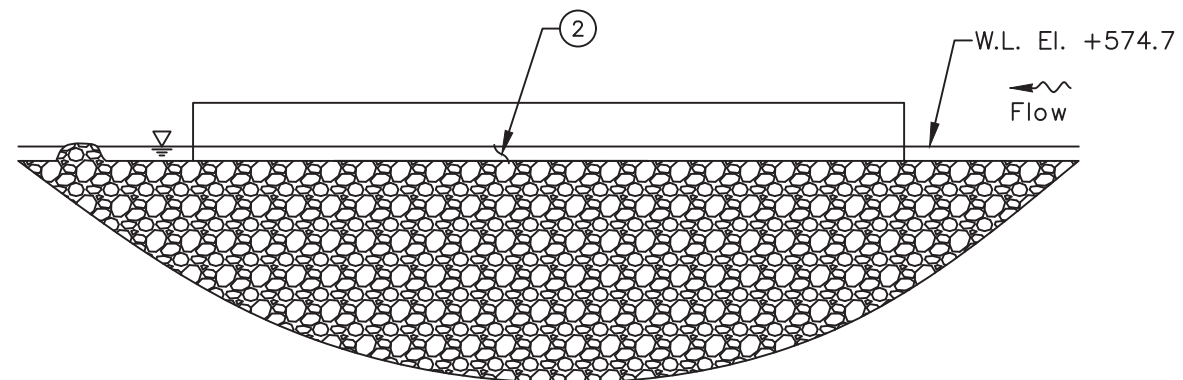
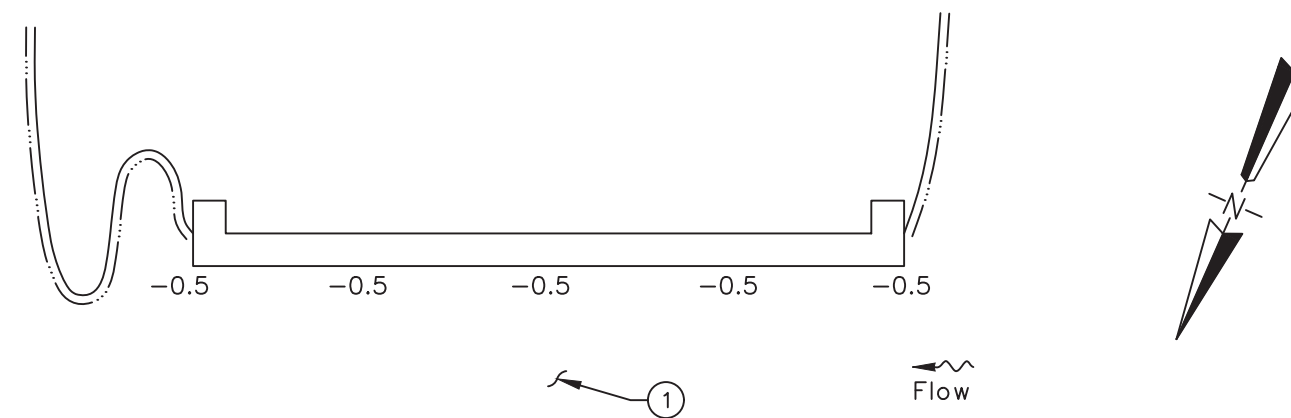
SR-2 OVER TOUSSAINT RIVER
 STRUCTURE NO. 6200133 (OTT-2-1079)
 ABUTMENT 1
 OTTAWA COUNTY, OHIO

- ① The channel bottom material consisted of riprap with approximately 2 in. probe rod penetration.
- ② The submerged portions of the pier were sound and smooth with no defects observed.

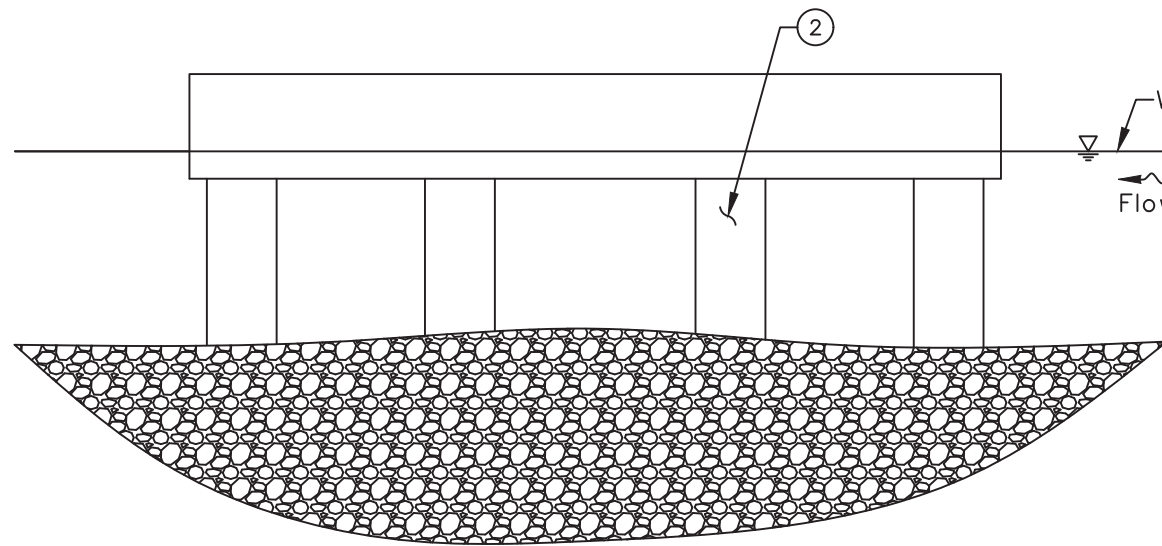
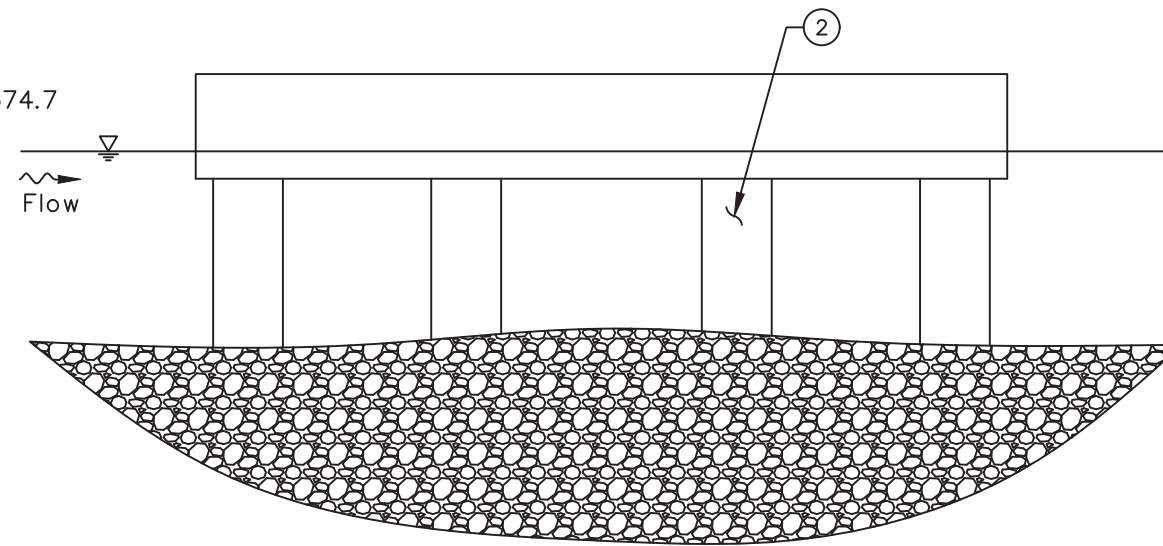
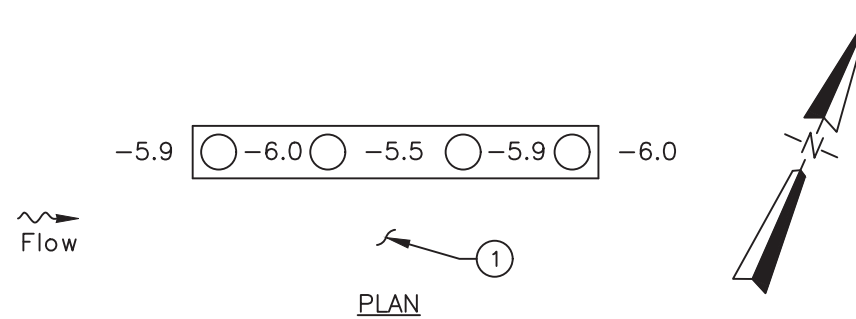
SR-2 OVER TOUSSAINT RIVER
 STRUCTURE NO. 6200133 (OTT-2-1079)
 BENT 1
 OTTAWA COUNTY, OHIO

The channel bottom material consisted of silt, cobbles, and riprap at abutments with approximately 2 in. probe rod penetration. Refer to Figure 6 in Exhibit 1 for detailed inspection notes of Bent 1. Refer to Photographs 9 and 10 in Exhibit 2 for views of Bent 1.

- ① The channel bottom material consisted of silt and cobbles with approximately 2 in. probe rod penetration.
- ② The submerged portions of the pier were sound and smooth with no defects observed.

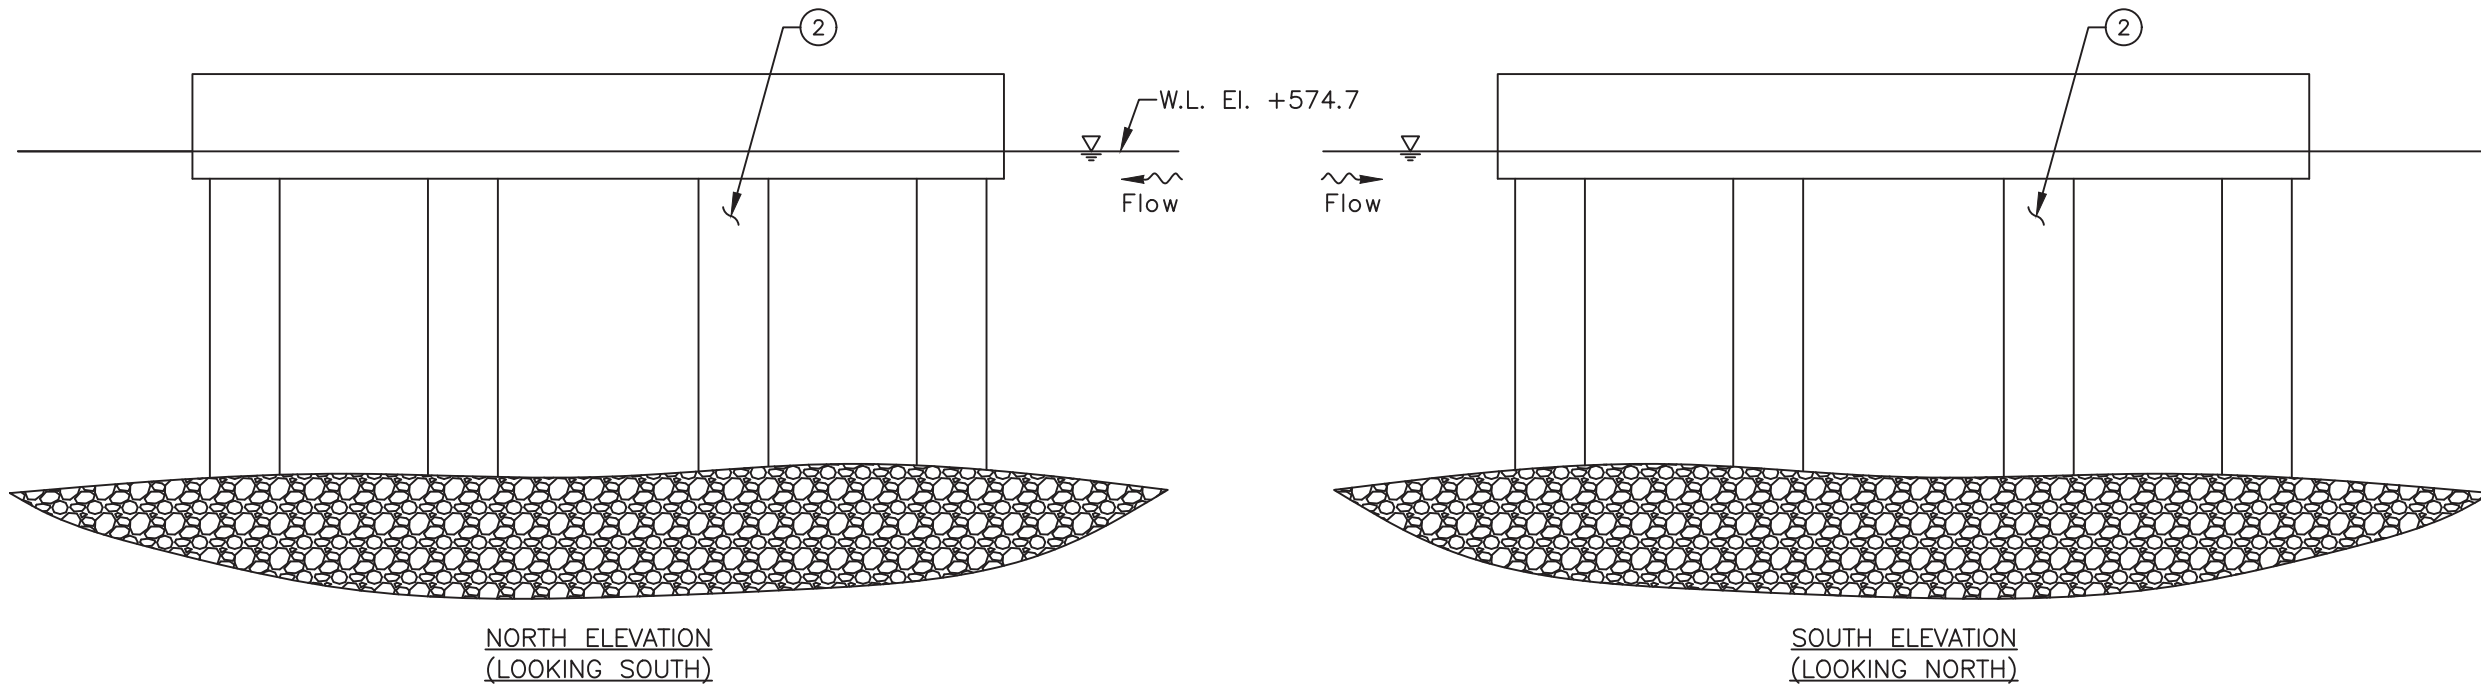
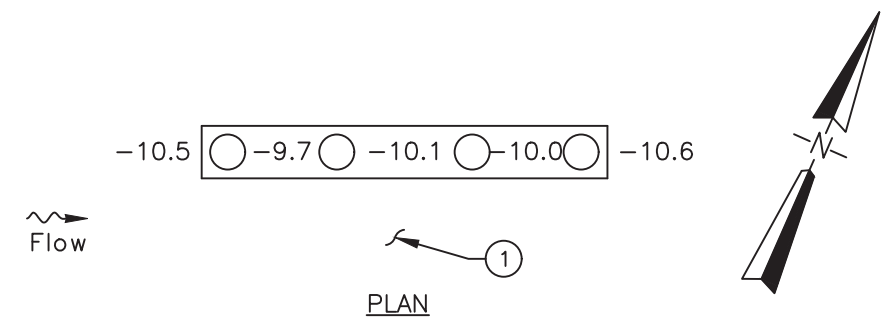
SR-2 OVER TOUSSAINT RIVER
STRUCTURE NO. 6200133 (OTT-2-1079)
BENT 2
 OTTAWA COUNTY, OHIO

The channel bottom material consisted of silt, cobbles, and riprap at abutments with approximately 2 in. probe rod penetration. Refer to Figure 7 in Exhibit 1 for detailed inspection notes of Bent 2. Refer to Photographs 11 and 12 in Exhibit 2 for views of Bent 2.

- ① The channel bottom material consisted of silt and cobbles with approximately 2 in. probe rod penetration.
- ② The submerged portions of the pier were sound and smooth with no defects observed.

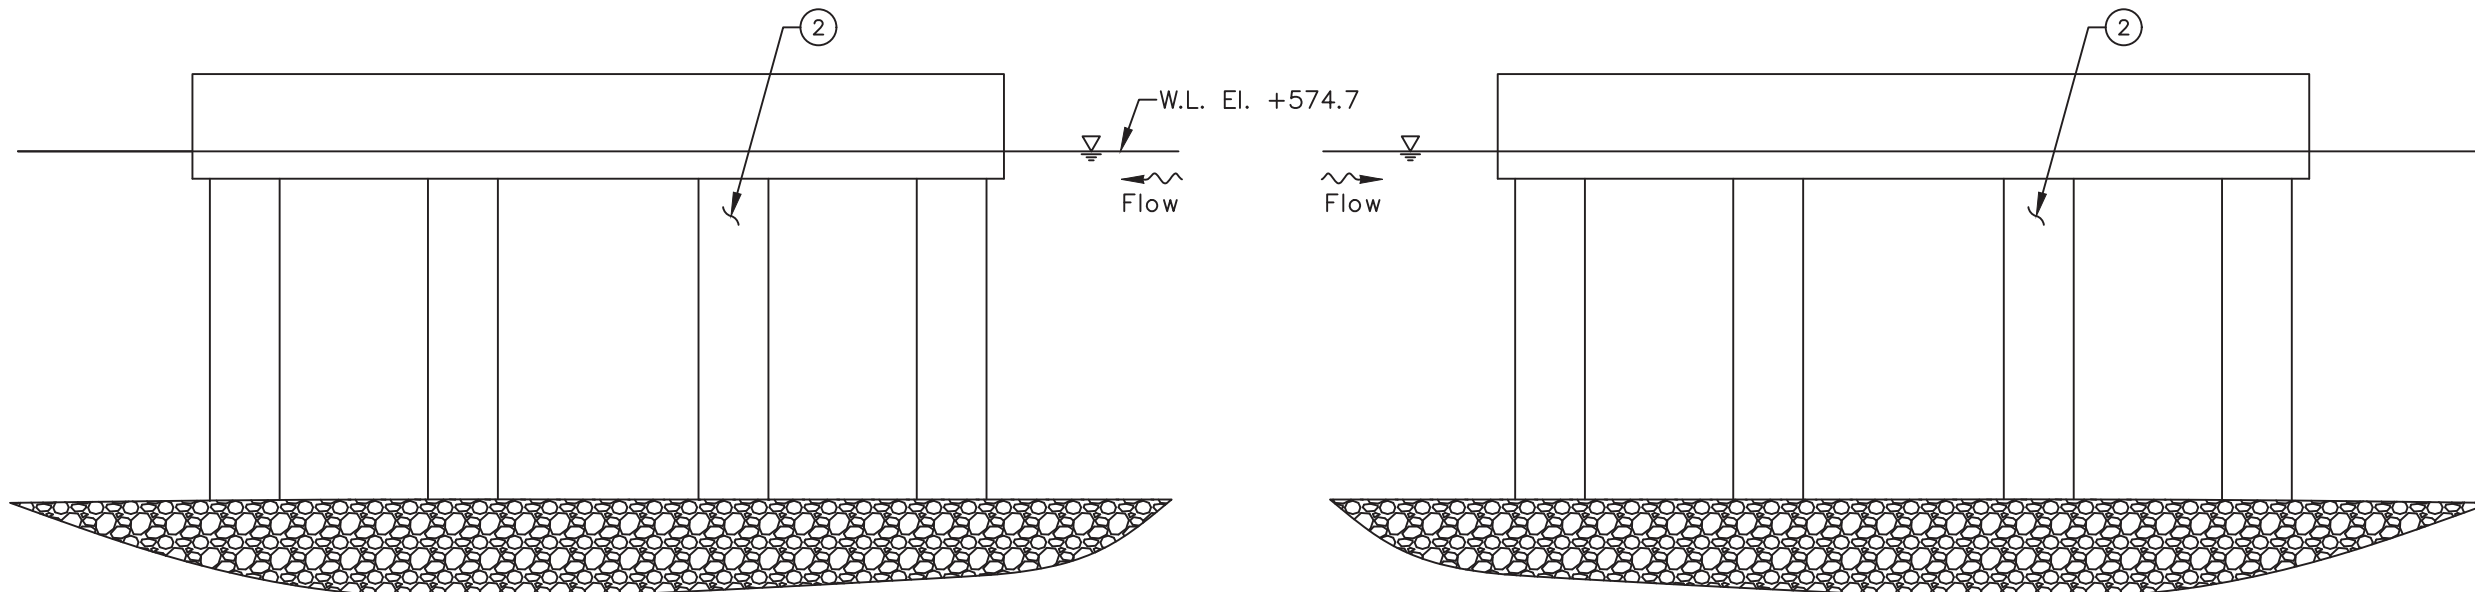
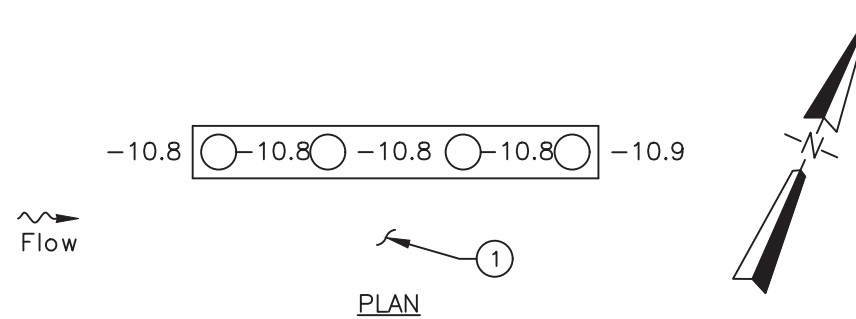
SR-2 OVER TOUSSAINT RIVER
 STRUCTURE NO. 6200133 (OTT-2-1079)
 BENT 3
 OTTAWA COUNTY, OHIO

The channel bottom material consisted of silt, cobbles, and riprap at abutments with approximately 2 in. probe rod penetration. Refer to Figure 8 in Exhibit 1 for detailed inspection notes of Bent 3. Refer to Photographs 13 and 14 in Exhibit 2 for views of Bent 3.

- ① The channel bottom material consisted of silt and cobbles with approximately 2 in. probe rod penetration.
- ② The submerged portions of the pier were sound and smooth with no defects observed.

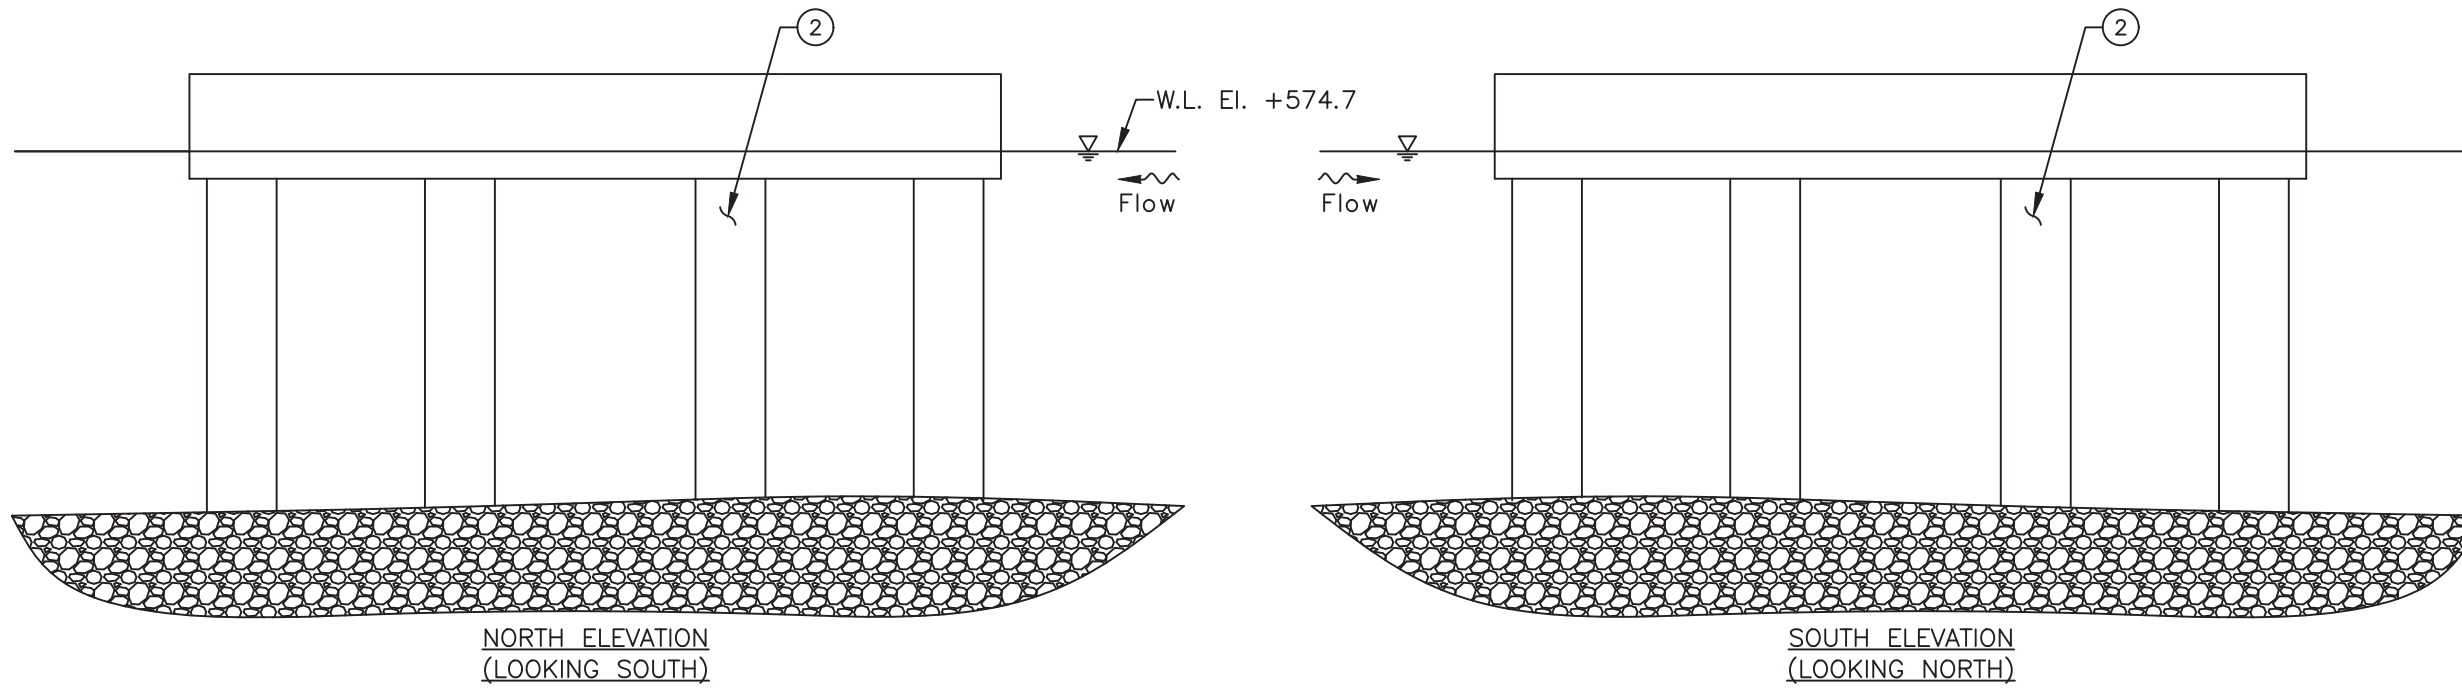
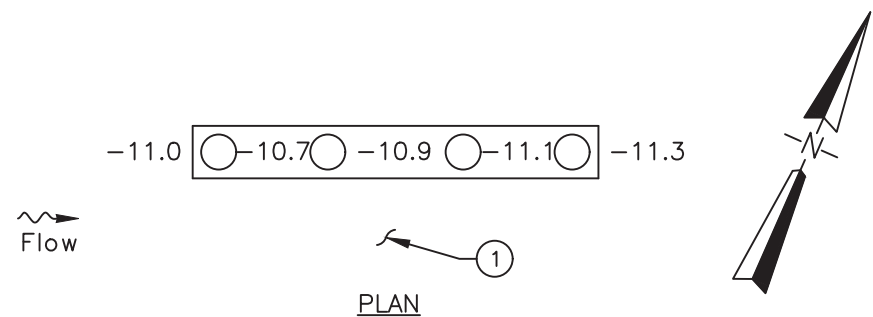
SR-2 OVER TOUSSAINT RIVER
STRUCTURE NO. 6200133 (OTT-2-1079)
BENT 4
 OTTAWA COUNTY, OHIO

The channel bottom material consisted of silt, cobbles, and riprap at abutments with approximately 2 in. probe rod penetration. Refer to Figure 9 in Exhibit 1 for detailed inspection notes of Bent 4. Refer to Photographs 15 and 16 in Exhibit 2 for views of Bent 4.

- ① The channel bottom material consisted of silt and cobbles with approximately 2 in. probe rod penetration.
- ② The submerged portions of the pier were sound and smooth with no defects observed.

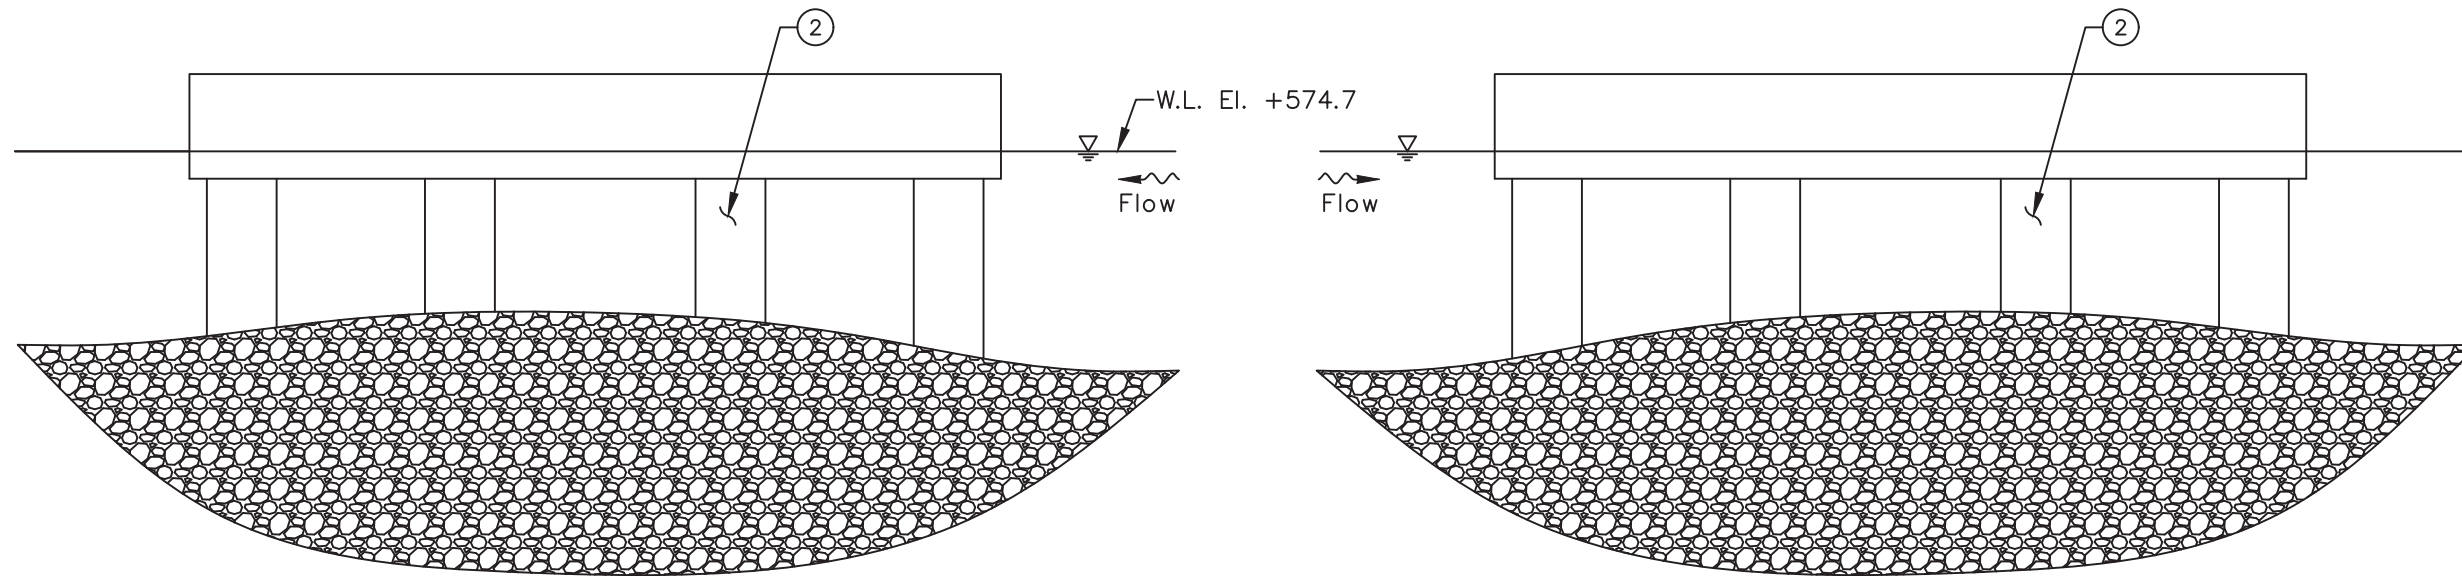
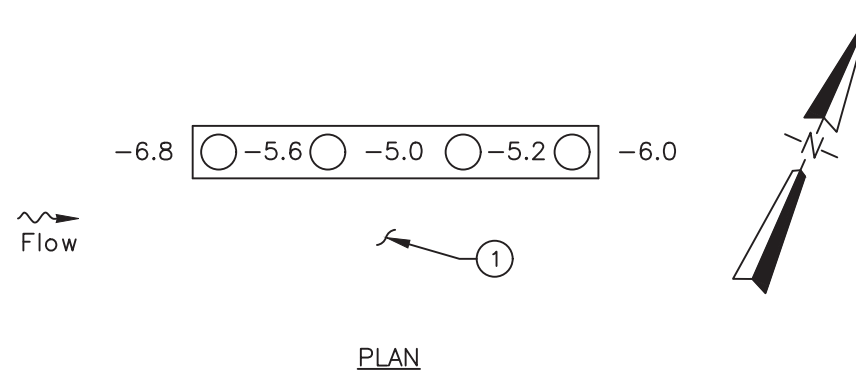
SR-2 OVER TOUSSAINT RIVER
 STRUCTURE NO. 6200133 (OTT-2-1079)
 BENT 5
 OTTAWA COUNTY, OHIO

The channel bottom material consisted of silt, cobbles, and riprap at abutments with approximately 2 in. probe rod penetration. Refer to Figure 10 in Exhibit 1 for detailed inspection notes of Bent 5. Refer to Photographs 17 and 19 in Exhibit 2 for views of Bent 5 and typical concrete condition at the waterline.

- ① The channel bottom material consisted of silt and cobbles with approximately 2 in. probe rod penetration.
- ② The submerged portions of the pier were sound and smooth with no defects observed.

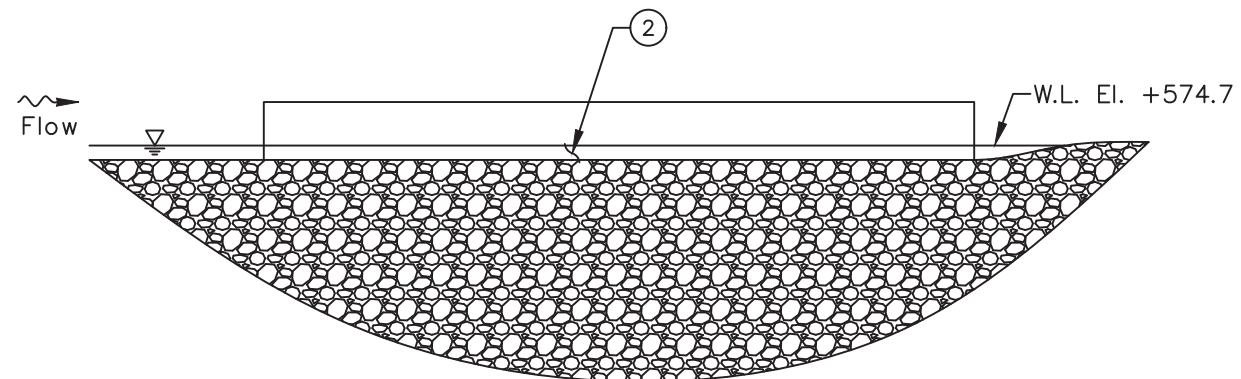
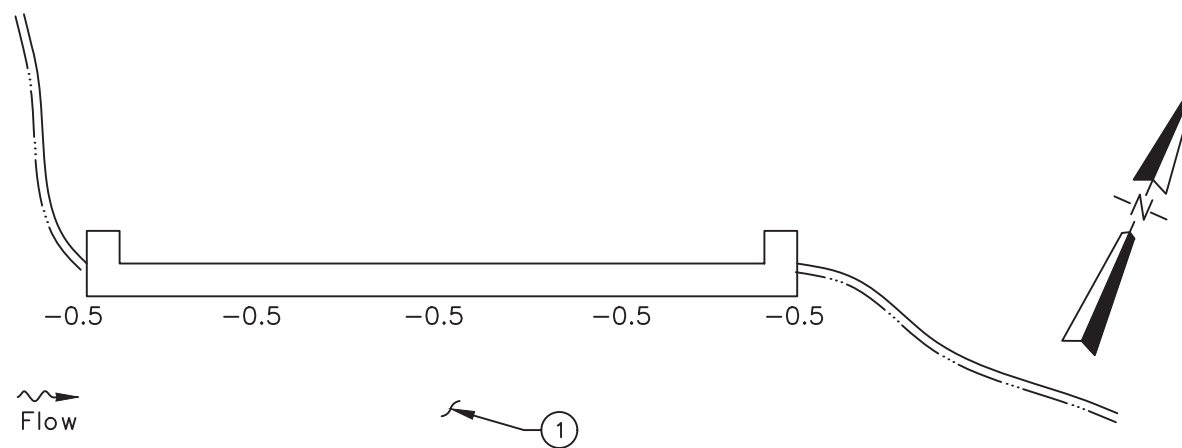
- ① The channel bottom material consisted of riprap with approximately 2 in. probe rod penetration.
- ② The submerged portions of the pier were sound and smooth with no defects observed.

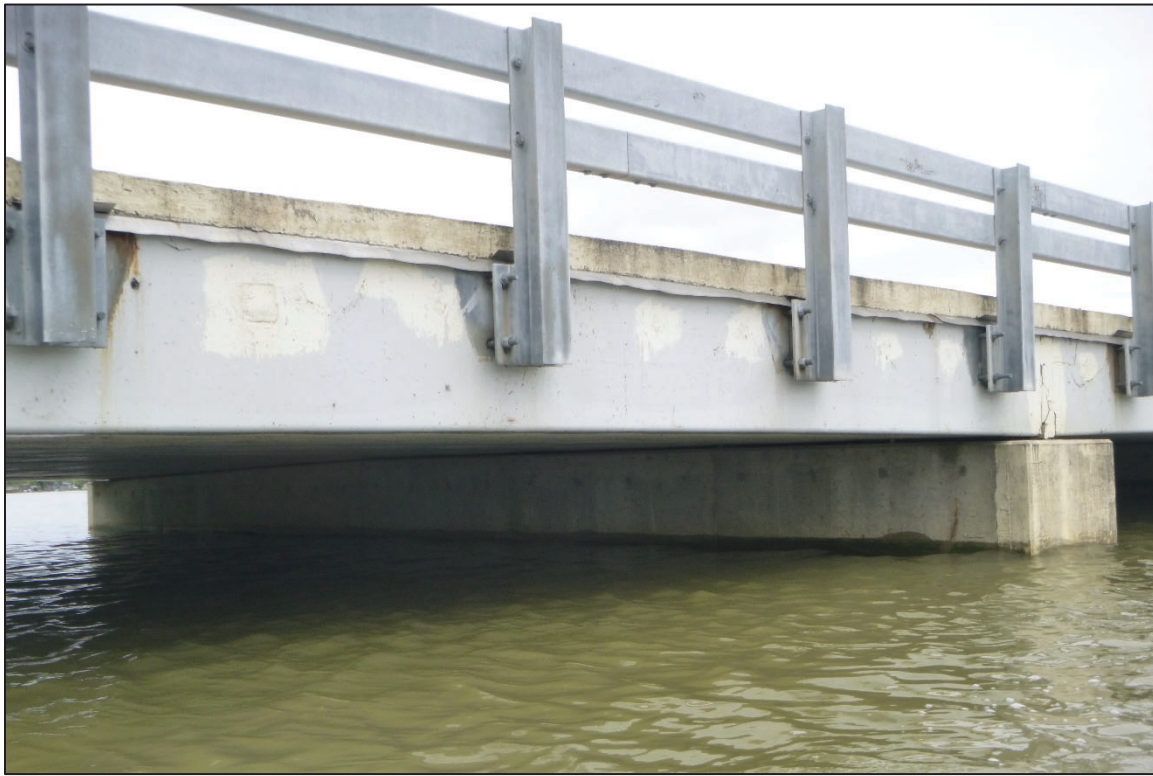
Photograph No. 9: View of the North Face of Bent 1, Looking Southeast.

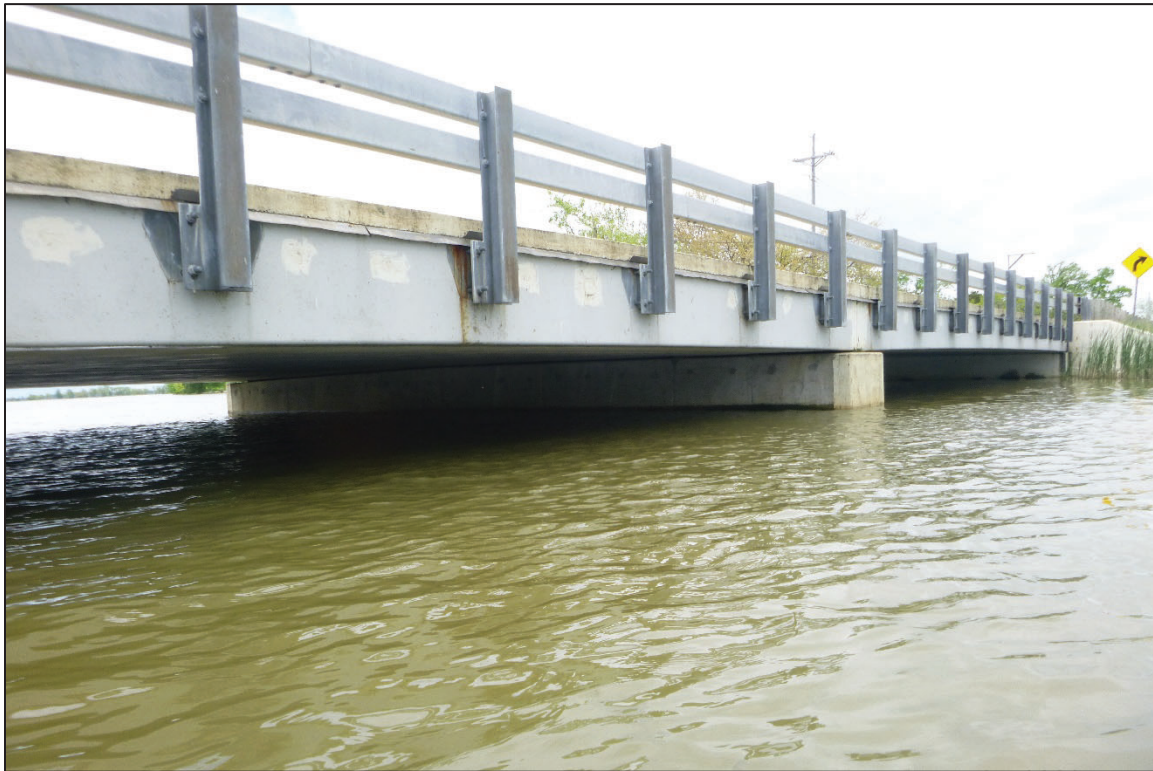
Photograph No. 10: View of the South Face of Bent 1, Looking Northwest.

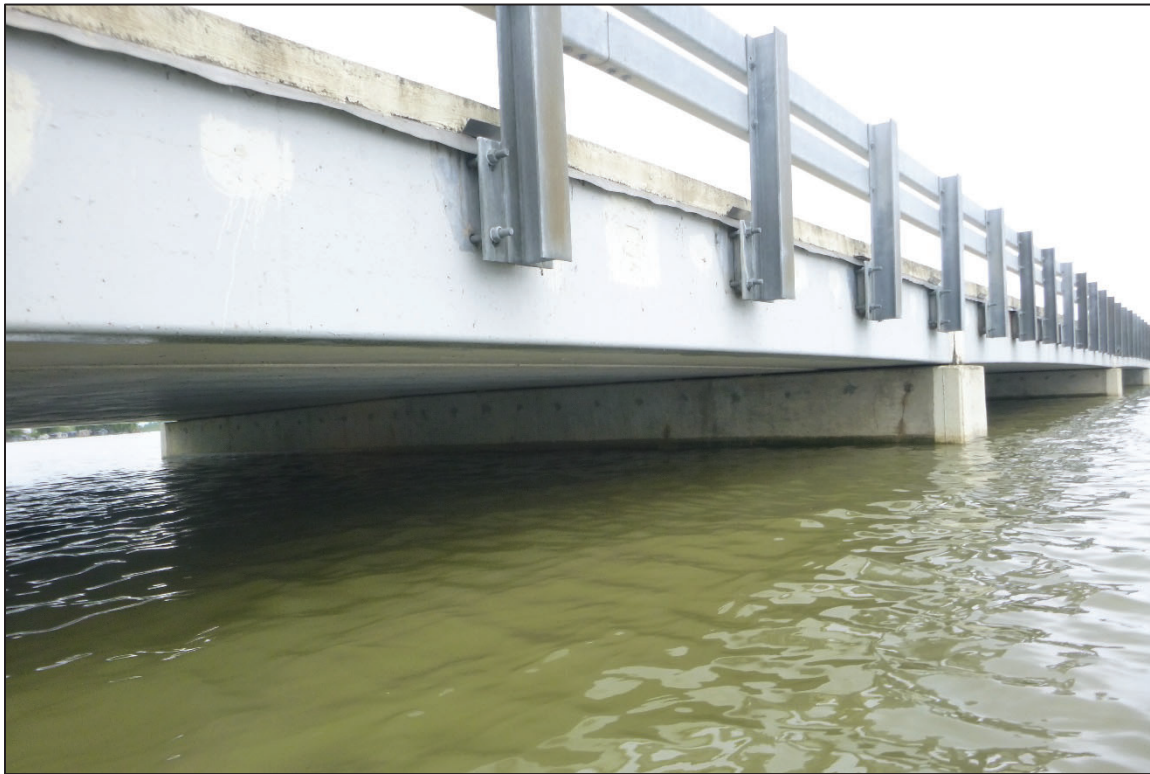
Photograph No. 11: View of the North Face of Bent 2, Looking Southeast.

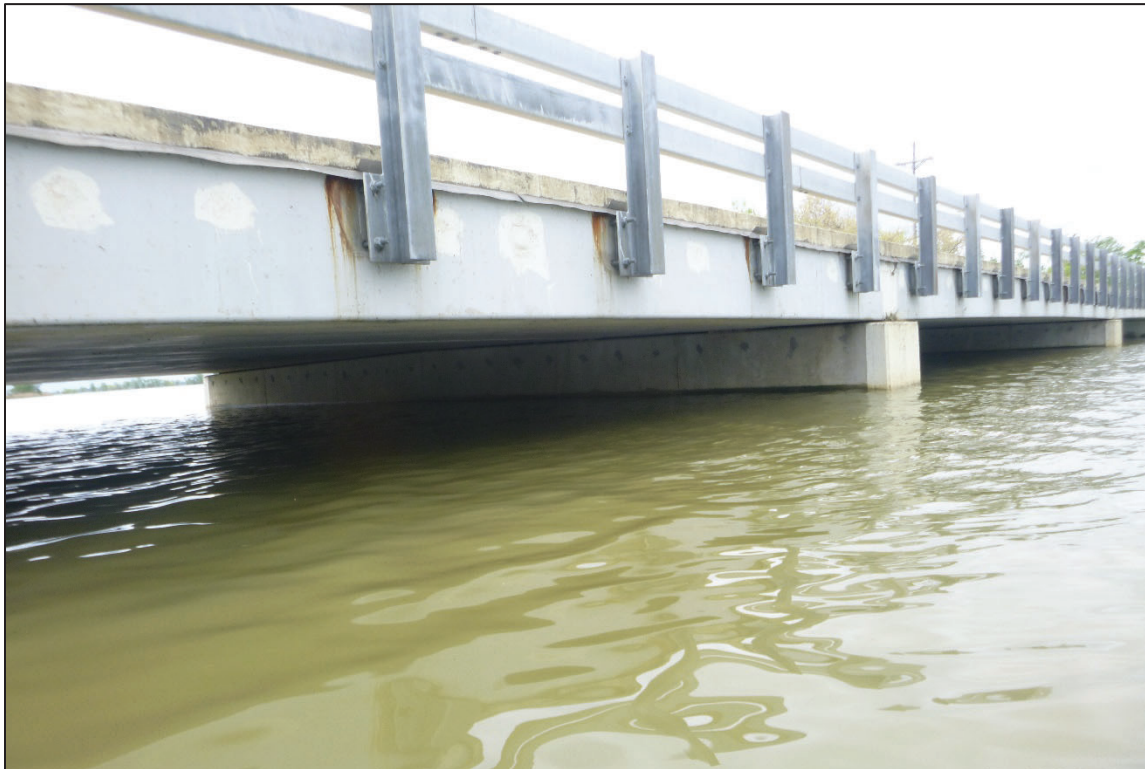
Photograph No. 12: View of the South Face of Bent 2, Looking Northwest.

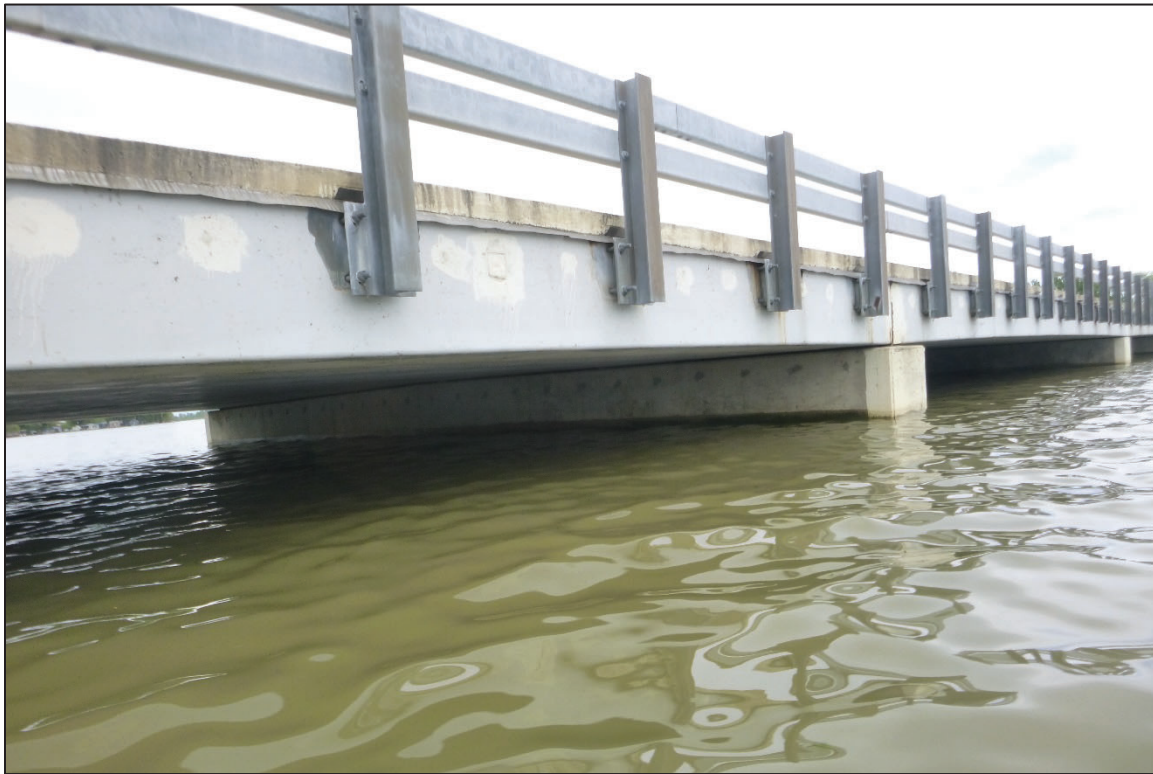
Photograph No. 13: View of the North Face of Bent 3, Looking Southeast.

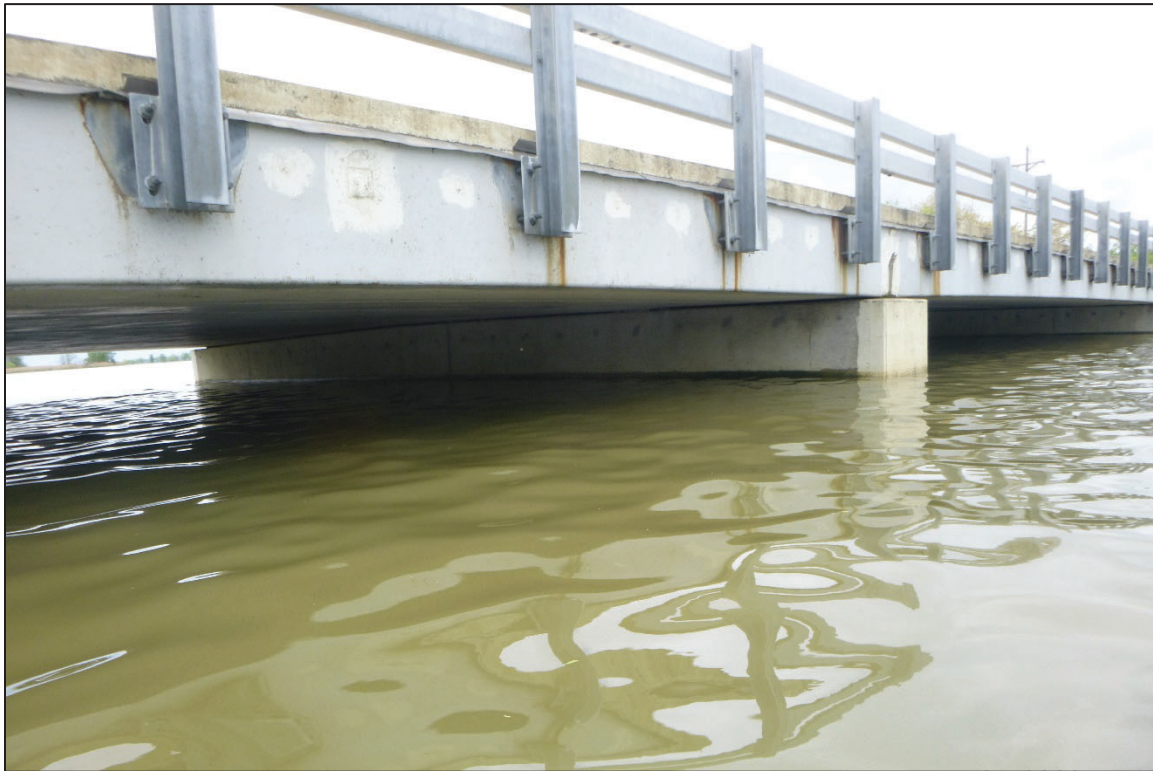
Photograph No. 14: View of the South Face of Bent 3, Looking Northwest.

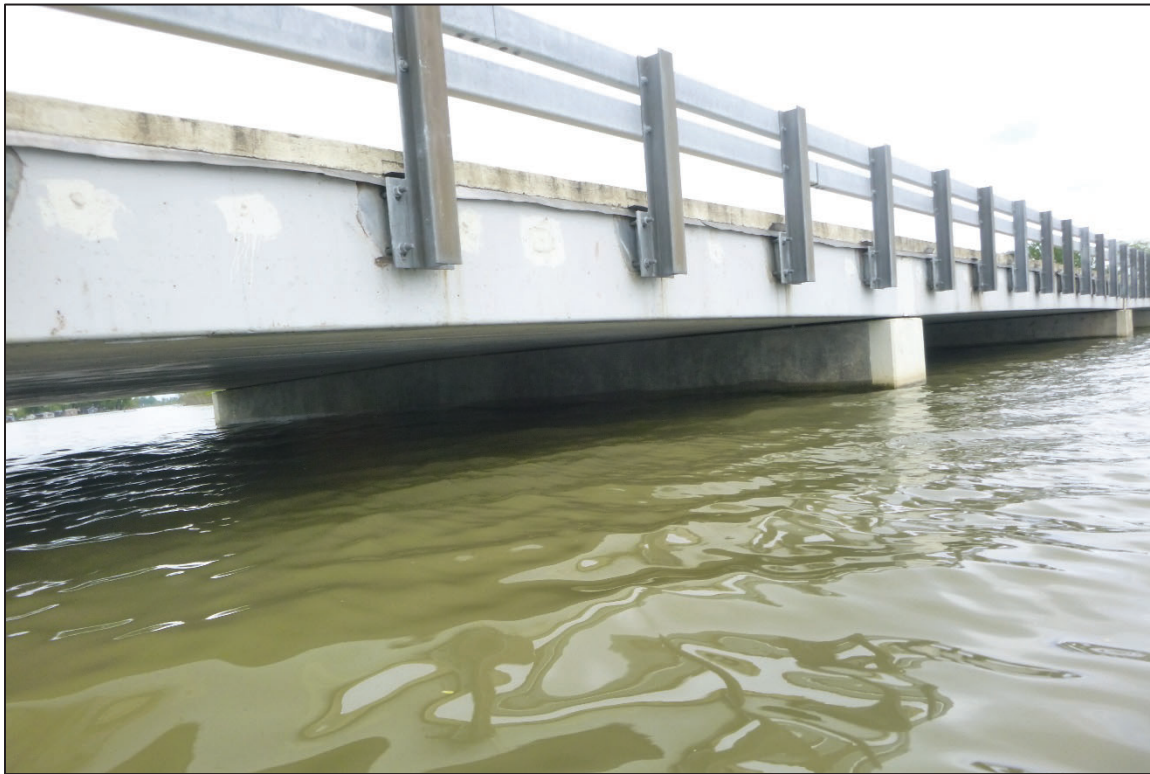
Photograph No. 15: View of the North Face of Bent 4, Looking Southeast.

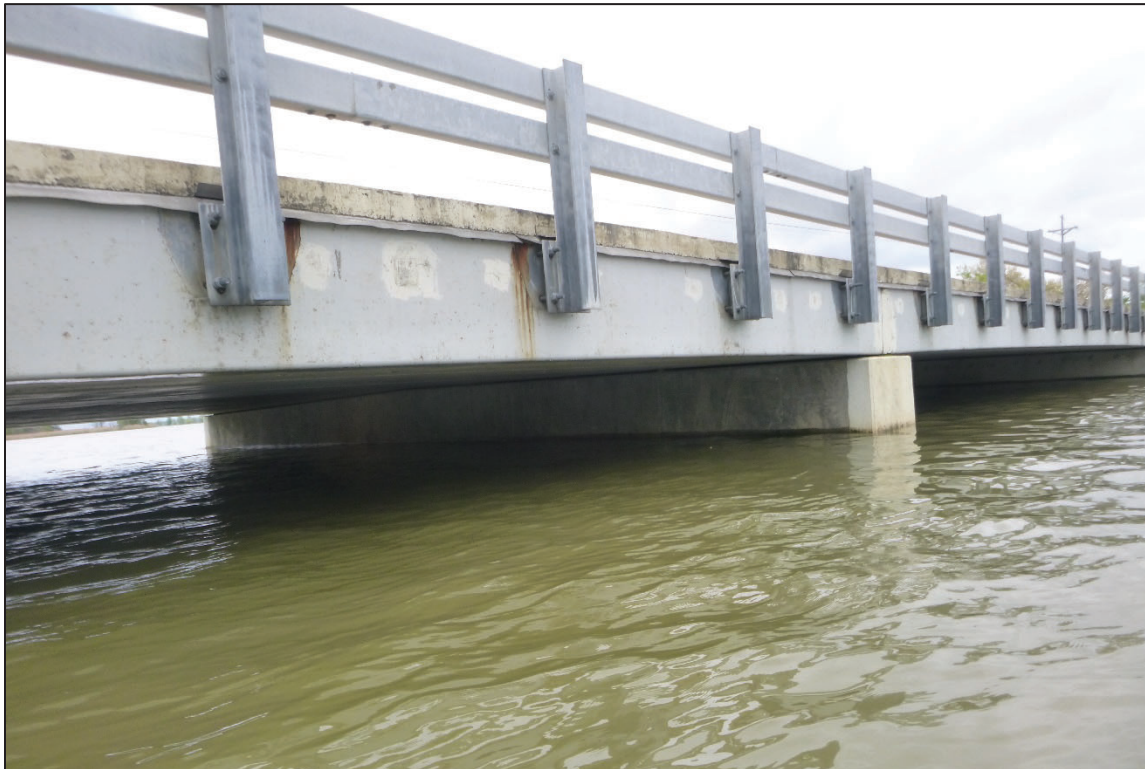
Photograph No. 16: View of the South Face of Bent 4, Looking Northwest.

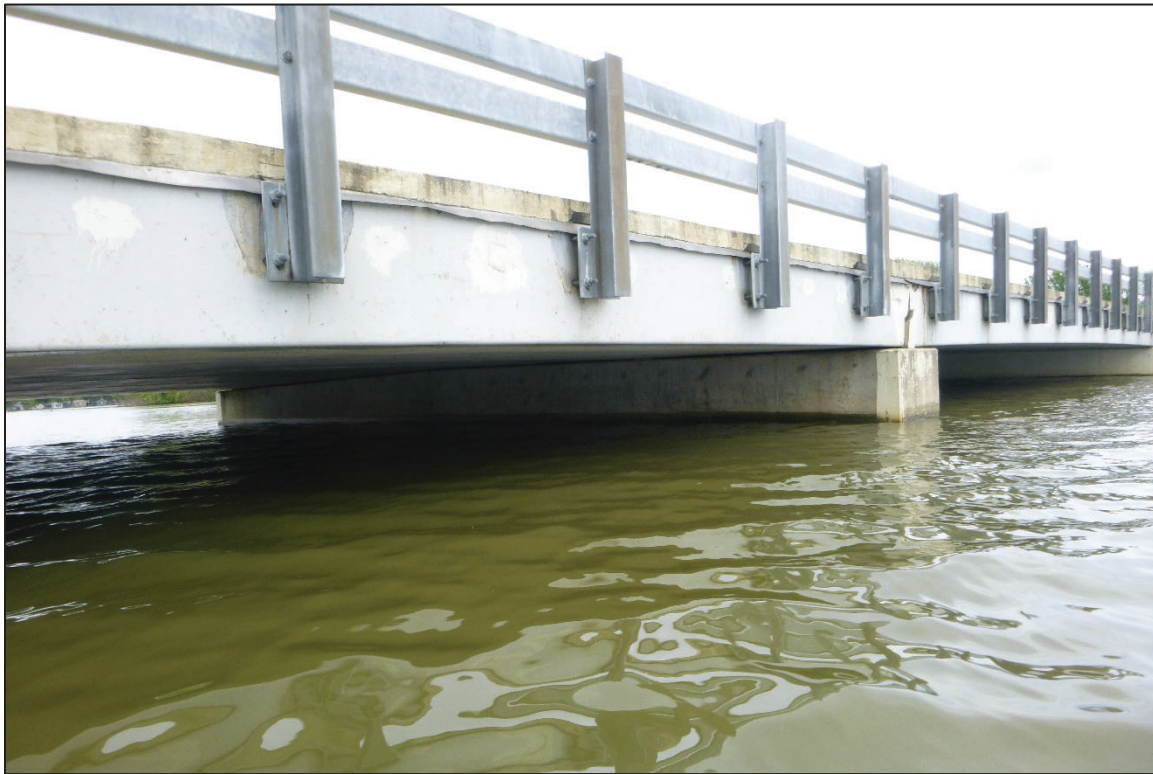
Photograph No. 17: View of the North Face of Bent 5, Looking Southeast.

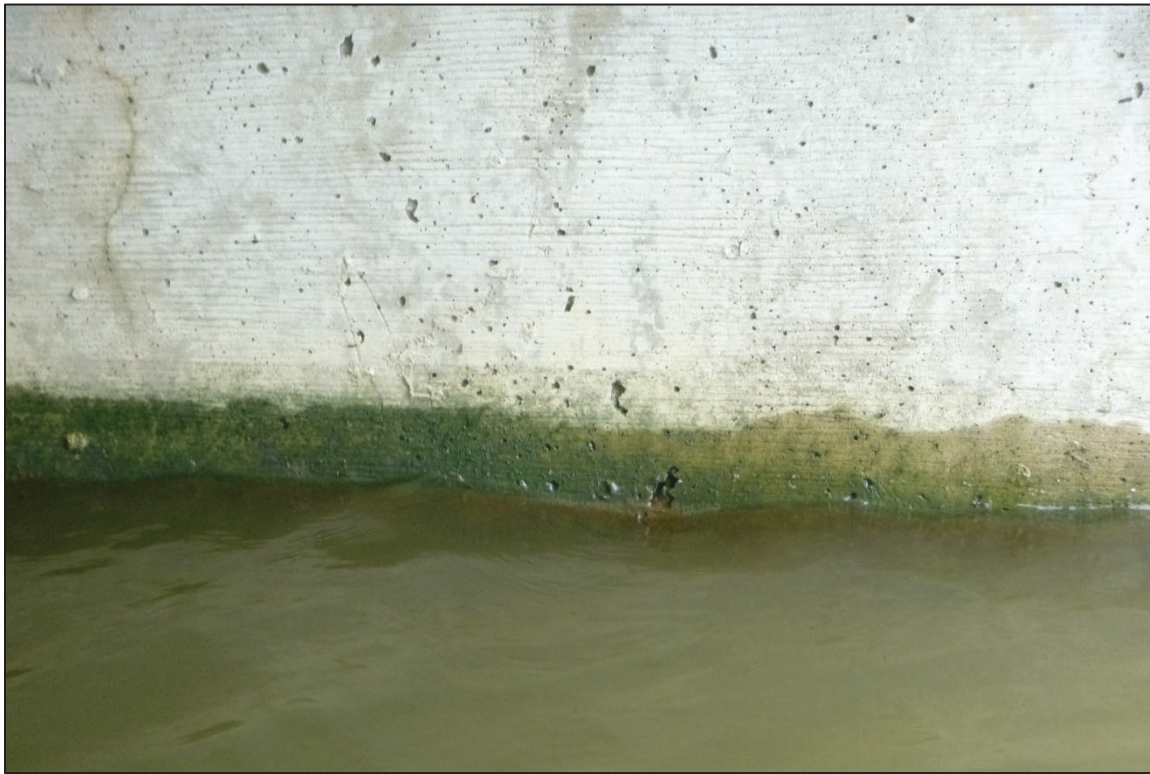
Photograph No. 19: View of the Typical Concrete Condition at the Waterline, Looking North.
