# UNDERWATER BRIDGE INSPECTION REPORT

STRUCTURE NO. 6200184 (OTT-2-1312)  
SR 2 OVER RUSHA CREEK  
OTTAWA COUNTY, OH  
DISTRICT 2

April 2020

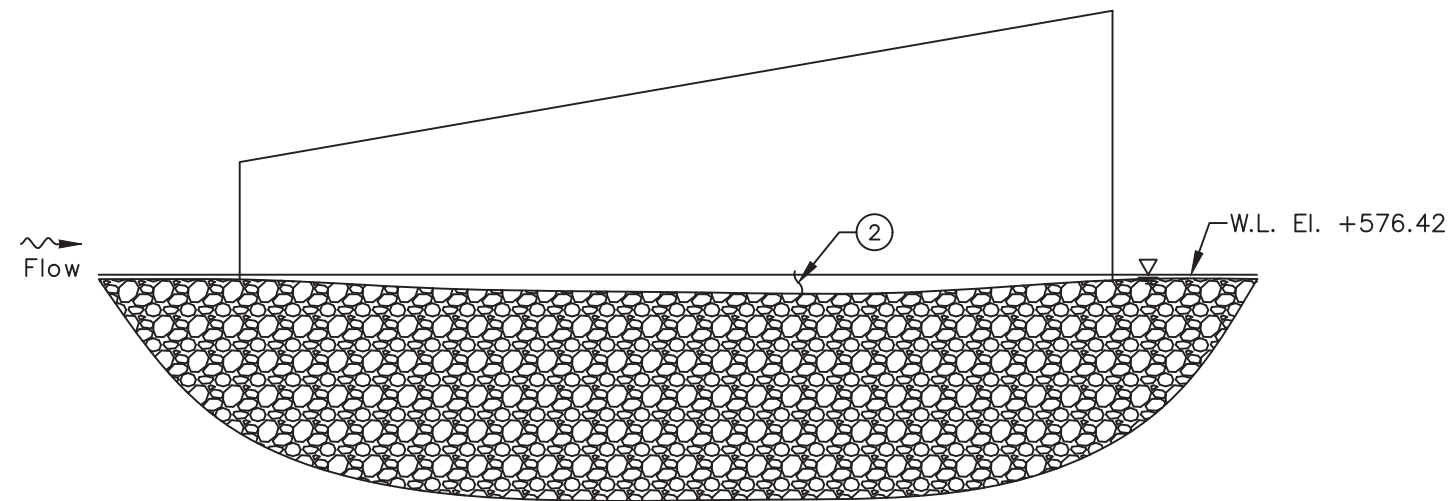
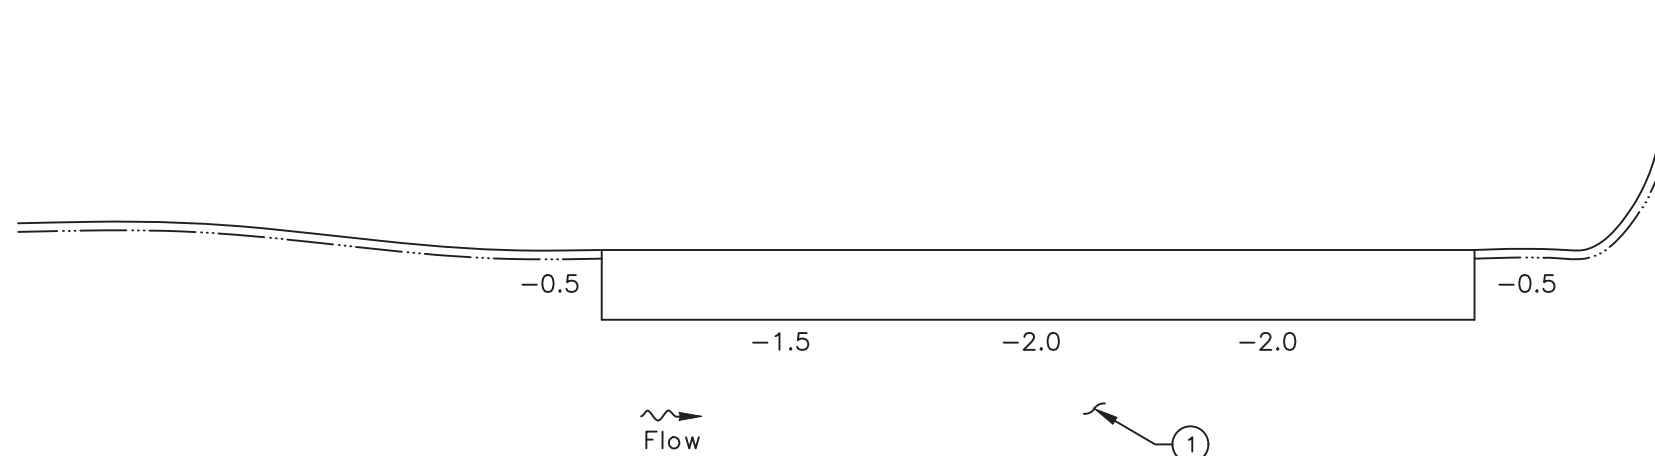
SR-2 OVER RUSHA CREEK  
 STRUCTURE NO. 6200184 (OTT-2-1312)  
 ABUTMENT 1  
 OTTAWA COUNTY, OHIO

The channel bottom material consisted of riprap and silt with approximately 6 in. probe rod penetration. Refer to Figure 6 in Exhibit 1 for detailed inspection notes of Abutment 1. Refer to Photographs 4 and 5 in Exhibit 2 for views of Abutment 1.

- ① The channel bottom material consisted of riprap and silt with approximately 6 in. probe rod penetration.
- ② The submerged portions of the pier were sound and smooth with no defects observed.

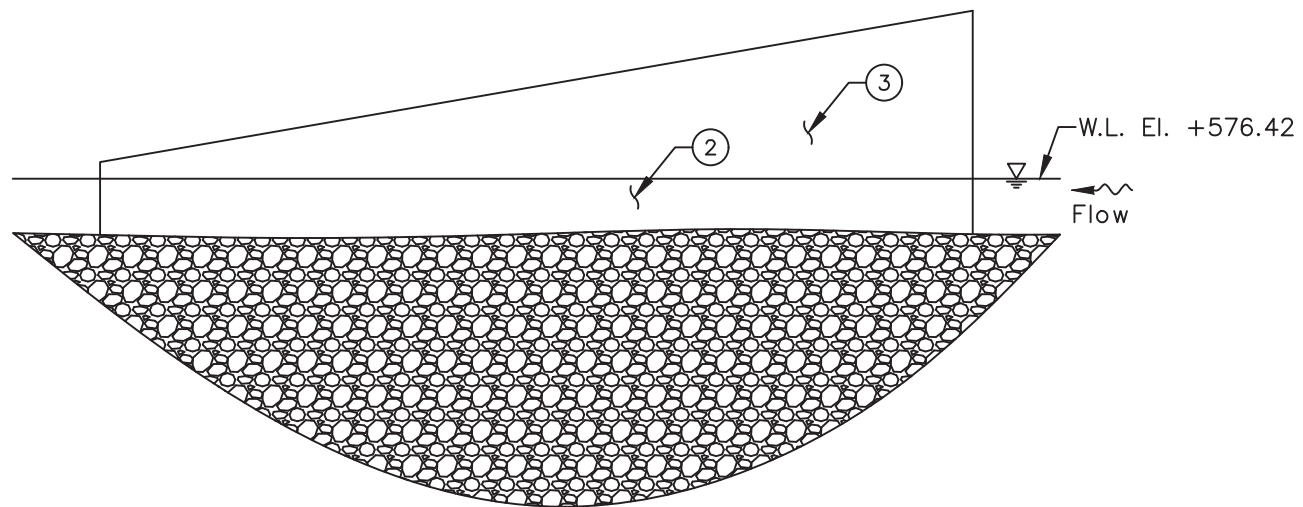
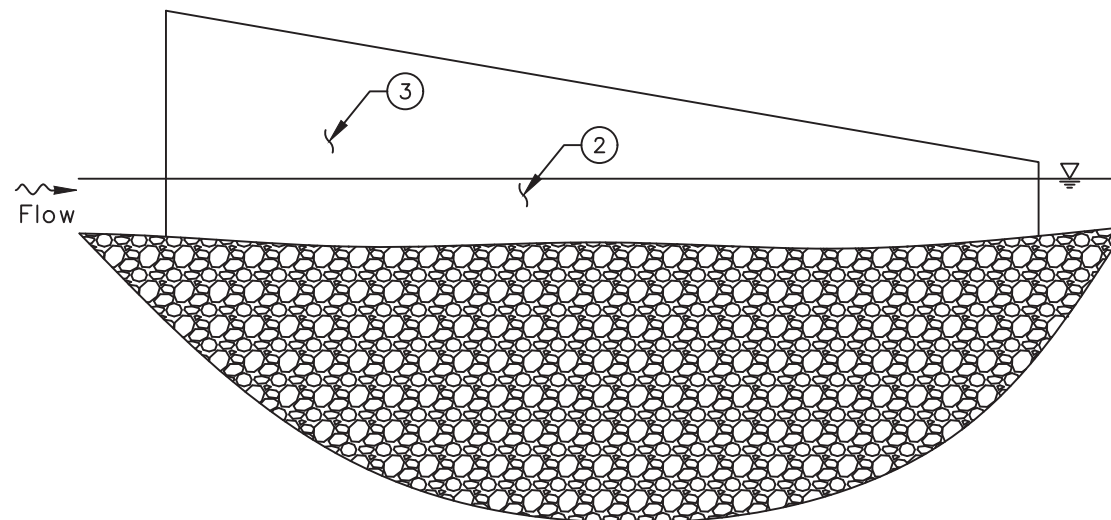
SR-2 OVER RUSHA CREEK  
 STRUCTURE NO. 6200184 (OTT-2-1312)  
 PIER 1  
 OTTAWA COUNTY, OHIO

The channel bottom material consisted of riprap and silt with approximately 12 in. probe rod penetration. The submerged portions of the pier were sound and smooth with no defects observed. Vertical cracking measuring 1/16 in. was observed throughout the pier faces spaced 6 ft on center. Refer to Figure 8 in Exhibit 1 for detailed inspection notes of Pier 1. Refer to Photographs 10 and 11 in Exhibit 2 for views of Pier 1.

- ① The channel bottom material consisted of riprap and silt with approximately 12 in. probe rod penetration.
- ② The submerged portions of the pier were sound and smooth with no defects observed.
- ③ Vertical cracking measuring 1/16 in. was observed throughout the pier faces spaced 6 ft on center.

The vertical cracks at Piers 1 and 2 and Abutment 2 are not structural concerns at this time. However, the cracks do provide a means for water infiltration and freeze-thaw damage. It is therefore recommended that these cracks be monitored during future underwater inspections. If further crack propagation or increased crack widths are observed, it may be necessary to repair the cracks by injection or patching with a repair material suitable for underwater applications.

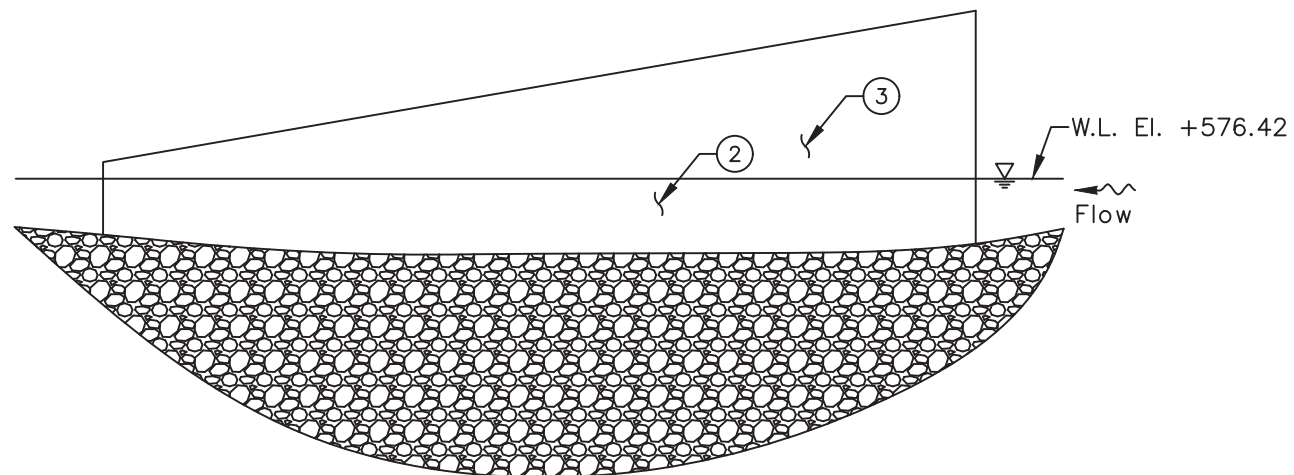
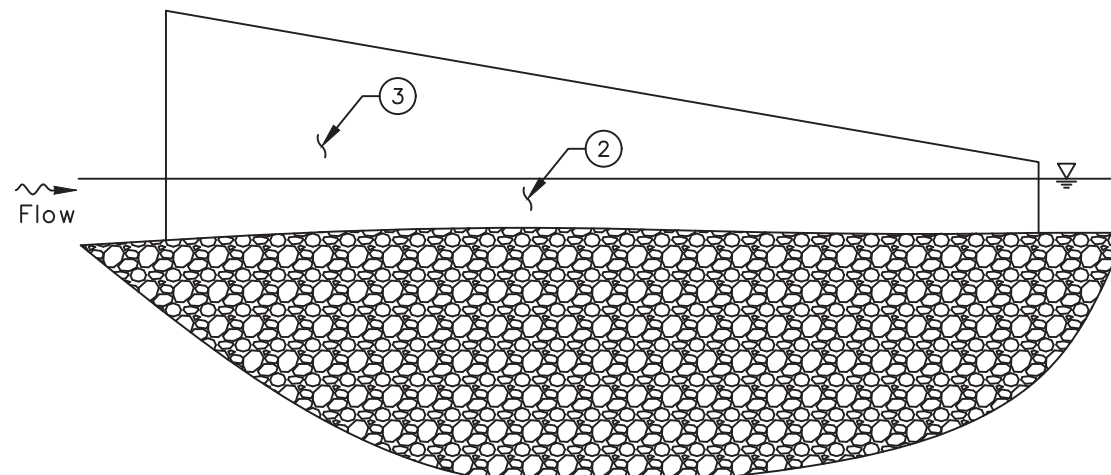
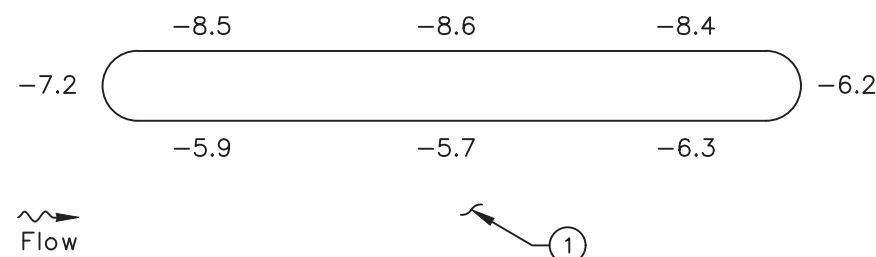
SR-2 OVER RUSHA CREEK  
 STRUCTURE NO. 6200184 (OTT-2-1312)  
 PIER 2  
 OTTAWA COUNTY, OHIO

The channel bottom material consisted of riprap and silt with approximately 12 in. probe rod penetration. The submerged portions of the pier were sound and smooth with no defects observed. Vertical cracking measuring 1/16 in. was observed throughout the pier faces spaced 6 ft on center. Refer to Figure 9 in Exhibit 1 for detailed inspection notes of Pier 2. Refer to Photographs 12 through 14 in Exhibit 2 for views of Pier 2 and typical concrete condition at the waterline.

- ① The channel bottom material consisted of riprap and silt with approximately 12 in. probe rod penetration.
- ② The submerged portions of the pier were sound and smooth with no defects observed.
- ③ Vertical cracking measuring 1/16 in. was observed throughout the pier faces spaced 6 ft on center.

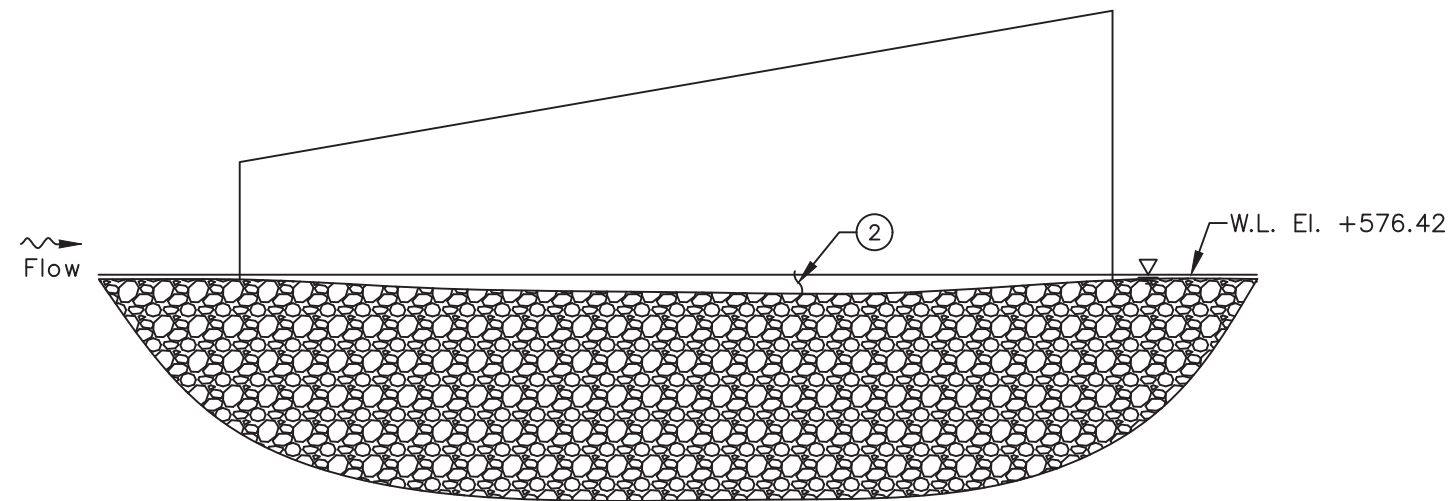
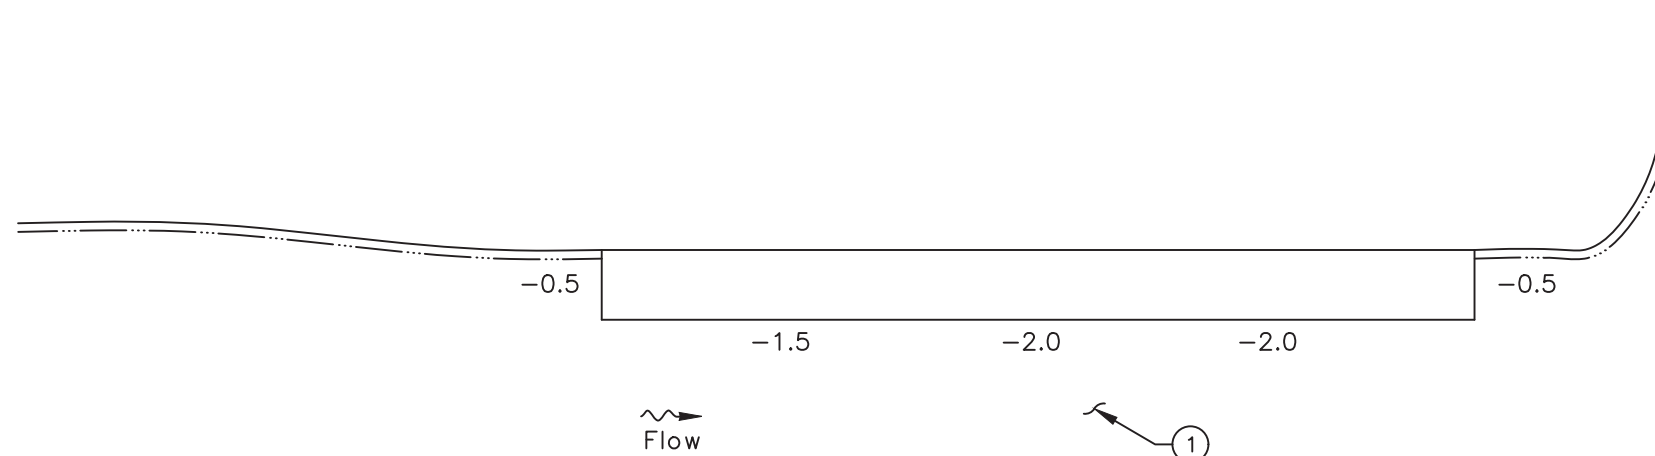
SR-2 OVER RUSHA CREEK  
 STRUCTURE NO. 6200184 (OTT-2-1312)  
 ABUTMENT 2  
 OTTAWA COUNTY, OHIO

The channel bottom material consisted of riprap and silt with approximately 6 in. probe rod penetration. The submerged portions of the pier were sound and smooth with no defects observed. Hairline cracking with efflorescence observed on 30 percent of the abutment face. Refer to Figure 10 in Exhibit 1 for detailed inspection notes of Abutment 2. Refer to Photographs 6 and 7 in Exhibit 2 for views of Abutment 2.

- ① The channel bottom material consisted of riprap and silt with approximately 6 in. probe rod penetration.
- ② The submerged portions of the pier were sound and smooth with no defects observed.

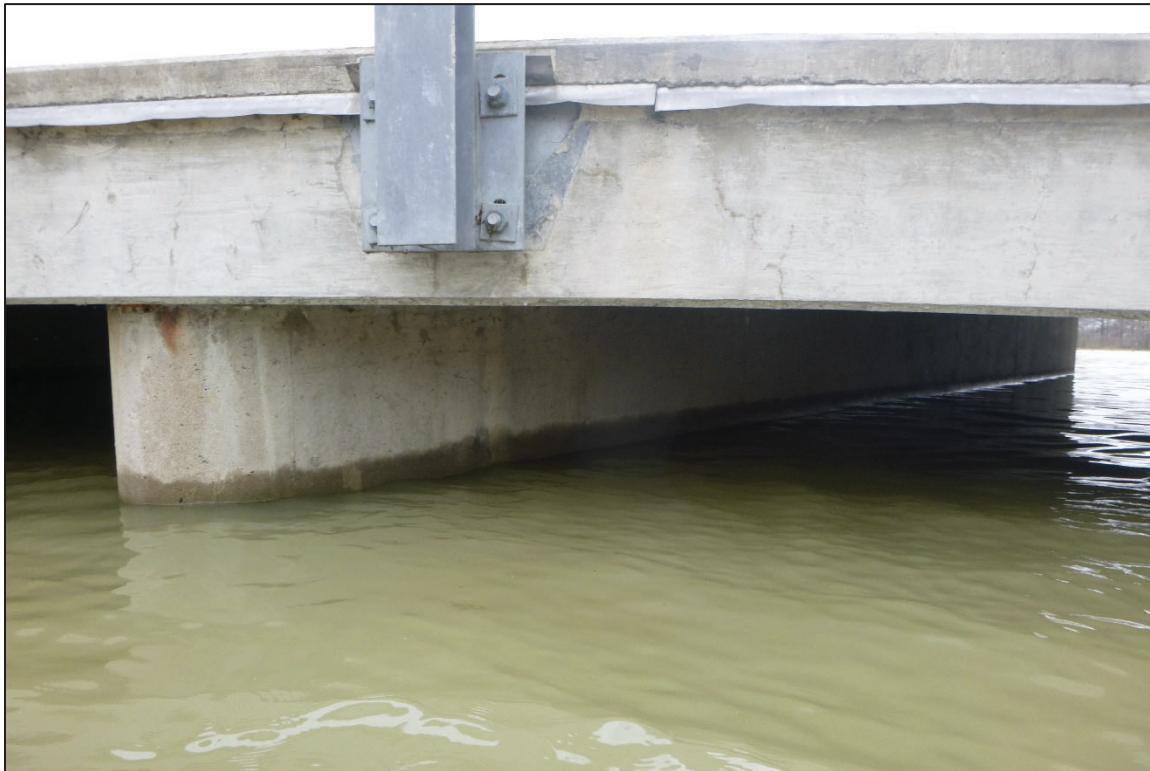
Photograph No. 10: View of the North Face of Pier 1, Looking South.

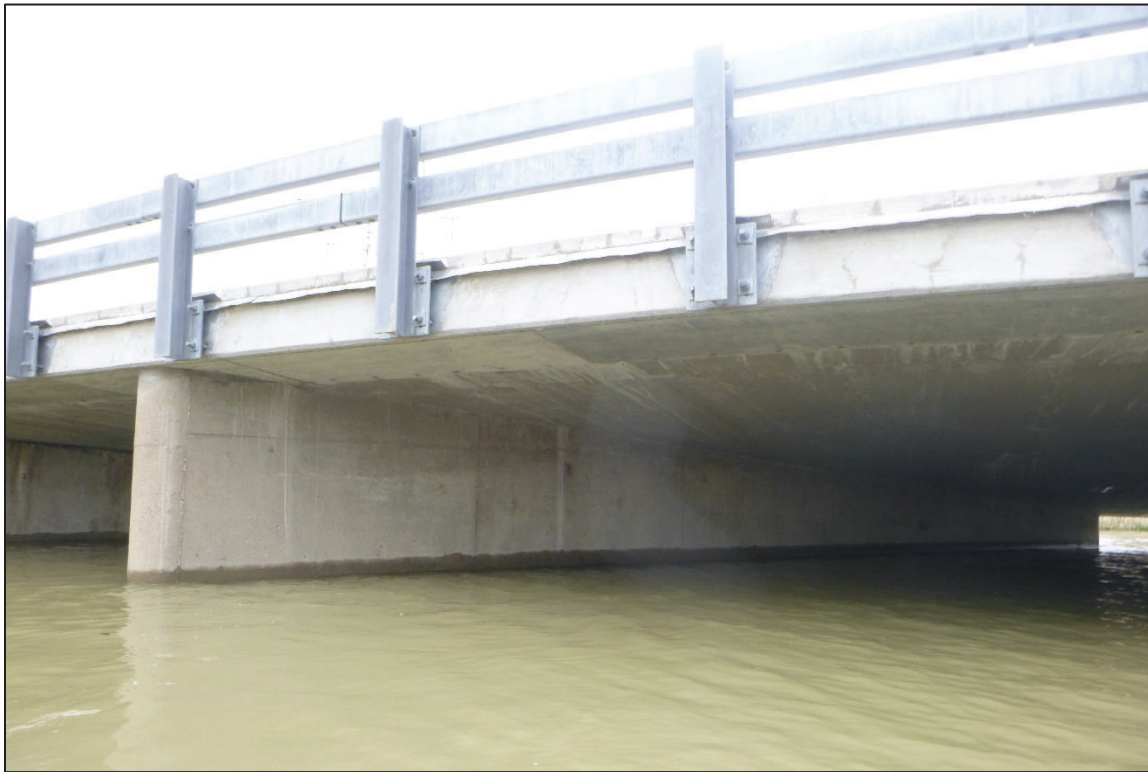
Photograph No. 11: View of the South Face of Pier 1, Looking North.

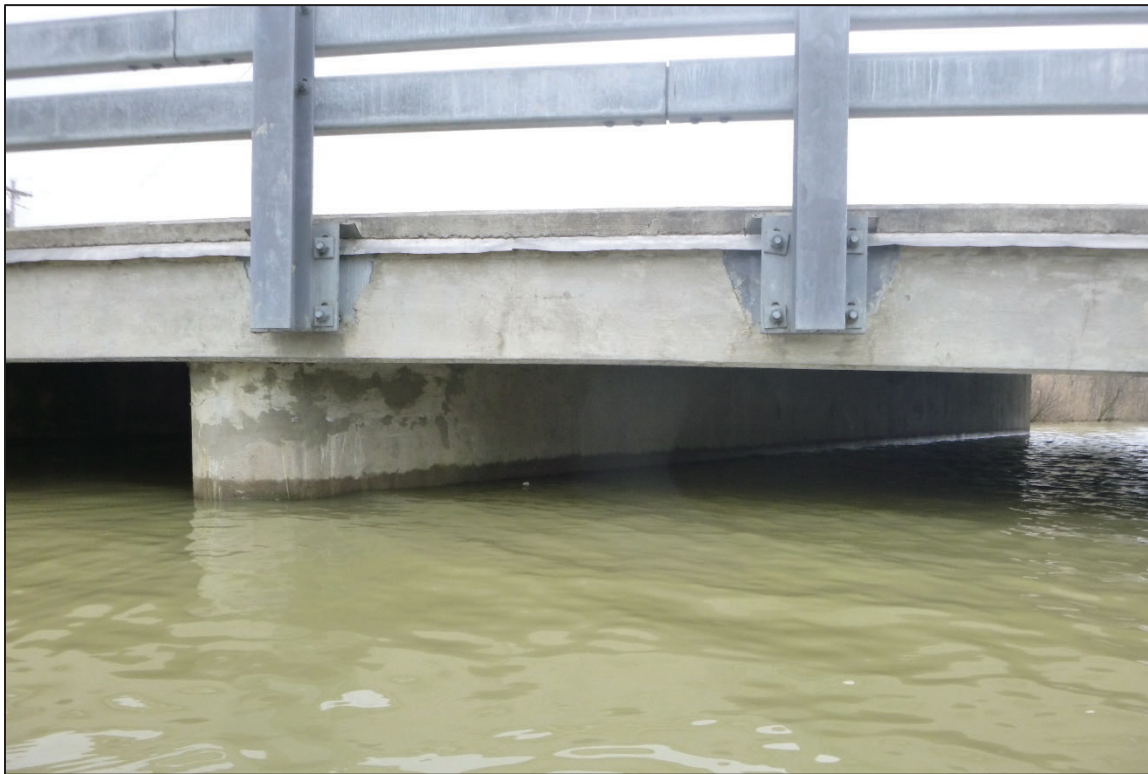
Photograph No. 12: View of the North Face of Pier 2, Looking South.

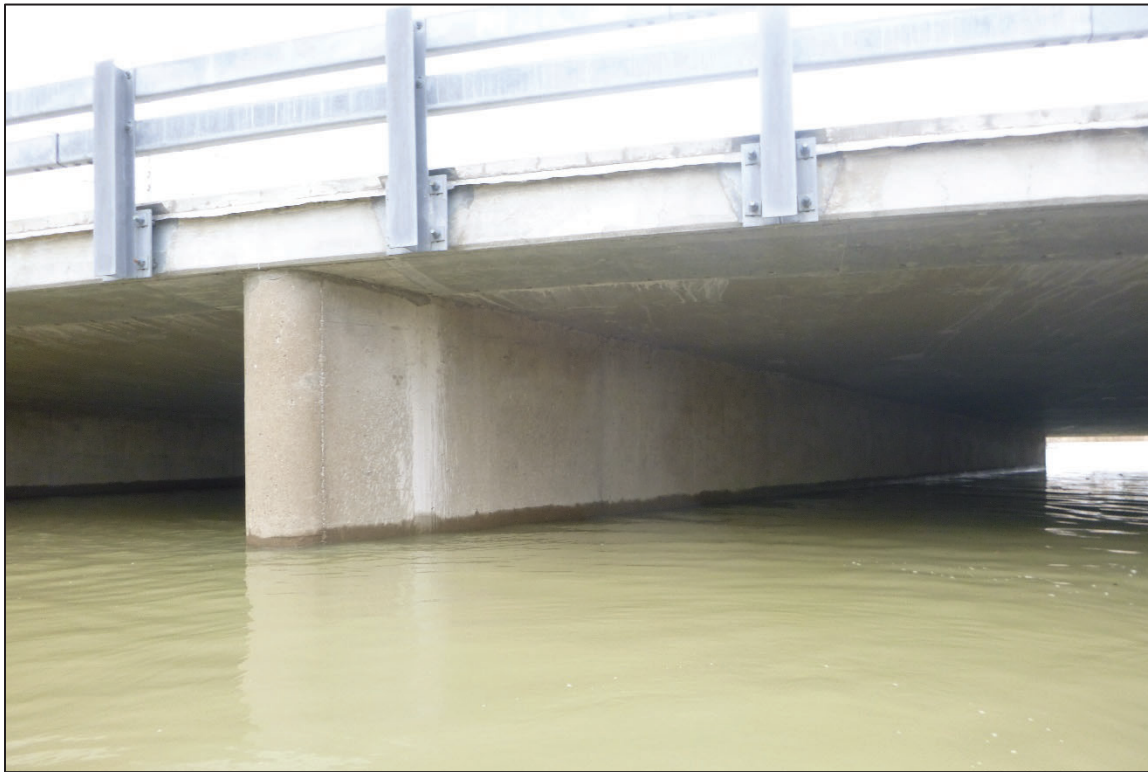
Photograph No. 13: View of the South Face of Pier 2, Looking North.

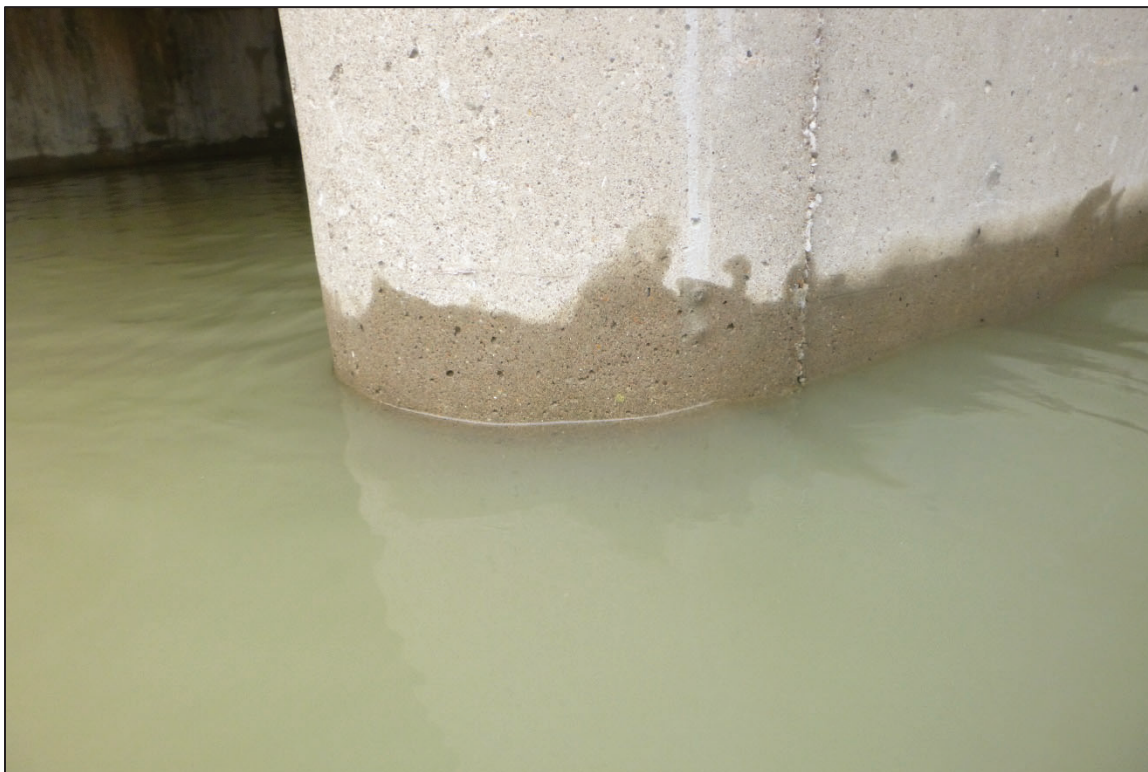
Photograph No. 14: View of the Typical Concrete Condition at the Waterline, Looking North.
