# UNDERWATER BRIDGE INSPECTION REPORT

STRUCTURE NO. 6200214 (OTT-2-1654)  
SR 2 OVER LACARPE CREEK  
OTTAWA COUNTY, OH  
DISTRICT 2

April 2020

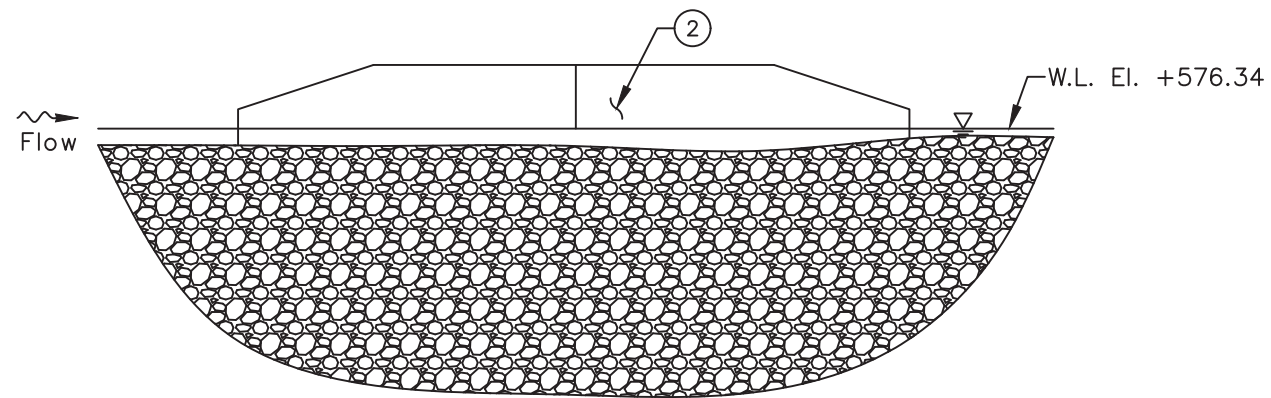
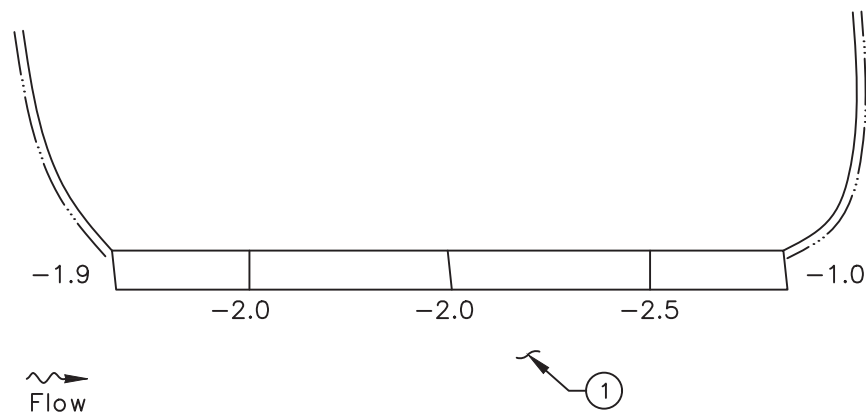
SR-2 OVER LACARPE CREEK  
 STRUCTURE NO. 6200214 (OTT-2-1654)  
 ABUTMENT 1  
 OTTAWA COUNTY, OHIO

The channel bottom material consisted of sand and silt with approximately 12 in. probe rod penetration. Random hairline cracks with efflorescence approximately 5 ft long were observed on the abutment wall. Refer to Figure 6 in Exhibit 1 for detailed inspection notes of Abutment 1. Refer to Photographs 3 through 5 in Exhibit 2 for views of Abutment 1 at the shoreline.

- ① The channel bottom material consisted of sand and silt with approximately 12 in. probe rod penetration.
- ② Random hairline cracks with efflorescence approximately 5 ft long were observed on the abutment wall.

The hairline cracking at Abutments 1 and 2 and Bents 1 and 2 are not structural concerns at this time. However, the cracks do provide a means for water infiltration and freeze-thaw damage. It is therefore recommended that these cracks be monitored during future underwater inspections. If further crack propagation or increased crack widths are observed, it may be necessary to repair the cracks by injection or patching with a repair material suitable for underwater applications.

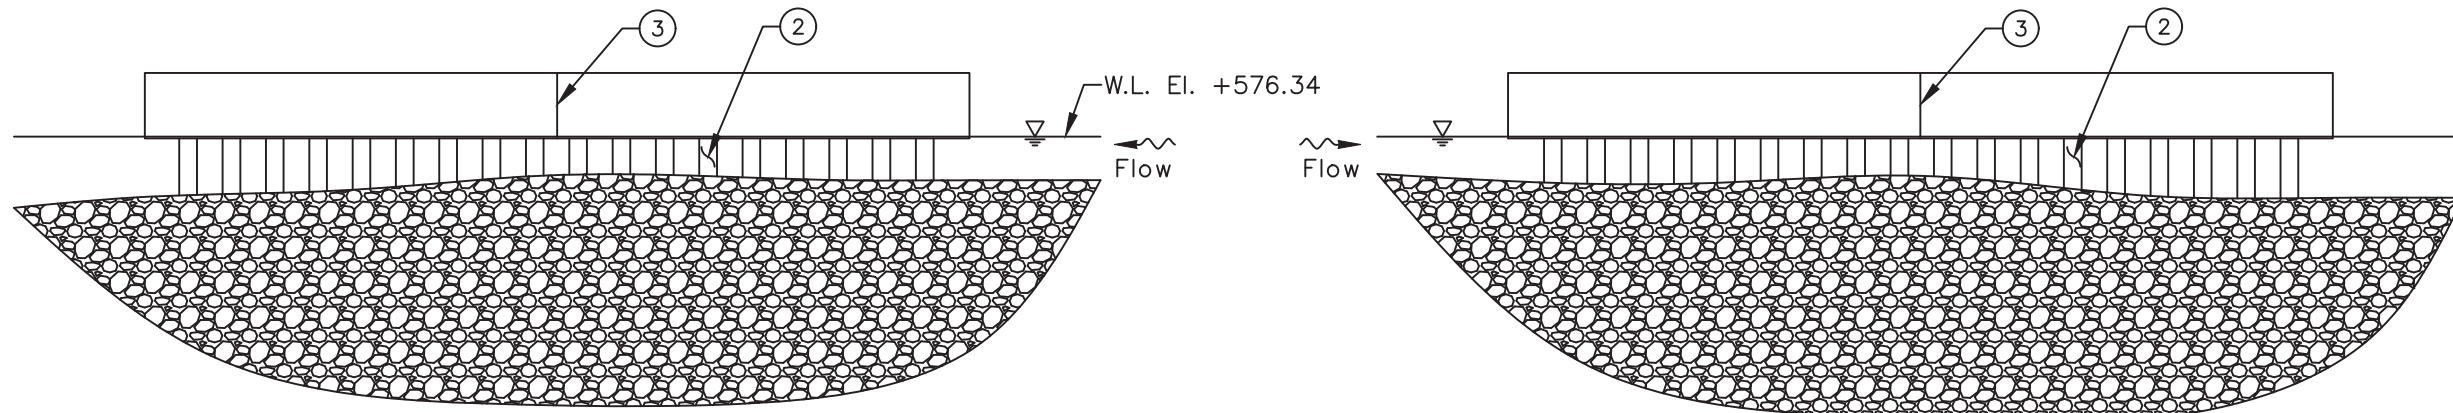
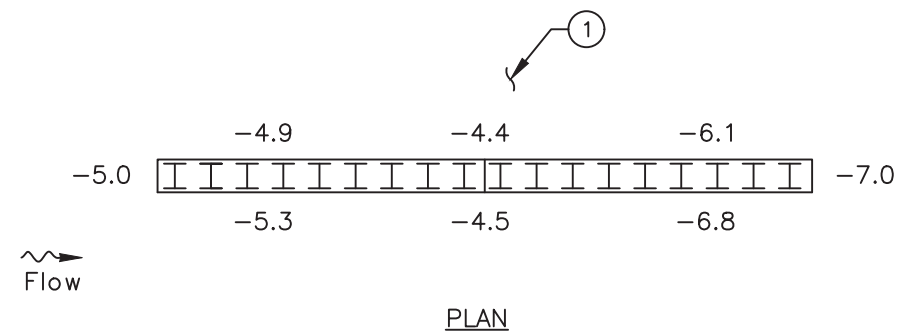
The channel bottom material consisted of sand and silt with approximately 12 in. probe rod penetration. The submerged portions of the bent were sound and smooth with no defects observed. Full-height hairline cracks spaced 4 ft on center throughout the bent cap. Refer to Figure 7 in Exhibit 1 for detailed inspection notes of Bent 1. Refer to Photographs 9 and 10 in Exhibit 2 for views of Bent 1.

- ① The channel bottom material consisted of sand and silt with approximately 12 in. probe rod penetration.
- ② The submerged portions of the pier were sound and smooth with no defects observed.
- ③ Full-height hairline cracks spaced 4 ft on center throughout the bent cap.

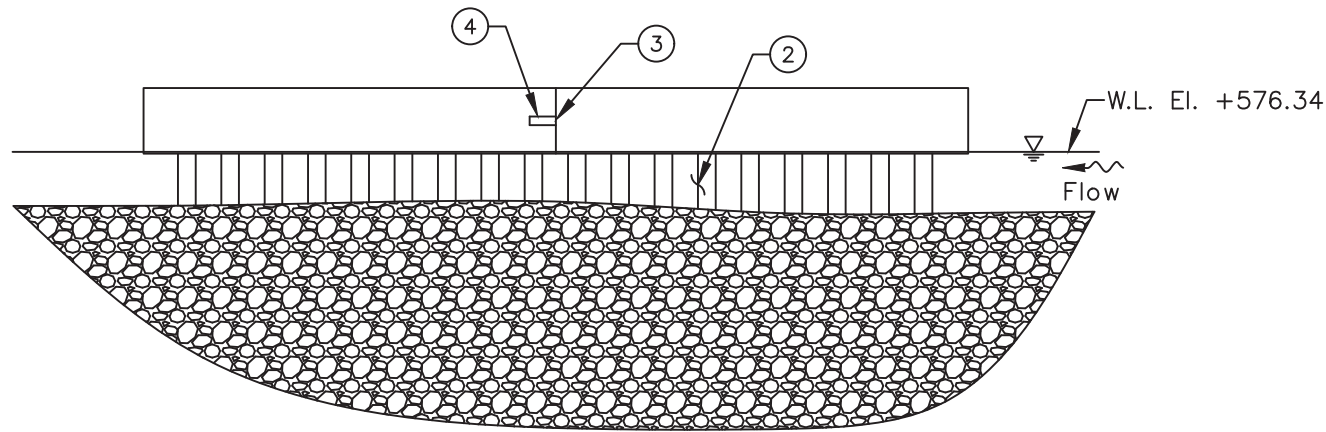
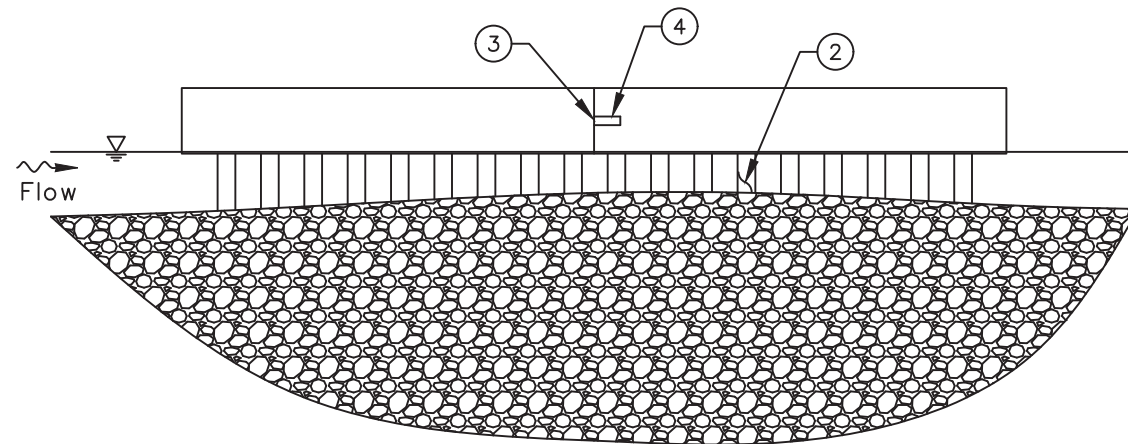
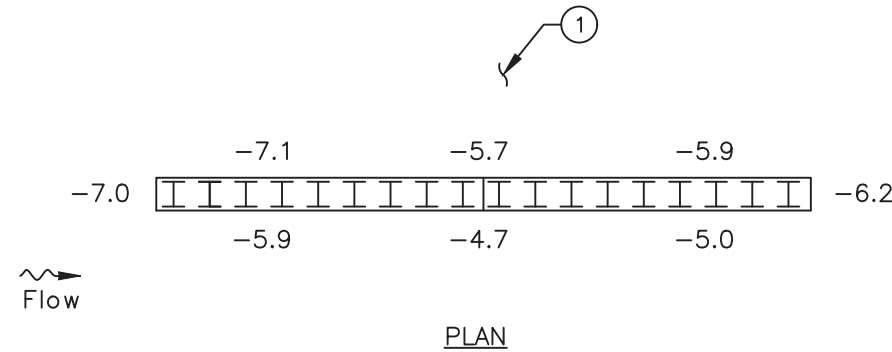
The channel bottom material consisted of sand and silt with approximately 12 in. probe rod penetration. The submerged portions of the bent were sound and smooth with no defects observed. Full-height hairline cracks spaced 4 ft on center throughout the bent cap. An area of delamination was observed on the north and south faces of the bent cap, measuring 1 ft high by 3 ft long. Refer to Figure 8 in Exhibit 1 for detailed inspection notes of Bent 2. Refer to Photographs 11 through 15 in Exhibit 2 for views of Bent 2, typical concrete condition at the waterline, and typical substructure joint conditions.

- ① The channel bottom material consisted of sand and silt with approximately 12 in. probe rod penetration.
- ② The submerged portions of the pier were sound and smooth with no defects observed.
- ③ Full-height hairline cracks spaced 4 ft on center throughout the bent cap.
- ④ An area of delamination was observed on the north and south faces of the bent cap, measuring 1 ft high by 3 ft long.

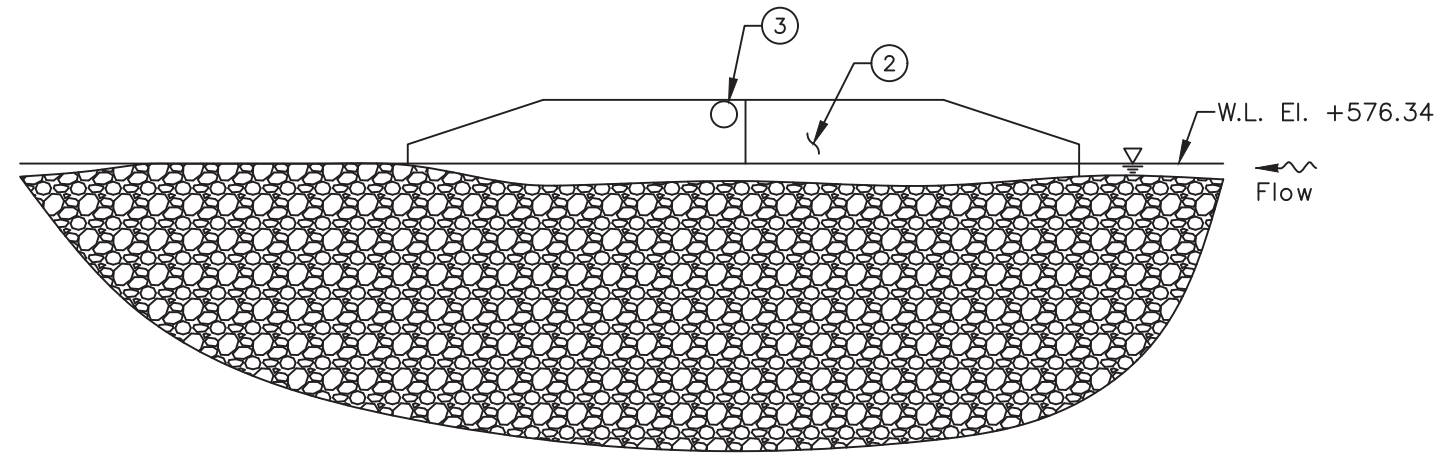
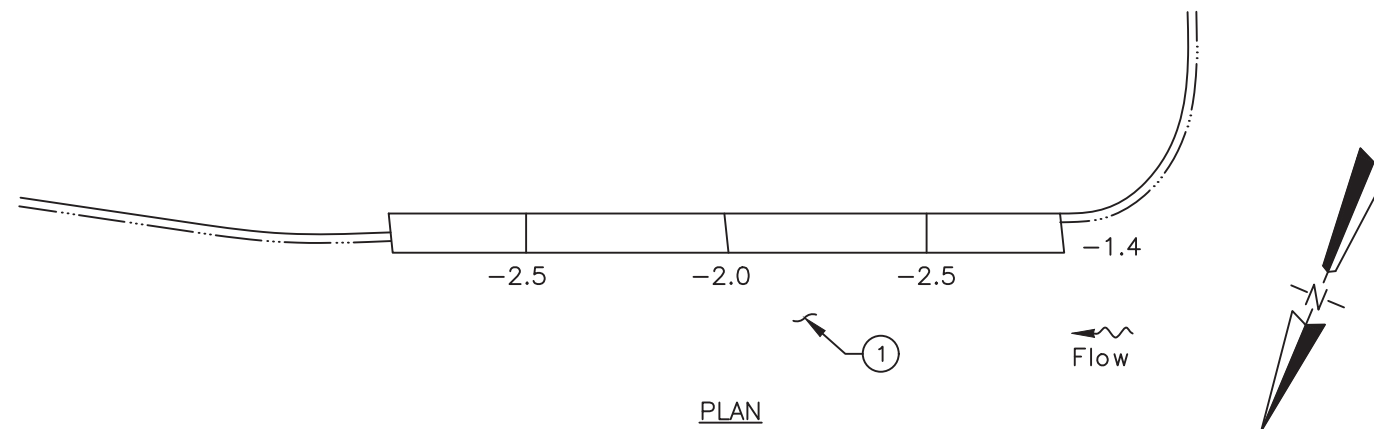
SR-2 OVER LACARPE CREEK  
 STRUCTURE NO. 6200214 (OTT-2-1654)  
 ABUTMENT 2  
 OTTAWA COUNTY, OHIO

The channel bottom material consisted of sand and silt with approximately 12 in. probe rod penetration. Random hairline cracks with efflorescence approximately 5 ft long were observed on the abutment wall. An area of delamination with failed patch was observed. Refer to Figure 9 in Exhibit 1 for detailed inspection notes of Bent 2. Refer to Photographs 6 through 8 in Exhibit 2 for views of Abutment 2 at the shoreline.

- ① The channel bottom material consisted of sand and silt with approximately 12 in. probe rod penetration.
- ② Random hairline cracks with efflorescence approximately 5 ft long were observed on the abutment wall.
- ③ An area of delamination with failed patch was observed.

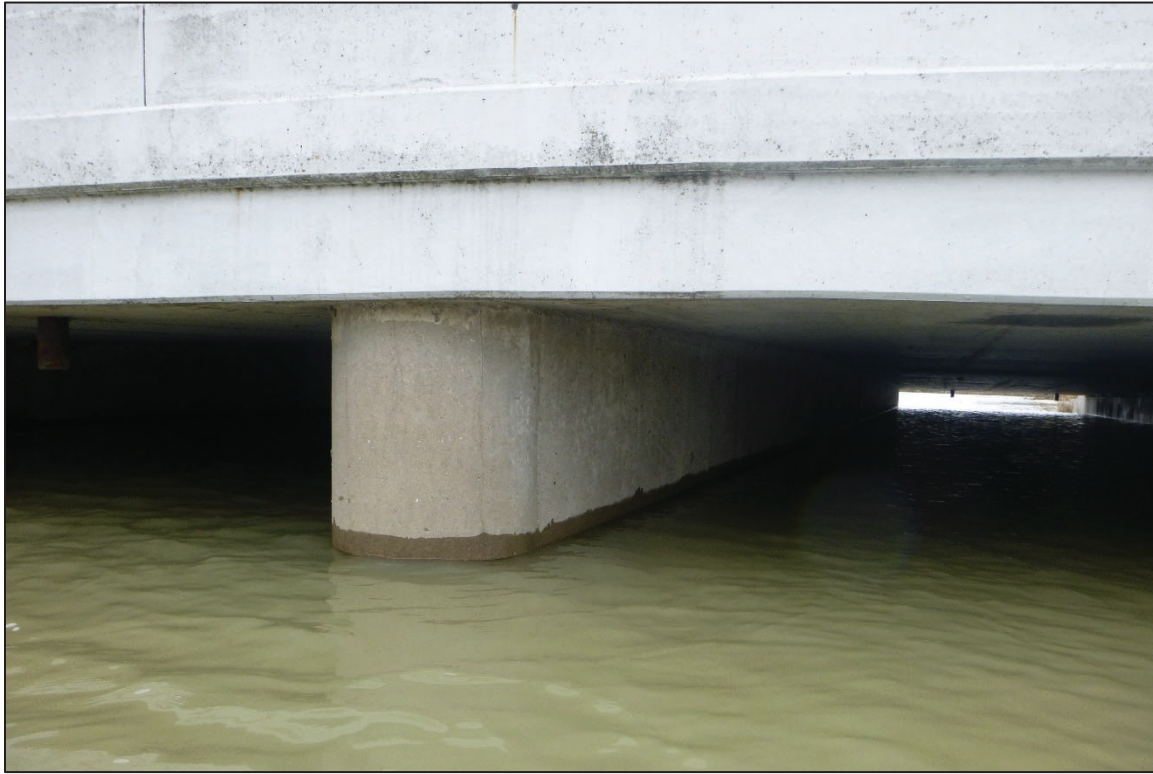
Photograph No. 9: View of the West Face of Bent 1, Looking South.

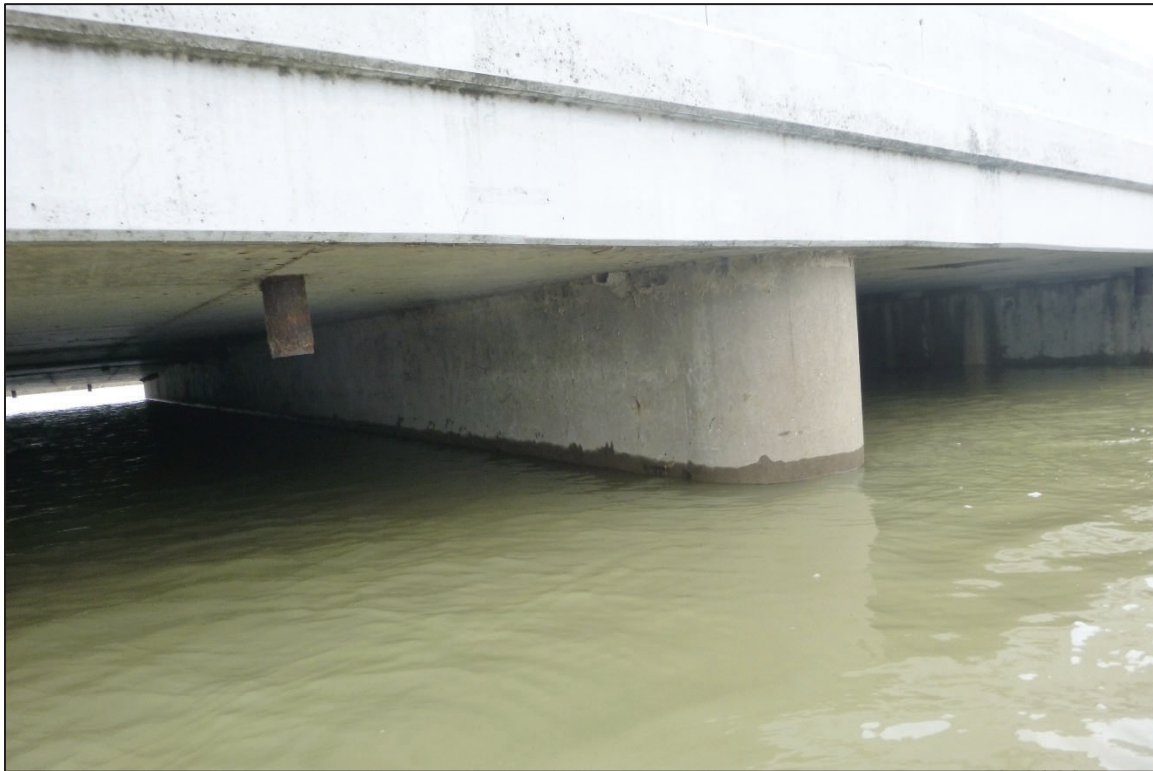
Photograph No. 10: View of the East Face of Bent 1, Looking West.

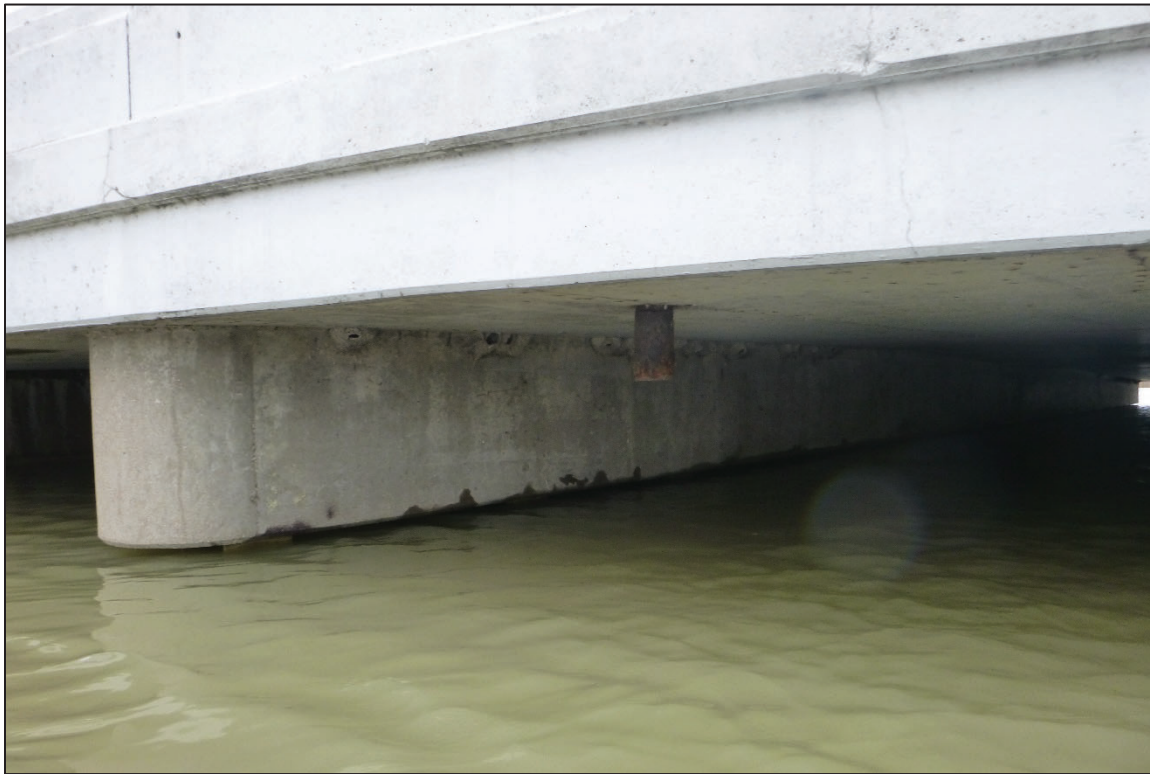
Photograph No. 11: View of the West Face of Bent 2, Looking South.

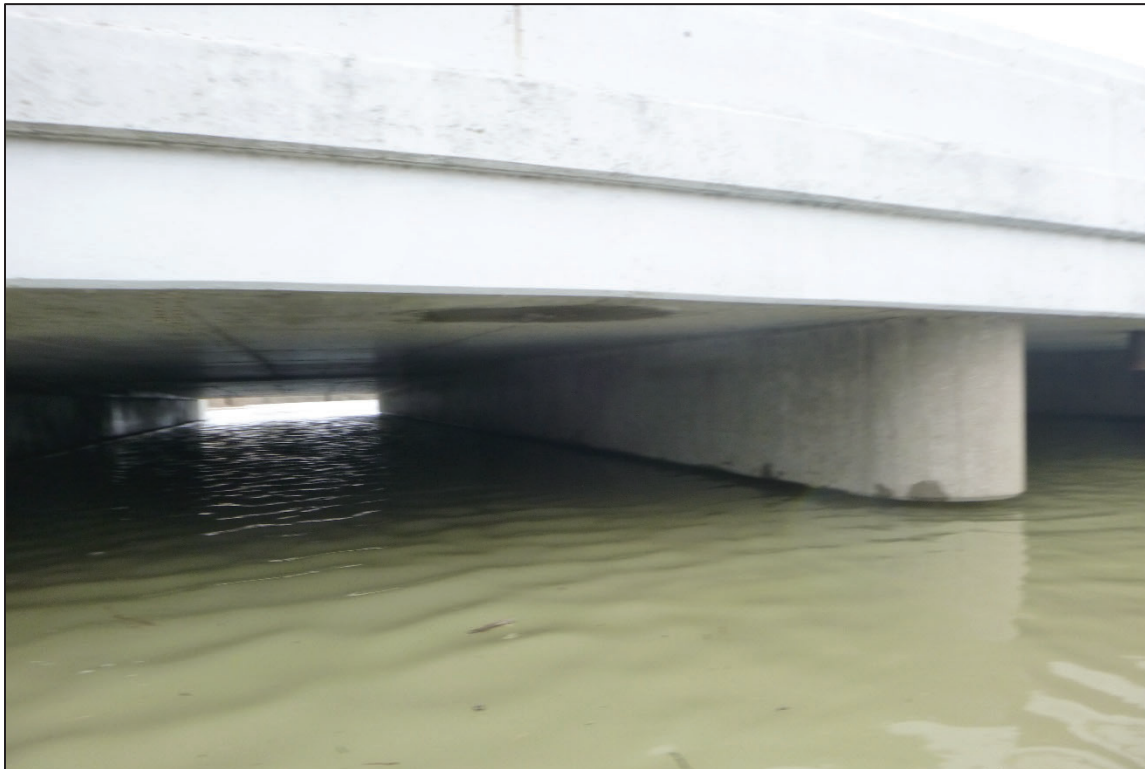
Photograph No. 12: View of the East Face of Bent 2, Looking West.

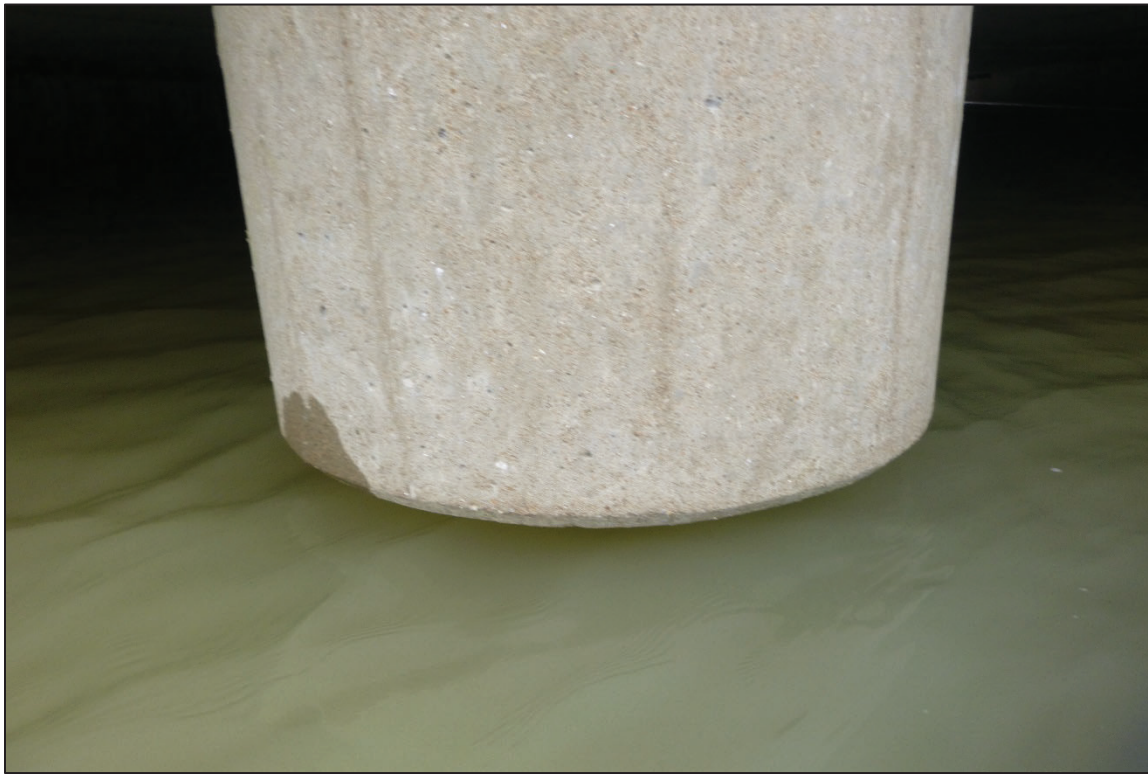
Photograph No. 13: View of the Typical Concrete Condition at the Waterline, Looking Southwest.
