UNDERWATER BRIDGE INSPECTION REPORT

STRUCTURE NO. 6200303 (OTT-2-1810)
SR 2 OVER PORTAGE RIVER OVERFLOW
OTTAWA COUNTY, OH
DISTRICT 2

May 2020

COLLINS
ENGINEERS INC.

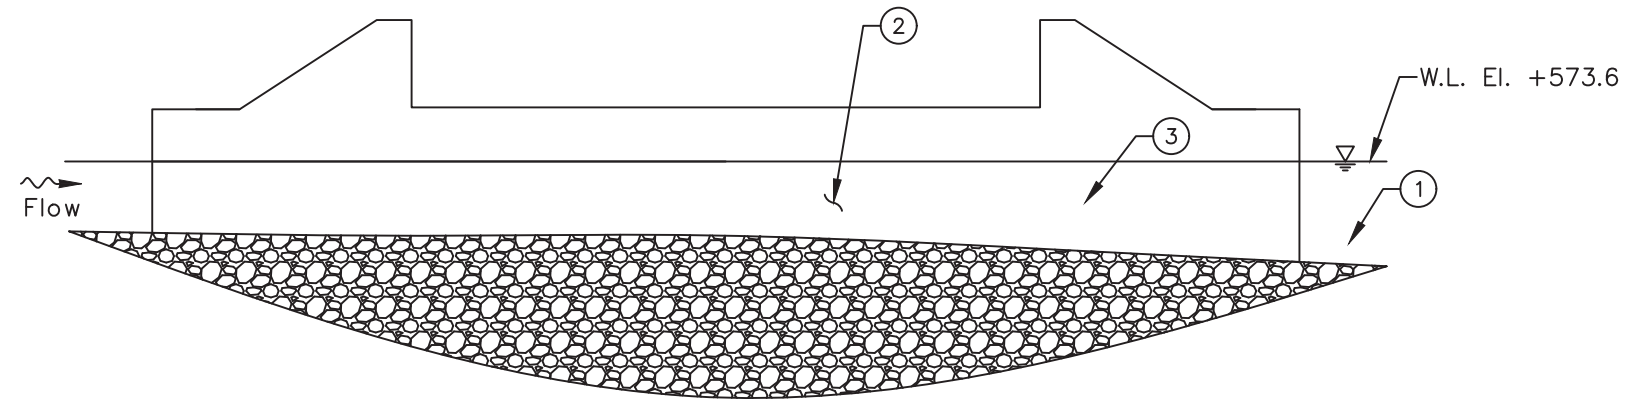
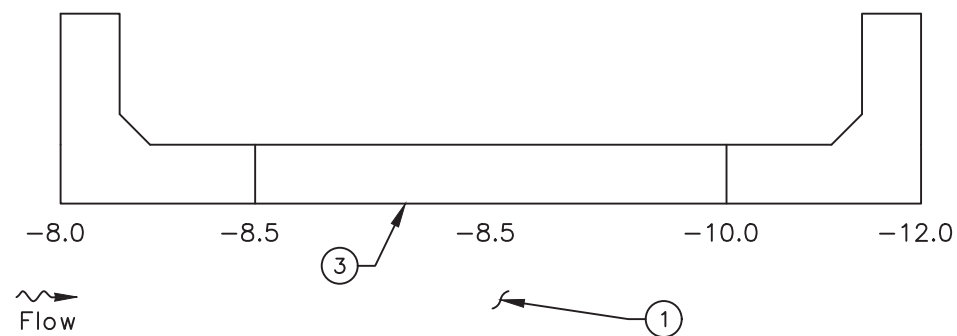
SR-2 OVER PORTAGE RIVER OVERFLOW
 STRUCTURE NO. 6200303 (OTT-2-1810)
 ABUTMENT 1
 OTTAWA COUNTY, OHIO

The channel bottom material around Abutment 1 consisted of gravel with scattered riprap up to 12 in. diameter with silt infill with up to 2 in. probe rod penetration. There was a 1 ft high band of scale at the waterline along the full length of both abutments. The scale was up to 1/8 in. deep in Abutment 1. Refer to Figure 6 in Exhibit 1 for detailed inspection notes of Abutment 1. Refer to Photographs 7 and 8 in Exhibit 2 for views of Abutment 1.

- ① The channel bottom material consisted of sand, gravel and cobbles with approximately 2 in. probe rod penetration.
- ② A 1 ft high band of scaling measuring up to 1/8 in. deep was observed at the waterline along the full length of the abutment.
- ③ The submerged portions of the pier were sound and smooth with no defects observed.

- Monitor area of poor concrete consolidation and spalls on Abutments 1 and 2.
- Monitor scaling on Abutments 1 and 2.

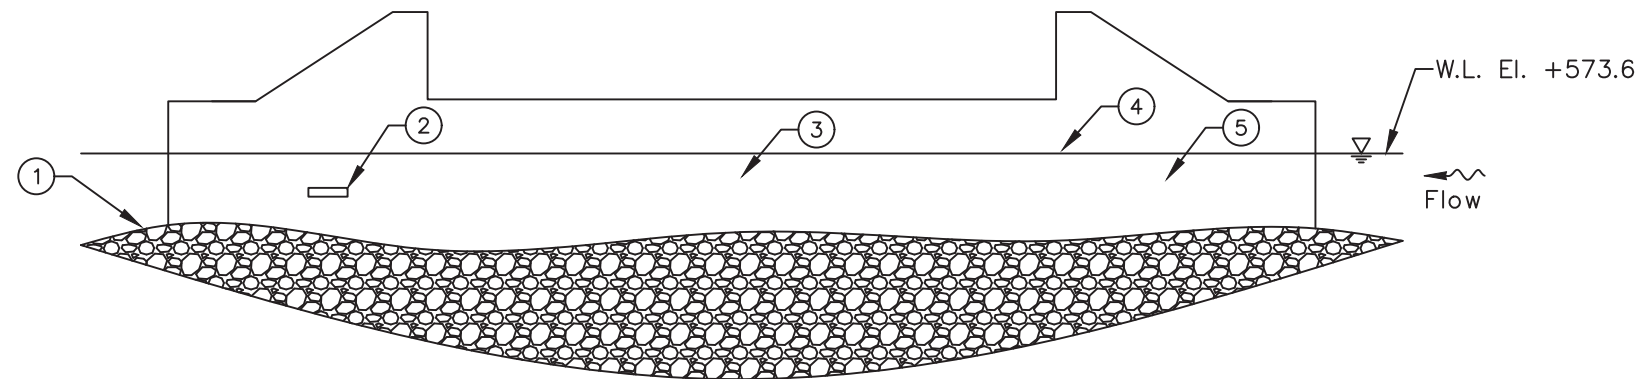
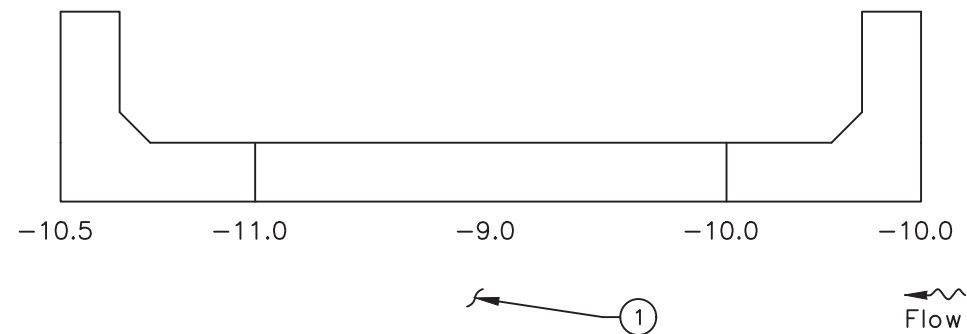
SR-2 OVER PORTAGE RIVER OVERFLOW
STRUCTURE NO. 6200303 (OTT-2-1810)
ABUTMENT 2
OTTAWA COUNTY, OHIO

The channel bottom material around Abutment 2 consisted of gravel with scattered riprap up to 12 in. diameter with silt infill with up to 2 in. probe rod penetration. spalls with dimensions 2 ft high by 1 ft wide by 3/4 in. deep were located on both faces of the downstream corner of Abutment 2. A spall with soft concrete had dimensions 4.5 ft wide by 1 ft high by 1 in. deep was located 20 ft from the downstream corner and 5 ft above the mudline of Abutment 2. The expansion joint at the center of Abutment 2 had up to 4 inches of separation and up to 1 ft wide spalling with up to 3 inches of penetration. There was a 1 ft high band of scale at the waterline along the full length of both abutments. The scale was up to 3/16 in. deep in Abutment 2. A spall with dimensions 4 ft high by 2 ft wide along the abutment and 1 ft wide along the wingwall by 3 in. deep was located at the upstream corner of Abutment 2 and 5 ft above the mudline. Refer to Figure 7 in Exhibit 1 for detailed inspection notes of Abutment 2. Refer to Photographs 9 through 11 in Exhibit 2 for views of Abutment 2 and typical concrete condition at the waterline.

- ① The channel bottom material consisted of sand, gravel and cobbles with approximately 2 in. probe rod penetration.
- ② A spall measuring 4.5 ft wide by 1 ft high by 1 in. deep with soft concrete was observed approximately 20 ft from the downstream corner and 5 ft above the mudline.
- ③ The expansion joint at the center of the abutment exhibited up to 4 in. of separation and spalling measuring up to 1 ft wide with up to 3 in. of penetration.
- ④ A 1 ft high band of scaling measuring up to an average of 3/16 in. deep with random areas measuring 1 in. deep was observed at the waterline along the full length of the abutment.
- ⑤ The submerged portions of the pier were sound and smooth with no defects observed.

The spalls observed on Abutment 2 are not a structural concern at this time given its size compared to the overall pier size, and as a result, no repairs are recommended. This area should be monitored during future inspections for increasing extent or severity of the scaling and exposure of reinforcing steel. If the extent or severity of the scaling is observed to be increasing or reinforcing steel becomes exposed, it may be necessary to repair the area at that time.

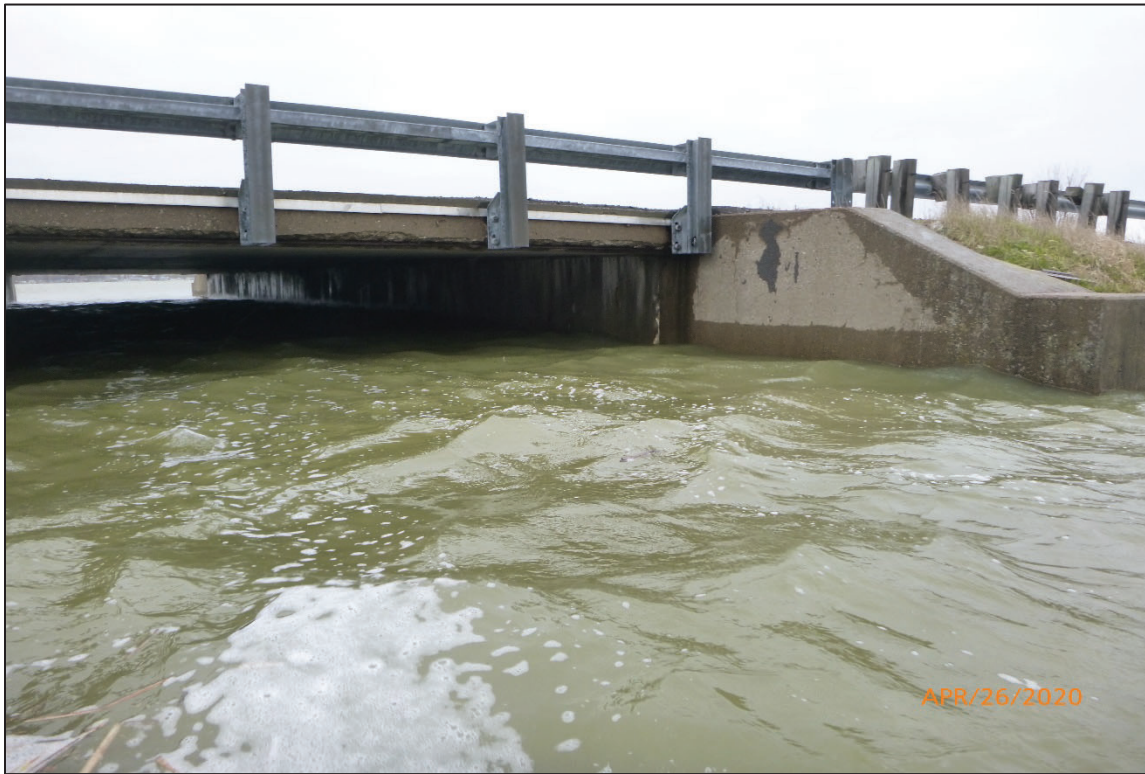
Photograph No. 7: View of the North Corner of Abutment 1, Looking Southwest.

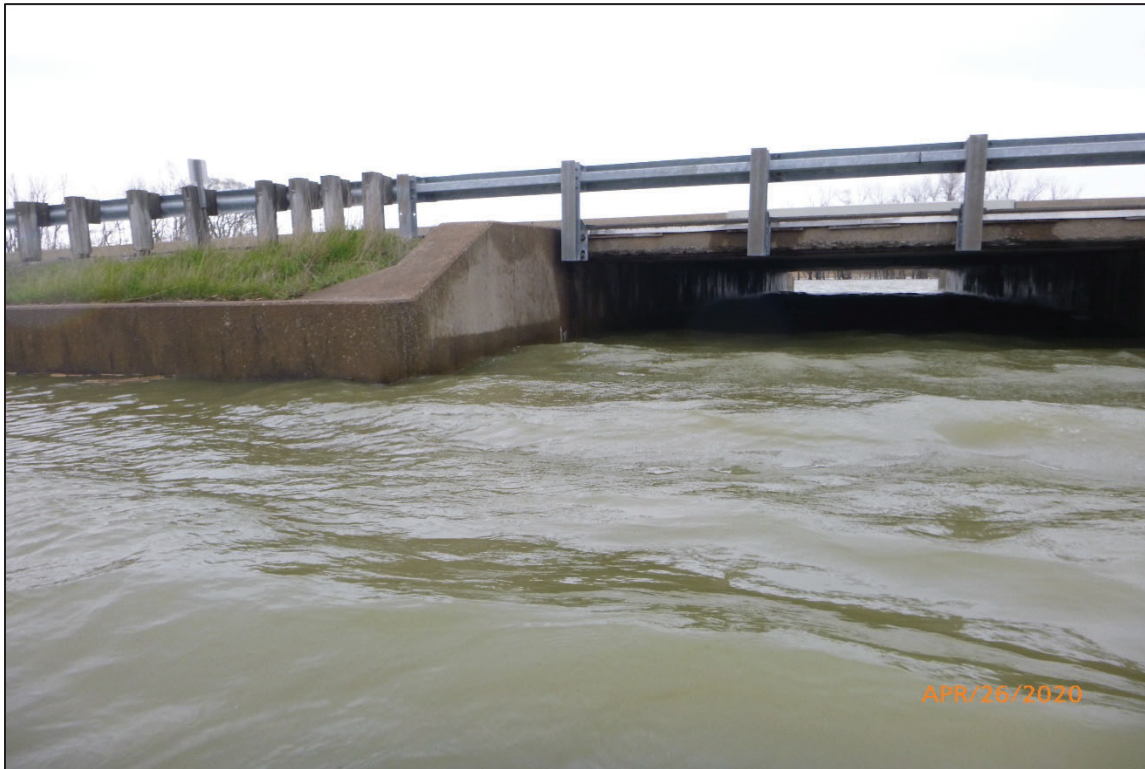
Photograph No. 8: View of the South Corner of Abutment 1, Looking Northwest.

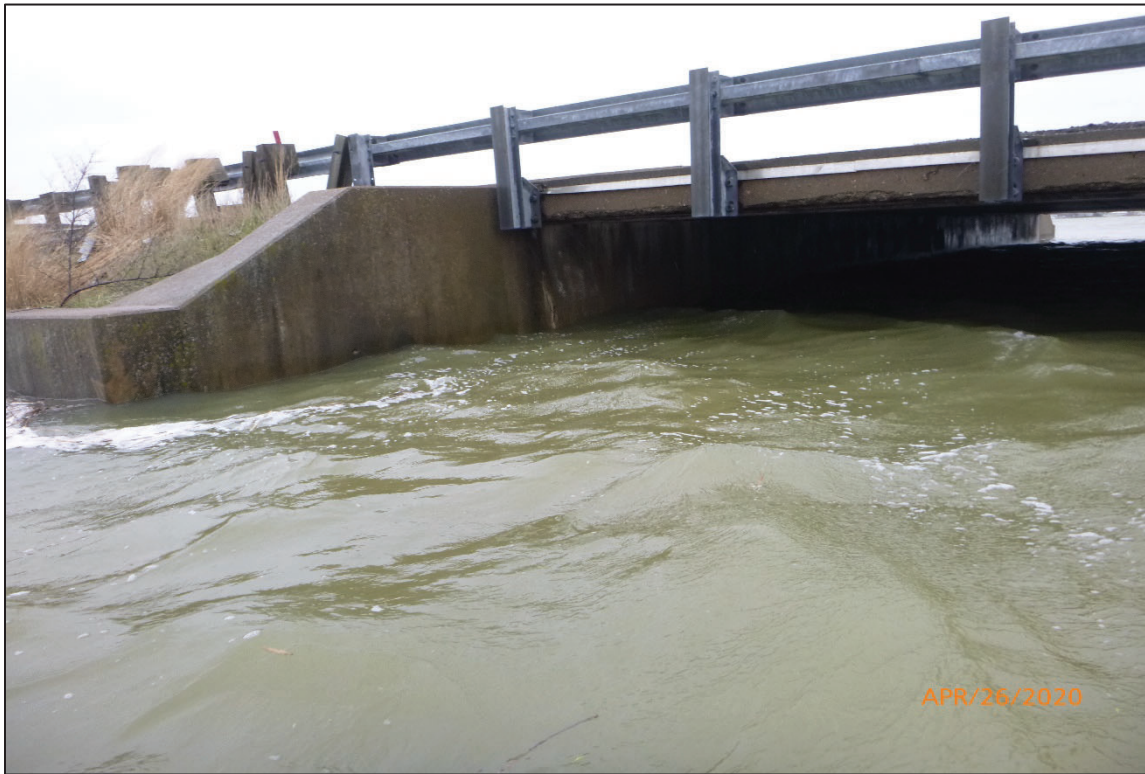
Photograph No. 9: View of the North Corner of Abutment 2, Looking Southeast.

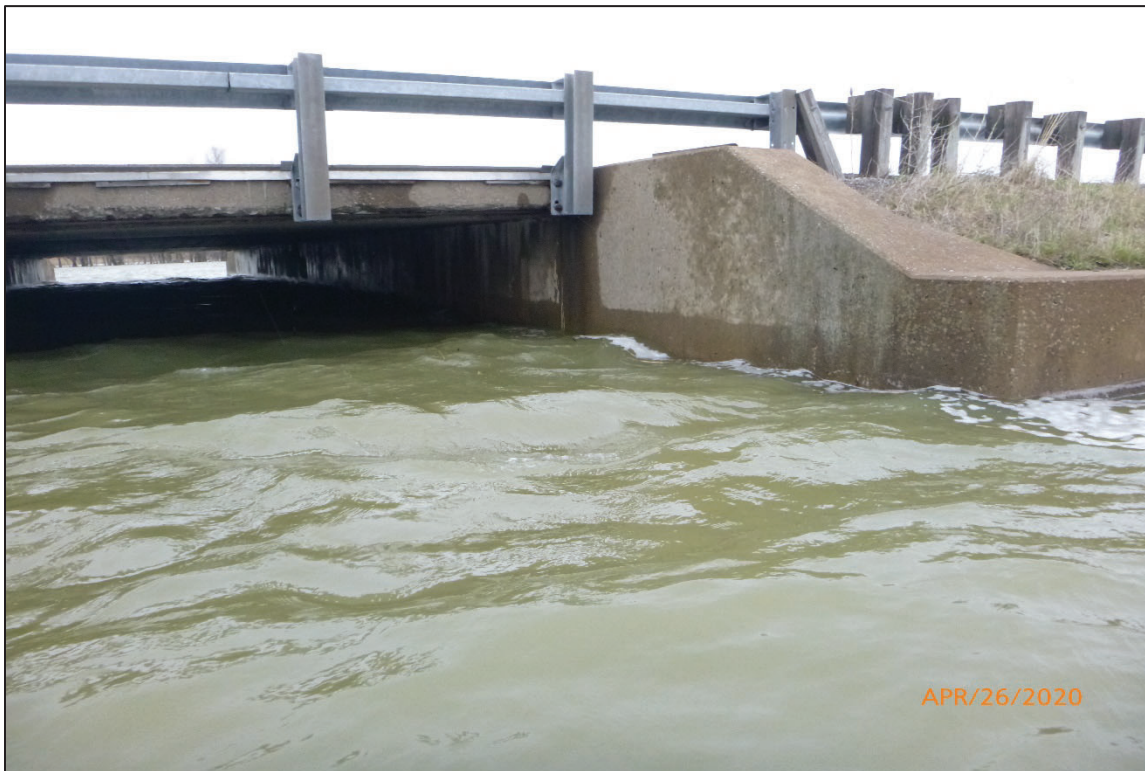
Photograph No. 10: View of the South Corner of Abutment 2, Looking Northeast.

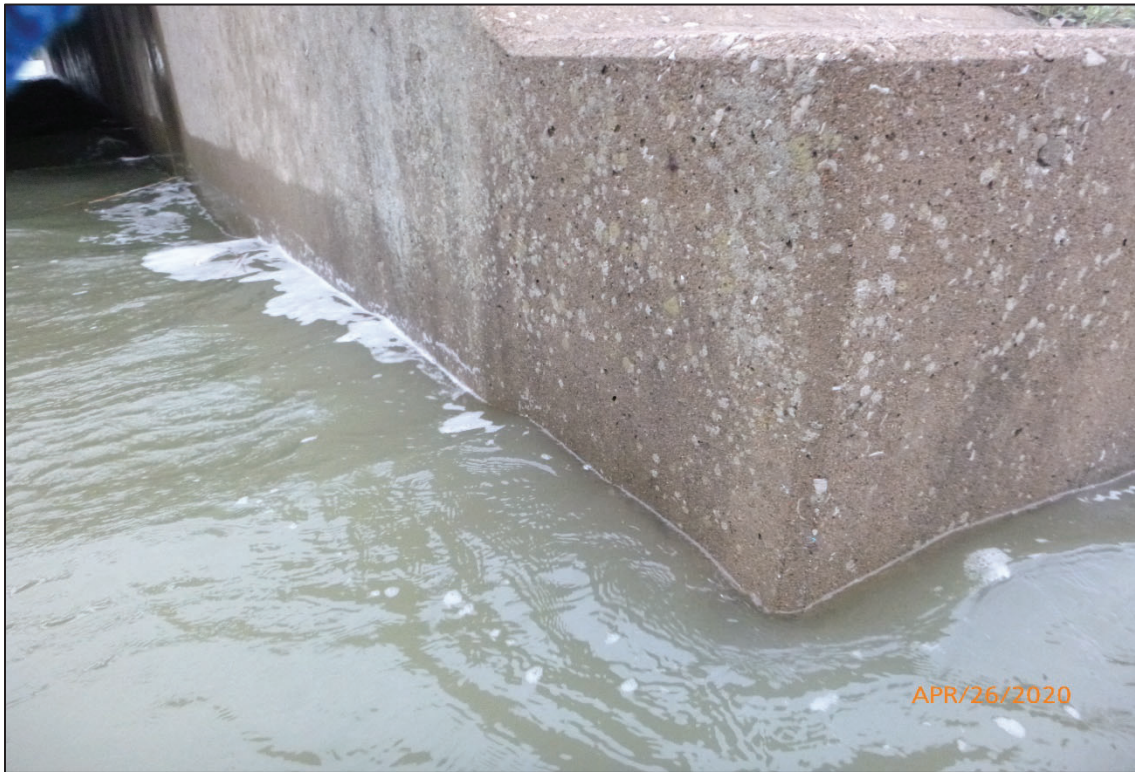
- The expansion joint at the center of Abutment 2 had up to 4 in. of separation and up to 1 ft wide spalling with up to 3 in. of penetration.
 - There was a 1 ft high band of scale at the waterline along the full length of both abutments. The scale was up to 3/16 in. deep in Abutment 2.

Photograph No. 11: View of the Typical Concrete Condition at the Waterline on the South Corner of Abutment 2, Looking Northeast.
