UNDERWATER BRIDGE INSPECTION REPORT

STRUCTURE NO. 6200338 (OTT-2-1830)
SR 2 OVER PORTAGE RIVER
OTTAWA COUNTY, OH
DISTRICT 2

May 2020

COLLINS
ENGINEERS INC.

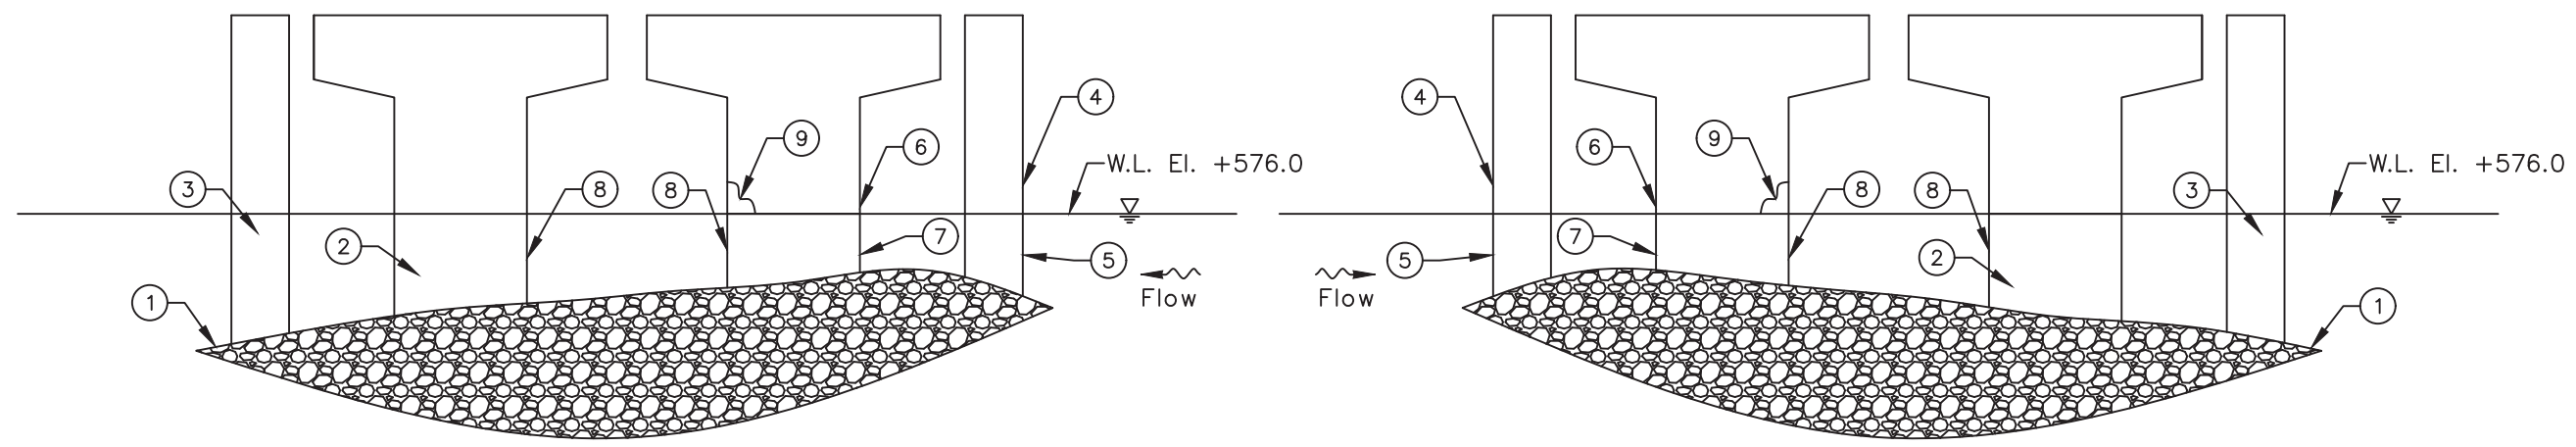
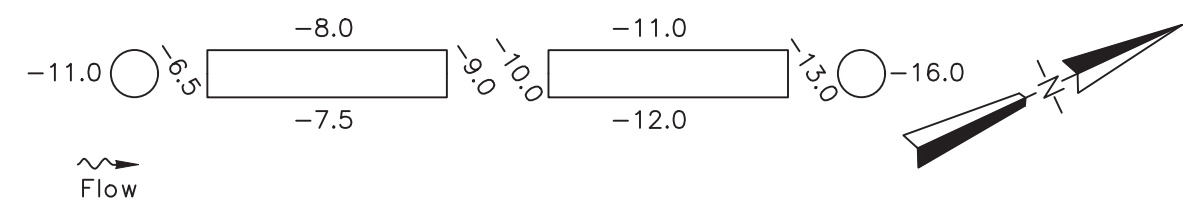
SR-2 OVER PORTAGE RIVER
 STRUCTURE NO. 6200338 (OTT-2-1830)
 PIER 2
 OTTAWA COUNTY, OHIO

- ③ Steel caissons observed to be in good condition with no pitting.
- ④ Steel on noses of piers exhibited pitting up to 1/16 in. deep.
- ⑤ Concrete around icebreakers exhibited spalling and delamination up to 1/2 in. deep by 6 in. wide.

- ⑥ A band of heavy scaling was observed extending from the mudline up 4 ft.
- ⑦ A spall measuring 4 ft vertically was observed extending from the quarter point on the south face to the quarter point on the north face with no exposed rebar.

- ⑧ A spall measuring 1 ft vertically by 6 in. wide was observed at -3 ft below the waterline on the upstream nose of the pier.
- ⑨ A spall measuring 5 ft vertically by 3 ft wide by 2 in. deep with 3 exposed bars and 10% section loss was observed extending from the waterline to +1 ft above the waterline.

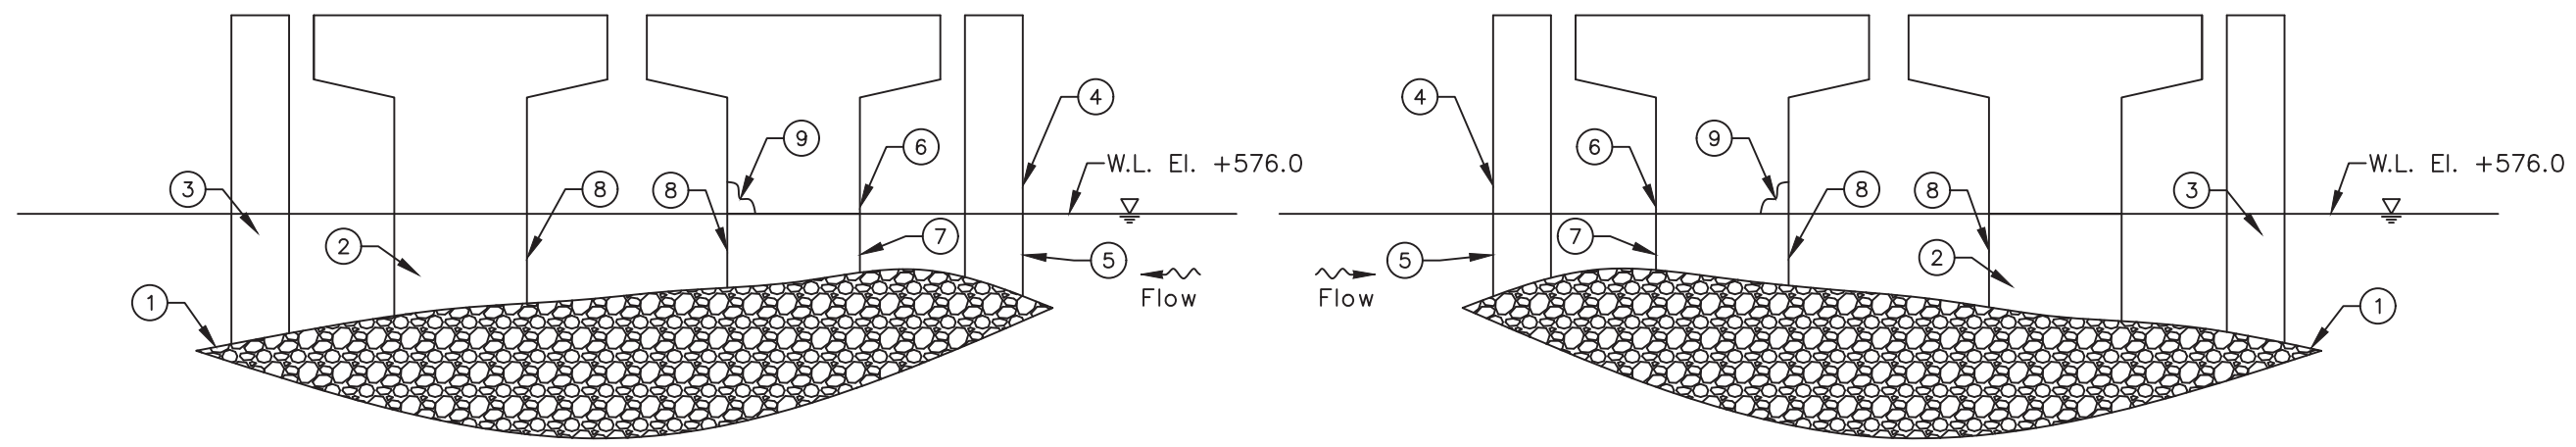
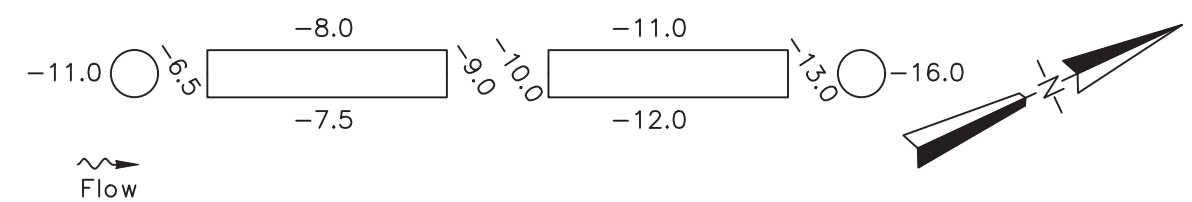
SR-2 OVER PORTAGE RIVER
 STRUCTURE NO. 6200338 (OTT-2-1830)
 PIER 4
 OTTAWA COUNTY, OHIO

- ③ Steel caissons observed to be in good condition with no pitting.
- ④ Steel on noses of piers exhibited pitting up to 1/16 in. deep.
- ⑤ Concrete around icebreakers exhibited spalling and delamination up to 1/2 in. deep by 6 in. wide.

- ⑥ A band of heavy scaling was observed extending from the mudline up 4 ft.
- ⑦ A spall measuring 4 ft vertically was observed extending from the quarter point on the south face to the quarter point on the north face with no exposed rebar.

- ⑧ A spall measuring 1 ft vertically by 6 in. wide was observed at -3 ft below the waterline on the upstream nose of the pier.
- ⑨ A spall measuring 5 ft vertically by 3 ft wide by 2 in. deep with 3 exposed bars and 10% section loss was observed extending from the waterline to +1 ft above the waterline.

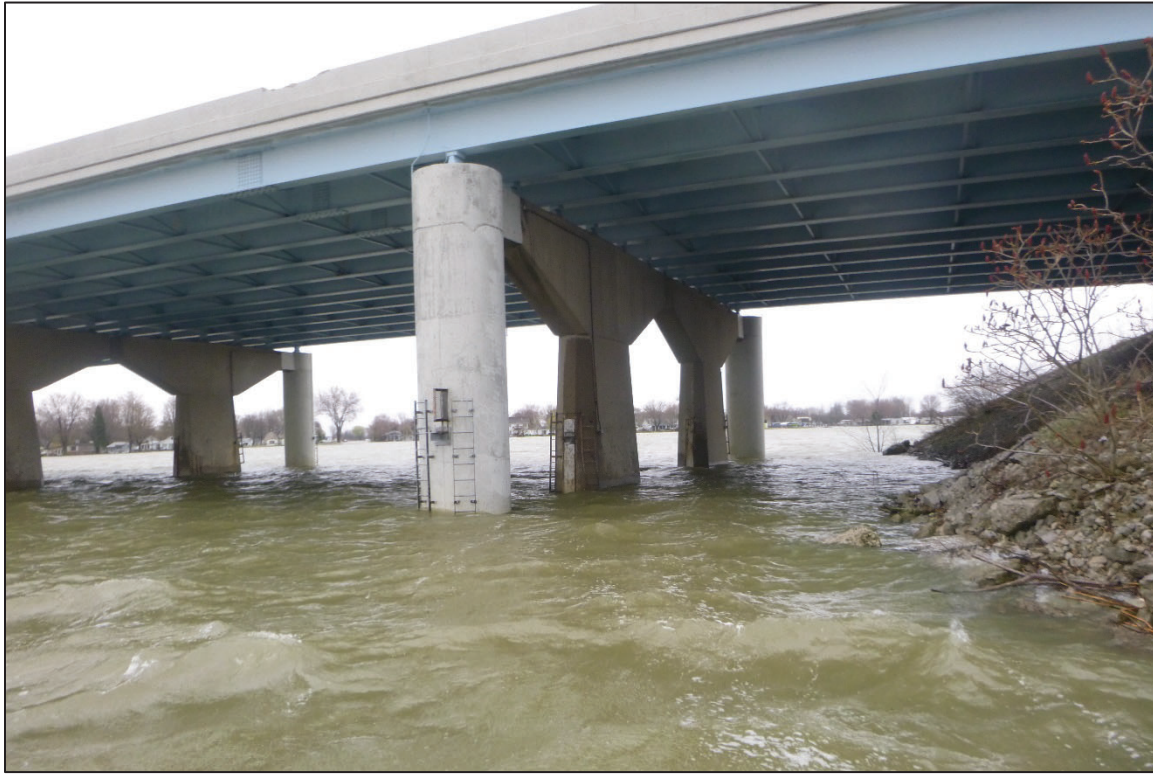
The channel bottom material consisted of sand with approximately 2 in. probe rod penetration. The submerged portions of the pier exhibited light scaling up to 1/10 in. deep. The steel caissons were in good condition and exhibited no pitting. The steel on the nose of Pier 1 exhibited pitting up to 1/16 in. deep. The concrete around icebreakers exhibited spalling and delamination up to 1/2 in. deep by 6 in. wide. Refer to Figure 6 in Exhibit 1 for detailed inspection notes of Pier 1. Refer to Photographs 9 and 10 in Exhibit 2 for views of Pier 1.

Photograph No. 9: View of the West Face of Pier 1, Looking South.

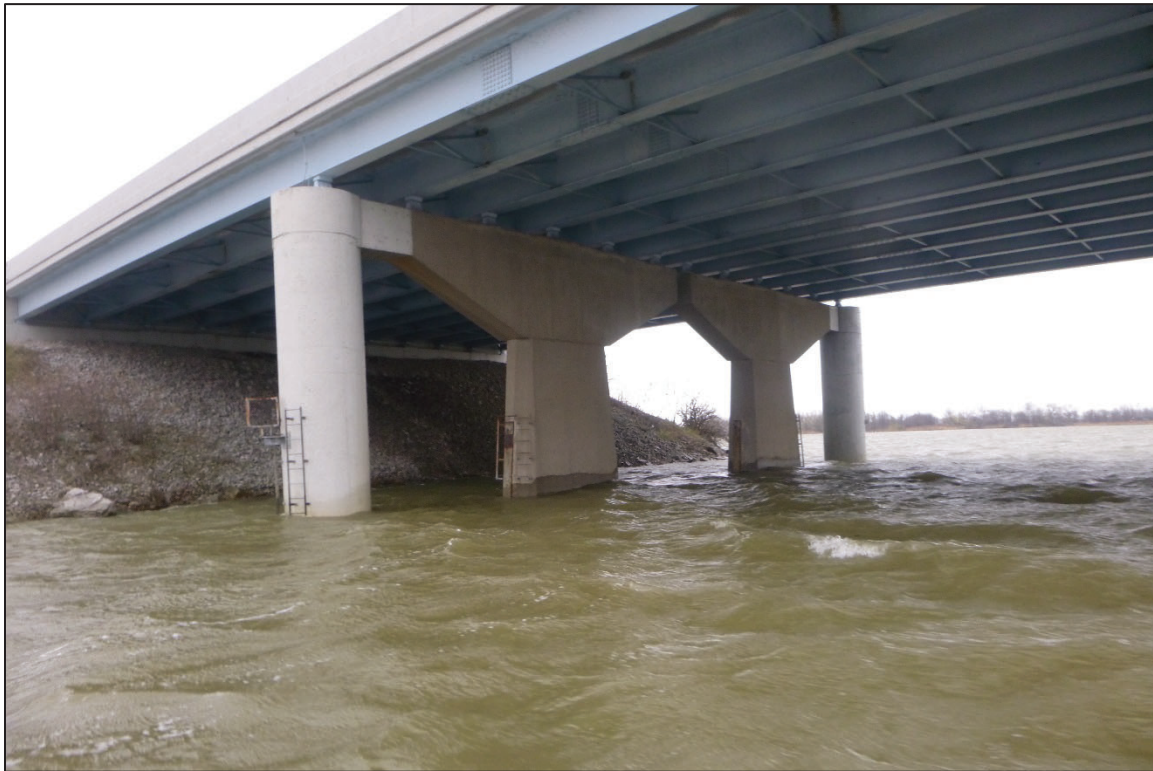
Photograph No. 10: View of the East Face of Pier 1, Looking North.

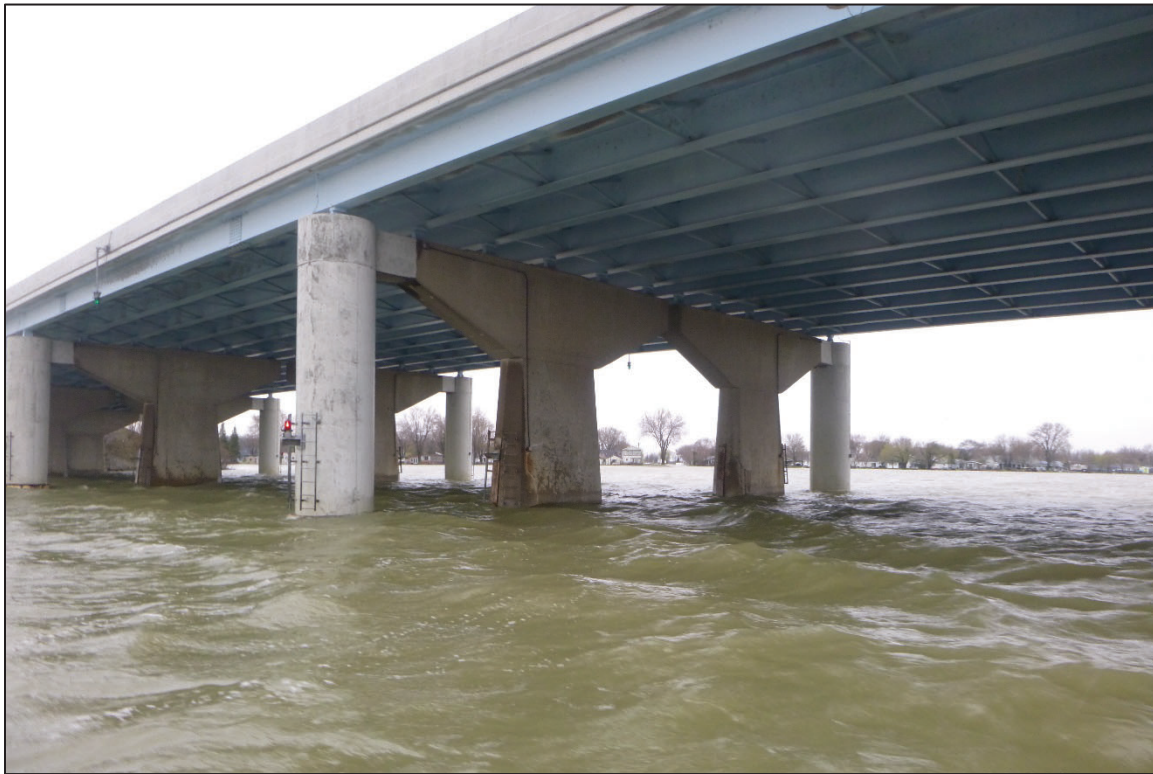
The channel bottom material consisted of riprap up to 2 ft diameter. The submerged portions of the pier were sound and smooth with no defects observed. The steel caissons were in good condition and exhibited no pitting. The steel on the nose of Pier 1 exhibited pitting up to 1/16 in. deep. The concrete around icebreakers exhibited spalling and delamination up to 1/2 in. deep by 6 in. wide. A band of heavy scaling was observed from the mudline up to +4 ft above the waterline. A spall was observed measuring 4 ft vertically from the quarter point on the south face to the quarter point on the north face with no exposed rebar. Typical spall was observed on all pier noses measuring 1 ft vertically by 6 in. horizontally at -3 ft below the waterline. A spall was observed from +1 ft above the waterline measuring 5 ft vertically by 3 ft horizontally by 2 in. deep with 3 exposed bars and 10% section loss. Refer to Figure 7 in Exhibit 1 for detailed inspection notes of Pier 2. Refer to Photographs 11 through 13 in Exhibit 2 for views of Pier 2.

Photograph No. 11: View of the West Face of Pier 2, Looking South.

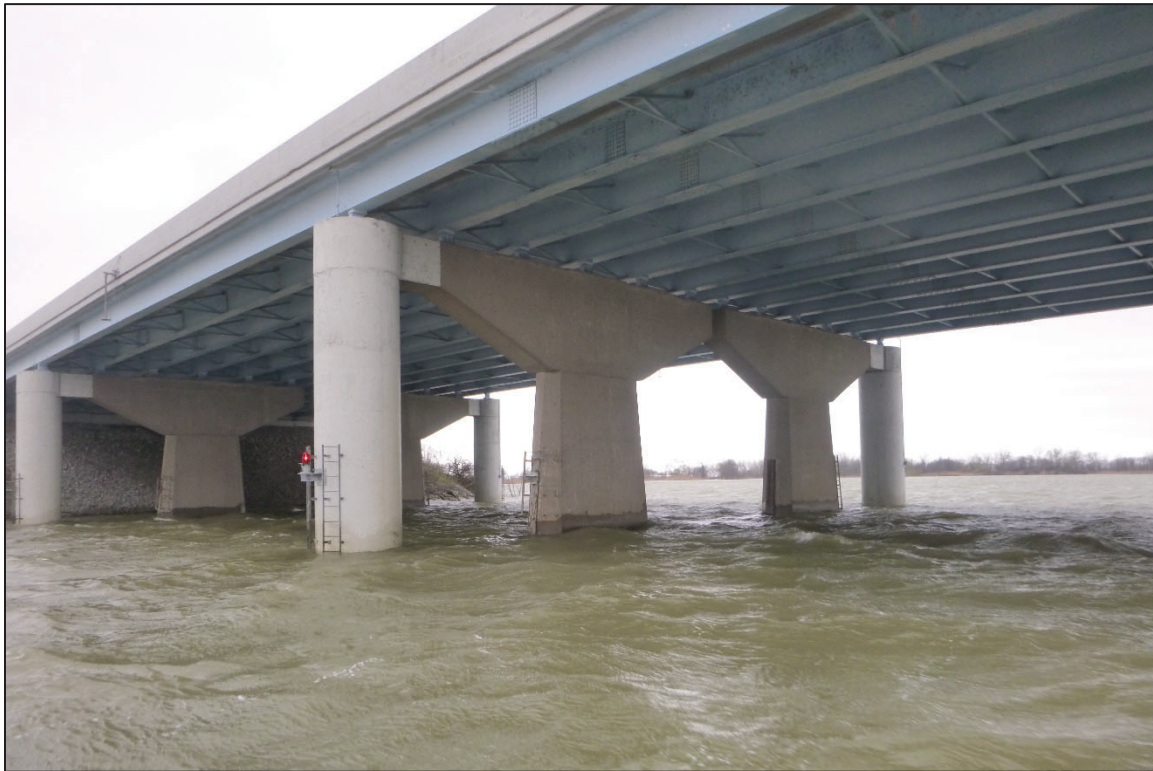
Photograph No. 12: View of the East Face of Pier 2, Looking North.

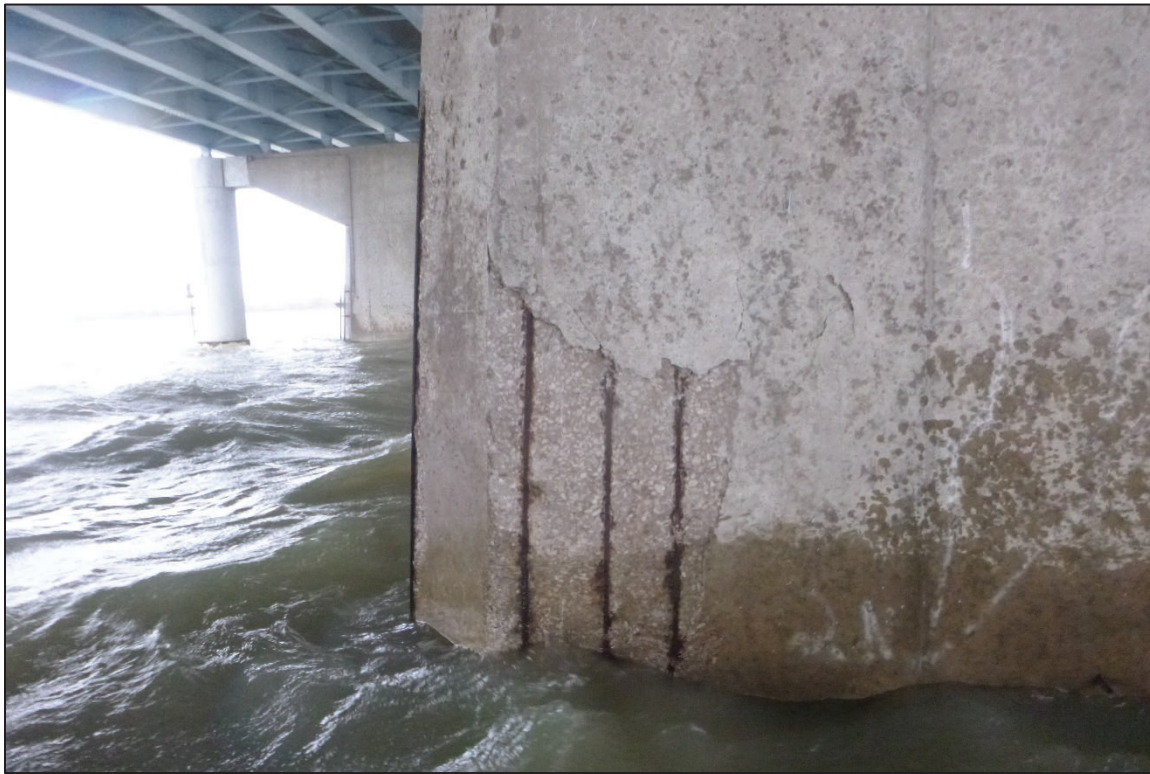
- A band of heavy scaling was observed from the mudline up to +4 ft above the waterline.
 - A spall was observed measuring 4 ft vertically from the quarter point on the south face to the quarter point on the north face with no exposed rebar.

Photograph No. 13: View of the Spall at the Upstream Nose of Pier 2.

The spalls and associated concrete delaminations at Piers 1 through 5 are not structural concerns at this time; however, they should be repaired to prevent further deterioration. The repairs should include removal of unsound concrete to a minimum of 1 inch behind the reinforcing steel, cleaning and replacing reinforcing steel as required, and placing concrete designed to provide high durability with low permeability.

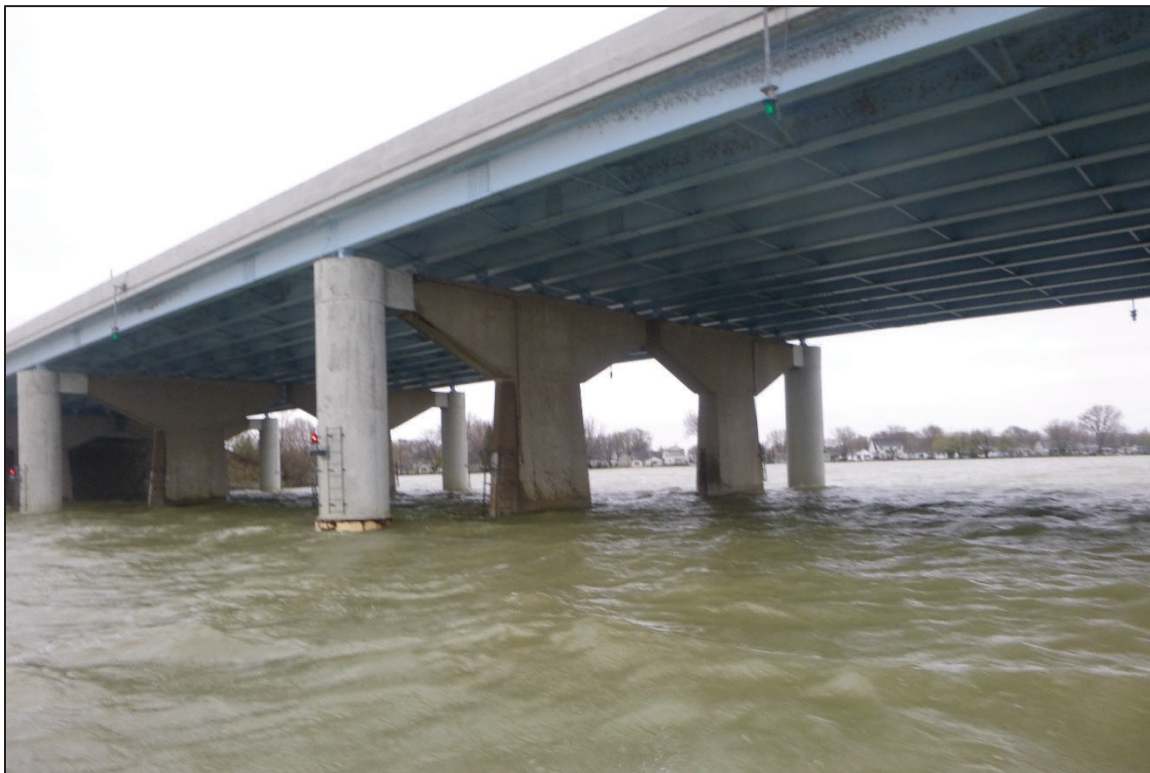
The channel bottom material consisted of riprap up to 24 in. diameter. The submerged portions of the pier were sound and smooth with no defects observed. The steel caissons were in good condition and exhibited no pitting. The steel on the nose of Pier 1 exhibited pitting up to 1/16 in. deep. The concrete around icebreakers exhibited spalling and delamination up to 1/2 in. deep by 6 in. wide. An exposed bar was observed on the upstream nose of the pier with 10% section loss. Typical spall was observed on all pier noses measuring 1 ft vertically by 6 in. horizontally at -3 ft below the waterline. Refer to Figure 8 in Exhibit 1 for detailed inspection notes of Pier 3. Refer to Photographs 14 and 15 in Exhibit 2 for views of Pier 3.

Photograph No. 14: View of the West Face of Pier 3, Looking South.

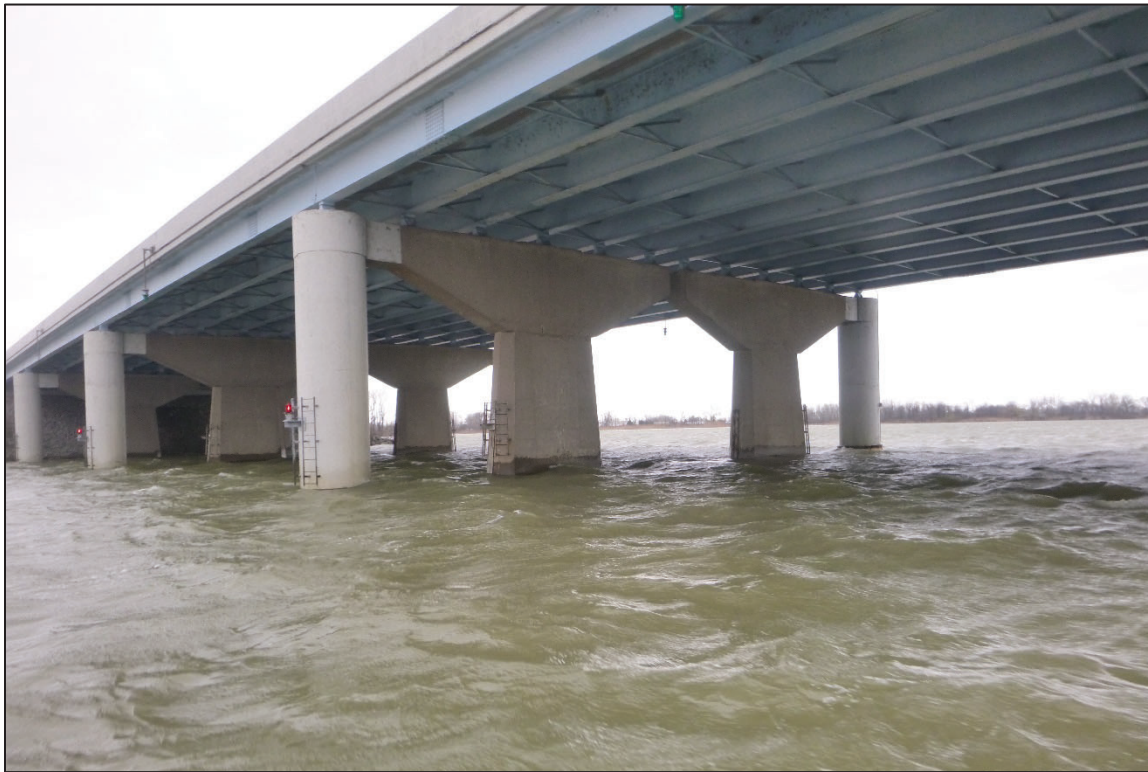
Photograph No. 15: View of the East Face of Pier 3, Looking North.

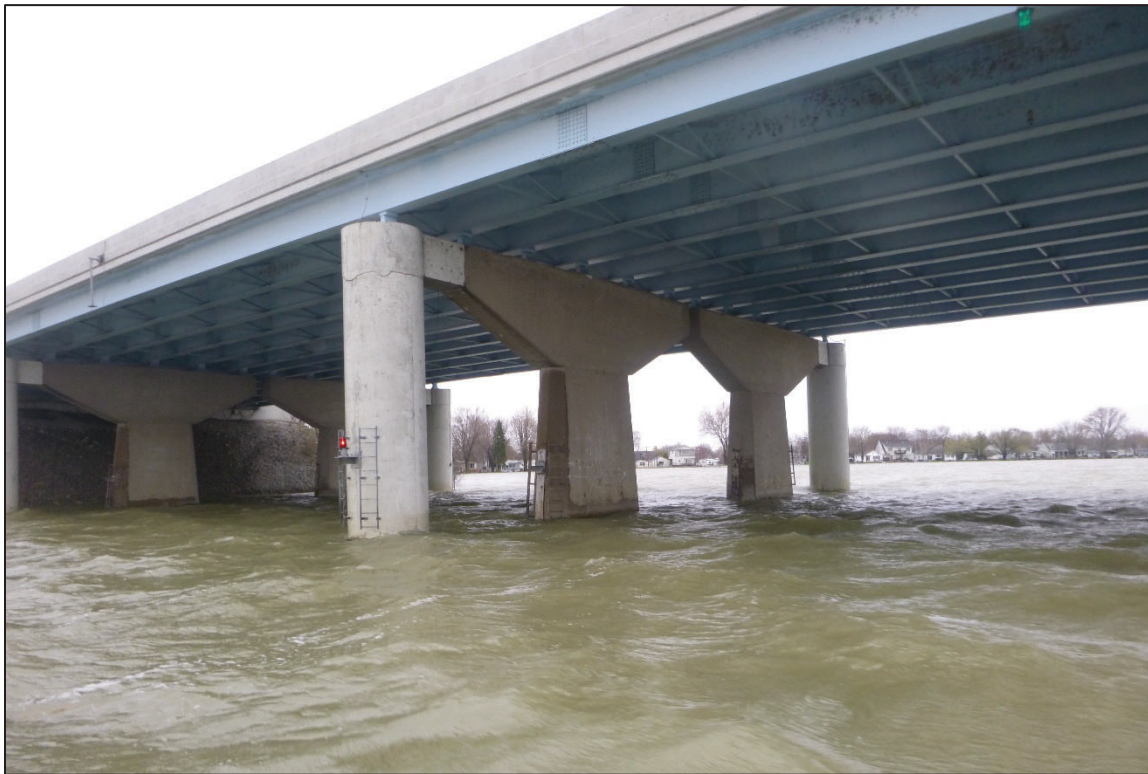
no pitting. The steel on the nose of Pier 1 exhibited pitting up to 1/16 in. deep. The concrete around icebreakers exhibited spalling and delamination up to 1/2 in. deep by 6 in. wide. Typical spall was observed on all pier noses measuring 1 ft vertically by 6 in. horizontally at -3 ft below the waterline. A band of poor consolidation measuring 6 in. vertically by 4 in. deep and fully encircling the caisson was observed at the column/caisson interface with 14 exposed bars. Refer to Figure 9 in Exhibit 1 for detailed inspection notes of Pier 4. Refer to Photographs 16 and 17 in Exhibit 2 for views of Pier 4.

Photograph No. 16: View of the West Face of Pier 4, Looking South.

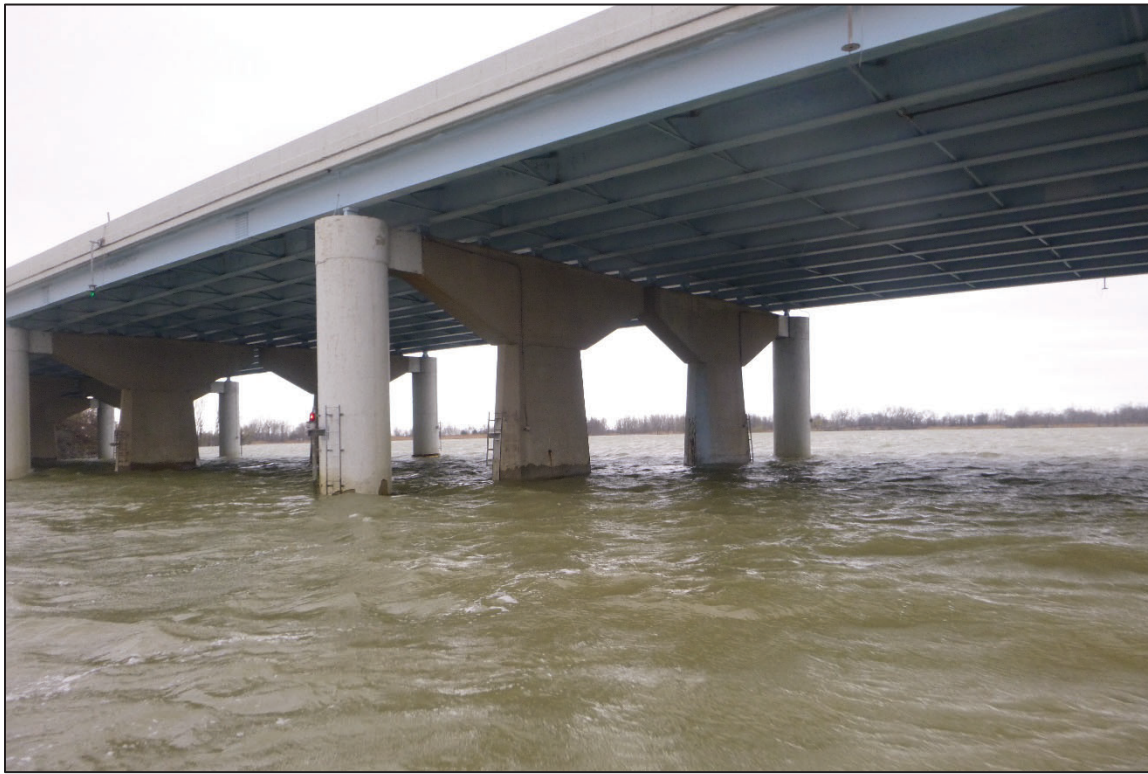
Photograph No. 17: View of the East Face of Pier 4, Looking North.

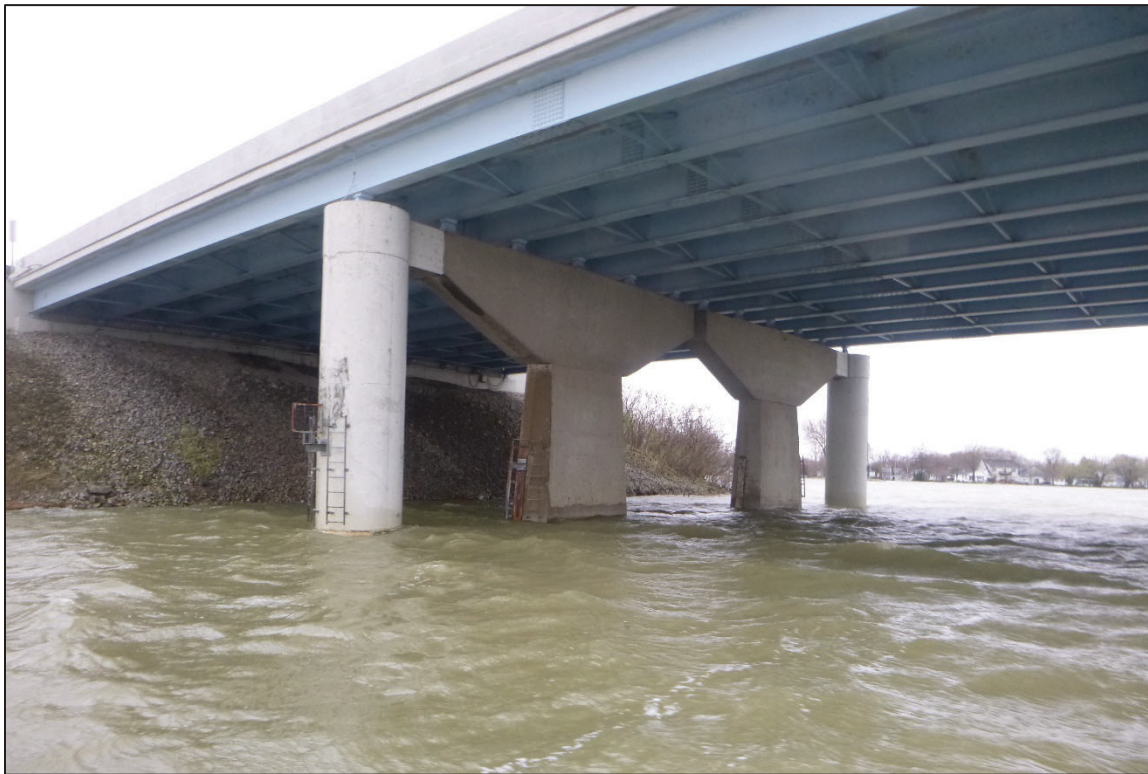
The channel bottom material consisted of gravel with no probe rod penetration. The submerged portions of the pier exhibited light scaling up to 1/10 in. deep. The steel caissons were in good condition and exhibited no pitting. The steel on the nose of Pier 1 exhibited pitting up to 1/16 in. deep. The concrete around icebreakers exhibited spalling and delamination up to 1/2 in. deep by 6 in. wide. Refer to Figure 10 in Exhibit 1 for detailed inspection notes of Pier 5. Refer to Photographs 18 through 21 in Exhibit 2 for views of Pier 5 and typical concrete condition at the waterline.

Photograph No. 18: View of the West Face of Pier 5, Looking South.

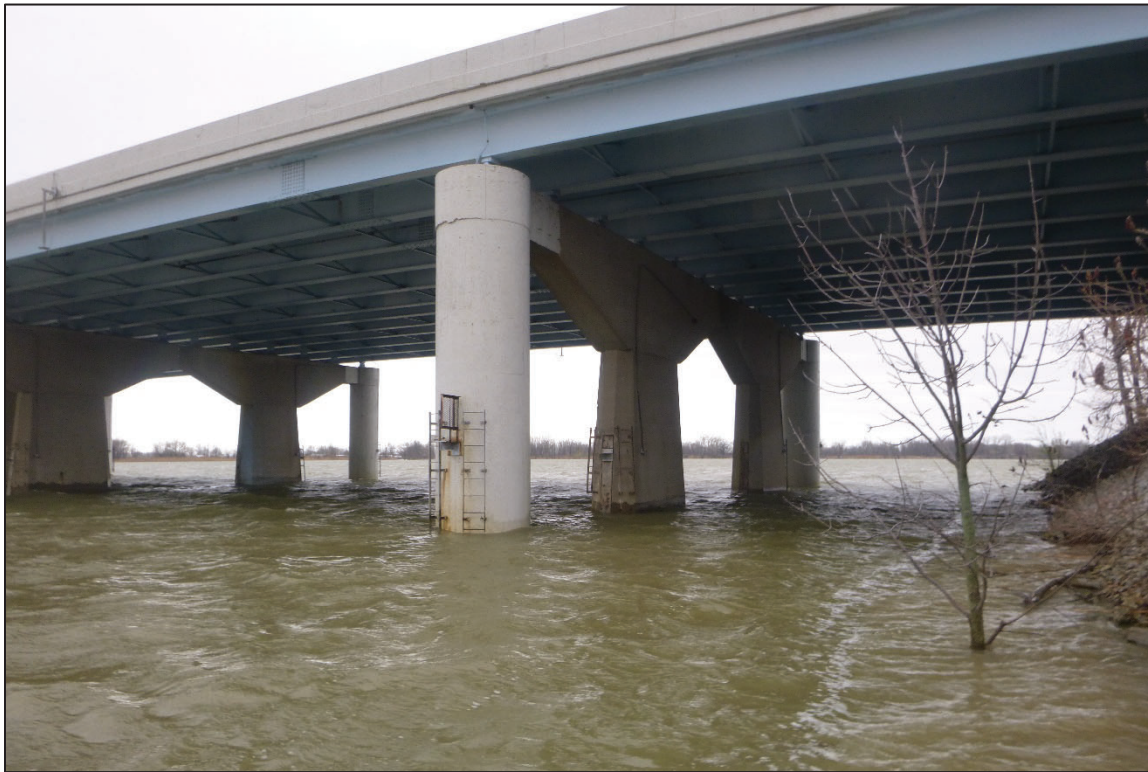
Photograph No. 19: View of the East Face of Pier 5, Looking North.

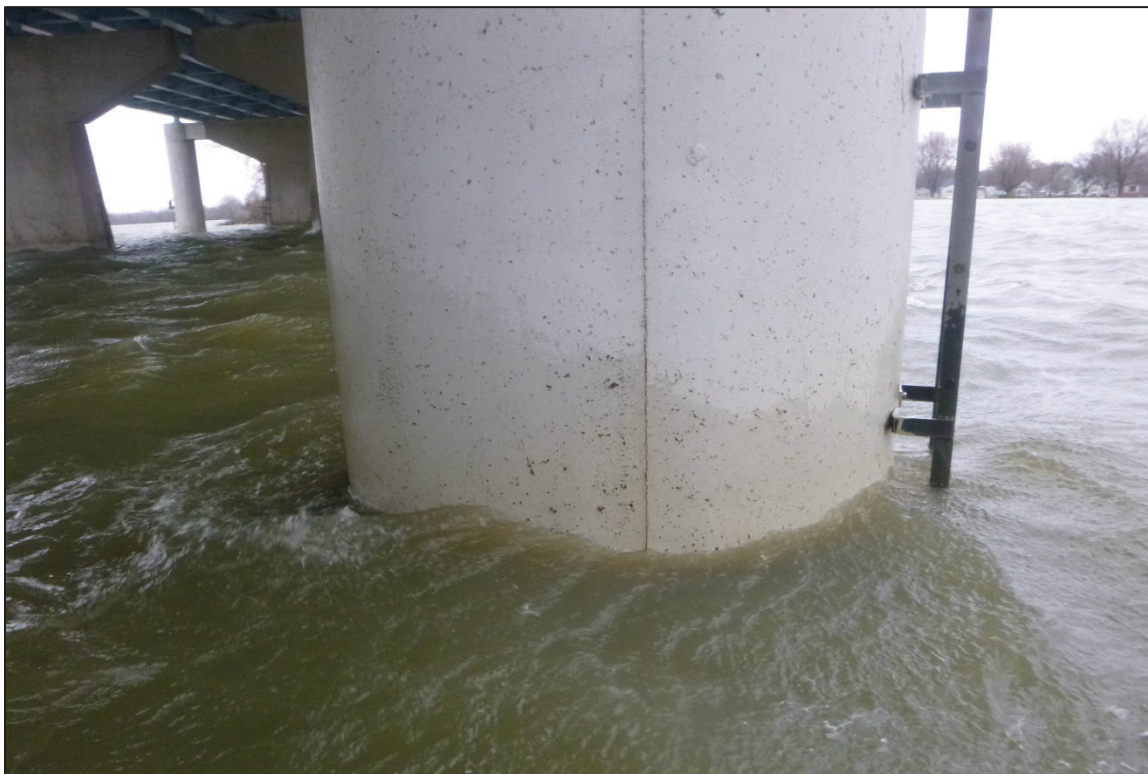
Photograph No. 20: View of the Typical Concrete Condition of the Caisson at the Waterline.

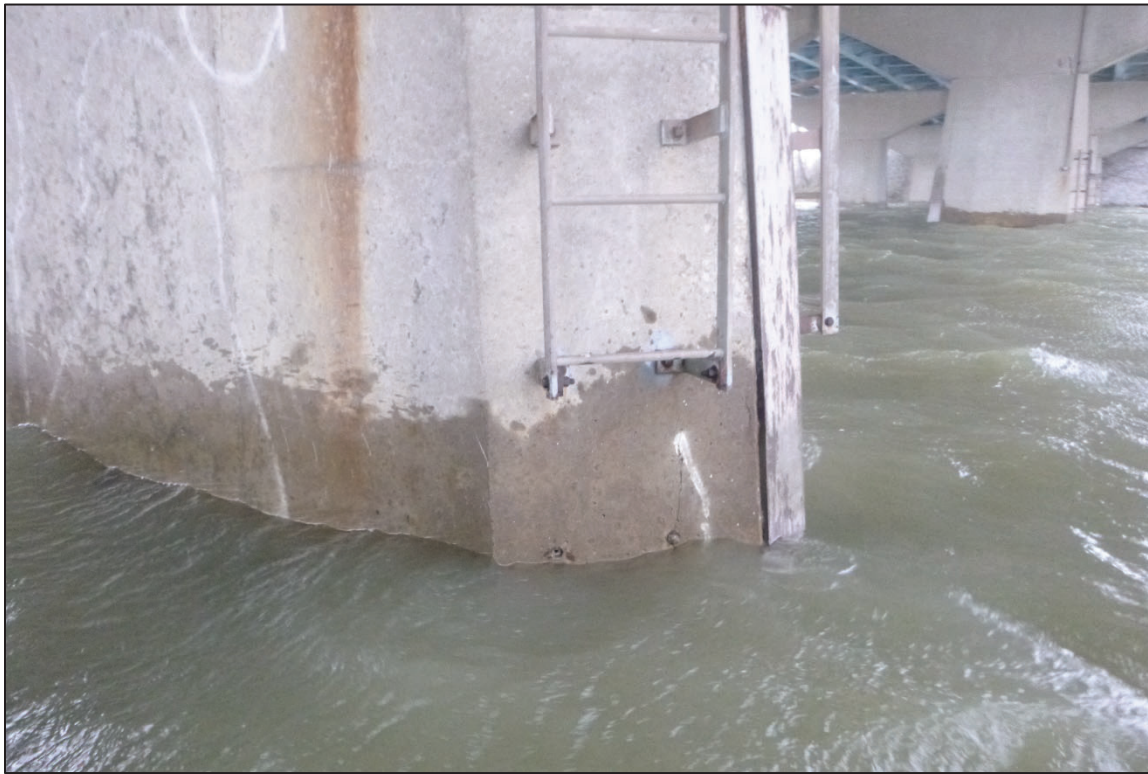
Photograph No. 21: View of the Typical Concrete Condition at the Pier at the Waterline.
