# UNDERWATER BRIDGE INSPECTION REPORT

STRUCTURE NO. 6200362 (OTT-2-1853)  
SR 2 OVER PORTAGE RIVER OVERFLOW  
OTTAWA COUNTY, OH  
DISTRICT 2

May 2020

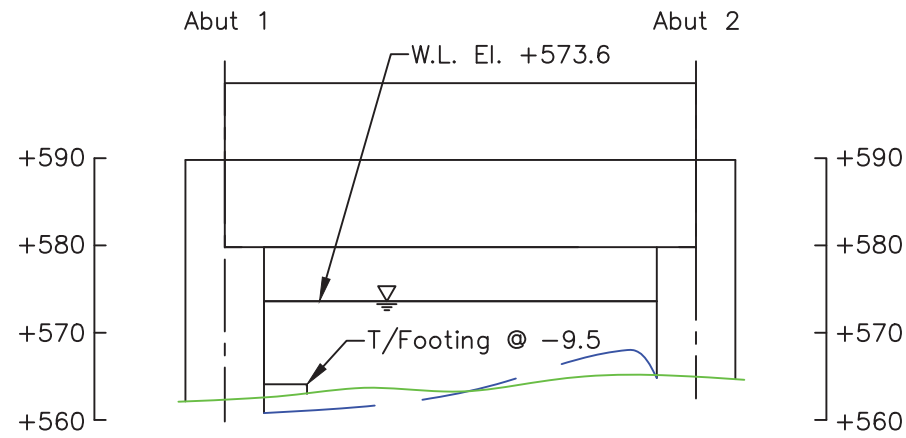
CHANNEL CROSS SECTION  
UPSTREAM FASCIA  
(LOOKING DOWNSTREAM)

Overall, the inspected substructure units of Structure No. 6200362 (OTT-2-1853) were in good condition. A comparison of the soundings recorded during the previous inspection on June 27, 2015 and the soundings taken during this inspection revealed no significant change in the channel bottom profile in the vicinity of the structure. Since no design or as-built plans were available for the bridge, the amount of embedment of the footings in the channel bottom is unknown. As a result, the channel bottom configuration should continue to be monitored during future underwater inspections to verify that localized scour or overall channel degradation is not occurring and that both pier footings remain adequately embedded in the channel bottom. Design or as-built drawings for the bridge should be obtained and reviewed, if possible, prior to the next underwater inspection to determine the exact construction of the piers and their foundations.

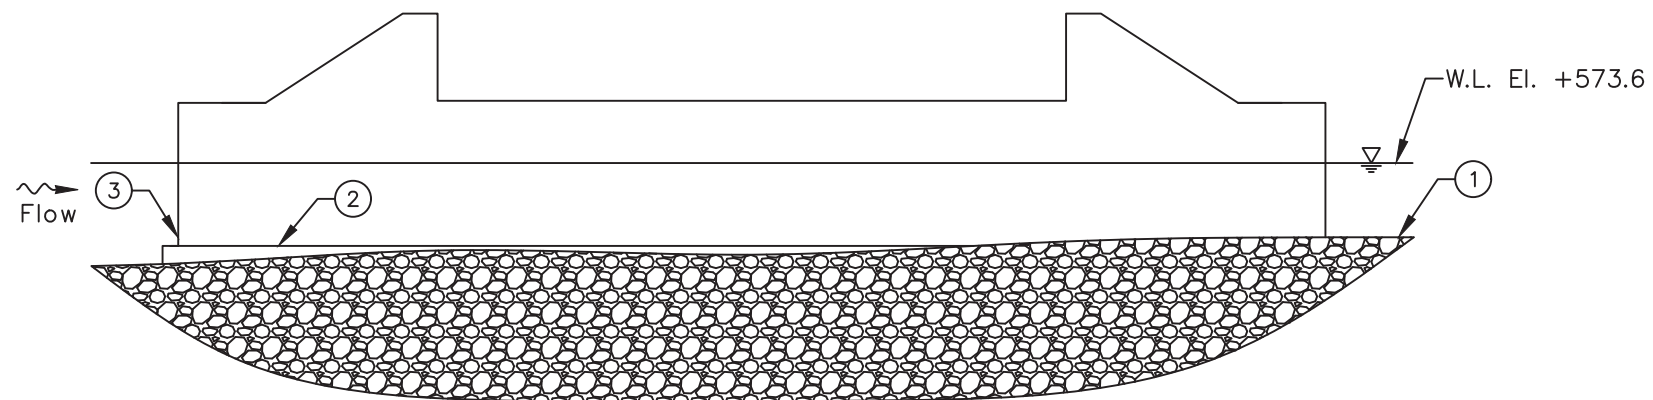
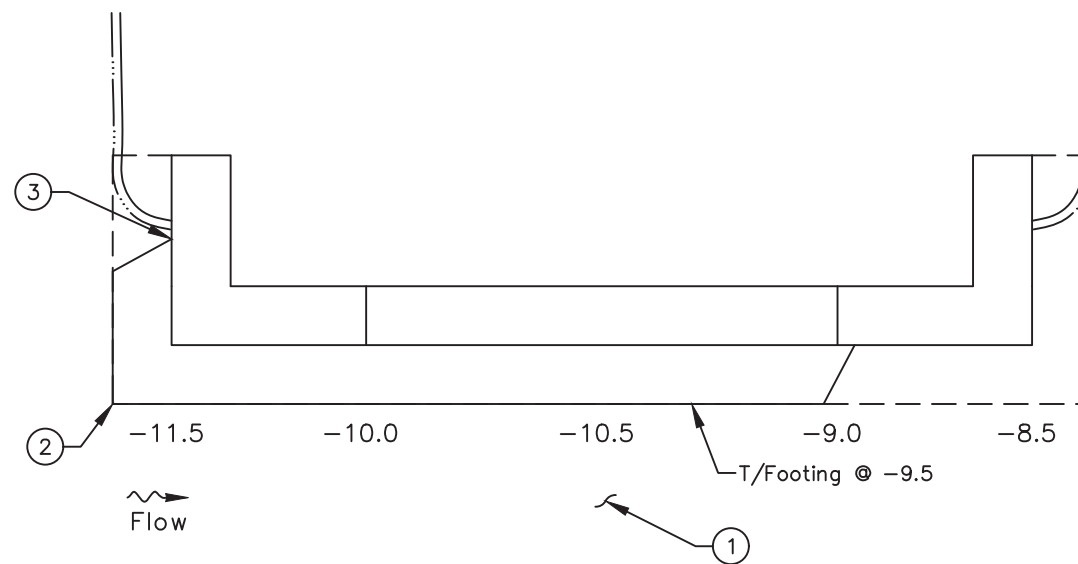
SR-2 OVER PORTAGE RIVER OVERFLOW  
STRUCTURE NO. 6200362 (OTT-2-1853)  
ABUTMENT 1  
OTTAWA COUNTY, OHIO

The channel bottom material around Abutment 1 consisted of sand with no probe rod penetration. The footing, located at 10.8 feet below the water surface, was exposed for a 90 foot total length, beginning 10 feet upstream of the northwest corner and continuing to 4.5 feet around the southwest corner, with varying amounts of vertical face exposure, up to 2 feet maximum. At the southwest wingwall, there was a spall measuring 10 inches wide by 2 feet high by 2 inches deep, with one exposed horizontal reinforcing bar and one exposed vertical reinforcing bar, located 2 feet above the footing. Refer to Figure 6 in Exhibit 1 for detailed inspection notes of Abutment 1. Refer to Photographs 7 and 8 in Exhibit 2 for views of Abutment 1.

- ① The channel bottom material consisted of sand.
- ② The footing, located at 10.8 ft below the water surface, was exposed for a 90 ft total length, beginning 10 ft upstream of the northwest corner and continuing to 4.5 ft around the southwest corner, with varying amounts of vertical face exposure, up to 2 ft maximum.
- ③ At the southwest wingwall, there was a spall measuring 10 in. wide by 2 ft high by 2 in. deep, with one exposed horizontal reinforcing bar and one exposed vertical reinforcing bar, located 2 ft above the footing.

The spalls observed on Abutments 1 and 2 are not a structural concern at this time given its size compared to the overall pier size, and as a result, no repairs are recommended. This area should be monitored during future inspections for increasing extent or severity of the scaling and exposure of reinforcing steel. If the extent or severity of the scaling is observed to be increasing or reinforcing steel becomes exposed, it may be necessary to repair the area at that time.

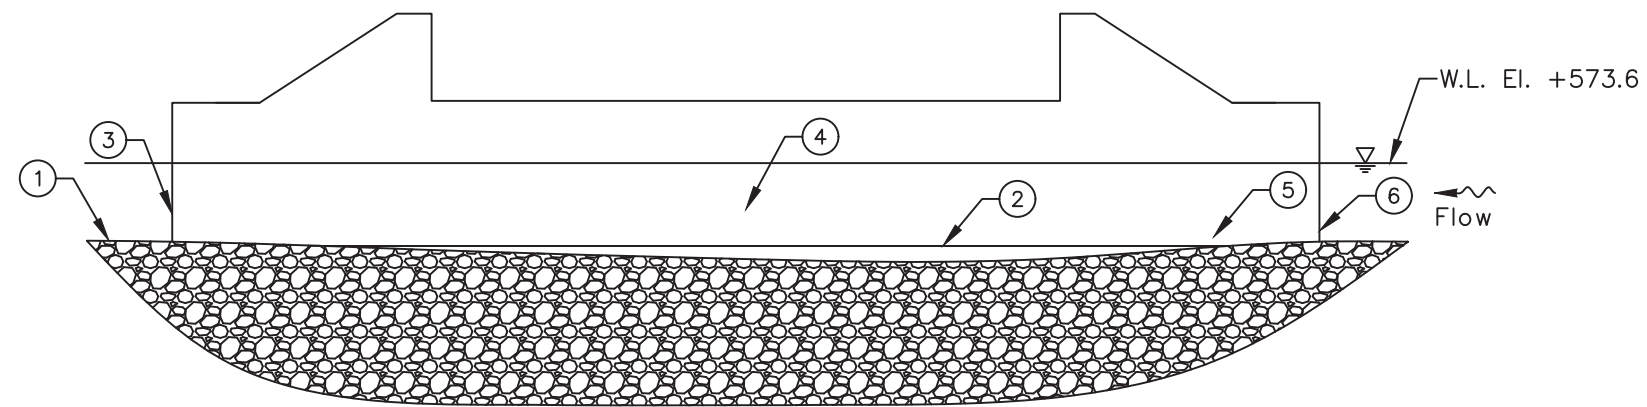
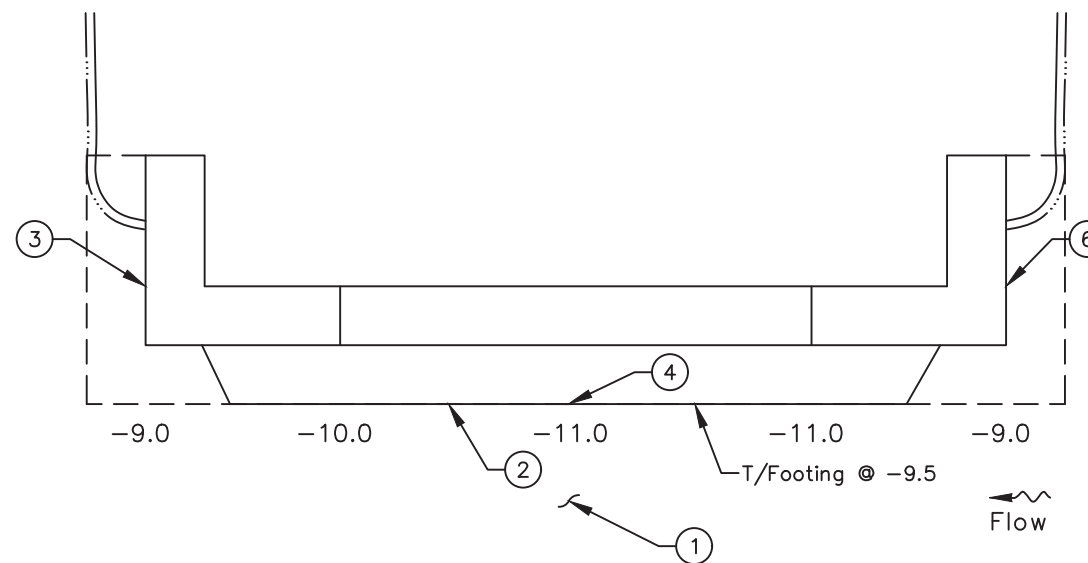
SR-2 OVER PORTAGE RIVER OVERFLOW  
 STRUCTURE NO. 6200362 (OTT-2-1853)  
 ABUTMENT 2  
 OTTAWA COUNTY, OHIO

The channel bottom material around Abutment 2 consisted of sand with no probe rod penetration. The footing, located at 10.8 feet below the water surface, was exposed for an 80 foot total length, beginning 10 feet upstream of the northeast corner and ending approximately 10 feet downstream of the southeast corner, with varying amounts of vertical face exposure, up to 2.5 feet maximum. At the northeast wingwall, there was a spall measuring 2.5 feet wide by 1 foot high by 1 inch deep. At the middle of the abutment stem, there was a spall measuring 5 inches wide by 18 inches high by 1 inch deep, located 5 feet above the footing at the construction joint. At the south end of the abutment stem, there was a spall measuring 5 inches wide by 3 feet high by 1 inch deep, located 2 feet above the footing. At the southeast wingwall, there was a spall measuring 5 inches wide by 3 feet high by 1 inch deep, located 18 inches above the mud line. Refer to Figure 7 in Exhibit 1 for detailed inspection notes of Abutment 2. Refer to Photographs 9 through 11 in Exhibit 2 for views of Abutment 2 and typical concrete condition at the waterline.

- ① The channel bottom material consisted of sand.
- ② The footing, located at 10.8 ft below the water surface, was exposed for an 80 ft total length, beginning 10 ft upstream of the northeast corner and ending approximately 10 ft downstream of the southeast corner, with varying amounts of vertical face exposure, up to 2.5 ft maximum.
- ③ At the northeast wingwall, there was a spall measuring 2.5 ft wide by 1 ft high by 1 in. deep.
- ④ At the middle of the abutment stem, there was a spall measuring 5 in. wide by 18 in. high by 1 in. deep, located 5 ft above the footing at the construction joint.
- ⑤ At the south end of the abutment stem, there was a spall measuring 5 in. wide by 3 ft high by 1 in. deep, located 2 ft above the footing.
- ⑥ At the southeast wingwall, there was a spall measuring 5 in. wide by 3 ft high by 1 in. deep, located 18 in. above the mud line.

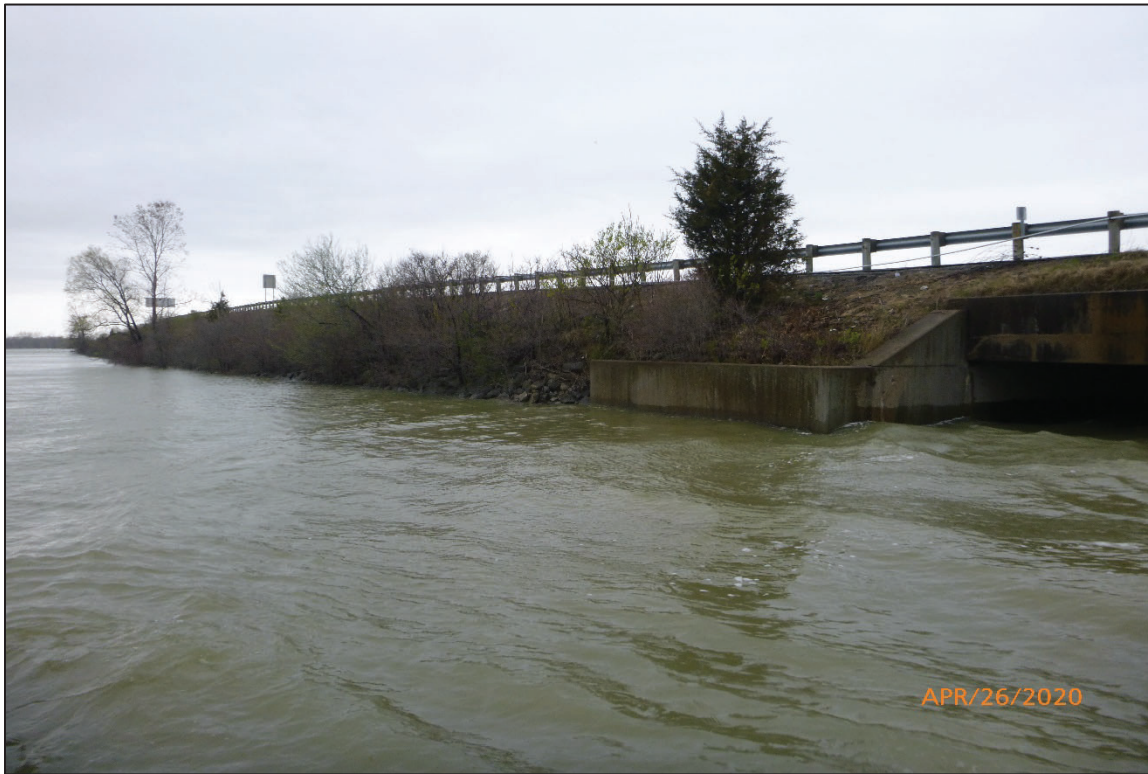
At the time of the inspection, the waterline of 6200362 (OTT-2-1853) was located approximately 8.7 ft below the top of headwall at the upstream end of Abutment 2, which corresponds to a waterline elevation of 571.8 ft. During the inspection, the waterway was flowing at approximately <1 ft per second. The bridge substructure skew was consistent with the channel alignment and does not require attention at this time. The west and east shorelines consisted of moderately vegetated, well protected moderate slopes with no signs of erosion. Refer to Photographs 3 through 6 in Exhibit 2 for views of the shorelines near the structure.

Photograph No. 3: View of the West Embankment Upstream of the Structure, Looking Northwest.

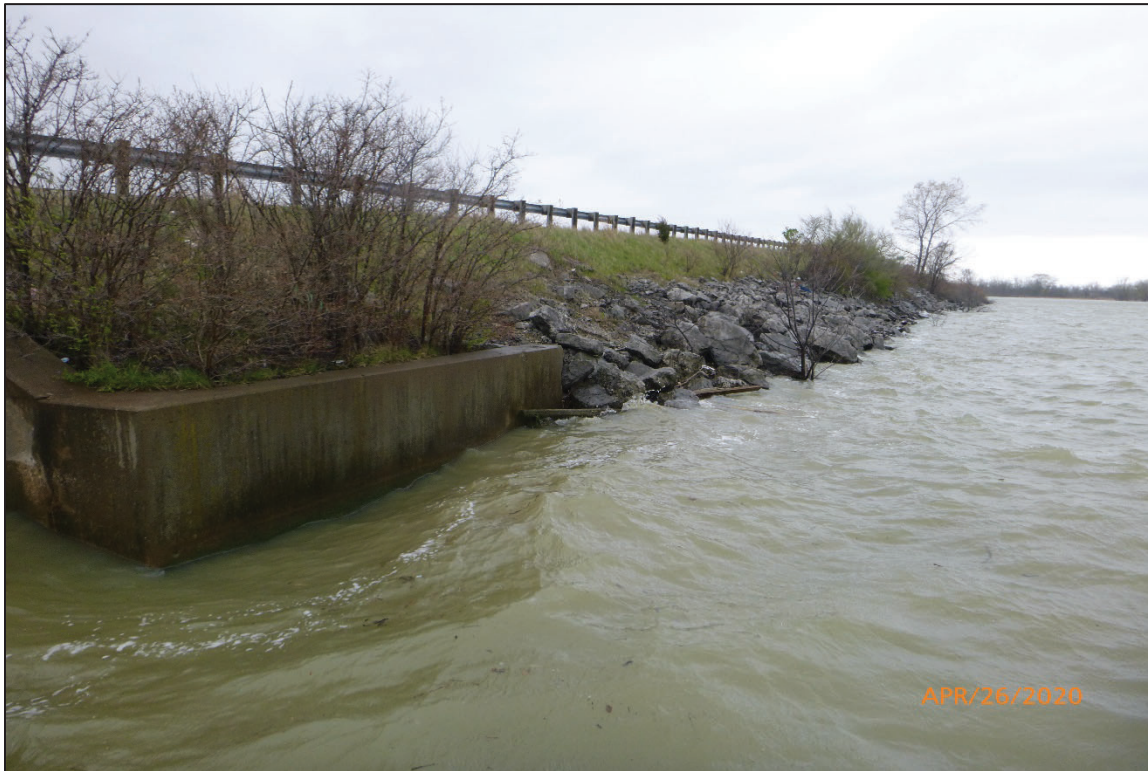
Photograph No. 4: View of the West Embankment Downstream of the Structure, Looking Southwest.

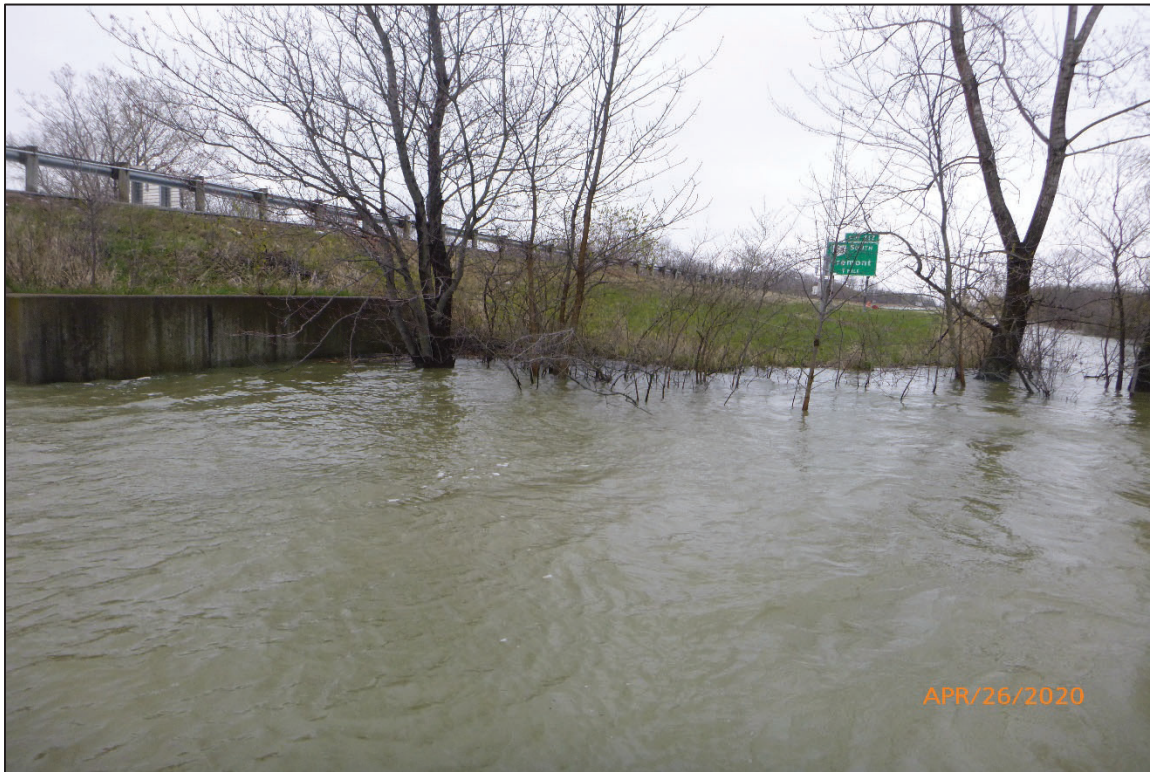
Photograph No. 5: View of the East Embankment Upstream of the Structure, Looking Northeast.

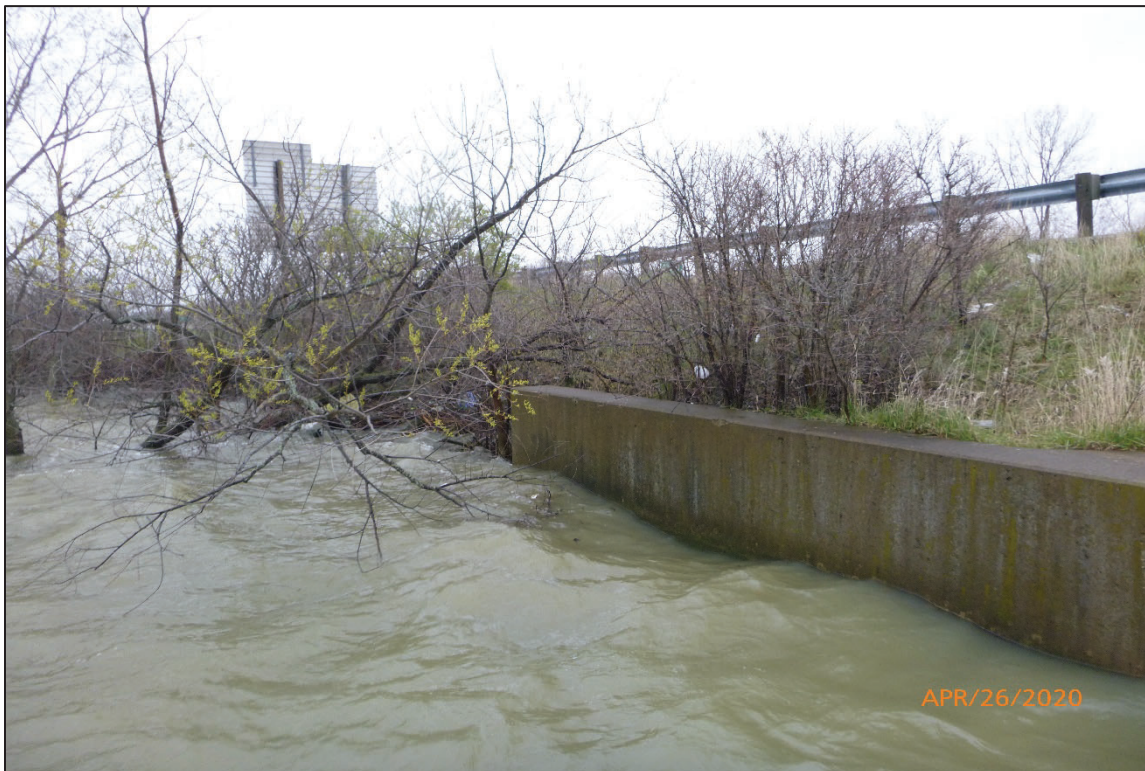
Photograph No. 6: View of the East Embankment Downstream of the Structure, Looking Southeast.

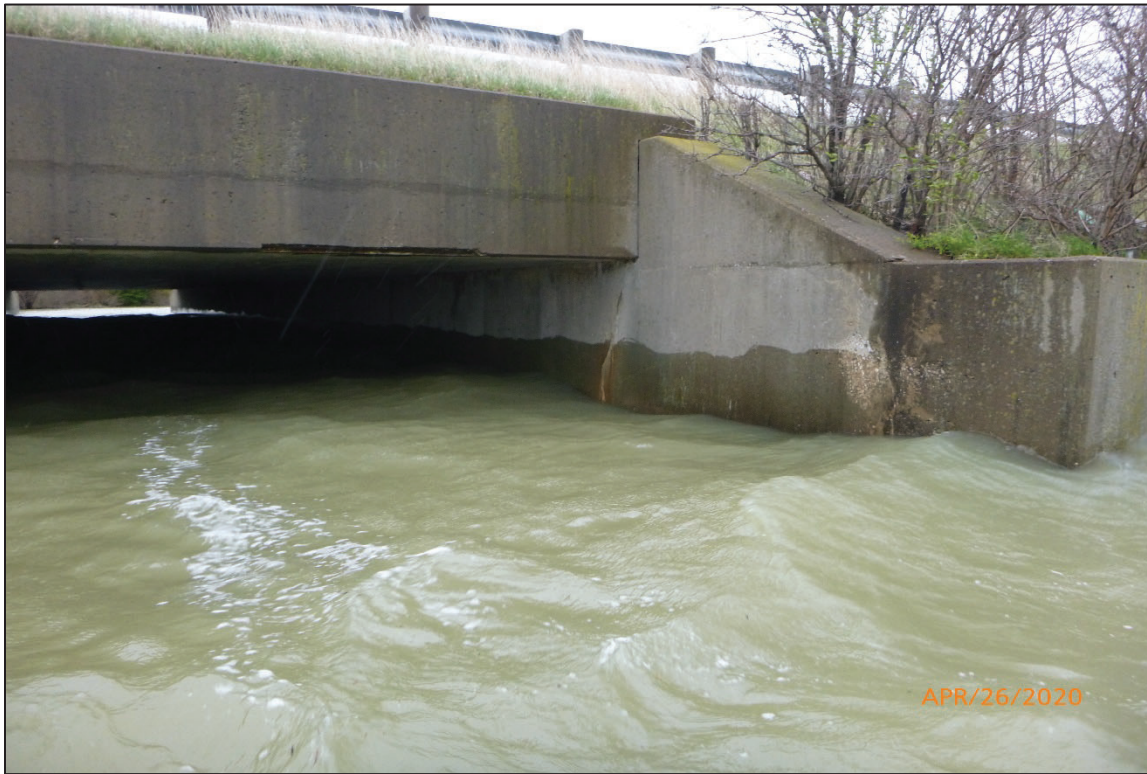
Photograph No. 7: View of the North Corner of Abutment 1, Looking Southwest.

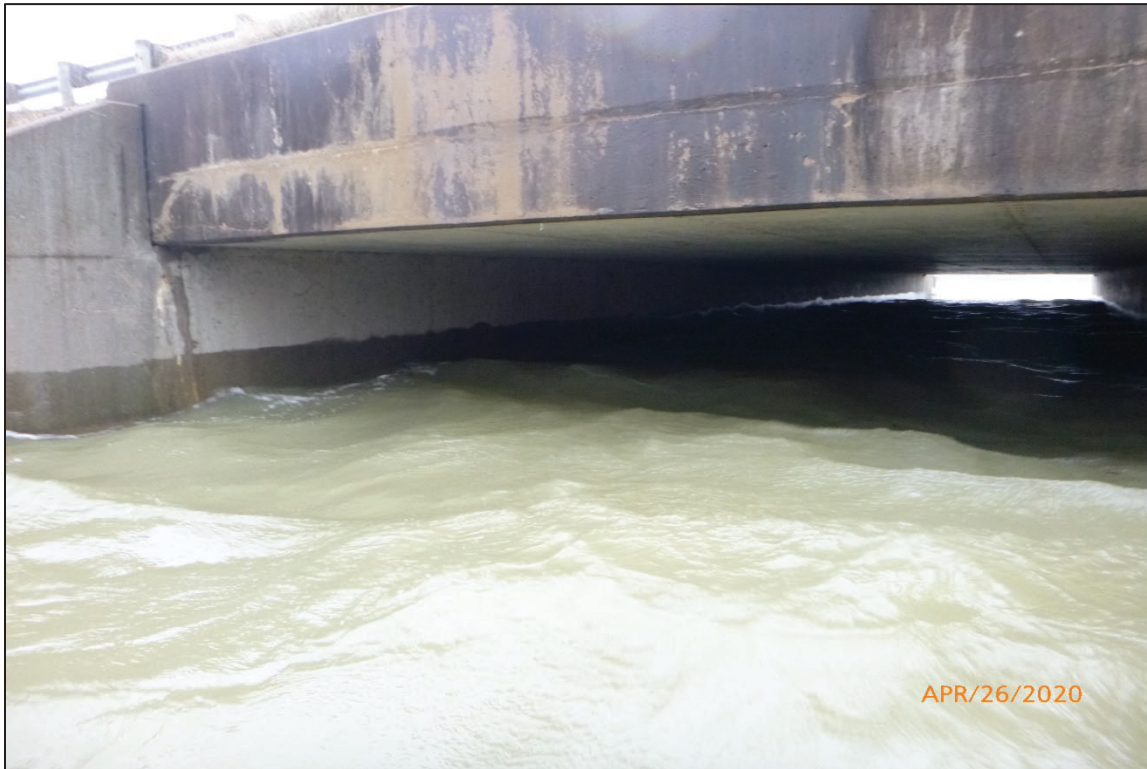
Photograph No. 8: View of the South Corner of Abutment 1, Looking Northwest.

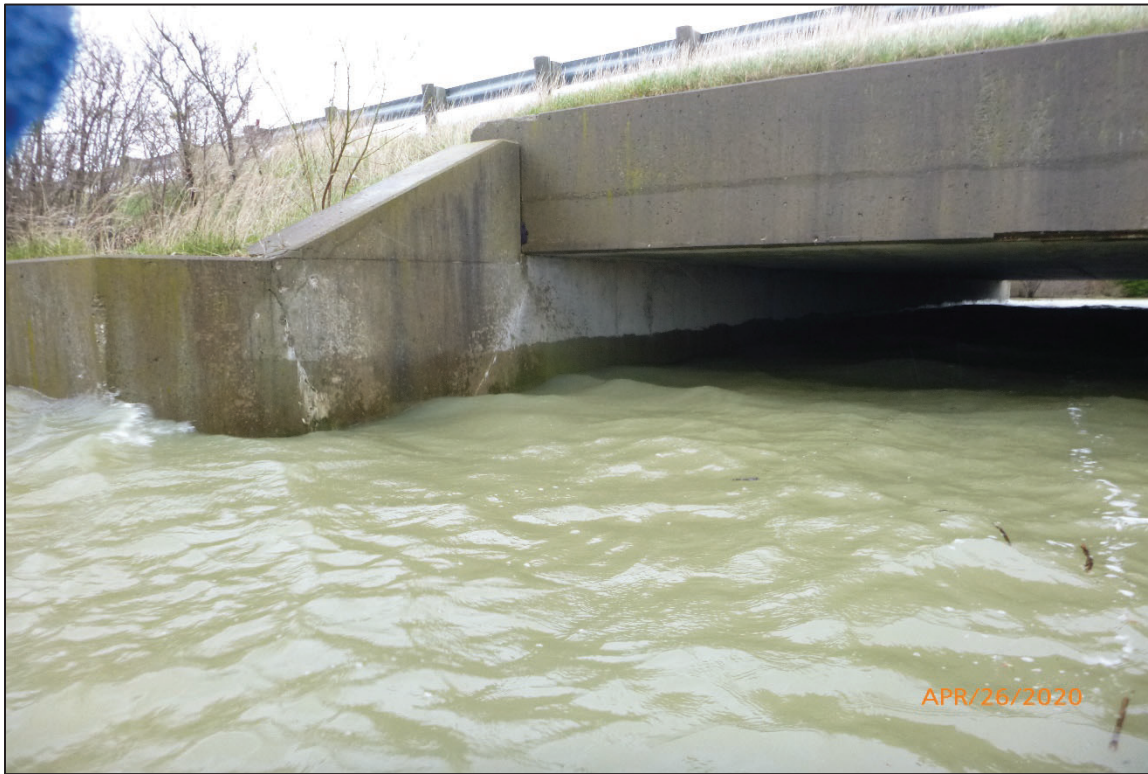
Photograph No. 9: View of the North Corner of Abutment 2, Looking Southeast.

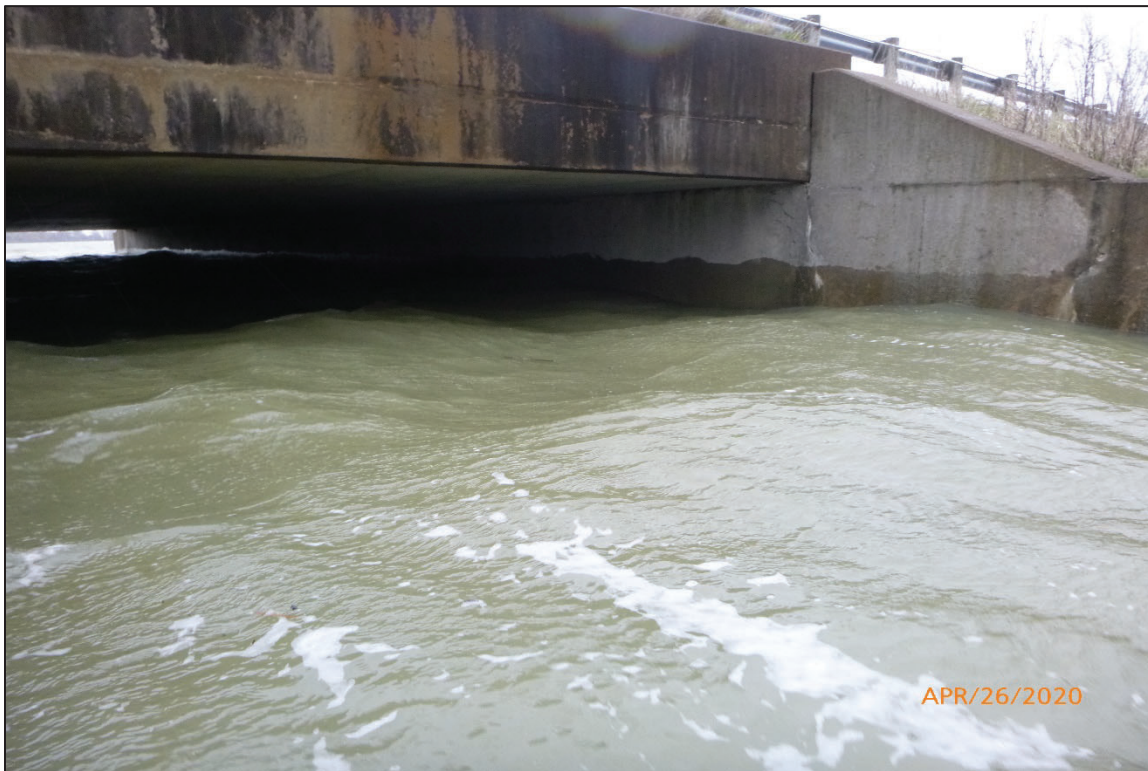
Photograph No. 10: View of the South Corner of Abutment 2, Looking Northeast.

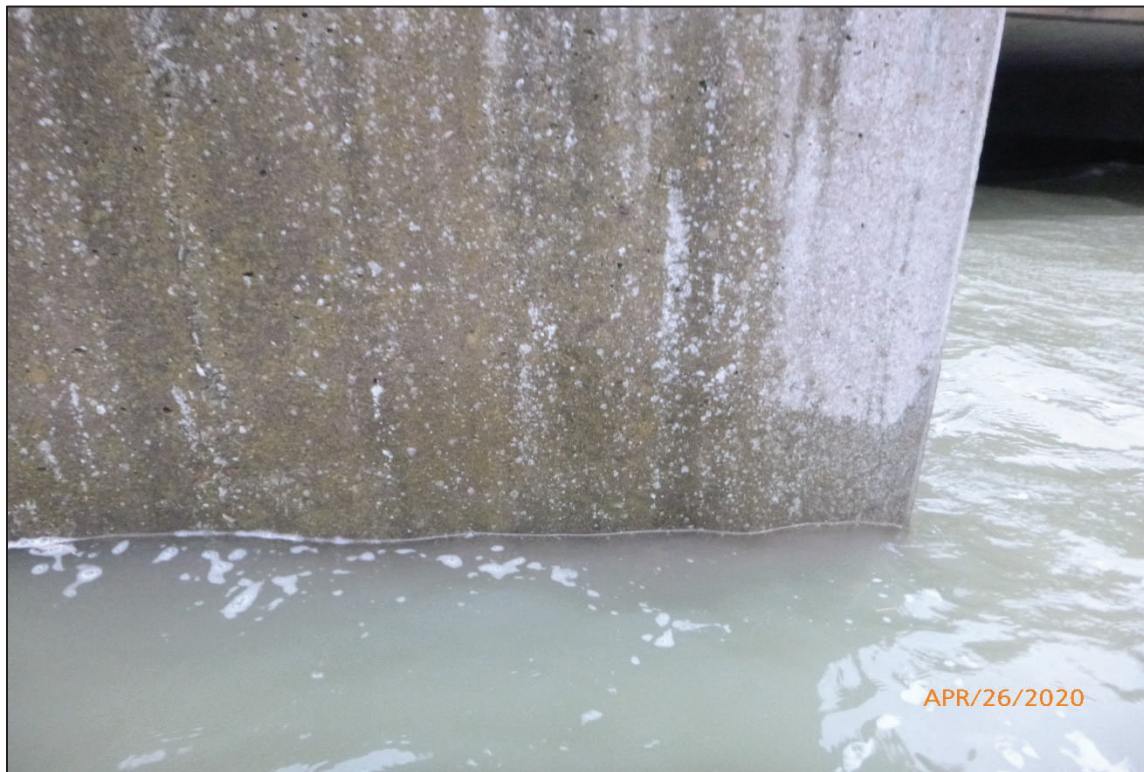
Photograph No. 11: View of the Typical Concrete Condition at the Waterline on the South Corner of Abutment 1, Looking North.
