UNDERWATER BRIDGE INSPECTION REPORT

STRUCTURE NO. 6200753 (OTT-2-2757)
SR 2 OVER SANDUSKY BAY OVERFLOW
OTTAWA COUNTY, OH
DISTRICT 2

May 2020

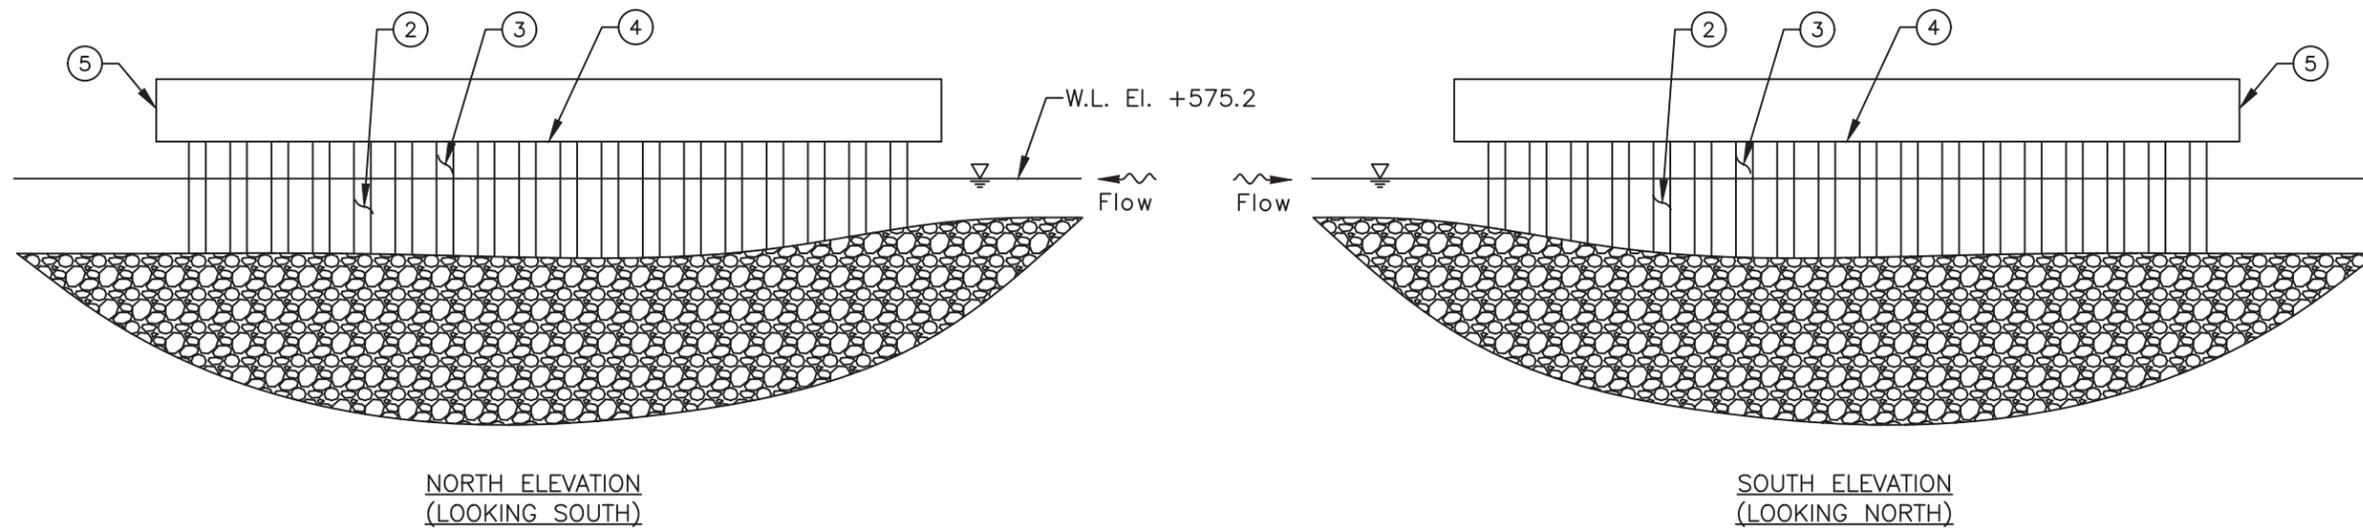
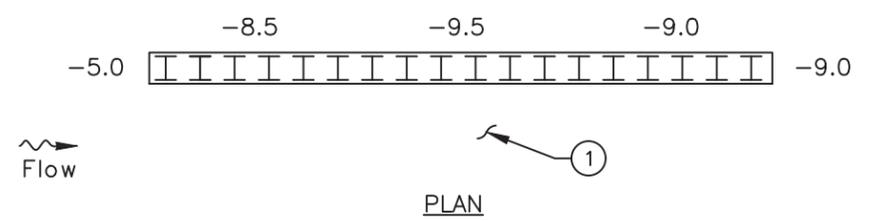
SR-2 OVER SANDUSKY BAY OVERFLOW
 STRUCTURE NO. 6200753 (OTT-2-2757)
 BENT 1
 OTTAWA COUNTY, OHIO

- ① The channel bottom material consisted of rip-rap up to 24 in. diameter with sand infill with no probe rod penetration.
- ② Submerged portions of the bent exhibited light marine growth up to 1/16 in.
- ③ Scattered rust nodules up to 1 in. diameter and pitting up to 1/16 in.
- ④ Heavy scaling up to 1/2 in. deep on strut.
- ⑤ Heavy scaling on downstream nose measuring 2 ft high by 2 ft wide and up to 3/4 in. deep.

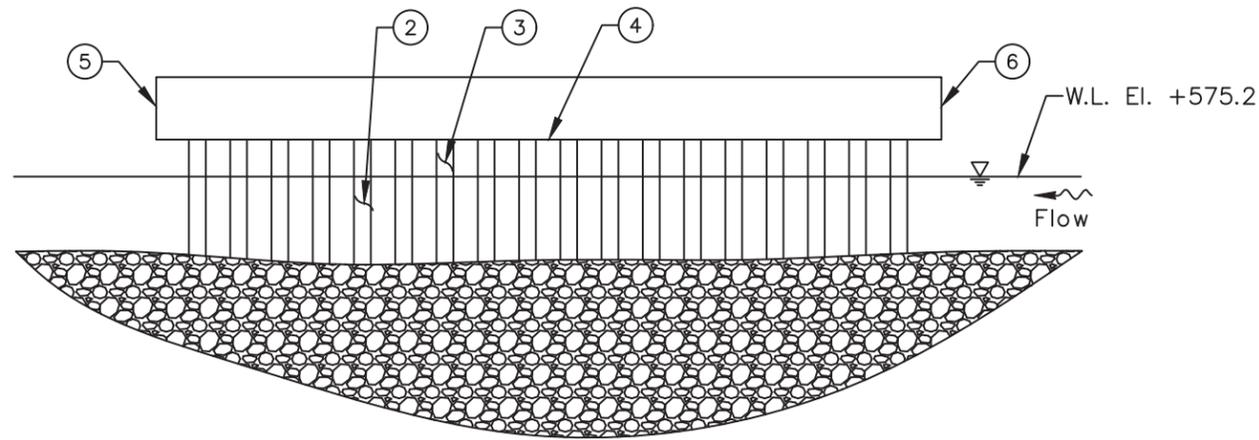
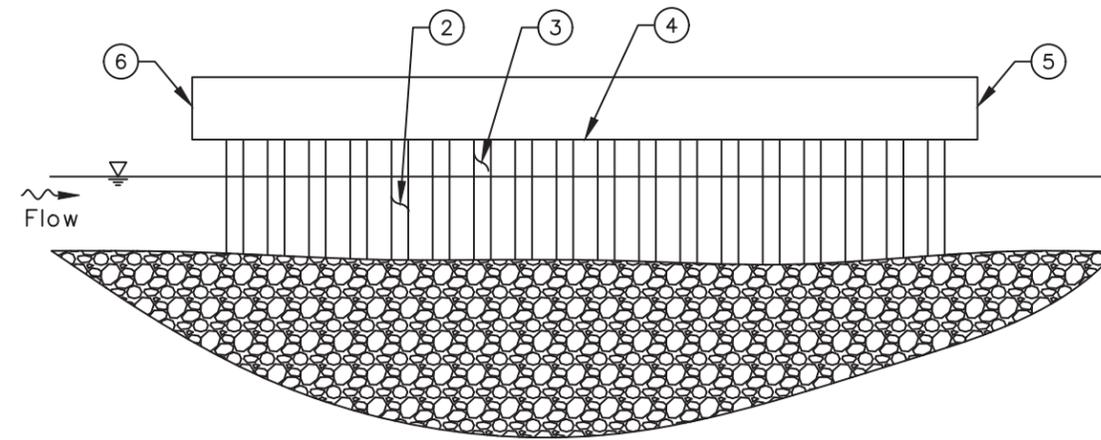
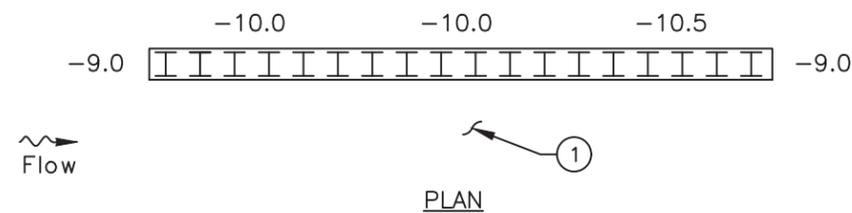
- ① The channel bottom material consisted of rip-rap up to 24 in. diameter with sand infill with no probe rod penetration.
- ② Submerged portions of the bent exhibited light marine growth up to 1/16 in.
- ③ Scattered rust nodules up to 1 in. diameter and pitting up to 1/16 in.
- ④ Heavy scaling up to 1/2 in. deep on strut.
- ⑤ Heavy scaling on downstream nose measuring 2 ft high by 2 ft wide and up to 3/4 in. deep.
- ⑥ Spall on upstream nose measuring 24 in. high by full width by 6 in. deep with exposed rebar with 25% section loss.

The spalling at Bent 2 is not a structural concern at this time; however, it should be repaired to prevent further deterioration. The repairs should include removal of unsound concrete to a minimum of 1 inch behind the reinforcing steel, cleaning and replacing reinforcing steel as required, and placing concrete designed to provide high durability with low permeability.

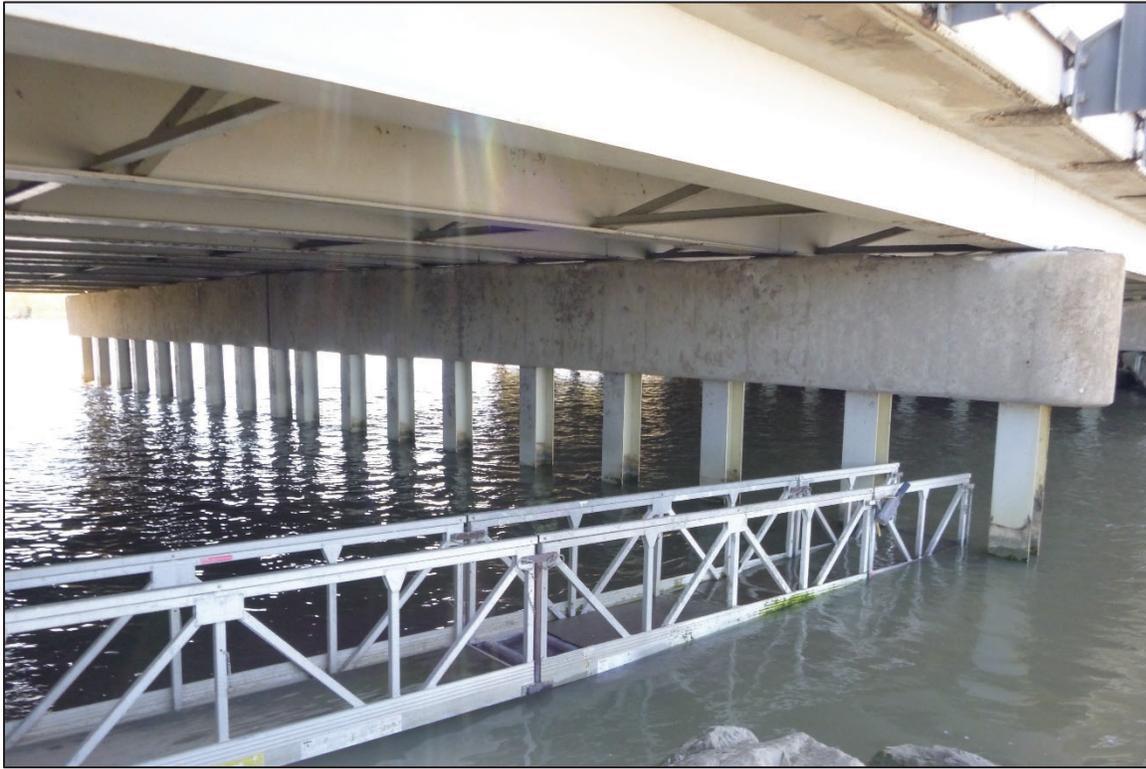
The channel bottom material consisted of riprap up to 24 in. diameter with sand infill with no probe rod penetration. Submerged portions of the bent exhibited light marine growth below the waterline. H-Piles exhibited scattered rust nodules measuring up to 1 in. diameter with pitting up to 1/16 in. Bent exhibited heavy scaling measuring up to 1/2 in. deep on strut. Bent exhibited heavy scaling on the downstream nose measuring 2 ft vertically by 2 ft horizontally up to 3/4 in. deep. Refer to Figure 6 in Exhibit 1 for detailed inspection notes of Bent 1. Refer to Photographs 9 and 10 in Exhibit 2 for views of Bent 1.

Photograph No. 9: View of the North Face of Bent 1, Looking Southeast.

- Monitor rust nodules and steel pitting on Bents 1 and 2.
- Monitor concrete scaling on Bents 1 and 2.
- Repair spalling on Bent 1.

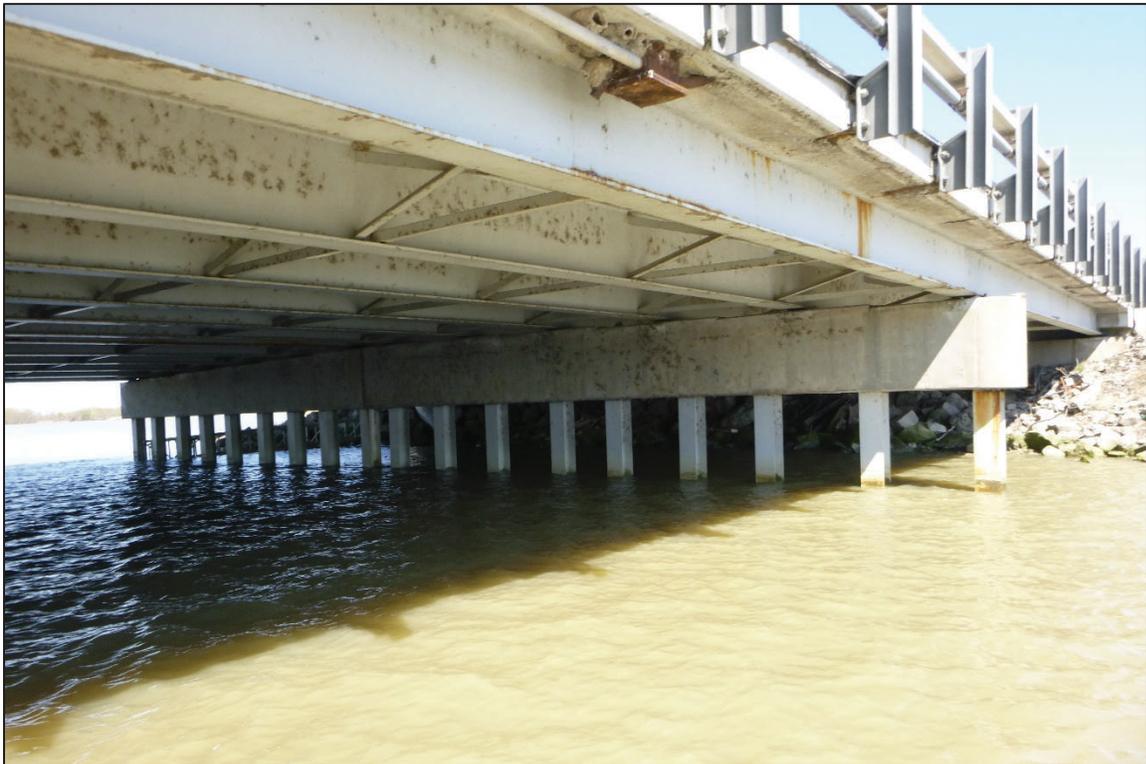
Photograph No. 10: View of the South Face of Bent 1, Looking Northwest.

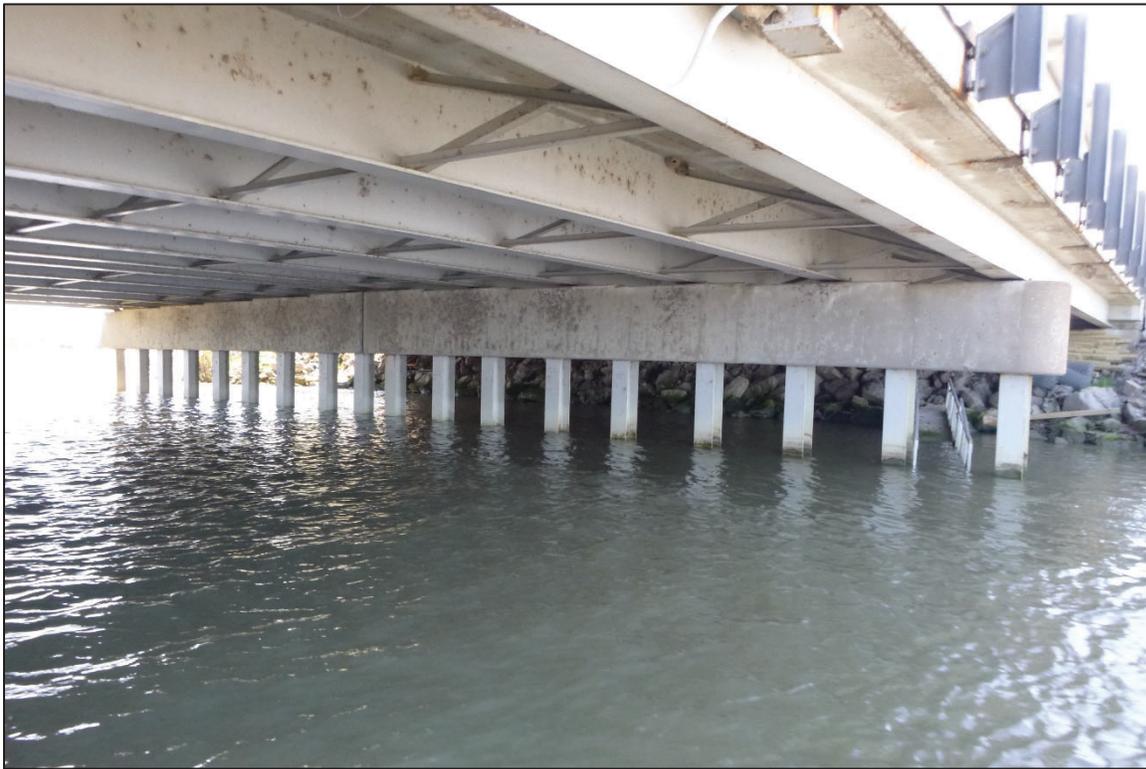
The channel bottom material consisted of riprap up to 24 in. diameter with sand infill with no probe rod penetration. Submerged portions of the bent exhibited light marine growth below the waterline. H-Piles exhibited scattered rust nodules measuring up to 1 in. diameter with pitting up to 1/16 in. Bent exhibited heavy scaling measuring up to 1/2 in. deep on strut. Bent exhibited heavy scaling on the downstream nose measuring 2 ft vertically by 2 ft horizontally up to 3/4 in. deep. Bent exhibited spall on upstream nose measuring full width by 24 in. high by 6 in. deep with exposed rebar with 25% section loss. Refer to Figure 7 in Exhibit 1 for detailed inspection notes of Bent 2. Refer to Photographs 11 through 13 in Exhibit 2 for views of Bent 2 and typical steel condition at the waterline.

Photograph No. 11: View of the North Face of Bent 2, Looking Southeast.

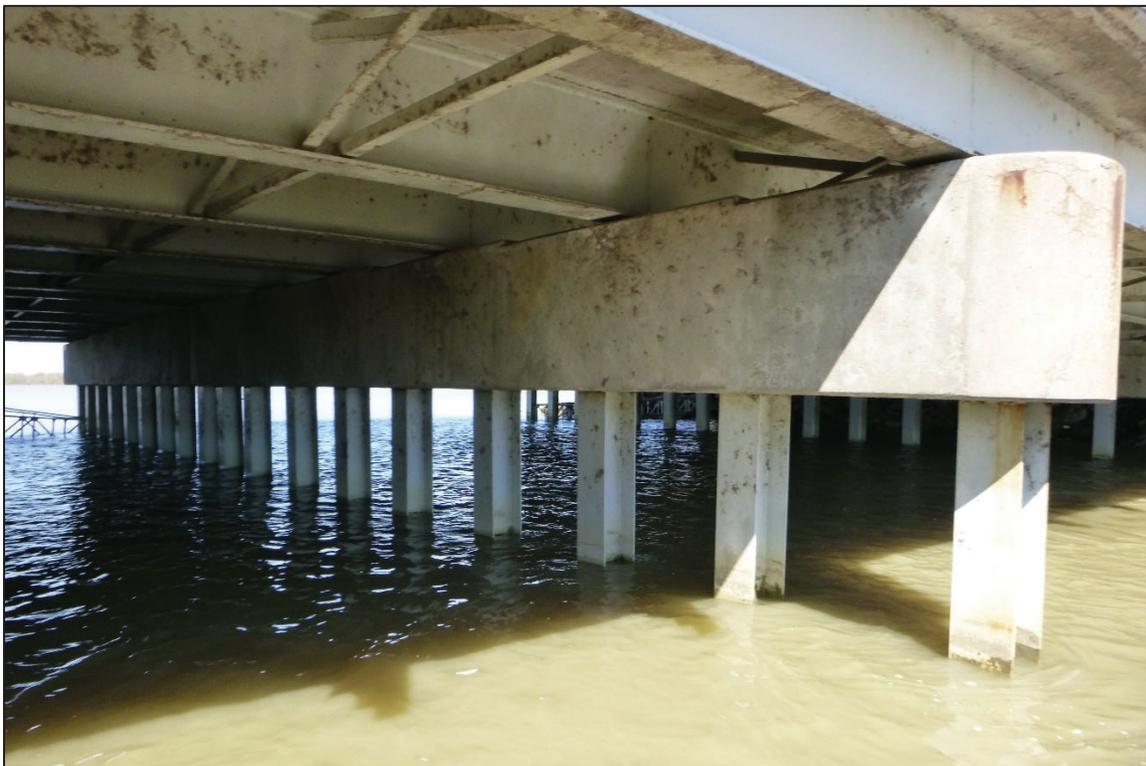
Photograph No. 12: View of the South Face of Bent 2, Looking Northwest.

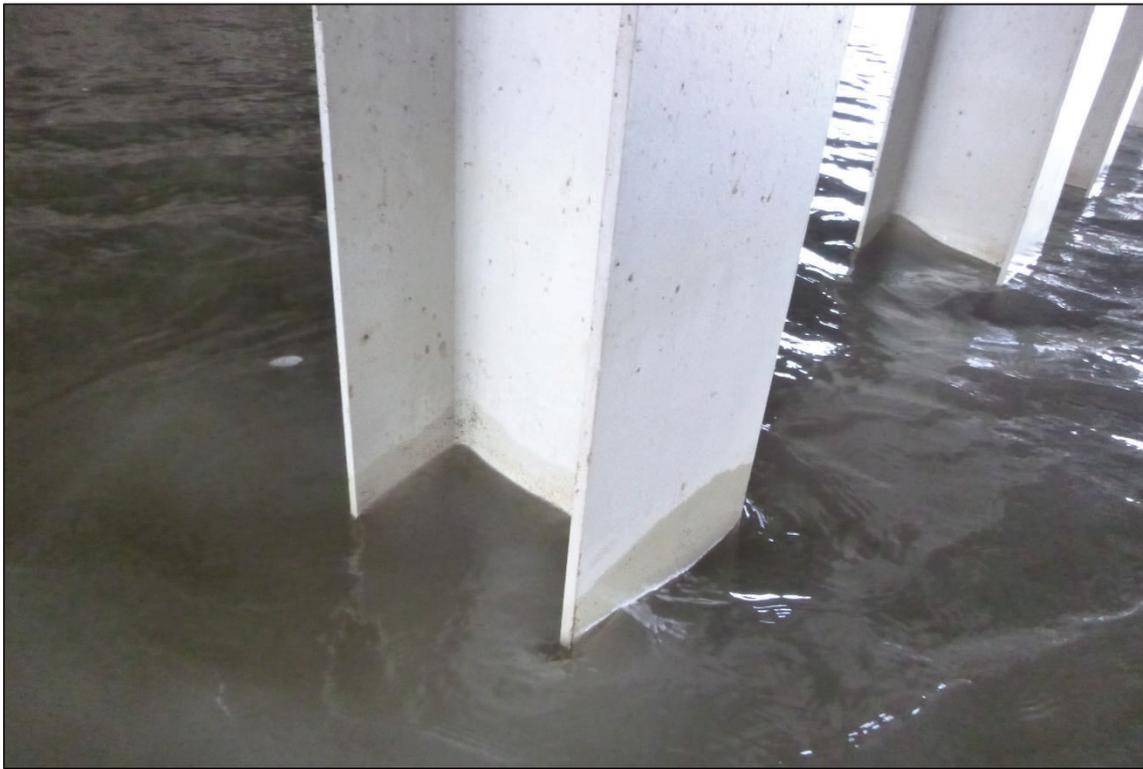
Photograph No. 13: View of the Typical Steel Condition at the Waterline of Bent 2, Looking Southeast.
