UNDERWATER BRIDGE INSPECTION REPORT

STRUCTURE NO. 6200788 (OTT-2-2839)
SR 2 OVER SANDUSKY BAY
OTTAWA COUNTY, OH
DISTRICT 2

May 2020

COLLINS
ENGINEERS INC.

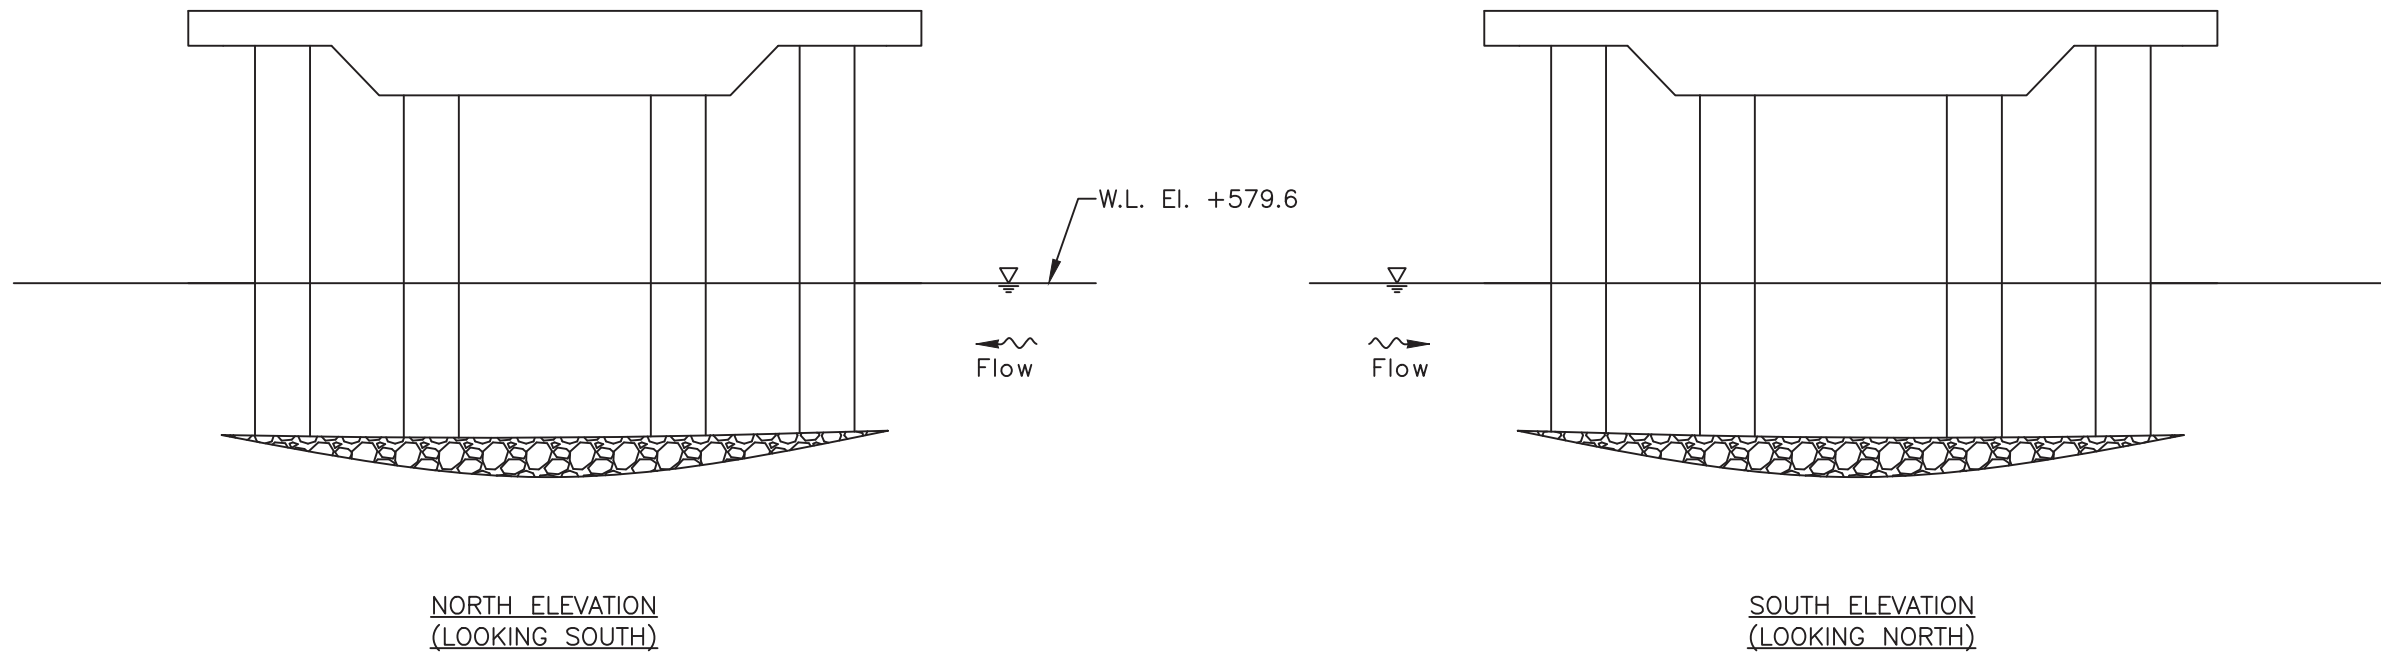
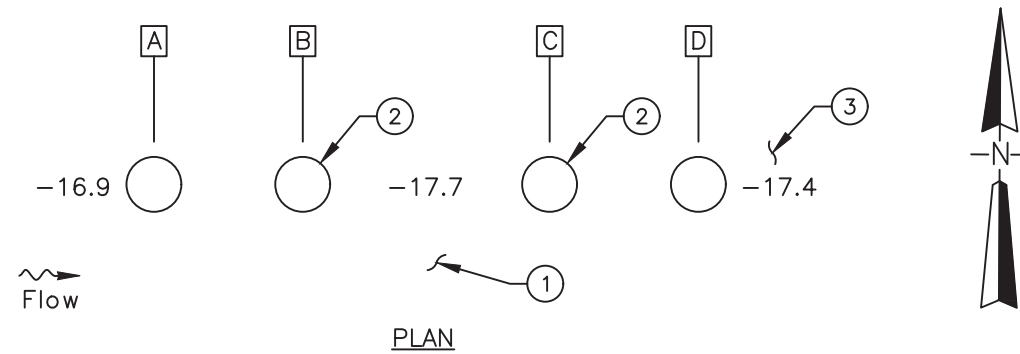
- A scour hole 5 ft diameter by 5 ft deep was observed around the North and South faces of the upstream nose at Column A.

- ① The channel bottom material consisted of riprap and sand infill with no probe rod penetration.
- ② Columns B and C typically exhibited moderate corrosion and rust nodules up to 1 in diameter with pitting up to $\frac{1}{8}$ in.
- ③ A scour hole 5 ft diameter by 5 ft deep was observed around the North and South faces of the upstream nose at Column A.

- Monitor timber debris accumulation at Bents 6 and 17.
- Monitor typical corrosion and rust nodules on steel caissons.
- Monitor scour pockets on Bents 4, 5, and 7.
- Monitor timber piles in fender system

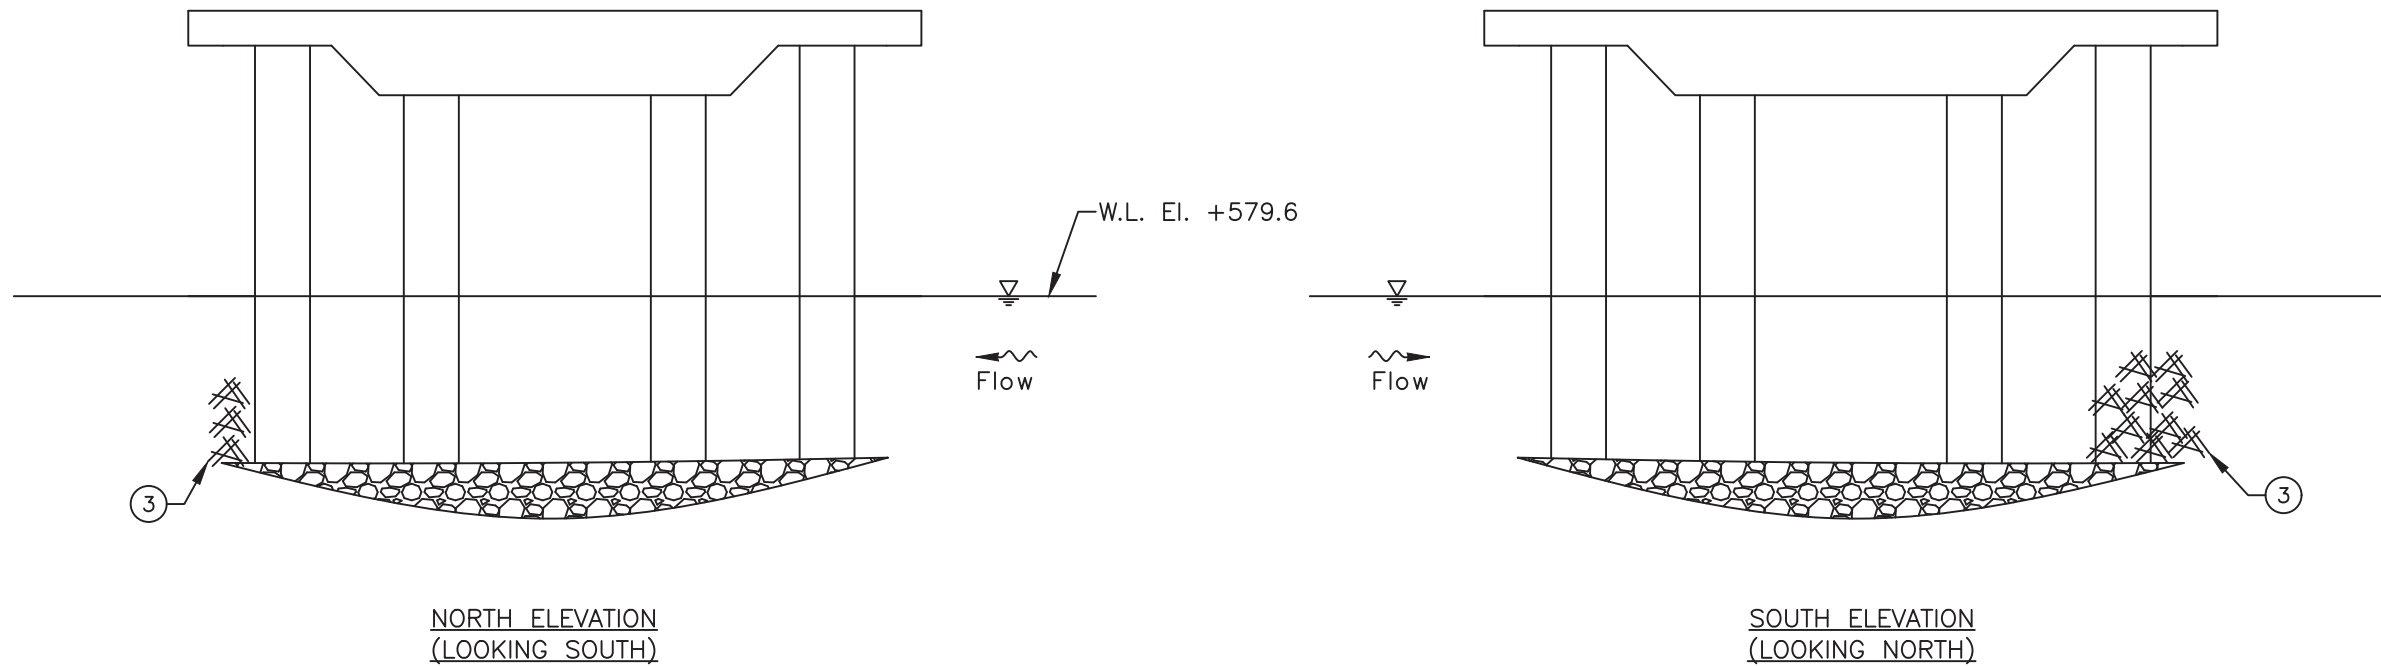
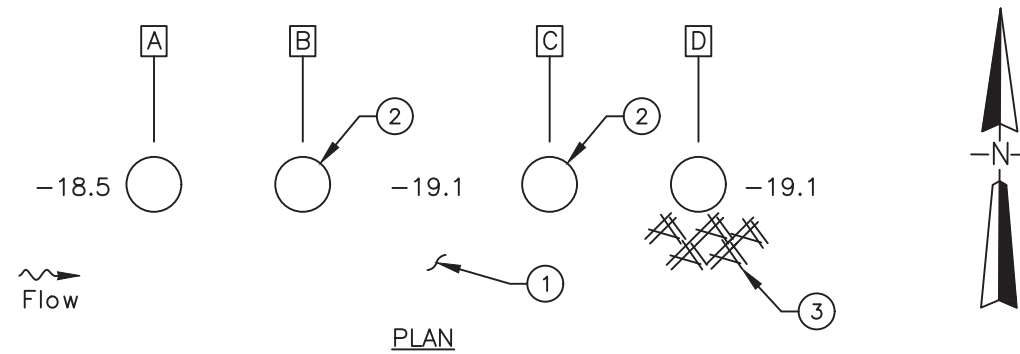
- A scour hole 4 ft diameter by 4 ft deep was observed on the downstream nose.
 - **Bent 6:**
 - The channel bottom material consisted of hard clay with no probe rod penetration.

- ① The channel bottom material consisted of riprap and sand infill with no probe rod penetration.
- ② Columns B and C typically exhibited moderate corrosion and rust nodules up to 1 in diameter with pitting up to $\frac{1}{8}$ in.
- ③ A scour hole 4 ft diameter by 4 ft deep was observed on the downstream nose.

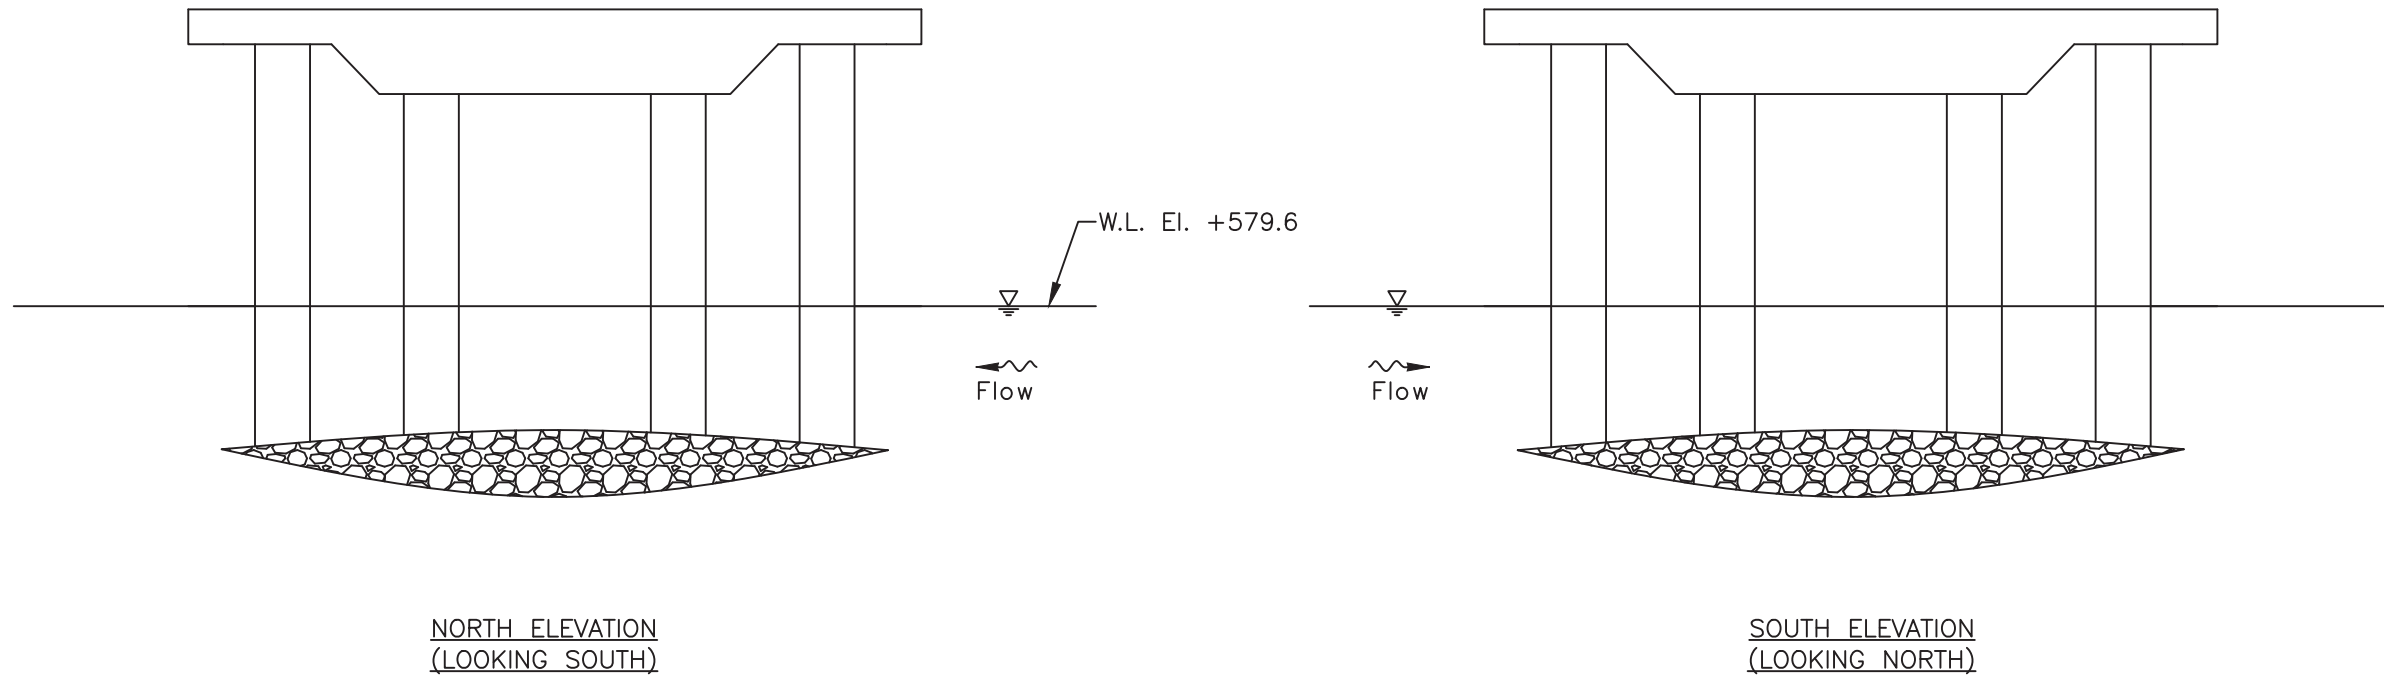
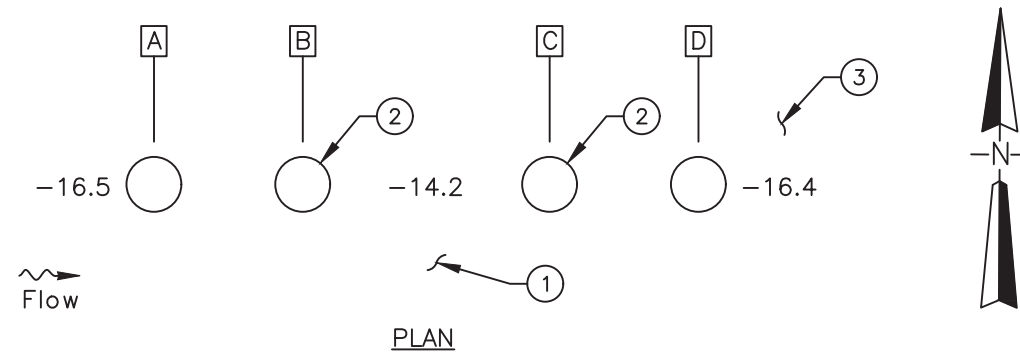
- The typical steel caisson on typical Columns B and C exhibited moderate corrosion and rust nodules up to 1 in. diameter with pitting up to 1/8 in.
 - Timber debris consisting of logs up to 18 in. diameter by 10 ft long was found on South face of Column D.

- ① The channel bottom material consisted of riprap and sand infill with no probe rod penetration.
- ② Columns B and C typically exhibited moderate corrosion and rust nodules up to 1 in diameter with pitting up to $\frac{1}{8}$ in.
- ③ Timber debris consisting of logs up to 18 in. diameter by 10 ft long was found on South face of Column D.

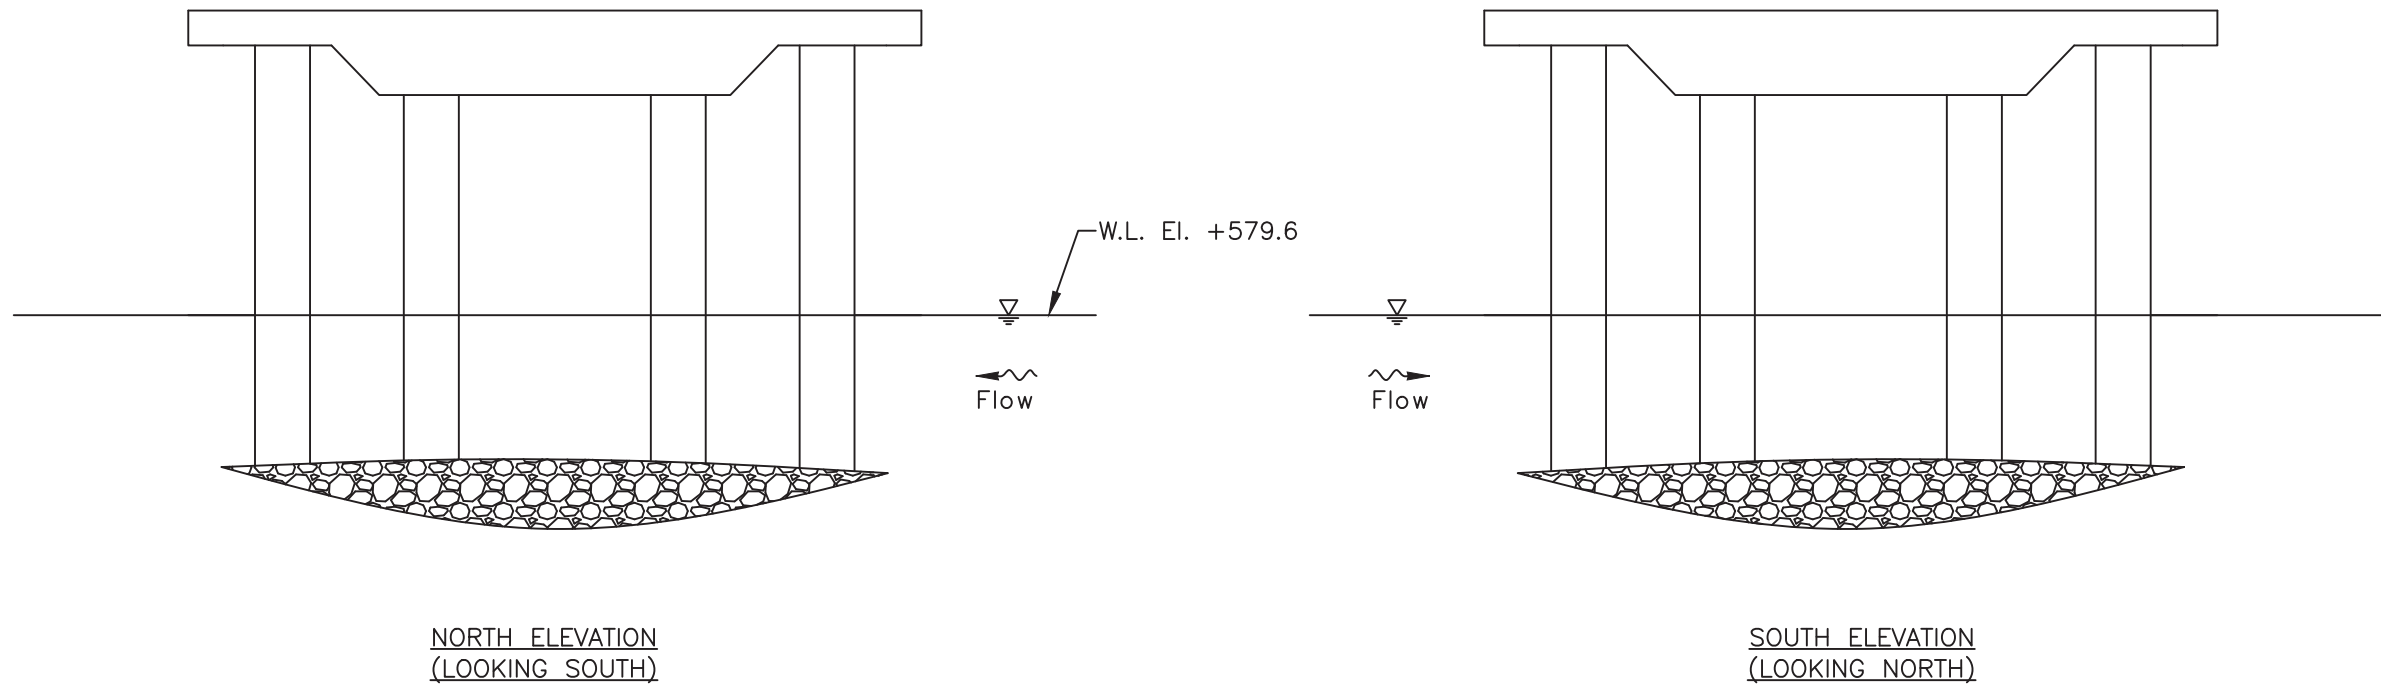
- A scour hole 4 ft deep by 4 ft diameter was found on the downstream nose.
 - **Bent 8:**
 - The channel bottom material consisted of hard clay with no probe rod penetration.

- ① The channel bottom material consisted of riprap and sand infill with no probe rod penetration.
- ② Columns B and C typically exhibited moderate corrosion and rust nodules up to 1 in diameter with pitting up to $\frac{1}{8}$ in.
- ③ A scour hole 4 ft deep by 4 ft diameter was found on the downstream nose.

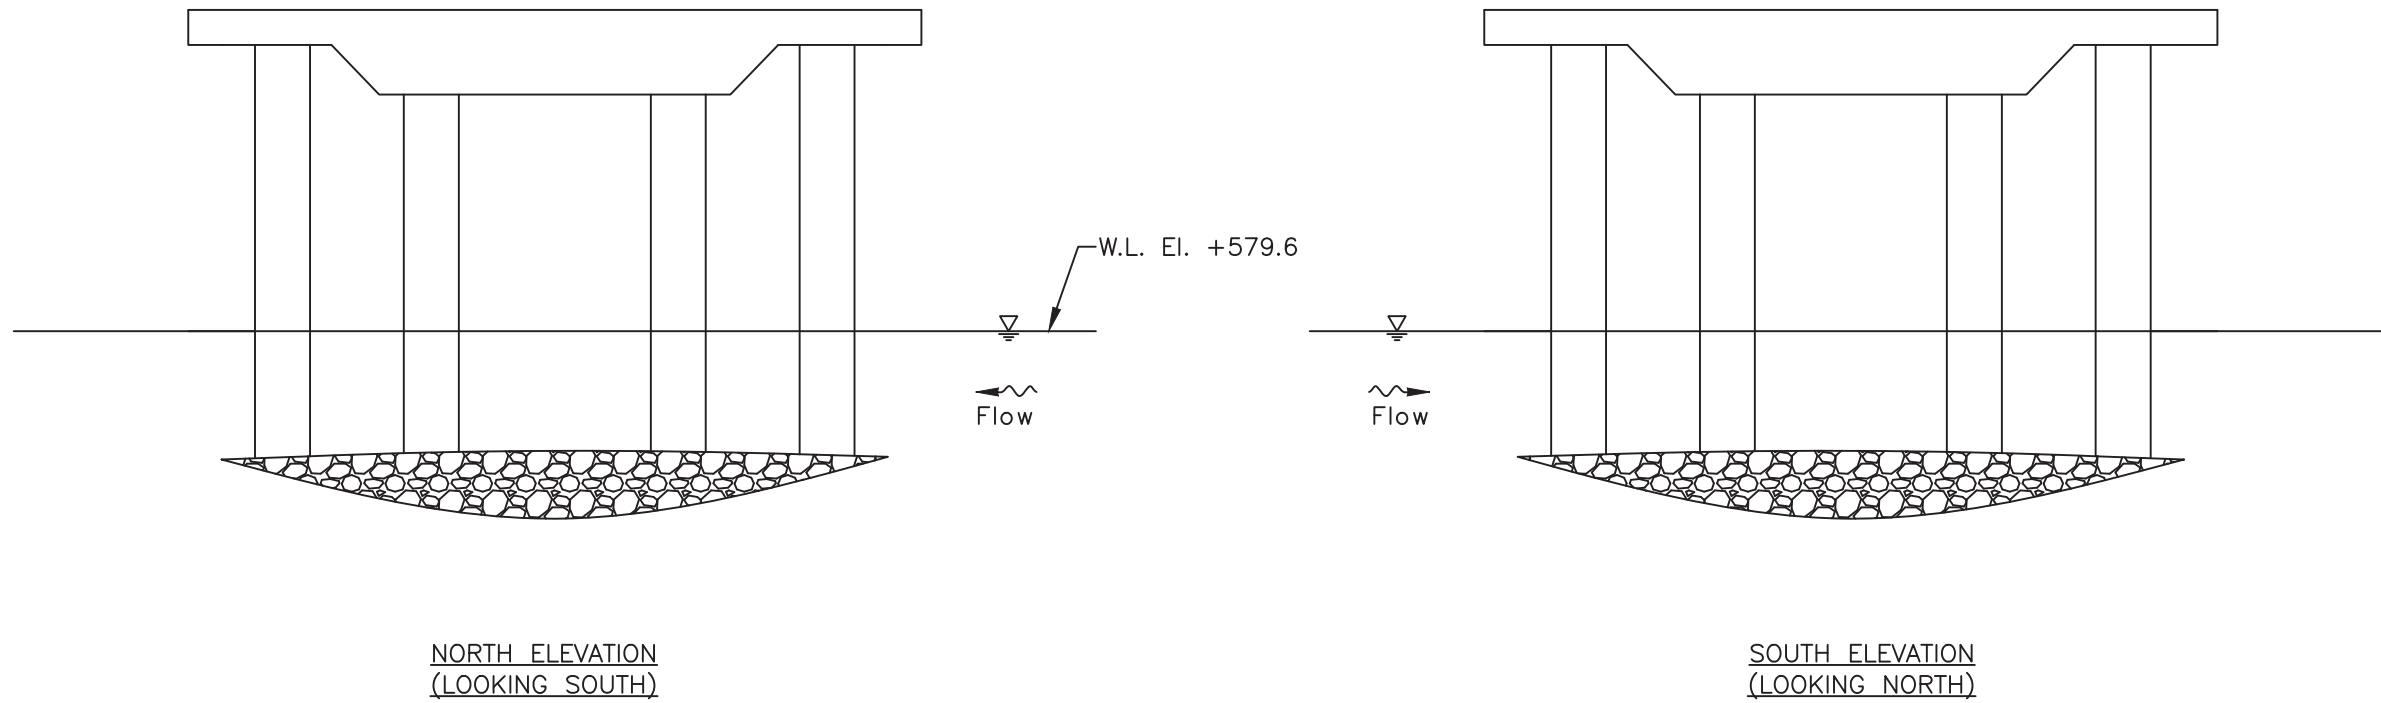
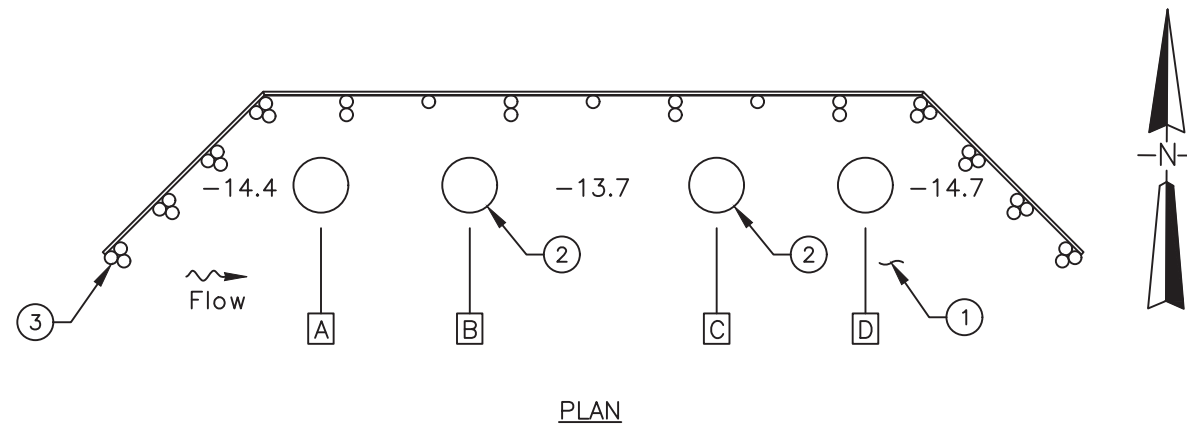
- ① The channel bottom material consisted of riprap and sand infill with no probe rod penetration.
- ② Columns B and C typically exhibited moderate corrosion and rust nodules up to 1 in diameter with pitting up to $\frac{1}{8}$ in.
- ③ The timber piles and fenders typically exhibited area splits and checks up to 1/8 in. wide with up to a maximum awl penetration of 3/16 in.

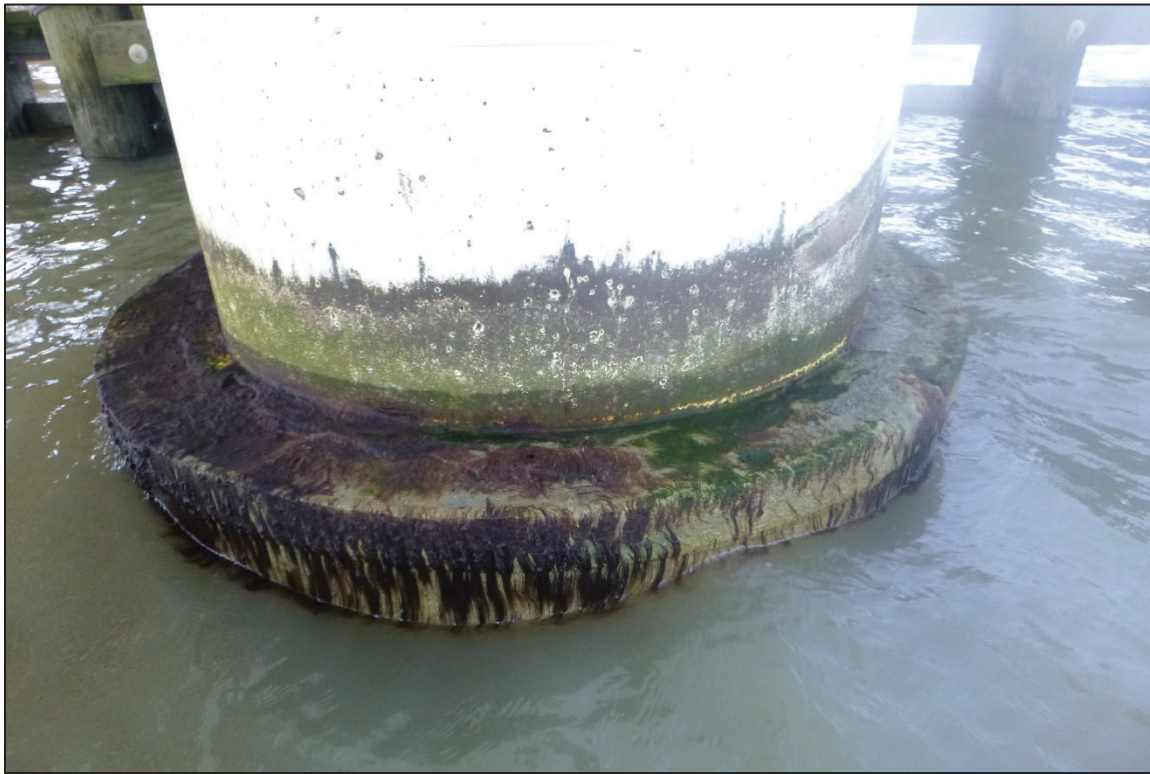
Photograph No. 53: View of the Typical Concrete and Steel Condition at the Waterline of a New Column design on the North Face of Bent 1, Looking South.

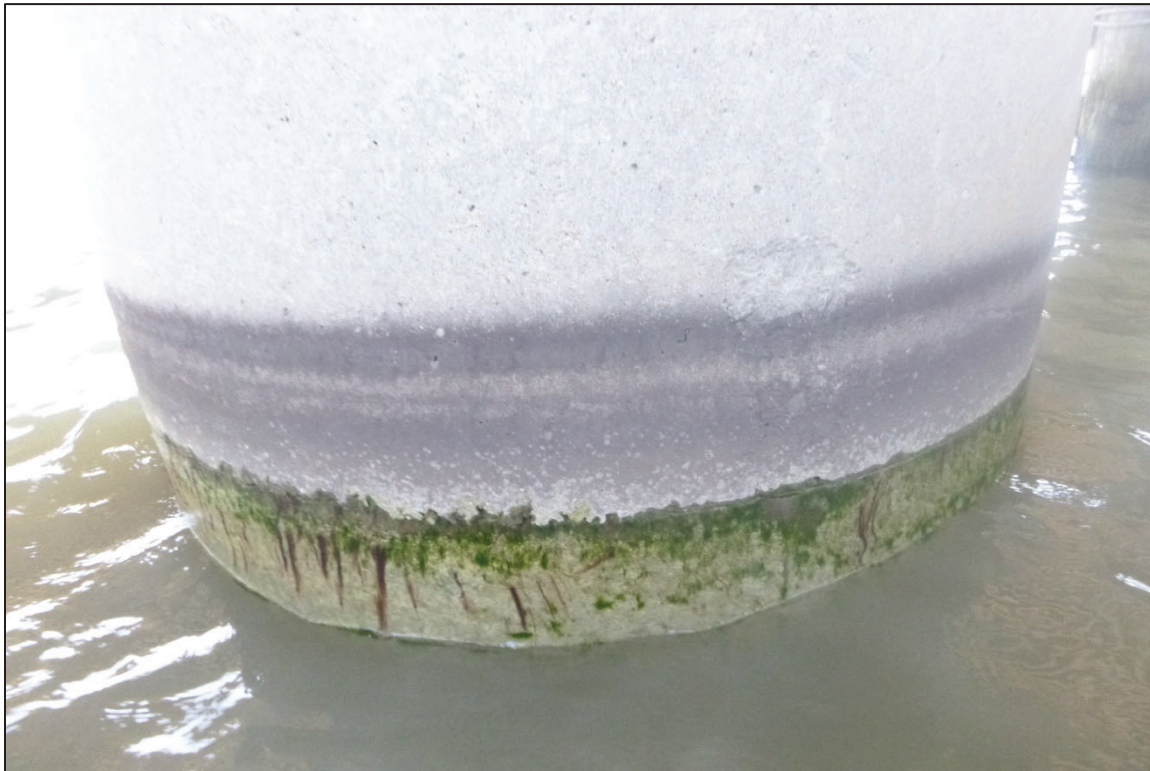
Photograph No. 54: View of the Typical Concrete Condition at the Waterline of an Original Column design on the North Face of Bent 1, Looking South.
