# UNDERWATER BRIDGE INSPECTION REPORT

STRUCTURE NO. 6200885 (OTT-19-0323)  
SR 19 OVER PORTAGE RIVER  
OTTAWA COUNTY, OH  
DISTRICT 2

May 2020

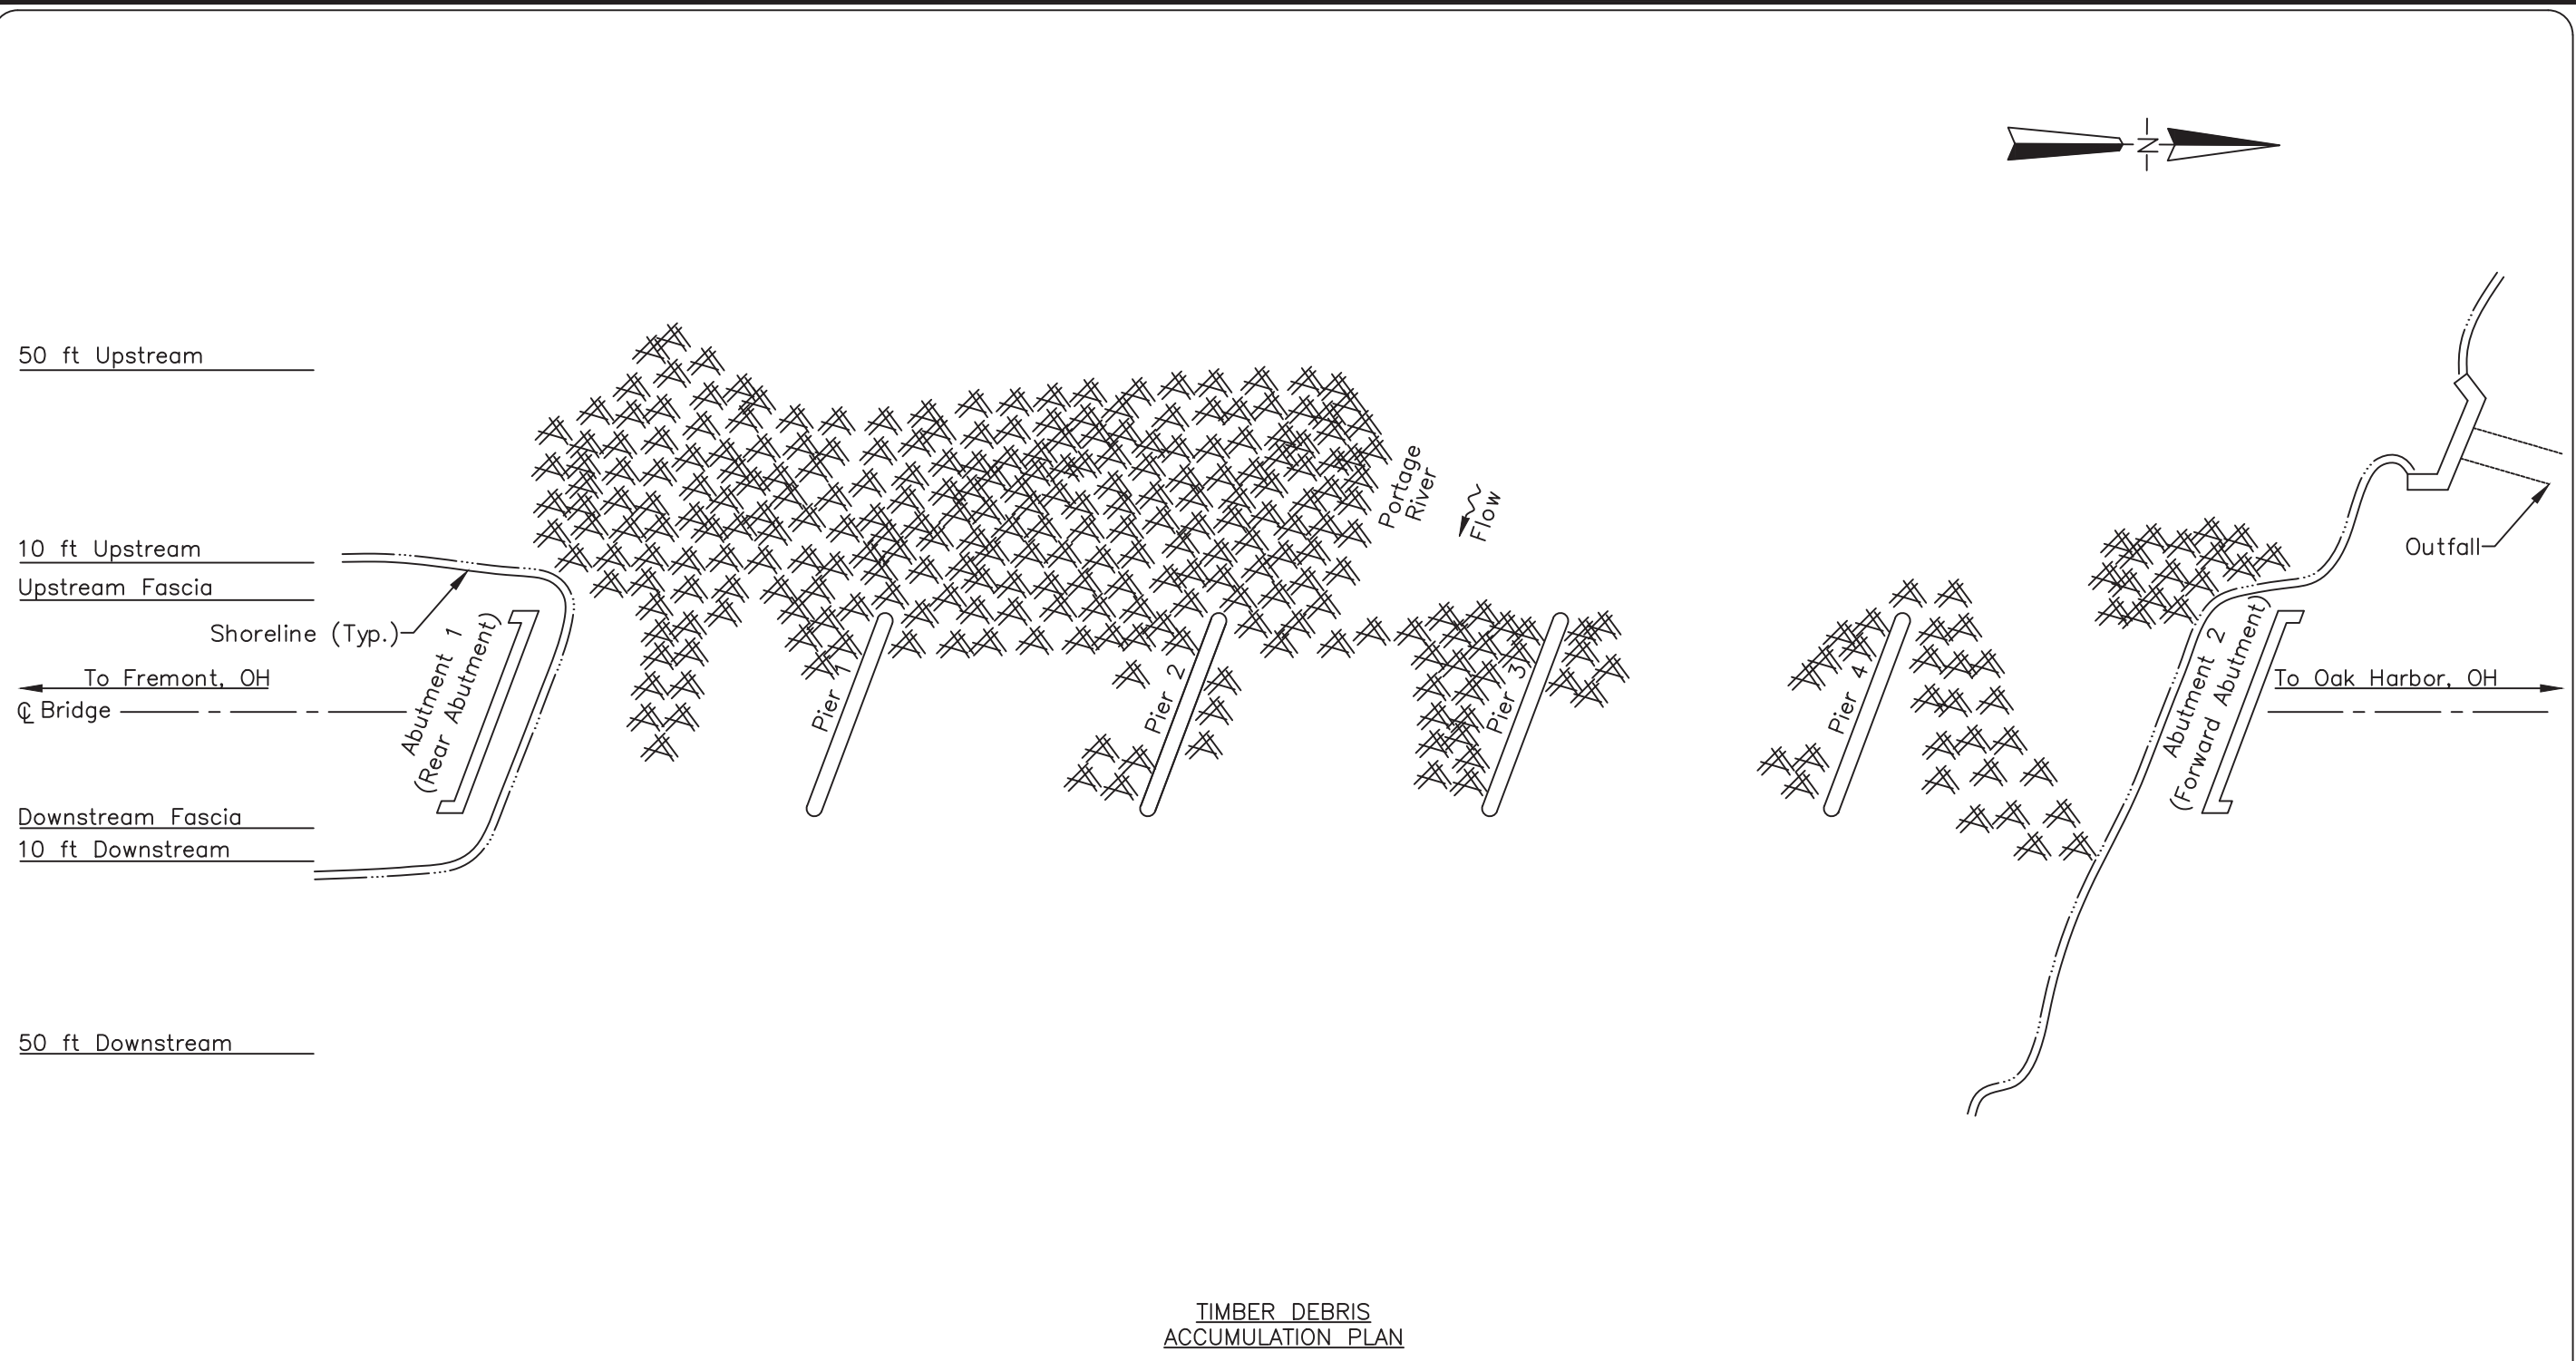
TIMBER DEBRIS  
ACCUMULATION PLAN

- Heavy timber debris consisting of logs up to 2 ft diameter were observed extending up to a 50 ft radius from the upstream nose from channel bottom to 1 ft above the waterline.

- Heavy timber debris consisting of logs up to 2 ft diameter were observed extending up to a 20 ft radius from the upstream nose from channel bottom to 1 ft above the waterline.

- 
- Heavy timber debris consisting of logs up to 2 ft diameter were observed extending up to a 30 ft radius from the upstream nose from channel bottom to 1 ft above the waterline.
  - **Pier 4:**
    - The channel bottom material consisted of timber and silt overlay with approximately 6 in. probe rod penetration.
    - The submerged portions of the pier were sound and smooth with no defects observed.
    - Heavy timber debris consisting of logs up to 2 ft diameter were observed extending up to a 40 ft radius from the upstream nose from channel bottom to 2 ft above the waterline.

- Remove timber debris at Piers 1 through 4
- Monitor footing exposure at Pier 3.

The timber debris accumulations at Piers 1 through 4 is obstructing channel flow and the cause of footing exposure and should be removed at this time. Removal of the timber debris will reduce excessive lateral loads on the pier, limit further debris accumulation, and reduce the likelihood of channel bottom degradation resulting from obstructed flow.

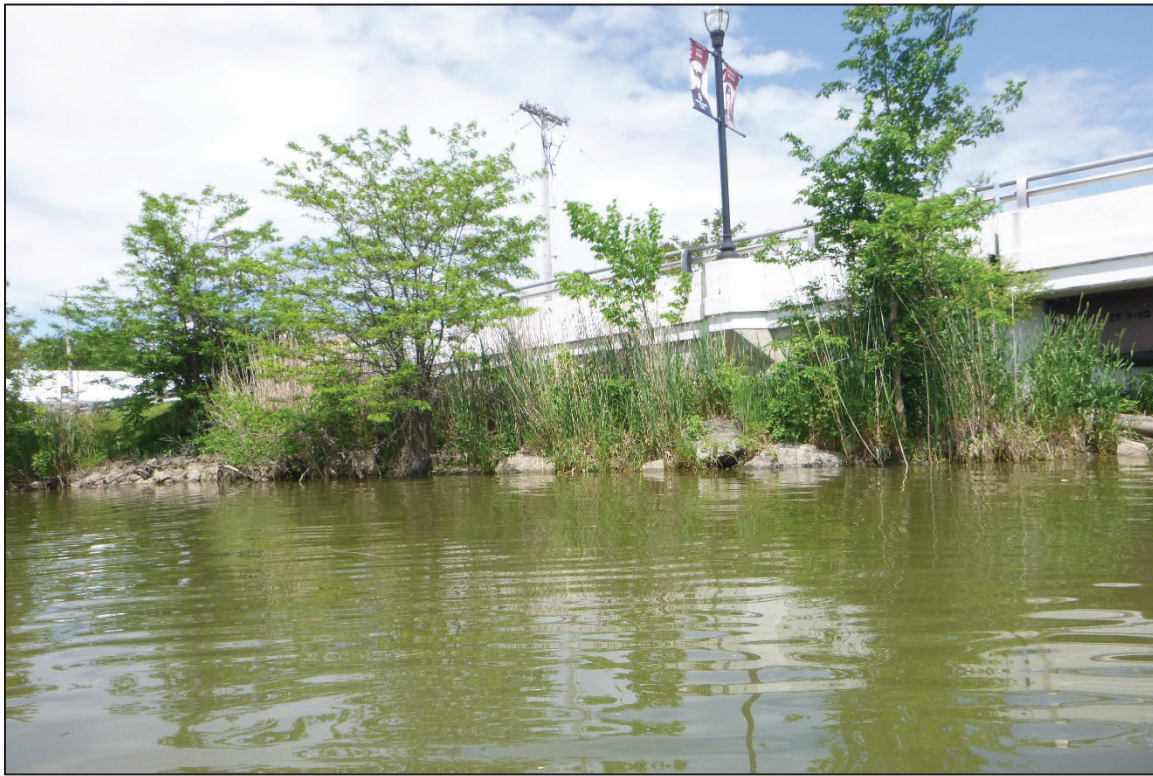
<b>Shoreline Conditions:</b>	The north and south shorelines consisted of well-protected, well-vegetated, mild slopes with minor erosion.

Photograph No. 3: View of the North Embankment Upstream of the Structure, Looking Northeast.

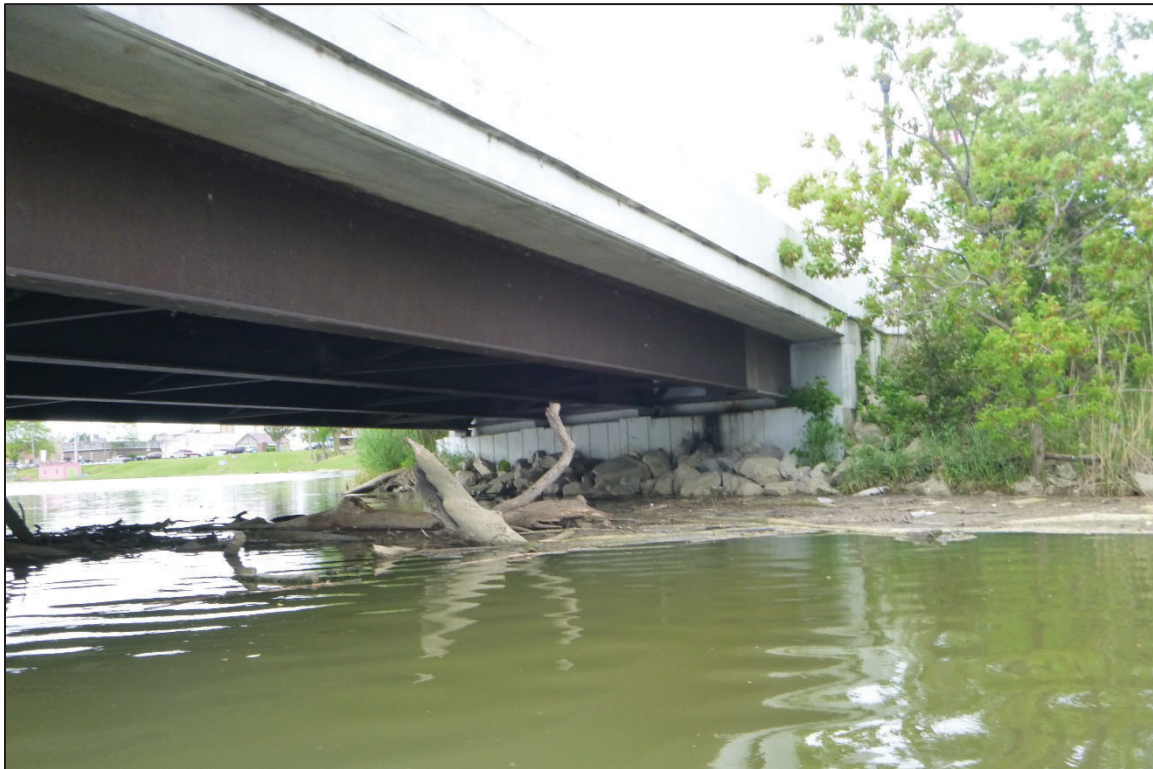
Photograph No. 4: View of the North Embankment at the Structure, Looking Northwest.

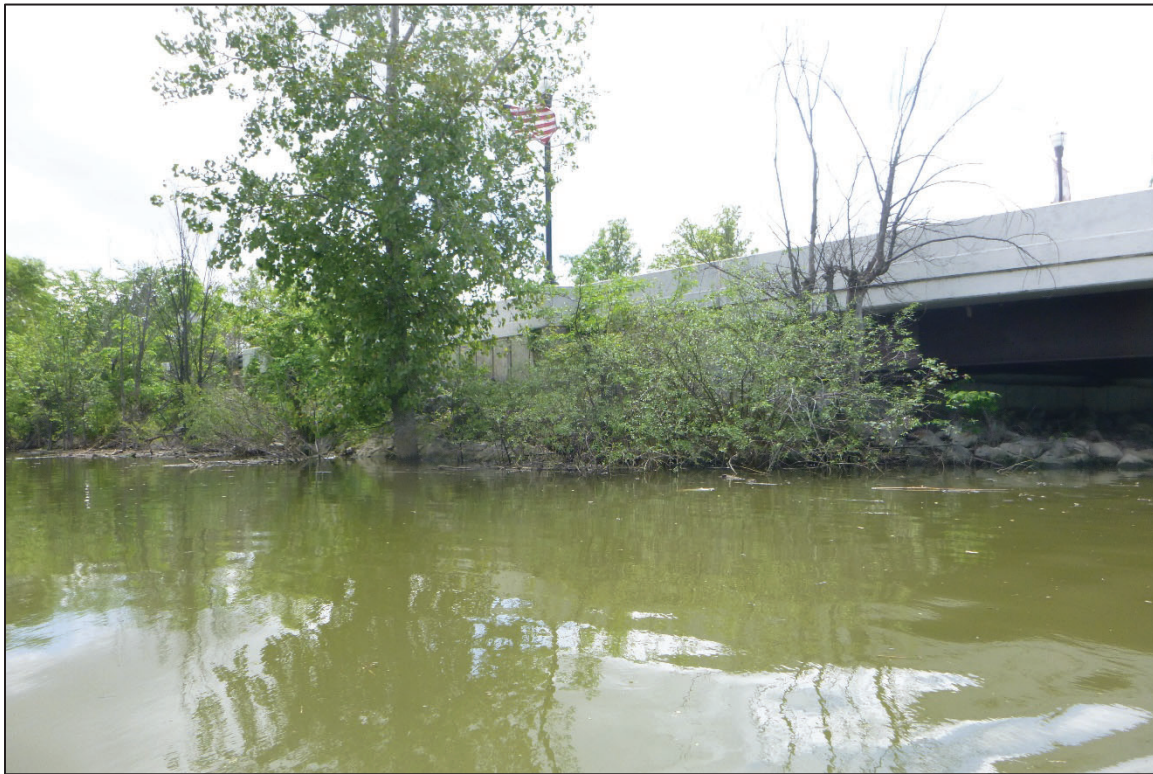
Photograph No. 5: View of the North Embankment Downstream of the Structure, Looking Southwest.

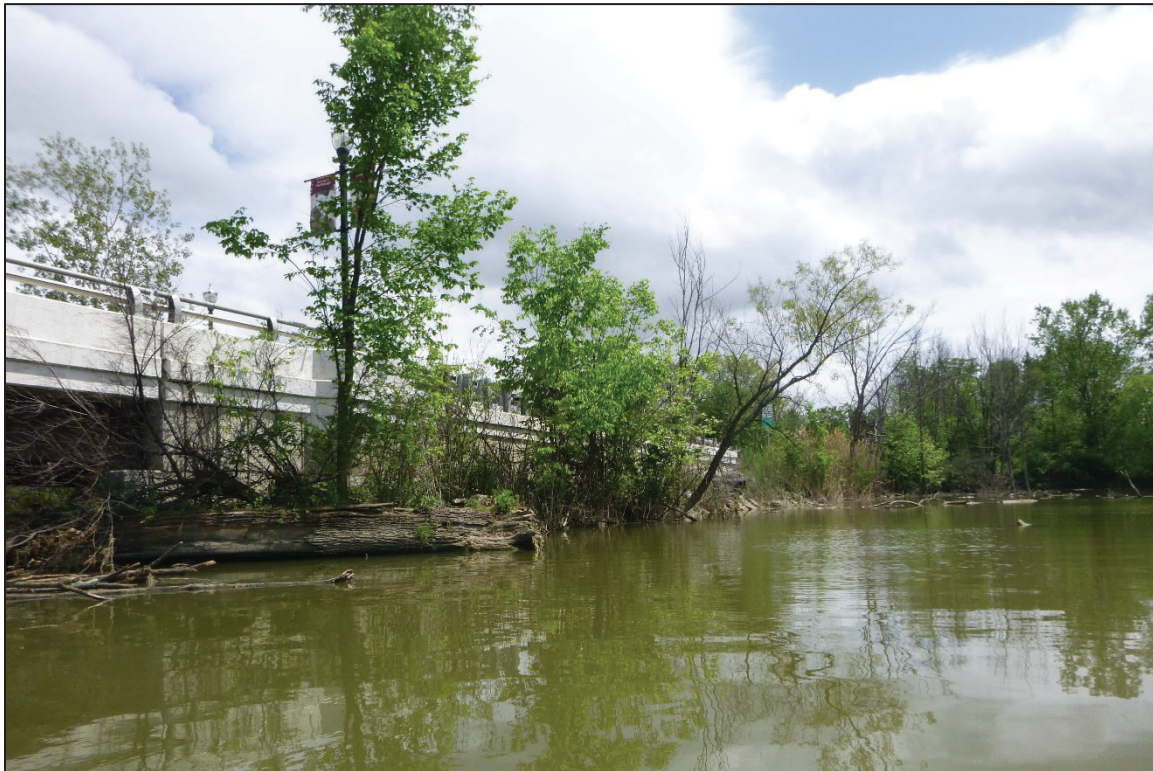
Photograph No. 6: View of the South Embankment Upstream of the Structure, Looking Southeast.

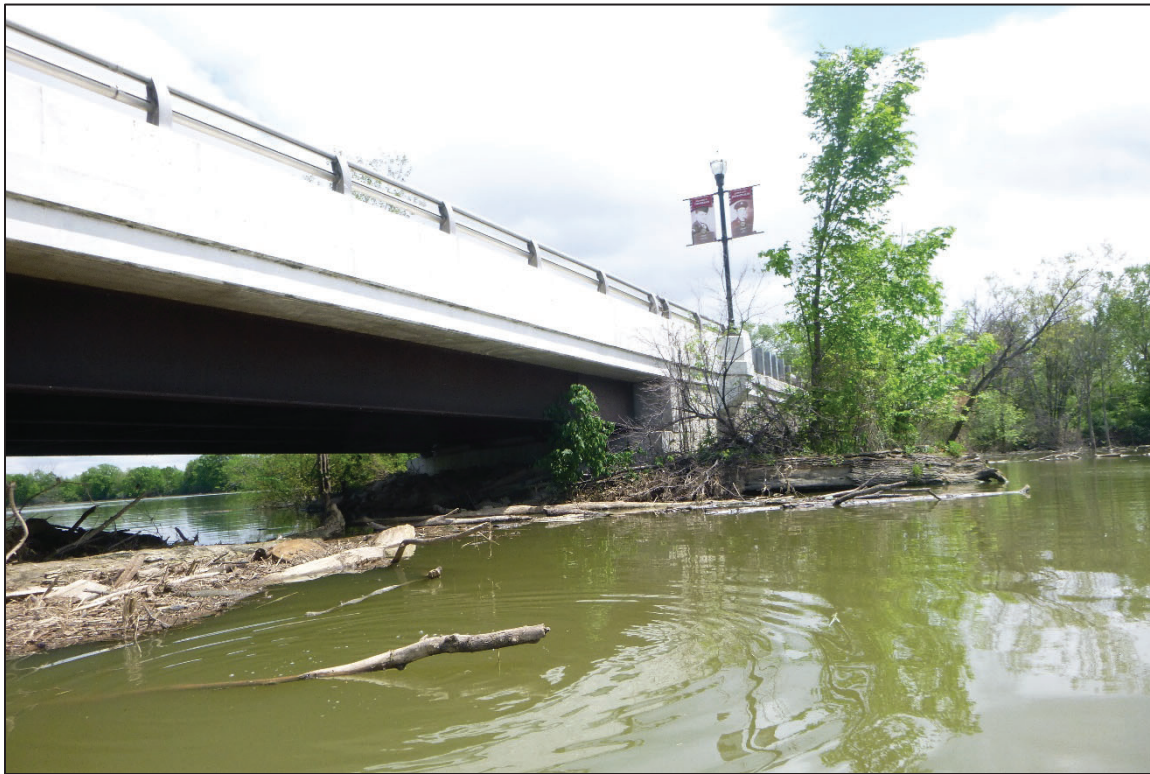
Photograph No. 7: View of the South Embankment at the Structure, Looking Southeast.

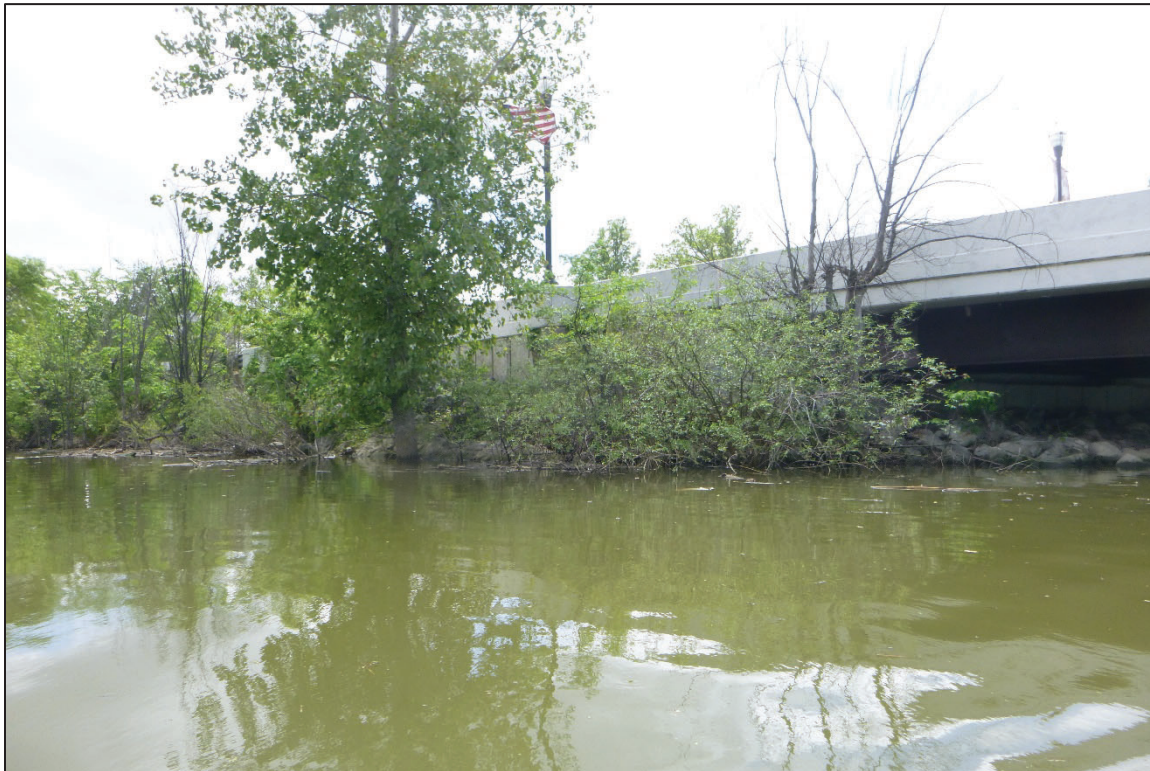
Photograph No. 8: View of the South Embankment Downstream of the Structure, Looking Southwest.

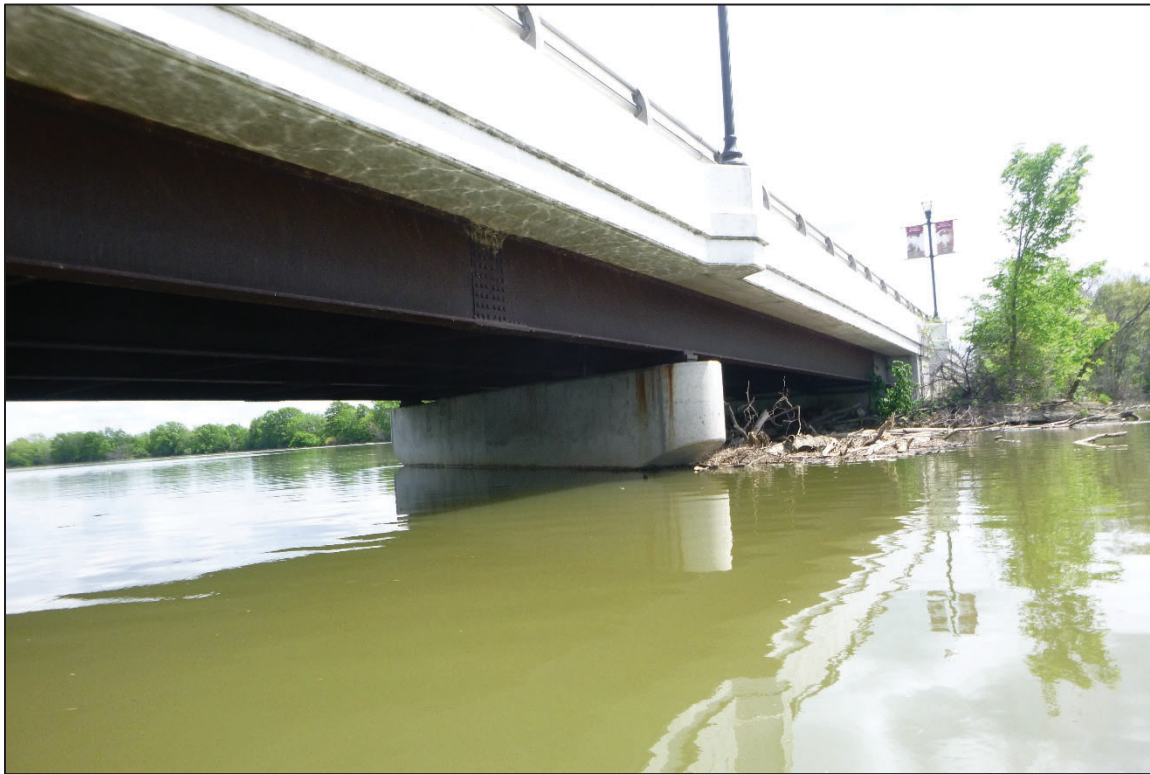
The channel bottom material consisted of timber and silt overlay with approximately 6 in. probe rod penetration. The submerged portions of the pier were sound and smooth with no defects observed. Heavy timber debris consisting of logs up to 2 ft diameter were observed extending up to a 50 ft radius from the upstream nose from channel bottom to 1 ft above the waterline. Refer to Figure 7 in Exhibit 1 for detailed inspection notes of Pier 1. Refer to Photographs 9 and 10 in Exhibit 2 for views of Pier 1.

Photograph No. 9: View of the North Face of Pier 1, Looking Southeast.

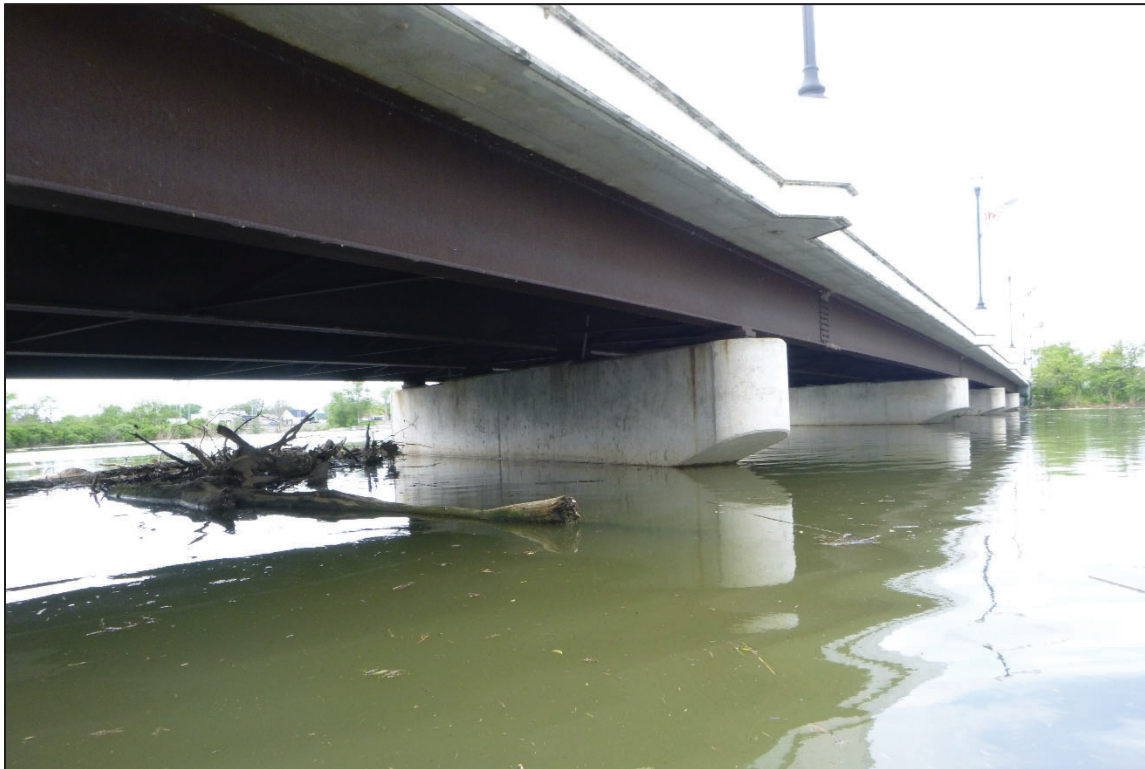
Photograph No. 10: View of the South Face of Pier 1, Looking Northwest.

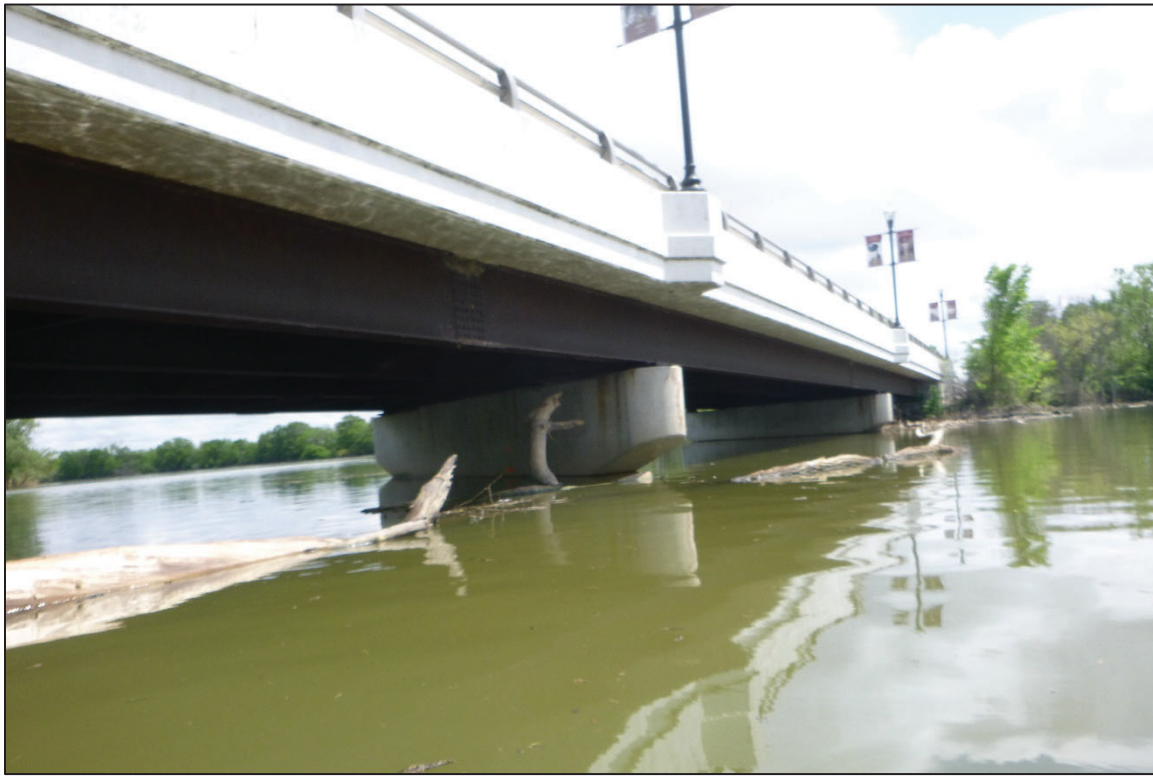
The channel bottom material consisted of timber and silt overlay with approximately 6 in. probe rod penetration. The submerged portions of the pier were sound and smooth with no defects observed. Heavy timber debris consisting of logs up to 2 ft diameter were observed extending up to a 20 ft radius from the upstream nose from channel bottom to 1 ft above the waterline. Refer to Figure 8 in Exhibit 1 for detailed inspection notes of Pier 2. Refer to Photographs 11 and 12 in Exhibit 2 for views of Pier 2.

Photograph No. 11: View of the North Face of Pier 2, Looking Southeast.

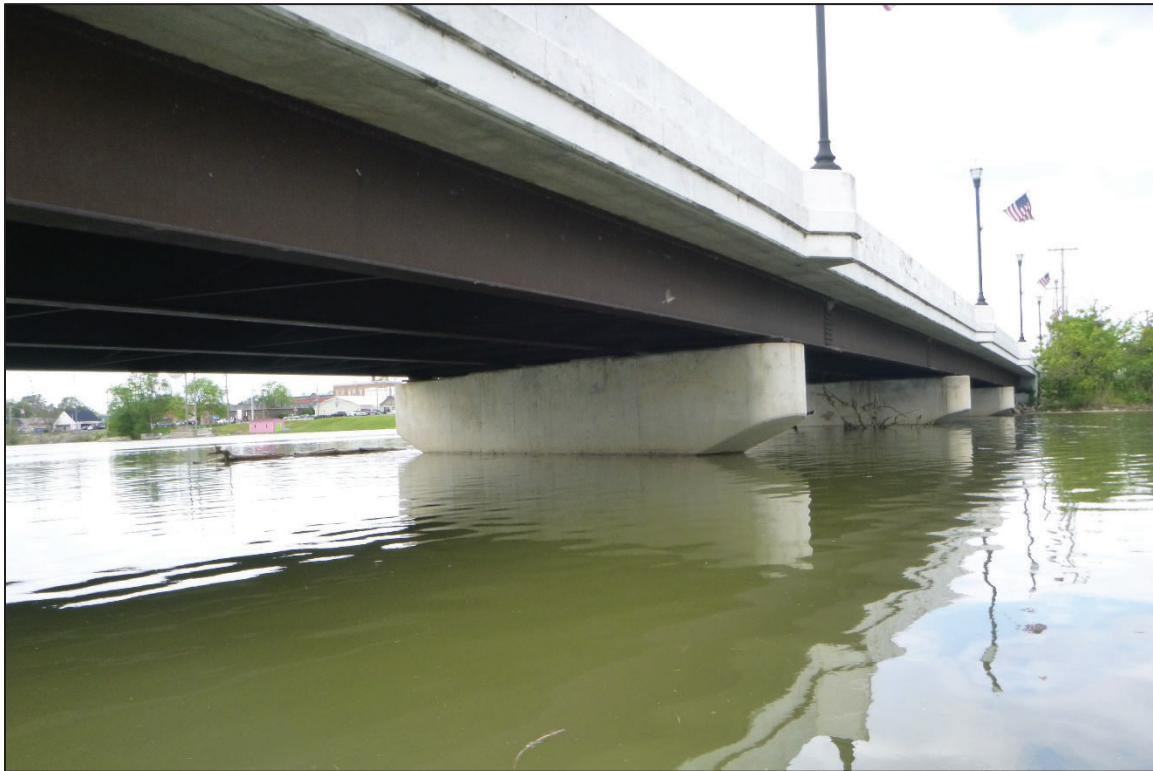
Photograph No. 12: View of the South Face of Pier 2, Looking Northwest.

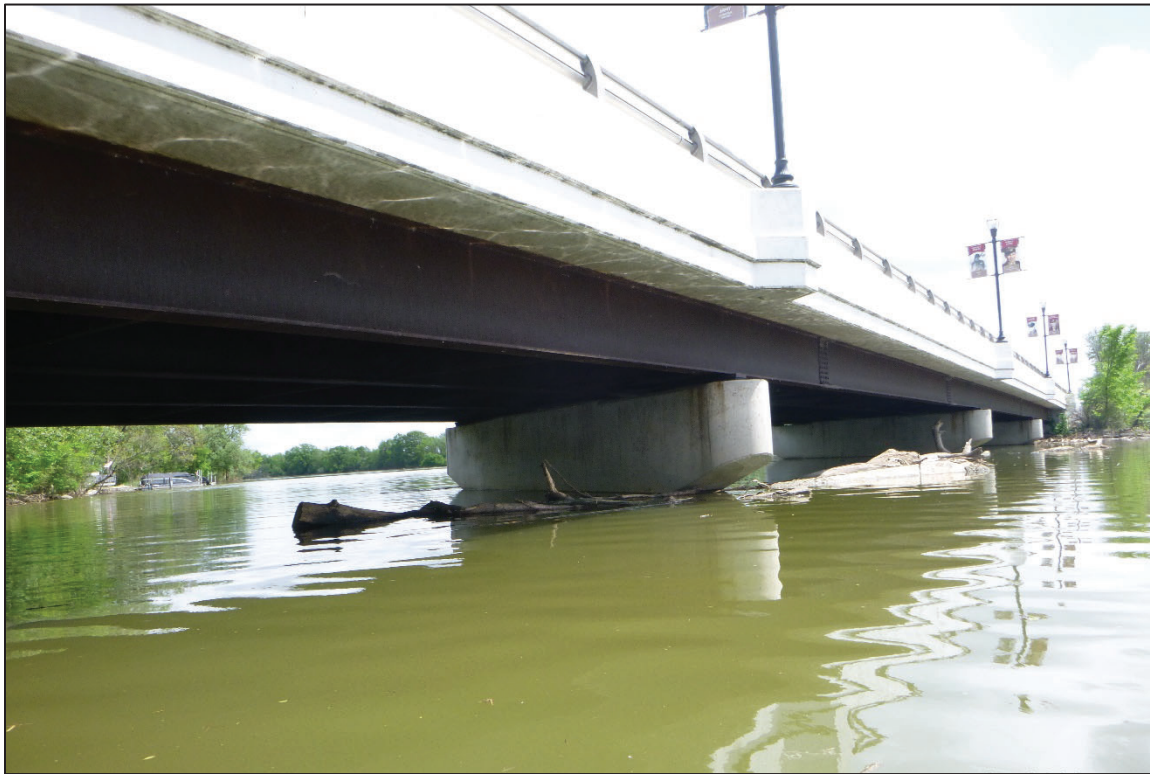
The channel bottom material consisted of timber and silt overlay with approximately 6 in. probe rod penetration. The submerged portions of the pier were sound and smooth with no defects observed. The top of footing was observed at 17.2 ft below the waterline extending from the midpoint along the north face around the downstream nose to the downstream quarter point of the south face with a maximum vertical exposure of 1.7 ft at the southeast corner. Heavy timber debris consisting of logs up to 2 ft diameter were observed extending up to a 30 ft radius from the upstream nose from channel bottom to 1 ft above the waterline. Refer to Figure 9 in Exhibit 1 for detailed inspection notes of Pier 3. Refer to Photographs 13 and 14 in Exhibit 2 for views of Pier 3.

Photograph No. 13: View of the North Face of Pier 3, Looking Southeast.

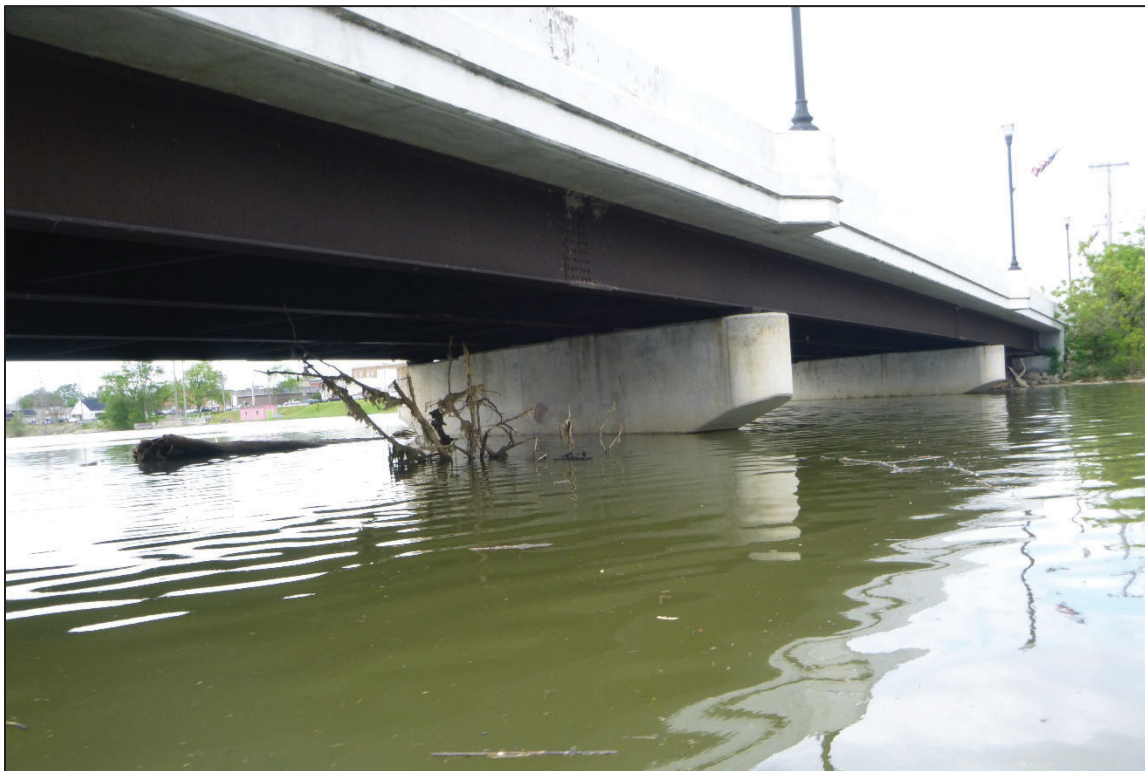
Photograph No. 14: View of the South Face of Pier 3, Looking Northwest.

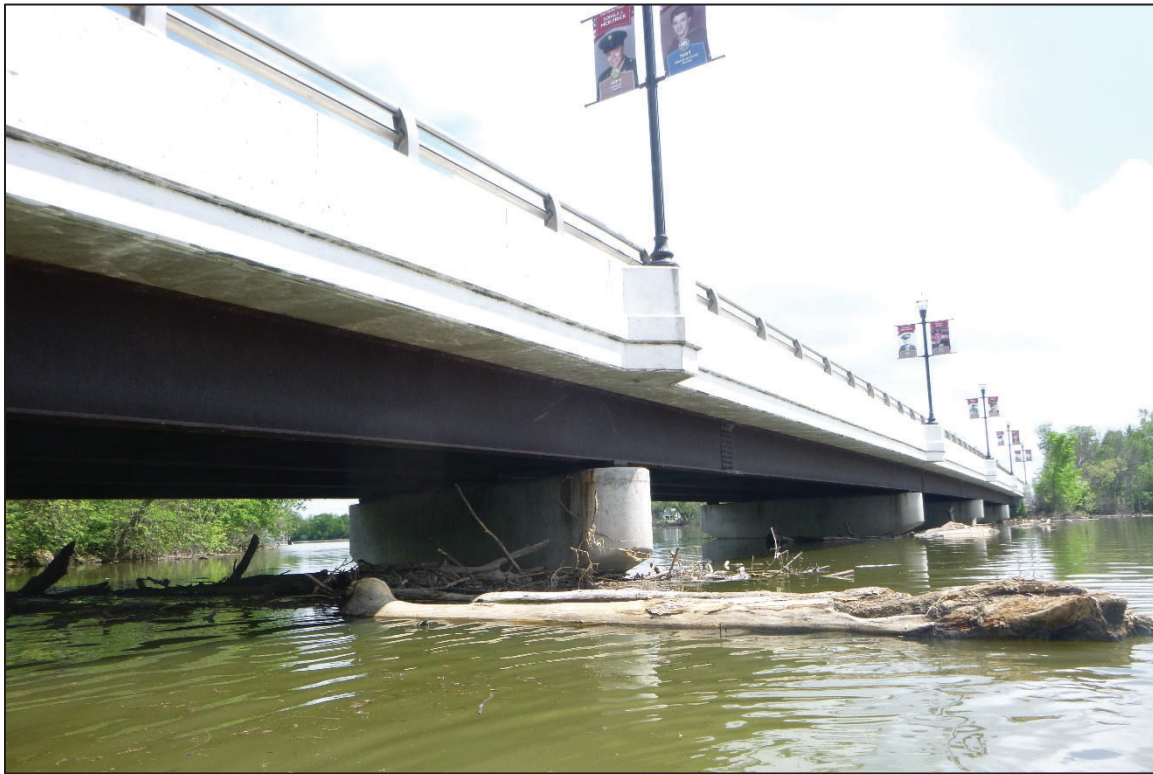
The channel bottom material consisted of timber and silt overlay with approximately 6 in. probe rod penetration. The submerged portions of the pier were sound and smooth with no defects observed. Heavy timber debris consisting of logs up to 2 ft diameter were observed extending up to a 40 ft radius from the upstream nose from channel bottom to 2 ft above the waterline. Refer to Figure 10 in Exhibit 1 for detailed inspection notes of Pier 4. Refer to Photographs 15 through 17 in Exhibit 2 for views of Pier 4 and typical concrete condition at the waterline.

Photograph No. 15: View of the North Face of Pier 4, Looking Southeast.

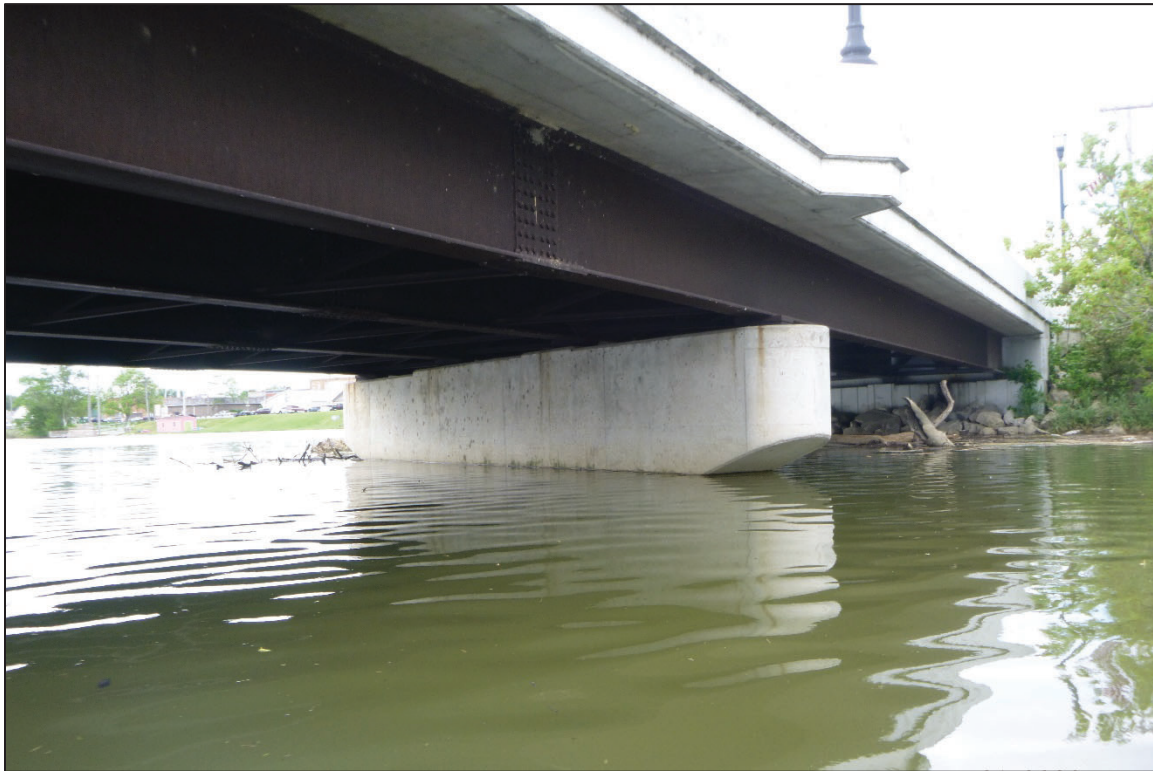
Photograph No. 16: View of the South Face of Pier 4, Looking Northwest.

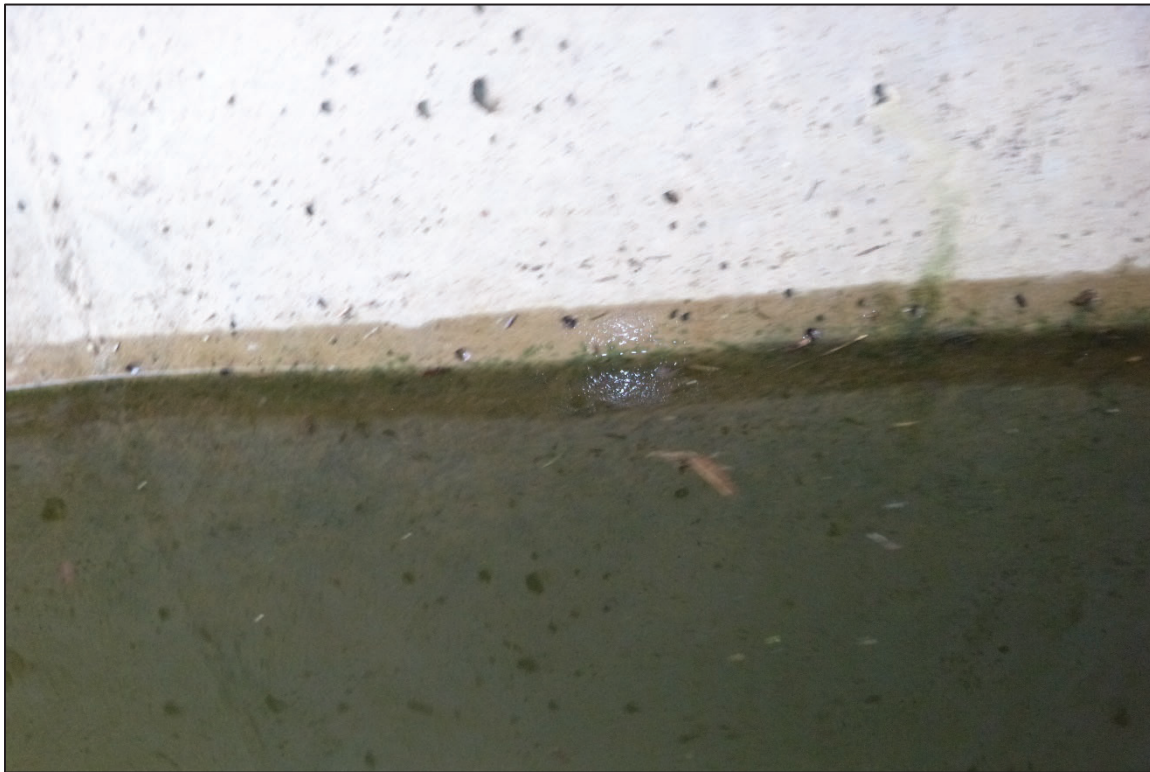
Photograph No. 17: View of the Typical Concrete Condition at the Waterline on the South Face of Pier 4.
