UNDERWATER BRIDGE INSPECTION REPORT

STRUCTURE NO. 6200931 (OTT-19-0811)
SR 19 OVER TOUSSAINT RIVER
OTTAWA COUNTY, OH
DISTRICT 2

May 2020

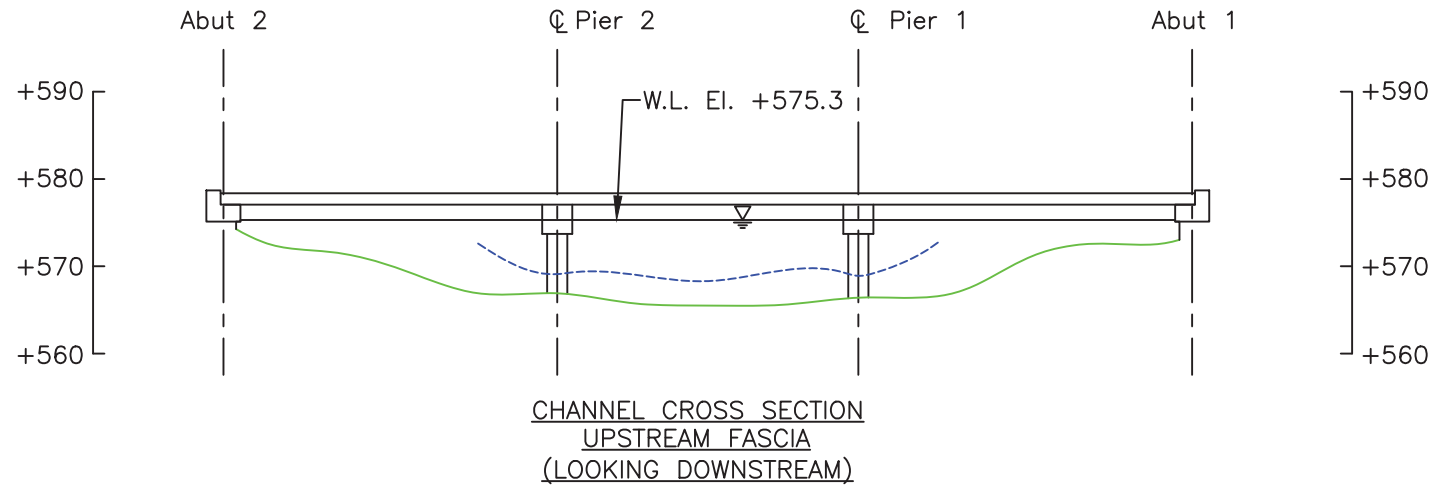
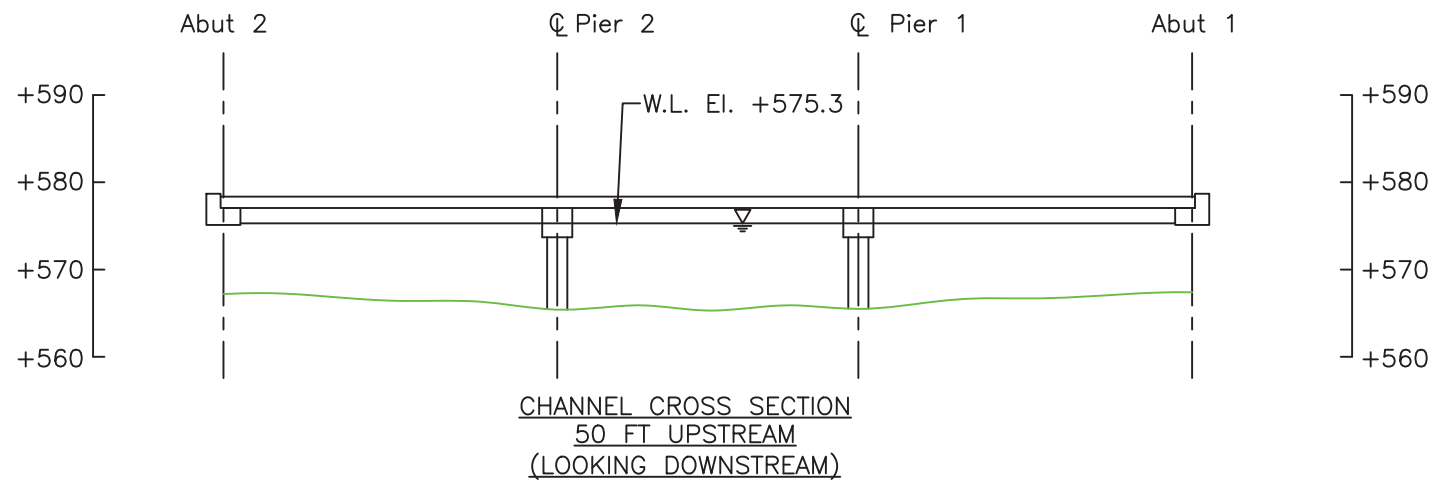
SR-19 OVER TOUSSAINT RIVER
STRUCTURE NO. 6200931 (OTT-19-0811)
CROSS SECTIONS - UPSTREAM
OTTAWA COUNTY, OHIO

UPSTREAM FASCIA LOOKING DOWNSTREAM	
Location	Y(ft)*
A2	4.1
1/4	5.0
1/2	7.3
3/4	9.7
P2	9.7
1/4	10.8
1/2	11.1
3/4	11.0
P1	10.2
1/4	9.5
1/2	5.5
3/4	4.0
A1	4.0

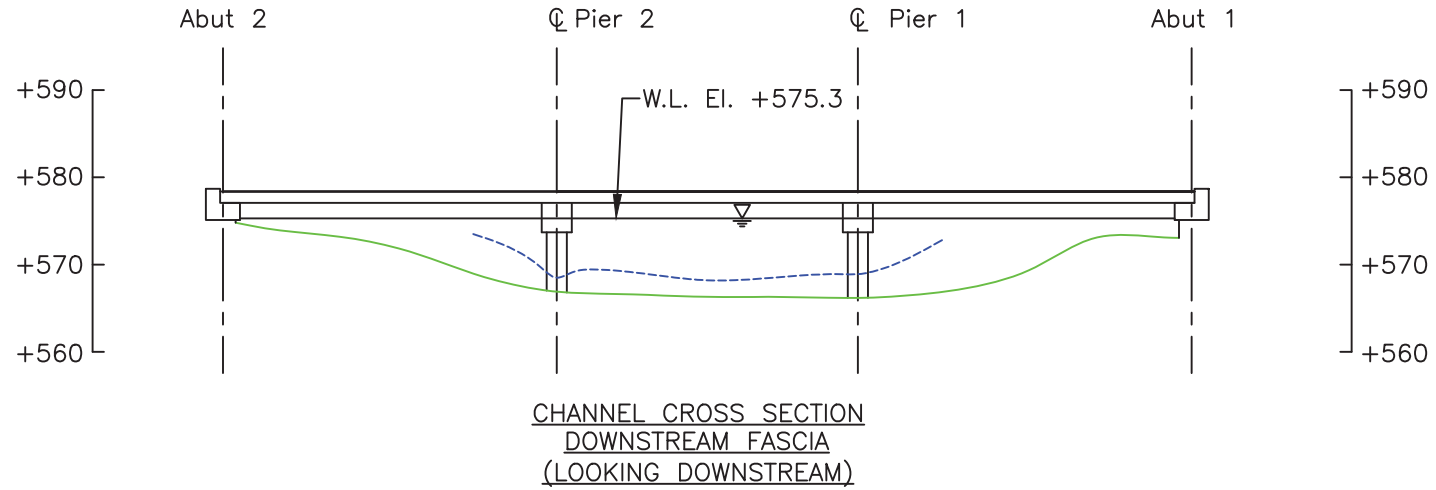
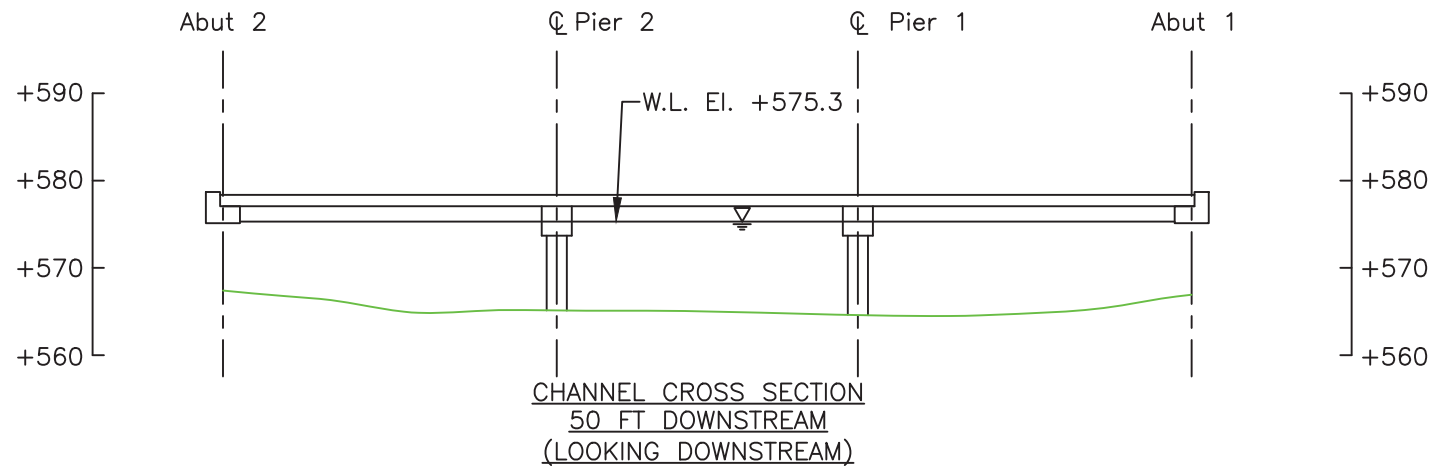
**SR-19 OVER TOUSSAINT RIVER
STRUCTURE NO. 6200931 (OTT-19-0811)
CROSS SECTIONS - DOWNSTREAM
OTTAWA COUNTY, OHIO**

DOWNSTREAM FASCIA LOOKING DOWNSTREAM	
Location	Y(ft)*
A2	2.5
1/4	3.4
1/2	5.0
3/4	7.9
P2	9.7
1/4	10.0
1/2	10.3
3/4	10.3
P1	10.5
1/4	9.4
1/2	7.1
3/4	3.5
A1	3.5

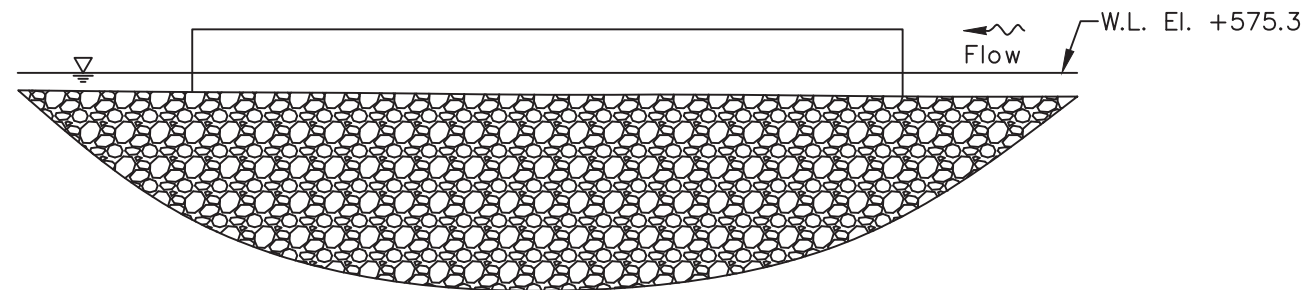
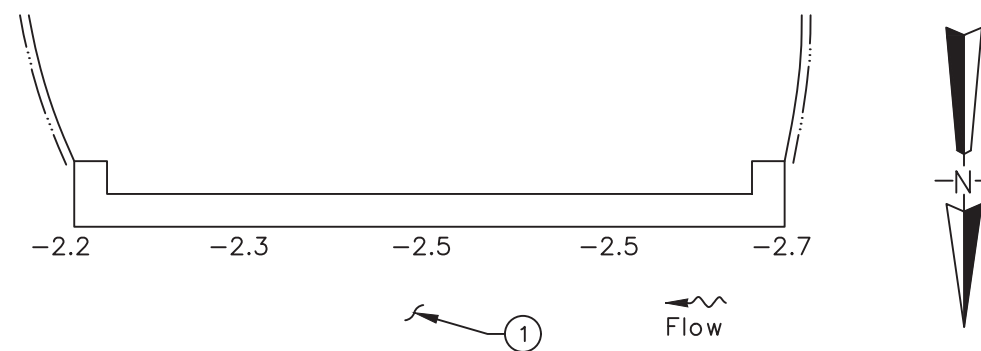
SR-19 OVER TOUSSAINT RIVER
 STRUCTURE NO. 6200931 (OTT-19-0811)
 ABUT 1
 OTTAWA COUNTY, OHIO

The channel bottom material consisted of riprap up to 18 in. diameter with no probe rod penetration. The submerged portions of the pier were sound and smooth with no defects observed. Refer to Figure 6 in Exhibit 1 for detailed inspection notes of Abutment 1.

- ① The channel bottom material consisted of rip-rap up to 18 in. diameter with no probe rod penetration.

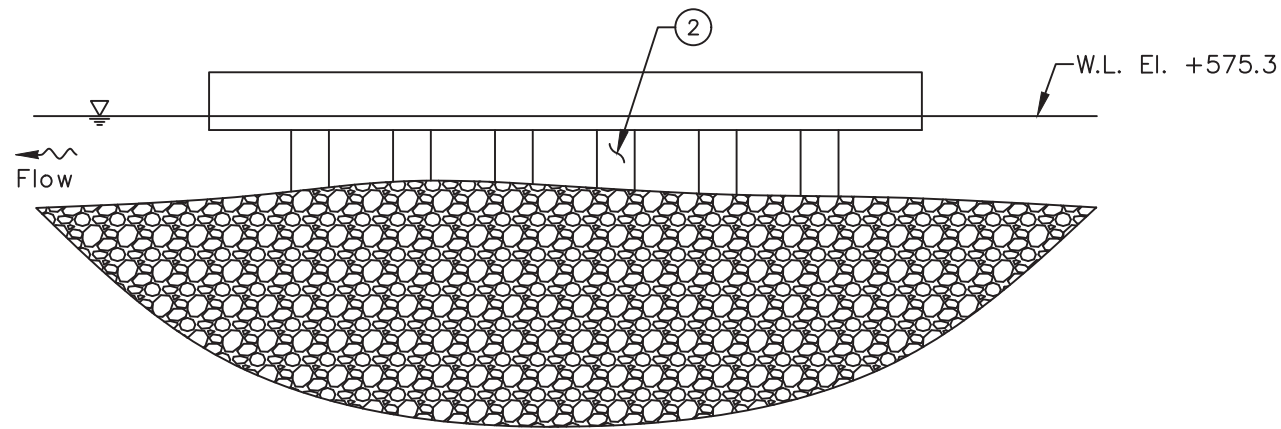
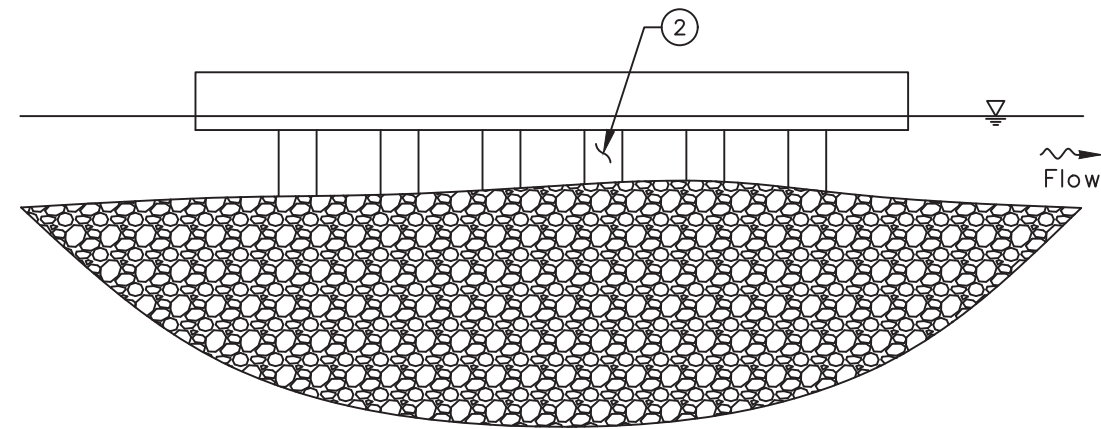
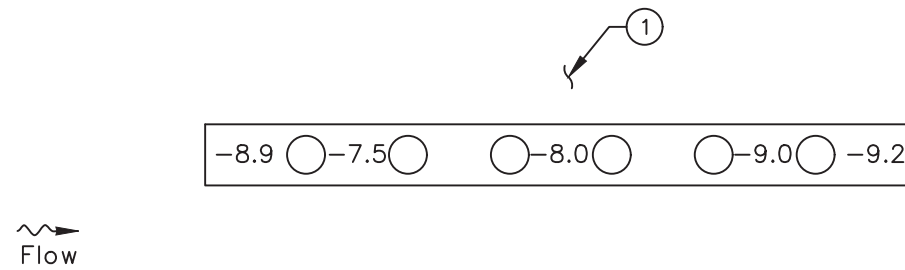
The channel bottom material consisted of sand and cobbles with approximately 2 in. probe rod penetration. The submerged portions of the bent were sound and smooth with no defects observed. Refer to Figure 7 in Exhibit 1 for detailed inspection notes of Bent 1.

- ① The channel bottom material consisted of sand and cobbles with approximately 2 in. probe rod penetration.
- ② The submerged portions of the pier were sound and smooth with no defects observed.

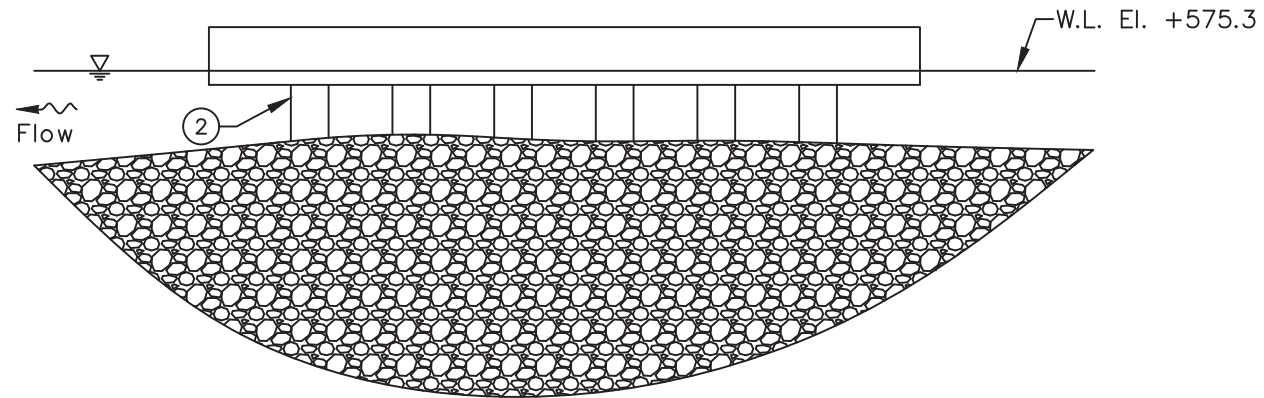
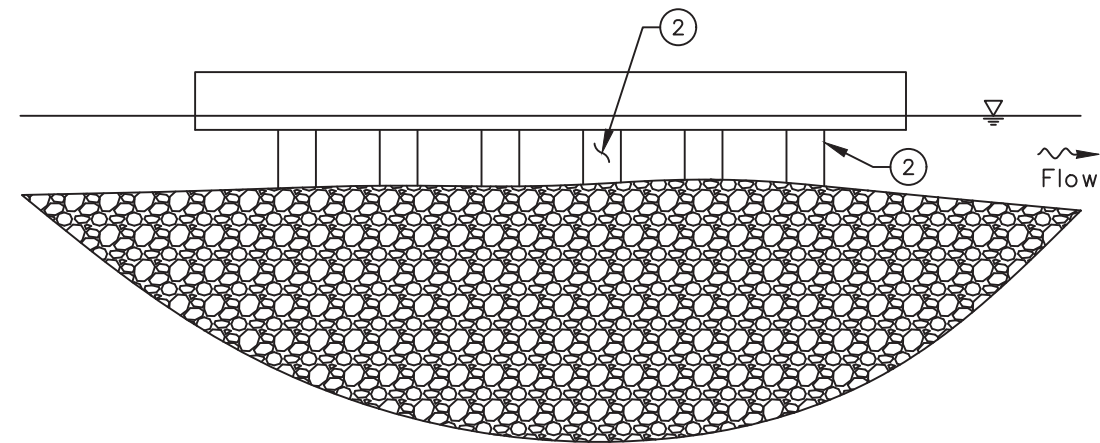
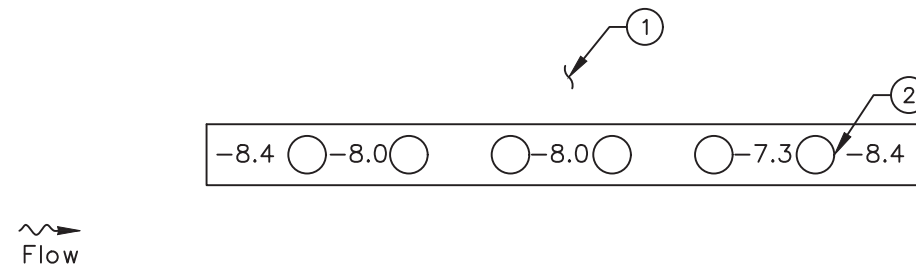
The channel bottom material consisted of sand and cobbles with approximately 2 in. probe rod penetration. The submerged portions of the pier were sound and smooth with no defects observed. An impact dent exists on the downstream (east) face of the eastern pile of Bent 2, approximately 2 ft below the waterline measuring 3 in. diameter by 1 in. deep. Refer to Figure 8 in Exhibit 1 for detailed inspection notes of Bent 2.

- ① The channel bottom material consisted of sand and cobbles with approximately 2 in. probe rod penetration.
- ② A spall measuring 3 in. diameter by 1 in. deep was observed on the downstream (east) face of the eastern pile of Bent 2.

- Monitor steel condition of submerged piles.
- Monitor concrete condition at the waterline.

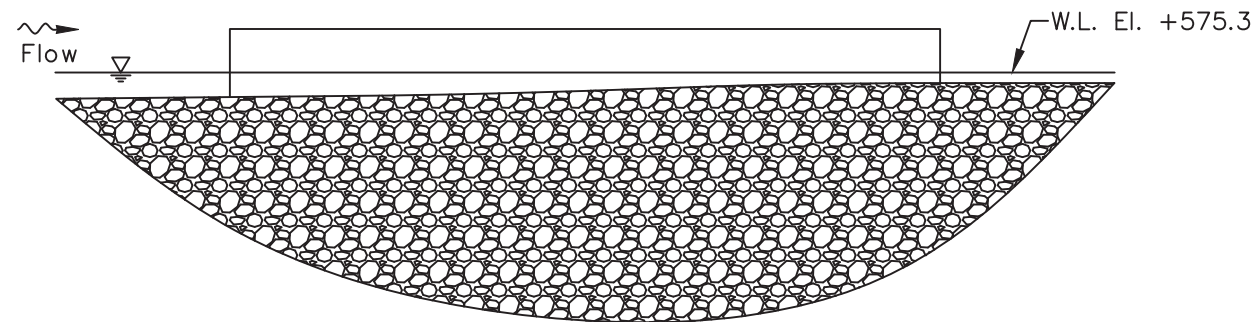
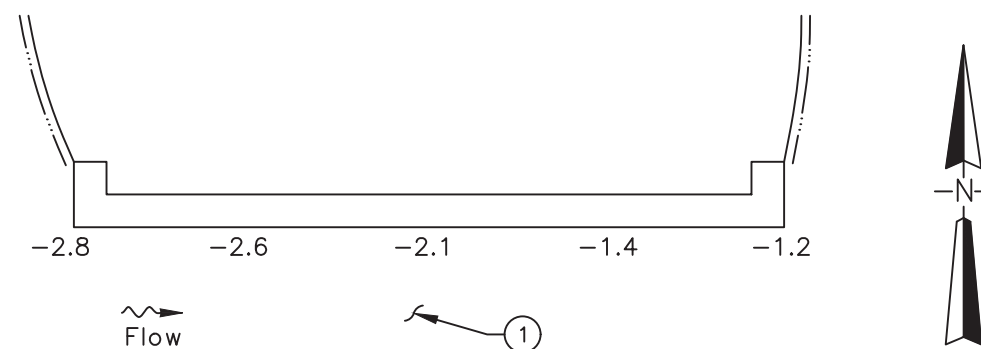
SR-19 OVER TOUSSAINT RIVER
 STRUCTURE NO. 6200931 (OTT-19-0811)
 ABUT 2
 OTTAWA COUNTY, OHIO

The channel bottom material consisted of riprap up to 18 in. diameter with no probe rod penetration. The submerged portions of the bent were sound and smooth with no defects observed. Refer to Figure 9 in Exhibit 1 for detailed inspection notes of Abutment 2. Refer to Photograph 7 in Exhibit 2 for views of the typical concrete condition at the waterline.

- ① The channel bottom material consisted of rip-rap up to 18 in. diameter with no probe rod penetration.

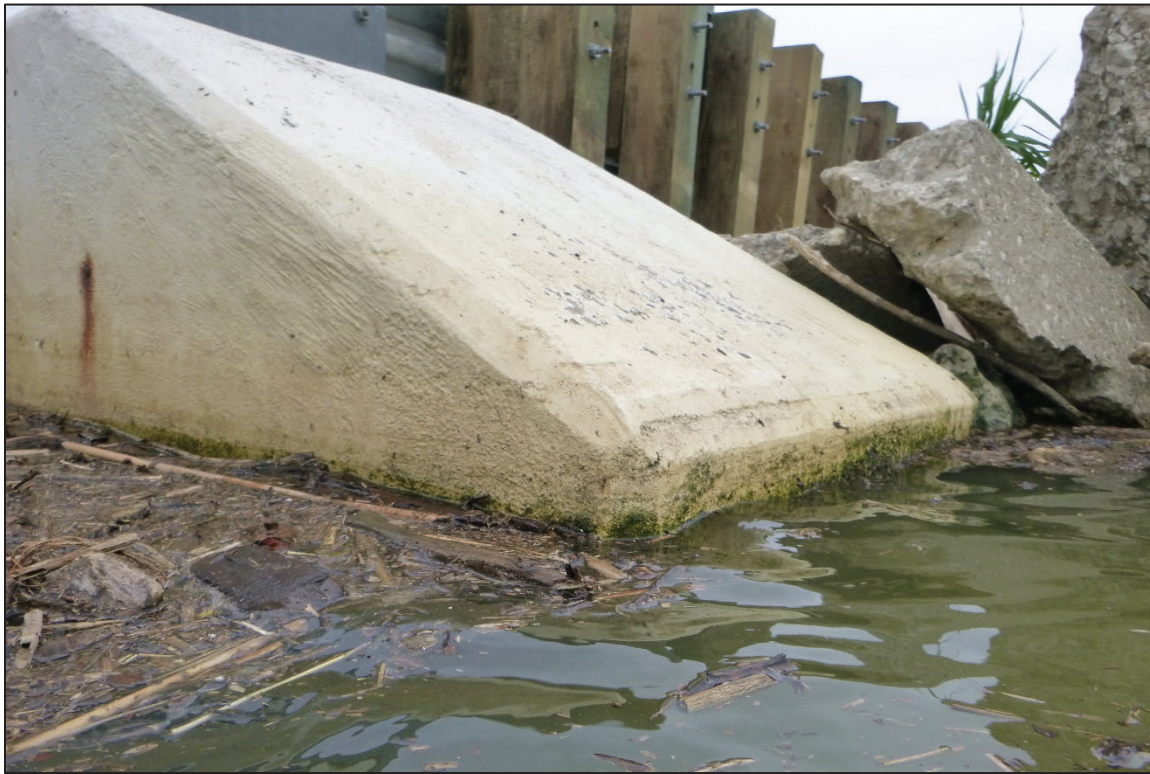
Photograph No. 7: View of the Typical Concrete Condition at the Waterline, Looking Northwest.
